Report on the Examination and Analysis of Mortar Samples from Brick Masonry

*Wayne County Courthouse
Nebraska, USA*

8th May 2018

Our Ref: M/1850/18
Your Ref: Wayne County Courthouse
Doc. Ref: M185018R1

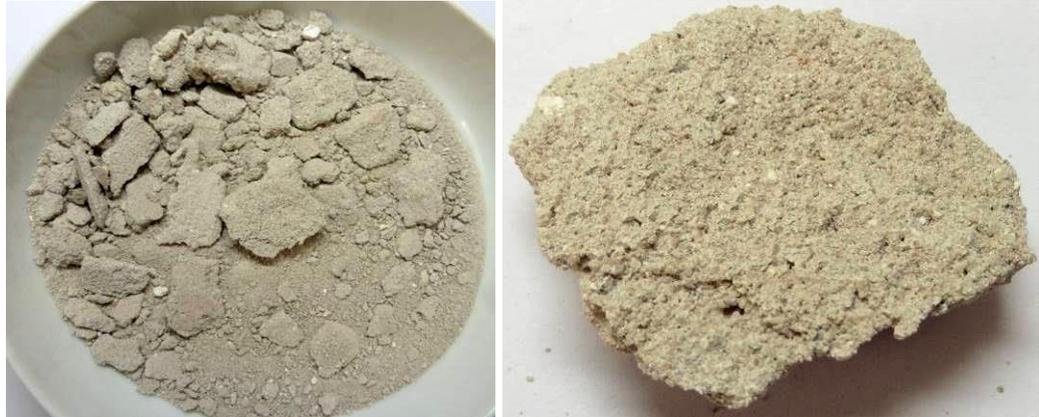
The mortar in this sample is well compacted and well bonded to the brick. Although compact the mortar could be broken down under moderate finger pressure, and once disrupted easily powdered under light finger pressure.

Plates No. 1 & 2: The above left plate shows the sample as received, with the left plate showing the mortar after being removed from the brick, and the right plate a close-up of the surface on the largest intact piece.

Water droplet tests indicated that the mortar had a well-connected pore structure with droplets placed onto freshly fractured surfaces being absorbed and diffused throughout the matrix relatively quickly. However, when placed onto masonry contact surfaces or an outer edge the water droplets were supported for a short period prior to slowly being absorbed. This may infer that either the wall had been treated at some time in the past or that water percolation across the brick/mortar interface had occurred over time with leaching and redeposition of lime within the pore structure, resulting in blockage of surface and near surface pores, which is considered the most likely cause.

On testing a freshly fractured surface of the mortar with a phenolphthalein indicator solution, the mortar was found to be fully carbonated.

Lime inclusions are abundant, with the majority being finer than 1.0mm in size but locally inclusions up to 5.9mm were observed. The inclusions are irregular to sub-angular in shape and appear to have formed from quicklime, rather than putty lime.

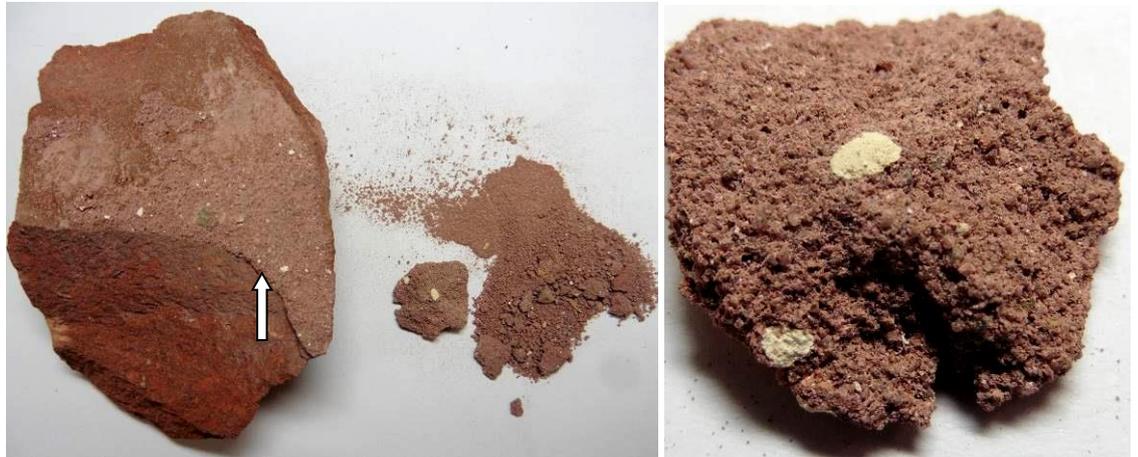
This sample consisted of pieces of a pink coloured mortar, bonded to a piece of brick. The mortar appears to have been well compacted and adhered well to the brick surface. On removal from the brick the mortar was found to be locally very friable, with intact pieces easily powdered under light to moderate finger pressure.

Plates No. 3 & 4: The left plate shows the sample as received, which is mostly of brick with a thin layer of adhering mortar, arrowed in plate. In addition, there were small mortar fragments and powdered fines. The right plate is a close-up of an intact piece of mortar which includes lime inclusions, which range in size from 0.2mm to 3.6mm.

The mortar was found on testing to be fully carbonated and porous, with the rapid absorption of water droplets placed onto fresh surfaces. The mortar also displayed a high entrained air content, which is not uncommon in lime-based mortars.

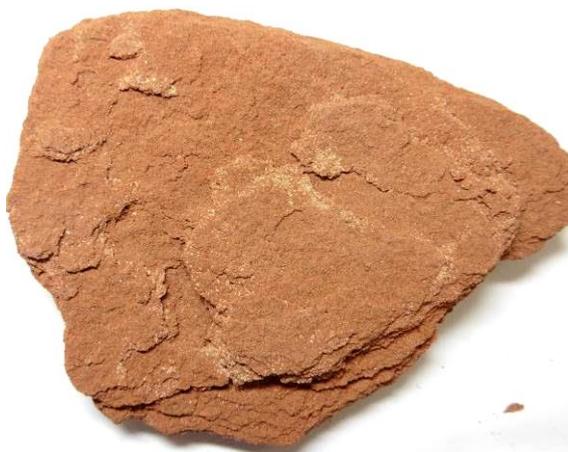
Plate No. 5:

The plate opposite is of the sandstone fragment received, which has the appearance of a fine grained pinkish red sandstone.

The sandstone was found to be 10R 5/6 “Red” in colour, on a freshly fractured surface.

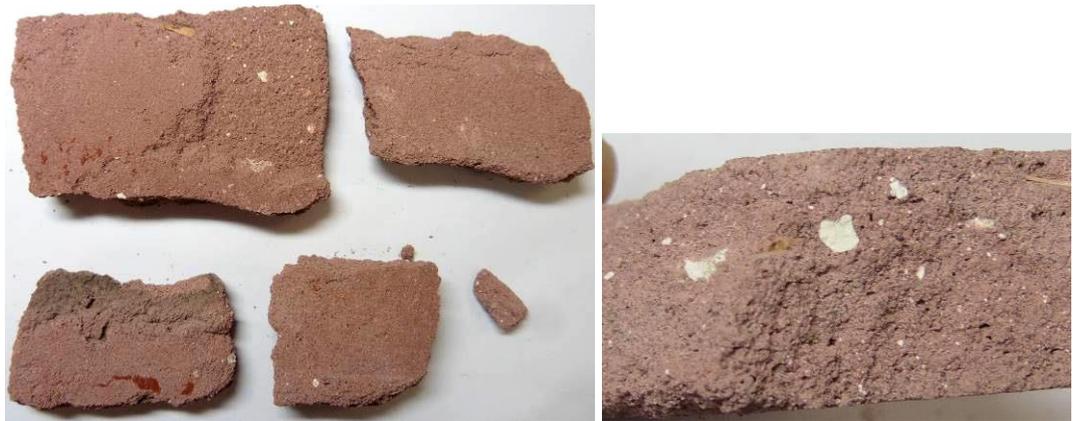
This sample consisted of several intact pieces of brick bedding mortar, the mortar being well compacted, dense and firm. However, the pieces could be broken under moderate finger pressure, and, once disrupted, powdered under light finger pressure.

Plates No. 6 & 7: The left plate shows the intact pieces in the sample, as received. With the right plate showing a close-up of a freshly fractured surface through a mortar fragment. Note the abundance of lime inclusions distributed throughout the section in view.

Spot tests with a phenolphthalein solution indicated that the mortar was fully carbonated. With water droplet tests confirming a well-connected open pore structure, with their rapid absorption, and diffusion throughout the thickness of the mortar sample tested.

The mortar contains an abundance of irregular to sub-angular lime inclusions with these up to 5.2mm in size. The inclusions are similar in shape and texture to those observed in samples S1 and S2 and again appear to have formed from quicklime and locally from balled hydrate.

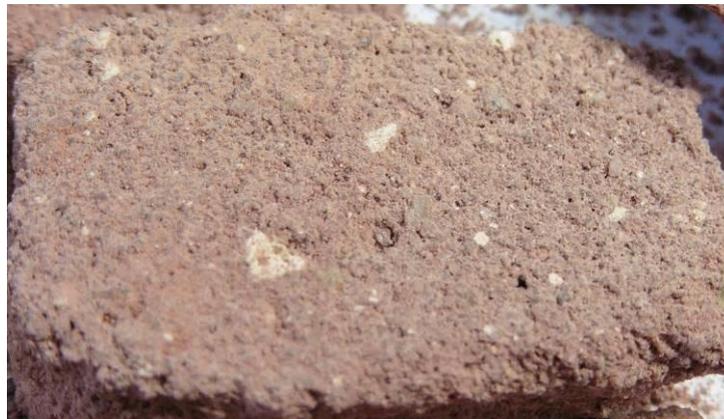
Plate No. 10:

Close-up of a bed face on one of the intact mortar pieces, note the presence of lime inclusions distributed throughout. Inclusions are up to 3.5mm in size.

The mortar was noted to again contain an abundance of small lime inclusions distributed throughout the mortar. Inclusions ranged in size from 0.2mm to 3.5mm, with the inclusions found to range in hardness from soft and powdery to firm, but the firm inclusions could be disrupted and powdered with a point pick under moderate pressure.

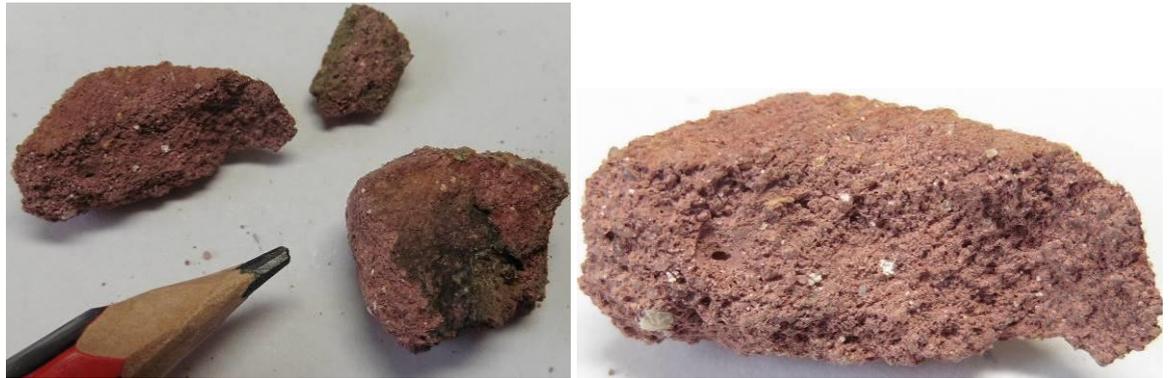
This sample was identified as an “Original” pointing mortar and consisted of three small fragments, that were too small to break with the fingers, but once disrupted could be powdered under light finger pressure. The lime inclusions were smaller than in the other samples examined and are possibly formed from compressed and balled hydrate.

Plates No. 11 & 12: The left plate shows the sample as received, with the pencil point added for scale. The plate on the right is a magnified view of one intact piece, where the dense fabric can be seen along with an abundance of small discrete lime inclusions.

The mortar in this sample was again fully carbonated and on testing with water droplets displayed a high connected pore structure with the rapid absorption of the droplets and diffusion of the water throughout the sample tested.

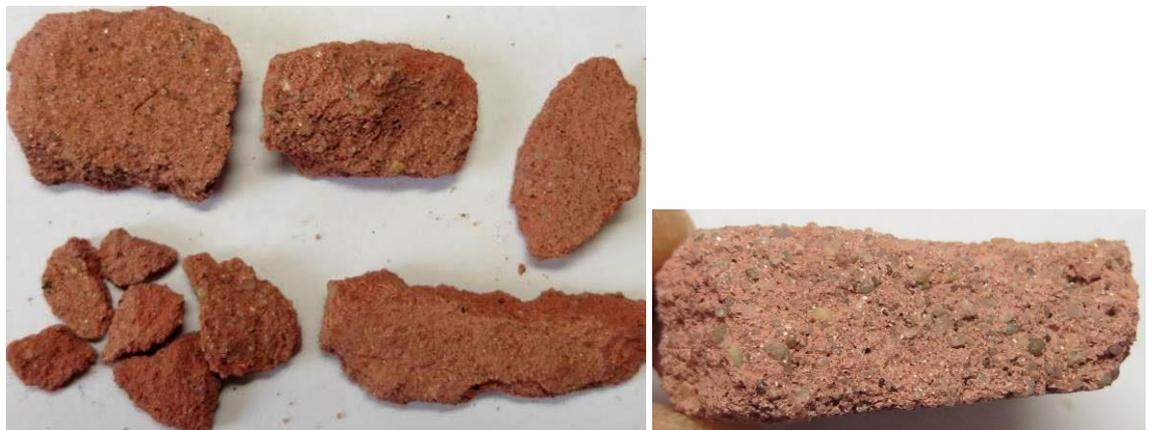
Plates No. 13 & 14: The plate above, left, shows the sample as received, with that on the right showing a close-up of a freshly fractured surface through the thickness of the mortar, note absence of lime inclusions.

The mortar is compact and moderately hard and required moderate to firm finger pressure to break, but once disrupted could be powdered under light finger pressure, with ease. There were no lime inclusions observed in any of the fragments in this sample.

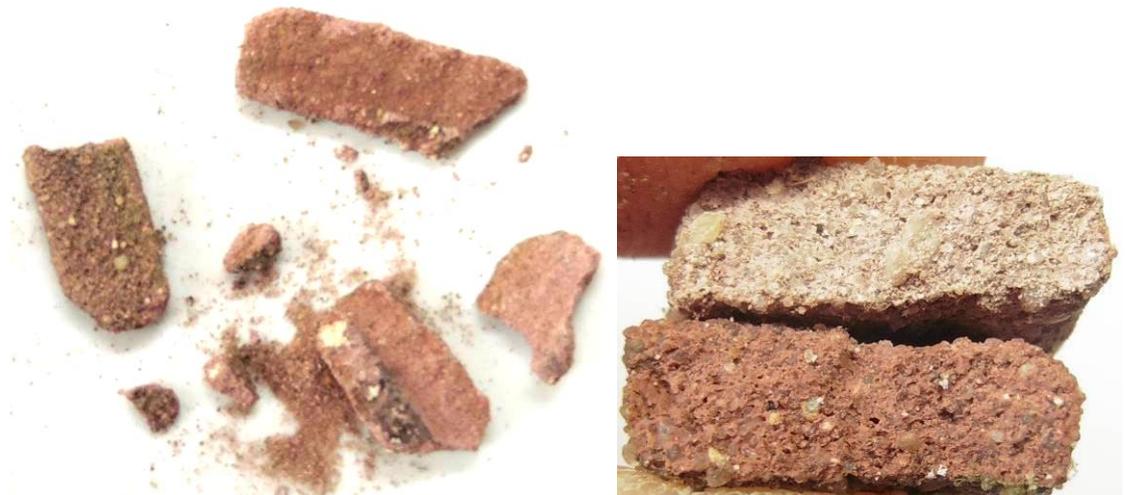
This sample was compact and firm which on breaking was found to break with an audible ‘snap’ but once broken could be powdered with ease. The mortar contained a few small lime inclusions, with the largest being 3.2mm in size.

Plates No. 15 & 16: The left plate is a view of the sample as received, with the right plate showing a magnified view of freshly fractured surfaces through the thickness of the sample. The lower piece had been tested with a phenolphthalein indicator to test for carbonation.

The mortar was found to be fully carbonated and on the basis of a water droplet test was indicated to have a well-connected open porosity.

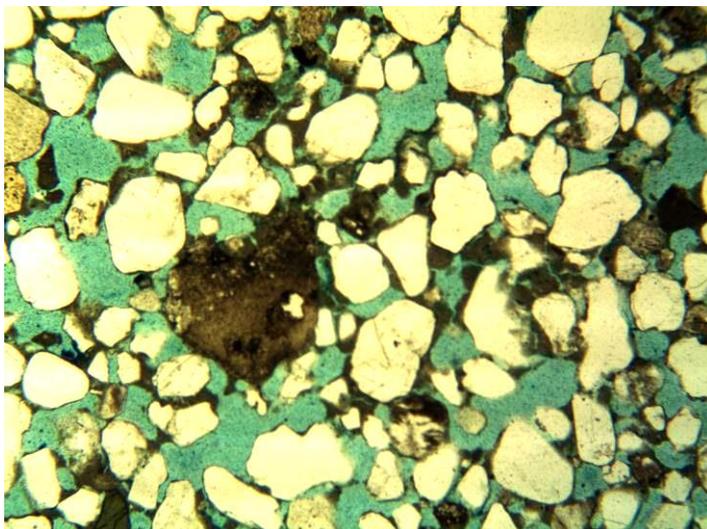
Plate No. 18:

A view in plane polarised light (ppl), of a typical area of the mortar where the highly voided condition of the mortar can be seen, highlighted by pigmented impregnating resin.

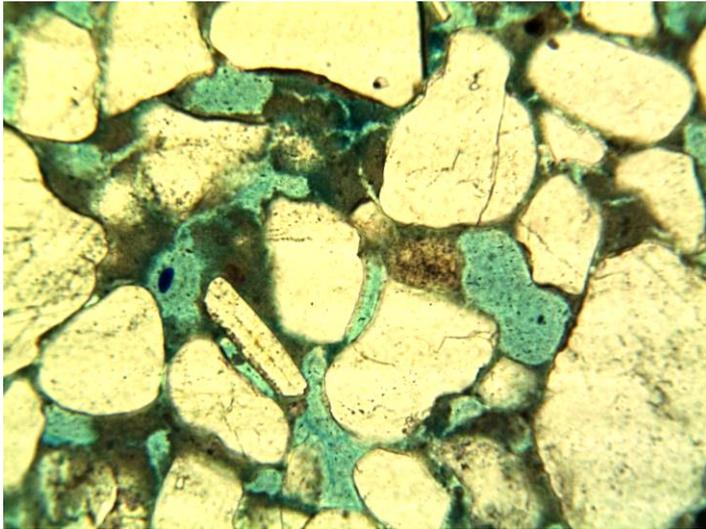
Plate No. 19:

Another view in ppl, of an area of paste containing binder showing a clotted appearance where compressed between sand grains. The aggregates in view are again dominated by quartz, with feldspars and other lithic particles.

A small partially slaked lime inclusion can be seen in the upper centre of the plate, which on examination under high magnification was noted to contain Portlandite, uncarbonated lime. Porosity is highlighted by the blue dyed resin. Field of view 1.2mm.

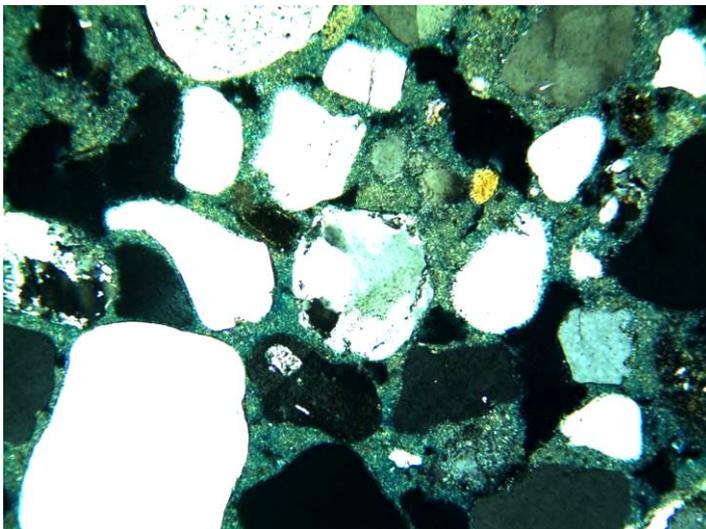
Plate No. 20:

A view in cross polarised light (xpl) of an area of the mortar where the paste is abundant and in this view is fully carbonated.

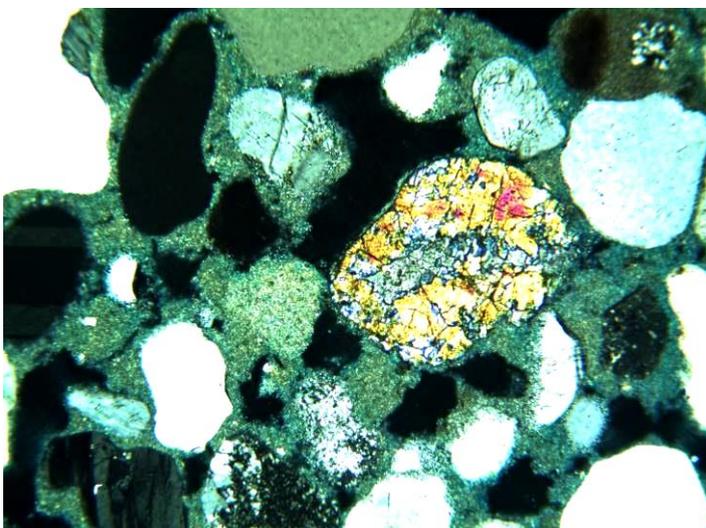
Plate No. 21:

Another view in cross polarised light (xpl) of a more open textured area towards the outer surface of the mortar. The paste is less dense and again fully carbonated. Quartz grains are also apparent, along with feldspar and altered volcanic igneous grains.

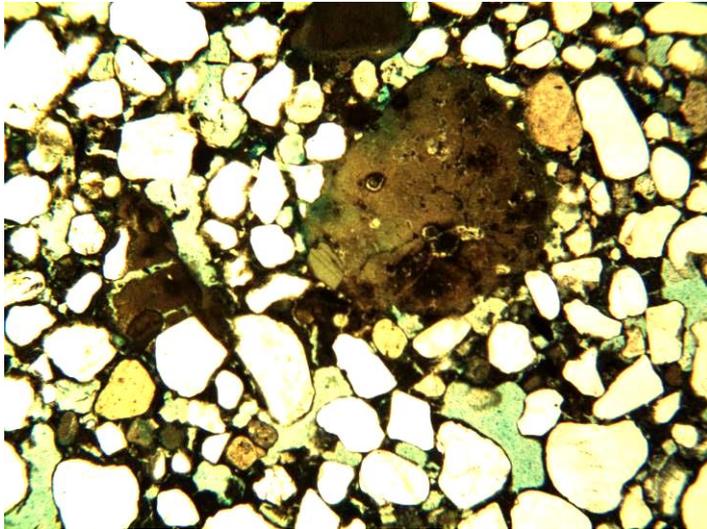
Plate No. 23:

A view in plane polarised light (ppl) showing a typical area of the mortar, with a partially slaked angular lime inclusion, in the centre of the plate, which contains Belite clusters, confirming a hydraulic component in the binder. The aggregates are dominated by quartz in this view, with minor feldspar and igneous fragments.

A high proportion of fine opaque grains are noted distributed throughout the paste, with this the Hematite added as a pigment.

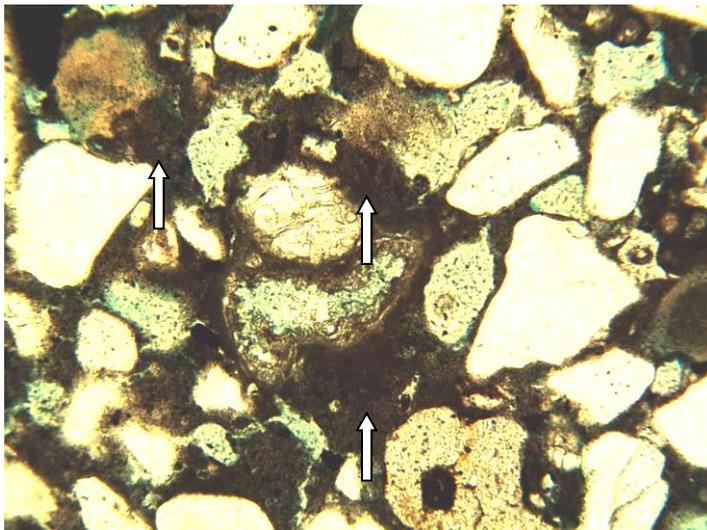
Plate No. 24:

A magnified view of a binder rich area of the mortar. Here the paste appears darker due to the high pigment content.

A partially infilled void can be seen in the centre of the plate, with this containing secondary minerals, gypsum.

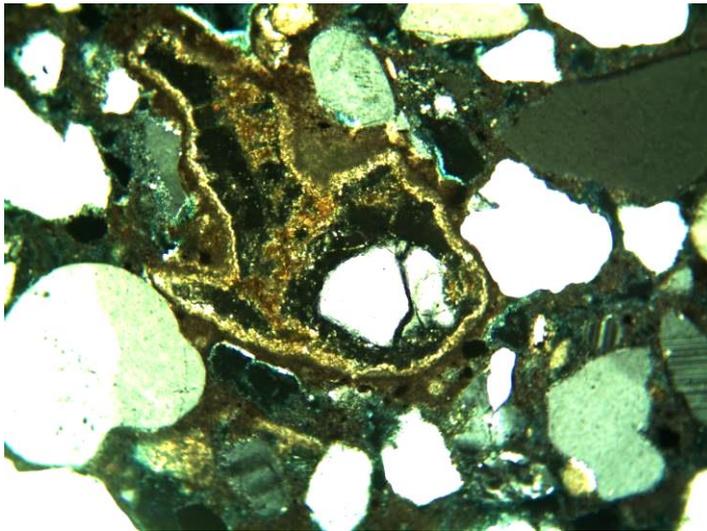
Plate No. 25:

A view in Cross polarised light (xpl), of an area containing a clinker grain, centre of plate, which can be seen to contain quartz grains and other indeterminate minerals. The clinker is surrounded by a fringe of calcite, which also permeates porous zones in the clinker.

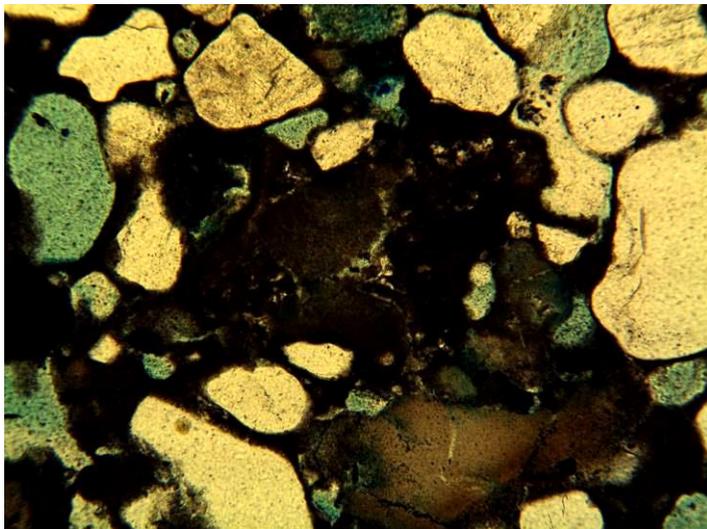
Plate No. 26:

A view in Plane polarised light (ppl), of an area containing two lime inclusions, the upper centre inclusion contains Belite and other clinkered components, whereas that in the lower centre is composed of a non-hydraulic lime.

Belite clusters are also observed within the paste compressed between aggregate grains.

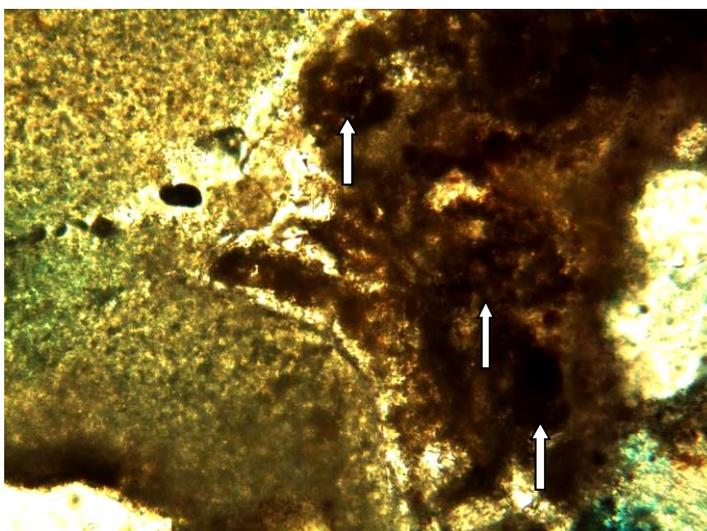
Plate No. 27:

A magnified view in Plane polarised light (ppl), of an area within the edge of the upper lime inclusion in plate No. 26 above.

The paste to the left is fully carbonated and can be seen to be separated from the inclusion by a fine shrinkage crack

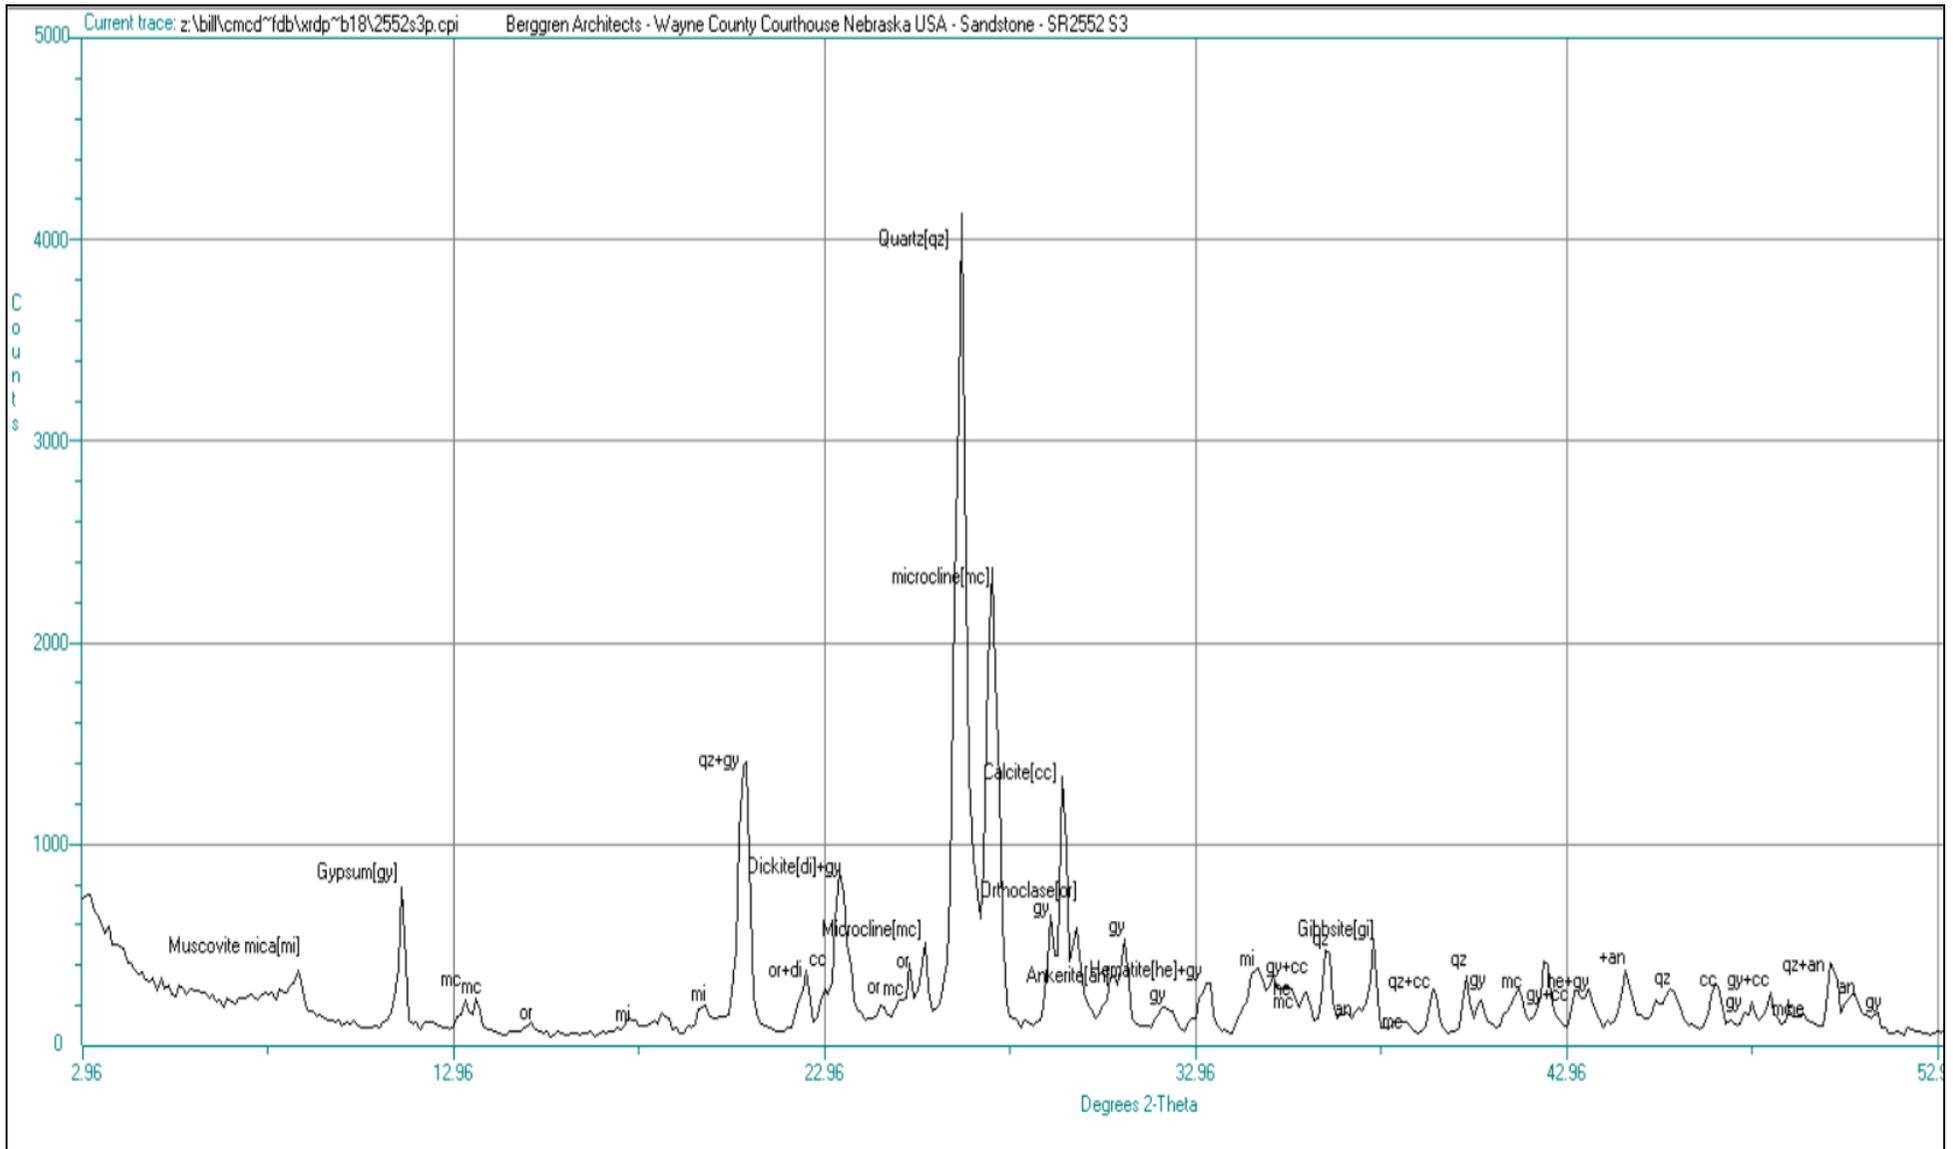
Figure No. 6 – SR2552-S3 – Piece of sandstone spalled from foundation stone masonry.
