Examination and Analysis of Mortar Samples from Stone Masonry Construction

*Vindolanda Roman Fort, Hadrian's Wall
Bardon Mill, Hexham, Northumberland*

Our Ref: M/1745/16
Your Ref: Vindolanda Fort
Doc. Ref: M174516R1

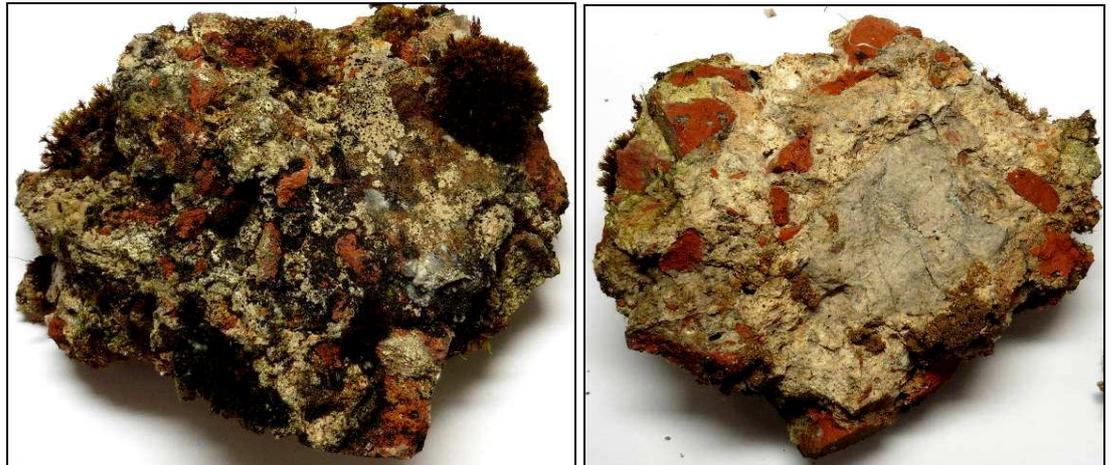
This sample is well compacted and moderately hard to locally hard and the aggregates are well bonded within the matrix of the mortar. The mortar could not be disrupted under firm finger pressure and required a hammer impact to disrupt an intact piece. However once disrupted the mortar could be further broken and aggregates plucked from the paste under firm to persistent finger pressure.

Plates No. 1 & 2: The above plates show the condition of the sample as received in the laboratory, with the left plate showing the outer surface of the mortar, which retained algae and moss adhering to its surface and penetrating into surface connected voids. The presence of the organic growths and surface soiling inferring that this mortar sample was removed from a section of masonry exposed at the surface. The right plate shows the inner masonry contact surface, where large tile/brick fragments along with a large limestone fragment appear to form the main aggregate components.

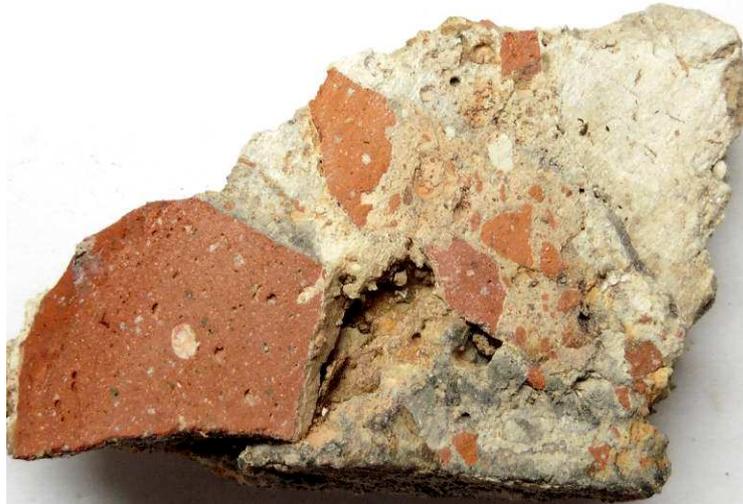
The aggregates are angular to sub-angular in shape, and dominated by clay tile fragments and limestone with a low proportion of quartz in the fine fractions. There is also an abundance of burnt fragments and fine particles of tile or pottery within the paste, perhaps suggesting the addition of a ground tile and ash as a pozzolan.

Plate No. 3: The image opposite shows a sawn surface cut through the thickness of the largest intact piece of the mortar, where again it can be seen that the dominant aggregate in the sample is crushed clay tile/brick and limestone, see upper right.

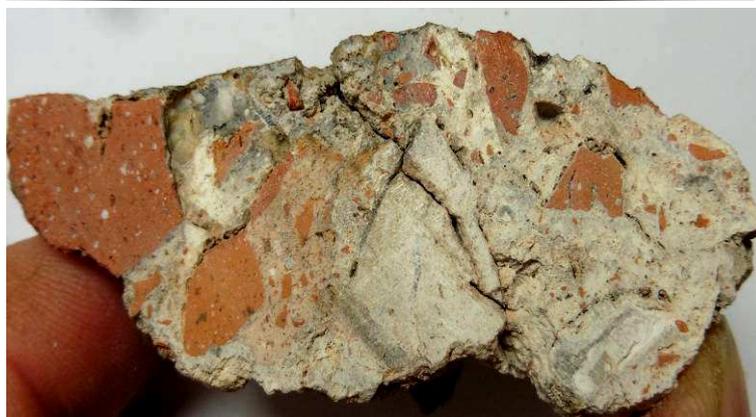
Plate No. 4: The image on the left shows the piece of the mortar from which the petrographic thin section was prepared.

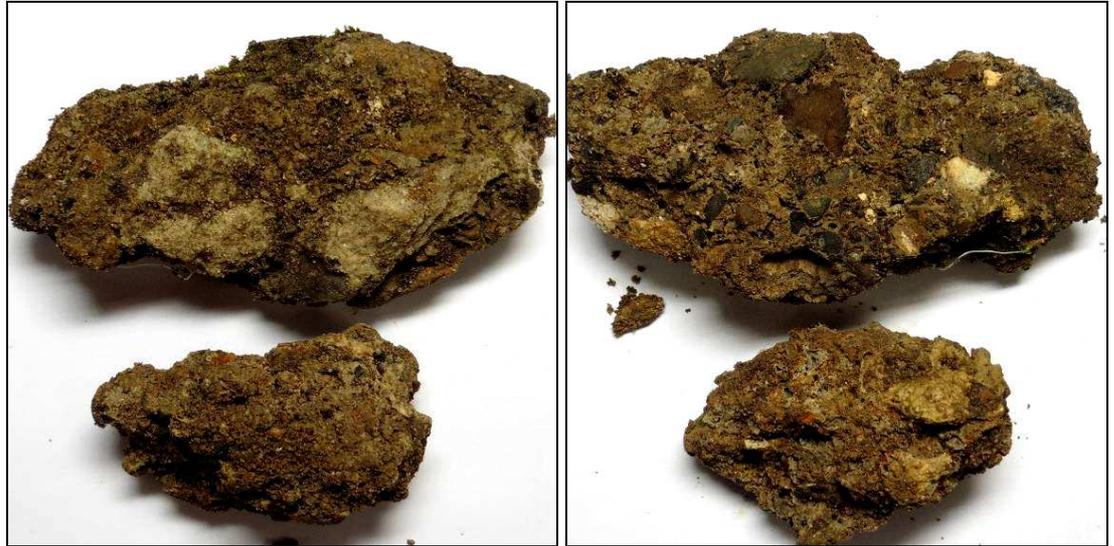
This sample was from a heavily weathered piece of mortar, which was found on examination to be easily disrupted under light to moderate finger pressure.

Plates No. 5 & 6: The left plate shows the sample, as received, with the sample orientated to show what appears to be an outer surface which retained soiling and organic growths. The plate on the right is of what appears to be an inner, fractured, surface where the mortar although discoloured by alteration and soiling due to weathering, does not support any organic colonisation.

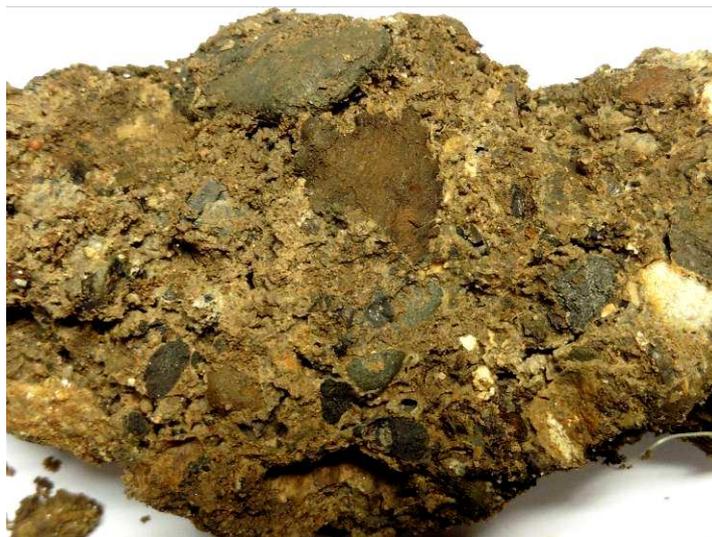
Plate No. 7: Close-up of the weathered inner fractured surface of the sample as received showing the condition of the matrix and the aggregates.

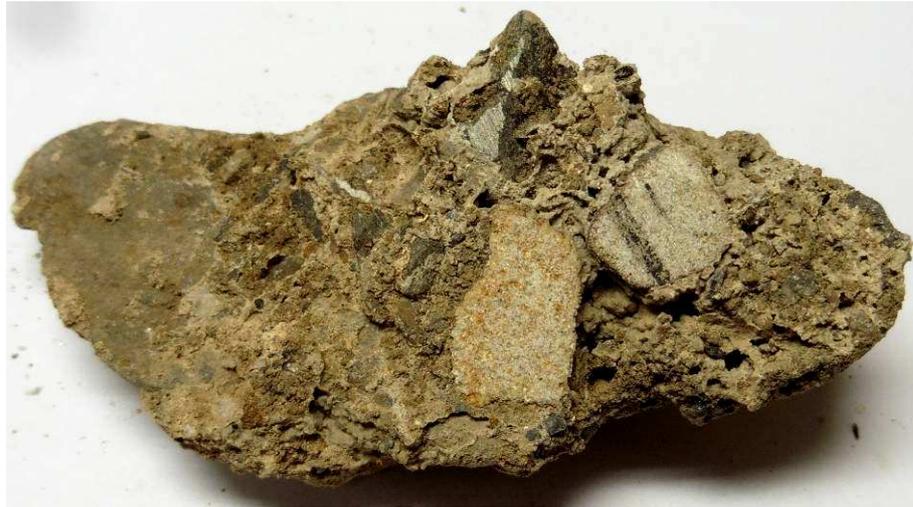
Plate No. 8: A magnified view of a sawn surface cut through the thickness of the largest piece of mortar for thin section preparation. However, the matrix was sufficiently friable for material in contact with the blade to be lost during cutting, and therefore the entire piece was impregnated with a resin, to consolidate the sample, prior to another cut being taken for petrographic thin section preparation.

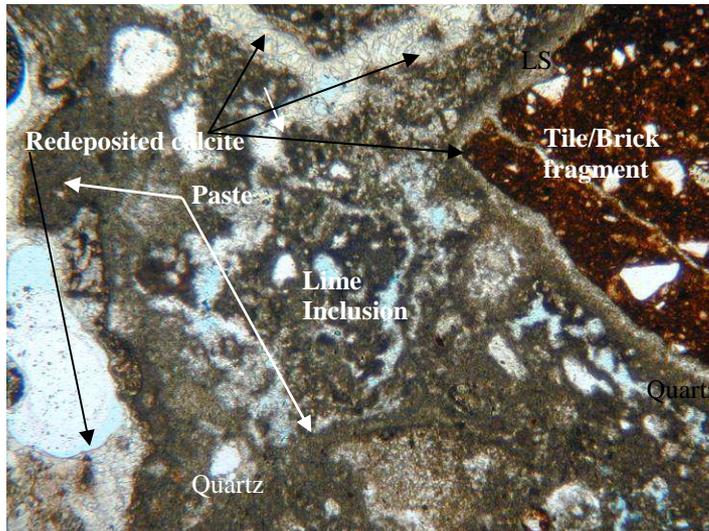
Plate No. 9:

A view in plane polarised light (ppl) showing a typical area of the mortar paste and the aggregate distribution. Aggregates are dominated by crushed clay Tile/Brick fragments in this view. The paste is relatively dense and uniform and is coloured light to dark grey in this plate. The paste is transected by a number of fine shrinkage cracks which are infilled with redeposited calcite. An area of high microporosity surrounds a partially disrupted lime inclusion in the centre of the plate. Porosity is highlighted by the blue dyed resin. Field of view 2.4mm.

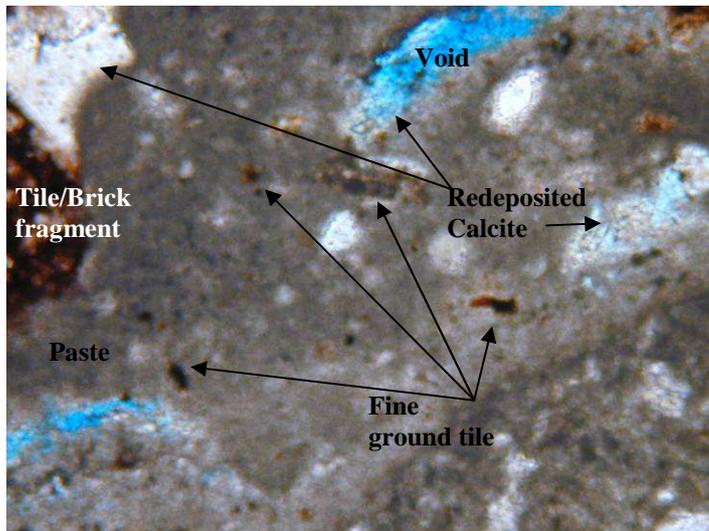
Plate No. 10:

Another view in ppl. A magnified view in plane polarised light, this image shows fine fragments of ground clay tile/brick distributed through the paste, some are diffuse in appearance, possibly indicating a reaction with the lime. The paste in this view is mostly dense with minor shrinkage cracks which show varying degrees of suturing with redeposited calcite. A fragment of clay tile/brick can be seen on the left side of the plate. Porosity is highlighted by the blue dyed resin. Field of view 1.2mm.

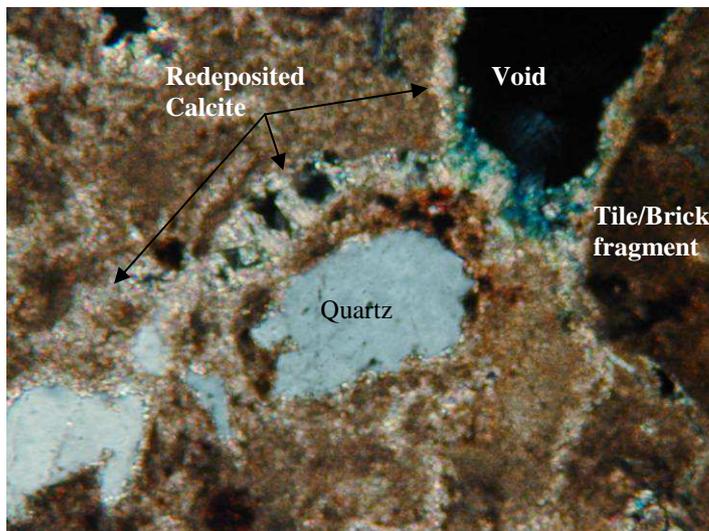
Plate No. 11:

Another magnified view in cross polarised light (xpl). This image shows an area of paste towards the edge of the sample where there is an abundance of reprecipitated calcite suturing and healing crack paths. The surrounding paste is compact and although there is no evidence of any clinker components, there are a few grains of ground tile/brick apparent (reddish brown in colour), some of which have diffuse margins. Porosity, voids and the blue dyed resin all appear dark in cross polarised light. Field of view 1.2mm.

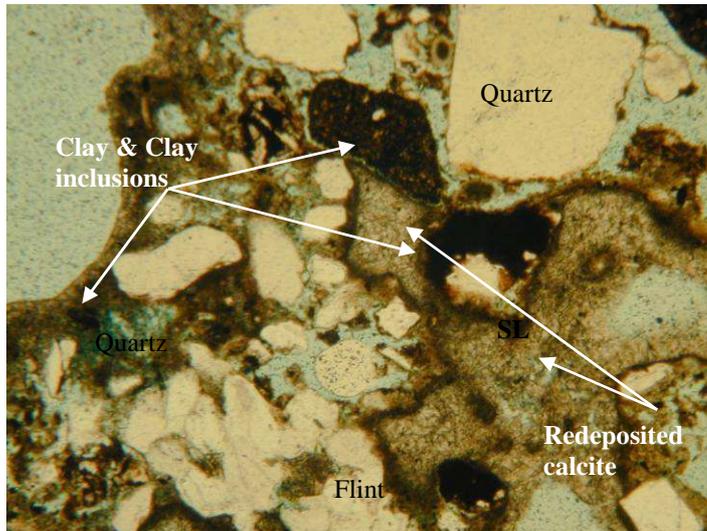
Plate No. 12:

A view in plane polarised light (ppl) showing a typical area of the mortar paste and the aggregate distribution. Aggregates are dominated by Quartz in this view, with quartzite and a limestone fragment. The paste is locally dense, where compressed between sand grains, left side of plate. Mostly the centre and right side of the plate show an area where the paste is depleted and replaced by redeposited calcite.

Porosity is highlighted by the blue dyed resin. Field of view 2.4mm.

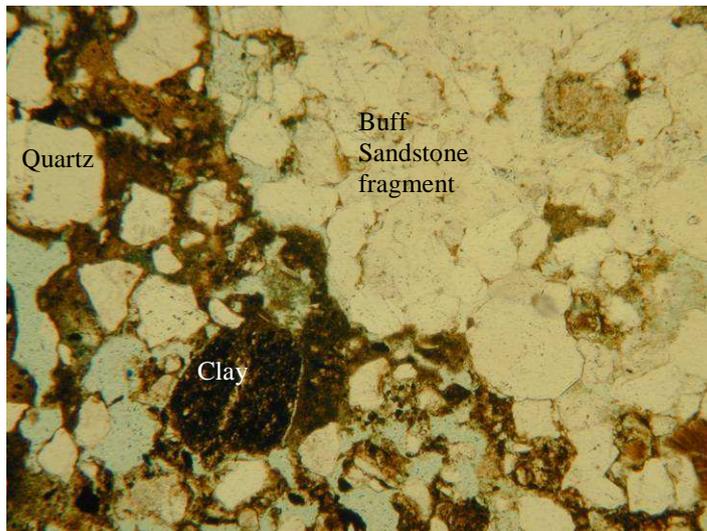
Plate No. 13:

Another view in ppl. This area is dominated by a large sandstone fragment, centre to right of the plate. The sandstone is a buff to white sandstone which contains clay, mica and iron oxide/hydroxide. It can be seen that the paste is well bonded to the sandstone at this location, with the paste discoloured by, and containing, an abundance of clay. Minor cracking can be seen, and where this occur they are sutured by fine fringes of calcite.

Porosity is highlighted by the blue dyed resin. Field of view 2.4mm.

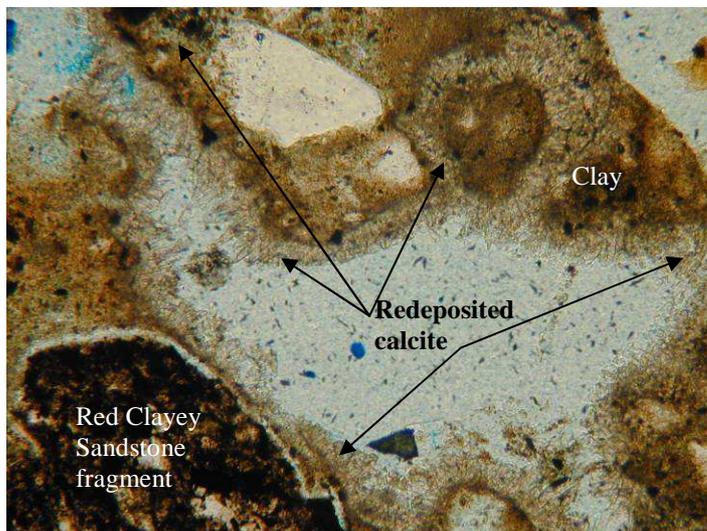
Plate No. 14:

Voids were abundant and it is likely given their abundance, shape and size that the mix has been affected by a significant degree of binder depletion and redeposition, suggesting prolonged periods of water percolation through the binder. It is also possible, given the void distribution and presence of channel ways, that the mortar was placed in a particularly wet (over workable) condition. The voids are typical of entrapped air and water voids and are typically irregular to sub-round in shape and up to 12mm in size. The voids are mostly lined or infilled with fringes of fine to coarse reprecipitated calcite crystals.

A magnified view in plane polarised light, this image shows a heavily voided area of the mortar, where aggregate grains are held within a patchy paste framework and welded together by fringes of coarse calcite crystals.

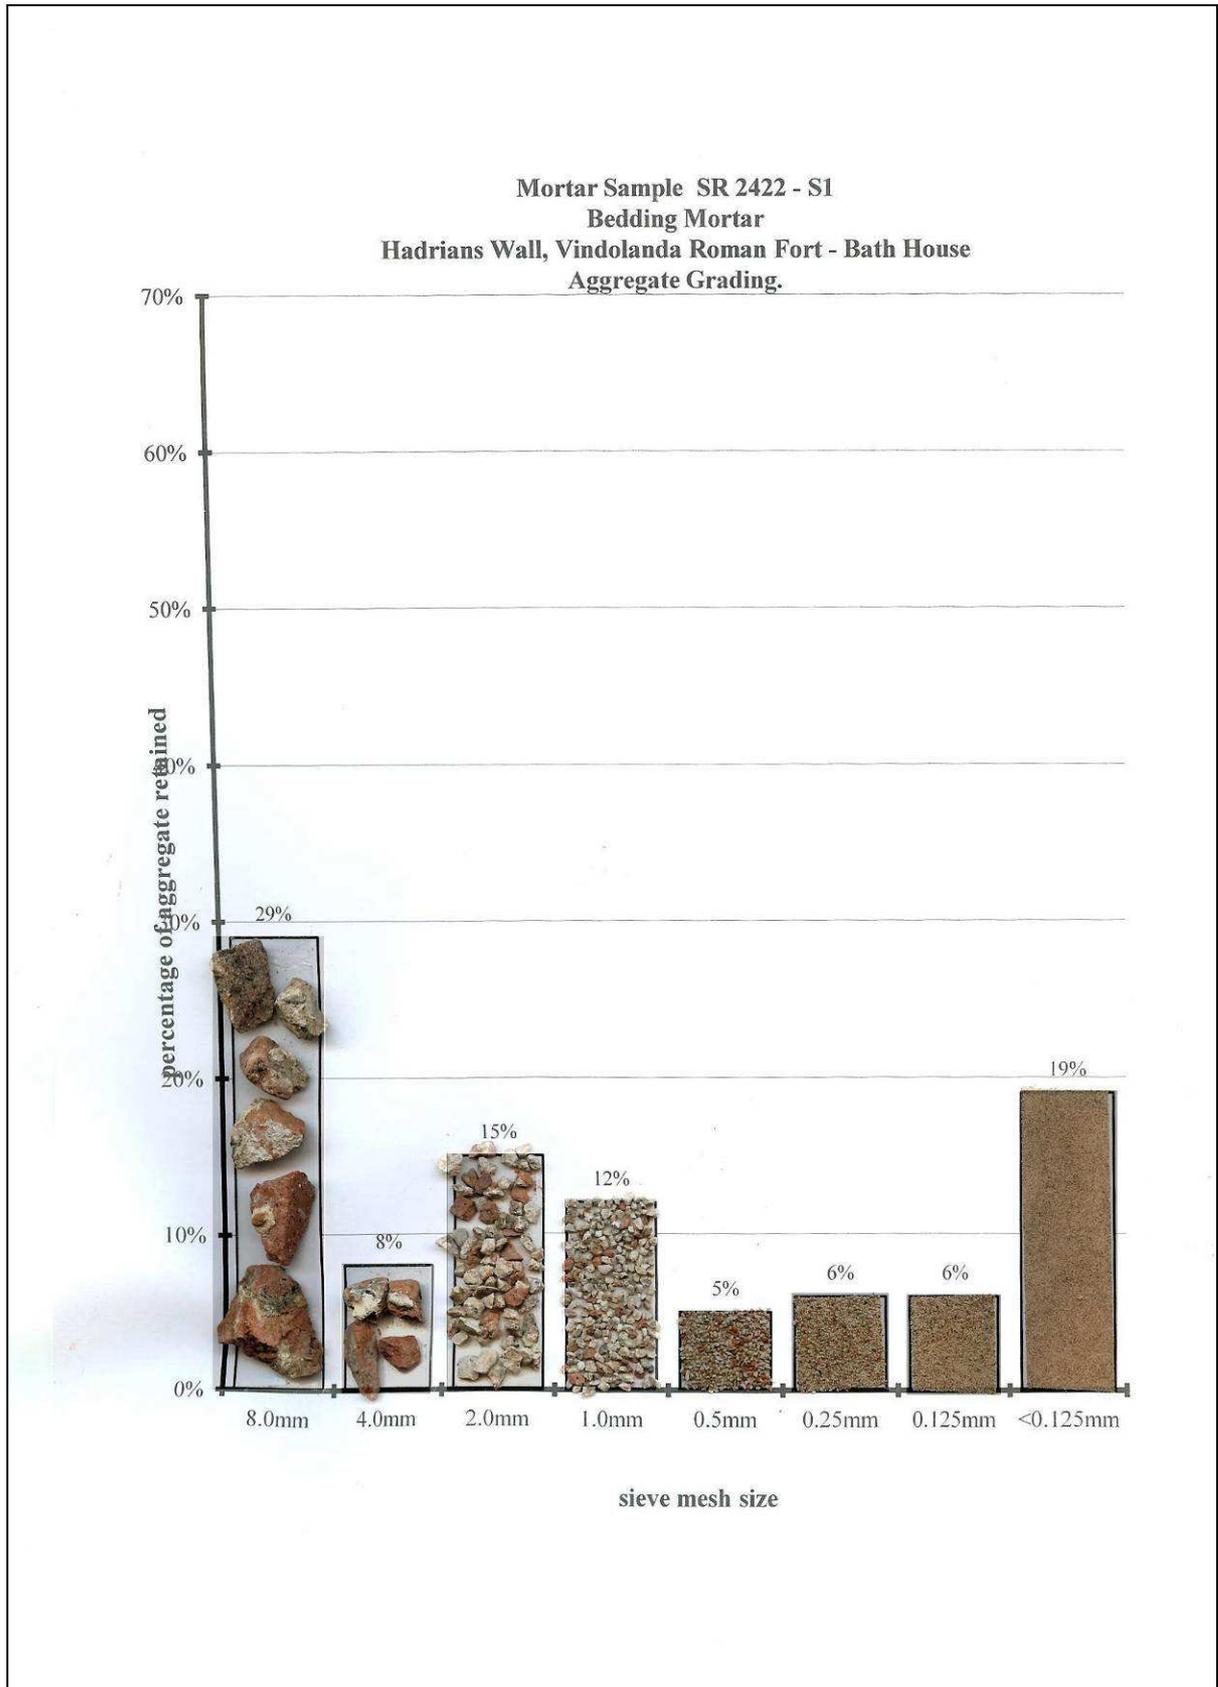
Figure No. 1 – SR2422 S1 – Recovered Aggregate – Particle Size Distribution

The aggregate particles greater than 4mm are predominantly of sub-angular pieces of broken clay tile/brick, with between 4mm and 0.5mm the grains are comprised of crushed limestone fragments, and fine tile/brick fragments, whereas below 0.5mm the aggregates are dominated by sub-rounded quartz grains with fine clay tile/brick fragments and a trace proportion of indeterminate lithic fragments. The fines in the aggregate appear to be from a natural quartz rich sand, which display water worn surfaces and this may therefore have been obtained from a river or river terrace source

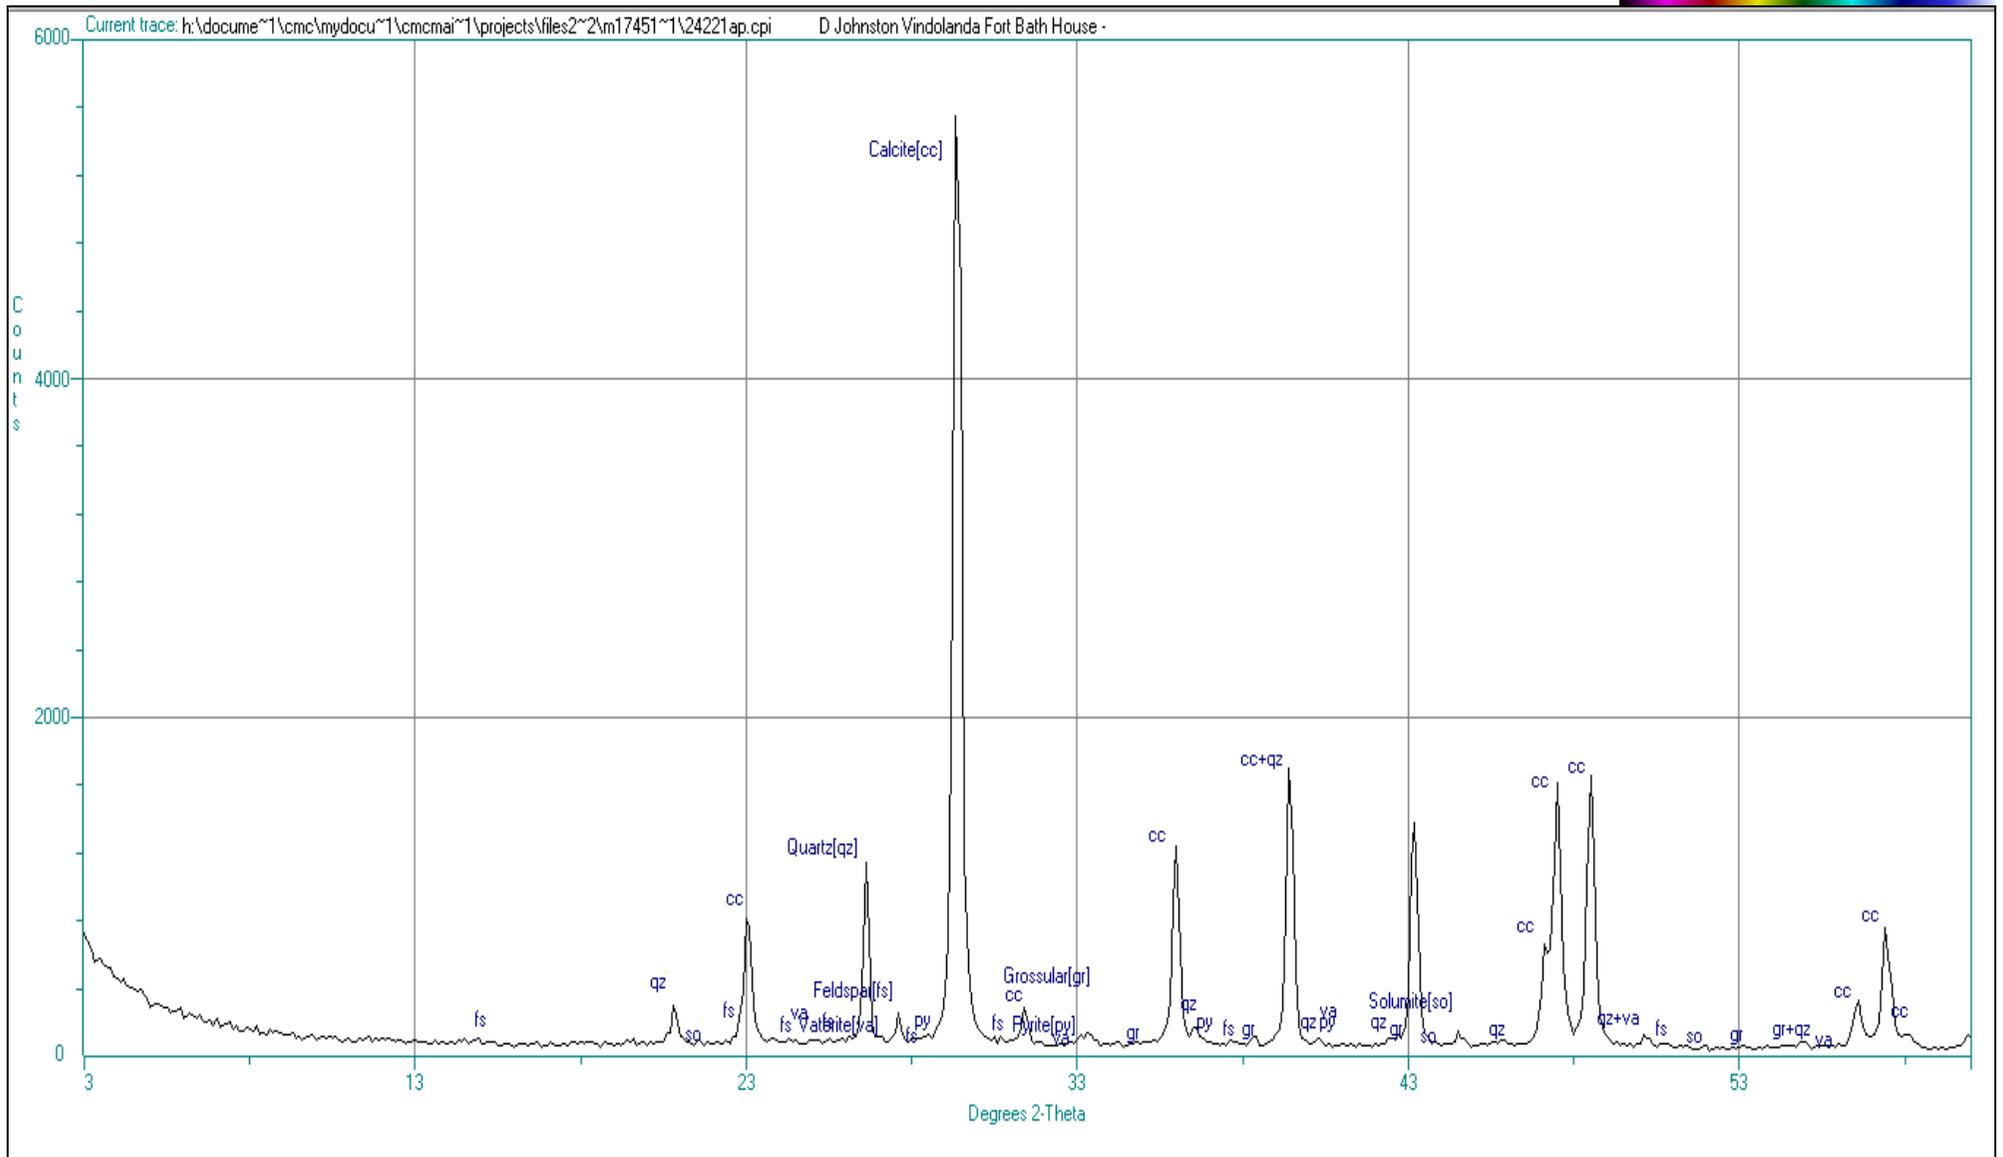
Figure No. 3 – SR2422 S1 – Pre-Hadrian - 100AD, Bath House, matrix sample,

From the mineralogical composition of the mortar in sample S1, and from the lime inclusion picked from the same sampled, it can be confirmed that the lime used was a high calcium air lime, which contained no hydraulic components. A further XRD analysis carried out on a piece of limestone present as an aggregate also confirmed that this was dominated by calcite with trace proportions of aragonite (probably from the shell within the limestone) along with dolomite, from alteration veins within the rock. It may, therefore, be suggested that the limestone aggregate encapsulated within the mortar was from the same source as the limestone used to produce the binder.

The presence of both AFm and c-s-h phases, albeit in trace proportions in the sample of concentrated fines from the matrix in sample S1, would infer that there has been a reaction between the ground clay tile and ash/clinker, in the fines, with the lime of the binder, with this producing the strength and durability apparent in this sample of mortar.

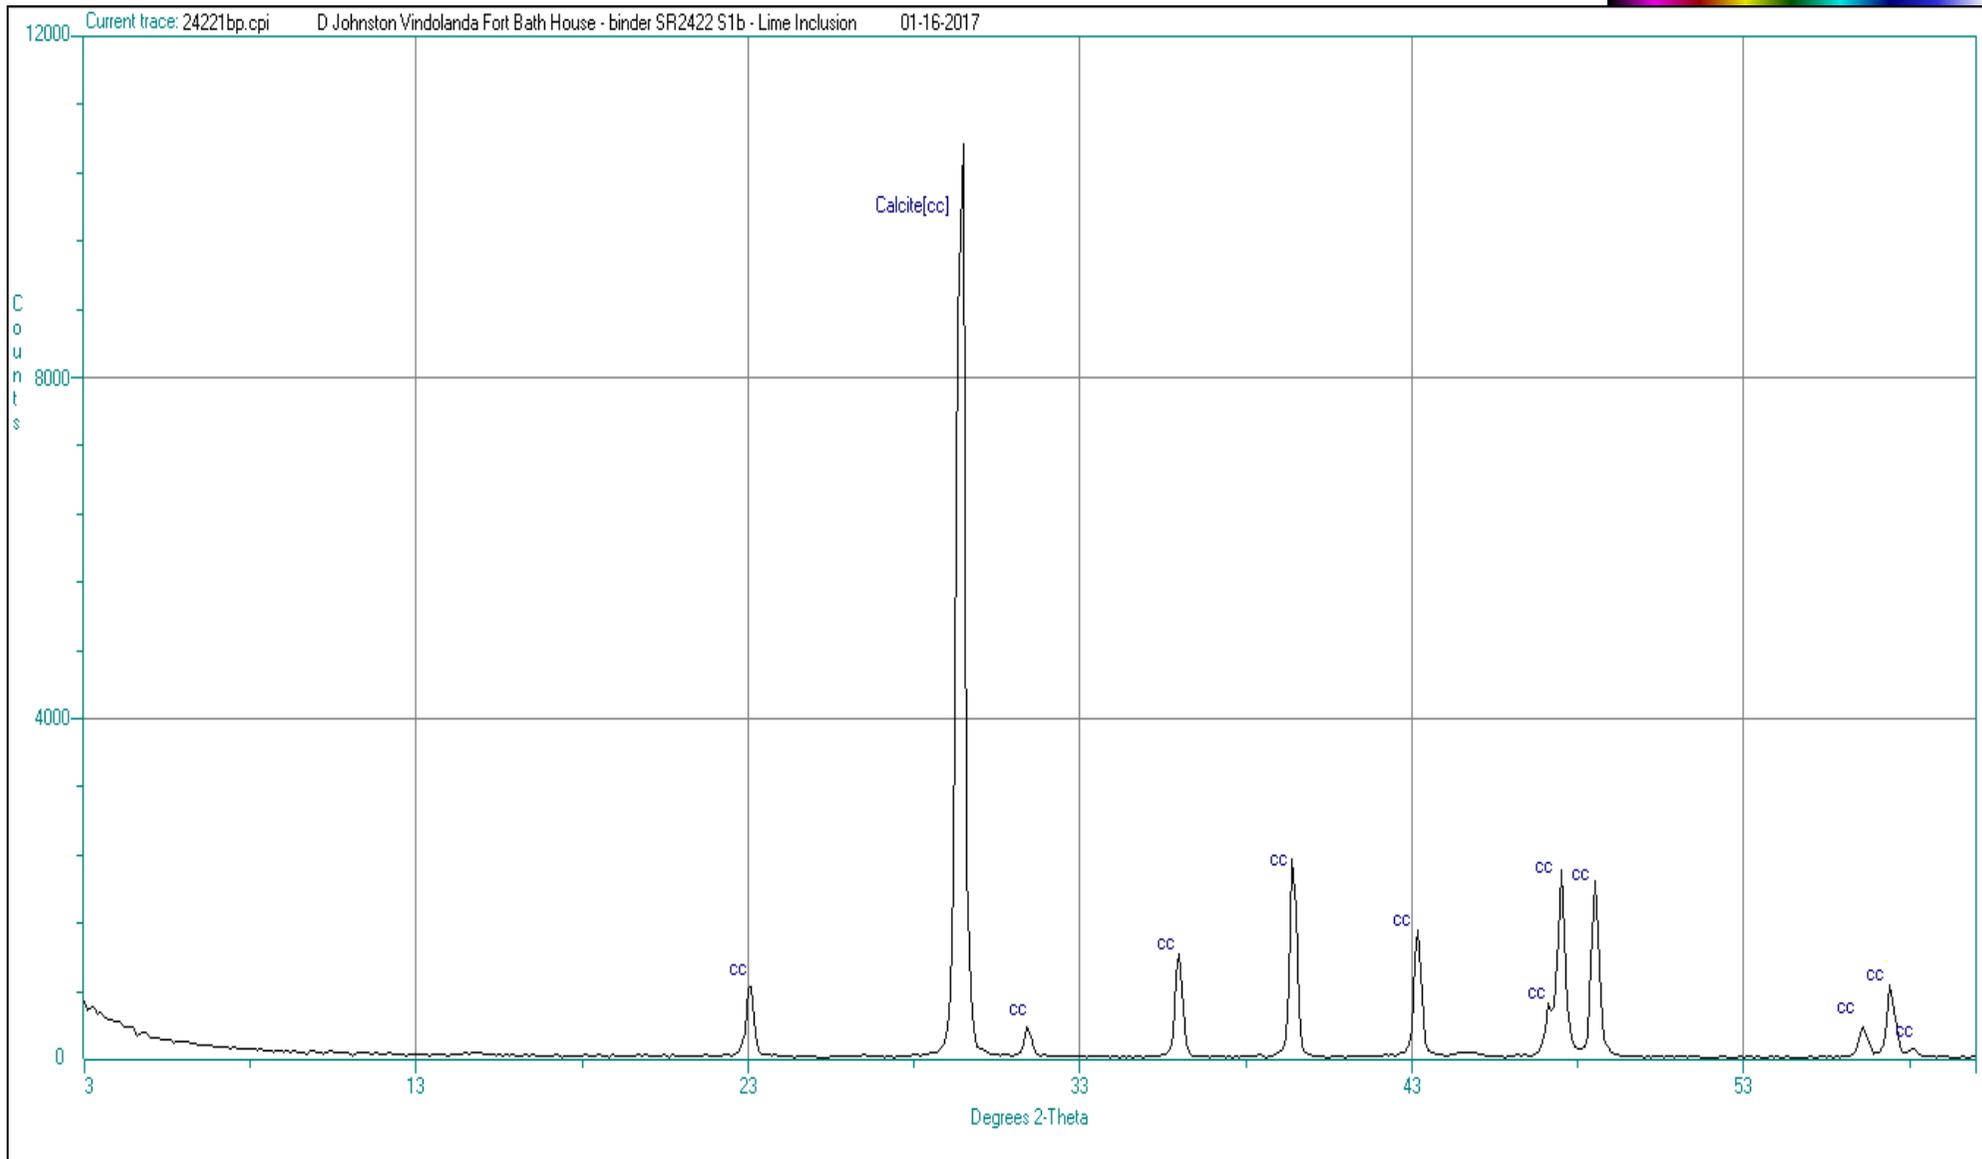
Figure No. 4 – SR2422 S1 – Pre-Hadrian - 100AD, Bath House, inclusion sample,

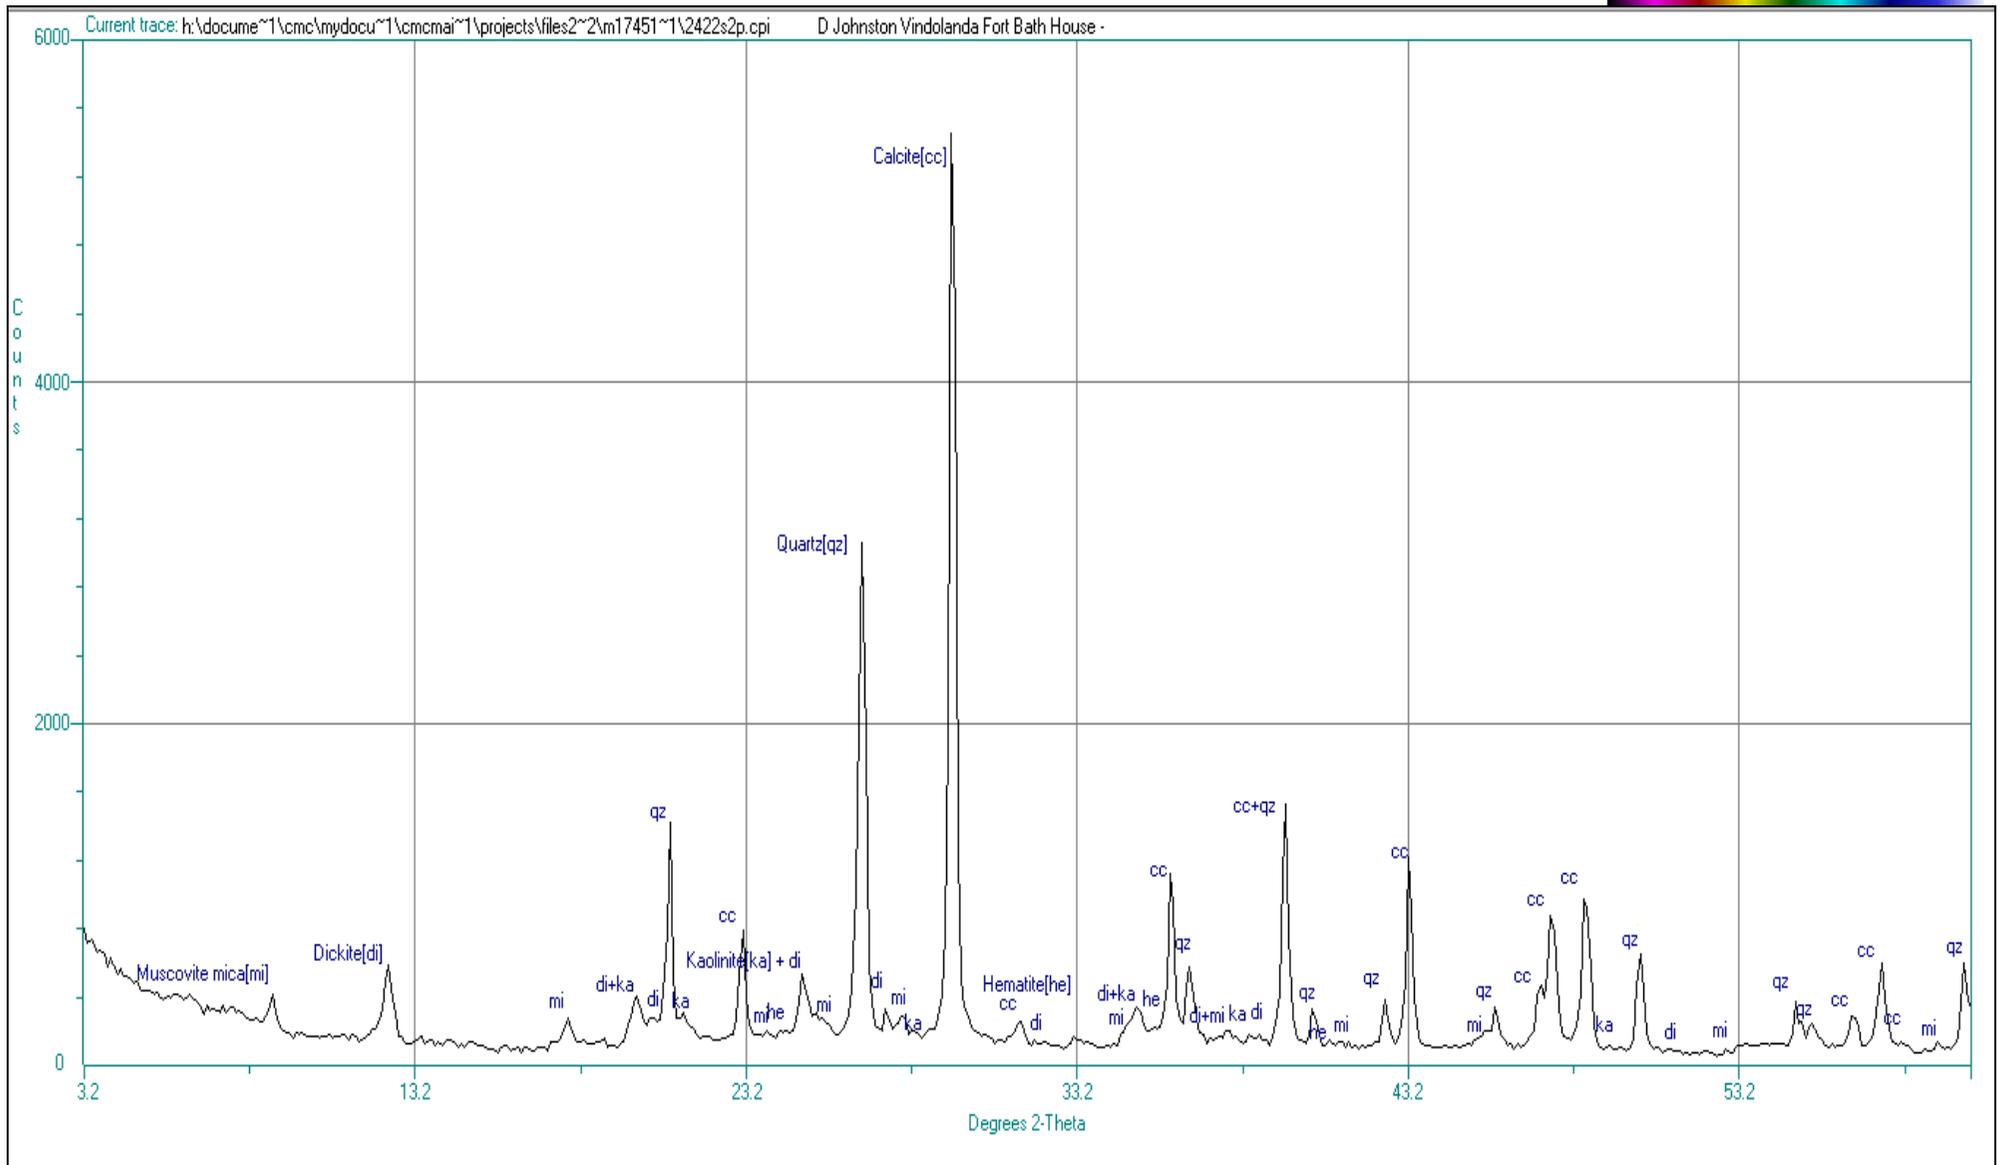
Figure No. 5 – SR2422 S2 – Fort Walls - 213AD, Rampart Backing, matrix sample.

The binder in sample S2 is again a high calcium lime with no hydraulic components detected in the mortar analysed. However, in this sample there were no pozzolanic materials detected with only common aggregate components observed, which were noted to contain a significant proportion of clay minerals. It may therefore be concluded, that in the absence of tile/brick fragments and ground tile (burnt clay) within the fines that this mortar was made using a non-hydraulic lime and an as-dug sand which contained a proportion of clay, or alternatively a proportion of clay had been added to the mortar, perhaps to increase its cohesiveness.

The hematite detected in this sample, may be from the decay of red sandstone, or pyrite, or other iron rich minerals included in the mortar, within the aggregates.
