The Archaeology and Conservation
of the
East Front of York Minster

Volume 2 of 2
Figures, Drawings and Appendices

Alexander B Holton

University of York

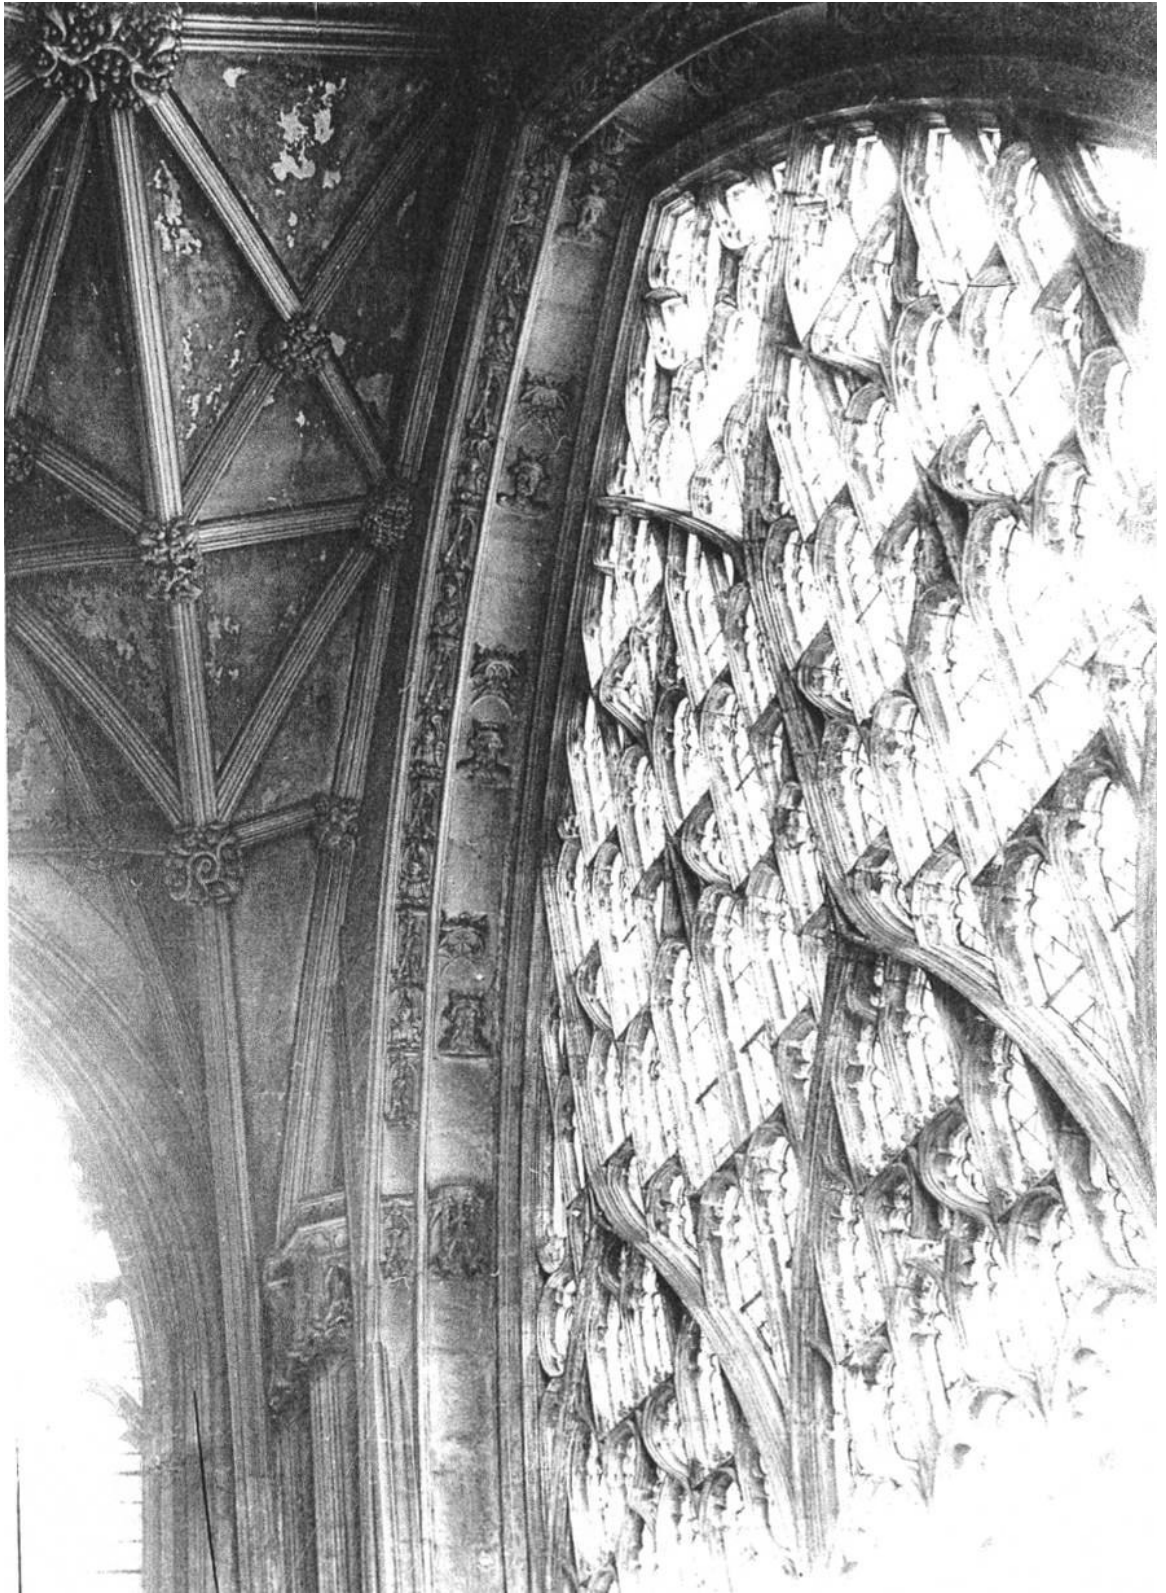
Figure 85: Sill carvings beneath Great East Window showing dark sulphation and structural cracking (Feilden 1976, 89)

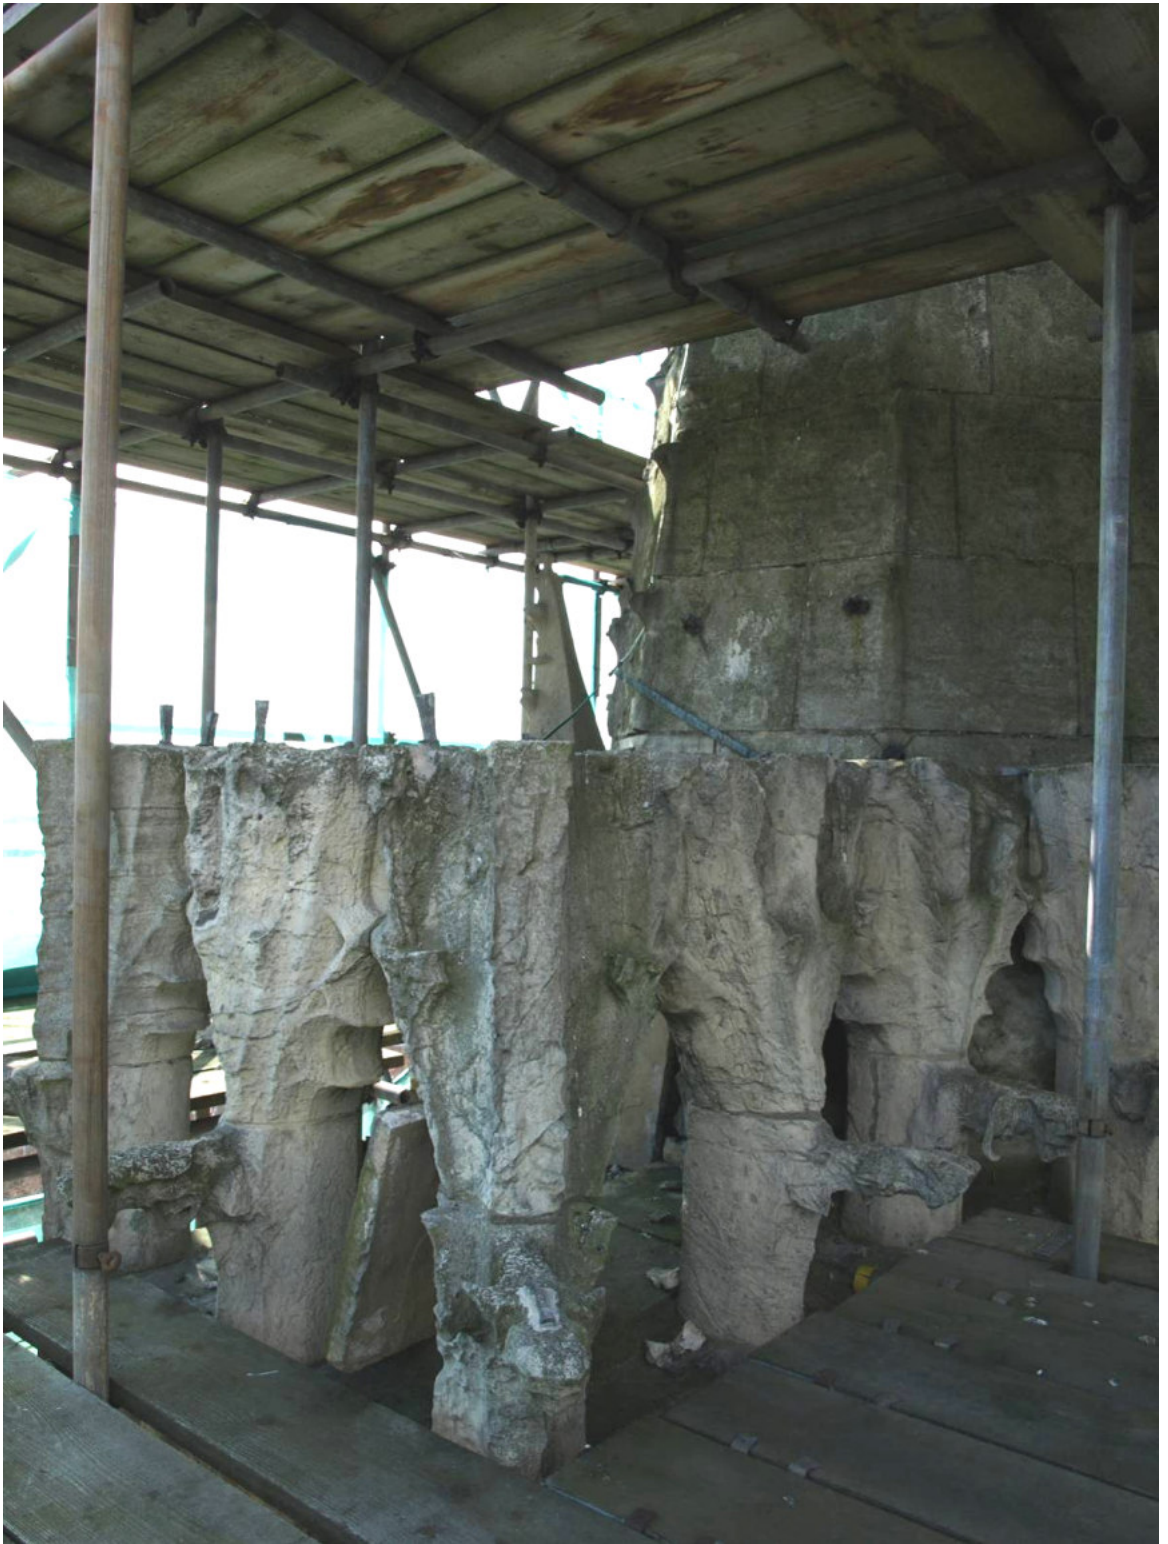
Figure 277: Roof space, Thoresby's east end; interior face of East Front illustrating fire damage adjacent to nineteenth-century replacement ashlar

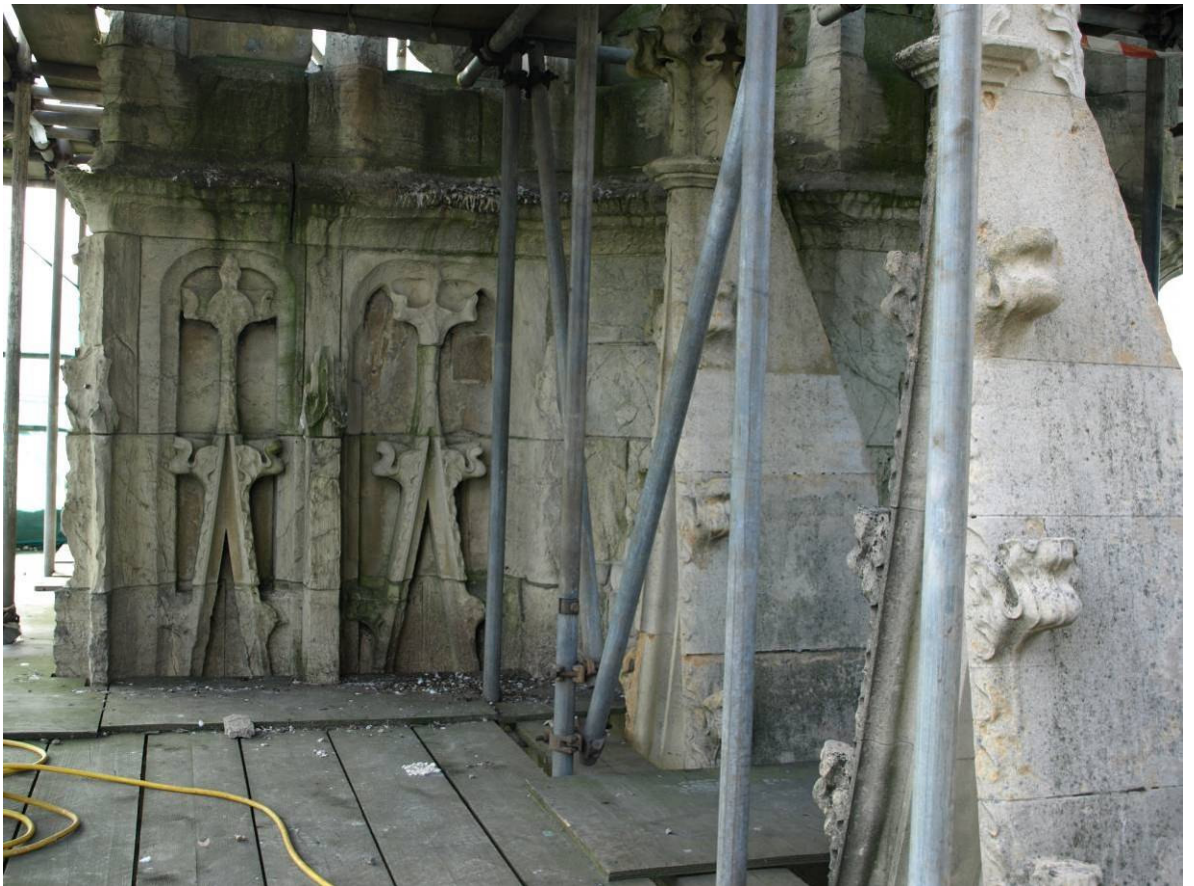
Figure 293: East Front, upper section of south buttress before repair, Level F (north face)

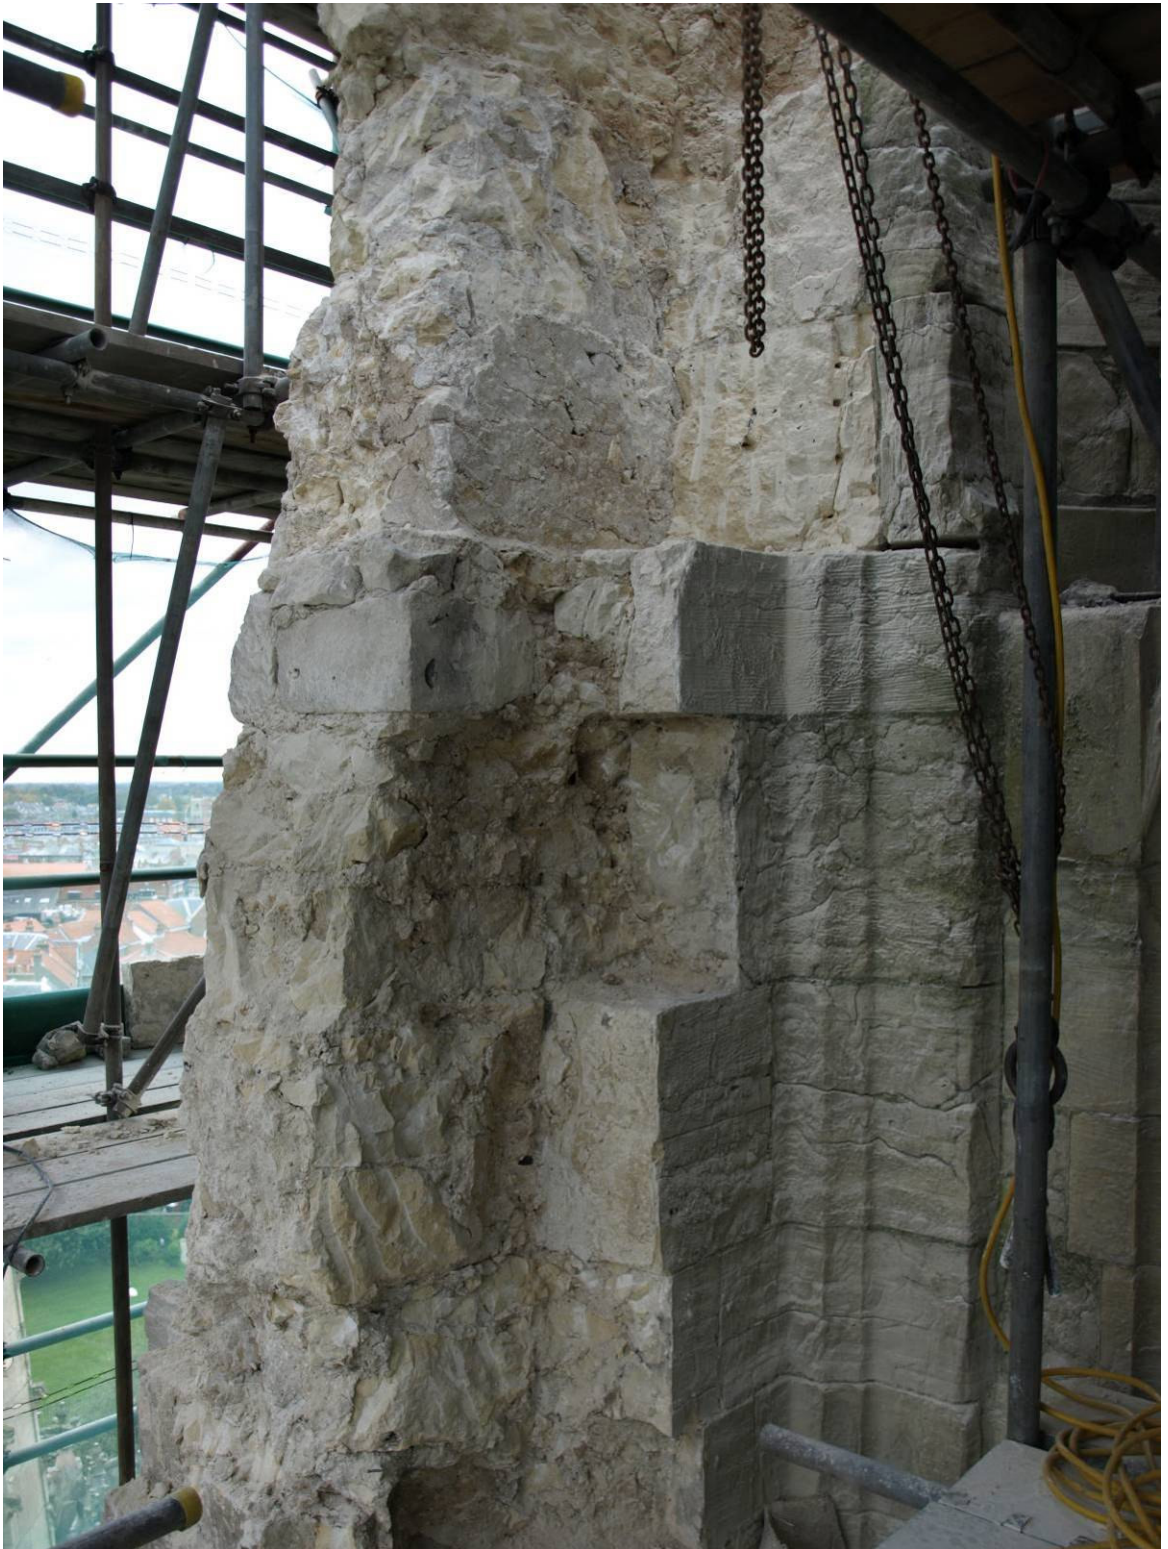
Figure 296: East Front, south buttress Level F during dismantling showing intact medieval core

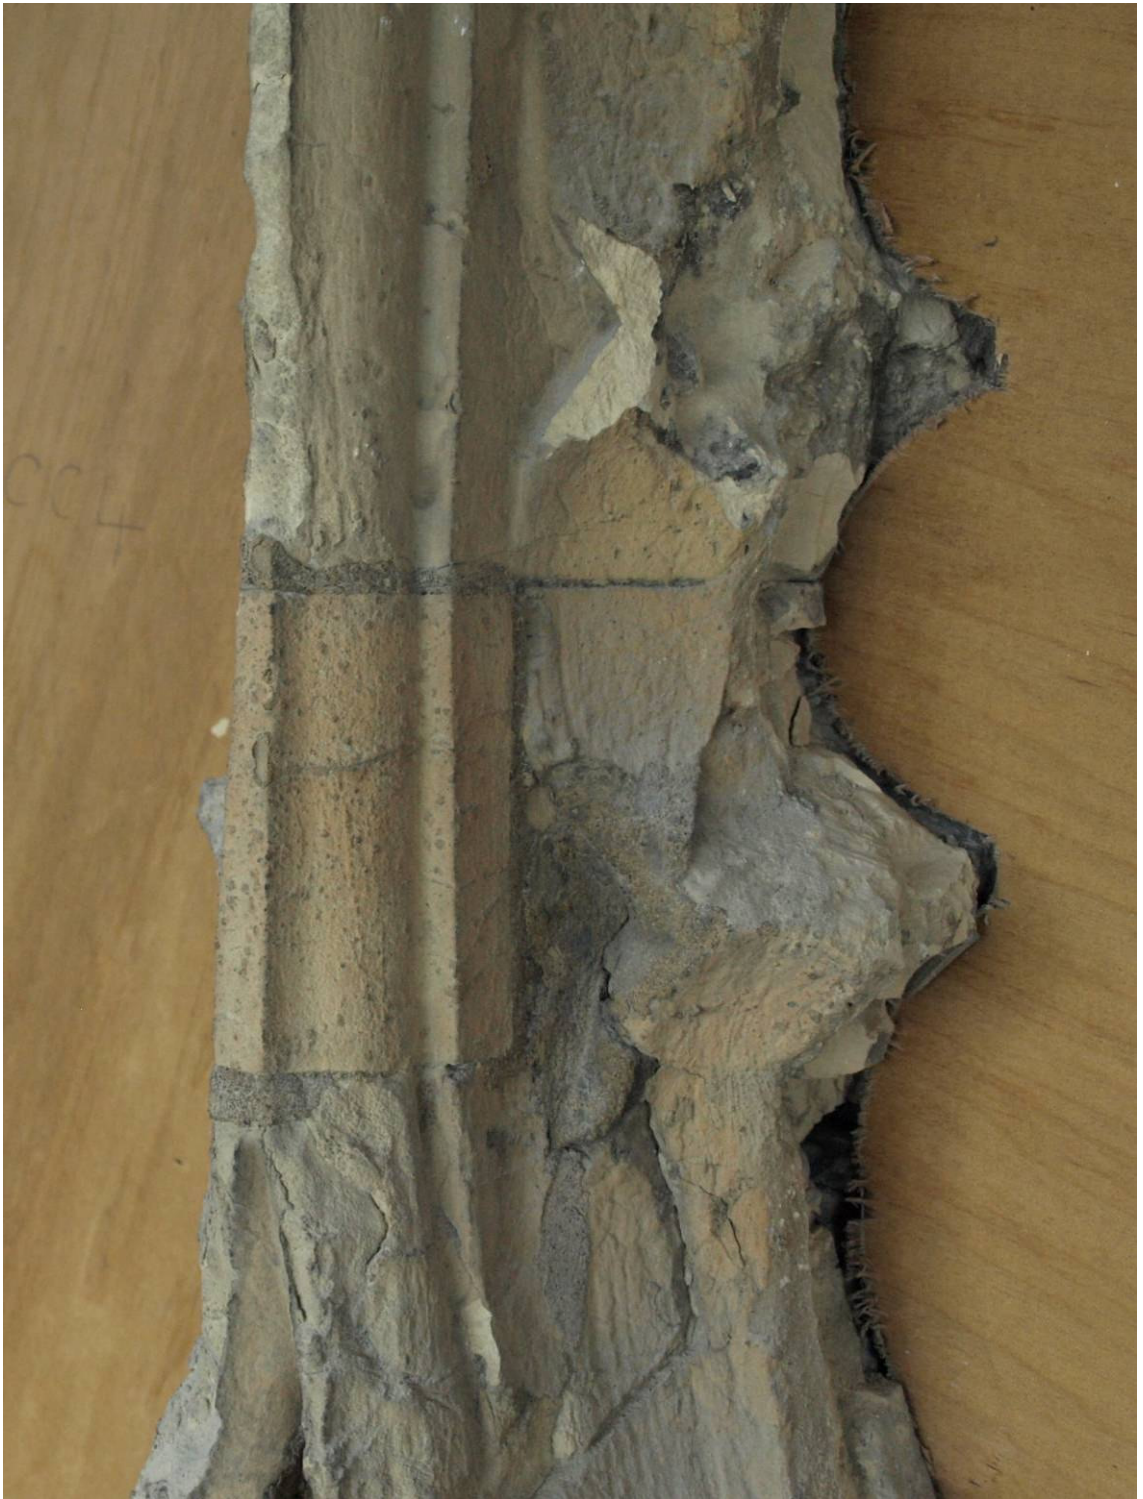
Figure 308: East Front, Great East Window exterior, medieval tracery detail showing typical weathering patterns, surface repairs and protective coatings

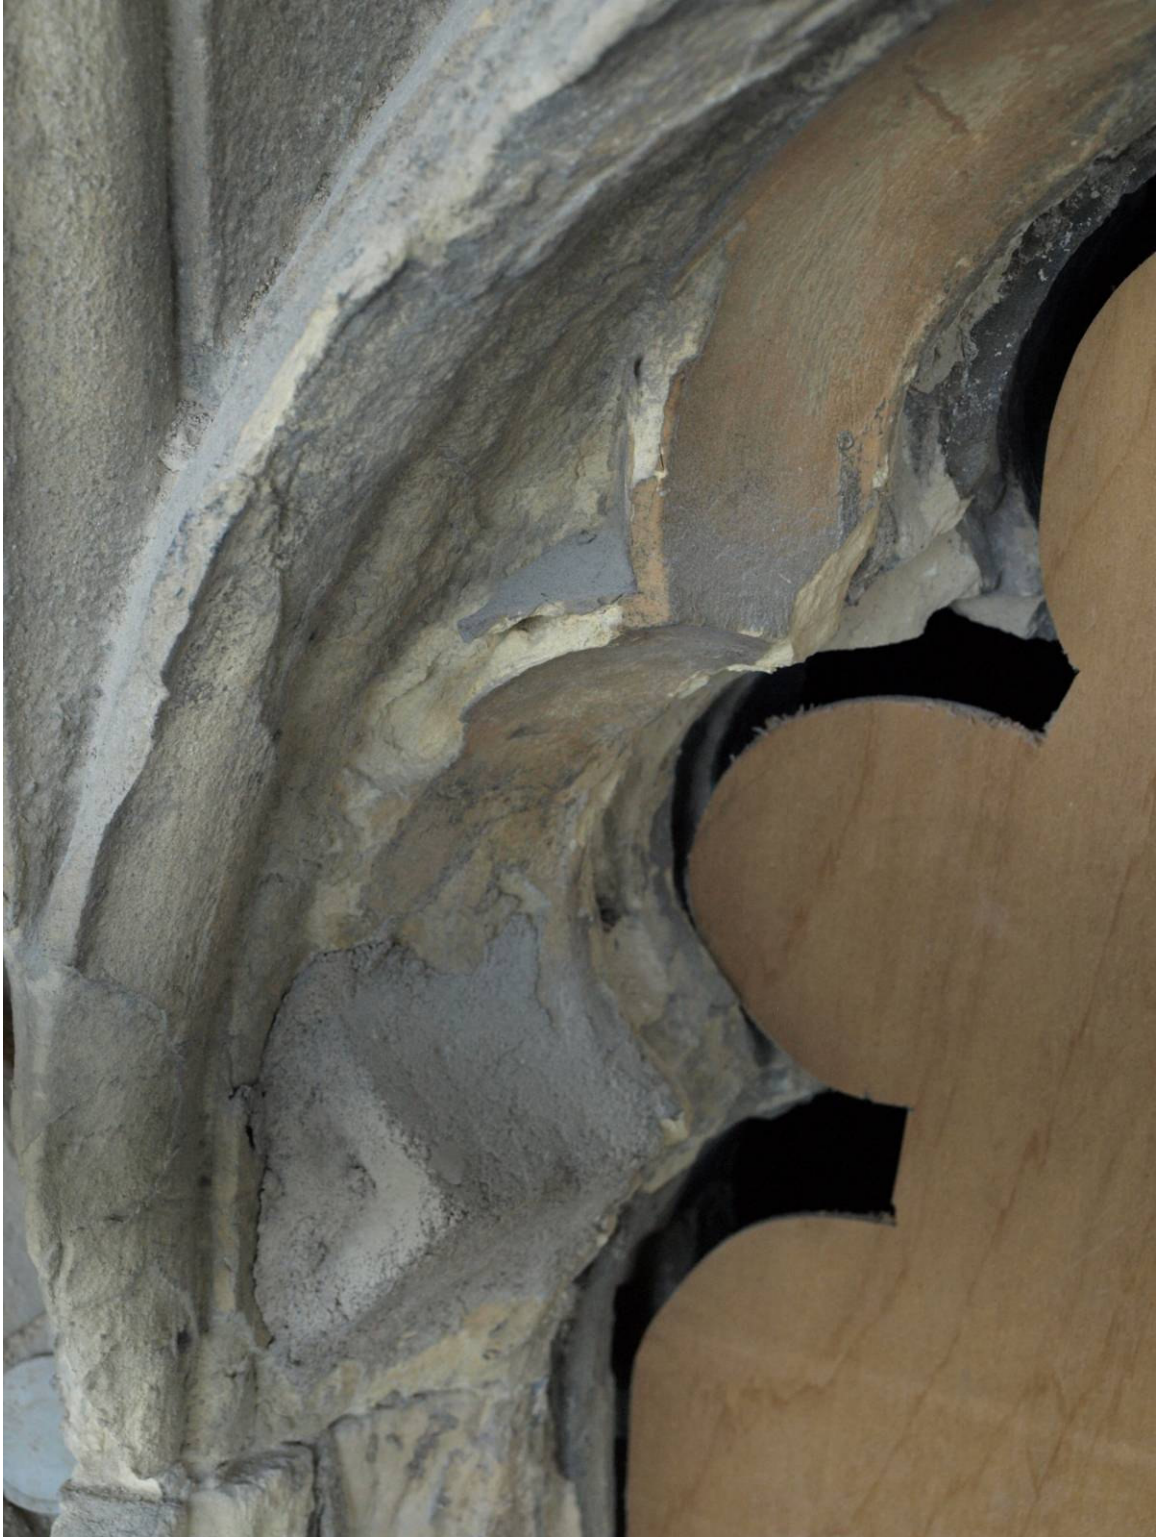
Figure 320: East Front, Great East Window exterior, detail of previous lime-based repairs

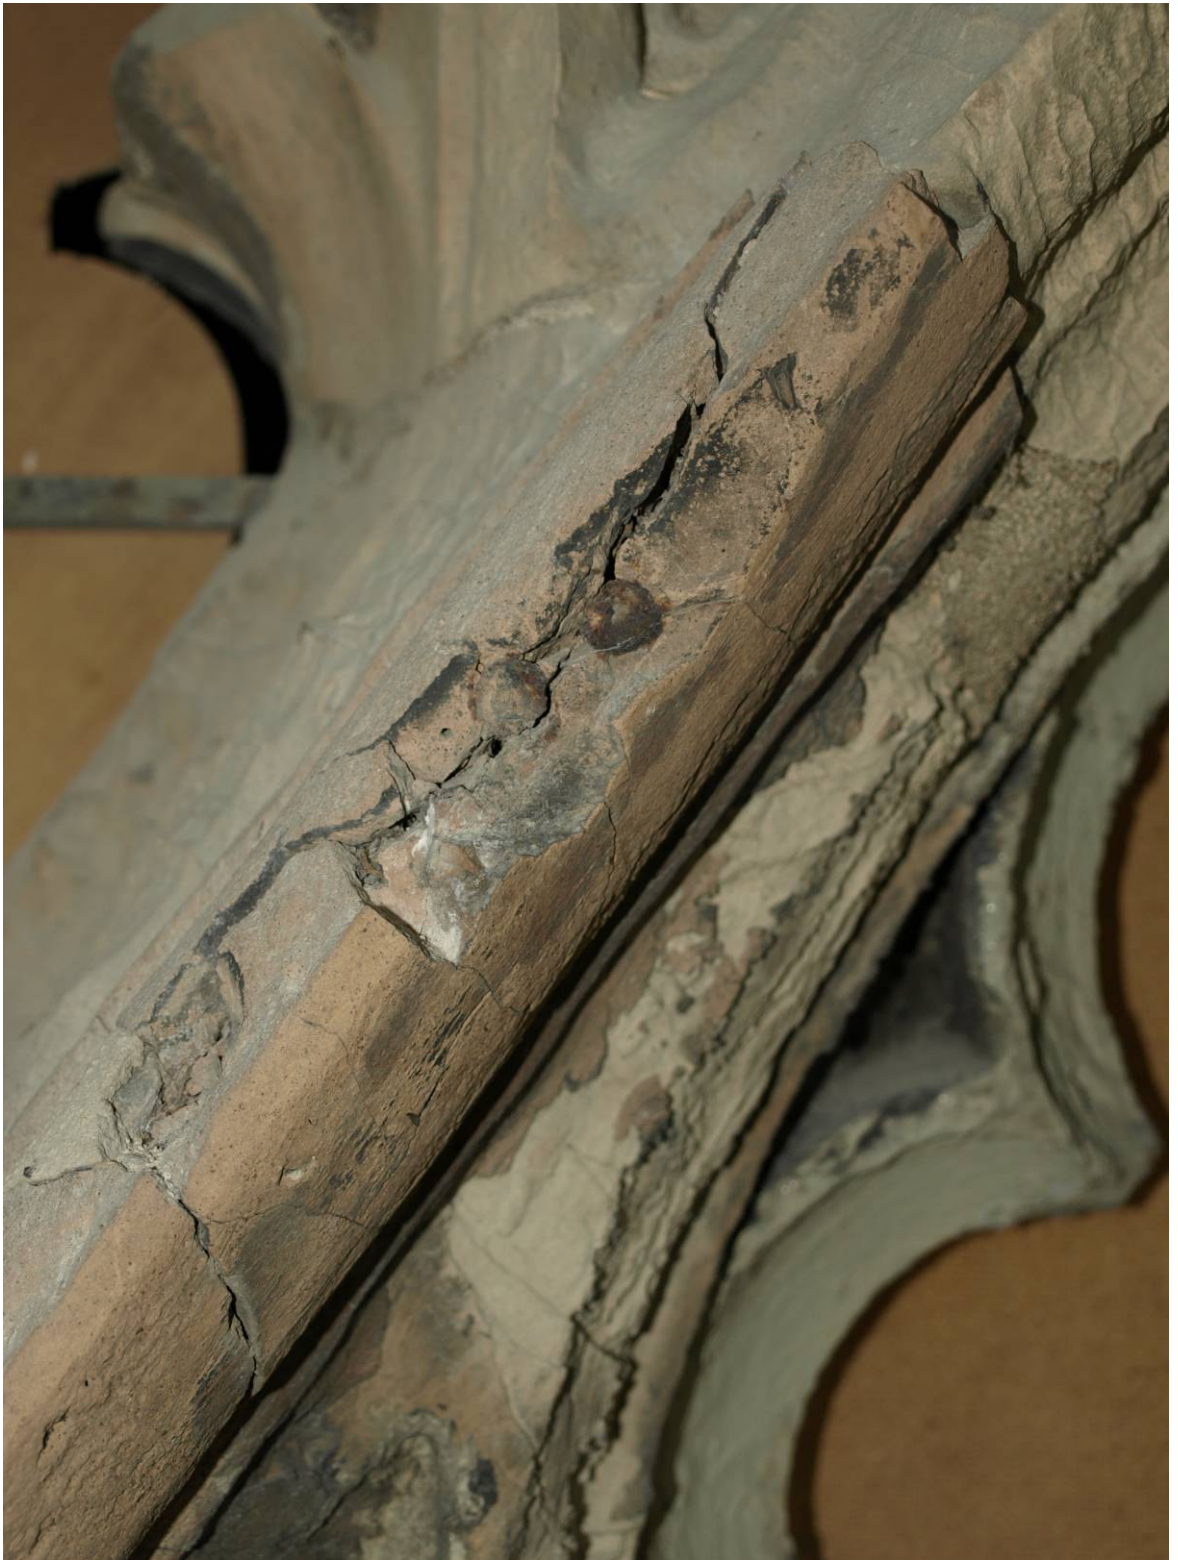
Figure 321: East Front, Great East Window exterior, detail of previous surface repairs and coatings

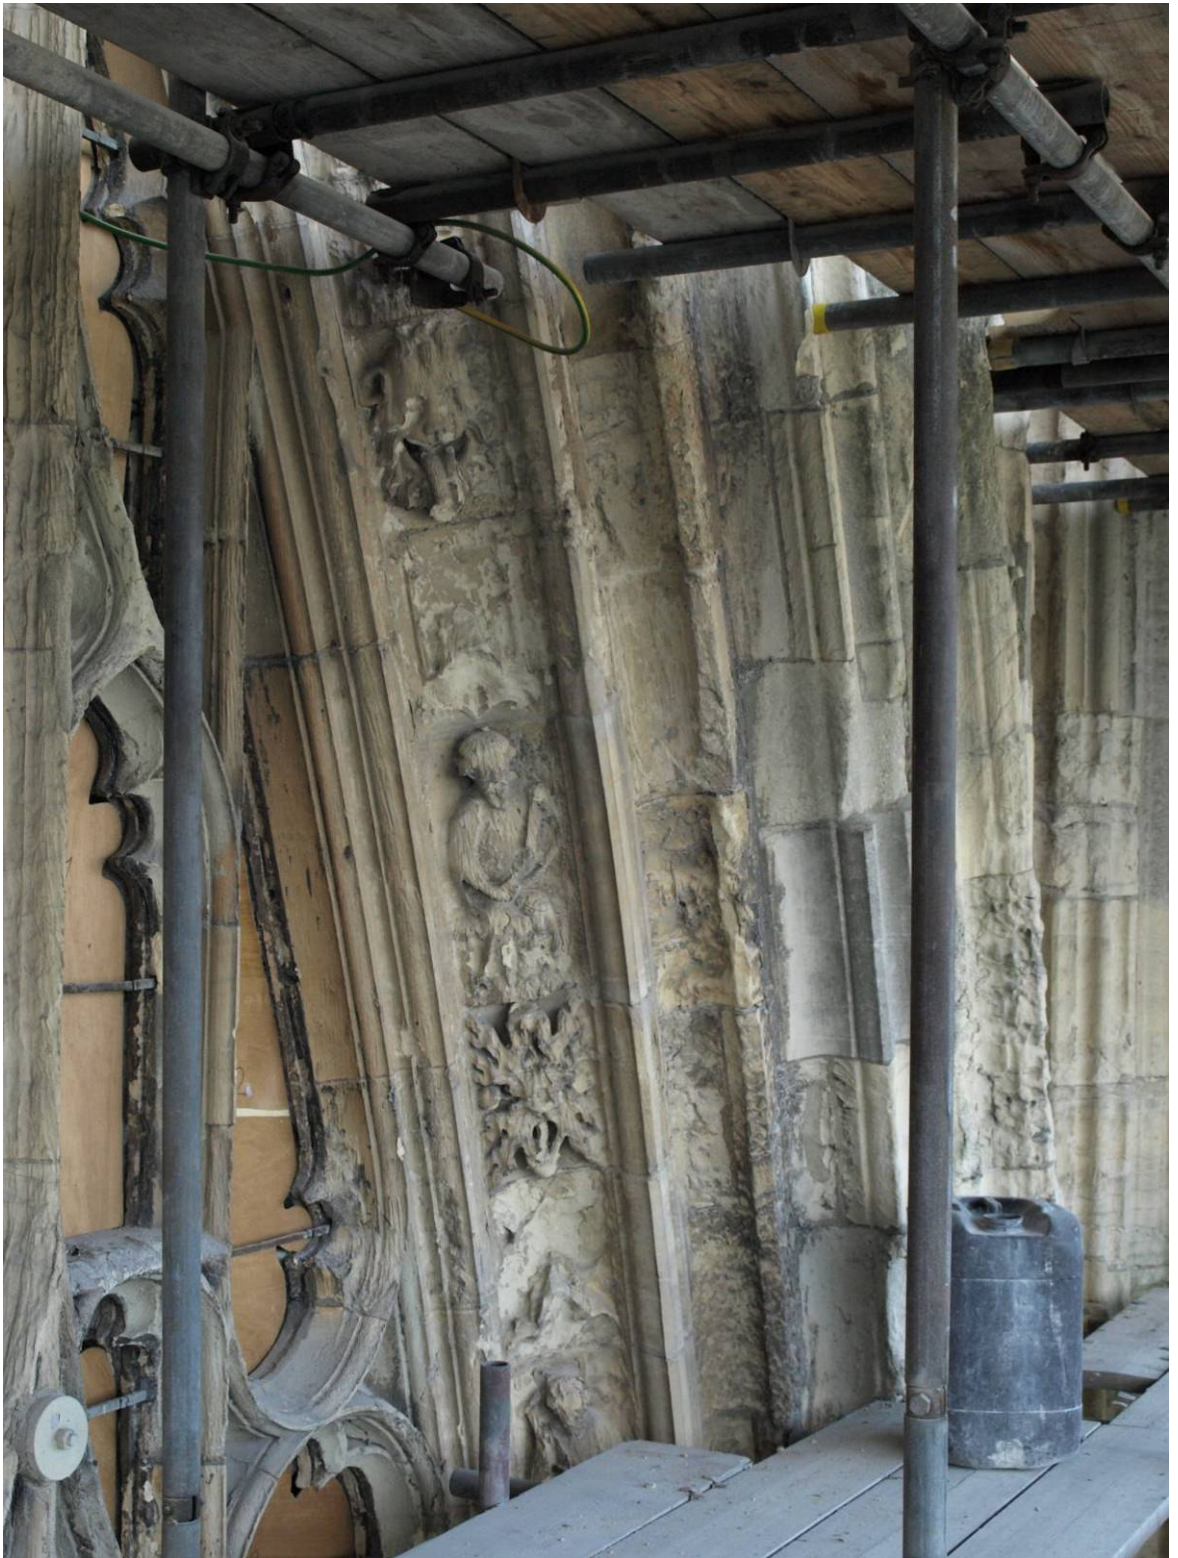
Figure 357: Great East Window, b1 illustrating typical decay patterns

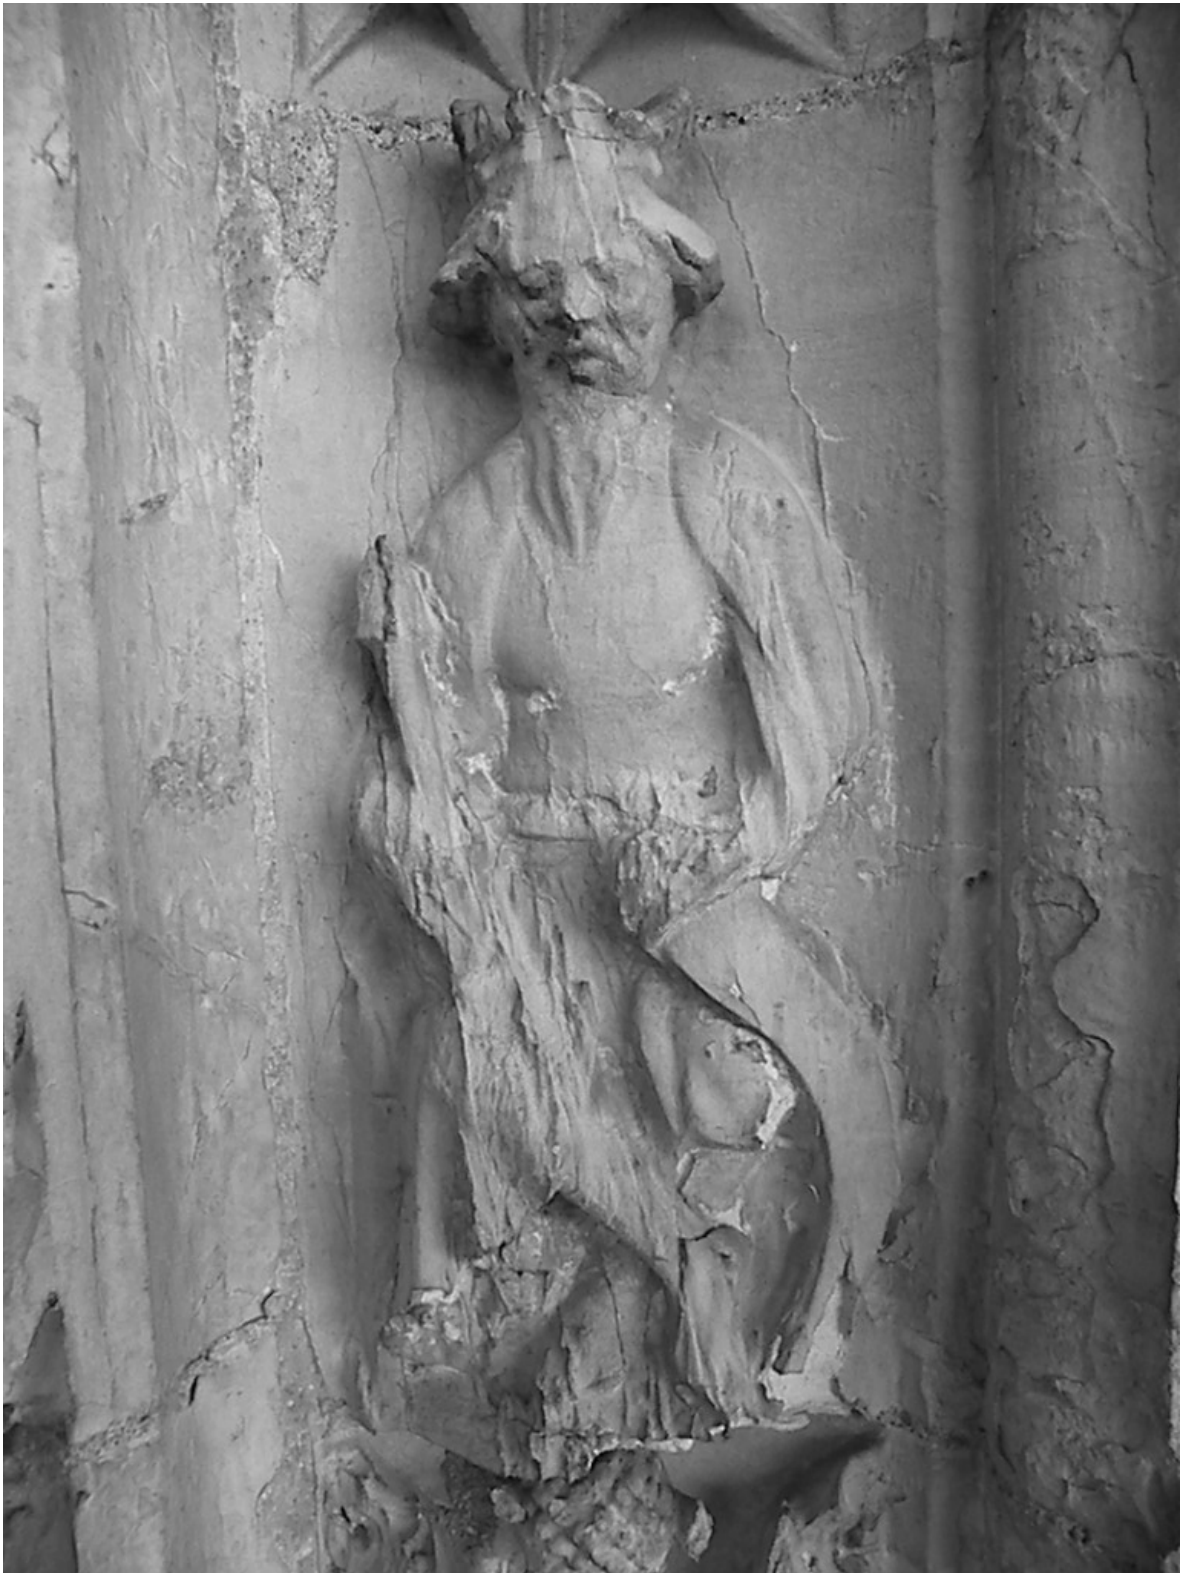
Figure 358: Great East Window, north side of arch showing decayed voussoirs adjacent to zones of substantial replacement of arch stones, indicating previous failure

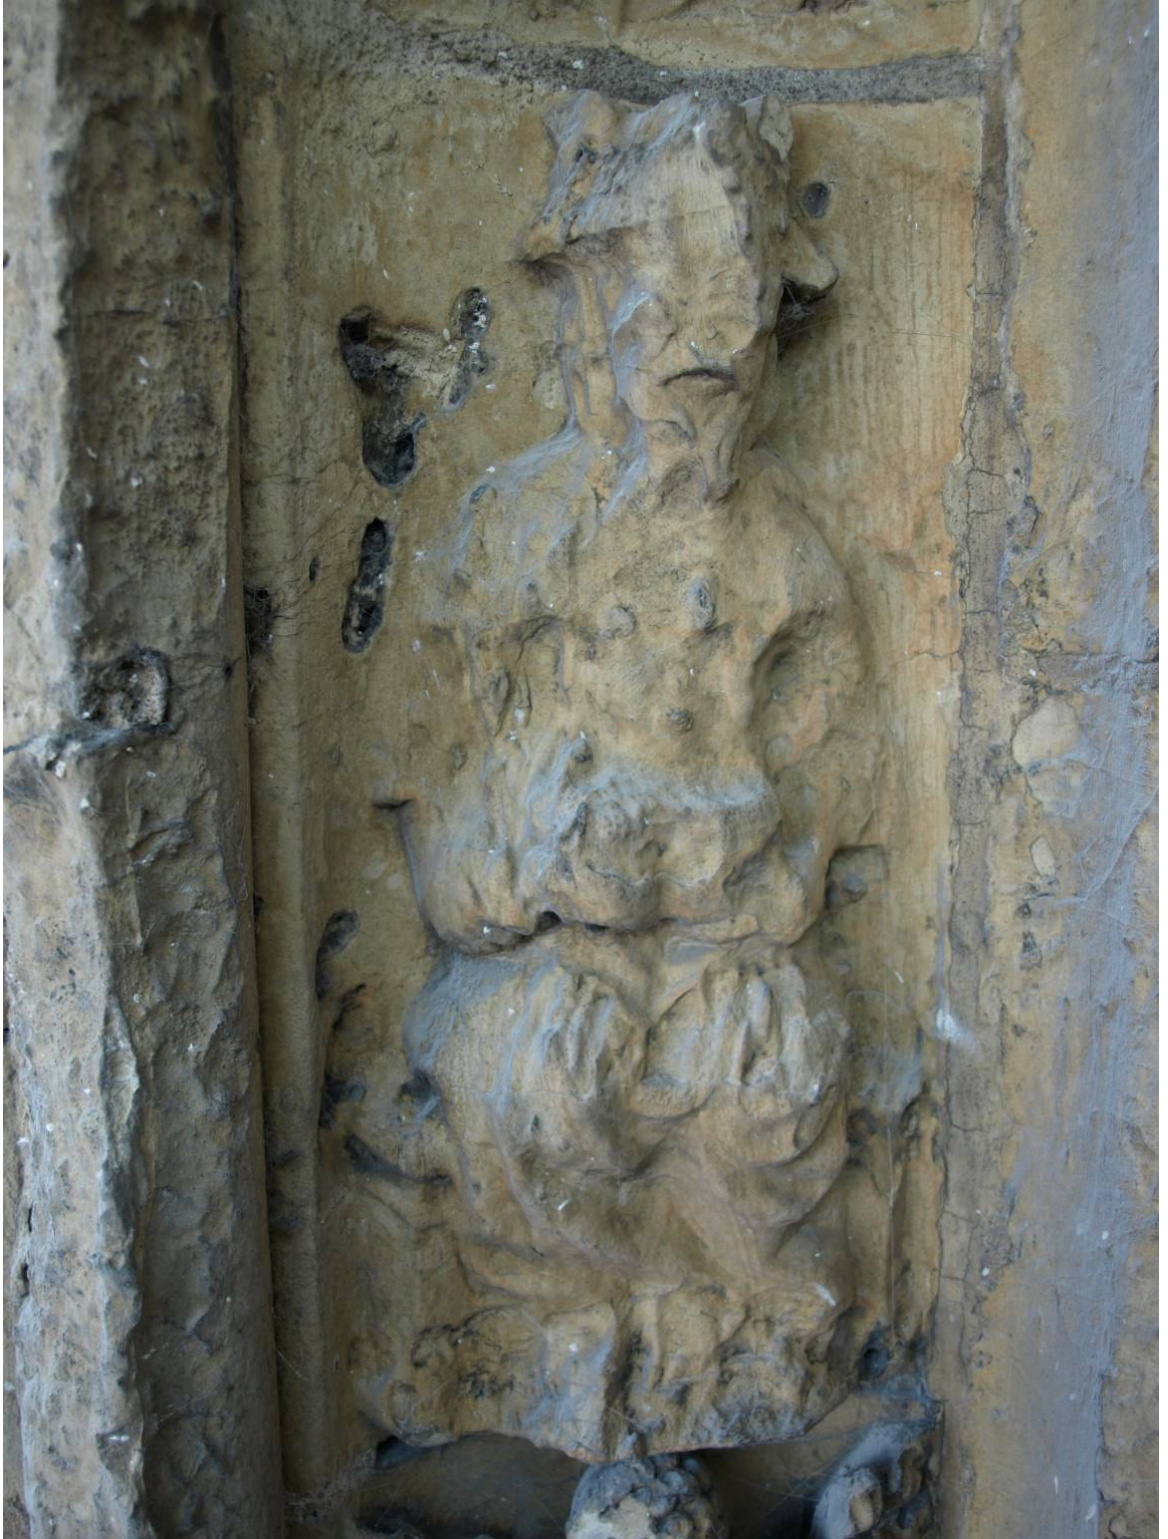
Figure 367: Voussoir b39, showing typical brown staining indicative of previous treatments with linseed oil

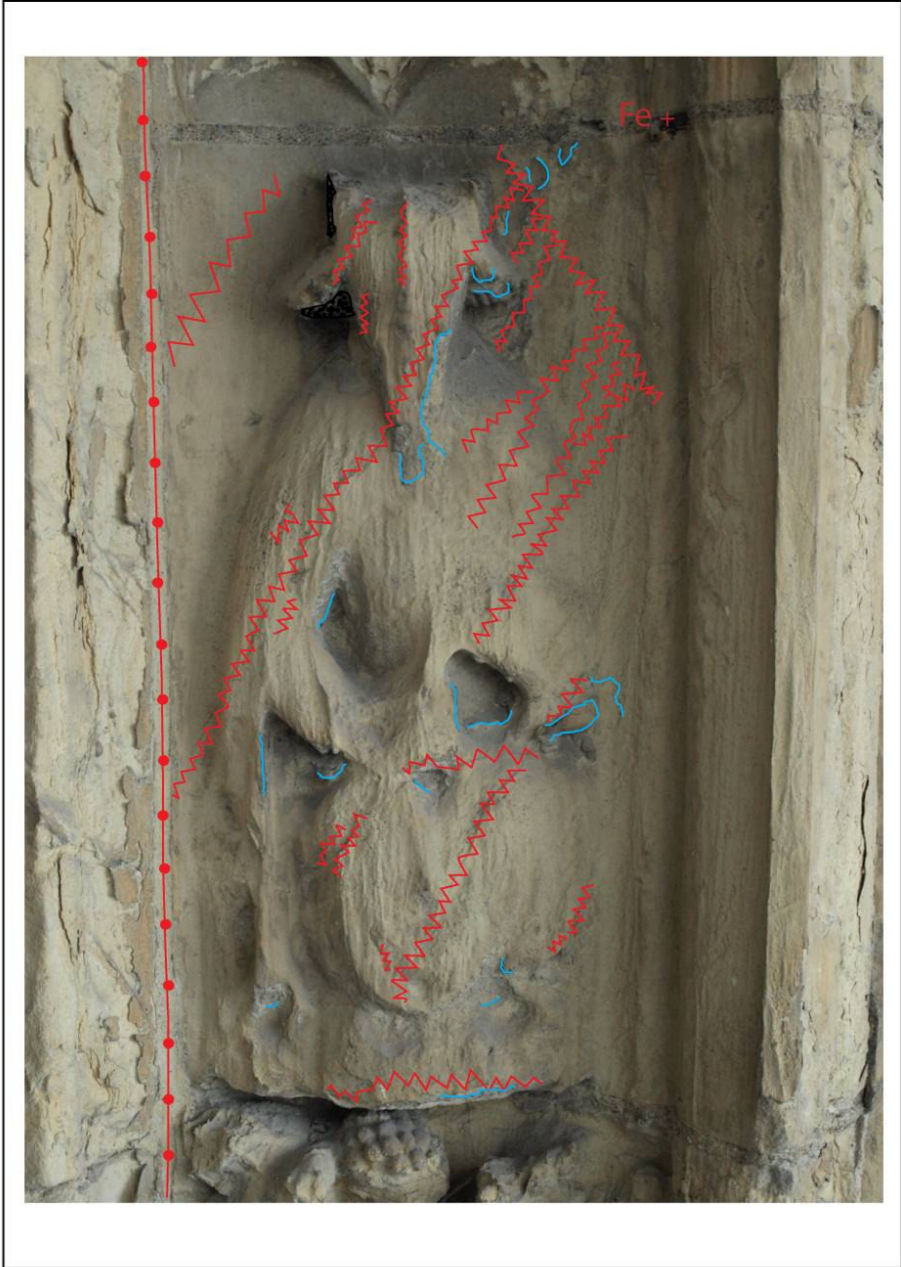
harmoniously weathered, sound condition overall

yellow-brown staining to surface

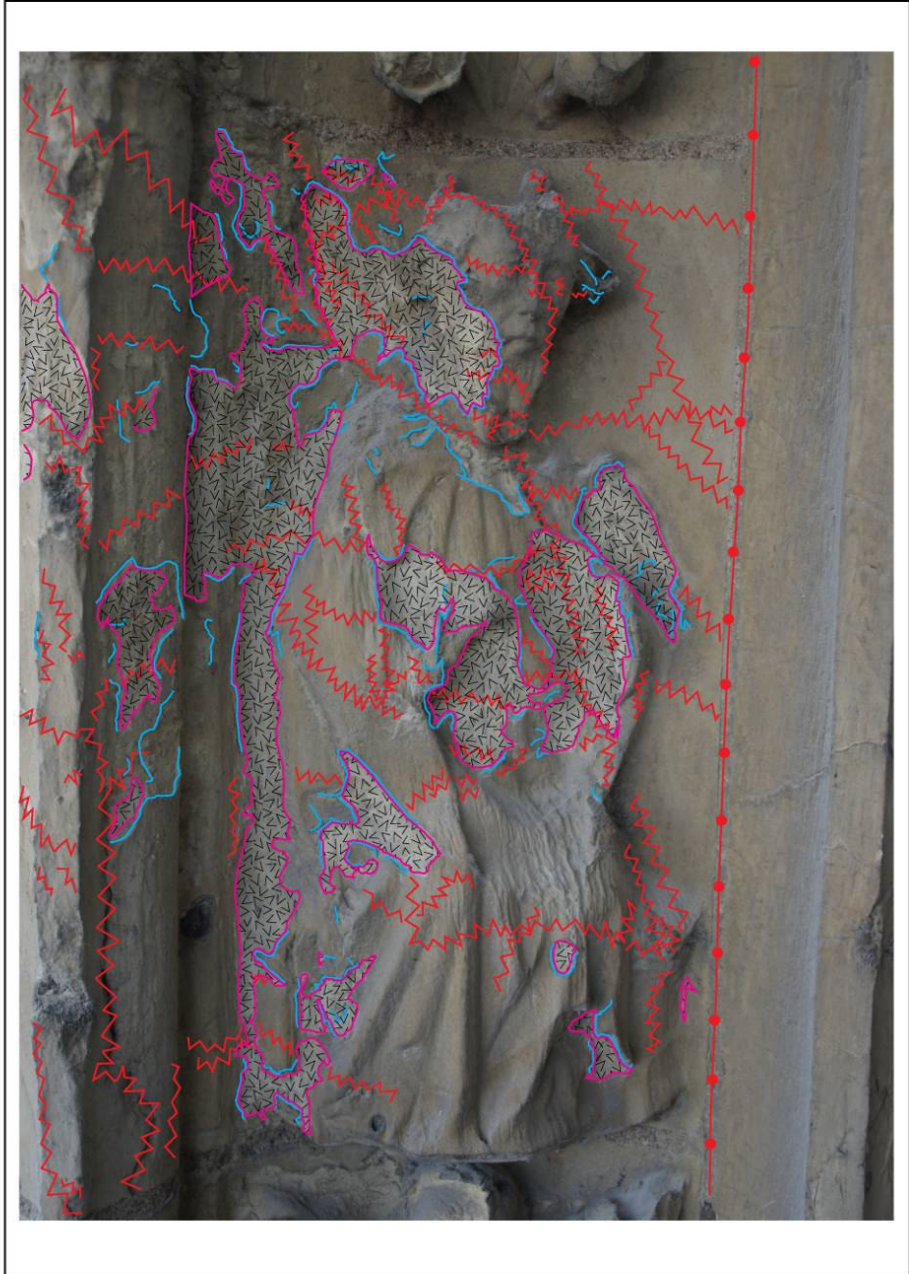
brown staining to extant sound surfaces

details of face and clothing softened by weathering

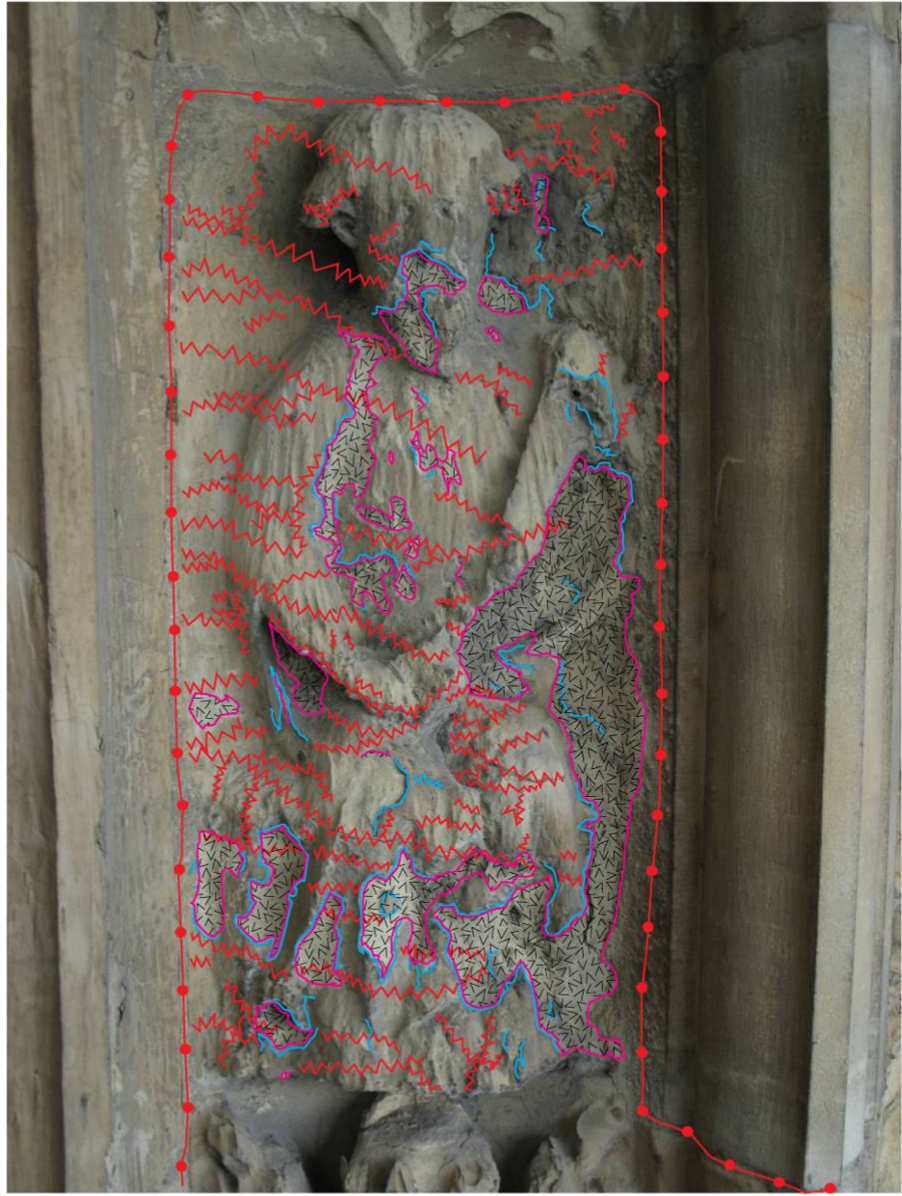
harmonious weathering to sound surfaces

no noticeable change since survey by Godfrey (2005)

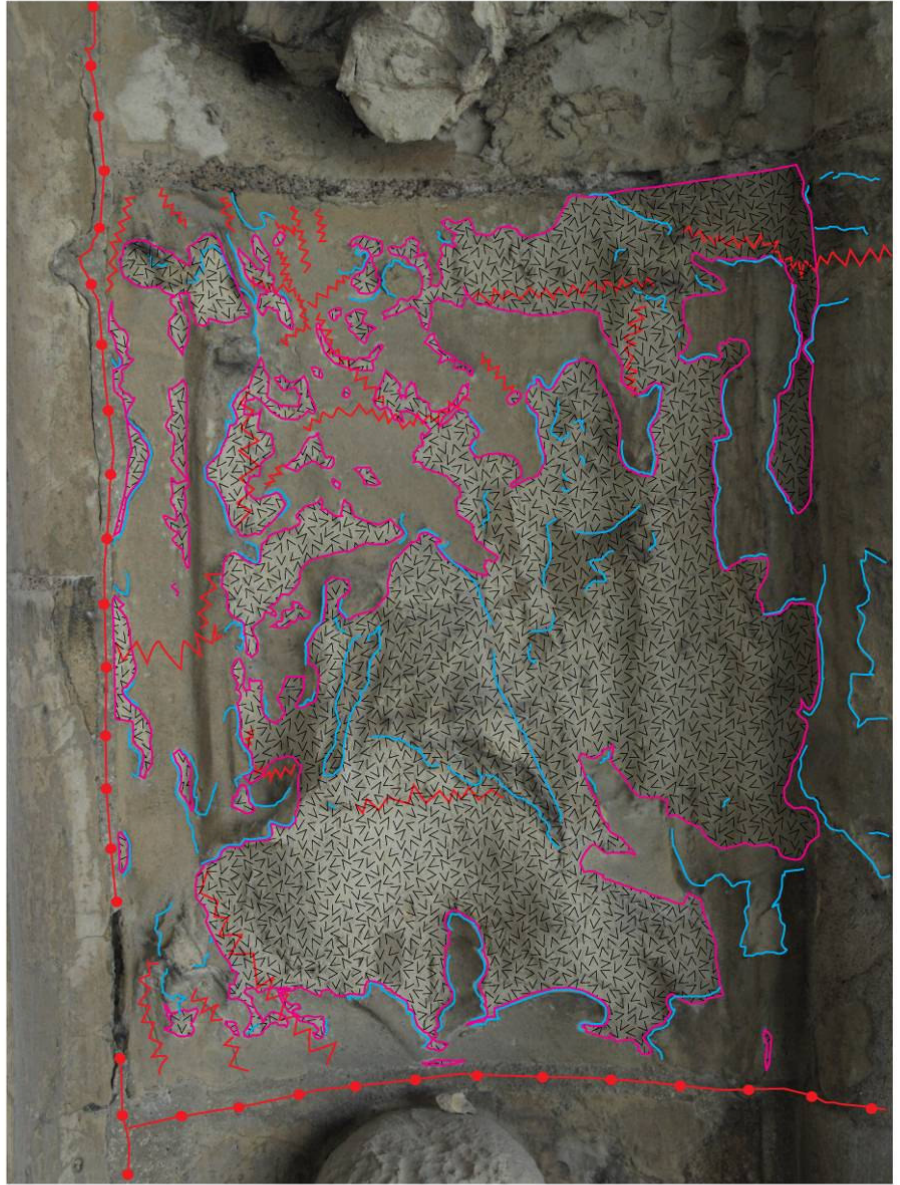
14thC original canopy  
 majority of carving  
 now lost  
 brown staining to  
 extant sound surfaces
