The Archaeology and Conservation
of the
East Front of York Minster

Volume 2 of 2
Figures, Drawings and Appendices

Alexander B Holton

University of York

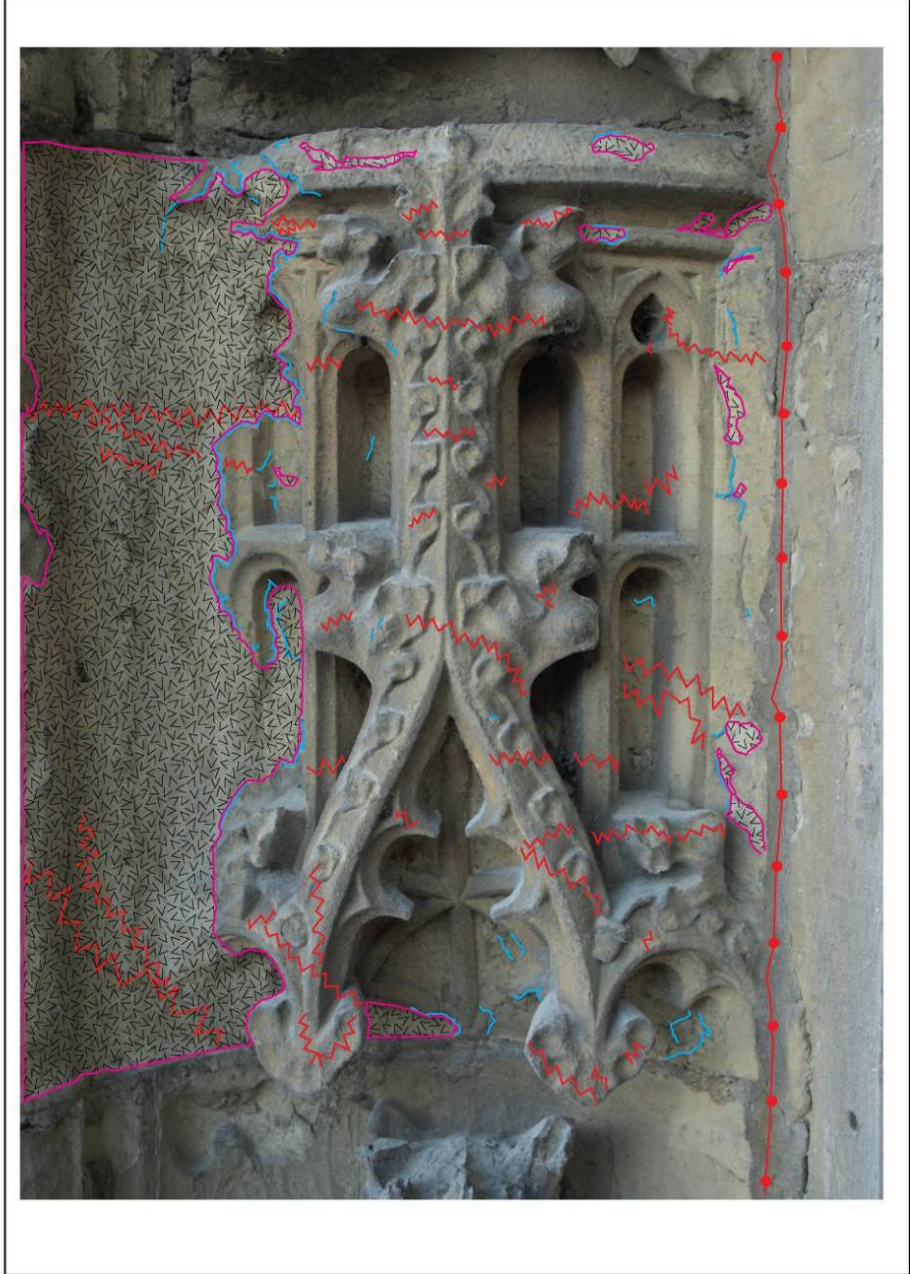
brown staining observed on sound surfaces

some softening of detail from weathering

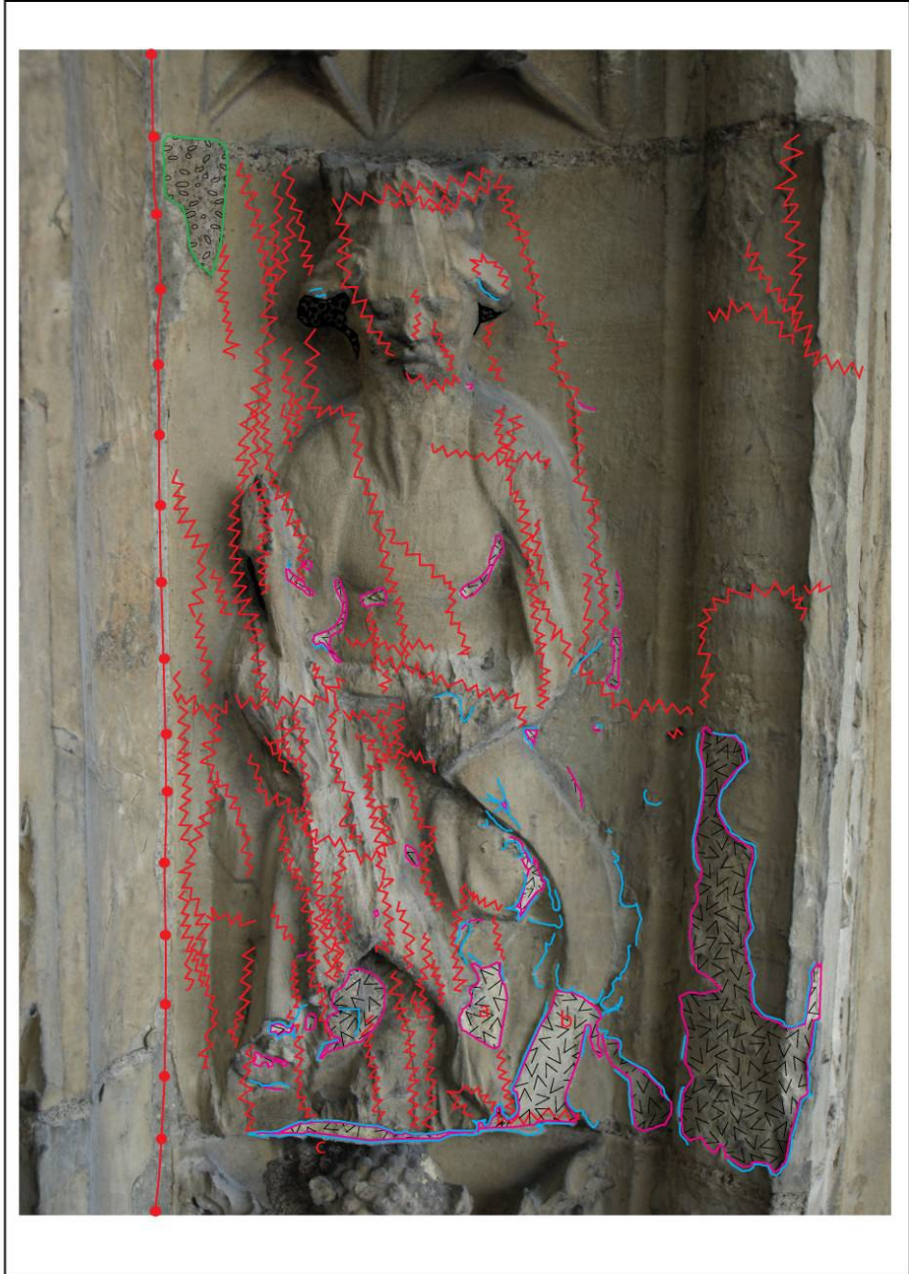
evidence of previous
dark sulphation

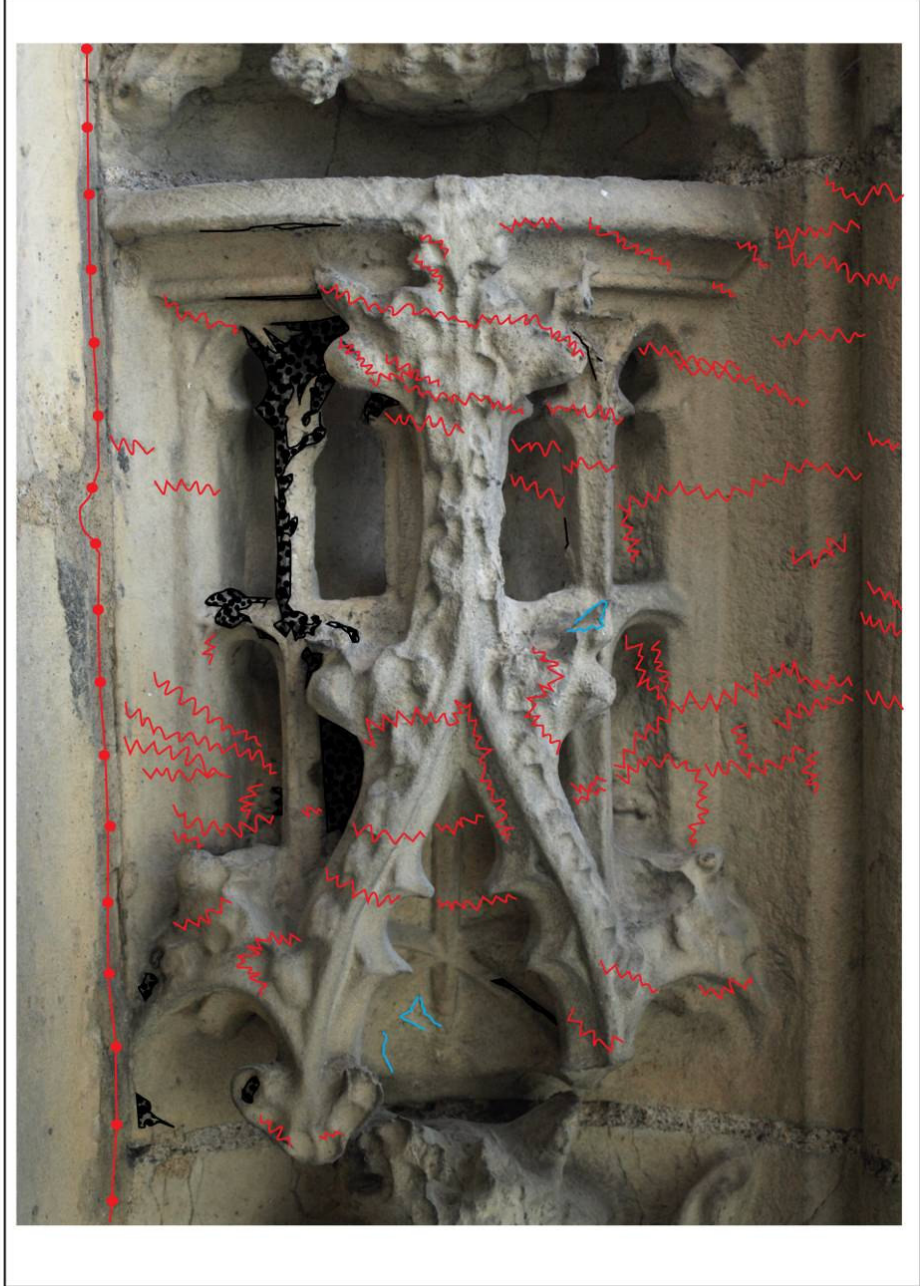
very little evidence of active decay

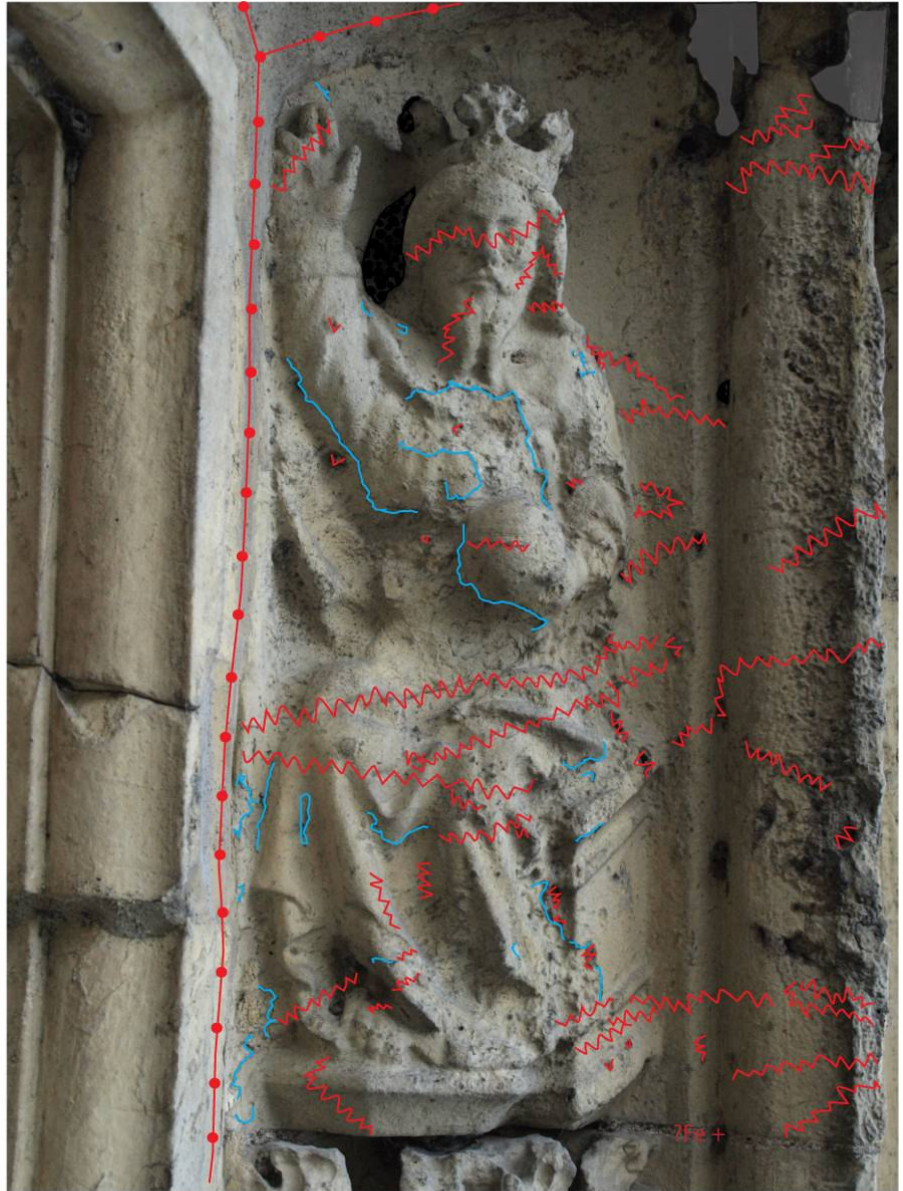
details softened by weathering
