Construction Materials Consultants Ltd.

CERTIFICATE OF ANALYSIS OF MORTAR SAMPLES FOR DETERMINATION OF MIX COMPOSITION & BINDER TYPE

Project Reference	:	North Yorkshire Moors – This Exploited Land of Iron
Sample Location	:	Rosedale East Stone Kilns
Sample Description	:	RESK1A – Typical Vault Brickwork, Kiln 1 Vault 4 RESK1B – Typical Vault Brickwork, Kiln 4 Vault 13 RESK2 – Rear Retaining, Wall kiln 4 RESK3 – Front Wall/Facing, kiln 4, Bedding mortar
Date Received	:	12 th March 2019
CMC Sample Ref	:	SR 2706-S1A = RESK1A – Kiln 4, Vault 4, Brick mortar SR 2706-S1B = RESK1B – Kiln 4, Vault 13, Brick mortar SR 2706-S2 = RESK2 – Kiln 4, Rear Retaining Wall SR 2706-S3 = RESK3 – Kiln 4 Front Wall/Facing
Date Analysed	:	5 th April to 20 th May 2019
Method of Test	:	Determination of binder type by X-Ray Diffraction analysis. Mix composition by acid digestion with grading analysis of recovered aggregate, and thin section examination.

Rosedale East Stone Kilns

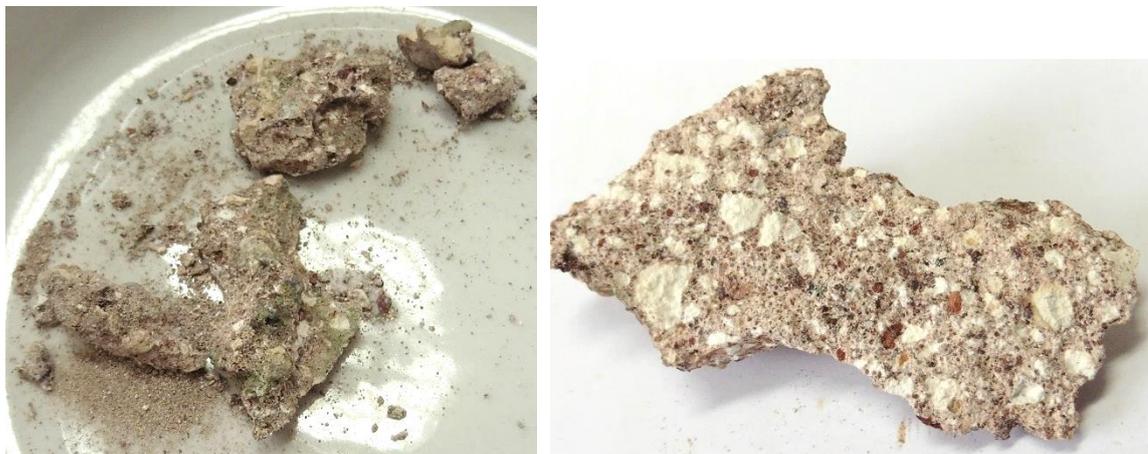
On examination the mortar was noted to contain an abundance of lime inclusions, up to 3.5mm in size. The inclusions were observed to be mostly sub-angular in shape, with a few retaining harder cores, perhaps indicating incompletely calcined lime.

Plates No. 1 & 2: The left plate shows the intact pieces in this part of the mortar sample. With the right plate showing a magnified image of a freshly fractured surface through the thickness of the sample. Note the abundance of lime inclusions, and possible limestone, observed randomly distributed throughout.

On testing a freshly fractured surface with phenolphthalein indicator the mortar was found to be fully carbonated. With water droplet tests confirming that the mortar was porous with the droplets being rapidly absorbed into the fabric.

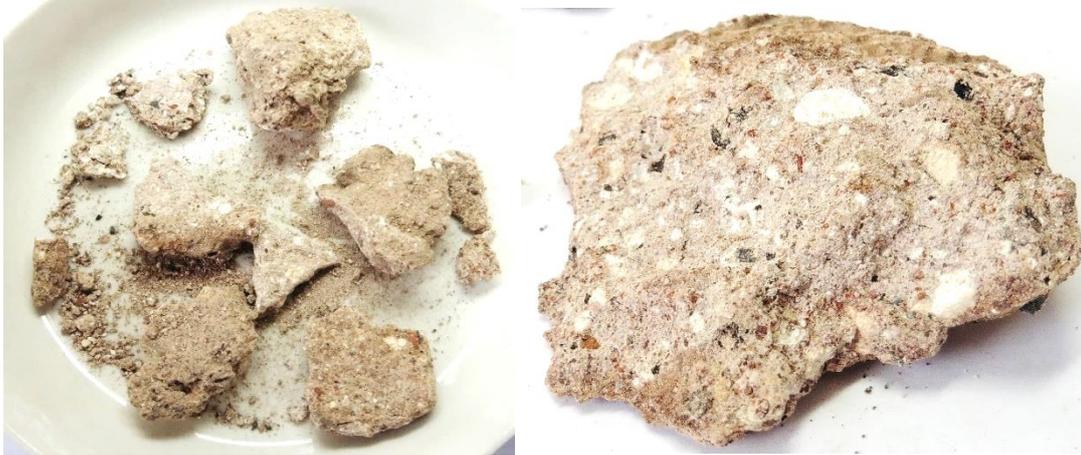
Plates No. 3 & 4: The left plate shows the sample as-received. The right plate shows a freshly fractured surface through the thickness of a large fragment, in which an abundance of lime inclusions and limestone fragments were apparent, with small dark coal fragments and red brick fragments distributed throughout.

Entrapped air voids measured up to 1.3mm in size were observed, with these containing an abundance of needle-like crystals (sulphate minerals) along with a patchy crystalline calcite coating, which would infer water percolation, through the mortar over time.

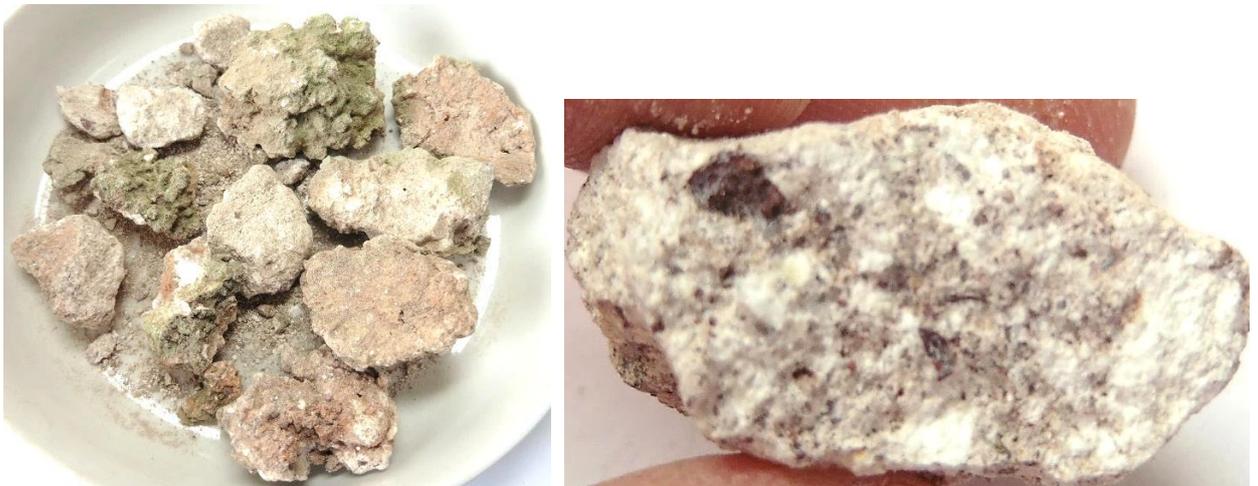
This sample consisted of an abundance of fragments, with a variable composition, perhaps indicating more than one mortar type in the sample, or, more likely, that the mortar had been poorly mixed.

Plates No. 5 & 6: The left plate shows the sample, as received. The right plate shows a close-up of a freshly fractured surface, where the dense condition of the fabric can be seen along with abundance of angular white lime inclusions, grey and white limestone fragments, dark coal fragments, with patches of grey ash.

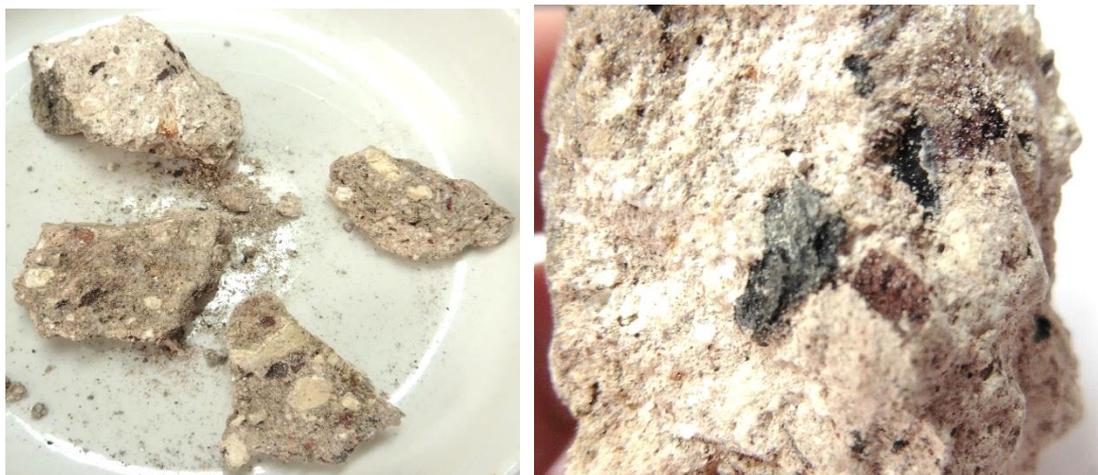
Plates No. 7 & 8: The left plate shows the four intact mortar fragments in the sample as received. The right plate shows a close-up of a fractured surface, through the largest intact piece. This shows a dense fabric, along with an abundance of lime inclusions and limestone fragments.

Phenolphthalein indicator tests confirmed that the mortar was fully carbonated. With water droplet tests indicating that droplets placed onto soiled outer surfaces were supported for an extended period, with those applied to fractured surfaces being quickly absorbed. This would infer that the mortar had a well-connected internal pore structure. With the outer surfaces coated in redeposited calcite with entrapped soiling, which had the effect of blocking the pore structure and sealing of the outer surfaces.

On examination of the fractured surfaces an abundance of white lime inclusions were observed, with these measuring up to 7.2mm in size. The inclusions are angular to sub-round in shape and have the appearance of being formed from a mixture of quicklime and limestone fragments, the latter including partially over burnt particles along with fresh, unburnt, limestone.

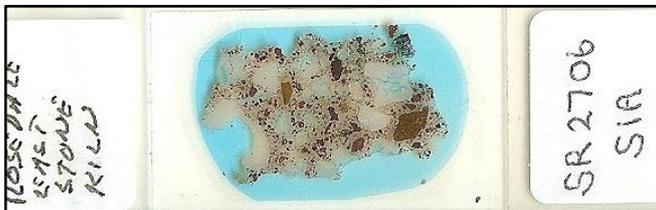
Plate No. 9:

Thin section prepared from mortar sample SR2706-S1A (RESK1A).

The binder is a non-hydraulic lime, with the abundance, of angular and sub-angular lime inclusions observed suggesting that the mortar had been mixed as a hot mixed mortar (HMM) and the quicklime had not been run to putty before use.

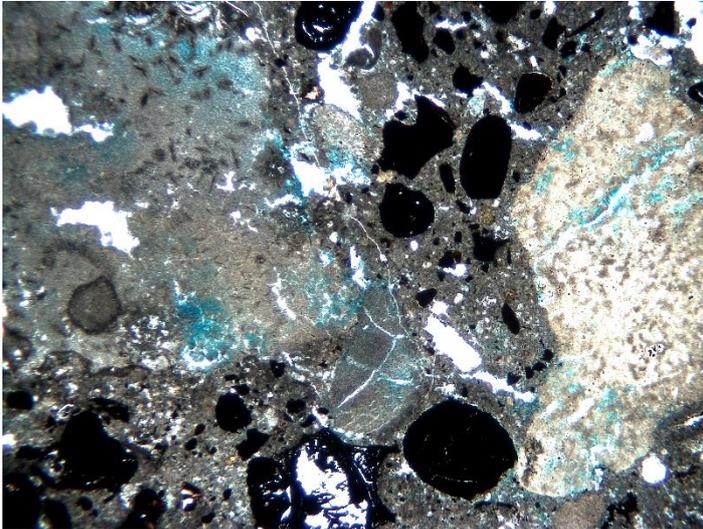
Plate No. 10:

A view in plane polarised light (ppl) showing a typical area of the mortar, with a partially hydrated inclusion seen in the left of centre and a limestone fragment on the right side. The paste is dense and fully carbonated, with no evidence of hydraulic clinker observed within this area. The aggregates are dominated by opaque particles (black in image), with fine ash grains distributed throughout the paste. Voids can be seen both within the lime inclusion and throughout the paste, along with fine shrinkage cracks. Porosity is highlighted by the blue dyed resin. Field of view 2.4mm.

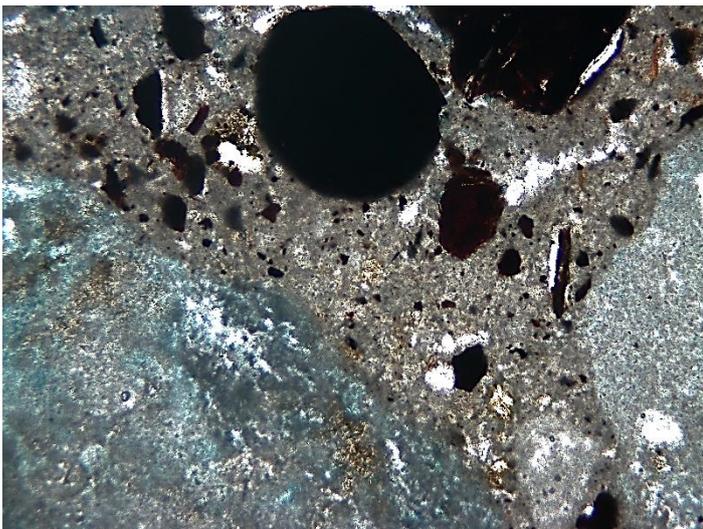
Plate No. 11:

A magnified view in ppl, of an area of paste where two inclusions can be seen, centre right, partially hydrated and lower left fully slaked and hydrated. Coal fragments can be seen in the upper part of the plate along with angular shards of coal clinker and slag materials distributed through the paste. Some of the fine grains show reaction rims and there are pseudo-morph Belite grains apparent in the centre of the plate, both inferring that the mortar has hydraulic/pozzolanic hydrates present. Porosity and voids are highlighted by the blue dyed resin. Field of view 1.2mm.

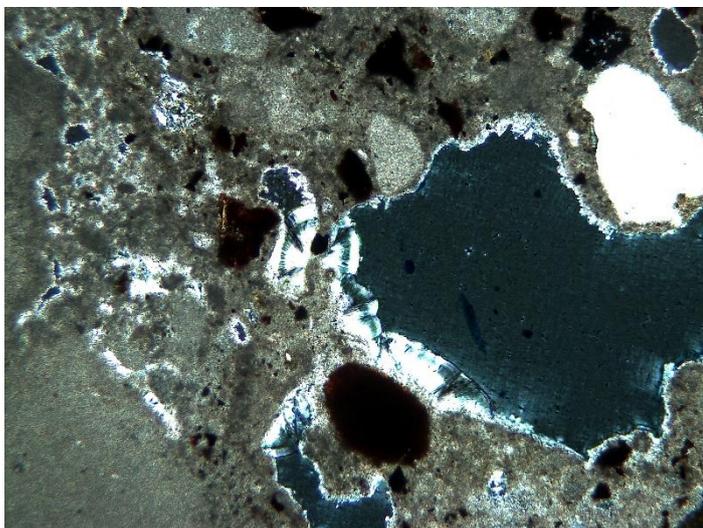
Plate No. 12:

A view in cross polarised light (xpl), of an area of dense fully carbonated paste. An irregular shaped void in the right of centre is rimmed with fine calcite with clusters of sulphate minerals in its lower left side (both white in image). The connecting channel ways, to the left are also lined with secondary minerals confirming water migration over time. Small lime inclusions can be seen in upper left with a larger inclusion in the lower left corner. The impregnating resin, porosity and voids all show dark in xpl. Field of view 1.2mm.

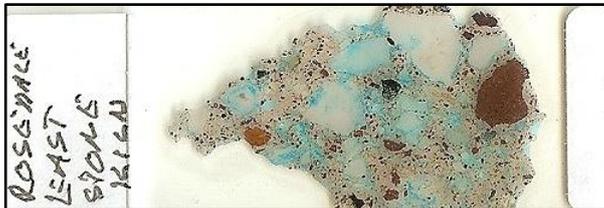
Plate No. 13:

This section was prepared from an intact piece of mortar from sample SR2706-S1B (RESK1B).

From the microscopic examination the main difference between this sample and sample S1A (RESK1A) was the abundance of pyrite minerals observed in the shale fragments and some flaky limestone fragments. This may be the cause of the higher proportion of sulphate minerals observed lining voids and the wider crack paths within this sample. Sulphates were also noted to locally permeate into the paste adjacent to the crack paths.

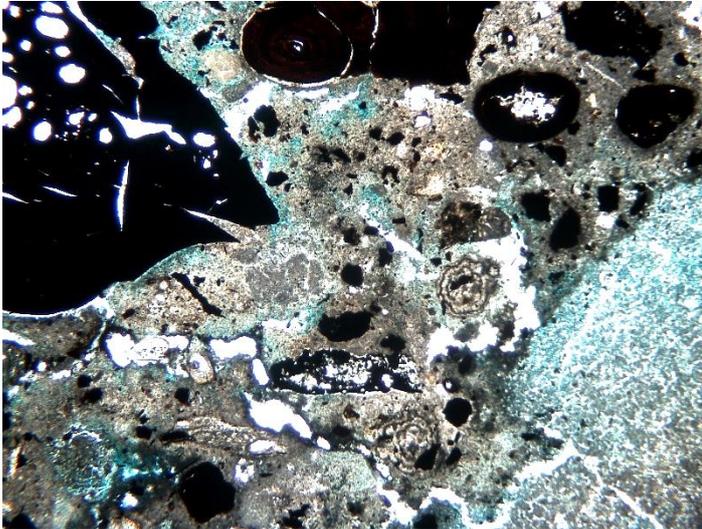
Plate No. 14:

A view in plane polarised light (ppl) of a typical area of the mortar. This shows the dense fabric with localised alteration of paste adjacent to opaque minerals. A lime inclusion fills the lower right corner with a partially burnt coal fragment in the upper left corner. Fine coal, ironstone and clinker grains are distributed throughout the paste as are small lime inclusions (putty) centre, and lower left. A number of the finer clinker particles display reaction rims, and these are taken to indicate that a pozzolanic reaction has occurred.

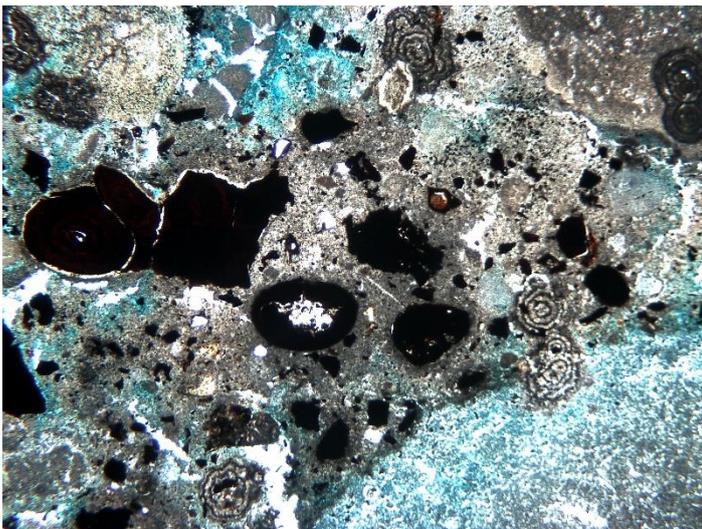
Plate No. 15:

A magnified view in ppl of an ash and slag rich area of fabric packed between two lime inclusions, one to the lower right the other upper left. A limestone fragment can be seen in the upper right corner. The paste is fully carbonated and contains an abundance of coal, ash, clinker and fine ironstone fragments. Note the pattern of Liesegang rings, right of centre at margin with an inclusion and in the lower centre, these are indicative of a change in differential morphology in response to cyclic reprecipitation of binder components.

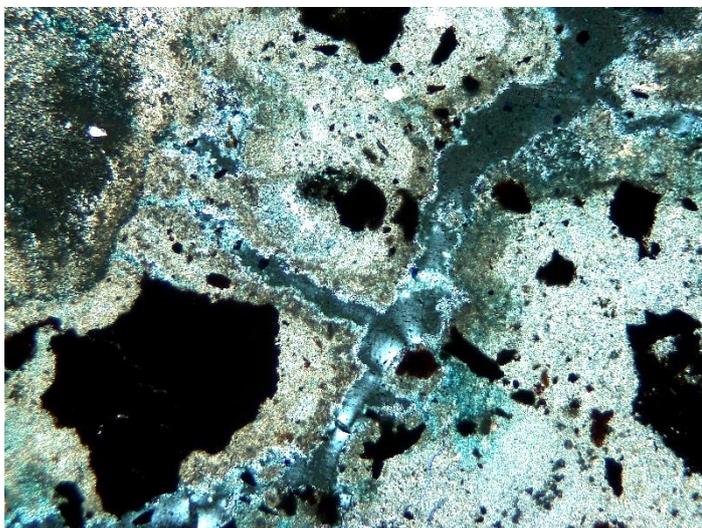
Plate No. 16:

A view in Cross Polarised Light (xpl), of an area of dense carbonated paste transected by a wide crack which has acted as a water percolation channel. Note the discolouration of the paste either side of the crack indicative of depletion with the redeposition of calcite and coarse sulphate minerals within the crack path. The paste on the left, lower quarter also shows sulphate minerals diffused through the paste around the large void in this area. The upper left shows a partially slaked and partially hydrated lime inclusion, with ash clusters in the upper right corner. Porosity, the blue impregnating resin and opaque minerals all appear black in xpl. Field of view 1.2mm.

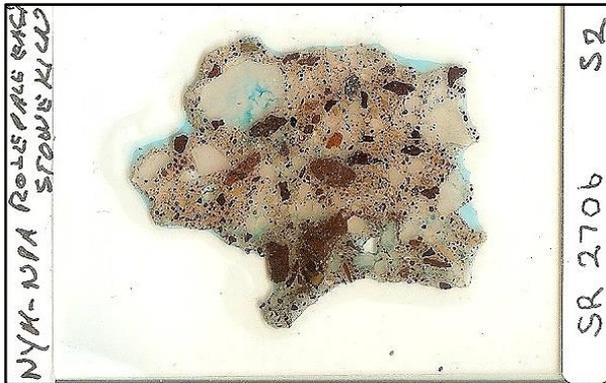
Plate No. 17:

This thin section was prepared from an intact piece of mortar from sample SR2705-S2 (RESK2).

This sample had the appearance of a well compacted mortar, with a dense fabric, having a relatively uniform appearance throughout its thickness. However as with samples SR2706S1A & B the components present appear to be the same, with only variations in the proportions of each being observed.

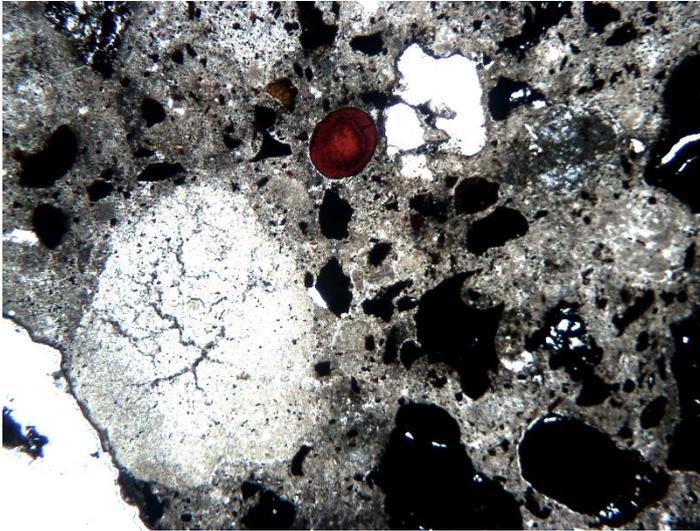
Plate No. 18:

A view in plane polarised light (ppl) showing a well compacted area of the mortar, where the paste is fully carbonated and is relatively dense. A fully slaked lime inclusion is apparent in the lower left quarter. The inclusion displays shrinkage cracking but has not diffused into the surrounding paste. Aggregates in view are mostly opaque minerals and include coal, ironstone fragments, with coal clinker and ash. A mapwork of very fine shrinkage cracks are apparent, around the perimeter of aggregates and distributed throughout the paste. Porosity is highlighted by the blue dyed resin. Field of view 2.4mm.

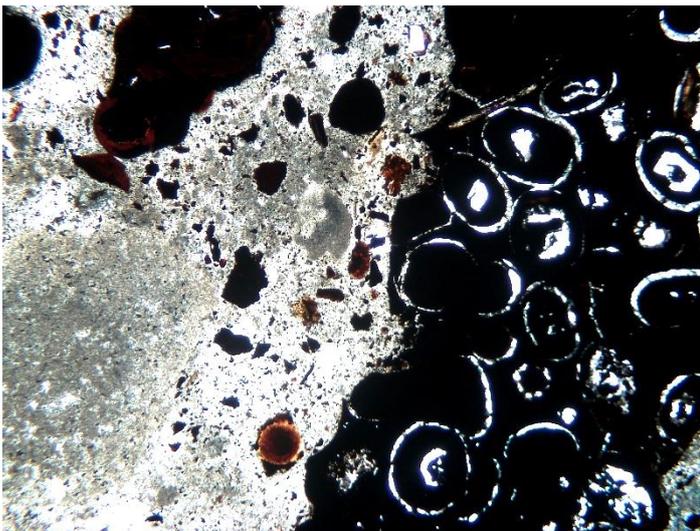
Plate No. 19:

A view in plain polarised light (ppl) of a dense area of paste, left side of image, in which a fully slaked lime inclusion can be seen, this has an angular outline, and it is fully encapsulated in a fully carbonated paste. This contains an abundance of opaque particles. The right side of the image is filled by a partially burnt ironstone particle. The paste in the upper centre also contains an abundance of fine ash particles, none of which appear to have reacted with the paste at this location, i.e. no pozzolanic activity. Porosity is highlighted by the blue dyed resin. Field of view 2.4mm.

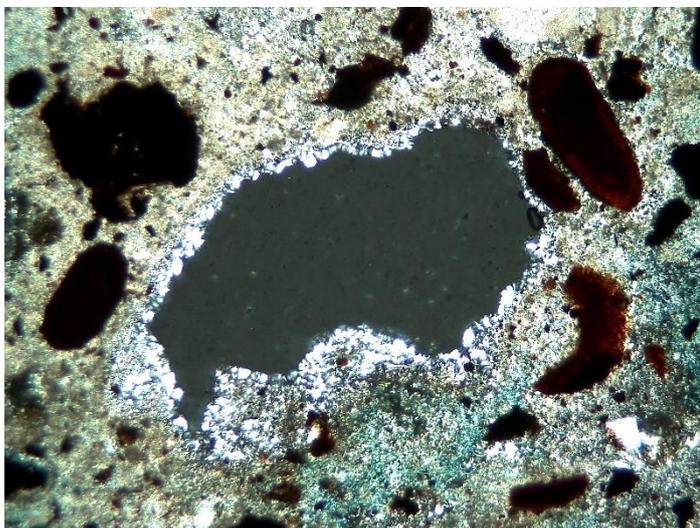
Plate No. 20:

A view in xpl, of a void rimmed with a heavy growth of secondary minerals dominated by calcite with minor sulphate minerals. The surrounding paste is fully carbonated and contains small coal and clinker fragments along with ash clusters, the latter mostly in the lower centre and right. A patchy discoloration can be seen adjacent to a number of the opaque minerals and this may be indicative of pozzolanic reactions having occurred. Porosity, the blue impregnating resin and opaque minerals all appear black in xpl. Field of view 1.2mm.

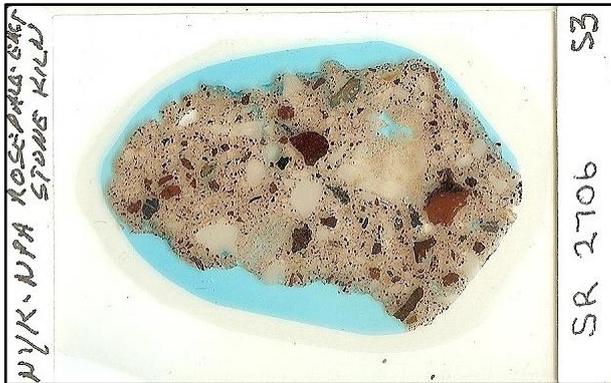
Plate No. 21:

This thin section was prepared from an intact piece of mortar from sample SR2706-S3 (RESK3).

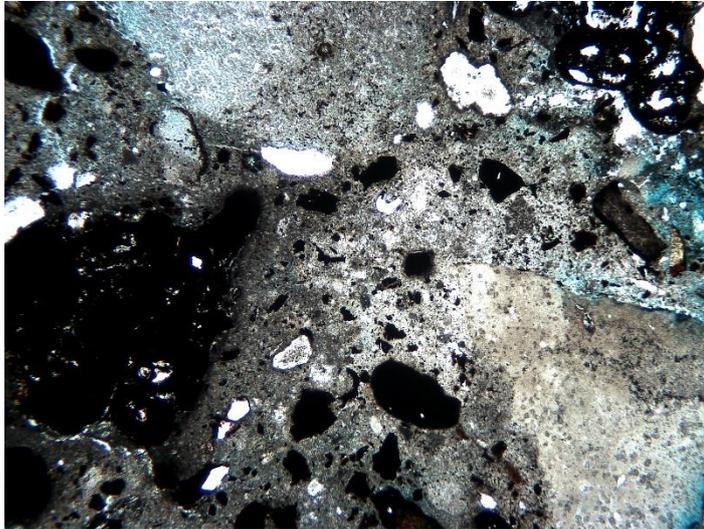
Plate No. 22:

A view in plane polarised light (ppl) of a typical area of the mortar. This shows a partially calcined and partially slaked, but not diffused, lime inclusion in the right side of the plate, this has performed as an aggregate in the mortar. A fully calcined but partially slaked, but locally diffused lime inclusion can be seen in the upper left. Aggregates in view include coal ash clinker, lower left, with fine coal and ironstone fragments, lower centre, upper left and right. Ash clusters can be seen in the centre and upper right of centre. The paste is dense and is fully carbonated. Porosity is highlighted by the blue dyed resin. Field of view 2.4mm.

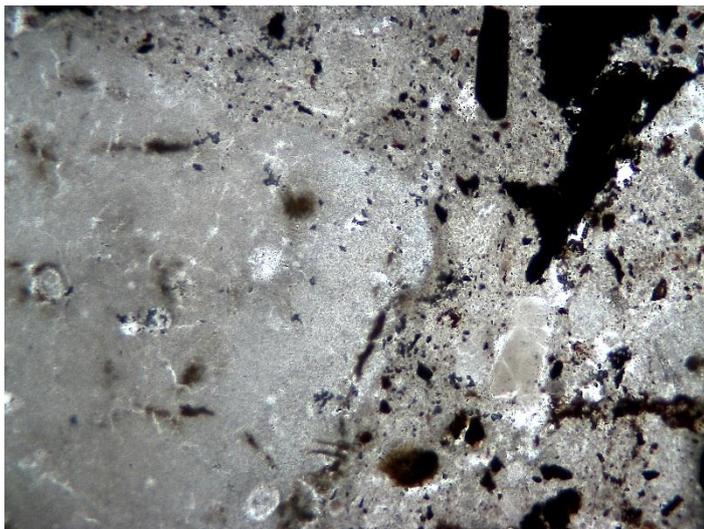
Plate No. 23:

A magnified view in ppl of fully slaked lime inclusion which fills the left part of the plate. Although fully calcined it is not fully hydrated. This contains some fine impurities. This inclusion displays a sharp outer margin and acts as an aggregate and does not diffuse into the paste. The paste in the right and upper centre is dense and well compacted, it is fully carbonated and contains small patches of fully hydrated lime (putty). Aggregates in view are mostly coal clinker and ash, with only minor evidence of any reactions occurring. Porosity and voids are highlighted by the blue dyed resin. Field of view 1.2mm.

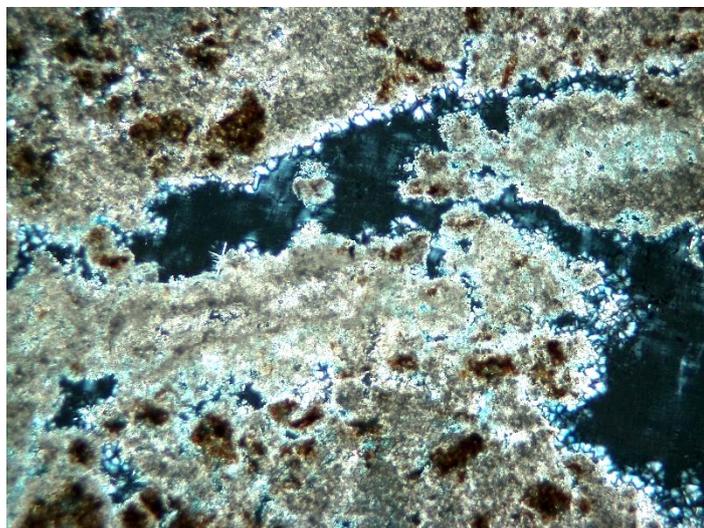
Plate No. 24:

All of the wider cracks are lined with secondary minerals, including both coarse calcite crystals and fine needle shaped sulphate minerals. These channel ways, therefore, appear to have functioned as water percolation channel ways, with water having accessed the mortar through them over an extended period of time.

A view in Cross Polarised Light (xpl), of an area of the mortar containing wide cracks that have acted as water percolating channel ways. The binder is locally depleted in the adjacent paste with coatings of calcite and gypsum crystals providing a white fringe to the channel way margins and connecting voids. The paste contains minor clinker and ash grains, some of which show reaction rim, indicating that a pozzolanic reaction had occurred. Porosity, the blue impregnating resin and opaque minerals all appear black in xpl. Field of view 1.2mm.
