**THE INFLUENCE OF CONTAMINATION ON THE FATIGUE
PERFORMANCE OF ELECTROFUSION JOINTS**

A thesis submitted for the degree of Engineering Doctorate of the
University of Sheffield

Department of Mechanical Engineering

December 2014

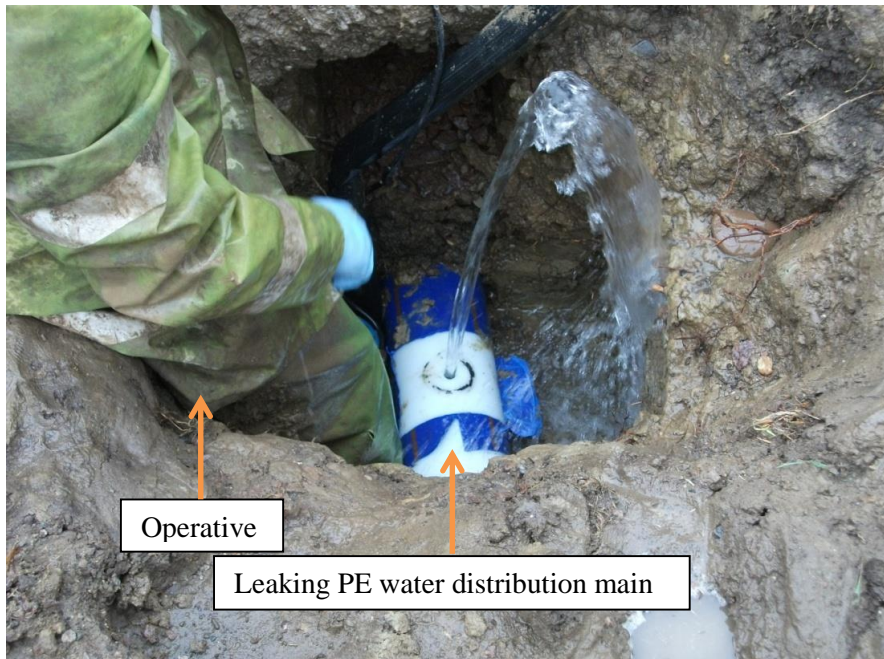
Figure 1-14 Tapping-tee failure causing leak to mains pipe

Figure 1-14 shows a failed tapping tee being repaired by the operative (left in Figure 1-14). It shall be noted that this example depicts a repair scenario and therefore not a new installation. The purpose of this example is to show the potential conditions that operatives may be required to work in. Specific attention should be paid to the depth as well as the overall size of the excavation. In this particular case, the failed electrofusion tapping tee (Figure 1-15) was replaced using a mechanical fitting.

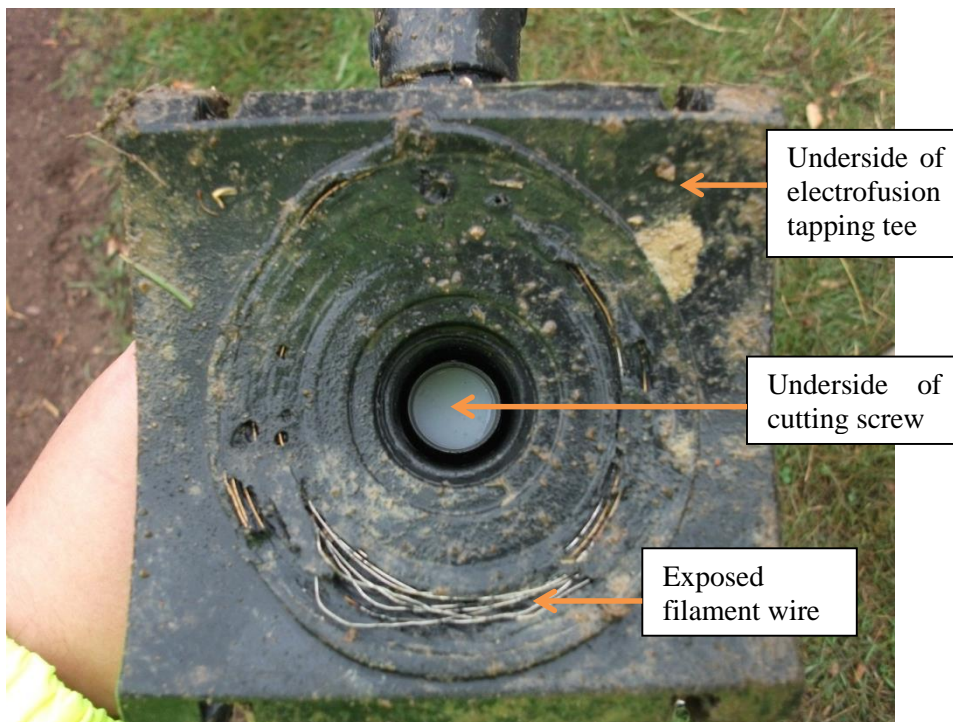
Figure 1-15 Failed tapping-tee (underside)

From observing Figure 1-15, small marks of the black top-tee are visible on the white pipe; which suggest that the failure was of a brittle nature as there are no remnants of the white pipe on the underside of the tapping tee.

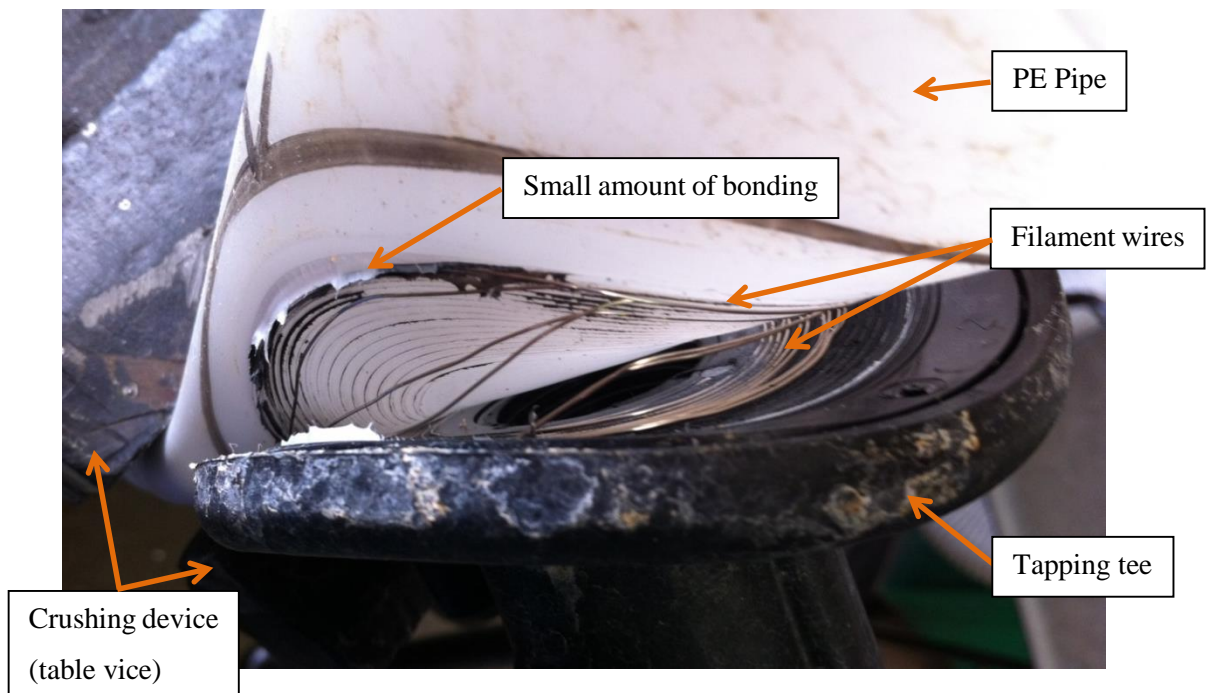
Figure 5-1 Aerial view of specimen post-crush test

Specimen L was contaminated with talc and subject to the crush decohesion test specified in ISO 13955 [60]. Figure 5-1 shows an aerial view of the pipe and fitting when the crushing device reached its maximum distance. As can be seen in Figure 5-1, very little bonding took place between pipe and fitting. Many of the filament wires were embedded into the pipe and it was assumed initially that these wires were offering some structural strength to the joint assembly despite being contaminated with talc.

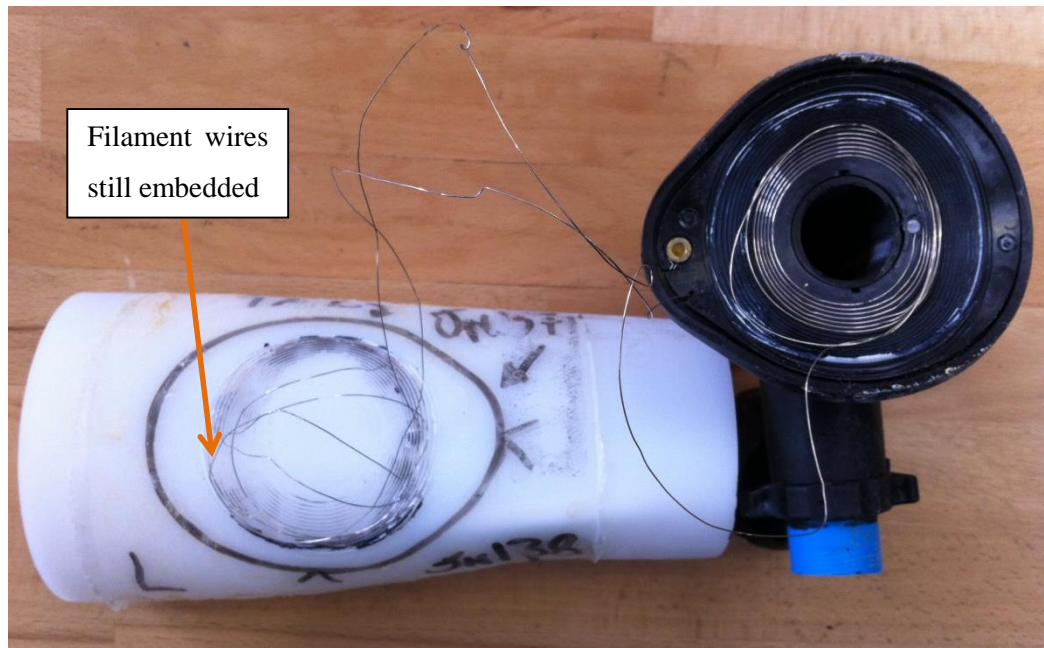
Figure 5-2 Talced specimen removed from crushing device

the outer circumference of the fusion interface; more specifically, either side of the indentations on the parent pipe created by the filament wires during the welding process.

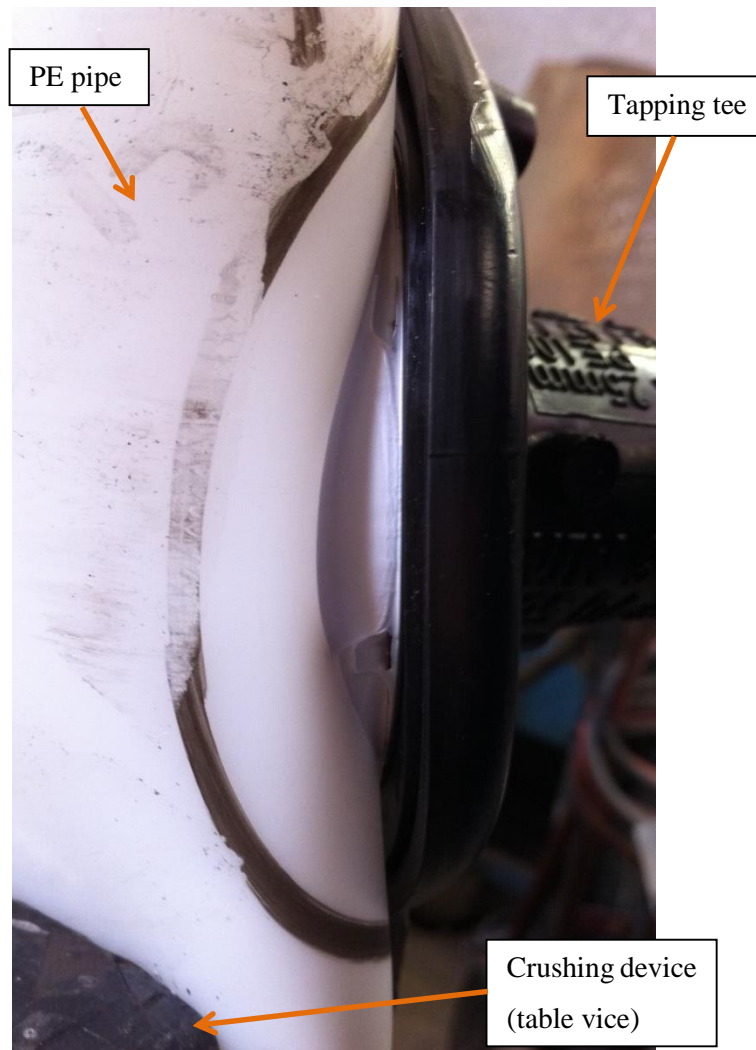
Figure 5-3 Post-crush of 'perfect' specimen

As a comparison, the crush test was conducted on a specimen that was welded to best practice. Figure 5-3 shows the specimen after it has been subject to the full extent of the crushing device. As can be seen, the specimen was just beginning to fail on the outer part of the fusion zone but still remains fully adhered to the PE pipe when the maximum crushing distance is reached; suggesting that a ductile failure would occur.

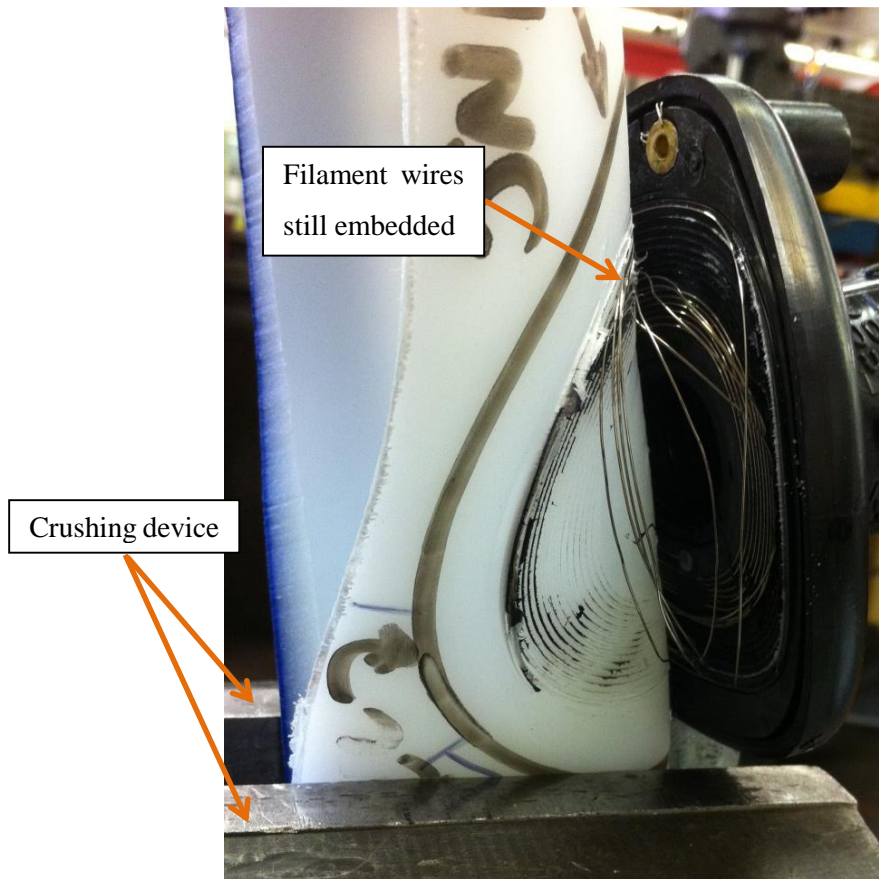
Figure 5-12 Specimen X during crush test

Similarly to Figure 5-1, specimen X quickly came away from the host pipe when it was subject to the crushing device (see Figure 5-12). Once the maximum crushing distance was achieved, the fitting was completely removed from the parent pipe by forcing the tapping tee away from the pipe by hand. Again, very little physical force was required to achieve this.

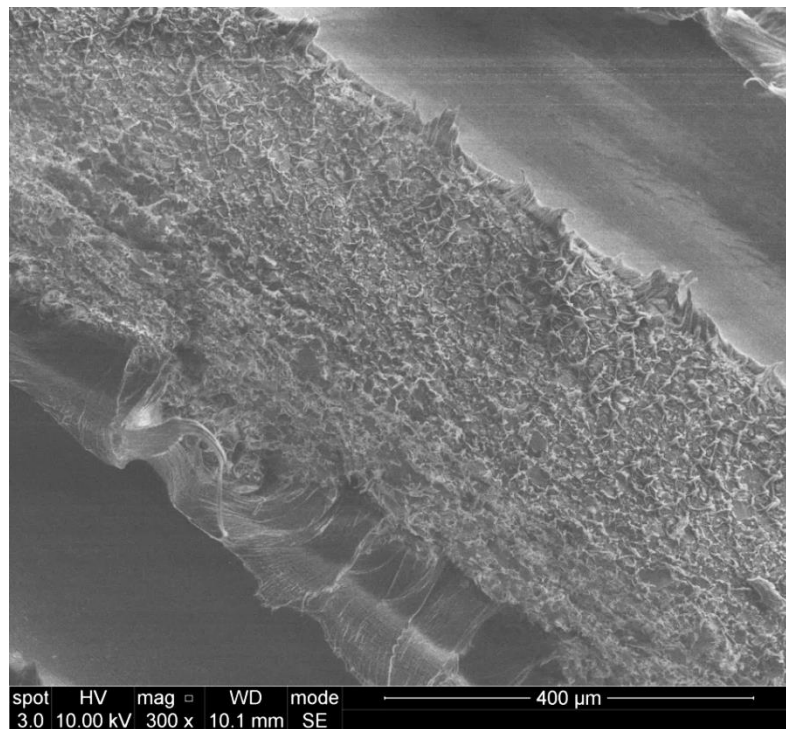
Figure 5-19 Sample 1 (x300 magnification)

A closer inspection of the area between the filament wire indentations can be seen in Figure 5-19. At the brink of the U-valleys there appears to be some elongation of polymer which suggests some ductility. In contrast, the centre of Figure 5-19 shows the failure-surface to be more brittle.

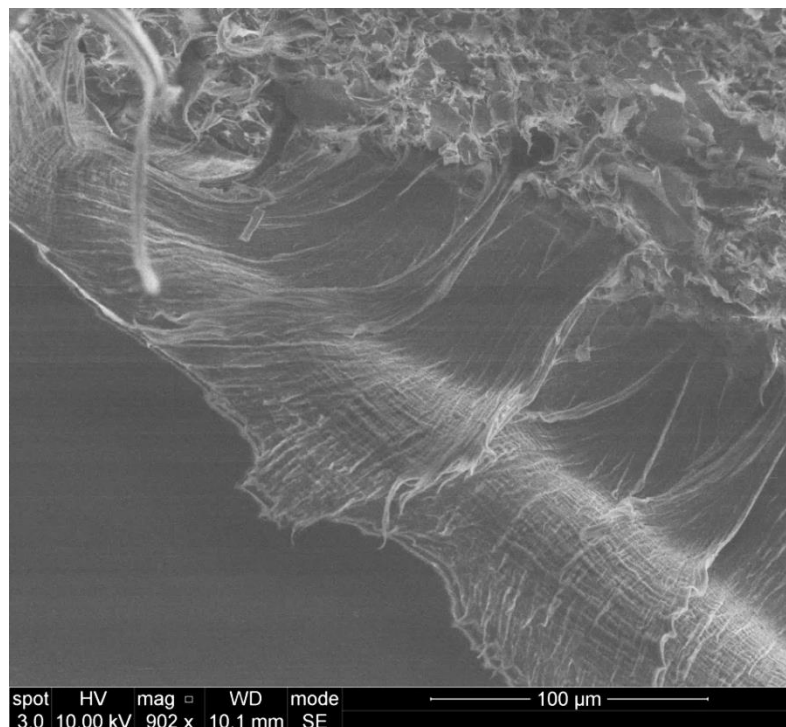
Figure 5-20 Sample 1 (x902 magnification)

Closer inspection of a ductile area at the threshold of the U-valley gives a clearer idea of the extent of ductility present in this region.

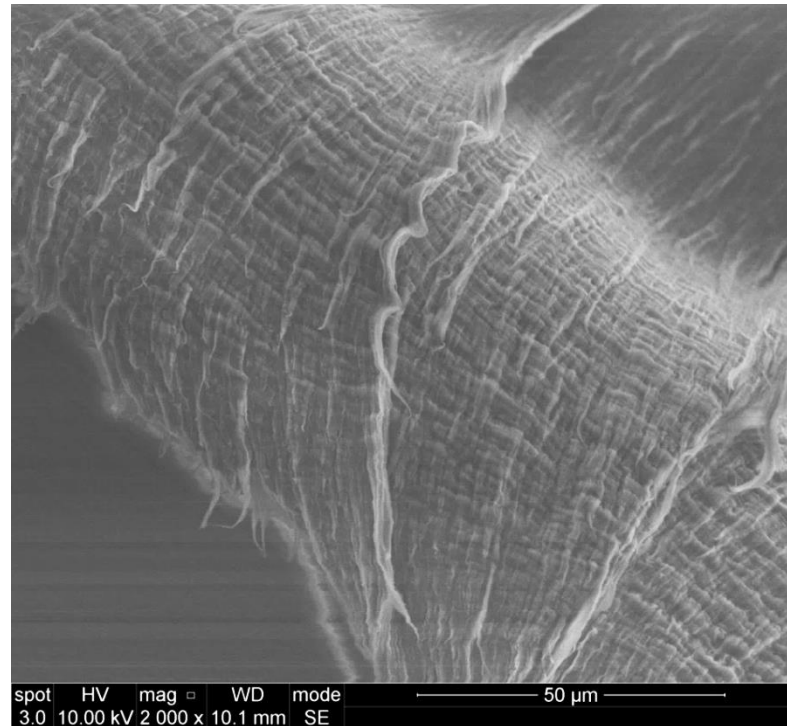
Figure 5-21 Sample 1 (x2000 magnification)

Figure 5-21 shows a ripple effect on a ductile elongation evident at 2000 times magnification; likely to be caused by the opening effect of the crush test. If this small area of the joint was adhered post-weld then it is likely that this type of failure can be expected when the tapping tee is subject to the crushing decohesion test.

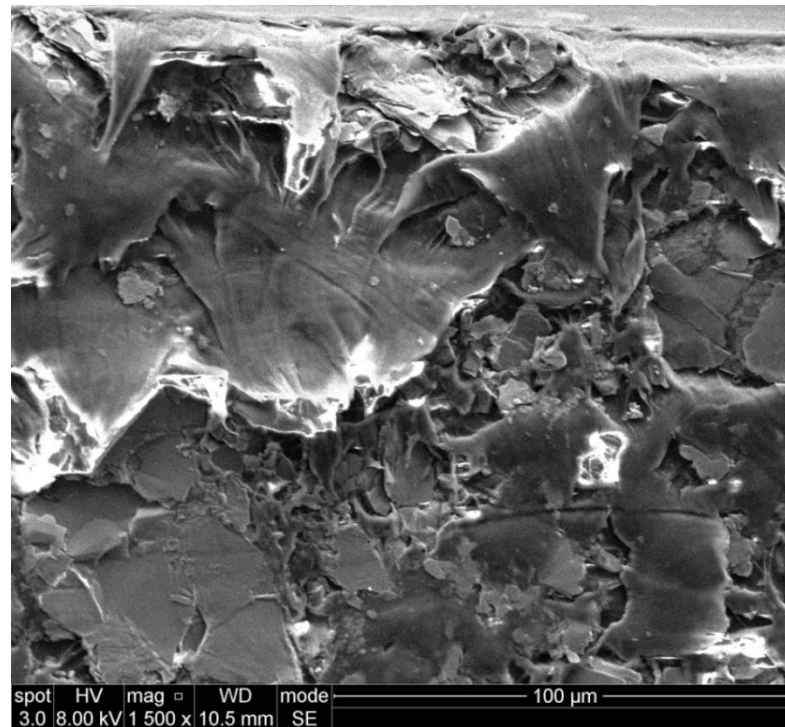
Figure 5-29 Sample 3 (x1500 magnification)

Figure 5-29 gives an indication of the brittle surface at 1500 time magnification.
