Misconnection Project Plan

For the initial trial, four outfalls along the tongue gutter water course located in Parsons Cross, Sheffield were chosen. Initial tests at the outfalls had shown there were misconnections somewhere in these systems.

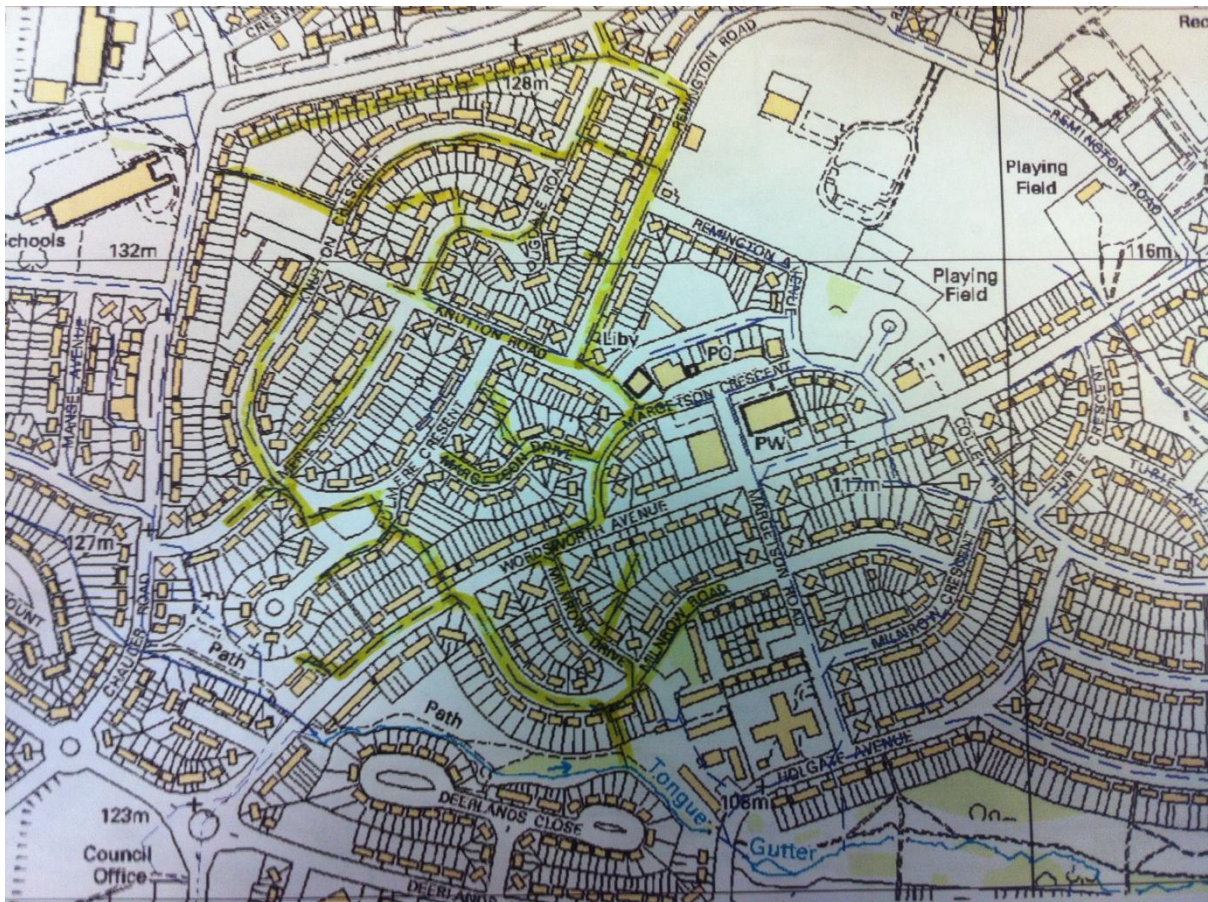
The first outfall tested was located on Milnrow Road, by No. 38. Initial tests indicated a misconnection in this system, but a visual survey of the outfall wasn't conclusive, so fourteen manholes were identified to place cotton samples in.

The system has two clear, left and right branches which is particularly interesting for this identification method.

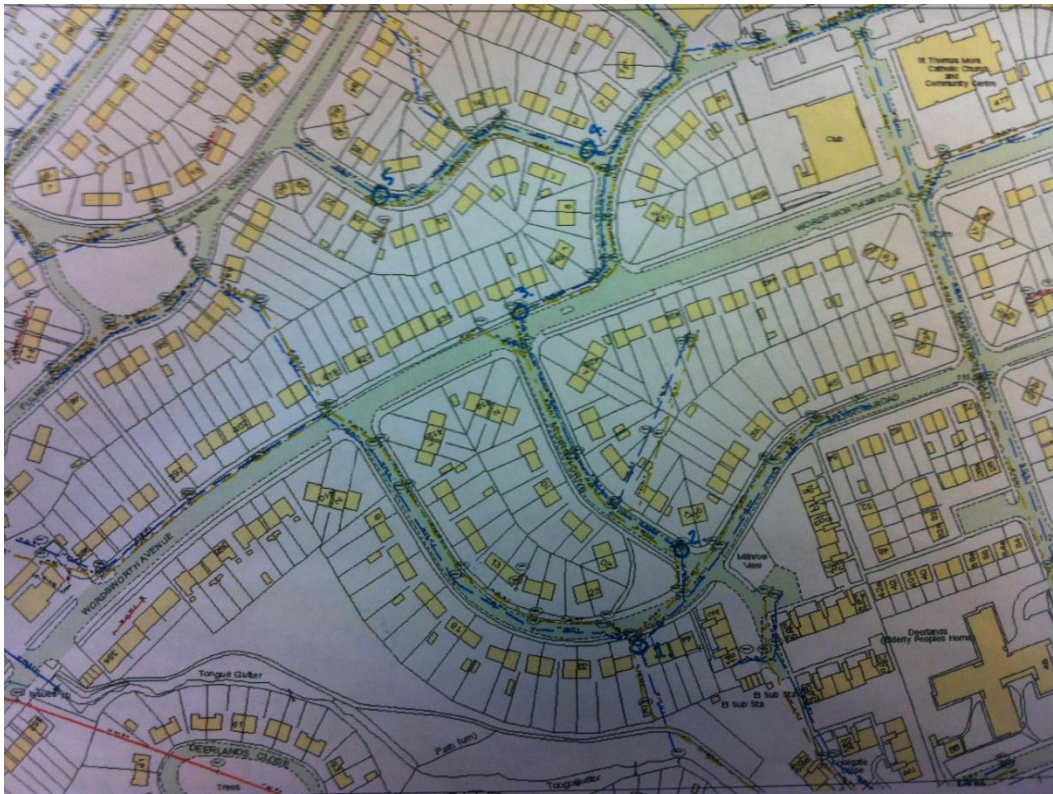
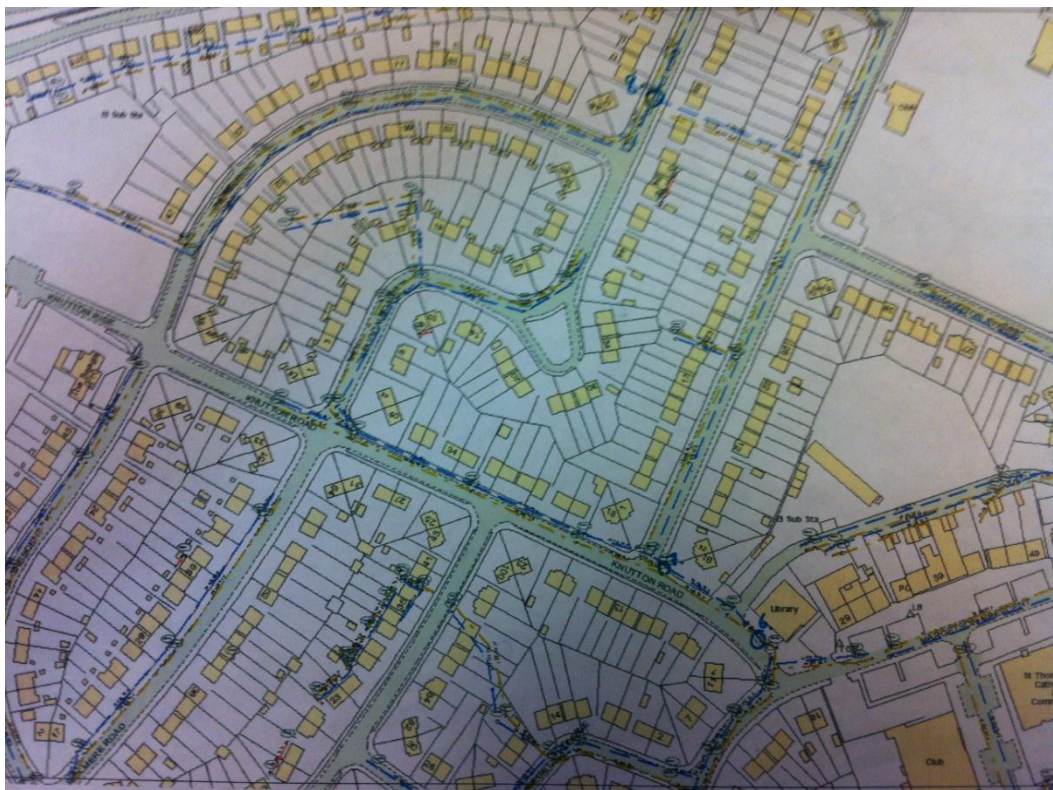
The right hand branch, shown here has eight manholes;

Originally, ten manholes were planned but once on site it was impossible to lift the manholes due to their age.

On the right hand branch the method has naturally narrowed it down to a very small area. The misconnection is between manhole 6 and manhole 7 on Knutton road. You can say for certain that there is a misconnection here, but there may also be further misconnections further down the system that cannot be detected until this one is resolved.

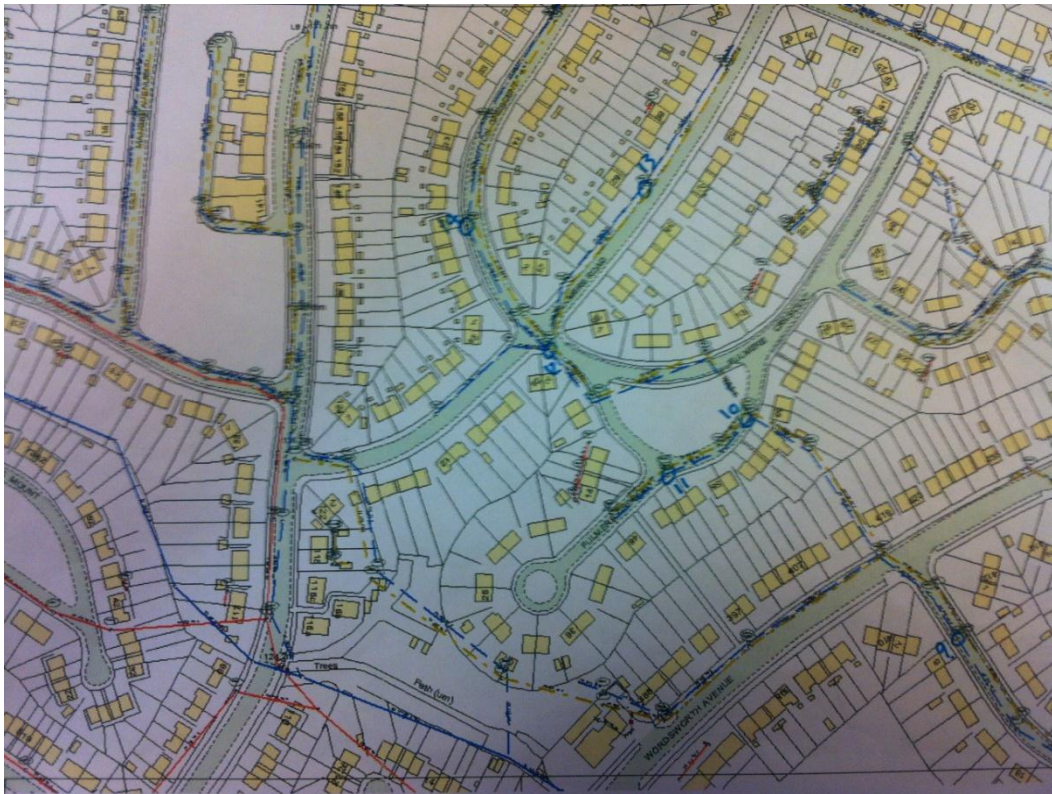
The left hand branch has 6 manholes;

The left hand branch also had a positive result for misconnection, this occurred near the start of the system. Manhole 9 gave a positive result but manhole 10 was negative. So the misconnection is either between number 385 and 419 on Wordsworth Avenue or its on Milnrow Road.

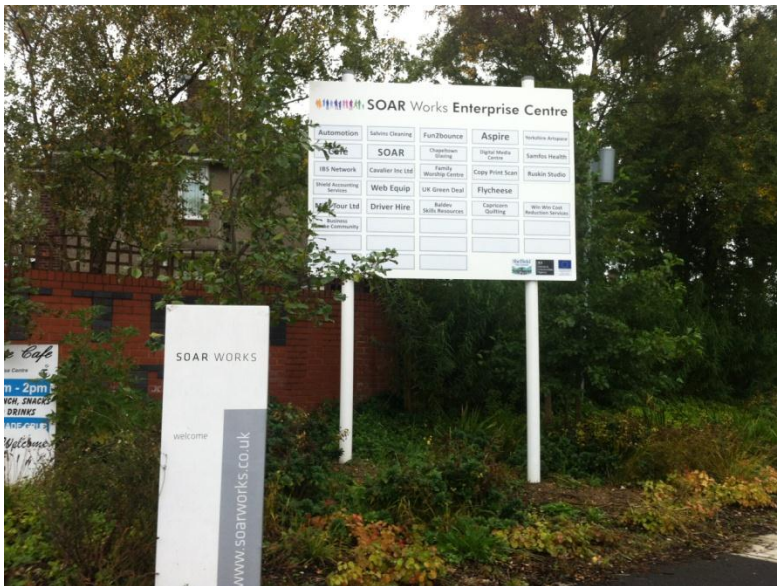
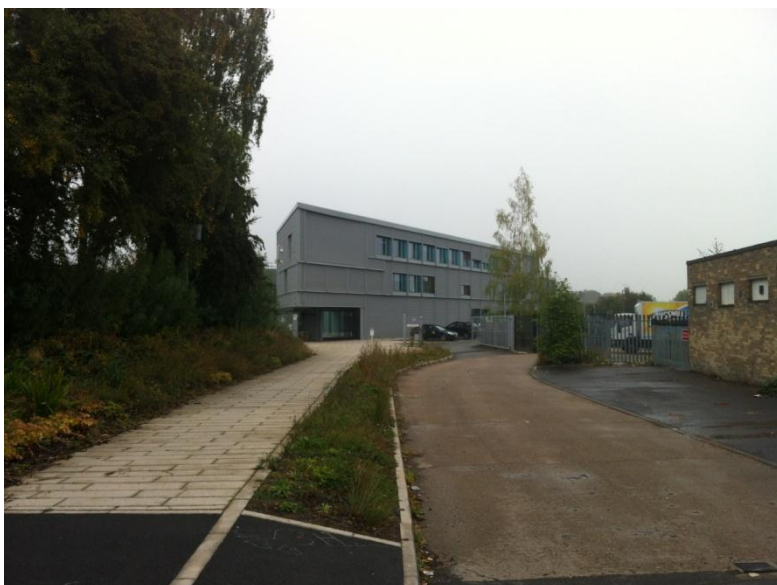
The small length of pipe between manhole 6 and 7 serves a recently built enterprise centre that isn't on our maps called SOAR Works.

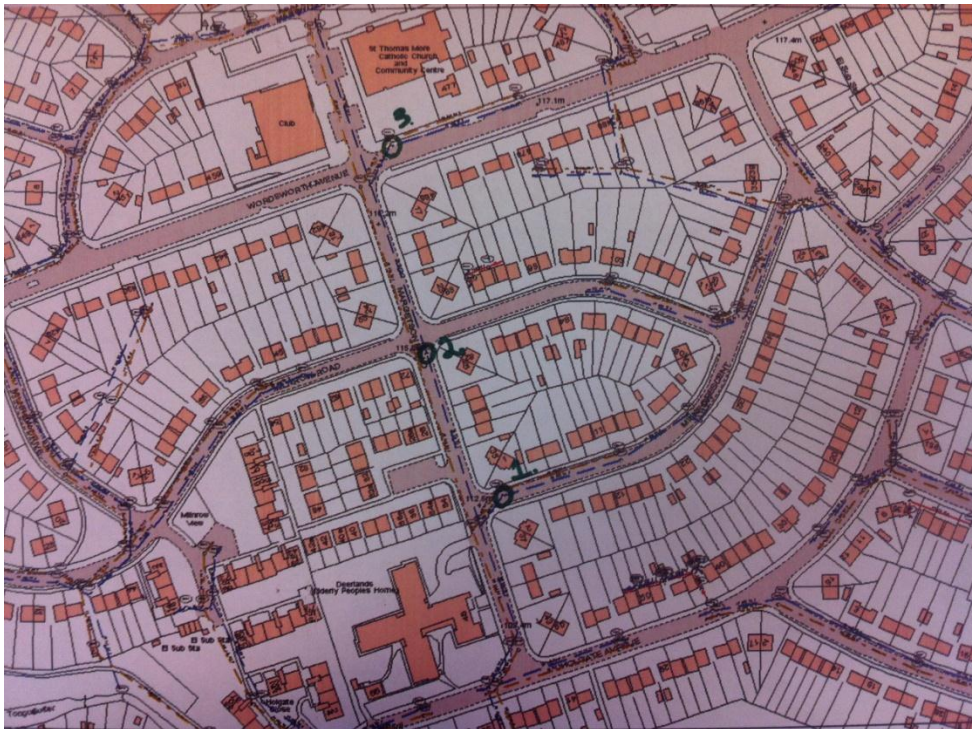
Outfall 2 is located at the bottom of Margetson Road and is quite a small system, only servicing five roads, although only serving a small amount of houses, initial tests at the outfall indicated a misconnection in the system. Five manholes were chosen to place samples in but once on site three of them were impossible to lift so an alternative manhole was chosen alongside the two originals. The samples were placed on the morning of 26/09/2013 and collected again on the morning of 01/10/2013, giving a five day sampling period. This slightly longer sampling period is not ideal as it gives the possibility for fouling of the samples but logistical problems meant this was the shortest period possible. As it is a small system with a low flow there was no fouling.

As there was only a small amount of samples in this system, the only place there is a misconnection for sure is on Milnrow Crescent as manhole 1 tested positive for optical brighteners. There could potentially be a misconnection at the bottom of Margetson Road but at the top of Margetson Road and onto Wordsworth Avenue there are no misconnections.

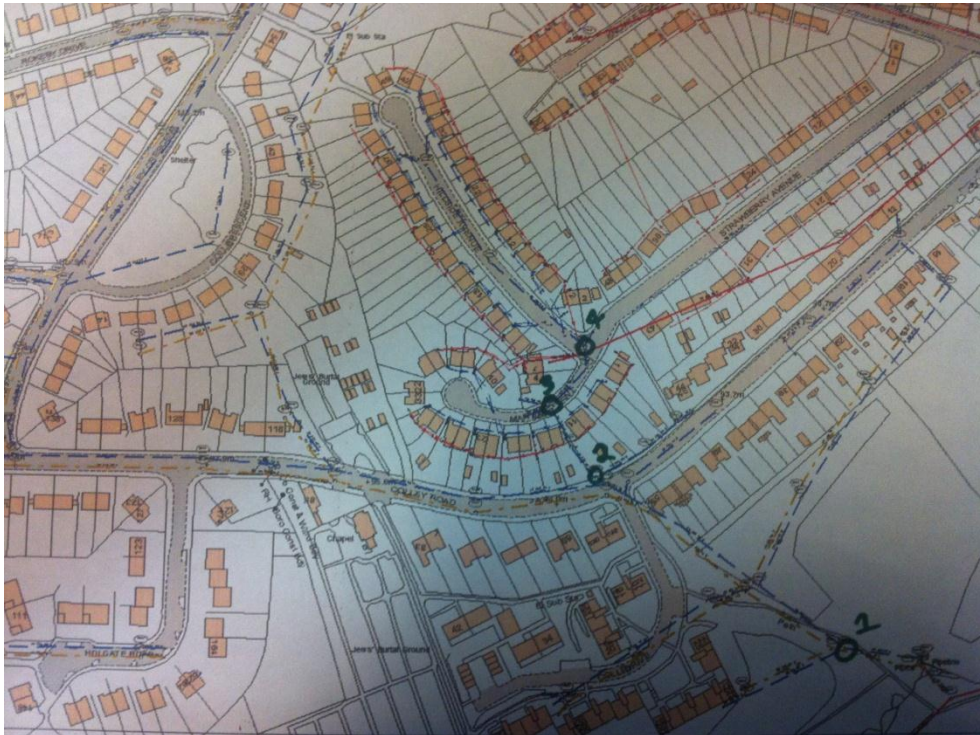
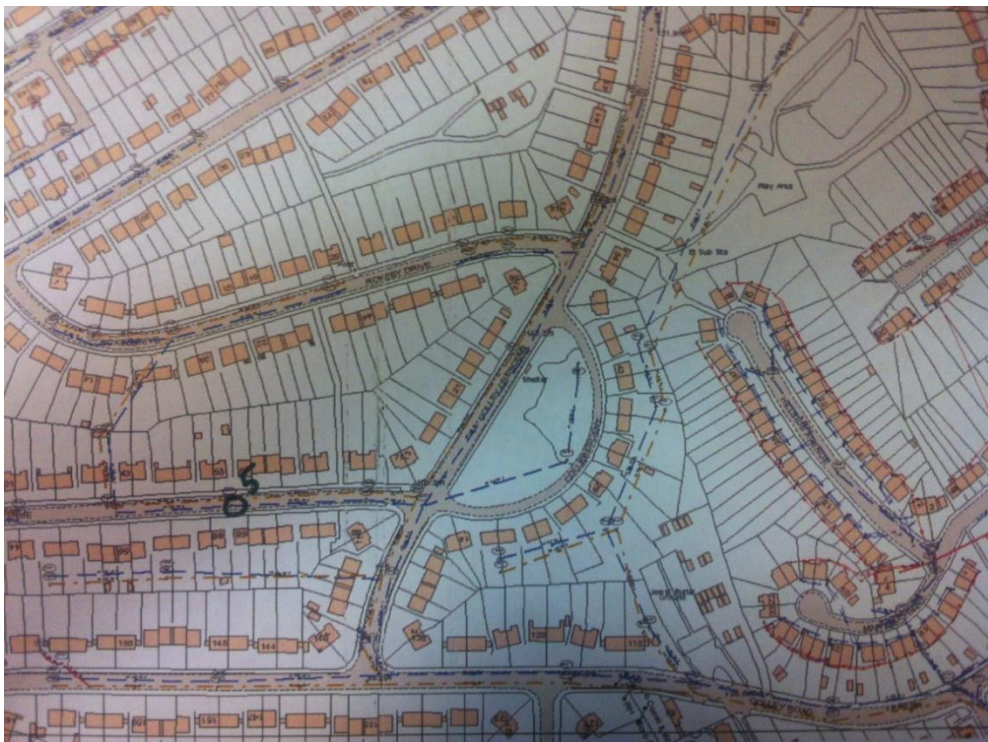
Outfall 4 is located just off Colley Drive, and is quite a large system. Again initial tests indicated that there was a misconnection in this system. Initially fifteen manhole sites were chosen to place samples in. Unfortunately once on site Colley Road had recently been resurfaced and the manholes had been covered over so it was not possible to place samples. There were then a further few manholes that couldn't be lifted because of their age. On the day it was only possible to place five samples which makes it very difficult to identify the area of the misconnection.

The results we got from this sampling group do narrow down the area the misconnection is in slightly. It can be said for certain the misconnection is not in Hillside Avenue or Martin Crescent. The results show that there is a misconnection either on Colley Avenue or the road behind; Rokeby Drive. Along with this misconnection it is possible that there is an additional misconnection somewhere along Colley Road.
