**Department
Of
Mechanical
Engineering**

**INVESTIGATION AND
CHARACTERISATION OF THE WEAR
MECHANISMS OF ABRADABLE
COMPRESSOR LININGS**

Thesis submitted for the Degree of Doctor of Philosophy

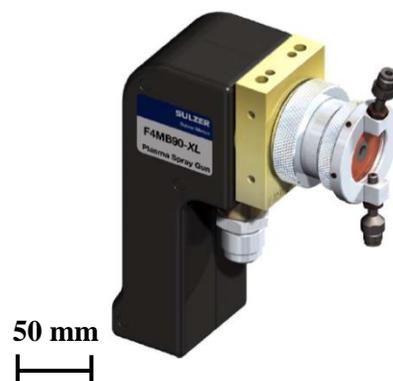
The coating was produced using thermal spray equipment. The equipment comprised a spray gun, a controller and a material feeder. The spray gun was a plasma gun Sulzer Metco F4 (Sulzer Metco, Switzerland), which is operated with a maximum rated power of 55kW and is typically used in the aero-engine industry [69]. Figure 3.2 shows the Sulzer Metco F4 MB90 –XL which was used to thermally spray the coating.

Figure 3.2. Sulzer Metco gun F4 MB90-XL [69].

The model used was right-angled, thus the angle of spray was 90°; it operated with combinations of argon and hydrogen, which were used for the primary and secondary gas flows respectively. Table 3.1 summarises the main spray gun specifications.

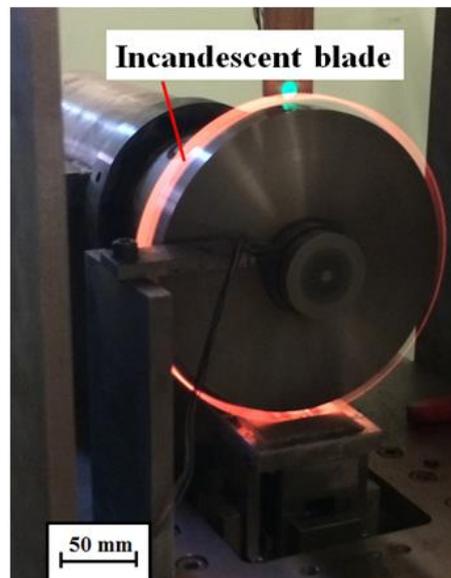
In the regions of wear in the wear map, on the soft coating at low incursion rate that corresponded to a low value of Peclet number, the blade rubbed and deformed the material, highlighted by the force ratio and the material response. The difficulty in removing material implied generation of heat in the contact, which had difficulty to penetrate into the coating because the coating had low thermal conductivity. Thus the insulated heat remained in the coating surface, and successive blade strikes interacted with the consolidate layer, a harder layer, and the force and the heat increased, and therefore the normal force was recorded as continuously increasing, until a significant heat started to penetrate into the blade and it started to melt. The thermal damage of the blade was suggested from various observations, namely the titanium transfer layer measured on the coating rub surface, the blade wear and the high level of thermal damage on the blade tip, the high level of consolidation observed with the material response, and finally from an image of the test rig captured during the test where an incandescent rotating blade was observed, as shown in Figure 9.11.

Figure 9.11. Image of the test rig during the test performed with coating hardness R15Y 54.6, incursion rate of $0.02\mu\text{m pass}^{-1}$ at blade speed of 100m s^{-1} .

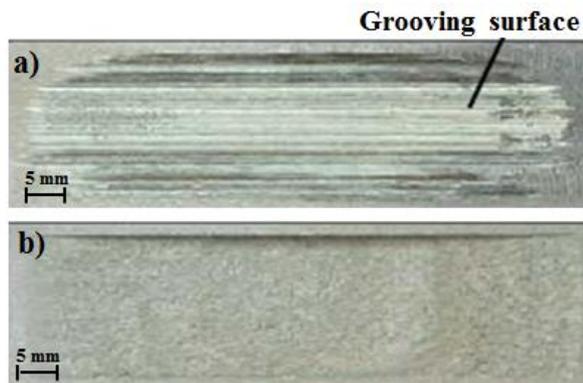
Additionally, the test rig used and developed during this research was a small-scale version of the full dimension test rig in order to be able to monitor the contact between the rotating blade and the coating and characterise the wear mechanism. The scaled dimensions did not represent a real issue, as the important aspect was to reproduce the same contact conditions, and these were obtained during this research. As highlighted in Figure 9.17, the rub surface obtained with the full dimension test rig had a grooving surface and well-cut surface at low (Figure 9.17a) and high (Figure 9.17b) incursion rates respectively, at high speed, showing a similar wear mechanism to that observed during this research.

Figure 9.17. Wear mechanism observed with full test rig with abradable material AlSi-hBN and titanium blade (Ti-6Al-4V), a) Low incursion rate; b) High incursion rate (Data provided by Rolls Royce Surface Engineering Group).

Furthermore, during this research a flat titanium blade was used with the same design as for the full test rig, and additionally a flat substrate was used in order to simplify the contact. However, similar wear mechanisms were observed and characterised with a wider range of incursion rates and coating hardnesses.
