The  
University  
Of  
Sheffield.

Department  
Of  
Mechanical  
Engineering.

# **Development of a Novel Bearing Concept for Improved Wind Turbine Gearbox Reliability**

A thesis submitted in partial fulfilment of the requirements for the degree  
of Doctor of Philosophy

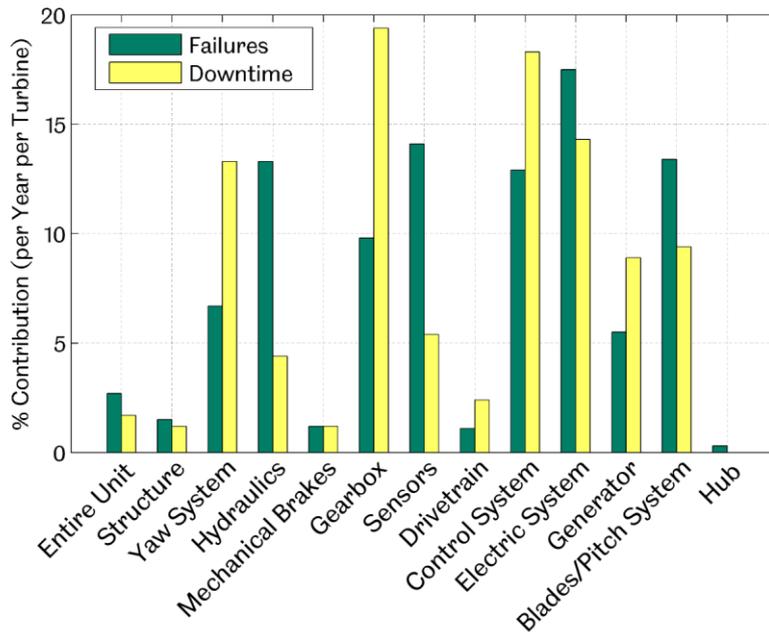
Figure 1.2: Distribution of failures and associated downtime per component recorded from a sample of Swedish wind turbines from 2000-2004 (adapted from [5])

Figure 1.2 presents data from a sample of around 650 wind turbines in Sweden recorded within the period 2000-2004 [5]. This provides a breakdown of failures and subsequent downtime per component recorded across the five year period as a percentage of the total system wide failure rates and downtime hours recorded respectively. The Wind Turbine Gearbox (WTGB) is particularly prominent here since, despite moderate failure rates, the downtime ensuing from such failures was found to be extremely high. Indeed, the average downtime resulting from a single gearbox failure was found to be equal to almost 257 hours, a significantly longer turnaround than that resulting from a control system failure, where total downtime was also similarly high, but an average single failure was found to have typically been resolved within around 185 hours by comparison.

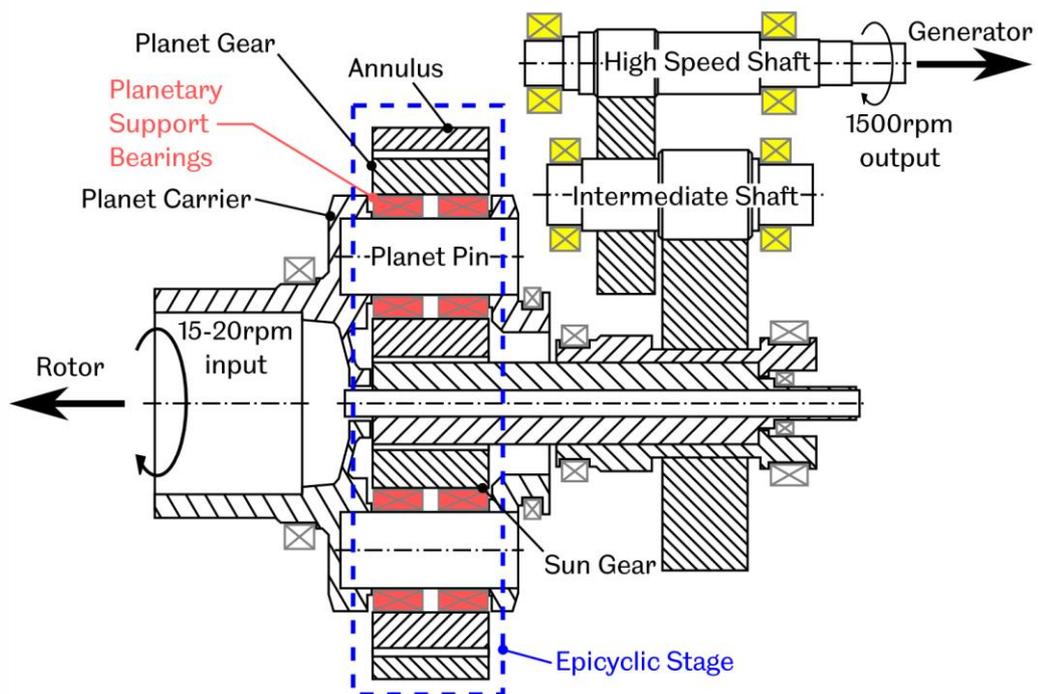
Figure 1.3: Cross section of a typical single stage planetary wind turbine gearbox illustrating critical locations for bearing failures (adapted from [8])

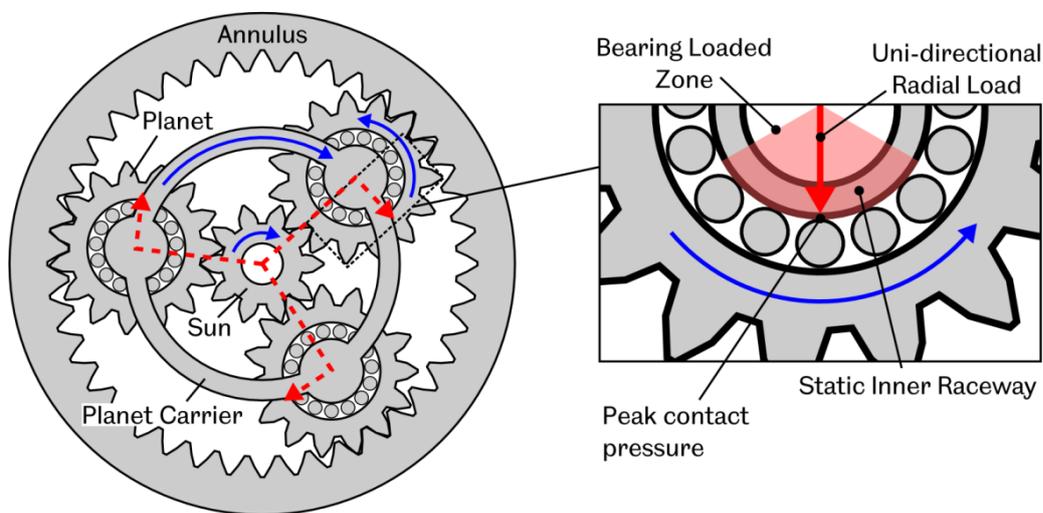
Figure 1.4: Illustration of the epicyclic stage of the WTGB and the loads induced upon the planetary support bearings from torque applied to the planet carrier

wear debris is introduced into the gearbox, which subsequently results in both misalignment issues and surface wear of gears themselves [9, 10]. Previous analysis has found that failures most frequently develop from planetary support bearings as well as intermediate and high speed shaft locating bearings [8, 10]. The location of the planetary support bearings are highlighted in red in Figure 1.3, and provide the key focus for this study. Here, cylindrical roller bearings are employed, where (as illustrated in Figure 1.4) inner raceways are static and mount directly to a planet pin, which rigidly couples to the planet carrier frame as shown in Figure 1.3. Subsequently, the bearing outer raceways rotate to permit rotation of the planet gears.

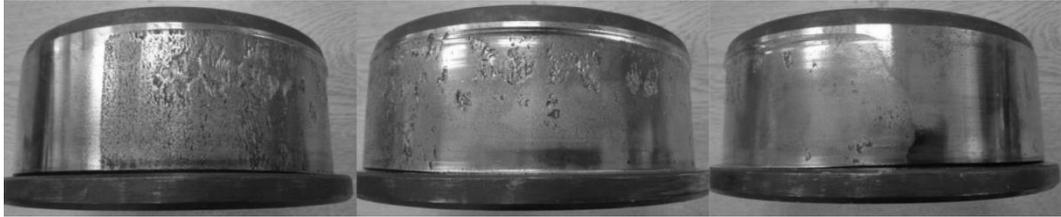
Figure 1.5 shows an ex-service planetary bearing inner raceway taken from a 600kW wind turbine gearbox. The failure mode here is typical of a planetary support bearing failure; where excessive spalling damage is observed across a localised portion of the inner raceway [11]. The localised nature of damage here is thought to be a consequence of such bearings having static inner raceways and applied load (resulting from the torque applied through the planet carrier) being purely radial and unidirectional (as shown in Figure 1.4). This is problematic, since the same portion of raceway material will always be under load, as dictated by the bearing loaded zone, and this localised raceway segment will therefore rapidly accrue a high number of rolling contact fatigue cycles as rollers repeatedly induce stresses in the material during bearing rotation. Effects are amplified here since contact between the inner raceway and rolling element is counter-formal and therefore stresses will be much higher

than those induced between the opposing outer raceway rolling element interface, despite both experiencing the same applied load.

Figure 1.5: Planetary support bearing inner raceway from a 600kW WTGB illustrating localised spalling damage across the bearing loaded zone (courtesy of T Bruce)

WTGB planetary bearing failures such as that observed in Figure 1.5 have been widely linked to an advanced rolling contact fatigue mechanism resulting in the formation of White Etching Cracks (WECs) within bearing materials [15]. The subsequent cyclic loading that then takes place during normal operation causes such cracks to propagate rapidly, resulting in a rolling surface failure via White Structure Flaking. Sub-surface initiation appears to be dominant for the case of planetary stage bearing failures specifically [16], and the initiation of WECs tends to be due to the presence of manganese sulphide (MnS) inclusions within the bearing steel [17].

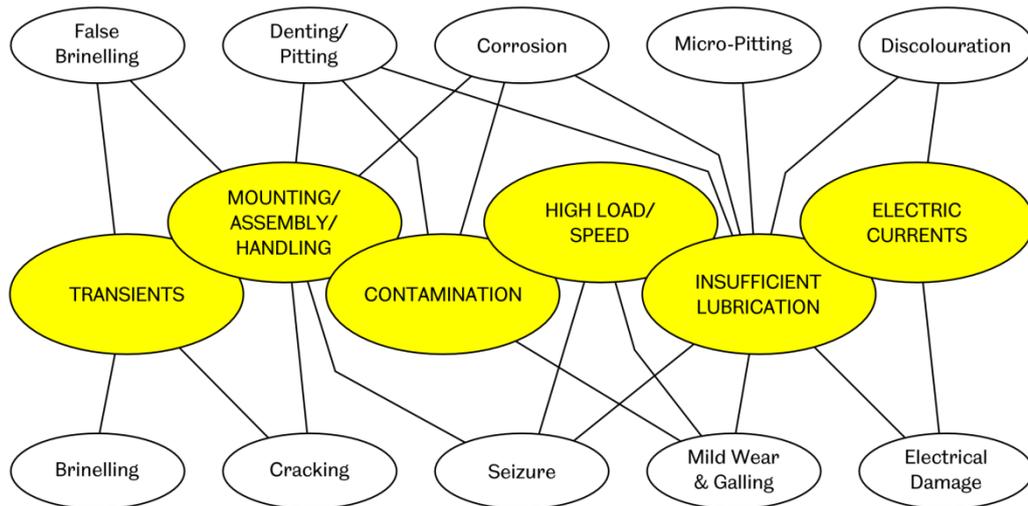
Figure 2.1: Typical bearing failure mechanisms resulting from associated off-design operational factors

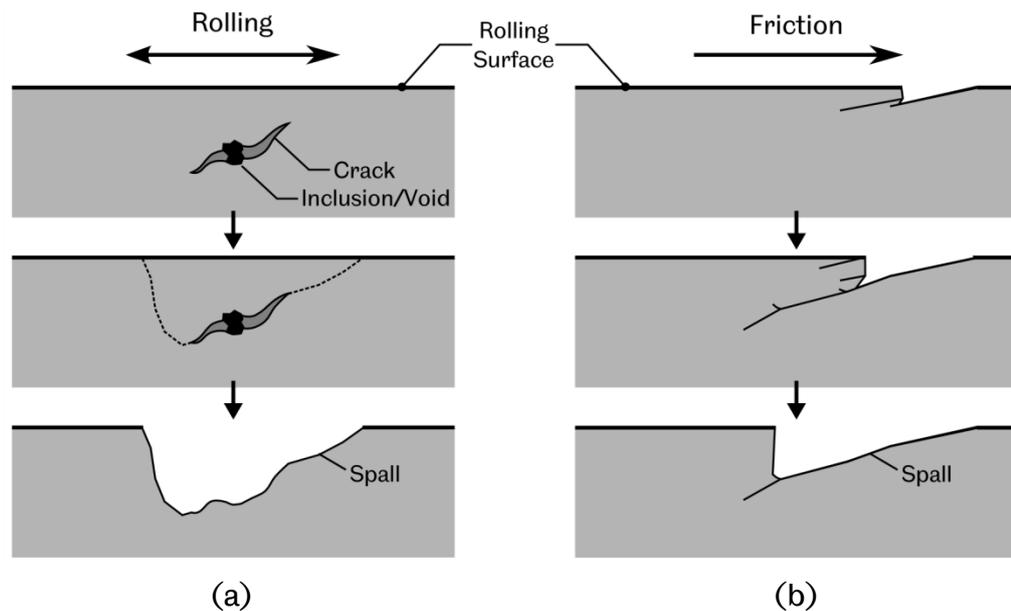
Figure 2.2: Illustration of (a) sub-surface and (b) surface initiated rolling contact fatigue resulting in surface spalling (adapted from [13, 17, 33])

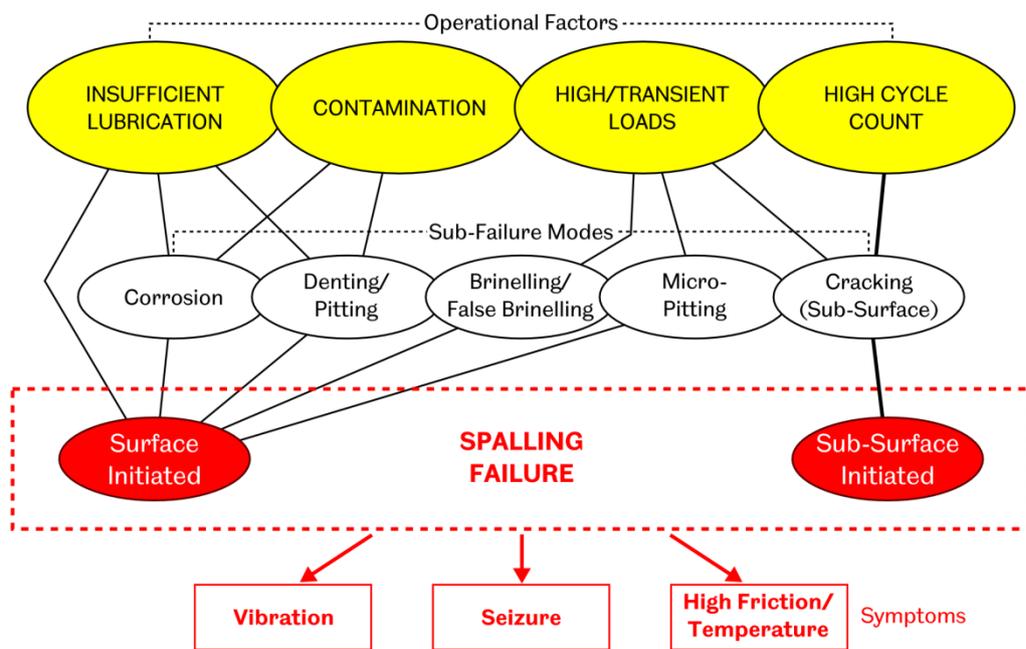
Figure 2.3: The process of bearing failure via rolling contact fatigue

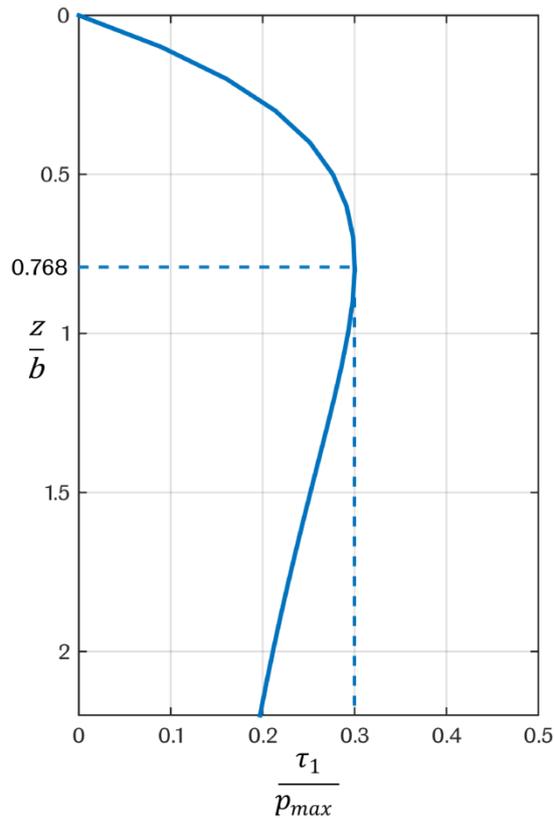
Figure 2.5: Maximum principal shear stress in the  $z$  axis ( $y = 0$ ) at various depths below the surface (reproduced from [29])

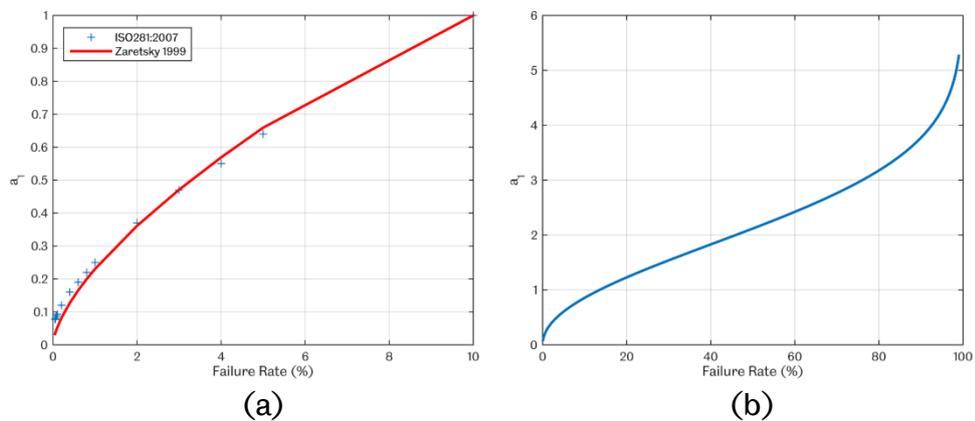
Figure 2.6: (a) Bearing life modification factors for reliability according to [12] as compared with earlier definitions, (b) extrapolation of  $a_1$  values for failure rates up to 99%

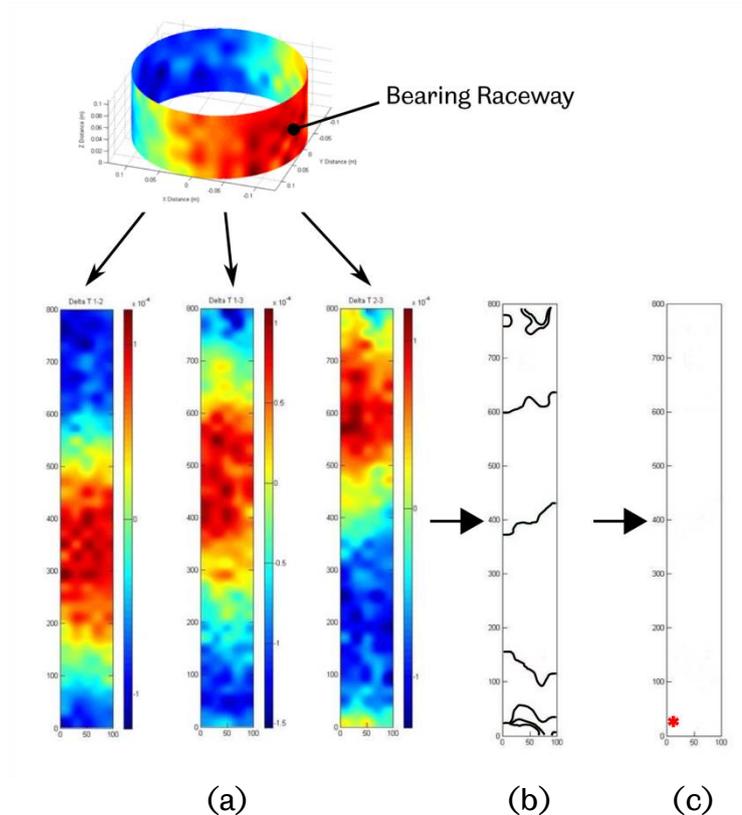
Figure 2.9: Location of a defect on a bearing raceway instrumented with three AE sensors (a) Intensity maps showing the difference in arrival times between sensor pairs 1 and 2, 2 and 3, and 1 and 3 (b) Possible locations based on signals from each sensor pair (c) ultimate defect location due to convergence in (b) (courtesy of J Naumann)

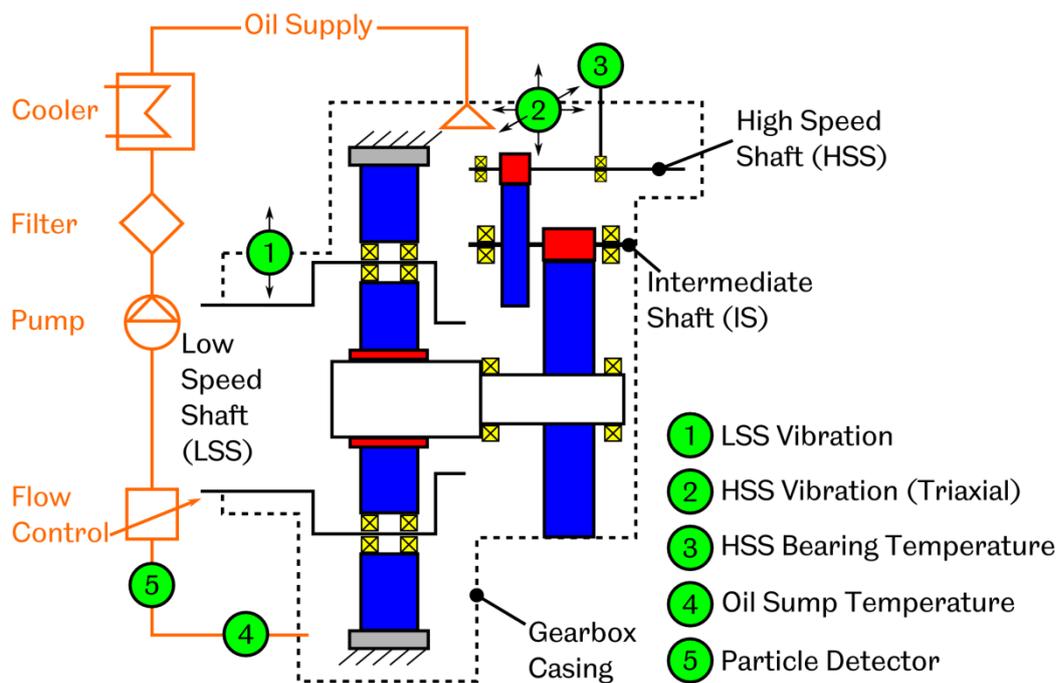
Figure 2.10: Standard WTGB sensors utilised in an advanced CM System (adapted from [61])

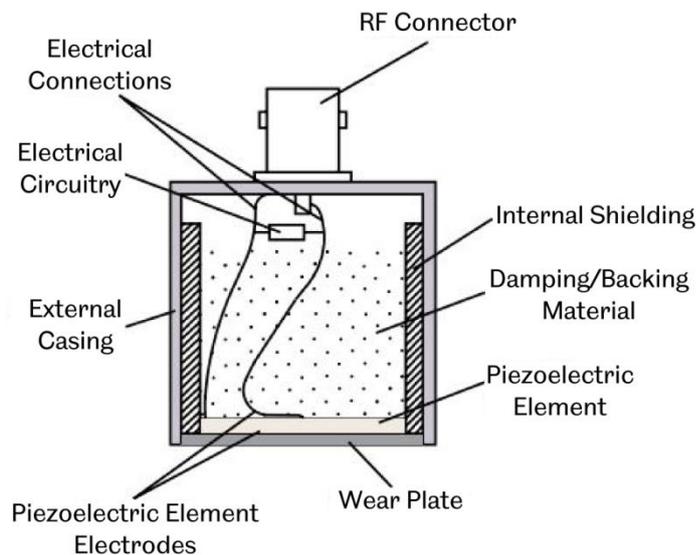
Figure 3.2: Composition of a standard commercial Ultrasound transducer (reproduced from [68])

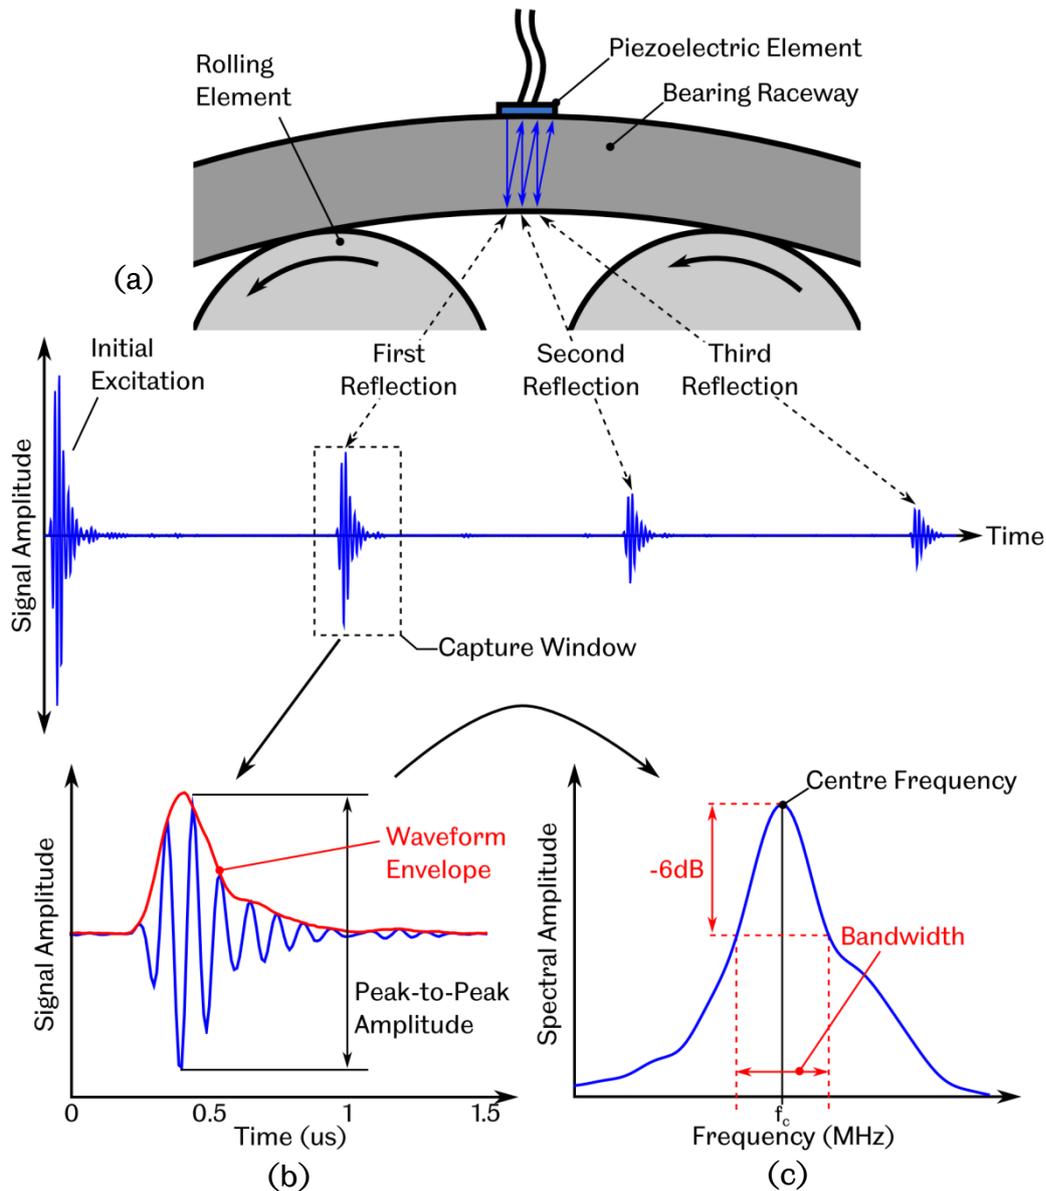
Figure 3.6: (a) Illustration of the ultrasonic reflections generated through a bearing raceway and further detail of the first reflection in both the (b) time and (c) frequency domain

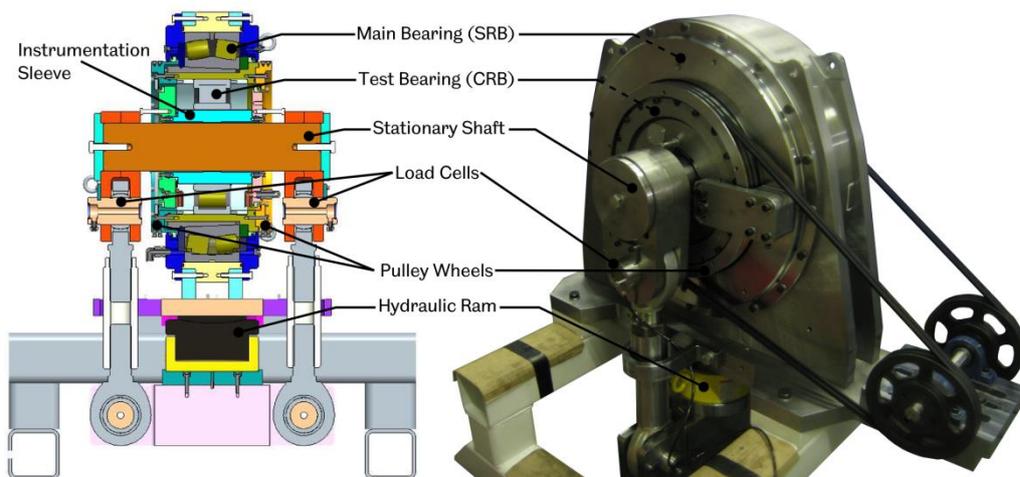
Figure 4.1: The MultiLife test rig

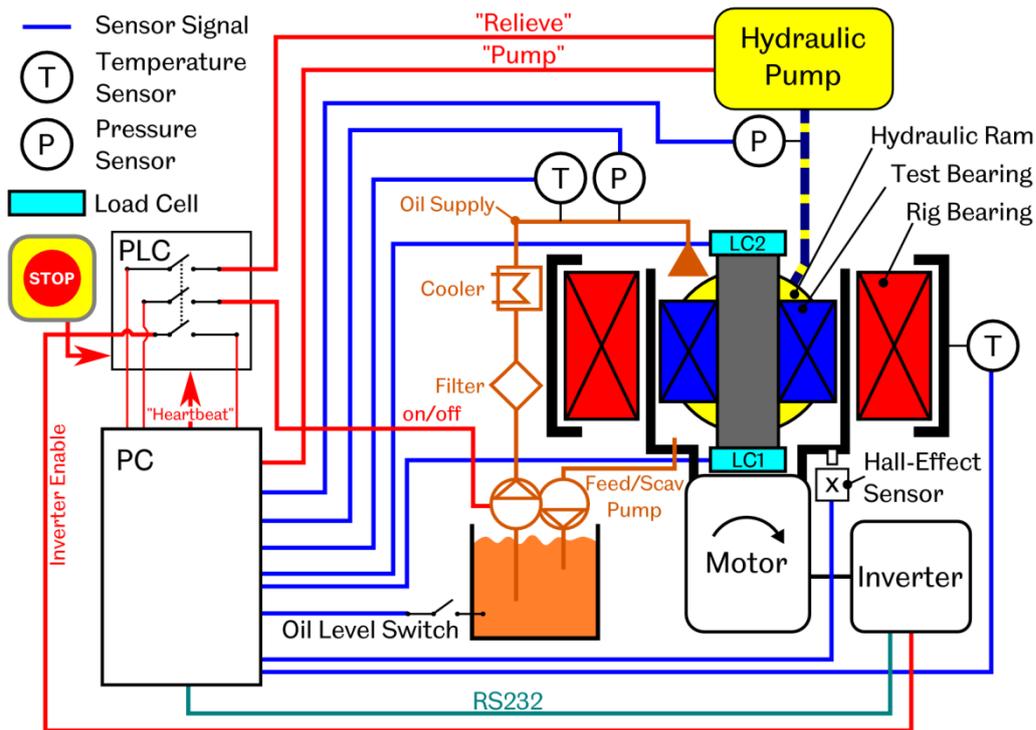
Figure 4.2: Schematic diagram of all test rig input and output signals for control of test parameters

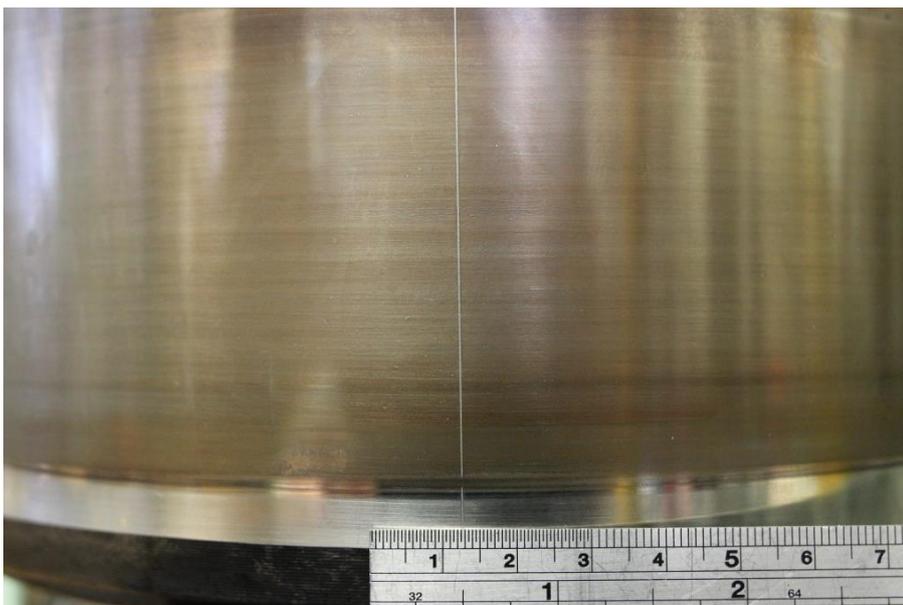
Figure 4.4: A test bearing inner raceway seeded with a geometric surface fault induced via wire-cut EDM

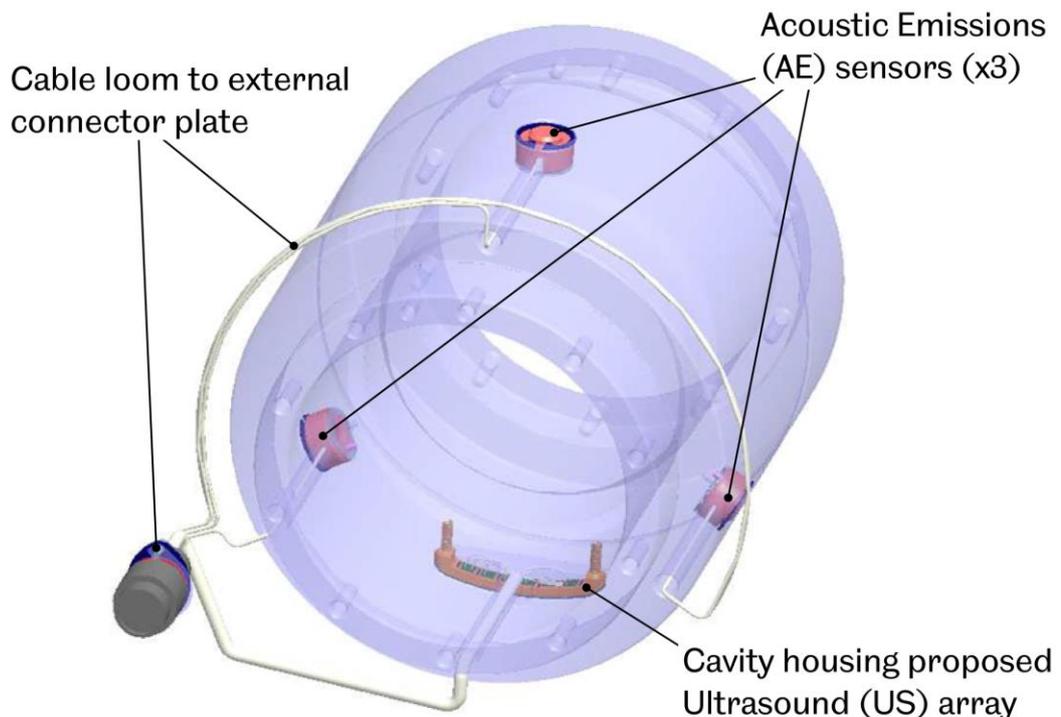
Figure 4.5: Test bearing internal sleeve to house condition monitoring instrumentation

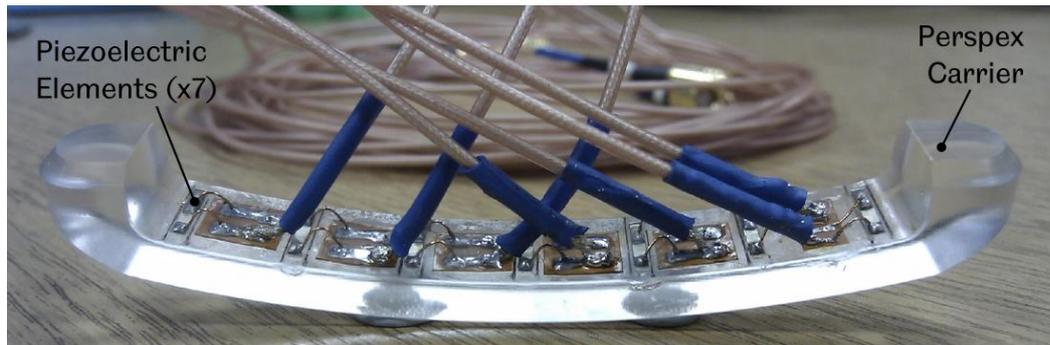
Figure 4.7: 1<sup>st</sup> iteration "Through-Transmission" ultrasound array

The initial design concept is shown in Figure 4.7, where piezoelectric elements were bonded to a Perspex carrier. This setup required that ultrasonic energy be transmitted through three discrete interfaces, and as such, consideration of acoustic mismatch and the associated ultrasonic reflection at media boundaries (as per Equation (3.4)) was essential to ensure that sufficient energy could be transmitted to the measurement interface. Given acoustic properties of the rubber layer as defined in [88] ( $c = 957\text{m/s}$  and  $\rho = 1420\text{kg/m}^3$ ); acoustic impedance was established, according to Equation (3.3), as  $z_r \approx 1.4\text{MN/m}^3$ .

Figure 4.8 shows the ultrasonic reflections that would be generated from a setup representative of the array shown in Figure 4.7, where an ultrasonic signal is transmitted through Perspex, rubber and steel layers of similar relative thicknesses. As illustrated, despite optimisation via acoustic matching; the overall thickness and multi-layer nature of the transmission path consequently resulted in relatively low amplitude signals received back from the measurement interface. It was also necessary to ensure thickness of the Perspex layer was accurately defined so as to ensure that pulses received from the measurement interface ( $I_c$ ) were out of phase with adjacent rubber-steel ( $I_b$ ) reverberations. However, despite signal amplitudes being sufficient to provide adequate measurements at room temperature, attenuation was found to increase significantly at test temperatures, owing to the low glass transition temperature of the Perspex (around  $100^\circ\text{C}$ ). As a result, signal-to-noise ratios were often found to reach unity at temperatures of around  $70^\circ\text{C}$ .

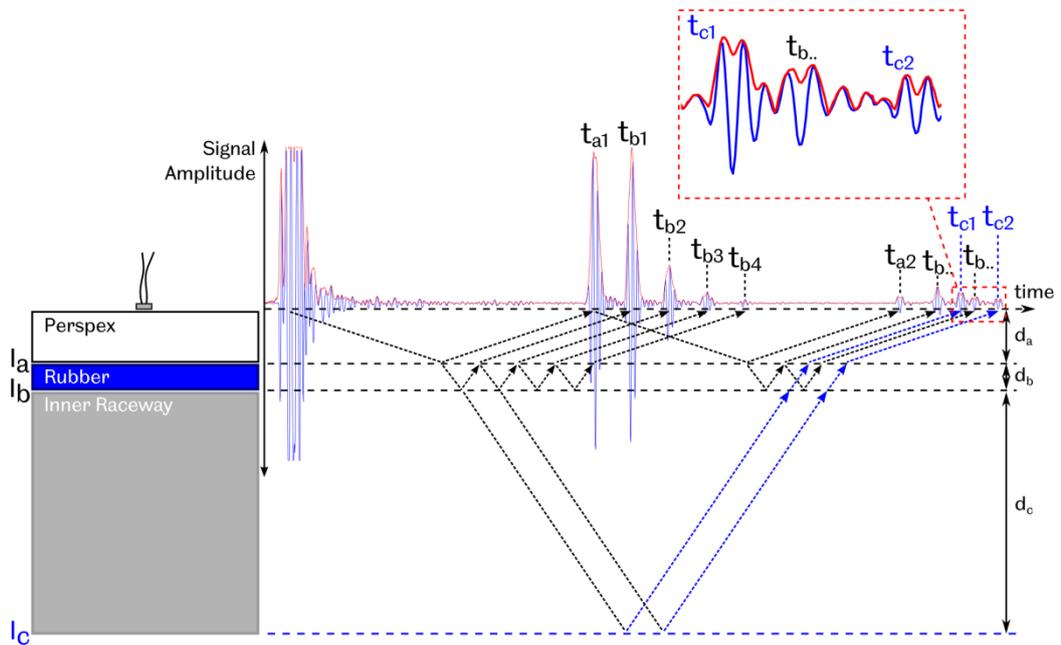
Figure 4.8: Ultrasonic reflections from a setup representative of the through transmission sensor array

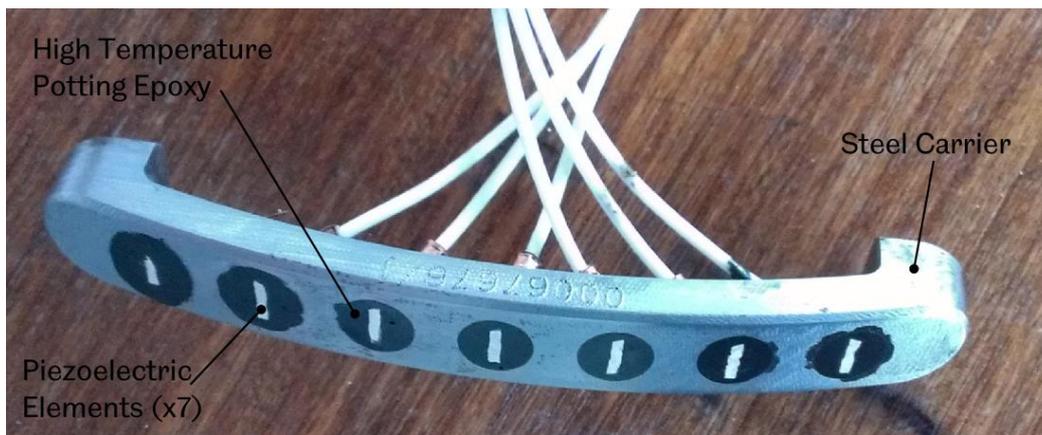
boundaries within the ultrasound transmission path, an alternative design was developed as shown in Figure 4.9. Here, the same carrier geometry was utilised, but piezo-electric elements were potted within individual holes drilled through a steel carrier at the desired sensor locations. By this method, piezo-electric elements could be coupled directly to the rubber layer; thus eliminating the need for a highly attenuative plastic layer entirely. Since ultrasound was no longer transmitted through the carrier body, acoustic matching was not necessary, and a more substantial engineering material could be employed.

Figure 4.9: 2<sup>nd</sup> iteration potted ultrasound array

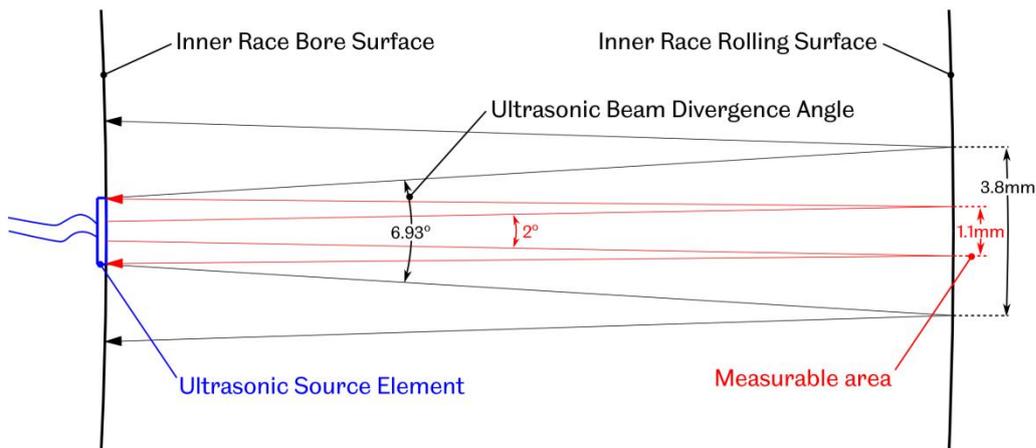
Figure 4.17: Illustration of inferred ultrasonic beam divergence angle based on measured width of the ultrasonic wave-front at the rolling surface, and the assumed region of the rolling surface that is “visible” to the source element

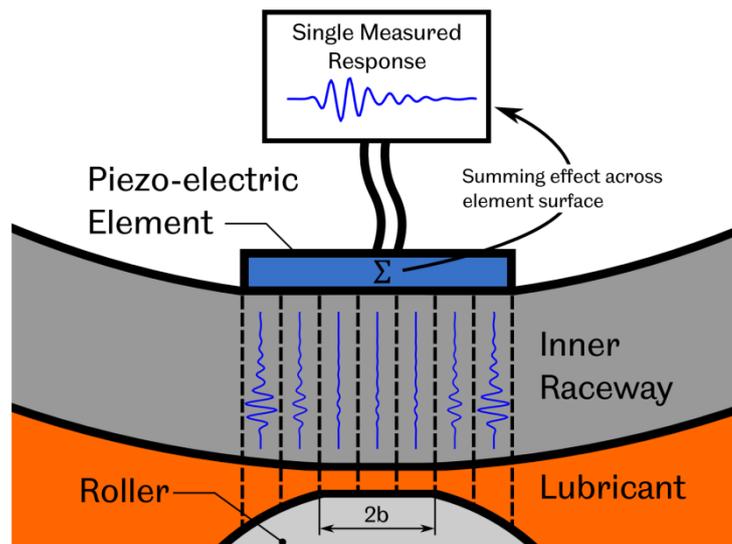
Figure 4.18: Consequence of non-parallelism across the ultrasonic wave-front leading to high observed reflection from the interface thus resulting in over-prediction of central film thickness (adapted from [72])

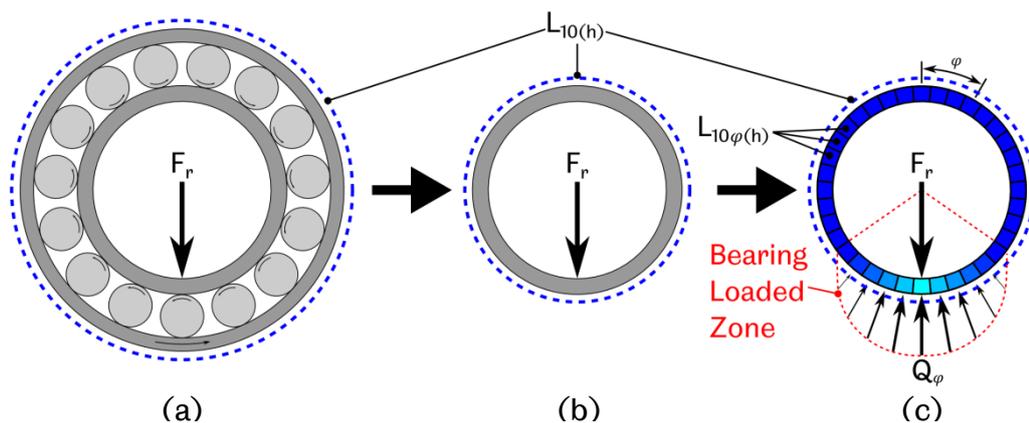
Figure 5.1: (a) and (b) Development of the effective  $L_{10(h)}$  life for a MultiLife Bearing and (c) subsequent representation at an elemental level

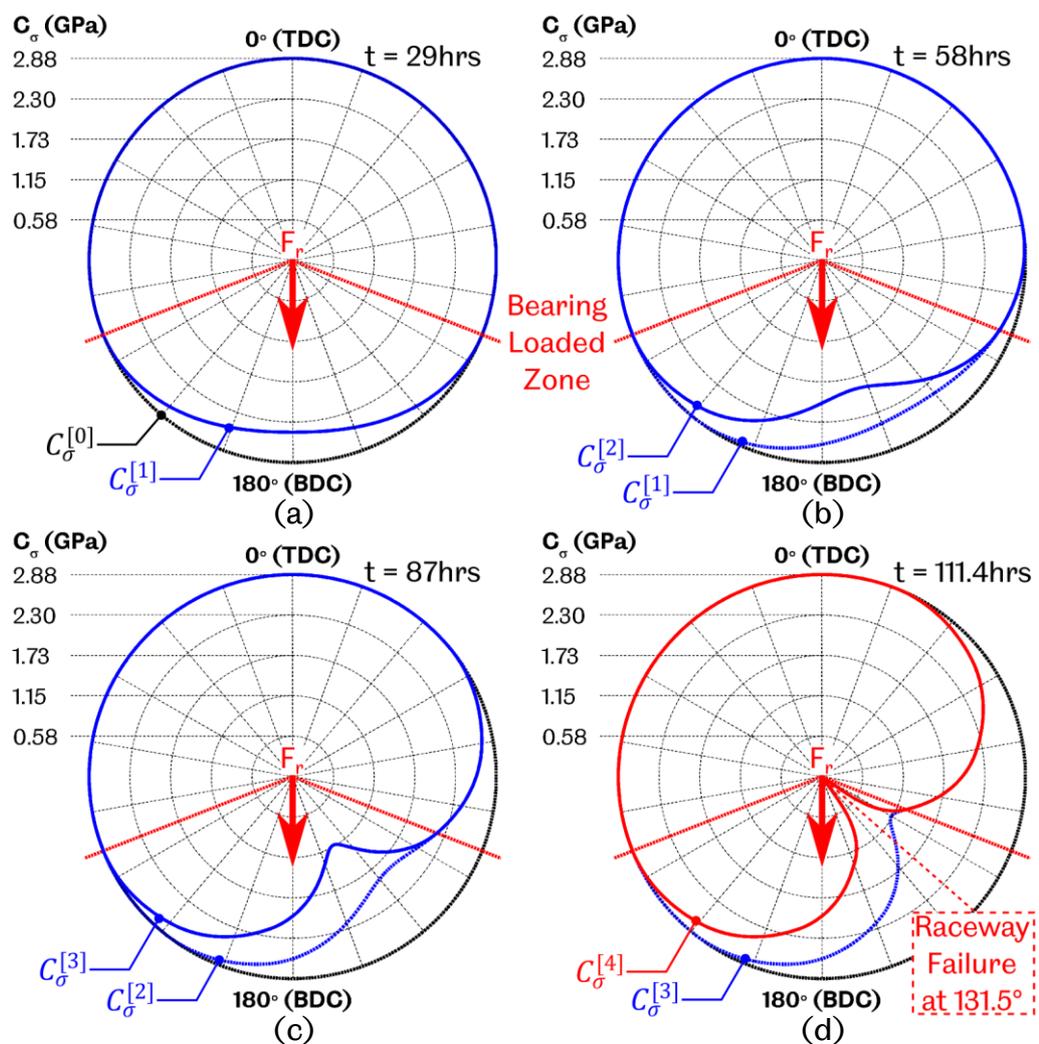
Figure 5.2: Incremental reduction in the dynamic stress rating and subsequent failure of a MultiLife bearing over four indexing periods (a)-(d), with a  $1140\text{kN}$  applied radial load ( $F_r$ ), and a regime of  $30^{\circ}$  indexing every 29 hours ( $\theta = 30, x = 29$ )

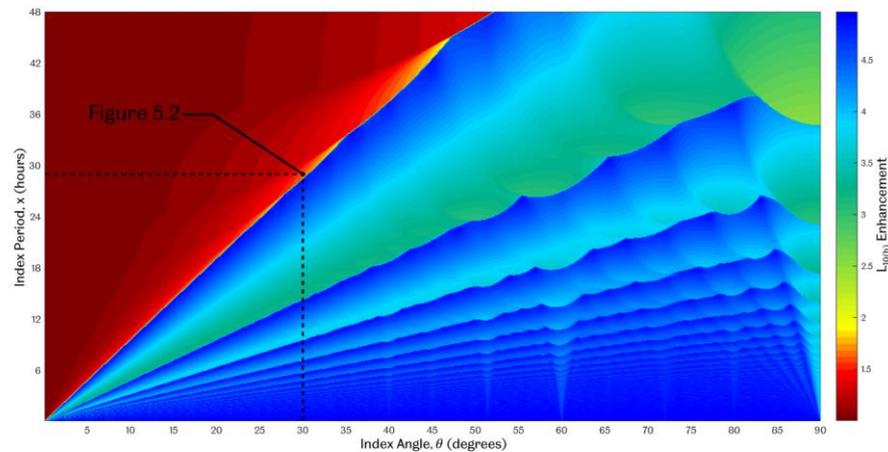
Figure 5.3: Intensity plot to illustrate the enhancement to the standard  $L_{10(h)}$  life for a MultiLife Bearing run at  $100rpm$  and  $1140kN$  under a range of indexing strategies

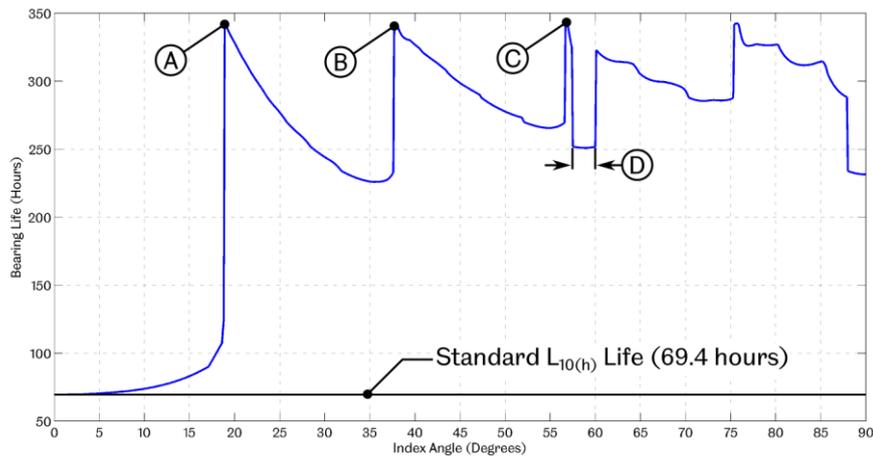
Figure 5.4: Bearing life for all indexing strategies where  $x = 18$  hours and  $0 \leq \theta \leq 90$  degrees

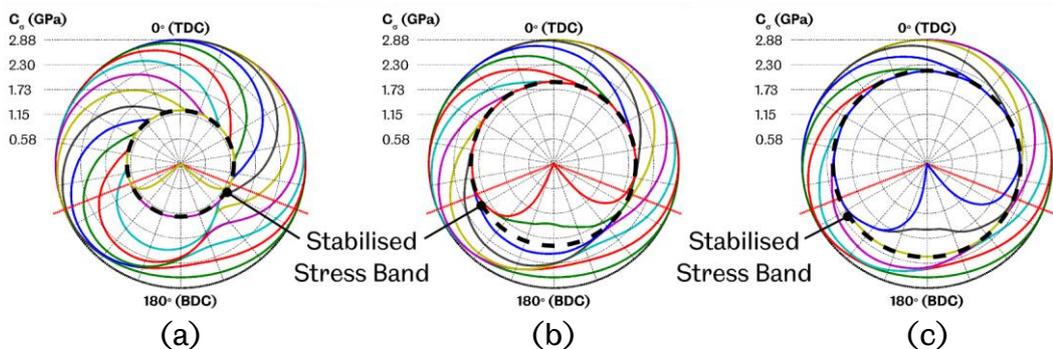
Figure 5.6: Incremental widening of the stabilised stress rating band for index angles of (a)  $20^\circ$ , (b)  $25^\circ$  and (c)  $30^\circ$  at  $x = 18$  hours

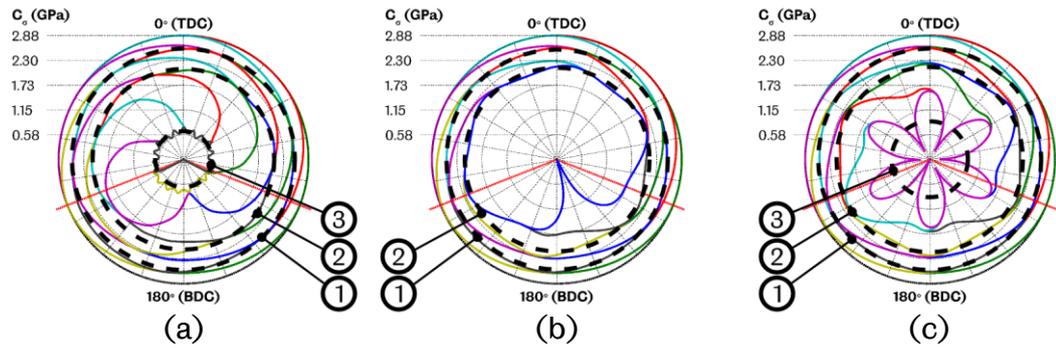
Figure 5.8:  $C_\sigma$  curves for (a)  $\theta = 56.8$ , (b)  $\theta = 58.6$  and (c)  $\theta = 60.1^\circ$  index angles at  $x = 18$  hours

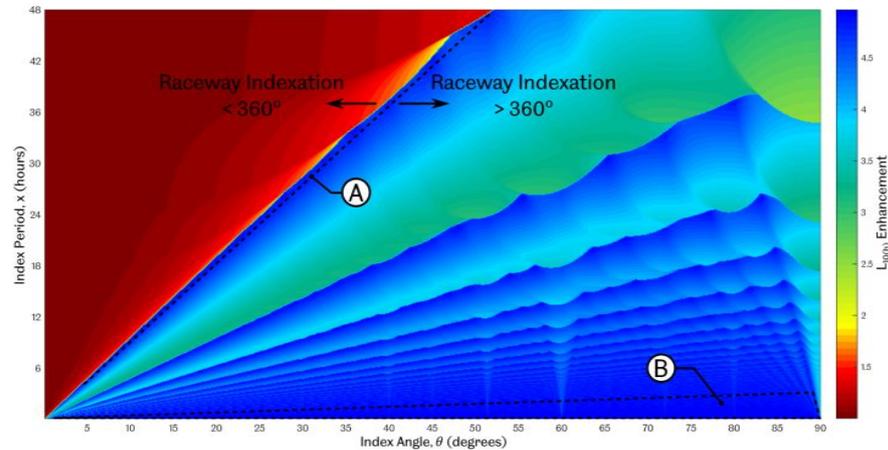
Figure 5.9: Illustration of the optimum strategies of raceway indexation

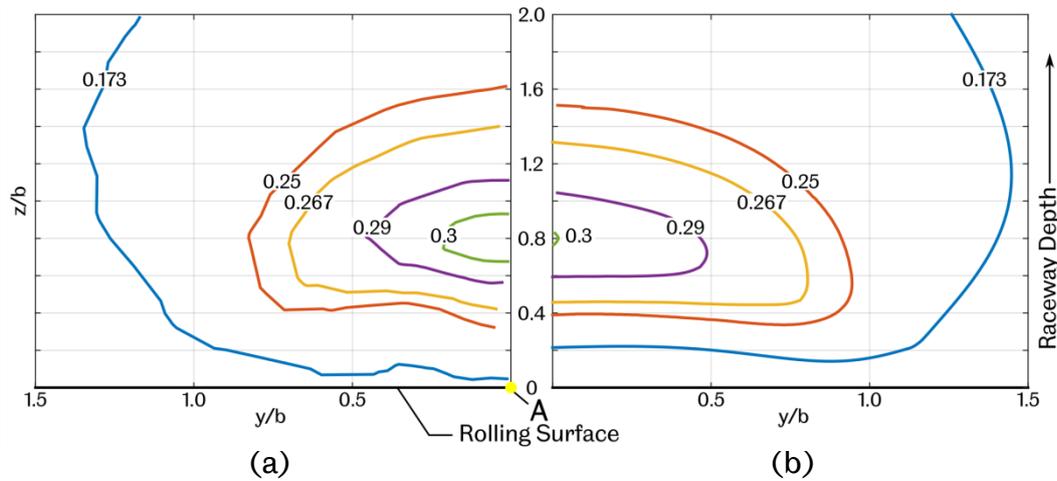
Figure 5.14: (a) Contours of constant principal shear stress normalised to maximum contact pressure ( $\tau_1/p_{max}$ ) obtained from the FEA model for the un-notched raceway. (b) Comparison to the same contours obtained theoretically for the elastic contact of cylinders (adapted from [29]). Point A in Plot (a) is equivalent to that shown in Figure 5.11.

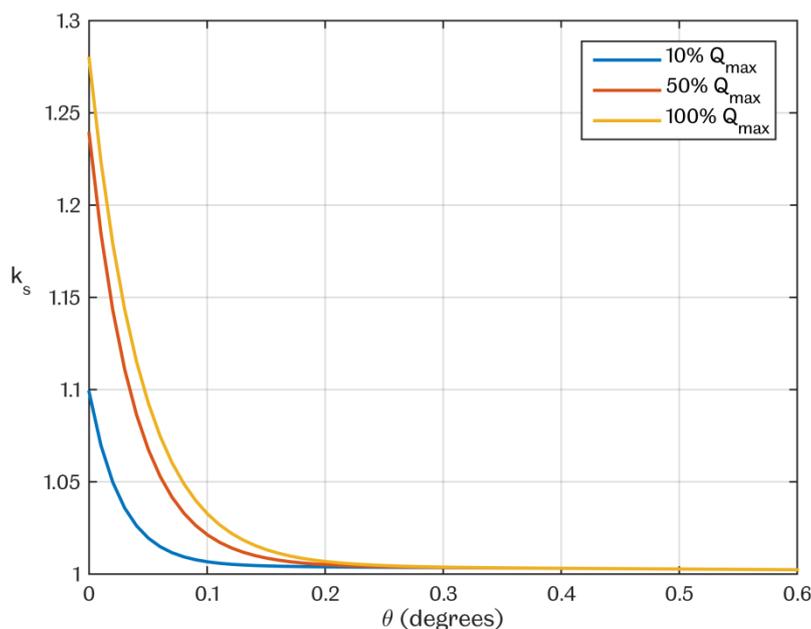
Figure 5.17: Stress concentration factor vs angular distance away from the raceway notch for normal load to the raceway-roller contact equivalent to 10%, 50% and 100% of  $Q_{max}$

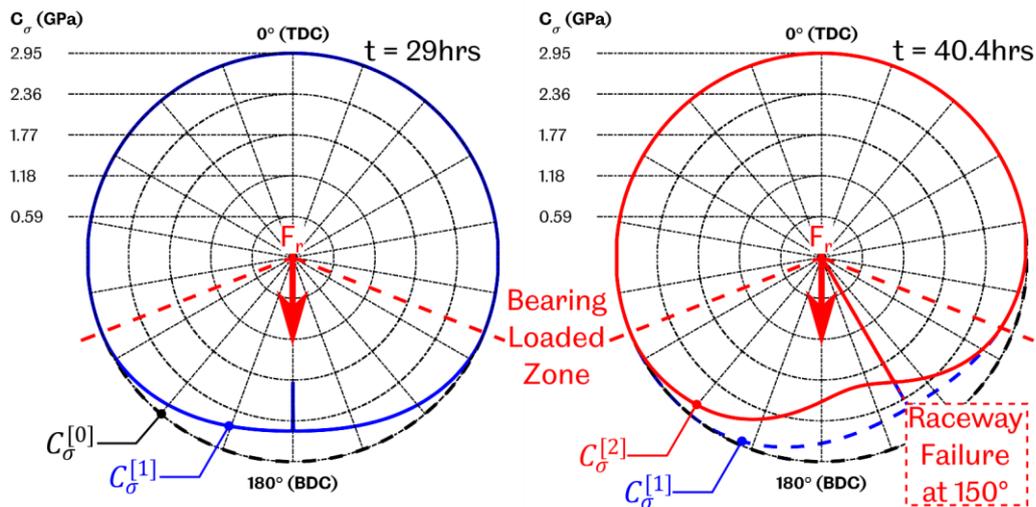
Figure 5.18: Incremental reduction in dynamic stress rating for a MultiLife bearing indexed by 30 degrees every 29 hours with a surface defect introduced at bearing bottom-dead-centre

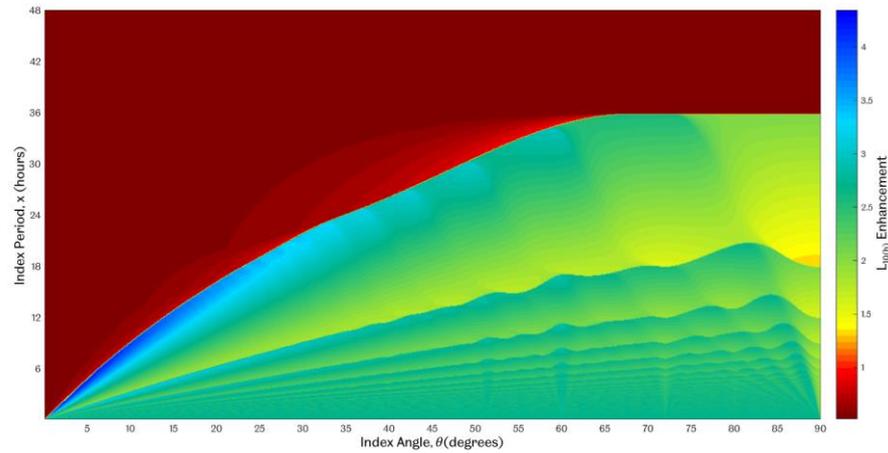
Figure 5.19: Life enhancement matrix for a bearing with a seeded defect at bottom-dead-centre, with a total radial bearing load of 1140kN applied

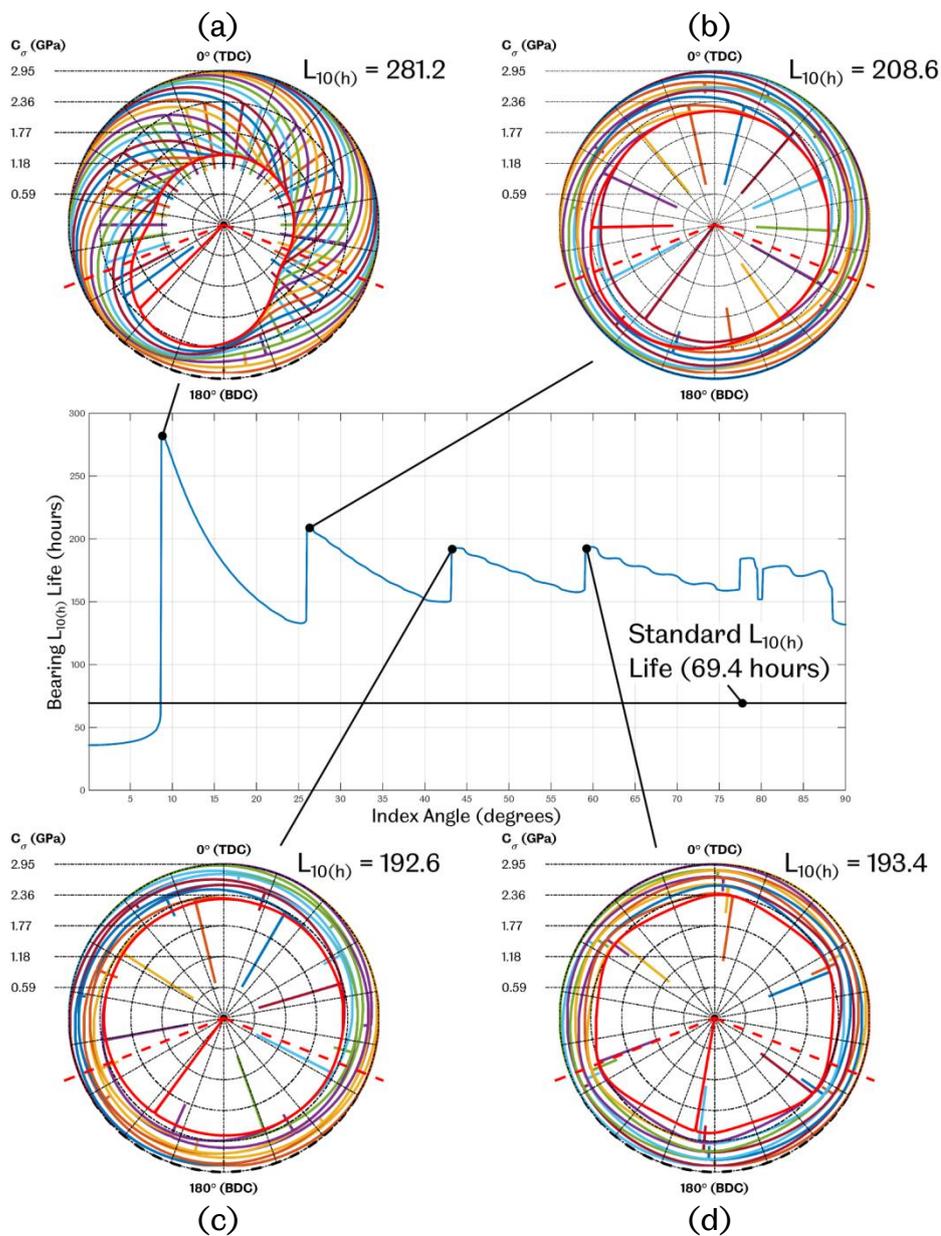
Figure 5.20: Stress rating plots for indexing strategies at a 8 hour index period and (a)  $\theta = 9^\circ$ , (b)  $\theta = 26.3^\circ$ , (c)  $\theta = 43.5^\circ$  and (d)  $\theta = 59.6^\circ$  with a surface defect introduced initially at bearing bottom-dead-centre

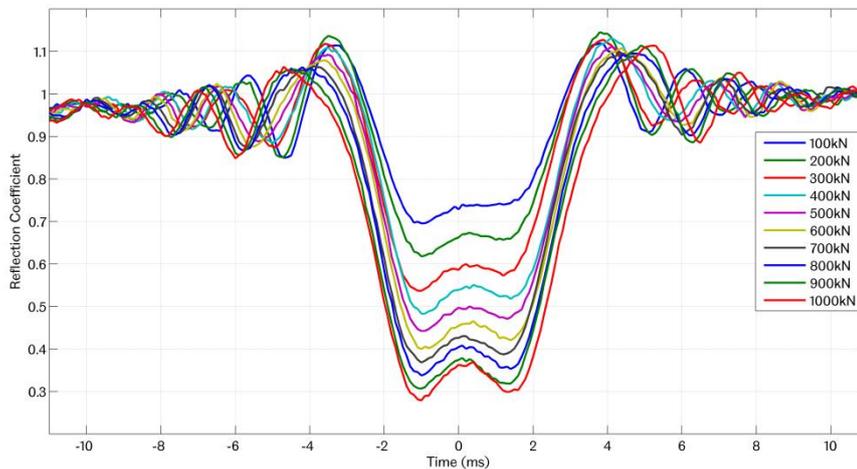
Figure 6.1: Reflection coefficient curves for a single roller pass at bearing loads between 100 and  $1000\text{kN}$
