The  
University  
Of  
Sheffield.

Department  
Of  
Mechanical  
Engineering.

# **Development of a Novel Bearing Concept for Improved Wind Turbine Gearbox Reliability**

A thesis submitted in partial fulfilment of the requirements for the degree  
of Doctor of Philosophy

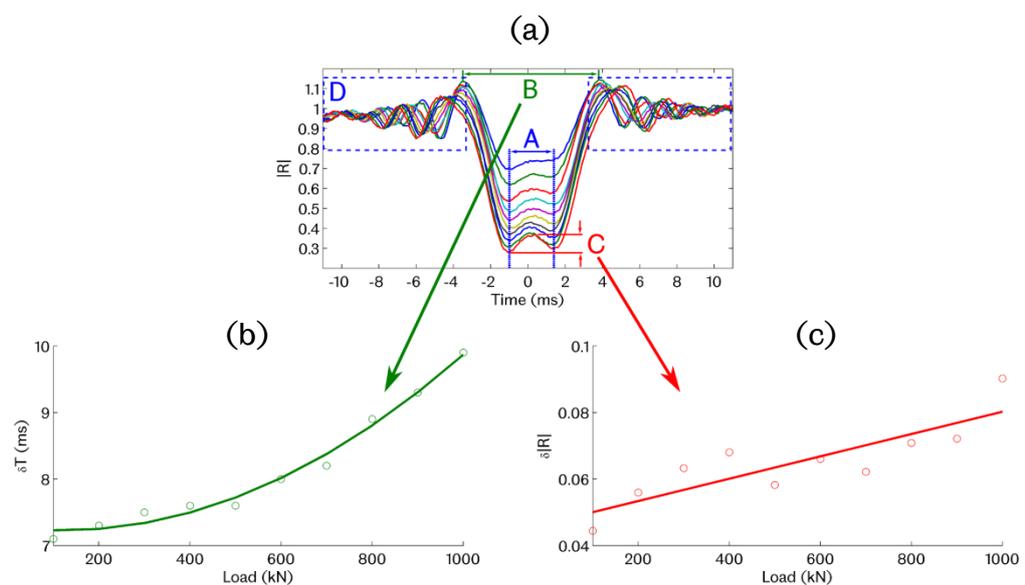
Figure 6.2: (a) Features of interest in Reflection Coefficient curves of Figure 6.1; (b) Correlation between width of contact region (Feature B) vs load; (c) Correlation between magnitude of central rise in reflection (Feature C) vs load

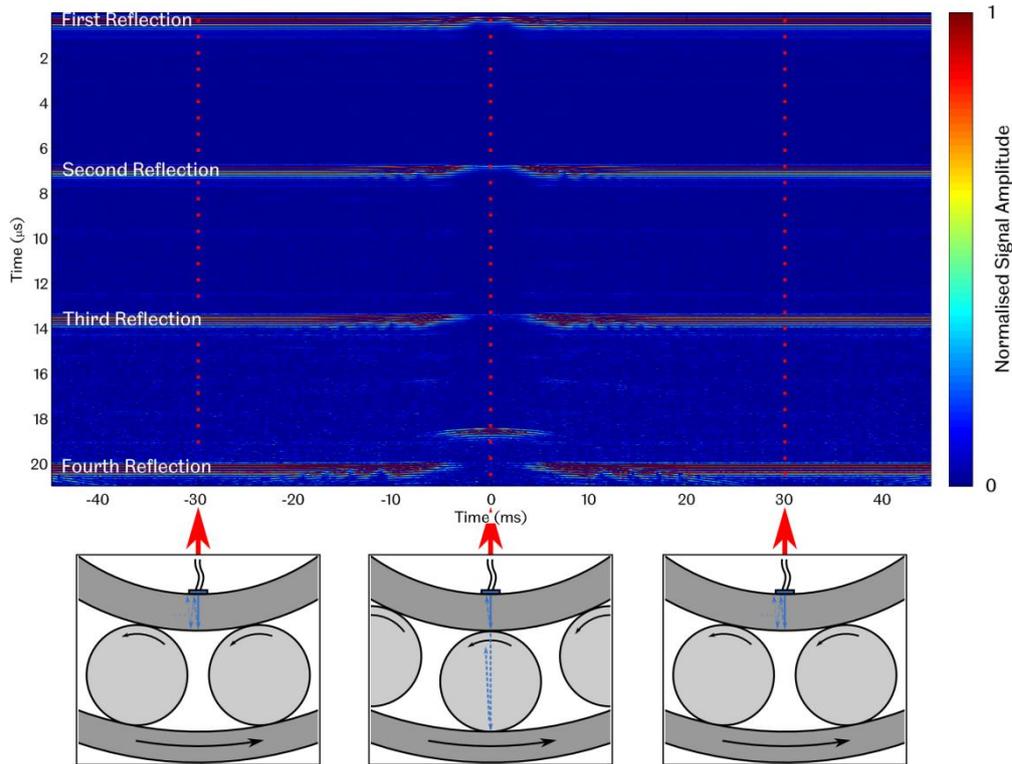
Figure 6.5: Colour plot to illustrate variations in signal amplitude throughout a single roller pass at 1000kN

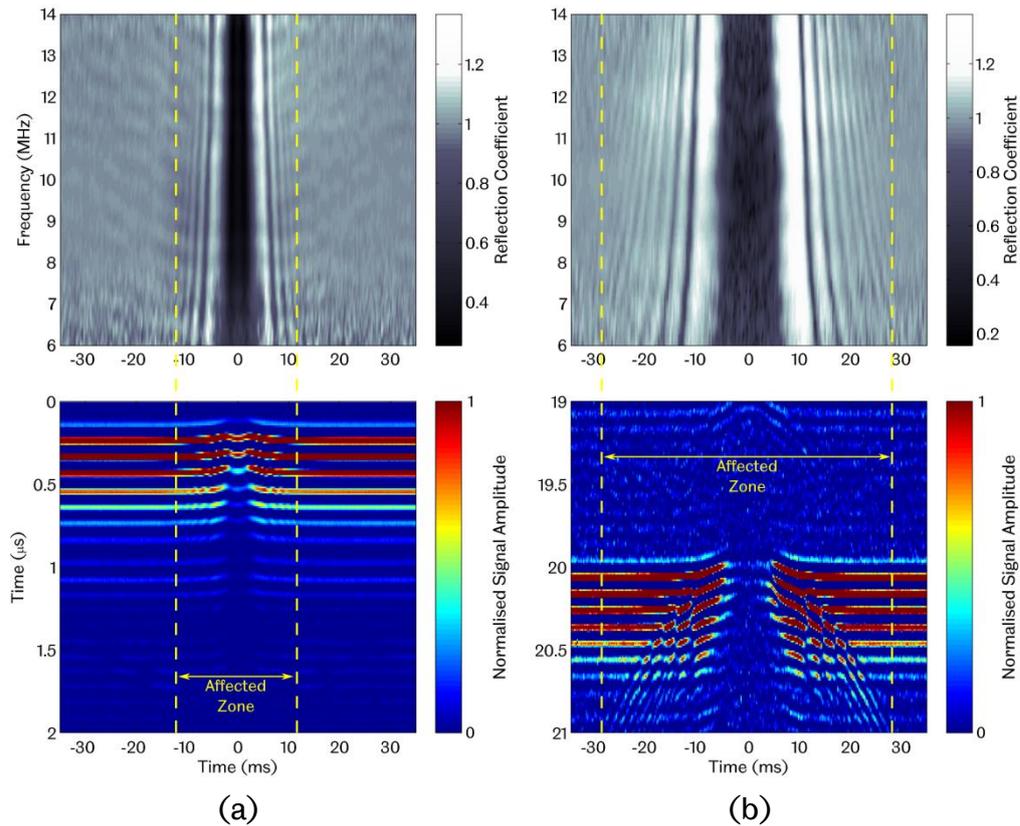
Figure 6.6: Closer inspection of (a) first reflection and (b) fourth reflection signals displayed as both frequency “Spectrograms” (top) and time domain intensity maps (bottom)

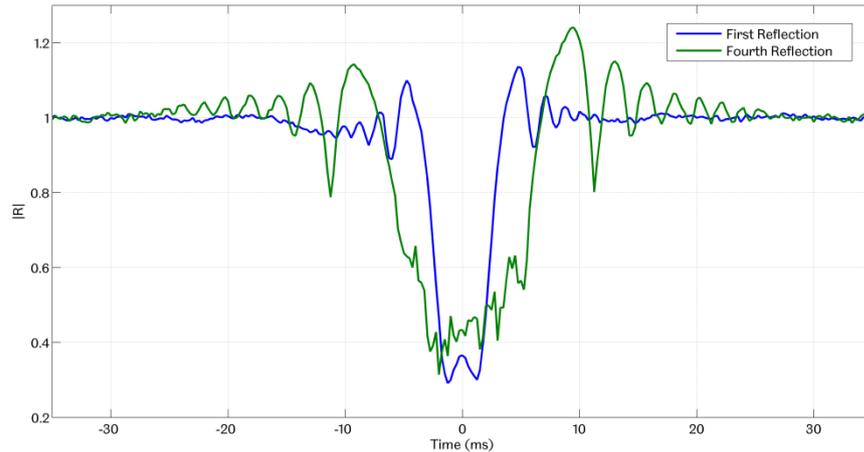
Figure 6.7: Comparison of reflection coefficient at 10MHz for the first and fourth reflection data of Figure 6.6

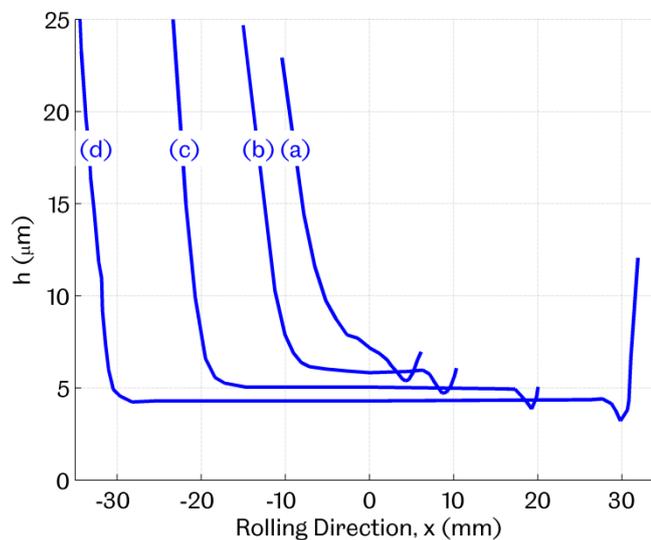
Figure 6.10: Film thickness profiles for a line contact with increasing contact pressure from (a) to (d) in the ratio 1:2:4:6 (adapted from [97])

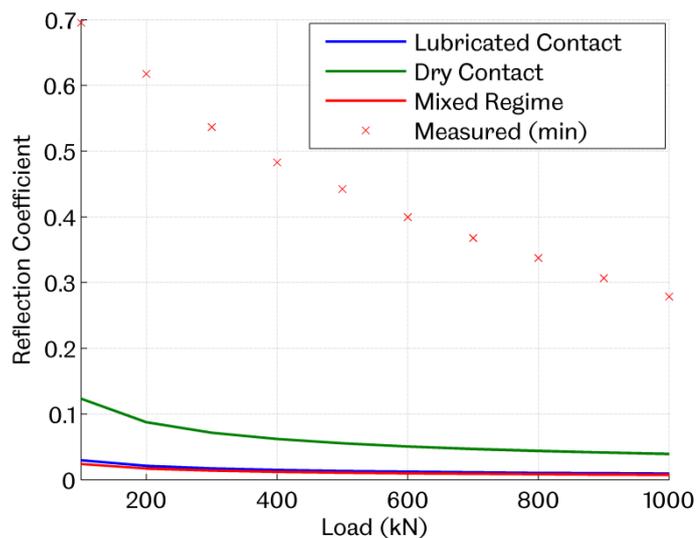
Figure 6.11: Comparison of spring model predictions of ultrasonic reflection (at 10MHz) for a dry, mixed and lubricated interface with test measurements overlaid

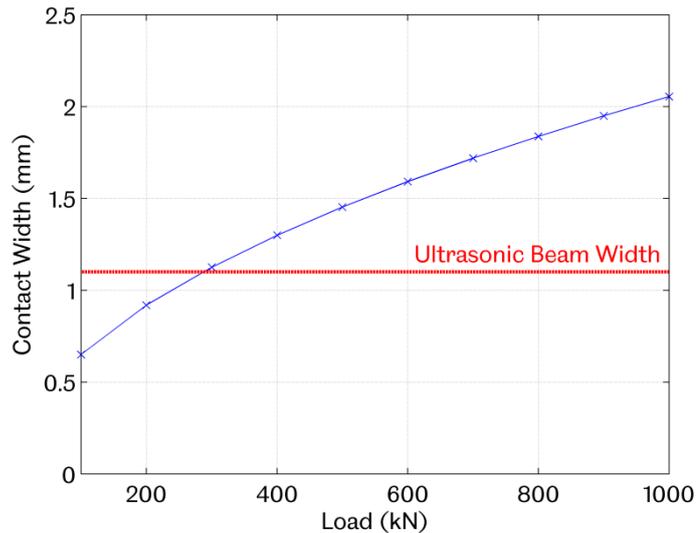
Figure 6.14: Theoretical contact width at each test load and comparison to the effective ultrasonic measurement width as determined in §4.3.3.1

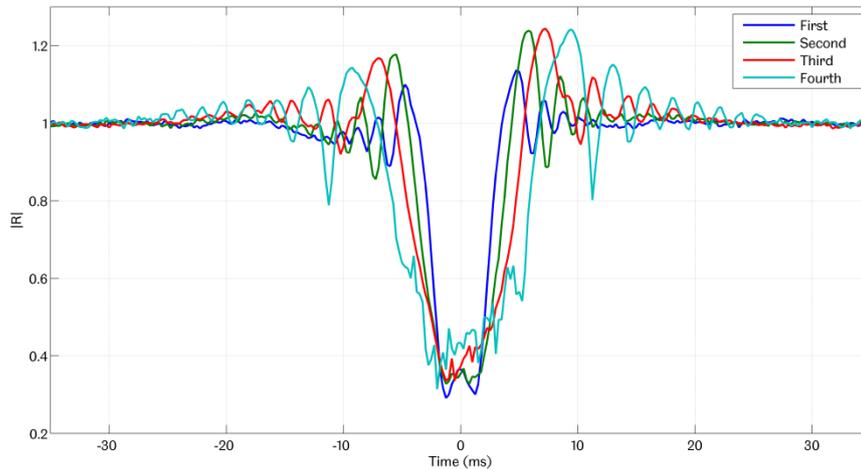
Figure 6.16: Reflection coefficient (at 10MHz) established from analysis of the first four reverberations from the roller-raceway interface during a 1000kN roller pass

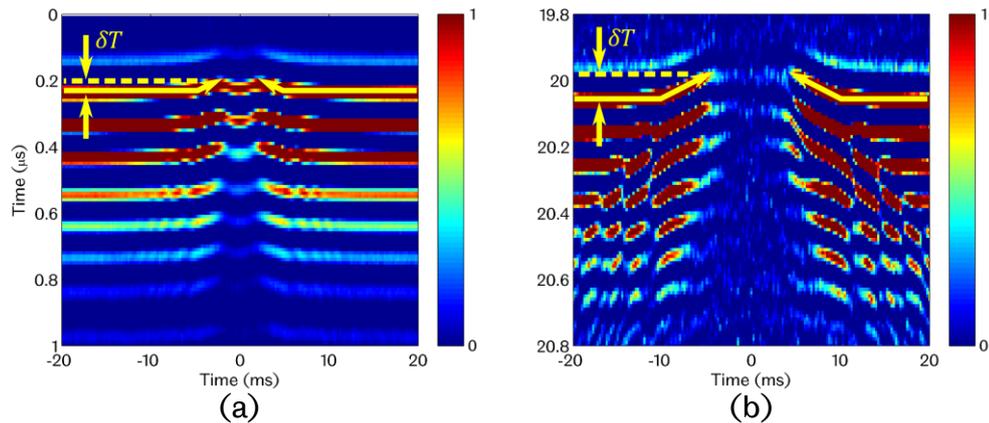
Figure 6.17: Time domain maps of Figure 6.6 in higher magnification to illustrate differences in time shift between (a) first and (b) fourth reflection pulses

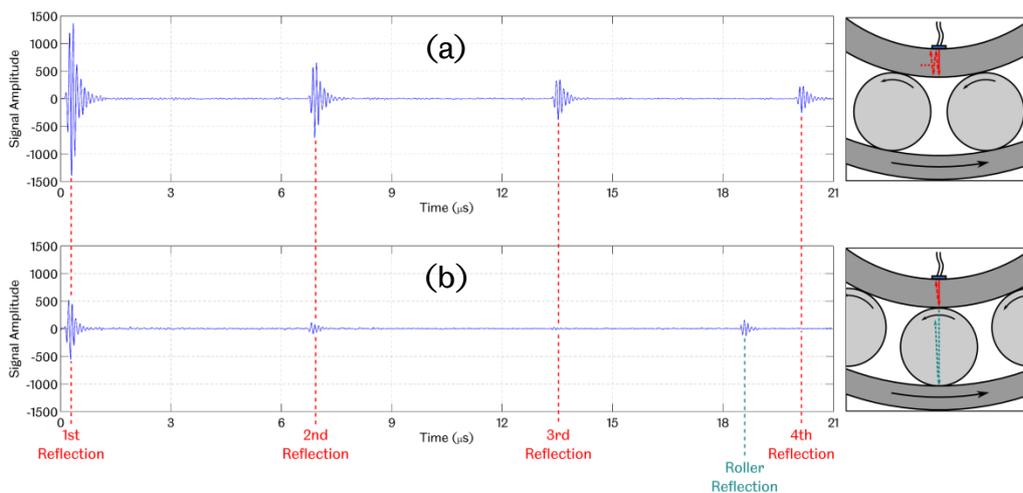
Figure 6.19: First four reflections (a) with no roller in the sensor line-of-sight and (b) when a roller is directly aligned with the sensor

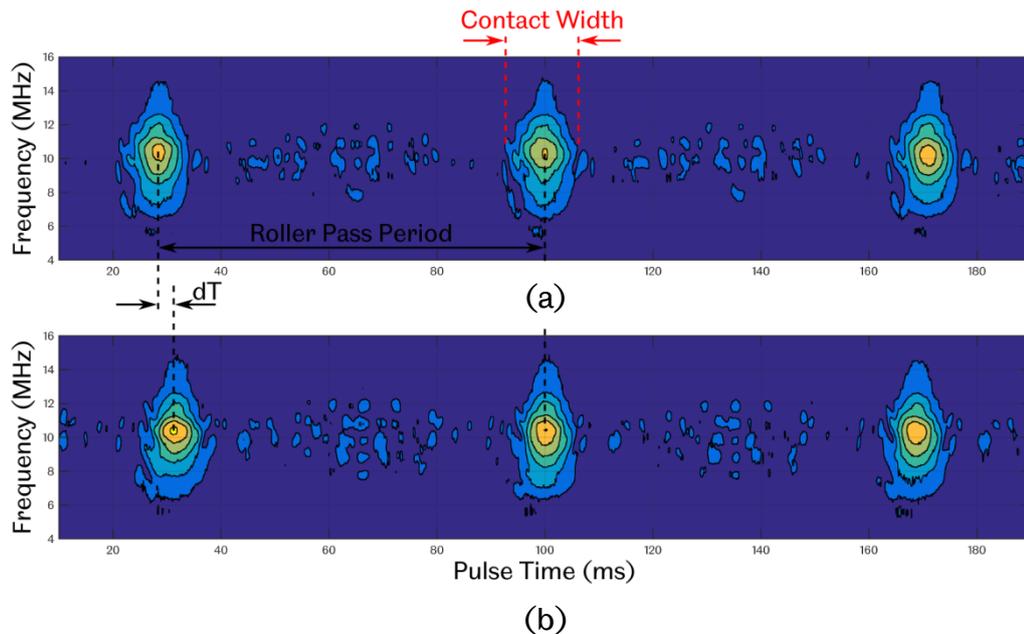
Figure 6.20: Spectrograms illustrating the emergence of the “through-roller” reflection within ultrasonic data obtained during three sequential roller passages at bearing loads of (a) 800kN and (b) 1000kN

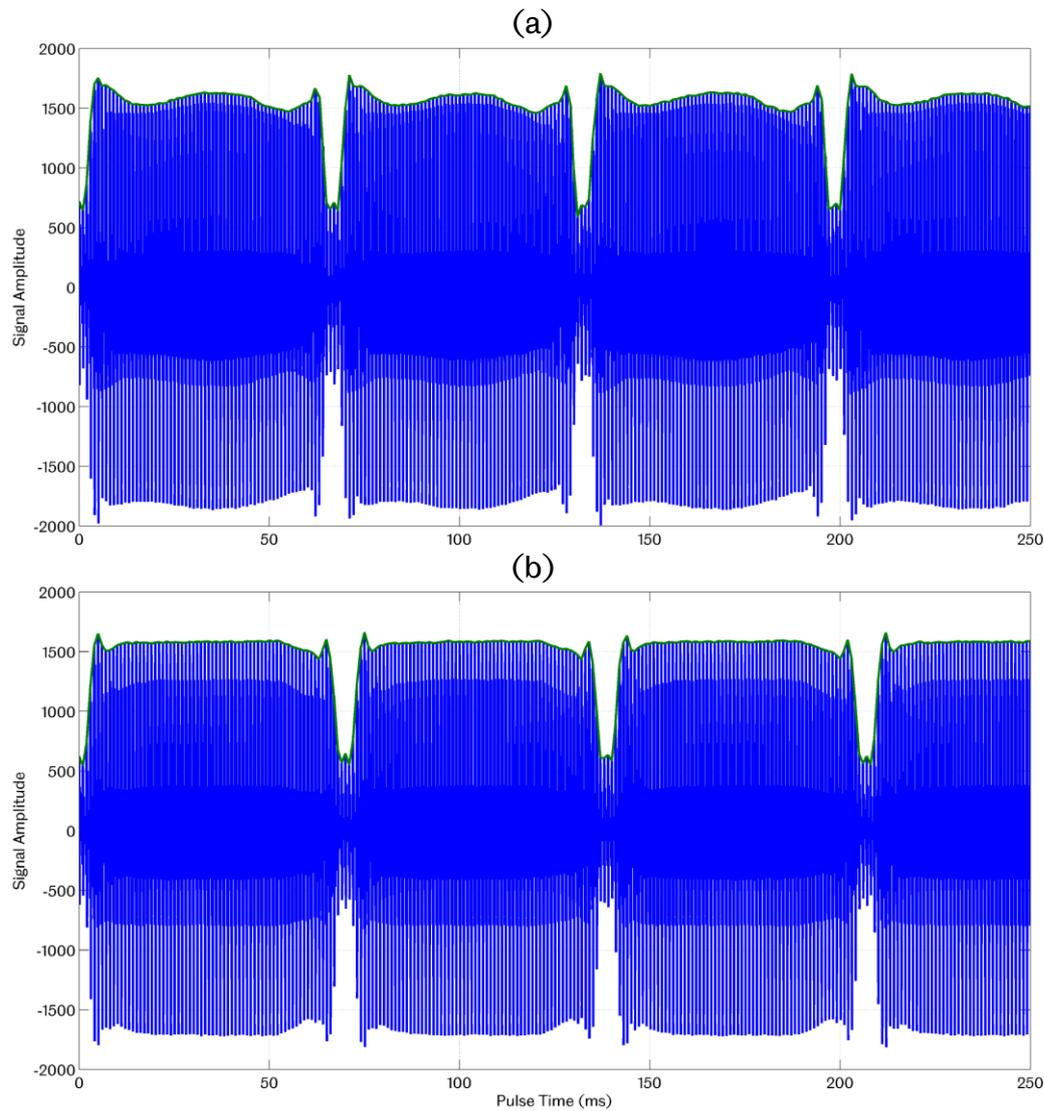
Figure 6.21: Raw ultrasonic waveform data captured at the beginning and end ((a) and (b) respectively) of an overnight test where an oil system failure was known to have occurred, consequently leading to lubricant starvation of the test bearing (bearing load and speed were maintained at  $1000kN$  and  $100rpm$  throughout)

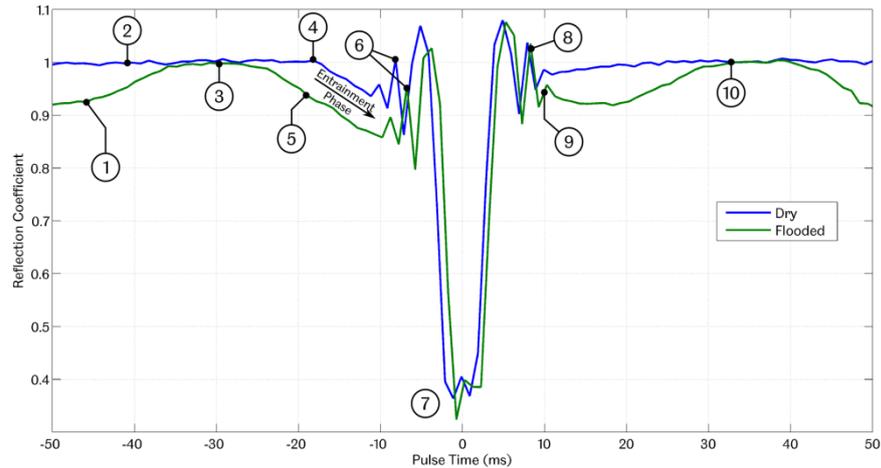
Figure 6.22: Reflection coefficient curves of the data presented in Figure 6.21 to illustrate a single roller pass under both dry and flooded lubrication conditions

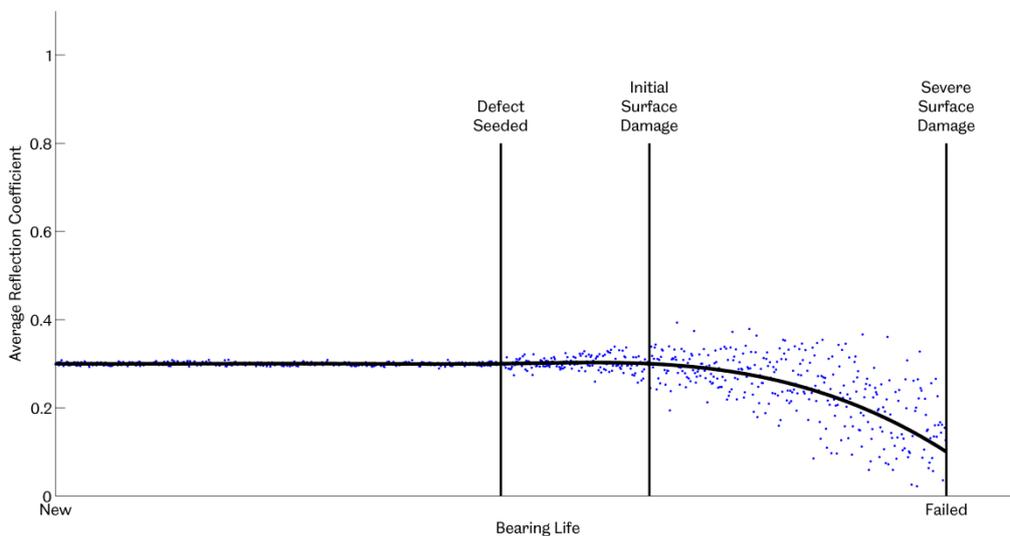
Figure 6.23: Anticipated progression of reflection coefficient through a full bearing life cycle

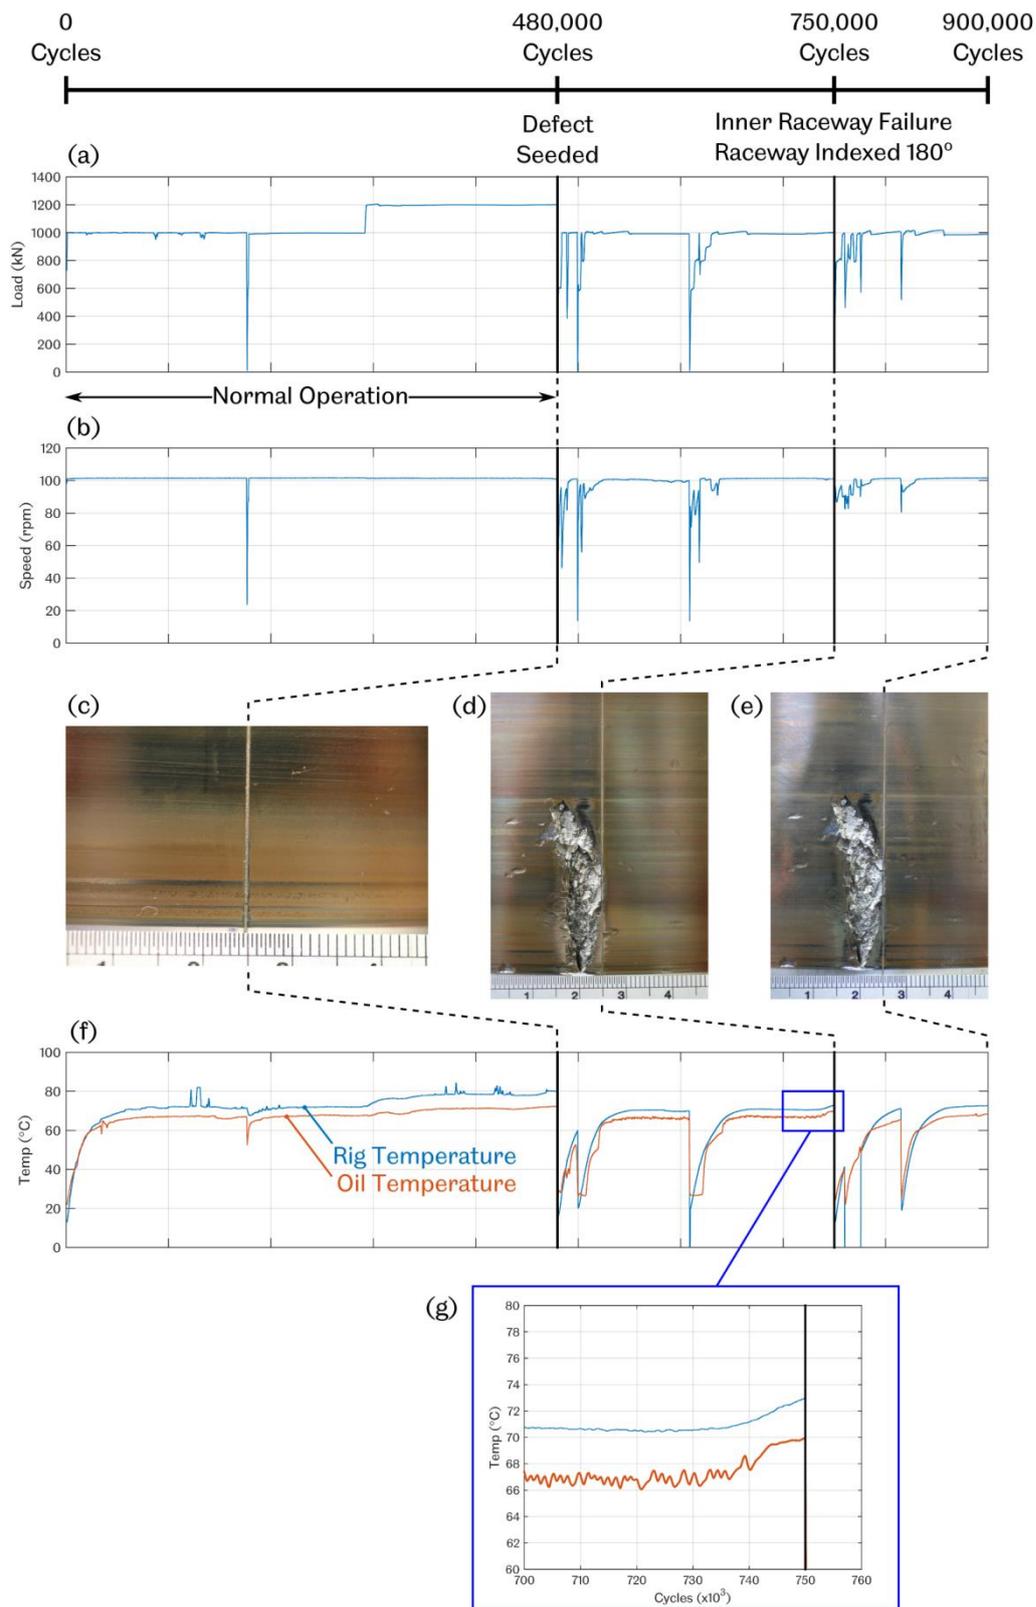
Figure 7.1: (a) and (b) Load and speed applied throughout the “Un-instrumented Bearing Test” (c) Illustration of the surface groove seeded at bearing BDC after 480,000 cycles (d) and (e) Illustration of the surface failure before and after indexing (f) and (g) Plots of lubricating oil and rig casing temperatures throughout the test

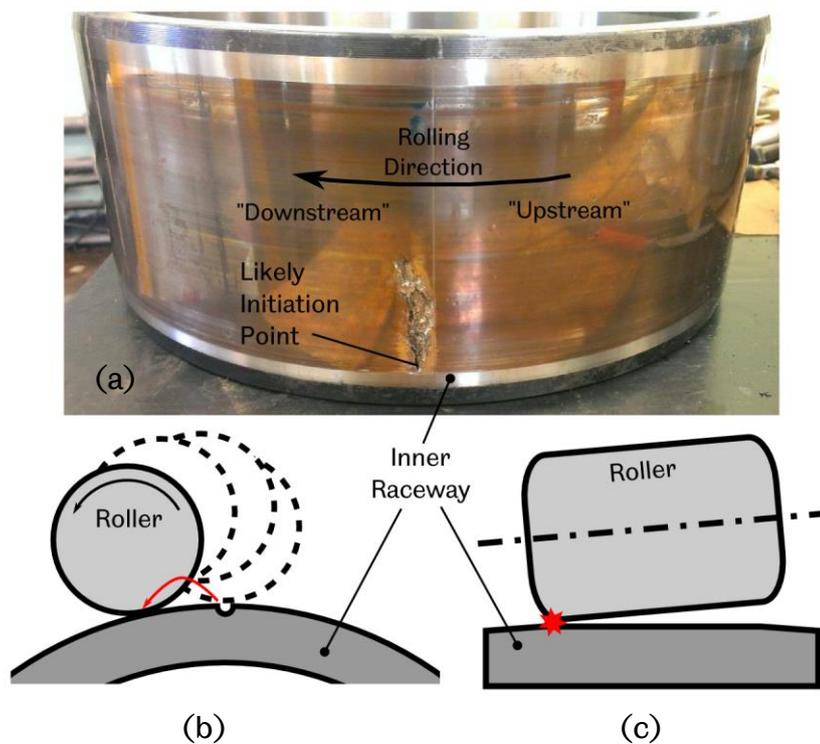
Figure 7.2: (a) Illustration of the inner raceway rolling surface across the loaded zone following inspection at 750,000 cycles (b) and (c) Exaggerated schematics of roller lift-off and edge impact assumed to have taken place as a result of the induced defect and misalignment of applied bearing load

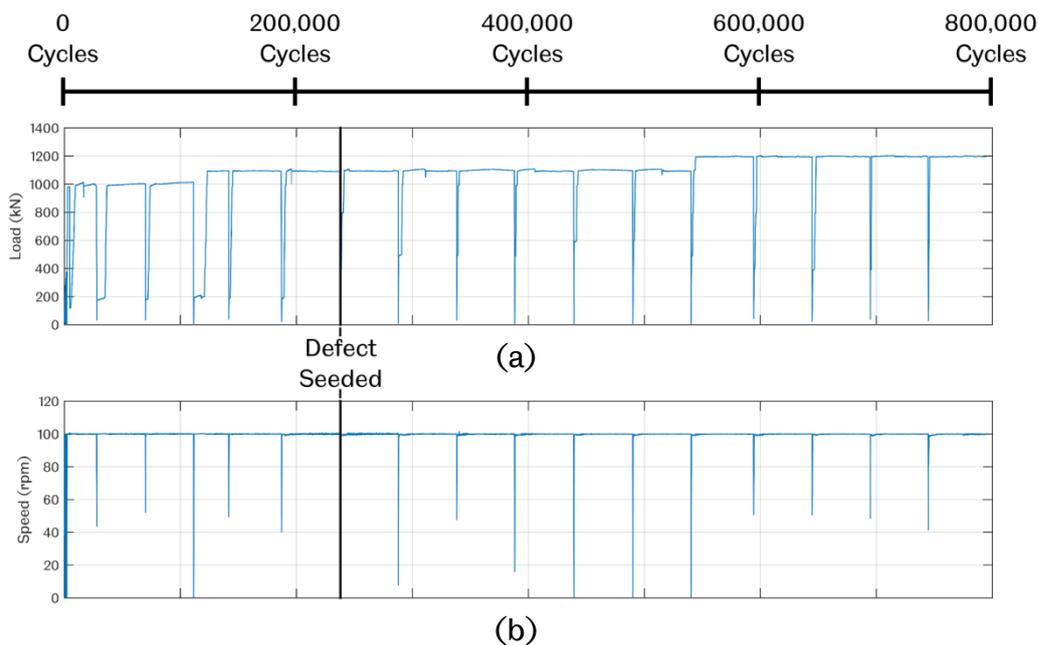
Figure 7.3: (a) Load and (b) Speed applied throughout the “Instrumented Bearing Test”

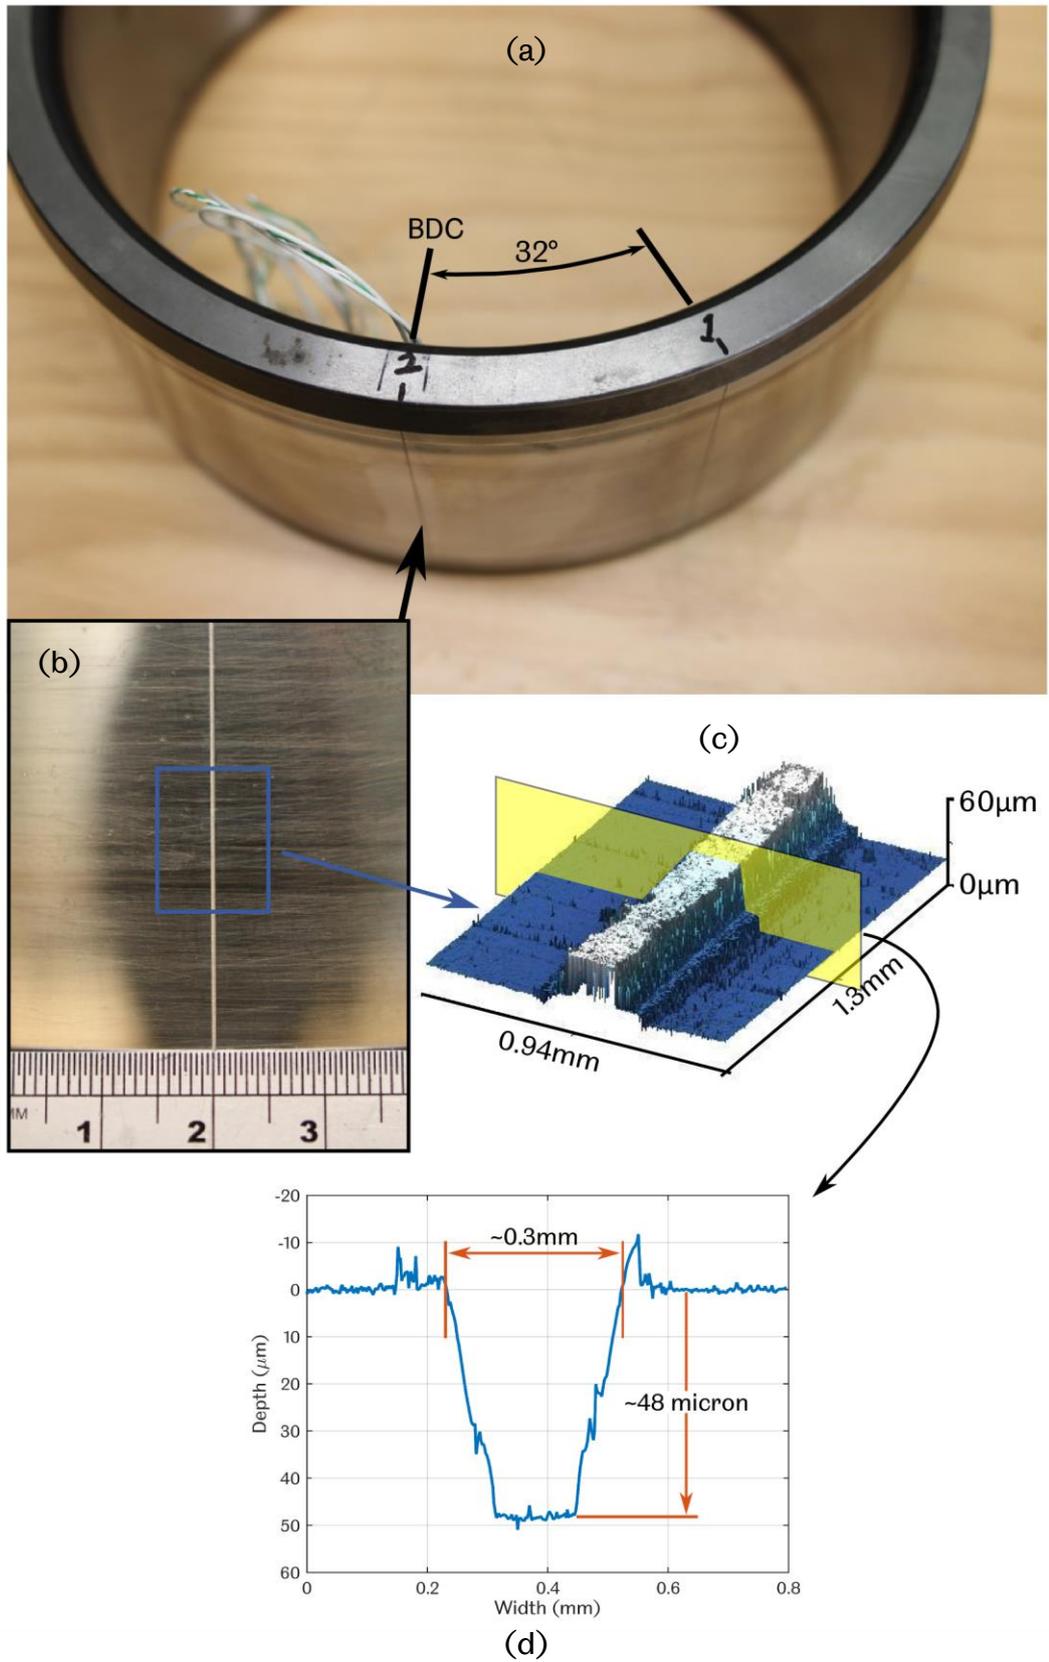
Figure 7.4: (a) Illustration of the test bearing inner raceway following the wire cut EDM process (b) Closer detail of the defect at BDC ("Defect 2") (c) 3D map of the defect (d) 2D profile to obtain defect width and depth

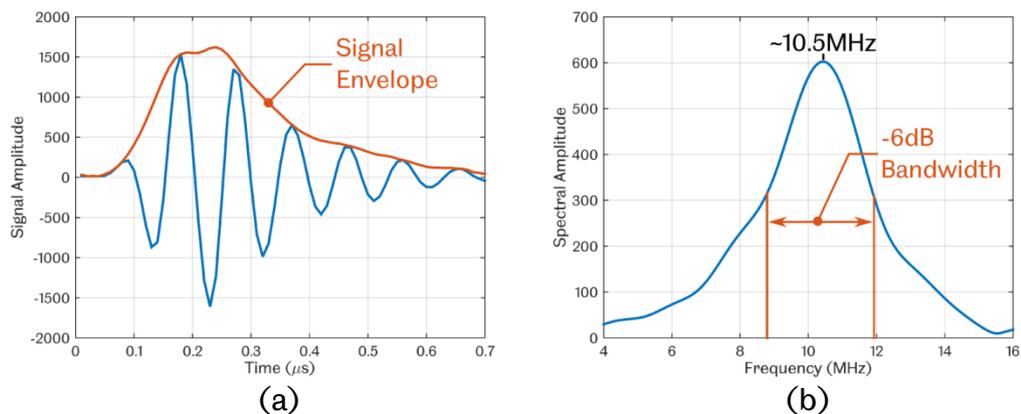
Figure 7.5: First reflection from the inner raceway rolling surface as obtained from an ultrasonic element installed at bearing BDC (a) Time domain signal (b) Frequency content

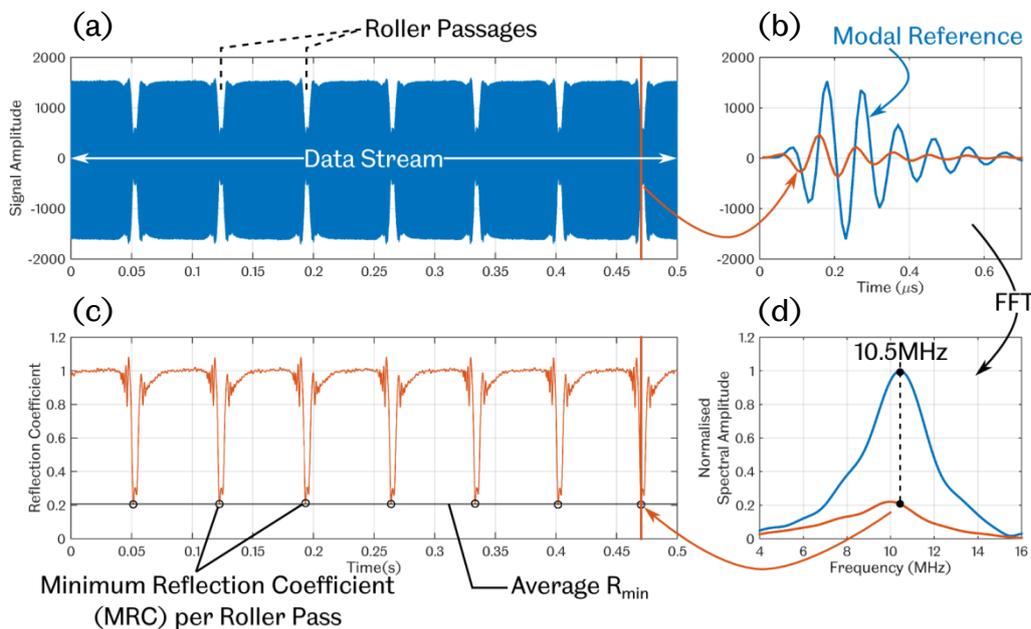
Figure 7.6: Illustration of the processing of ultrasonic data (a) A segment of a raw time domain “Data Stream” (b) Modal reference for the data stream and an example ultrasonic pulse recorded at  $t \approx 0.47s$  (c) Reflection Coefficient vs Time for the data stream obtained at the resonant frequency of 10.5MHz (d) Frequency content of the modal reference waveform and the example ultrasonic pulse

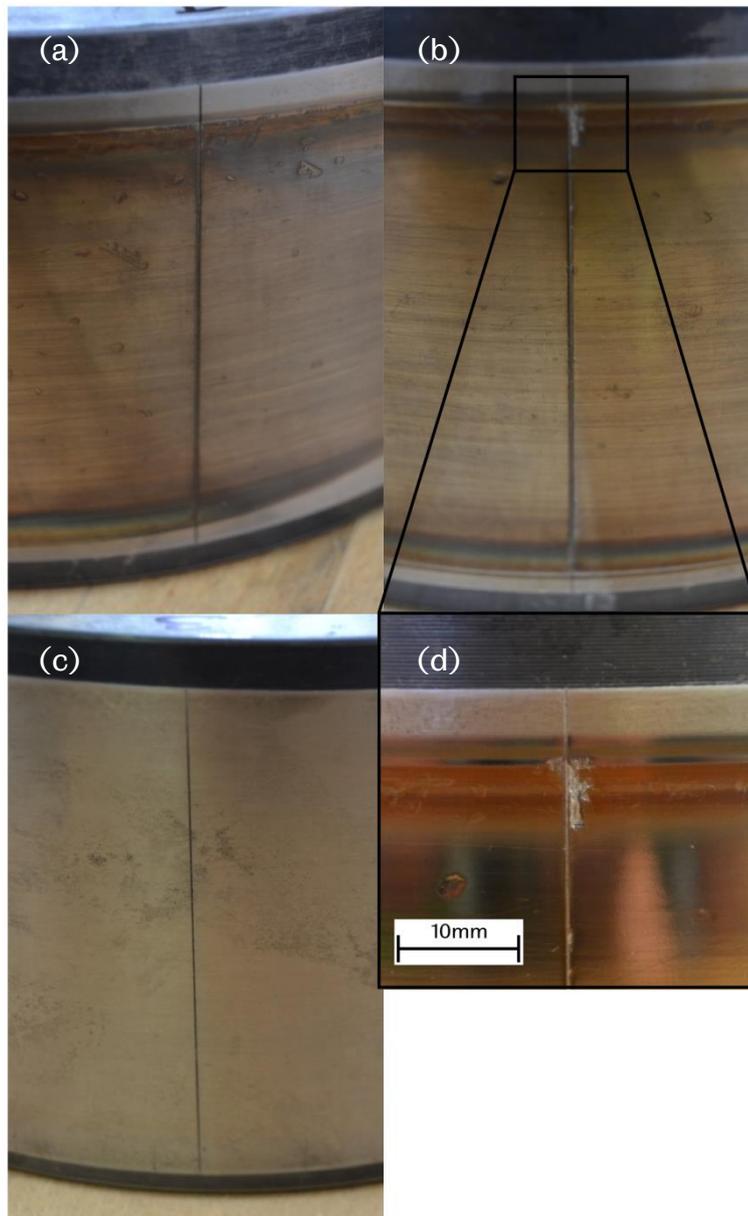
Figure 7.7: Status of the inner raceway rolling surface post-test at each of the defect locations ((a) "Defect 1," 148° (b) "Defect 2," 180° (c) "Defect 3," 356° from bearing TDC) (d) Closer detail of the spalling failure at defect location 2

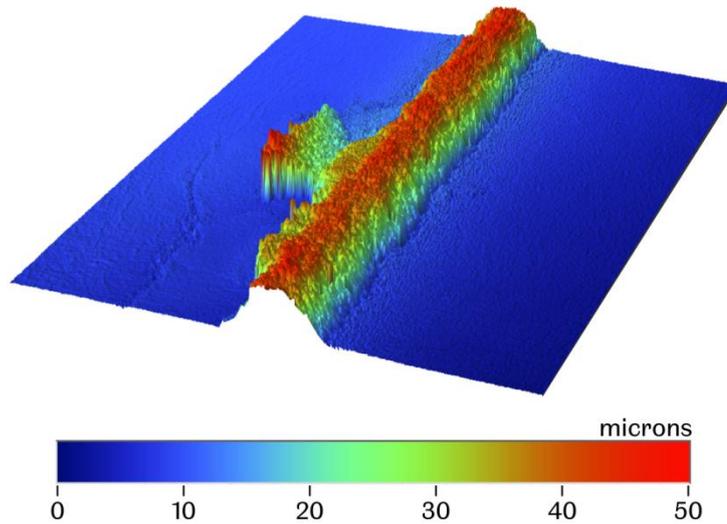
Figure 7.8: 3D map of Defect 2 post-test, illustrating additional early stage spalling damage around the defect

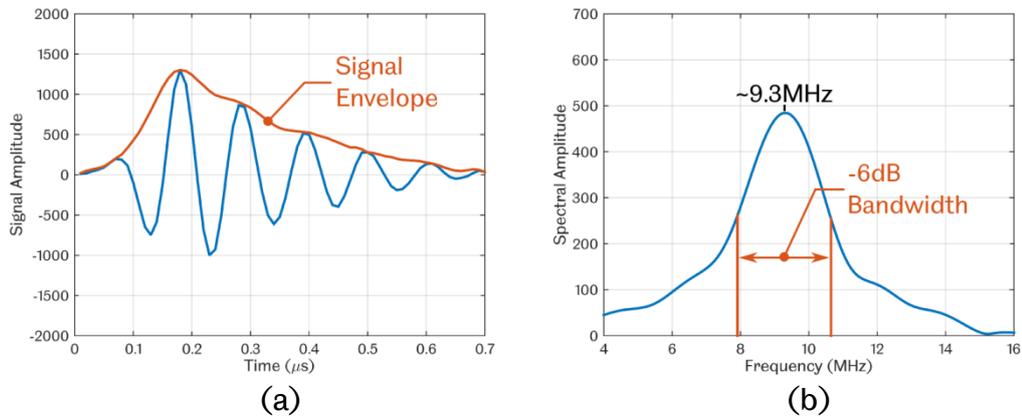
Figure 7.9: First reflection from the inner raceway rolling surface as obtained from the same ultrasonic element after partial de-bonding and a subsequent alteration to signal configurations (a) Time domain signal showing a reduced level of damping (b) Frequency content illustrating a reduced bandwidth, lower resonant amplitude and shift in the location of the resonant peak to a lower frequency level

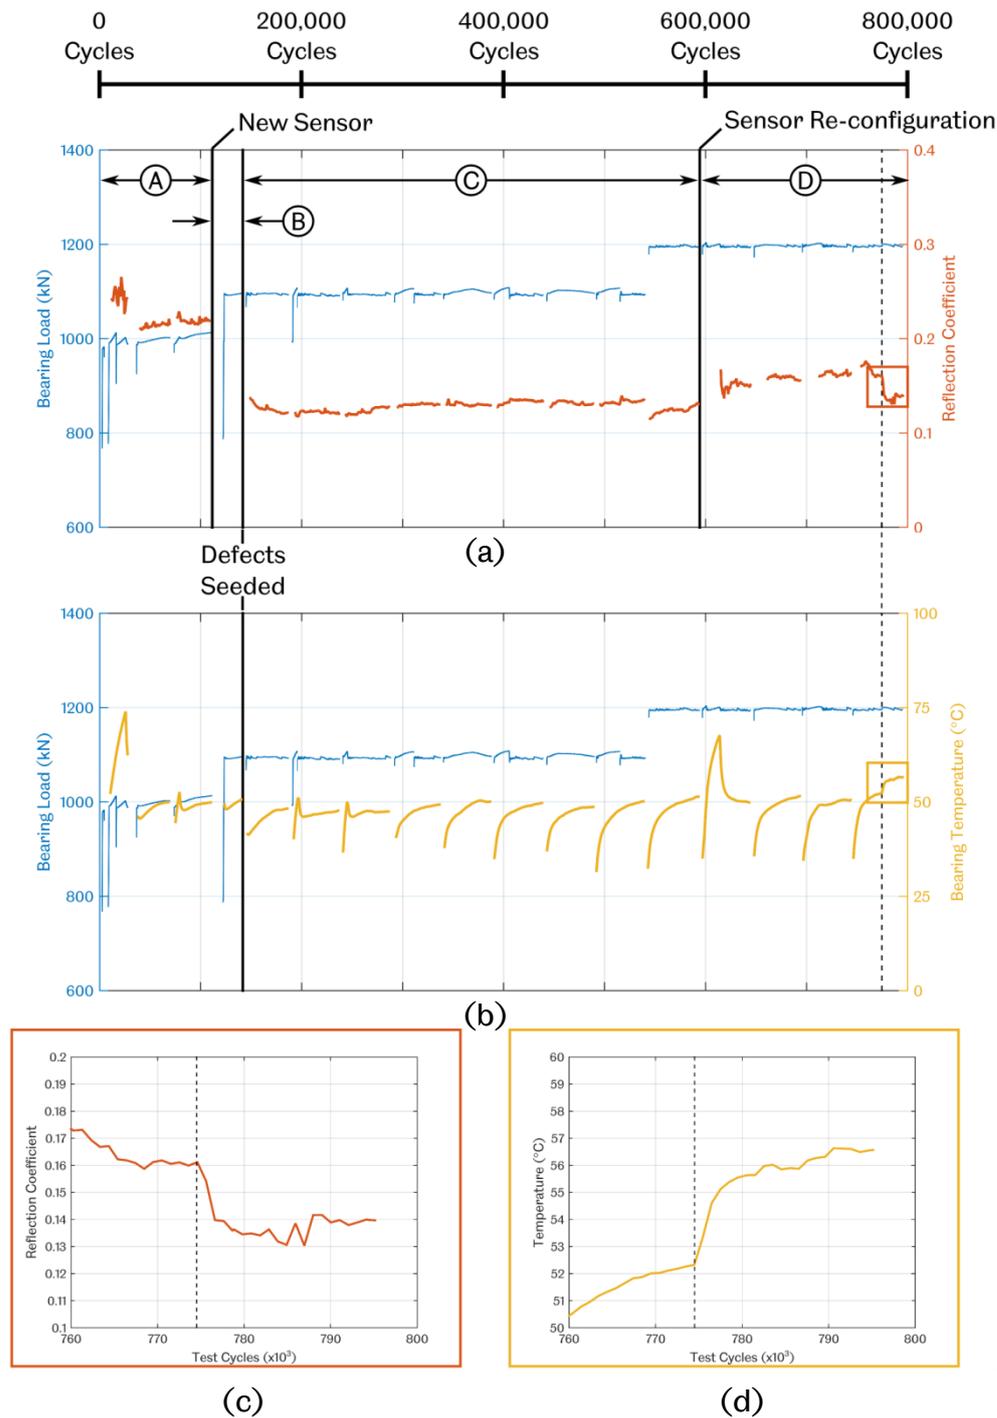
Figure 7.10: (a) Average Minimum Reflection Coefficient (MRC) and (b) inner raceway temperature vs test cycles throughout the full “Instrumented Bearing Test” with applied load overlaid (c) and (d) more detail of MRC and temperature traces respectively in the 45,000 cycles prior to the end of the test

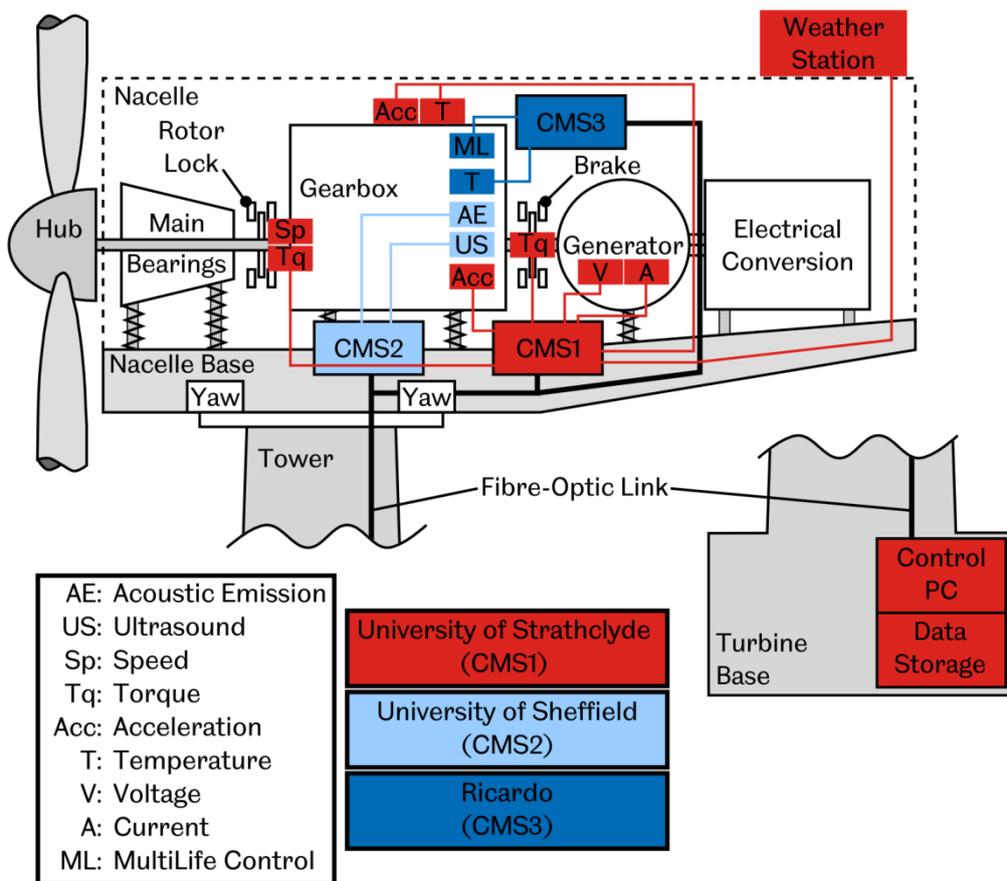
Figure 8.1: Full CMS sensor definition and breakdown of individual system requirements (adapted from [103])

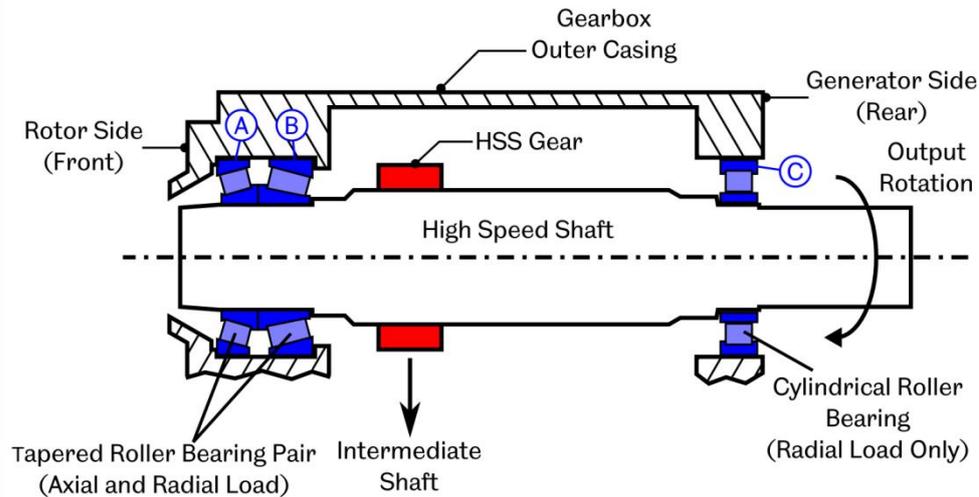
Figure 8.2: High speed shaft bearing configuration

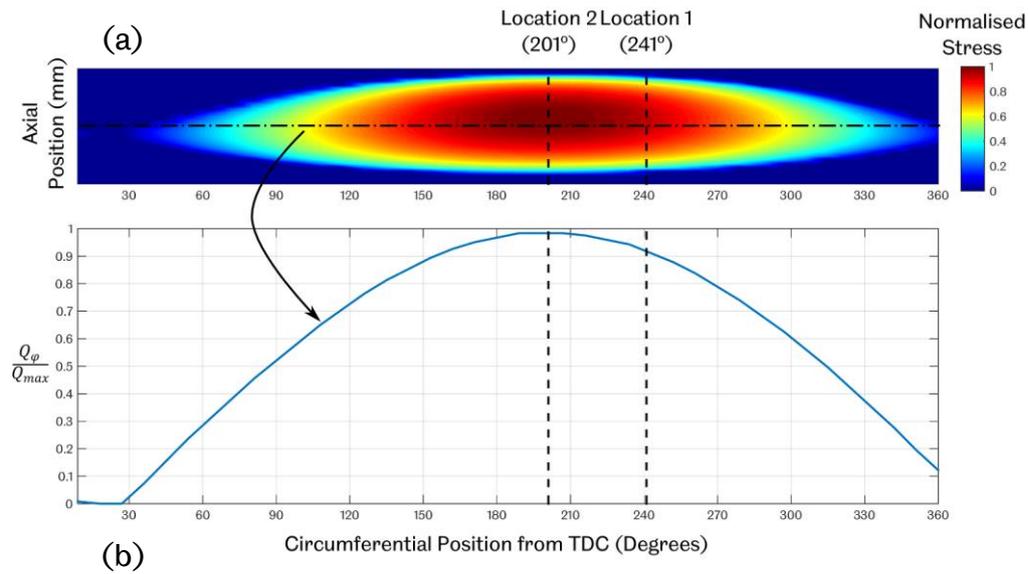
Figure 8.3: (a) Expected stress distribution (normalised) around the maximum loaded HSS bearing (Bearing B, Figure 8.2) (b) Inferred distribution of internal load  $Q_\varphi$  through the centre of the outer raceway (normalised to  $Q_{max}$ ) based on a cross section of the stress distribution map in (a)

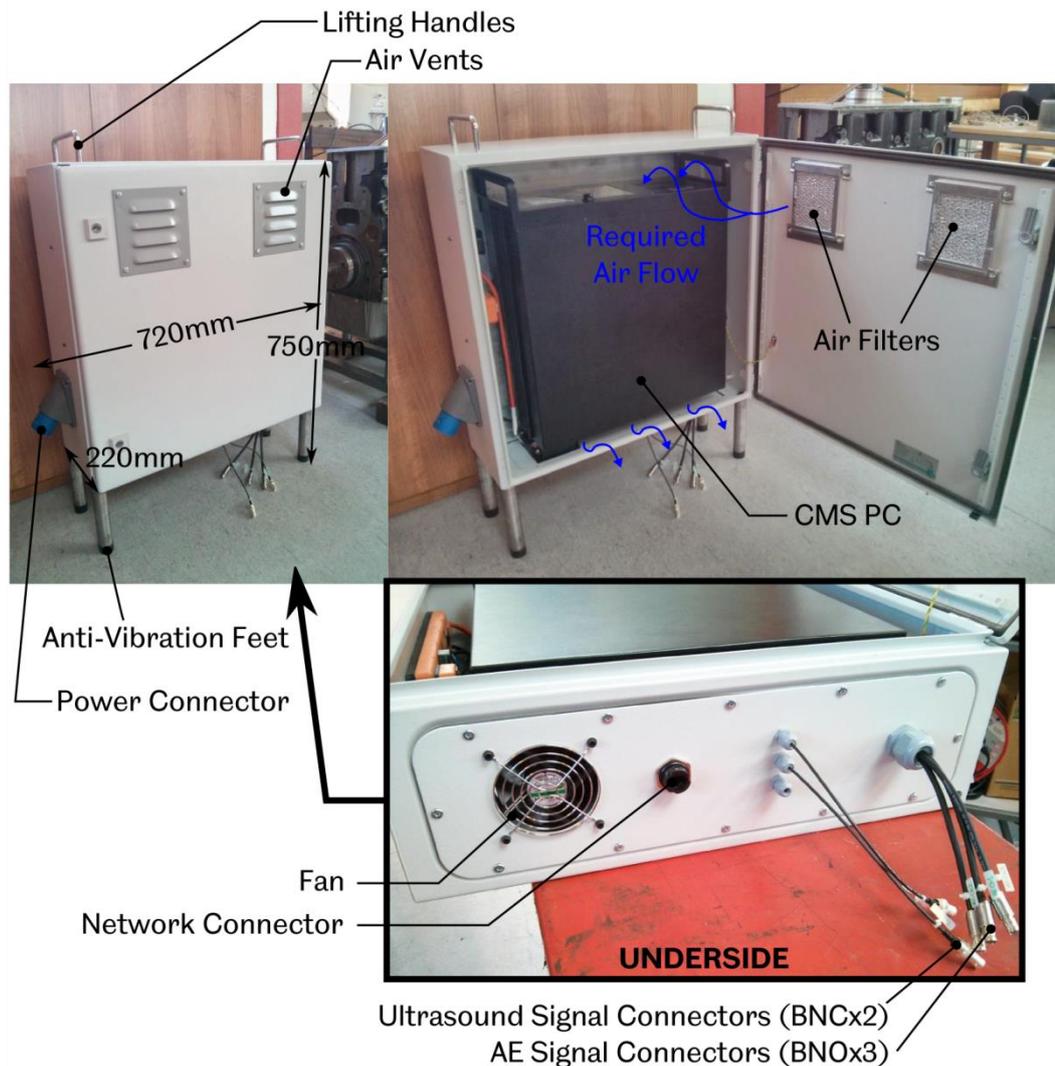
Figure 8.8: Final CMS2 system prior to installation

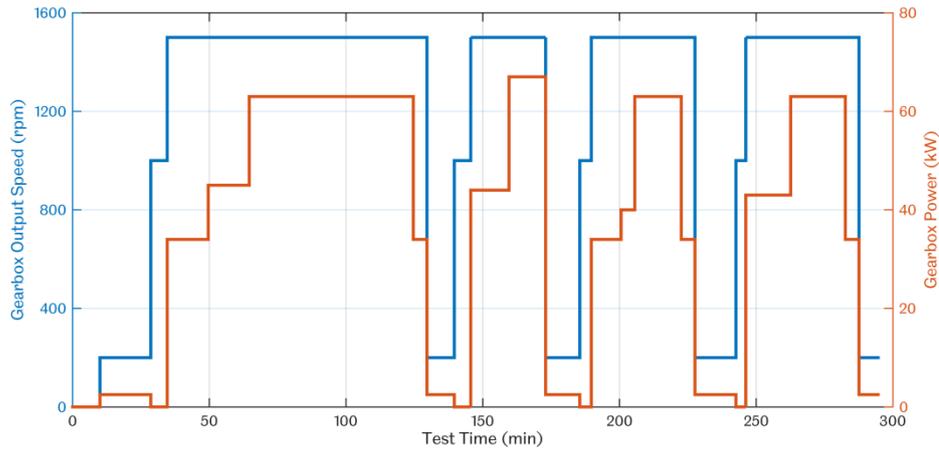
Figure 8.10: Gearbox endurance test conditions

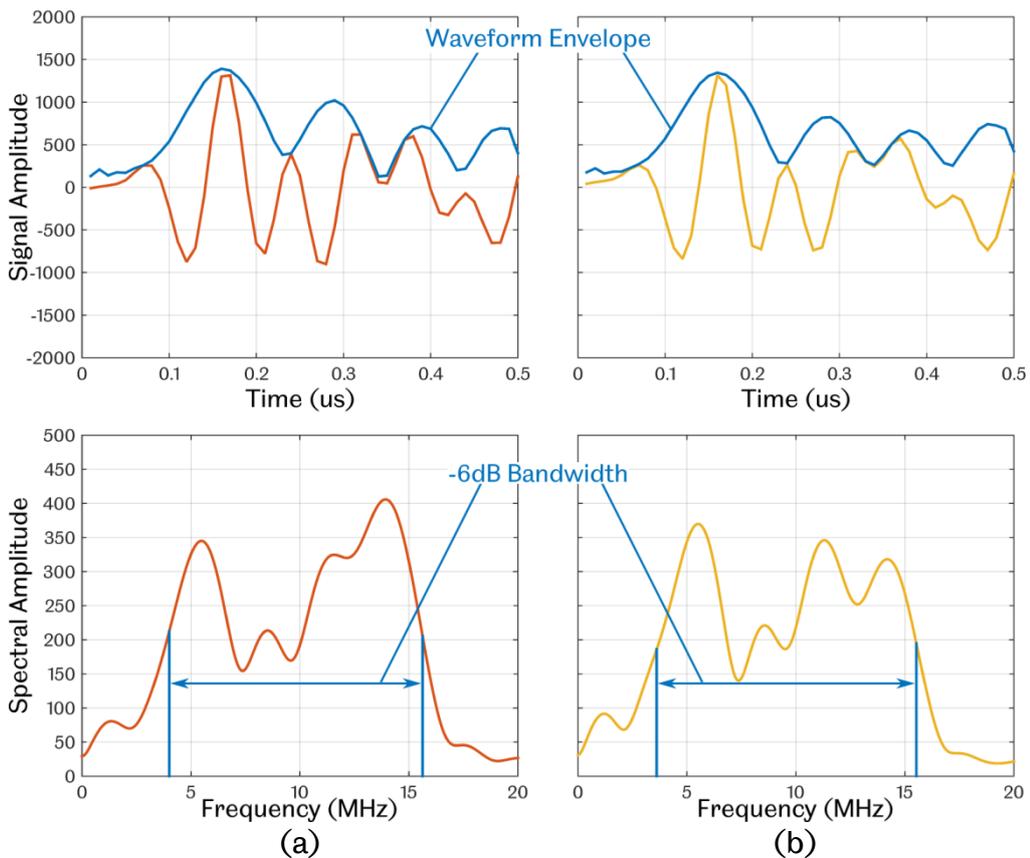
Figure 8.11: Reference signals obtained from HSS ultrasound sensor locations (a) 1 and (b) 2 in both the time (top) and frequency domain (bottom), obtained at  $t = 60\text{min}$  into the gearbox endurance test
