The  
University  
Of  
Sheffield.

Department  
Of  
Mechanical  
Engineering.

# **Development of a Novel Bearing Concept for Improved Wind Turbine Gearbox Reliability**

A thesis submitted in partial fulfilment of the requirements for the degree  
of Doctor of Philosophy

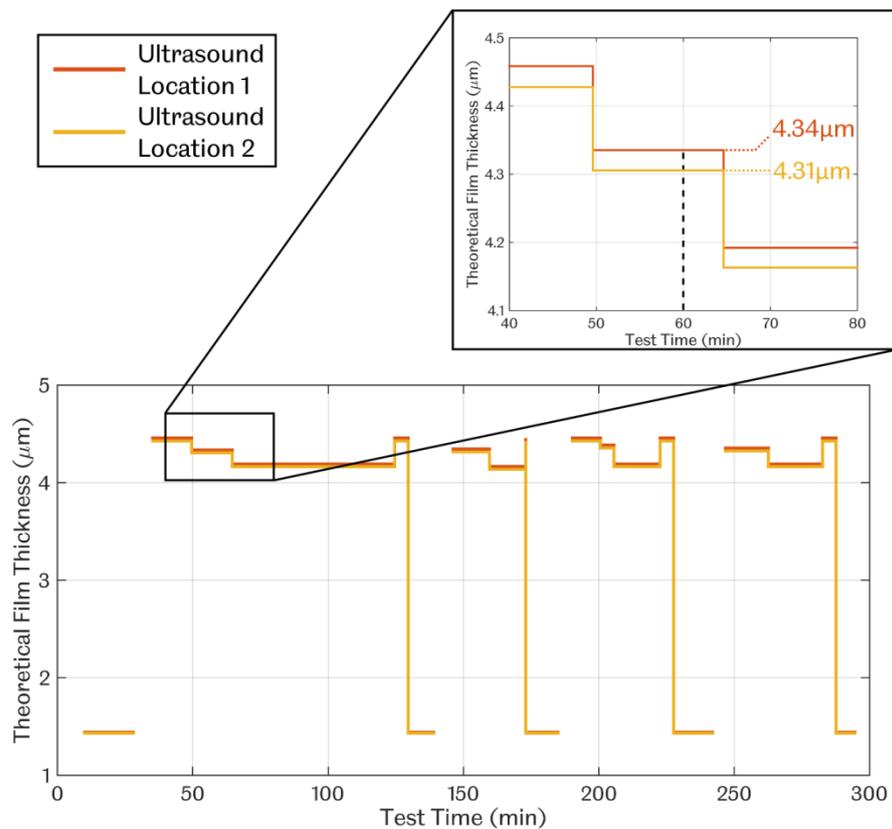
Figure 8.12: Theoretical film thickness formation within the 32222 HSS bearing based on gearbox power and speed throughout the endurance test as defined in Figure 8.10

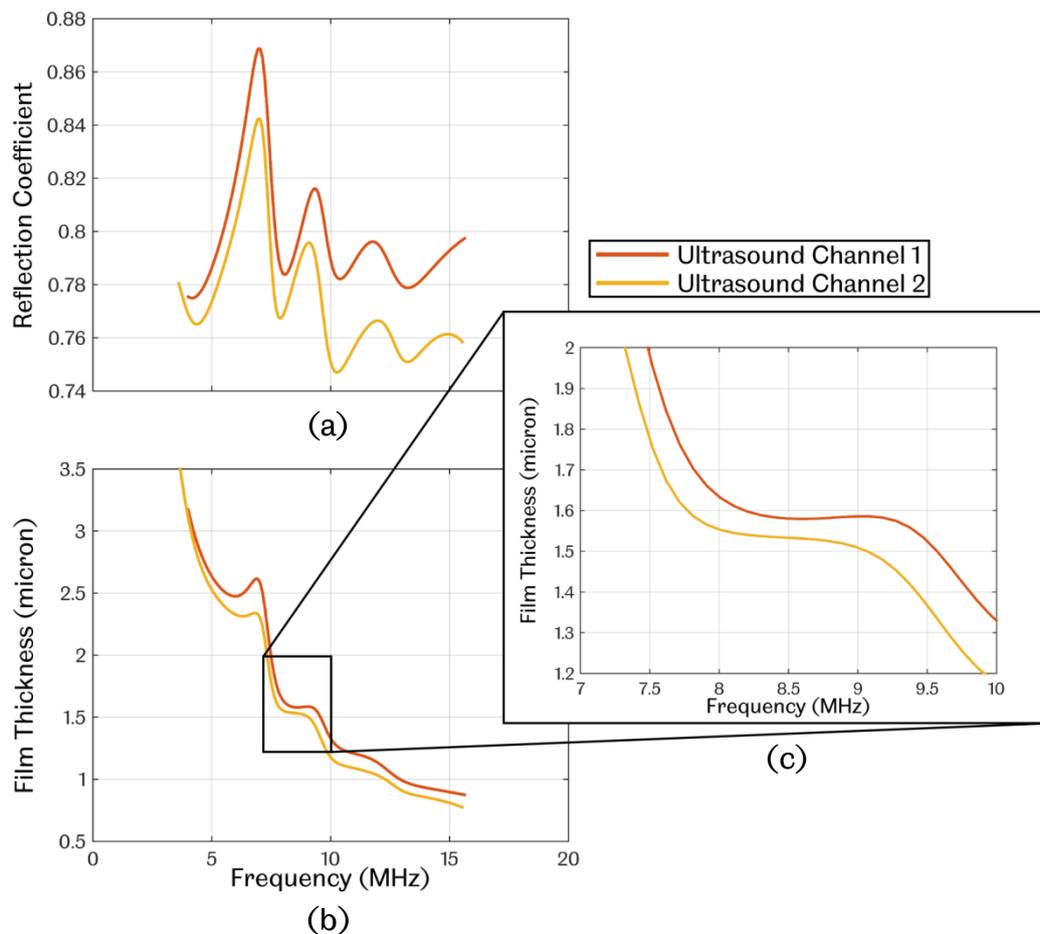
Figure 8.13: (a) Reflection Coefficient vs Frequency within the bandwidth of the two ultrasonic sensors (as defined in Figure 8.11) and (b) subsequent film thickness based on Equation (3.16). (c) shows the frequencies over which a constant film thickness output is achieved

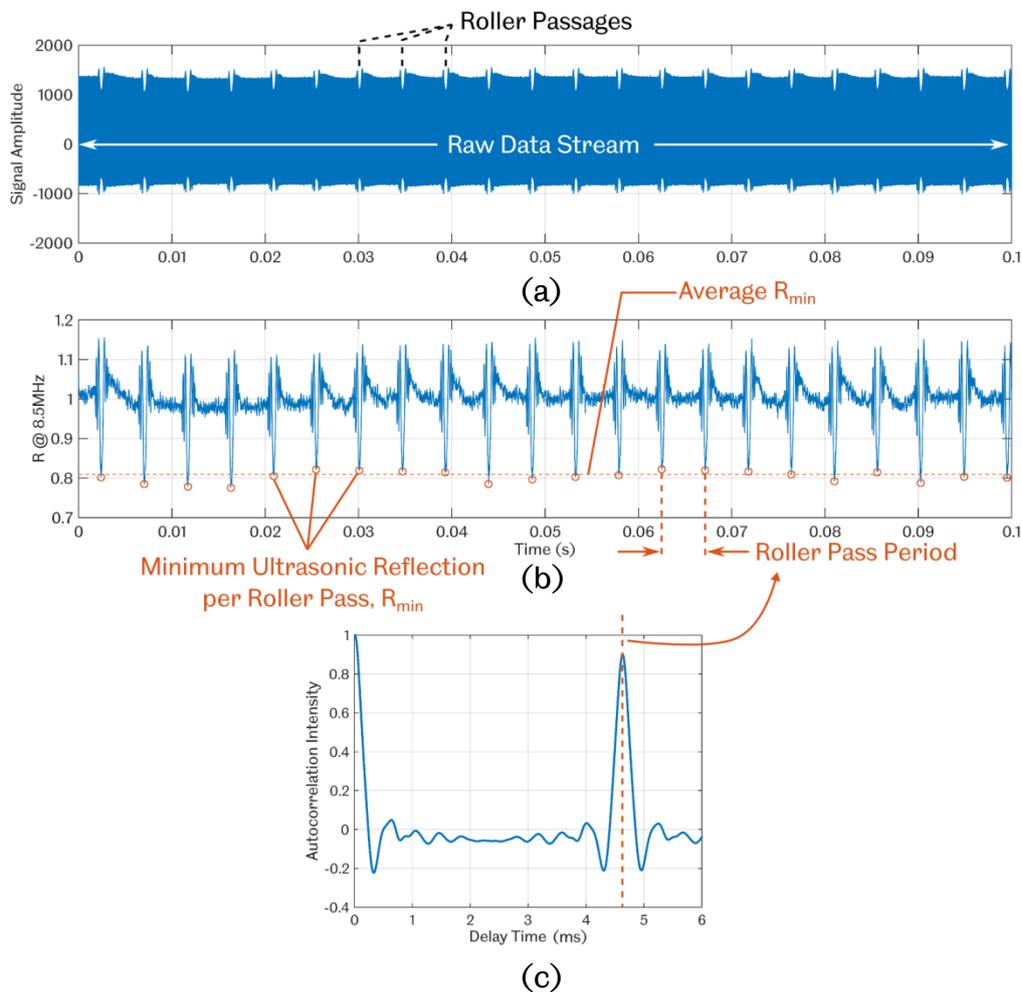
Figure 8.14: (a) Segment of raw ultrasonic data obtained from Sensor 1 during gearbox operation (b) reflection coefficient calculated from the raw data using the 8.5MHz frequency component (c) Autocorrelation of the reflection coefficient curve to obtain the roller pass period

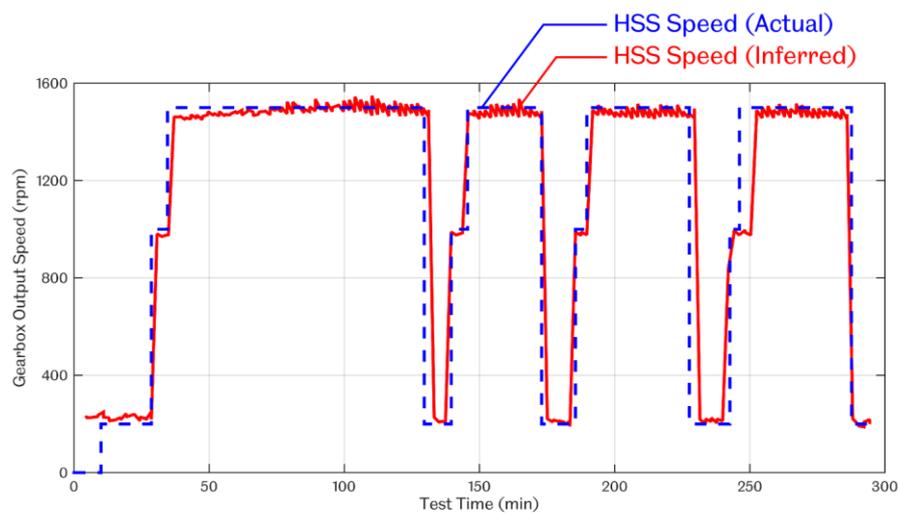
Figure 8.15: Comparison between actual gearbox output speed and that inferred from the roller pass frequency measured from ultrasound data

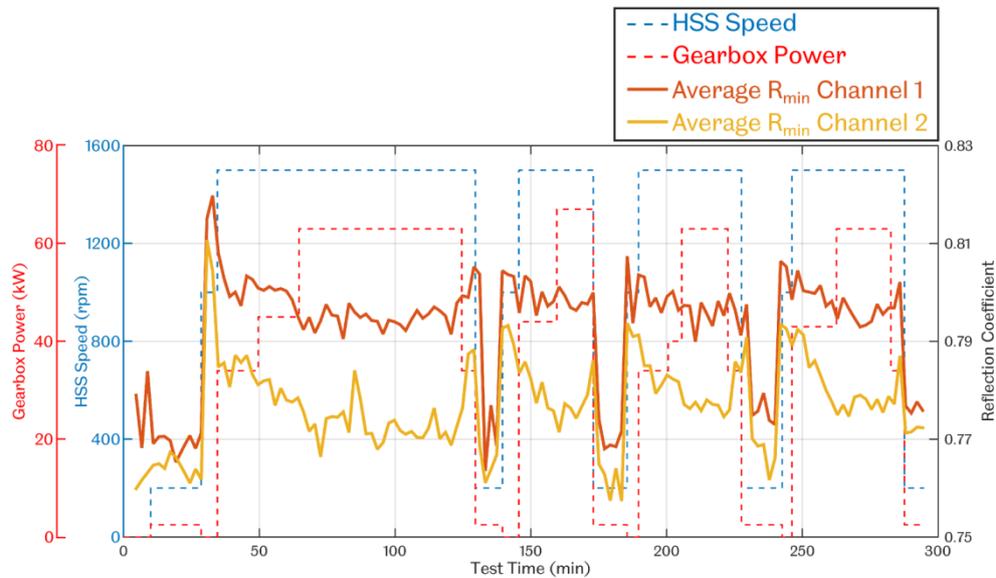
Figure 8.16: Comparison of the average ultrasonic reflection per roller pass per channel against gearbox power and speed

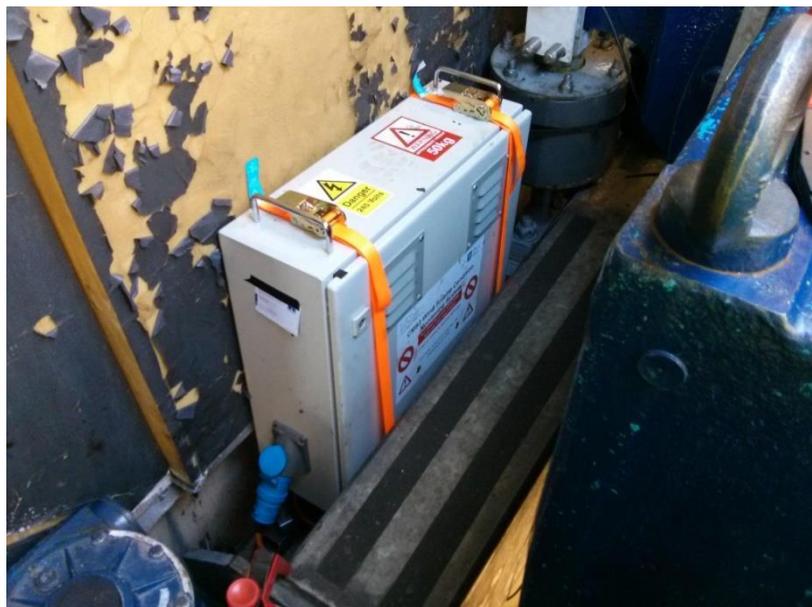
Figure 8.17: CMS2 unit installed within the nacelle

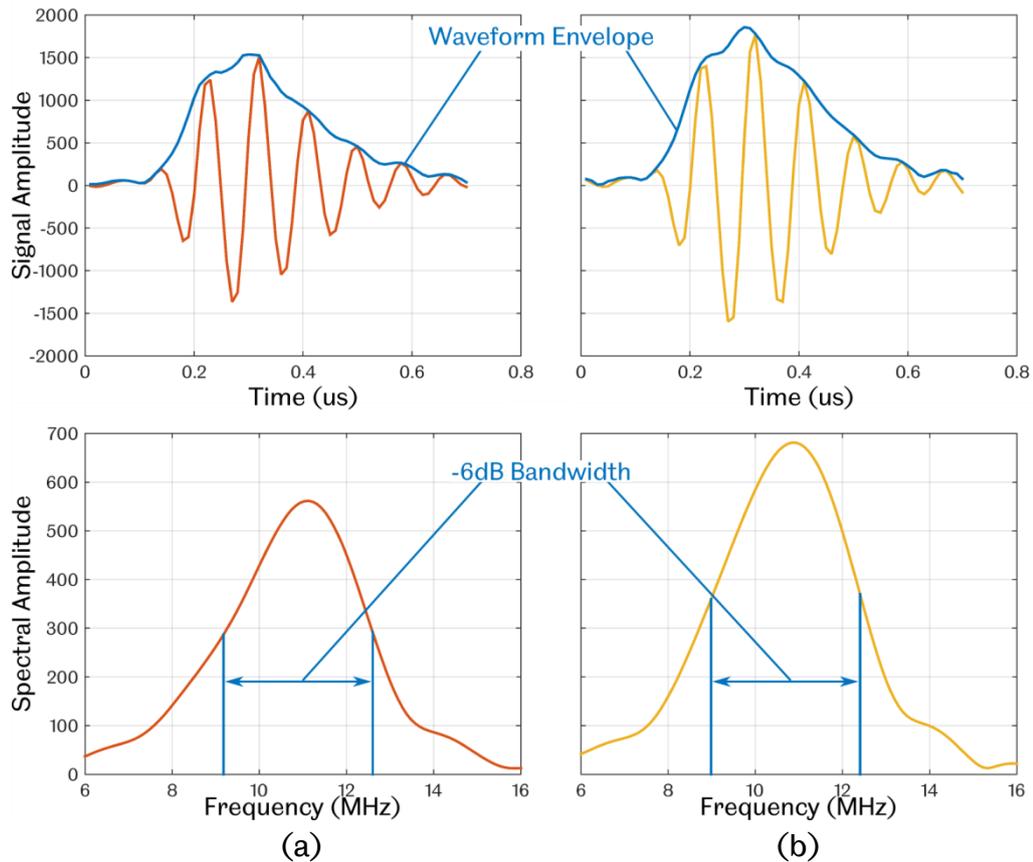
Figure 8.18: Ultrasonic reflection signals obtained from (a) ultrasound sensor 1 and (b) ultrasound sensor 2 in both the time (top) and frequency domain (bottom) following final installation within the wind turbine nacelle

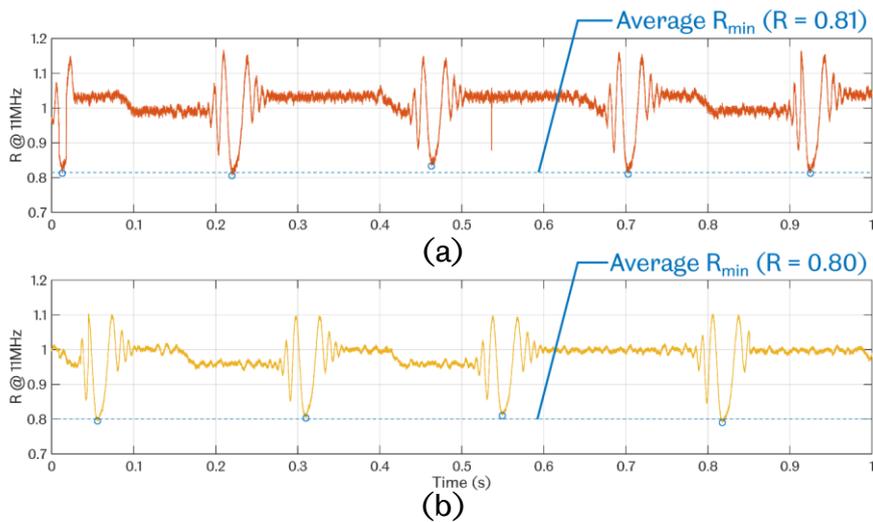
Figure 8.19: Reflection coefficient vs Time (at the 11MHz resonant frequency as identified in Figure 8.18) from a 2 second data stream obtained from (a) ultrasound sensor 1 and (b) ultrasound sensor 2
