**CONSERVATION OF BRITISH COLONIAL BUILDINGS
BUILT BETWEEN 1800 AND 1930 IN MALAYSIA**

**Thesis Submitted to
the School of Architectural Studies,
University of Sheffield
for the Degree of Doctor of Philosophy**

October 1993

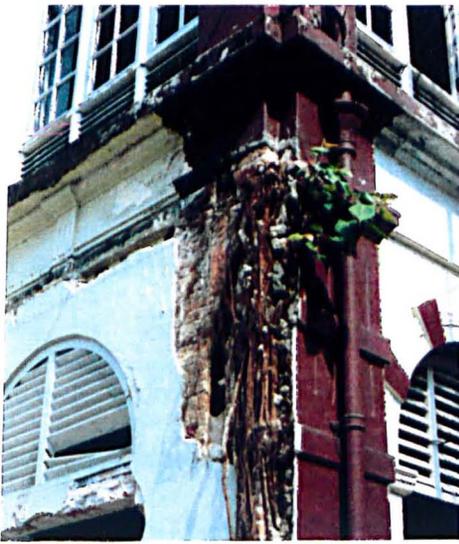
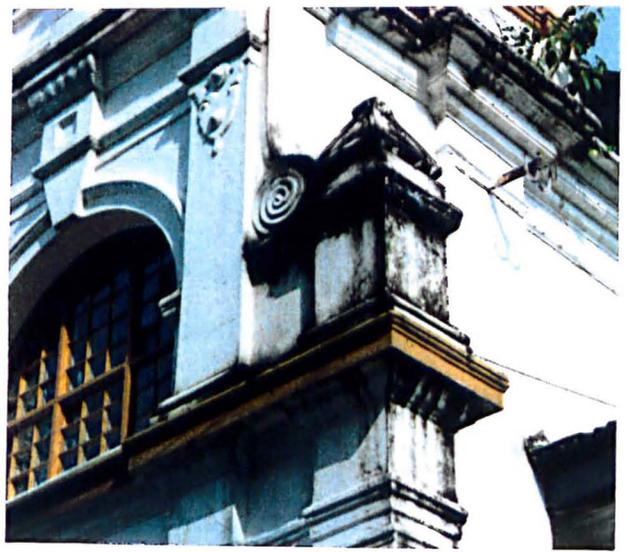
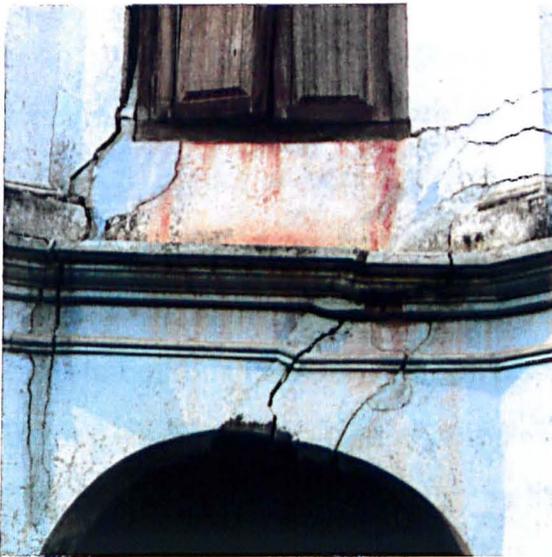
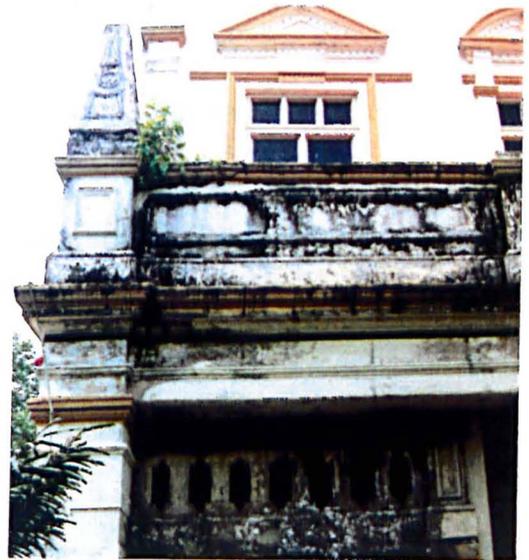
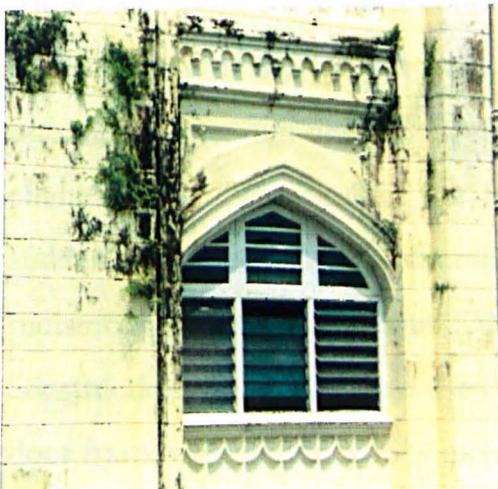
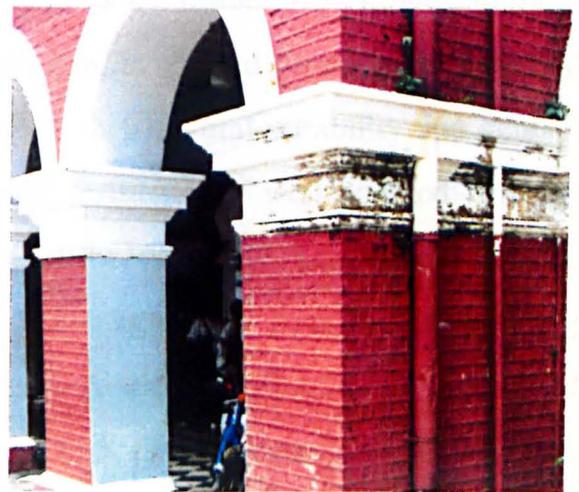
Fig.44 Examples of common building decays in British colonial buildings

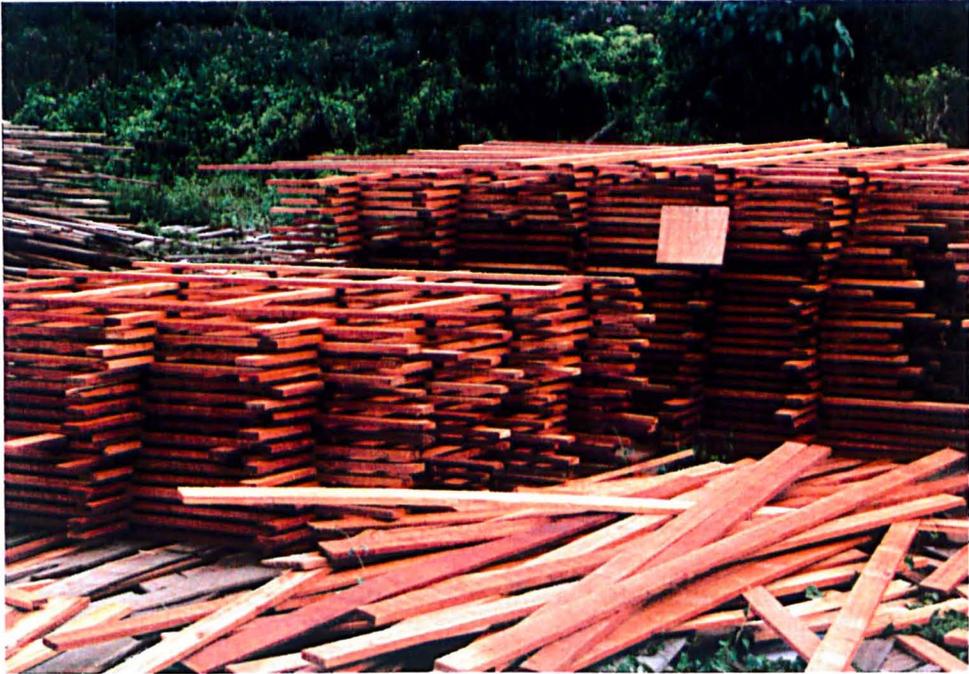
Fig.45 Timbers are stacked into layers in air seasoning methods

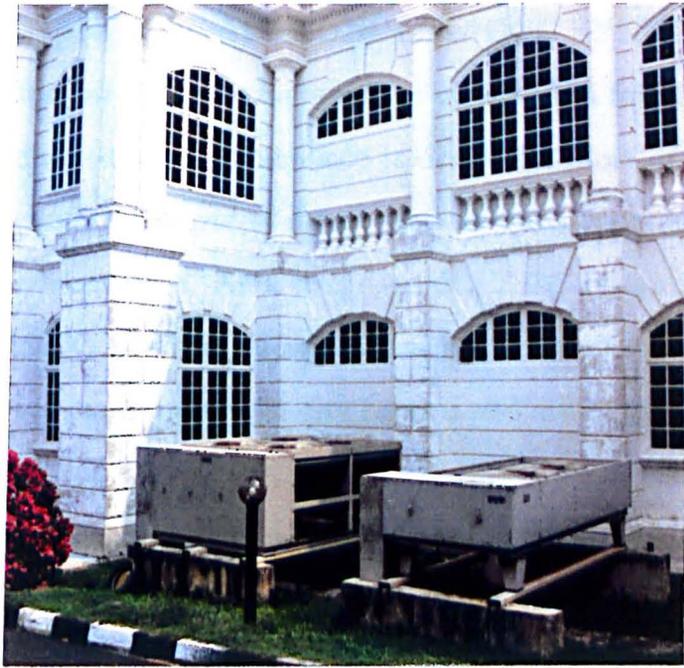
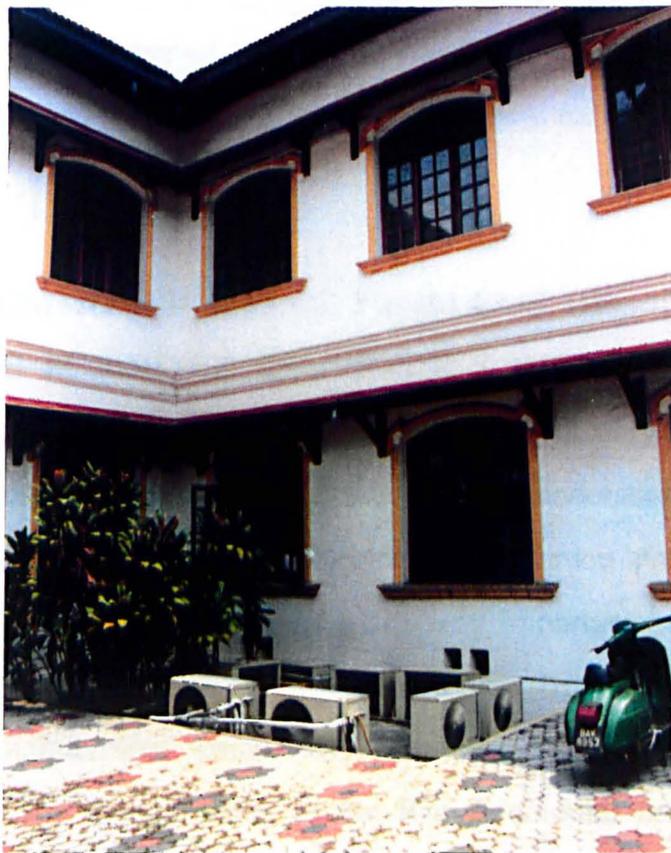
Fig.48 Placing air-conditioning units at outside is more preferable than on windows and walls

When it is decided to install an air-conditioning system into an old building, several aspects of building conservation should be considered. The main objectives of this approach are that the introduction of air-conditioning units should not destroy or degrade building materials, affect the appearance of the building; and should be as unobtrusive as possible. Careful placement of the unit plays a major role in achieving these objectives. Where a split system is installed, for instance, it is important to place the compressor and condenser units on ground level at the back of a building or other suitable location. If the units are placed on the ground level and not to be visible, it is of a good idea to put screening devices such as short plants, shrubs or fences around the units. Any ducts should not run in full view but placed above a suspended ceiling. However, if the suspended ceiling reduces the room height and also causes other problems to the building structures and fabric, then it is advisable to leave the ducts visible. For the ducts on upper floor, they can be concealed conveniently in a roof space. A new chiller plant room, if necessary, may be constructed outside the building to protect the compressor and condenser units. For the domestic-scale packaged system, the placement can be in a corridor, balcony or verandah, in the conditioned space itself but not on window units or fixed onto walls. To match and blend with the existing colour of a building, the air-conditioning units and electrical wirings may be painted.

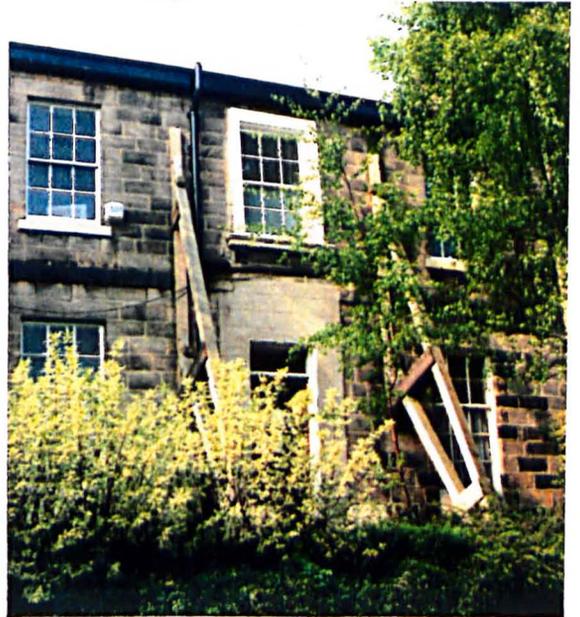
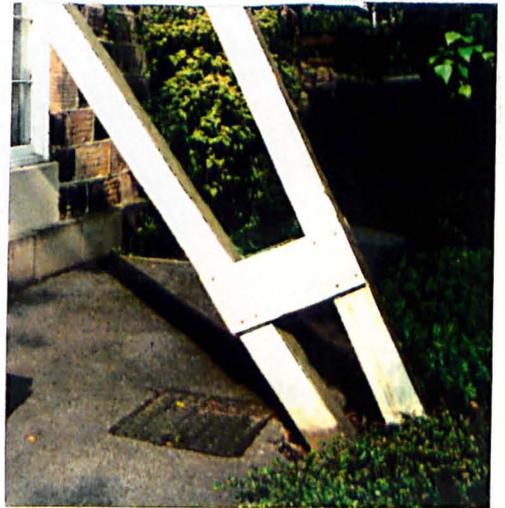
Fig.52 Method of raking shores for temporary support to a leaning wall

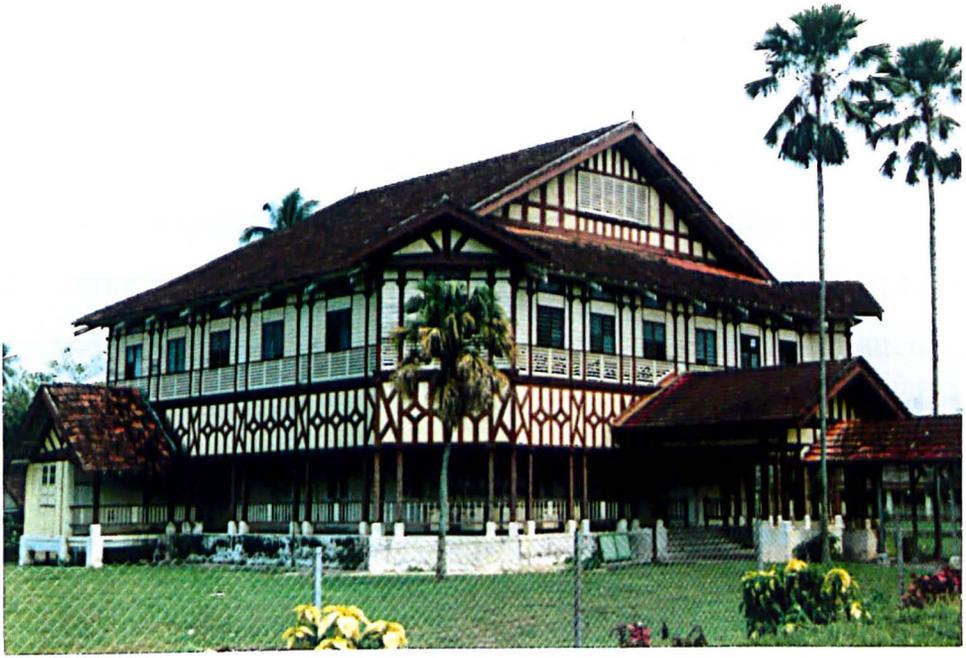
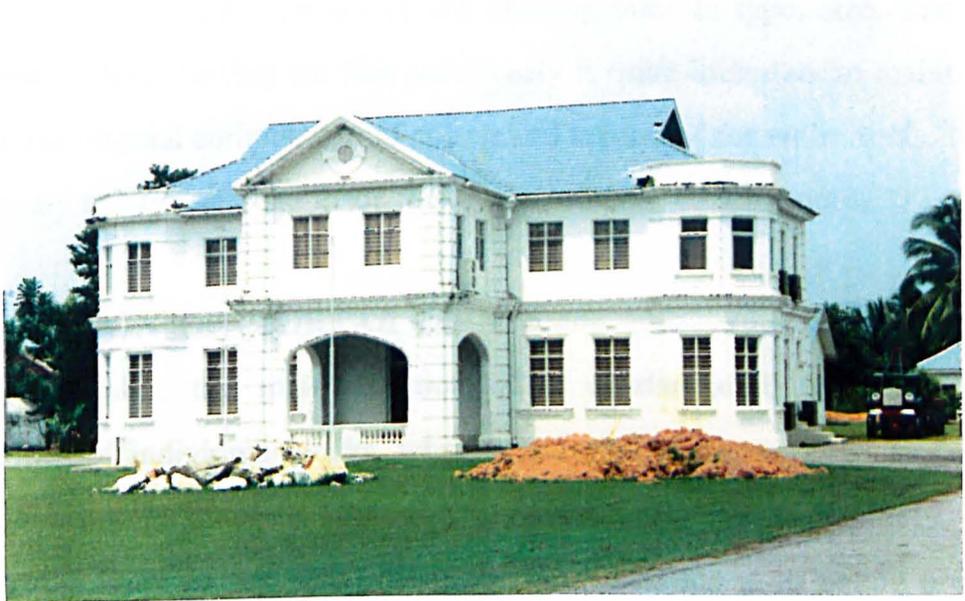
Fig.54 Old and new roof tiles

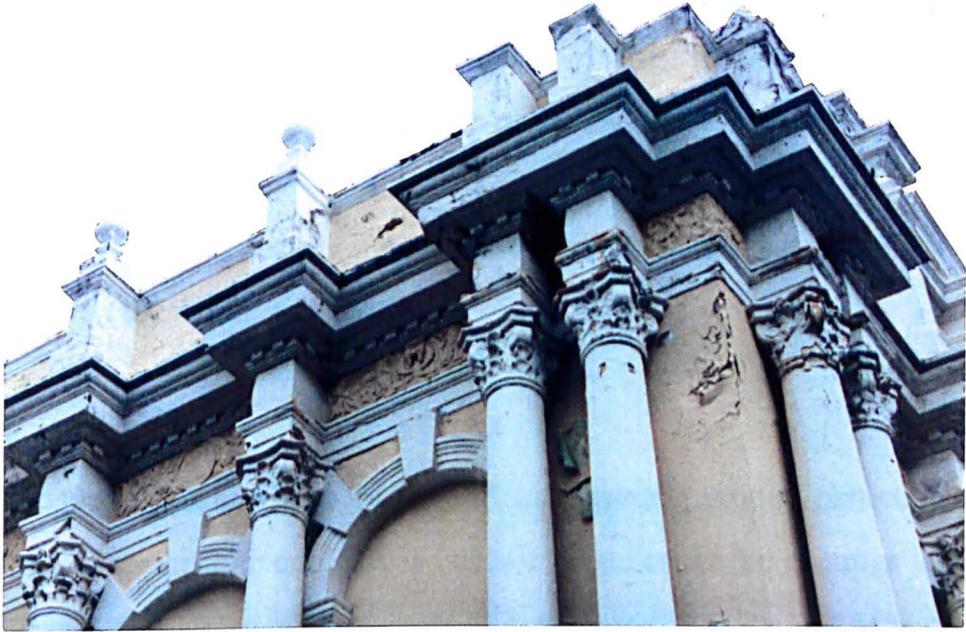
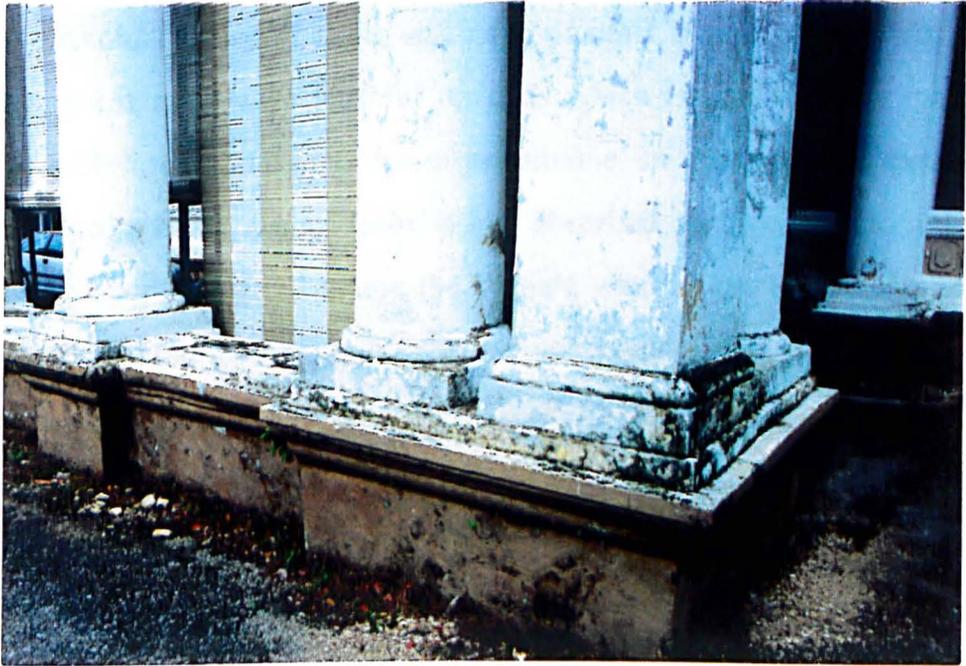
Fig.56 Peeling paint on areas exposed to excessive rain and dampness

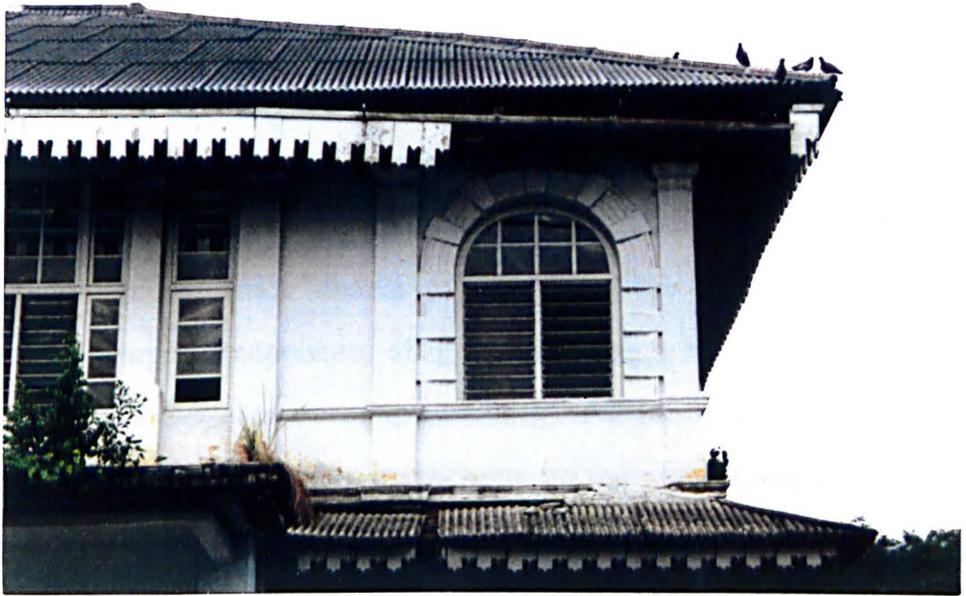
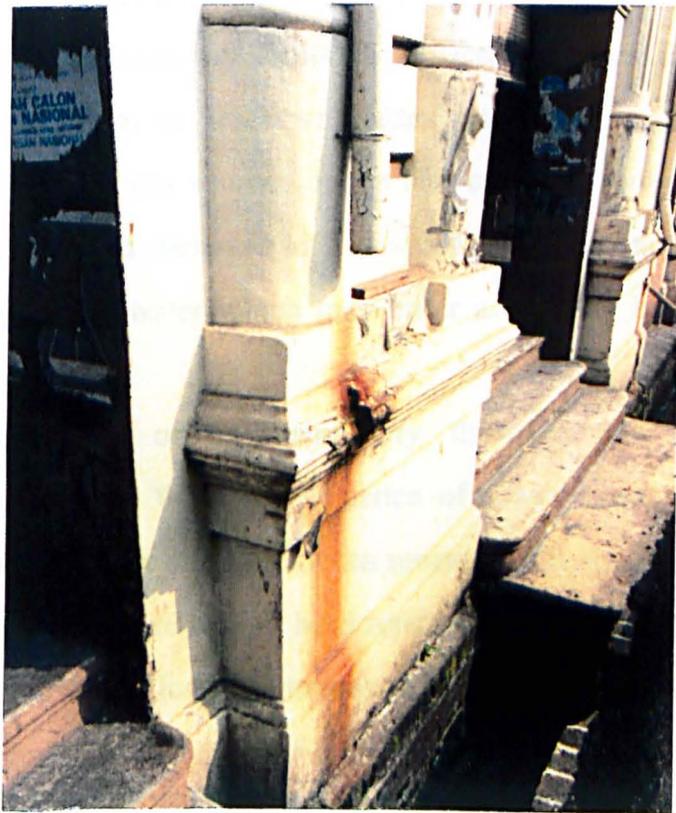
Fig.57 Common problems associated with defective rainwater goods

In regard to the iron downpipes, it is important to fix them on spacers two or more inches clear of the wall. This is to ensure that any leaking will tend

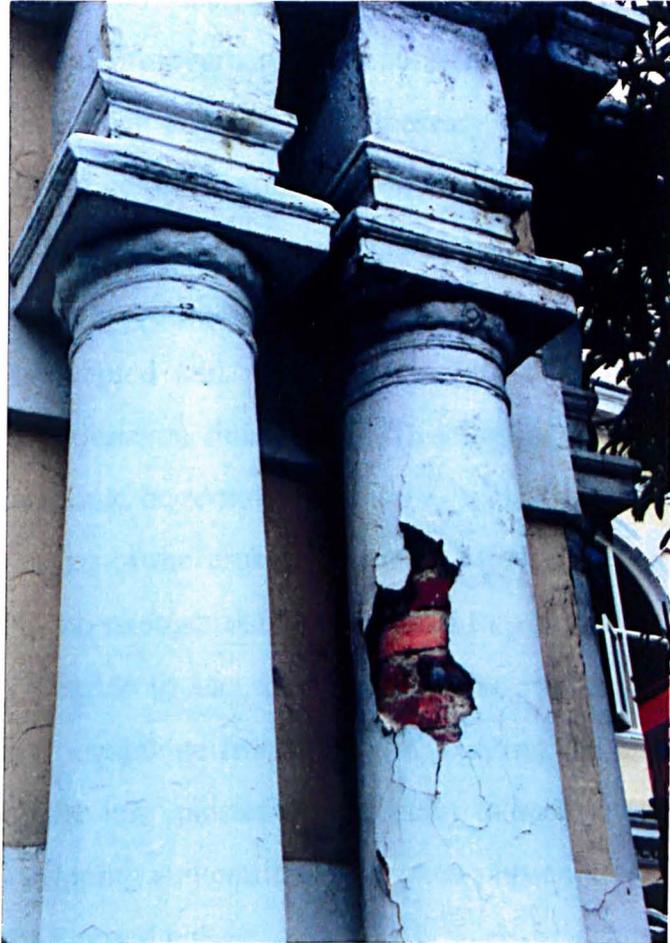
Fig.60 Broken plaster caused by biological attack

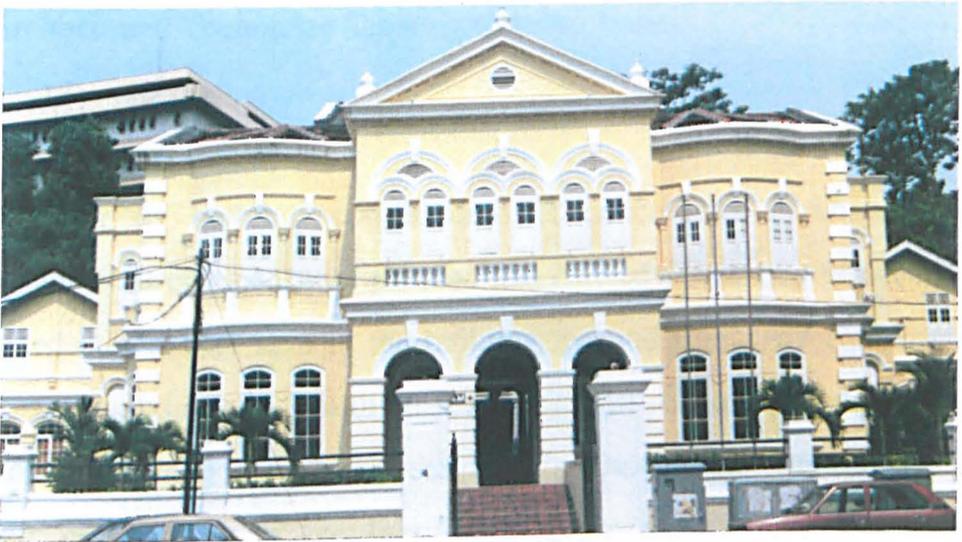
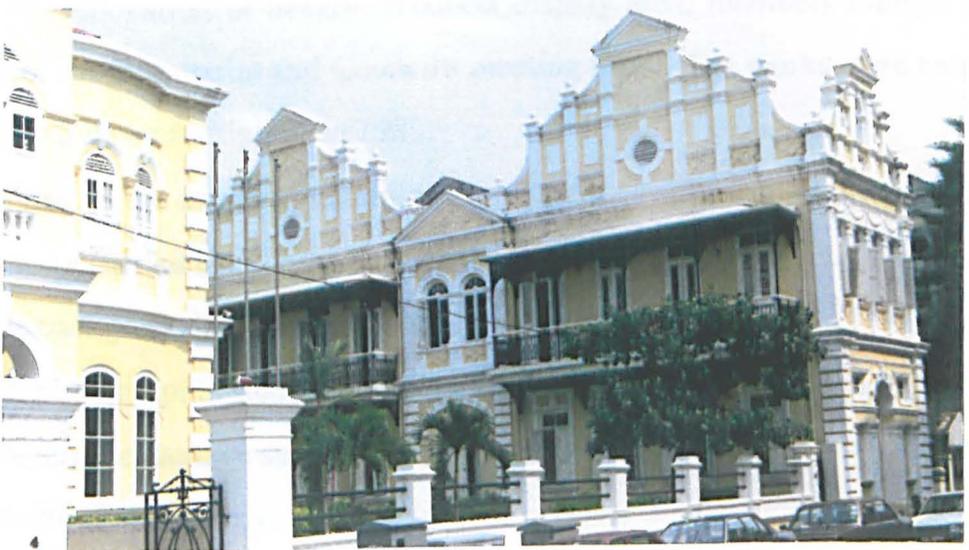
Fig.88 PAM Centre before (above) and after (below) renovation.

Before the PAM Centre was restored, its building condition was in the state of disrepair. Roof leaks and rotting timber were the main problems. A structural survey in late 1983 indicated that the main roof was in dangerous state of collapse developing from extensive termite attack and rot. Also the problem of earth movement at the back of the building. The external walls had to be

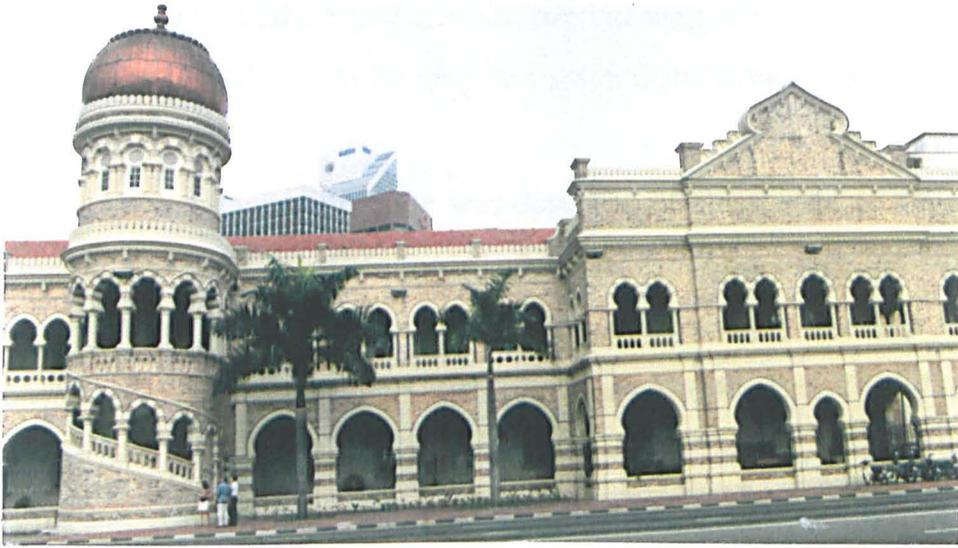
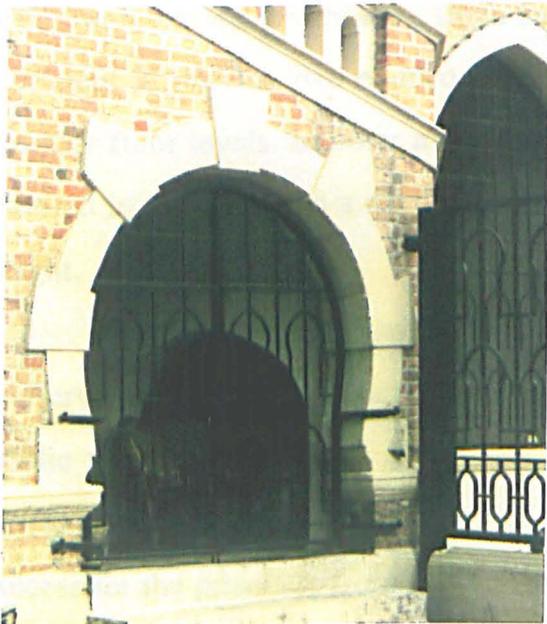
Fig.94

Iron grilled screens were fixed for security reason.

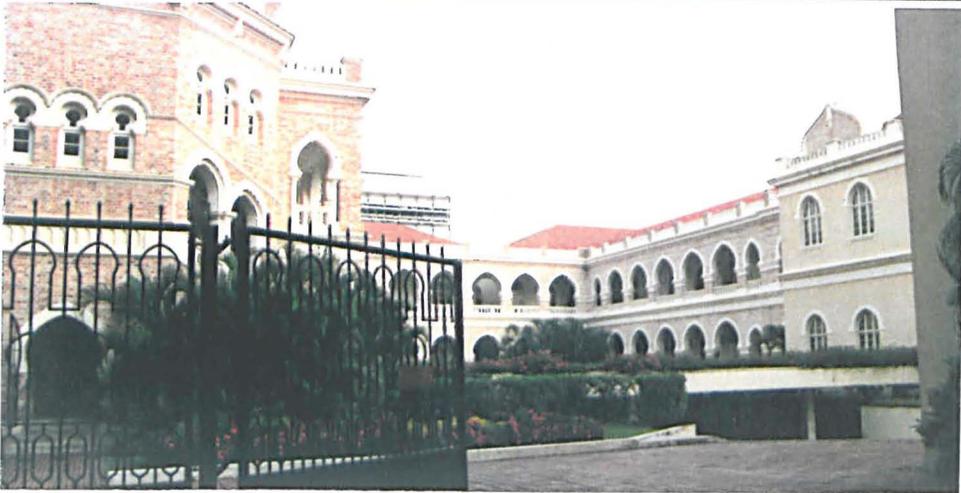
Semi-sunken car park in the courtyard.

Of later constructions is the semi-sunken car park located in the courtyard. The car park, which can accommodate 32 cars, is covered by a concrete slab with planting on top. This solution deals with parking, often a visual problem for historic buildings. Another addition is the overhead bridge connecting the Sultan Abdul Samad Building and the nearby Old General Post Office building. This gives an easy access for staff, judges and officials to get into these buildings from the first level. An interesting thing about this bridge is that it maintains some of the characteristics of the existing buildings. These can be seen from its exposed bricks, pointed arches and plastered mouldings. The total cost of renovating and restoring the building was MR17.2 million.

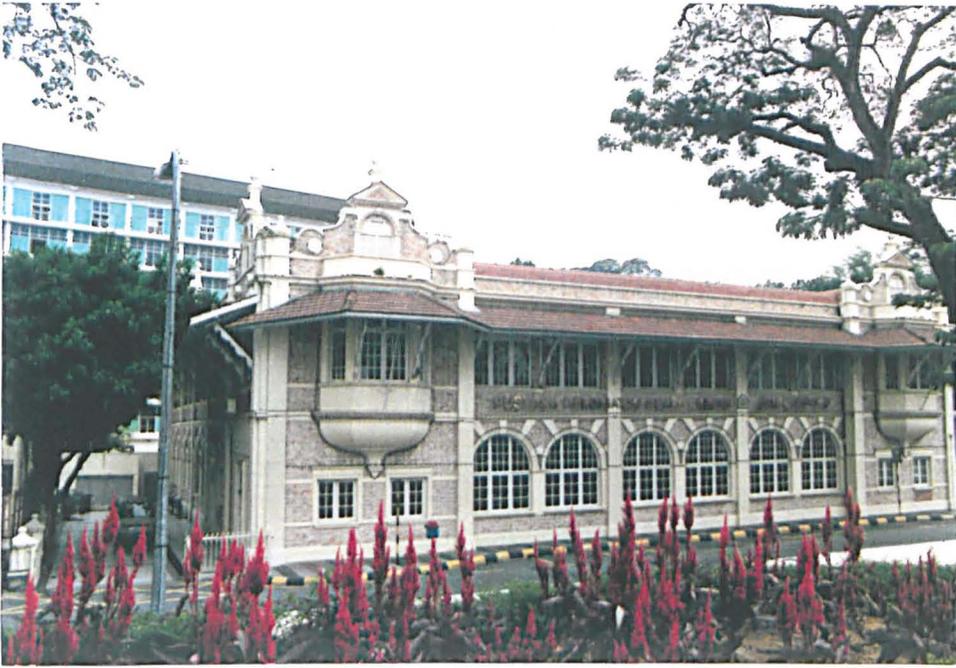
The problem with the awnings is that they were placed at different level and created a bad design especially at building corners.
