**Wear and rim damage of UHMWPE acetabular cups in total  
hip replacement**

Submitted in accordance with the requirements for the degree of Doctor of  
Philosophy

The University of Leeds  
School of Mechanical Engineering

December 2016

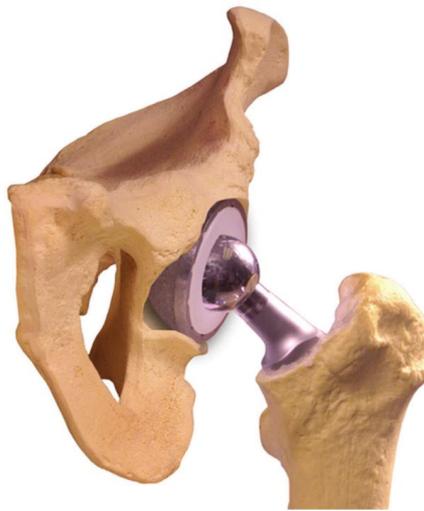
**Figure 1-2 Total Hip Arthroplasty (Malik, 2007)**

In total hip replacement the femoral head is removed and replaced by an artificial head, which articulates against an artificial cup implanted into the acetabulum. The head is attached to a stem that is fixed to the inside of the femoral shaft (Figure 1-2). Fixation of the femoral component is achieved using cement (cemented) or by adding a porous coating and press fitting into the shaft of the femur (uncemented), promoting bone growth directly on to the component. Likewise, the acetabular cup can be cemented directly into the acetabulum or it can be fixed to the acetabulum with screws, spikes or bone ingrowth.

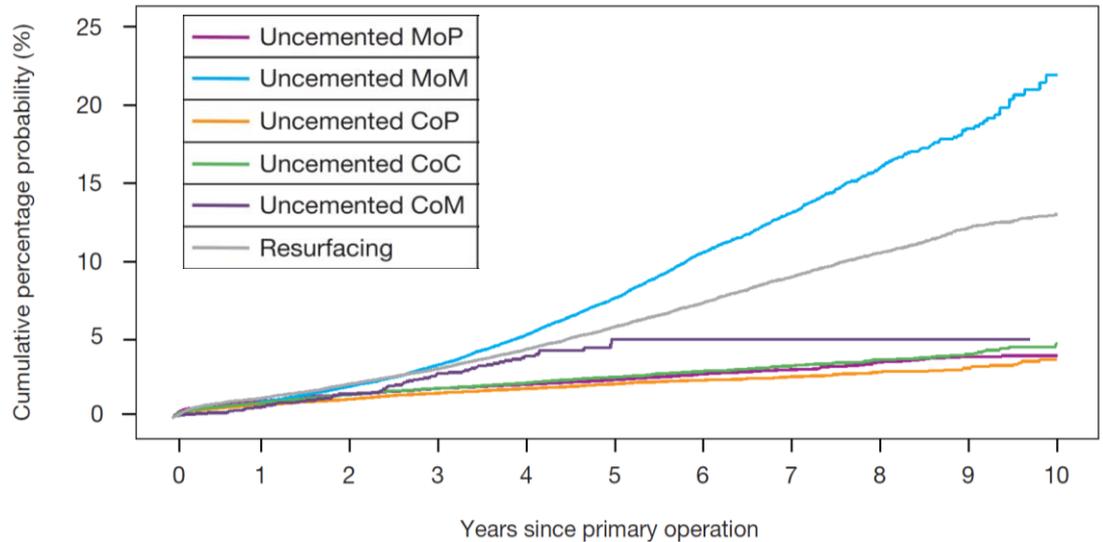
**Figure 1-3 Comparison of cumulative probability of revision (Kaplan-Meier estimates) for uncemented primary hip replacements with different bearing surfaces (National Joint Registry, 2014)**

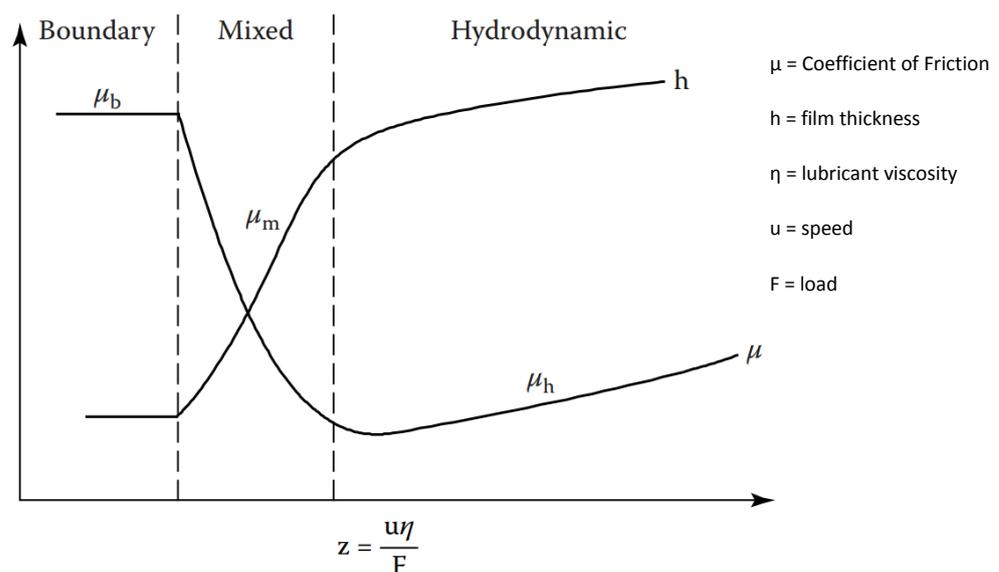
**Figure 1-9 Graph of Boundary, Mixed and and Hydrodynamic Lubrication Regimes. Adapted from Biresaw (2008)**

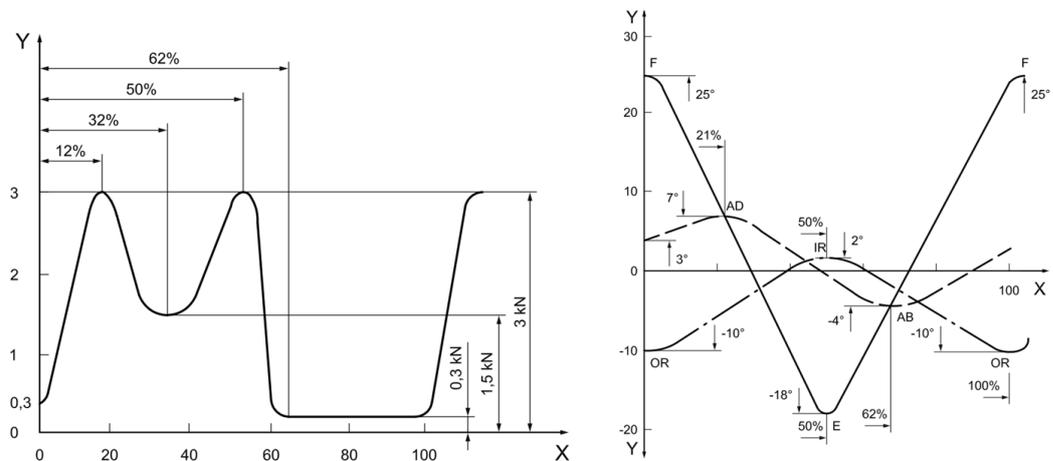
**Figure 1-14 Load (right) and motion (left) parameters described in ISO 1424-1 (2014) where AB = Abduction, AD = Adduction, E = Extension, F = Flexion, IR = Inward rotation and OR = Outward rotation (BS ISO 14242-1:2014)**

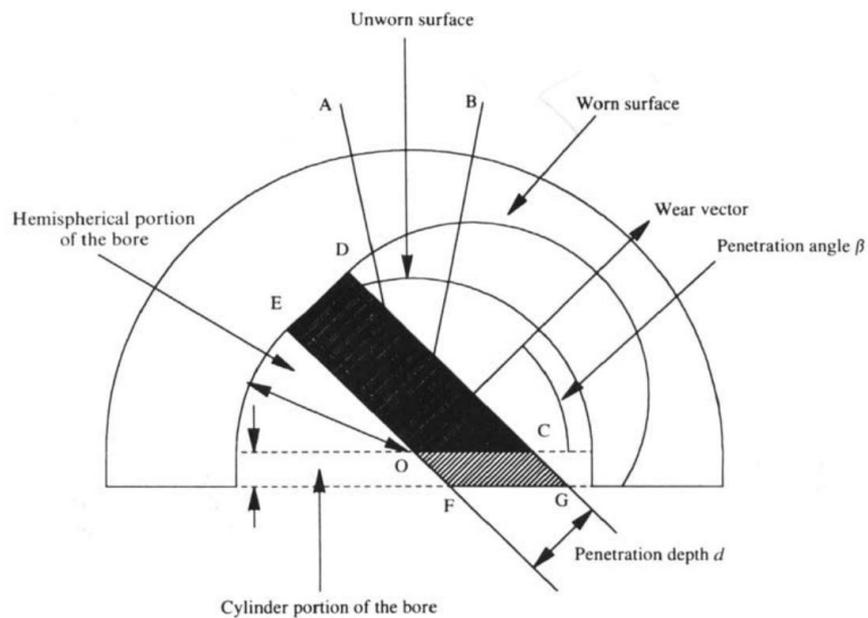
**Figure 1-15 schematic of the wear volumes for a Charnley acetabular cup showing the cylindrical and spherical regions and the wear volume (parallelogram EDCGFO; (Hall and Unsworth, 1995))**

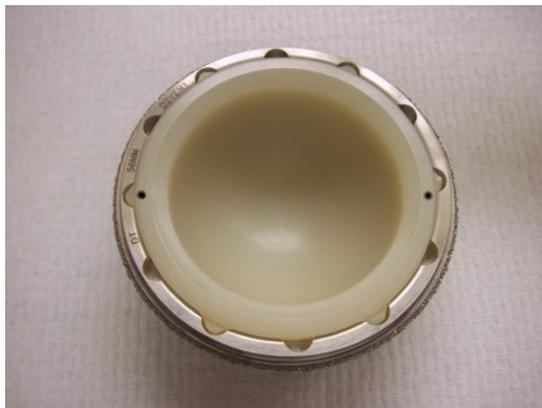
**Figure 2-1 An assembled Pinnacle® acetabular shell showing the ARD tabs on the UHMWPE liner and the ARD scallops on the titanium shell**

The Pinnacle® total hip replacement liners (XLPE, Aged PE and AOPE liners) in these studies comprised a 56mm outer diameter titanium alloy shell and a press fit 36mm inner diameter UHMWPE liner with taper lock and anti-rotation device (ARD) tabs that mate with anti-rotation device scallops (Figure 2-1).

The liner thickness for all materials was 7.8mm at the apex and 5.1mm at the rim. The compression moulded acetabular cup design comprised of a 36mm inner diameter non-removable compression moulded UHMWPE interior with Gription® porous coating on both the inner and outer surfaces of a 48mm outer diameter titanium shell (Figure 2-2). The UHMWPE in the compression moulded cup was 2.7mm thick.

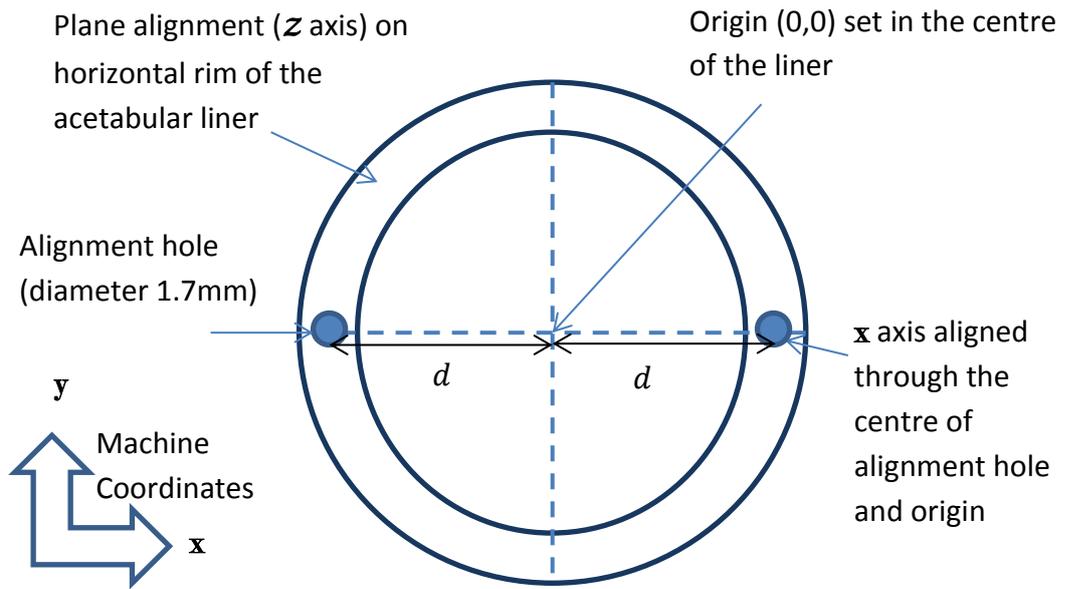
**Figure 2-4 Alignment of an acetabular cup on the CMM: origin  $(0_x, 0_y)$  is set at  $(d_x, 0_y)$  from the centre of one of the alignment holes and the x axis is aligned through the origin and the centre of one of the alignment holes. The horizontal liner rim is aligned with the z plane.**

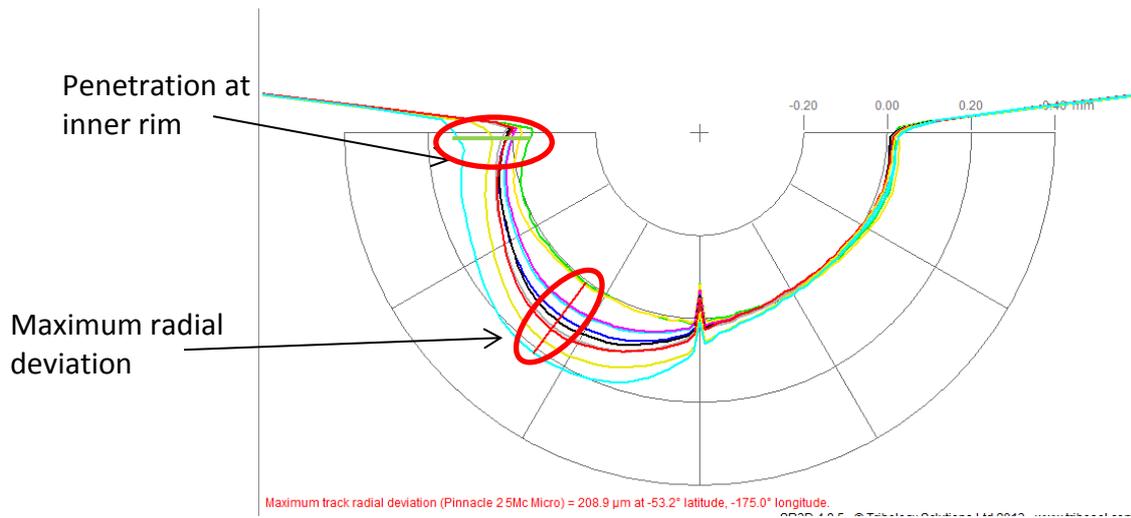
**Figure 2-5 SR3D image of a cross section of an AOPE acetabular liner (AOPE 2) after 5Mc of standard loading and 5Mc of edge loading. The maximum radial deviation at the area of articulation is marked with a red line (208.9  $\mu\text{m}$ ) and the radial deviation at the rim is marked with a green line (157.9 $\mu\text{m}$ ). Profile deviations are at x40 magnification**

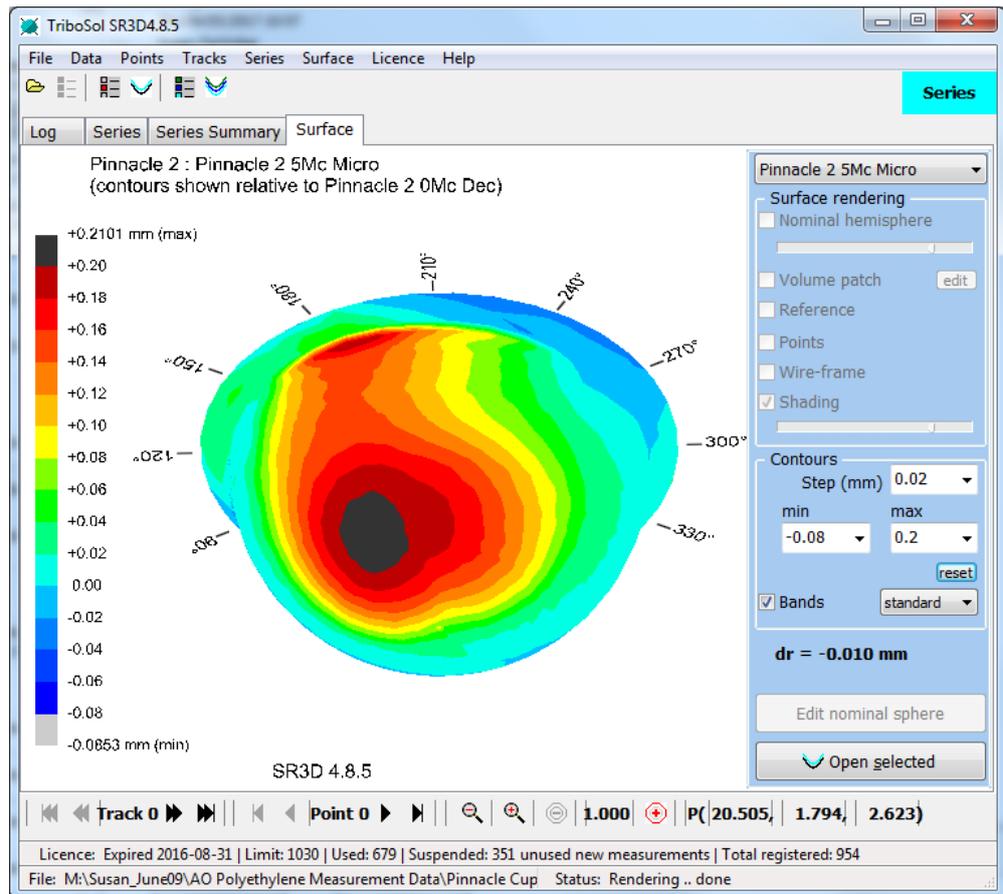
**Figure 2-6 Geometric reconstruction of volume change for an AOVE acetabular liner after 5Mc of standard loading and 5Mc of edge loading (AOPE 2). Volume change on the bearing surface and close to the inner rim is shown.**

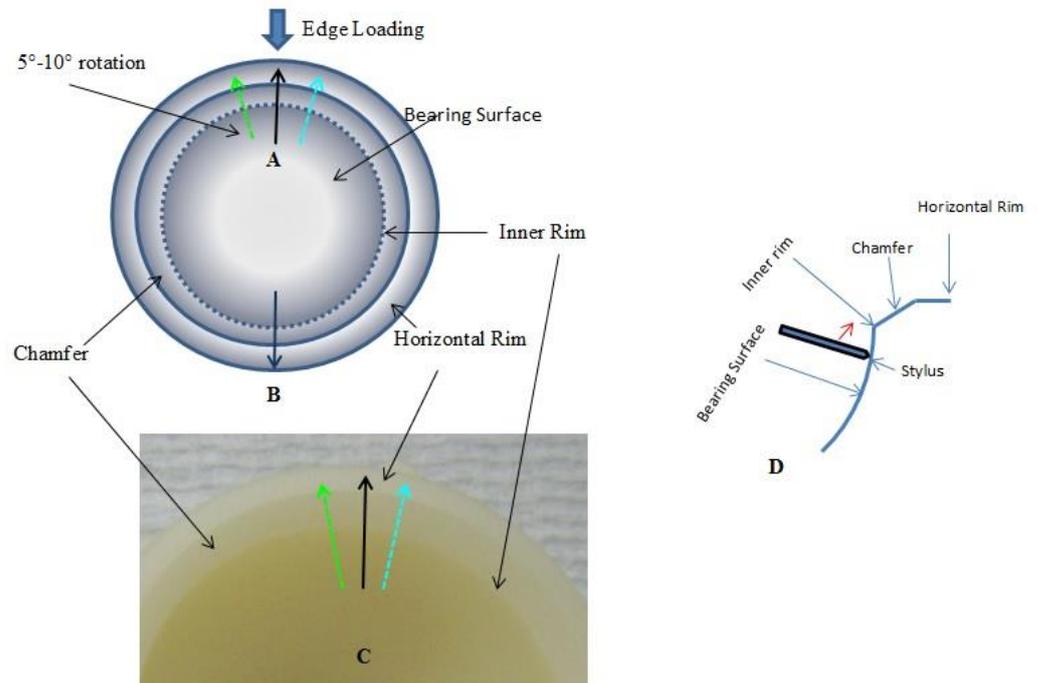
**Figure 2-10 Schematic of an acetabular liner showing the Talysurf traces taken from the bearing surface to the horizontal rim including: (A) three traces taken across the edge loaded region, (B) a fourth trace taken across an unworn region of the liner (the colours represent those used to plot the traces in Matlab in section 2.5.3) and (C) a photo of the liner showing the same traces in the schematic and (D) cross section of the rim showing where the stylus took the traces**

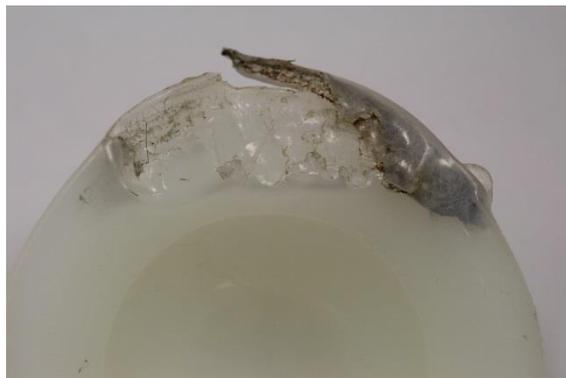
Occasionally, a trace was omitted due to extensive damage to the liner in that region, which may have resulted in damage to the stylus (Figure 2-12).

**Figure 2-12 Example of an explanted acetabular liner with extensive damage to the rim. No talysurf traces were taken over the rim in this area to avoid damage to the stylus.**

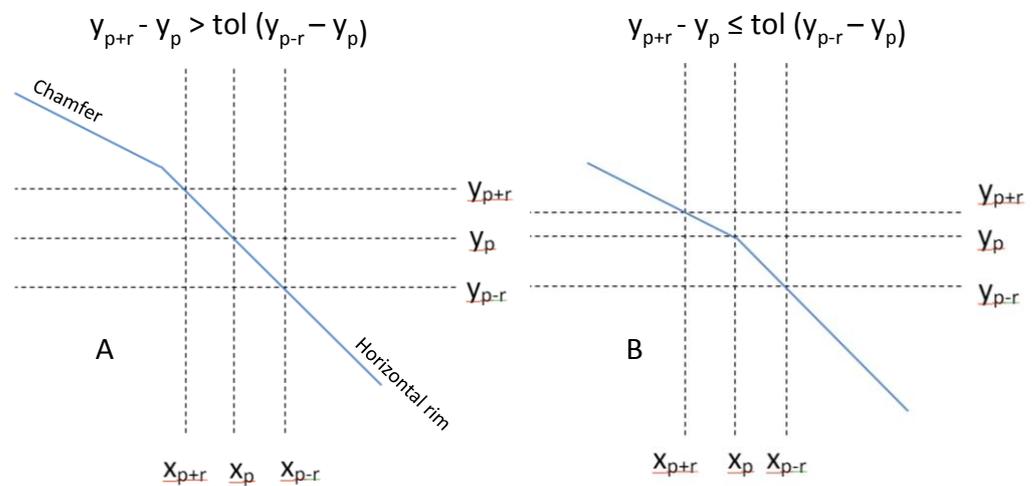
**Figure 2-14 Two cases where (A) the constraint was not satisfied and the datum was not identified at  $x_p$  and (B) the constraint was satisfied and the datum was identified at  $x_p$ . Note that the datum is identified before the traces are levelled.**

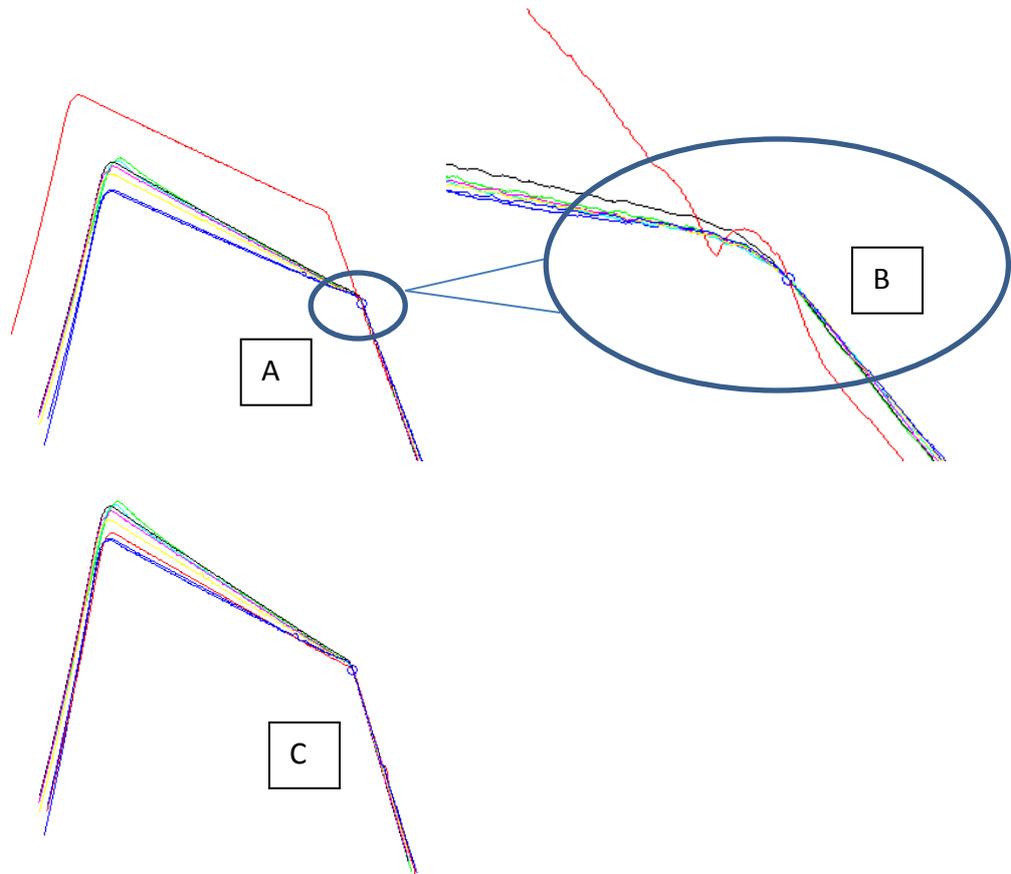
**Figure 2-15 Talysurf traces with an example of an explant with (A) a wrongly identified datum for one of the traces (red), (B) a close up of the scratch that caused the datum to be located in the wrong place and (C) correct identification of the datum after lowering the tolerance value (note that the traces have not been levelled yet).**

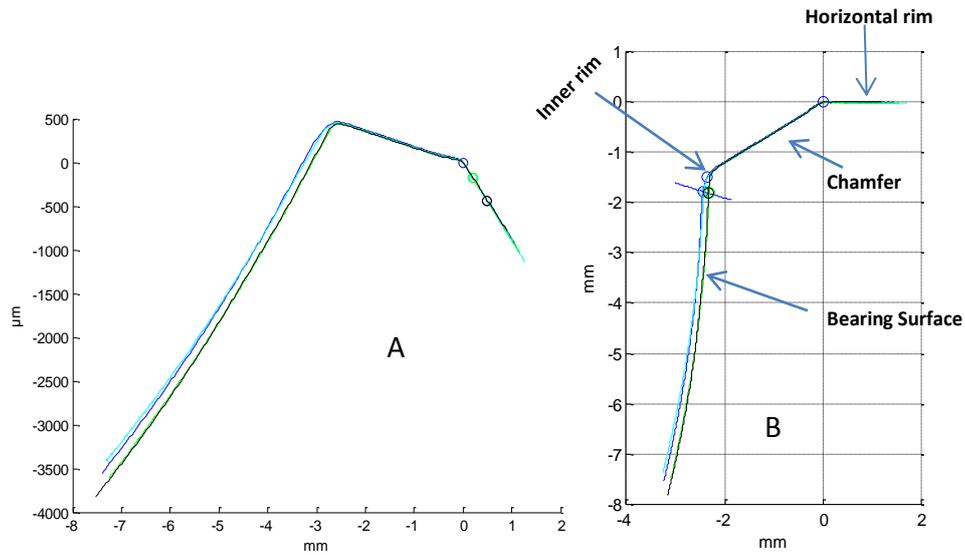
**Figure 2-16 Four Talysurf traces that have been (A) datum matched and rotated to align with the unworn trace along the horizontal rim and (B) rotated about the datum to the horizontal plane (levelled) and scaled to plot both axes in mm (Note: unworn trace = blue, worn traces = cyan, green and black; XLPE simulator liner, AM9)**

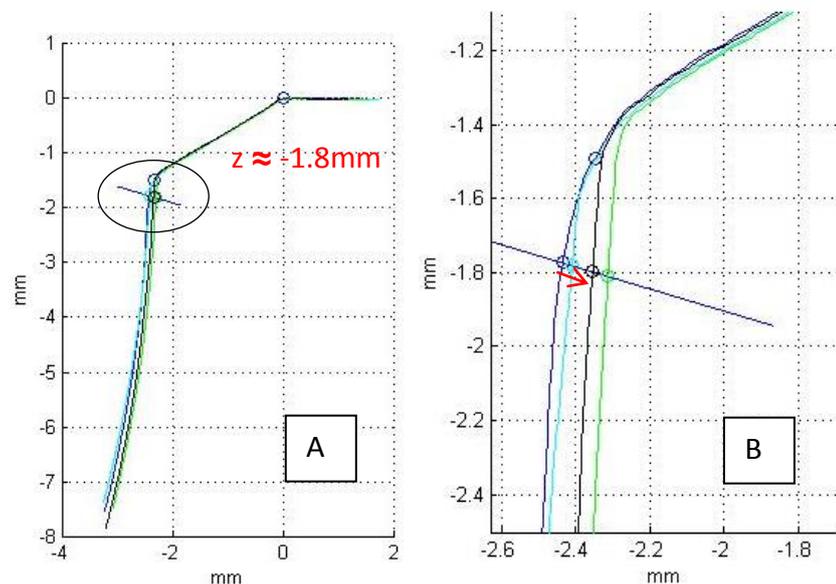
**Figure 2-18 Four Talysurf traces with (A) the location of the point from which the penetration was calculated and (B) a close up with a red arrow to mark the penetration distance between the unworn (dark blue) and worn traces (black, cyan, green; mean=0.07mm) normal to the unworn trace (XLPE simulator liner, AM9).**

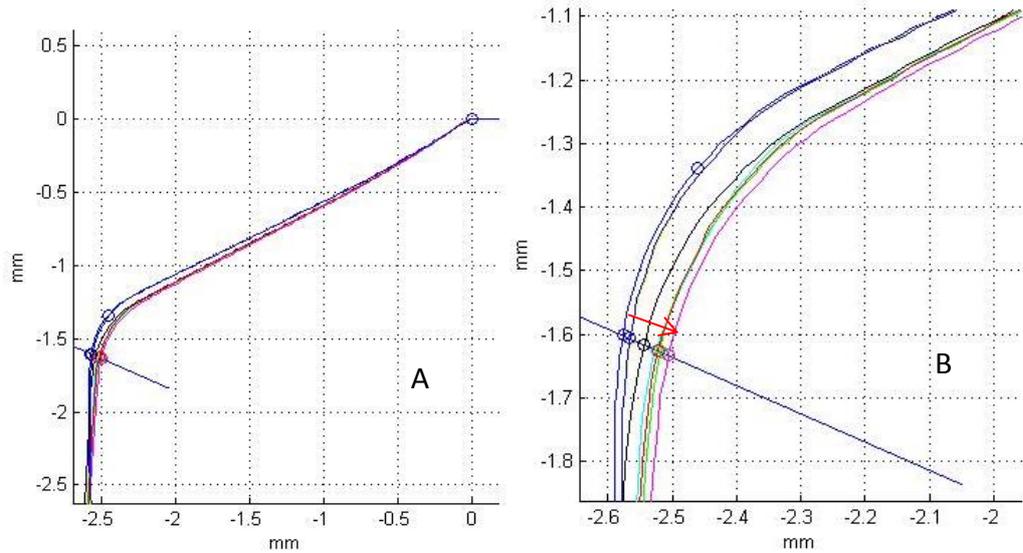
**Figure 2-21 (A) A close up of the eight Talysurf traces taken at 45° intervals around the circumference of control liner AM11 showing how a difference in gradient along the length of the chamfer resulted in a misaligned trace at the inner rim and (B) a close up of the inner rim showing a mean difference of 0.04mm between traces.**

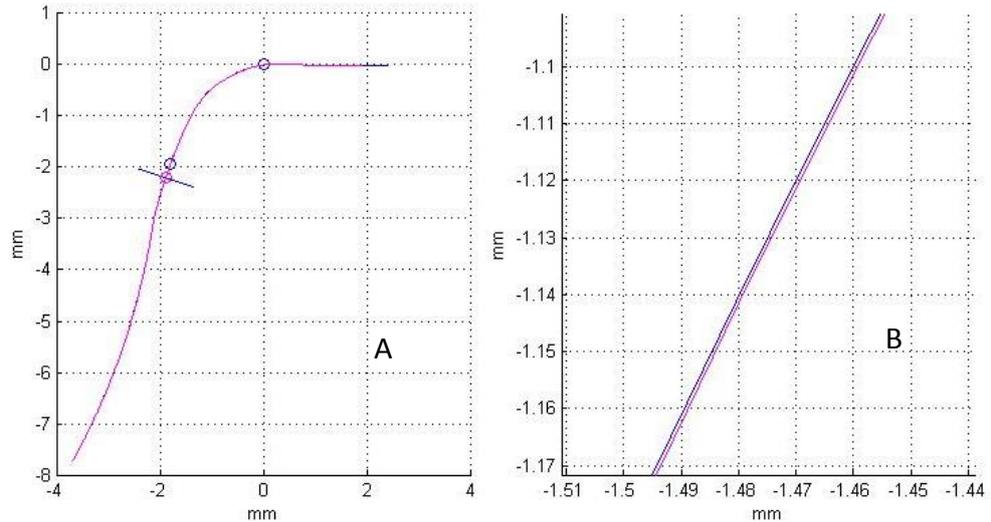
**Figure 2-23 Two Talysurf traces across the same region of a ceramic liner (without moving the liner between traces) showing (A) a full plot of the two traces and (B) a close up of the traces showing a distance between the two of 0.00083mm**

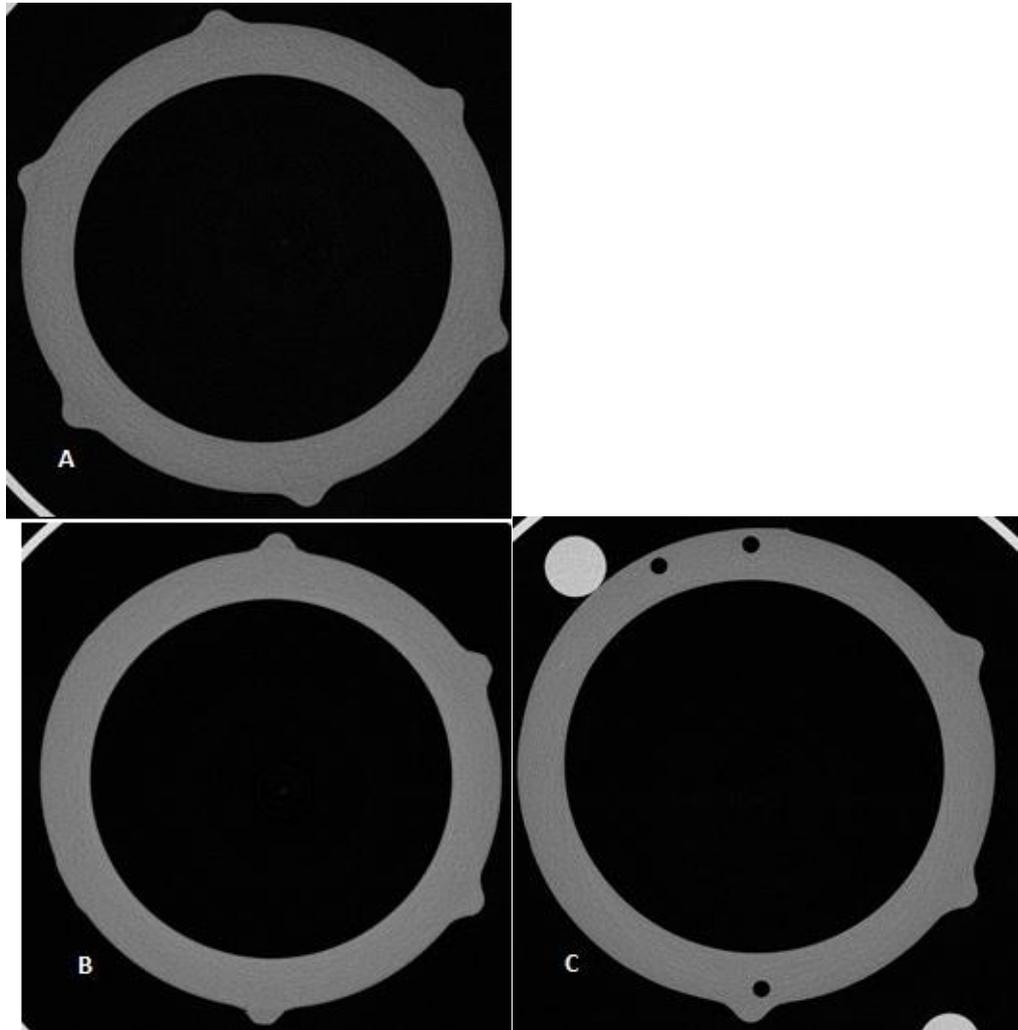
Figure 2-26 MicroCT images of (A) an XLPE control liner, (B) an aged PE liner and (C) an AOPE liner

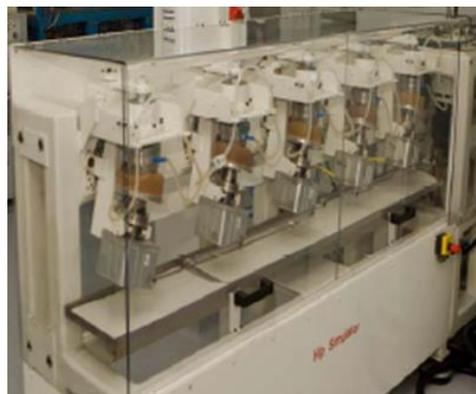
A ten station Prosim pneumatic hip joint simulator (Simulation Solutions Ltd, UK) was used in this study (Figure 3-2). A simulator station comprised a femoral head and acetabular cup positioned anatomically and surrounded by a silicone gaiter containing lubricating fluid.

**Figure 3-2 Group 1 of the Prosim ten station hip joint simulator showing five stations with serum in gaiters surrounding the joint interface.**

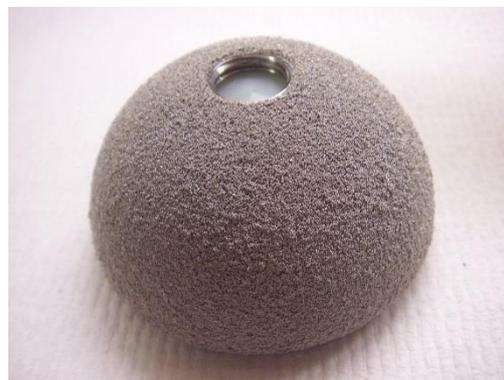
A hole and a screw in the back of both the simulator cup holder and the titanium shell allowed the UHMWPE liner to be pushed from behind to remove it from the shell at measurement points. A small UHMWPE tab was placed in the hole in the titanium shell to protect the liner from damage.

**Figure 3-4 The backside of a titanium shell showing the hole through which the liner was pushed out by a screw at measurement points.**

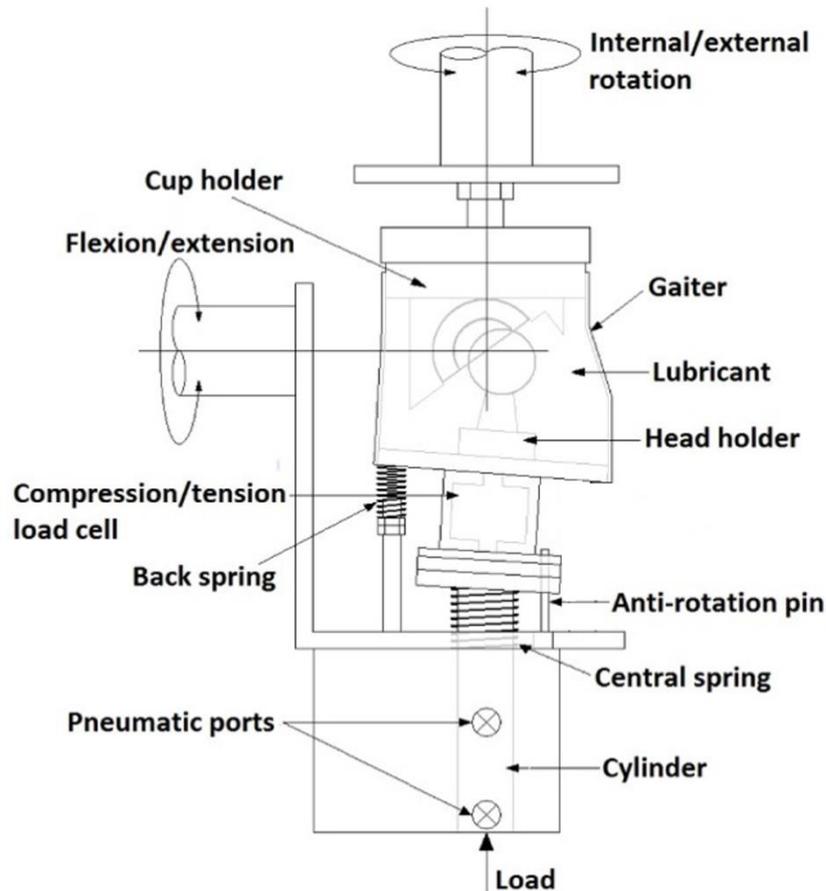
**Figure 3-6 Schematic of a side view of a single station of the Prosim hip simulator with the set-up for edge loading conditions. A back spring pushed the femoral head laterally during the swing phase of gait causing the femoral head to contact with the acetabular rim on heel strike (lateral sliding distance 0.5mm-1mm)**

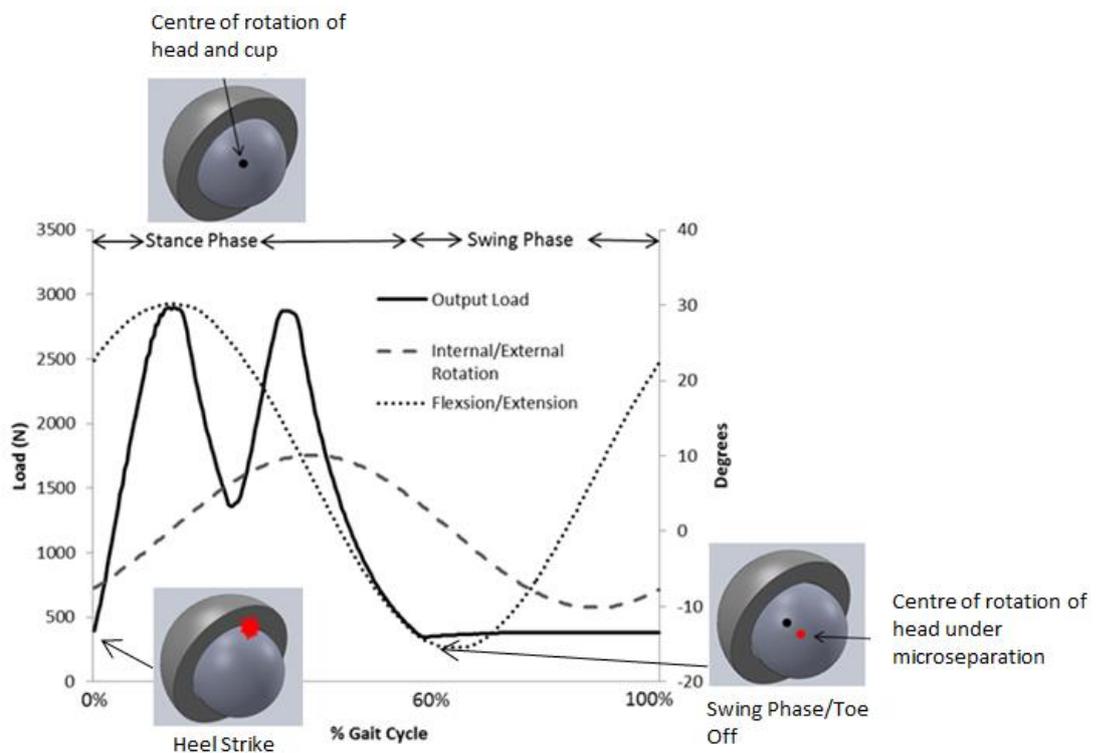
**Figure 3-7 Load and motion output profiles for one cycle of gait with the femoral head position highlighted for heel strike, stance phase and toe off.**

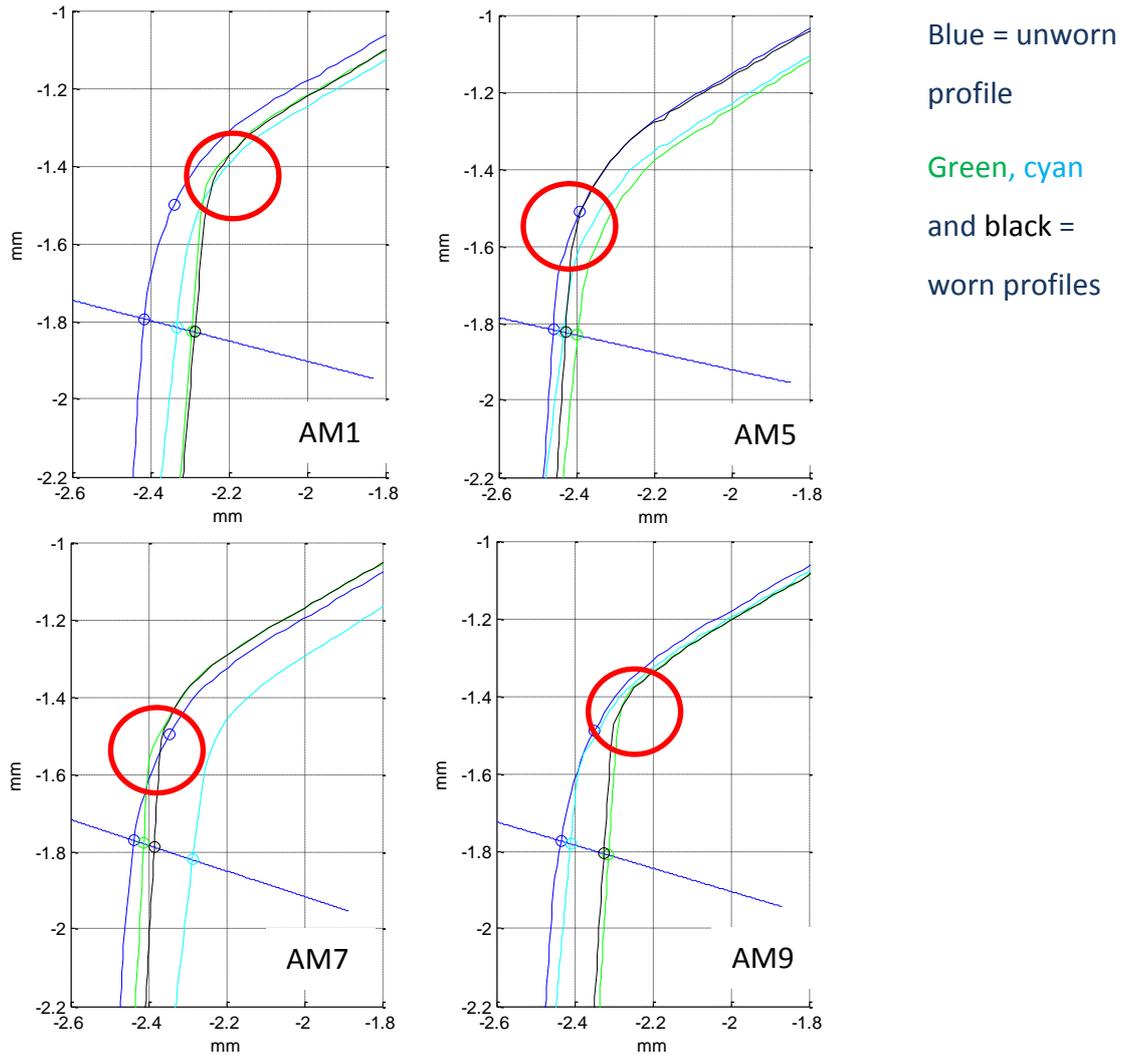
**Figure 3-10 Worn and unworn rim profiles for XLPE liners (A) AM1, (B) AM5, (C) AM7 and (D) AM9 showing the points at which the penetration values were measured for a section zoomed to the inner rim. The red circle highlights the sharp change in radius between the bearing surface and chamfer for the worn profiles. The unworn profile is the dark blue line.**

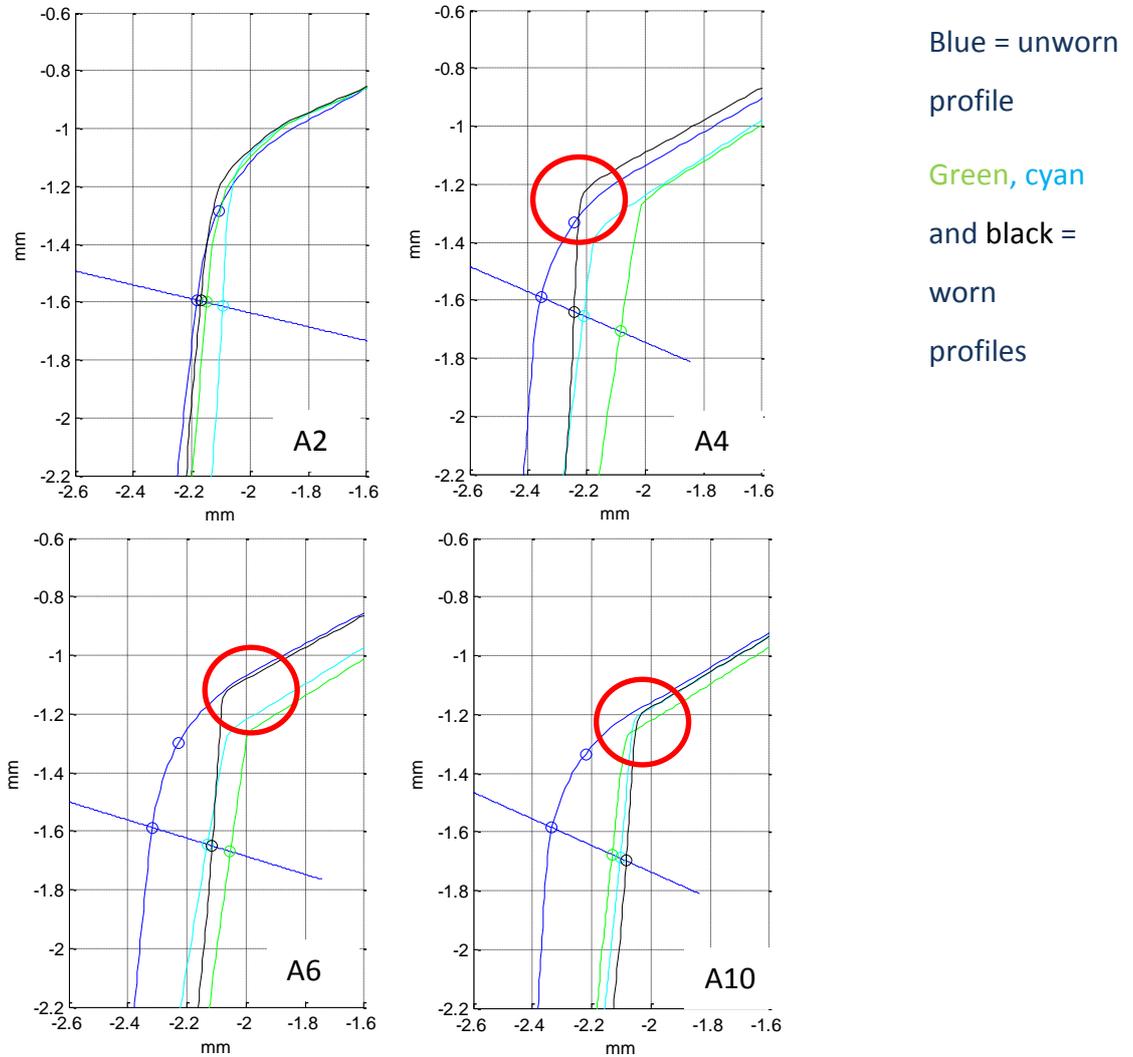
**Figure 3-11 Worn and unworn rim profiles for aged PE liners A2, A4, A6 and A10 showing the points at which the penetration values were measured for a section zoomed to the inner rim. The red circle highlights the sharp change in radius between the bearing surface and chamfer for the worn profiles.**

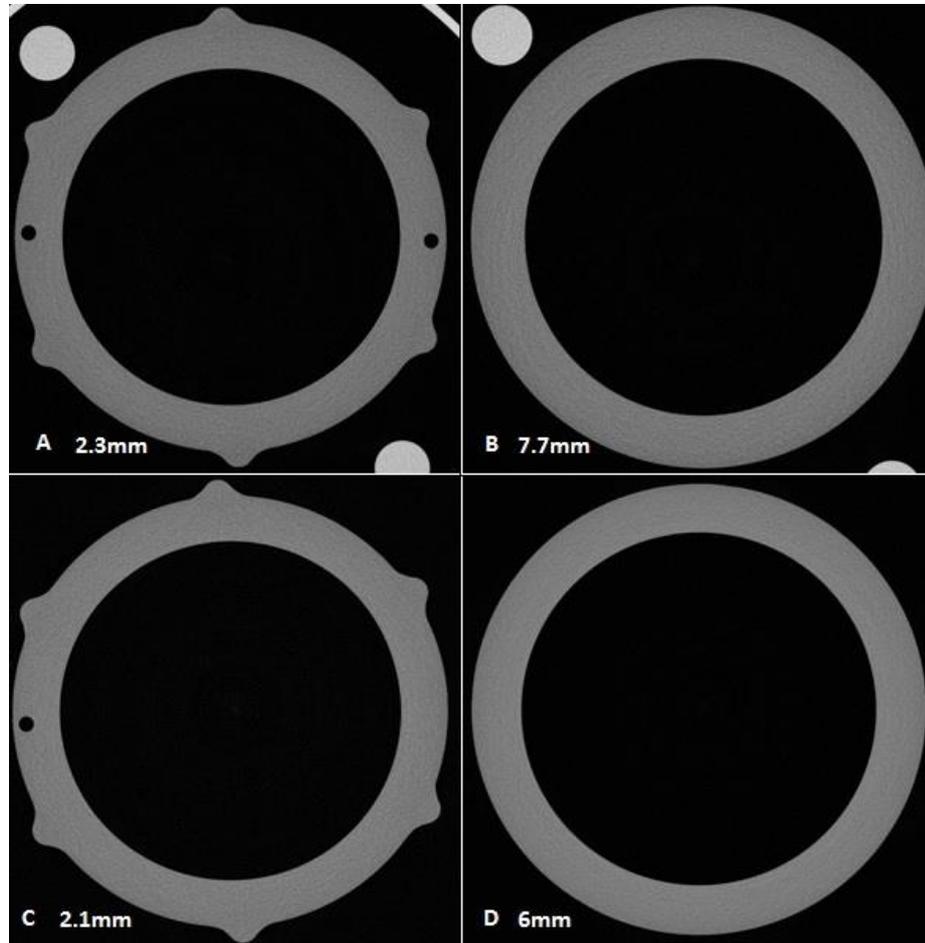
**Figure 3-12 MicroCT 2D reconstructed slices with no visible cracking: (A&B) XLPE liner AM1 at 2.3mm and 7.7mm below the horizontal surface of the rim and (C&D) XLPE liner AM5 at 2.1mm and 6mm below the horizontal surface of the rim. View is a cross section of the liner looking down onto the rim.**

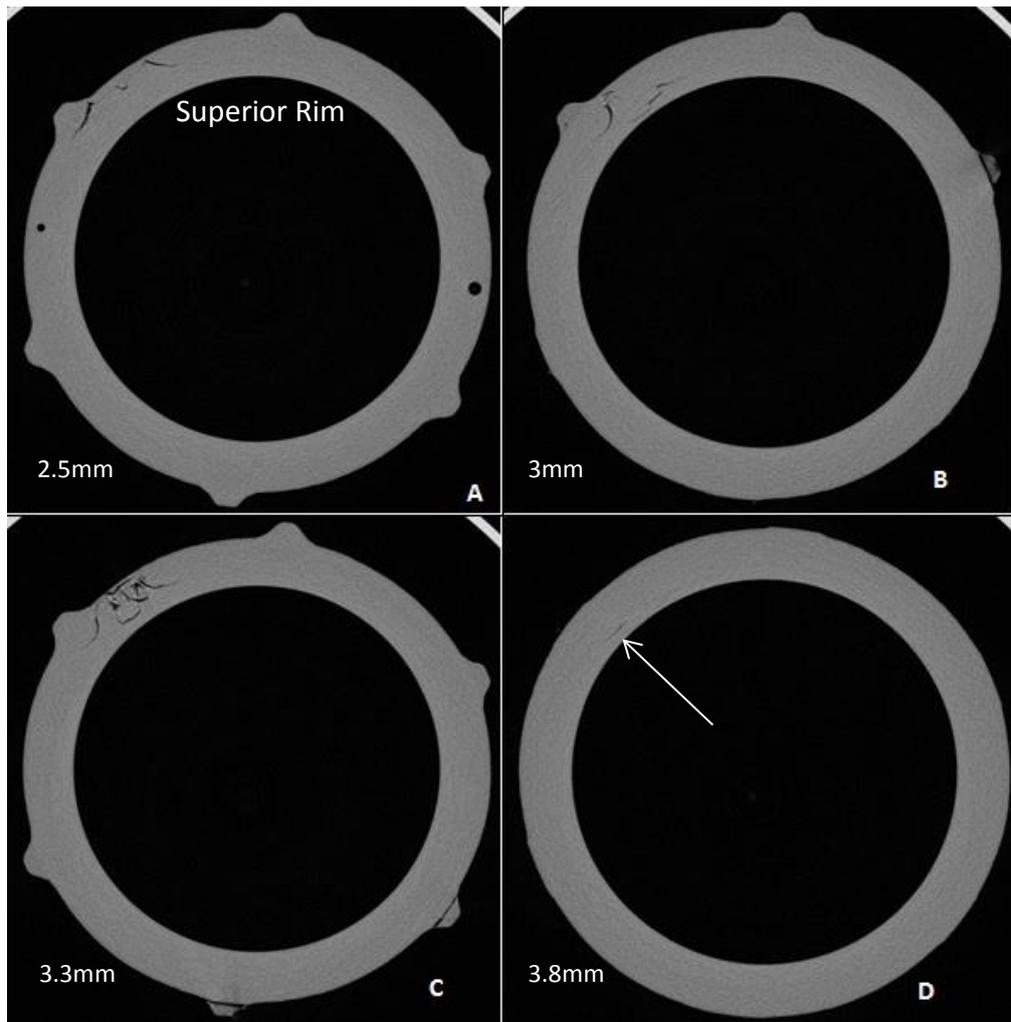
**Figure 3-13 MicroCT 2D reconstructed slices showing subsurface cracking on aged PE liner A10 showing (A) circumferential cracking at outer rim and at an anti-rotation tab 2.5mm below the horizontal surface of the rim (B) cracking around an anti-rotation tab 3mm below the horizontal surface (C) extensive multi-directional cracking near the outer rim and anti-tab 3.3mm below the horizontal surface and (D) circumferential cracking near the inner rim 3.8mm below the horizontal surface. View is a cross section of the liner looking down onto the rim.**

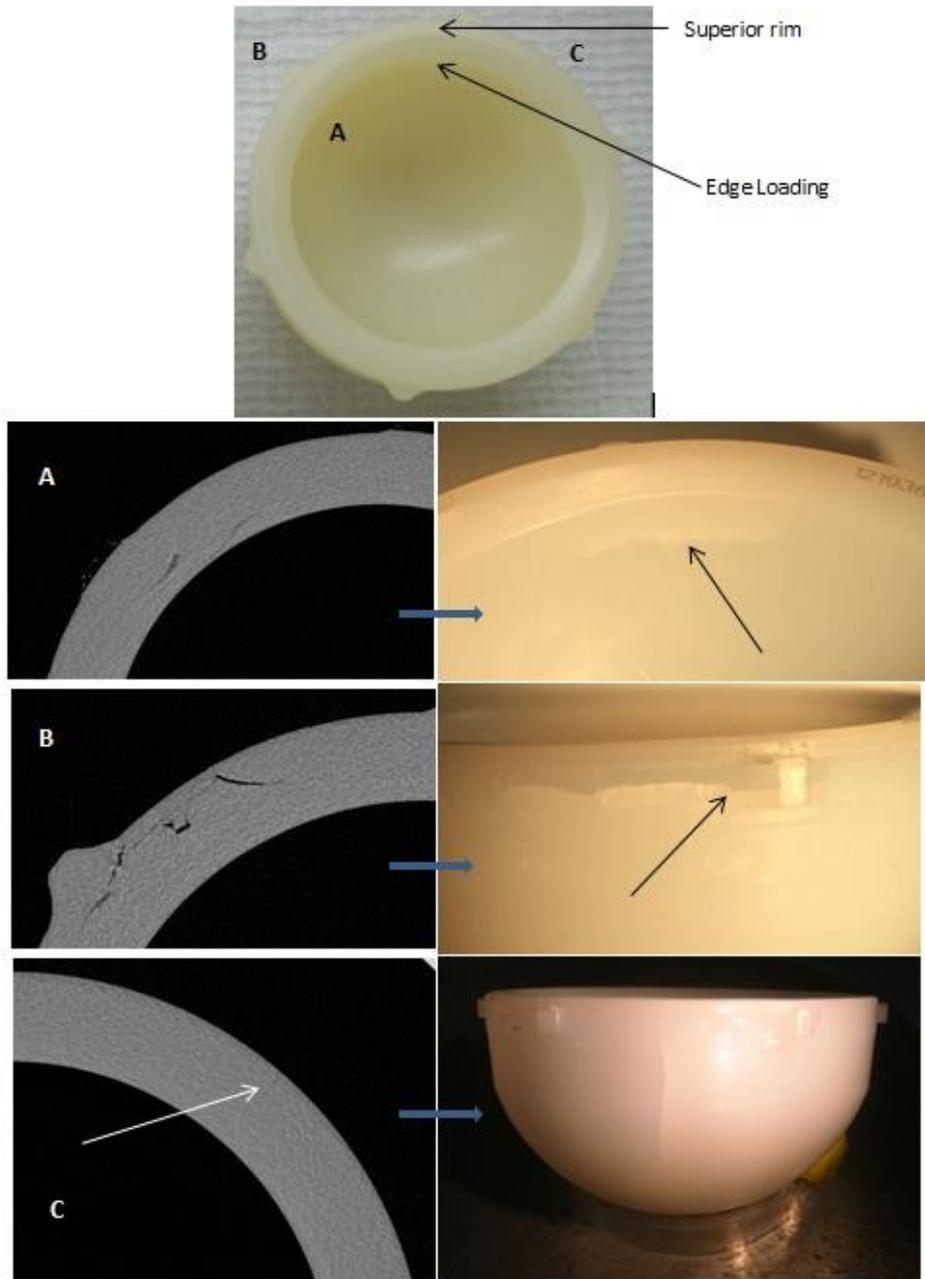
**Figure 3-14 MicroCT 2D reconstructed slices with the corresponding photos of an aged PE liner (A10) showing (A) cracks propagating circumferentially close to the inner rim and the corresponding whitening at the inner rim, (B) Cracks propagating circumferentially along the outer rim from at an anti-rotation tab and the corresponding photo and (C) a radial crack and the corresponding backside crack. The location of these damage mechanisms is shown in the first image.**

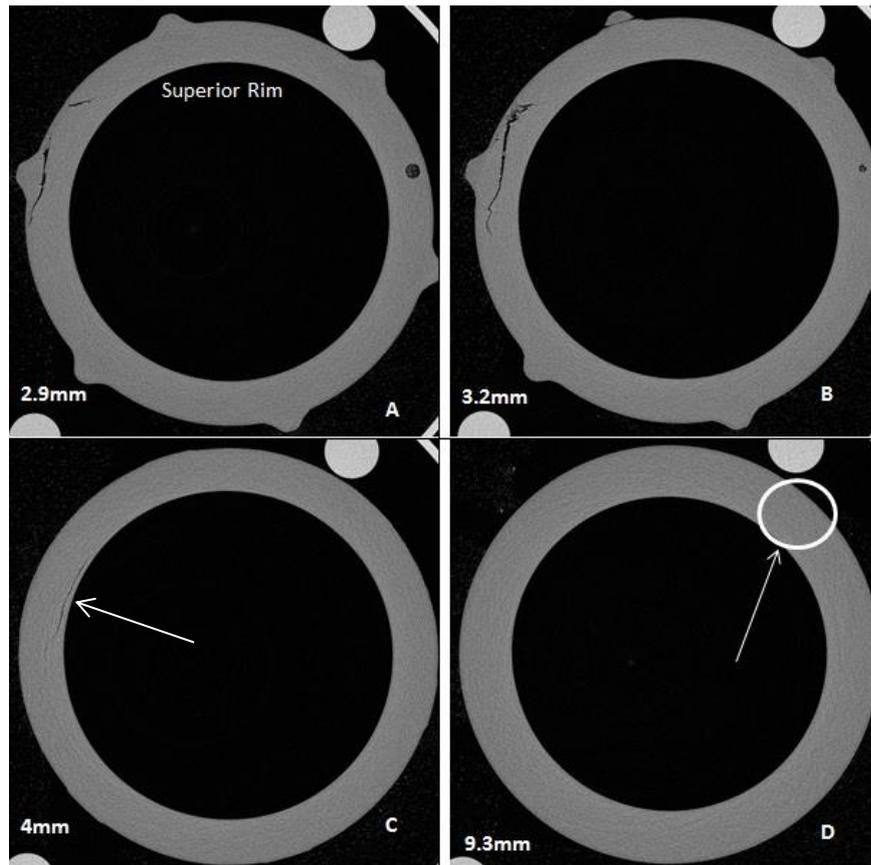
Figure 3-15 Subsurface cracking on aged PE liner A2 showing (A) circumferential cracking at outer rim and around an anti-rotation tab 2.9mm below the horizontal surface of the rim (B) cracking around an anti-rotation tab 3.2mm below the horizontal surface (C) circumferential cracking near the inner rim 4mm below the horizontal surface and (D) Radial crack initiating at the outer rim and extending towards the inner bearing surface 9mm below the horizontal surface of the rim (see Figure 3-16 for detail). View is a cross section of the liner looking down onto the rim.

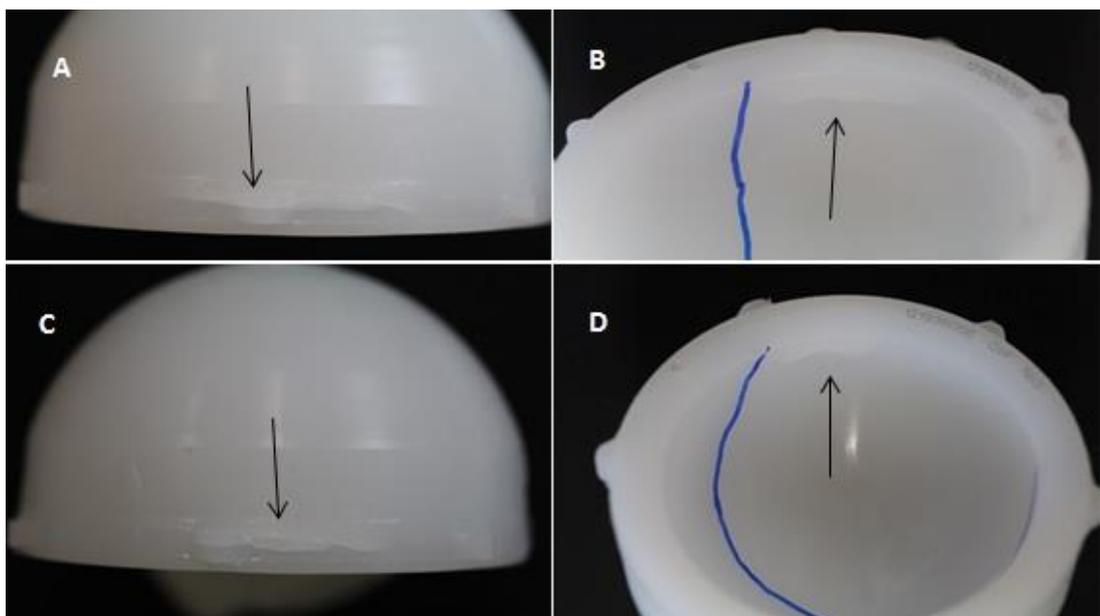
**Figure 3-18 Images of cracking on aged PE liners after 5Mc of edge loading showing cracking along an anti-rotation tab (A, Aged PE liner A2; C, aged PE liner**

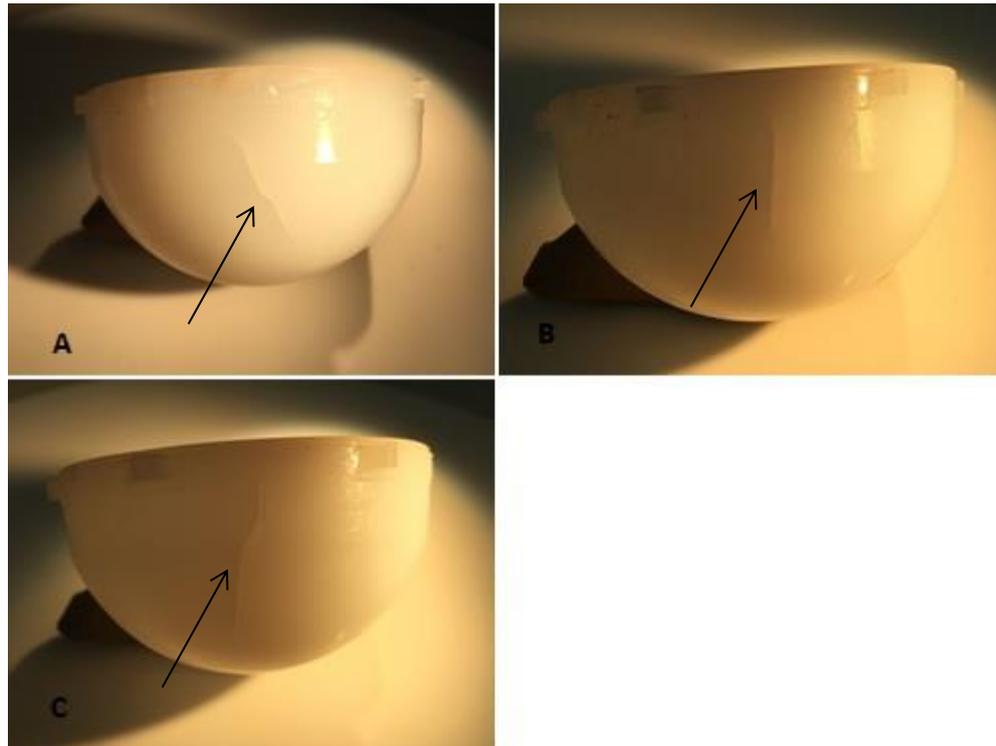
**Figure 3-19 Radial cracking on the backside of aged PE liner (A) A2, (B) A4 & (C) A10 after 5Mc of edge loading**
