**Wear and rim damage of UHMWPE acetabular cups in total  
hip replacement**

Submitted in accordance with the requirements for the degree of Doctor of  
Philosophy

The University of Leeds  
School of Mechanical Engineering

December 2016

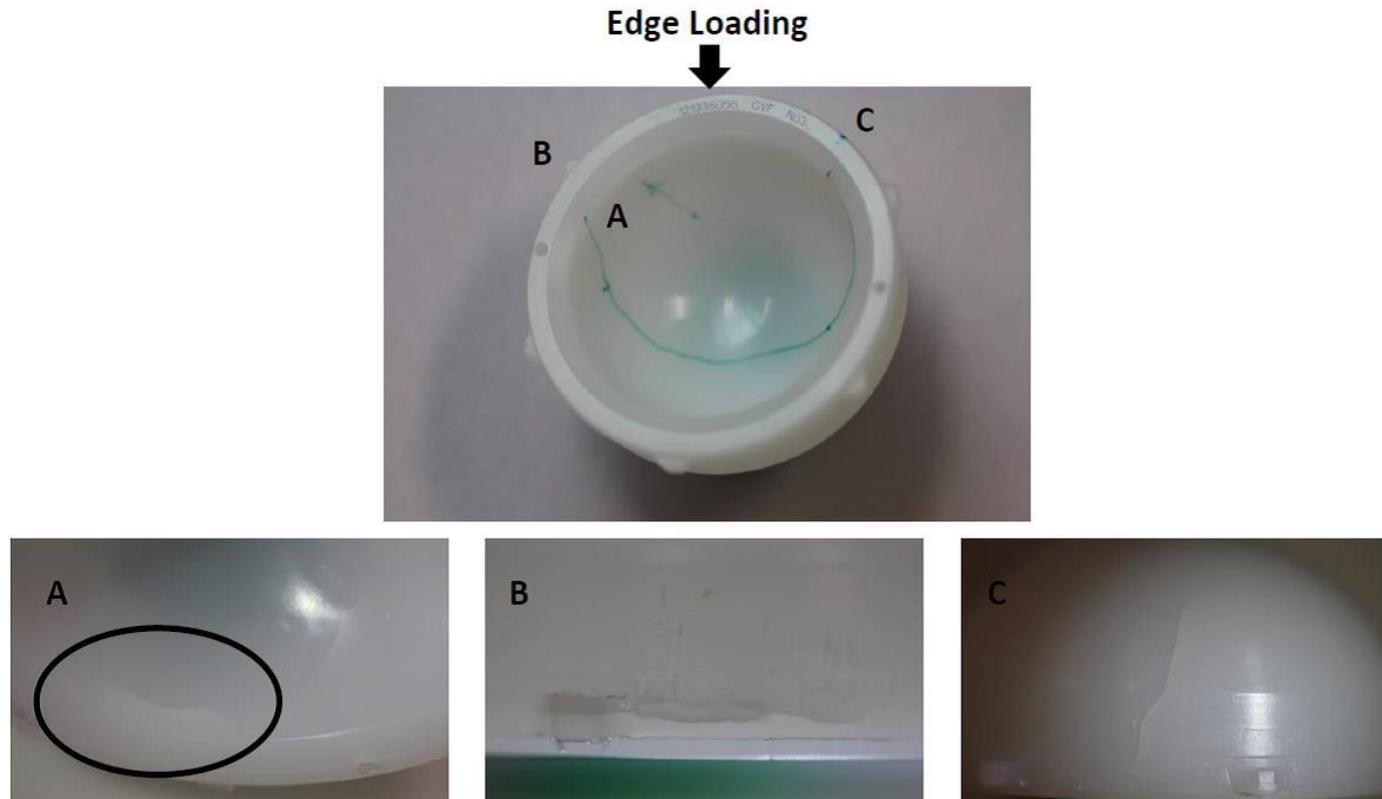
Figure 3-20 (Top image) Location of damage to aged PE liners (A10 shown) with respect to orientation during edge loading (Bottom image A) Subsurface cracking and whitening of the material at the inner rim (Bottom image B) cracking along anti-rotation scallop (Bottom image C) radial crack on backside.

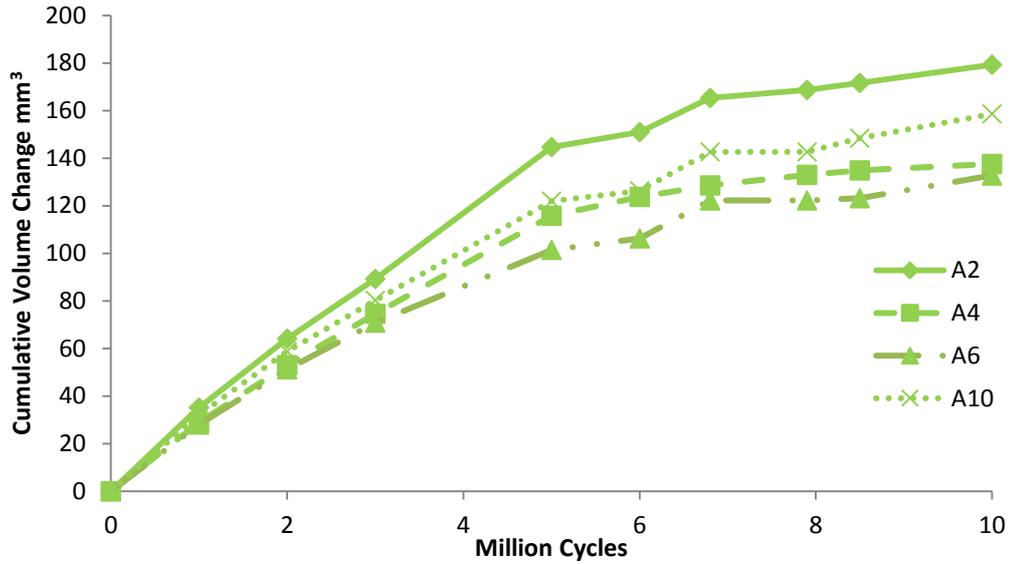
**Figure 3-23 Cumulative volume changes measured gravimetrically for the aged PE liners after 5Mc of standard loading (0-5Mc) and 5Mc of edge loading (5-10Mc) in a hip simulator**

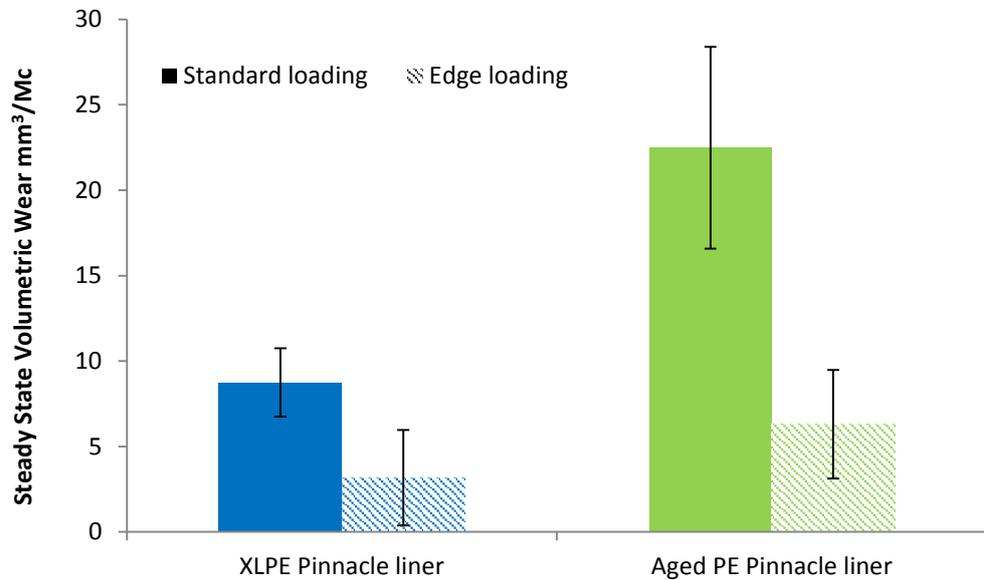
**Figure 3-24 Mean steady state wear rates calculated using gravimetric measurements for the XLPE and aged PE liners under standard and edge loading conditions in a hip simulator ( $\pm 95\%$  Confidence intervals;  $n=4$ )**

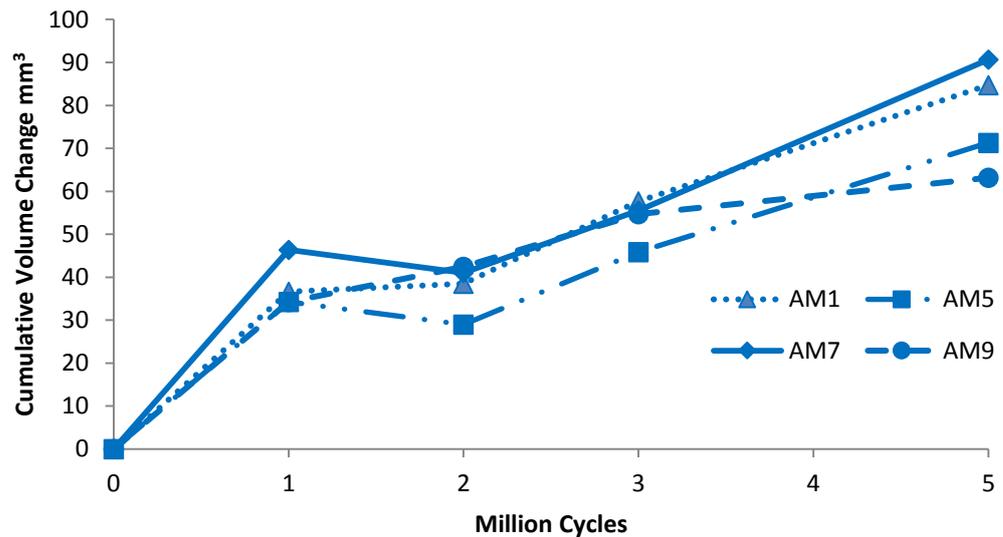
**Figure 3-25 Cumulative volume change measured geometrically for the XLPE liners after 5Mc of standard loading in a hip simulator**

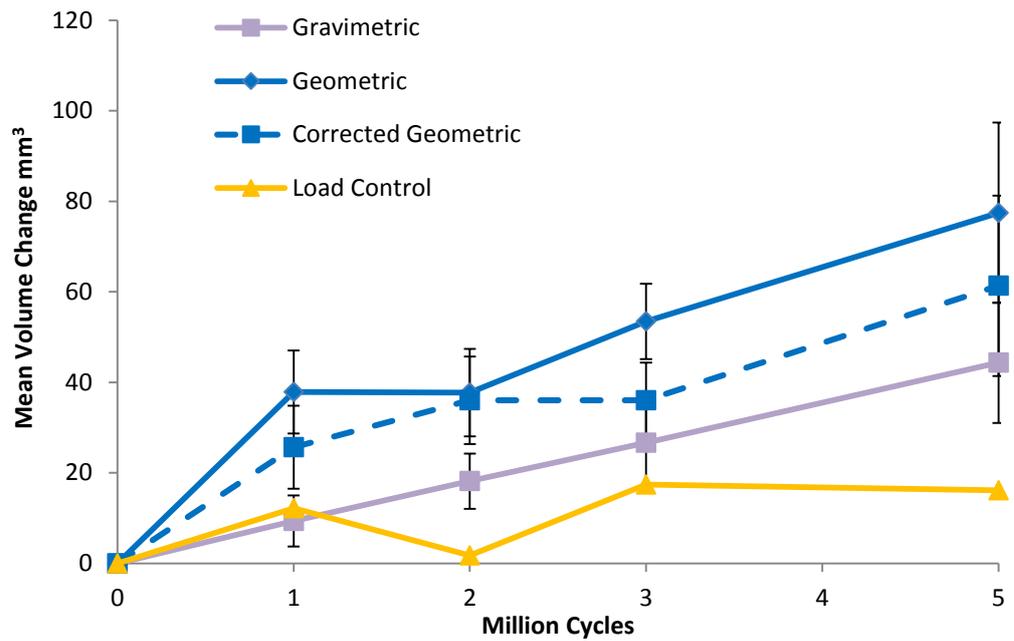
**Figure 3-26 Mean volume change for the XLPE liners over 5Mc of standard loading: comparison of gravimetric, geometric, geometric corrected with load control ( $\pm 95\%$  Confidence Intervals;  $n=4$ ), and load control measurement**

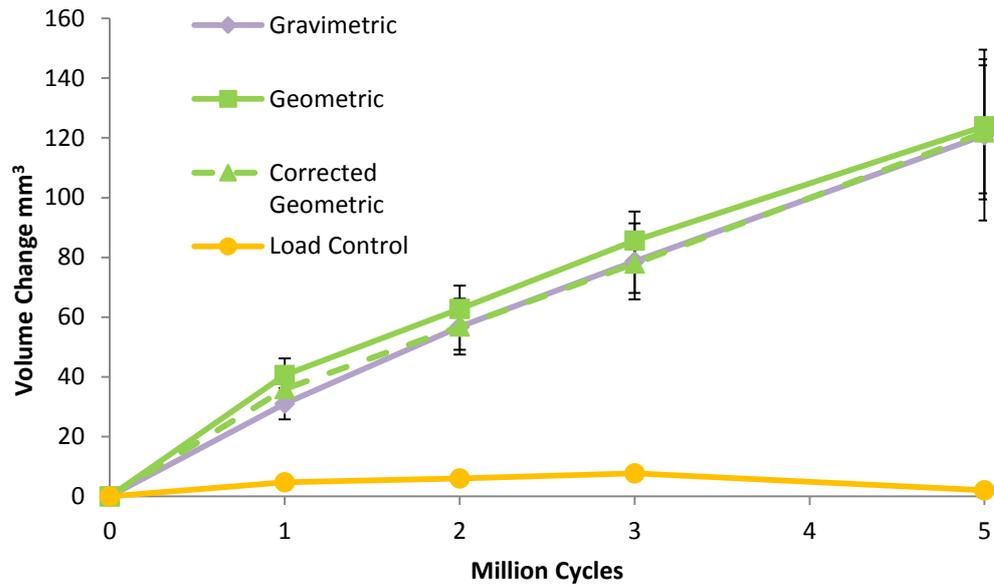
**Figure 3-28 Mean volume changes for the aged PE liners over 5Mc of standard loading: comparison of gravimetric, geometric, geometric load control corrected ( $\pm 95\%$  Confidence Intervals;  $n=4$ ), and load control measurements**

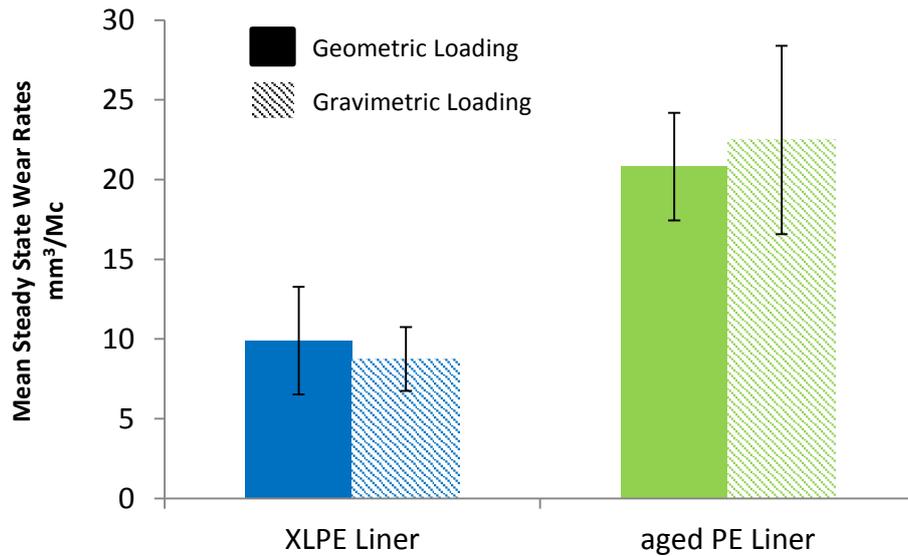
**Figure 3-29 Mean steady state wear rates calculated from the geometric and gravimetric measurements of the XLPE and the aged PE liners under standard loading conditions ( $\pm 95\%$  Confidence intervals;  $n=4$ )**

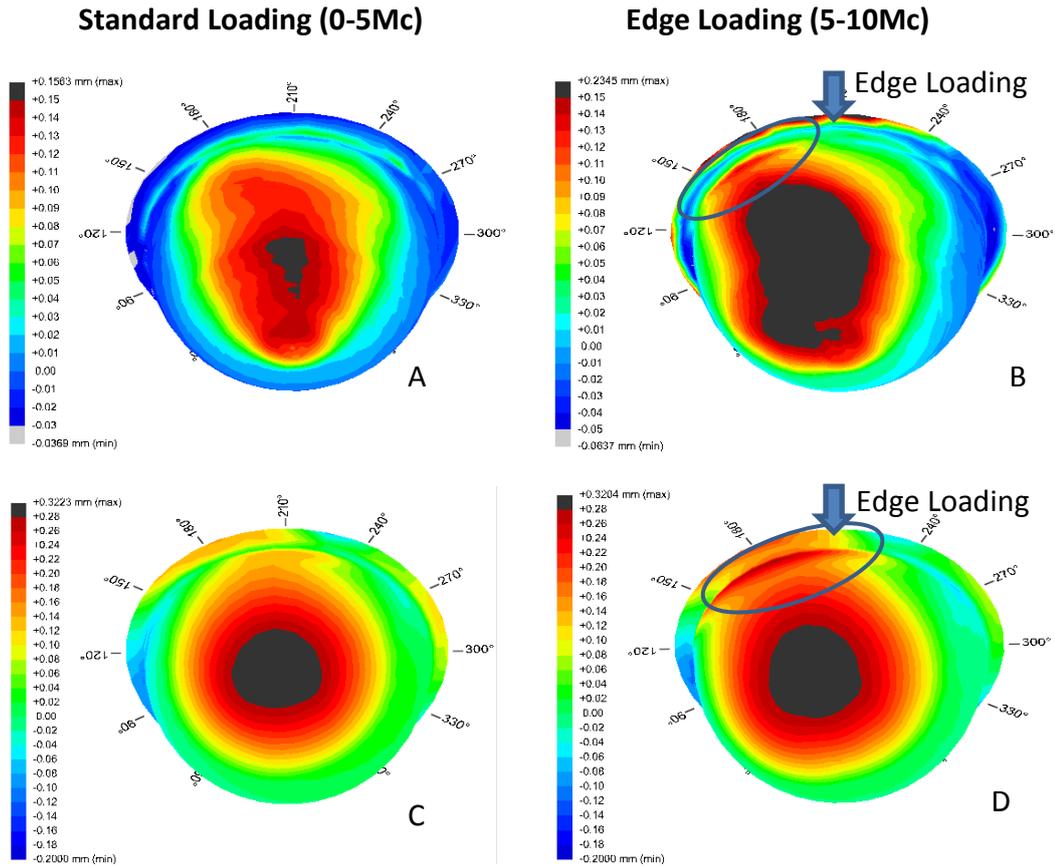
**Figure 3-30 SR3D geometric reconstructions of volume change after 5Mc standard loading and 5Mc edge loading conditions for XLPE liners (A & B; AM9) and aged PE liners (C & D; A10 )**

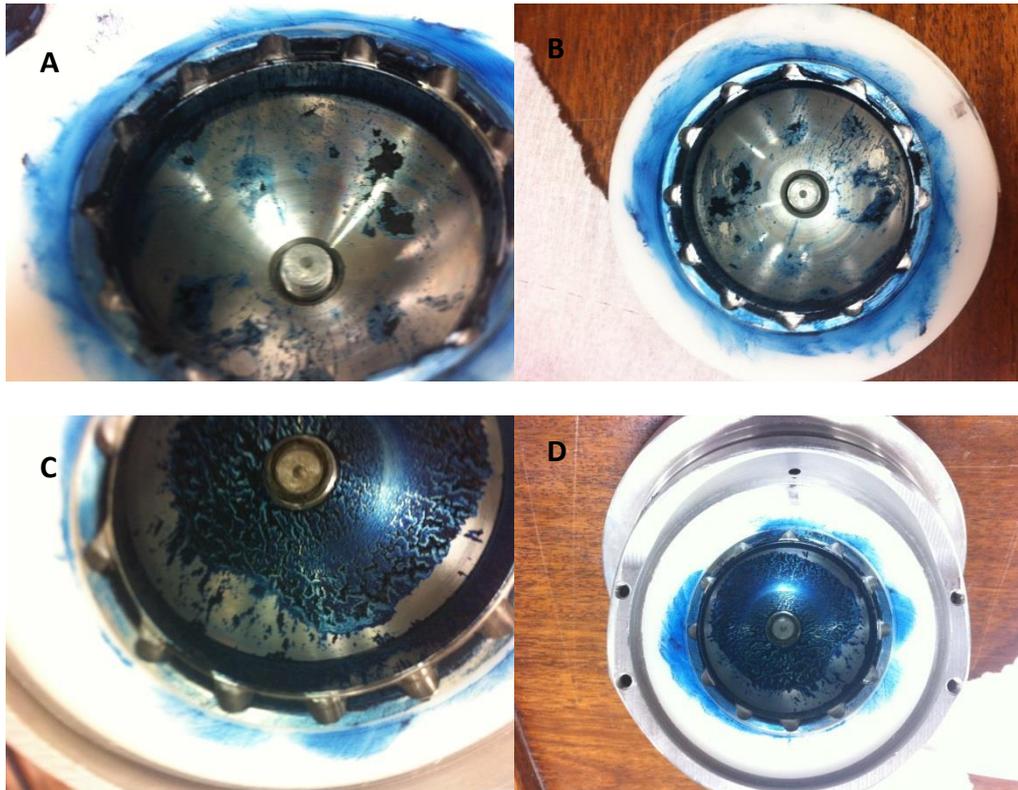
**Figure 3-31 Pinnacle shells after the backside of the liners were covered in engineering blue then inserted and removed from the shell. (A & B) areas of contact for an XLPE liner (C &D) areas of contact for an aged PE liner**

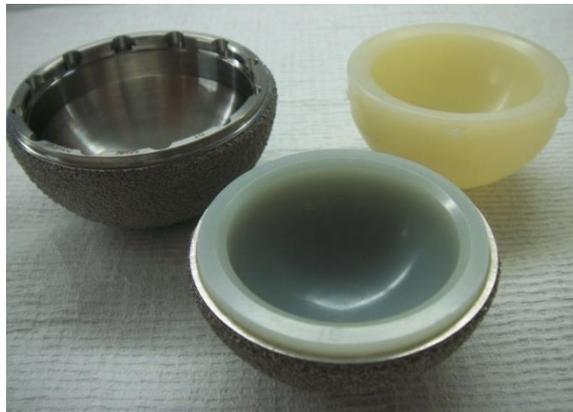
**Figure 4-1 A compression moulder acetabular cup (foreground; AOPE cup) and a Pinnacle<sup>®</sup> compatible liner with titanium shell (background; AOPE liner)**

hindered phenols to remove free radicals and lower the risk of oxidation. The density of the UHMWPE was 0.9403 g/cm<sup>3</sup>. Two different acetabular cup designs were studied (Figure 4-1), a Pinnacle compatible liner (AOPE liner; n=4) and a compression moulded acetabular cup (AOPE cup; n=4). The Pinnacle<sup>®</sup> compatible design comprised a 56mm outer diameter titanium shell and a press fit 36mm inner diameter anti-oxidant UHMWPE liner with taper lock and anti-rotation device (ARD) tabs that mate with scallops on the titanium shell. The liner thickness was 7.8mm at the apex and 5.1mm at the rim. This design was the same as the design of the XLPE and aged PE liners described in sections 2.2.1 and 3.2.1.

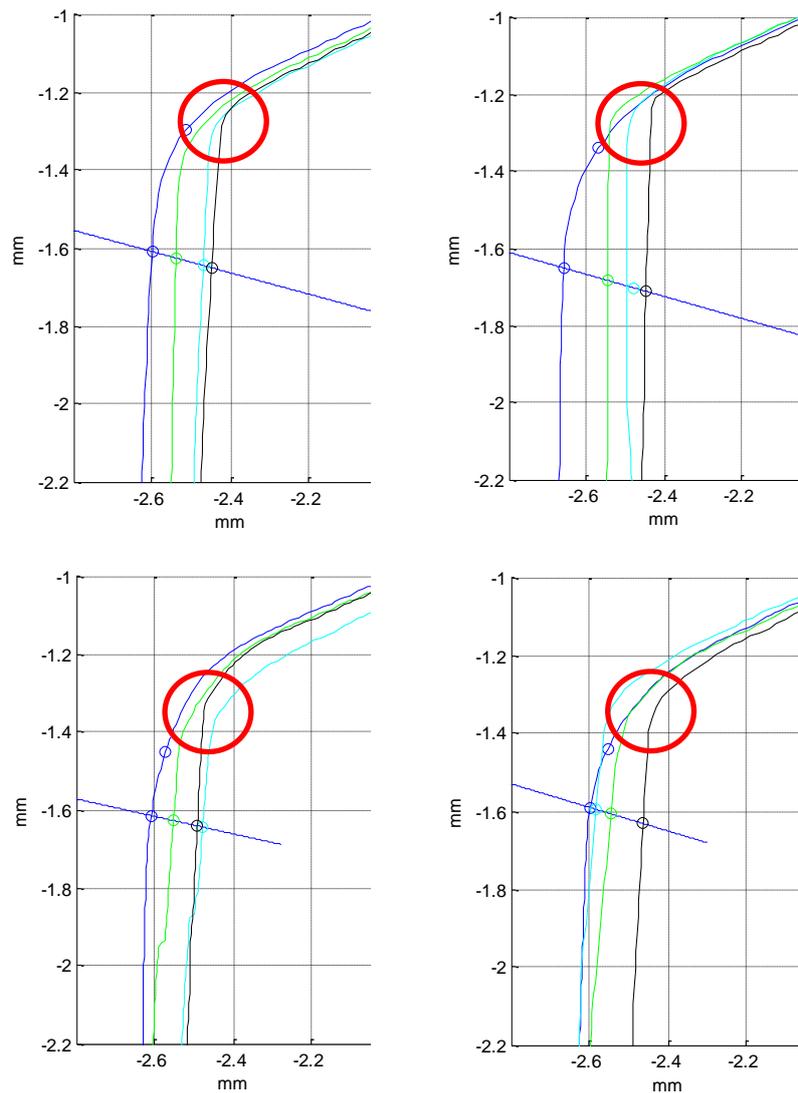
**Figure 4-3 4-4 A close up of the inner rim showing worn and unworn rim profiles for the AOPE liners. The point at which the penetration values were measured is shown and a sharp change in radius at the inner rim can be observed. The dark blue liner is the unworn profile and the green, cyan and black lines are the worn profiles.**

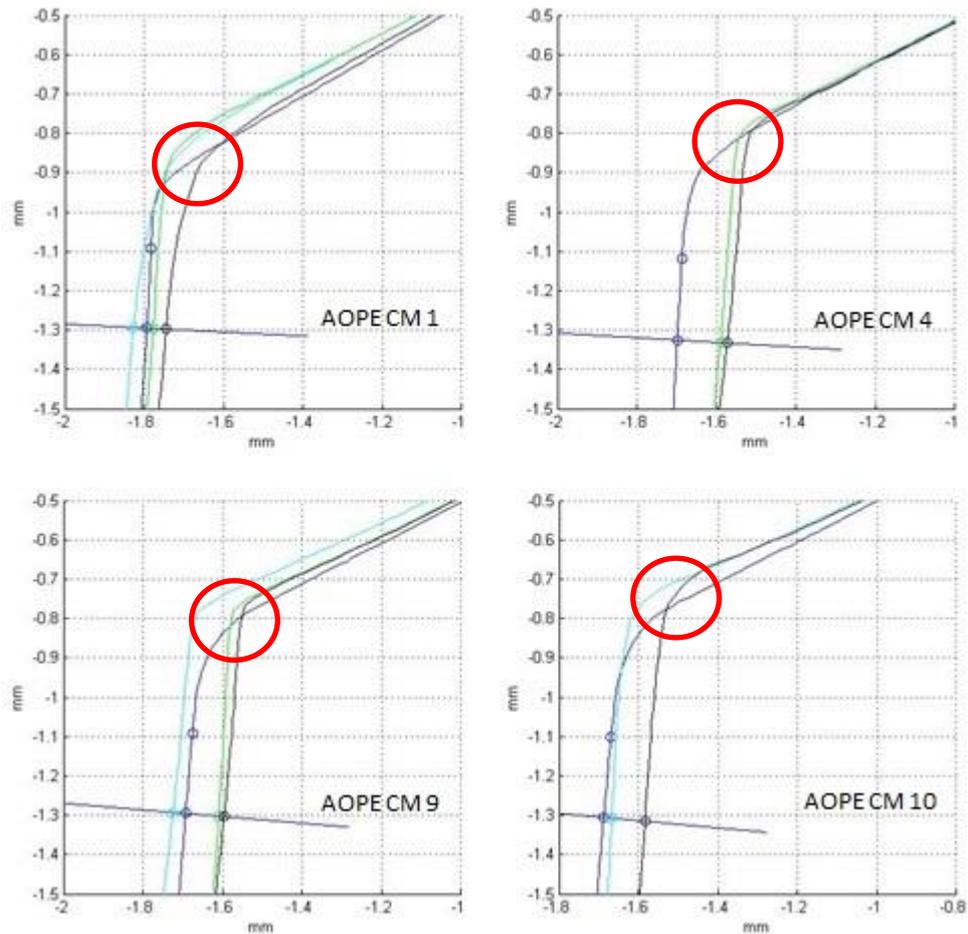
**Figure 4-5** A close up of the inner rim showing worn and unworn rim profiles for the AOPE cups. The point at which the penetration values were measured is shown and a sharp change in radius at the inner rim can be observed. The dark blue liner is the unworn profile and the green, cyan and black lines are the worn profiles.

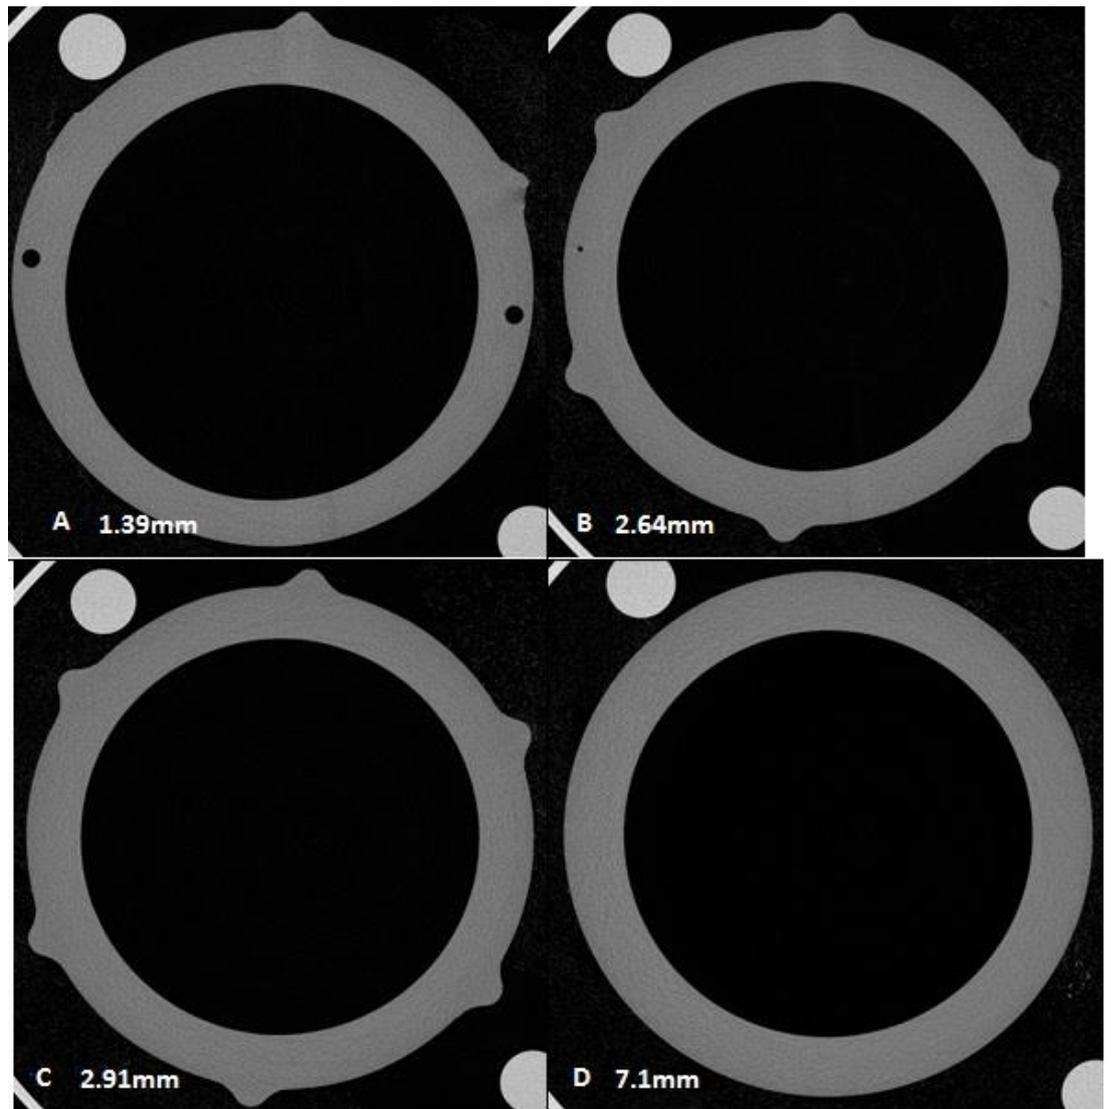
**Figure 4-6 MicroCT 2D reconstructed slices with no visible cracking: AOPE liner AOPE 5 at (A) 1.39mm. (B) 2.64mm, (C) 2.91mm and (D) 7.1mm below the horizontal surface of the rim. The holes are reference holes used in the CMM measurements. View is a cross section of the liner looking down onto the rim.**

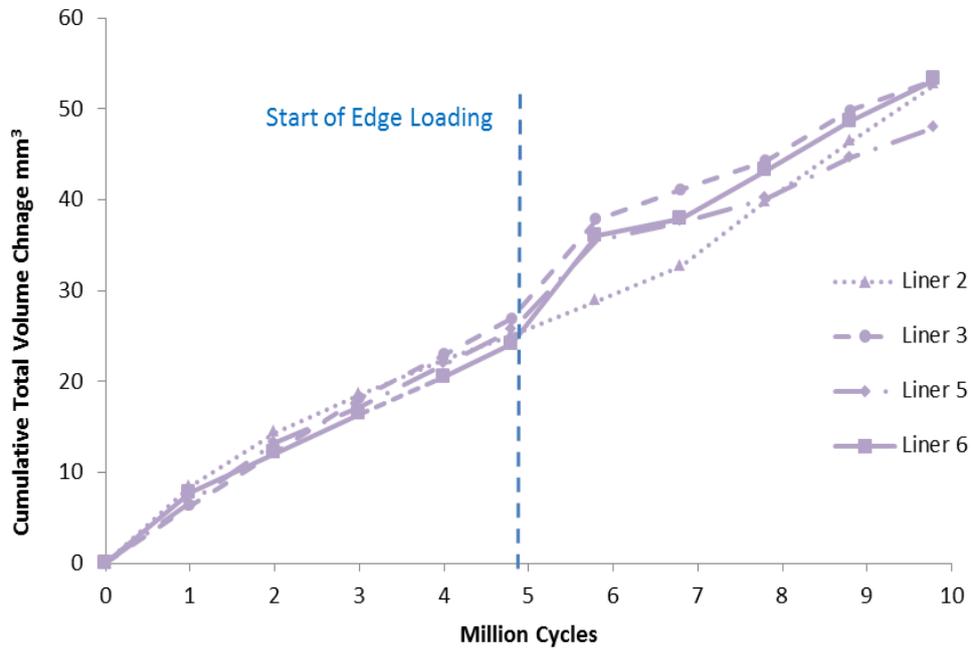
**Figure 4-8 Cumulative volume changes measured gravimetrically for the AOPE liners after 4.8Mc of standard loading (0-5Mc) and 5Mc of edge loading (5-10Mc) in a hip simulator**

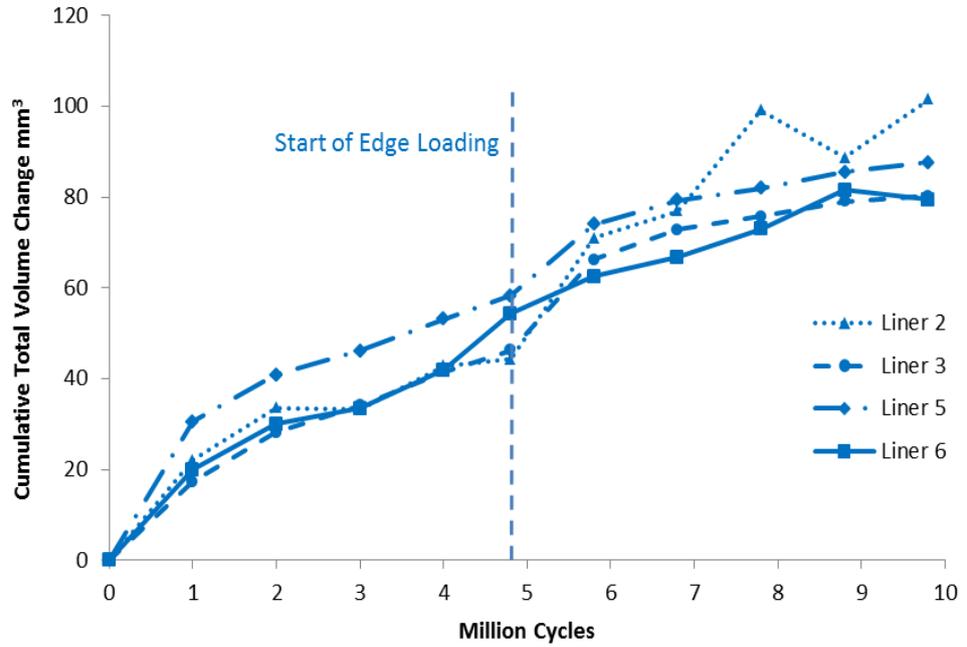
**Figure 4-9 Cumulative volume changes measured geometrically for the AOPE liners after 4.8Mc of standard loading (0-5Mc) and 5Mc of edge loading (5-10Mc) in a hip simulator**

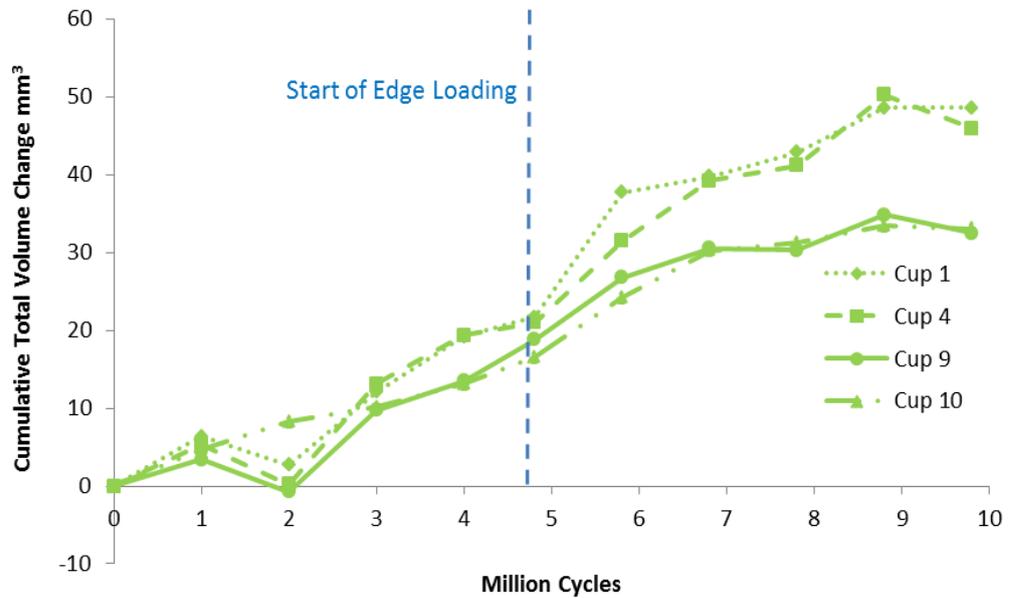
**Figure 4-10 Cumulative volume changes measured geometrically for the AOPE cups after 4.8Mc of standard loading (0-5Mc) and 5Mc of edge loading (5-10Mc) in a hip simulator**

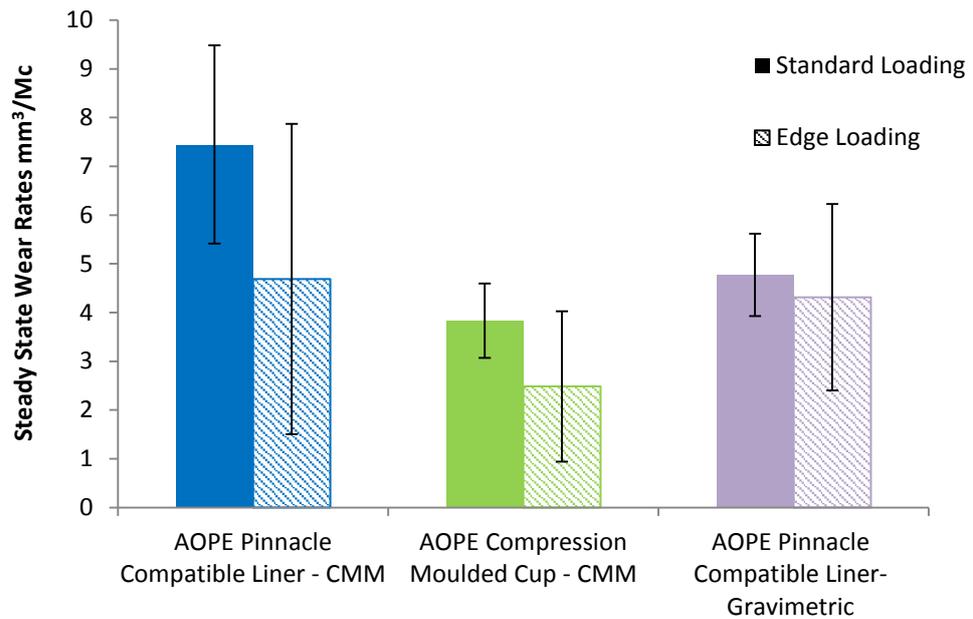
**Figure 4-11 Mean steady state wear rates for the AOPE liners and AOPE cups after 4.8Mc of standard and 5Mc of edge loading conditions calculated using geometric measurements and gravimetric measurements (AOPE liners only); ( $\pm$ 95% Confidence Intervals; n=4)**

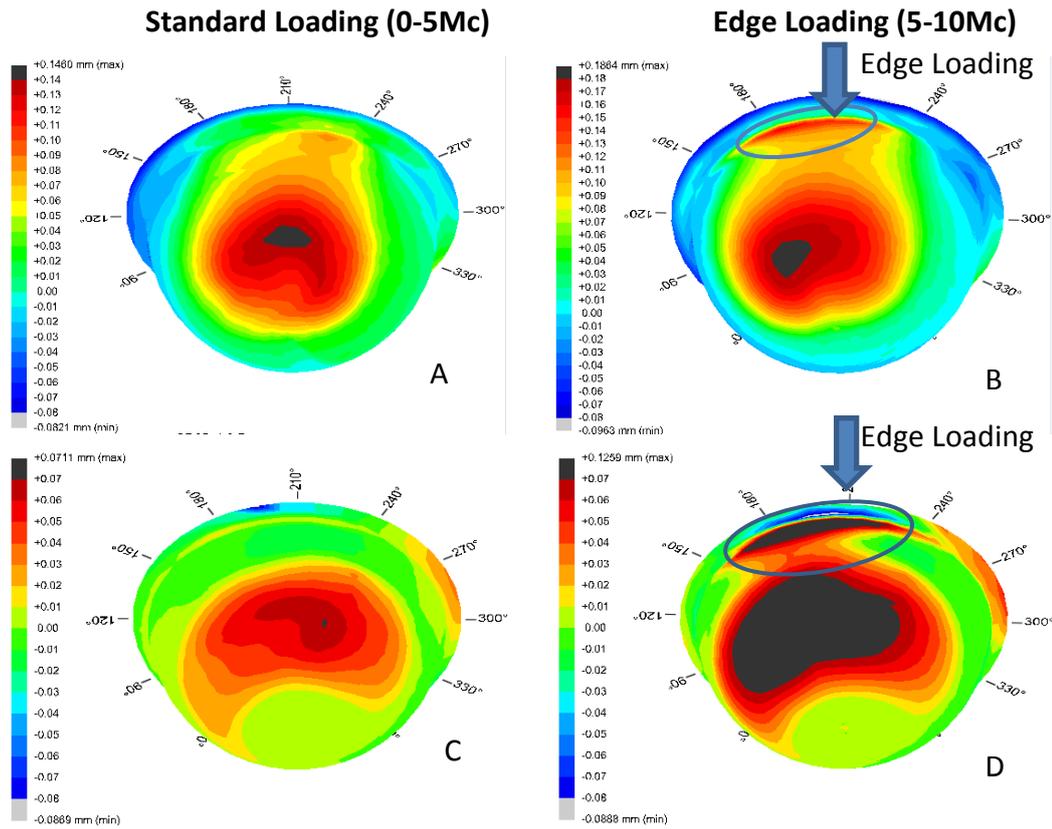
**Figure 4-12 SR3D geometric reconstructions of volume change after 5Mc standard loading and 5Mc edge loading conditions for the AOPE liners (A & B; AOPE 6) and AOPE cups (C & D; AOPE CM 2). Superior region of the liner/cup is at the top of the image.**

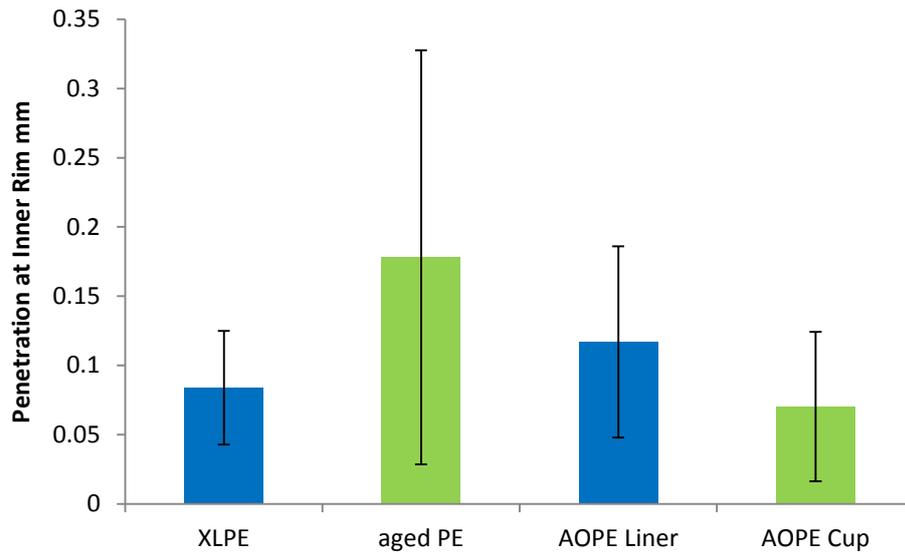
**Figure 4-13 Mean penetration values at the inner rim for the XLPE liners, Aged PE liners, AOPE liners and AOPE cups (95% Confidence Intervals; n=4)**

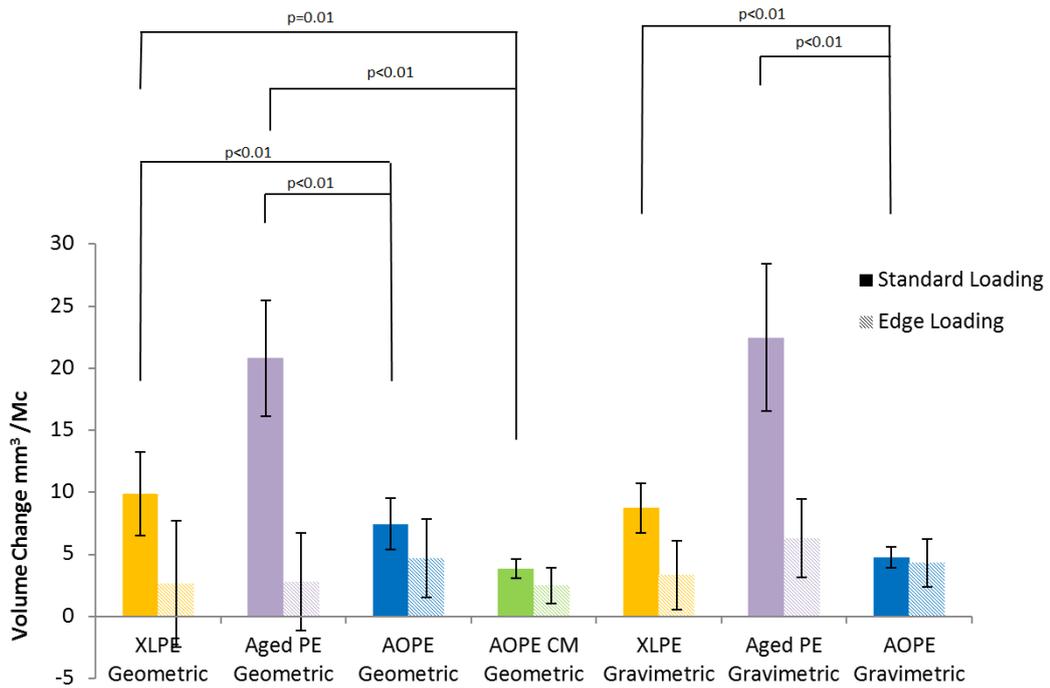
**Figure 4-14 Mean steady state wear rates measured gravimetrically and geometrically for the AOPE liners, AOPE cups, XLPE liners and aged PE liners for standard loading and edge loading conditions ( $\pm 95\%$  Confidence intervals;  $n=4$  for each liner/cup; all XLPE and aged PE data previously presented in results sections 3.4.1)**

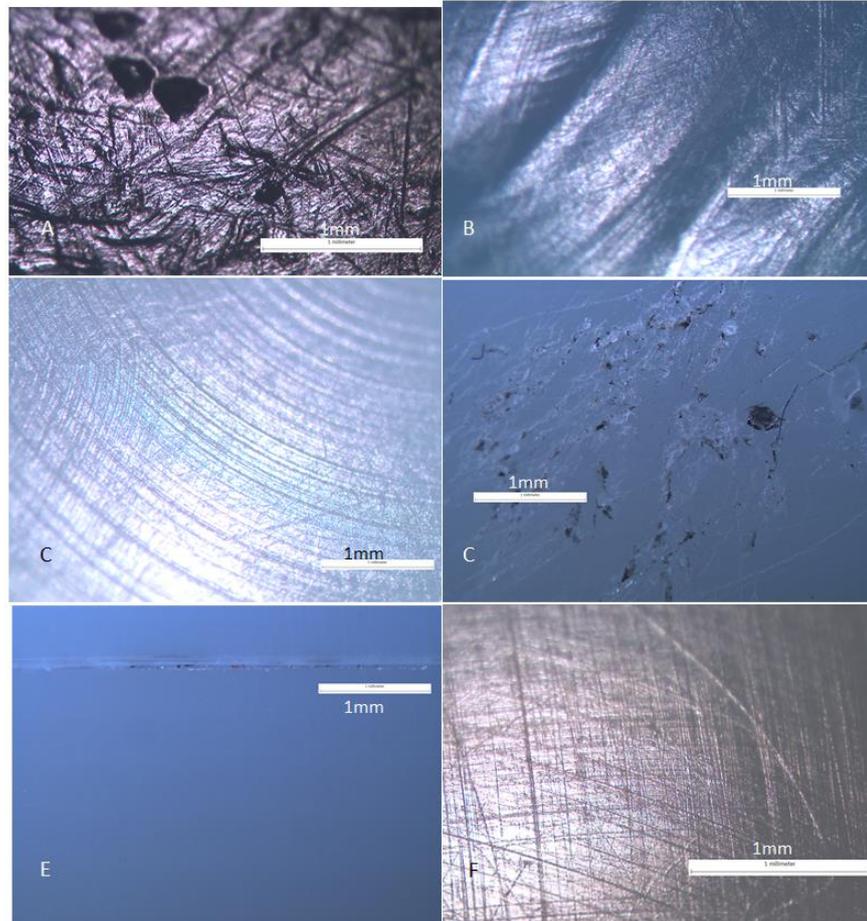
**Figure 5-4 Microscopy image taken at x30 magnification showing (A) pitting, (B) surface deformation (indentations), (C) unworn surface with machining marks still visible, (D) abrasion, scratching and embedded debris, (E) large scratch and (F) fine scratching and burnishing**

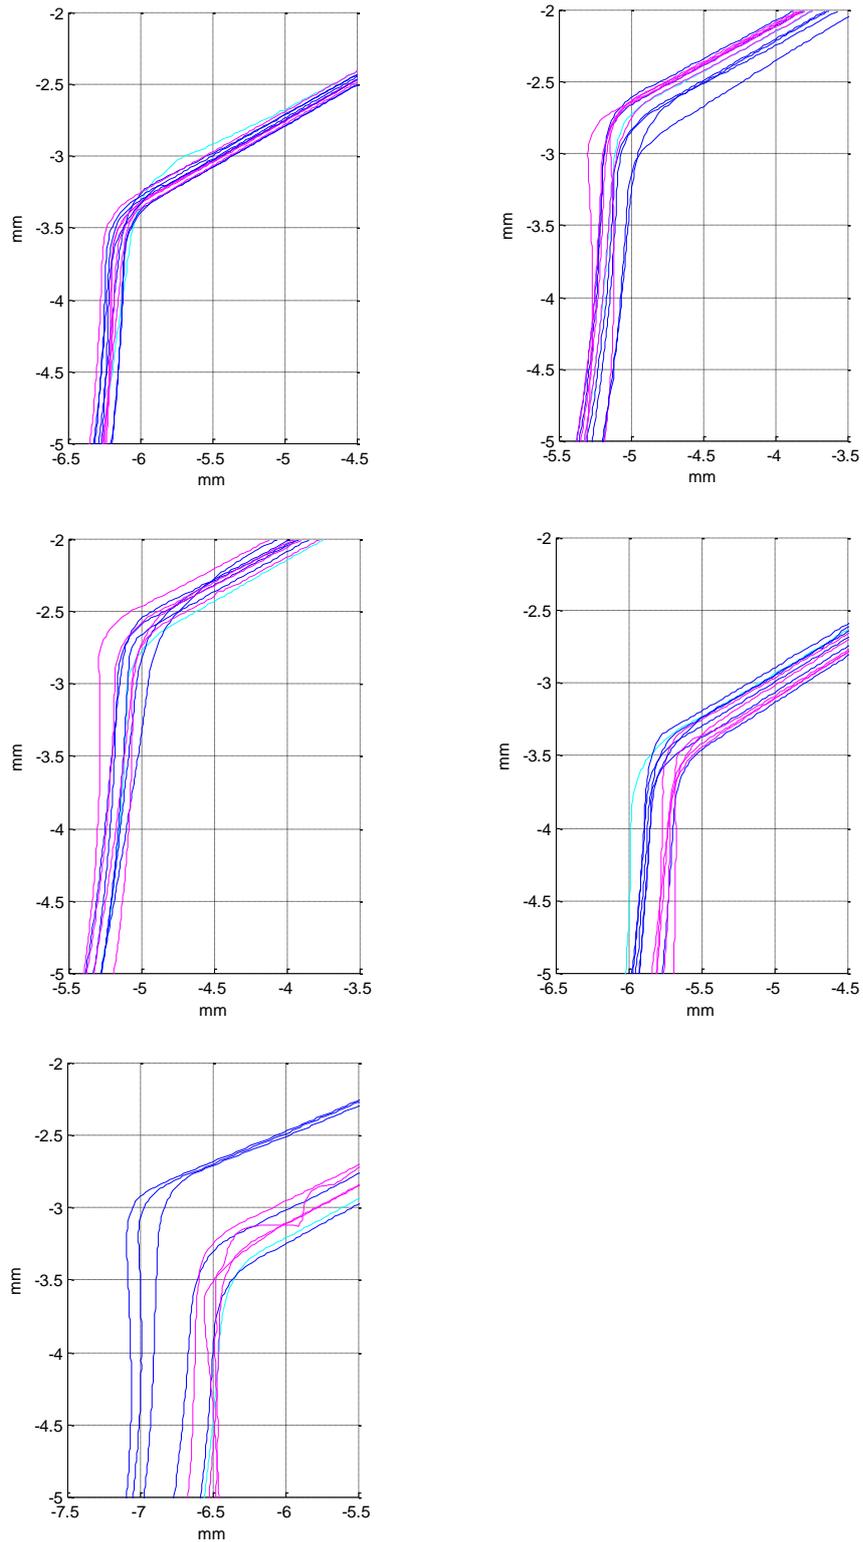
**Figure 5-5 Close up of the inner rims of five of the neutral liners with no visible deformation and/or wear. Blue traces are taken over the unworn region and pink traces over the worn region. Cyan traces are taken from the anterior and posterior unworn regions of the liner.**

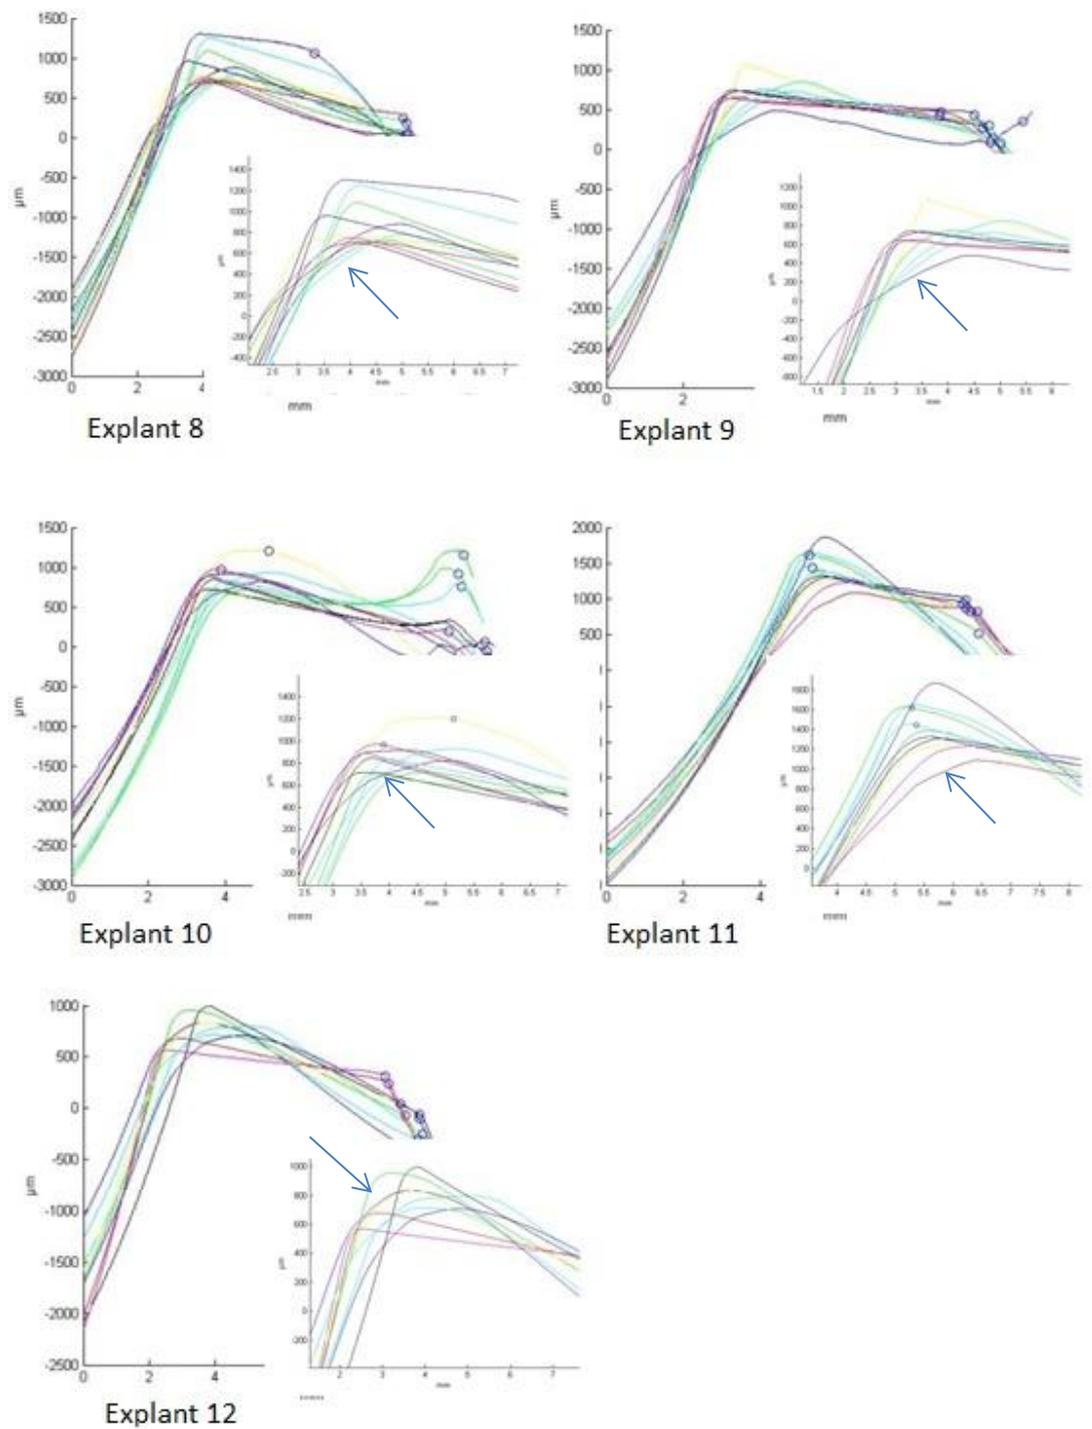
**Figure 5-7 Full traces and close up of the inner rims of the five dissociated neutral liners with large deformations in the form of a flattened curve on the superolateral rim (identified for one of the superolateral traces with an arrow)**

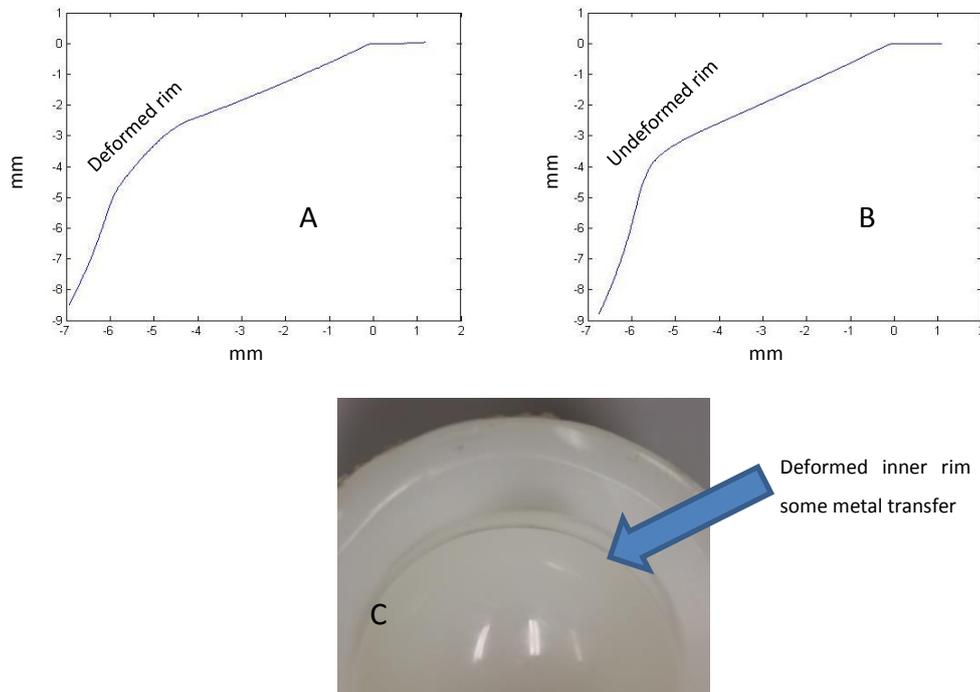
**Figure 5-8 Talysurf traces of (A) a flattened inner rim on the superior region of dissociated neutral liner, explant 12D, (B) an undeformed region of the same liner (or less deformed) and (C) a photographic image of the deformed inner rim (explant 12D)**

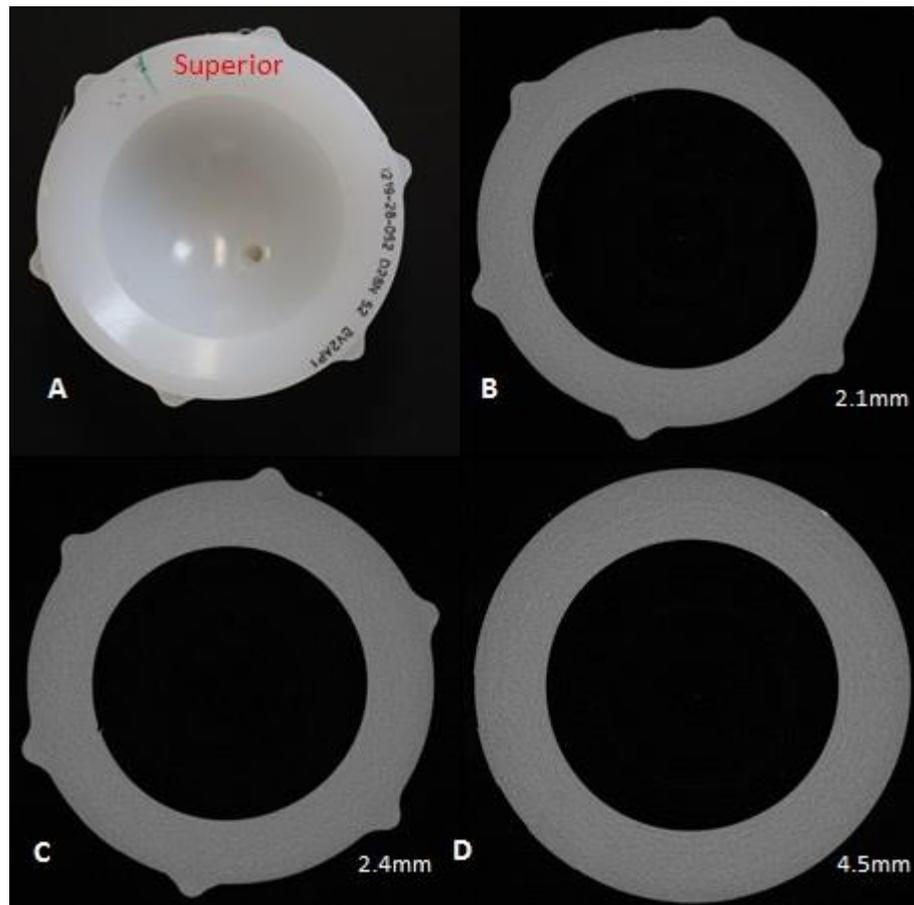
**Figure 5-9 A** Photographic image and MicroCT images of the subsurface damage observed on a non-dissociated neutral liner (explant 3N) showing (A) a photo of the component and orientation *in vivo*, (B, C & D) visibly undamaged sections of the liner between 2.1mm and 4.5mm below the horizontal rim.

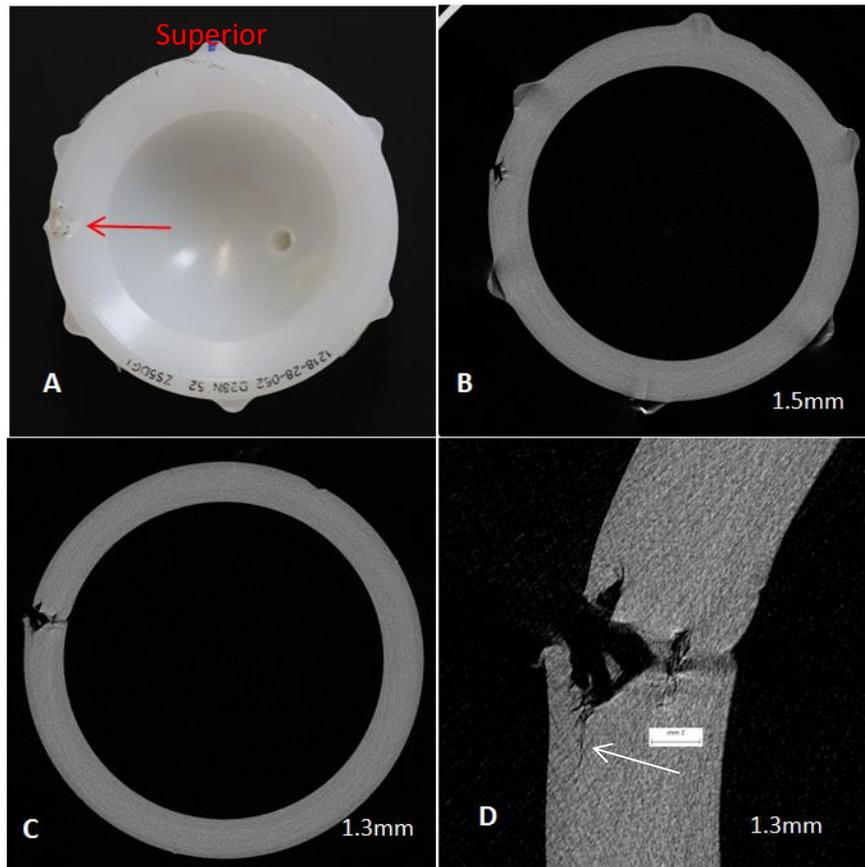
**Figure 5-10 A Photographic image and MicroCT images of the subsurface damage observed on a non-dissociated neutral liner (explant 2N) showing (A) a photo of the component and orientation *in vivo*, (B) visibly undamaged section of the liner 5mm below the horizontal rim (C) a visibly damaged section showing cracking 1.3mm beneath the surface damage and (D) a close up of the damage in (C) showing cracks extending circumferentially and perpendicular to the outer rim (arrow; scale bar 1mm).**

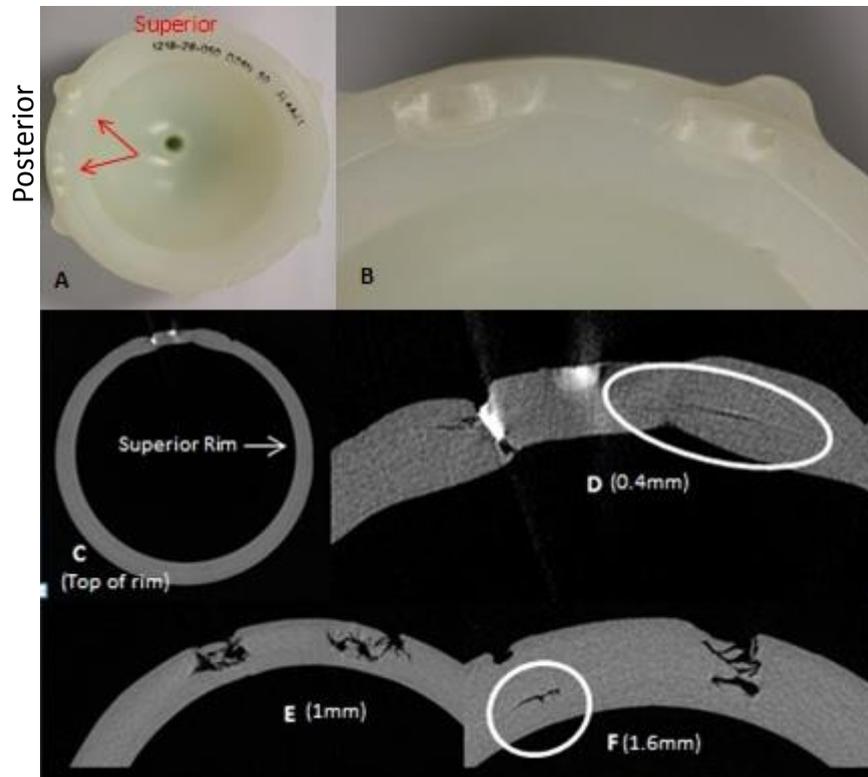
Figure 5-11 Photographic images and MicroCT images of the subsurface damage observed on a non-dissociated neutral liner (explant 5N) showing (A) a photo of the component and orientation *in vivo*, (B) a close up photographic section of the damaged rim showing surface damage in the posterior region, (C) a complete MicroCT slice at the top (horizontal section) of the liner rim, (D) a crack propagating circumferentially 0.4mm beneath the surface damage, (E) extensive multi-directional cracking 1mm underneath the surface damage and (F) a crack propagating circumferentially 1.6mm below the surface damage.
