**Wear and rim damage of UHMWPE acetabular cups in total  
hip replacement**

Submitted in accordance with the requirements for the degree of Doctor of  
Philosophy

The University of Leeds  
School of Mechanical Engineering

December 2016

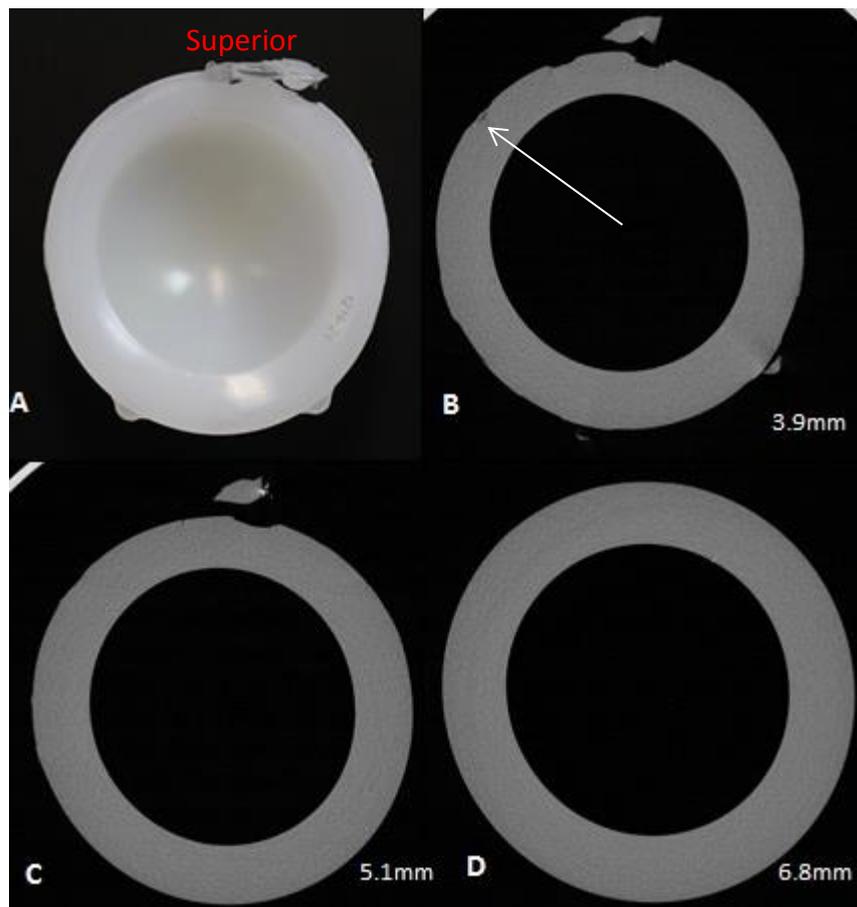
**Figure 5-12 Photographic images and MicroCT images of the subsurface damage observed on a dissociated neutral liner (explant 11D) showing (A.1) a photo of the fractured superior rim with absent anti-rotation tabs, (B) the fractured superior rim and cracking adjacent to the location of an absent anti-rotation tab 3.9mm below the horizontal liner rim, (C) a visibly undamaged section, except for the fracture in the superior region, 5.1mm below the horizontal rim, (D) a visibly undamaged section 6.8mm below the horizontal liner rim**

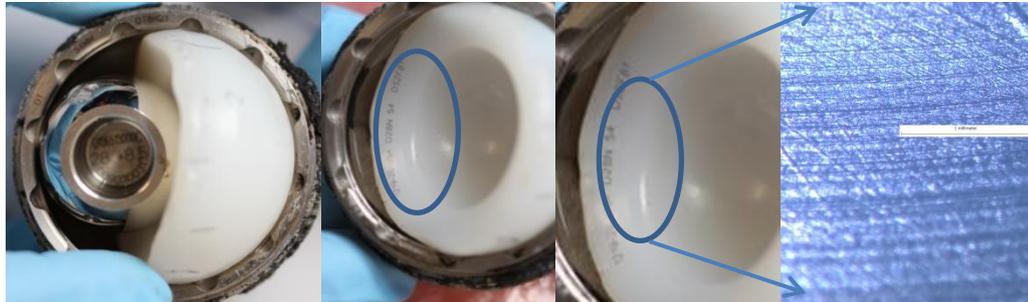
The dissociated neutral liners were badly damaged at the time of retrieval. However, the majority of this damage was caused after the liners had dissociated. Information about the extent and type of damage prior to dissociation was more valuable when attempting to identify the cause of dissociation. It was therefore necessary to identify when the flattening of the rim occurred. For all the dissociated neutral liners, the femoral head articulated against the metal shell after dissociation. This is indicated by scratching and metal transfer on the femoral head as well as damage to the inside of the metal shell (Figure 5-18). When the bearing couple was reassembled in the dissociated position using the ridge on the backside of the liner and the area of damage on the metal shell as landmarks, it could be argued that damage to the inner rim was not caused post-dissociation, because in this position there was no contact between head and inner rim and a much greater degree of damage would be expected across the entire superior rim region if there was articulation in this area (Figure 5-25). For example, the product reference numbers and machining marks would no longer be visible. It could therefore be hypothesised that damage to the inner rim was sustained before the dissociation event. This would support the hypothesis that the mechanism of edge damage to

the dissociated neutral liners prior to dissociation was different to the edge damage sustained by the non-dissociated neutral liners.

**Figure 5-25 (A) Reassembled dissociated neutral explant (explant 10D) showing (A) the position of the head with respect to the liner following the dissociation, (B) the deformed region of the inner rim and (C) a close up of the relatively undamaged rim region and (D) a microscope image of the rim area with machining marks still visible (x30 magnification)**

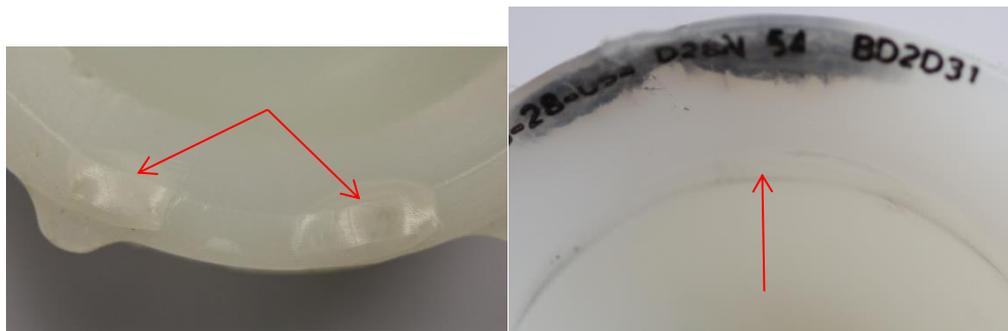
Fracture and deformation was observed on the rims of some of the non-dissociated neutral explants and a deformation of the inner rim was observed on the dissociated neutral explants that may have been attributable to severe edge loading or femoral neck impingement (Figure 6-4).

**Figure 6-4 Rim damage on (A) a non-dissociated neutral explanted liner and a (B) dissociated neutral liner that may have been cause by femoral neck impingement.**

Femoral neck impingement has been reported in several explant studies and is estimated to occur in as many as 60% of cups (Isaac et al., 1992; Yamaguchi et al., 2000; Shon et al., 2005; Usrey et al., 2006). Impingement is known to cause loosening of both femoral stems and acetabular cups and has been implicated in fatigue fracture of liners rims (Duffy et al., 2009). Deformation in this study was observed close to the outer rim of the explanted liners and in some cases, resulted in minor cracking and/or fracture of the components. The microCT measurements provided information about the initiation and propagation of subsurface cracks when damage was sustained on the surface of the component. Simulator
