*Department of Mechanical Engineering*

**Effect of Surface Traction and Non-Metallic Inclusions  
on the Premature Failure of Wind Turbine Gearbox  
Bearings**

Thesis submitted to the Department of Mechanical Engineering, University  
of Sheffield in partial fulfilment of the requirements for the degree of

**Doctor of Philosophy**

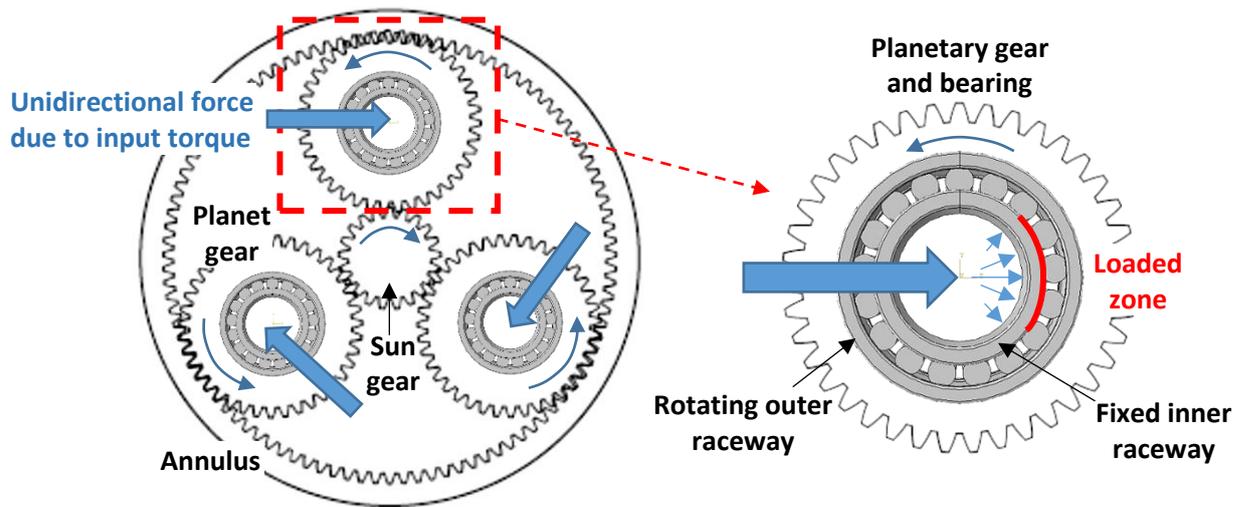
In this research, the damage of the planetary bearings was investigated, which have been observed in previous studies to be one of the WTGB that are vulnerable to premature failure [31][37]. Figure 2.1.3 shows how the inner raceway of the planetary bearing is mounted to the pin which is not rotating, while the outer raceway rotates with the planetary gear. This configuration transfers the load from the low speed shaft to the planet carrier in a unidirectional way which exposes the loaded zone of the inner raceway to greater damage.

**Figure 2.1.3: Generic WT planetary stage illustrates the unidirectional load on the inner raceway of the planetary bearings and the loaded zone**

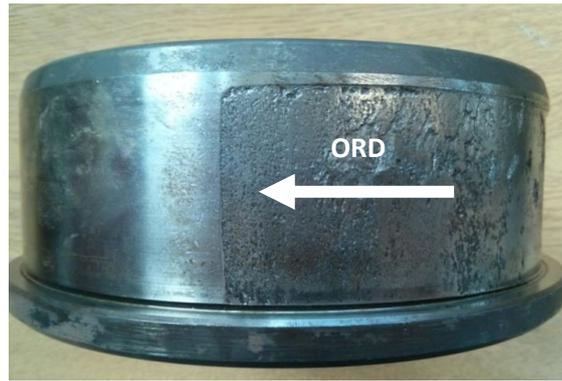
**Figure 3.1.2: The part of the inner raceway of the uncoated failed bearing which was not examined in this research (Courtesy of Tom Bruce [19])**

Only half of the inner raceway of the uncoated failed bearing was available for examination in this research, and the results obtained refer only to that half. The other half, shown in Figure 3.1.2 was used in another study [19]. The uncoated bearing was in service for five years before it was replaced after a site inspection due to abnormal noise during operation. The visual inspection showed extreme surface damage on the inner race compared with the outer raceway. The damaged area was in the loaded-zone where the unidirectional load is applied in a planetary bearing as shown in Figure 2.1.3. Three regions can be identified on the surface of the examined part of this bearing as shown in Figure 3.1.3. The first region consists of big spalls (more than 3 mm maximum dimension) spread on the downwind side of the raceway. The width of this region was about 20 mm. At the entrance to the loaded zone, less damage (spalling) was observed with the largest spalls in this region located on the flange side. The red dotted line in Figure 3.1.3 shows that the wear trace was not parallel to the axial axis of the raceway. This could be due to skewing of the rollers at the entrance to the loaded zone. Outside these two regions, no spalling was observed although an optical microscopic examination of the surface showed some micro-indentations. The examined part was sectioned in the circumferential and axial directions in order to prepare samples for the subsurface examination.

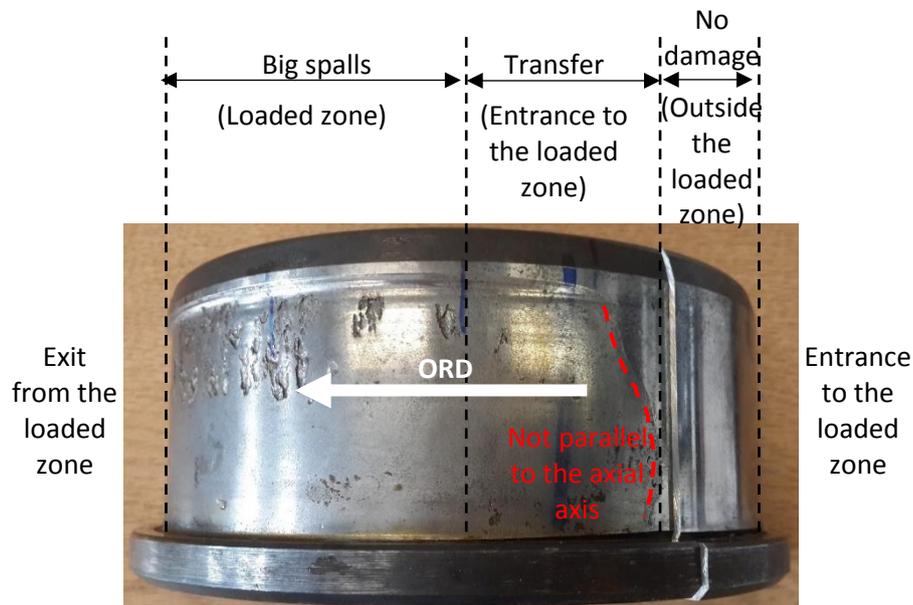
**Figure 3.1.3: Inner raceway of the uncoated failed bearing examined in this study**

caused by the debris carried from the damaged region, have been observed along almost the whole circumference of the raceway outside the loaded zone. However, the indents show higher density and greater size (more than 3 mm maximum dimension) at the exit from the loaded zone compared with those at the entrance to it.

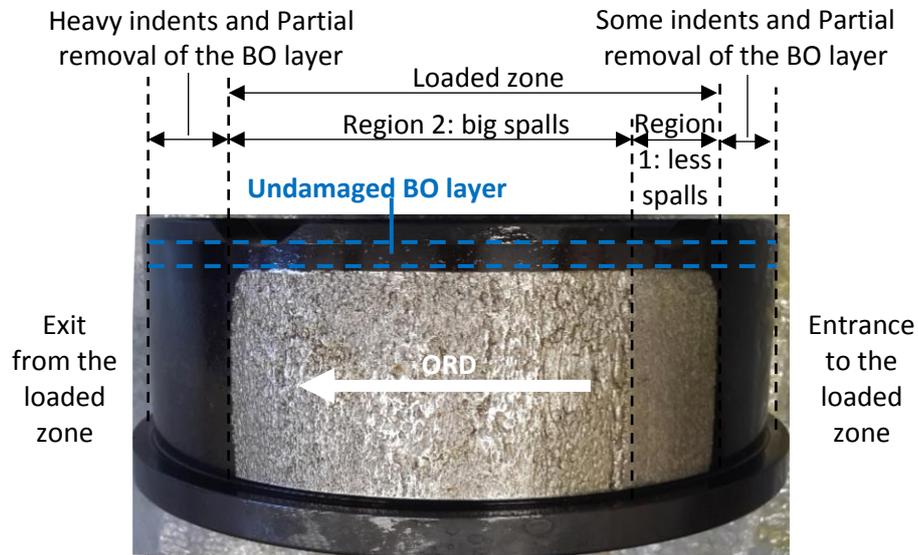
**Figure 3.1.4: Inner raceway of the BO failed bearing**

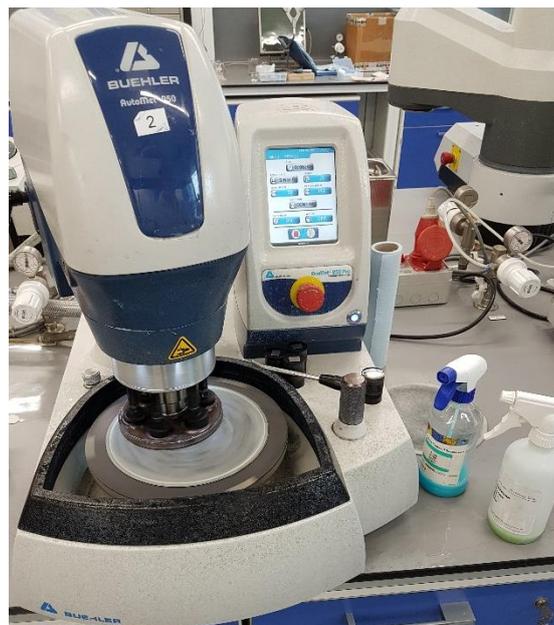
**Figure 3.2.5: The automated grinding and polishing machine BUEHLER Automet 250**

The sectioning of samples leaves the cut surfaces very rough and the scars on those surfaces make it very difficult to recognize the features of interest under microscopic examination. Therefore automated grinding was carried out using silicon carbide SiC abrasive grinding papers with three levels of roughness using an automated grinding and polishing machine (BUEHLER Automet 250) shown in Figure 2.2.5. The grit specifications were 240, 600 and 1200 of median grain size of 58.5, 25.8 and 15.3  $\mu\text{m}$  respectively [122]. The force used at each grinding stage was 20 N and the grinding time was 2 minutes and water was applied during the process. The base speed used for the base was 200 rpm and the head speed was 60 rpm respectively as shown in Table 3.2.1.

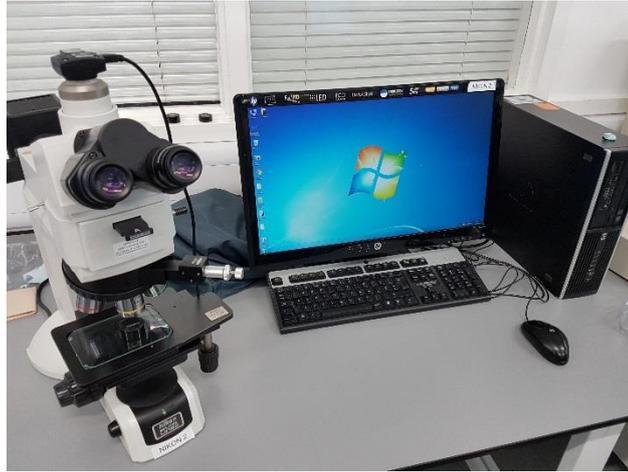
**Figure 3.3.1: Optical microscope Nikon ECLIPSE LV150**

Optical microscopy was performed by using a computerized Nikon ECLIPSE LV150 microscope, with a magnification power from 50 to 1000 times, as shown in Figure 3.3.1. After the final polishing stage, each sample was scanned at 100 times magnification to cover a depth of up to 1 mm below the surface. This preliminary scanning was used to perform the steel cleanliness analysis which will be further discussed in Section 3.4.2. The scan was repeated using 200 times magnification over a range of 500 microns below the surface, and focusing on features which could be less obvious to be seen after etching, such as cracks and debondings. Occasionally a higher magnification up to 1000 times was used when smaller features needed to be examined. The software associated with the optical microscope enabled measurements of the dimensions and angles of imaged features which was used extensively in order to collect a data-base for characterizing the damaged inclusions.

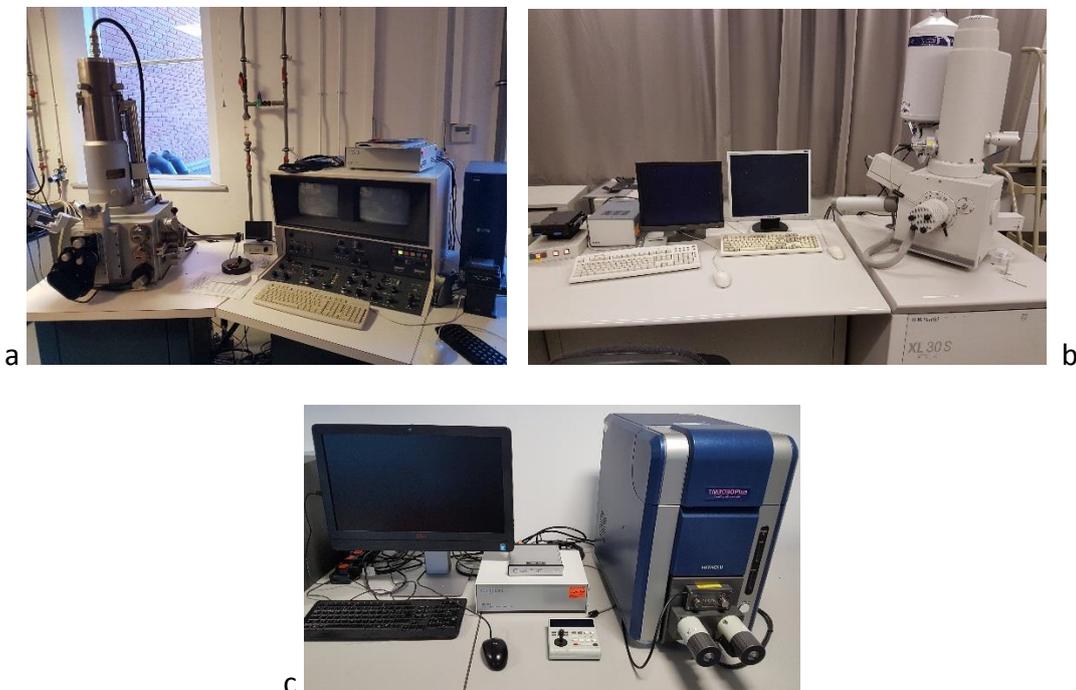
After identifying the location of the features that needed to be investigated at a greater magnification than 1000 times, SEM imaging was performed using a camscan Series II, FEI/Philips XL-30, and the tabletop HITACHI TM3030 plus, as shown in Figure 3.3.2. Both the Secondary electron (SE) and the Back-scattered Electron (BSE) detectors were used with accelerating voltages in the range of 15 - 20 kV. The BSE was mainly used to clearly differentiate between materials of different atomic number such as the non-metallic inclusions in the steel matrix. In this case the inclusions were darker because their atoms caused fewer backscattered electrons to reach the detector. The opposite effect applied to the heavier atoms of the iron.

**Figure 3.3.2: Scanning electron microscopes (a) Camscan Series II (b) FEI/Philips XL-30 (c) HITACHI TM3030 plus**

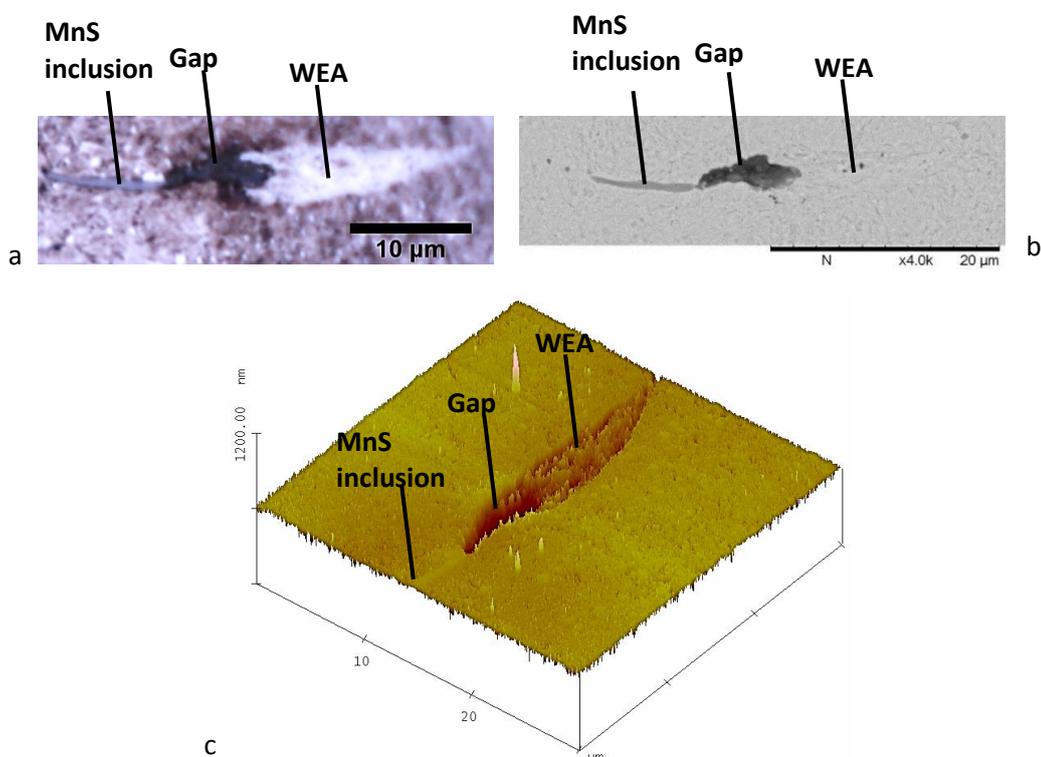
**Figure 3.3.3: Illustration of the difference between images of the same feature taken by different microscopic techniques (a) optical microscopic (b) SEM (c) AFM**

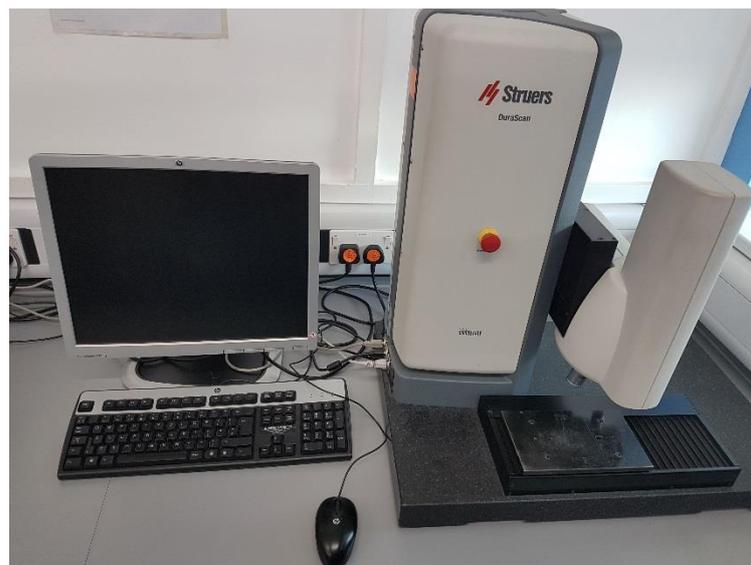
**Figure 3.3.6: Automated indentation machine (Struers Micro/Macro Hardness tester DuraScan)**

The variation of the hardness under the surface was measured for polished samples prepared from the uncoated bearing, the BO coated bearing and the samples of the RSTs. These measurements were made using the Struers Micro/Macro Hardness tester

(DuraScan) shown in Figure 3.3.6. Although this machine is automated; a different approach was needed to manually measure the out-of-focus indents, or discard the outliers of the measurements. The adopted pattern of indentation was a matrix of  $6 \times 3$  indents with the first row positioned at  $70 \mu\text{m}$  from the contact surface, and the distance between the centre of the indents in the horizontal and vertical direction at  $100 \mu\text{m}$ , as shown in Figure 3.3.7. The distance from the contact surface and between indents were chosen to avoid edge effects. This distance should be more than 2.5 to 3 times of the mean diagonal length of the indentation [127]. The mean value and the standard deviation were calculated for indents at the same depth, the three in each row in Figure 3.3.7. The Vickers hardness test was conducted with a load of 0.3 kgf and a holding time of 15 seconds. The size of the indents' diagonals did not exceed  $25 \mu\text{m}$ . This size for the distance from the edge (surface) and between the centre of the indents meets the manufacturers' recommendations and the ISO standard [127][128]. By selecting this load and indentation pattern, it ensured to capture the variation of hardness where higher load causes bigger distance between indents and thus only allows less number of indents. The results of the hardness measurements are presented in Chapter 6, 7 and 8.

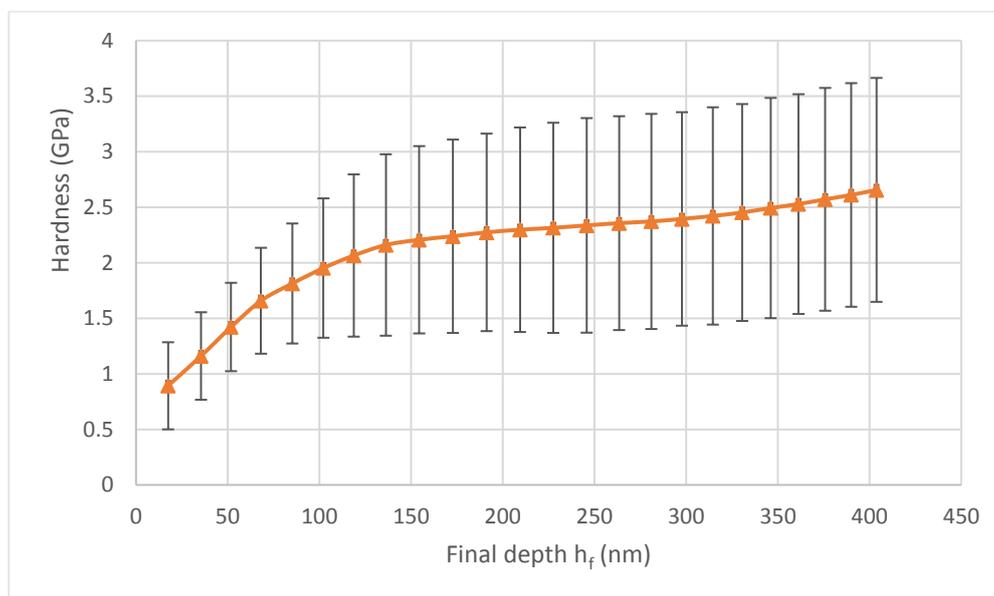
**Figure 3.3.12: The Nano-indentation hardness for the undamaged BO layer measured at 25 steps of loading-partial unloading (see Section 6.5 for full details)**

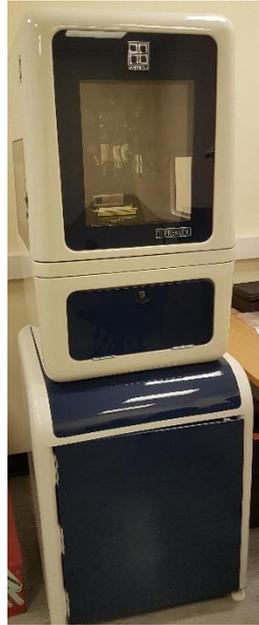
**Figure 3.3.13: Nano-indentation system Hysitron TI Premier**

As it will be discussed in Section 6.5, it was found that measuring the full thickness of the undamaged BO layer was not possible even with the maximum load capacity of the Hysitron Triboscope Nano-mechanical transducer because higher load was needed. To achieve this another Nano-indentation system, the Hysitron TI Premier was used and this is shown in Figure 3.3.13. In this system the maximum load is 1368 mN and the maximum z displacement is 91.863  $\mu\text{m}$ . The measurement of the Nano-mechanical properties using this system was conducted in the same way as discussed earlier; however, different number of indents, loading-partial unloading steps and maximum load were used as discussed in Section 6.5. In addition to measuring the thickness of the BO layer and characterising its mechanical properties, the hardness of damaged inclusions and associated WEA were also measured and will be presented in Chapter 5.

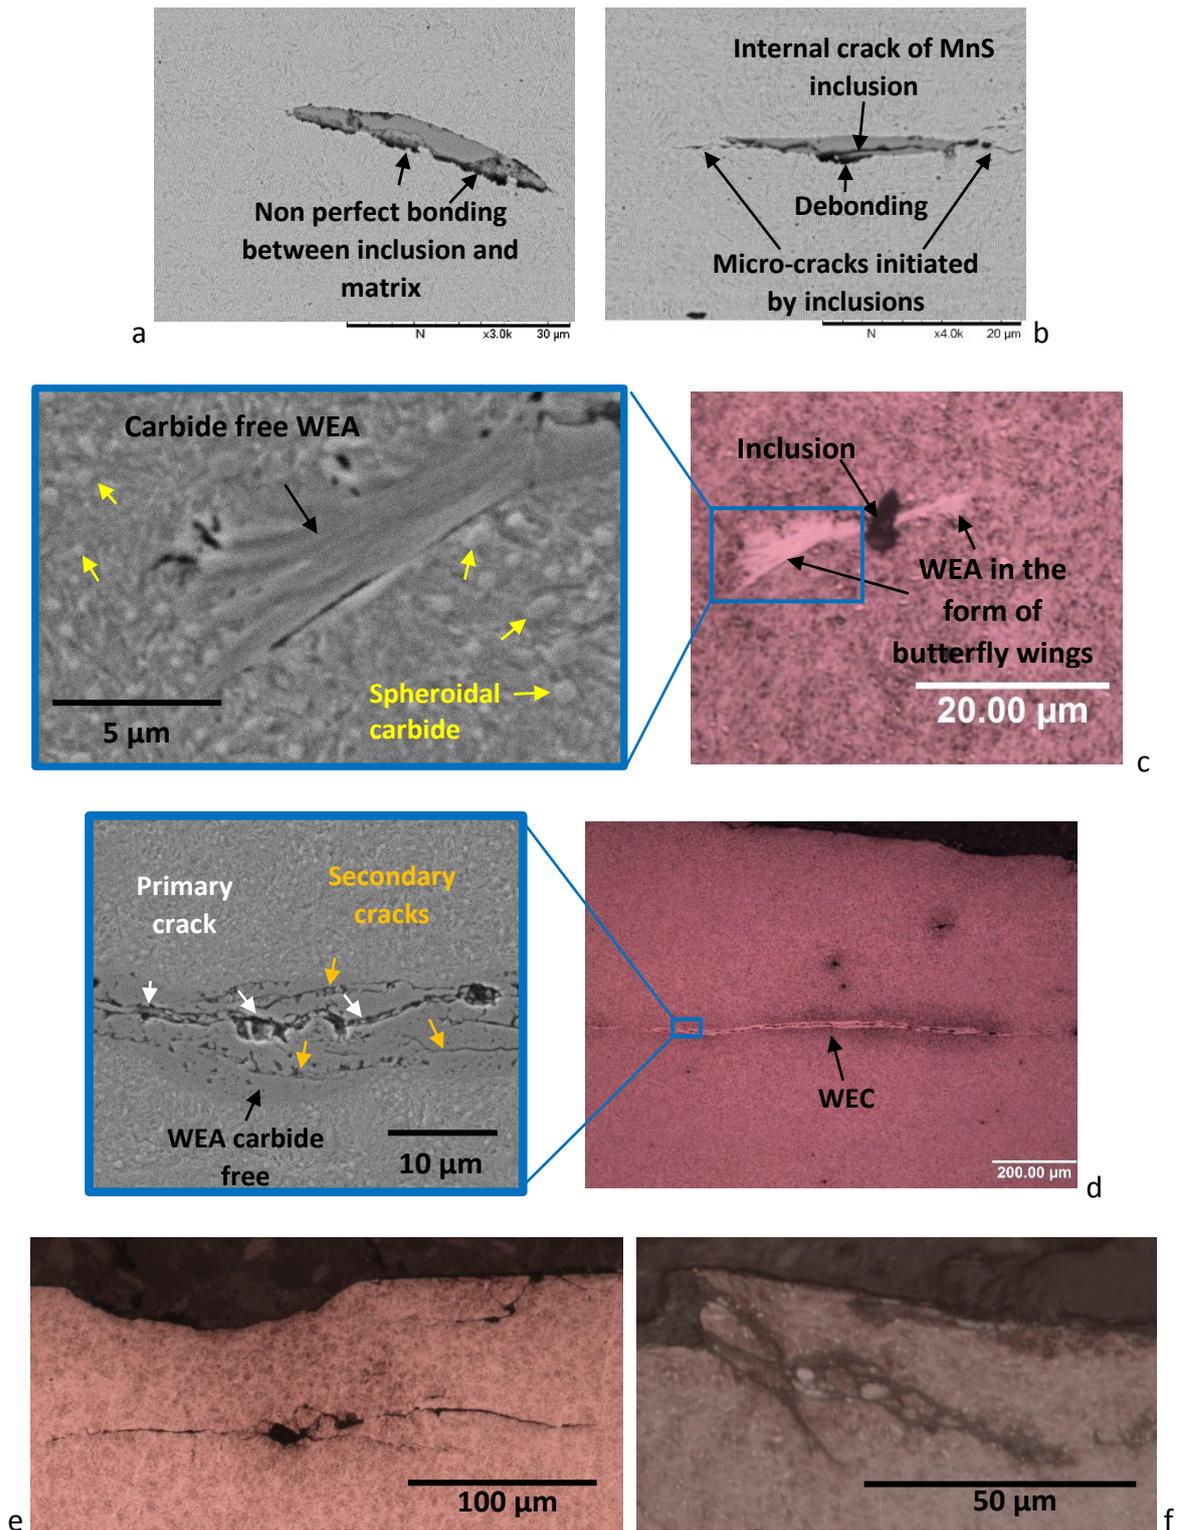
Figure 3.4.2: Examples for the damages defined in Table 3.4.1 (a) Debonded inclusion (b) Cracked inclusion with micro-cracks initiated by inclusions (c) Butterfly (d) WEC (e) Subsurface cracks in the axial section (f) Surface-linked RCF cracks

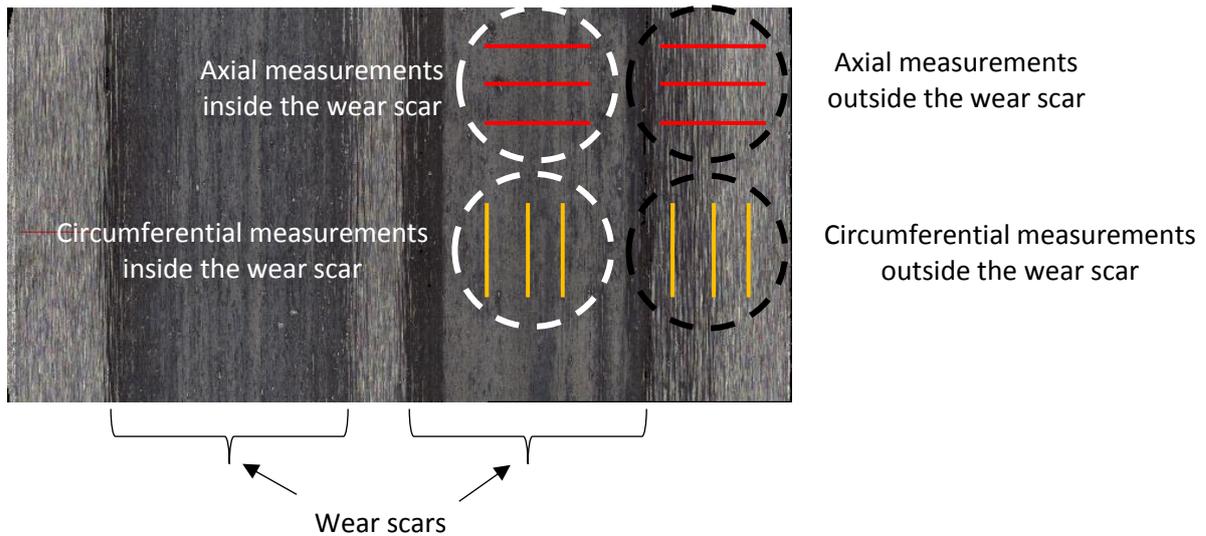
**Figure 4.3.2: Example for the roughness measurement pattern applied on the specimens of the RSTs.**

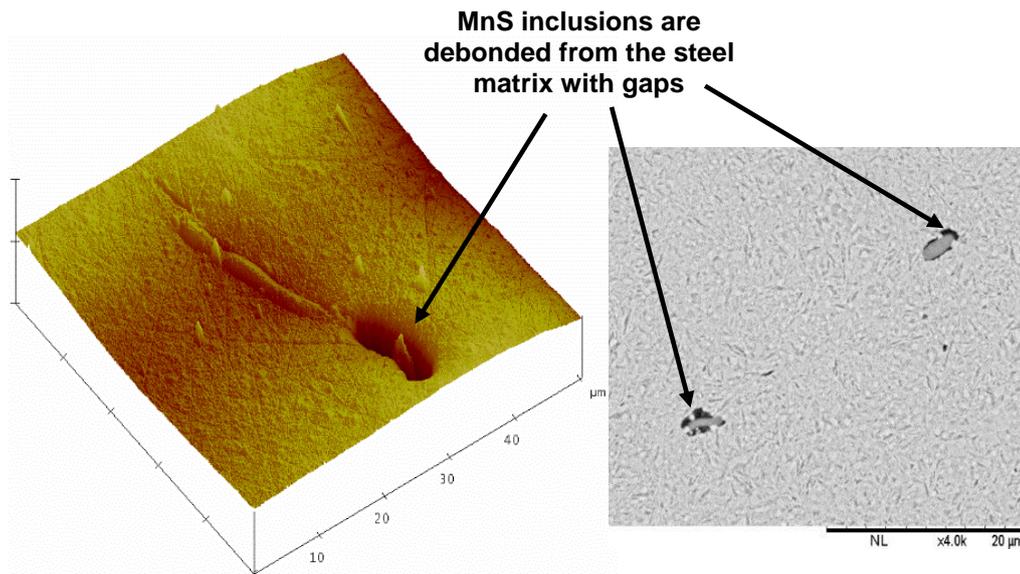
**Figure 5.1.1: (Left) AFM 3D image and (Right) SEM image of debonded inclusions at 1300  $\mu\text{m}$  from the contact surface**

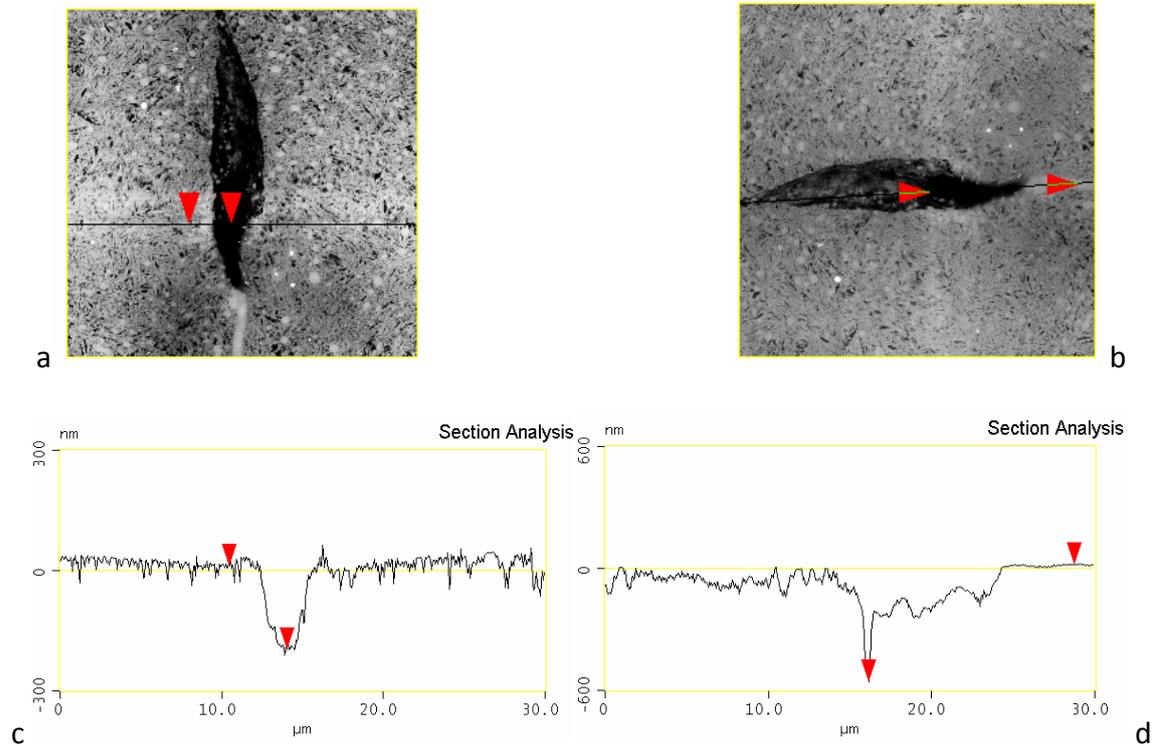
**Figure 5.1.2: AFM analysis shows the debonding between a MnS inclusion and WEA (butterfly wing)**

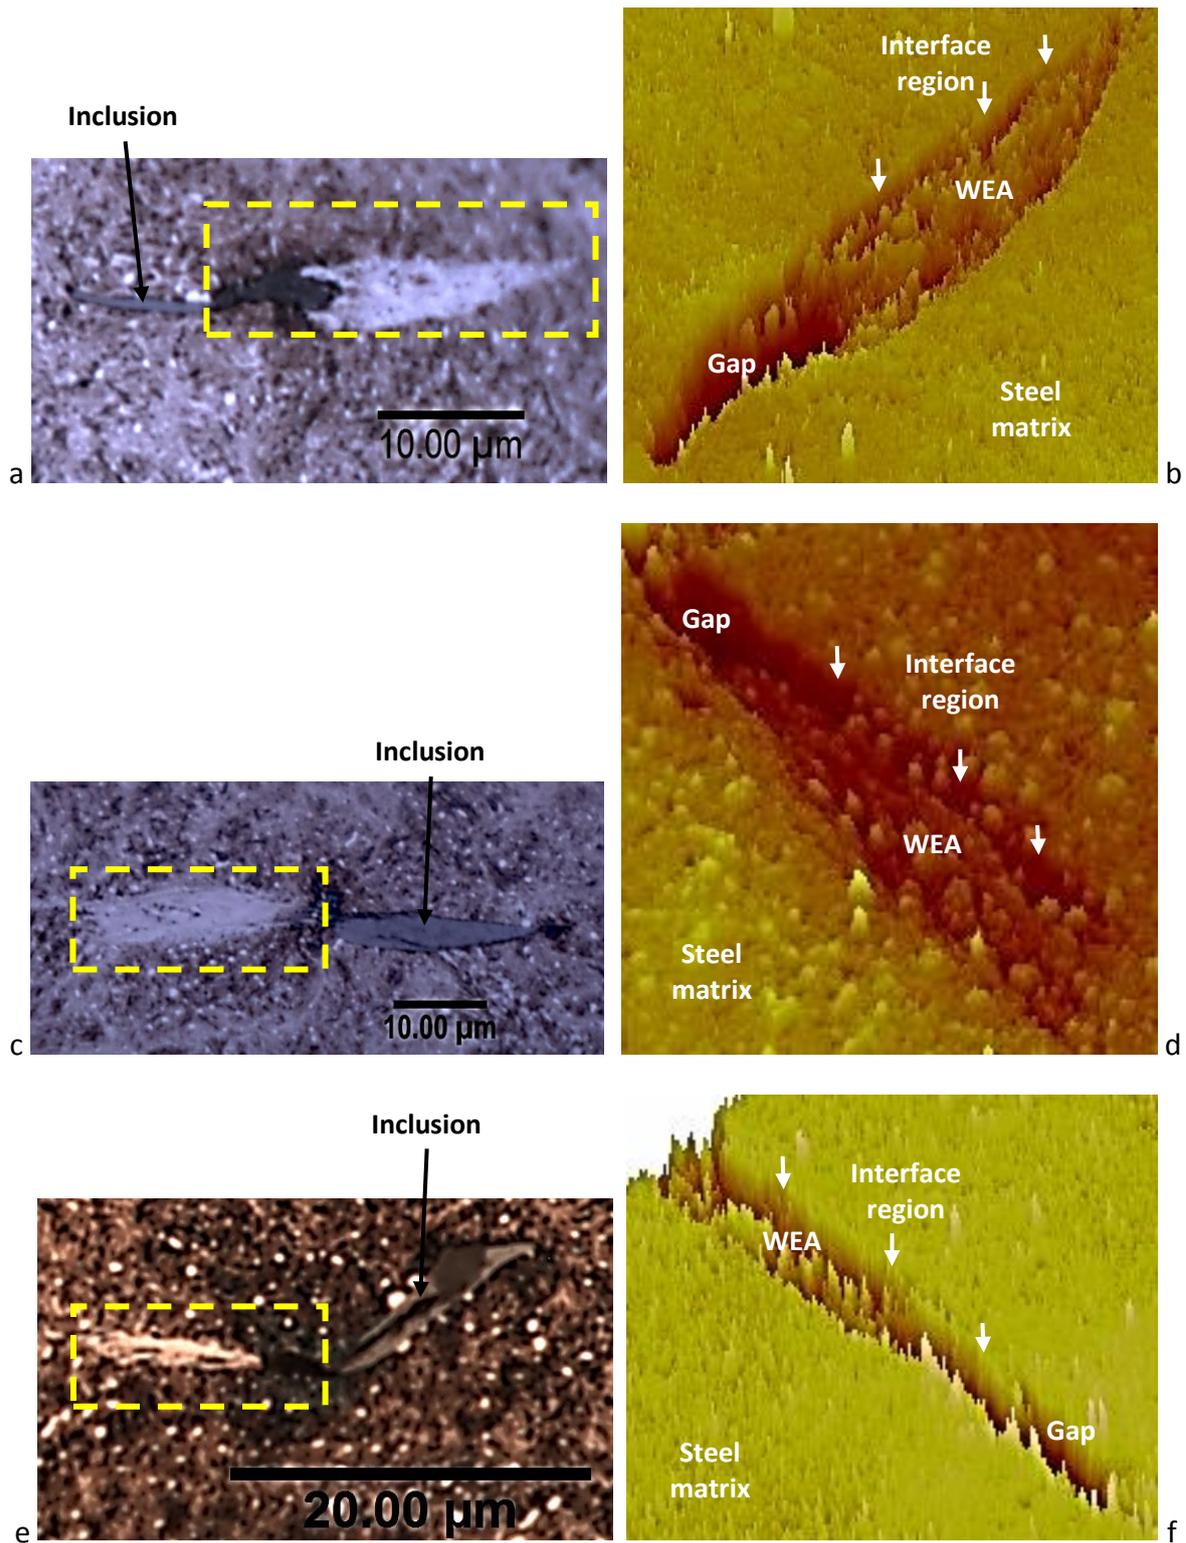
Figure 5.1.3: (Left) optical images for debonded MnS inclusions attached to WEA. The highlighted parts are the 3D AFM images to show the discontinuity of the WEA, and the debonding at the boundaries between the WEA and the steel matrix. The images in (a) to (d) are from axial sections; and (e) and (f) are from circumferential section with ORD from left to right

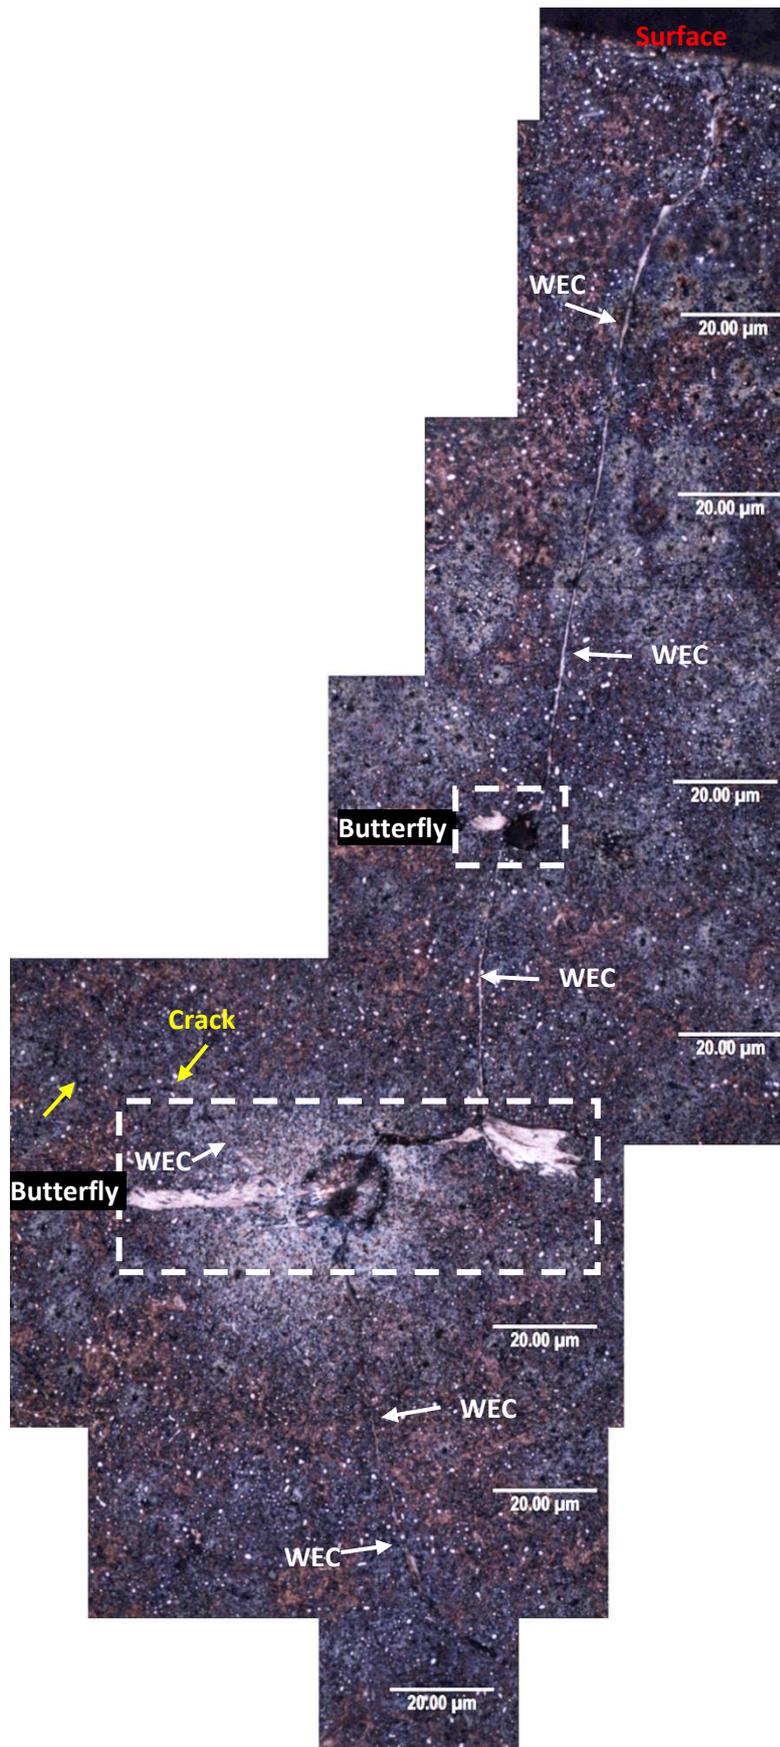
Figure 5.1.7: WEC propagated almost vertically toward the surface and linked two butterflies

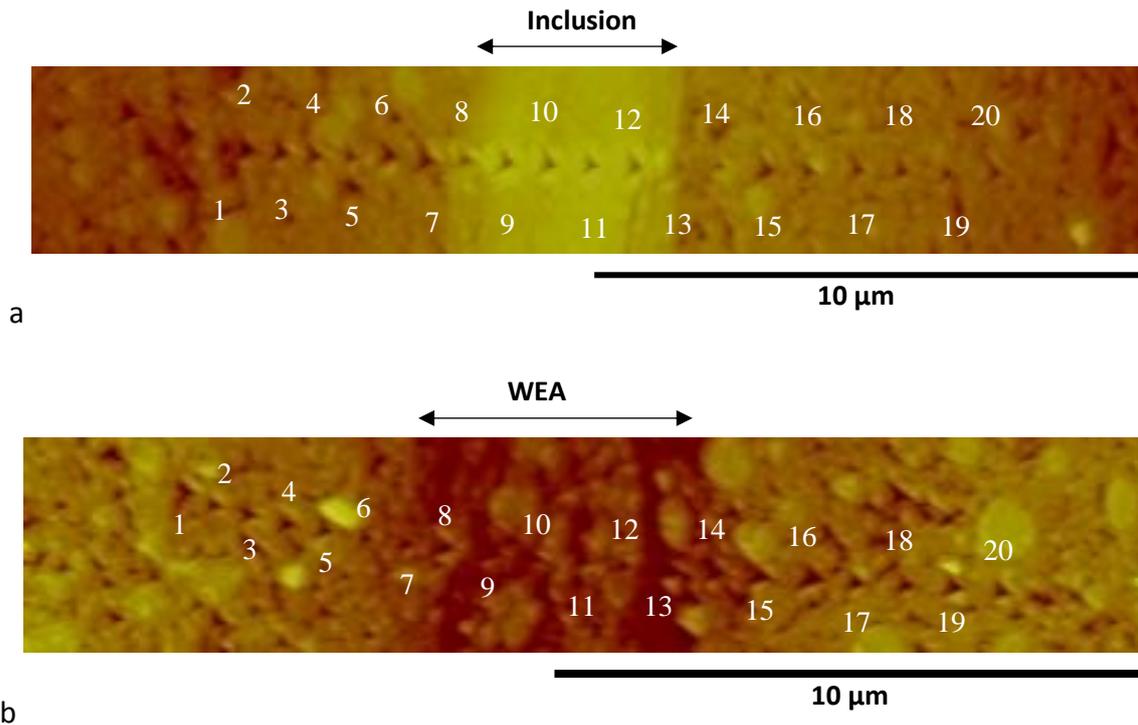
**Figure 5.1.8: Nano-indentations across (a) MnS inclusion and (b) WEA for the butterfly in Figure 5.1.3 (c)**

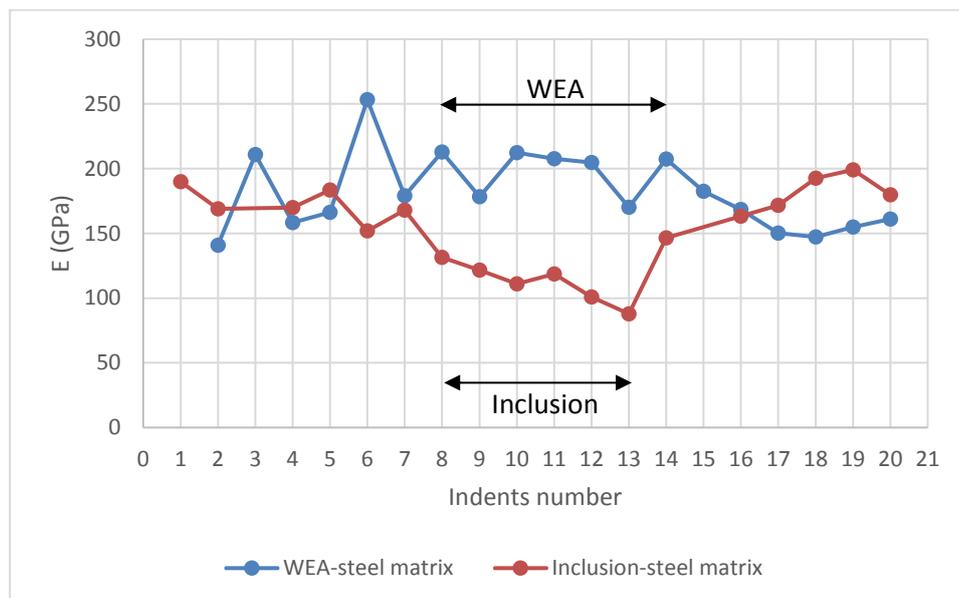
**Figure 5.1.10: Modulus of elasticity measured across a MnS inclusion and WEA in a butterfly**

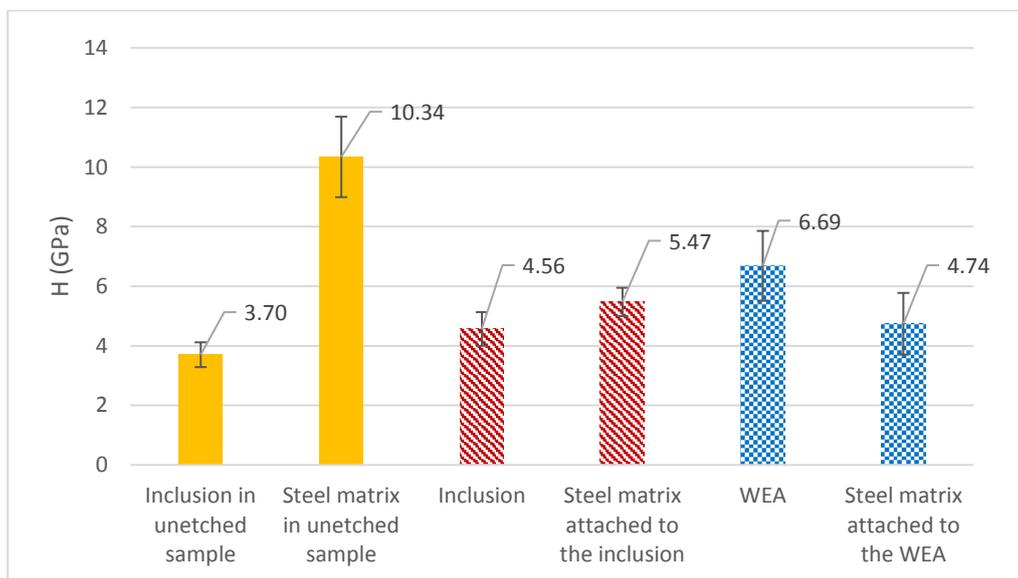
**Figure 5.1.11: The average value and standard deviation of Nano-indentation hardness for a MnS inclusion, WEA and attached steel matrix in an etched sample and a MnS inclusion and attached steel matrix in un-etched sample**

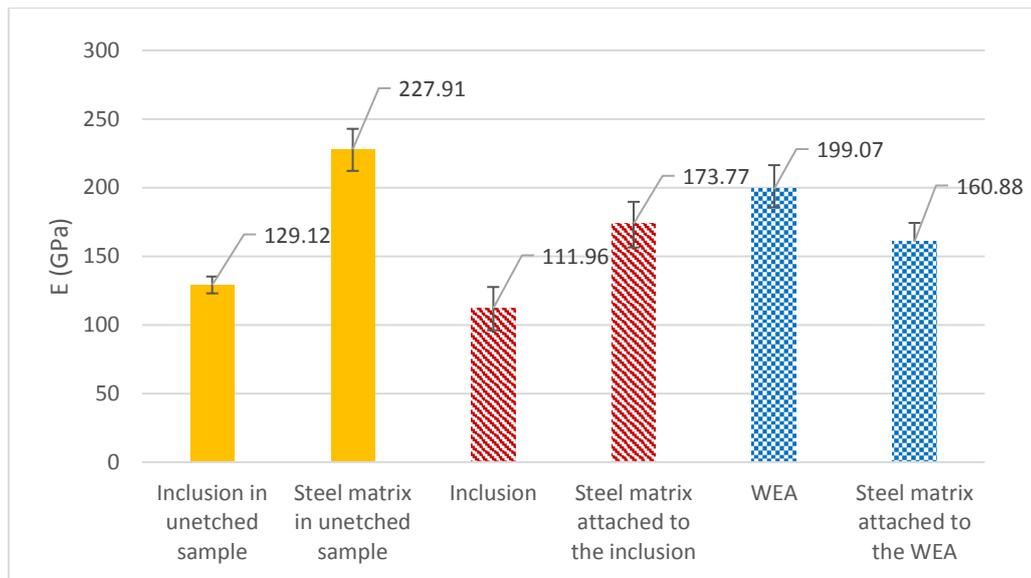
**Figure 5.1.12: The average value and standard deviation of modulus of elasticity for a MnS inclusion, WEA and attached steel matrix in an etched sample and a MnS inclusion and attached steel matrix in un-etched sample**

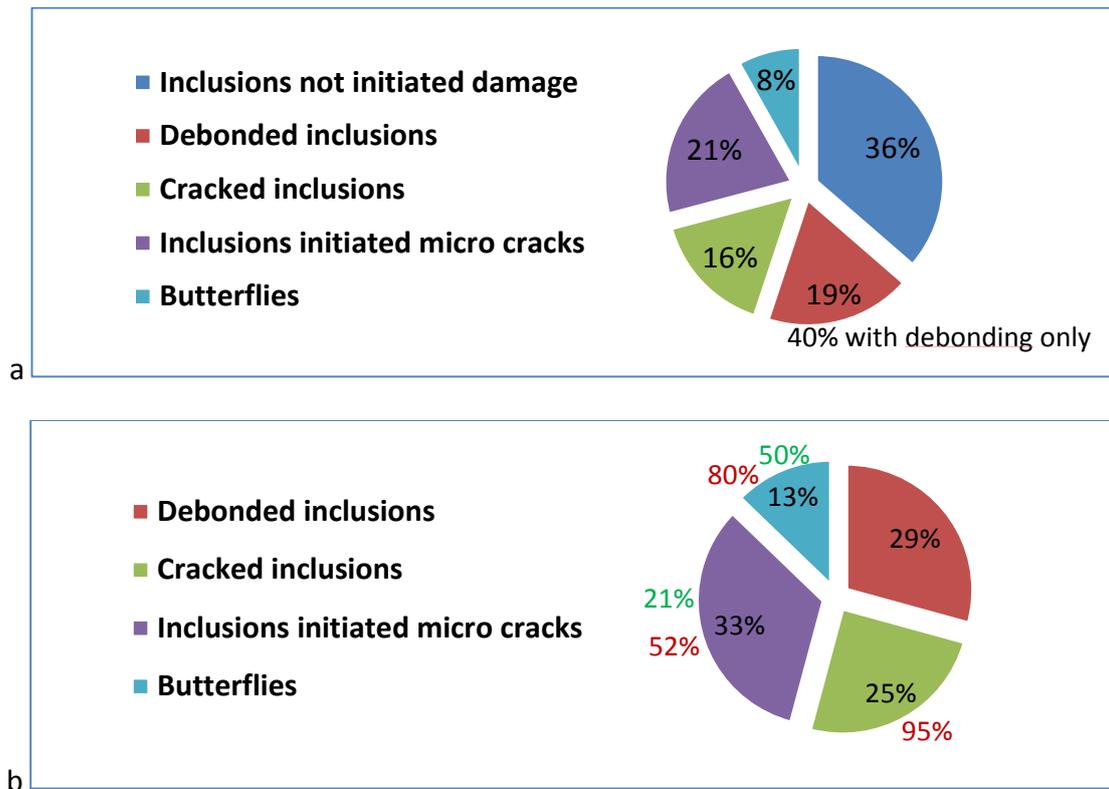
**Figure 5.2.1: Percentage of catalogued inclusions (a) out of the total catalogued inclusions (b) out of the inclusions that initiated damage only with the red and green percentage refer to the debonded and cracked inclusions respectively**

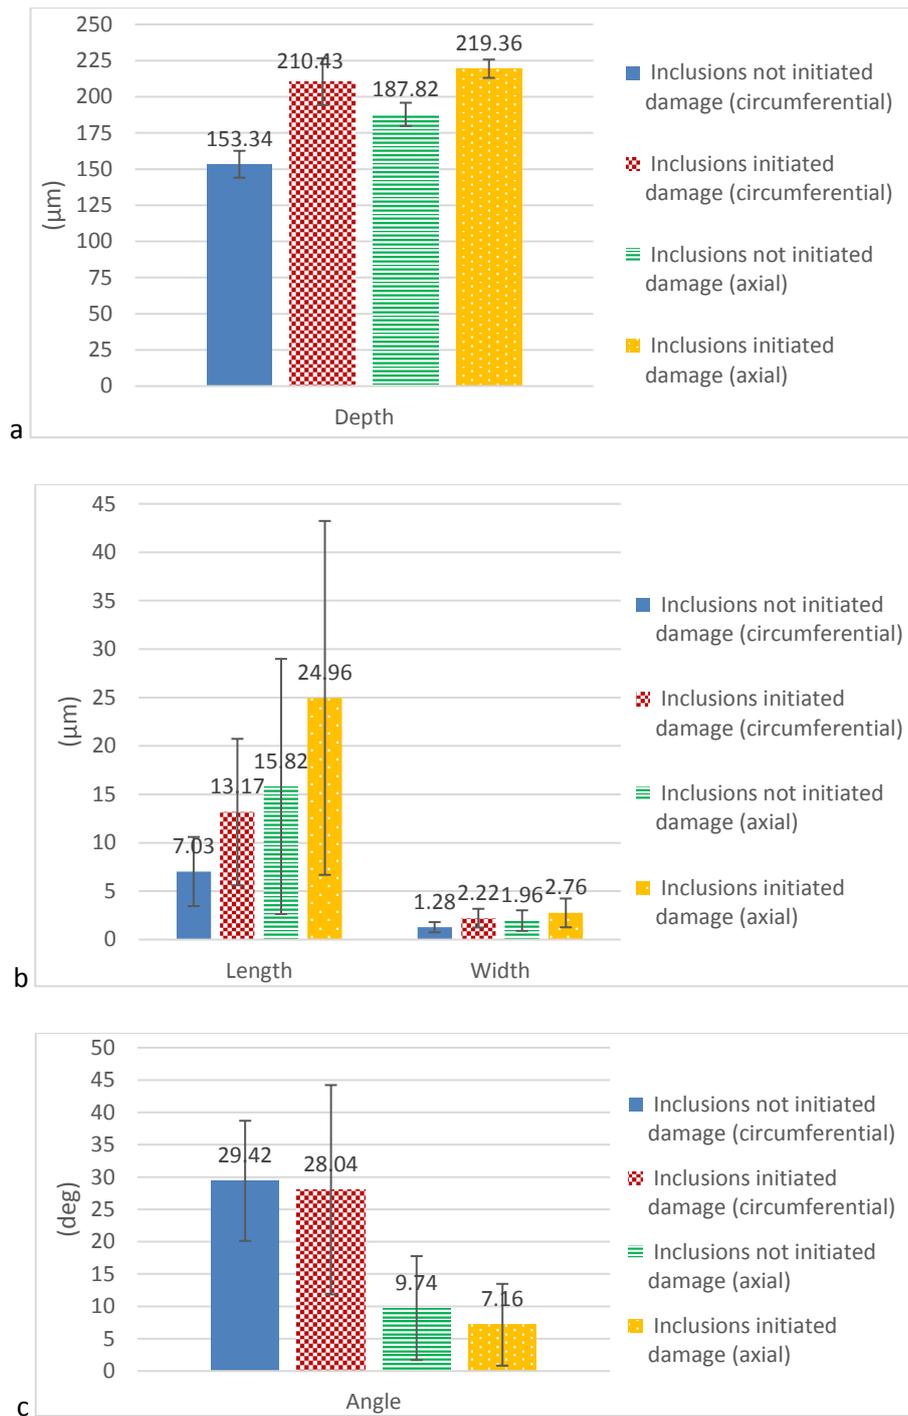
**Figure 5.2.2: Characteristics of catalogued inclusions (average values with the error bars show  $\pm$  one standard deviation)**

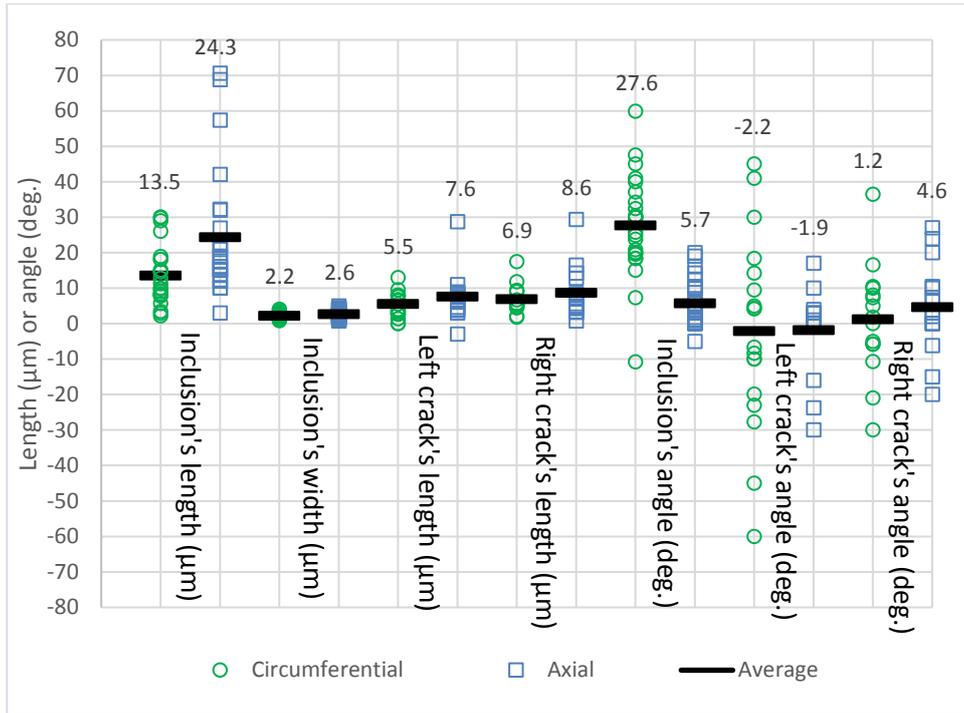
Figure 5.2.3: Characteristics of micro-cracks initiated by inclusions with their initiating inclusions (the number above each characteristic refers to the average value)

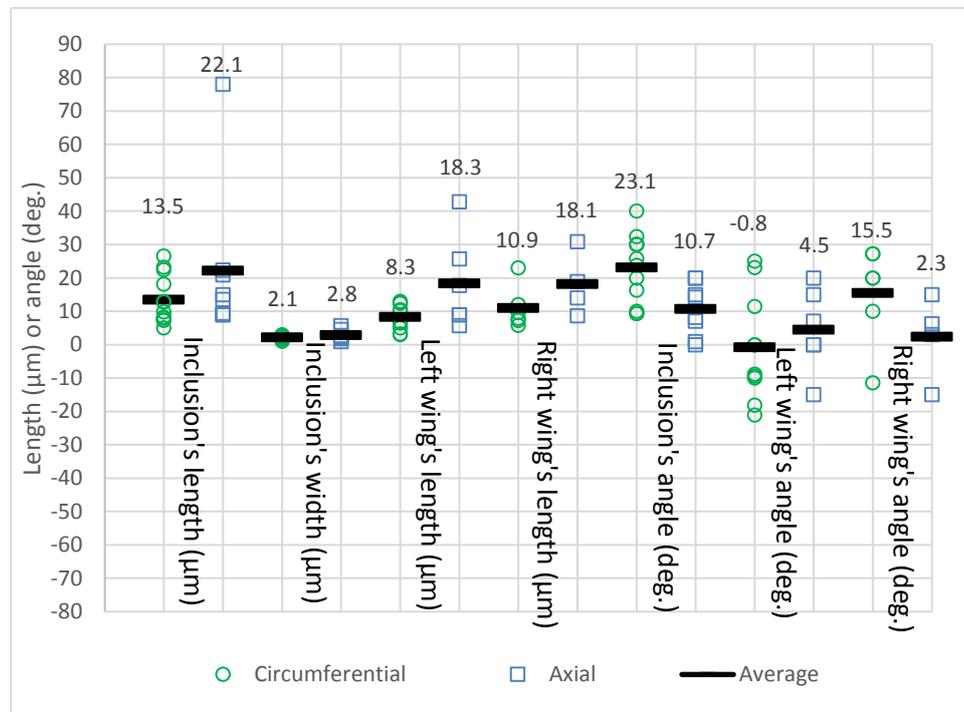
Figure 5.2.4: Characteristics of butterflies' wings with their initiating inclusions (the number above each characteristic refers to the average value)

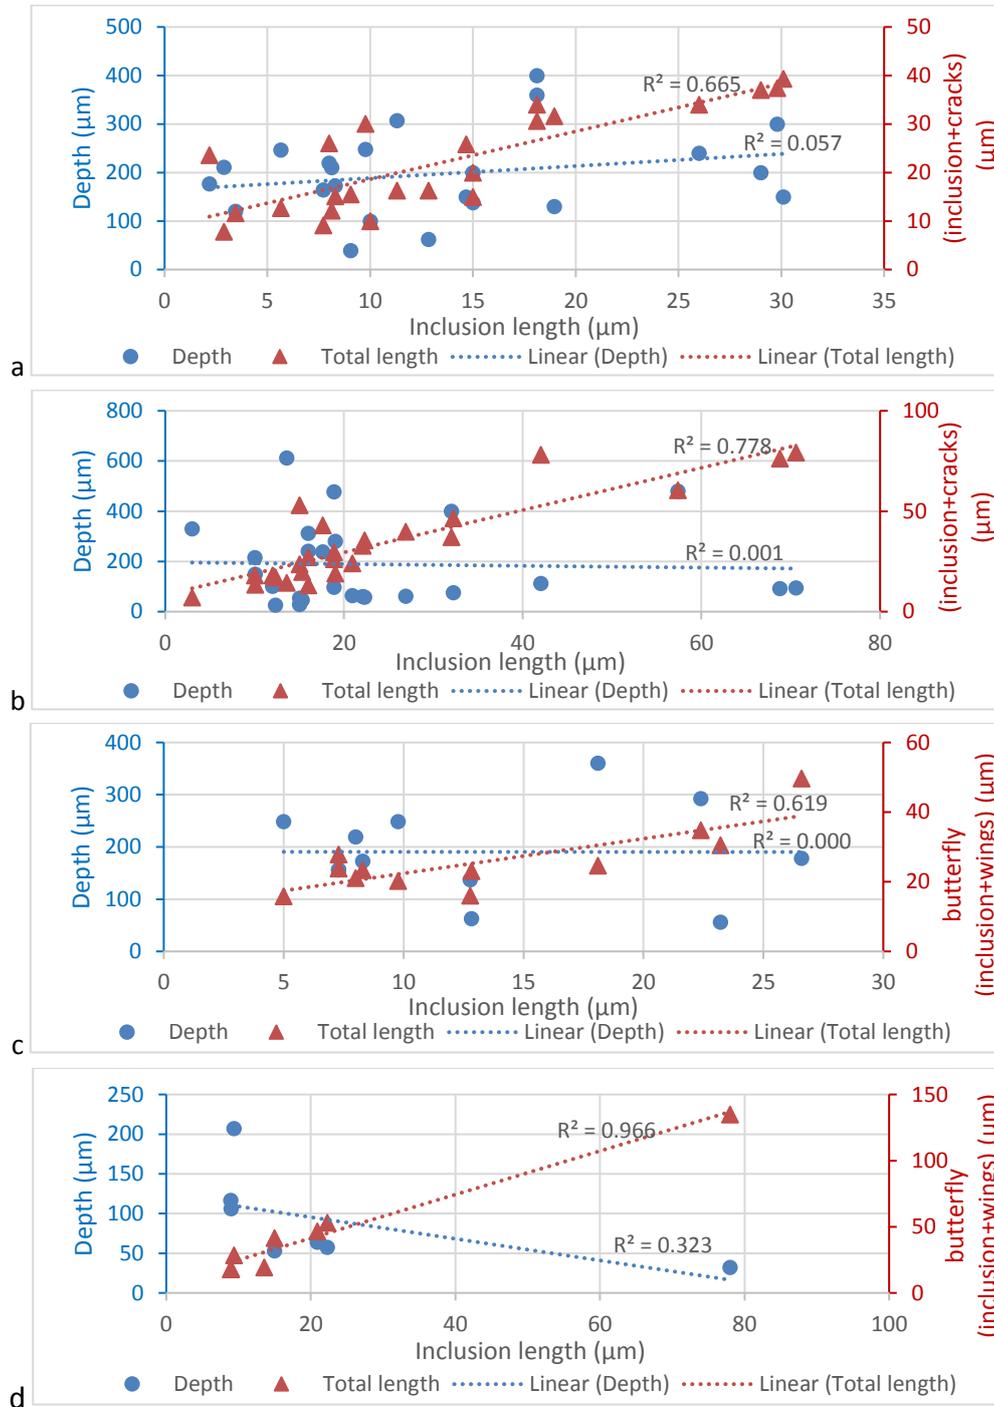
**Figure 5.2.5: Inclusion length vs total length with the depth of inclusions (a) cracks initiated from inclusion in circumferential sections (b) cracks initiated from inclusion in axial sections (c) butterflies in circumferential sections (d) butterflies in axial sections**
