*Department of Mechanical Engineering*

**Effect of Surface Traction and Non-Metallic Inclusions  
on the Premature Failure of Wind Turbine Gearbox  
Bearings**

Thesis submitted to the Department of Mechanical Engineering, University  
of Sheffield in partial fulfilment of the requirements for the degree of

**Doctor of Philosophy**

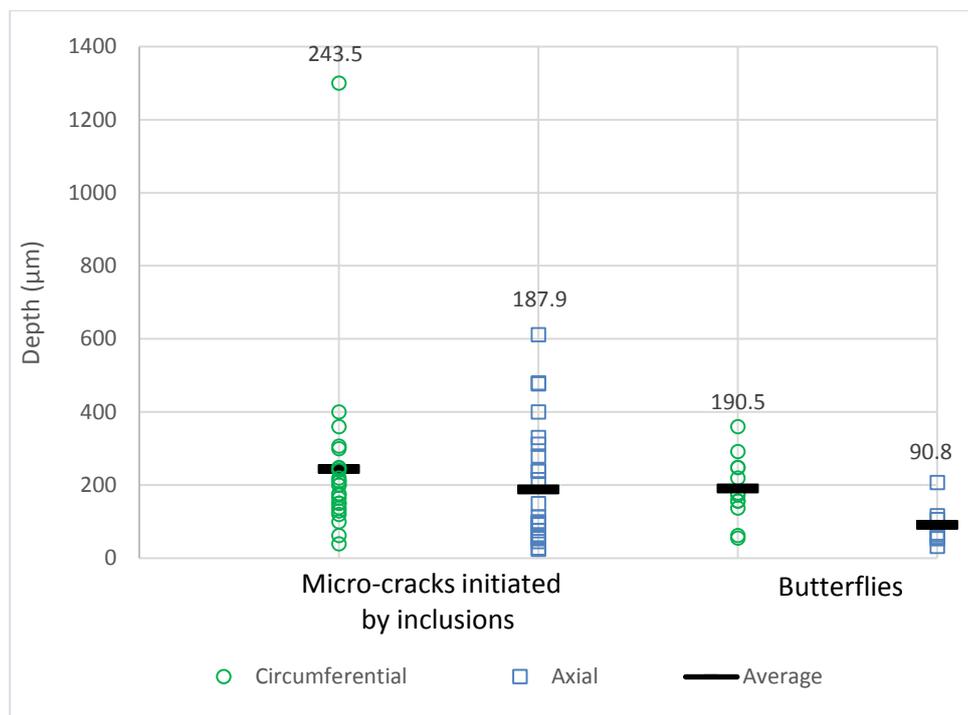
**Figure 5.3.1: Depth of inclusions initiating micro-cracks and butterflies in axial and circumferential sections (the number above each characteristic refers to the average value)**

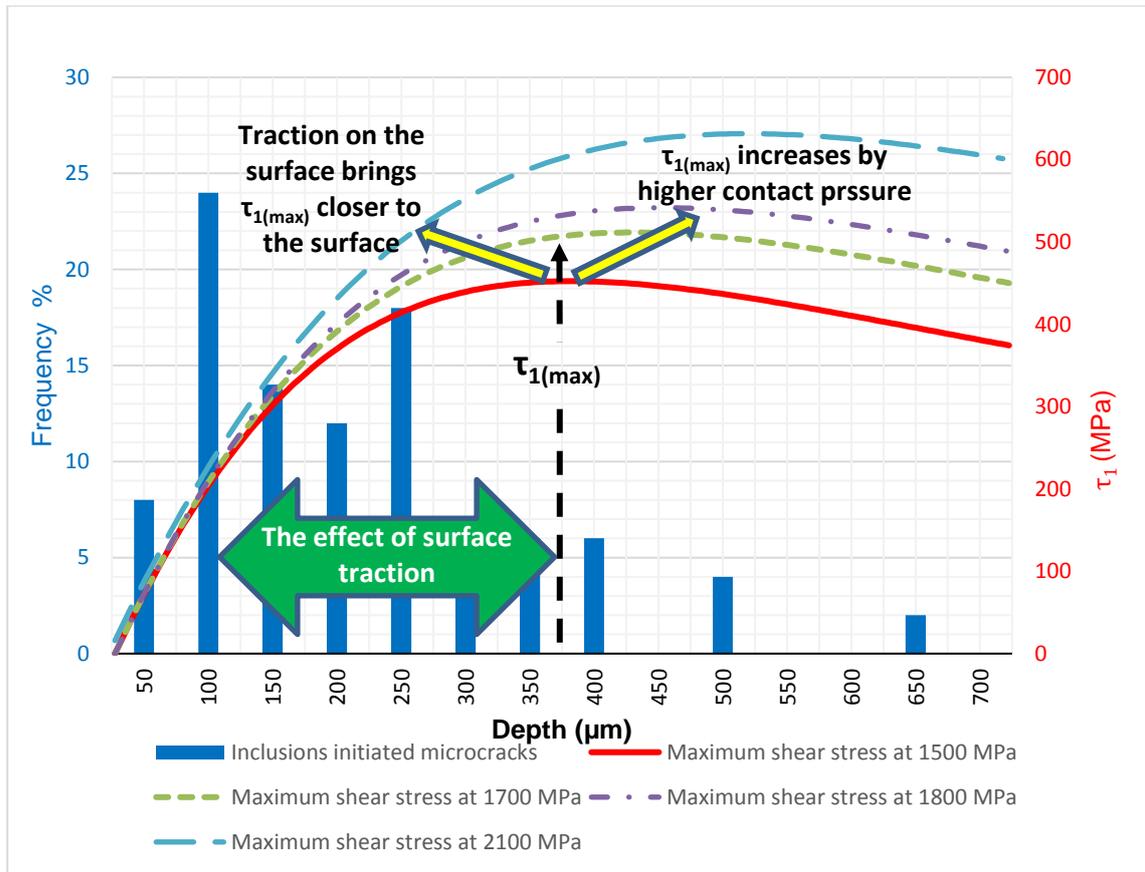
**Figure 5.3.2: Depth of micro-cracks in axial and circumferential sections compared with the depth of subsurface maximum shear stress  $\tau_{1(max)}$  at various levels of contact pressure**

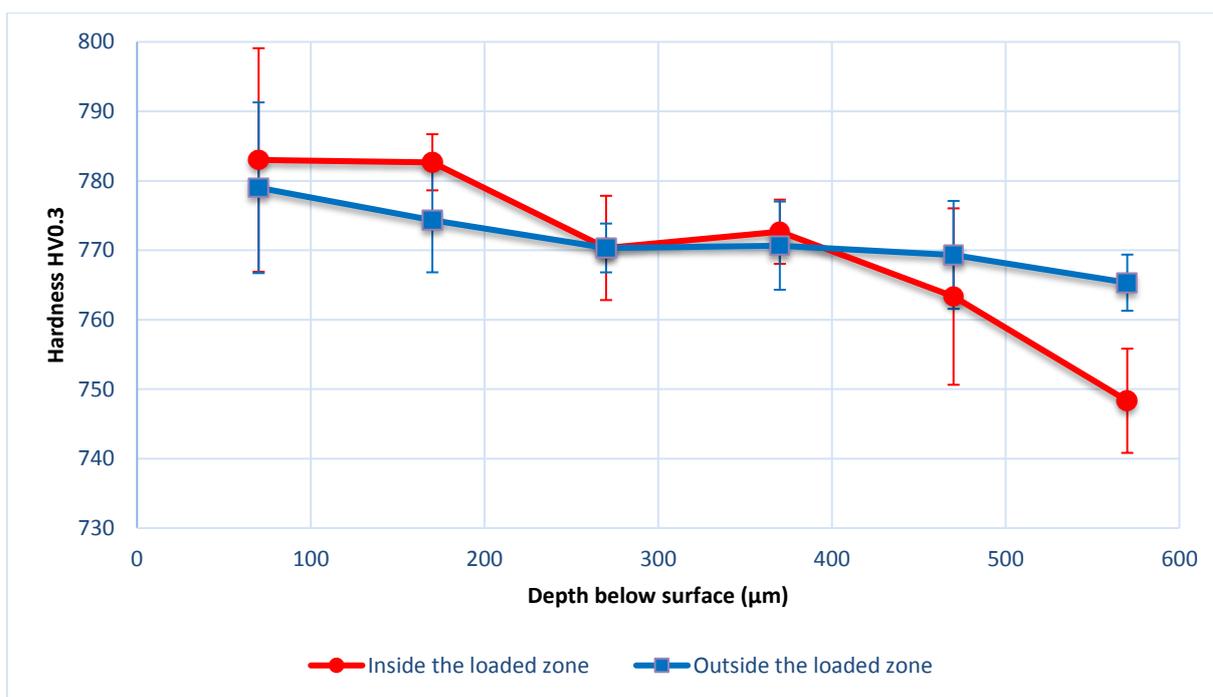
Figure 5.3.3: Hardness variation with depth below the surface for the uncoated bearing

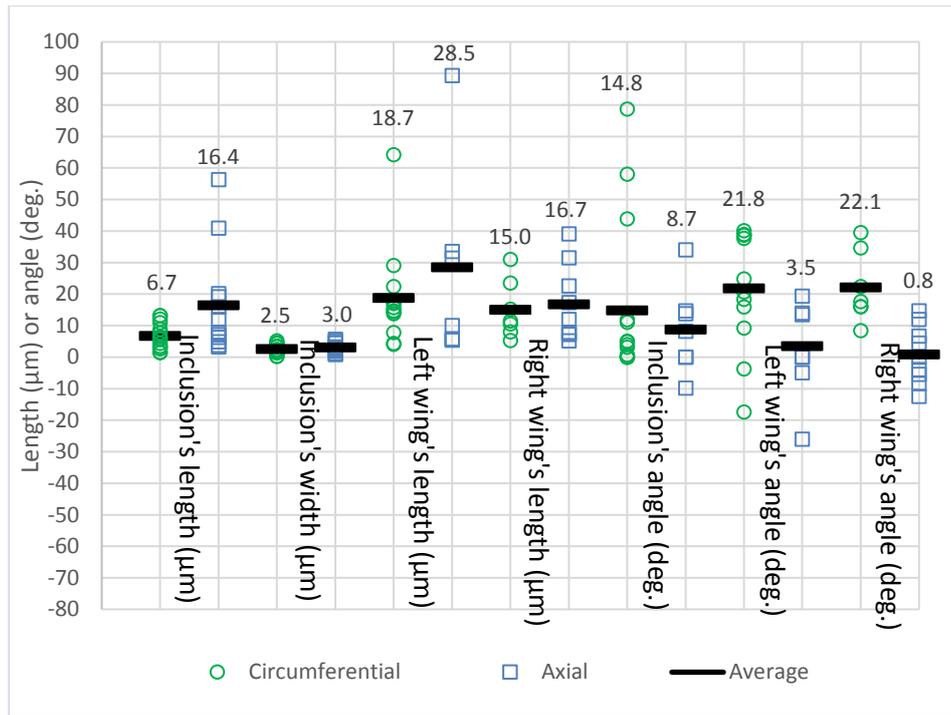
Figure 6.2.1: Characteristics for butterfly wings and their initiating inclusions (the number above each characteristic refers to the average value)

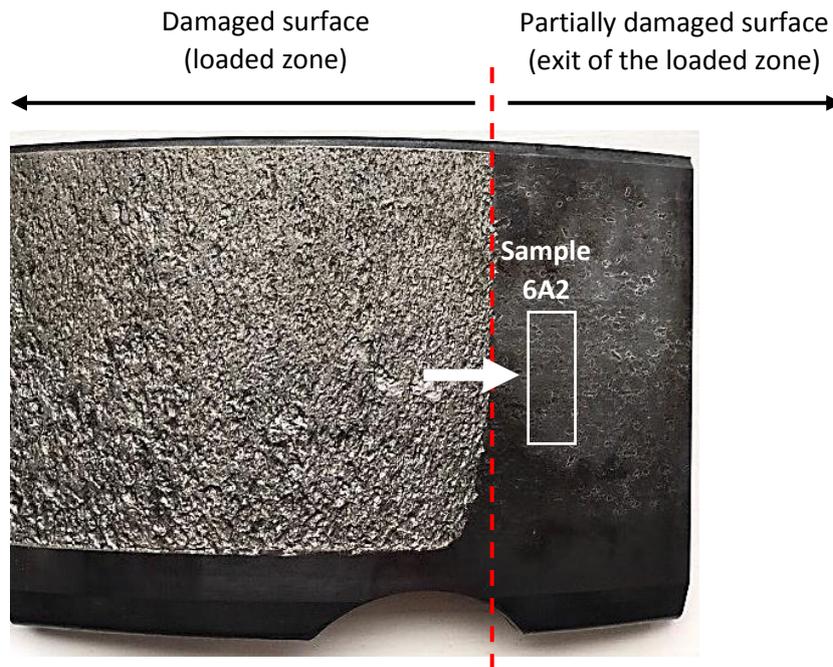
**Figure 6.2.3: Sample 6A2 at exit to loaded zone with white arrow represents the observation direction**

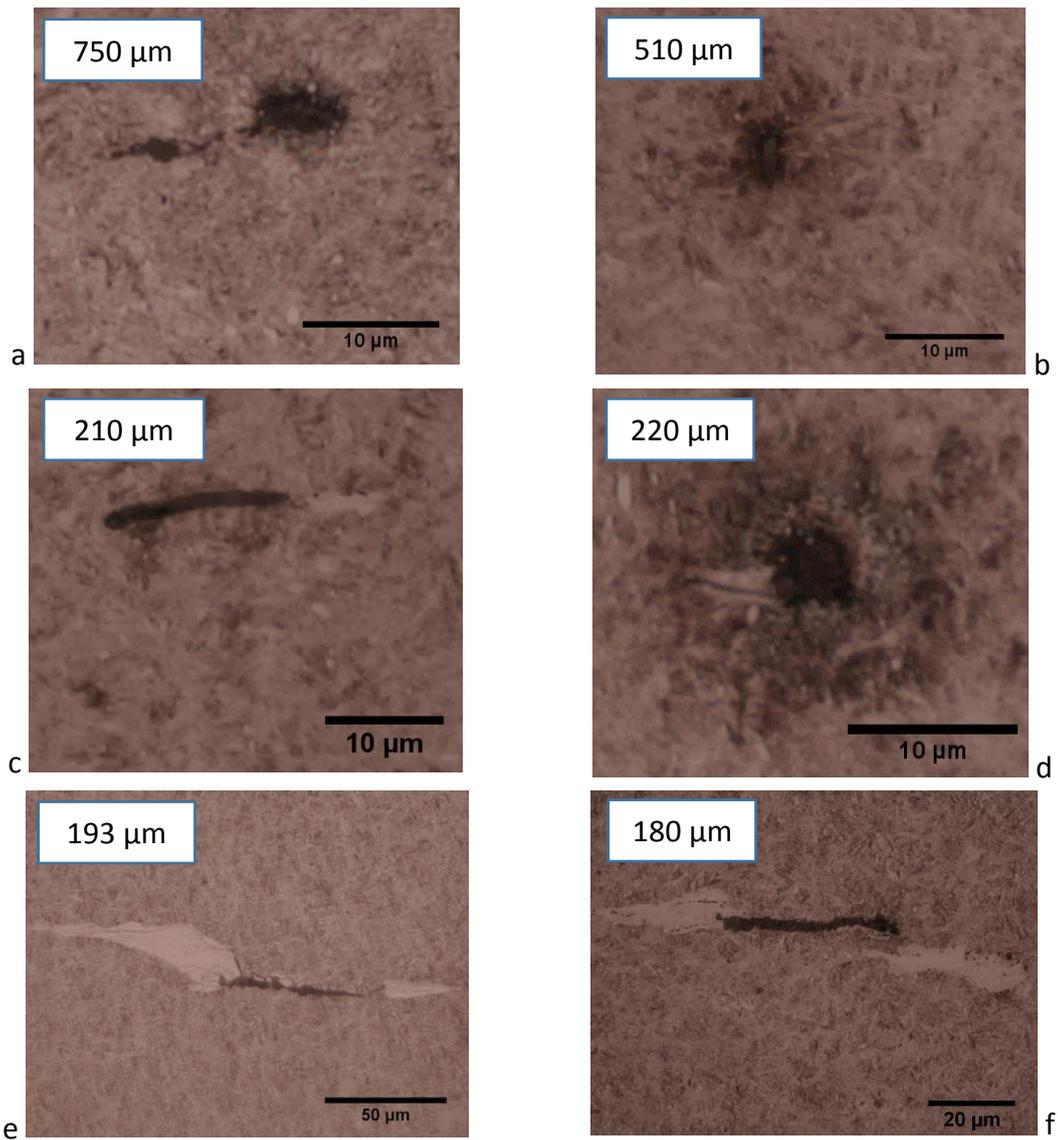
Figure 6.2.4: Observations from axial sample 6A2 (Depth is shown in the upper left corner)

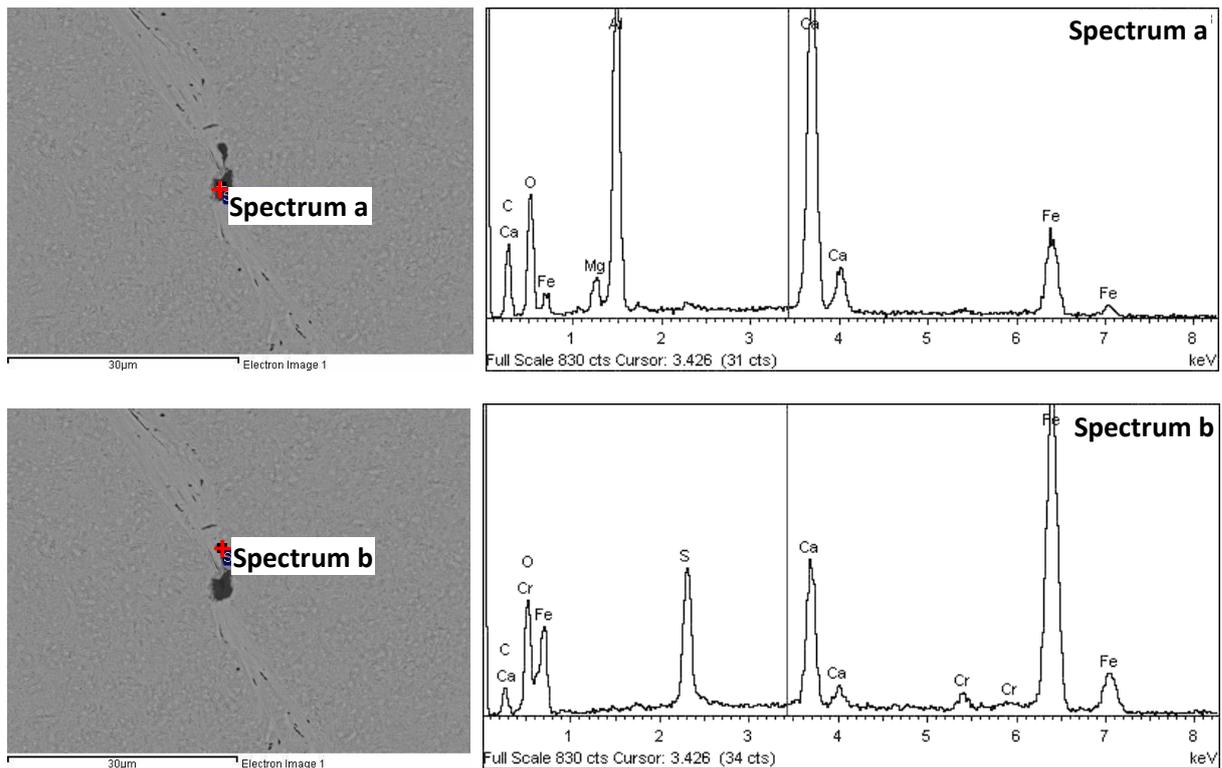
**Figure 6.2.5: EDX analysis of the inclusion which initiated the longest butterfly in circumferential direction**

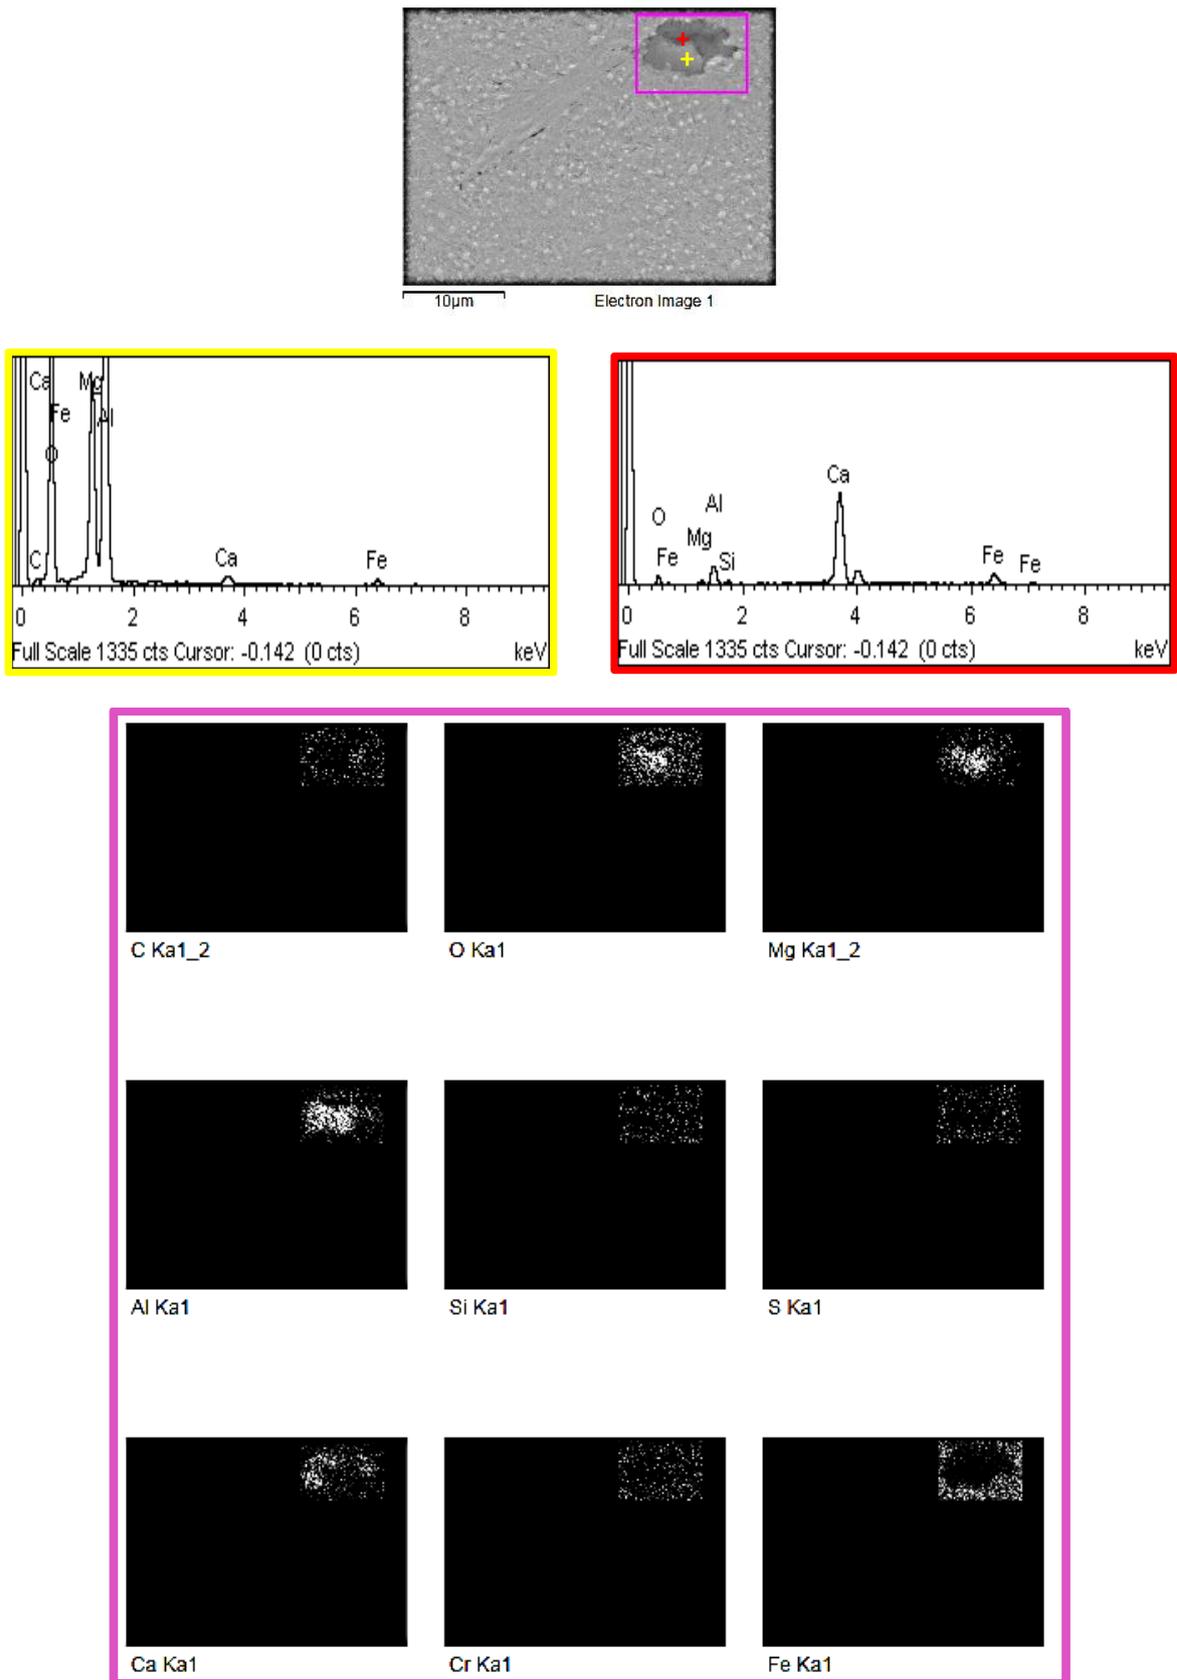
Figure 6.2.6: Mg-Al-O inclusion

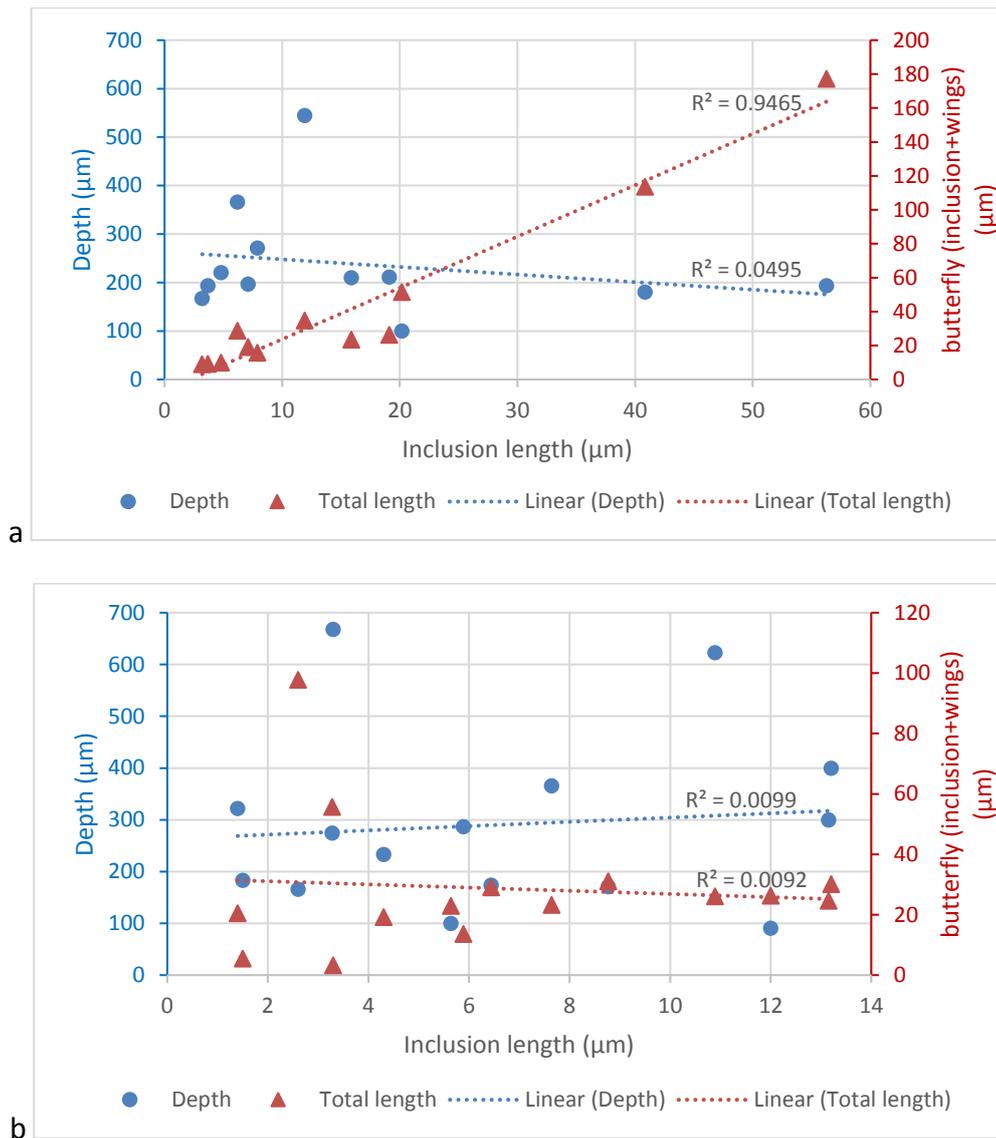
**Figure 6.2.7: Inclusion length vs total length with the depth of inclusions (a) butterflies in axial sections; and (b) butterflies in circumferential sections**

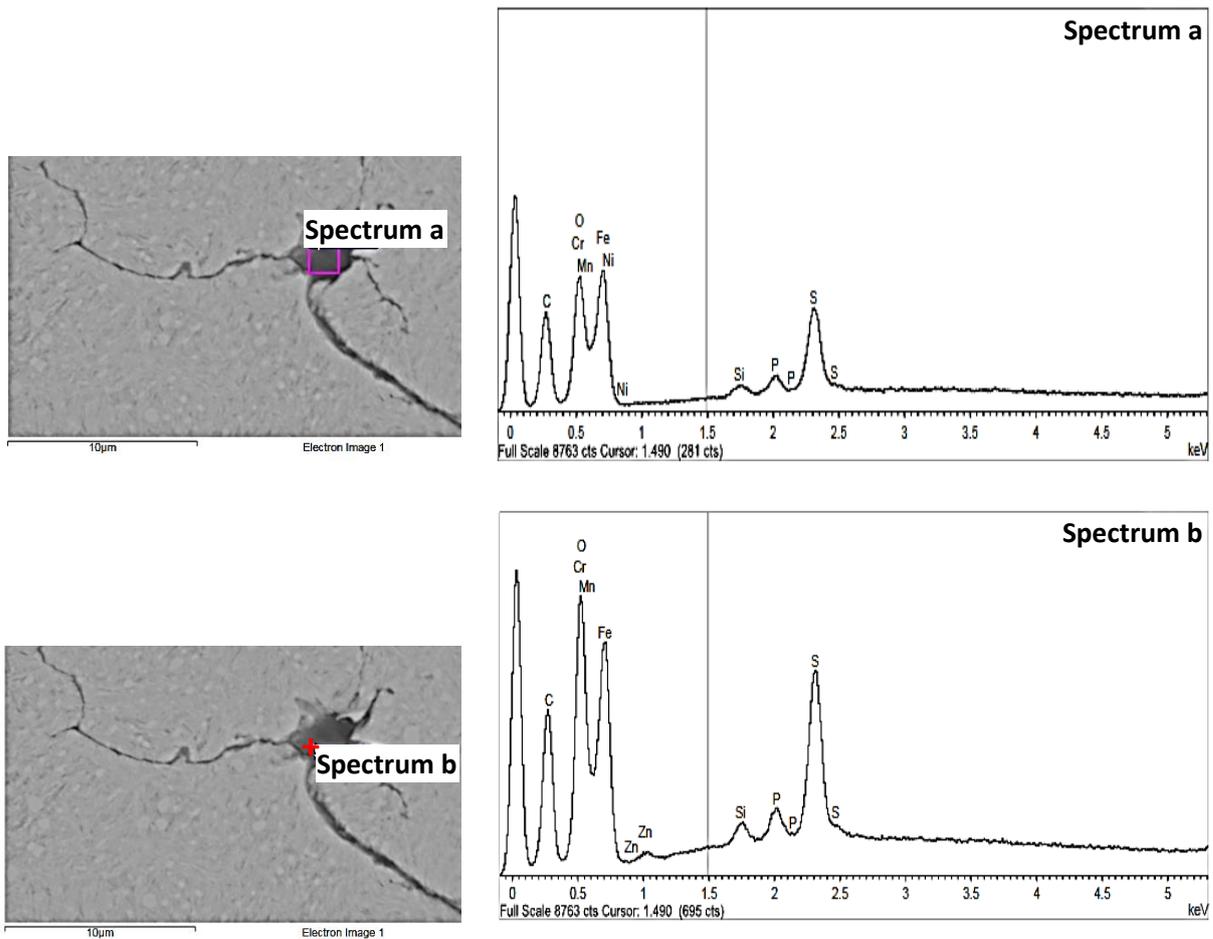
**Figure 6.3.3: EDX analysis of highlighted inclusion in Figure 6.3.2**

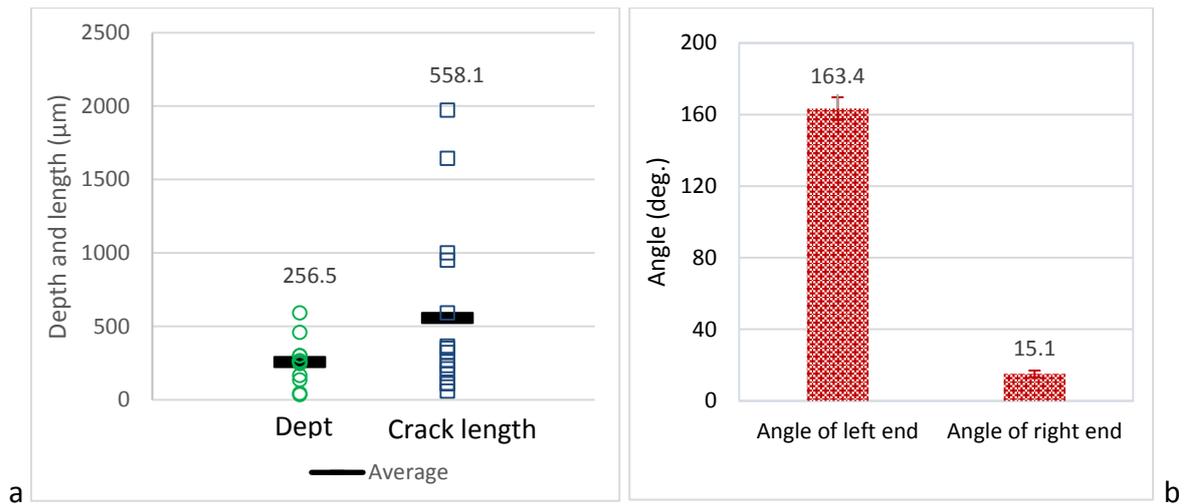
**Figure 6.3.4: Characteristics of subsurface cracks in axial sections (a) depth and length (the number above each characteristic refers to the average value) (b) angle (average values with the error bars show  $\pm$  one standard deviation)**

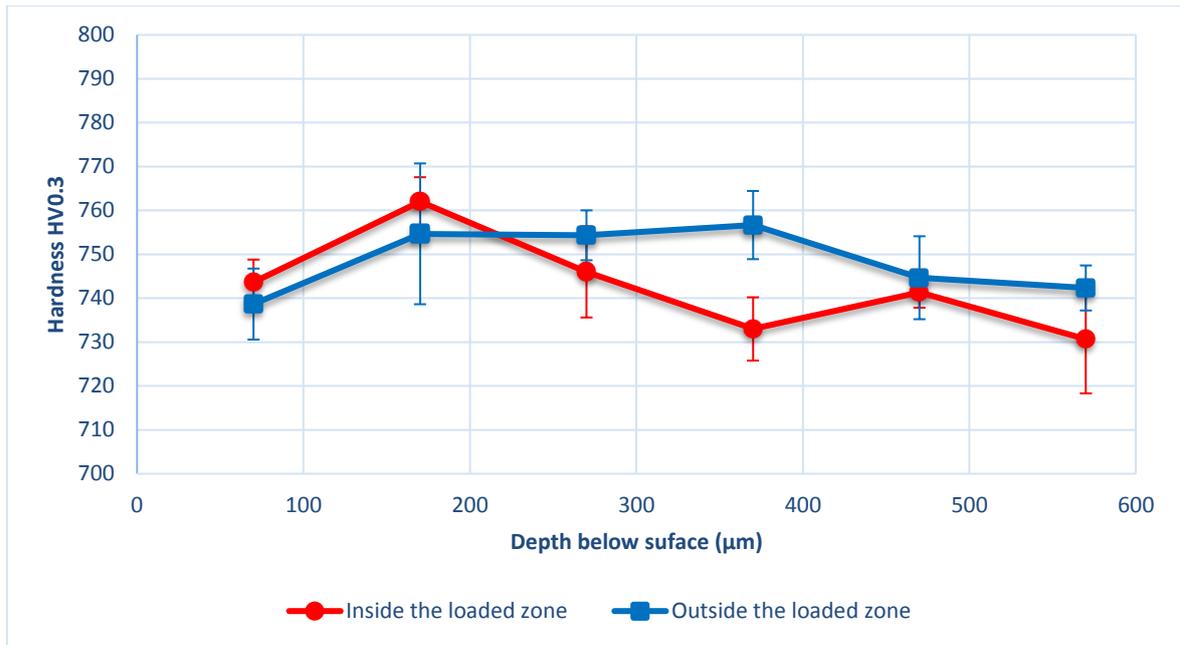
Figure 6.3.6: Hardness variation with depth below the surface for BO coated bearing

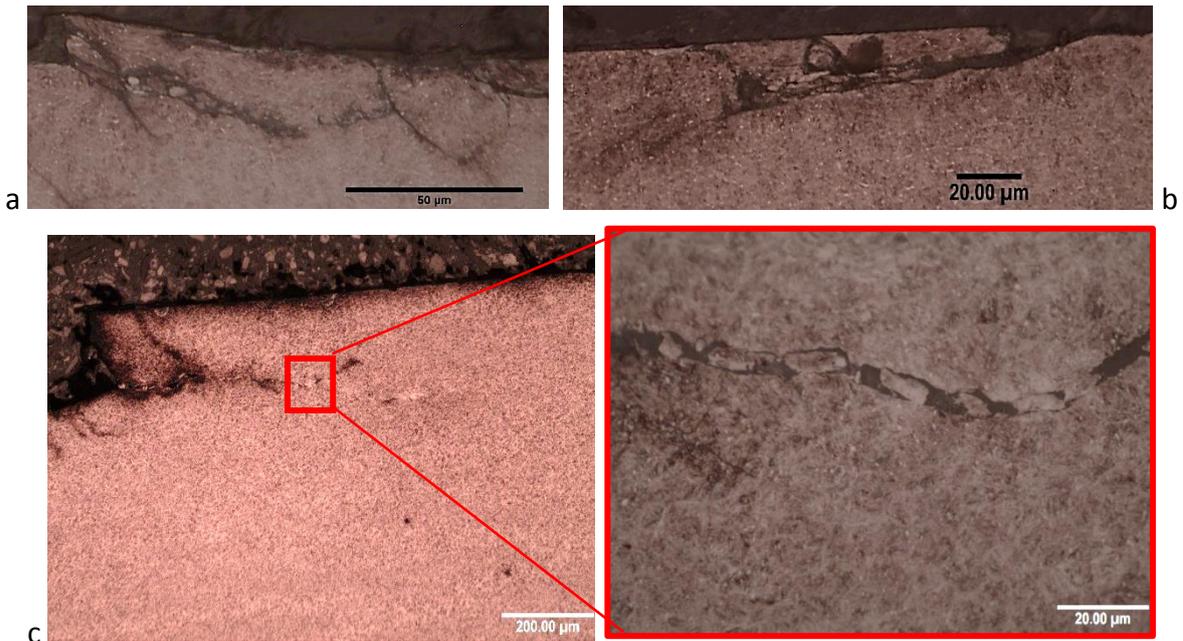
**Figure 6.4.1: Surface-linked RCF cracks (a) and (c) in circumferential sections and (b) in axial section**

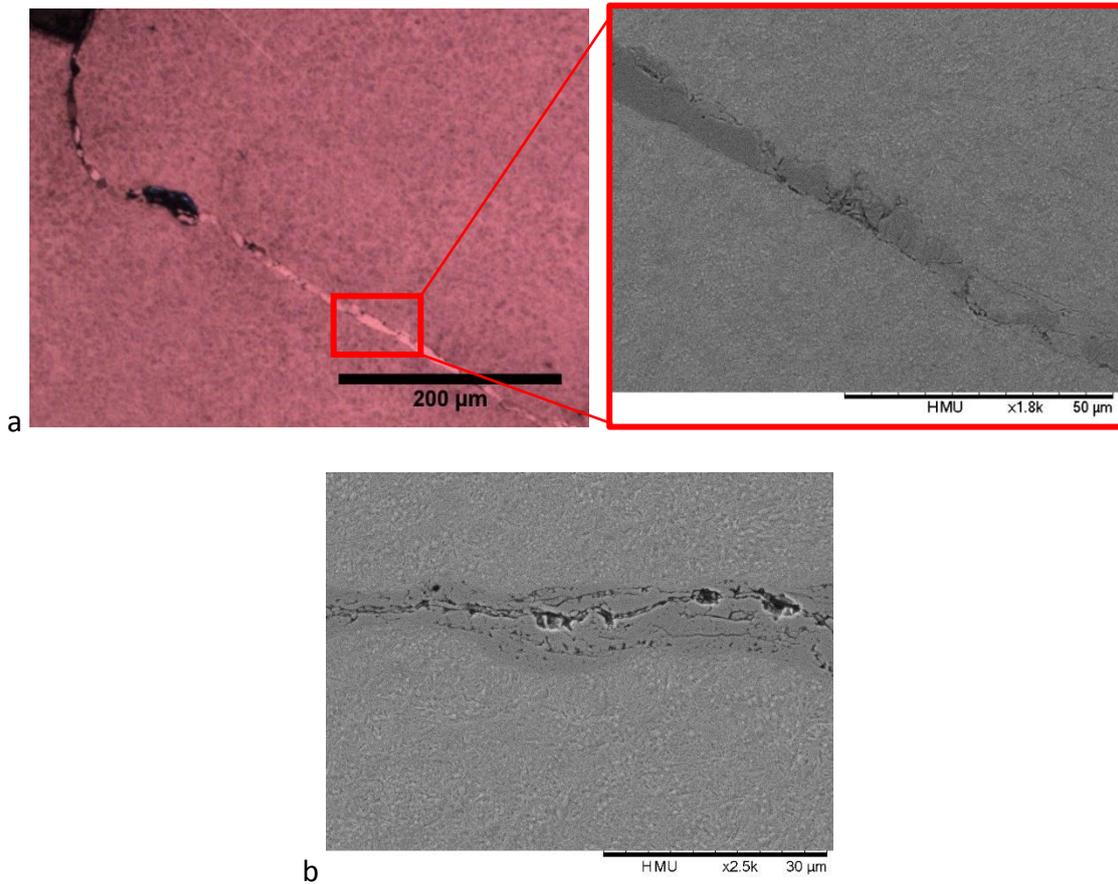
Figure 6.4.2: Surface-linked RCF cracks appears similar to WECs (a) from circumferential section and (b) WEC from axial section

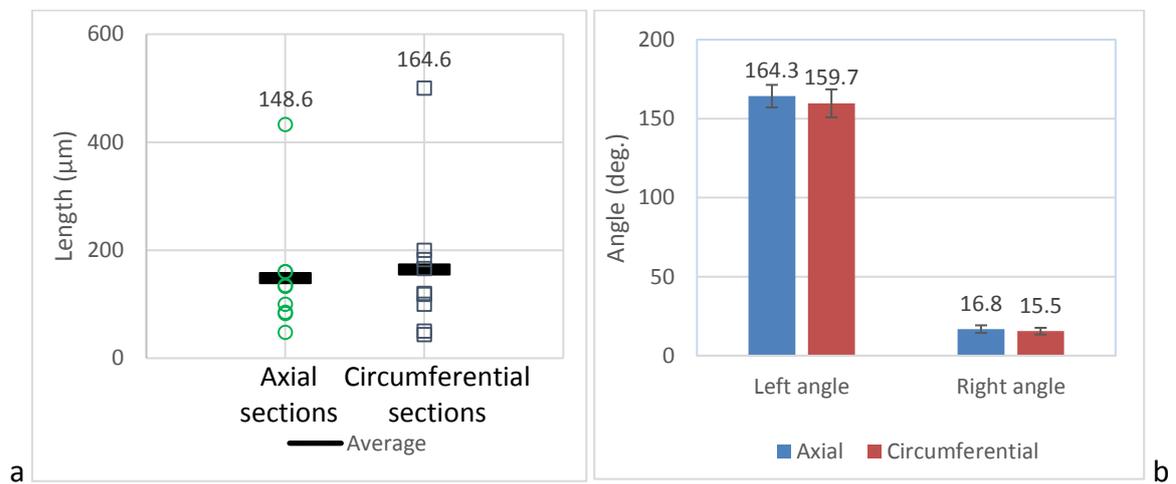
Figure 6.4.3: Characteristics of surface-linked RCF cracks (a) length (the number above each characteristic refers to the average value) (b) angle (average values with the error bars show  $\pm$  one standard deviation)

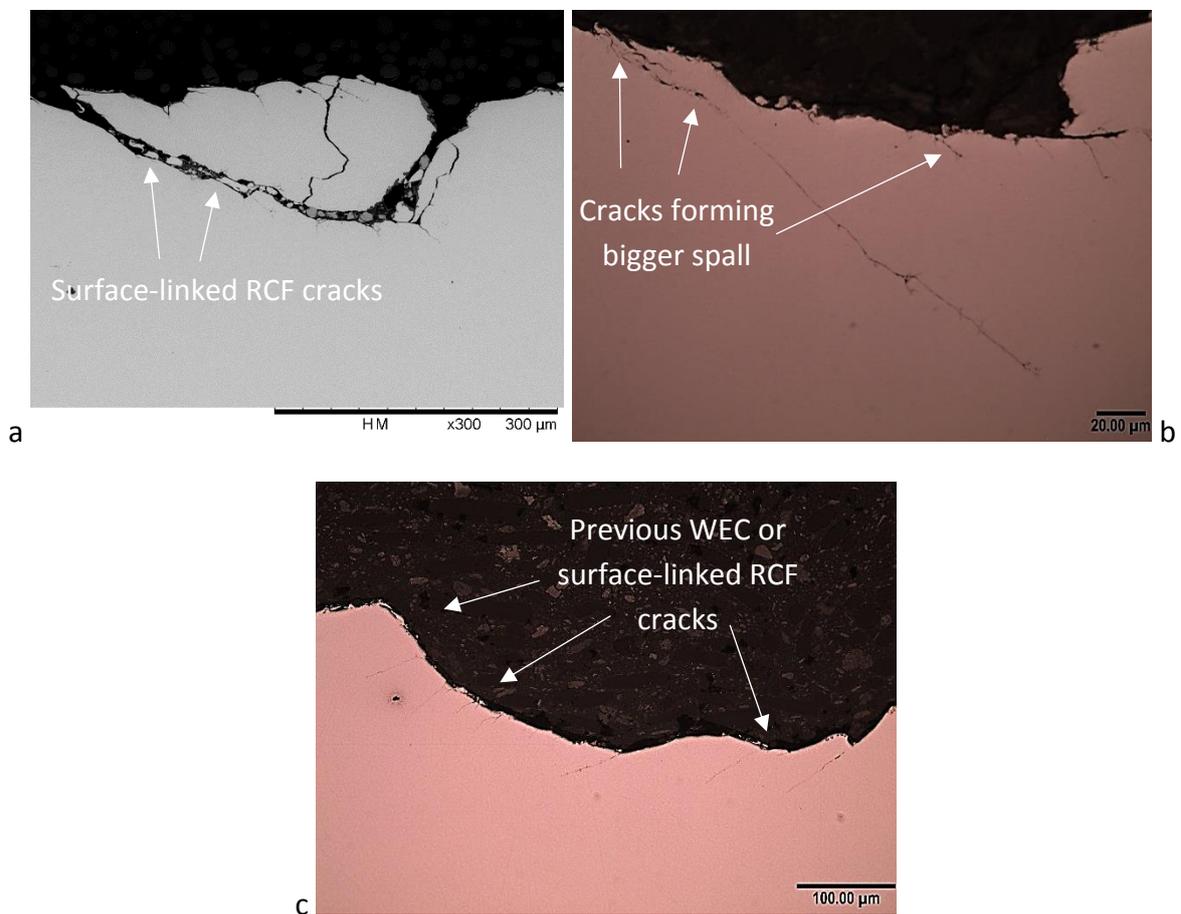
Figure 6.4.5: Spall created by surface-linked RCF cracks in circumferential sections (ORD from left to right)

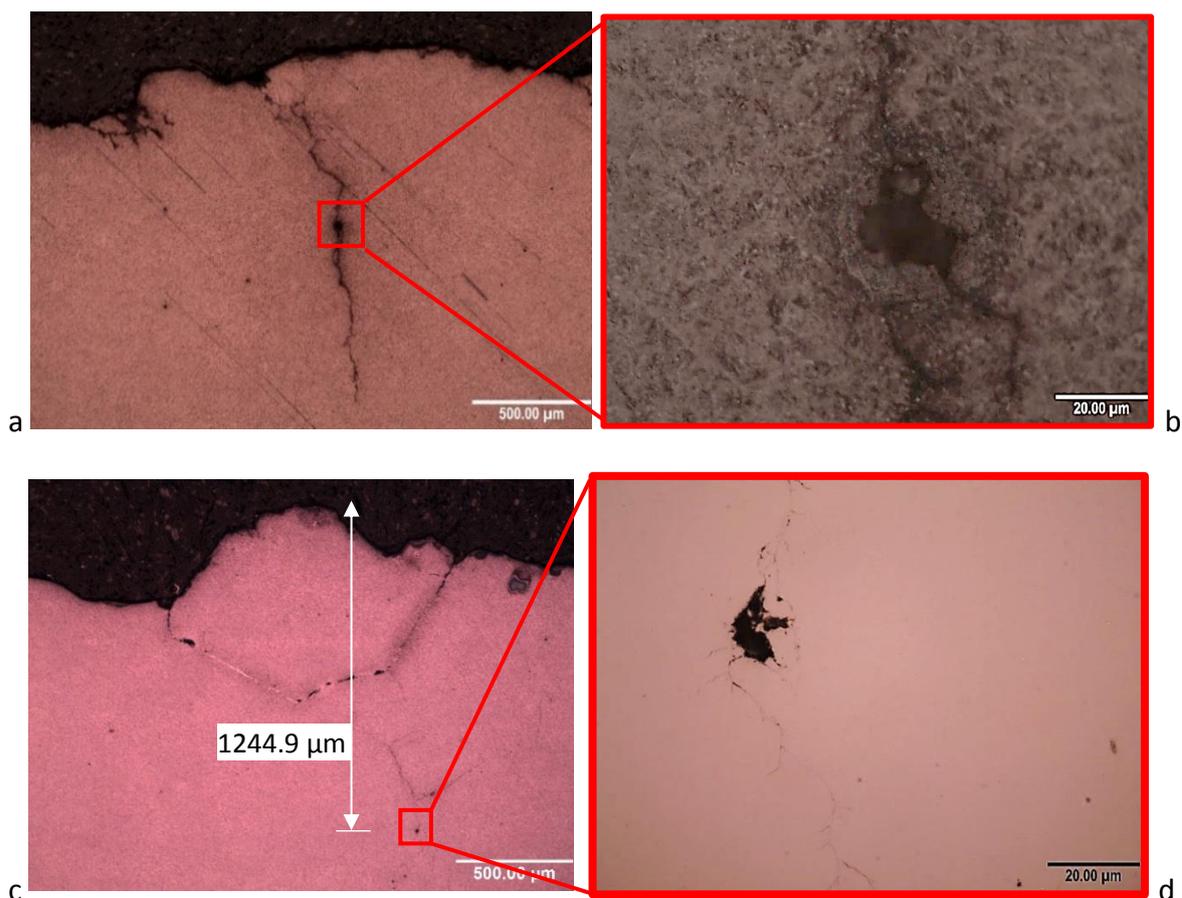
**Figure 6.4.6: Vertical surface cracks passing through an inclusion**

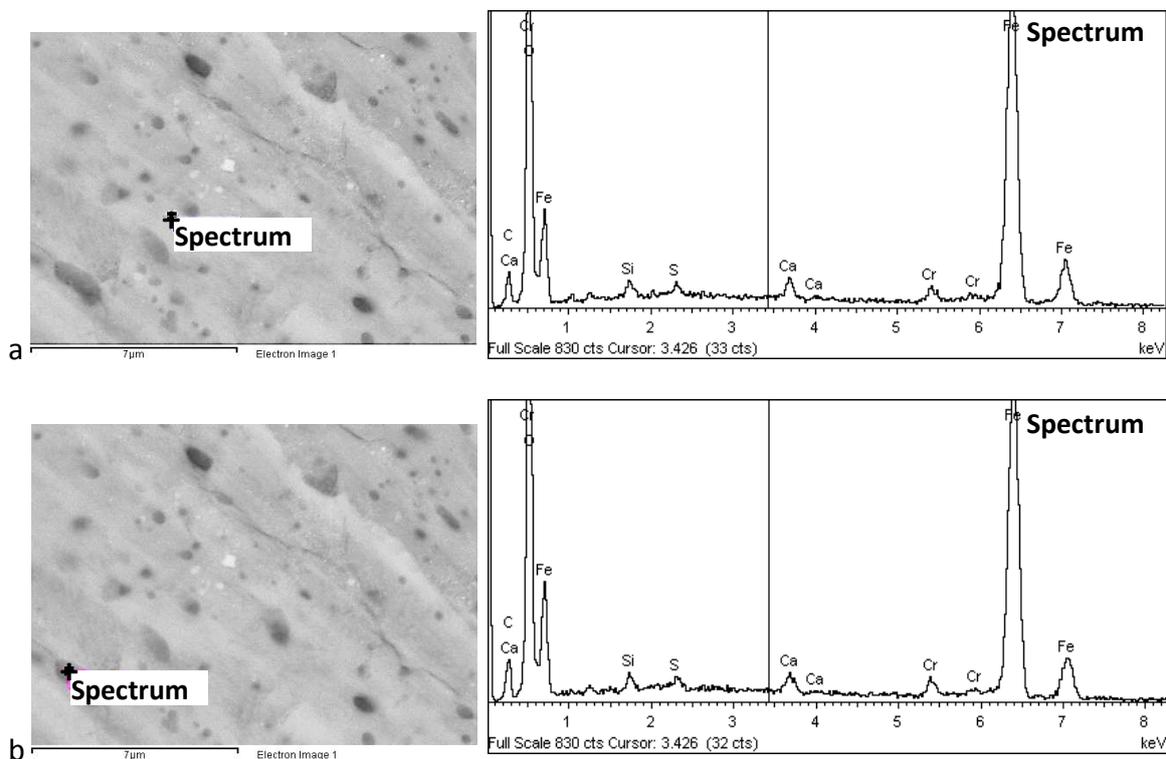
Figure 6.5.1: EDX analysis of the BO layer

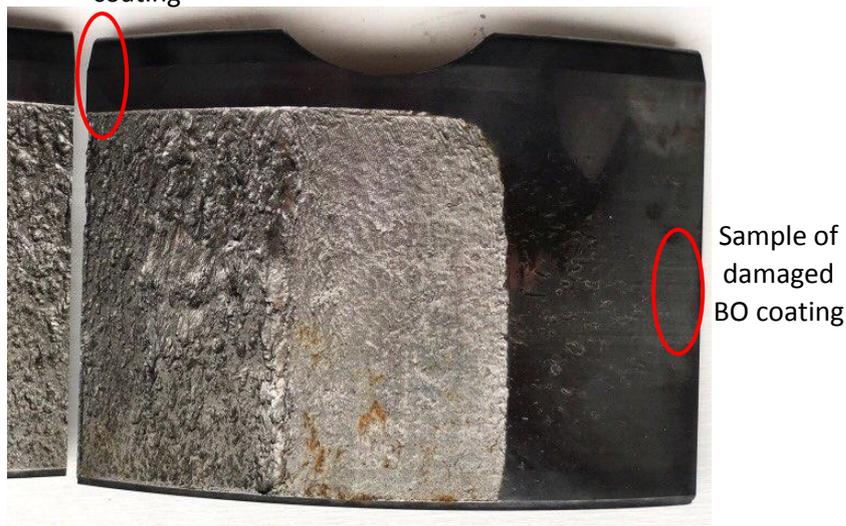
Sample of undamaged BO coating

Figure 6.5.2: BO regions used for EDX and Nano-indentation analyses

The chemical composition of this layer was found by EDX analysis, as shown in Figure 6.5.1 (a). The analysis was conducted on the undamaged region of the BO layer, at the side of the raceway, as shown in Figure 6.5.2. Because the x-ray can penetrate the very thin BO layer, the analysis shows main peaks of iron oxide and others observed in the bearing steel. In Figure 6.5.1 (b), dark dots appear in the SEM image of this layer, which have a similar spectrum of chemical elements as the rest of the BO layer. Accordingly, these dark dots can indicate the porosity of the oxide.

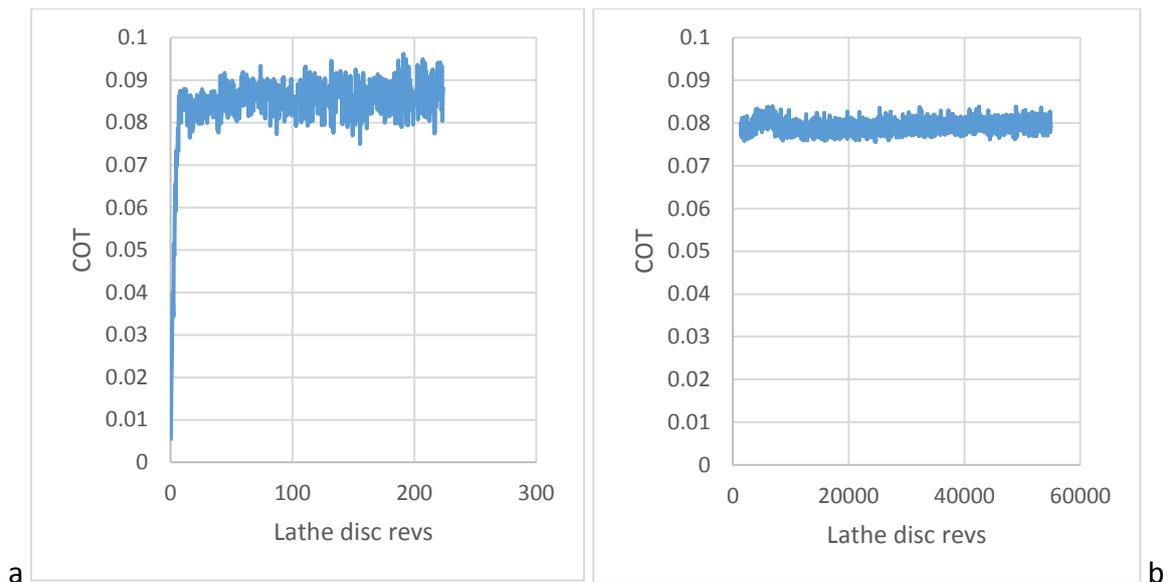
Figure 7.2.1: COT variation with number of cycles according to Table 7.1.1 (a) COT1 (b) COT2

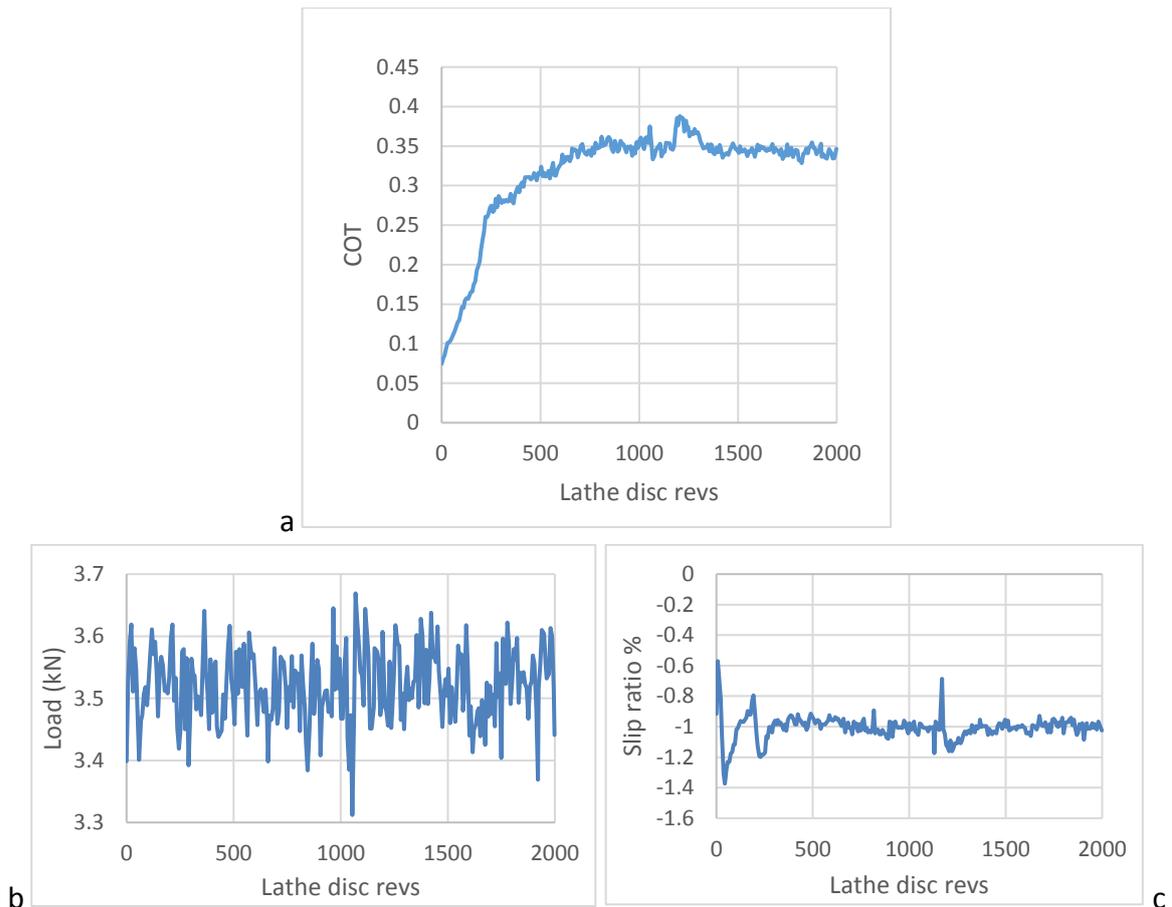
**Figure 7.2.2: (a) COT variation with number of cycles for dry contact (COT3) according to Table 7.1.1 (b) applied load (c) slip ratio**

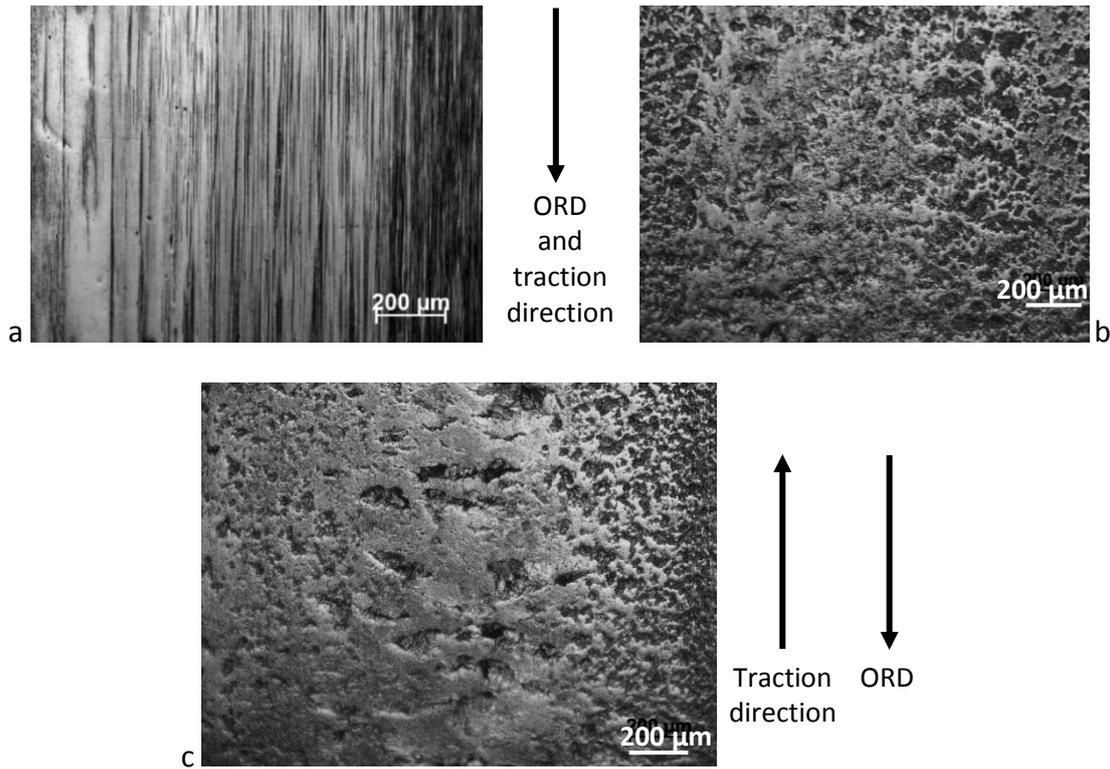
**Figure 7.2.3:** The surface after the COT measurement tests in Figures 7.2.1 and 7.2.2 (a) F1S after lubricated tests; (b) F1S after high speed dry test; and (c) C1 after high speed dry test.

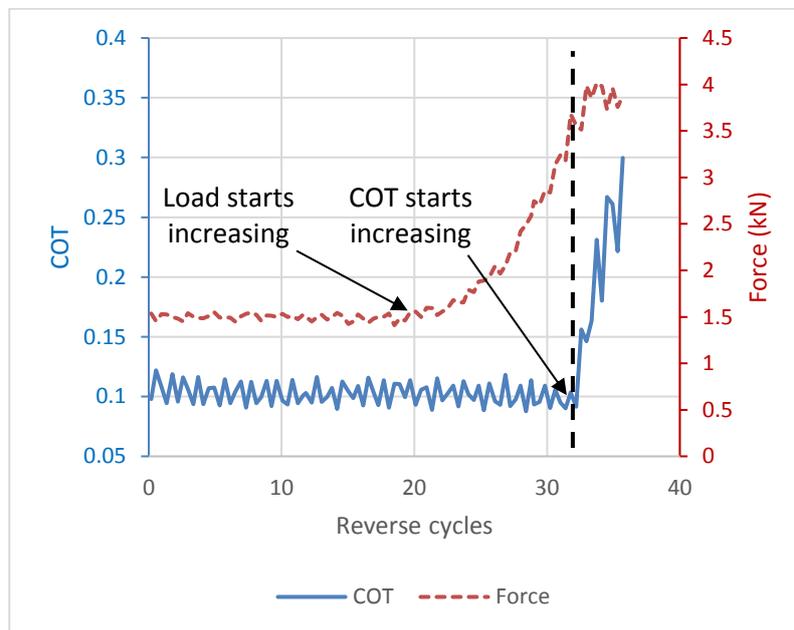
**Figure 7.2.4:** COT during reversed rotation according to testing conditions in Table 7.1.2.

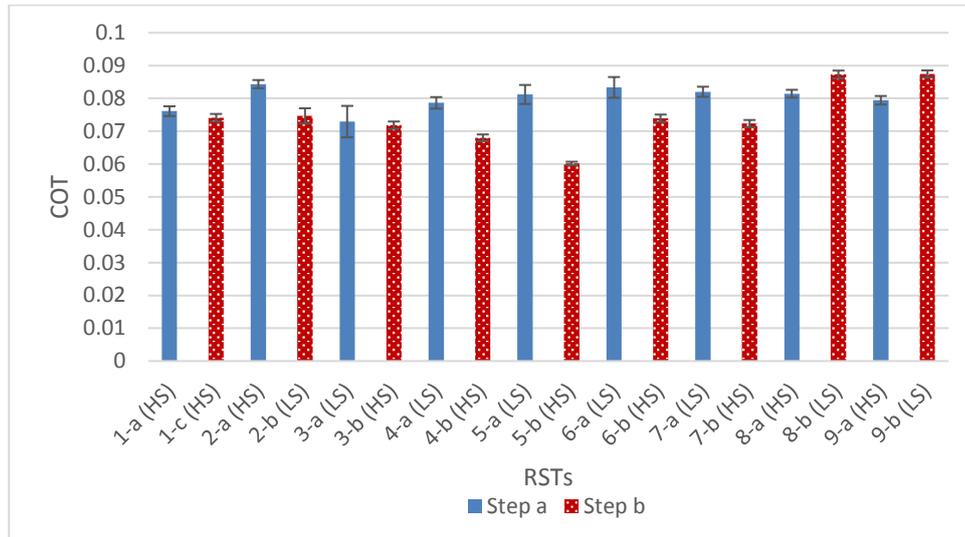
Figure 7.2.5: COT of RSTs 1 to 9 at High Speed (HS) and Low Speed (LS) steps
