*Department of Mechanical Engineering*

**Effect of Surface Traction and Non-Metallic Inclusions  
on the Premature Failure of Wind Turbine Gearbox  
Bearings**

Thesis submitted to the Department of Mechanical Engineering, University  
of Sheffield in partial fulfilment of the requirements for the degree of

**Doctor of Philosophy**

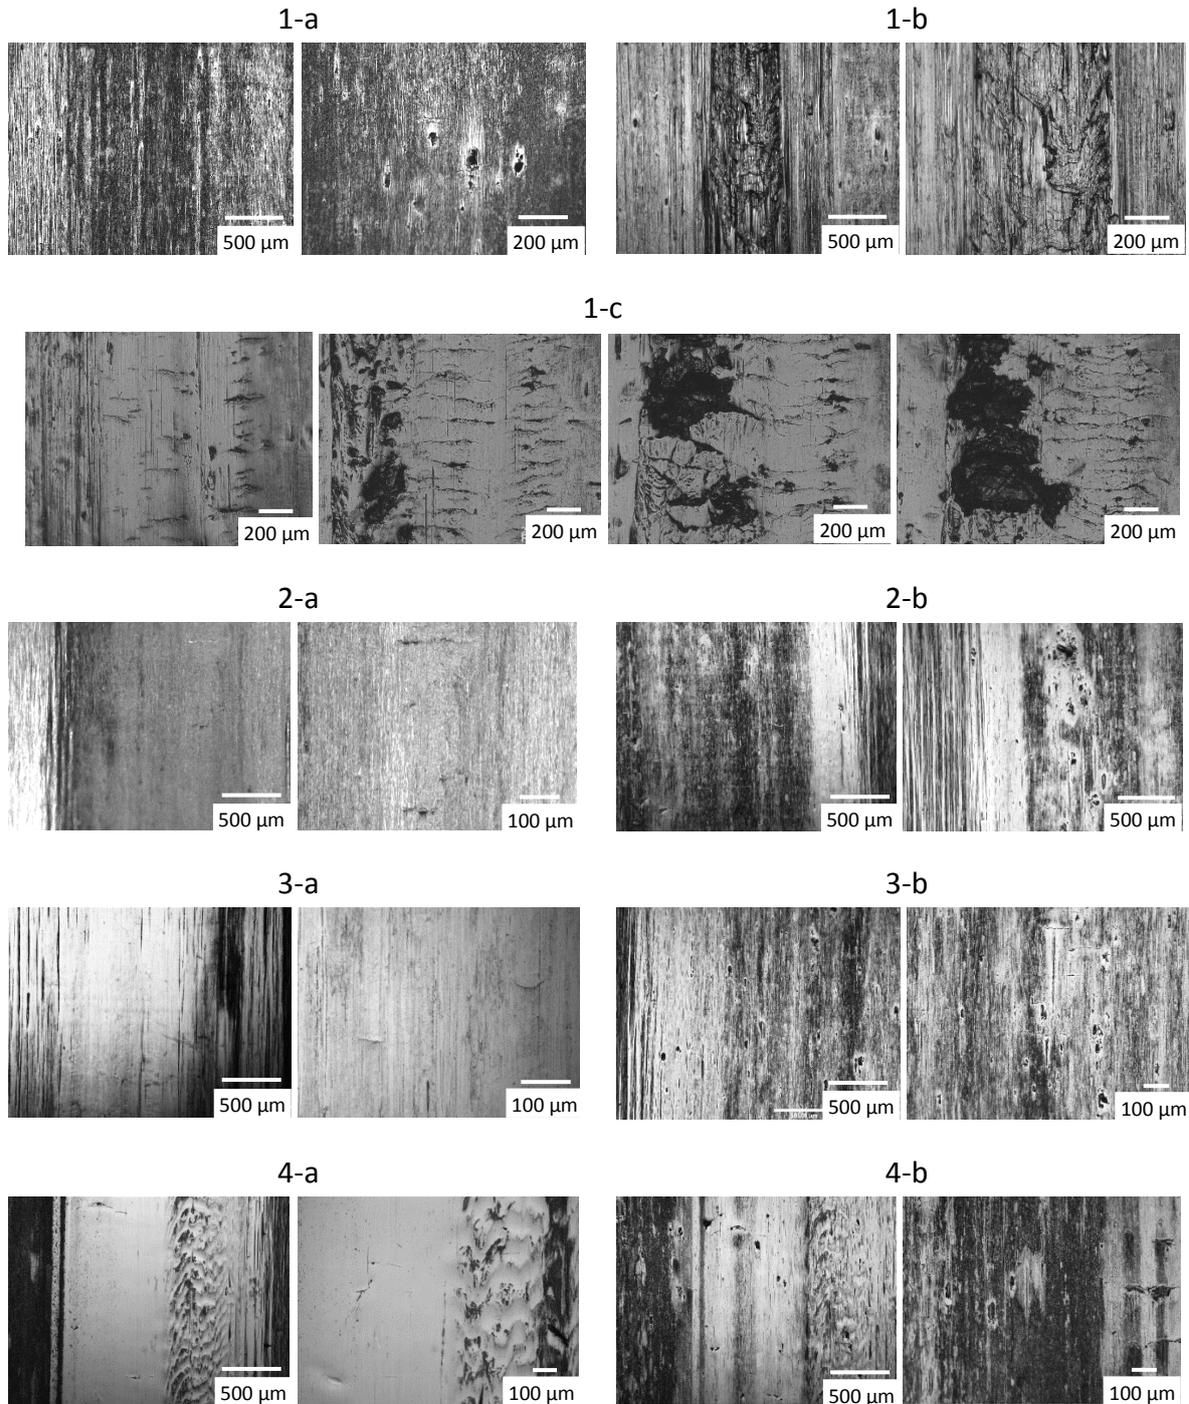
**Figure 7.3.1: Non-crowned specimen surfaces at the middle of the contact width after each step of RSTs 1 to 9 (continue to the next page)**

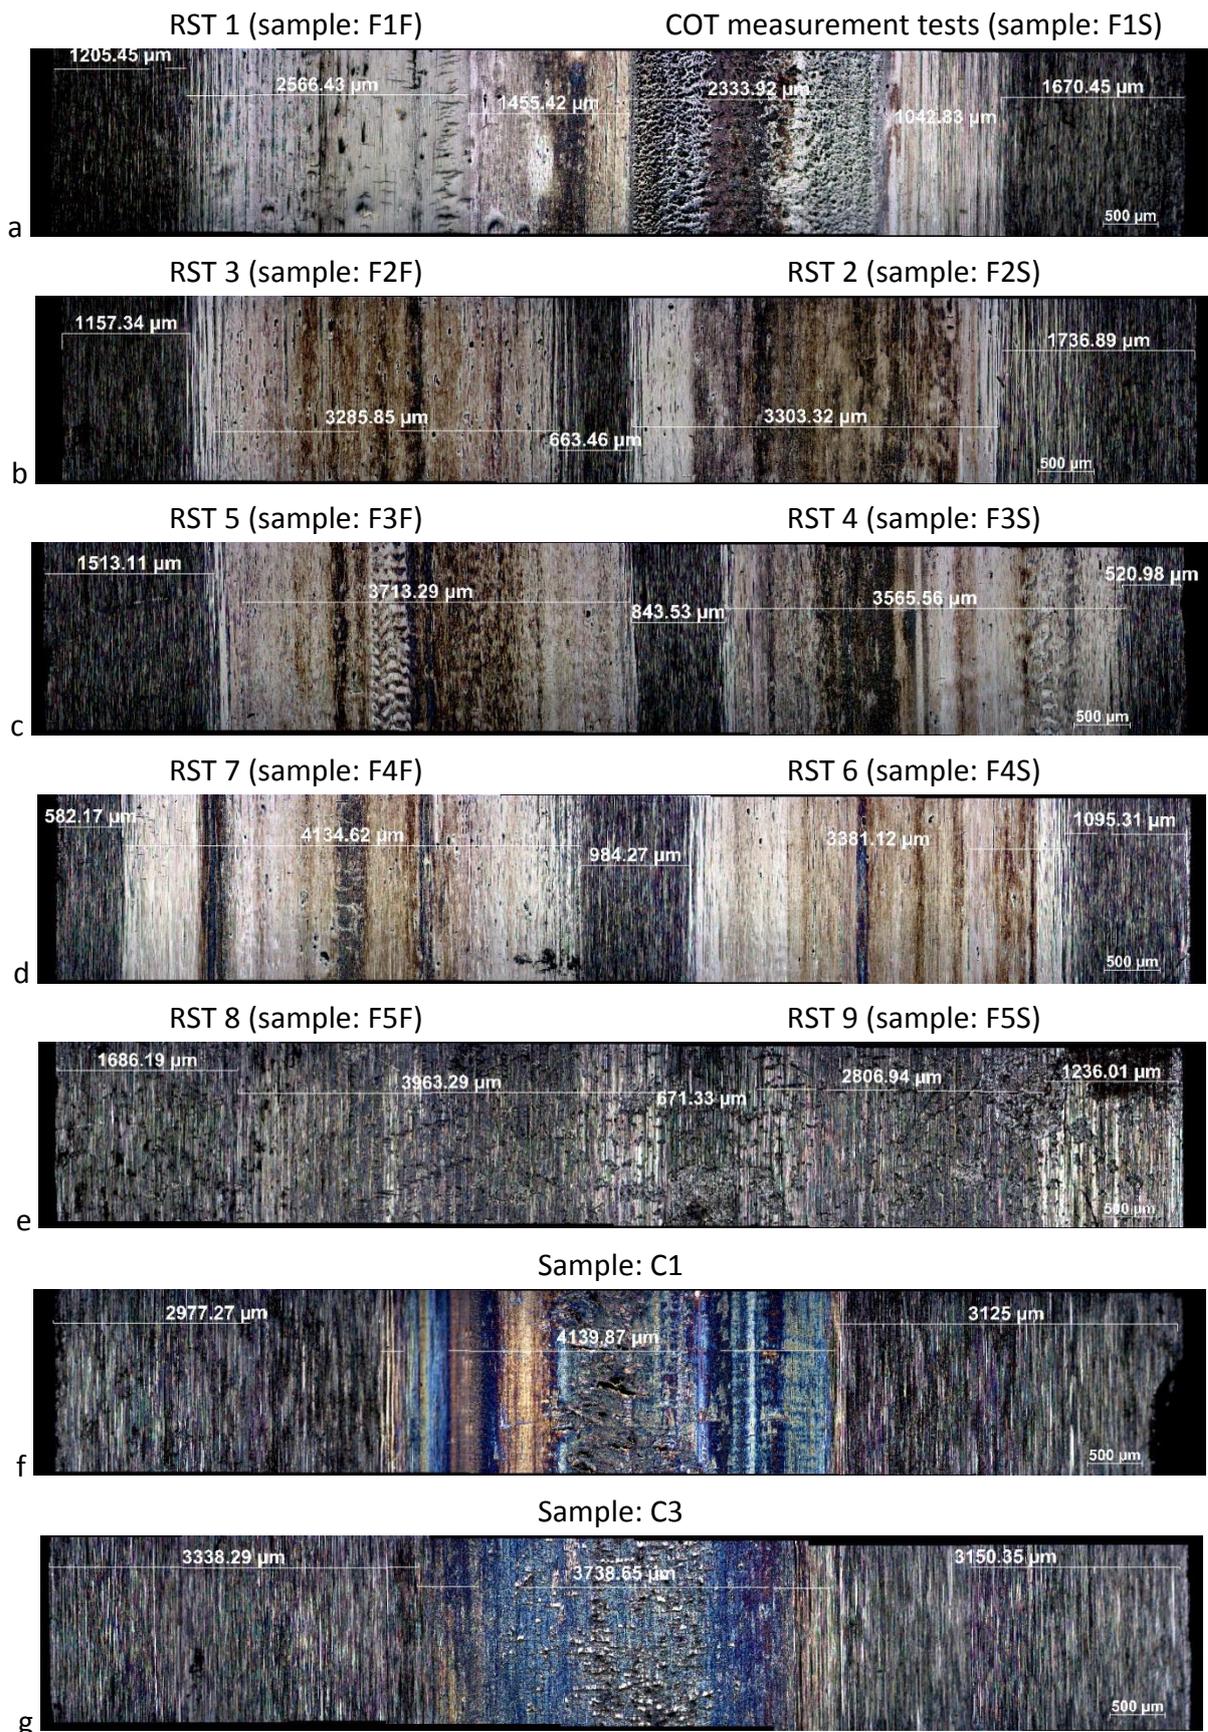
Figure 7.3.2: Specimen surfaces after RSTs and COT measurement tests

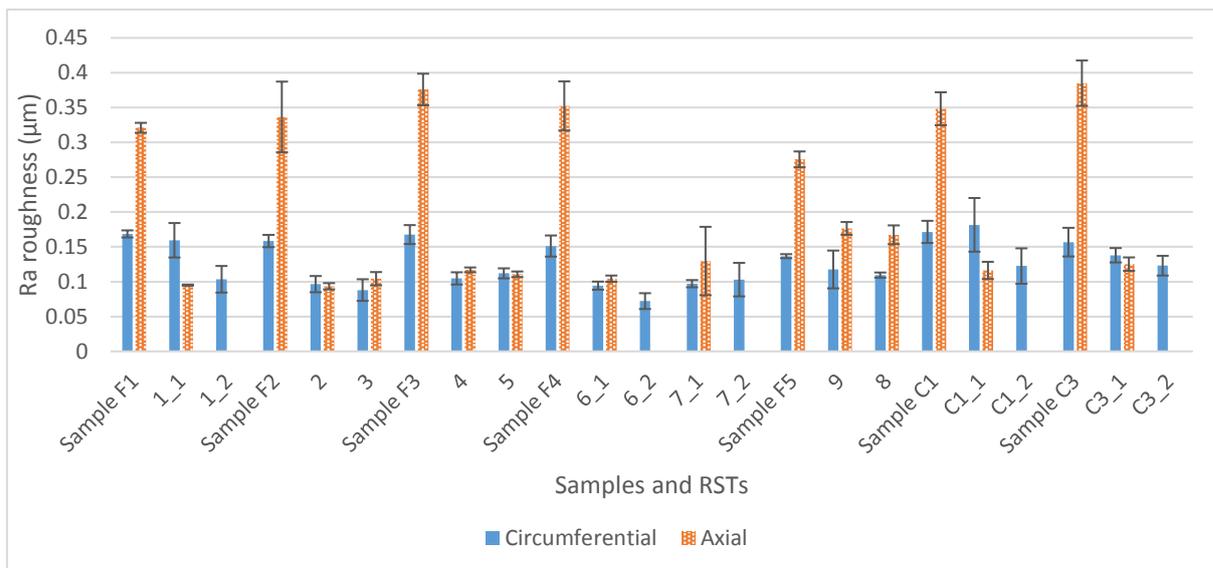
**Figure 7.3.5: Surface roughness of specimens before and after RSTs 1 to 9. The under-scroll sign 1 and 2 refer to the measurement inside the central band of the wear scar or outside it, respectively**

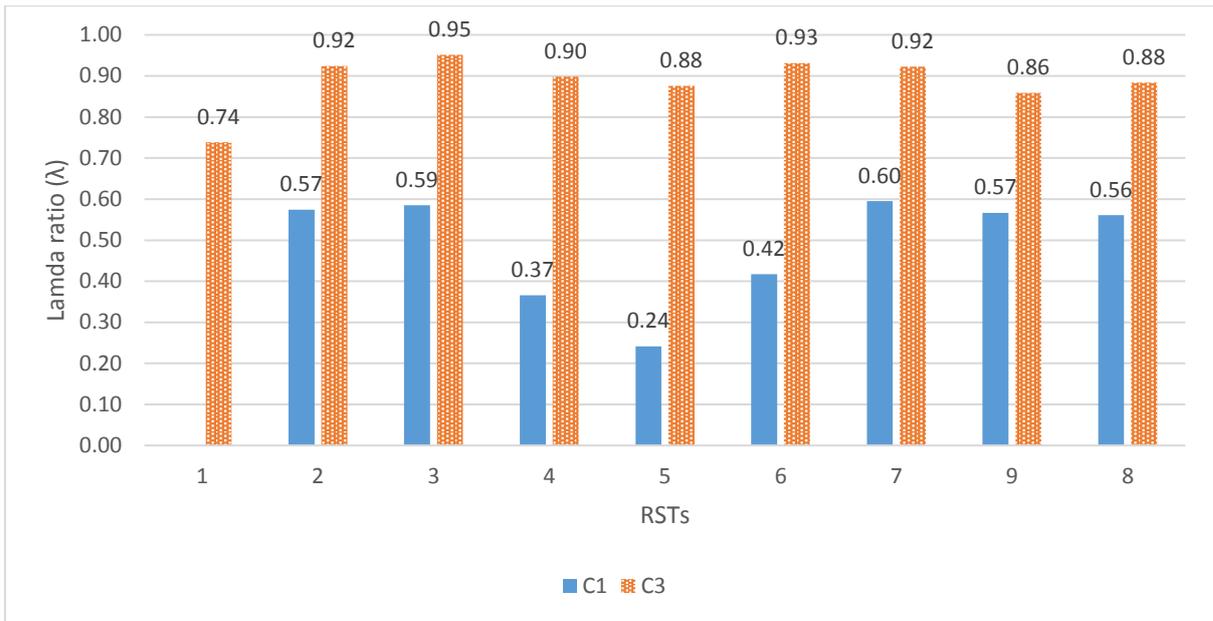
Figure 7.3.6: Lambda ratio (λ) after RSTs 1 to 9

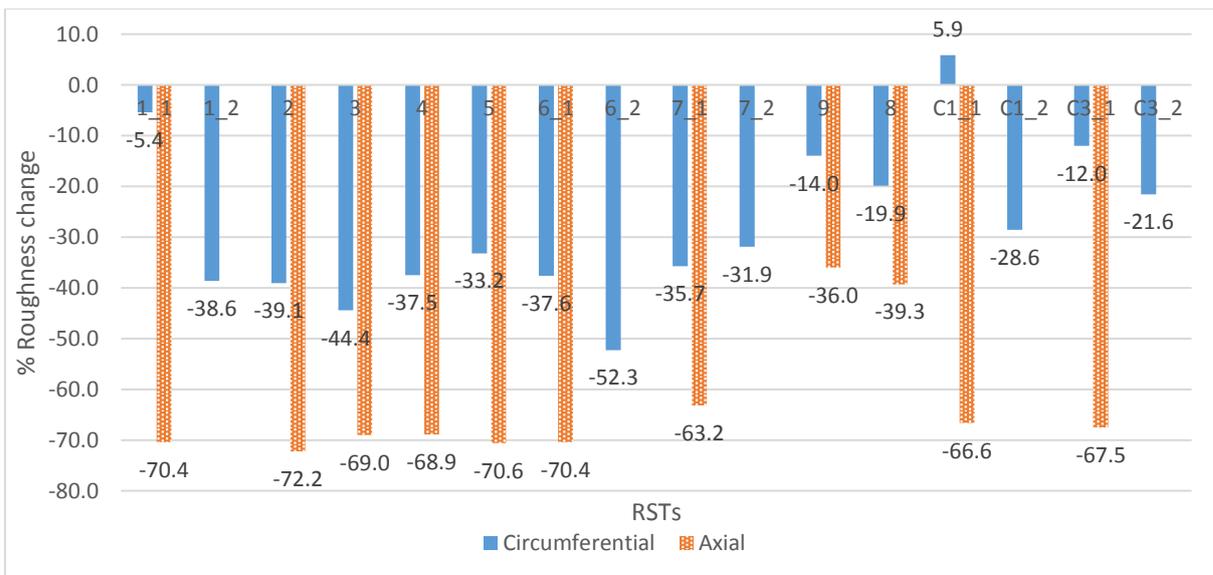
Figure 7.3.7: Percentage change of surface roughness after RSTs 1 to 9

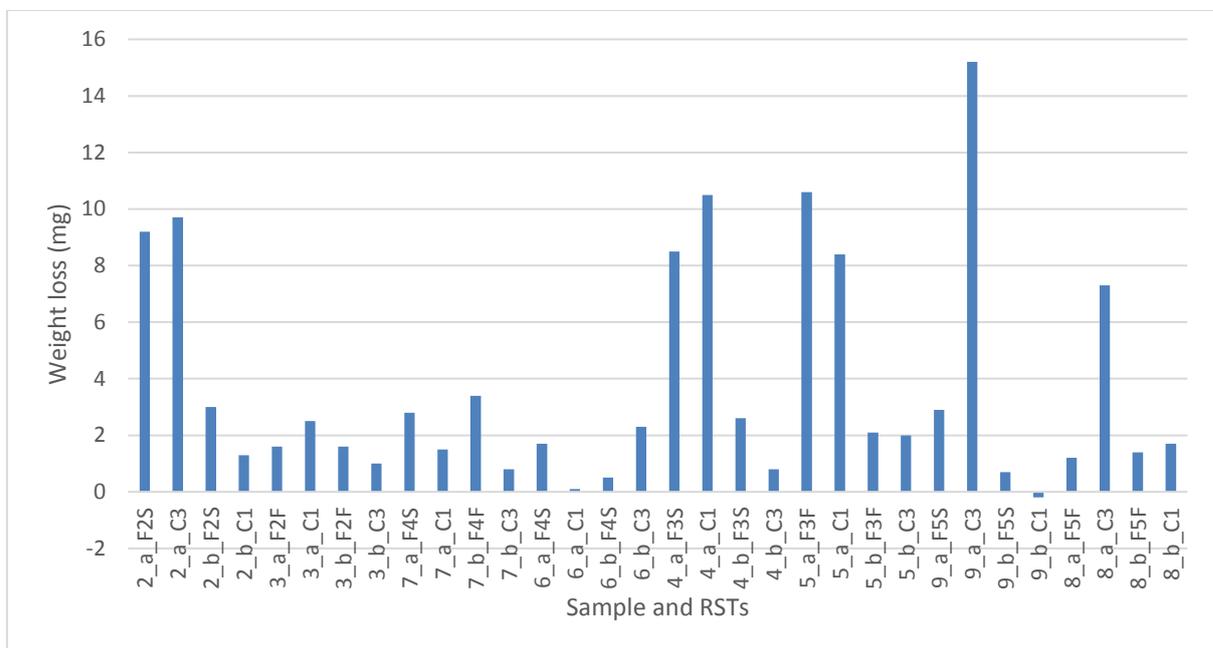
**Figure 7.3.8: Specimen weight loss after each step of the RSTs 1 to 9 (each of the labels of the x-axis refers to the test number, steps and specimen used for the test separated by an under-scroll)**

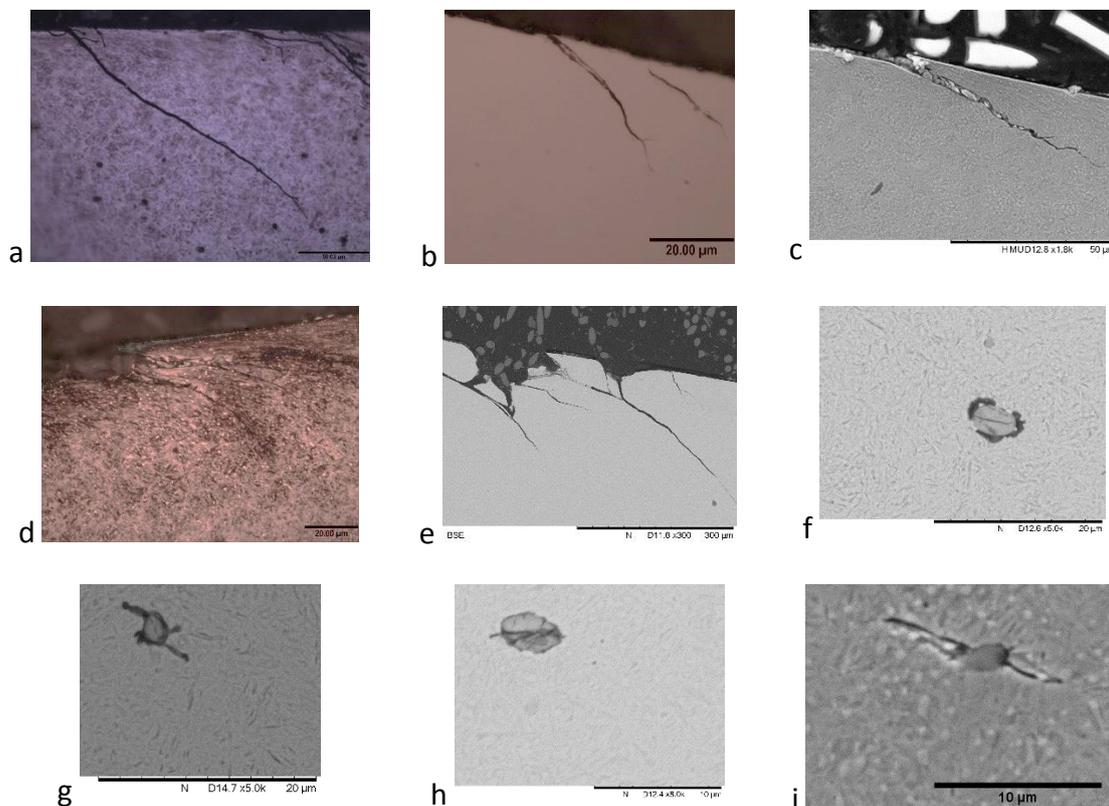
**Figure 7.4.1: Observations from metallurgical examination of RSTs specimens: (a) - (c) Surface-linked RCF cracks, (d) and (e) Pits and spalls (f) Debonded and cracked inclusion (g) and (h) Cracked inclusions initiated micro crack and (i) Possible butterfly**

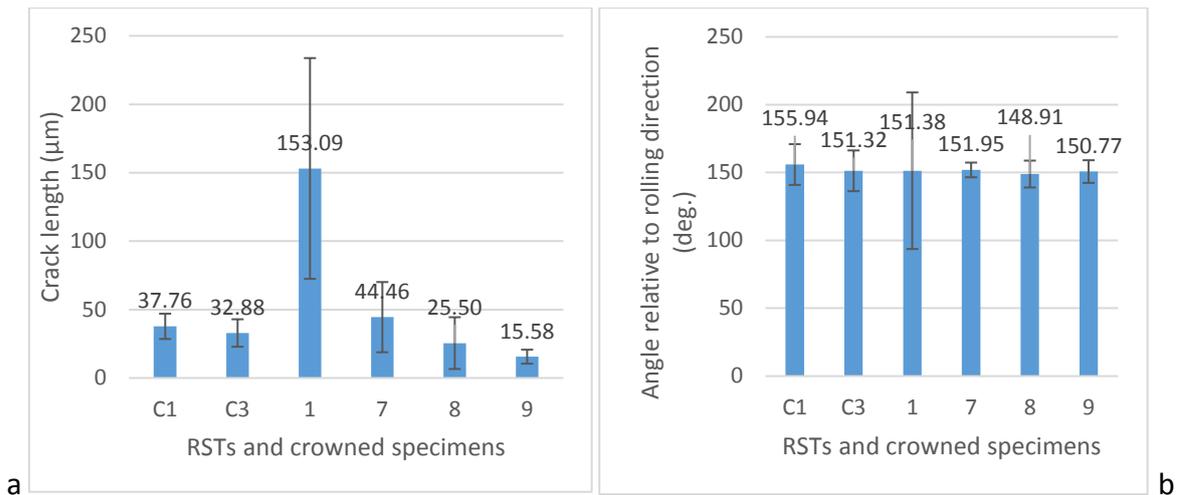
Figure 7.4.2: Surface-linked RCF cracks in circumferential direction: (a) Length and (b) Angle

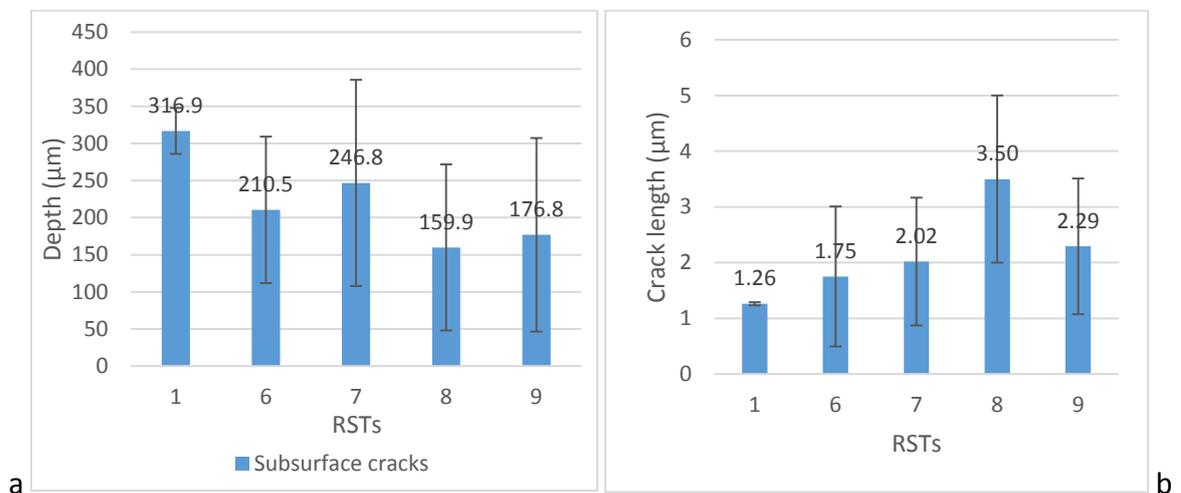
Figure 7.4.3: Micro-cracks initiated by inclusions: (a) Depth in axial and circumferential direction (b) Length in circumferential direction

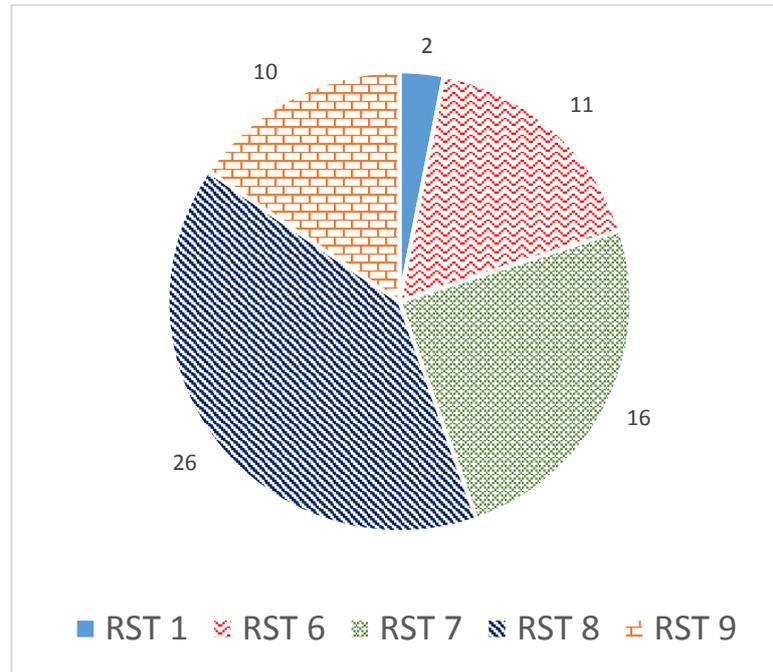
**Figure 7.4.4: Number of inclusion initiated micro-cracks in axial and circumferential sections**

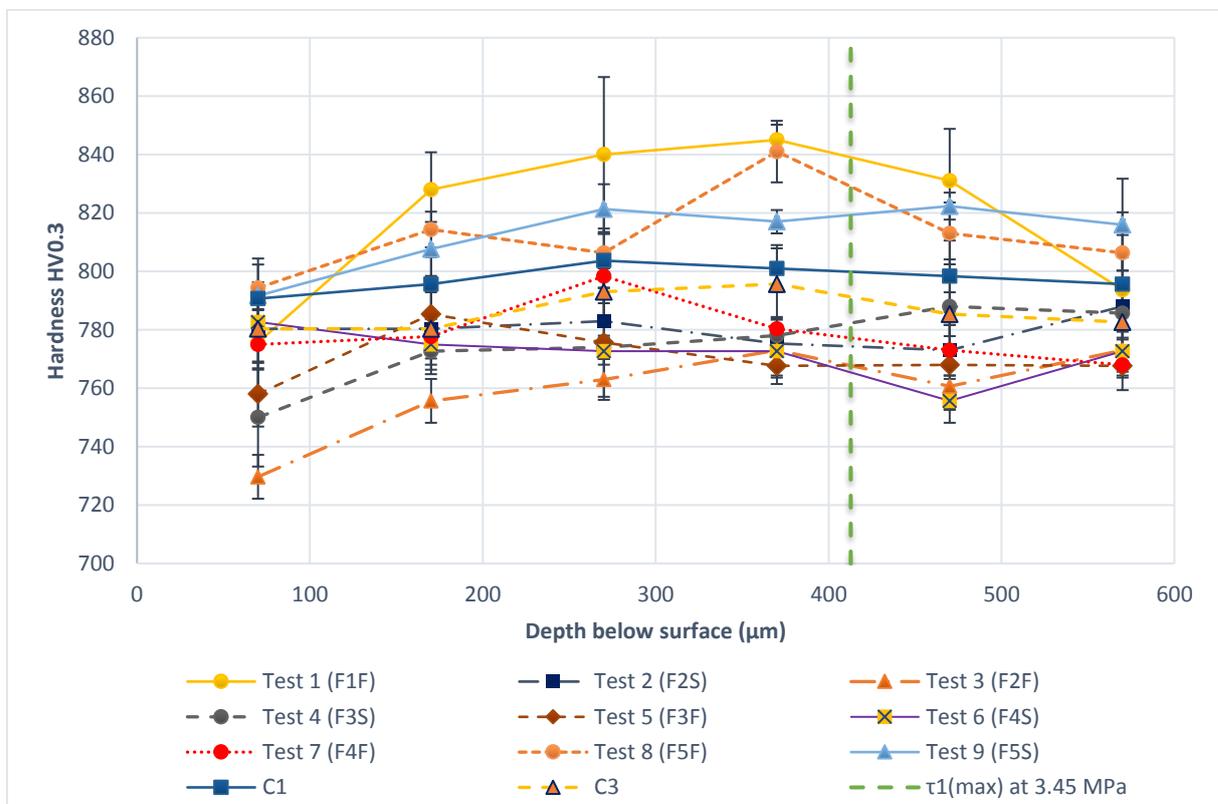
Figure 7.4.5: Variation in subsurface hardness after RSTs

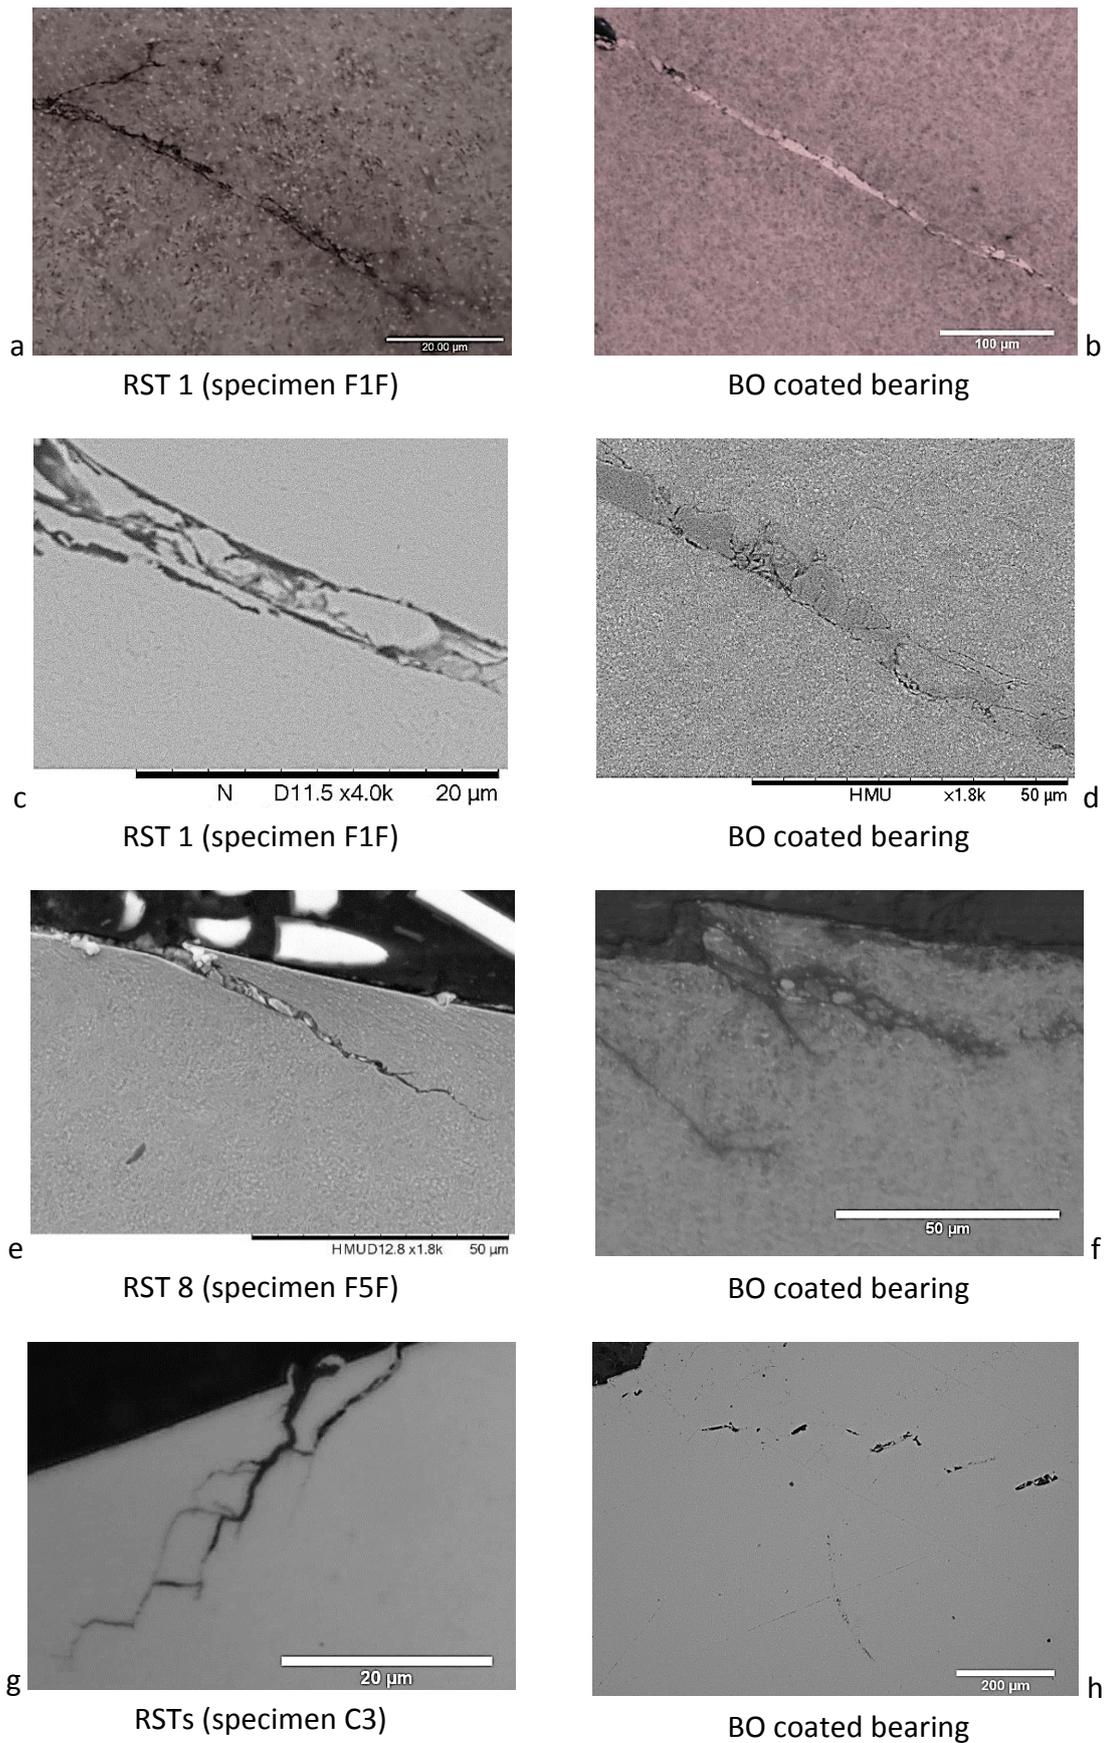
**Figure 7.5.1: Surface-linked RCF cracks in circumferential sections (a), (b), (c) and (d) cracks start from surface spall; (e) and (f) cracks start from the surface; and (g) and (h) stair-like cracks**

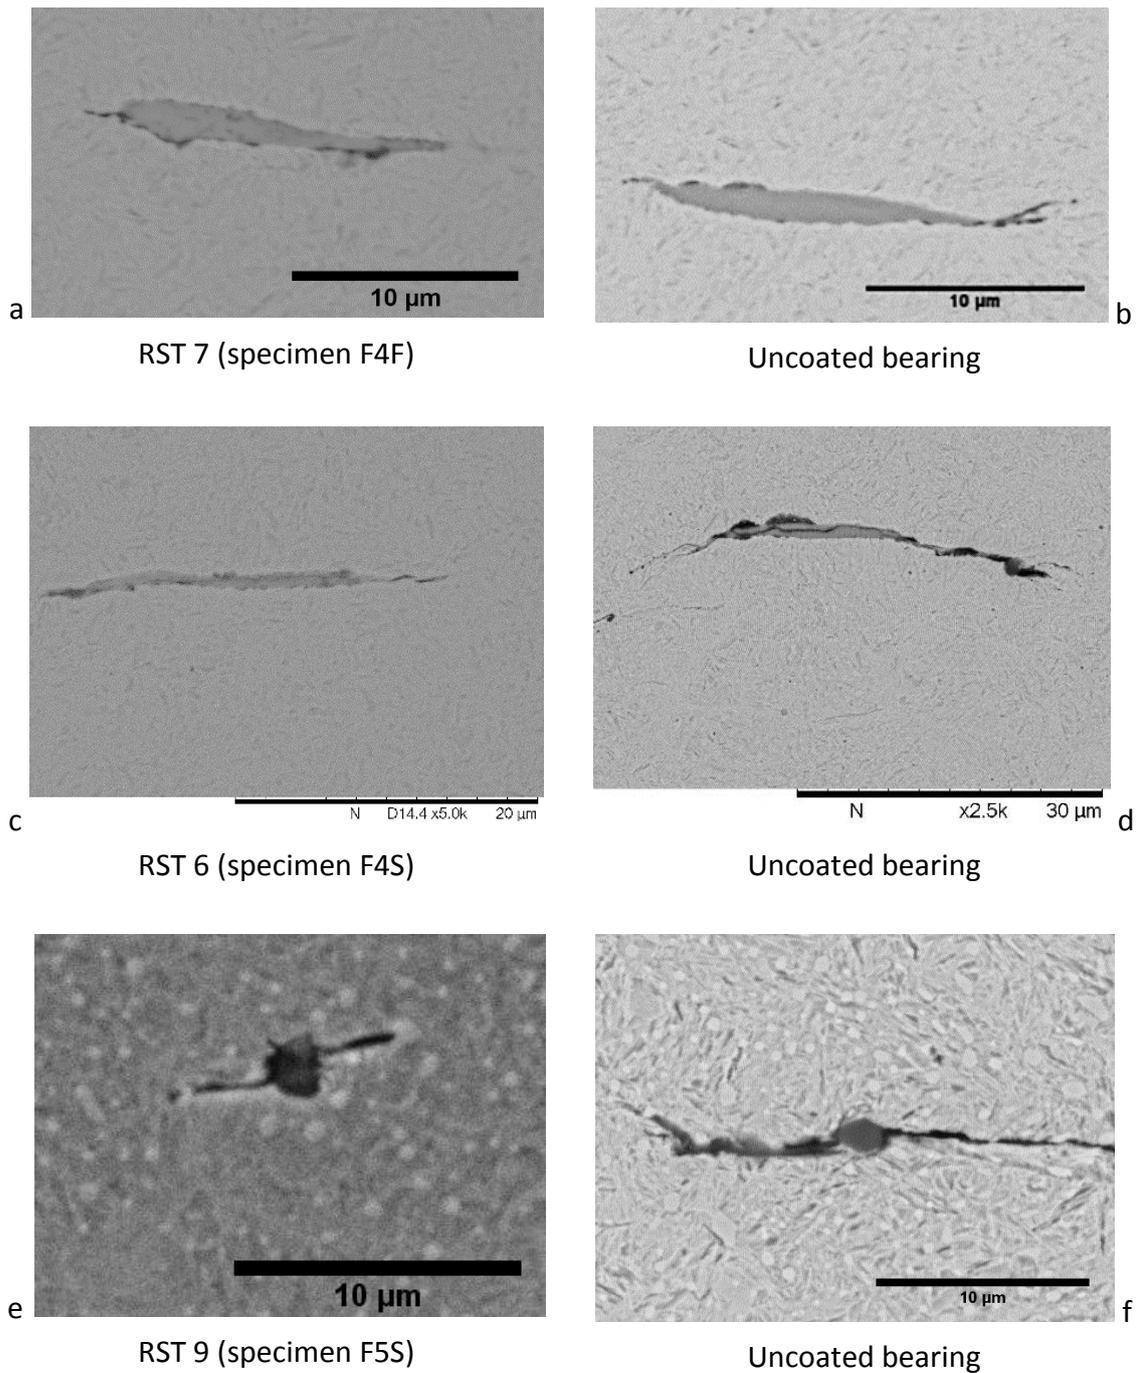
**Figure 7.5.2: Inclusion initiated micro-crack (a) and (b) debonded inclusions in axial sections; (c) cracked inclusion in axial section; (d) cracked and debonded inclusion in axial section; and (e) and (f) undamaged inclusions in circumferential section**

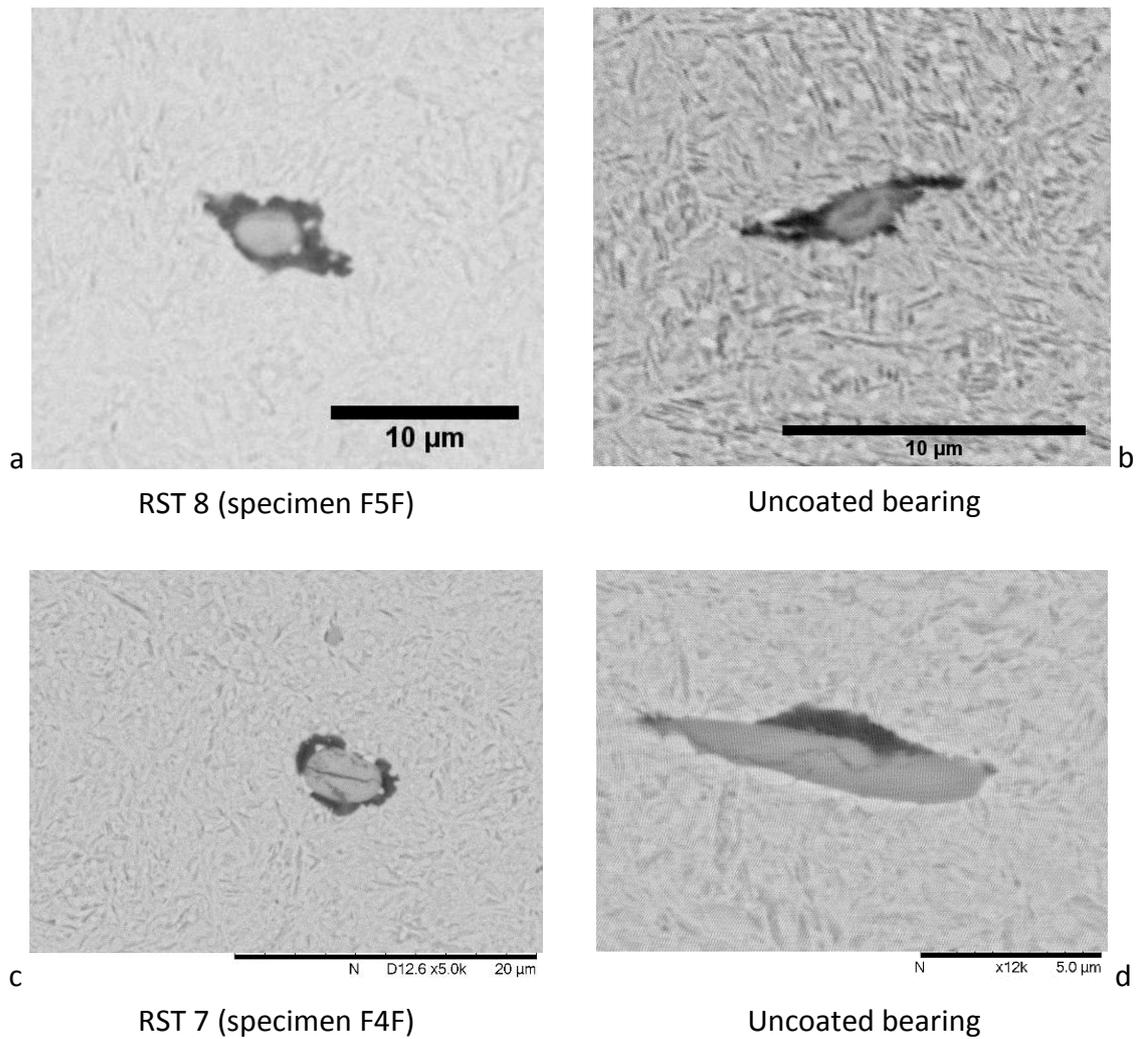
**Figure 7.5.3: Debonded inclusion (a) and (b) debonding expanded to micro cracks in circumferential section; and (c) and (d) debonded and cracked inclusions in circumferential and axial sections, respectively**

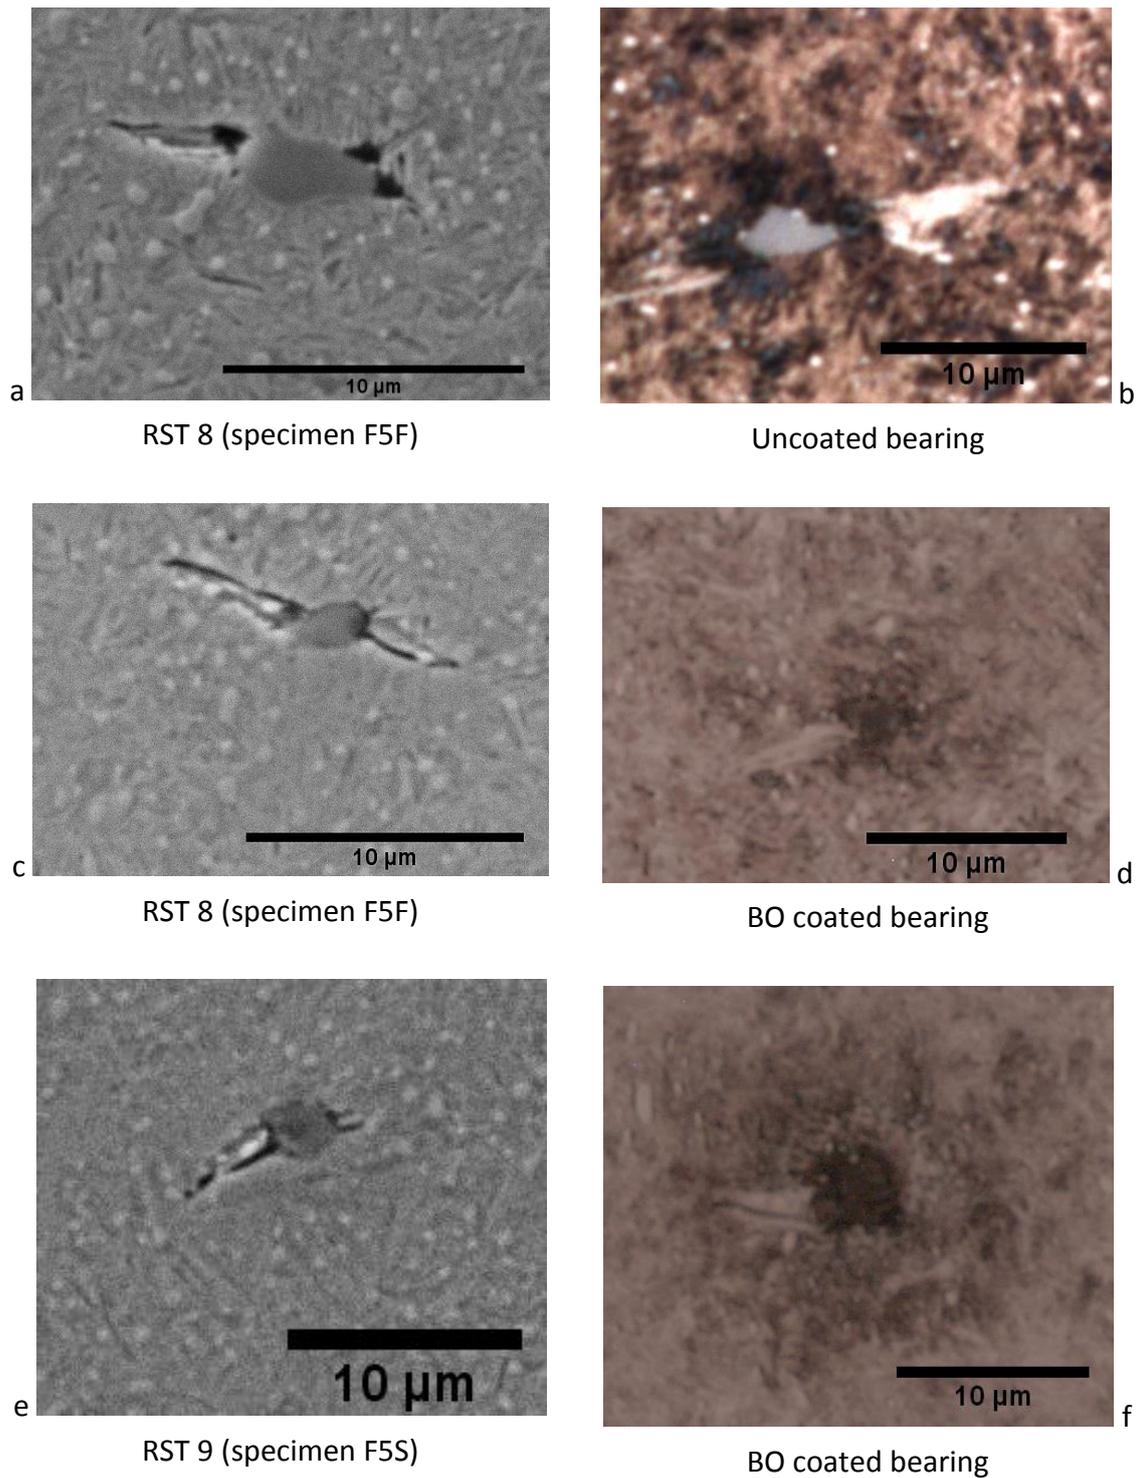
**Figure 7.5.4: Possible WEA and butterfly wings in circumferential sections (a) and (b) debonded inclusions and butterfly wings; and (c), (d), (e) and (f) butterfly wings and micro-cracks.**

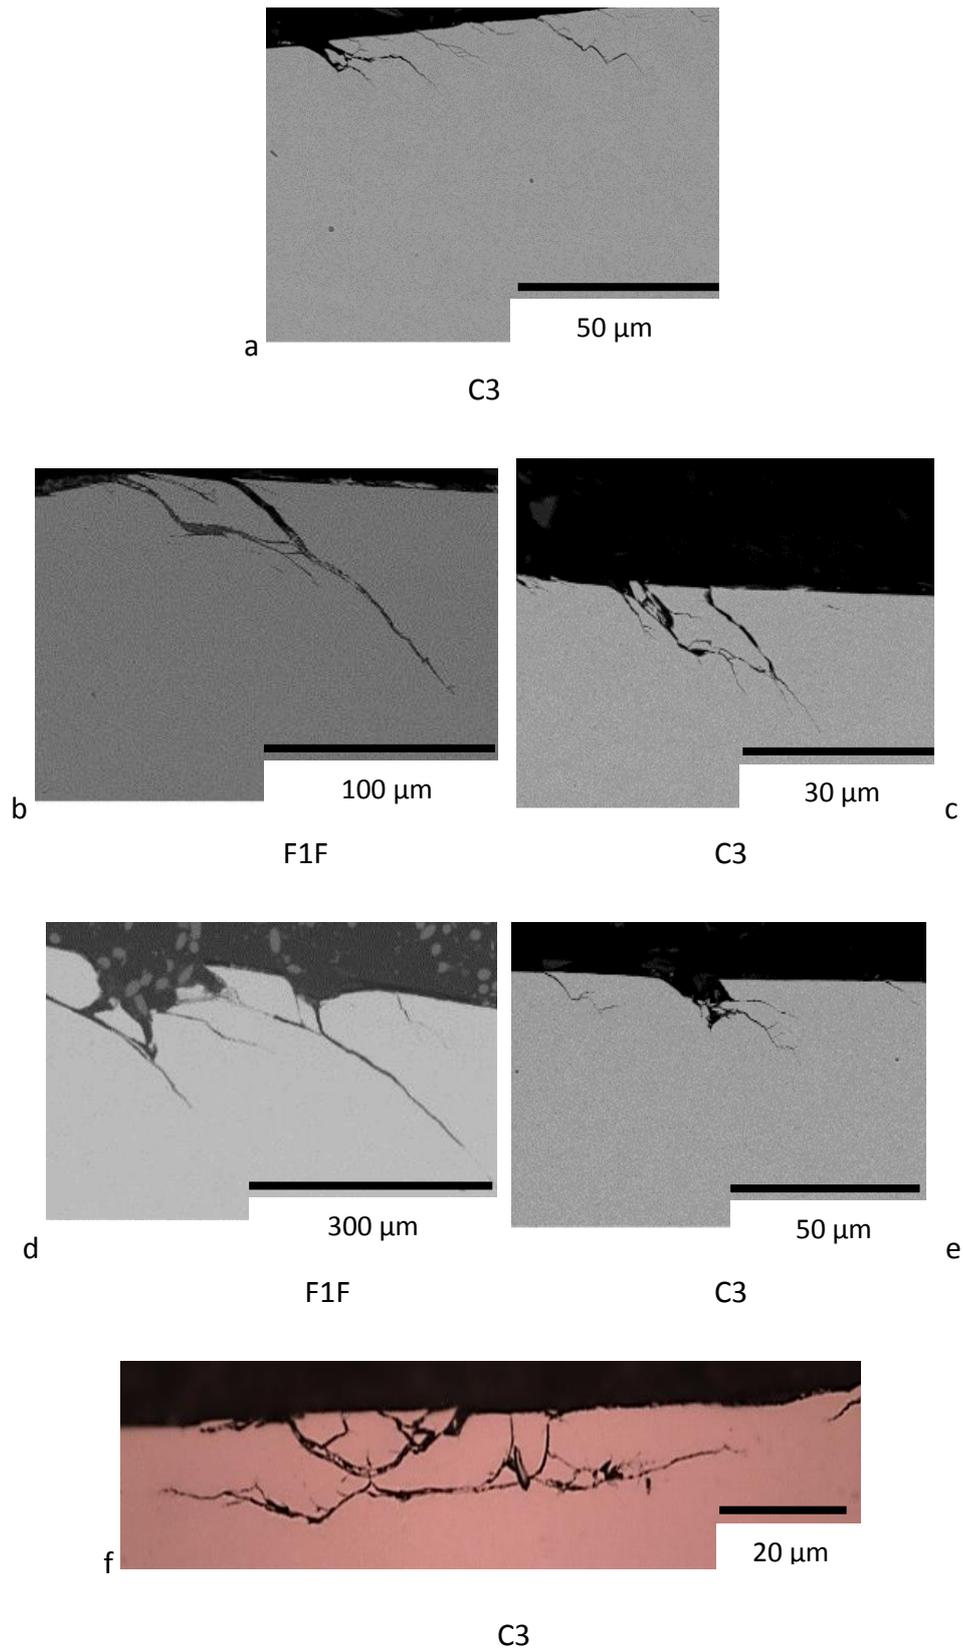
**Figure 7.6.2: Pits and spalls formation in circumferential sections (a) surface-linked RCF cracks propagate close to each other; (b) and (c) surface-linked RCF cracks interact to form a spall; (d) and (e) spall with cracks extending to form bigger spalls; and (f) crack network in axial section**

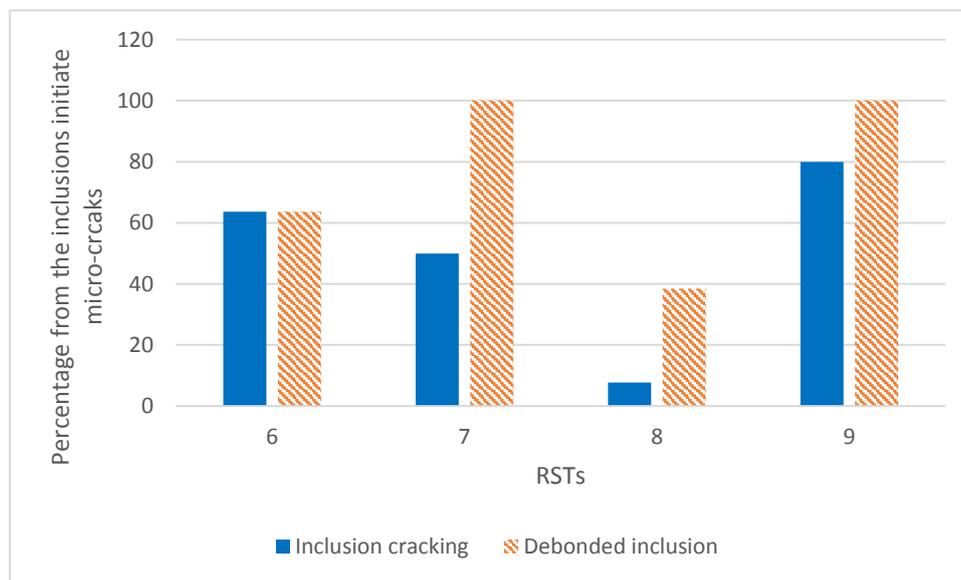
**Figure 7.6.3: Percentage of cracked and debonded inclusions in inclusions that initiated micro-cracks**

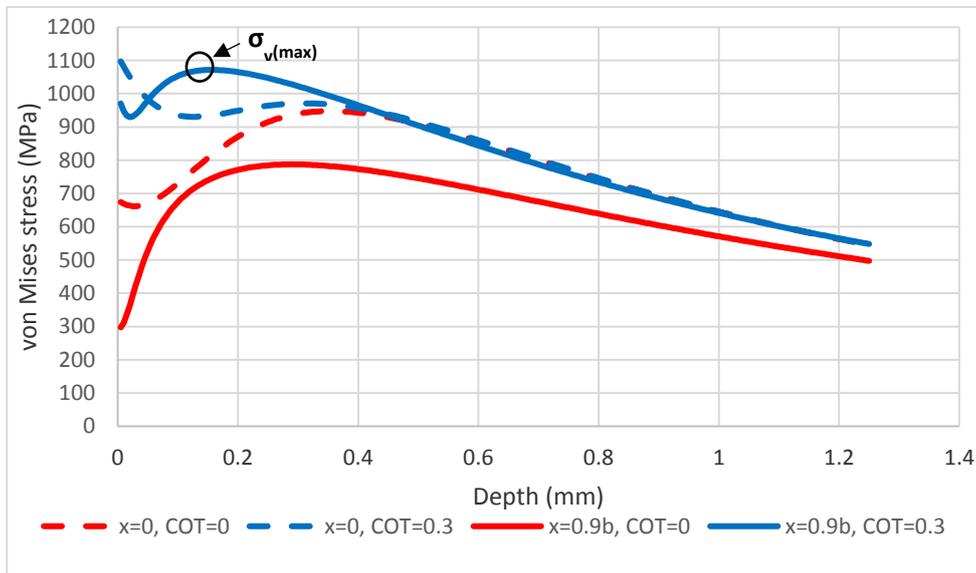
Figure 8.1.6: Subsurface  $\sigma_v$  at different COT under  $x=0$  and  $x=0.9b$  at  $p_{\max}=1700$  MPa

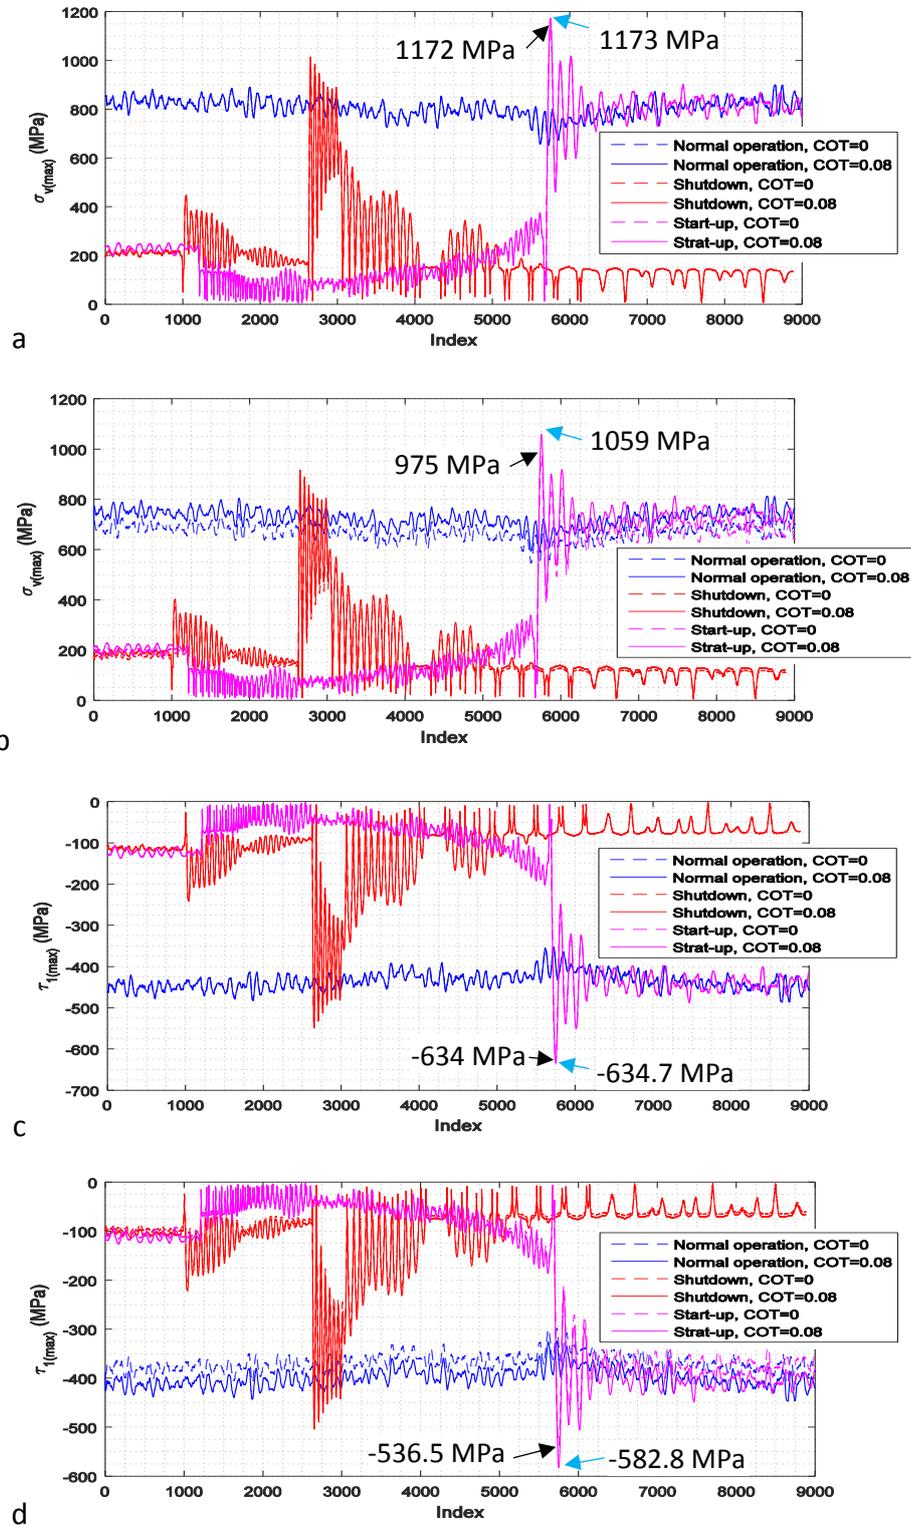
Figure 8.1.7:  $\tau_{1(max)}$  and  $\sigma_{v(max)}$  with and without surface traction at different operation conditions (a) and (c) are for point 1 ( $x=0, z=0.78$ ); and (b) and (d) are for point 2 ( $x=0.9b, z=0.5$ )). Blue and black arrows show maximum value with and without surface traction.

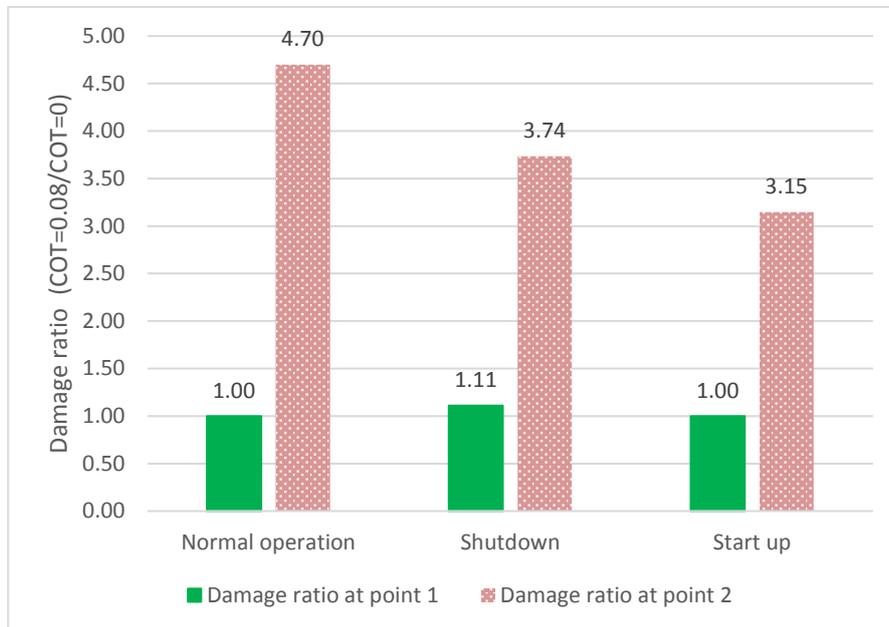
**Figure 8.1.8: Damage accumulation ratio at different operation events with and without surface traction (COT=0.08)**

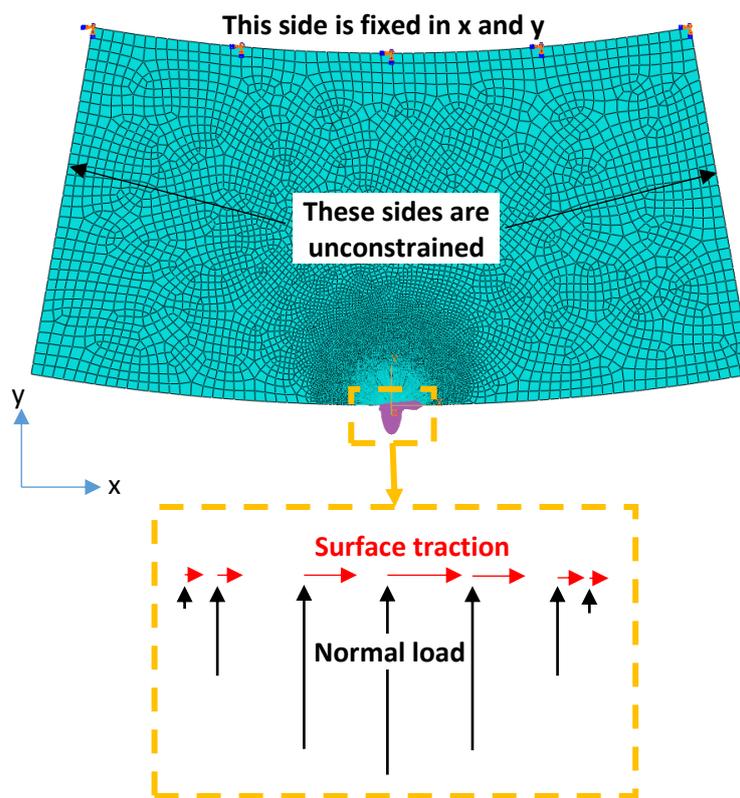
Figure 8.2.1: Illustration of M1-2D models
