*Department of Mechanical Engineering*

**Effect of Surface Traction and Non-Metallic Inclusions  
on the Premature Failure of Wind Turbine Gearbox  
Bearings**

Thesis submitted to the Department of Mechanical Engineering, University  
of Sheffield in partial fulfilment of the requirements for the degree of

**Doctor of Philosophy**

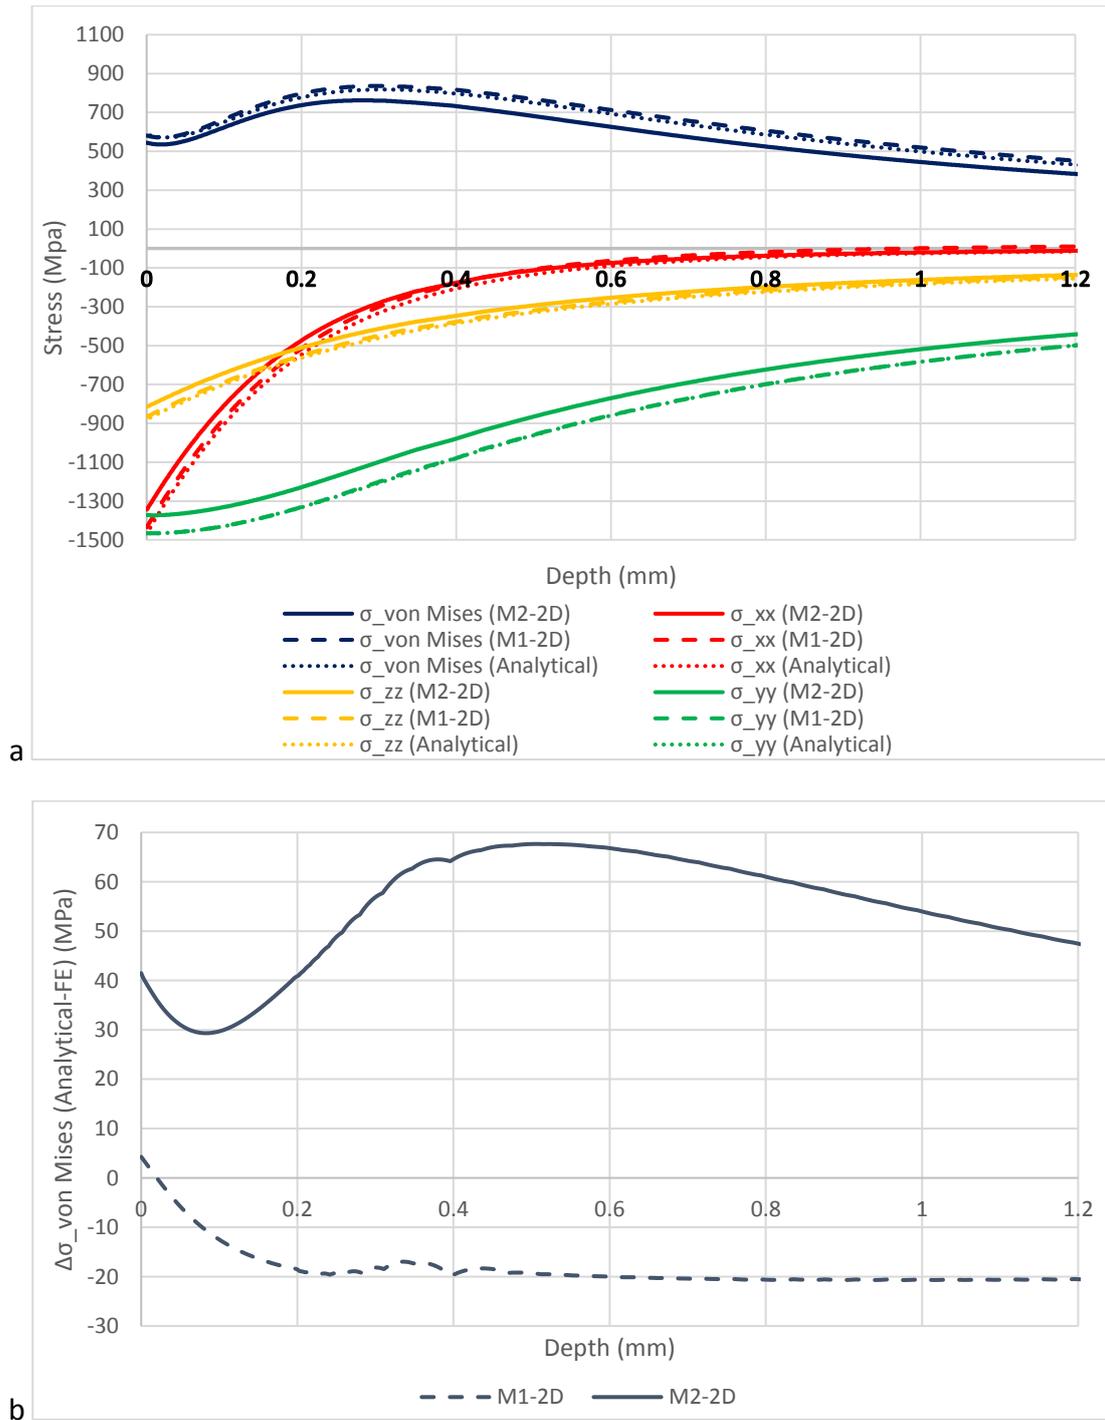
**Figure 8.2.5: (a) Comparison of subsurface stresses at  $x=0$  under  $p_{max}=1466$  MPa and no surface traction using FE models M1-2D and M2-2D, and analytical solution (Figure 8.2.3 shows the axes) (b) the uncertainty of M1-2D and M2-2D**

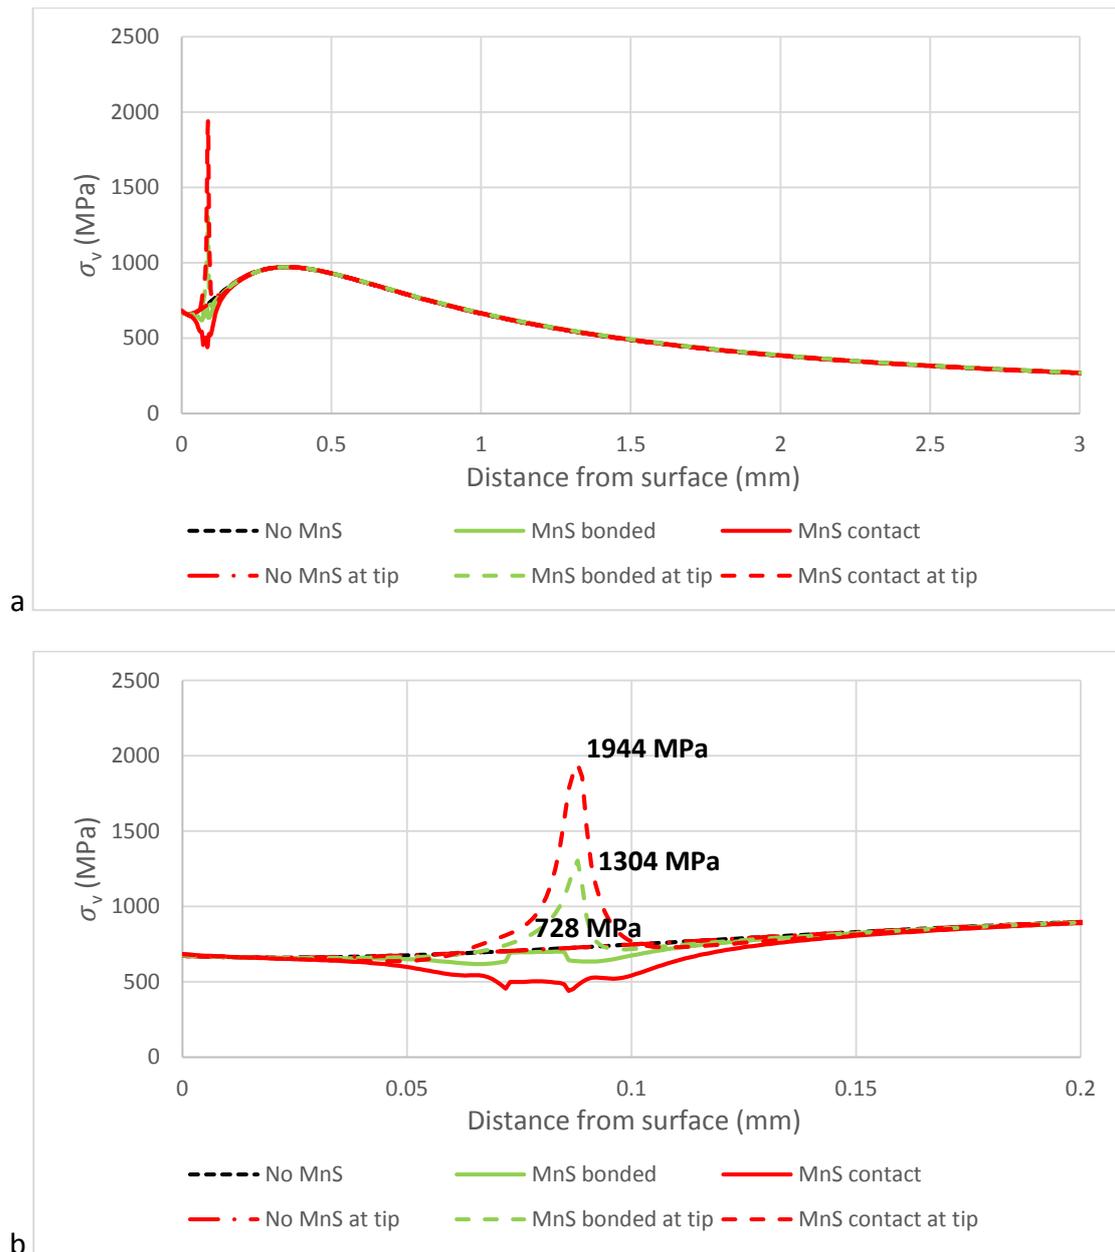
**Figure 8.2.11: Local effect of inclusion on the variation of  $\sigma_v$  under  $p_{\max}=1700$  MPa**

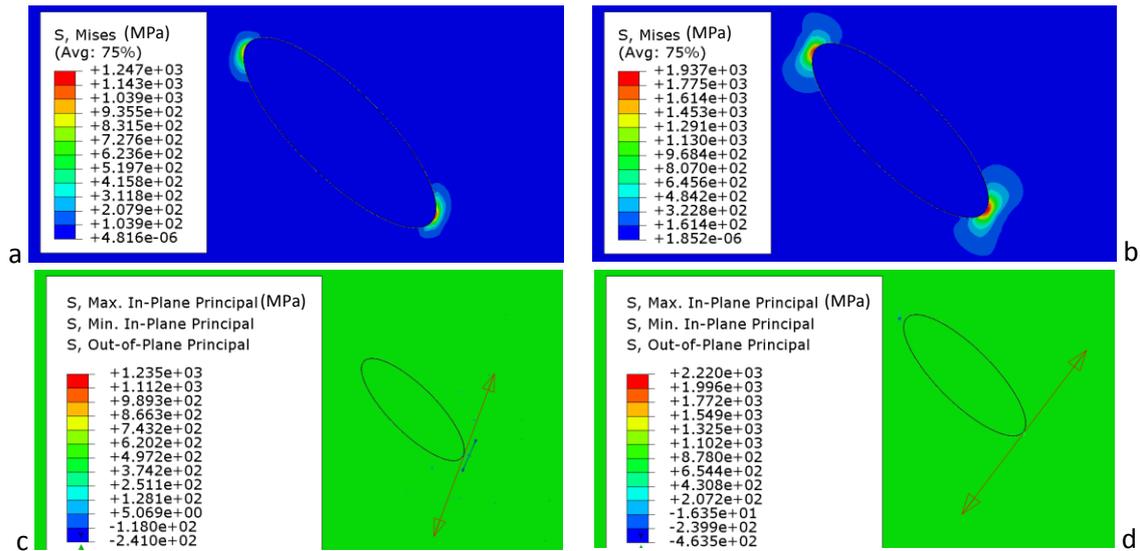
**Figure 8.2.17: Residual tensile stresses (a) and (c) after  $p_{\max}=1700$  MPa; and (b) and (d) after  $p_{\max}=1700$  MPa and  $q_{\max}=600$  MPa**

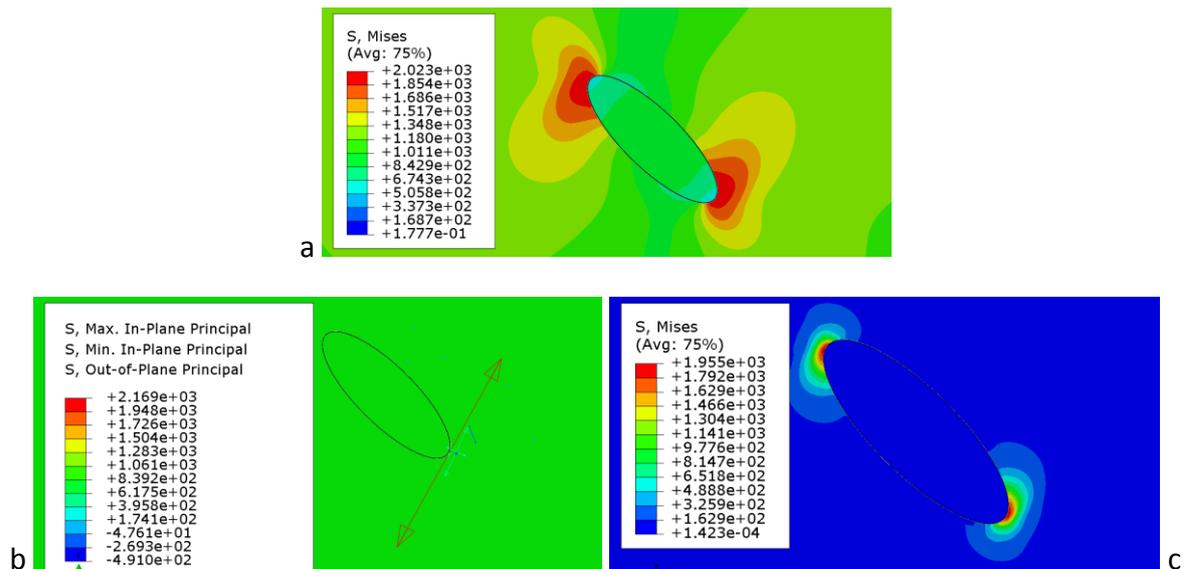
**Figure 8.2.18: Stresses resulting from  $p_{max}=3000$  MPa (a) equivalent stress at maximum loading; and (b) and (c) residual tensile stresses**

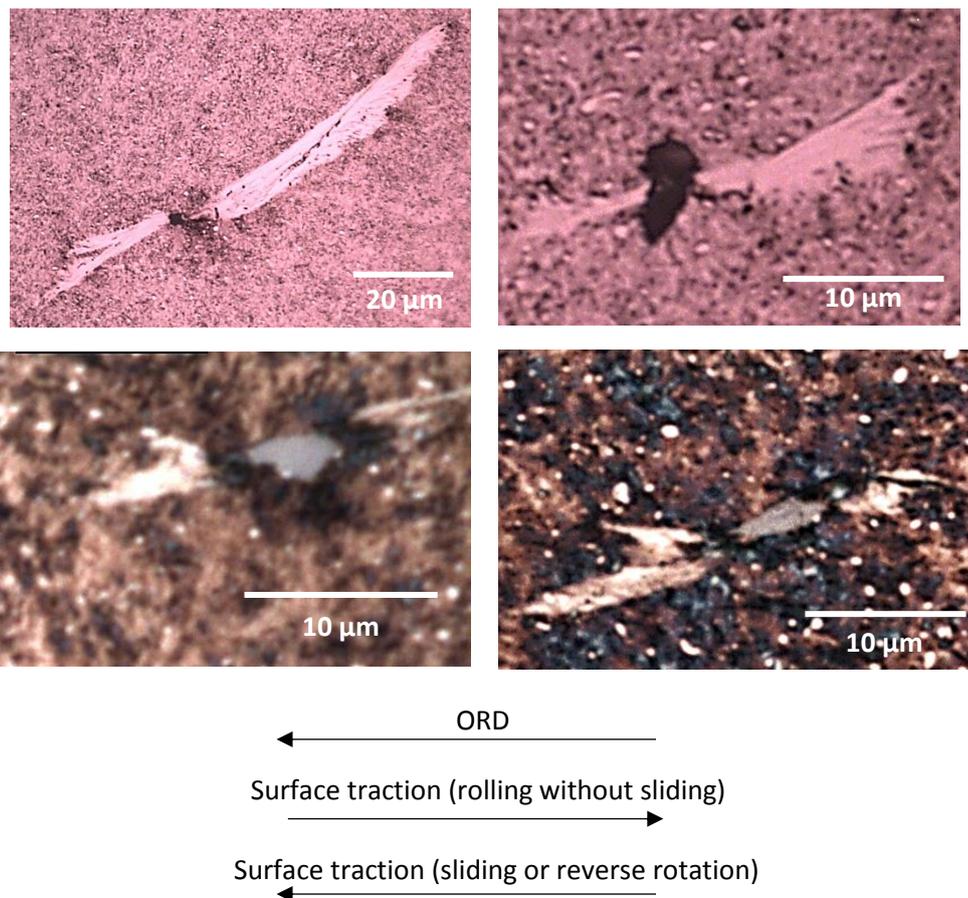
**Figure 8.2.28: Butterfly wing angle relative to rolling direction (surface of contact is below the butterflies and rolling direction from left to right)**
