NINETEENTH-CENTURY PAINTED DECORATIONS

IN BRITAIN AND AUSTRALIA:

AN APPROACH TO CONSERVATION

Volume Two
(Appendices)

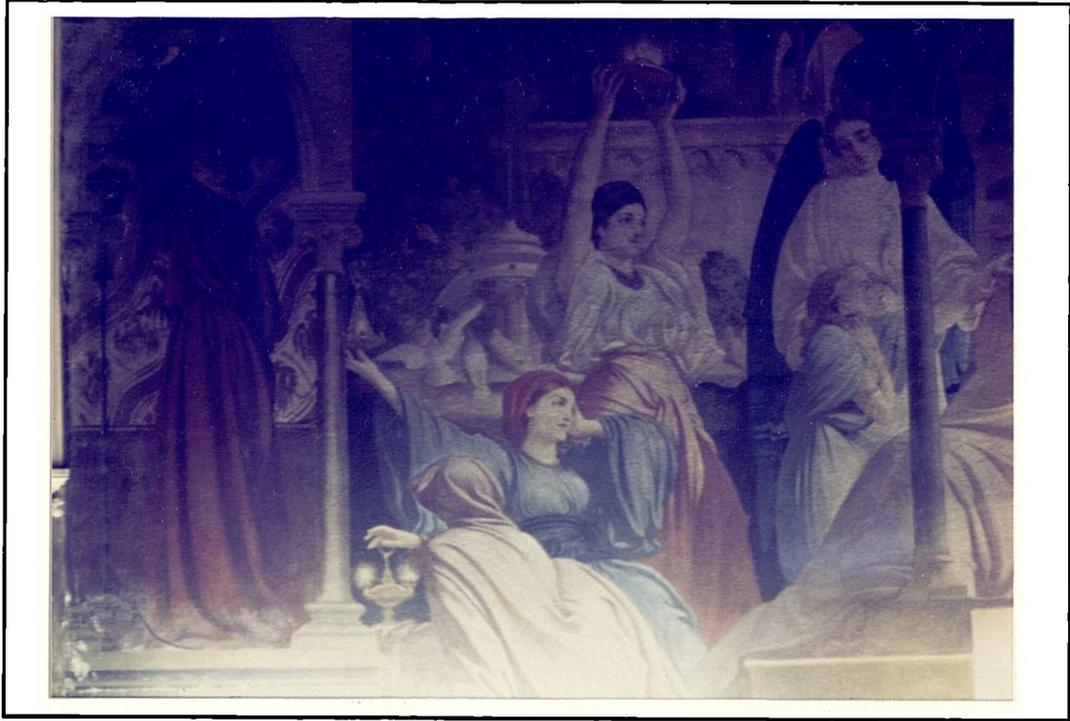
Fig. 123
Detail of the spirit fresco painting of 'the Last Supper' by Lord Frederick Leighton, PRA in St Michael's and All Angels, Lyndhurst, Dorset.

use of all the fresco mediums.²² The material was composed of wax, resins and volatile oils which were mixed by the decorators themselves.²³ The technique proved to be durable on stable grounds (Spirit fresco decorations in St Michael and All Angels, Lyndhurst, Dorset,²⁴ 1864 and St Leonard's, Newland, Worcestershire,²⁵ 1865, survive in excellent condition) however an unacknowledged difficulty in mixing and maintaining colour consistency on the job might account for the limited use of the medium.

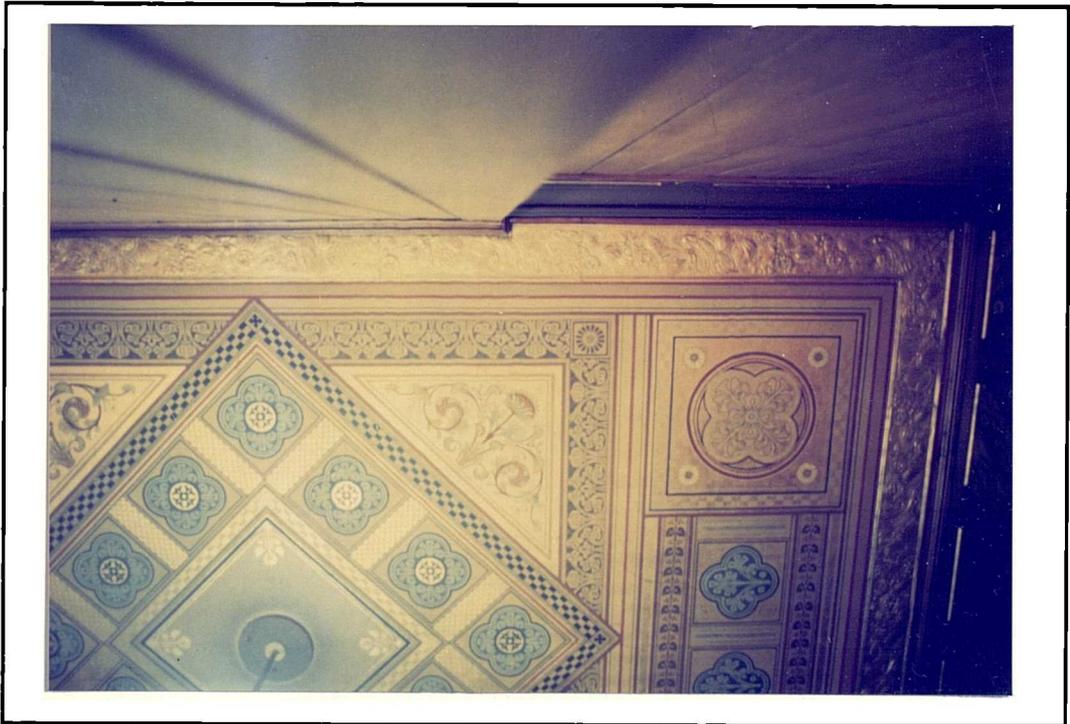
Fig. 124
Detail of ceiling decorations in the residence of Sir George Verdon, Collins Street, Melbourne, 1887. The decorations by Andrew Wells feature gilding over a sanded ground to give life to the gold.

⁴³See *figs 124, 126 and 127*. It can be observed that the gilding was applied to moulded surfaces and textured surfaces of paper, fabric and sand.

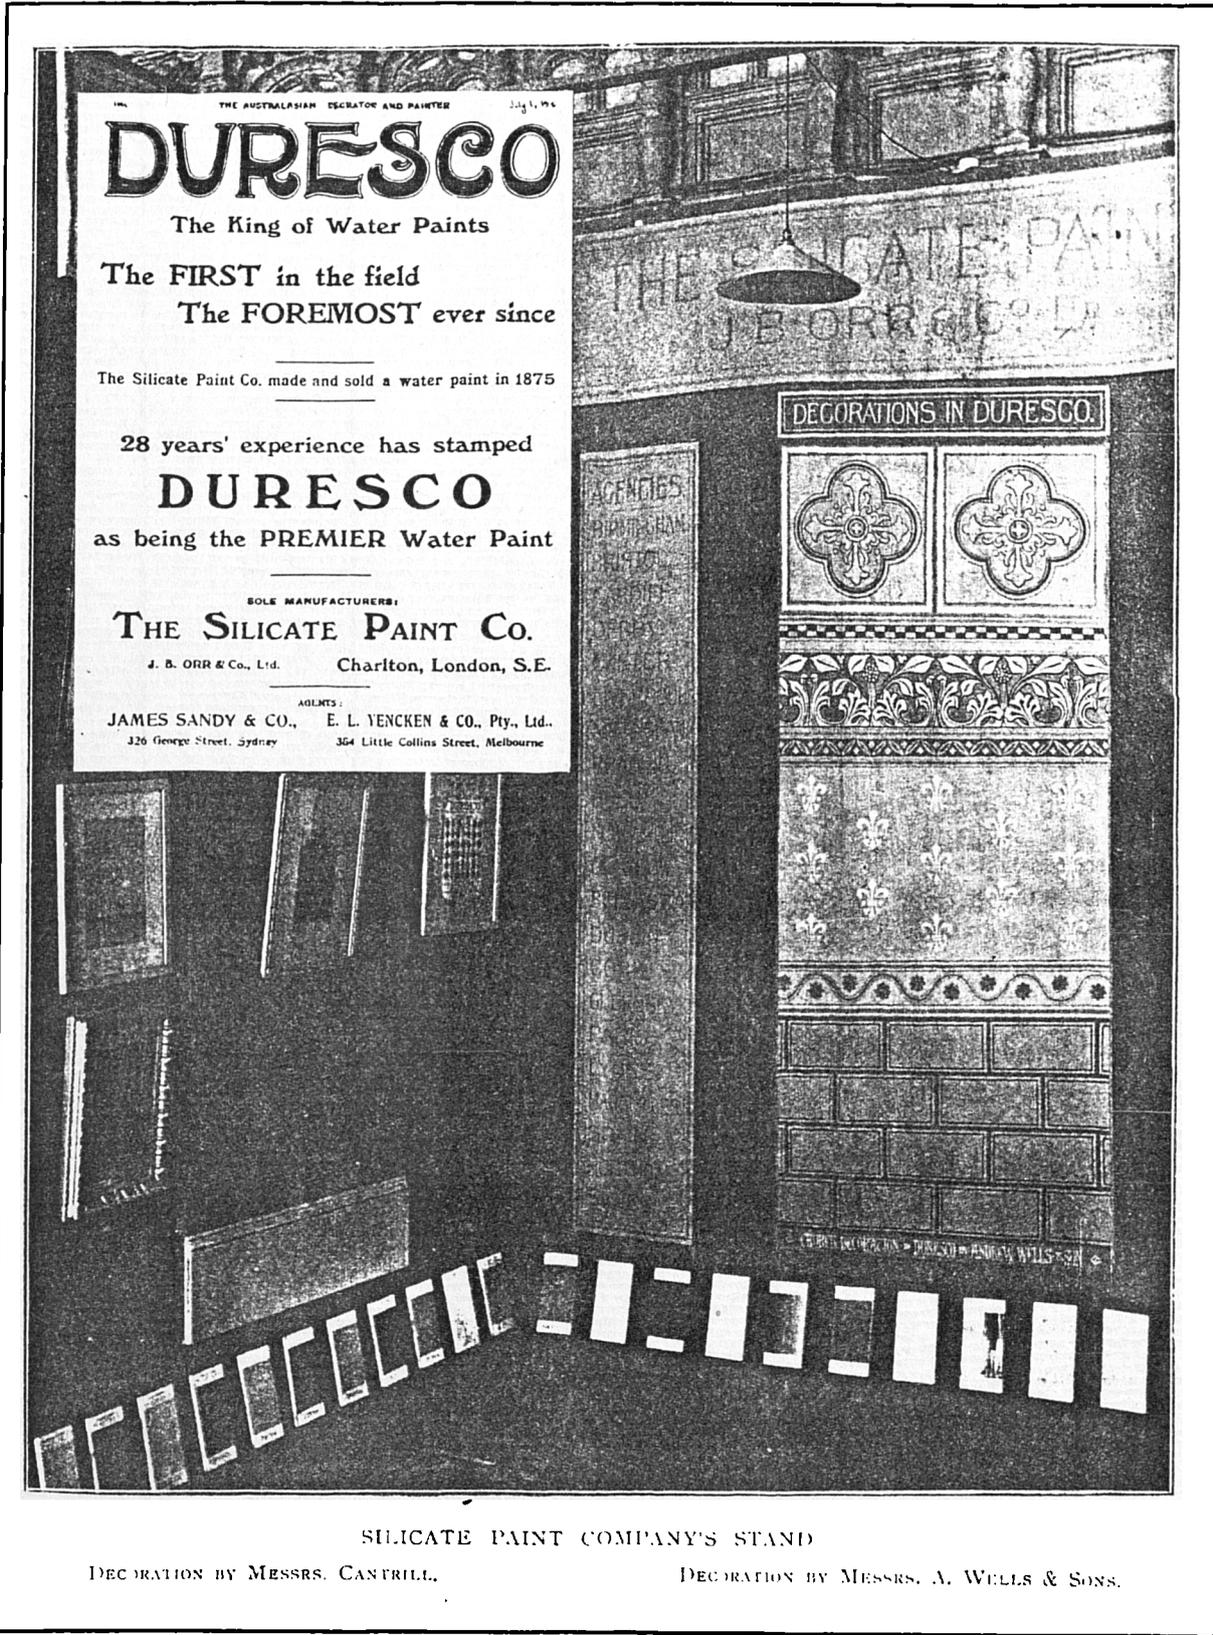
Fig. 125
View of a display stand presented by the Silicate Paint Company with examples of 'Duresco' decoration prepared by Messrs Andrew Wells and Sons of Glasgow. *The Journal of Decorative Art*, November 1896. The advertisement for Duresco appeared in *The Australasian Decorator and Painter*, 1 July 1906.

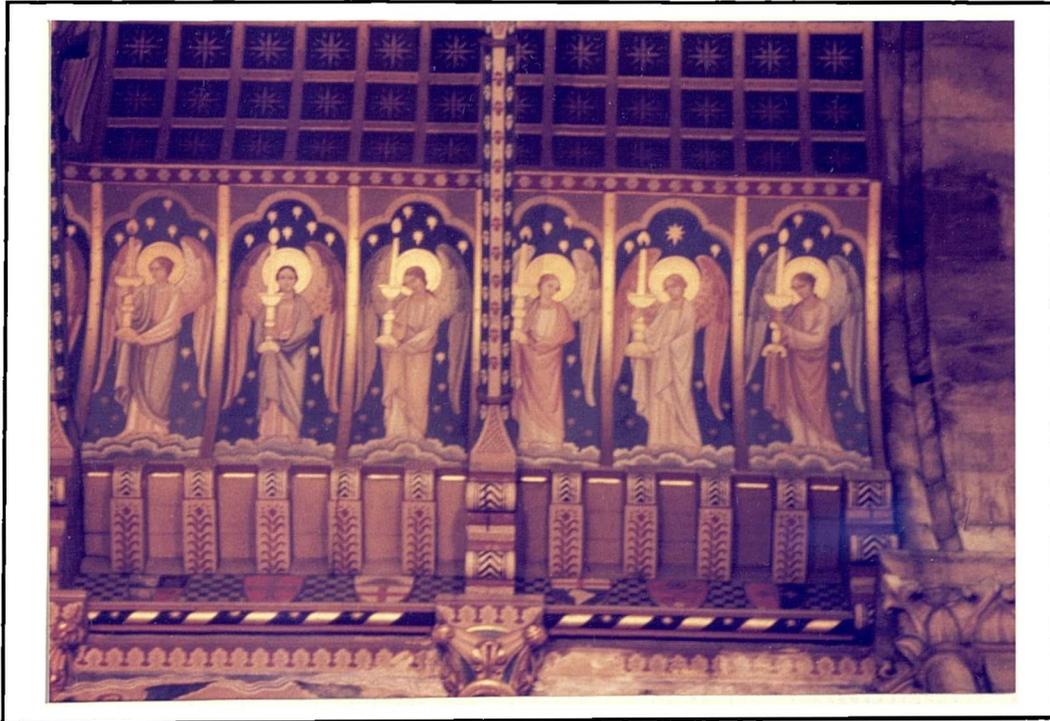
Fig. 126
Detail of the ceiling of St Finn Barre's Cathedral, Cork, with decorations by Campbell Smith to the design of William Burges.

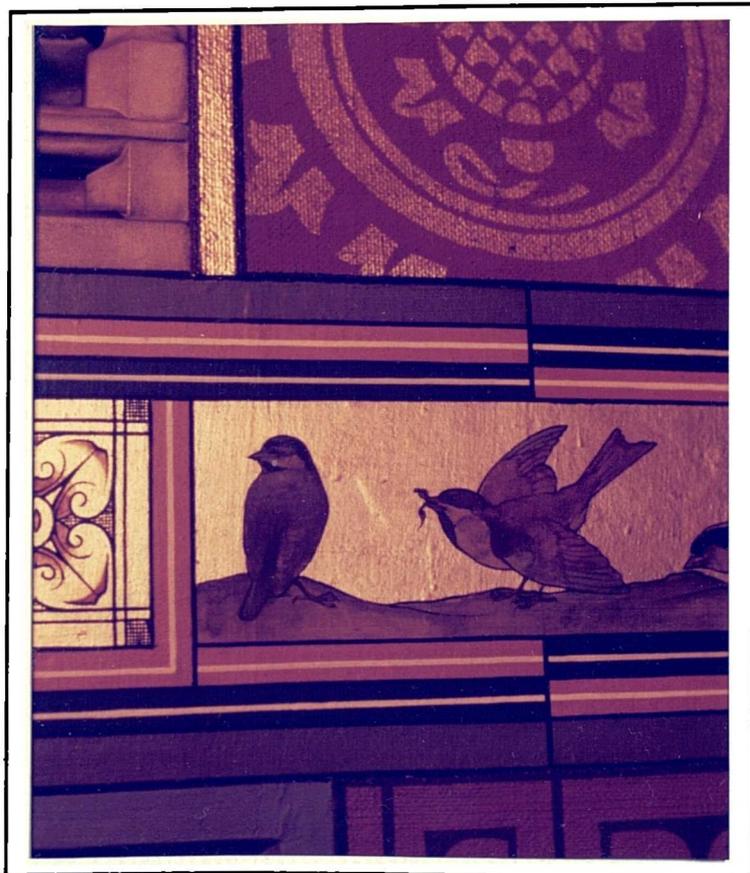
Fig. 127
Detail of wall decorations designed by William Burges in the library of Cardiff Castle. The design motifs drawn from a variety of sources including Japan and the Eastern World, are painted in part onto textured paper.

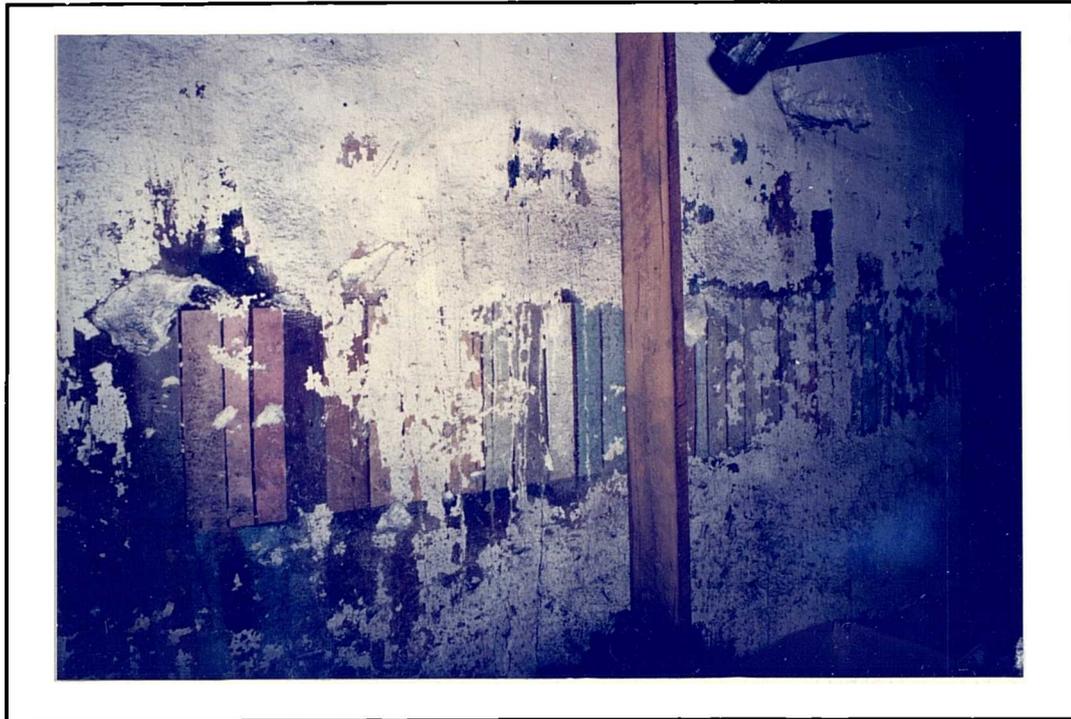
Fig. 128
 Painted palette of colours in 'Tahlee House', NSW (circa 1880), believed to be sample colours which were brushed out by a decorator to indicate the finishes to be used in decorations.

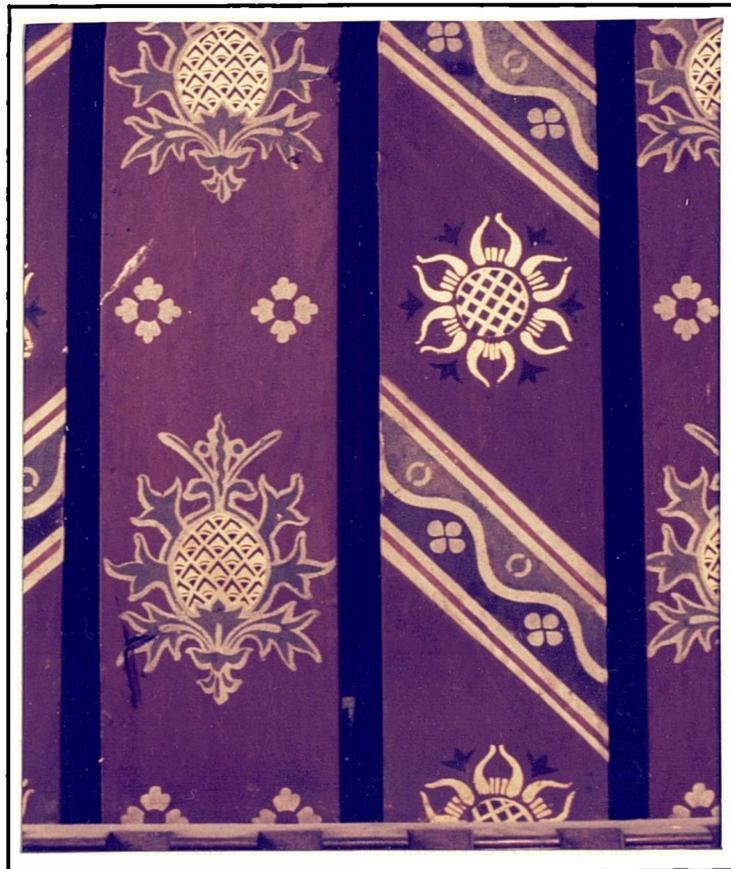
Fig. 129
 Decoration by Clayton and Bell to organ pipes in St Nicholas, Silton, Devon. The gold is contrasted with flatted Indian red colour on the wooden pipes.

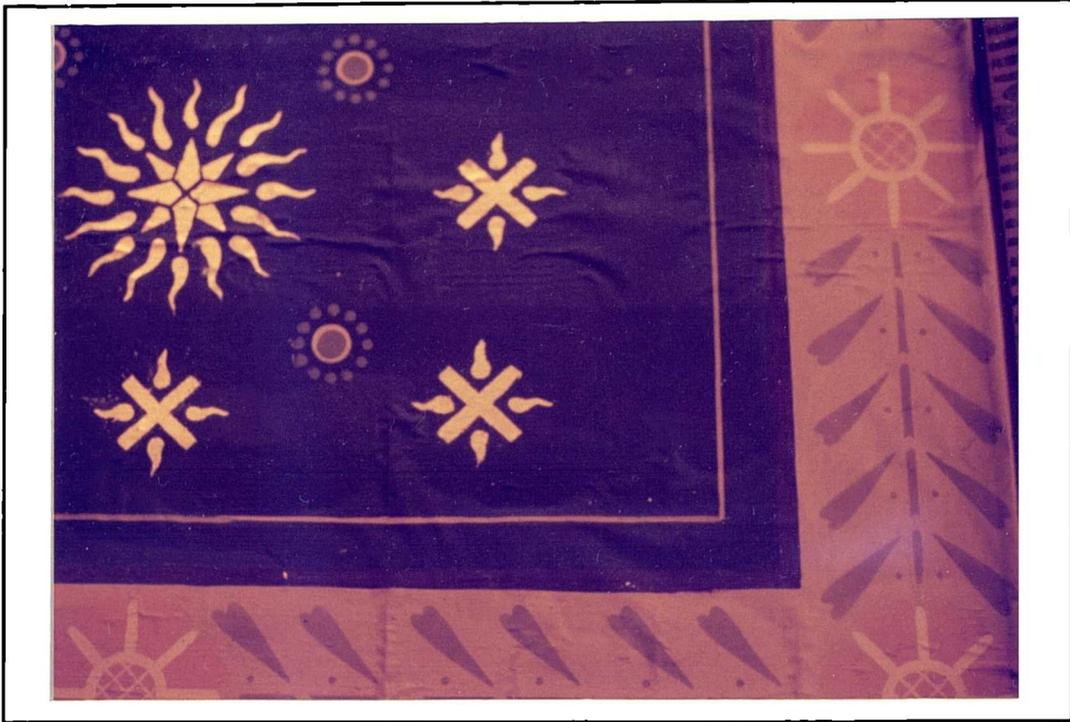
Fig. 130
Ceiling decorations in St Andrew's College, Sydney University, decorated in 1875 by Lyon, Cottier and Co. The decorations are painted in distemper onto a linen ground which is fixed with tacks to the boarded roof lining.

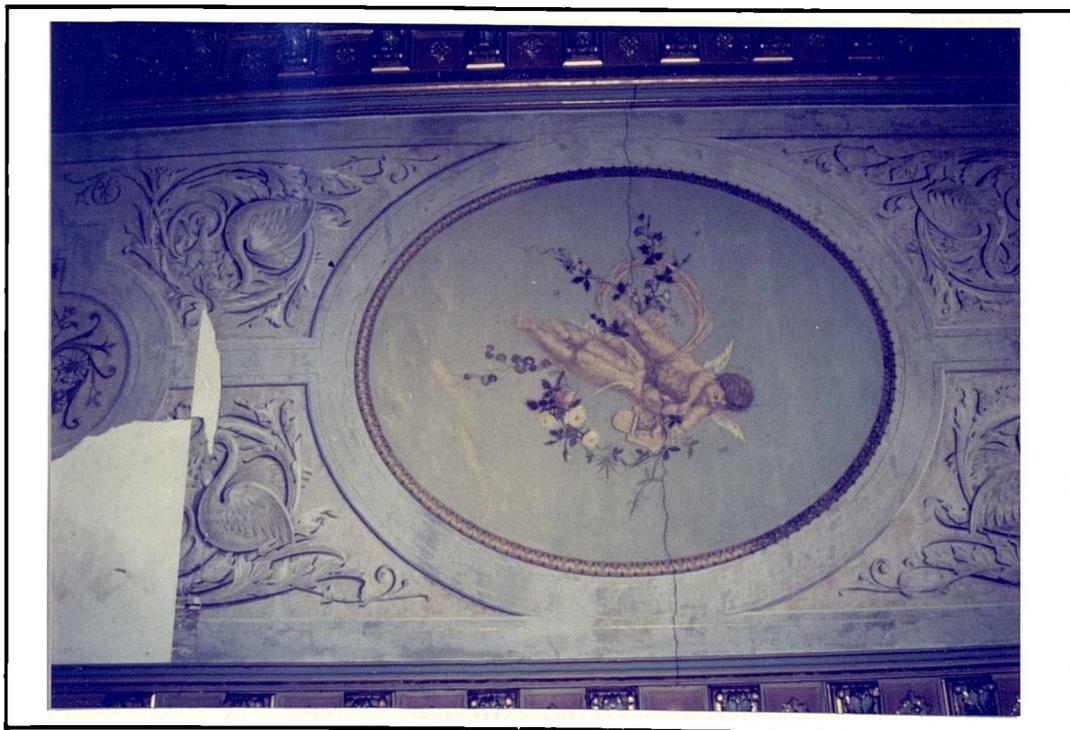
Fig. 131
View of the ceiling of the Drawing Room in 'Villa Alba', Melbourne, decorated by the Paterson Brothers, 1884. The decorations were painted onto lining paper over plaster. The loss of adhesion reveals the method used.

Technical manuals recommended the use of lining paper as a foundation for high quality work, especially work undertaken in distemper on poor quality surfaces.⁵⁹ Site research undertaken in Sydney and Melbourne for this study confirms that a high proportion of painted ceiling decorations were applied onto lining paper, applied in the same manner as conventional wallpapers (*fig.131*).

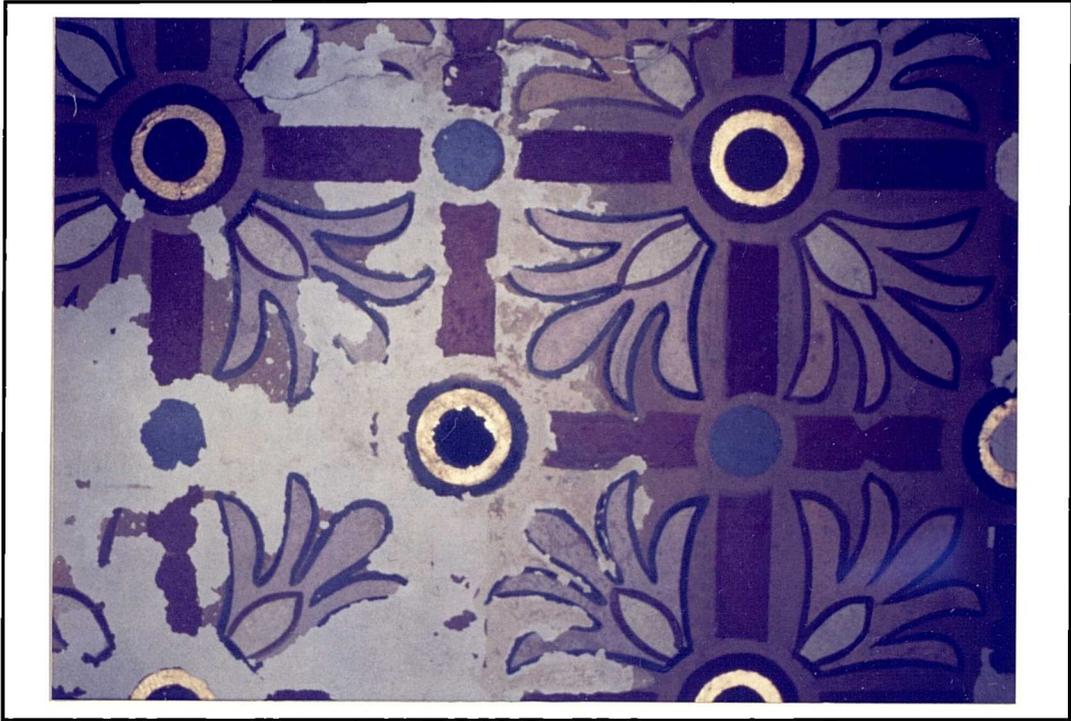
Fig. 132
 Paint losses from wall decorations in the hall of Bishops Court, Clyst Honiton, Devon. The areas of loss clearly show that there is no physical bond between the paint and the plaster, except where the gold size appears to have penetrated through to the plaster.

When a paint film is broken, the process of flaking will proceed rapidly as a result of the loss of vacuum bond⁴ between the paint film and the substrate (*fig.132*). Therefore painted decorations are unstable and vulnerable on surfaces through which water is either absorbed or lost, or if they are lying on a substrate which becomes affected by moisture. The presence of excessive moisture in a porous substrate can lead to disruption of the paint film and, ultimately, severe flaking.

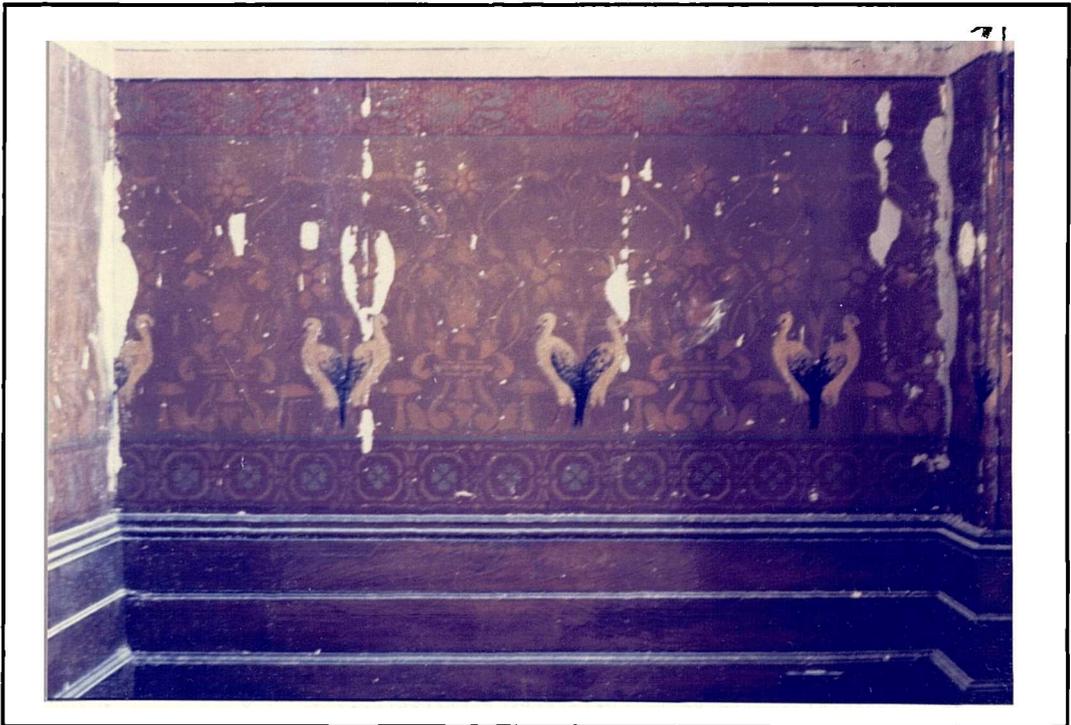
Fig. 133
 Dado decoration in the former residence of Samuel Lyons, Sydney. The paint losses occur in vertical zones along the alignment of the laps of a lining paper which had been superimposed over the decorations and itself painted. Movement in the lining paper has weakened the bond of the underlying paint causing losses in the zone of greatest movement.

⁵In the former residence of Samuel Lyons (now the Domremy Convent) the walls of the main rooms were painted early this century to provide light, uniformly painted room interiors for educational purposes. The painted decorations by Lyon, Cottier and Co. were covered with lining paper prior to the painting. With seasonal changes the overlayer of paint and paper expanded and contracted with changes in relative humidity in the room causing significant loss of the original paint film along the vertical joints of the lining papers where the movement in the paper was most pronounced.

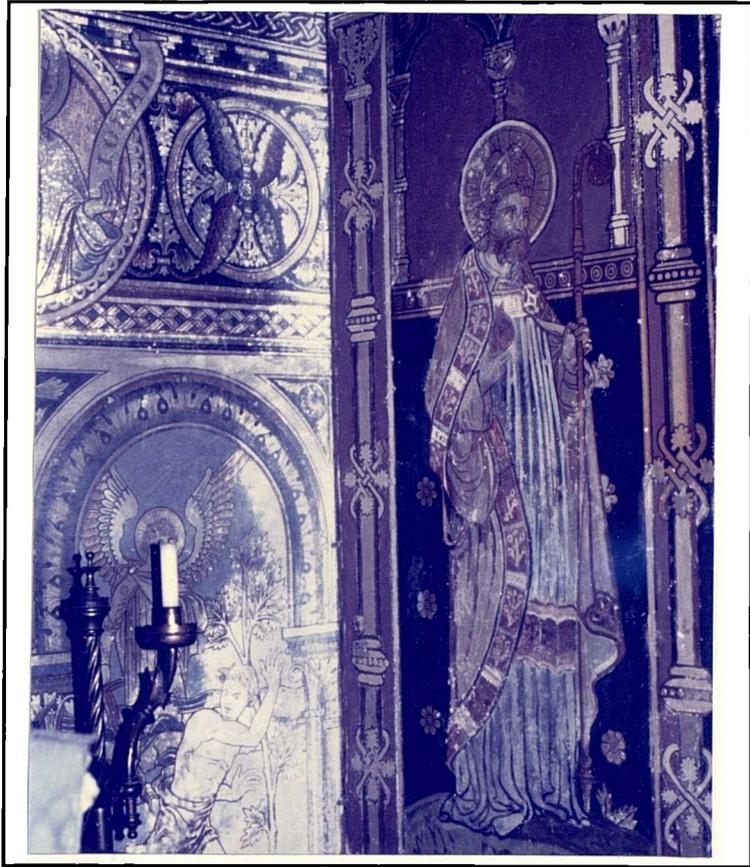
Fig. 134
 Damaged wallpaintings in the nave of the church at Garton-on-the-Wolds,
 East Yorkshire. The losses are most serious on the inside of the exterior
 wall and the contiguous interior cross wall due to penetration of moisture.

Deterioration caused by damp is often accompanied by chemical activity arising from the presence and migration of acids and alkaline salts. Damp-induced chemical activity is commonly observed in areas where water enters a building around windows and in corners, conveying soluble salts whose origins are atmospheric pollutants or the masonry building fabric itself (*fig.134*).

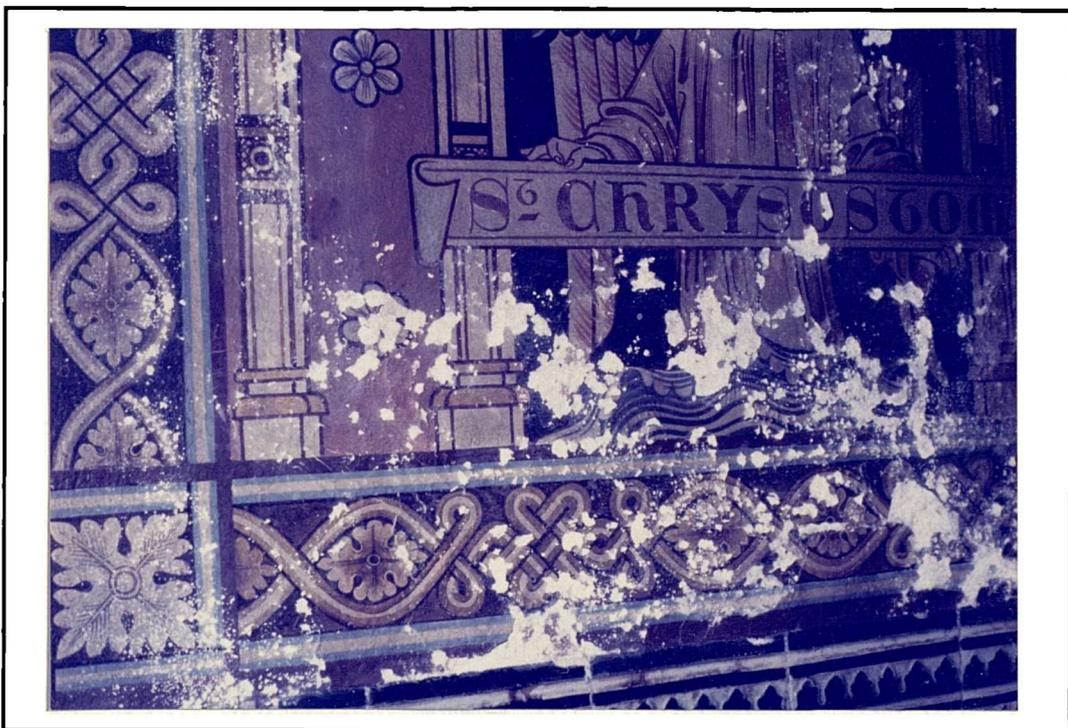
Fig. 135
 Deteriorated painted decorations at Garton-on-the-Wolds. The losses relate
 to the effect of moisture and salt contamination in the masonry and plaster.

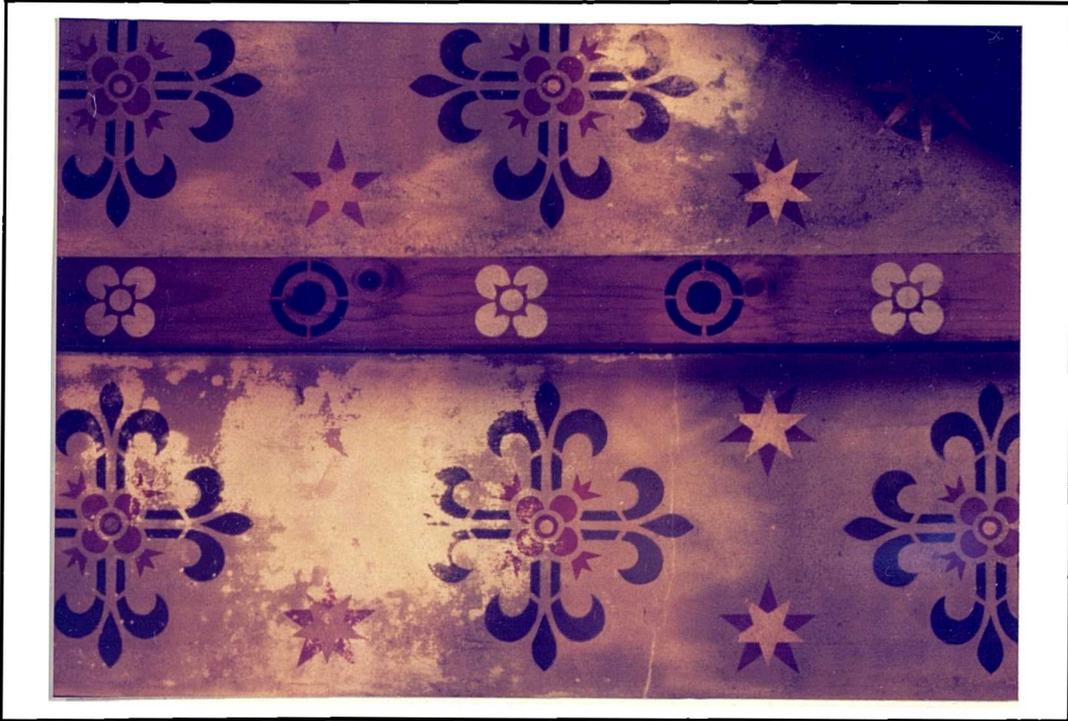
Fig. 136
Ceiling decorations in the Church of St Issey, Cornwall. The fungal growth is under the surface of a clear varnish which was applied over the painting.

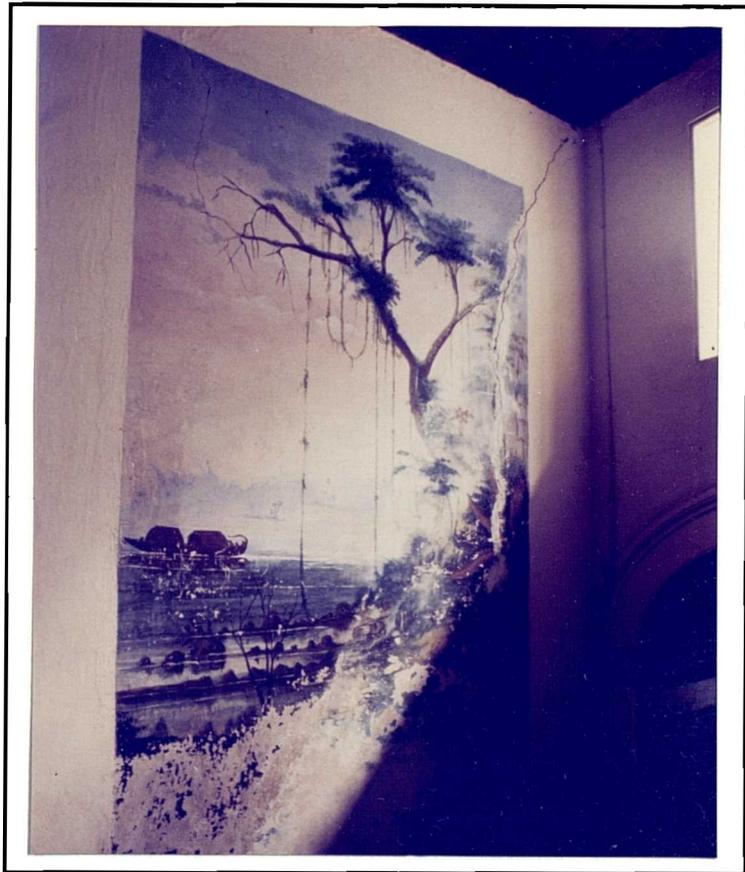
Fig. 137
Amateur wall painting in the Commandant's residence, Port Arthur, Tasmania. The structural crack has admitted moisture accelerating deterioration of the painting.

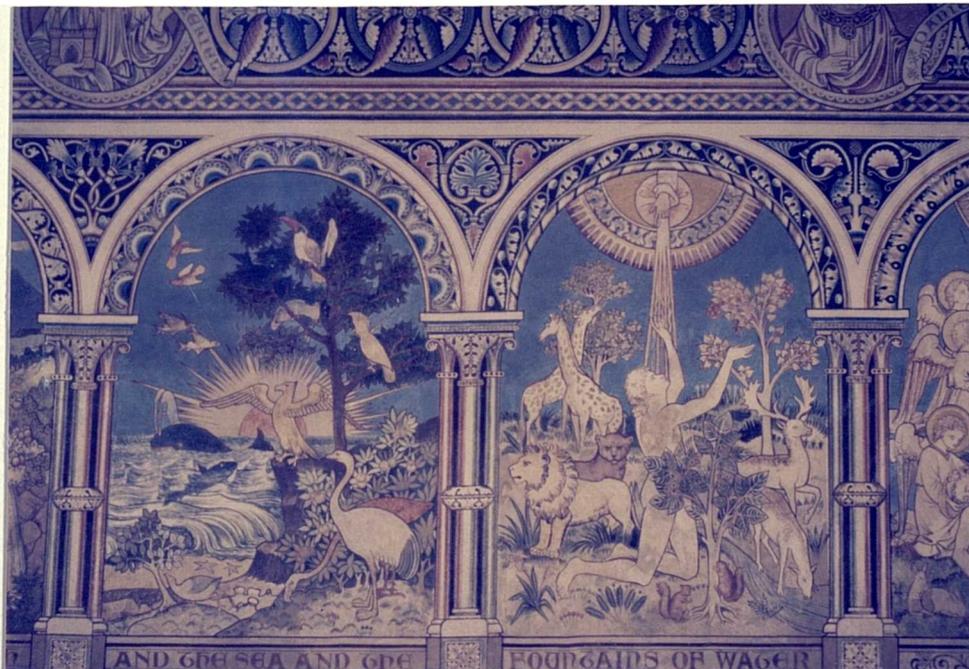
Illustration

Large areas of the wall decorations were disfigured by salt efflorescences and, where the salt activity had gone unchecked, there were significant losses of paintwork. The plaster remained intact everywhere except on the south wall of the nave where an area became detached from the masonry. There was a clear relationship between the poor condition of the wallpaintings and deterioration of the fabric of the building. The plaster was detached from the wall in areas of the lower south wall. An earlier attempt to restore the paintings on the east wall of the nave resulted in areas of different tonality, requiring further treatment.

Following recording and repair of the building fabric and the analysis and trial work on the wallpaintings, the conservation work proceeded in small areas in accordance with a five step procedure.

1. **Removal of salt efflorescences**
Salt efflorescences were removed from the surfaces of the painted decorations by light brushing.
2. **Consolidation of hollow plaster and flaking paint**
According to the degree of damage the plaster was re-attached using a traditional lime and washed sand plaster or by the introduction, to small voids, of lime milk made workable by the addition of casein. Areas of fresh plaster were ready to receive paint within a few days. Friable and powdery surfaces were consolidated with diluted casein applied from a hand spray.

4. **Repair of plaster losses**
Plaster losses were infilled with new sand/lime plaster.

Losses and areas of missing decoration were infilled or reconstructed in casein emulsion paint to which a few drops of linseed oil were added. Colours were matched on site by the conservators who made up the colours from a selected range of stable pigments.

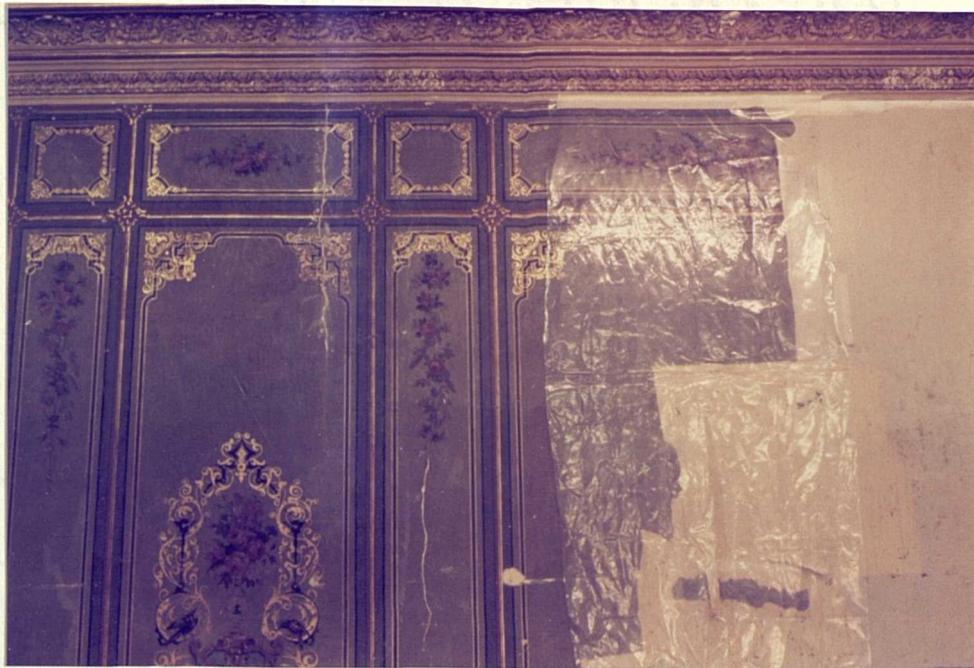
Illustration

The significant scheme of painted decorations survived in excellent condition underneath an overpainting of cream water-soluble distemper and several coats of alkyd enamel and acrylic emulsion paint finishes. The topcoats were showing signs of failure due to the poor condition of the underlying distemper. The presence of this distemper greatly facilitated the ease of separation of the overlayers from the original paintwork.

The topcoats of acrylic emulsion paint were removed with spatulas after they were softened with a hot air tool.⁵ The cream distemper lying over the c.1840 decorations was removed by means of water (to soften the distemper) and cotton swabs. This method enabled the removal of the overlayers without any damage to the oil medium *impasto*.

The sound condition of the decorations, and their resistance to the effects of water, made it possible for the unskilled assistants to use the cotton swabs to remove the distemper without damage to the oil painted surfaces below. It is a striking feature of the restored decorations that they show no signs at all of having been overpainted. The *impasto* has retained a truly beautiful texture.

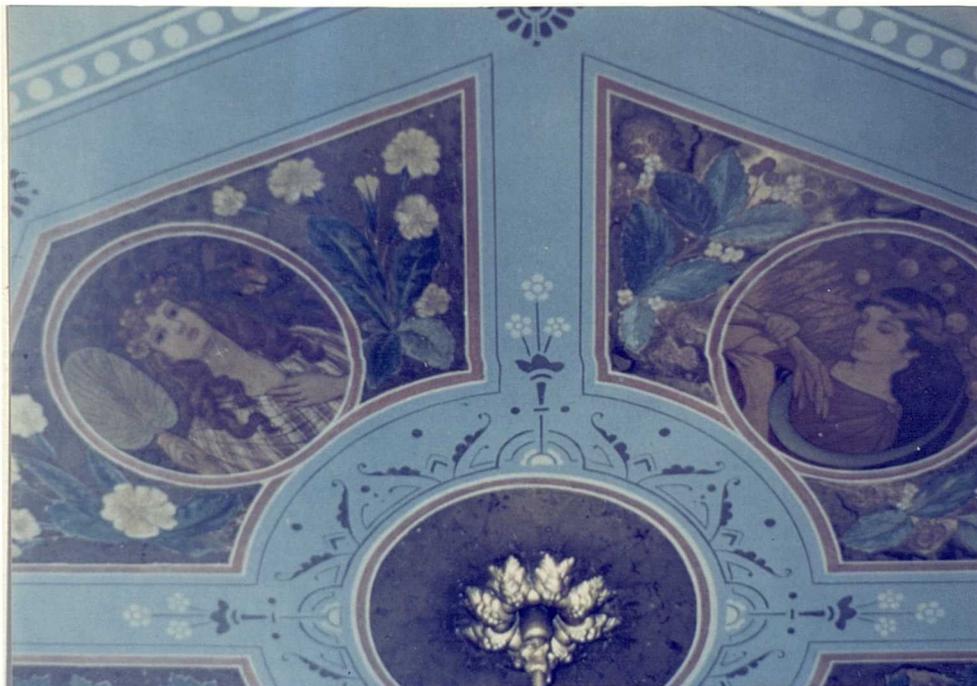
Illustration

The ceiling decorations survive from a comprehensive Aesthetic scheme which conformed to the model developed in Britain by the Art decorators. They had become soiled and slightly damaged, requiring consolidation and cleaning.

Although Government House was a very well maintained building, the interior decorations were not conserved to the same high standard as the building fabric. Only the painted ceiling decorations of the original aesthetic scheme remained intact following many overpaintings of all of the wall and joinery decorations, commencing from the 1930s. The paintwork on the ceilings had become soiled during more than one hundred years of exposure. There were minor paint losses due to flaking in some areas and discoloration in other areas where earlier repair work had been carried out in unstable materials. It was proposed therefore to clean the ceilings and to undertake essential consolidation and repairs in 1936.

staining of the main border of gilding which is believed to relate to salt efflorescences which arise from condensation on the gold facilitating the movement of salts from the plaster.

It was observed that the ceilings had been cleaned some time before, leaving some areas undercleaned and others overcleaned, causing an uneven appearance. Thus it was agreed to aim for uniformity rather than total cleaning. Special care was taken with the high and pointed impasto of the stencil work to avoid removal of the raised stippling. On the coated oil gilding the cleaning aimed to remove the salt efflorescences and the crumbling varnish in the areas of the efflorescences. The cleaning was undertaken with a solution of 50% acetone and 50% de-ionised water applied with a cotton swab which was used also to pick up the softened dirt and degraded material. Plain de-ionised water only was used on the Four Seasons.

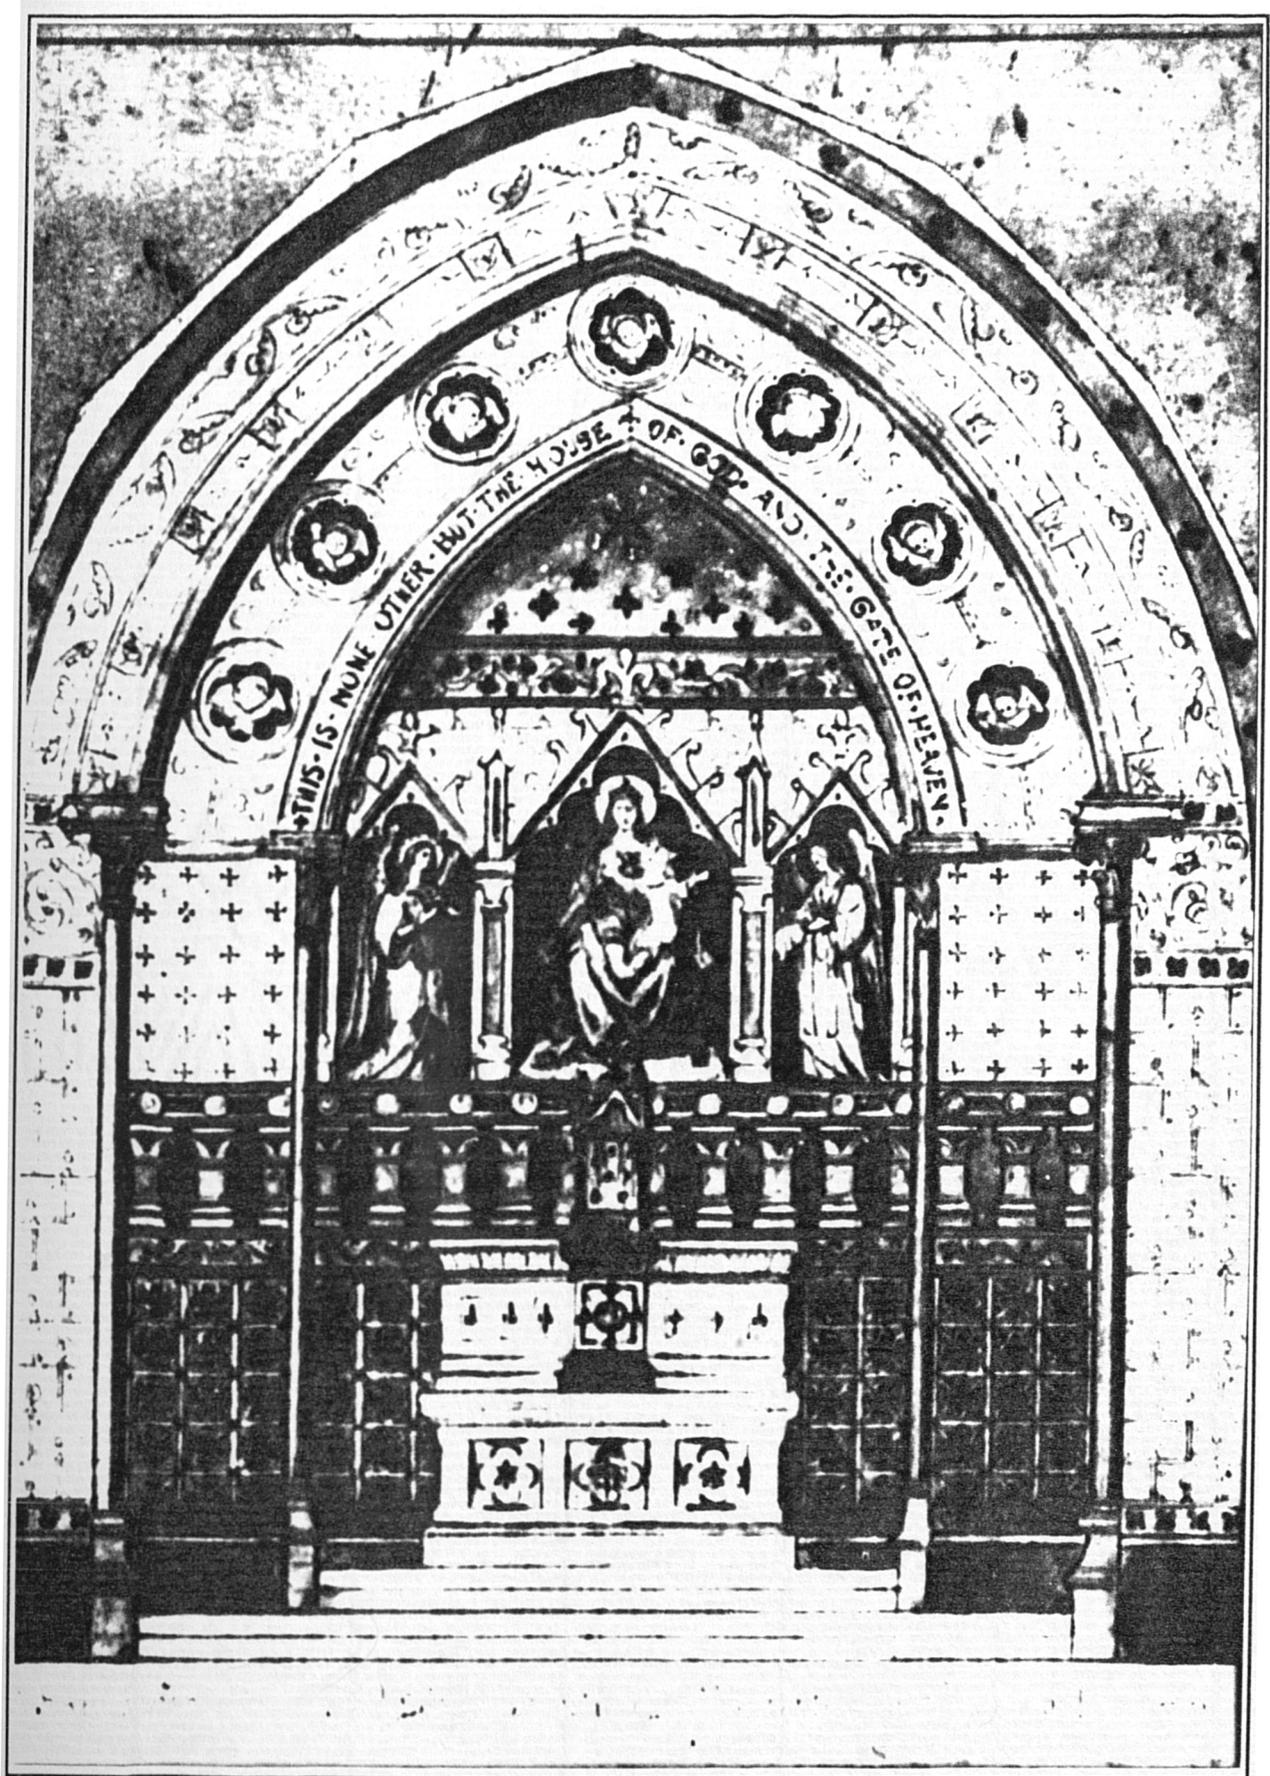
Design by Lyon, Cottier and Co. for the painting of the East End of the Second Chapel (1897). Source: Mitchell Library, Sydney.

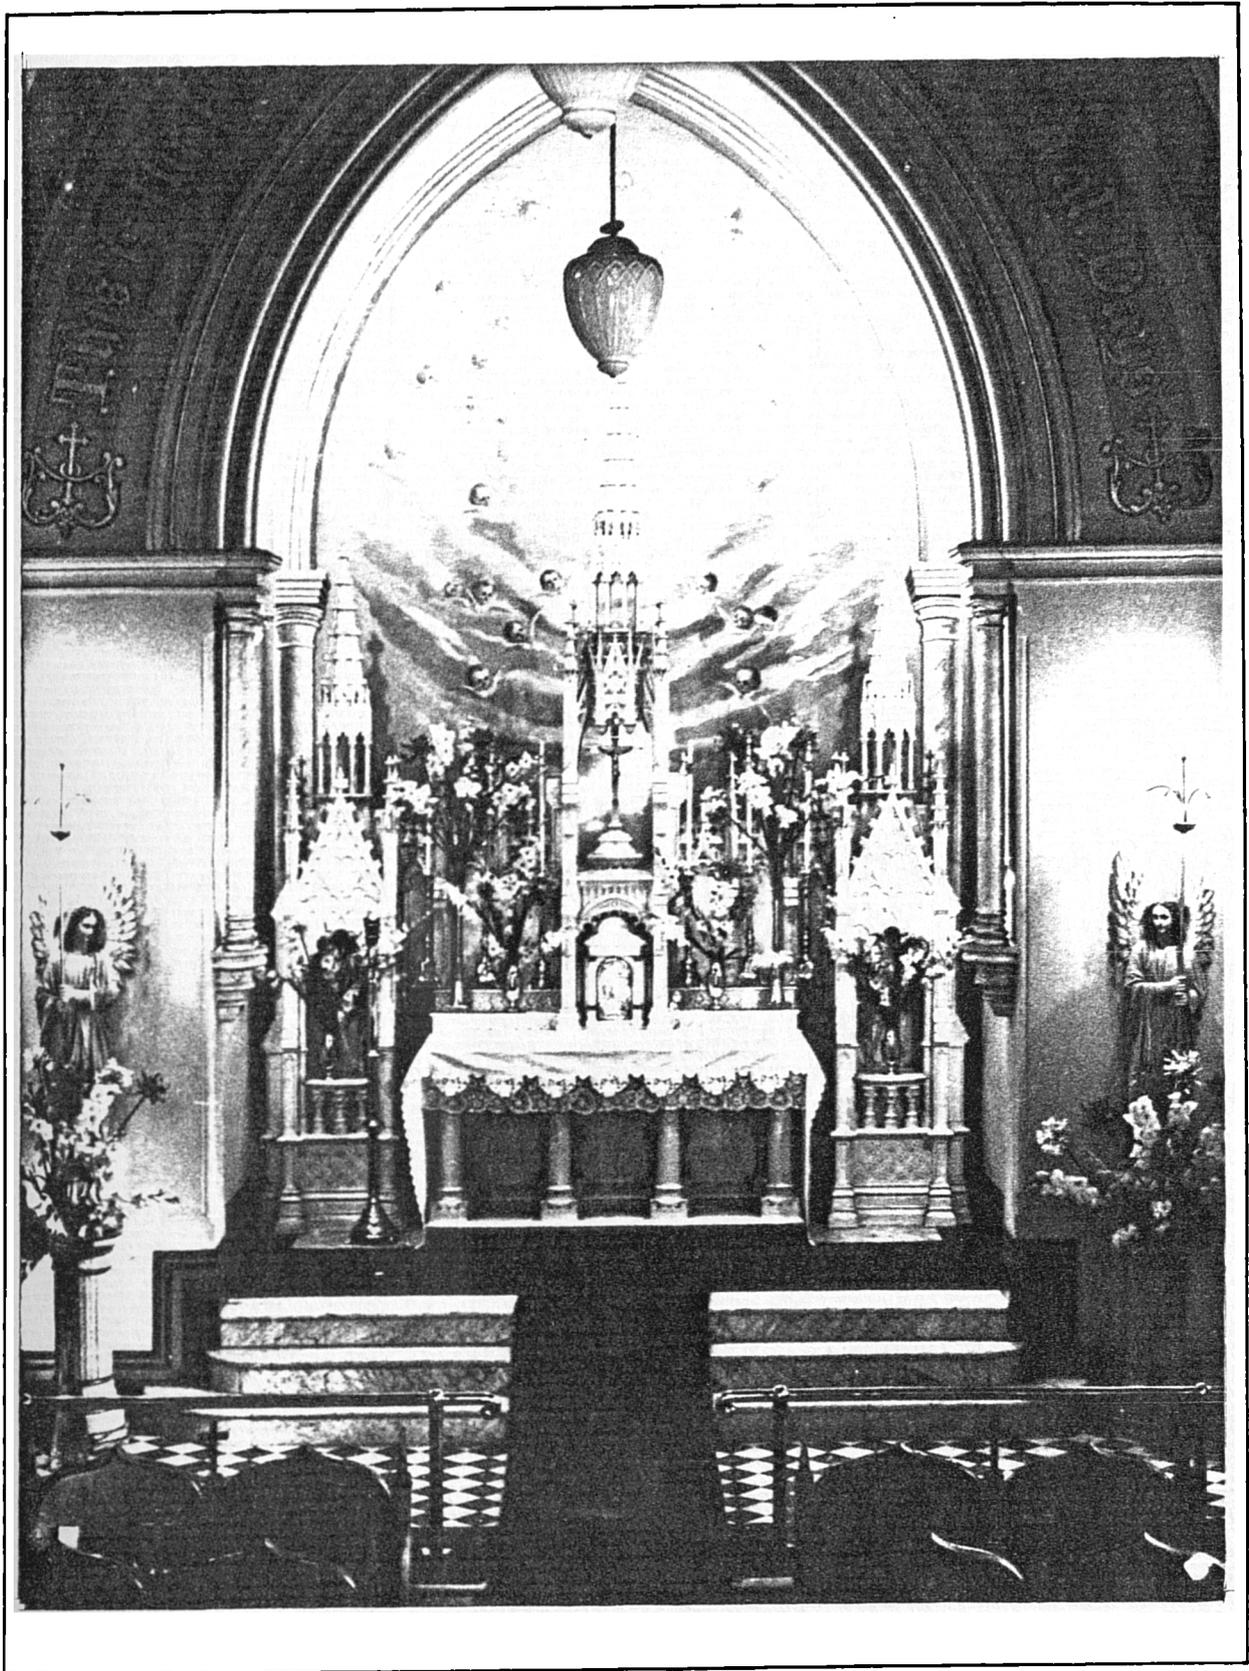
View of the East End of the Second Chapel (c.1930) showing the second scheme of painted decorations. Source: St Vincent's Hospital Archives, Sydney.
