NINETEENTH-CENTURY PAINTED DECORATIONS

IN BRITAIN AND AUSTRALIA:

AN APPROACH TO CONSERVATION

Volume Two
(Appendices)

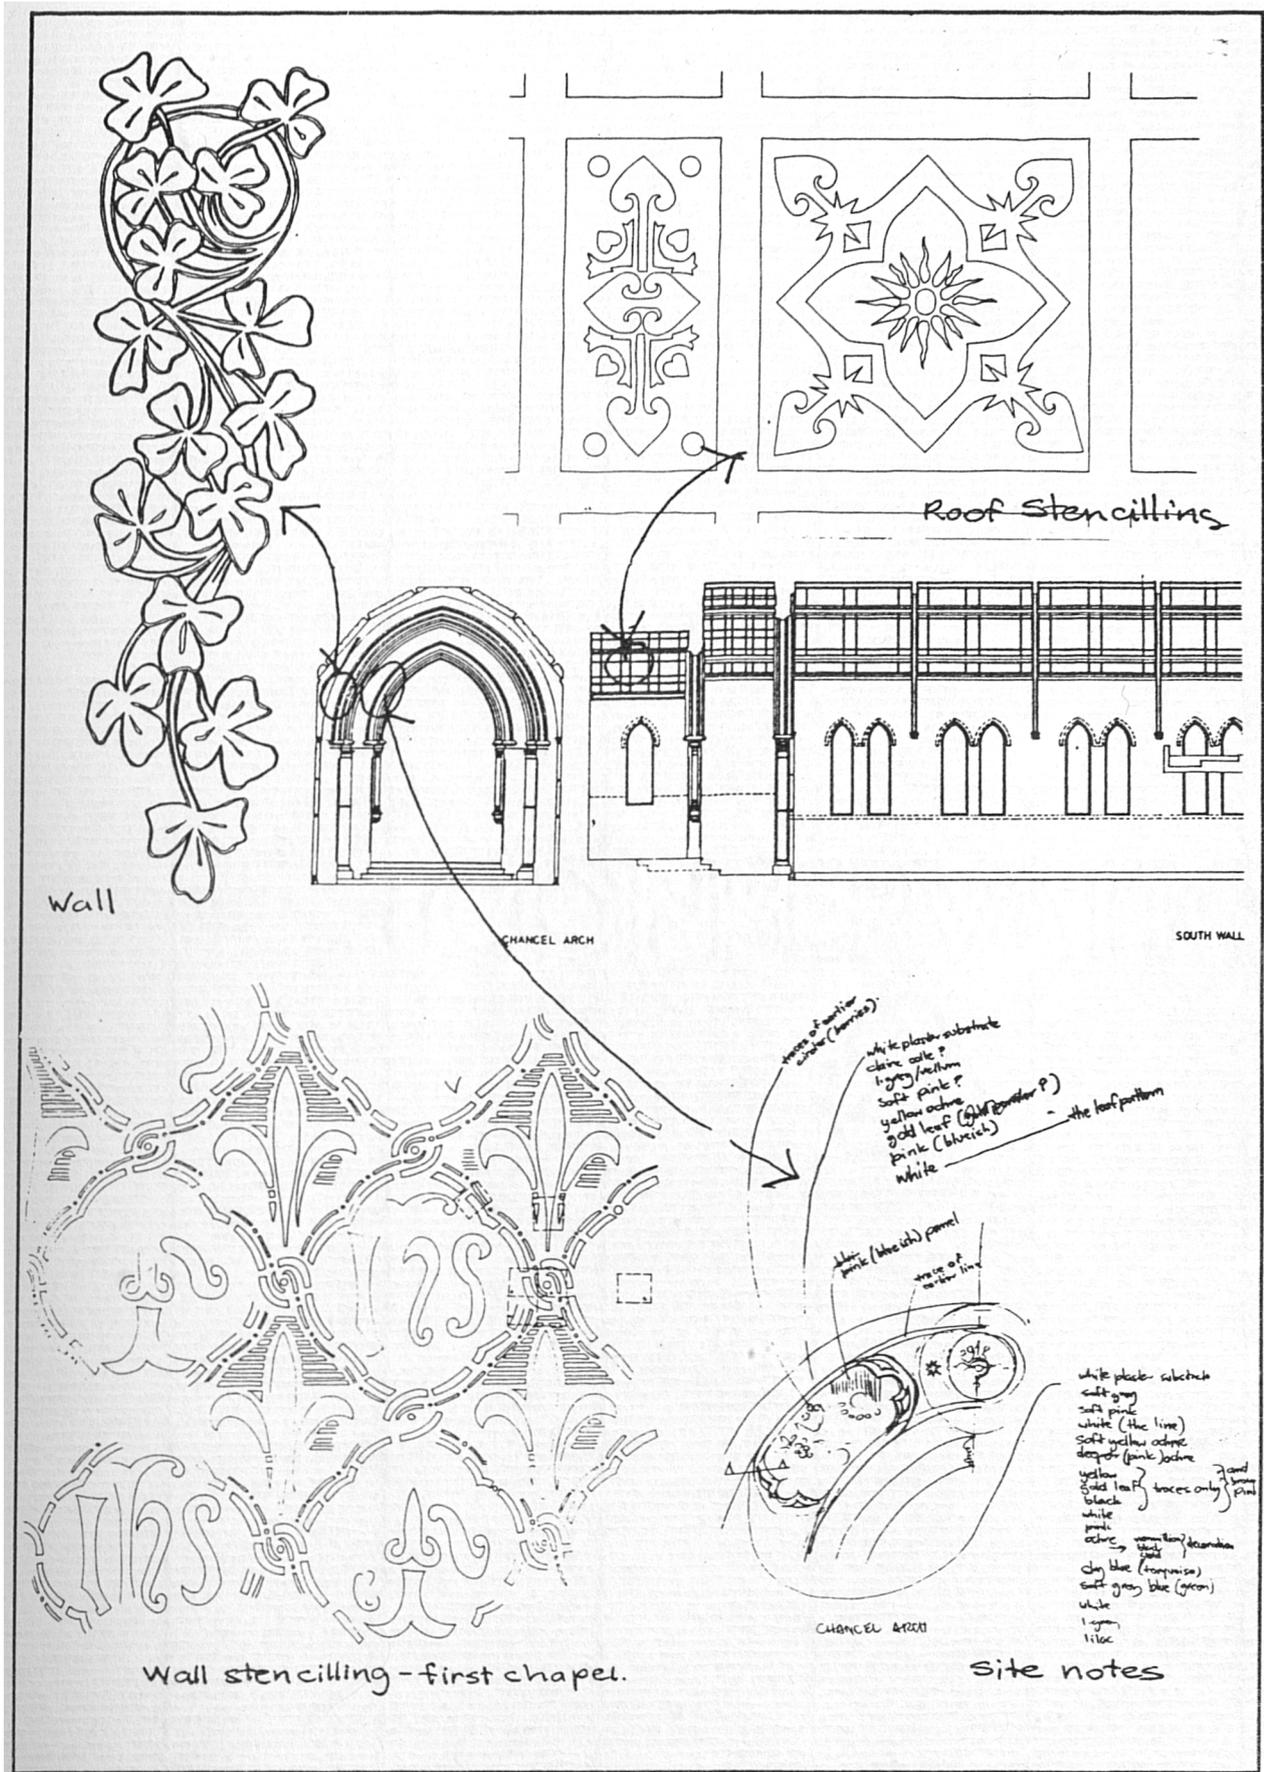
Examples of the reduced scale drawings of the painted decorations exposed during research on the Chapel at St Vincent's Hospital in 1986. Source: NSW Public Works Department.
