# Construction Materials Consultants Ltd.

## CERTIFICATE OF ANALYSIS OF PLASTER SAMPLE FOR BINDER TYPE DETERMINATION & MIX COMPOSITION

Project Reference	:	Old York House, Malton, North Yorkshire
Sample Source	:	Internal Plasterwork
Sample Description	:	Finish coat Plaster.
Date Received	:	19 <sup>th</sup> June 2019
CMC Sample Ref	:	SR 2735 - S1
Method of Test	:	Mix composition by acid digestion, and binder type by XRD analysis by in-house procedures, with fabric condition from a thin section examination.

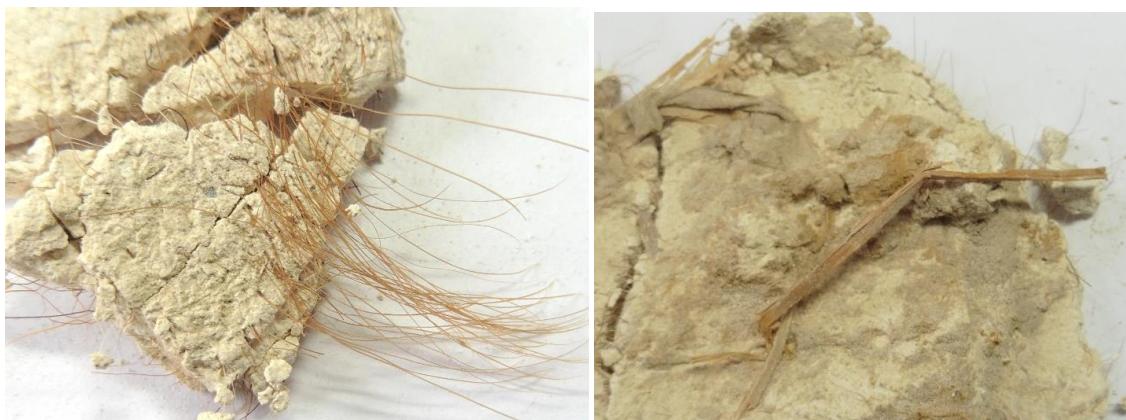
**Plates No. 3 & 4:** The left plate above is a close-up of a fractured edge, showing the abundance of hair present in the plaster coat. With the right plate being a magnified view of the inner contact surface with retained clay mortar and straw reinforcement from the base coat plaster adhering strongly to the plaster finish coat.

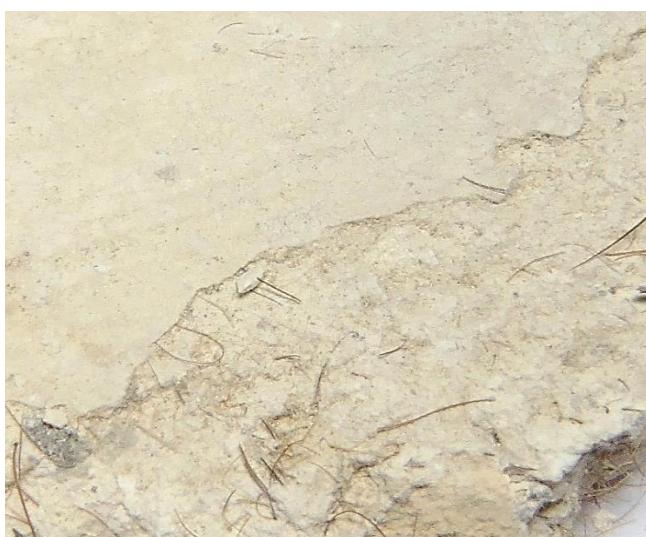
**Plate No. 5:**

The plate on the left is a close-up of the surface, showing the thin outer surface formed from a skim coat, which had received a surface applied coating at some time in the past. The coating may be a distemper or a lime wash, but to confirm if it was a gypsum gauged skim coat a sample was obtained and analysed by XRD.

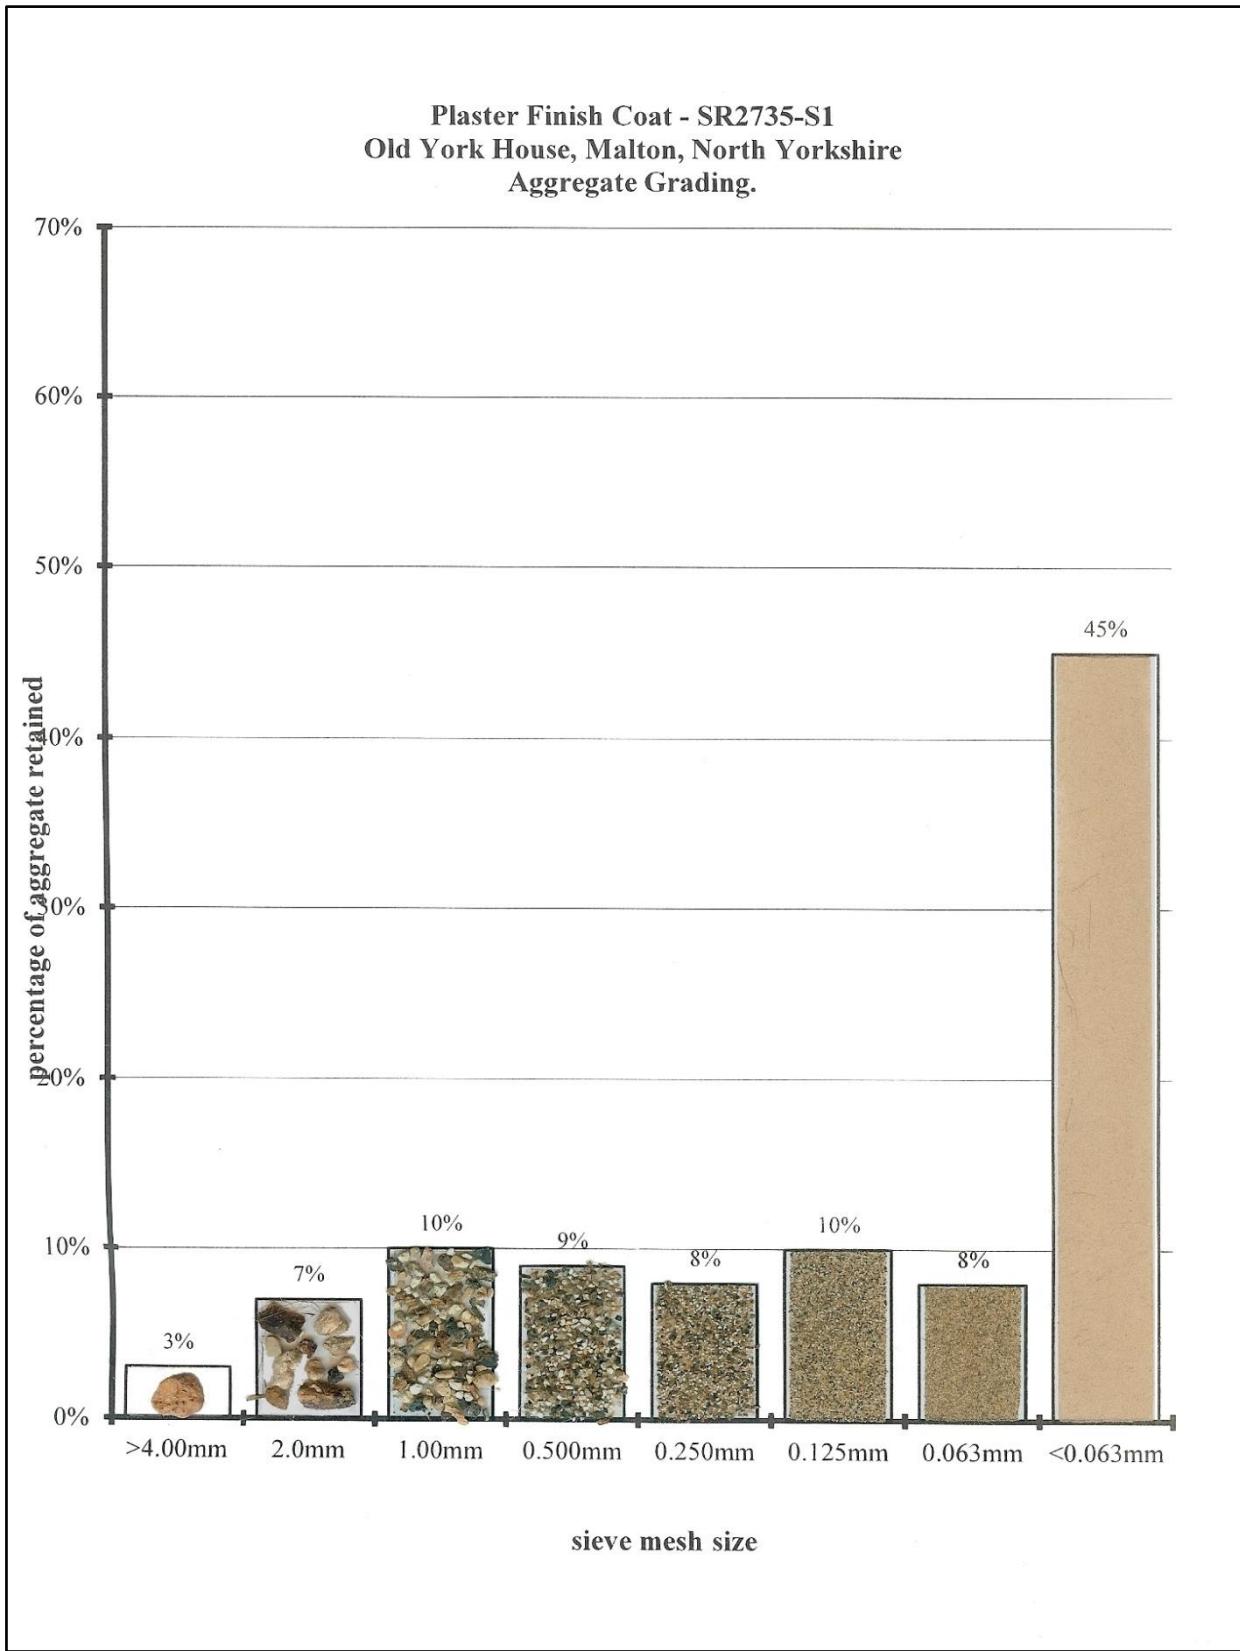
The aggregate from the acid digestion was recovered and the particle size distribution determined. The results of the aggregate grading are presented in the form of an aggregate filled histogram, in the appended figure No. 1 and in the table below:

Sample Reference	SR2735 – S1 Finish Coat Plaster		
	British Standard Sieve Size	Percentage Retained	Percentage Passing
8.00mm	0	100	
4.00mm	2.5	97.5	
2.00mm	7.1	90.4	
1.00mm	9.8	80.6	
0.500mm	8.7	71.9	
0.250mm	8.4	63.5	
0.125mm	10.3	53.2	
0.063mm	8.4	44.8	
Passing	44.8

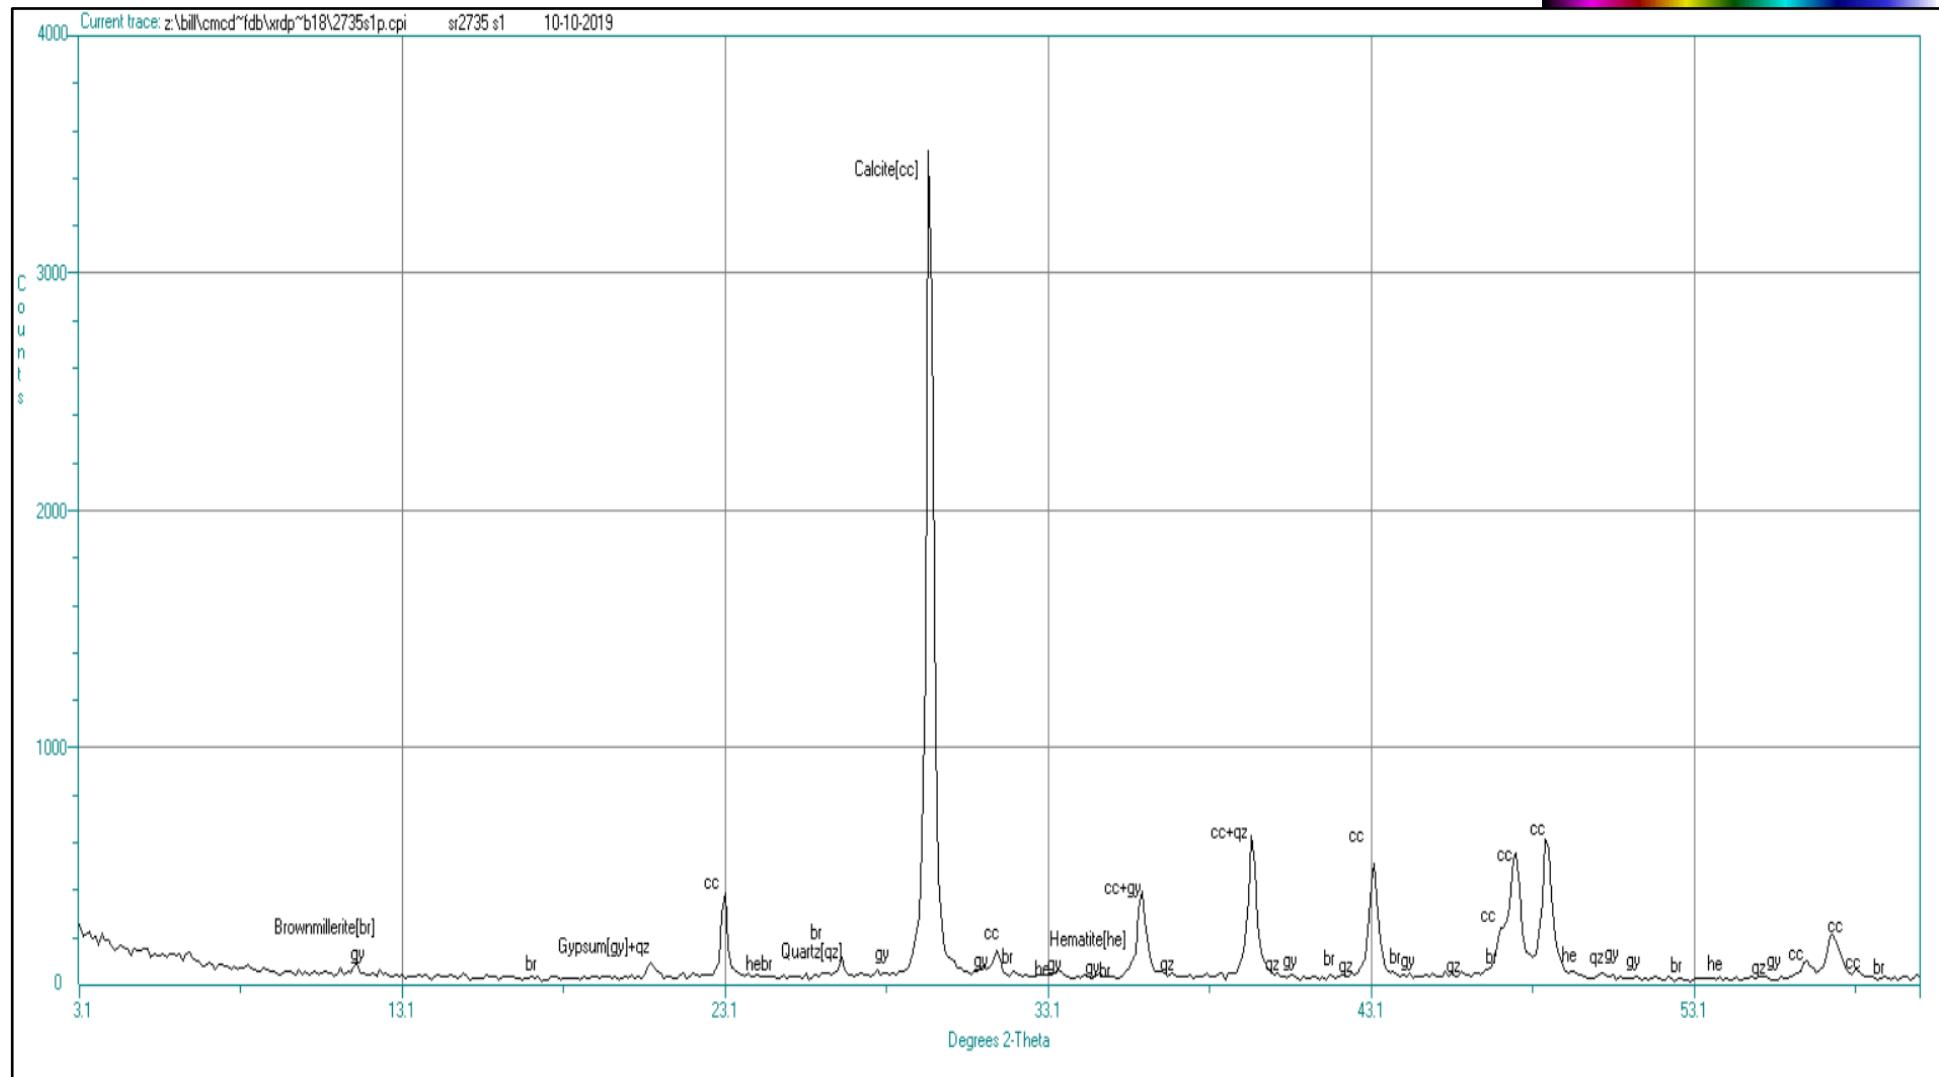
**Figure No. 2:** Sample SR2735-S1 – Internal Finish Coat Plaster, ex The Old York House, Malton,

On the basis of the XRD analysis, it is indicated that plaster sample was made from a non-hydraulic air lime. The plaster is fully carbonated and there was only limited evidence of a sulphate reaction product present, which may be due to the presence of ash in the mix, or the age of the plaster sample. There was no gypsum in the outer skim coat.

The sample is composed mainly of calcite (Carbonated lime), with the minor quartz, from the fine aggregate, which included a proportion of coal ash and clinker. Gypsum is present as a reaction product within the body of the plaster coat, probably between the lime in the binder and sulphates in the ash, or from the impact of environmental sulphates (soot, smoke, rising damp, etc.). The Iron Oxide is considered to be a component of the ash added to the plaster. The low hydraulic component detected is considered also to be a function of the presence of the ash in the plaster, rather than infer tah the lime was feebly hydraulic.

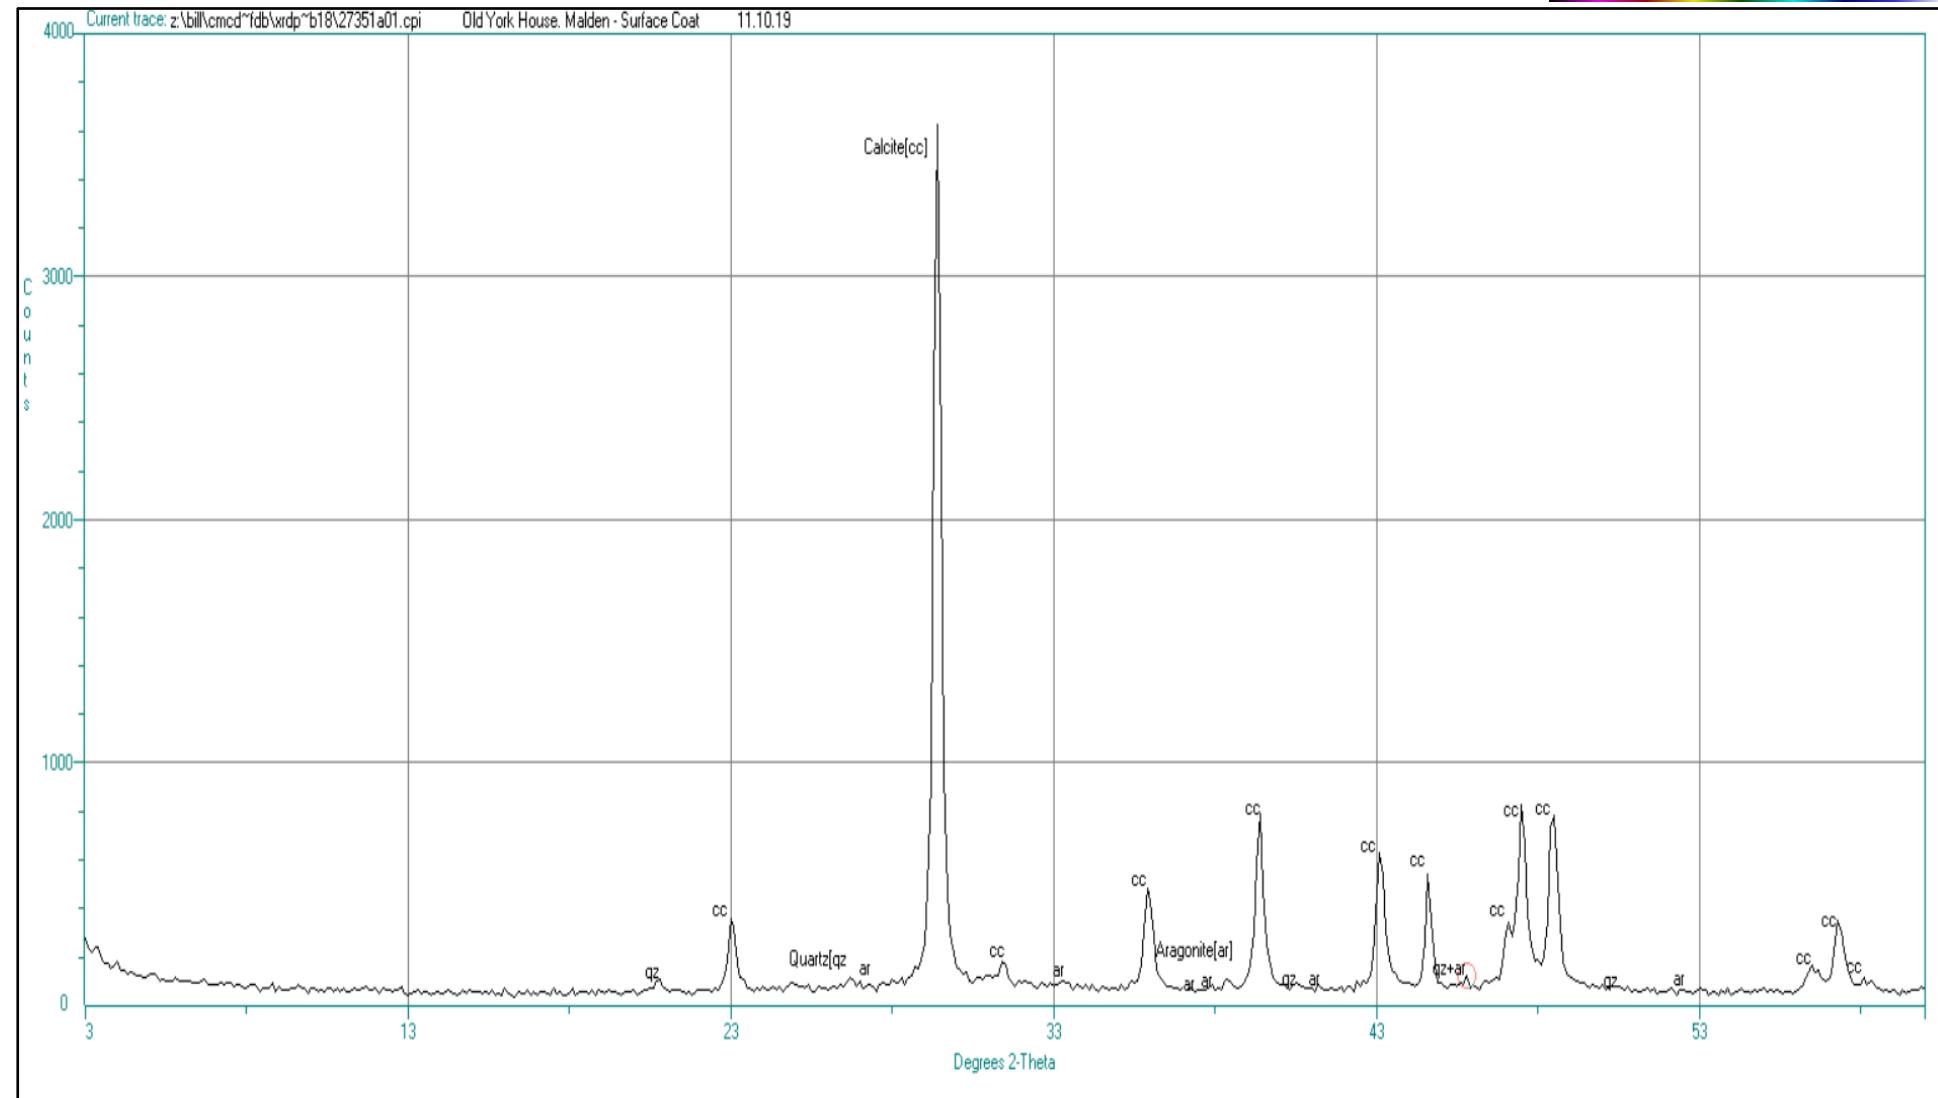
**Figure No. 3:** Sample SR2735-S1a – Thin coating on outer surface of Finish Coat Plaster

The thin outer surface is composed of calcite, with aragonite, which may suggest that it had received a coating of distemper or a lime wash sometime in the past.
