**Historic Timber-built Seacoast Piers of Eastern  
England: Technological, Environmental and  
Social Contexts**

Volume 1 of 2

University of York

Archaeology

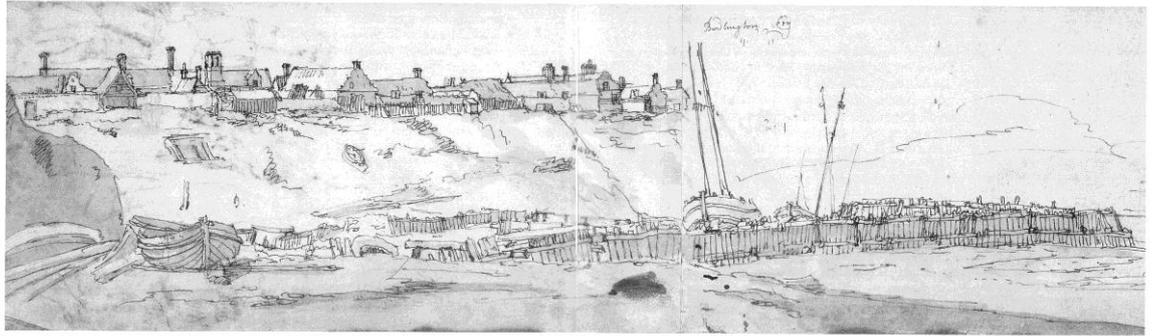
Figure 2, *The south pier at Bridlington c. 1700 as drawn by Francis Place (reproduced from Neave 2000; original held by British Library)*

The inner and outer walls of the piers depicted in the Francis Place drawing were of close-driven pile type and this is likely to have been the case since the 16<sup>th</sup>-century at least. We know from the Henrician documentation that a number of pile-drivers (*rames*) were used during construction at any one time (TNA E 101/622/29). Further, the survey of 1554 lists the timber requirements for repairs to a 110 foot (33.5m) stretch of the damaged north pier as being 120 timbers, each being a foot (0.3m) square and 24 feet (7.3m) in length. The cross sectional timber size mirrors that of the driven piles that formed the walls of the piers at Great Yarmouth.

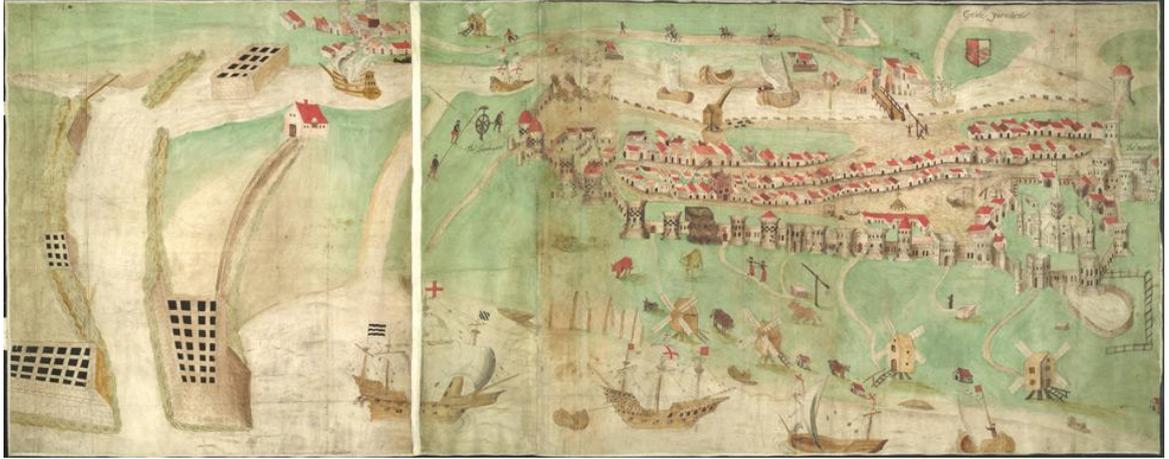
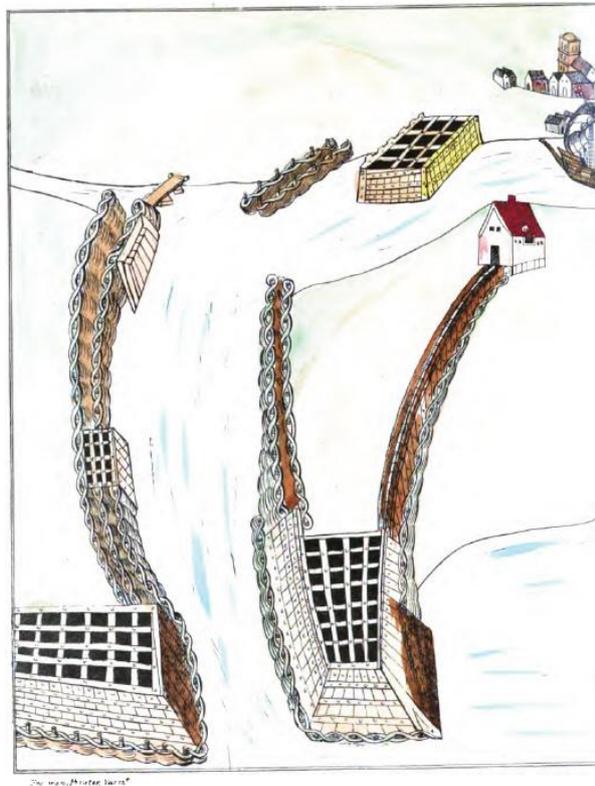
*Figure 3, Town of Great Yarmouth with the piers shown to the left. Stated to originate around 1570, this picture map is perhaps more likely to date to the time of the proposals of 1560 (British Library, Cotton Augustus l.i. f.74)*

*Figure 4, Detail of Figure 3 (reproduced from Palmer (1854))*

The depictions, (Figure 3 and Figure 4: detail), show the quay with its various riverside facilities on the west side of the town. Both sides of the channel are depicted as being stoutly revetted, mostly with wattle-work, whilst some vertical timber-work is also evident. This lining to the newly cut channel was to secure its course and prevent the waters straying. Two projecting works, one of brushwood and one of timber, are shown on the west side of the bend of the river adjacent to the channel. The primary function of these was probably to deflect the southwards current of the river thereby assisting the waters flow into the channel. The north and south piers have the appearance of short bulwarks rather than the long piers of the documentary sources. This may be the result of artistic impression or could even represent an early intention. However, the depiction of their structural detail does not appear to contradict the documentary sources of the 1560 and 1580 estimates. Both structures appear slightly wider at the base than the top whilst three rows of what may be “*longers*” are shown on the exterior faces of the piers. These are affixed against upright timbers that are either a cladding of the three inch planks or the walling of piles. The brushwood around the base of the piers accords well with the “*worck throughe which all the said piles shalbe drevyn being for the fowndacyon therof*” of the 1580 estimate. An interesting detail of the depiction concerns the framework of lateral timbers and three rows of longitudinal timbers within the pier itself. Correlation for such in a documentary context may be the “*bynding*” of the 1560 estimate. This arrangement also accords well with the “*beames*” of the 1580 document equating to the lateral members and the “*to every beame thre brasinges*” representing the longitudinal members.

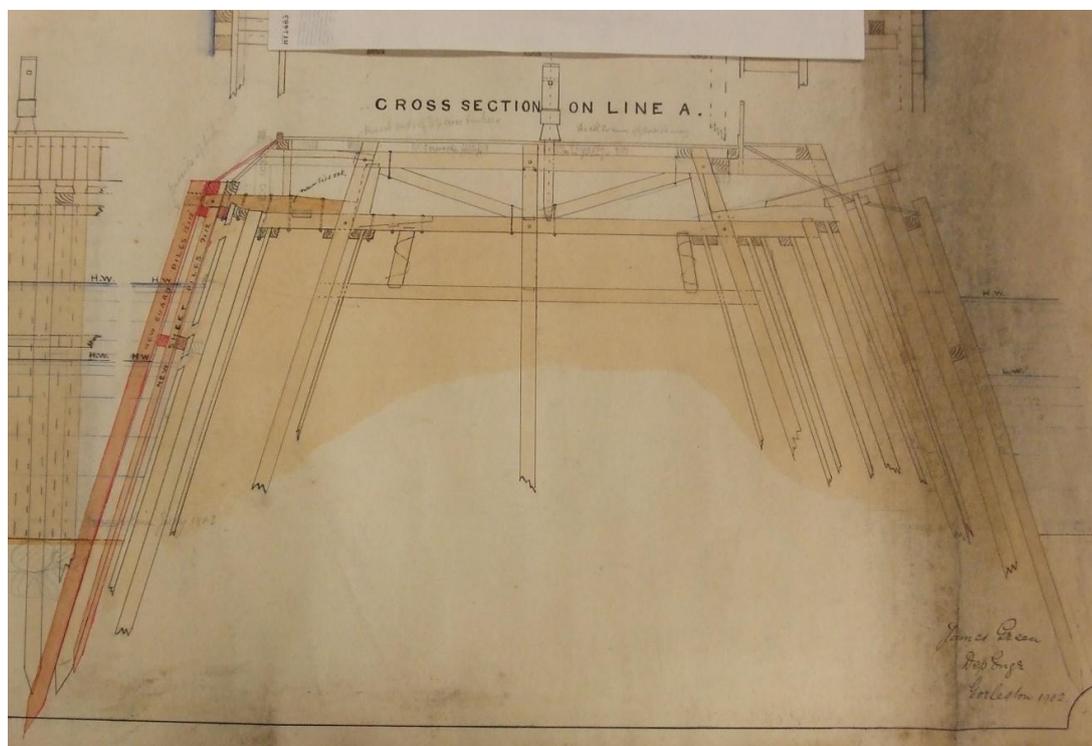
*Figure 5, Section through Great Yarmouth north pier by John Coode, 1902, (NRO Y/PH 1360). Note the multiple re-facings*

pier Coode stated that “*this Pier is a formidable mass of old timber Piling, in some parts there are as many as eleven tiers of longitudinal oak Piles, and from two to four skins or faces of timber sheeting on the Sea and Harbour sides, the hearting, or centre, consisting of marl, shingle, and small chalk stones, and the whole resting upon a sand and shingle bottom*”. What Coode is describing in his “*eleven tiers*” is the successive re-casing of the pier, rather in the manner of a Russian doll, as decay and damage necessitated repair. Coode produced a number of detailed measured sections through the piers, one of which, dating to 1902, through the south pier and showing the multiple encasings is reproduced as Figure 5 (NRO Y/PH 1360). This shows a multiple series of angle driven piles connected at a high level by transverse members or tie-beams. The innermost sets of piles are of earlier date and those towards the exterior later. Between many of the successive walls of driven piles there are horizontal timbers that are almost certainly ‘wales’. In many instances successive pile walls were secured to the older body of the pier by short struts. One consequence of successive re-sheathing of the piers is that their width became ever greater. Such multiple re-cladding implies the likelihood of considerable antiquity for the earliest components – possibly as far back as the original piers of the 16<sup>th</sup>-century?

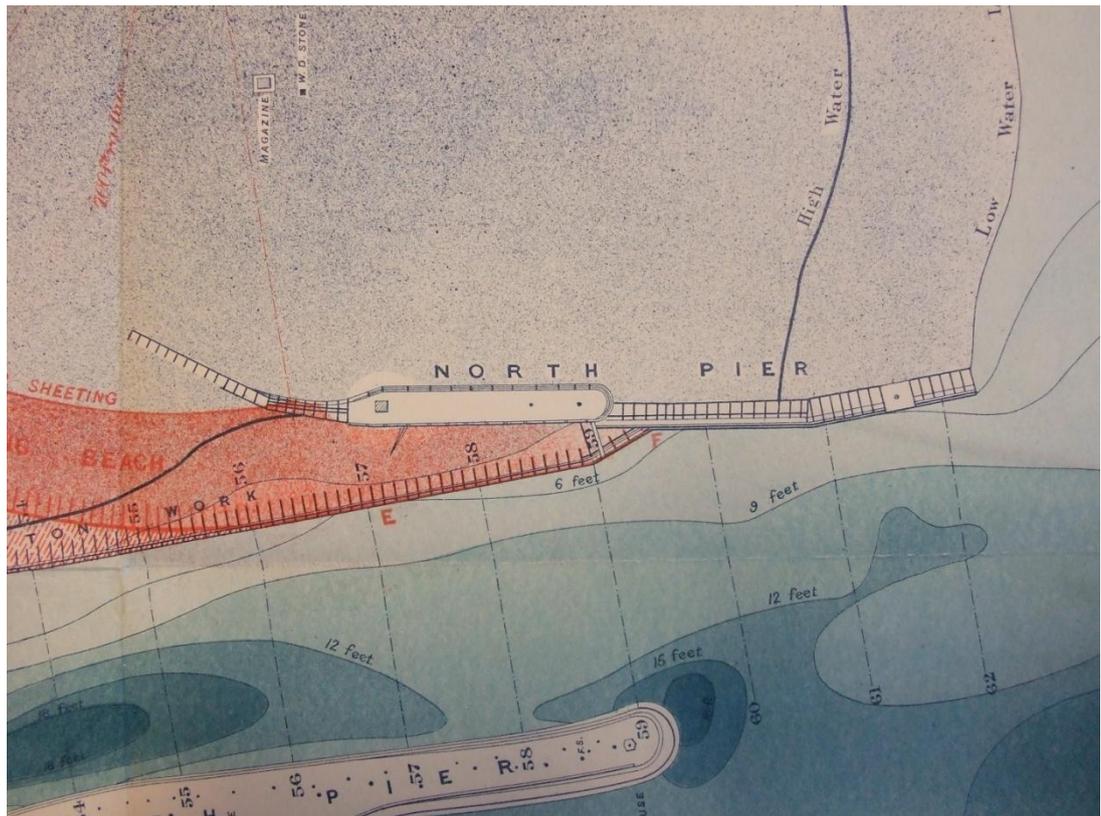
Figure 6, Plan of Great Yarmouth north pier by John Coode, 1885, showing lateral divisions within (NRO Y/PH 120c)

A report by Coode dating to 1885 (NRO Y/PH 120c) is accompanied by a plan of the piers in which the principal elements of the north pier are visible in outline, Figure 6. This shows the walls of the pier with their interior spaces as being divided by a series of transverse lines representing lateral bracing or tie-beams that partition the pier into a series of bays. Further reports by Coode of 1896 (NRO Y/PH 120d) provides similar detail as does an 1865 drawing of Joseph Cubitt (NRO Y/PH 1199).

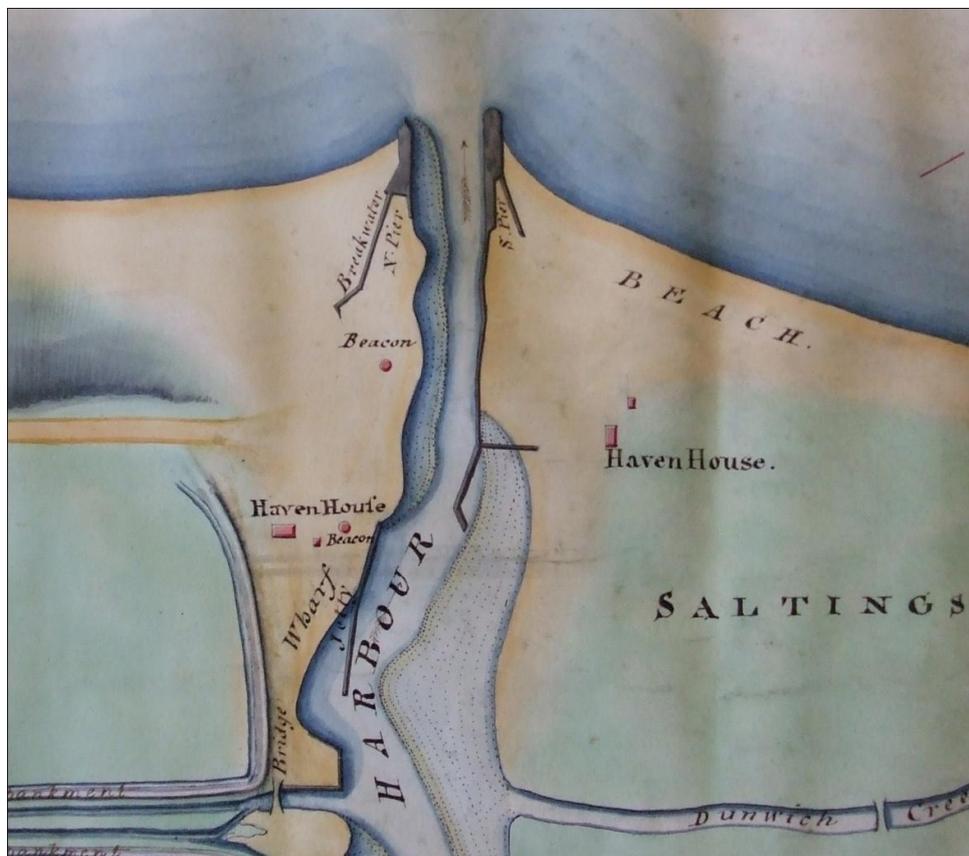
*Figure 8, Extract of 1830 plan of Southwold harbour by T.W. Ellis. North is to the left. (S  
R O: B15082.23)*

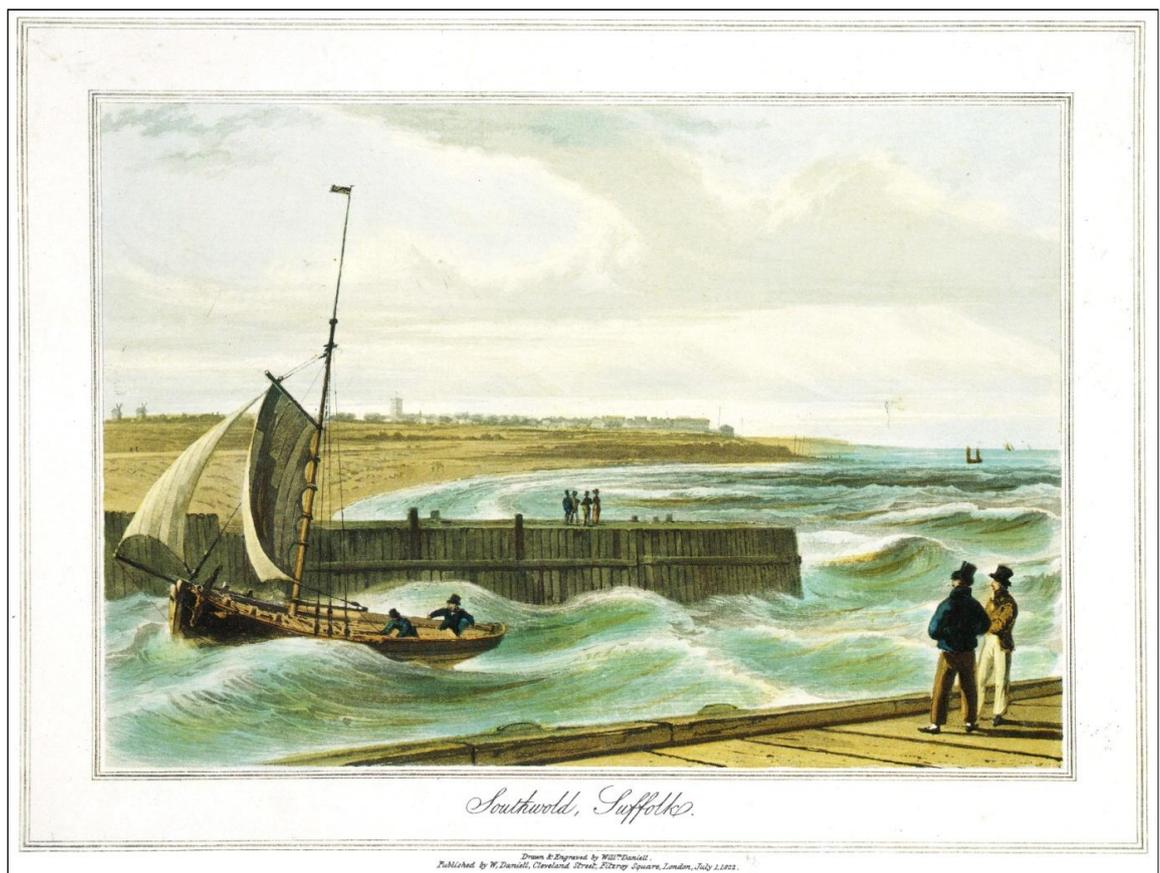
*Figure 9, Engraving of Southwold piers, 1822, looking north (reproduced from a print in  
Southwold Museum)*

Excepting plans the earliest depiction of Southwold piers is an engraving of 1822 which shows its basic form of construction, Figure 9. The inner wall of the north pier is shown as close-piled whilst the profile of the end of the pier suggests these to have been driven at a steep, but not vertical, angle. Towards the top of the pier a stout horizontal wooden rail can be seen. This appears to have helped retain the pile sides in alignment and is likely to have been connected internally to a series of tie-beams or other structural members. Visible areas of decking are all of laterally lain planks.

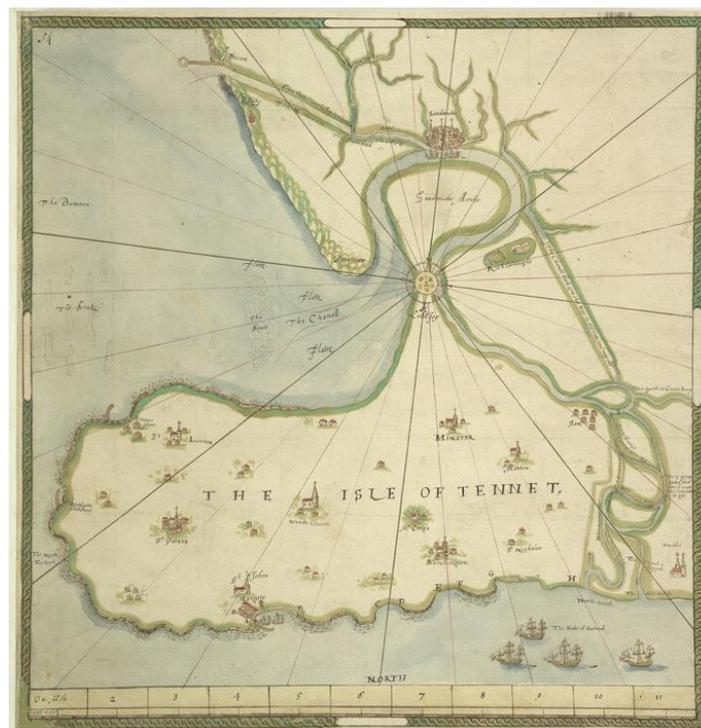
*Figure 10, Map of 1548 showing Rogers' proposed cut of across Sandwich Marsh to the sea. Note the pier arrangement at the cut – sea interface. This is also the earliest known depiction of the timber piers of Ramsgate, Broadstairs and Margate. North is to the bottom of the map. (British Library, Cotton Augustus l.i. f.54)*

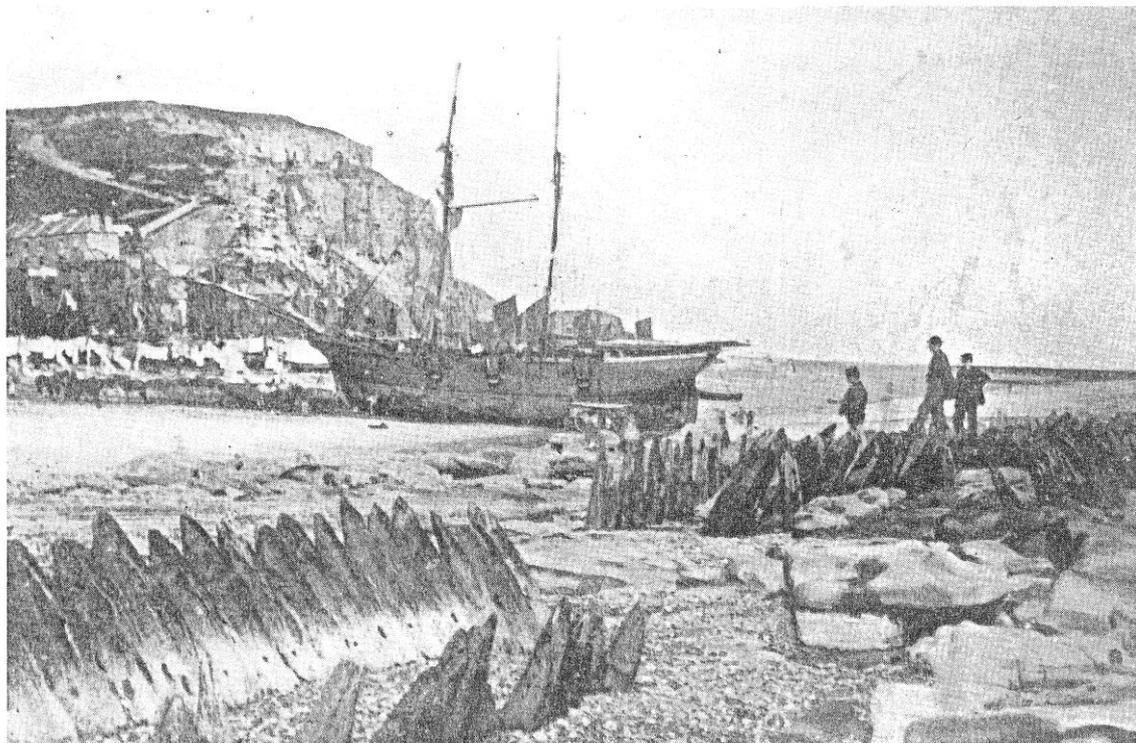
WOODEN PILES OF THE ELIZABETHAN HARBOUR, c.1870

*Figure 11, Photograph of c1870, showing timber pier remains at Hastings. (from: Manwaring Baines, J. 1946)*

Material remains of pier structures were visible at Hastings until the later 19<sup>th</sup>-century. Four 19<sup>th</sup>-century images of these remains, including one photograph of c. 1870, are known, Figure 11. These show the remains of “*pier rocks*” and of timber piles. The photograph of the pier remains is particularly informative in that it shows at least five rows of driven piles. A number of large rocks, relating to the ballast, are also to be seen in the right foreground. The piles show three aspects of especial interest. Firstly, the multiple rows argue for at least two or more phases of construction. Secondly, whilst one row of piles appears vertically set the others are set at an angle. It is probable therefore that at different times the pier was constructed with vertically driven walls and at others with angled walls. Thirdly, the rows of piles are set edge to edge, indicating the walls to have been close-piled, no doubt strengthened within by “*braces*” and “*crosse dogs*” referred to within the documentary sources.

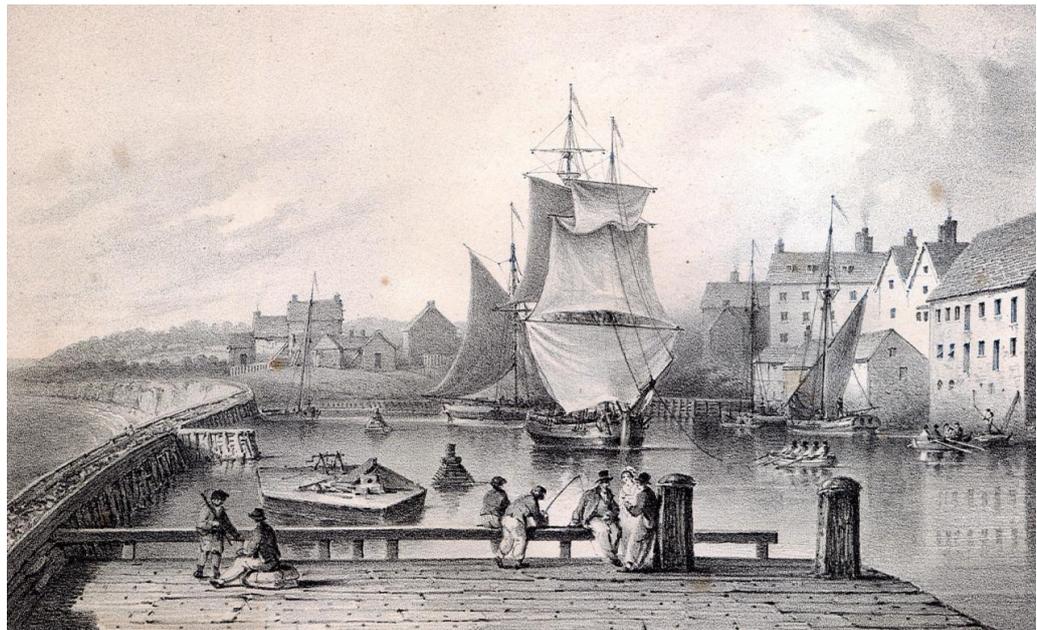
*Figure 13, View of Bridlington south pier, looking west (East Riding Museums Service)*

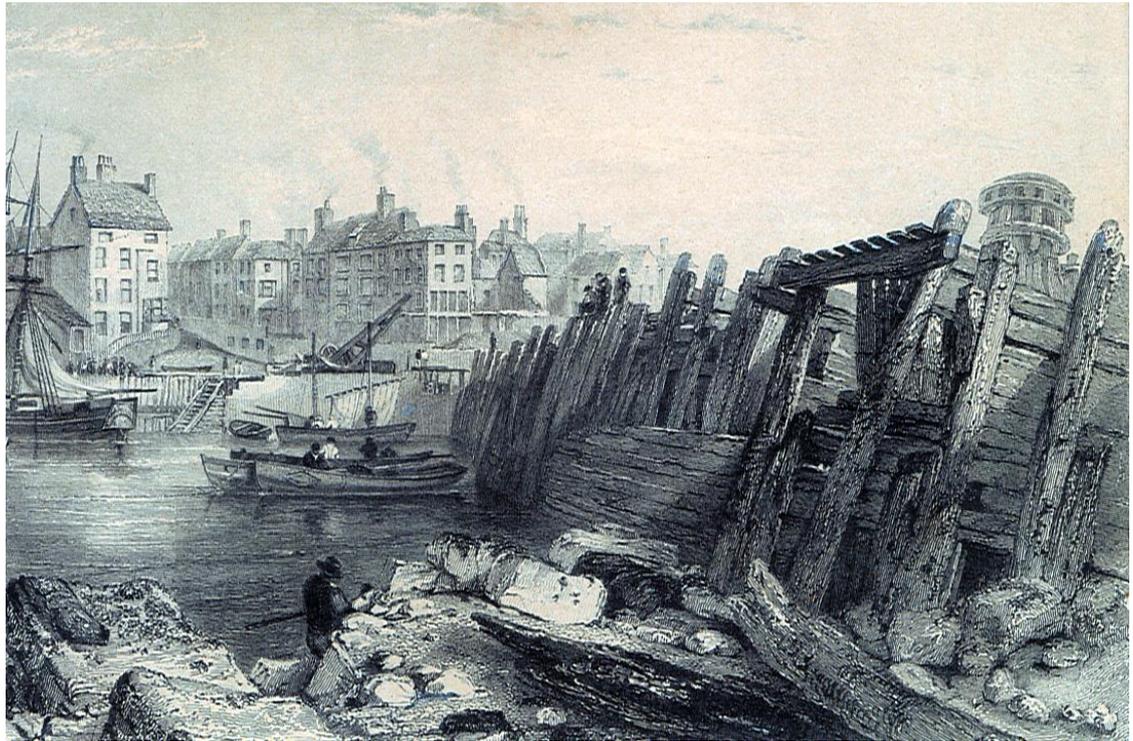
*Figure 15, Inner face of Bridlington north pier in the early 19<sup>th</sup>-century showing lateral division within the pier (East Riding Museum Service)*

Although bay division is not mentioned in the 18<sup>th</sup> and 19<sup>th</sup>-century documentary sources the pictorial evidence indicates that this was indeed present. These bay units were defined by opposed pairs of angle set piles, and, using the scaling on the engineer Goodrick's plan of 1814, Figure 14, we can determine an average bay width of around 4.40 yards (4.02m) (Goodrick 1814). Although there is no documentary reference for internal lateral division between bays, some evidence for this is apparent in Figure 15, which shows lateral planking within part of the inner side of the dilapidated north pier.

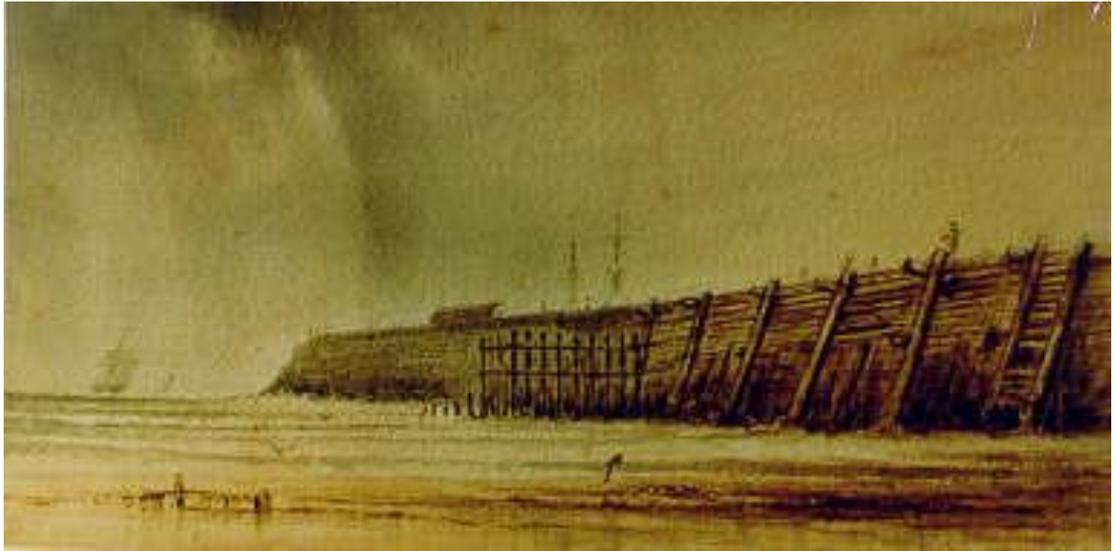
*Figure 16, Exterior of Bridlington north pier, looking south-south-west (East Riding Museums Service)*

Figure 16, of c.1810 shows that two rows of tie-beams extended across the width of the north pier. This situation can be seen with greater clarity in Figure 17. Although this latter figure depicts a breakwater-type structure that abutted the northern end of the north pier its structural characteristics of angle driven piles, tie-beams, horizontal timber cladding and timber decking indicate that it was constructed along the same lines as the piers. Because this structure was built to reduce the force of waves rather than stop them, it was constructed without external cladding in its upper parts. We can with some degree of reliability therefore, use this visible additional detail to inform us of the construction of the piers themselves. Reconstruction drawings of a single bay unit are presented in Figure 18.

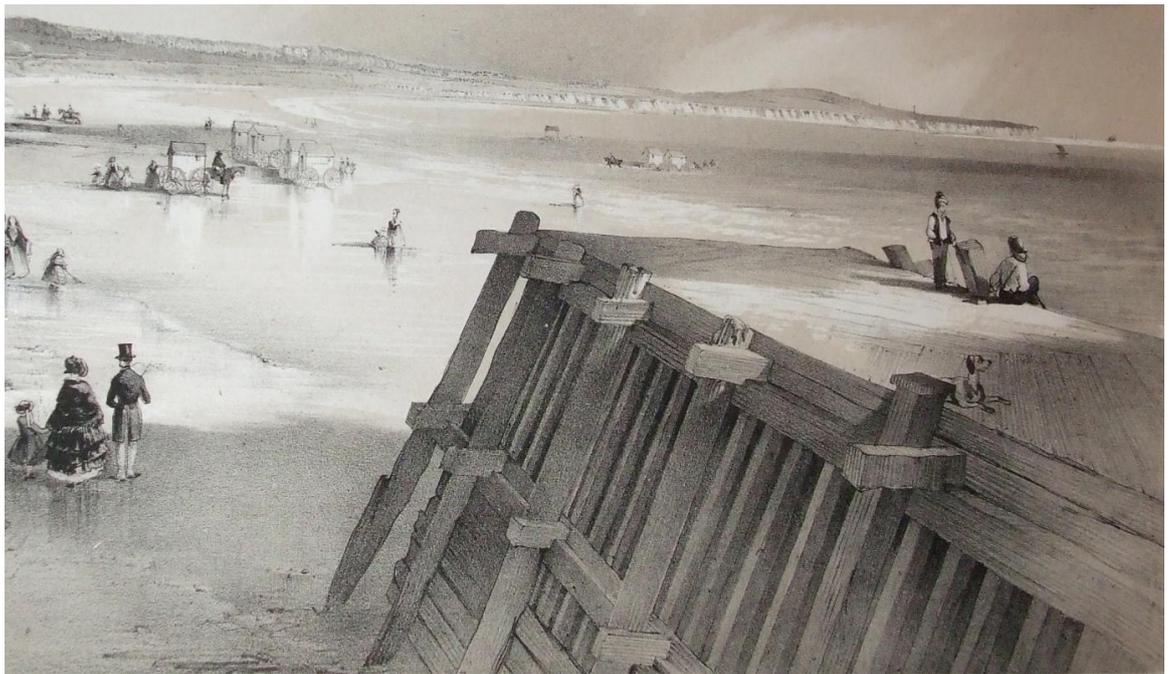
*Figure 17, Breakwater adjacent to Bridlington north pier, looking north, early 19<sup>th</sup>-century (Bayle Museum, Bridlington)*

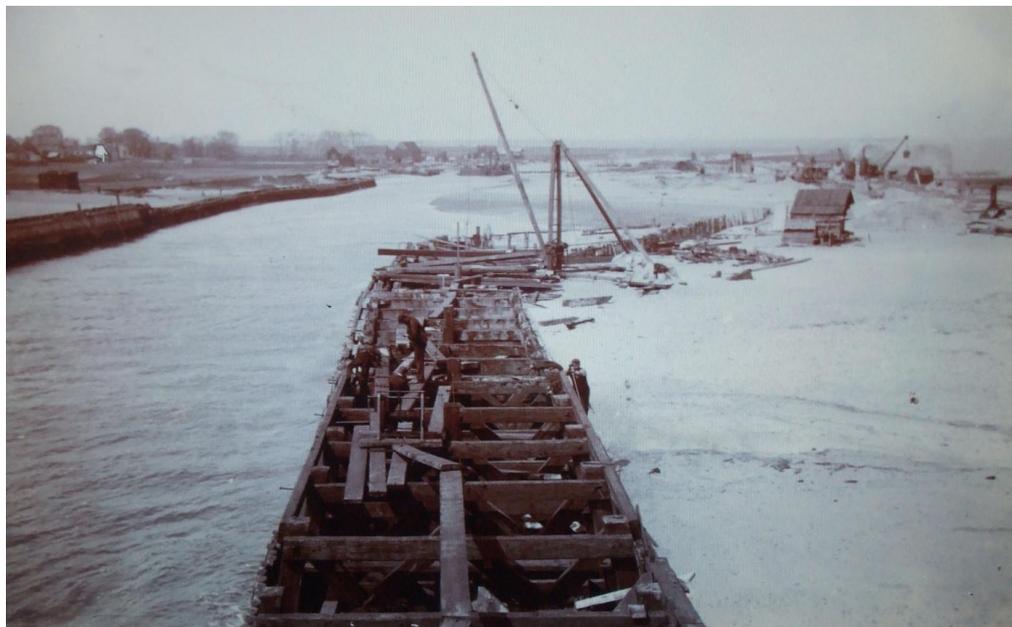
Figure 22, Photograph of rebuilding of Southwold North Pier, early years of 20<sup>th</sup> - century. Looking West (copyright Southwold Museum)

The early 20<sup>th</sup>-century rebuild of the piers at Southwold can be seen as something of a hybrid. The three lines of ‘main piles’ together with the ‘cross walings’, ‘cross braces’ and ‘walings’ clearly form an earth-fast frame divided into regular bay units. However, the walls of angle driven close-piling being driven for some depth below the ground surface clearly formed something more than a mere cladding.

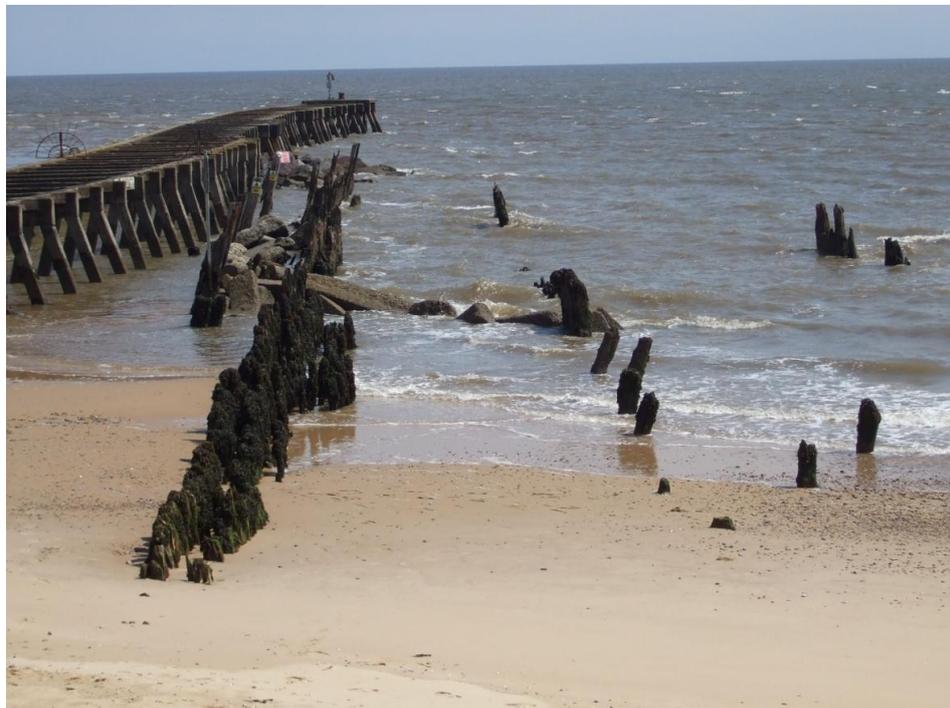
*Figure 23, Photograph of extant timber-built pier remains, Southwold. The existing south pier is to the left. Remains to the right relate to elements of the south piers originating in both the later 18<sup>th</sup> and 20<sup>th</sup> centuries. Looking East*

Since the 1930s the piers at Southwold have been built of steel and concrete. However, adjacent to the existing work a palimpsest of posts and close-piled remnants of timber piers, seemingly dating from the older pier as well as that of the early years of the 20<sup>th</sup>-century survive, Figures 23 and 24.

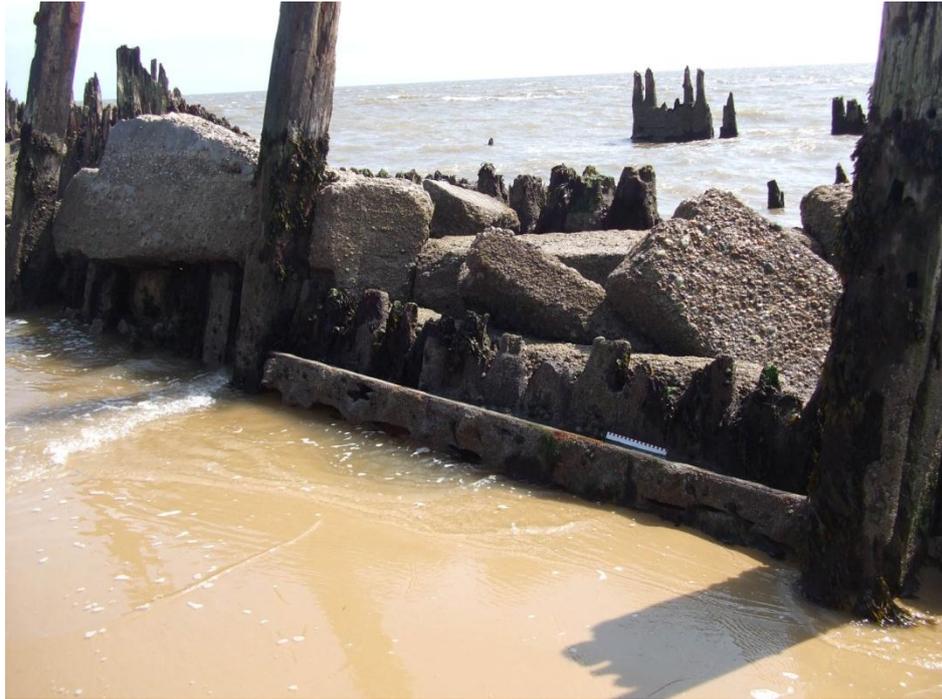
*Figure 24, Photograph detail of extant pier remains, Southwold. In the foreground early 20<sup>th</sup>-century work of the north side of the south pier at its point of junction with older pier remains behind. Tall angle driven main piles can be seen. Between these are edge to edge driven timber sheet piles bolted between ‘waling’ to front and rear. The large blocks behind are in fact concrete with that directly behind the timber being cast directly against it. Looking South-east*

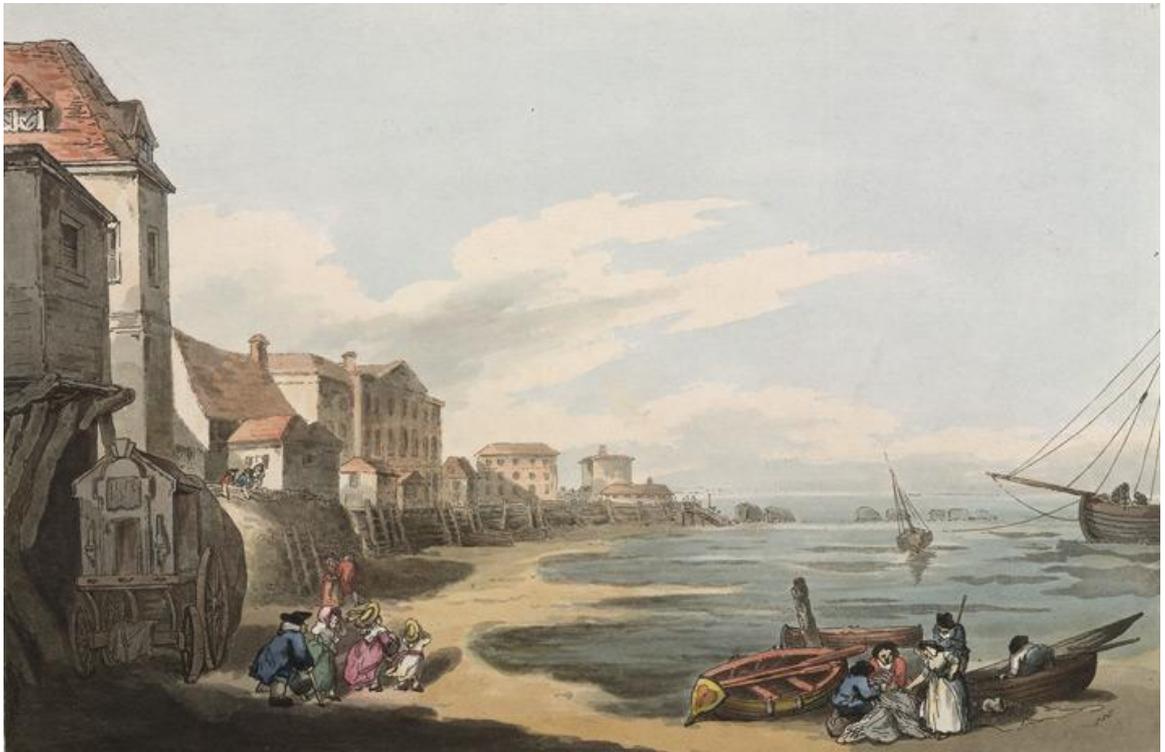
*Figure 26, The 'defended' shoreline west of the pier, Margate 1790 (British Library KTOP17 4-d)*

Support for the structural interpretation of this view can be found in a detailed picture of 1790, Figure 26. The 1736 and 1790 depictions show close resemblances between the pier and shoreline sea-wall, the implication being that they were constructed along similar lines. The more detailed later depiction clearly shows the timber sea-wall to be constructed of planks set behind vertical posts. Lewis's view of 1736 shows this sea-wall as comprised of three sets of walling interrupted by three lanes running down to the shore. Several sets of steps are also shown extending from the tops of the sea-walls to the shore. There are a number of mid 17<sup>th</sup>-century documentary sources relating to carpentry options for replacing these sea-walls (J.H.L. 1647; Cal. S.P. Dom 1649; Cal. S.P. Dom 1650). It was estimated that 55 rods of work were required with 5.5 tons of timber being needed for each rod if carried out as single work, with so much more needed if carried out as double work. It is assumed that single work was comprised of vertical timber piles retaining a single plank wall, with double work being two such walls laid in parallel; presumably connected by tie-beams/braces and with an infill occupying the space between the walls. Such a structure would of course resemble an earth-fast frame pier.

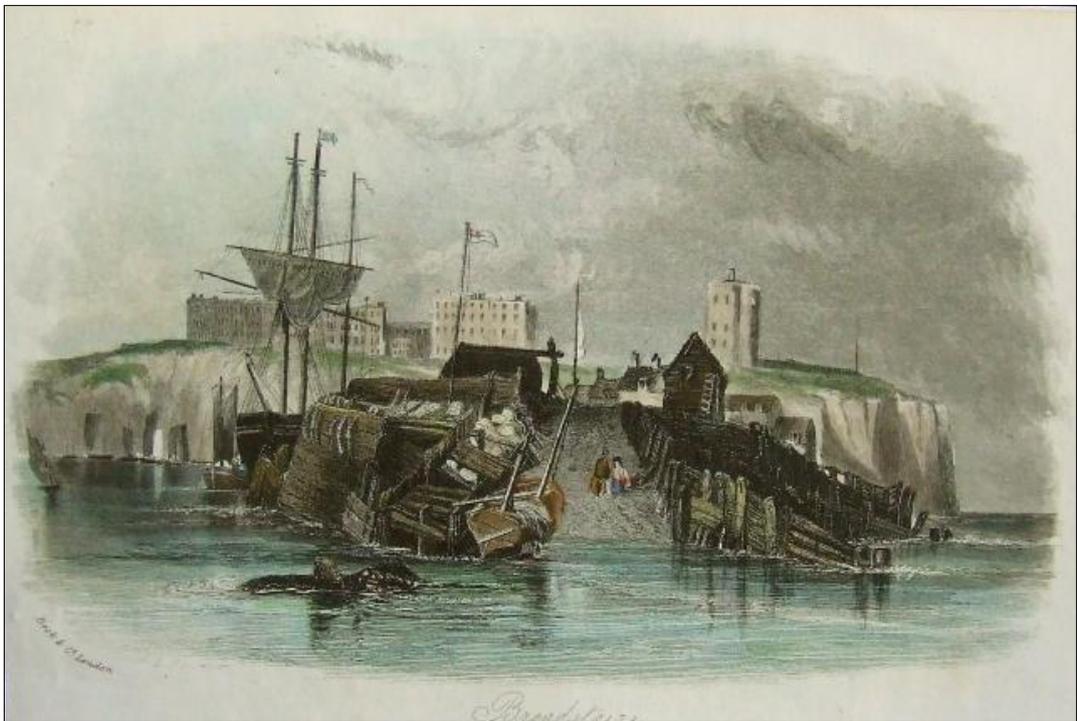
*Figure 29, Mid 19<sup>th</sup>-century view of part of the head of Broadstairs pier, looking north.  
(source: National Maritime Museum: 23646)*

Figure 29, is a view of the head of the pier looking along its length and shows an unusual arrangement. The inner wall of the pier is clearly visible. This is of horizontal planking and appears to be strengthened by a number of tie-rod arrangements. Immediately to the right of the inner wall is a further wall set at a slightly elevated level. It is probable that the lower wall represents an ‘added on’ re-facing of the inner wall. Alternatively, this inner wall may be a parapet. The outer wall of the pier is also visible and although few details can be discerned groynes extend from this out into the sea. Perhaps the most unusual element in this view is the slipway extending from the pier top down to the sea, an arrangement which appears to be unique to Broadstairs.

This letter is detailing a proposed method of repair to a damaged face of the pier. The intention was to drive a line of piles parallel to, and in front of, the damaged face, these piles being spaced 8 feet apart. Each of the piles was to be attached to the main body of the pier by two horizontal braces. Horizontal planking was then to be spiked to the inner face of the line of new piles. Finally, the space between the new wall of piles and planking and the body of the damaged pier was to be in-filled with chalk. In effect, part of the old pier was being re-faced. It is probable that this system of earth-fast frame repair broadly mirrored the form of construction of the pier. What looks like a similar kind of repair can be seen in Figure 29.

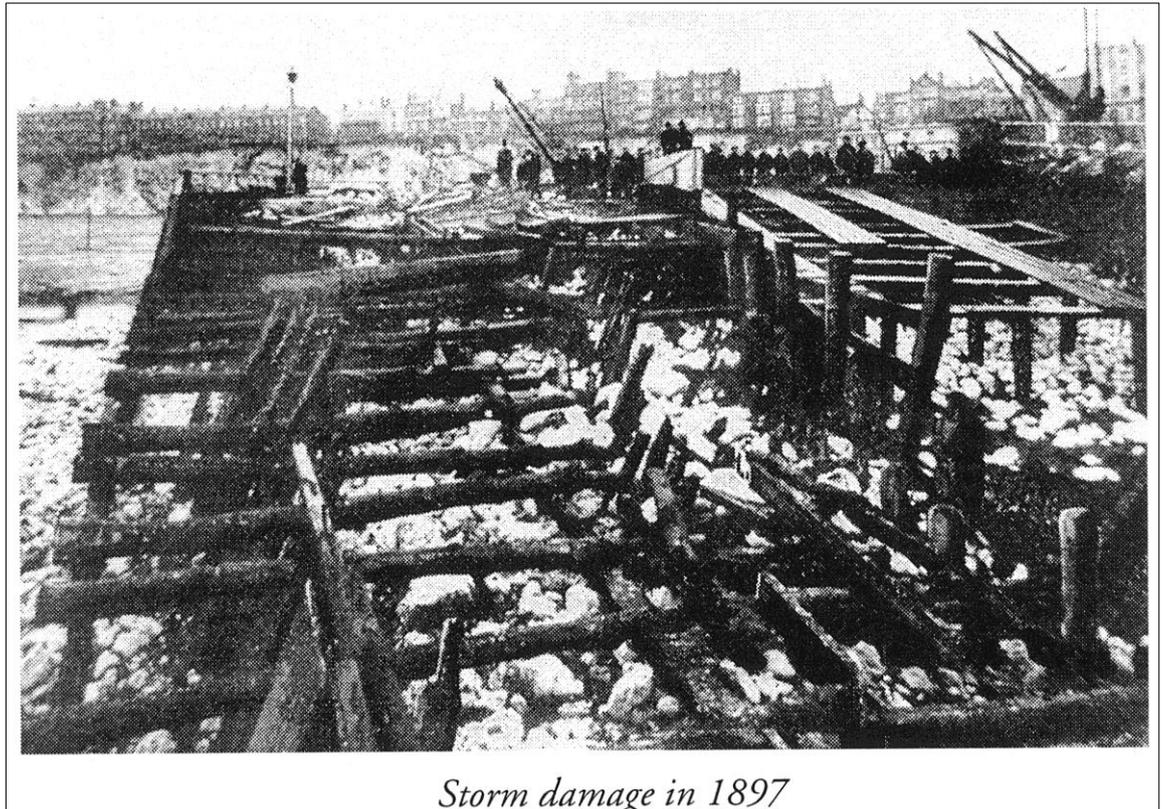
*Figure 30, Broadstairs. Pier frame exposed by storm damage, 1897. (reproduced from: Simmonds 2006)*

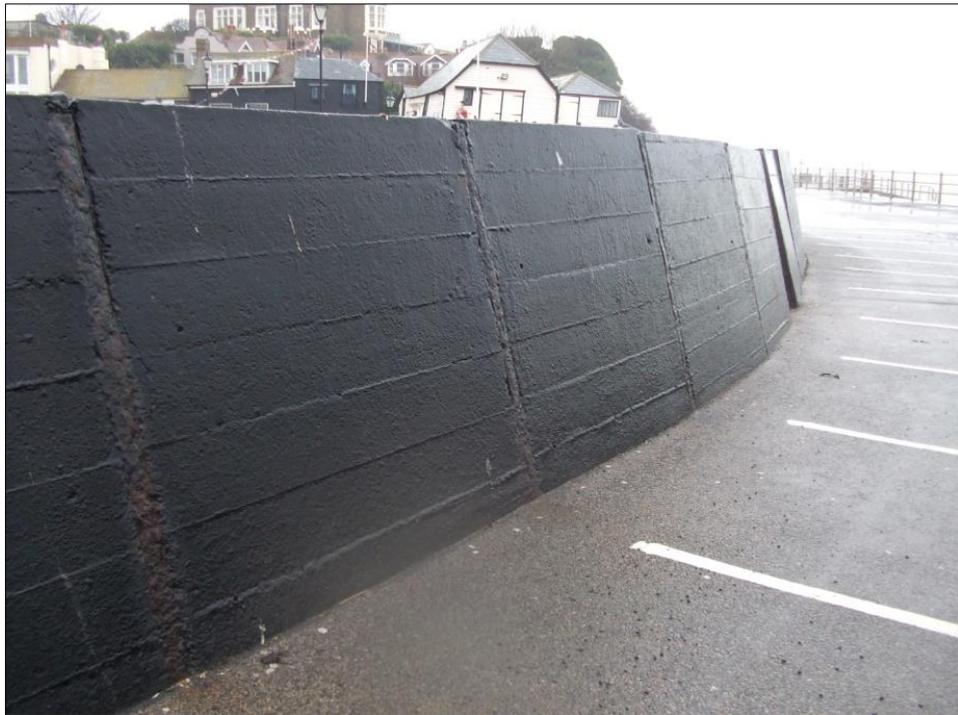
*Figure 33, Broadstairs. Photograph detail of elevated walling (in position of former outer face of pier) now in concrete*

steel stanchions between each of which the walls are of concrete cast between planked shuttering, Figure 33. As well as marking the old eastern limit of the pier the concrete walling resembles the parapet shown in Figure 28. The existing arrangement accurately reflects the old arrangements, but in modern materials. Site inspection also confirms that a small stretch of timber-work, albeit of 20<sup>th</sup>-century date, survives on the inner face of the pier towards the head, Figure 34. This is seemingly the last piece of ‘active’ timber-built seacoast pier on the east coast.

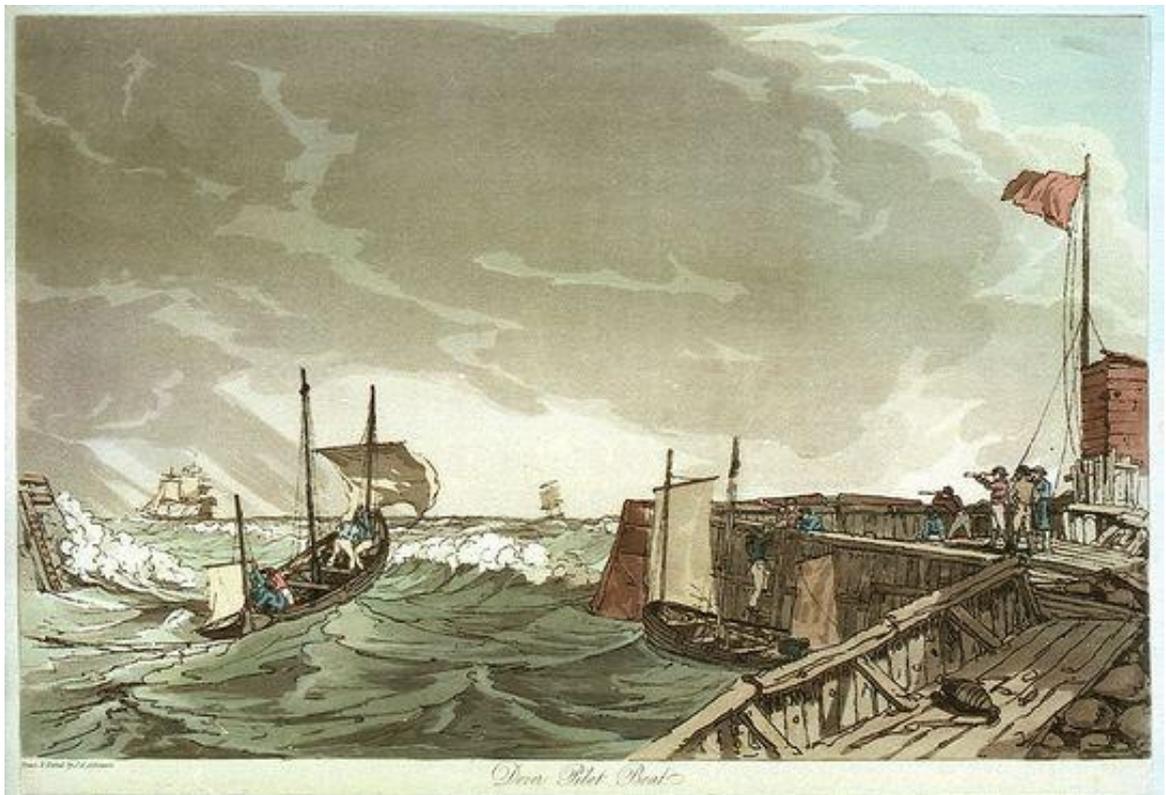
*Figure 40, View of the head of the south pier, Dover, early 19<sup>th</sup>-century looking south-east (National Maritime Museum: PU 7779)*

whilst parts of the internal stone ballast can also be seen in Figure 40. The walls of the piers are shown to be comprised of steeply angled timbers which John Smeaton described in the 18<sup>th</sup>-century as piles and which were probably of square section (Smeaton 1769). Horizontal rails can be seen to be present to the exterior of the walls. Figures 40 and 41 show the walls of the piers to rise up above the level of the walkways thereby forming a safety parapet capped off with large baulks of timber. Bracing between the parapet and walkway is also evident in Figure 40. At the head of the south pier a small, tall, timber-built lookout can be seen. The flag apparatus affixed to this was used to signal when access to the harbour was possible by vessels of larger draught.

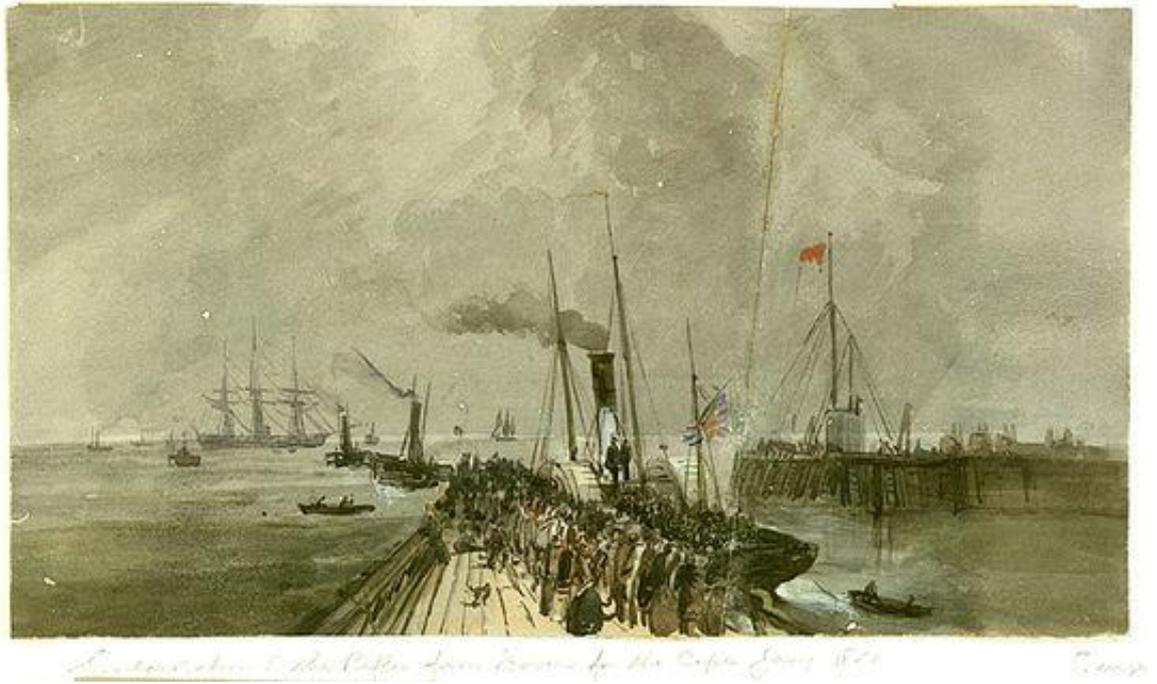
*Figure 41, View of the pier heads at the entrance to Dover Harbour in 1851, looking south (National Maritime Museum: PUO 982)*

There are references to extensive repairs, rebuilding and reconfiguration works to the entrance piers of Dover harbour in the 17<sup>th</sup>, 18<sup>th</sup> and 19<sup>th</sup> centuries by which time their Elizabethan form was largely lost (J. H. L. 1646; Leach 2005). They continued to be of timber construction however and are shown in a number of 19<sup>th</sup>-century depictions, Figures 40, 41 and 42. The walkways can be seen to be of longitudinally lain planks

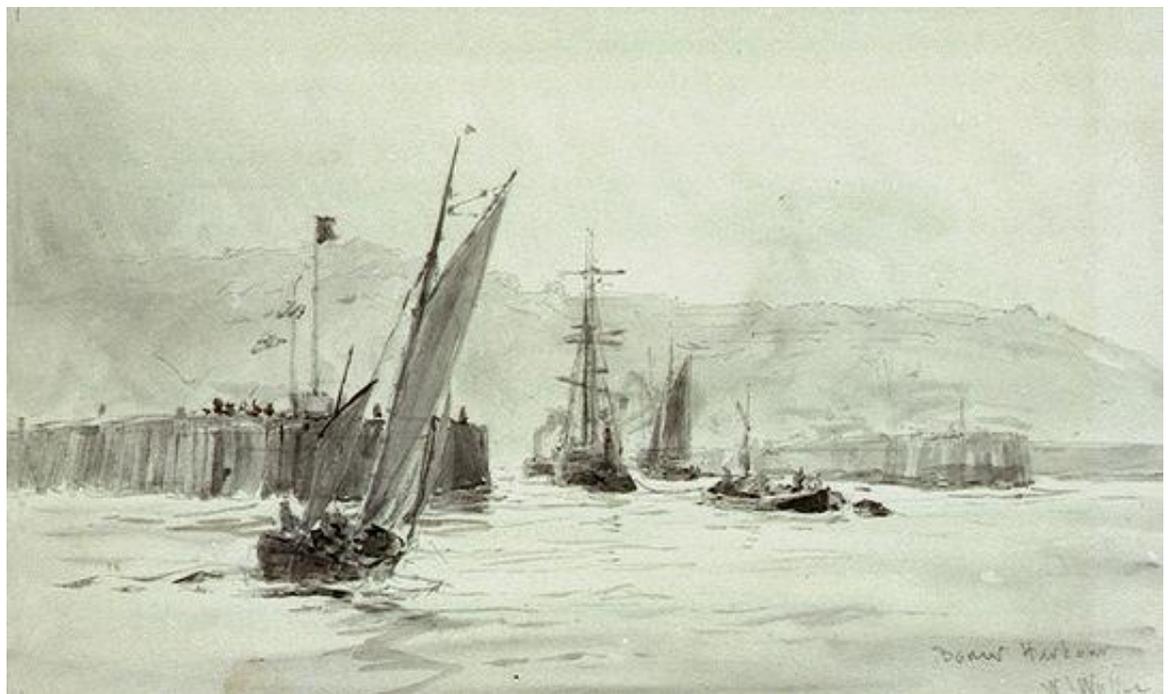
*Figure 42, Pier heads at Dover harbour in the 2<sup>nd</sup> half of the 19<sup>th</sup>-century by William Wyllie, looking north. (National Maritime Museum: PU 9038)*

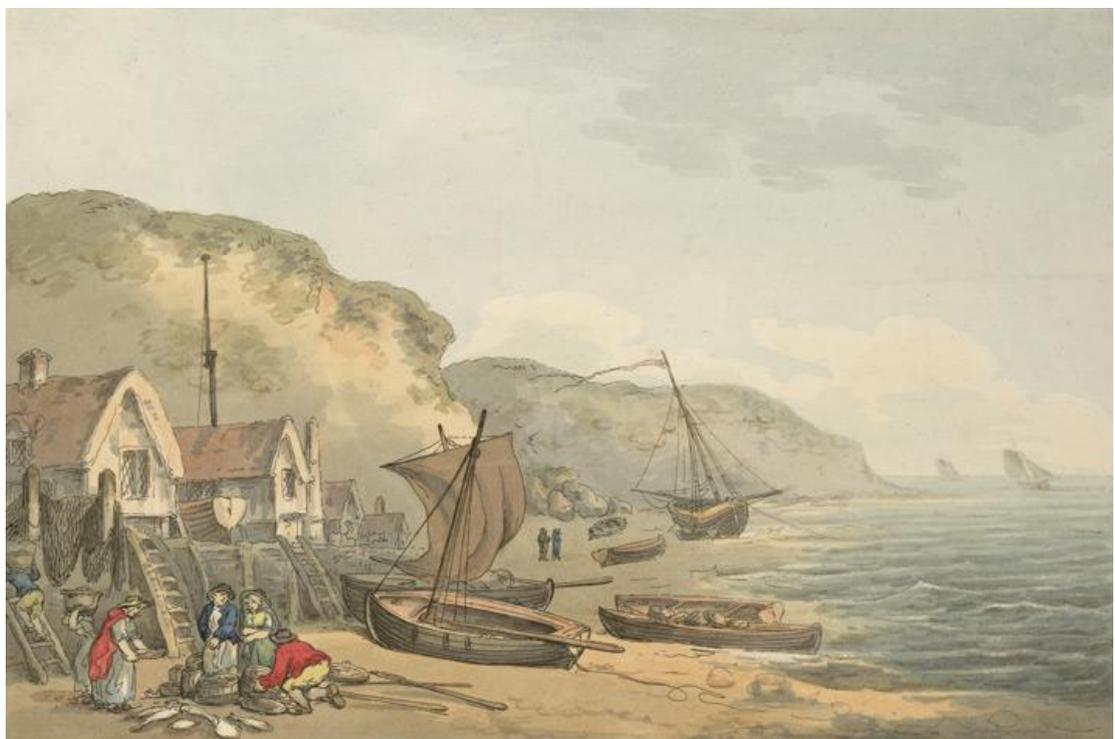
*Figure 45, Folkestone. View near the Stade, looking east. Note the timber revetting work comprised of posts with horizontal planking behind. 1790 (British Library: kotp XVI, 55e)*
