**Historic Timber-built Seacoast Piers of Eastern  
England: Technological, Environmental and  
Social Contexts**

Volume 1 of 2

University of York

Archaeology

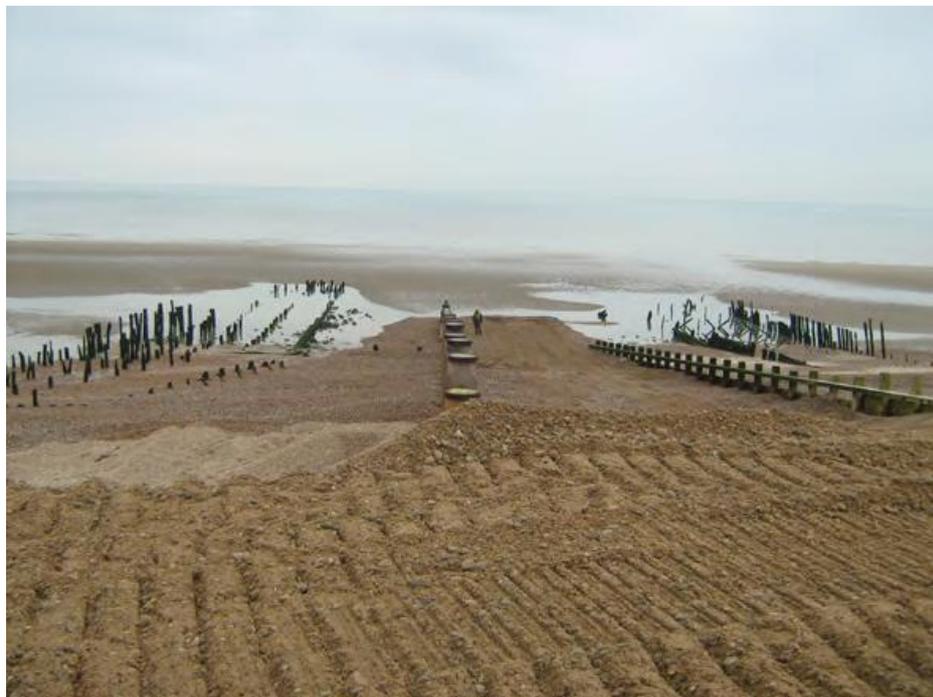
*Figure 46, Rye. Photograph of the mouth of the 18<sup>th</sup>-century harbour between two pier extensions of timber, looking south-east (later groynes also present) (Photograph reproduced from ASE 2008)*

timber. No contemporary description of the timber piers is known and plans of the period are of insufficient scale to provide any structural detail. However, some material remains do survive, Figure 46. Both piers were comprised of regularly spaced vertically driven piles of square section, mostly spaced less than 1m apart and for the most part arranged in three parallel rows. Both piers were of earth-fast frame type. Given the relatively close spacing of the vertical piles, the remainder of the walls were in all probability comprised of either horizontal, or vertical, planking affixed to the piles by longitudinal wales. The inner rows of piles suggest the likely presence of both cross-waling and cross-braces for the purposes of lateral stability. The presence of an adjacent and unlimited supply of shingle raises the likelihood that this was utilised as an internal ballast within the piers.

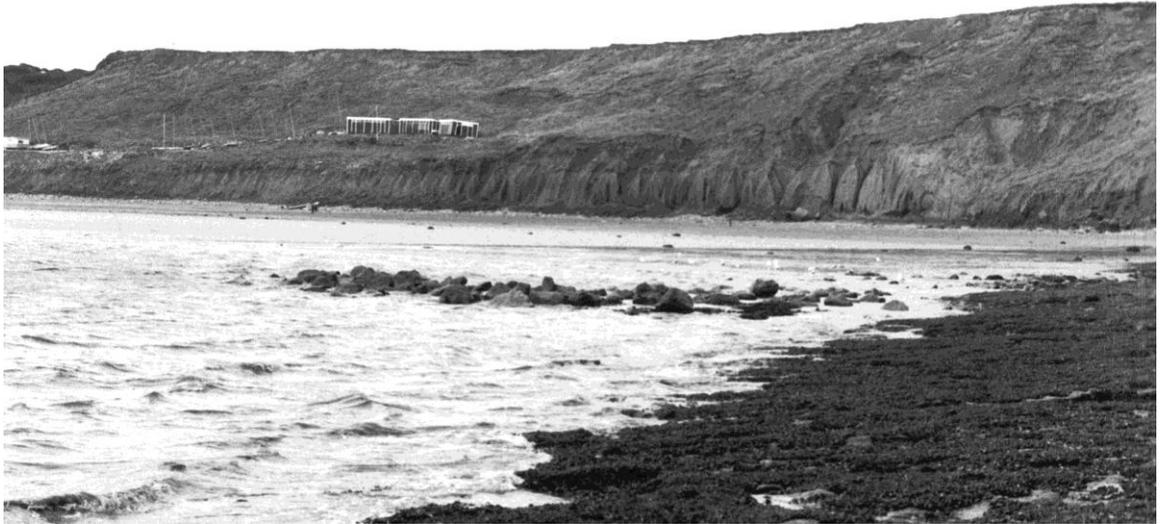
*Figure 48, Filey. Old Quay Rocks, between tides, looking S.W.*

However, the material remains themselves provide clues that permit an interpretation to be postulated, Figures 48, 49 and 50. The mass of stone known as Old Quay Rocks is located some 70m south of the west central portion of the southern cliffs of Carr Naze at a height fractionally above that of mean low water. The remains consist of a slightly curvilinear concentration of boulders and stones aligned approximately north-east to south-west. These measure around 28m in length and have a core width of 4.5m – 6m, with a less concentrated spread a few metres to either side of this. At their north-east end the remains have a height above the immediate surroundings of approximately 1.3m, this height tailing off progressively towards the south-west end where the remains stand little above 0.5m. The boulders have a maximum size of 1.3m (in any direction) most being somewhat smaller than this and are of types local to Carr Naze together with a number of what are probably glacial erratics. No coursing or ordered laying of the boulders is apparent. The north-eastern end of the remains lay directly over bedrock, the remainder on/within sand beneath which the bedrock extends. No timber remains or postholes have been observed at this site.

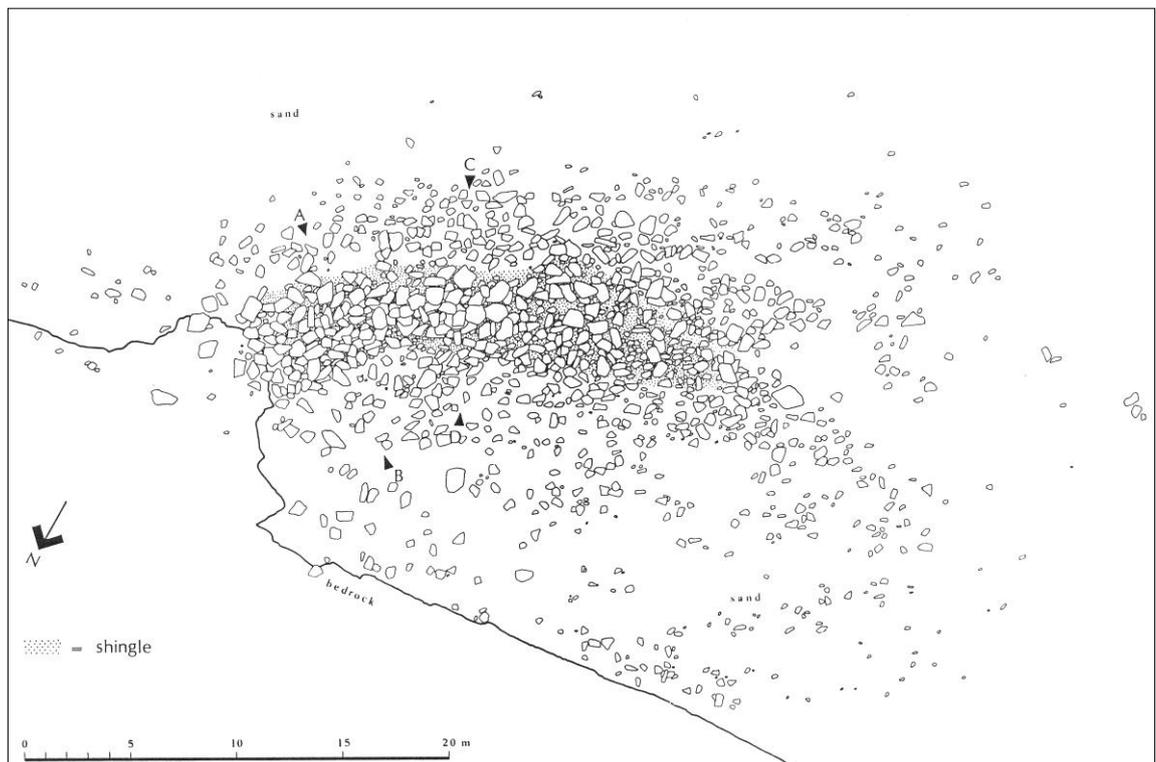
*Figure 49, Plan of material remains, Old Quay Rocks, Filey (from Johnson 1998)*

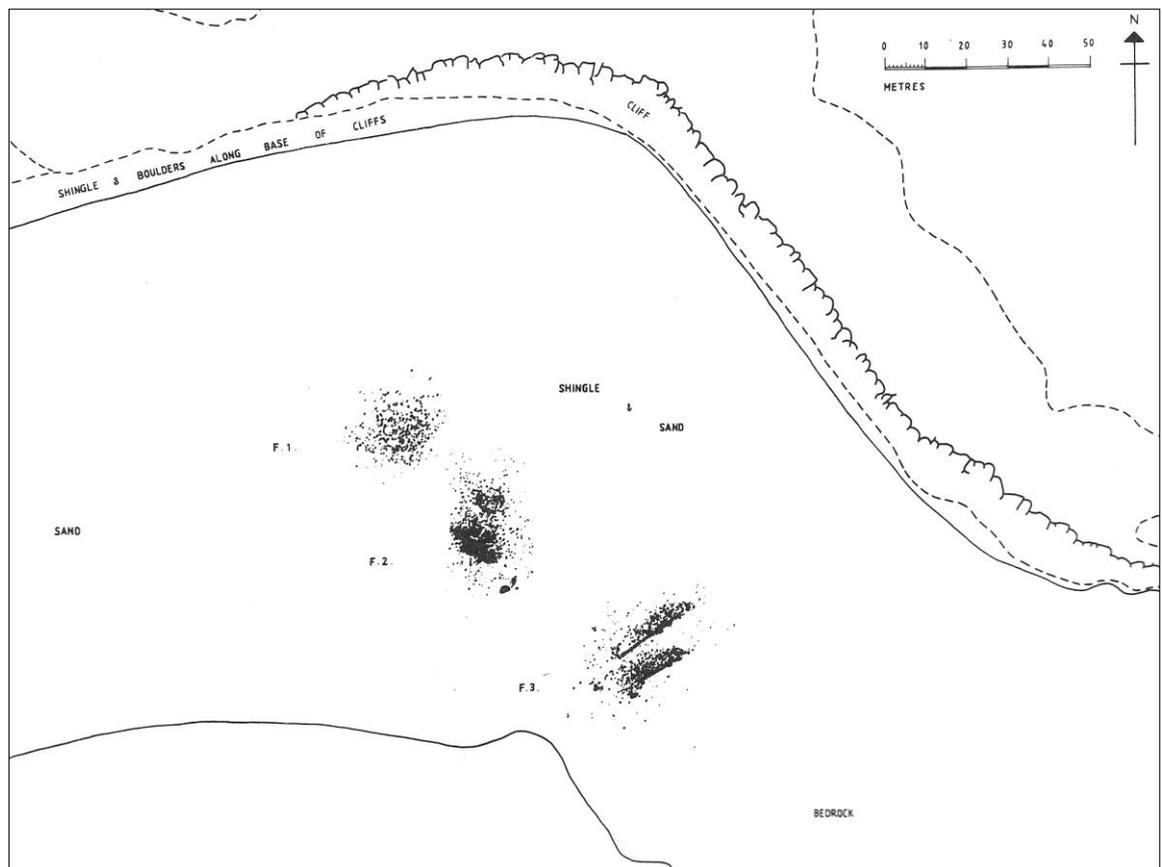
*Figure 52, Plan of material remains at South Landing, Flamborough (Johnson 1988)*

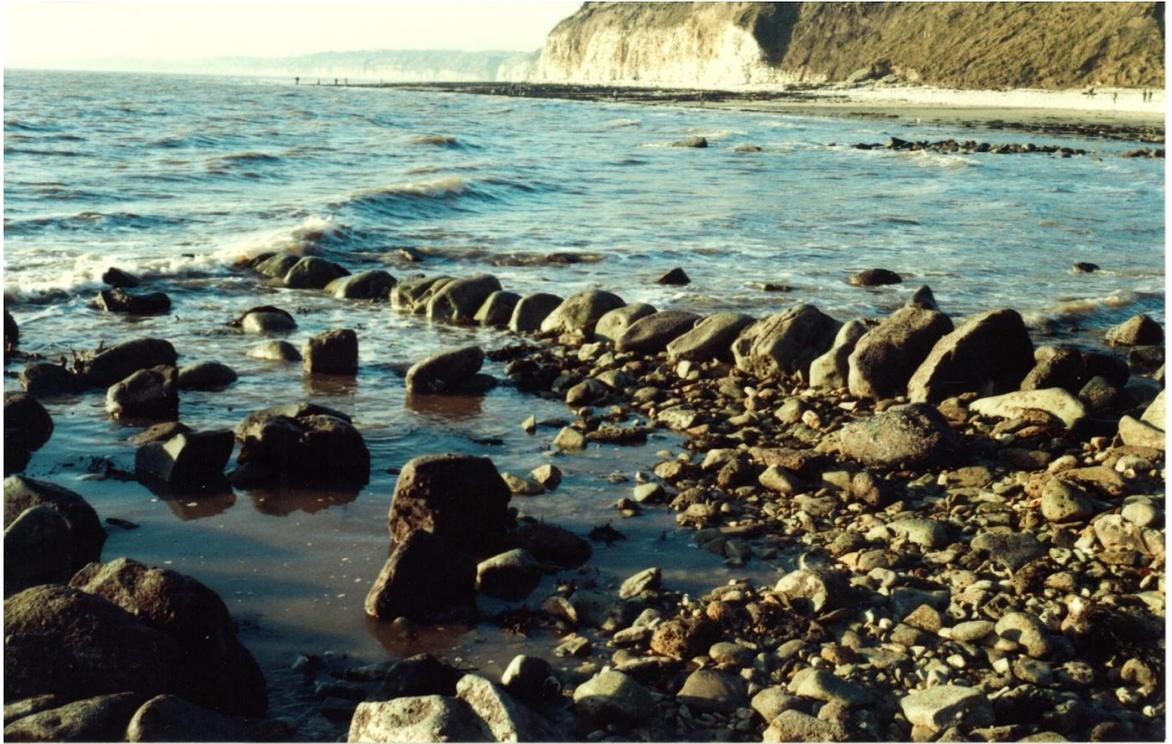
*Figure 53, Part of the N.W. arm of Feature F3 at Flamborough – probable ‘rock armour’ for a pier toe. Remains of part of Feature F2 towards upper right. Looking south.*

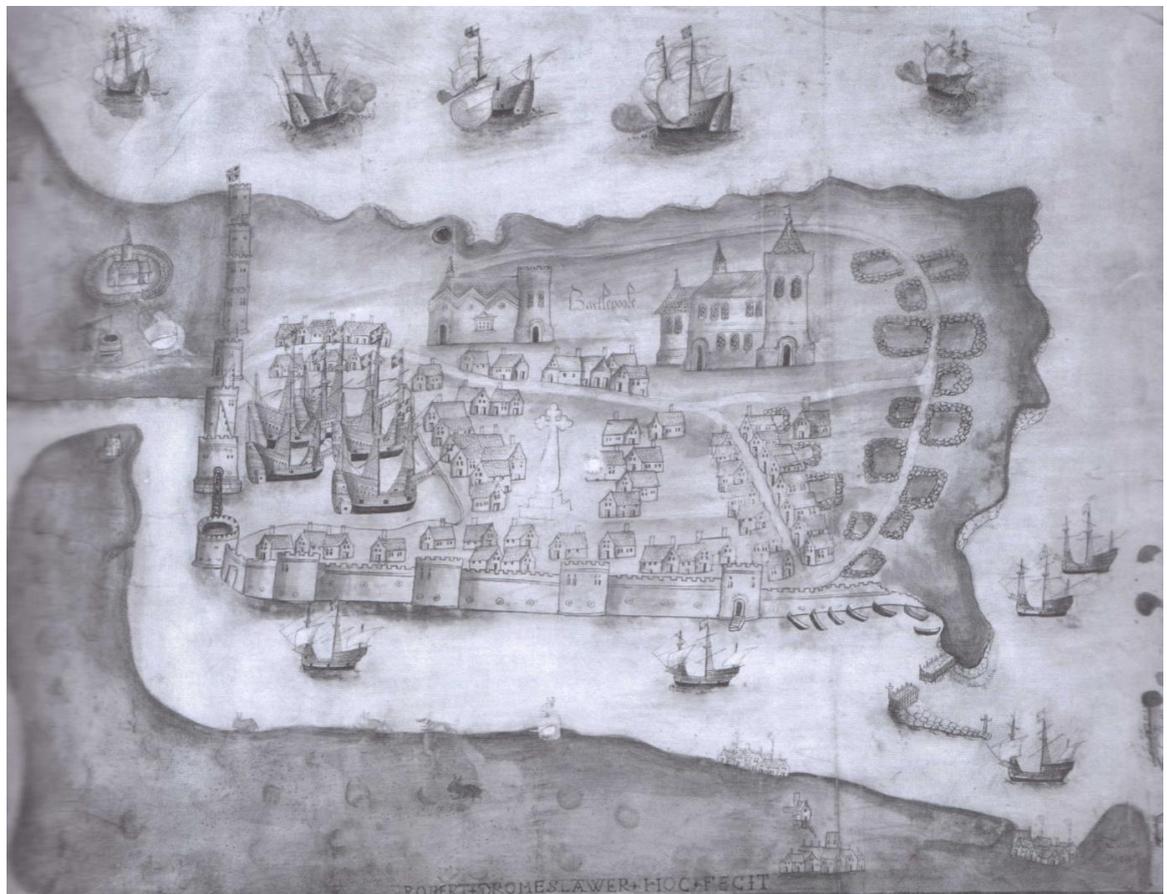
*Figure 54, Picture map of Hartlepool as depicted by Robert Dromeslawer c 1540-9. Note the docks of the inner harbour enclosed by defences to centre left and the pier to lower right. North runs diagonally from lower left to upper right. (reproduced from: Daniels 2010)*

Operating as a port from at least the mid 12<sup>th</sup>-century, the early focus of maritime activity at Hartlepool seems to have been in the Southgate area and did not involve the use of a pier (Daniels 2010, 144). Here a succession of dock-like structures was constructed within a small natural inlet known as the inner harbour, the earliest of which date from at least the early 13<sup>th</sup>-century (Sharp 1851, 150; Daniels 1988; Daniels 2010, 144-167). The construction of a pier to the east of the inner harbour created a deeper water refuge known as the outer harbour. Both harbours, including the pier are shown in Dromslawer’s depiction of the mid 16<sup>th</sup>-century, Figure 54.

Dromeslawer’s picture map of the mid 16<sup>th</sup>-century (Figure 54 and Figure 55 (detail)) shows a pier and associated island pier, in the lee of a small projection to the headland. Both structures are vertically sided and, judging from the detail of their upper surfaces, appear to be stone filled. The sides are depicted in a lattice effect, containing a number of vertical members and at least two that are horizontal. The vertical elements project upwards beyond the level top of the structures. As only timber could so project, it can be argued that the lattice is entirely of timberwork. Whilst the vertical timbers could be interpreted as rubbing posts, this is unlikely to be the case with the horizontal members. It is likely therefore that this relates to an external timber framework that was in-filled with stone. Whilst the piers were probably of earth-fast frame type, this cannot be conclusively proved. Two crosses, that are probably navigational markers, are depicted on this picture map, one on the island and the other adjacent to it.

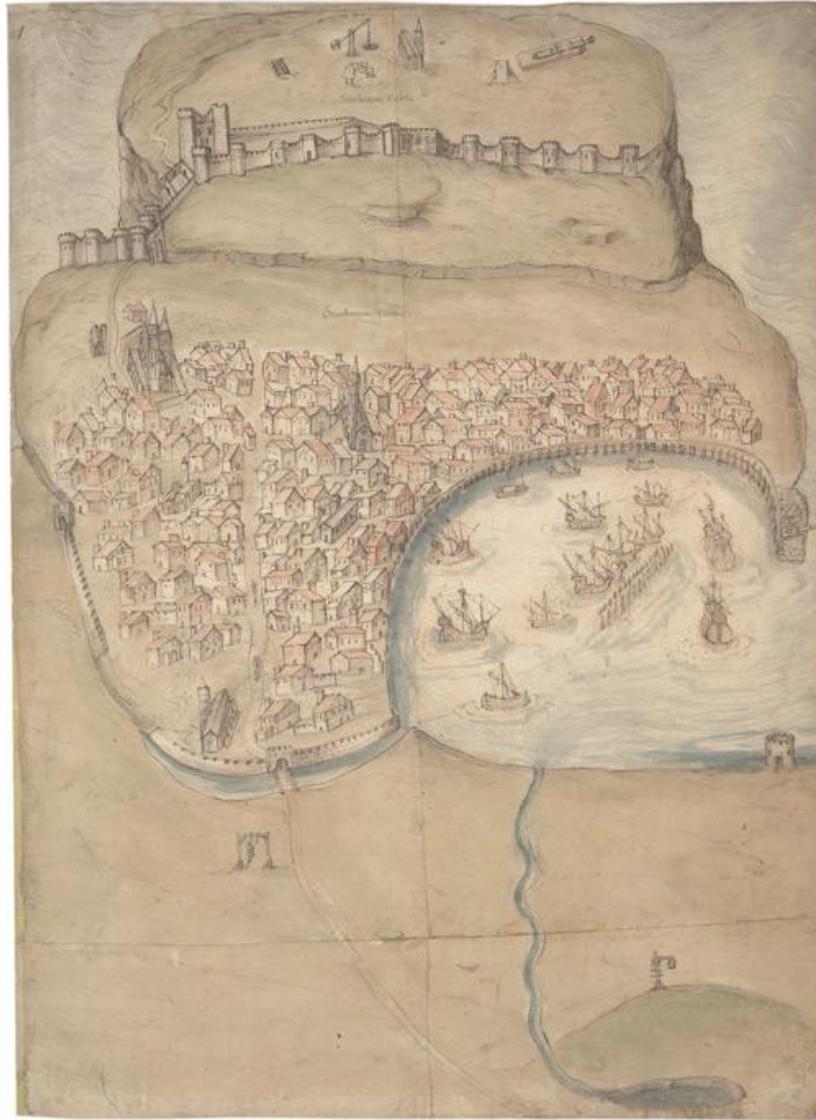
*Figure 56, Birds eye view, Scarborough 1538-9 (British Library, Cotton Augustus l.ii, f.1)*

A birds eye view of the town, dated to 1538-9 shows the timber-built pier and shoreline waterfront at Scarborough as it then appeared, Figure 56 and Figure 57 (detail).

The infrastructure of the port in this view can be seen to be comprised of three principal elements, a single pier that extended from the headland, an arc of waterfront lining the bay that extended seamlessly to the pier and an island pier situated between the two. The clearest structural members visible are a series of regularly spaced vertically set timbers that are present to all three elements. The only other structural members that can be identified with any certainty are a number of regularly spaced horizontals visible in the upper surface of the pier and almost certainly tie-beams extending between the inner and outer walls of the pier. Between these horizontals are what may be an internal ballast of stones or other infill. That the vertical timbers of the pier are depicted as regularly spaced,

rather than as a continuous line of edge to edge timbers may suggest that construction at this date was of earth-fast frame type. The same is likely to apply to the island pier.

The earliest building for which we have evidence is that at Scarborough depicted in the drawing of 1538-9, Figure 56. This shows a single storey building with pitched roof. The close proximity of this to pier mounted artillery suggests that it may have formed a residence/store for the gunner/s rather than a harbour store. A further early depiction is the single storey, with attic, pitched roof building located at the landward end of the north pier shown on the Great Yarmouth platt of c.1560, Figure 3. The building may equate with a Haven House mentioned in 1564 that measured some 20 feet (6.1m) by 16 feet (4.88m) and was built of lime and stone. This building functioned as a store for tools and shelter for the workmen and labourers and was located to the south side of the haven’s mouth (Manship: in Palmer (ed) 1854, 92-3). At Bridlington in 1539 there is reference to

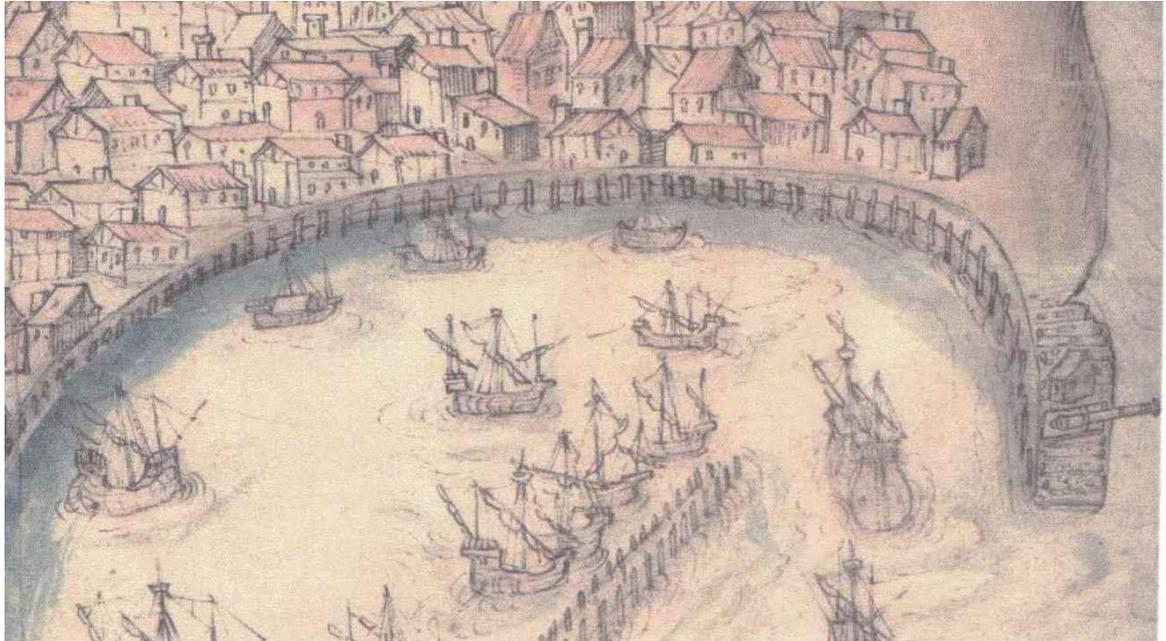
*Figure 57, Detail of Scarborough harbour within Figure 56*

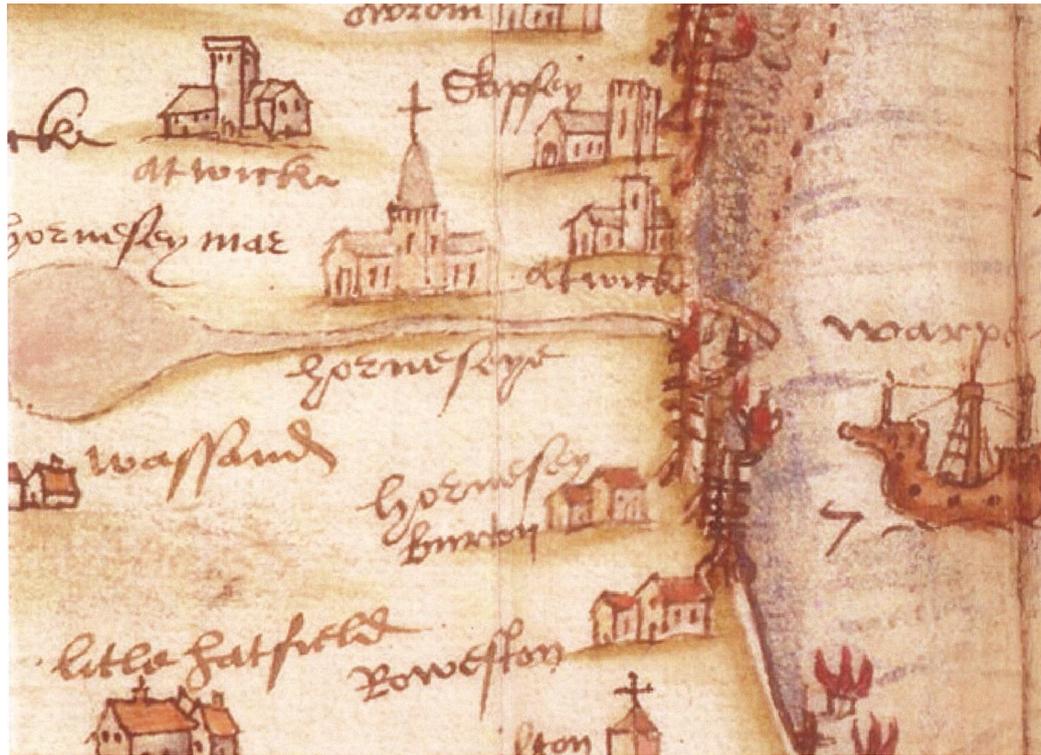
Figure 60, Extract of manuscript map of 1595 showing the pier at Hornsea. There are distinct suggestions of a double pier arrangement with a large pier to the north of the stream of Hornsea Beck and a smaller pier to the south. (British Library, Royal. MS. 18. D. 111, f.63)

A pier at Hornsea is first positively recorded in 1537, though documentary evidence does infer its existence at an earlier date, seemingly in the 15<sup>th</sup>-century (L. & P. Henry VIII 1537b; Purvis 1949, 69-73). The last indicator we have is its depiction in a map of 1595 (British Library 1), (Figure 60). The first record of construction materials is in 1556 when we are informed of “*xx tonne of tyMBER & two lytell pecs of tyMBER (at Hull Bridge) wch was the Kinge & Quenes tyMBER And was pr(ov)ided to have repaired the pere at horneseye*” which was seemingly stolen (ERRO DDCC 139/65).

The documentary evidence for Hornsea refers to a pier (singular). However, the map of 1595 does suggest the possibility that the arrangement at Hornsea may have been a twin ‘enclosing’ pier configuration, much like those depicted at Bridlington and Flamborough on the same map. The information within the available sources gives no real clue as to the typological form of Hornsea’s pier though the presence of a contemporary pier at nearby Bridlington of ‘piled wall type’ raises the possibility that such may have been the case here. It is worth noting that on the manuscript map of 1595 the wording “*warpe in and owte*” appears next to the pier itself. In nautical parlance ‘to warp’ is to move a vessel by means of ropes (warps) fixed to a secure point such as a pier, anchor or buoy, and the presence of shallow waters is implied.

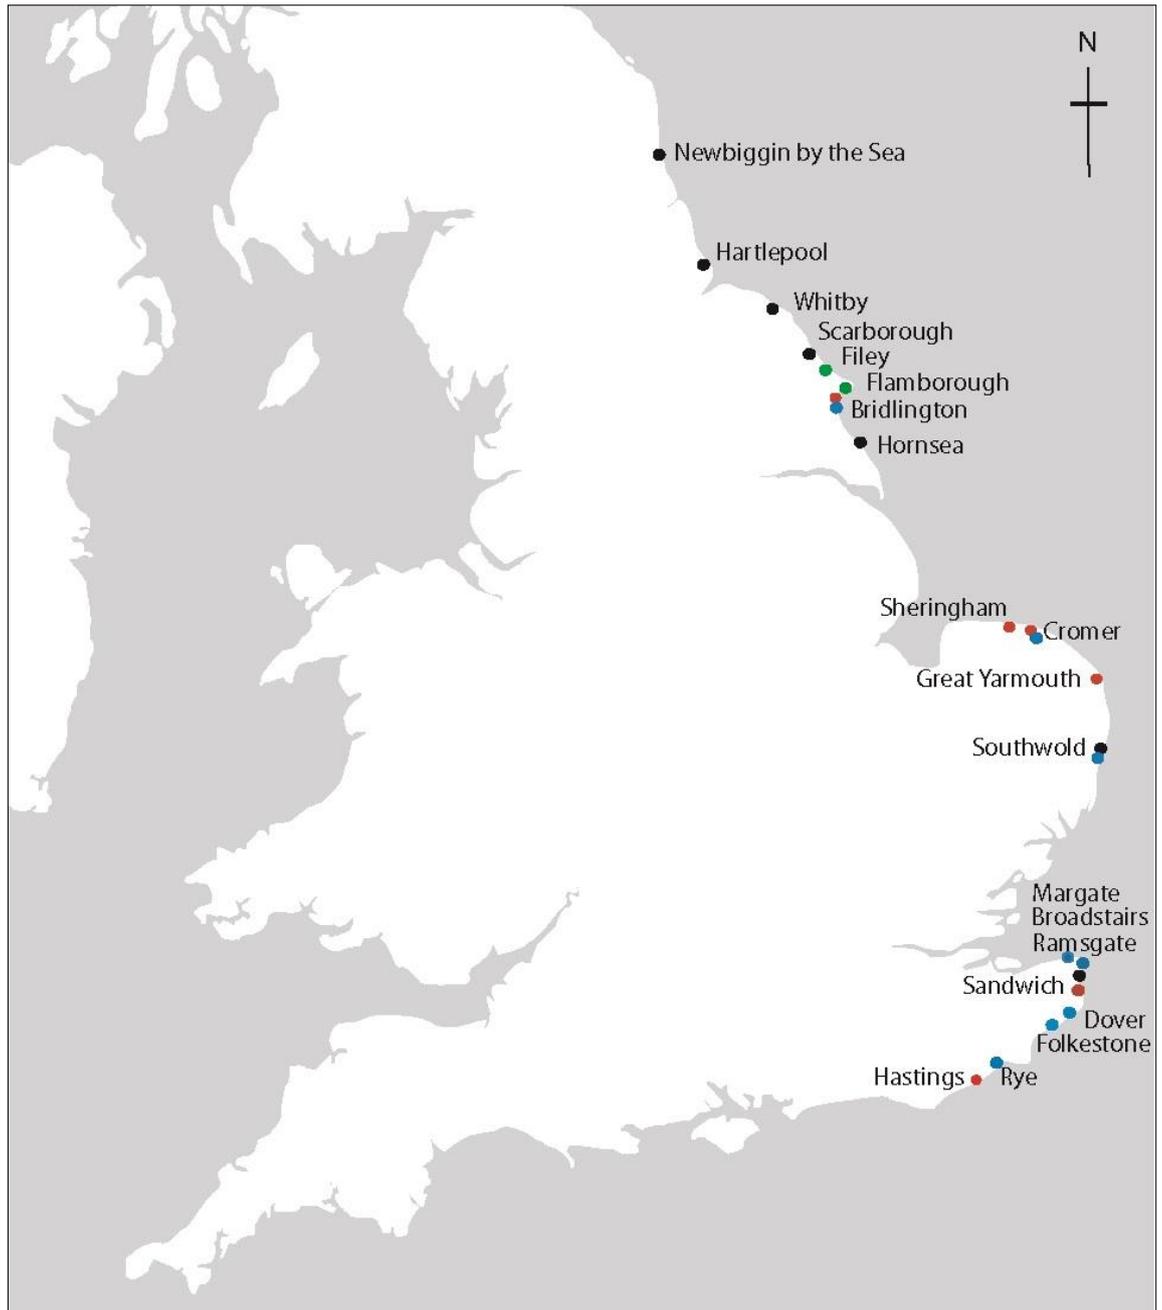
*Figure 63, Geographical distribution of the pier sites by typology. Red = close-piled, Blue = earth-fast frame, Green = free-standing frame, Black = not determined*

Table 1 and Figure 63 below summarise the evidence for variation of technical form in relation to date range, geographical distribution and ownership/controlling authorities.

Inevitably, our data in terms of precise dates of origin and full technical detail are not complete. However, the piers for which we have earliest recorded technical details are of the 16<sup>th</sup>-century and of these five are of close-piled form and three of earth-fast frame. Moving through time we can see that by the 18<sup>th</sup>-century newly constructed piers were overwhelmingly of earth-fast frame type (four) rather than close-piled (one). Whilst the

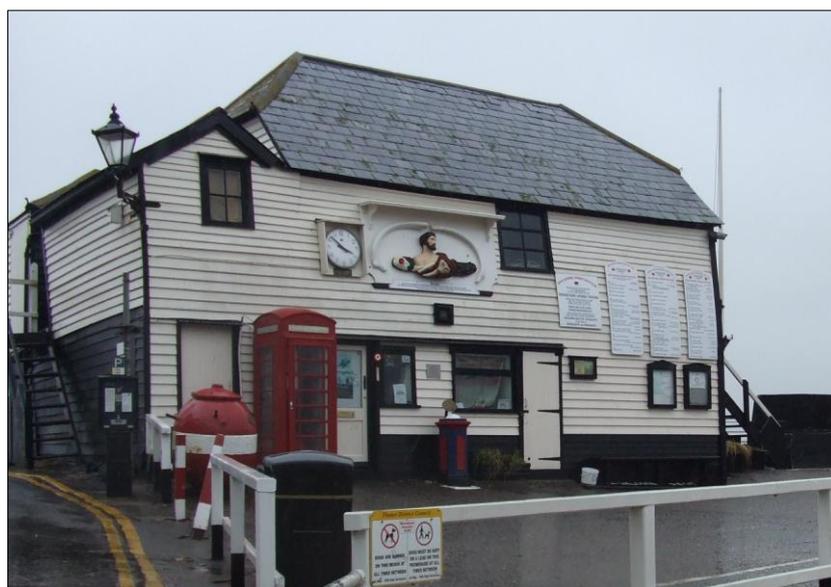
*Figure 65, Photograph. Broadstairs Look-out and Stores/Boathouse, looking East.*

There is but one building that stood on a timber-built pier that survives, that known as the Boathouse at the landward end of Broadstairs pier, Figures 65, 66 and 67. Timber built with weatherboarding and presently roofed with slate, this structure probably dates to the late 18<sup>th</sup>-century. It is of two storeys and, of two parallel ranges with hipped roofs though the northern end of the east range has a gabled roof aligned at 90 degrees to the others. To the west side there is a single storey extension with lean-to roof. There are external staircases leading to the first floor at both north and south ends. The arrangement of doors to the ground floor is irregular, as are the window arrangements to both floors. Internally, the building is presently divided into a number of mostly small spaces and the building clearly has a complex structural history. There are a number of depictions and references to this building, from the late 18<sup>th</sup> – 20<sup>th</sup> centuries, particularly in the 'Broadstairs Pier Books' (CKS Q/Rum 389B; EKA UD/BS (uncat.) Box 2 1843-1853; UD/BS (uncat.) Box 8 1912-1923). At various times this building, or parts thereof, have served as a Harbour Masters office and lookout, a store, boat store and shop. Given the small size of Broadstairs pier this building's usage may always have been multi-functional.

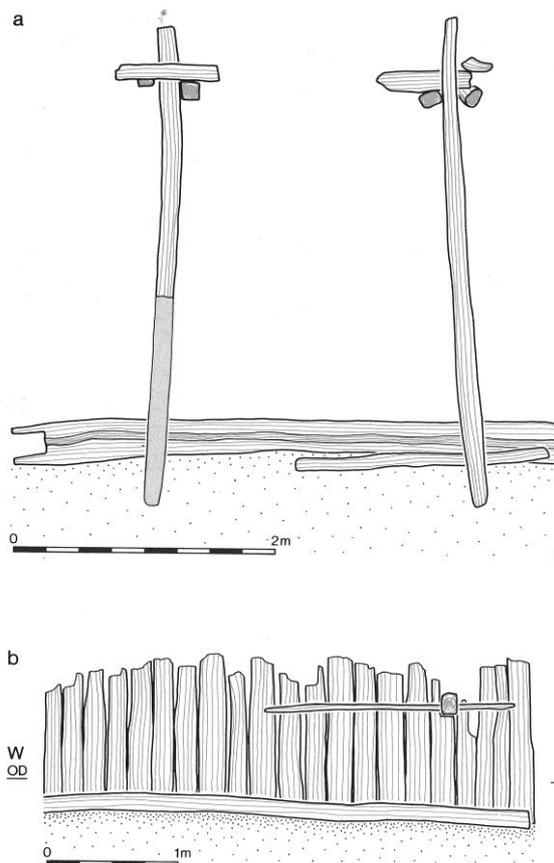
*Figure 68, Waterfront structure BG10 (Billingsgate, London), mid – late 12<sup>th</sup>-century. Plan to top, elevation below. Note the rail/locking bar arrangement retaining wall of vertical planking. (reproduced from Milne 1992)*

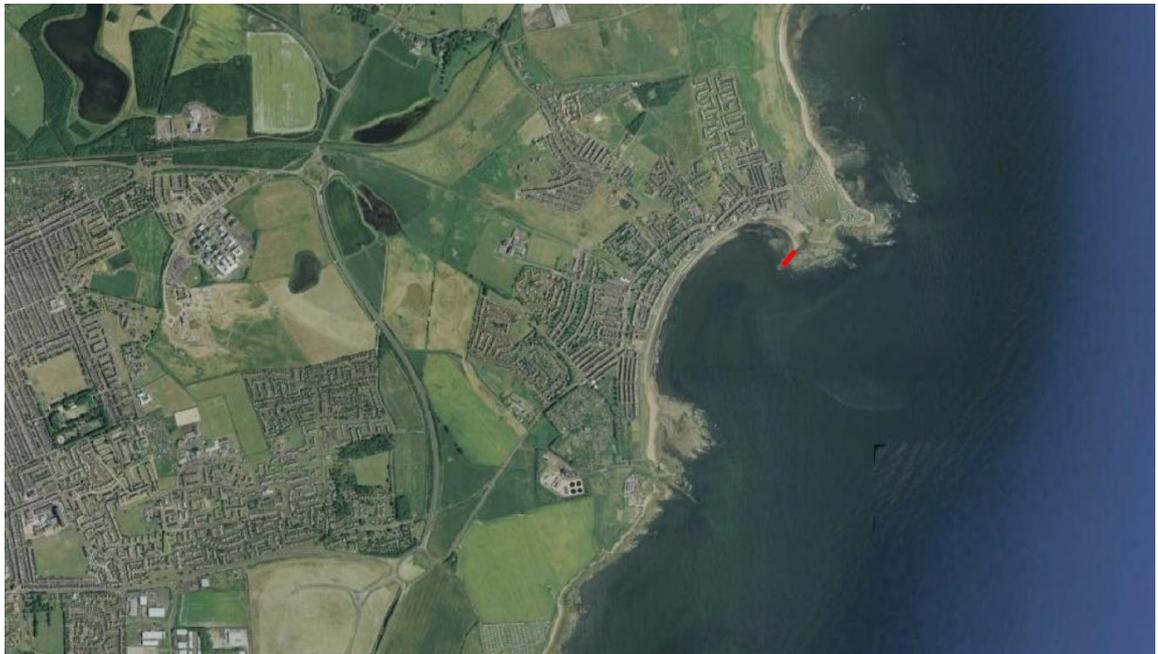
*Figure 69, Newbiggin by the Sea and its sheltered bay. The medieval pier is believed to have been located in the area of the northern headland and probably extended into the sea in a south or south-westerly direction – perhaps in the same location as a modern stone mole. Probable pier site shown in red. (source: Google Earth)*

The pier at Newbiggin appears likely to have had a life-span restricted to the early – mid 14<sup>th</sup>-century, Figure 69. Visible pier remains were present in the mid 18<sup>th</sup>-century though were absent by the 20<sup>th</sup>-century (Cal. Pat. Rolls 1316; Hodgson 1832, 216, 219; Hodgson 1902, 74, 216, 219; Wallis 1769, 340). The reason for this later absence of material remains is believed to relate to post-medieval coal mining that has locally served to lower the seabed and led to increased rates of coastal erosion (Atkins 2004, 12-13).

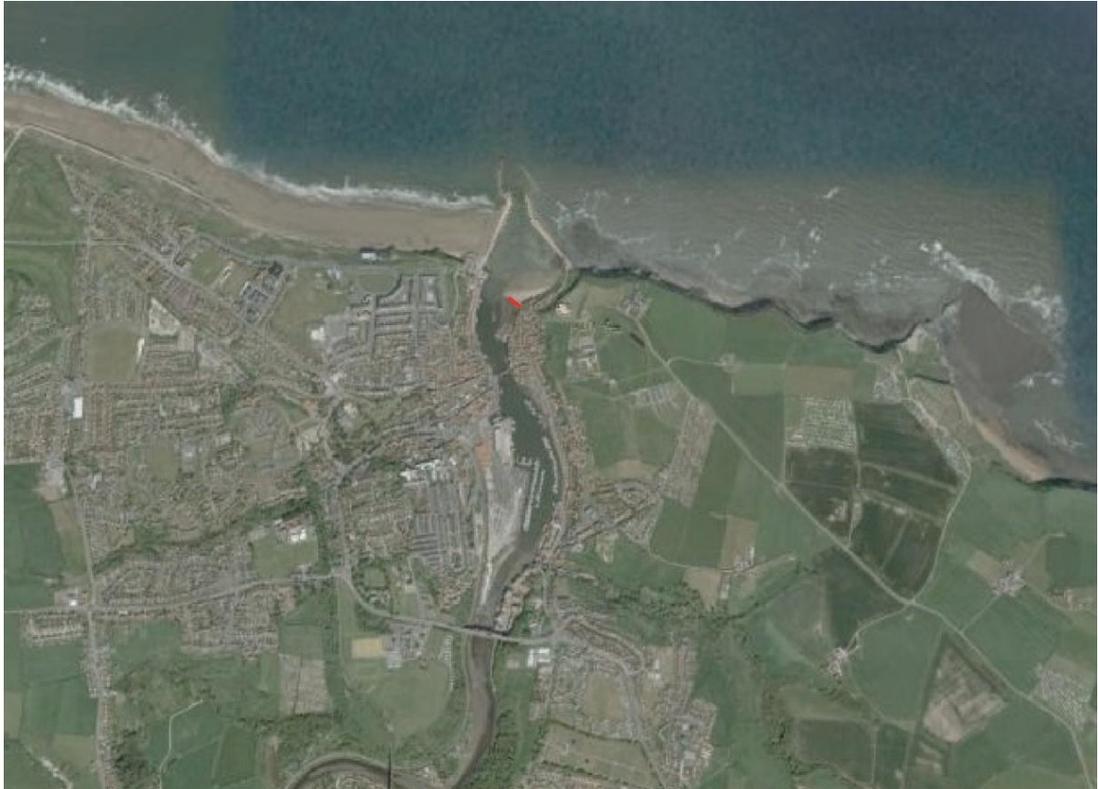
*Figure 71, The likely location of Whitby's timber-built pier (red) in relation to coastline and River Esk (source: Google Earth)*

The slightly anomalous member within Zone 1 is Whitby whose timber-built pier lay at the western side of the mouth of the River Esk, though even here a degree of protection was afforded by the east and west cliffs, Figure 71. The historic lower harbour of Whitby lay on the upriver side of the pier. Although located at the mouth of the estuarine Esk this watercourse was only navigable a little way to the south of the town and only then at

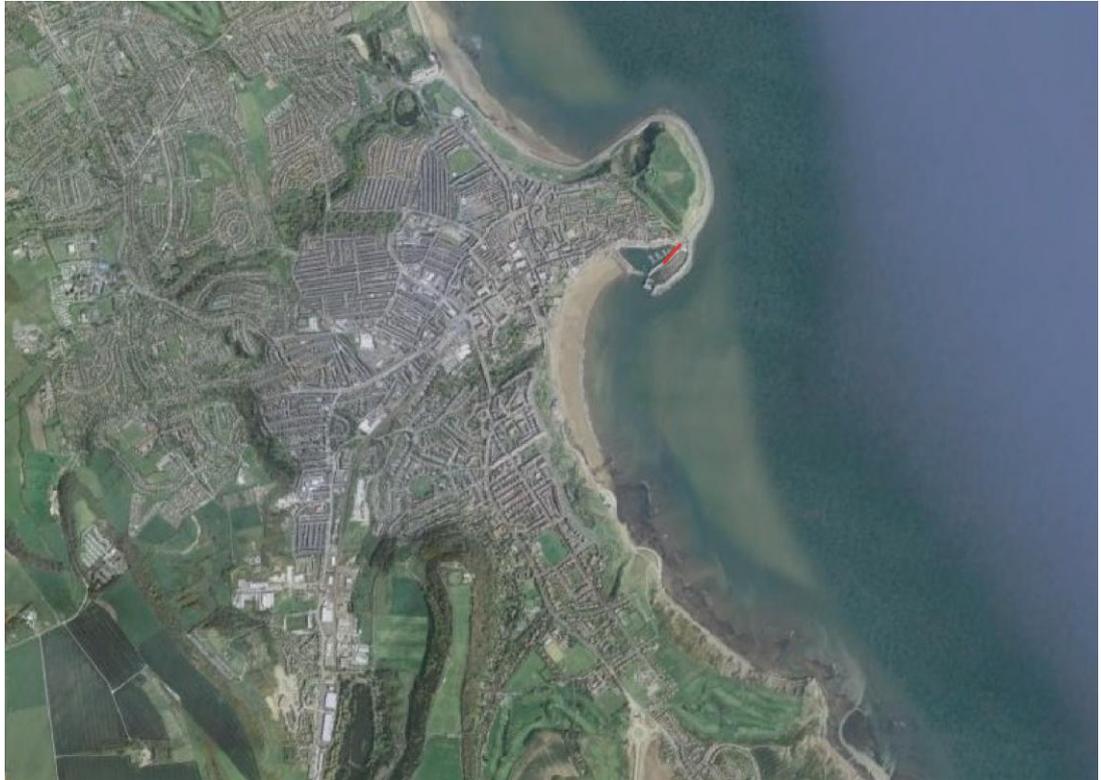
*Figure 72, The setting of the medieval pier at Scarborough (red) in relation to coast, headland and town (source: Google Earth)*

The planned town of Scarborough lies at the northern end of Scarborough Bay and nestles on the southern slope of the neck of land that connects to the tall headland, Figure 72. The port was comprised of both a pier, extending from the south-east end of the headland, and an adjoining waterfront below a former cliff-line, that followed the curve of the bay eastwards of the pier. Whilst both elements, together with an island pier, functioned as an integrated entity it is uncertain if one of these elements developed as a formal structure before the others. An entry in the Patent Rolls for 1252 authorised the building of a new port at Scarborough and a stated aim was to create a deep water harbour “*where all ships may enter and leave without danger, as well at the beginning of the flood of the seas as at*

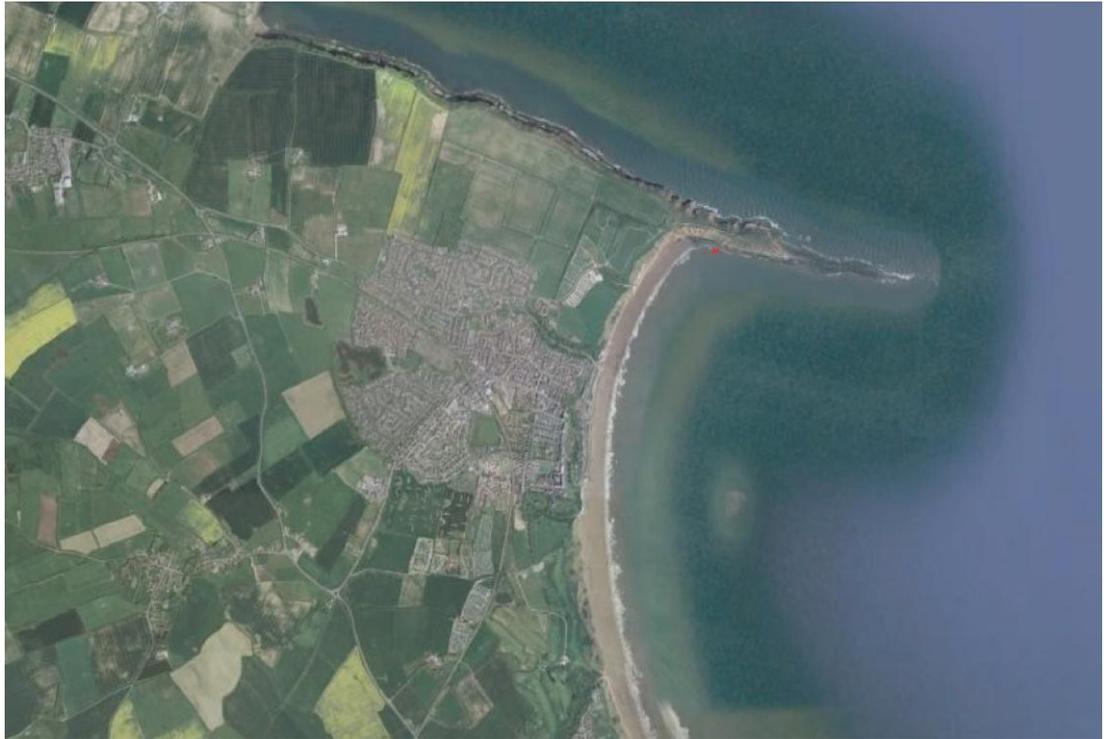
*Figure 73, The setting of the pier remains at Filey (red) in relation to Filey Brigg and town (source: Google Earth)*

The settings of the piers at Filey, Figure 73, and Flamborough, Figure 74, differ from most others along the east coast, being located over 1km from their associated settlements situated on higher ground with access being via ravines. The importance of precise topographic location in the siting of these structures, directly in the lee of headlands, is highlighted by the observation that access to each required the traversing of around 200m plus of foreshore. It may be the relative isolation of these sites that permitted the survival of material remains as well as associated place-names (Quay Rocks and Quay Hole – Filey and Key Hole – Flamborough) Both sites lie a little over 50m from existing cliff faces. This proximity demonstrates the relatively slow rates of erosion at both sites. As befits the scale of their related settlements Filey and Flamborough were both small piers accessible by vessels only at higher states of tide, and originated in manorial contexts. Neither survived beyond the earlier part of the 17<sup>th</sup>-century.

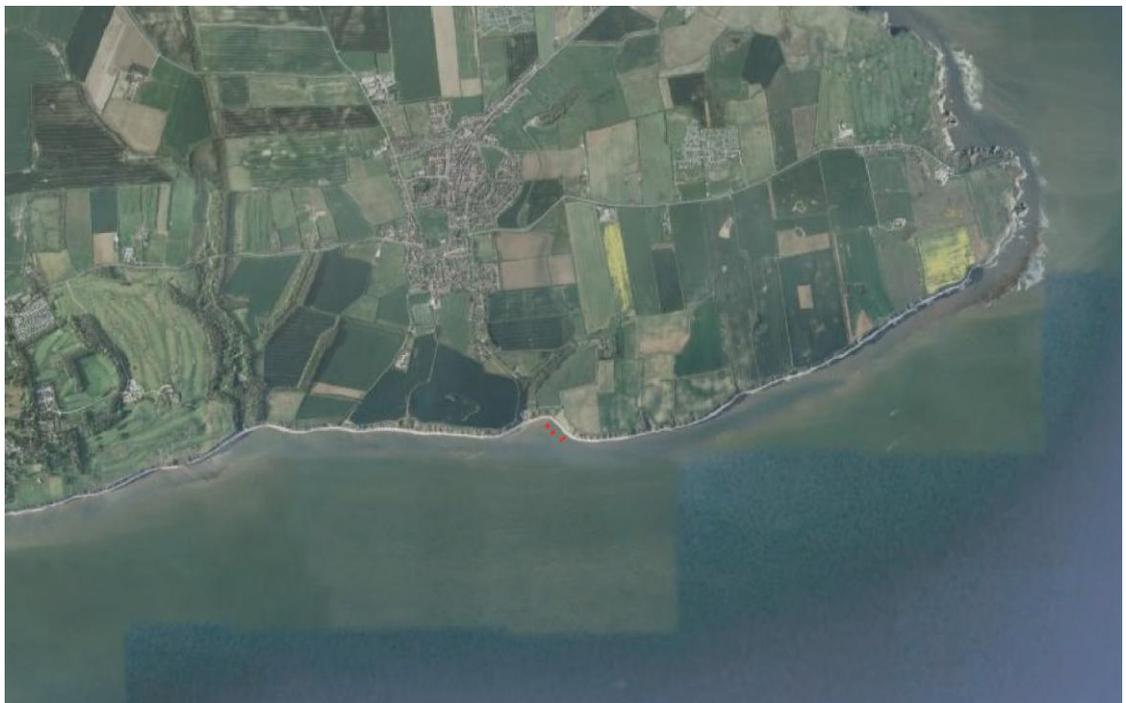
*Figure 74, The location of the historic port infrastructure at Flamborough (red) in relation to Flamborough head and village (source: Google Earth)*

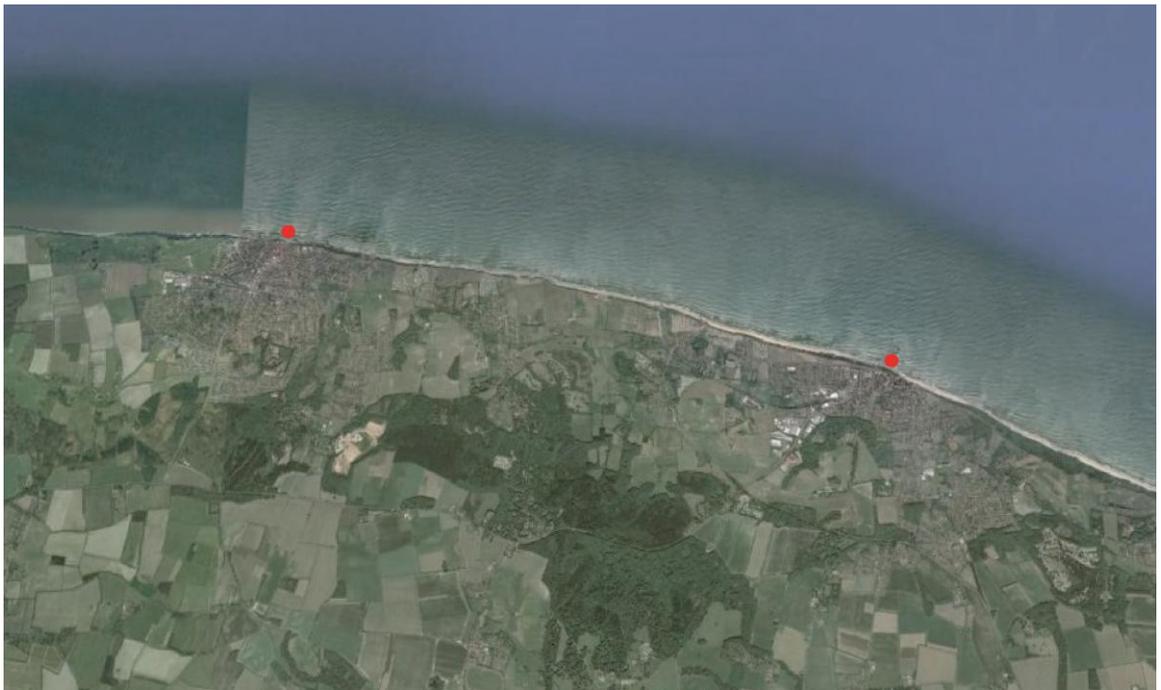
*Figure 76, The timber-built pier sites of Sheringham (left) and Cromer (right) (source: Google Earth)*

The north Norfolk coast in the area of Sheringham and Cromer is of soft cliffs generally under 40m tall and composed predominantly of thick, soft, clays, silts, sands and gravels overlaying cretaceous chalk, Figure 76, (BGS). The upper surface of the chalk is sometimes exposed on the foreshore at Sheringham but is permanently sealed by

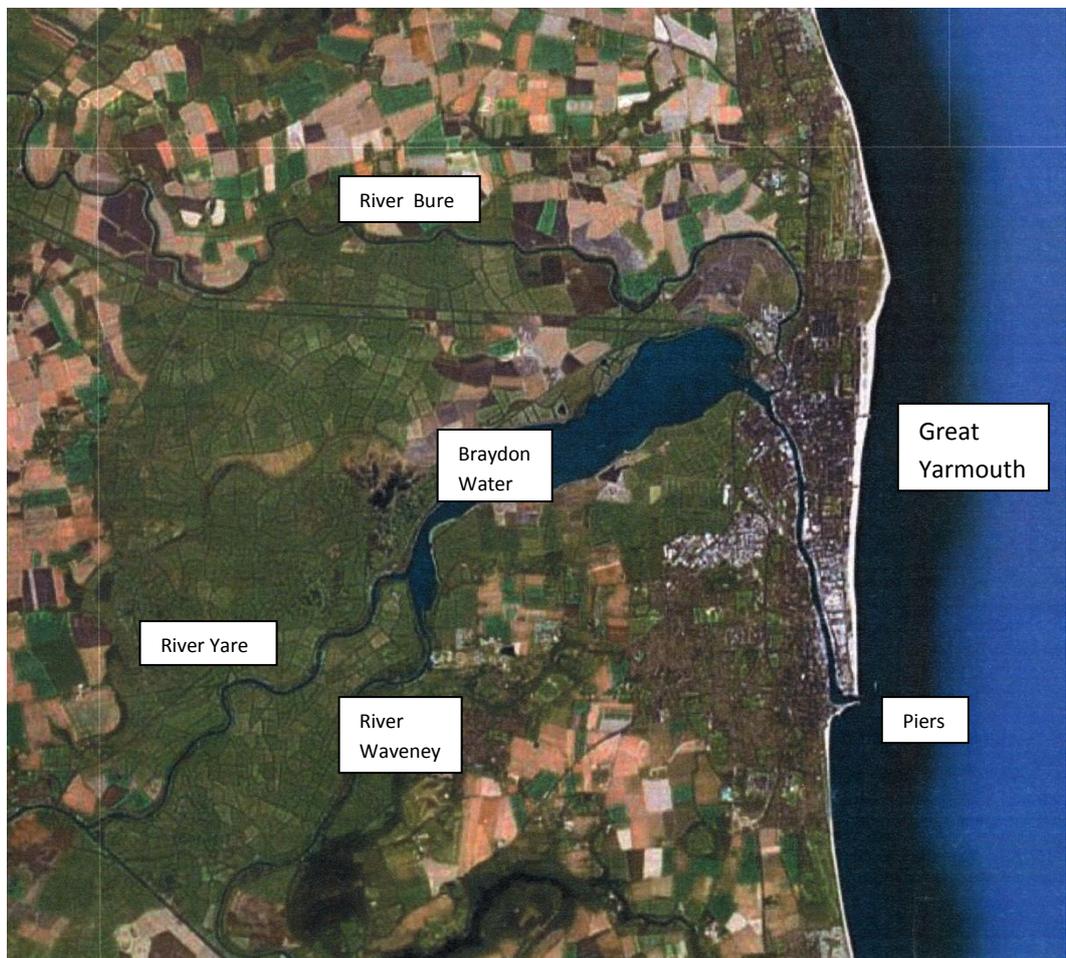
*Figure 77, Great Yarmouth and its immediate setting (source: Google Earth)*

Great Yarmouth is located on a north – south aligned spit formed of sands and gravels bounded to the east by the North Sea and to the west and south by waters issuing from Breydon Water, Figure 77. The rivers Bure, Yare and Waveley drain much of the lands and Broads inland from Great Yarmouth. Only to the north does the town have uninterrupted land access to its surroundings. In recent years the potential of offshore sandbank systems to support wind farms and marine aggregate extraction has encouraged the comprehensive study of the geomorphical evolution of the area. The broadest overview of the current state of knowledge has been that of Hannah Evans from which much of the next paragraph has been drawn (Evans 2010).

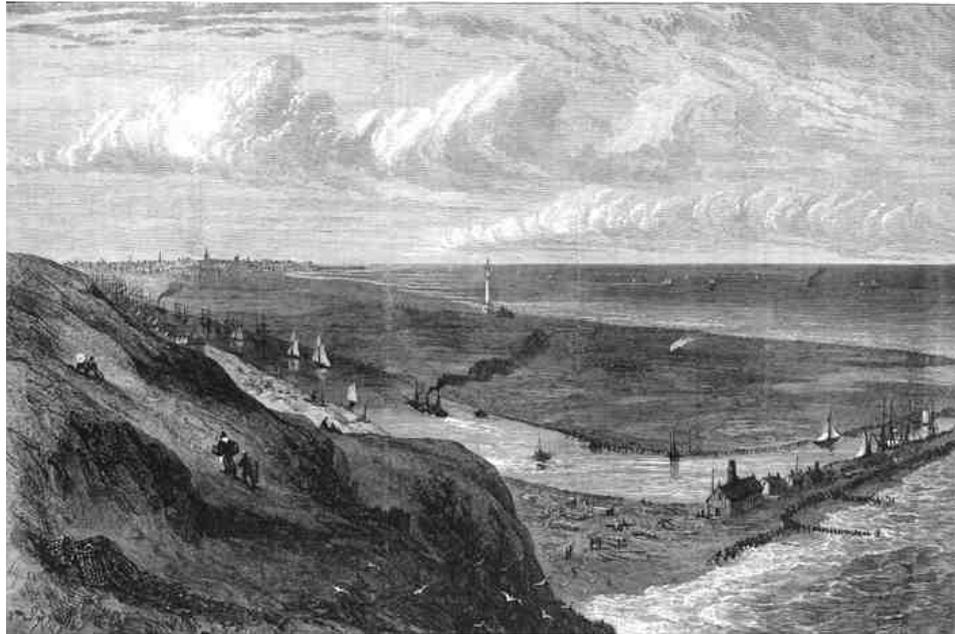
*Figure 79, Topographic setting of Great Yarmouth haven, 19<sup>th</sup>-century. The River Yare flows between the mainland and spit, turning sharply to reach the sea between the piers. The spit south of the haven had long disappeared by this date and groynes had been placed to prevent further erosion. (Norfolk Online Access to Heritage website)*

The succession of historic havens at Great Yarmouth attest the difficulties of maintaining a port in such a geomorphologically dynamic setting. The available documentary evidence suggests that the first six of the documented havens failed because of the choking up of their mouths due to the north - south drift of sediment along the spit. Long-term channel stability was finally achieved by the building of the seventh haven with piers. To contemporaries, it was accepted that the success of the seventh haven was due almost entirely to the piers and their related works. In all likelihood the piers were constructed far enough into the sea to counteract the worst effects of longshore drift induced sediment blockage whilst the channelling of the River Yare up to and through the piers deterred sediment build-up. However, it is known that by 1695 a bar had formed across the mouth of the haven (Evans 2010, 27) and that this did sometimes necessitate the warping in of vessels by pier mounted capstans (Preston 1819, 151-156). Late 17<sup>th</sup>-century attempts to cut a channel through the bar may have had only limited success (Palmer 1854, 290). Success in stabilising the location of the seventh haven came at an enormous cost, aside from the constant expenditure of pier maintenance. This cost was the removal of around 10km of spit to the south of the piers by erosion which can be “*attributed to interruption and transferral further offshore of the sediment drift patterns by these structures (the piers)*” (Evans 2010, 24). In other words the piers prevented the supply of new sediment to the spit whilst continuing erosion resulted in its eventual removal. At this final stage it eventually became necessary to build works to protect the landward end of the southern pier itself, Figure 79.

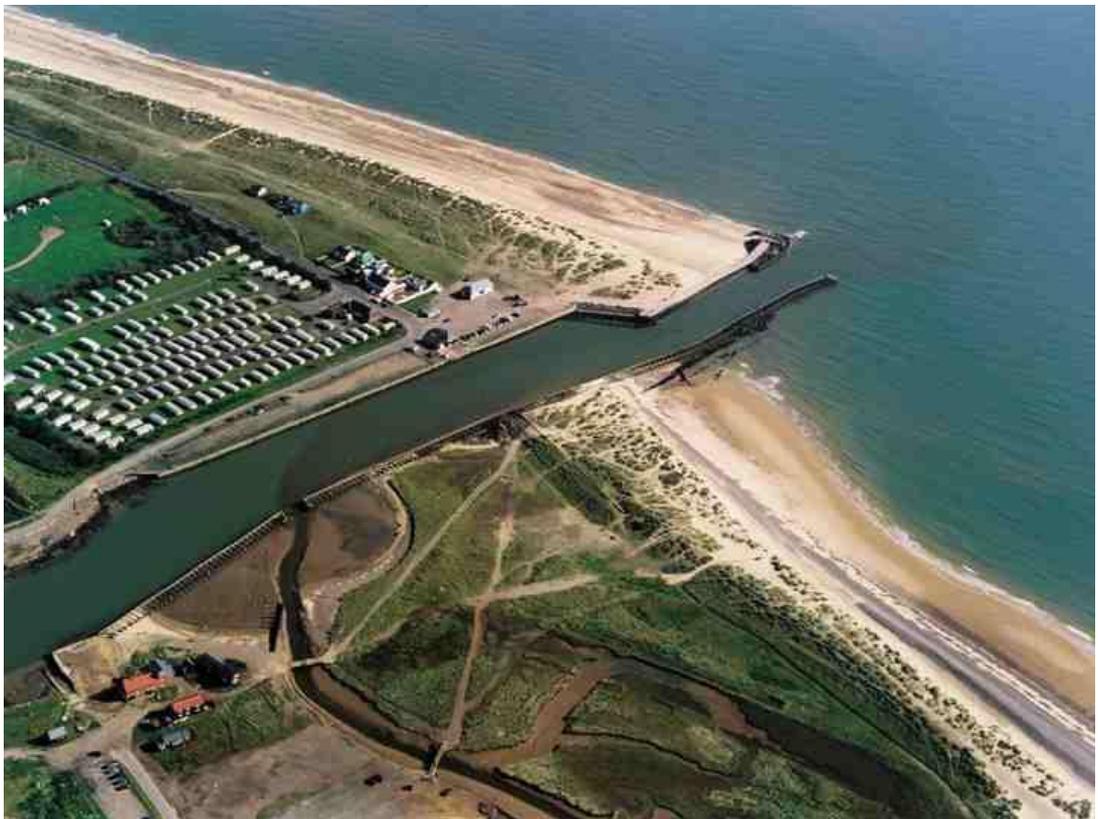
Figure 83, Oblique aerial photograph of Southwold harbour piers, looking NE. The stepped nature of shore to either side of the harbour show the effects of longshore drift  
 (source: <http://www.eadt.co.uk/photos>)
