**Historic Timber-built Seacoast Piers of Eastern  
England: Technological, Environmental and  
Social Contexts**

Volume 1 of 2

University of York

Archaeology

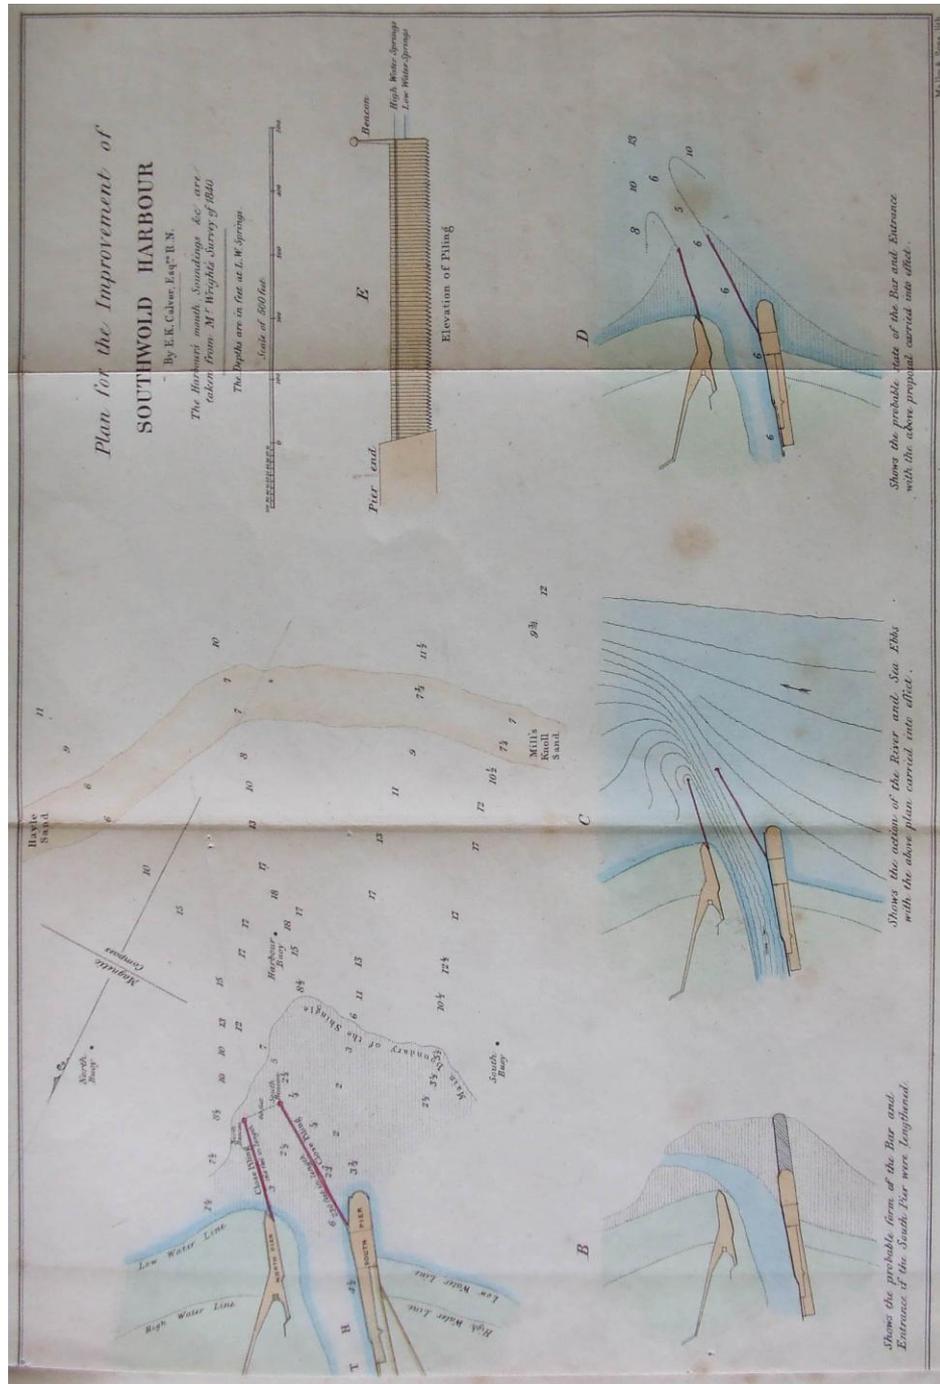
Figure 84, Southwold. Calver's proposals of 1844 for extending the piers with walls of close piling. Note the drawings suggesting different bathymetric outcomes with various pier arrangements (SRO B15082.23)

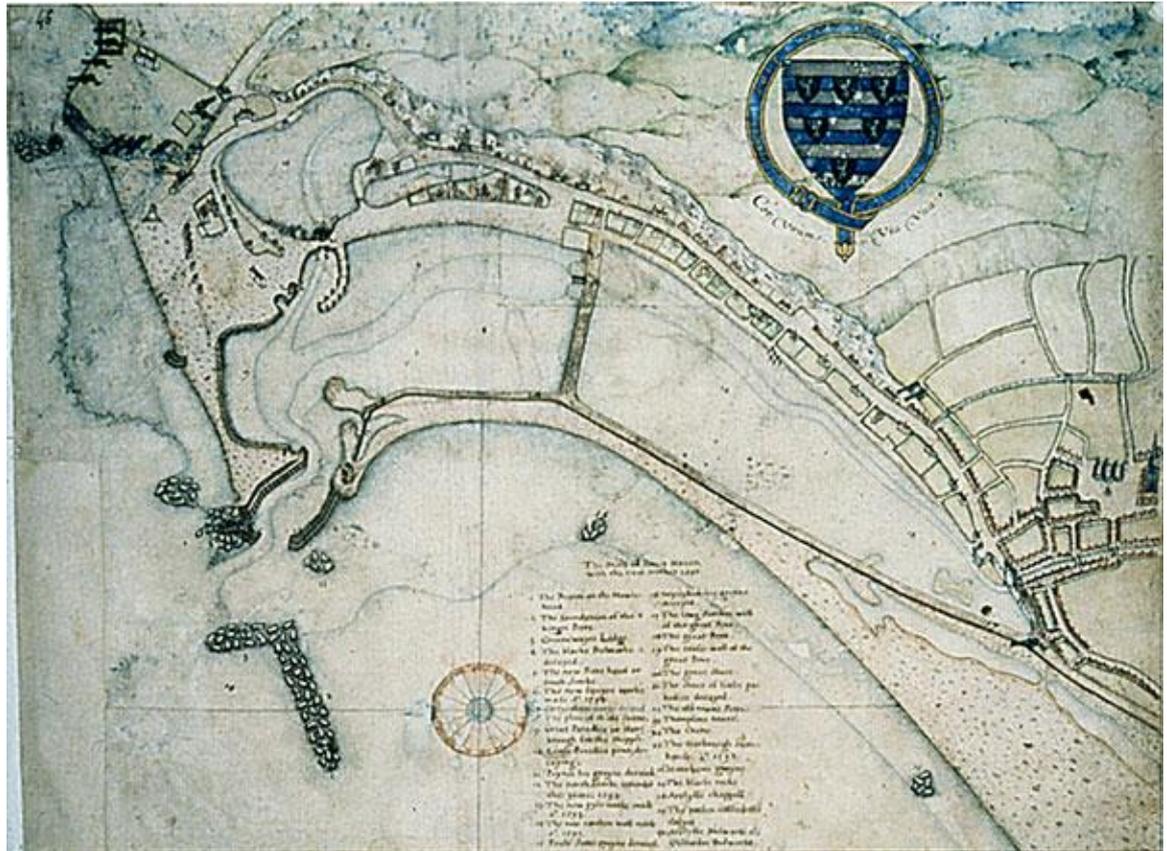
Figure 87, *Dover harbour in 1595, by Thomas Digges. Controlled release of water via a sluice in the internal cross-wall of the harbour served to scour the lower basin and harbour mouth. North is to the right (British Library Cotton Augustus I.i.46)*

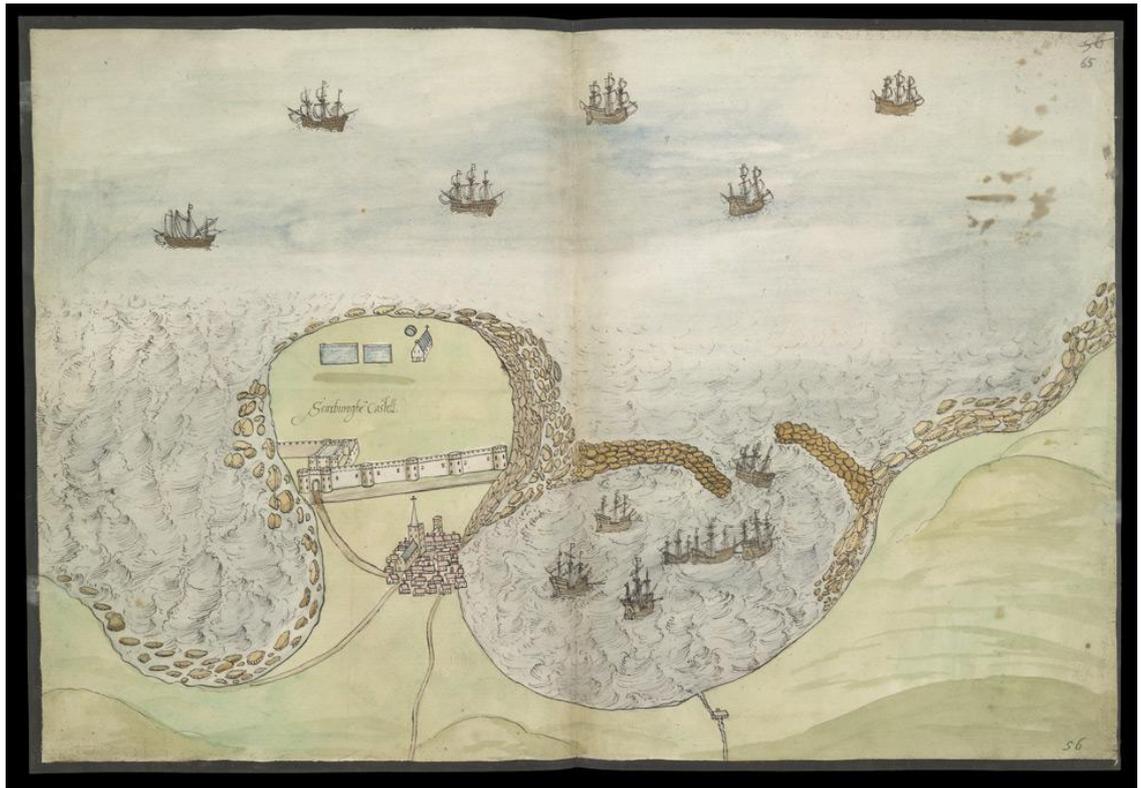
*Figure 92, Plan of Scarborough, 1595, showing entirely stone-built piers constructed of loose stone by the floatation and dropping method. (British Library, Royal MS. 18. D.III f.65)*

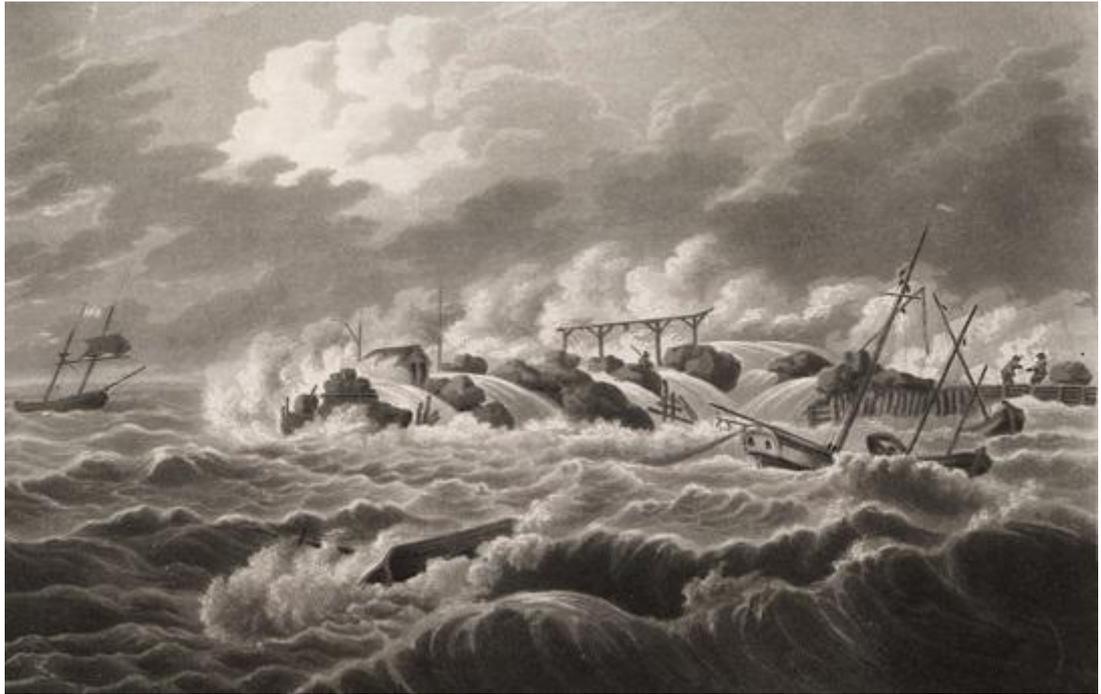
*Figure 93, The stone clad pier at Margate destroyed by storm in 1808 (British Library, Ktop XVII 4-f-2)*

At Margate an Act of Parliament of 1787, which revised the financial system of maintenance of the pier, provided the legal authority for taking down the old wooden pier, this was to be “*entirely taken down, and a new stone head built in its room*” (Act of Parliament 1787). However, writing shortly after this date the historian Edward Hasted noted that instead “*the old wooden pier has begun to be cased (clad) on both sides with stone, and extended, and the whole is now completely finished*” (Hasted vol. 10, 1800). This observation was also recorded by another contemporary writer (Nichols 1793, 26). The stone clad timber pier proved to be a short-lived arrangement, it largely being destroyed by a storm in 1808, Figure 93, and the existing all stone pier was built shortly thereafter (English Heritage 2007, 70).

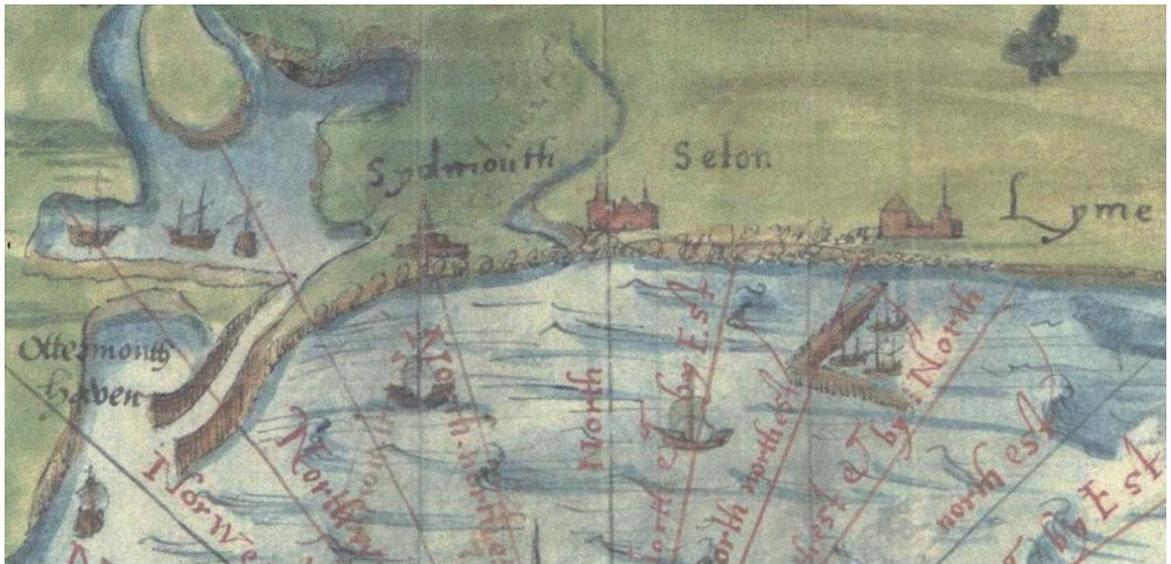
*Figure 94, Map of c. 1540 showing the timber-built pier at Lyme Regis (right) and the proposed piers at Ottermouth Haven (left) (British Library: Royal MS. 18. D.111 f.10)*

proposed around 1540. Several other timber-pier sites are suspected but have yet to be confirmed. Those at Lyme Regis and Ottermouth Haven are both shown on a map drawn c. 1540 that once formed part of a large collection of maps belonging to the Elizabethan statesman William Cecil, Figure 94. The pier at Lyme is depicted as an unusual ‘L’ shaped arrangement whilst the haven at Ottermouth is of twin pier form. The piers at both sites appear to have walls constructed of vertically driven timbers. The technical details, including the internal stone infill, at Lyme can be better comprehended in a picture map of 1539, Figure 95. It is thought that Lyme’s pier, which was under the control of the local community, may have originated in the 12<sup>th</sup>-century, whilst a manuscript of 1313 details a structure of a timber outer casing with an internal fill of large stones (Wilson et al. 2007). The extant stone pier at Lyme is commonly, but erroneously, held to be medieval, there probably being little, if any, in-situ fabric earlier than the 18<sup>th</sup>-century.

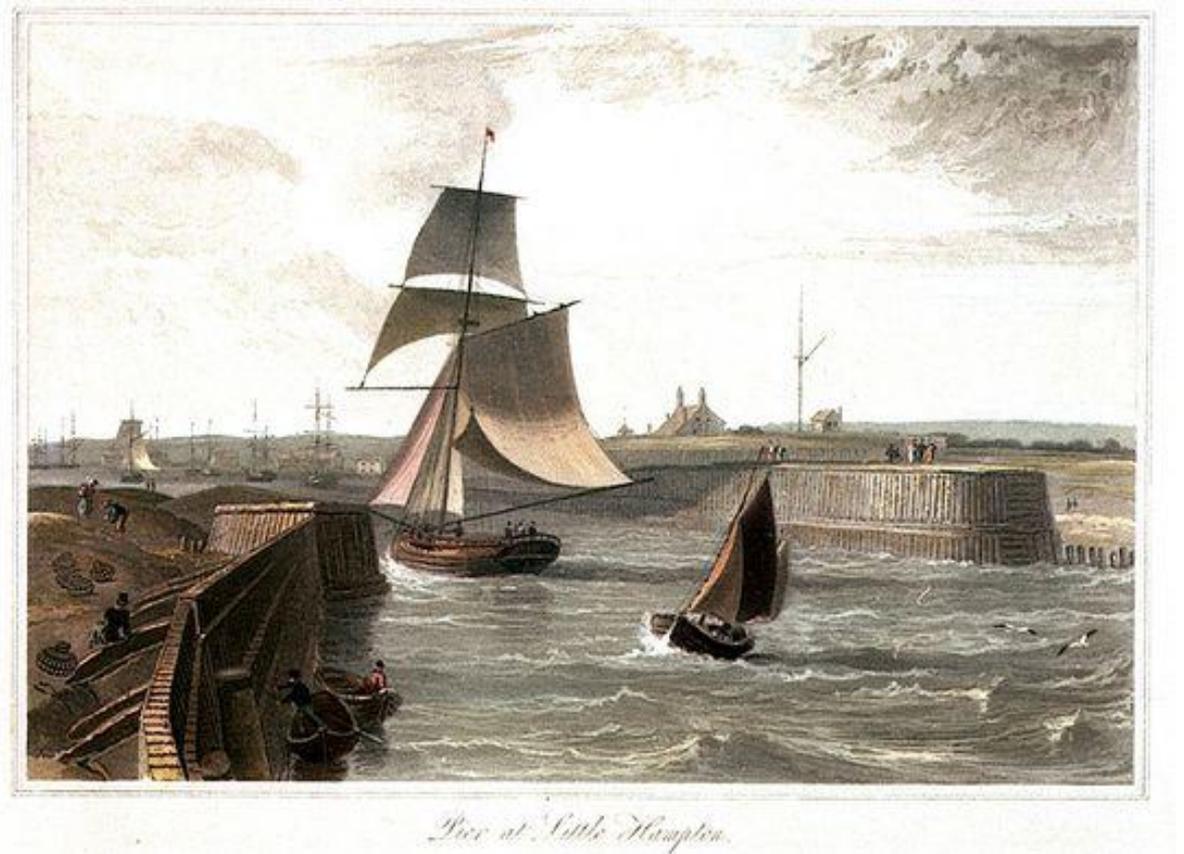
*Figure 97, Piers at Littlehampton, 1823. Constructed of slightly angled close set piling with horizontal rails part way down the wall (National Maritime Museum: PU1052)*

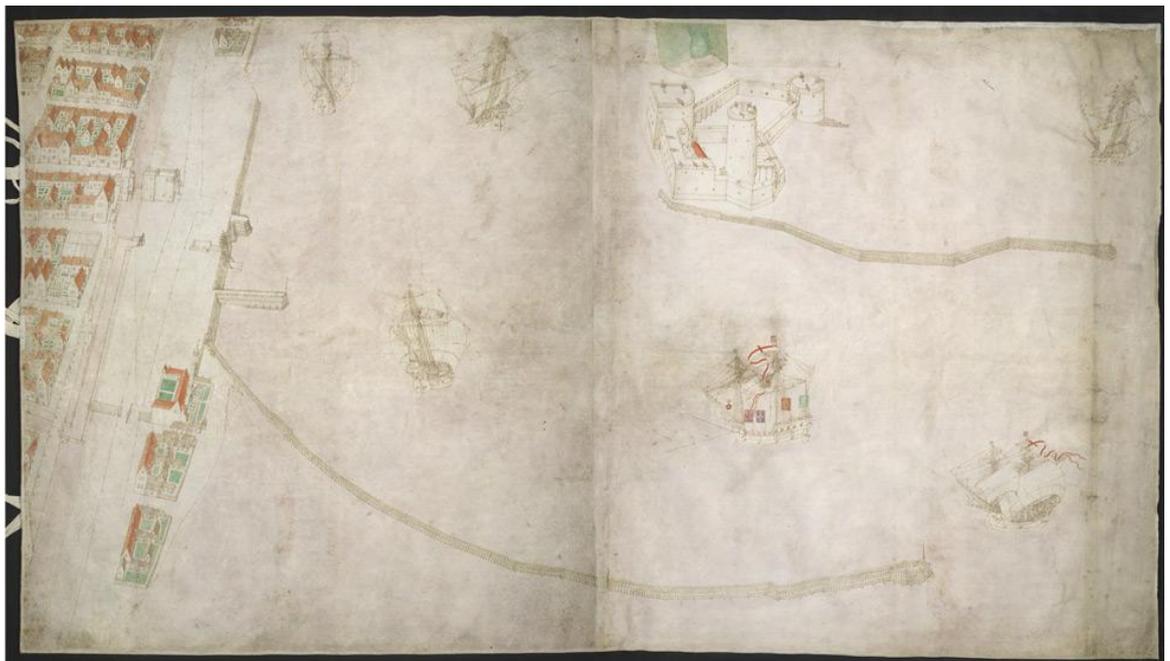
*Figure 99, Piers at Calais, 1545-50 (British Library, Cotton Augustus l.ii. f 57)*

Whilst its timber piers are believed to have been present by the early 16<sup>th</sup>-century the earliest known view of the works at Calais dates to 1545 and shows an extensive twin pier system (British Library, Cotton Augustus l.ii. f 57B). A more detailed map of 1545-50 shows the pier system and two small jetties together with other defensive works, Figure 99. These works were the result of investment in its continental foothold by the English crown. At least part of the west pier was recorded as being built of English timber framed in Bettingham's Wood in the Weald of Kent whilst both piers had an infill of chalk rubble (Colvin 1975, 346-8). Sluices are known to have been used for scouring the harbour (Colvin 1975, 357). The detail of the latter manuscript map is particularly fine with walls of near vertical piles, external rails and raking external braces - probably at points of bay division, all being evident. Analysis of a large scale copy of this image has the potential to elucidate much fine structural detail.

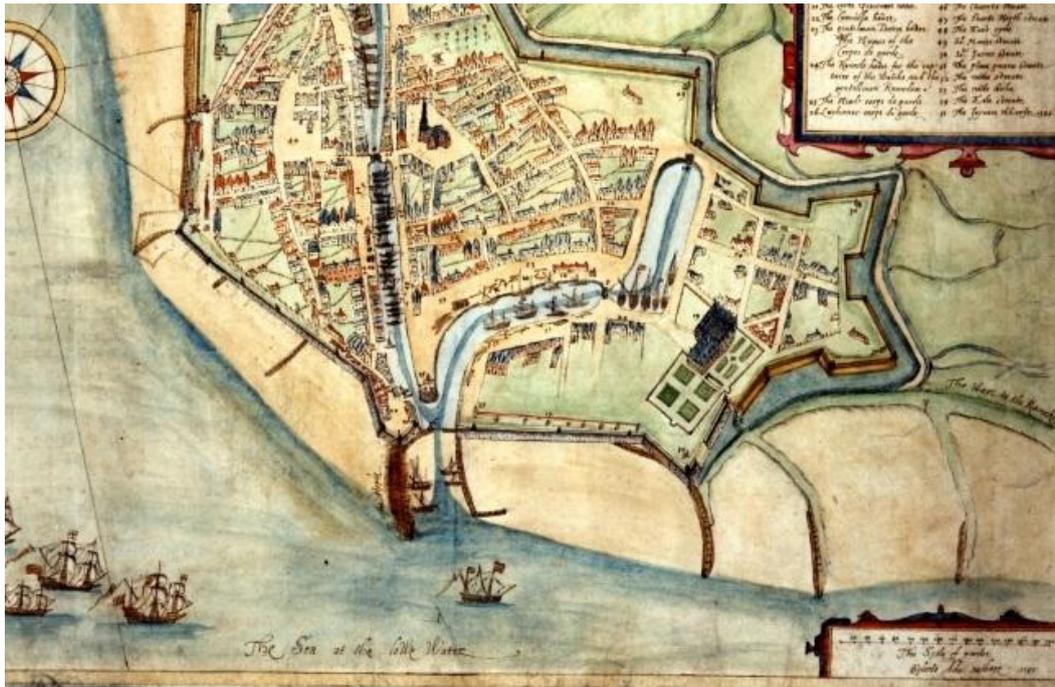
There are a number of historic views of Vlissingen. One of the earliest of these, dating to 1585, depicts twin piers through which a channel flows and which provides access to docks in the heart of the town, Figure 103. One of the principal elements of the walls of the piers are shown to be wide spaced vertically driven piles, probably with timber planking behind, whilst tie-beams are also evident. A number of lesser piers to either side appear to be glorified groynes. On the basis of a painting of 1669 these lesser piers

*Figure 103, Piers at Vlissingen 1585. A map by Robert Adam (from; Skelton and Summerson 1971)*

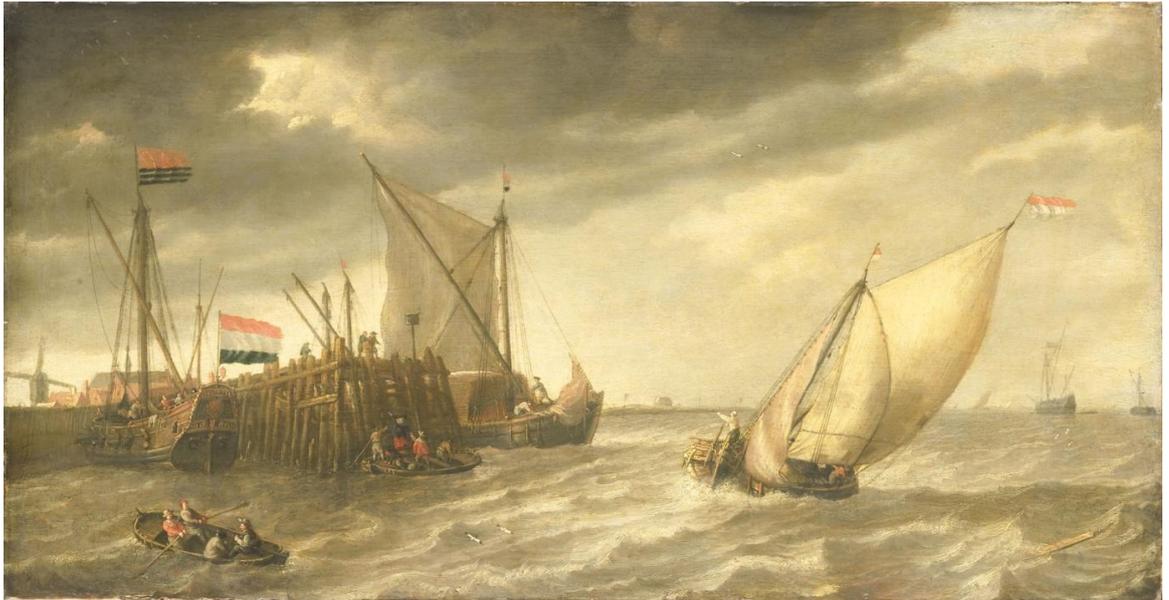
A painting of 1652 depicts a somewhat dilapidated and patched-up pier near the mouth of the River Scheldt, Figure 106. This can be seen to be constructed of narrow spaced, slightly angle driven piles, a high level external timber rail and a decking of timber.

Figure 106, *Pier near the mouth of the Scheldt*, detail of a painting by Bonaventura Peters, 1652 ([www.rijksmuseum.nl](http://www.rijksmuseum.nl))

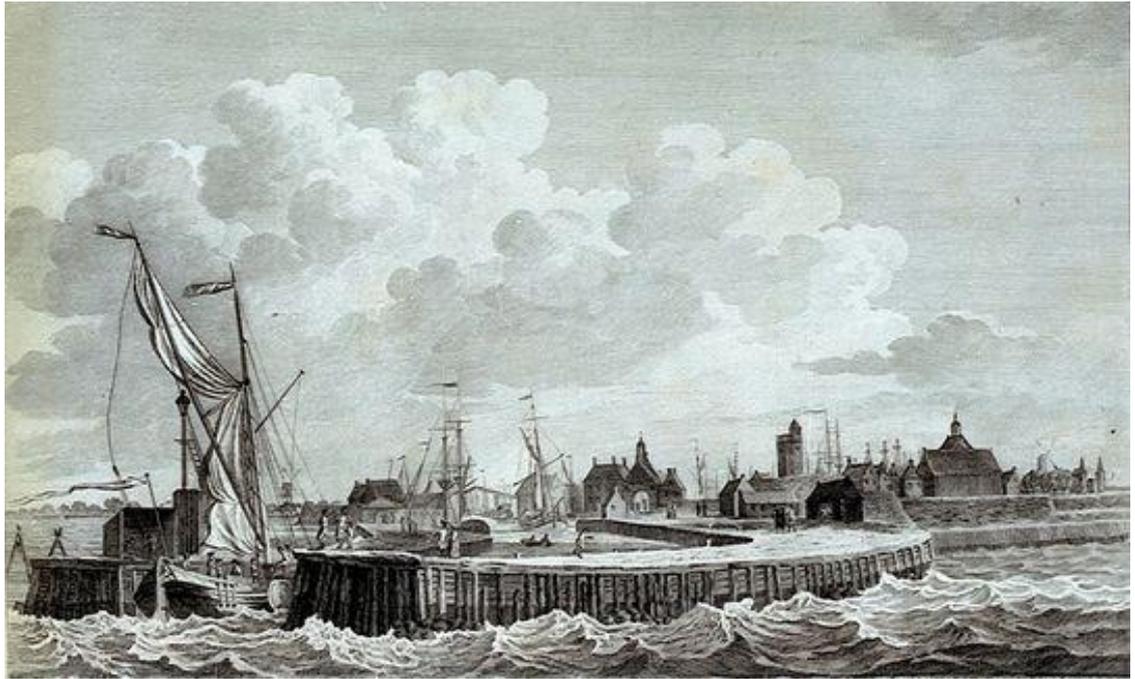
A late 18<sup>th</sup>-century engraving of a twin pier arrangement at Harlingen with a narrow canal-like channel between bears some similarity to the form seen at Dunkirk and Gravelines, Figure 109. At Harlingen the walls can be seen to be of narrow spaced timber piles with horizontal planking behind. The walkways are not of timber and so an infill of solid material is implied.

*Figure 109, Twin piers at Harlingen, 1781. (National Maritime Museum, Greenwich: PW7388)*

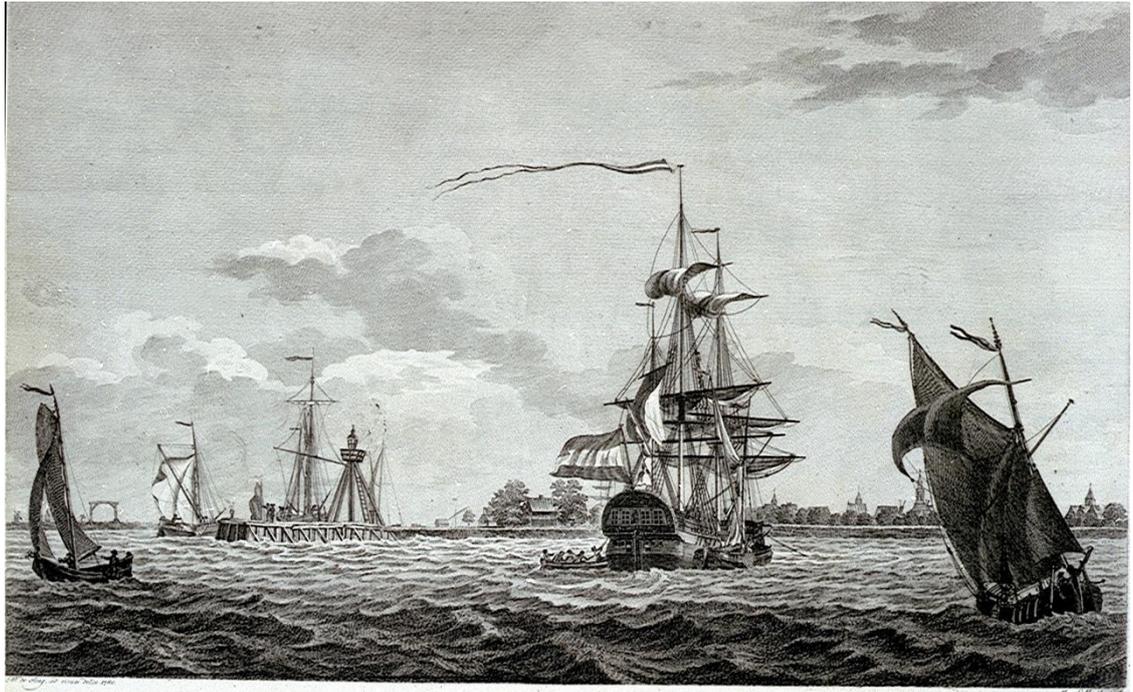
A timber-built pier at the port of Edam on the Zuider Zee is depicted in an engraving of 1780, Figure 110. This pier has wide spaced vertically set piles, a high level external rail and raking timber bracing. The walls behind the piles were probably of horizontal timber planking. It is likely that this pier was of earth-fast frame type.

*Figure 110, Pier, De Haven van Edam 1780 (National Maritime Museum, Greenwich:  
NMM PW7378)*

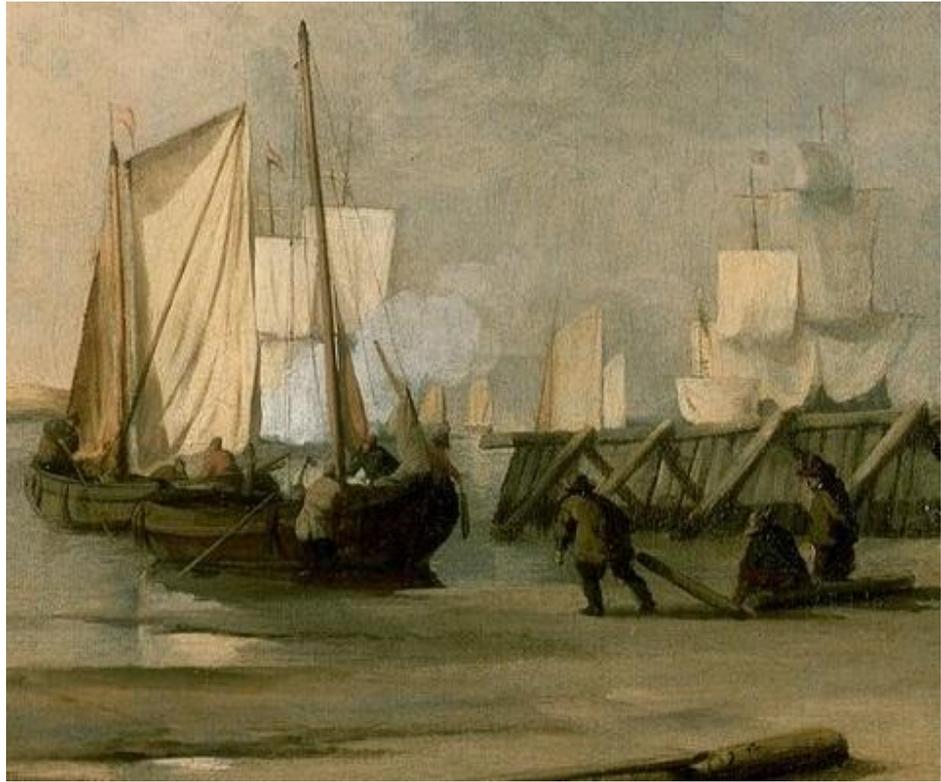
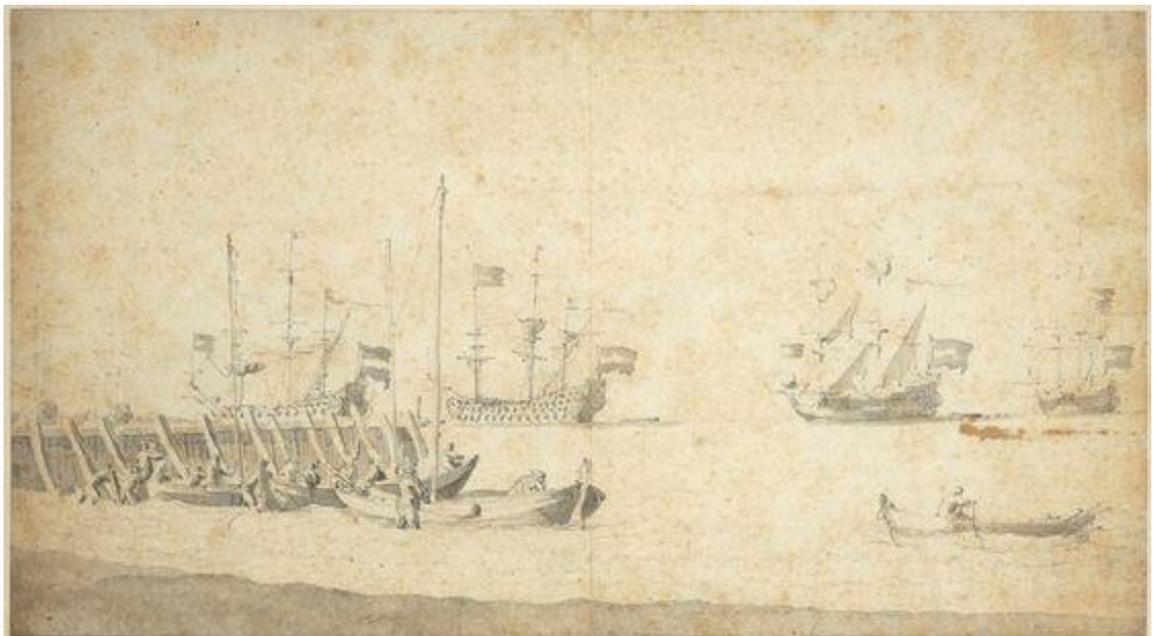
The National Maritime Museum, Greenwich possesses a number of images which show Dutch timber-built piers, the locations of which are not known. A selection of these is reproduced below, Figures 111, 112, 113 and 114. The first two are of interest in that they both show angled external bracing, a feature not observed in the English study area examples. The latter two are of angled and vertical close-piled form.

*Figure 111, Unidentified pier, Dutch 1654 (National Maritime Museum, Greenwich:  
BHC0896)*

*Figure 112, Unidentified pier, Dutch 1665 (National Maritime Museum, Greenwich:  
PY1732)*

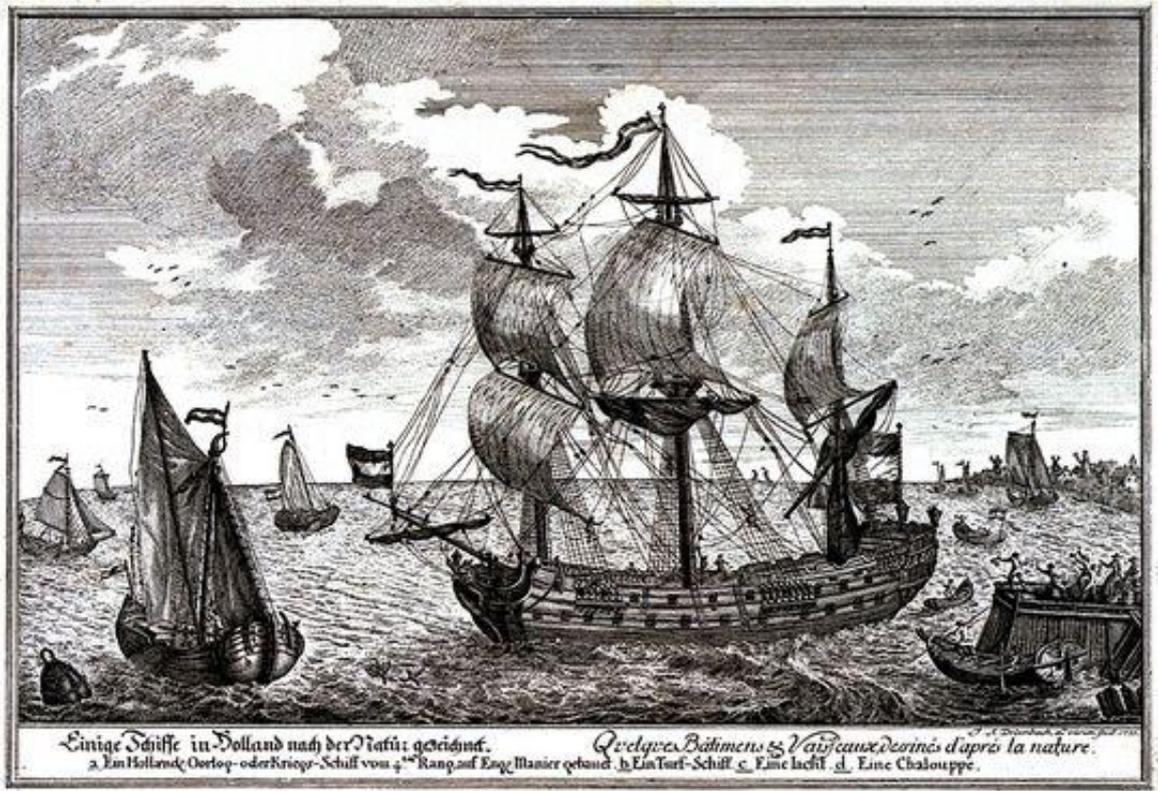
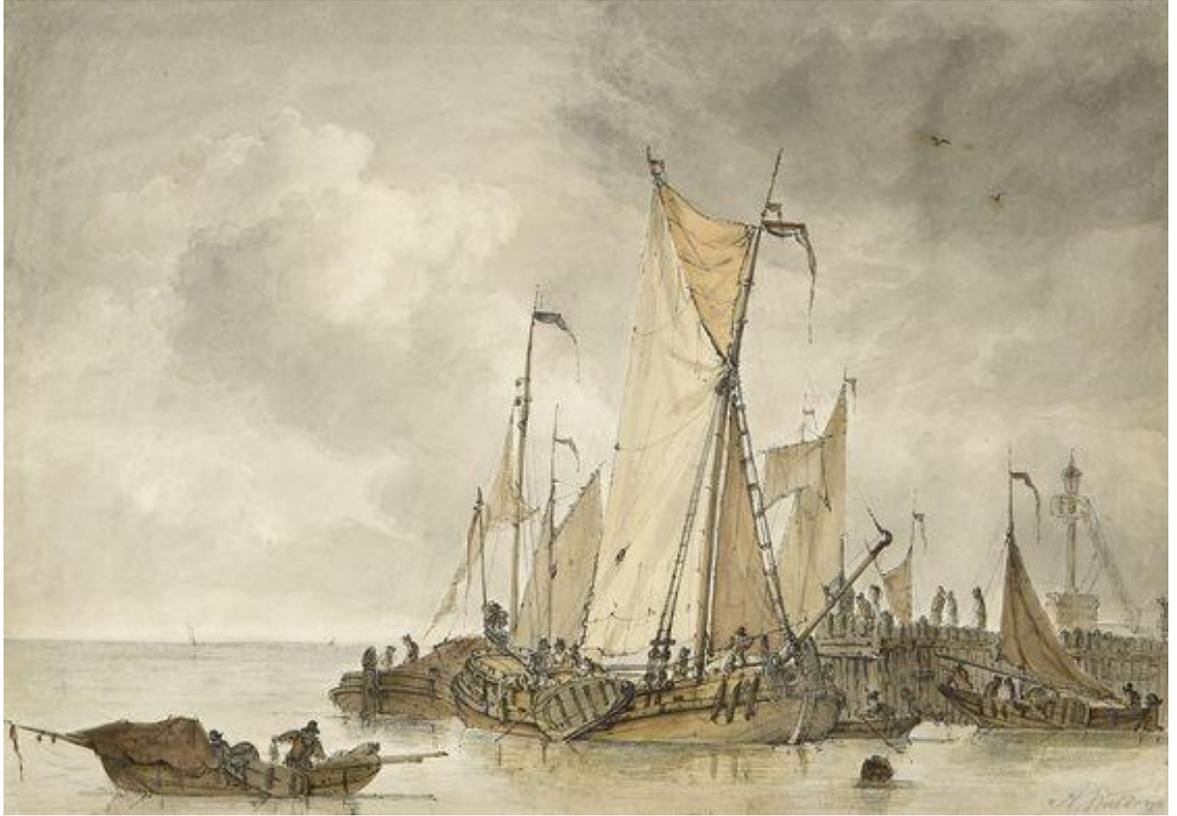
Figure 113, Unidentified pier, Dutch 1733, (National Maritime Museum, Greenwich: PU0255)

*Figure 114, Unidentified pier, Dutch 1856, (National Maritime Museum, Greenwich: PY8382)*
