A COMPUTATIONAL MODELLING
STRATEGY FOR HISTORIC MASONRY
STRUCTURES

Submitted in accordance with the requirements for the degree of
Doctor of Philosophy

The University of Leeds

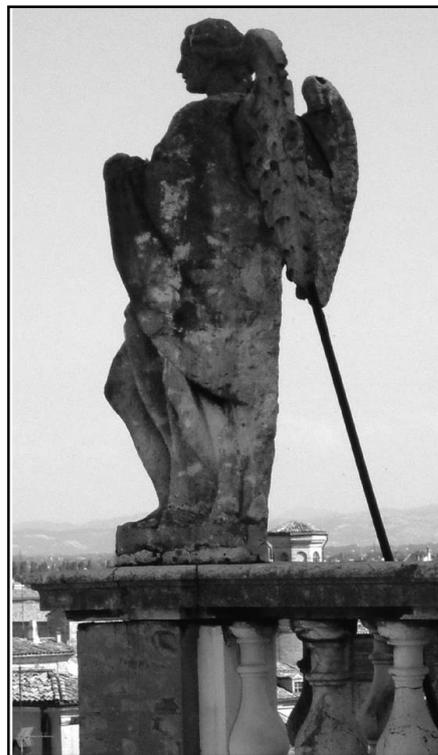
Figure 2.10: Roof statue of the church of Santa Maria Della Steccta, Parma. Note the induced gap between the supporting pillar and the statue base, as well as the supporting iron bar (Rahman and Suter, 1993).

This can lead to hazardous failure of parts of the structure such as buckling of entire panels of masonry veneers and claddings (Rahman and Suter, 1993). Figure 2.10 also

depicts spalling of the surface on roof of the church of Santa Maria Della Steccta in Parma.

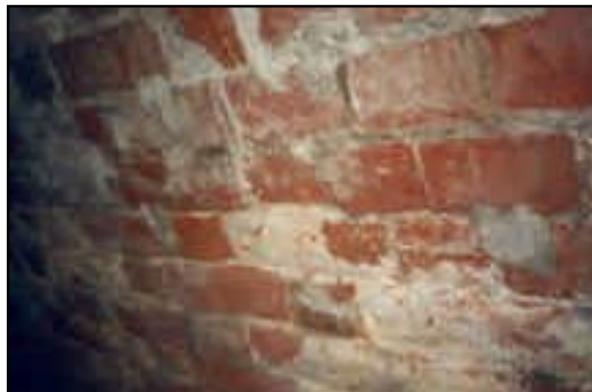
Figure 2.12: An example of efflorescence and crypto-florescence (Harrison, 1998).

In fired-clay masonry, there exists a phenomenon called crypto-florescence, which is also known as crypto-efflorescence⁷ or sub-florescence (De Vent, 2009). Crypto-florescence is described as “a harmful mechanism whereby various soluble salts, crystallise in pores below the surface of the brick” (De Vent, 2009; Forth and Brooks, 2000).

In masonry structures, normally when brick dries out, the existing salts are pushed to the surface of the brick. However, a situation could arise where the water evaporates before the salts gets to the surface. This is when the salts turn into crystals by getting deposited into the brick pores, forming a dried zone in masonry. These salts cause expansion, and so, an internal pore pressure below surface of the brick, at the interface of mortar bed joint and brick. The now-crystallised-salts spall the brick and in some cases result in removal of the whole brick surface; hence the term crypto-efflorescence (Bremner, 2002; Forth and Brooks, 2000; Harrison and De Vekey, 1998; Hardesty, 1944; Butterworth, 1933; Chin and Petry, 1993). Typical examples of efflorescence and crypto-florescence can be seen in Figure 2.12.

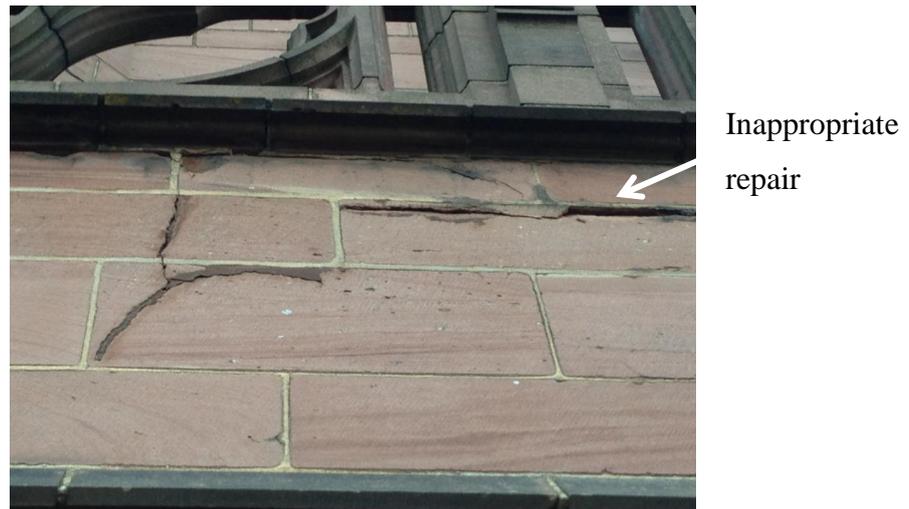
Another example of repair, where material coherence decreases is the restoration of the outer leaf of multi-leaf historic walls. Replacement of the outer leaf with new masonry causes disturbance in connection between the wall leaves. This means that the inner and outer leaves carry load separately, leading to failure of the wall with lower load bearing capacity.

Figure 2.20: Inappropriate repair on the outer surface of the Liverpool Anglican Cathedral has caused further crack and damage.

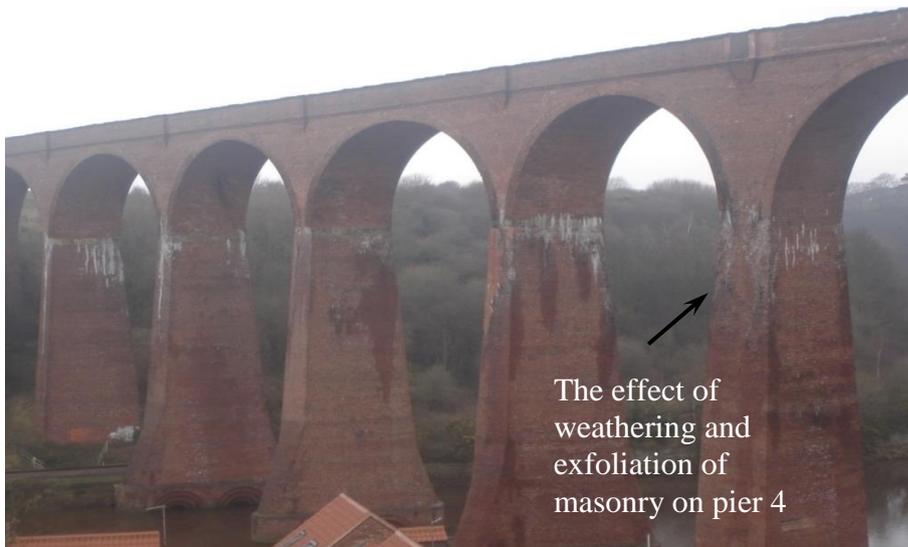
Figure 5.7: Weathering and exfoliation of the eroded masonry evident on piers of Larpool Viaduct.

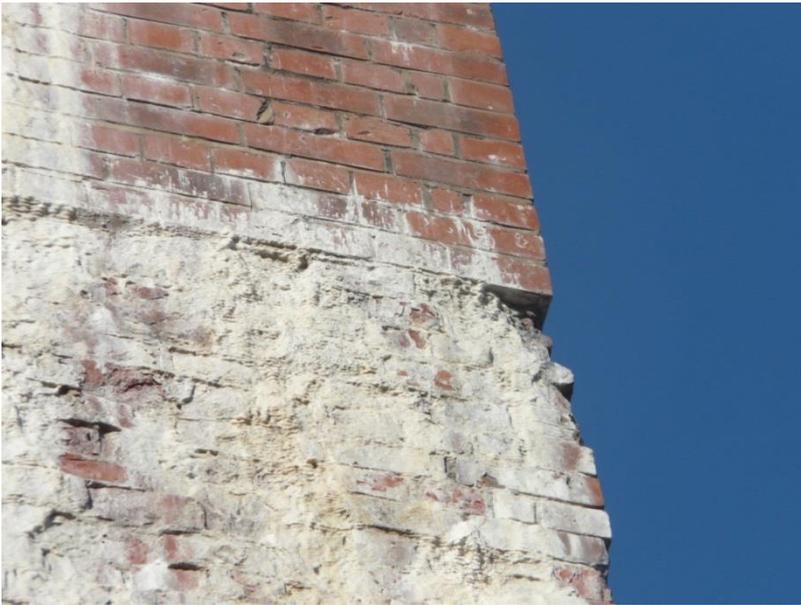
Figure 5.11: Pier rehabilitation works on Larpool Viaduct.

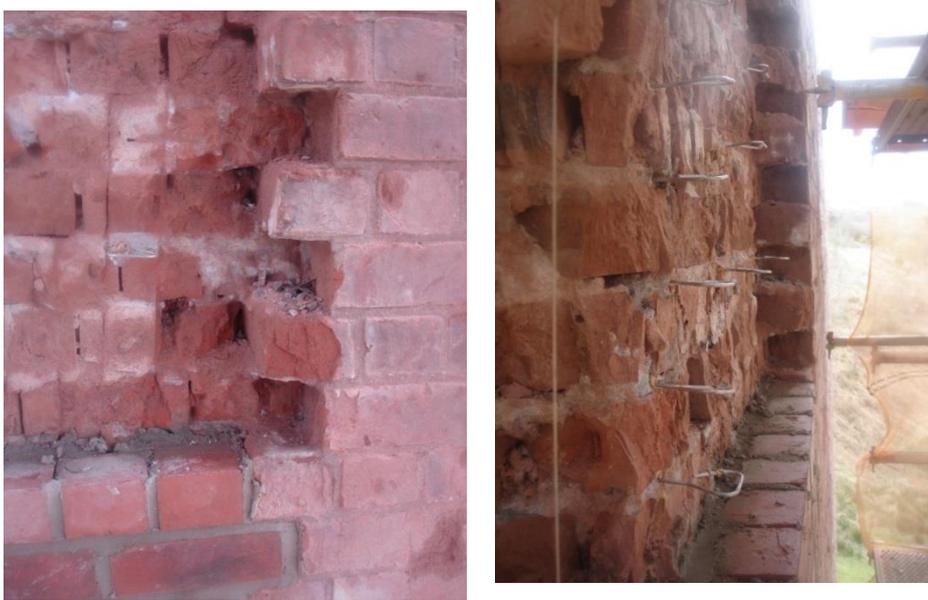
Figure 5.24 : Repair of the brickwork on piers of Larpool Viaduct, illustrating ties.

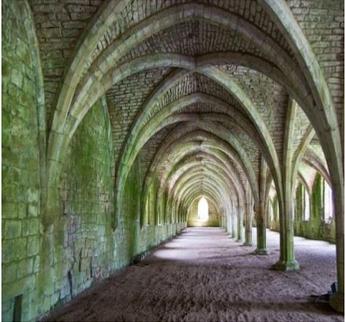
Biological growth	Colour	Appearance	Habitat	Effect on masonry	Examples
Algae	Usually green, occasionally black, red, orange or yellow	Mats, films, patches or streaks lacking defined borders	<ul style="list-style-type: none"> • Seen on wood, stone, soil, glass, plastic, etc. • Favours areas which are often moist. Requires relatively high light levels. 	Unless growth is heavy, algae are normally benign, but may be slippery on paving stones.

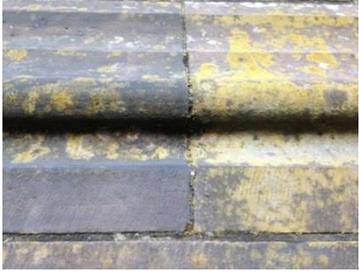
<p align="center">Liverpool Anglican Cathedral</p>

<p align="center">Fountains Abbey, Ripon</p>
Lichens	White, grey, orange, red, black, yellow, or green	Variable surface crusts or leaf-like structures growing away from the surface with well-defined borders. Slow growing to several cm in diameter.	Stone, wood and soil. Often found in conditions that are too hostile for other organisms. Most species have a low tolerance to air pollution and are most common in rural sites.	Normally benign, although rare instances of blistering and pitting are known.

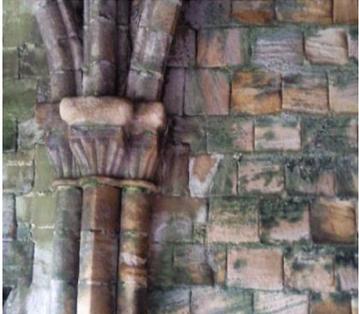
<p data-bbox="1731 1150 2036 1177">Kirkstall Abbey, Leeds</p>

<p data-bbox="1749 687 2018 715">Fountains Abbey, Ripon</p>
Cyanobacteria (previously known as bluegreen algae)	Blue-green, grey or green	Similar to the above	As above, but in areas away from direct sunlight, or in enclosed spaces adjacent to artificial lights.	Unless growth is heavy, algae are normally benign, but may be slippery on paving stones.

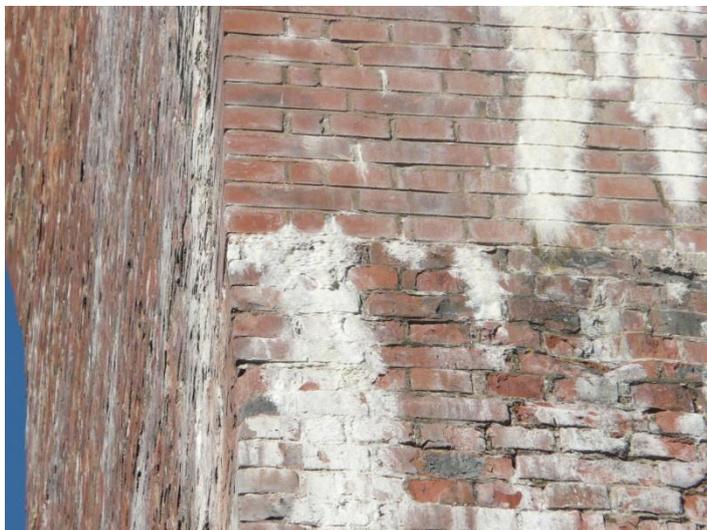
Figure F.2: Salt-damp defect on the top 9m of the pier, present on both repair and unrepaired parts.

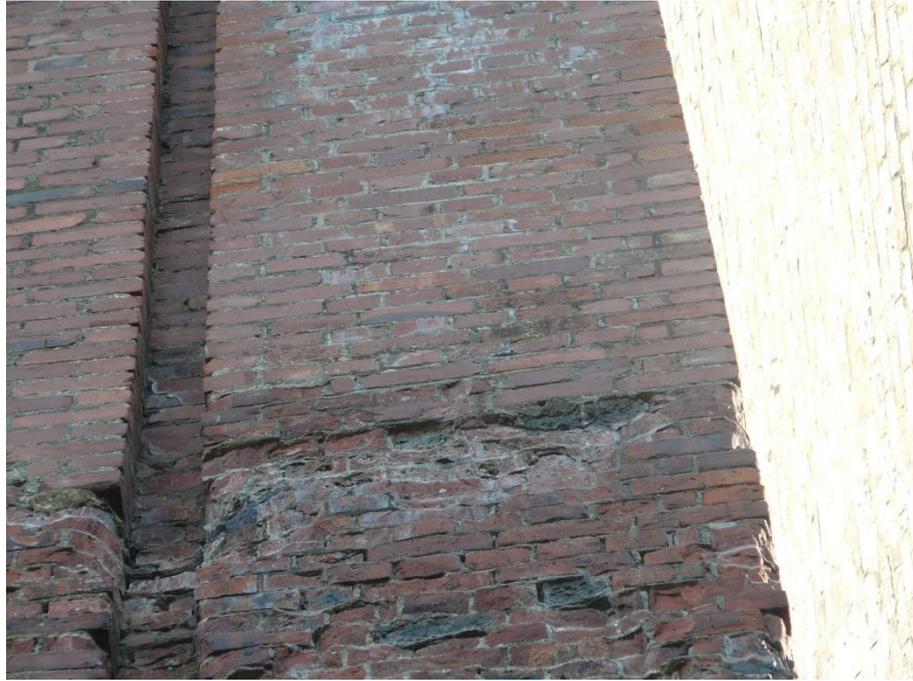
Figure F.3: Weathering defects causing exfoliation of stone on face 4 of the pier.

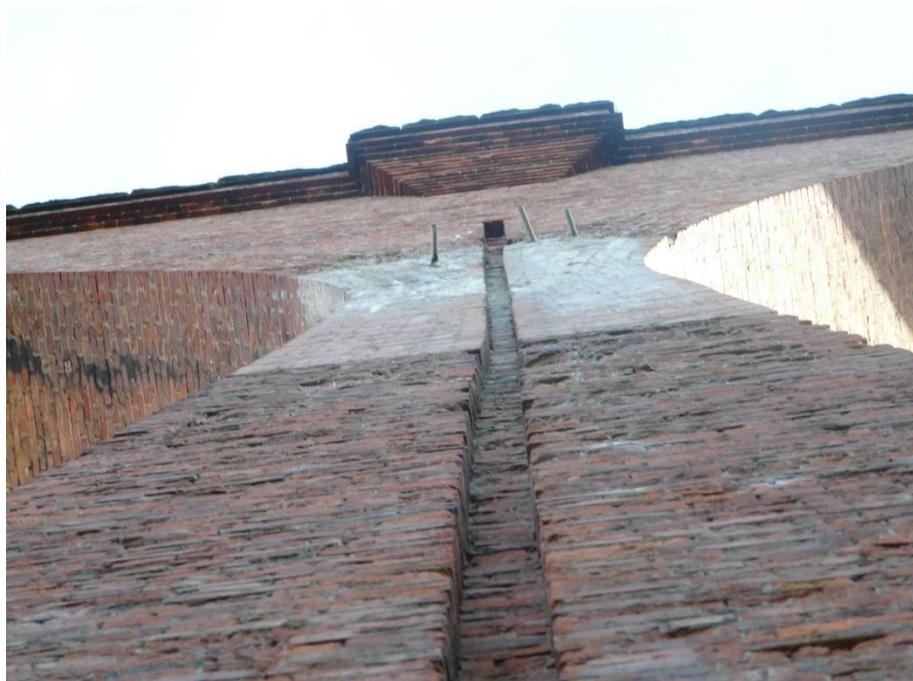
Figure F.4: Face 4 of the pier, different between the repaired and unrepaired section of the face.

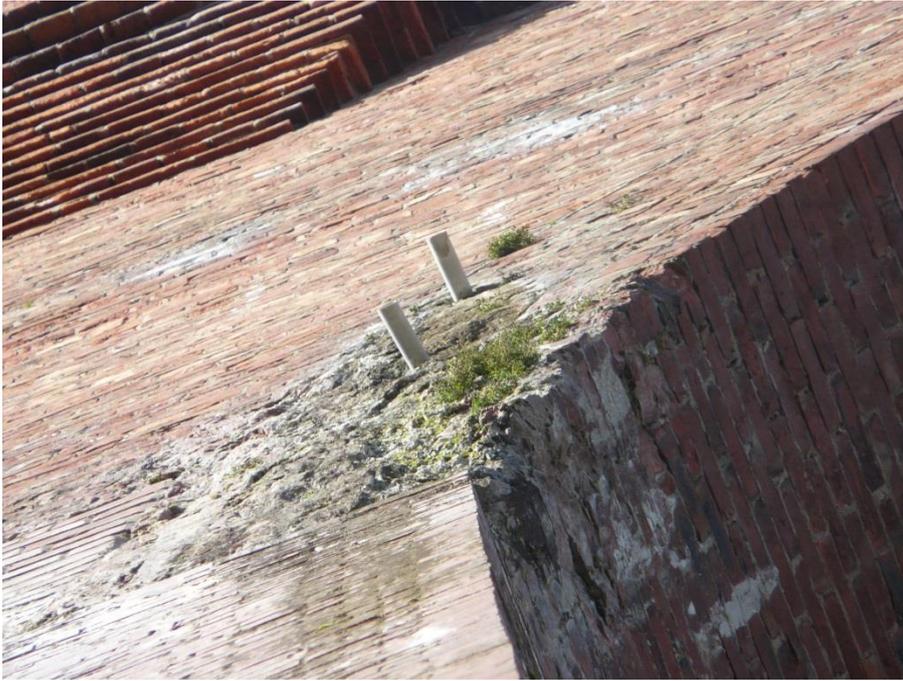
Figure F.5: The eroded zone around the drainage section on face 4 of the pier, showing plant growth close to the drainage pipes.

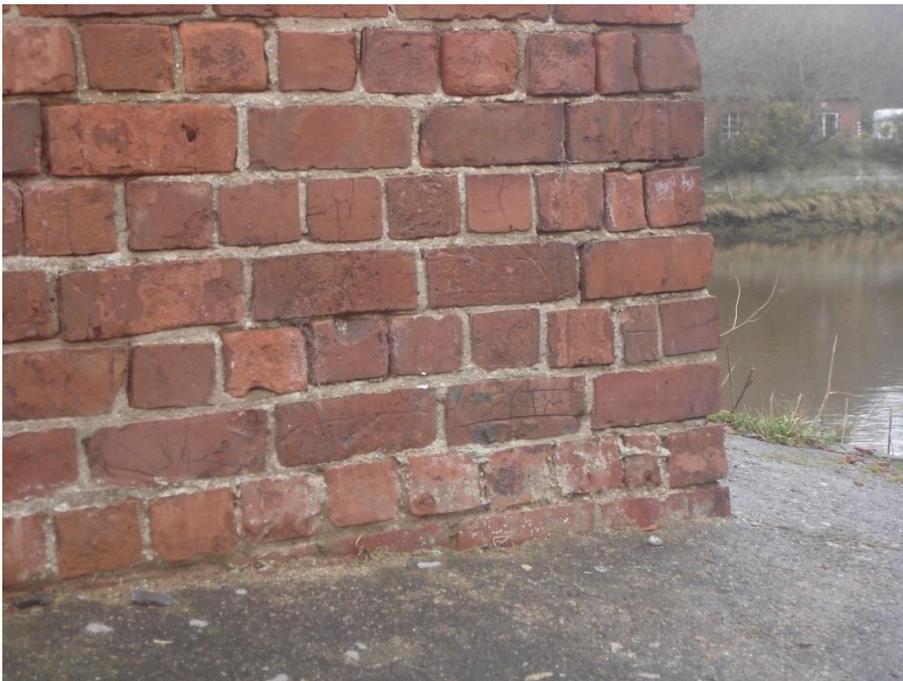
Figure F.6: Cracks on the outer faces of bricks, indicating spalling of face 1 surface.

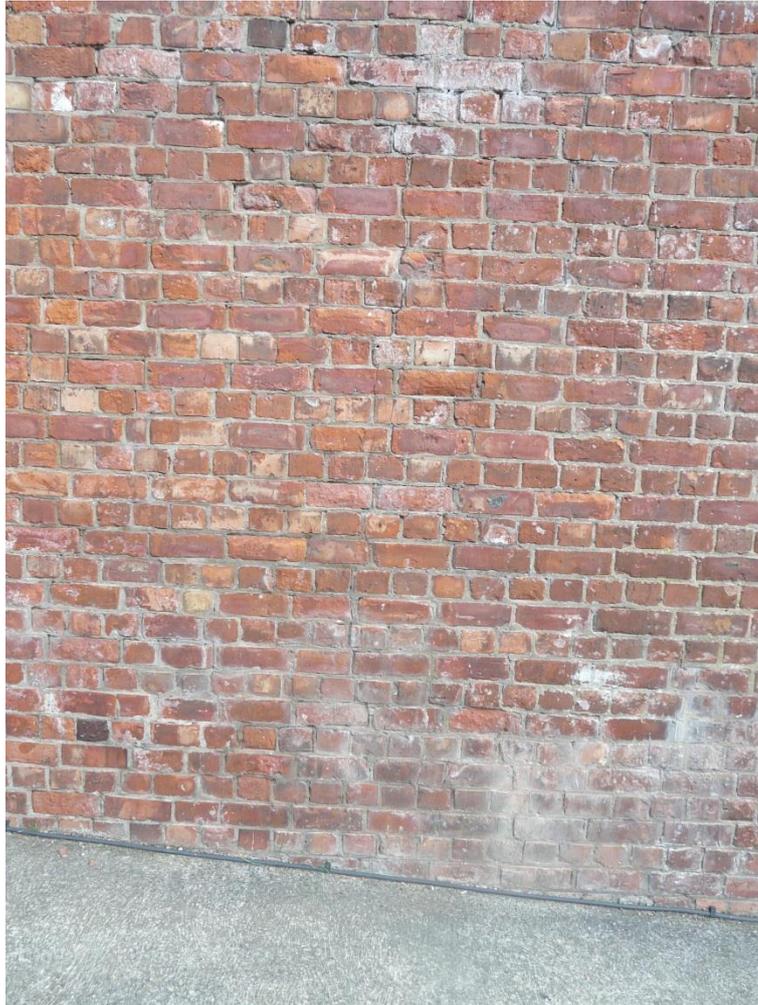
Figure F.7: Vertical cracks seen on the bottom 2.5 meters of the pier

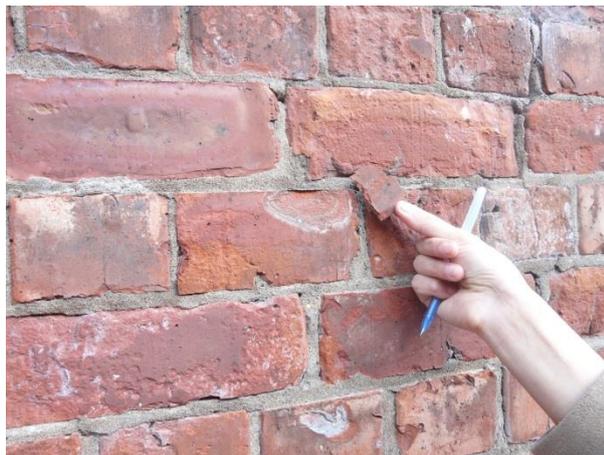
Figure F.8: Spalling of the outer layers of brick
