**BIOGRAPHIES OF PEOPLE AND PLACE:  
THE HAREWOOD ESTATE, 1698-1813**

**NO. 2 OF 2 VOLUMES:  
FIGURES & APPENDICES**

**TIMUR GURAN TATLIOGLU**

**UNIVERSITY OF YORK**

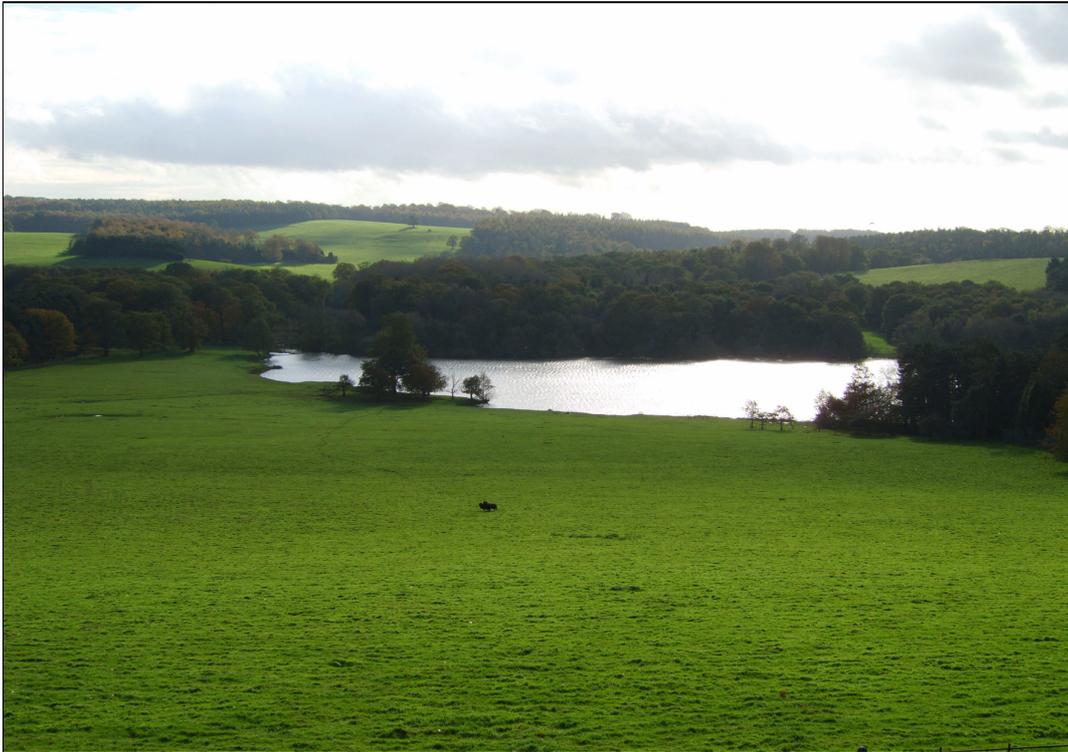
3.4 The south-facing view from the terrace of Harewood House showing the site of Gawthorpe Hall. The hall is likely to have been situated in the plateau indicated by the area cast in shadow. On the horizon are the Sugar Hills, while the adjacent parkland was mainly laid out in the late-eighteenth century.

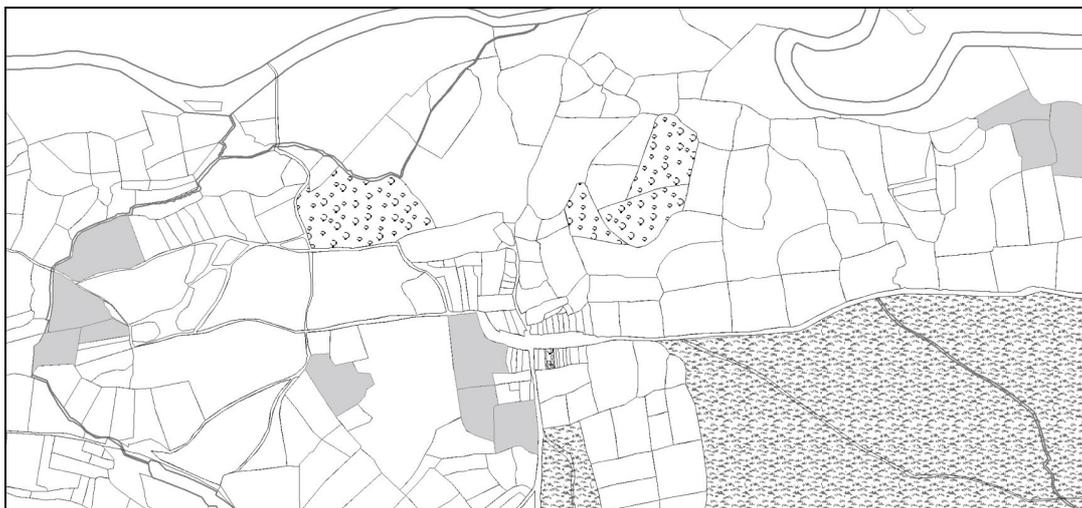
3.8 Digitised copy of the 1698 estate map showing the cultivation patterns in 1738, as well as the position of the common fields (Pinfold Field, Wheat Field, & Little Field).

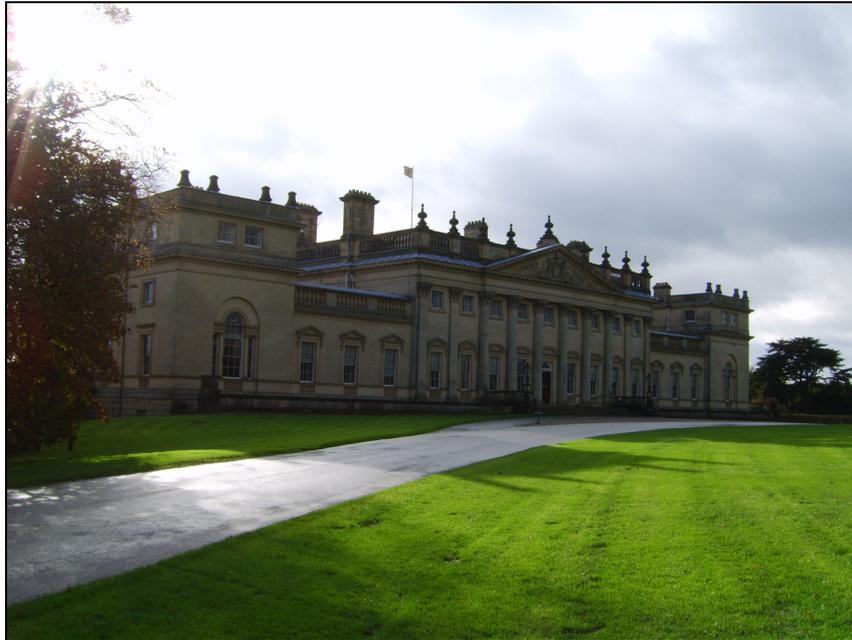
4.3 The northern façade of Harewood House designed by John Carr of York. Carr’s central nine-bay section includes giant Corinthian pilasters supporting a pediment incised with the Lascelles’ coat of arms.

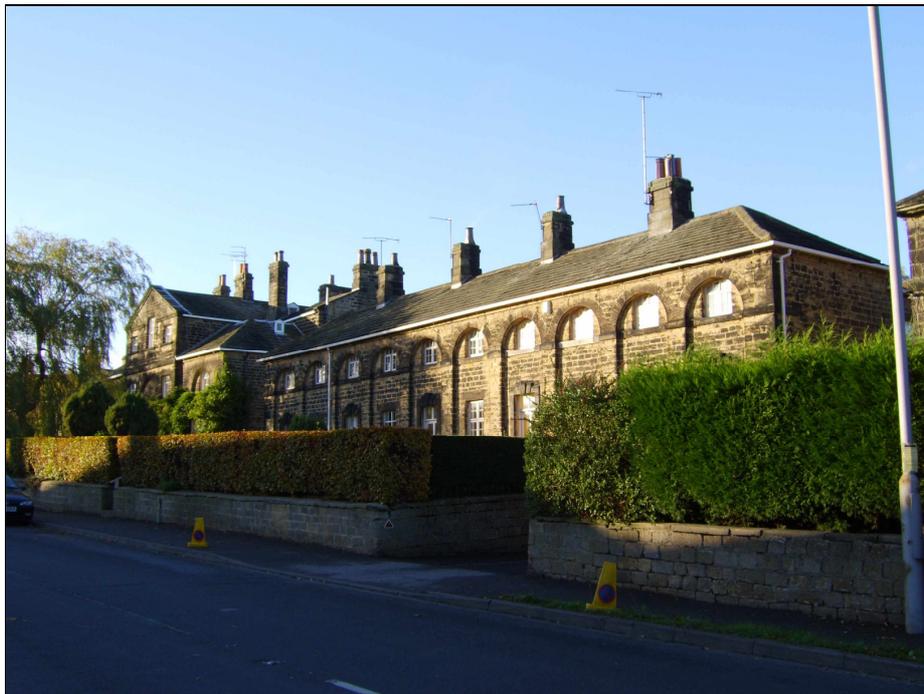
4.7 The likely arrangement of the original 'Cottage-in-the-Walls' and its likely position within an eighteenth-century terrace (Ward 1998).

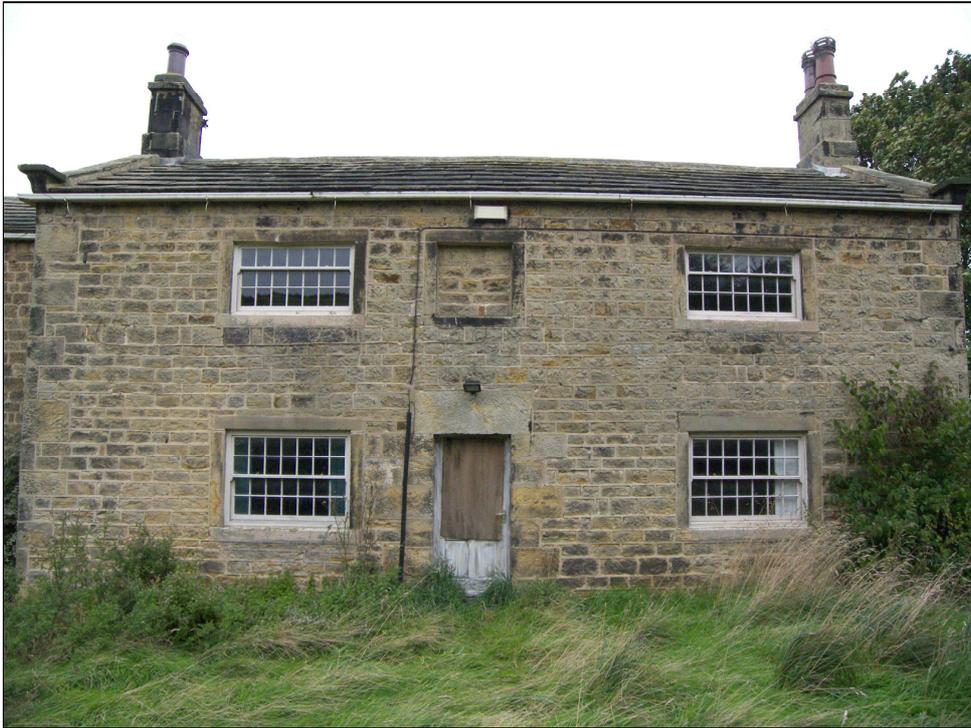
4.14 Front elevation of Stockton Grange farmhouse. The awkward proportions of the elevation may suggest that local craftsmen were only beginning to work with classical designs when the building was constructed in the 1760s.

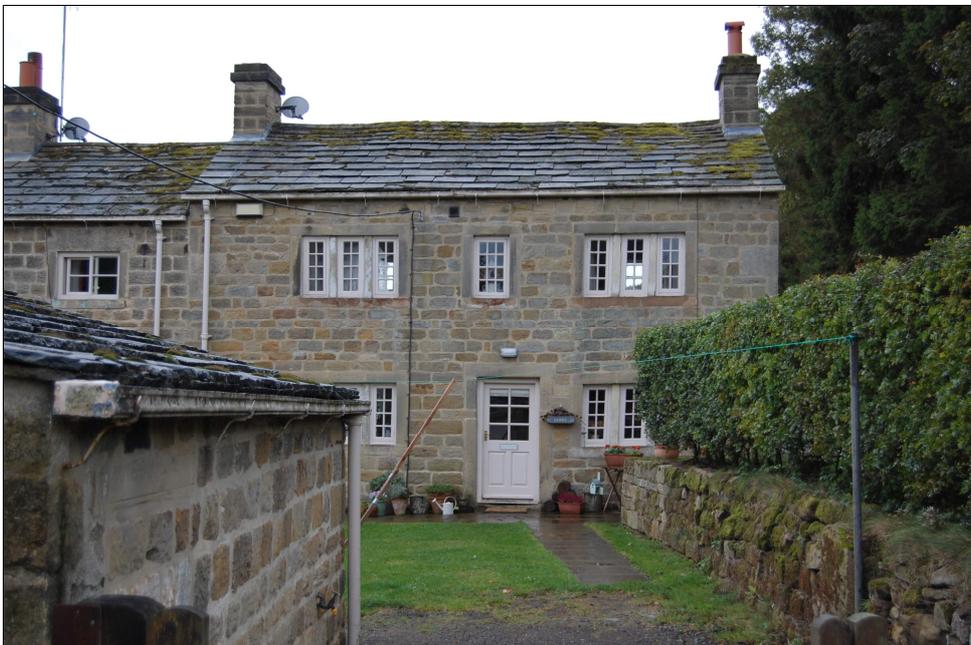
4.15 The west elevation of Carr House, one of the few farmhouses on the Harewood Estate of the period 1755-71 where mullioned windows continued to be used.

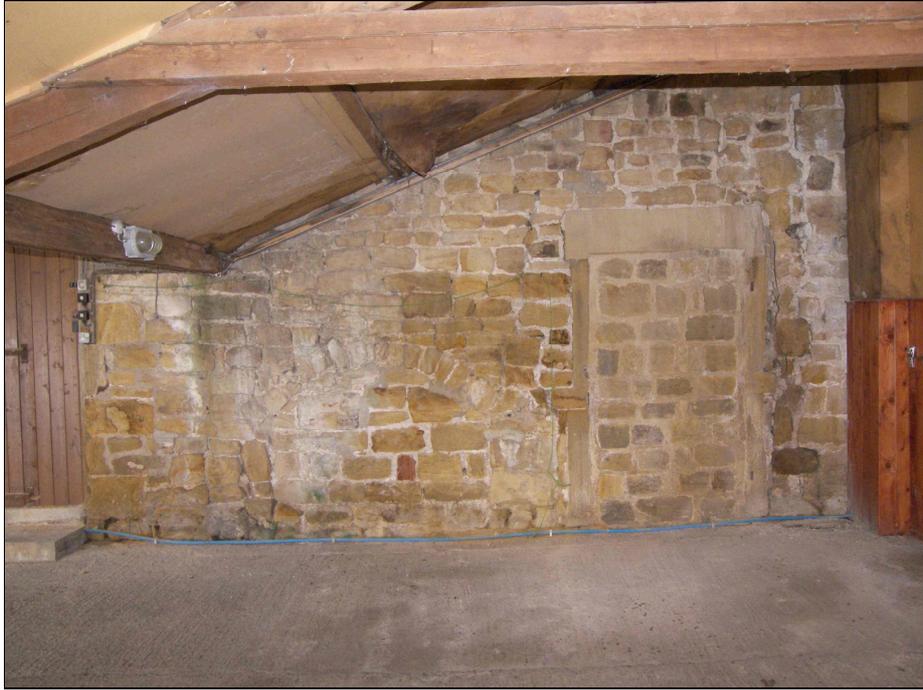
4.16 The east elevation of the barn at Stockton Farm showing entrances to mistalls at one end of the building. Multiple entrances and their fills suggest that the building was altered to accommodate new practices and agricultural methods.

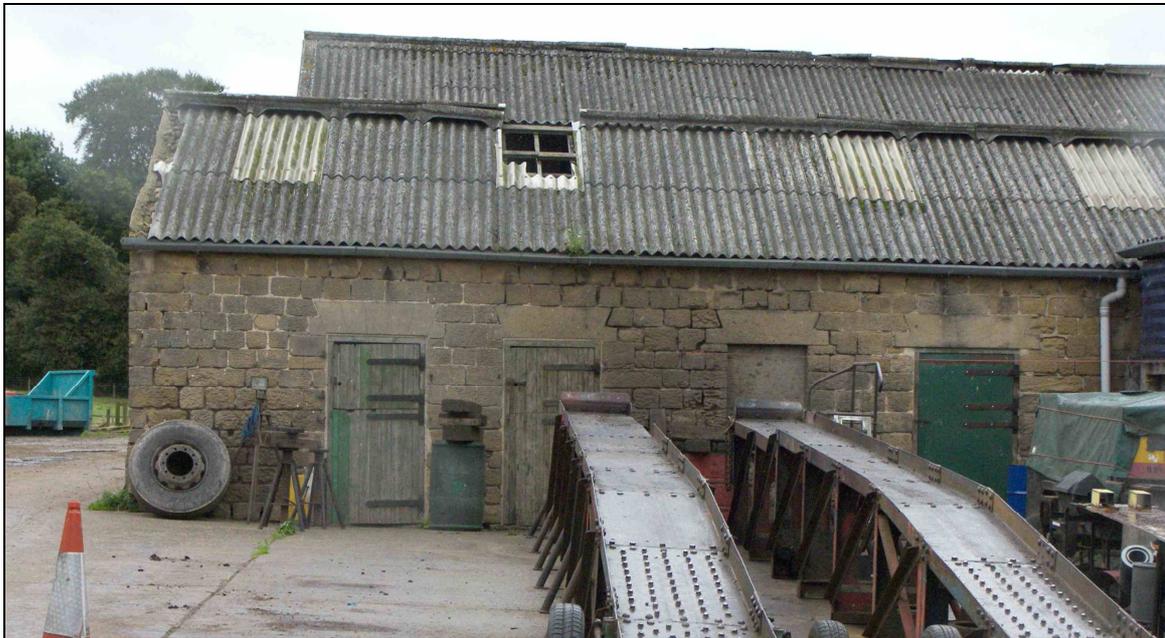
4.17 False voussoirs in the lintels of the stables at Lofthouse Grange Farm. This arrangement did not become a part of the local vernacular architecture until the final quarter of the eighteenth century.

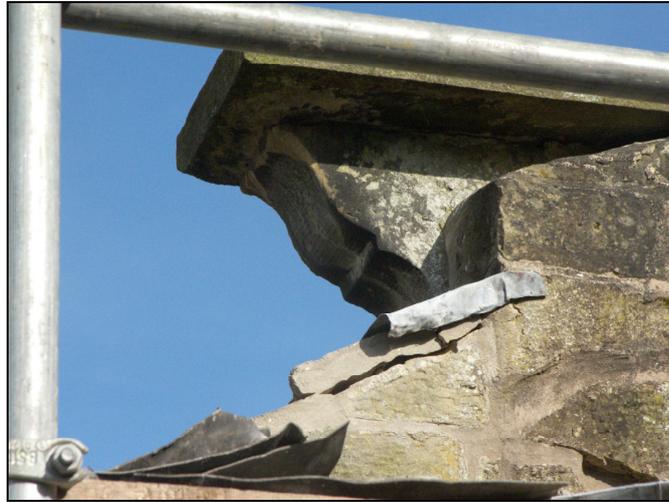
4.18 Cyma-recta mouldings on the moulded kneelers at Stables Farm. This type is also found at Stables House and the accompanying barn.

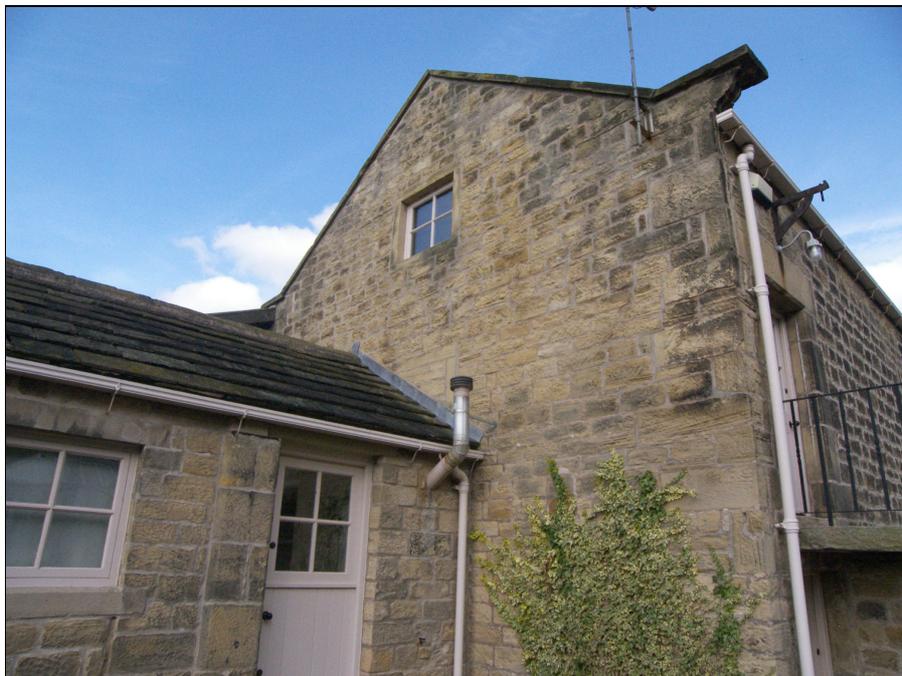
5.6 The western elevation of the barn at Stables Farm. To the right of the image a wall bracket is visible and is likely to be evidence of a granary. The bracket would have been used to hoist grain to the first floor.

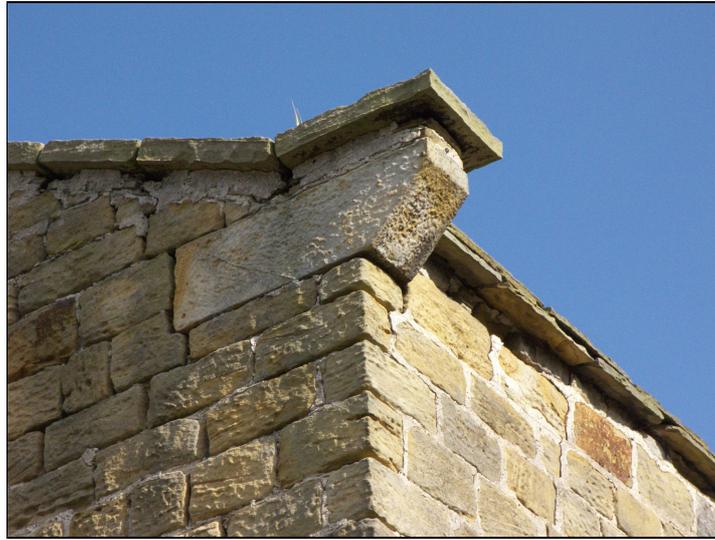
5.9 A simplified kneeler at Stockton Farm dating to the late-eighteenth century. The moulding had simplified considerably from the cyma-recta found at Stables Farm built in the 1760s.

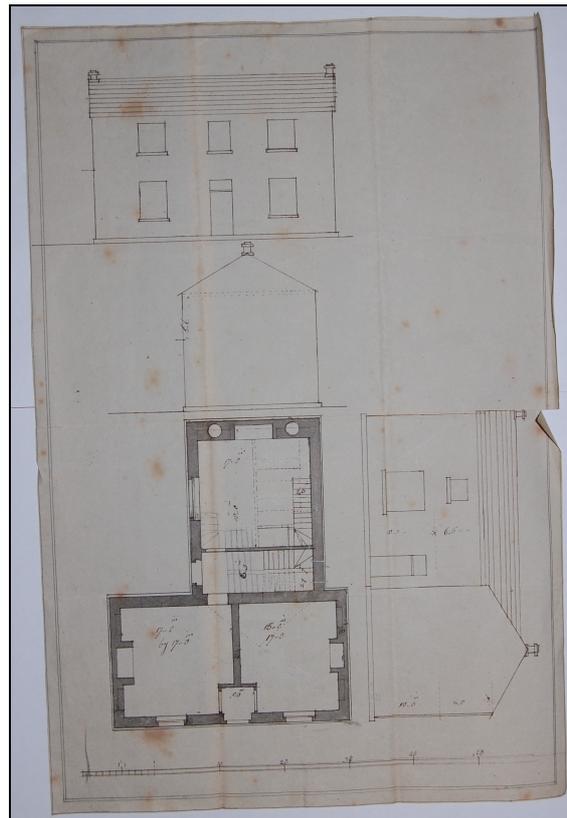
5.10 A design for a 'T'-shaped farmhouse in the Harewood Estate archive. This design was a prominent feature of early-nineteenth century farmhouses in Harewood. (Reproduced by the kind permission of the Earl and Countess of Harewood and Trustees of the Harewood House Trust)

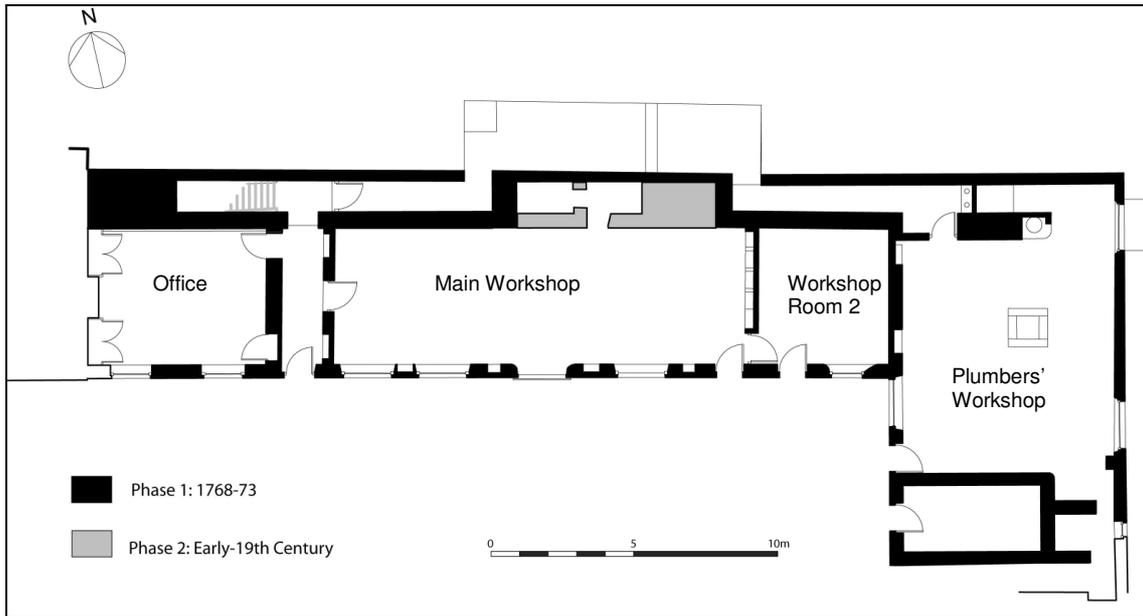
6.4 Ground Floor Plan, Joiners' Workshop (after Lane 2008, reproduced courtesy of Scott Wilson Ltd)

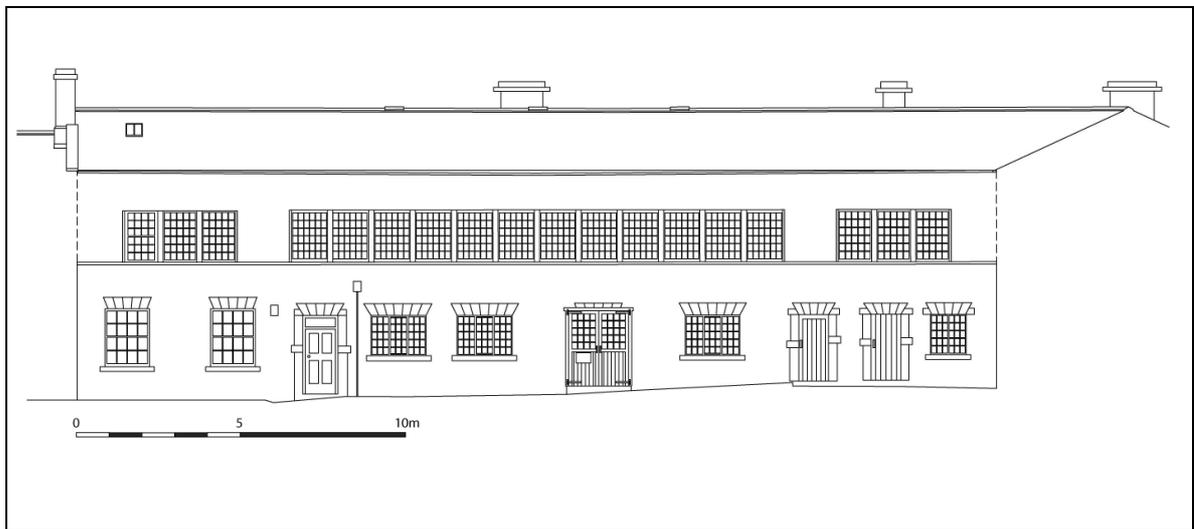
6.5 South Elevation, Joiners' Workshop (after Lane 2008, reproduced courtesy of Scott Wilson Ltd)

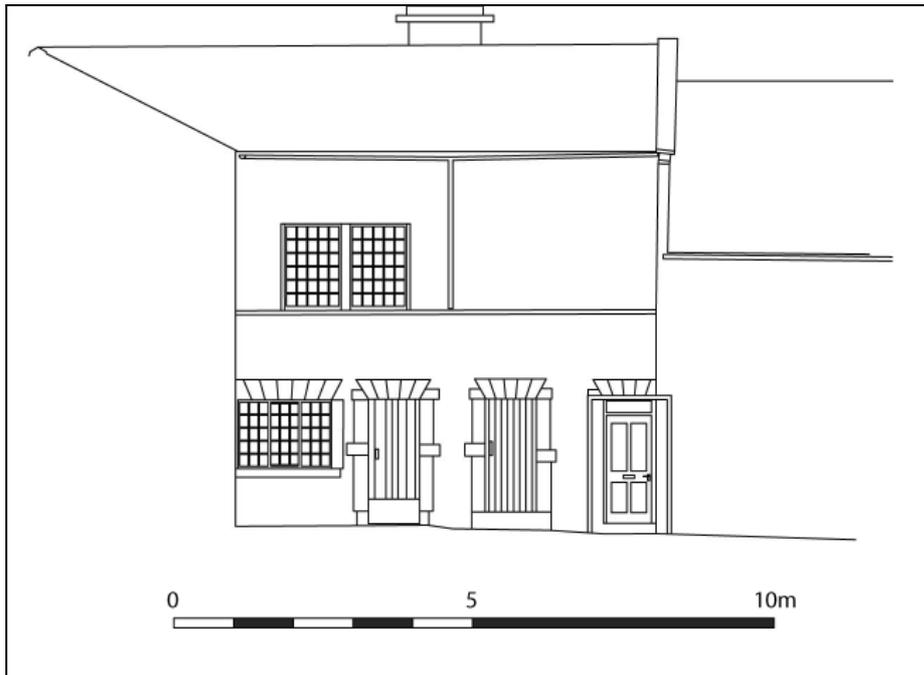
6.6 West Elevation, Joiners' Workshop (after Lane 2008, reproduced courtesy of Scott Wilson Ltd)

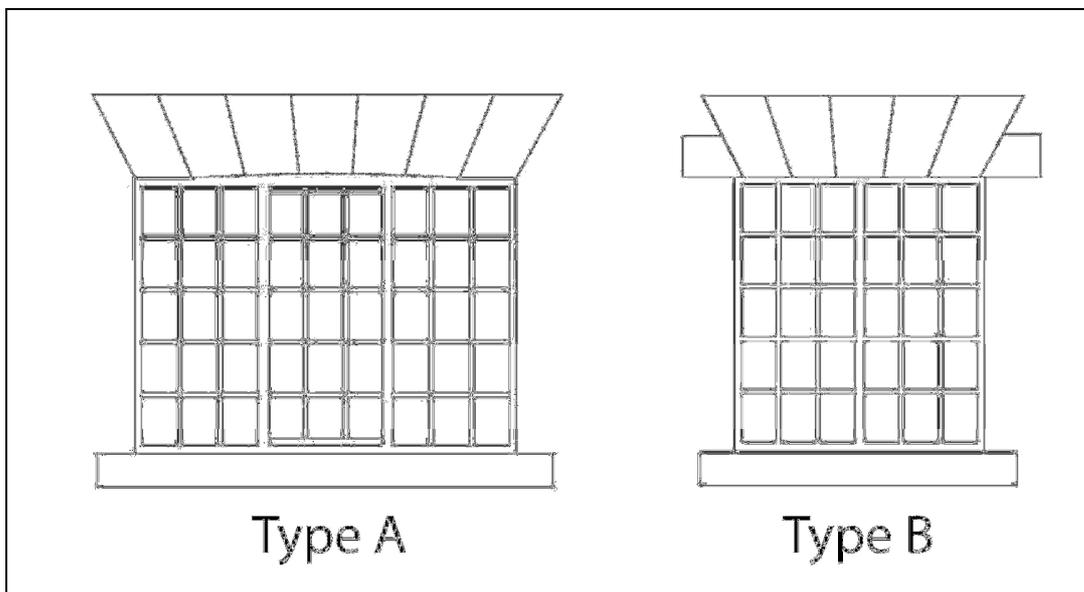
6.7 Two forms of window included on the south elevation of the workshop. Type A: Yorkshire sliding sash; Type B: casement window.

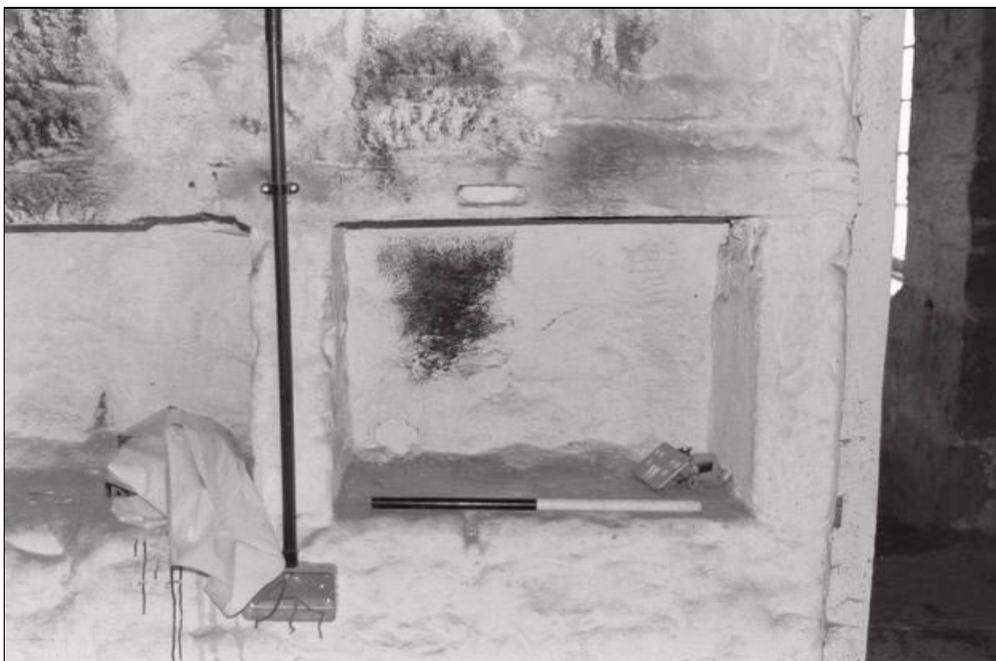
6.9 Wall niches in the eastern wall of the main workshop room (Lane 2008, reproduced courtesy of Scott Wilson Ltd)

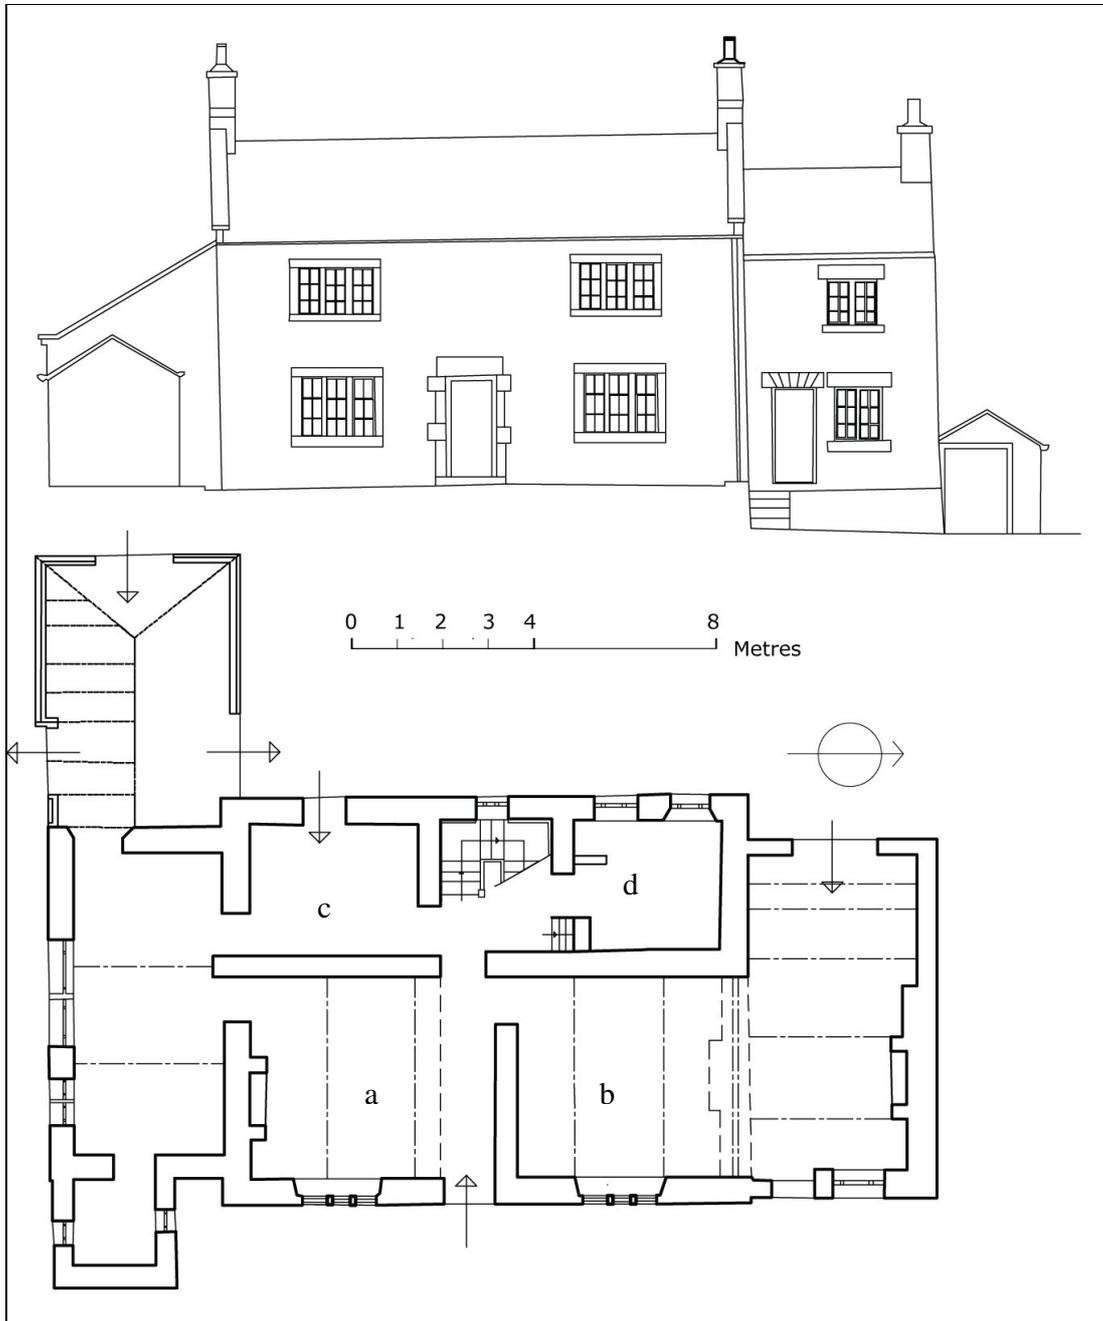
7.2 Measured survey of Stables Farmhouse. Extensions are visible on either side of the building.  
(a) Parlour (b) 'Best' Parlour (c) Kitchen (d) Dairy

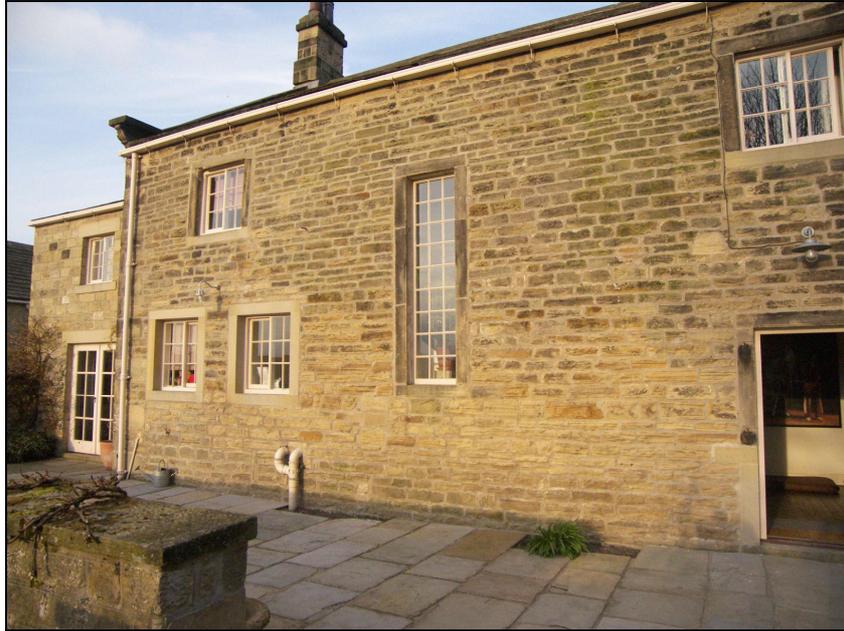
7.3 The rear elevation of Stables Farmhouse with a symmetrical layout. The doorway to the right has been extended from a former fenestration, while those on the ground floor in the left of the elevation have been inserted in the twenty-first century. A moulded kneeler is visible on the gable end.

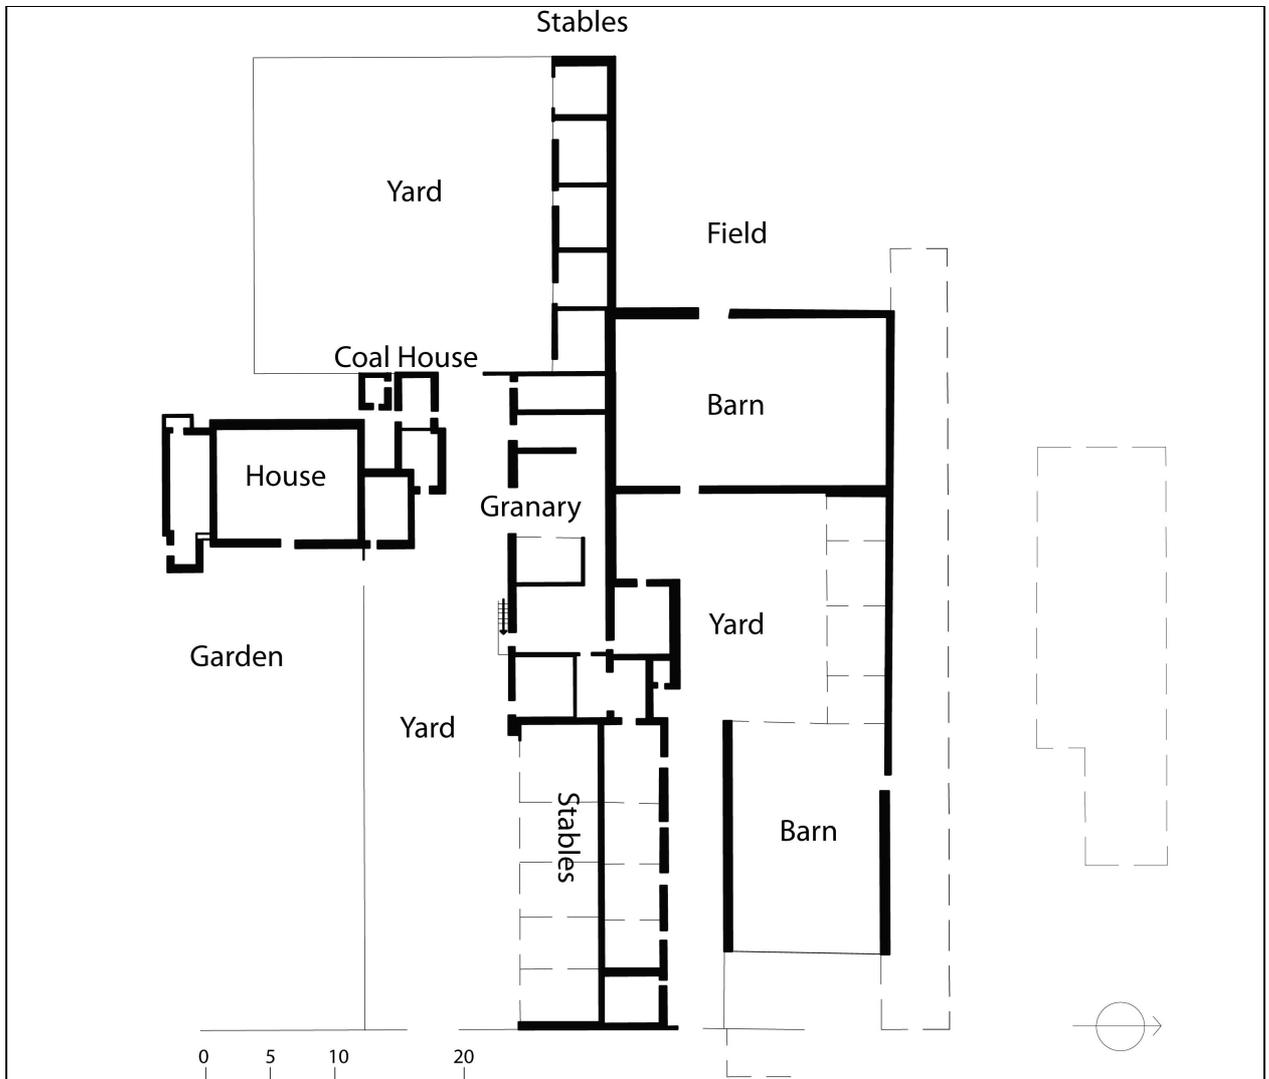
7.5 A plan of Stables Farm drawn in 1979. By 1814, and through a series of alterations the farmstead took the form of a linear plan rather than the L-shape recorded by Kent, Claridge and Pearce. The building noted as the 'Granary' is the original barn.

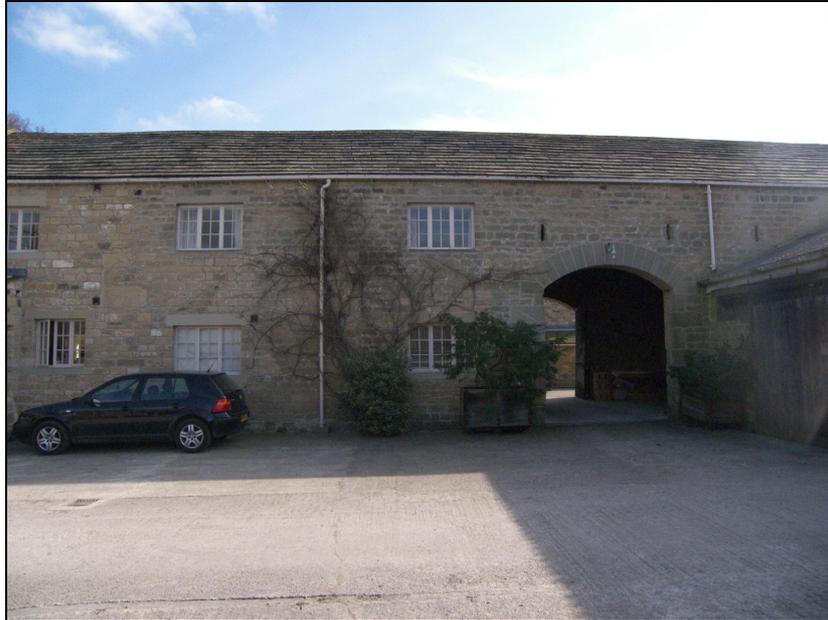
7.6 The barn at Stables Farm viewed from the north. Ventilation slits above the arched doorways indicate the existence of a threshing floor.

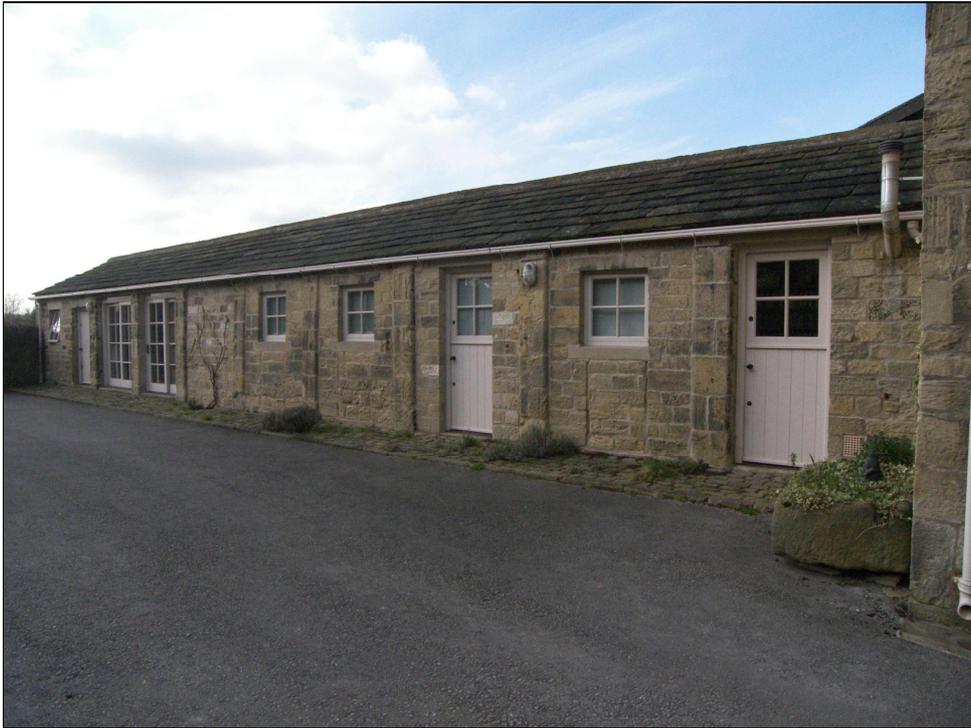
7.8 The stables at Stables Farm built in the early-nineteenth century but repointed and altered in the early twenty-first century.

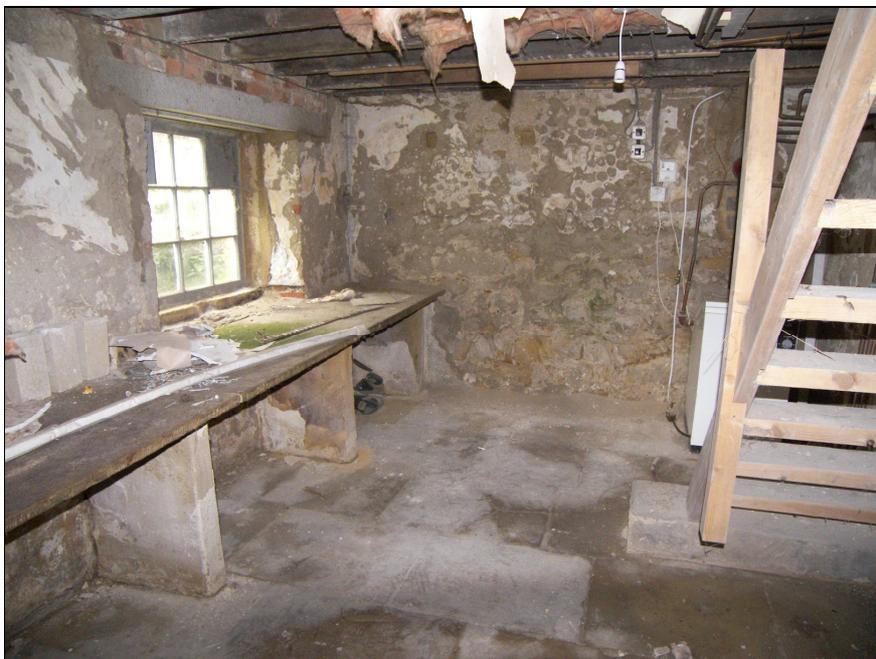
7.9 Cellar at Lofthouse Grange farmhouse, similar to that at Sandygate. Hooks in the ceiling indicate where meat and other types of foodstuff were hung and stored during the winter months.

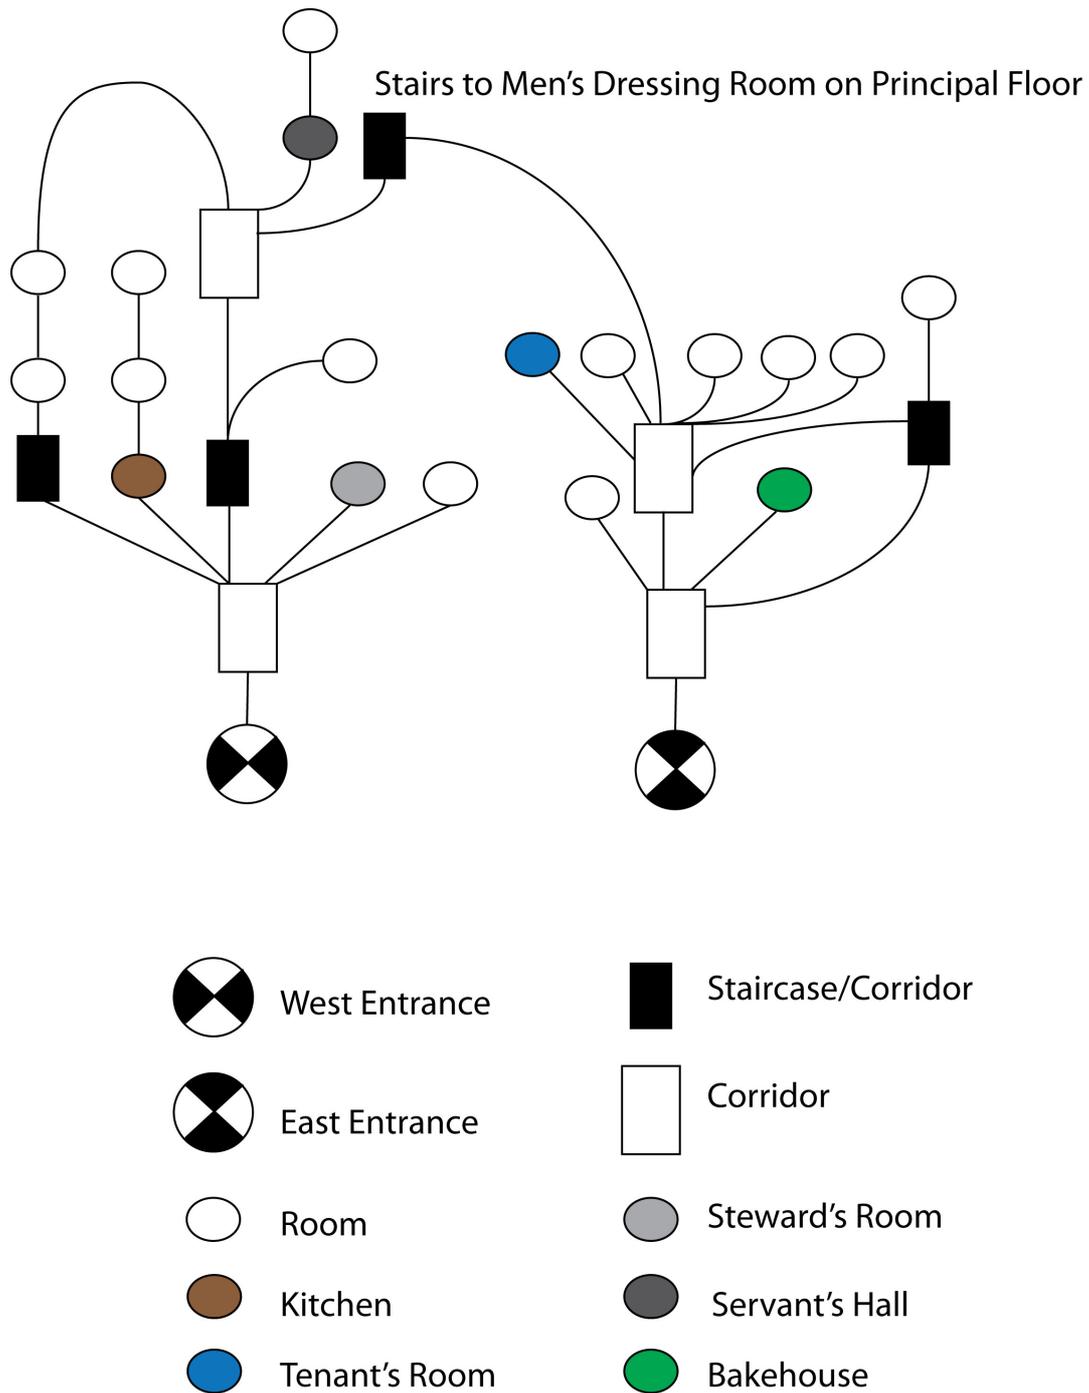
8.8 A gamma map showing access from both entrances in the basement storey of Harewood House. The map is directly related to the basement floor plan shown in Fig. 8.7. The position of the Steward's room provided Samuel Popplewell with unrestricted movement through the floor, i.e. he did not have to enter any other rooms when walking to either entrance or the Men's Dressing Room on the ground floor. The gamma map therefore provides an illustration of the spatial relationship between Samuel Popplewell and the layout of Harewood House .

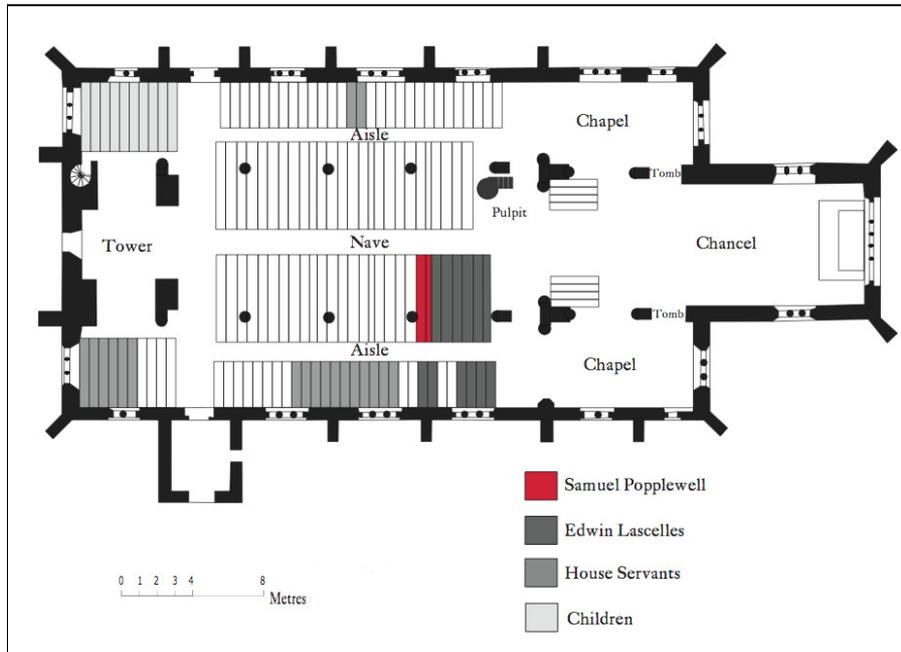
8.9 Layout of All Saints' Church, Harewood, c.1775. The plan is taken from a mid-nineteenth century plan (WYAS WYL 250/4) and has been adjusted according to the description provided by the Parish Registers and the pew layout.
