FATIGUE DAMAGE ACCUMULATION IN
NICKEL BASE SUPERALLOYS

Thesis submitted for the degree of Doctor of Philosophy

Department of Engineering Materials

University of Sheffield

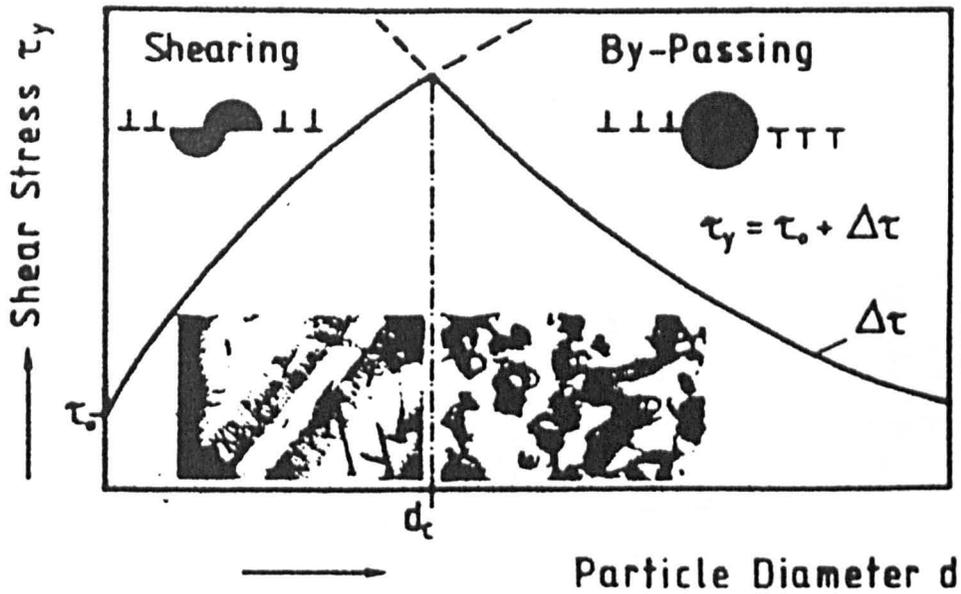
Fig. 2.2. Transition from shearing to by-passing as a function of particle diameter [62].

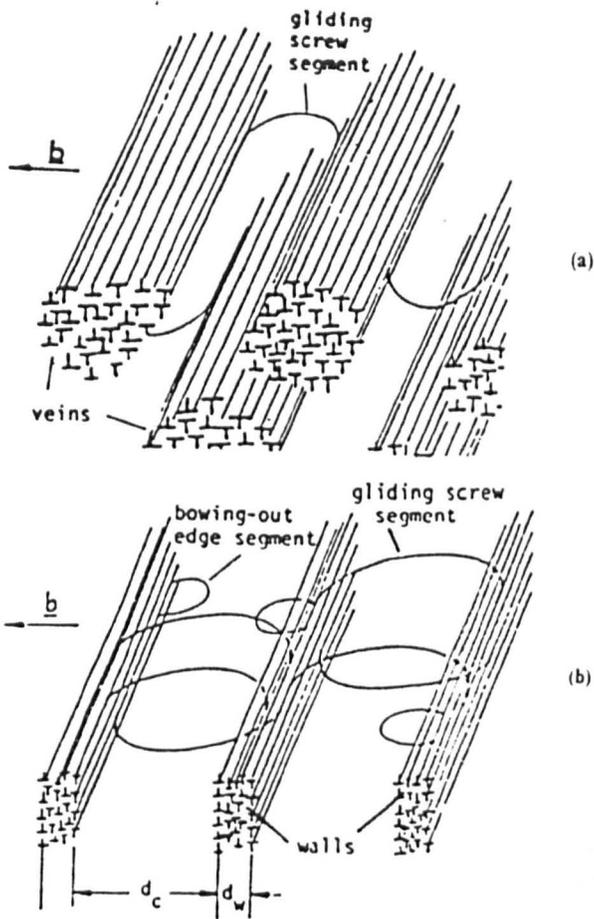
Fig. 2.3. Schematic arrangement of dislocations (a) matrix and (b) persistent slip band [110].

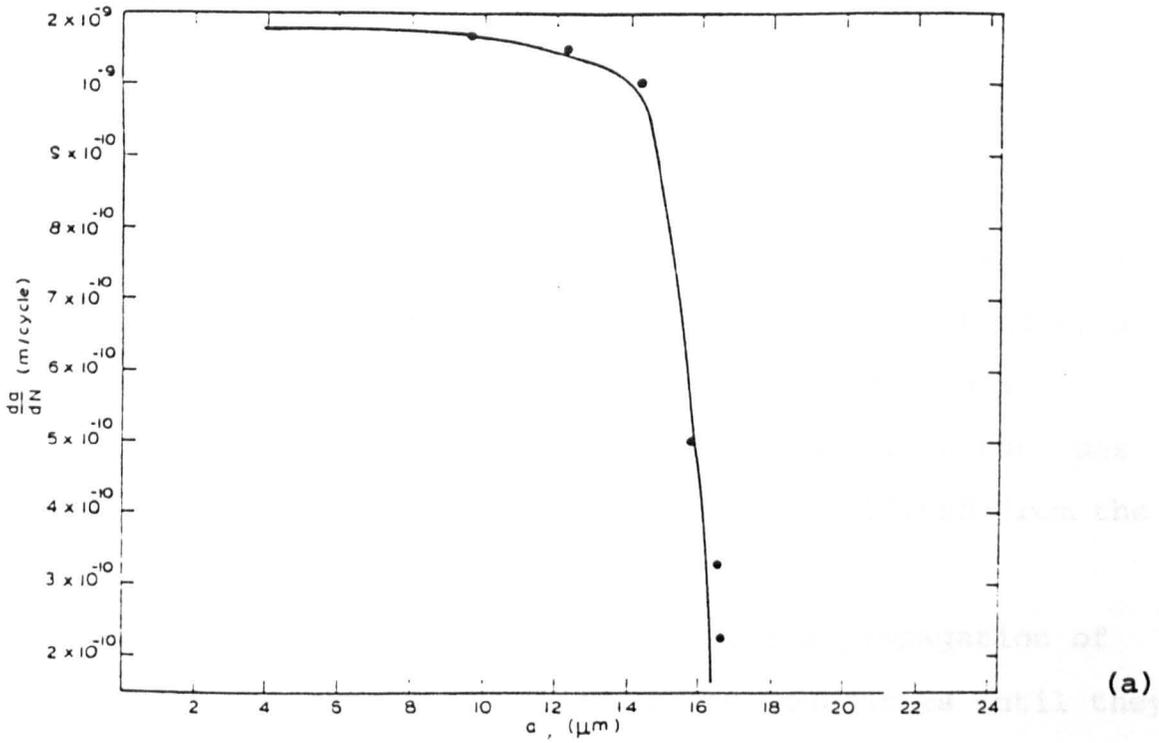
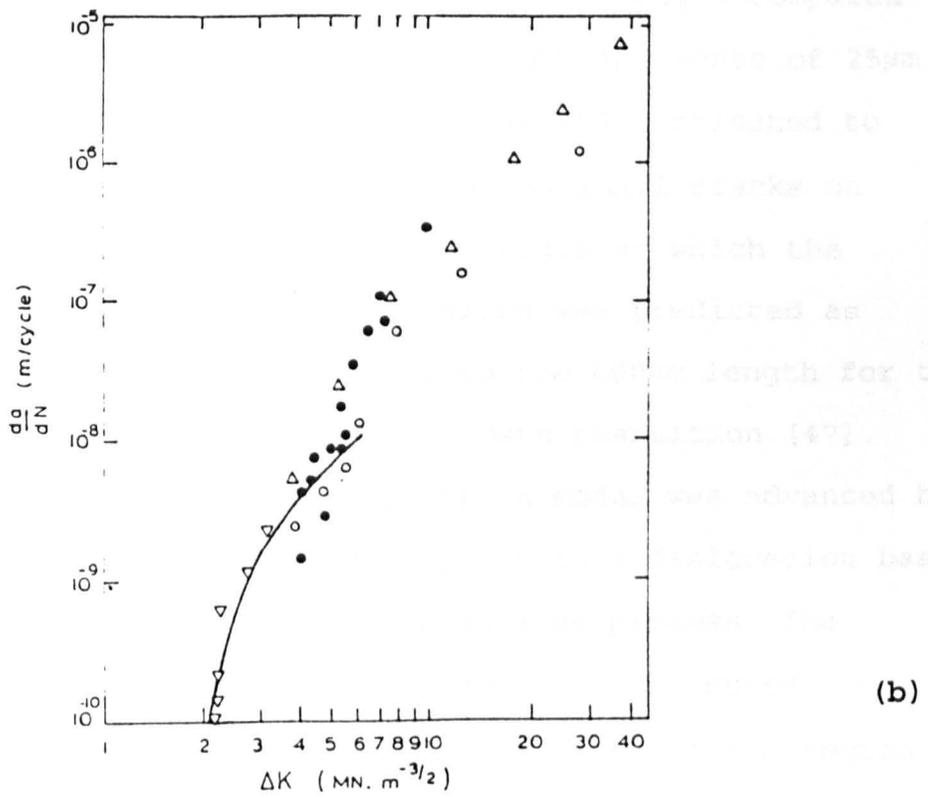
Fig. 2.11. Short crack growth behaviour in 7075-T6 aluminium alloy [138], (a) up to first grain boundary from equation (2.13), (b) after first grain boundary.

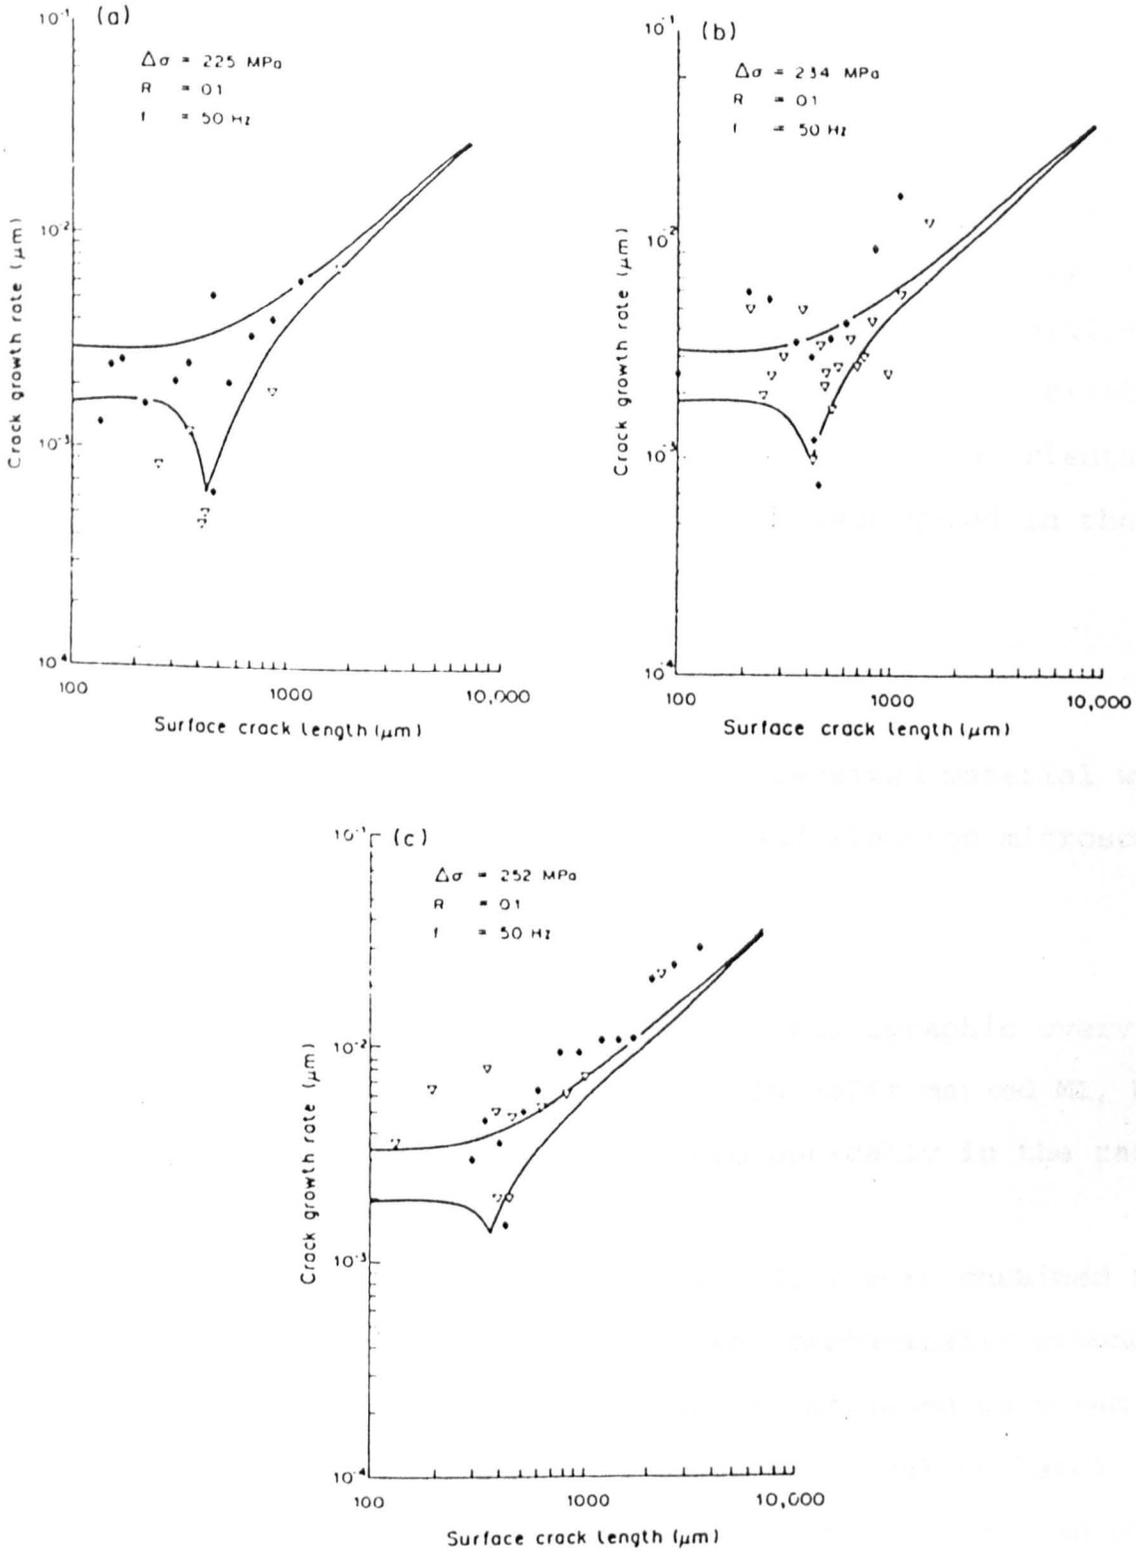
Fig. 2.14. A comparison between theoretical short crack growth rate curves and experimental results from the Al-Li alloy [145].

When applied to the Al-Li system shown in Fig. 2.14, most of the experimental points were found to lie within the prediction envelopes, those outside reflected the microstructural variability of a real as opposed to ideal equiaxed grain structure [145].

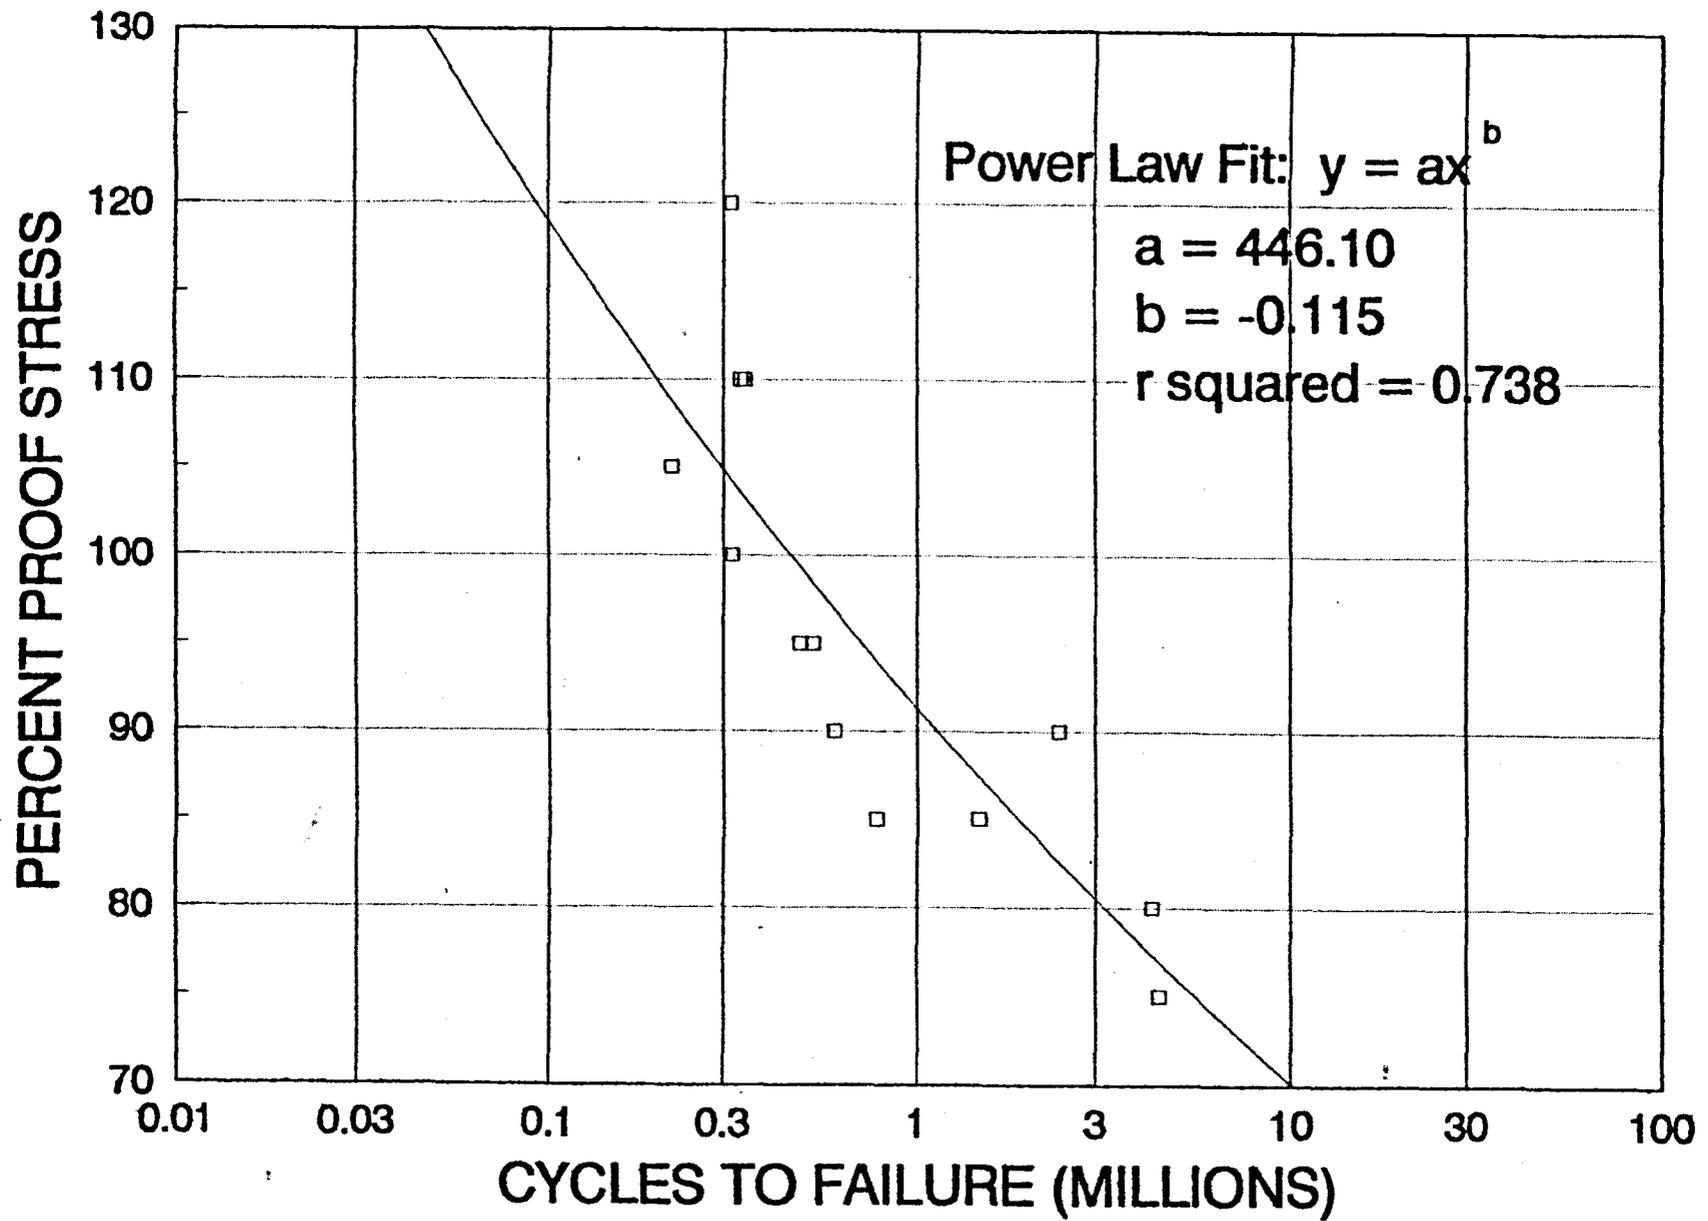
Fig. 4.8. SN Curve.

Prior to failure, the fatal cracks were seen on some of the specimens by the naked eye from the uplift of the gauge surface. In some cases this was observed only a fraction of lifetime before failure, for example, on specimen H24 (100%PS) an estimated 2mm crack was noticed after 279,600

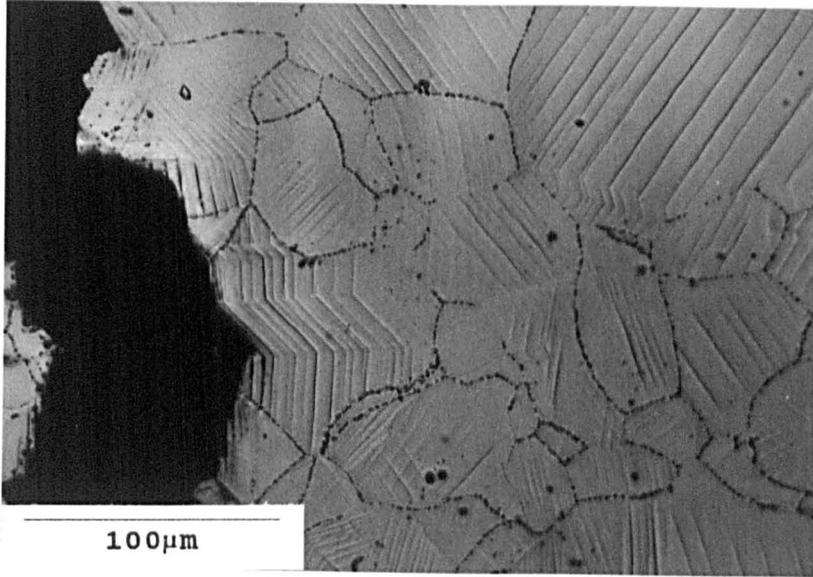
Fig. 4.9. Optical micrograph from failed SN specimen H3 (80%PS) showing slip bands adjacent to the primary crack, (stress axis horizontal).

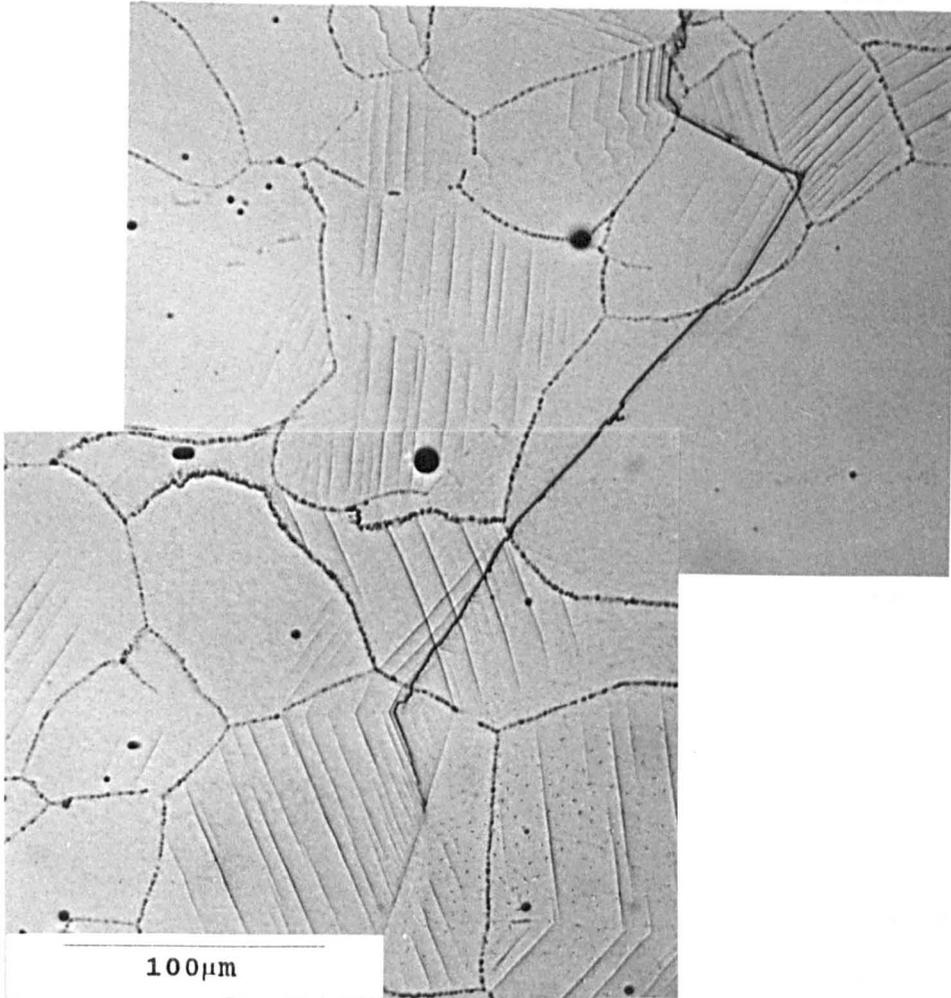
Fig. 4.12. Optical micrograph of a secondary crack 9mm from the primary crack on failed SN specimen H27 (105%PS). Stress axis horizontal.

Numerous secondary cracks were observed on specimens' gauge surfaces, an example is shown by Fig. 4.12. It is not

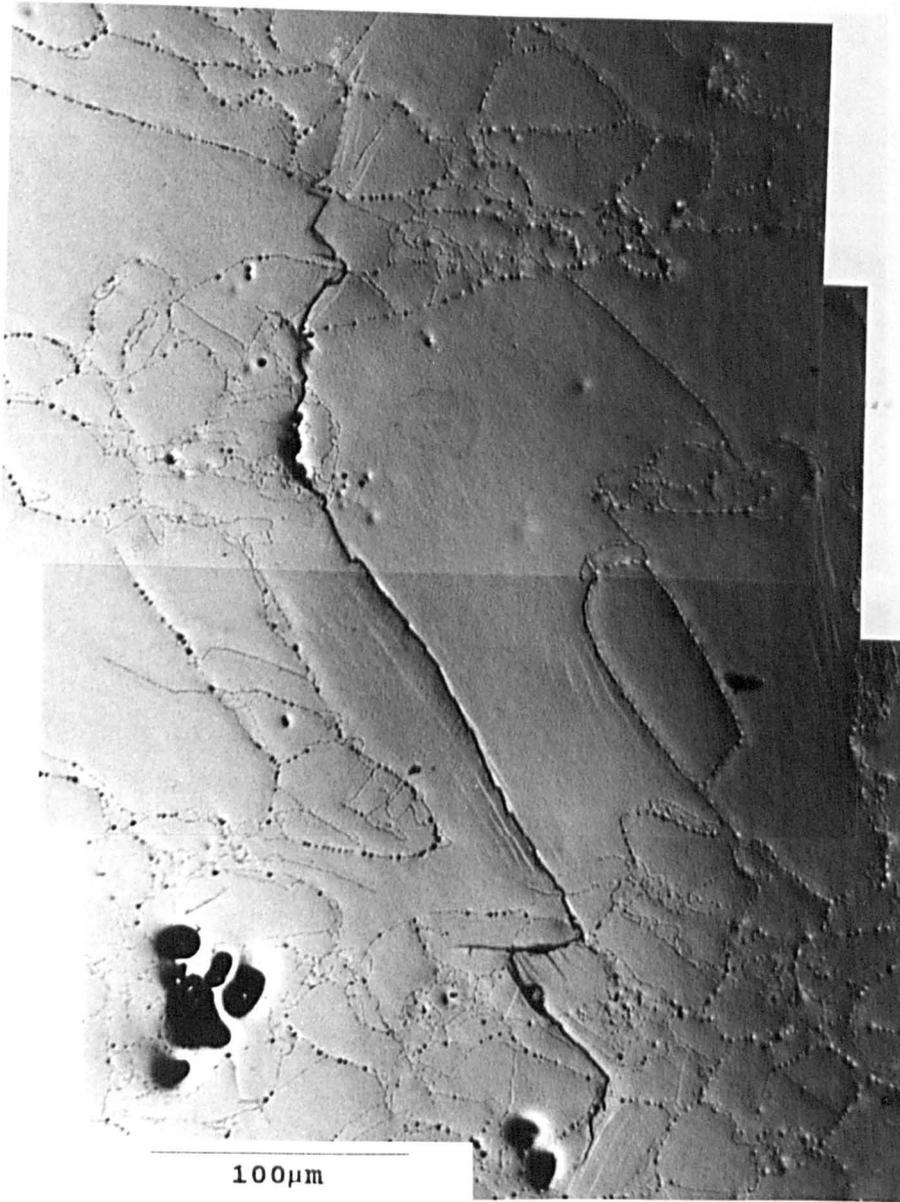
Fig. 4.14. Optical micrograph of a secondary crack 5mm from the primary crack on fatigued specimen H25 (100%PS). Stress axis horizontal.

A similar observation was made on a secondary crack on specimen H25 shown in Fig. 4.14, located by replicas. The crack can be seen at 50,000 cycles propagating away from a line of inclusions (see arrow on Fig. 4.15(a)). After 300,000 cycles the crack is virtually in its final condition, and is shown by Fig. 4.15(b). Other examples of cracks initiating from inclusions are shown by Figs. 4.16 and 4.17; these examples are from the 80%PS replicas taken from specimen H29 and show initiation taking place at 500,000 cycles. Inclusions have been reported as one of the most common fatigue crack initiation sites for nickel base superalloys [49]. The above cracks from the 80%PS replicas are shown by Figs. 4.16(b) and 4.17(b) as spanning 5 grains and 4 grains respectively, i.e. they are still considered to be short cracks.

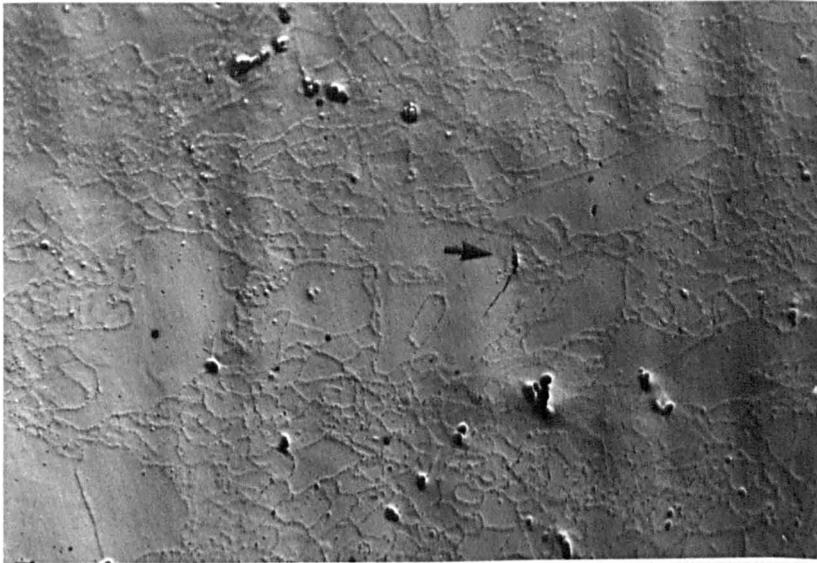
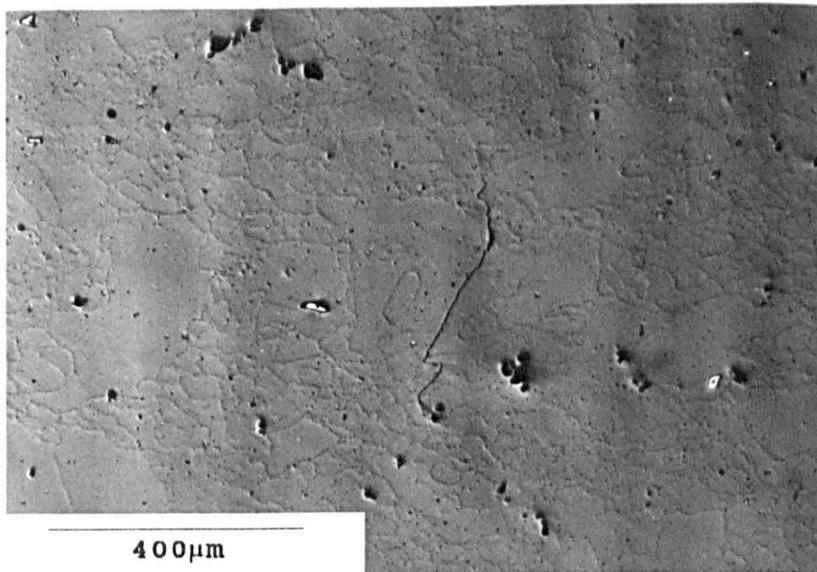
Fig. 4.15. Optical micrographs from 1-stage replicas taken from specimen H25 (100%PS) showing the secondary crack of Fig. 4.14, after (a) 50,000 and (b) 300,000 cycles. Arrow on (a) shows initiation site. Stress axis horizontal.

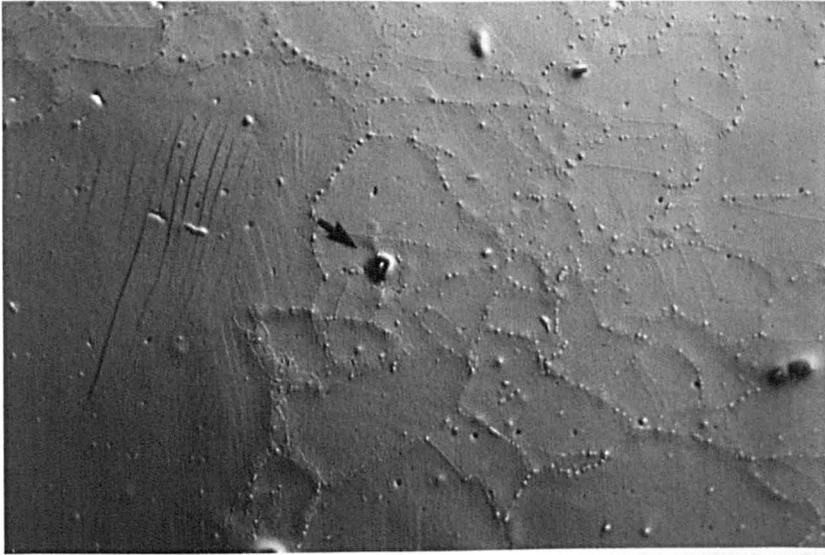
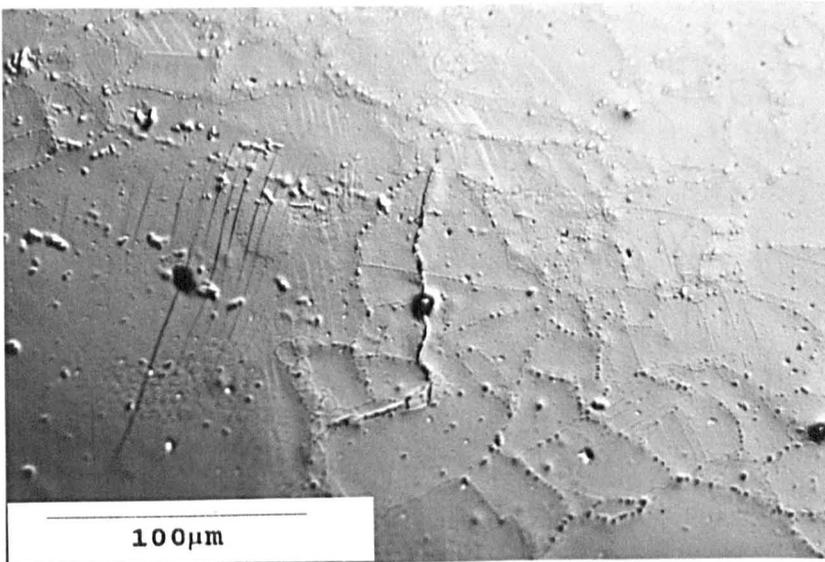
Fig. 4.16. Optical micrographs from 1-stage replicas taken from specimen H29 (80%PS) showing a secondary crack after (a) 500,000 and (b) 1,750,000 cycles. Arrow on (a) shows initiating inclusion. Stress axis horizontal.

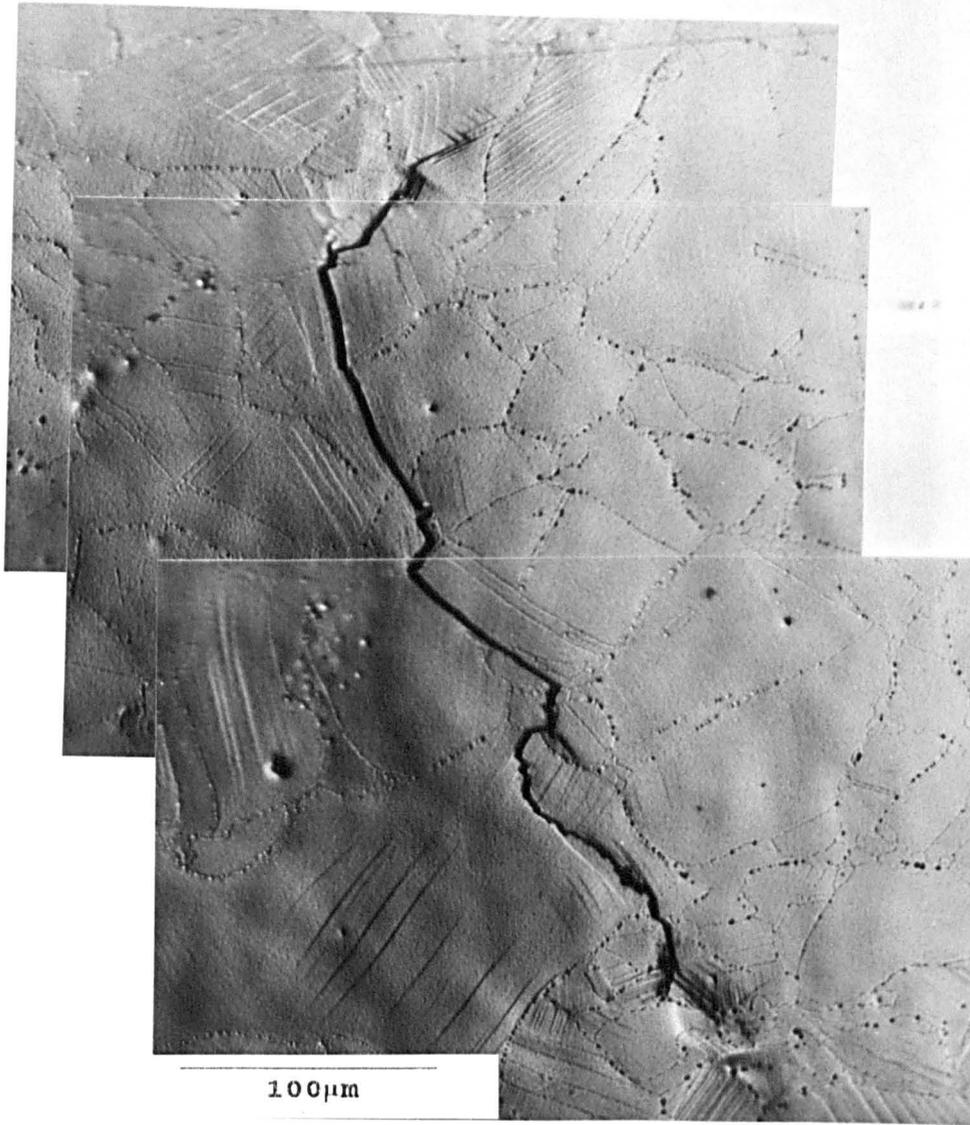
Fig. 4.18. Optical micrograph of a secondary crack 2mm from the primary crack on fatigued specimen H25 (100%PS). Stress axis horizontal.

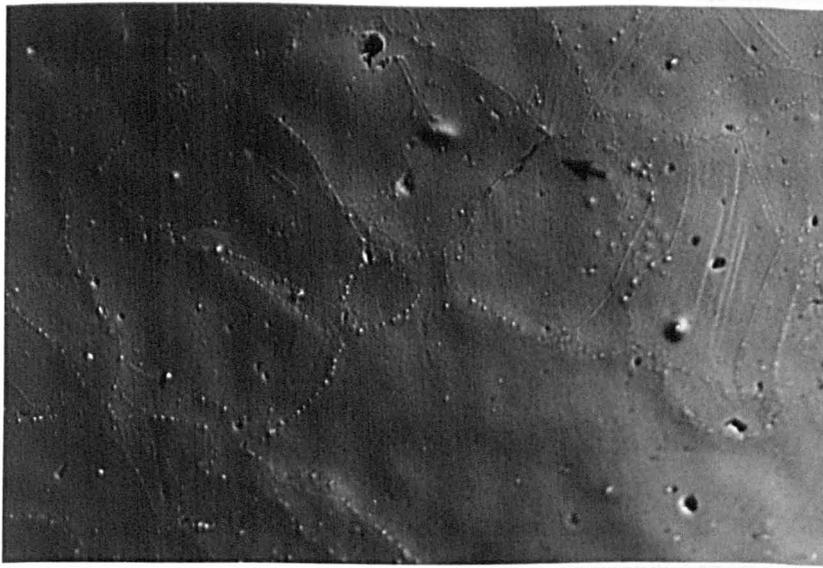
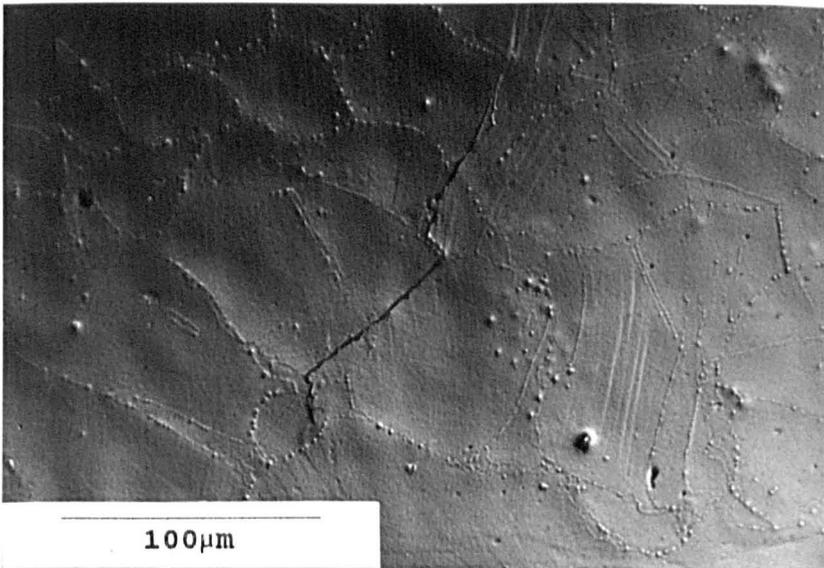
Fig. 4.19. Optical micrographs from 1-stage replicas taken from specimen H25 (100%PS) showing the secondary crack of Fig. 4.18 after (a) 50,000, (b) 175,000 and (c) 225,000 cycles. Arrow on (a) shows initiation site. Stress axis horizontal.

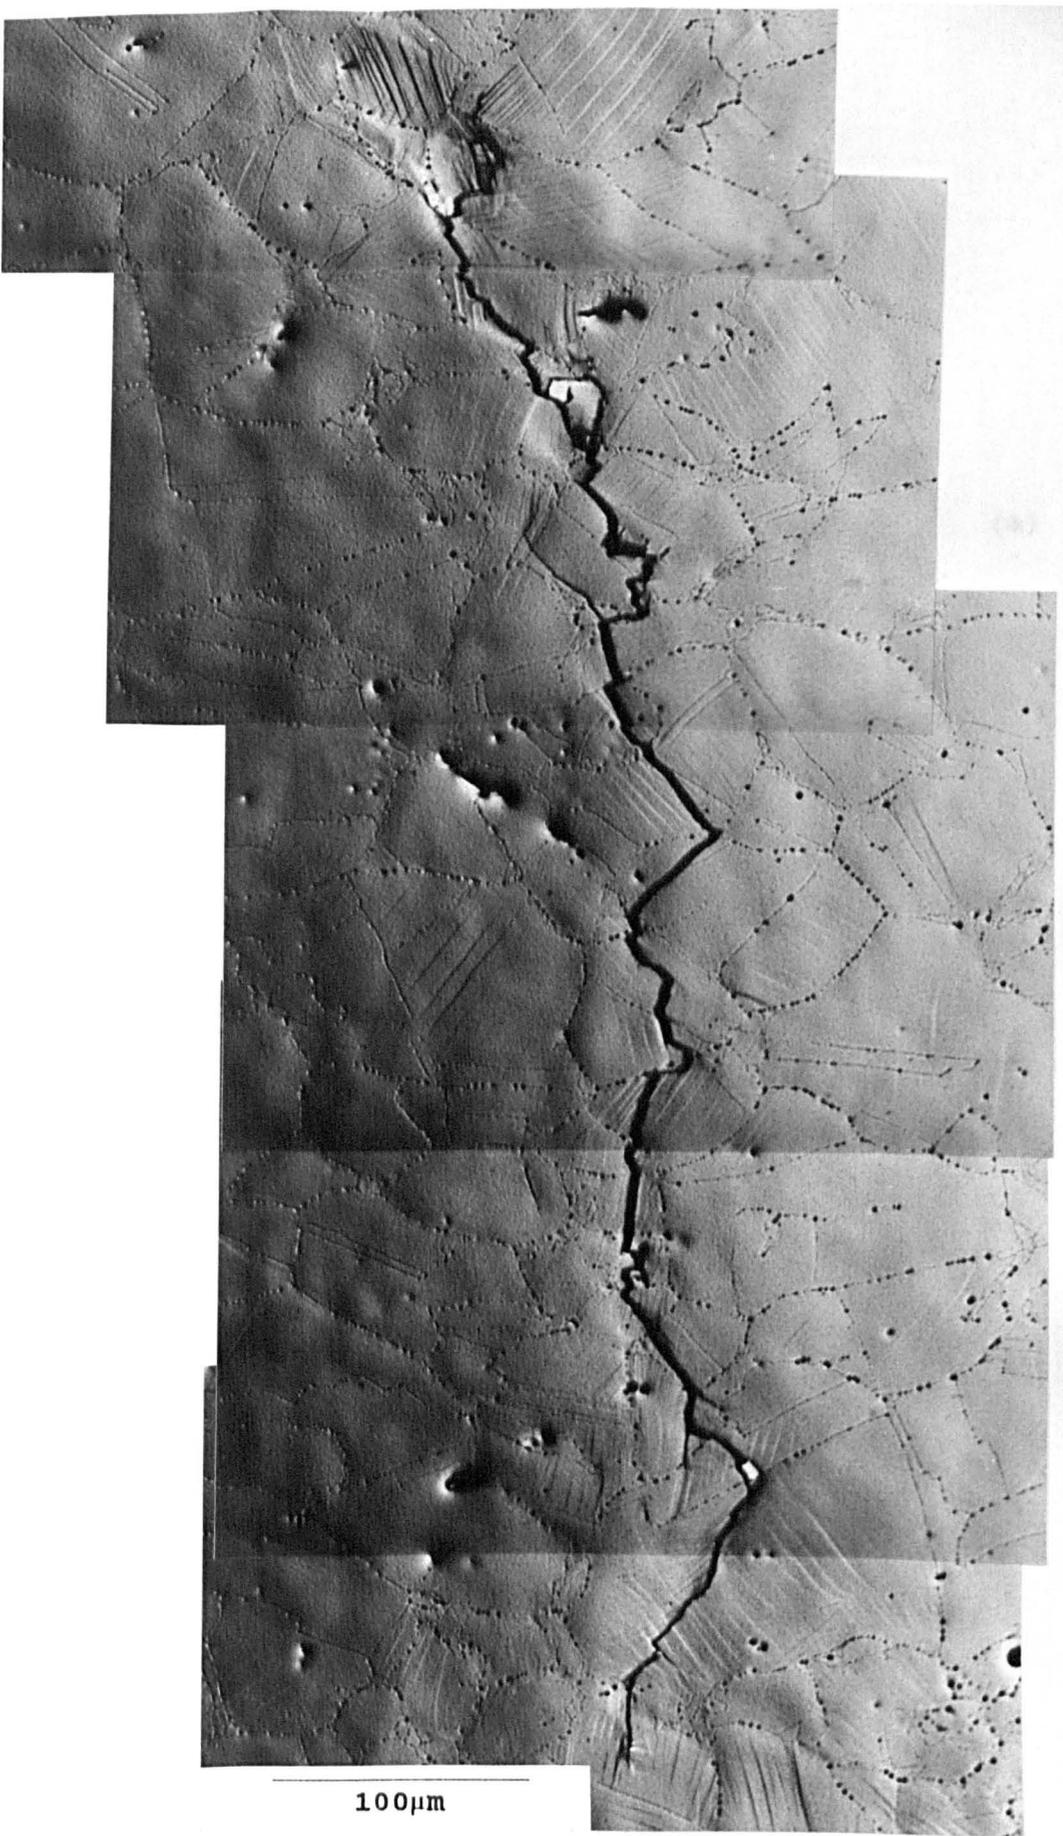
Fig. 4.20. Optical micrograph of a secondary crack 2mm from the primary crack on fatigued specimen H25 (100%PS). Stress axis horizontal.

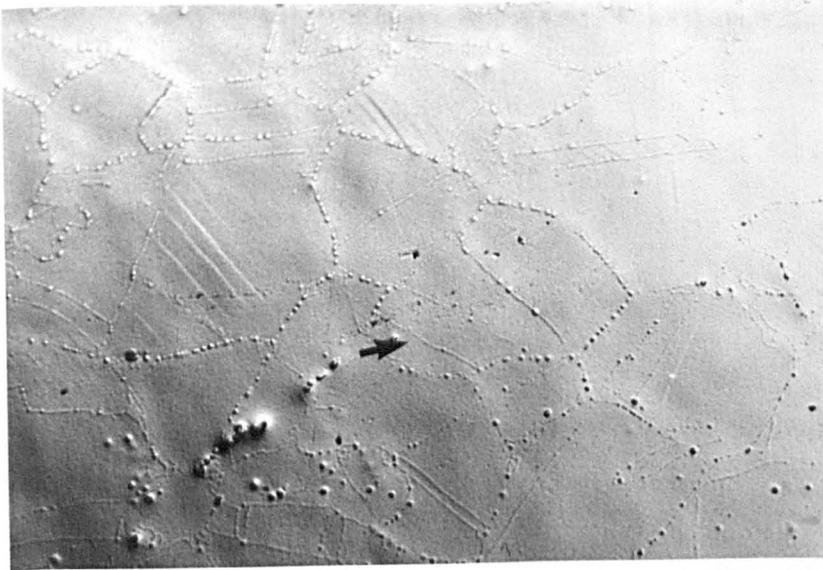
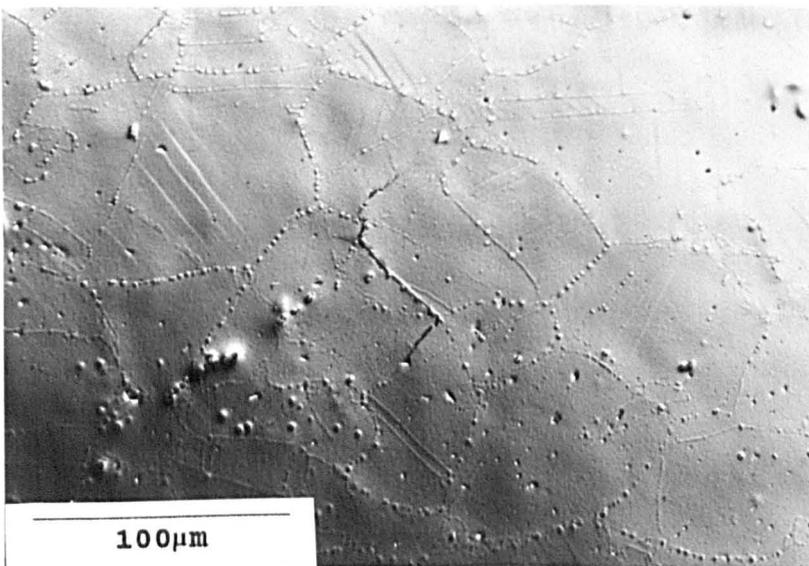
Fig. 4.21. Optical micrographs from 1-stage replicas taken from specimen H25 (100%PS) showing the secondary crack of Fig. 4.20 after (a) 25,000, (b) 100,000 and (c) 125,000 cycles. Arrow on (a) shows initiation site. Stress axis horizontal.

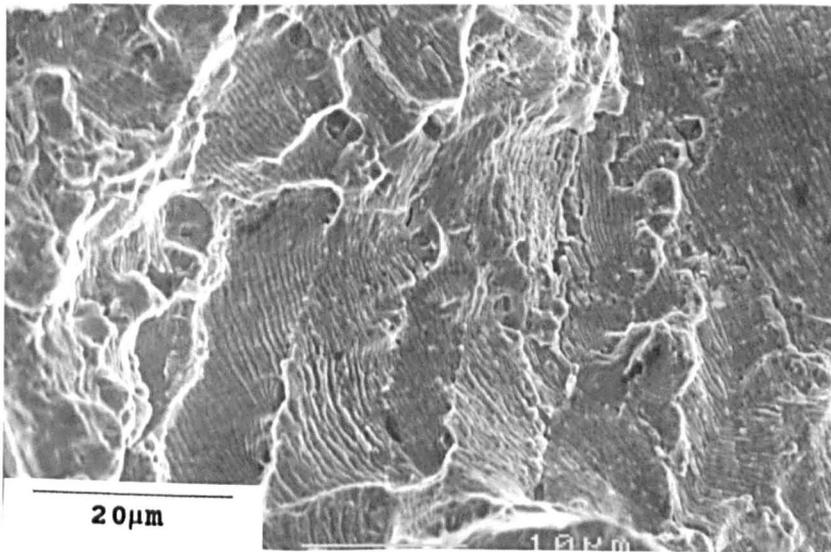
Fig. 4.24. Scanning electron micrographs from the fracture surface of specimen H24 (100%PS); (a) initiation site, (b) stage-I growth faceted appearance and (c) stage-II growth striated appearance. Propagation occurred in a near vertical direction from top to bottom.

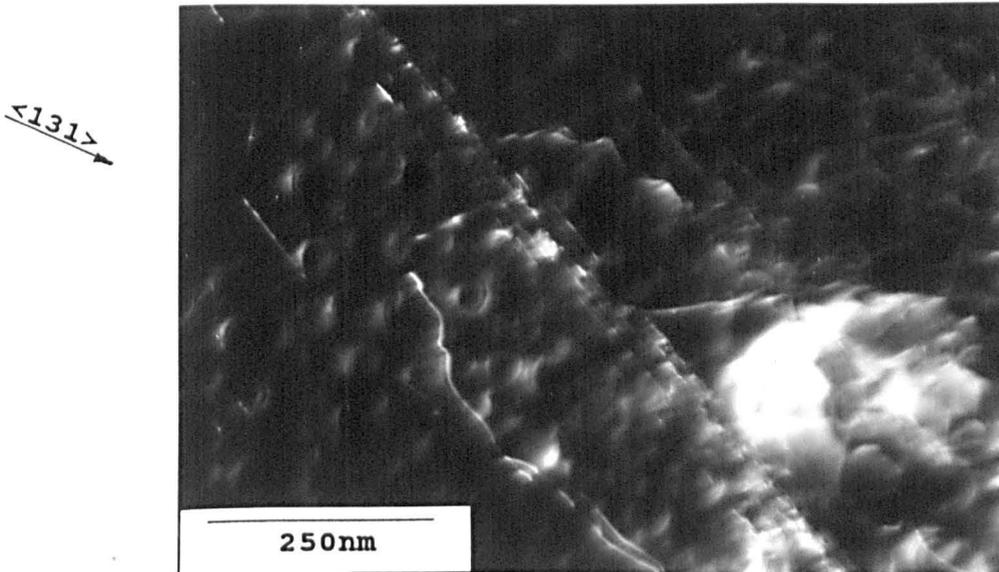
Fig. 4.26. Dark field transmission electron micrograph of a back-thinned foil from specimen H5 (5,000 cycles at 100%PS) illustrating slip activity on up to 8 closely spaced planes when viewed edge on; $\langle 112 \rangle$ orientation.

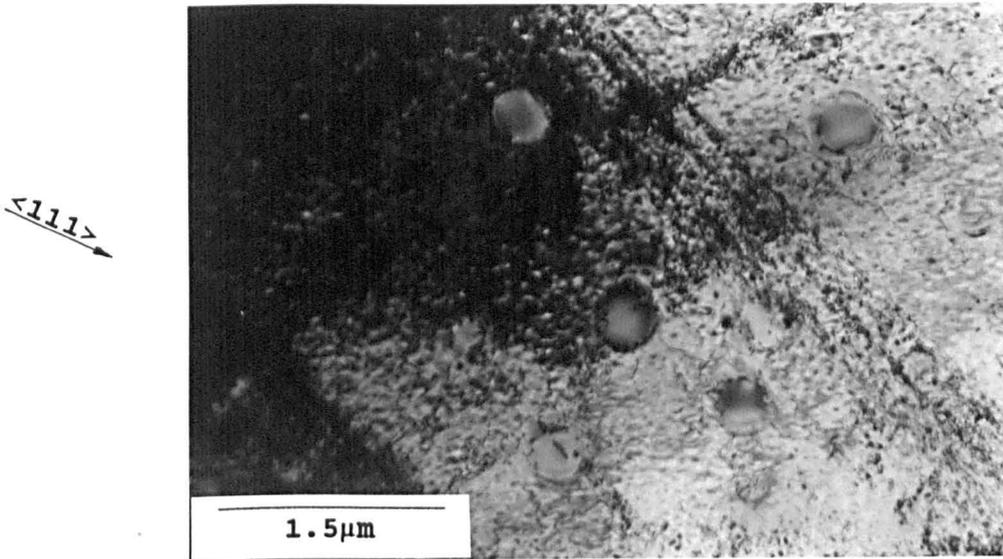
Fig. 4.30. Bright field transmission electron micrograph of a back-thinned foil from specimen H5 (5,000 cycles at 100%PS) illustrating the evidence of two active slip planes at low magnification; $\langle 112 \rangle$ orientation.

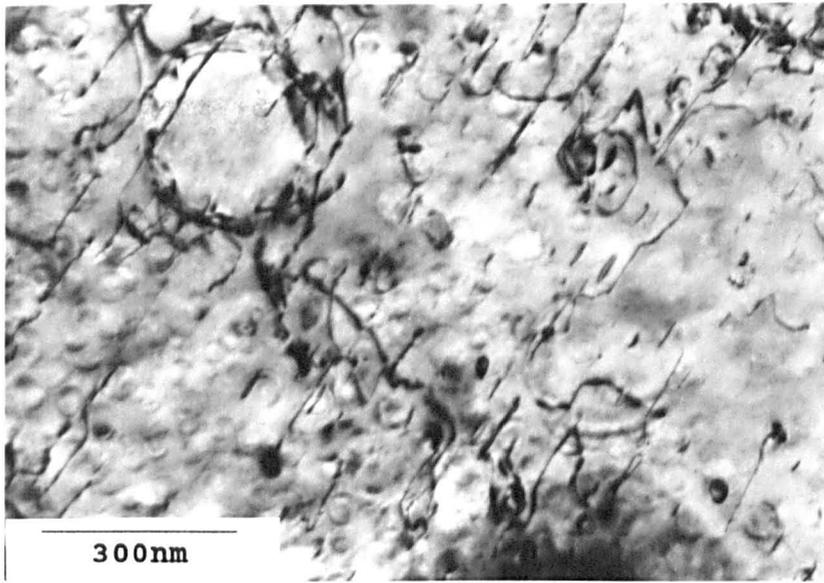
Fig. 4.35. Bright field transmission electron micrograph of a back-thinned foil from specimen H13 (10,000 cycles at 100%PS) illustrating the beginning of slip band formation (dislocations running from top right to lower left) in the same region as initial cell wall formation (wavy dislocations looping the large precipitate in upper left); $\langle 011 \rangle$ orientation.

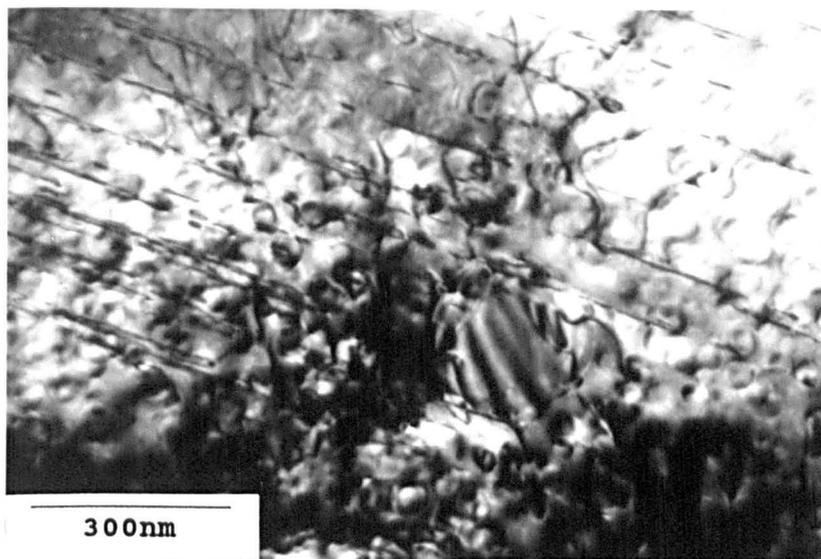
After 20,000 cycles at 100%PS planar slip was widespread, shown by Fig. 4.36; this was much more commonly observed than in early life and the dislocations illustrated were irresolvable. After 50,000 cycles at 100%PS in some areas slip bands were more sharply defined, Fig. 4.37(a) shows a good example of this, thus a gradual transition from finely spaced planar slip bands to clear PSBs was observed. Fig. 4.37(b) illustrates precipitate shearing resulting in significant γ' distortion; a displacement of 34nm was measured in this case. Not only were the large γ' sheared, but also virtually all contained dislocation networks at the γ/γ' interface. For example, a dislocation array is present in the upper γ' particle illustrated by Fig. 4.37(b); in addition, the dislocation networks extended some way into the matrix as shown by the lower γ' particle of Fig. 4.37(a, b).

Fig. 4.37(c) shows the general increase in dislocation density observed between the planar slip bands. Dislocation

Fig. 4.37. Bright field transmission electron micrographs of back-thinned foils from specimen H22 (50,000 cycles at 100%PS) showing (a) more sharply defined slip bands, (b) precipitate distortion and (c) precipitates surrounded by dislocation networks. Orientations: (a): $\langle 113 \rangle$, (b) and (c): $\langle 011 \rangle$.

direction appeared to be random, but they were frequently bounded by large γ' particles. In addition, numerous evidence of dislocation loops around the fine γ' were found, e.g. Figs. 4.37(b) and 4.38(a).

In addition to the cellular structures described above, more densely packed dislocation networks were observed around some of the large γ' , shown by Fig. 4.37(b). Such dislocations appeared to be discrete and generally did not extend between the large precipitates. However, an absolute differentiation between the cellular and interfacial networks was not possible. Only occasional examples of cell structures in nickel base superalloys have been reported

to the structures observed in the current work (Figs. 4.39 and 4.40) but also important differences. The dislocation networks reported in Rene' 80 at 982°C [26] were very similar in appearance to the interfacial networks shown in Fig. 4.37(b). However, the high temperature employed in the cycling of the Rene' 80 [26] allowed dislocation rearrangement by climb to lower energy structures, i.e., sub boundaries of hexagonal dislocation networks around the γ' . In the Waspaloy of the current work, dislocation rearrangement was very difficult due to the low temperature. Nevertheless, allowing for the differences in temperature, the mechanism in the current work is considered to be similar to that in the Rene' 80 [26].

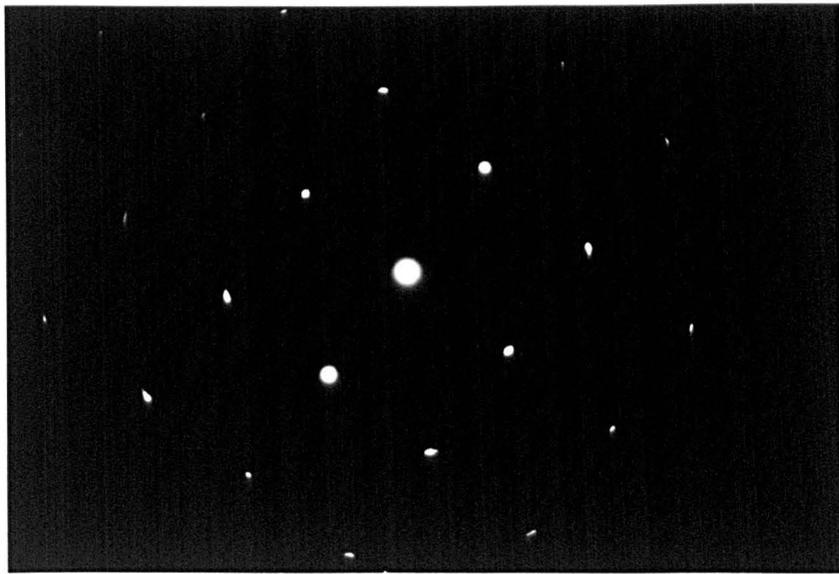
Fig. 4.41. Transmission electron micrograph of a diffraction pattern taken over a number of cells in a back thinned foil from specimen H16 (20,000 cycles at 100%PS). The orientation is almost straight down a $\langle 001 \rangle$ zone, and the peripheral spot splitting or asterism is due to the different orientations of neighbouring cells.

supports the observations that low angle dislocation boundaries have been formed. Indeed, image fringing around large precipitates as shown in Fig. 4.40(b, c) also indicates a true low angle grain boundary has been formed.

The slip band and its associated dislocation networks observed by Lerch and Gerold [20] was very similar to that of Fig. 4.42(a), also, the cellular deformation was not too dissimilar to the examples shown in Figs. 4.39(a) and 4.47(b). Furthermore, the diffraction pattern of Fig. 4.41 showing spot splitting, was very similar to those reported by Lerch and Gerold [20]. However, one noticeable difference was the obvious way that the dislocations encircled and were pinned by the large γ' precipitates of the Waspaloy in the present work (Fig. 4.39), whereas this was not apparent in the Nimonic 80 [19]. However, the Nimonic 80 [19, 20] only contained very fine spherical γ' (13nm in diameter), hence, such dislocation/precipitate interactions would be more difficult to observe.

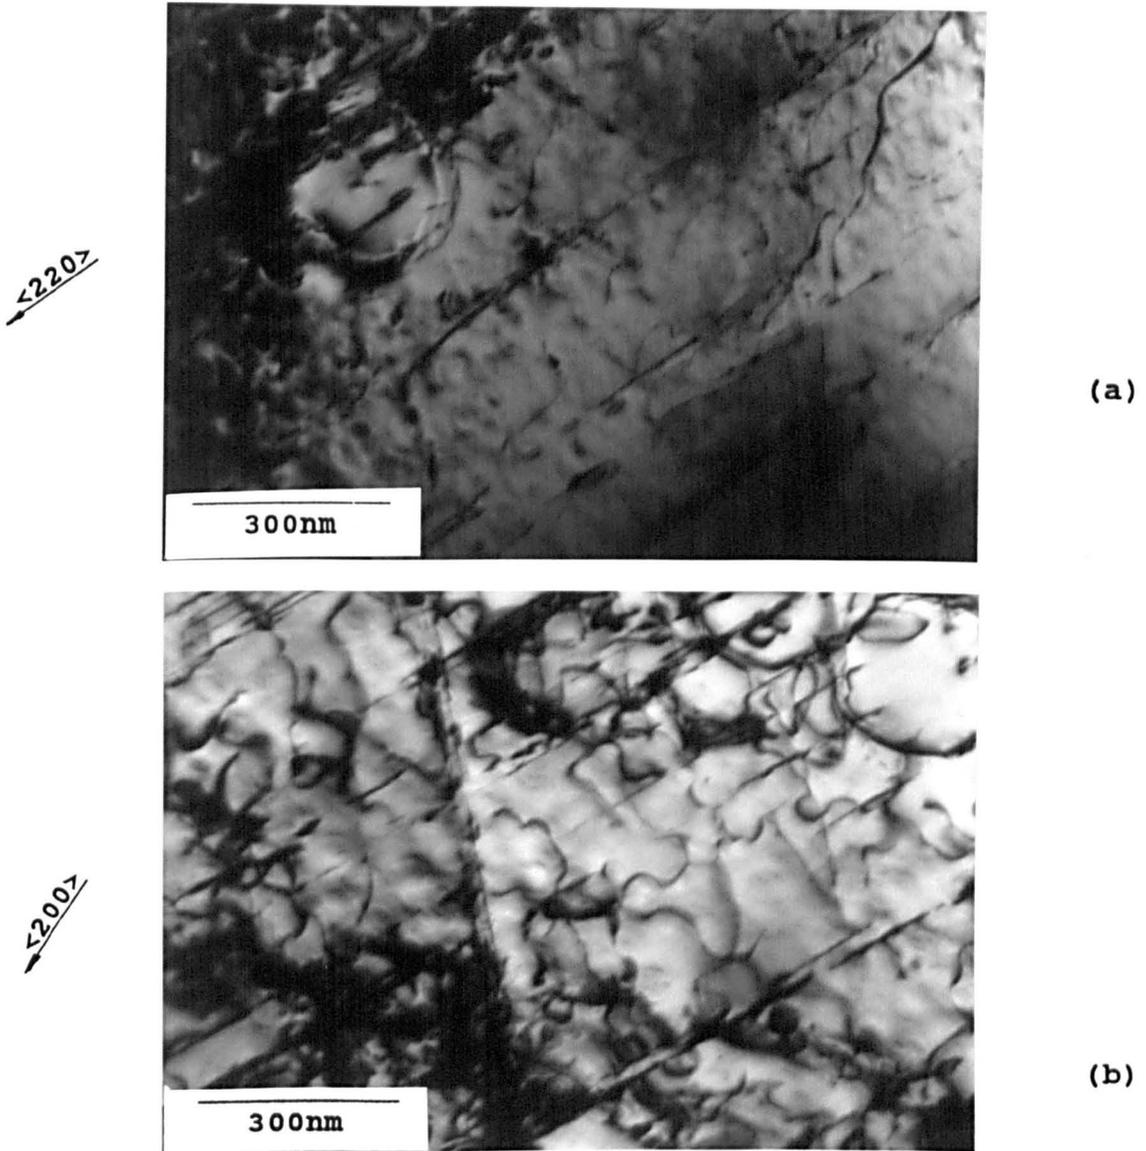
Fig. 4.45. Bright field transmission electron micrographs of back-thinned foils, (a) from specimen H34 (200,000 cycles at 100%PS) showing a fairly well developed slip band (upper left) running parallel to a series of individual dislocation lines, $\langle 112 \rangle$ orientation and (b) from specimen H31 (2,400,000 cycles at 80%PS) showing planar slip on two active systems in the same area as wavy dislocations, apparently pinned by the small precipitates, $\langle 011 \rangle$ orientation.
