FATIGUE DAMAGE ACCUMULATION IN
NICKEL BASE SUPERALLOYS

Thesis submitted for the degree of Doctor of Philosophy

Department of Engineering Materials

University of Sheffield

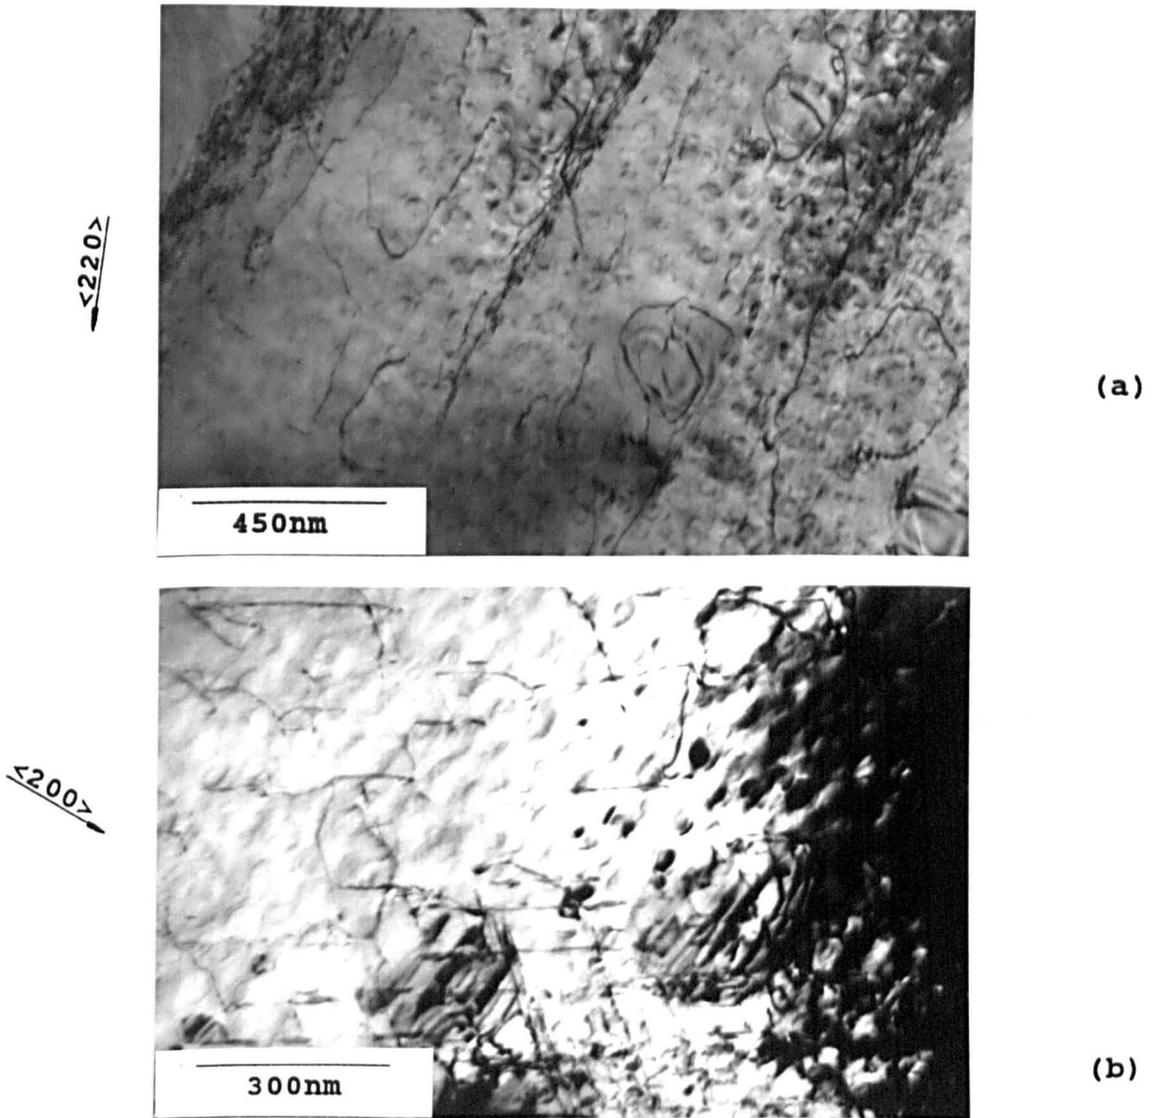
Fig. 4.46. Bright field transmission electron micrographs of back-thinned foils from specimen H28 (100,000 cycles at 100%PS) showing some areas of lower dislocation density observed and slip occurring on two active systems; orientations: (a): $\langle 113 \rangle$ and (b): $\langle 011 \rangle$.

In contrast, it was possible to locate occasional areas of low dislocation density, as shown by Fig. 4.46, where it

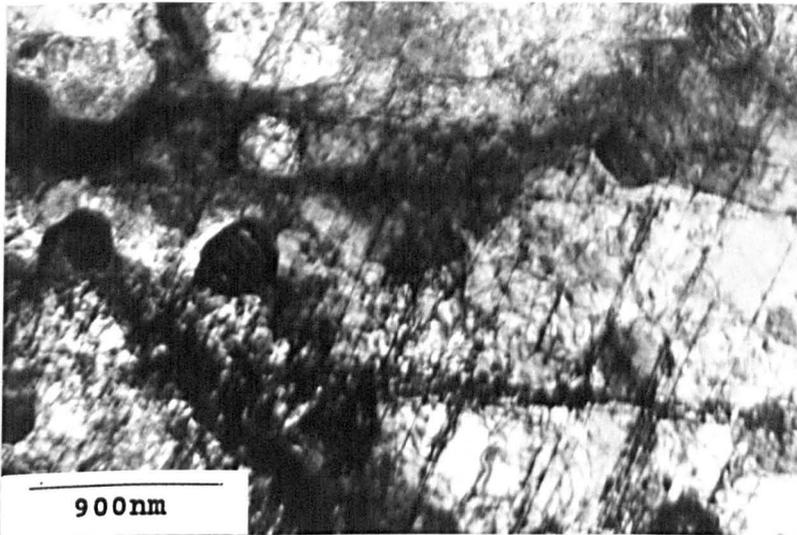
(b)

In these late stages of fatigue, images of cell structures were almost impossible to obtain. There was an extremely high dislocation density present and planar deformation in the form of slip bands was well established. Fig. 4.47 shows that after 200,000 cycles at 100%PS the many long, straight, planar style dislocations had much stronger contrast and only a faint indication of background cell structures could be seen. In contrast, it may be seen from Fig. 4.48 that areas of low dislocation density did exist and that long wavy dislocations may have just started to tangle up to form new cell boundaries.

Fig. 4.47. Bright field transmission electron micrographs of back-thinned foils from specimen H34 (200,000 cycles at 100%PS) illustrating the much stronger contrast from planar dislocations, making images of cell structures very difficult to obtain; also, the extremely high overall dislocation densities typically observed.

The slip band and its associated dislocation networks observed by Lerch and Gerold [20] was very similar to that of Fig. 4.42(a), also, the cellular deformation was not too dissimilar to the examples shown in Figs. 4.39(a) and 4.47(b). Furthermore, the diffraction pattern of Fig. 4.41 showing spot splitting, was very similar to those reported by Lerch and Gerold [20]. However, one noticeable difference was the obvious way that the dislocations encircled and were pinned by the large γ' precipitates of the Waspaloy in the present work (Fig. 4.39), whereas this was not apparent in the Nimonic 80 [19]. However, the Nimonic 80 [19, 20] only contained very fine spherical γ' (13nm in diameter), hence, such dislocation/precipitate interactions would be more difficult to observe.

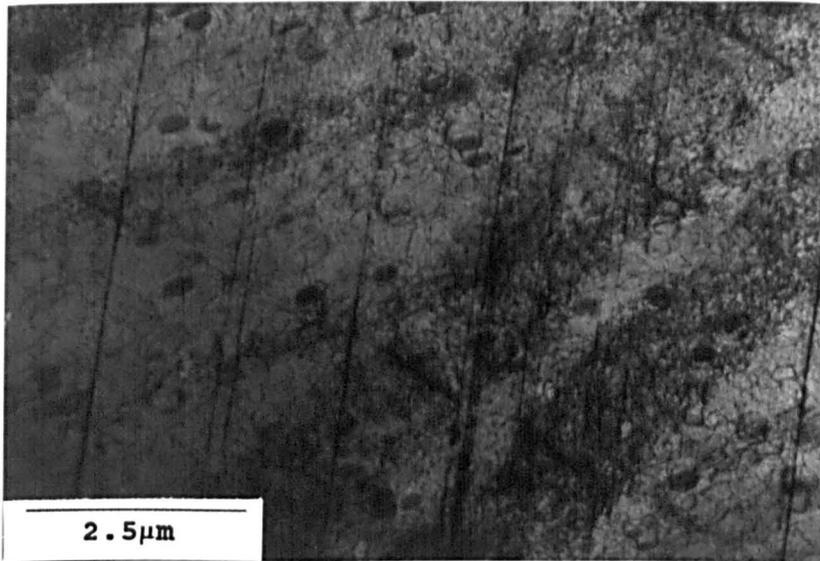
Fig. 4.49. Bright field transmission electron micrographs of back-thinned foils from specimen H2 (fracture at 100%PS) showing slip occurring on three active systems and bands of various thickness; in addition, (b) illustrates precipitates encased by dislocations giving them a dark appearance and the planes running in an almost vertical direction are being viewed edge on; $\langle 011 \rangle$ orientations.

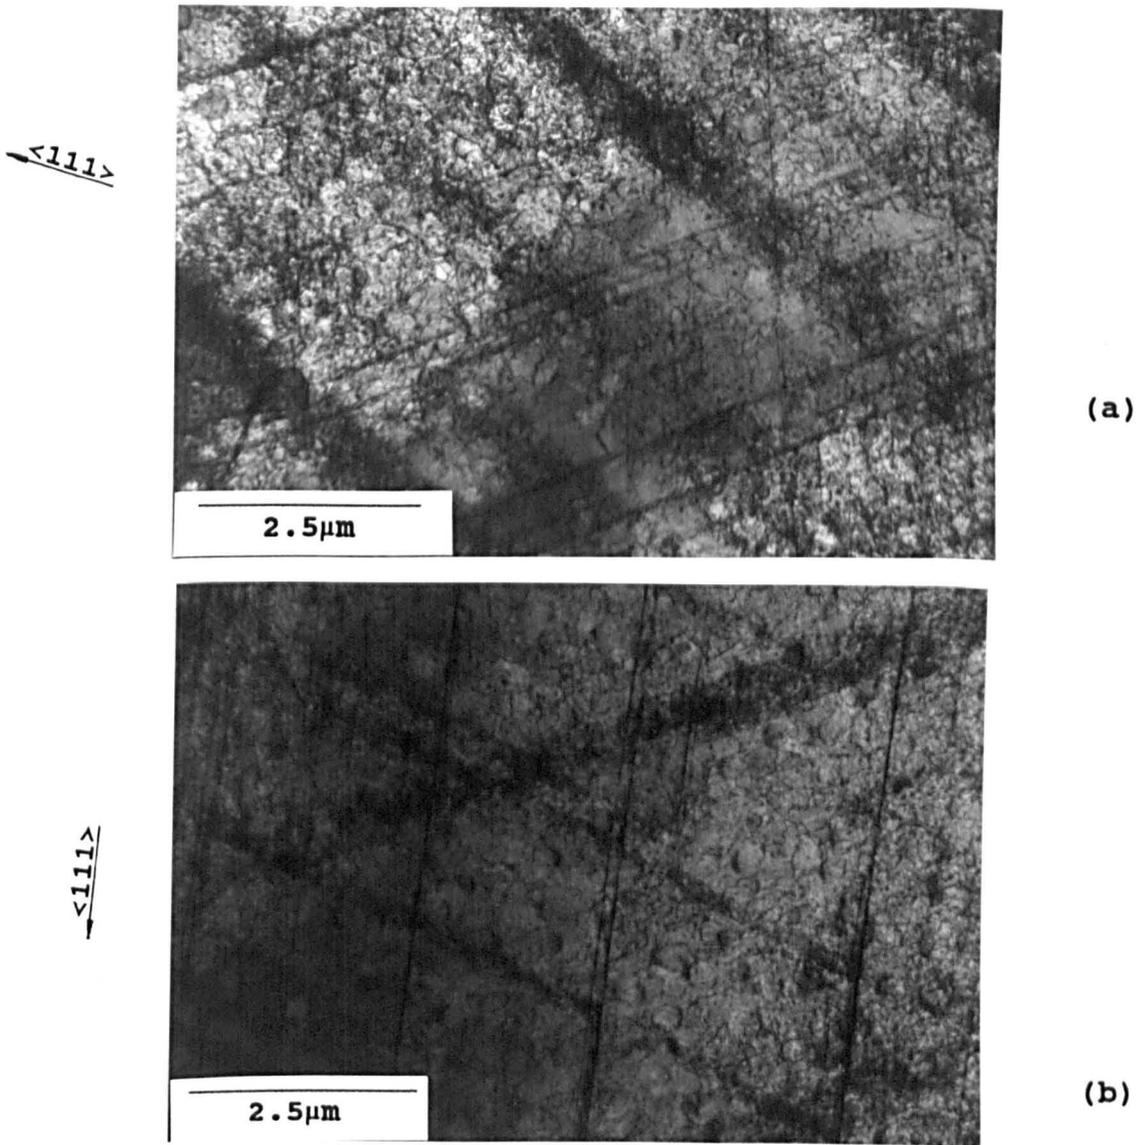
Fig. 4.50. Bright field transmission electron micrographs of back-thinned foils from failed specimens showing slip occurring on three active systems and bands of various thickness; (a) illustrates the high dislocation density typically observed at fracture from specimen H19 (fracture at 80%PS) and (b) shows the planes running in an almost vertical direction viewed edge on from specimen H2 (fracture at 100%PS); $\langle 011 \rangle$ orientations.

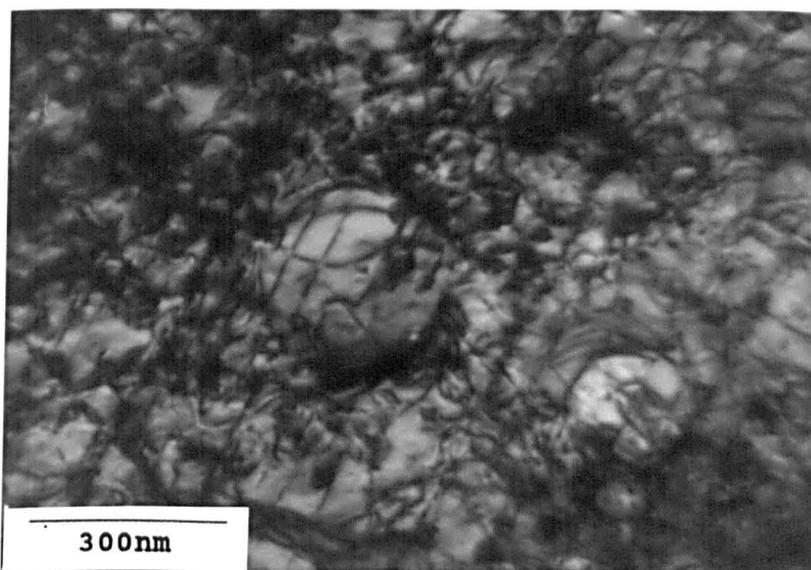
Fig. 4.51. Bright field transmission electron micrographs of back-thinned foils from failed specimens showing (a) slip occurring on two active systems and wavy dislocations interacting with precipitates, (b) the high dislocation density typically observed at fracture making the clear imaging of individual features very difficult at high magnification. (a): from specimen H2 (fracture at 100%PS), (b): from specimen H19 (fracture at 80%PS); <011> orientations.

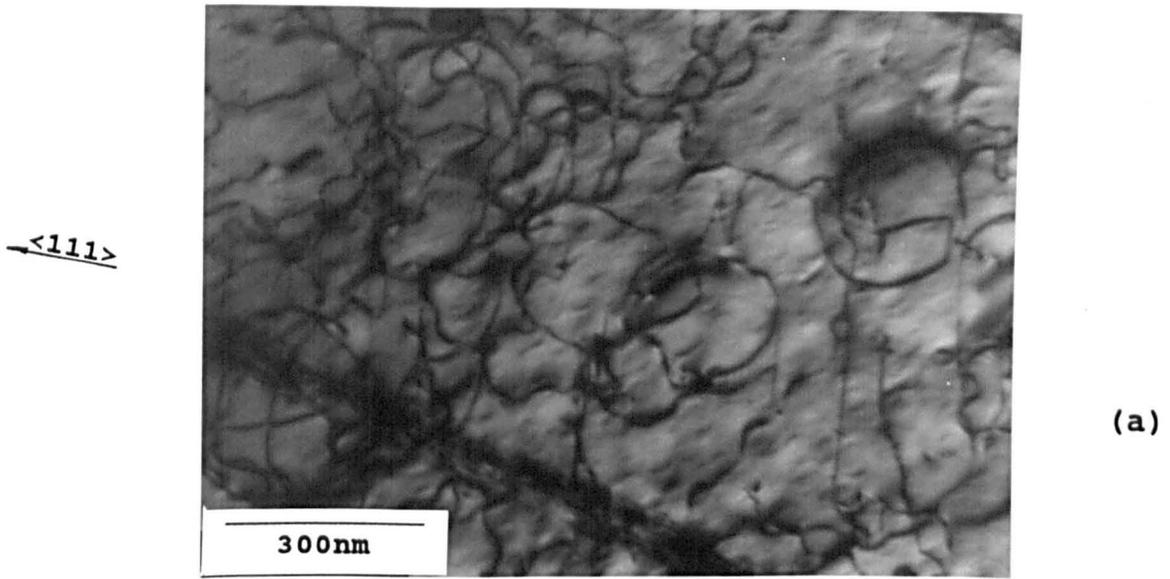
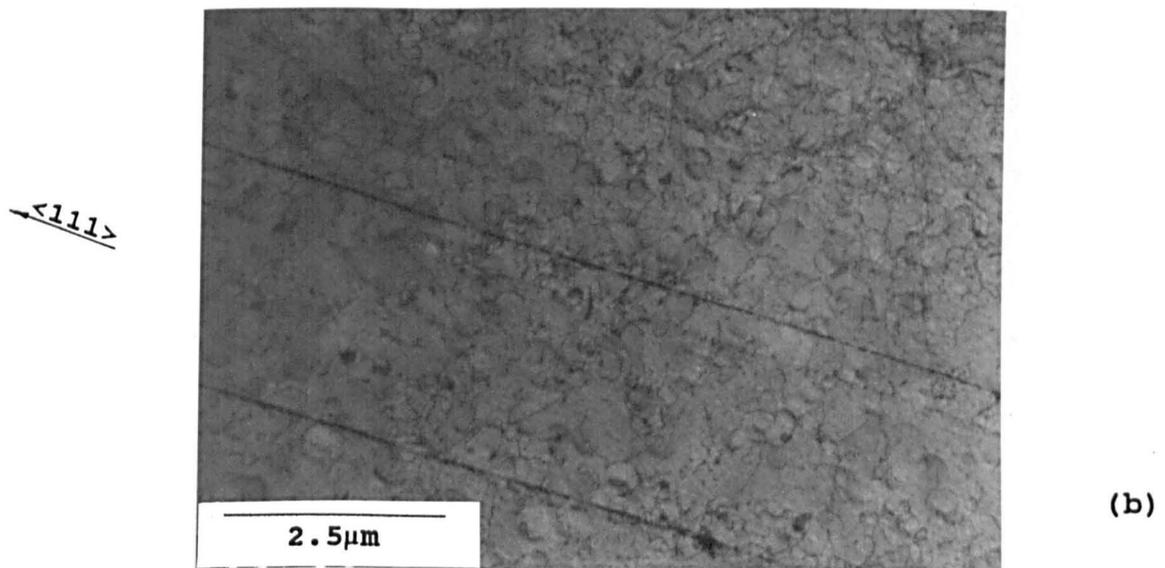
Fig. 4.52. Bright field transmission electron micrographs of back-thinned foils from specimen H3 (fracture at 80%PS) showing (a) wavy dislocations pinned by both large and small precipitates and a slip band in the bottom left and (b), the high density of wavy dislocations in existence between slip bands when viewed edge on; $\langle 011 \rangle$ orientations.

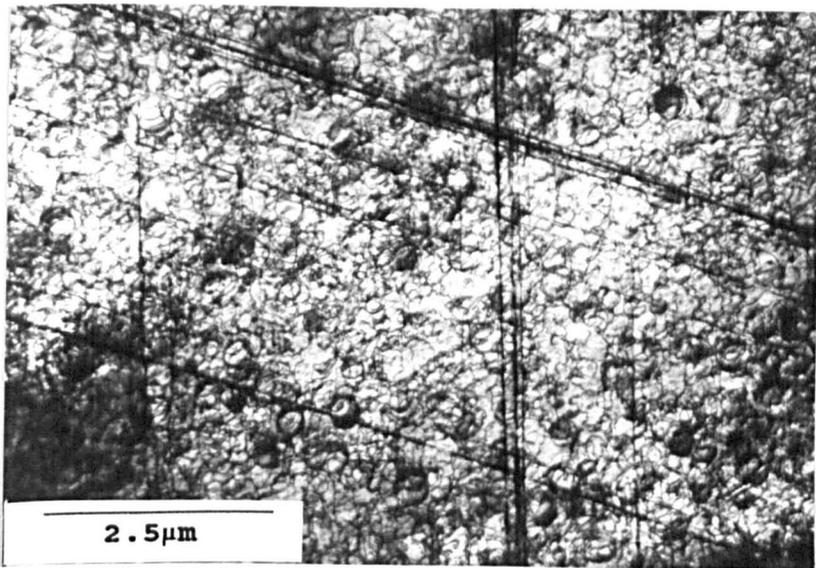
Fig. 4.55. Bright field transmission electron micrograph of a cross-sectional foil from specimen H3 (fracture at 80%PS) showing a surface grain at a depth of approximately 10 μ m. Slip has clearly occurred on two active systems and the bands (viewed edge on) are lying at angles of 20° and 82° to the fatigue surface. The high dislocation densities made it difficult to image dislocation/precipitate interactions; $\langle 011 \rangle$ orientation.

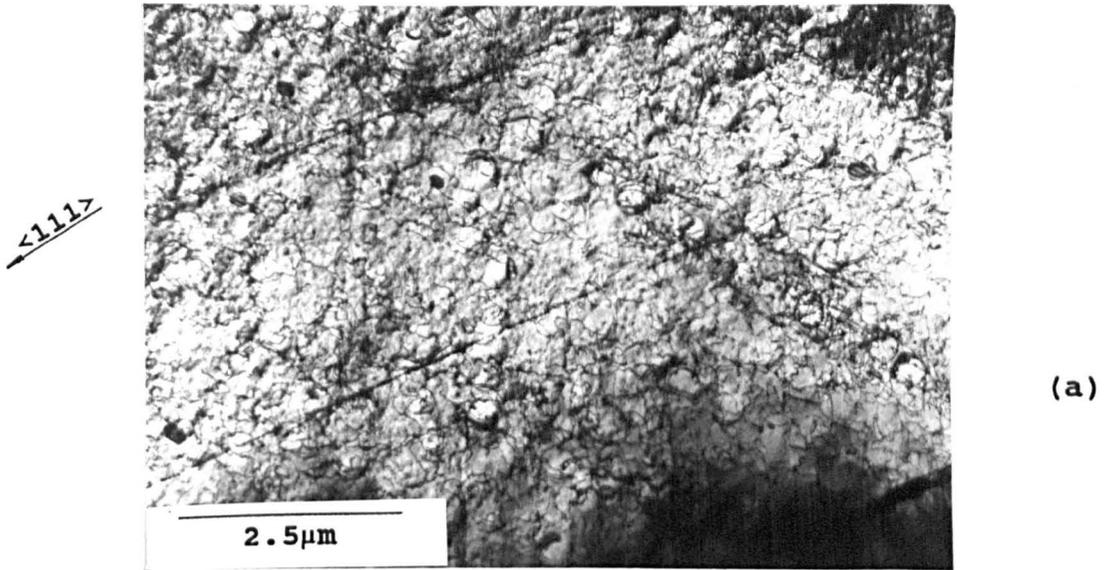
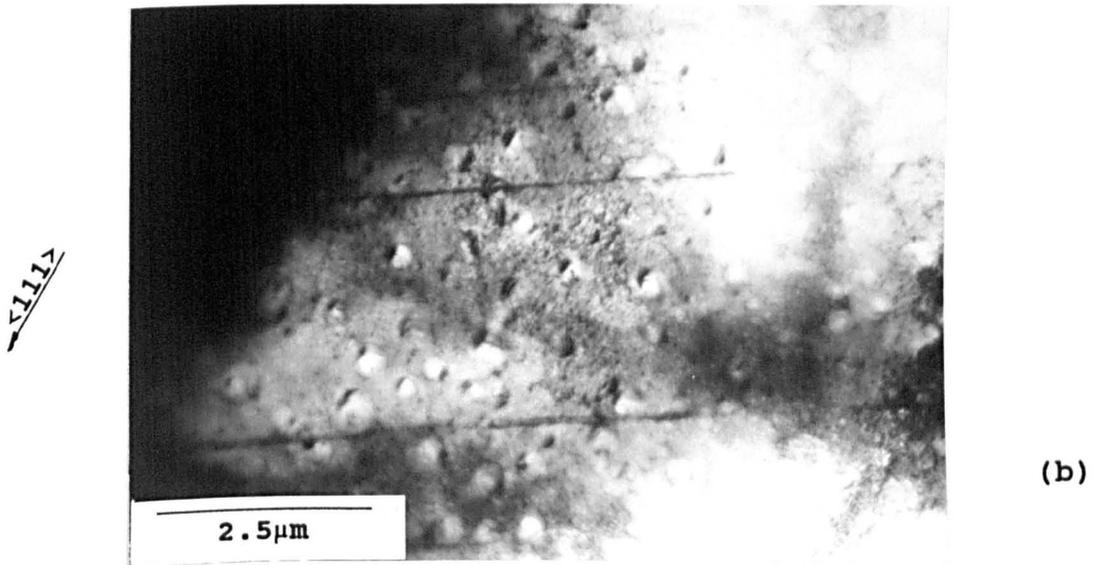
Fig. 4.57. Bright field transmission electron micrographs of cross-sectional foils, at approximate depths of (a) $42\mu\text{m}$, and (b) $40\mu\text{m}$ from the fatigue surfaces of (a) specimen H19 (fracture at 80%PS) and (b) specimen H12 (fracture at 100%PS); the micrographs illustrate examples of the differences in deformation observed at similar depths; (a) shows a high dislocation density in an annealing twin with two active slip systems, the bands lie at 35° and 22° to the fatigue surface; alternatively, (b) shows little deformation with a few bands lying parallel to the fatigue surface; $\langle 011 \rangle$ orientations.

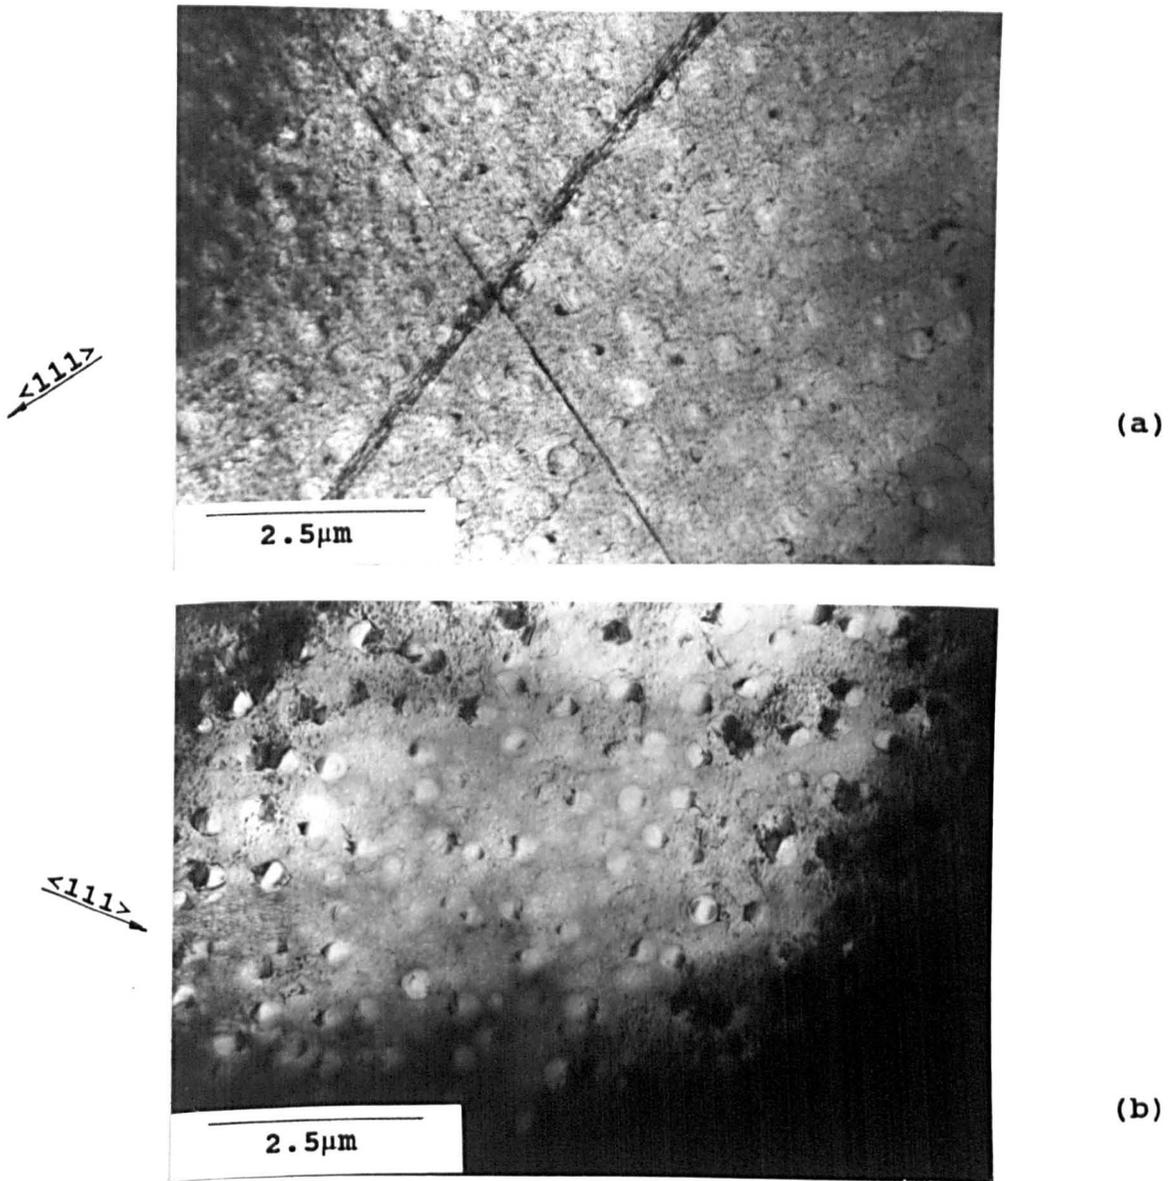
Fig. 4.58. Bright field transmission electron micrographs of cross-sectional foils from specimen H12 (fracture at 100%PS) at approximate depths of (a) $60\mu\text{m}$ and (b) $62\mu\text{m}$ from the fatigue surface; the micrographs illustrate examples of the differences in deformation observed at similar depths; (a) shows two very obvious slip bands, running at 68° and 42° to the fatigue surface; in contrast, (b) shows no observable deformation; $\langle 011 \rangle$ orientations.

A similar observation was made at a depth of approximately 60 μ m in a 100%PS foil. Fig. 4.58(a) illustrates a grain containing two very obvious slip bands running in different directions, whereas Fig. 4.58(b) shows nothing more than occasional dislocations partially looped around the larger γ' . It was noted however, that no deformation was observed after a depth of 60 μ m on the 80%PS foils and 62 μ m and 70 μ m on the 100%PS foils. At 80%PS, a depth of 60 μ m would correspond to an applied fatigue stress of 717MPa (from Fig. 4.59); similarly at 100%PS, the depths of 62 μ m and 70 μ m would correspond to applied stress values of 896 and 894MPa respectively.

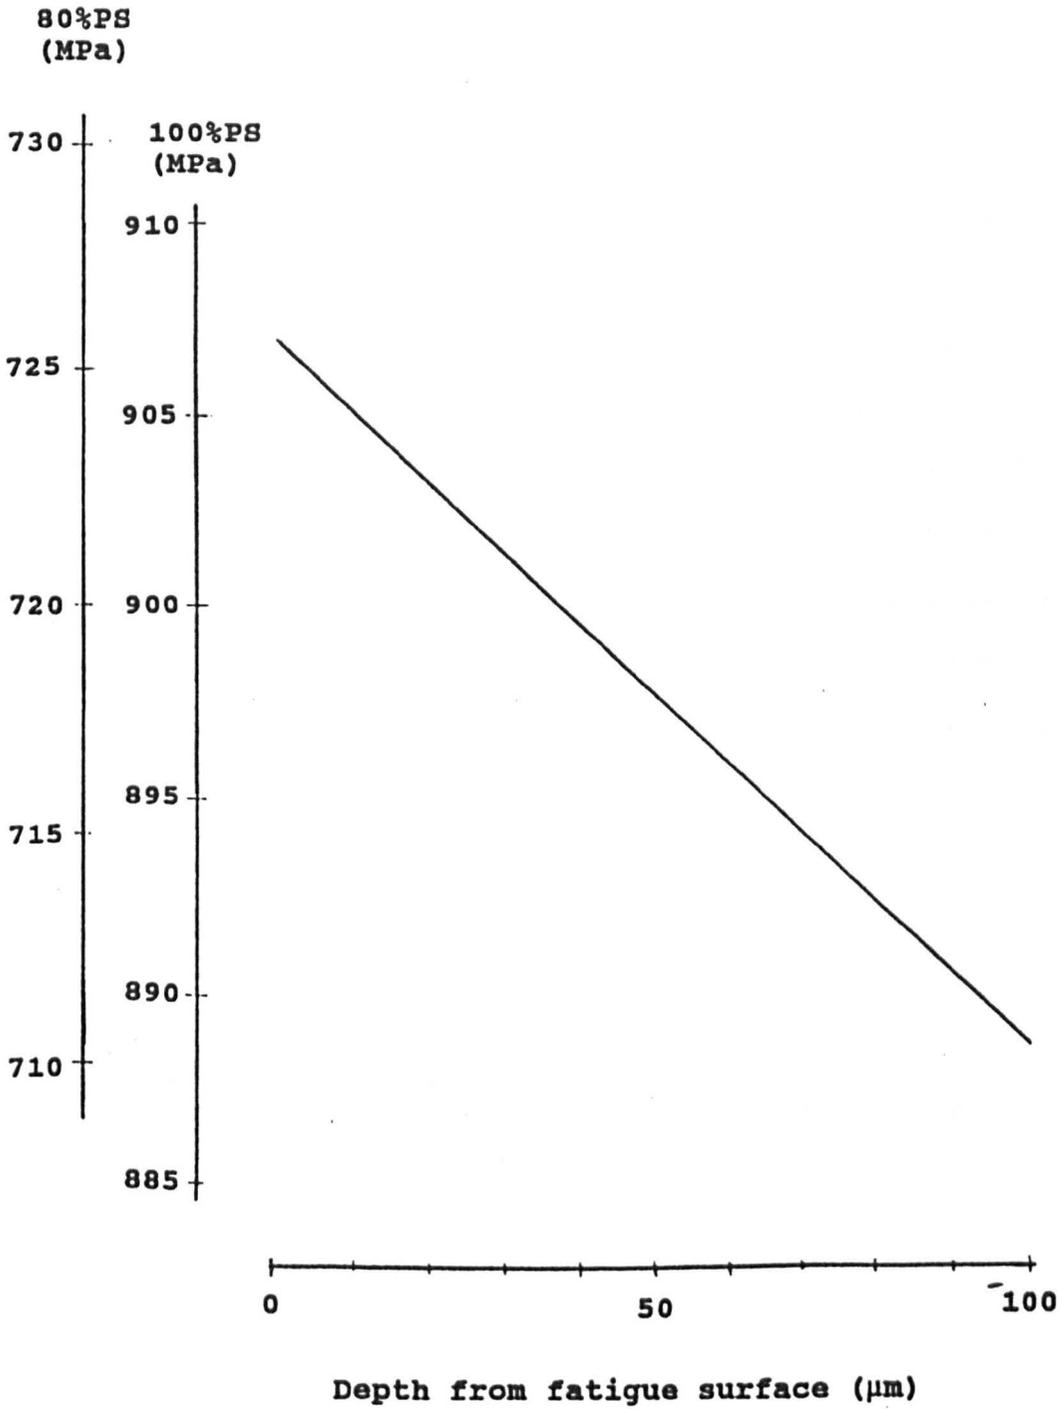
Fig. 4.59. Fatigue stress with depth from gauge surface.

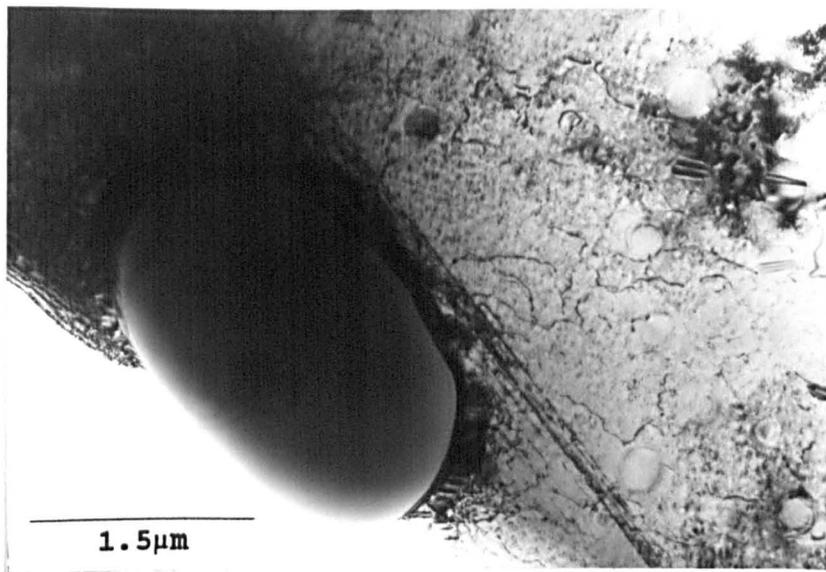
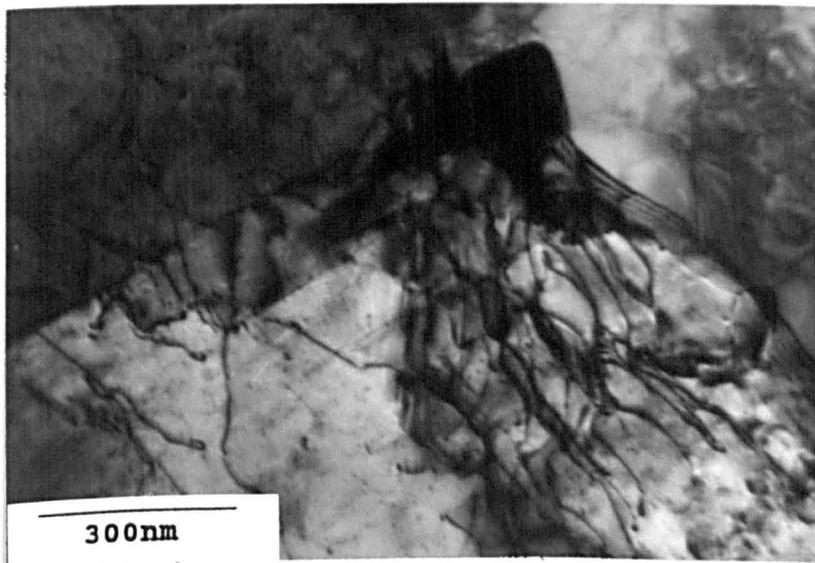
Fig. 4.60. Bright field transmission electron micrographs of cross-sectional foils from specimen H24 (fracture at 100%PS) showing possible crack initiation sites, (a) shows a surface particle or inclusion and (b) shows a grain boundary triple point 20 μ m from the fatigue surface; neither of the micrographs illustrate any evidence of initiating cracks; (a): $\langle 112 \rangle$ orientation.

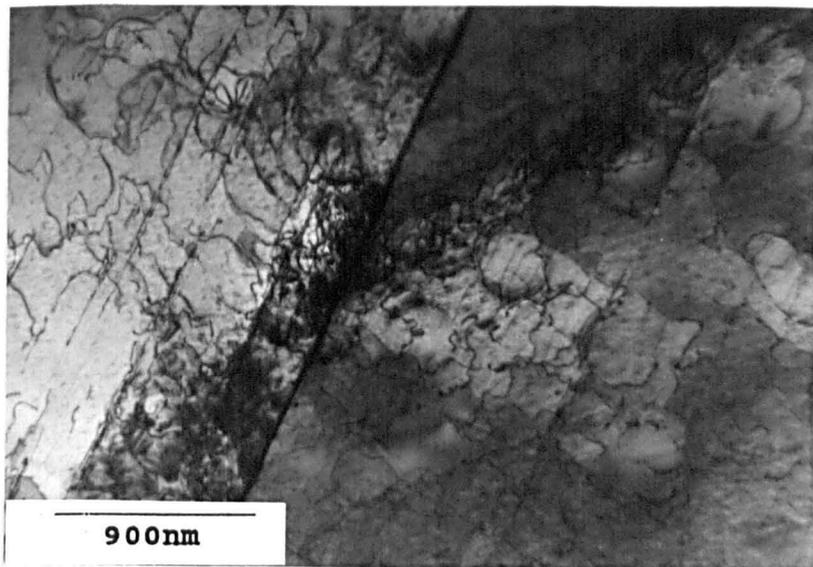
Fig. 4.66. Bright field transmission electron micrograph of a cross-sectional foil from specimen H3 (fracture at 80%PS) showing the arrest of slip over a twin boundary, at a depth of 30 μ m.

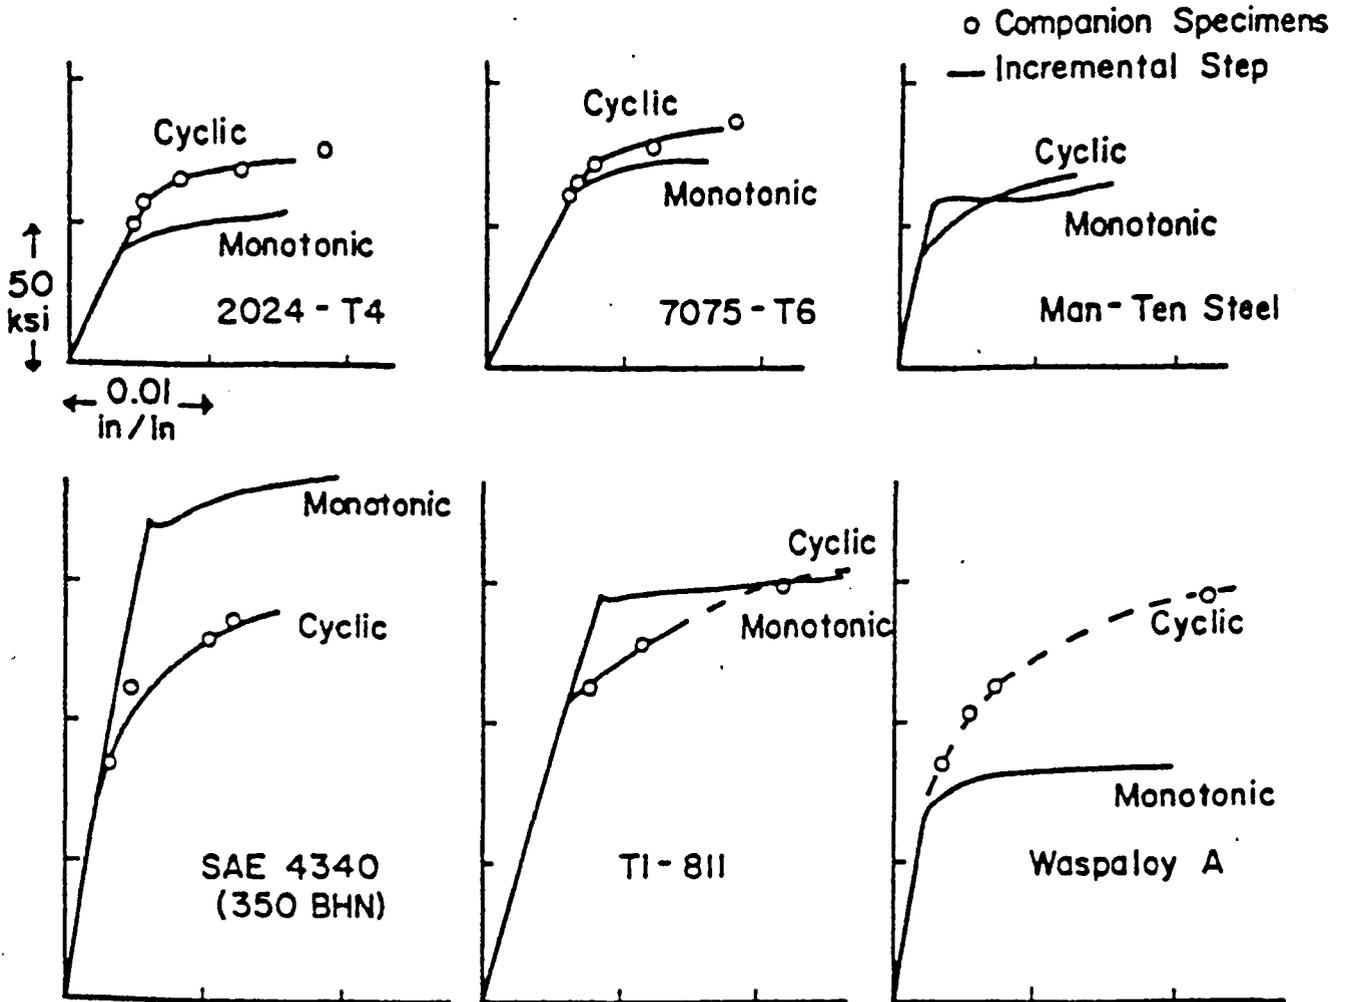
Fig. 5.1. Monotonic and cyclic stress-strain curves for representative materials [94].
