**Numerical and Experimental Investigation of Unreinforced
Masonry Wall Retrofitted with Timber Panels**

Submitted in accordance with the requirements for the degree of
Doctor of Philosophy

The University of Leeds
School of Civil Engineering

January 2020

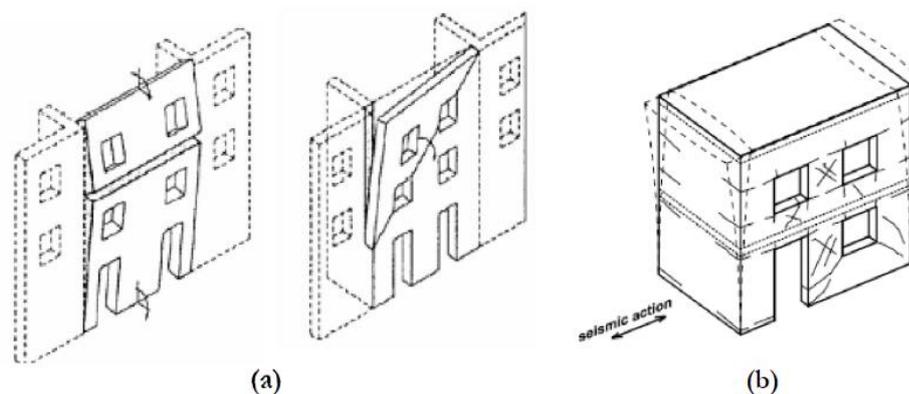
Figure 2.3. Failure mechanism modes; (a) Mode I: local collapse mechanism (D'Ayala and Speranza, 2003), (b) Mode II: global collapse mechanism (Magenes and Calvi, 1997).

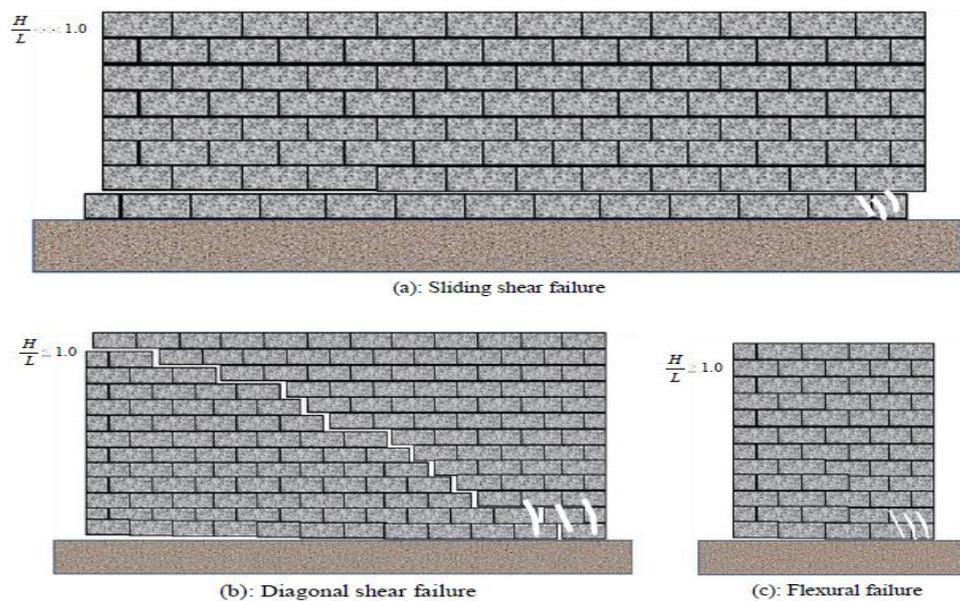
Shing et al. (1991), Davidson and Brammer (1996) and Nazir (2015) concurred that URM walls exhibit three simple forms of in-plane failure, as shown in figure 2.4. The wall geometry influences these failure mechanisms i.e. the ratio of wall height to its length (H/L) and layout of joints (Brunner and Shing, 1996; Minaie, 2009). As deduced from Nazir (2015), a shorter wall ($H/L \ll 1.0$) tends to fail as bed joint sliding shear (Fig 2.4a). While a short wall ($H/L \leq 1.0$) tends to fail due to diagonal cracking induced by the principal tension perpendicular to diagonal strut (Fig. 2.4b). For walls with ($H/L > 1$), flexural failure is the most common failure exhibited (Fig 2.4c).

Figure 2.4. In-plane failure modes of URM (Nazir, 2015)

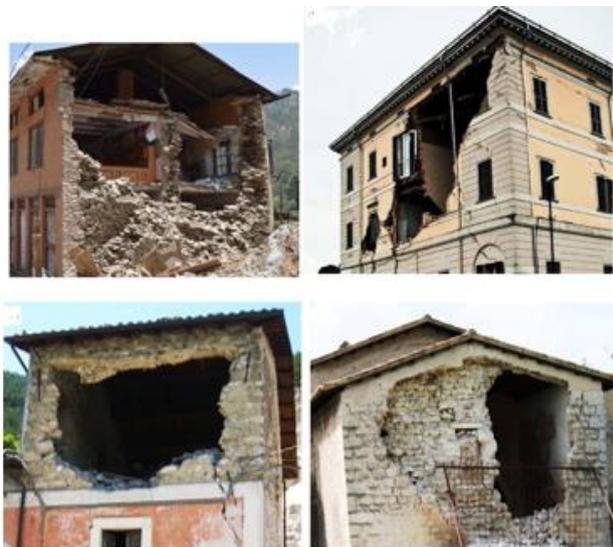
Figure 2.5. Out-of-plane failure modes of URM (De Santis et al., 2015)

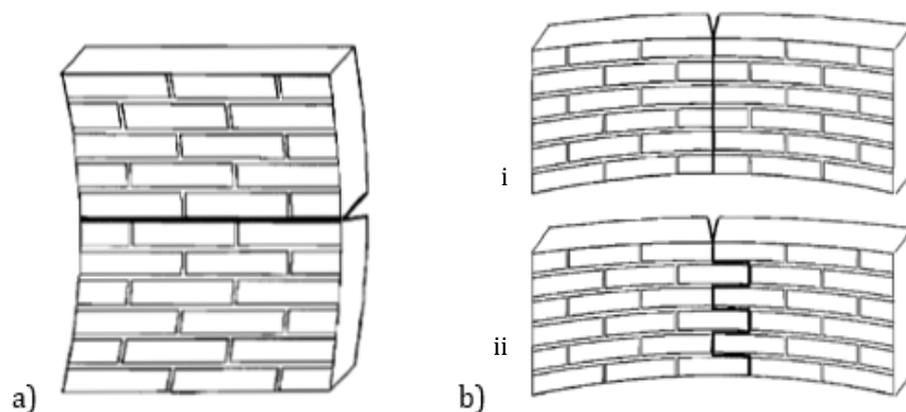
Interestingly, using the tables mentioned above, the characteristic flexural strength of masonry with the plane of failure parallel to the bed joint (f_{xk1}) is smaller than its contemporary with failure perpendicular to the joint (f_{xk2}). For instance, using a combination of clay masonry unit and general-purpose mortar of strength greater than 5N/mm^2 , f_{xk1} is 0.1N/mm^2 while f_{xk2} is 0.4N/mm^2 . Clearly, this supported the observation that the failure plane parallel to the bed joint is the weakest and the most devastating failure mode in masonry walls with strong unit-weak joint combination.

Figure 2.6. URM failure plane: (a) parallel to bed joints, (b) perpendicular to bed joints (BSI, 1996)

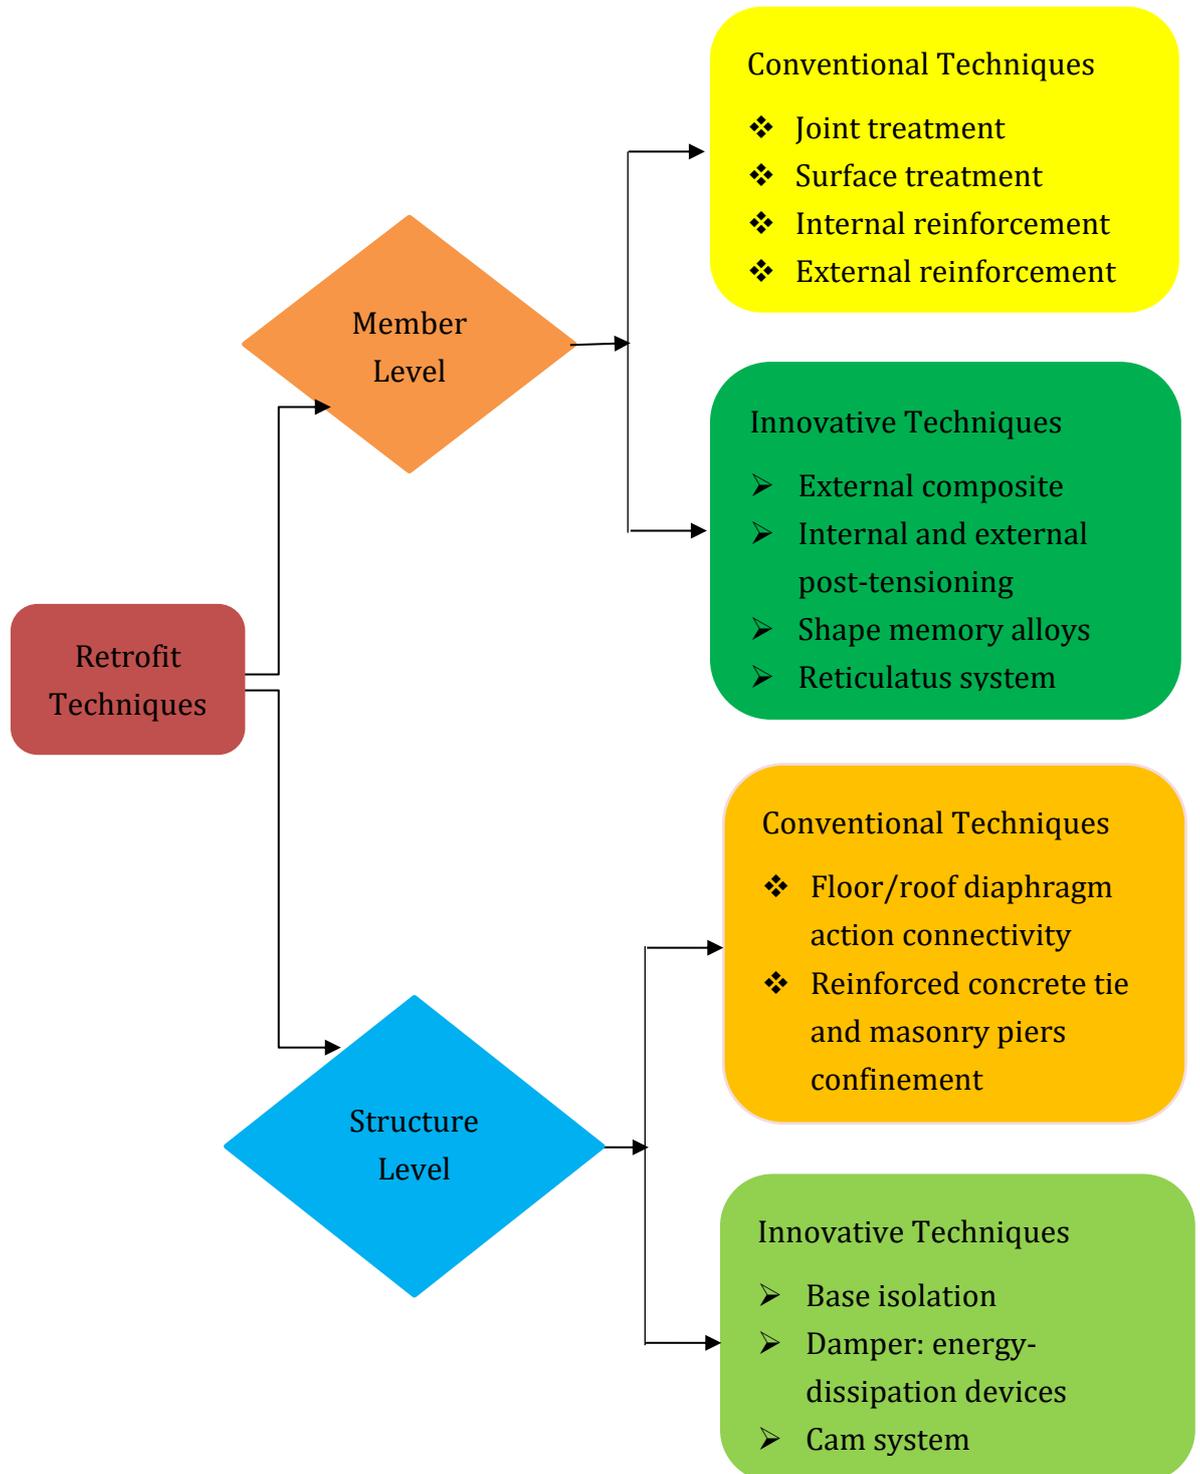
Figure 2. 7. Classification of retrofit techniques

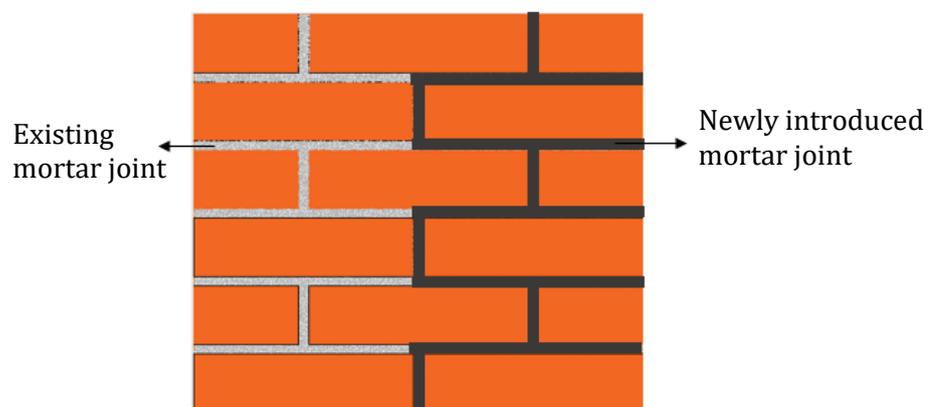
Figure 2. 8. Joint treatment of URM walls

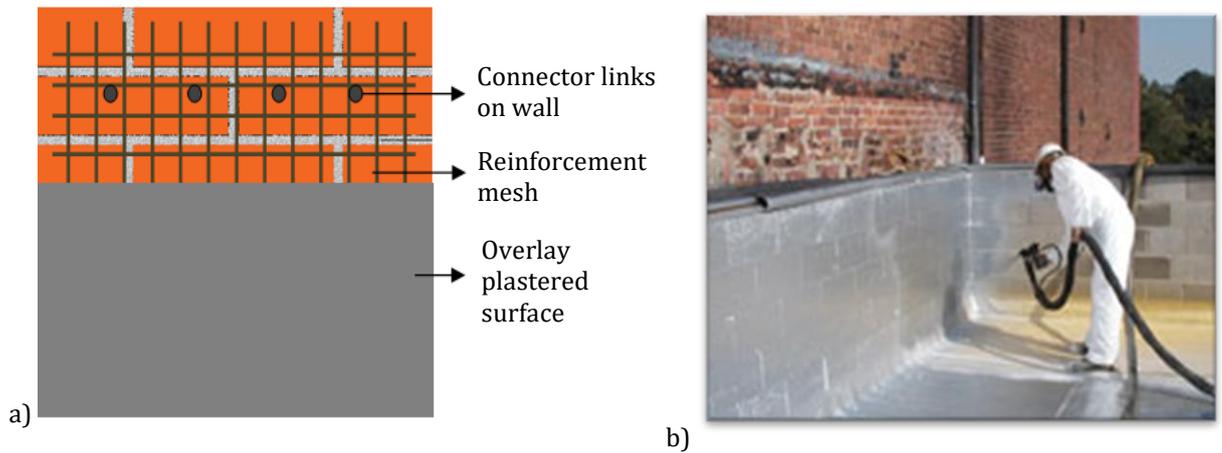
Figure 2.9: Surface treatment of URM wall: (a) Drawing (b) Application (Ward, 2004)

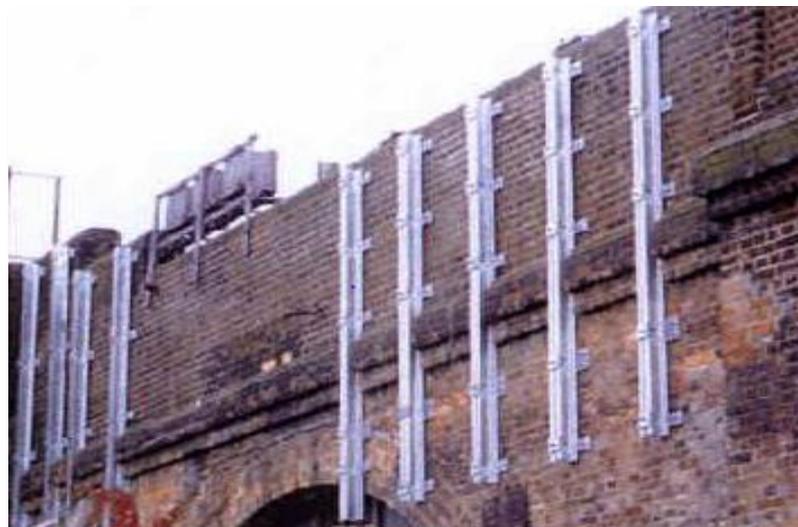
Supplemental strong back: This is an installation of external supplemental support to masonry structures to provide additional gravity support or seismic resistance. The supplemental support may be in the form of corbels installed under the location where the structural capacity upgrade is required. Jansen and Tilly (1999) submitted that seismic strengthening of masonry wall is sometimes carried out by bolting vertical steel channel girders to the wall externally. Steel reinforcements such as wind posts to safeguard URM wall against damages from the abnormal horizontal forces can also be used (Dawson, 2015). Recent investigation on the application of supplemental steel on URM are rare due to the noted challenges of cost and increased dead load on the existing structures (Lantz et al., 2016). The method requires regular maintenance via coating. Thus, it is an unappealing method in historical buildings because of its appearance (Fig. 2.10).

Figure 2.10: Externally strengthen wall with supplemental steel (Jansen & Tilly, 1999)

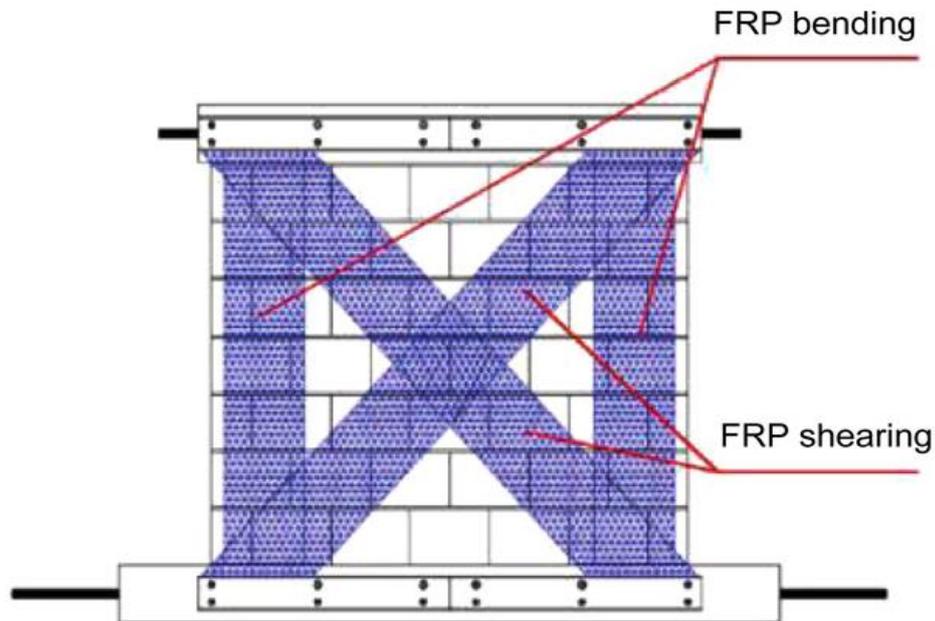
Figure 2.13: FRP strengthening approach on masonry wall (Wang, et al., 2018)

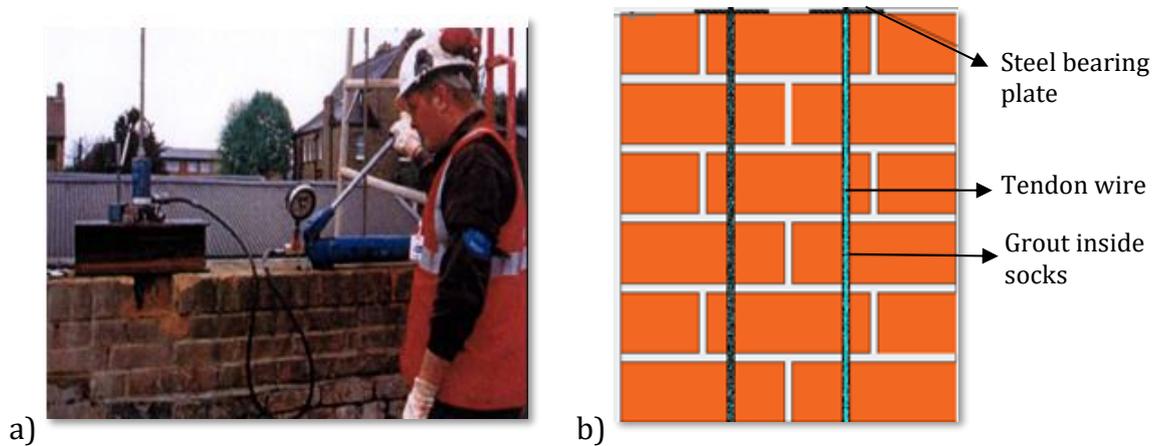
Figure 2.14: Post-tensioning of URM wall; a) Application (Jansen & Tilly, 1999) b) Schematic

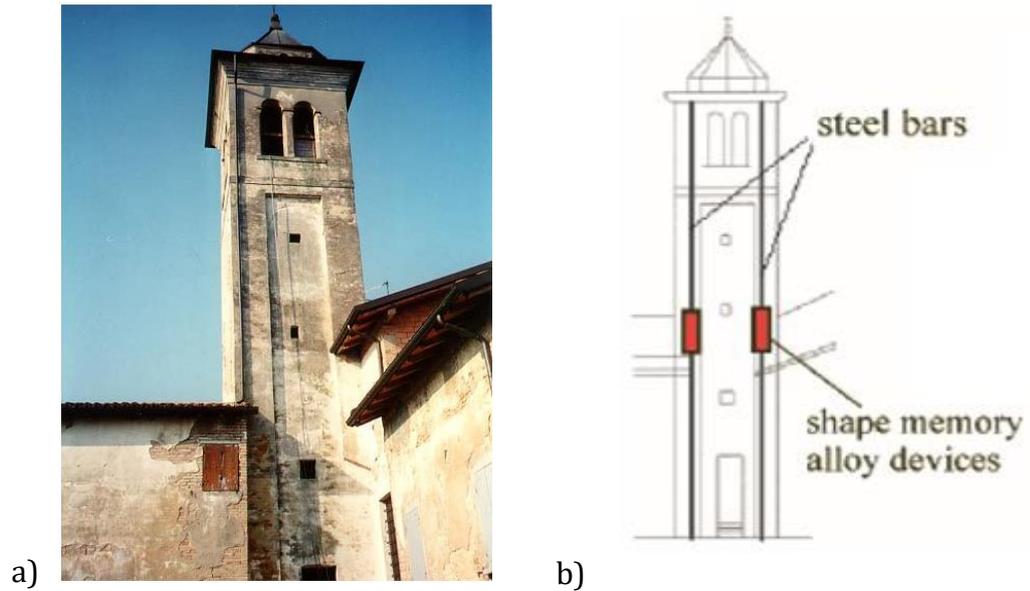
Figure 2.15: St. Giorgio bell tower retrofitted with SMA: (a) general view (b) retrofit location
(Indirli et al., 2001)

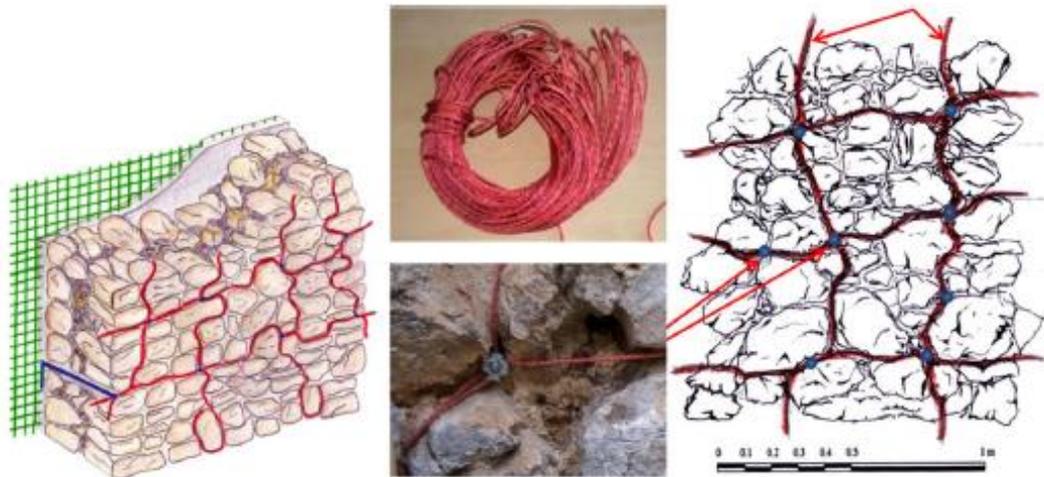
Figure 2.16: Reticulatus system showing the reinforcement idea and pattern (Fonti et al., 2017)

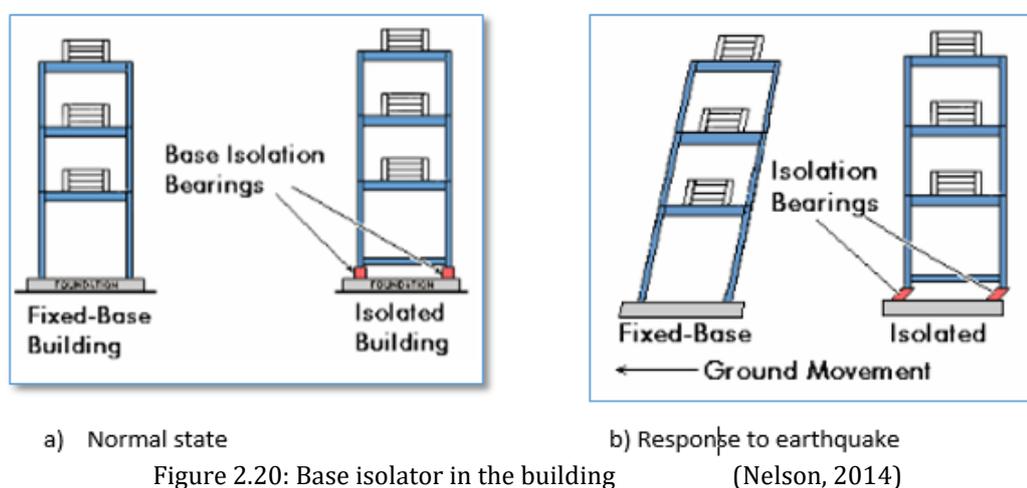
Figure 2.20: Base isolator in the building (Nelson, 2014)

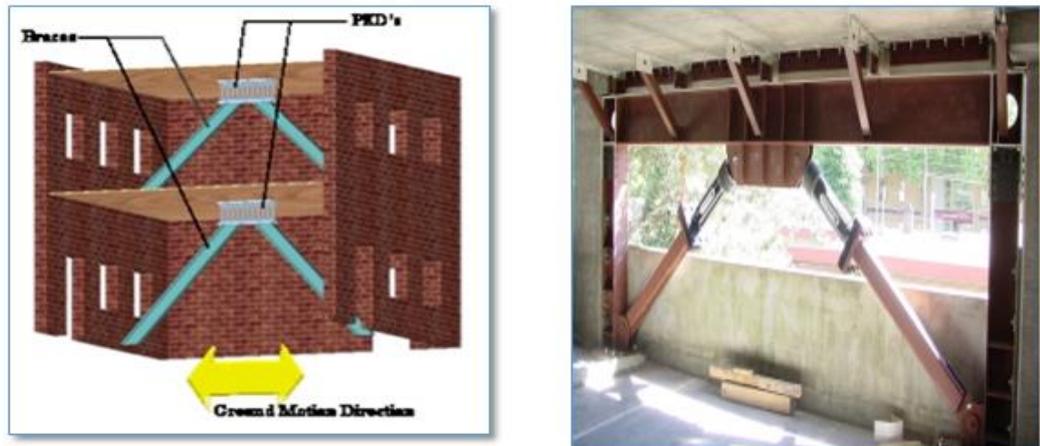
Figure 2.21: Seismic energy dissipation in building

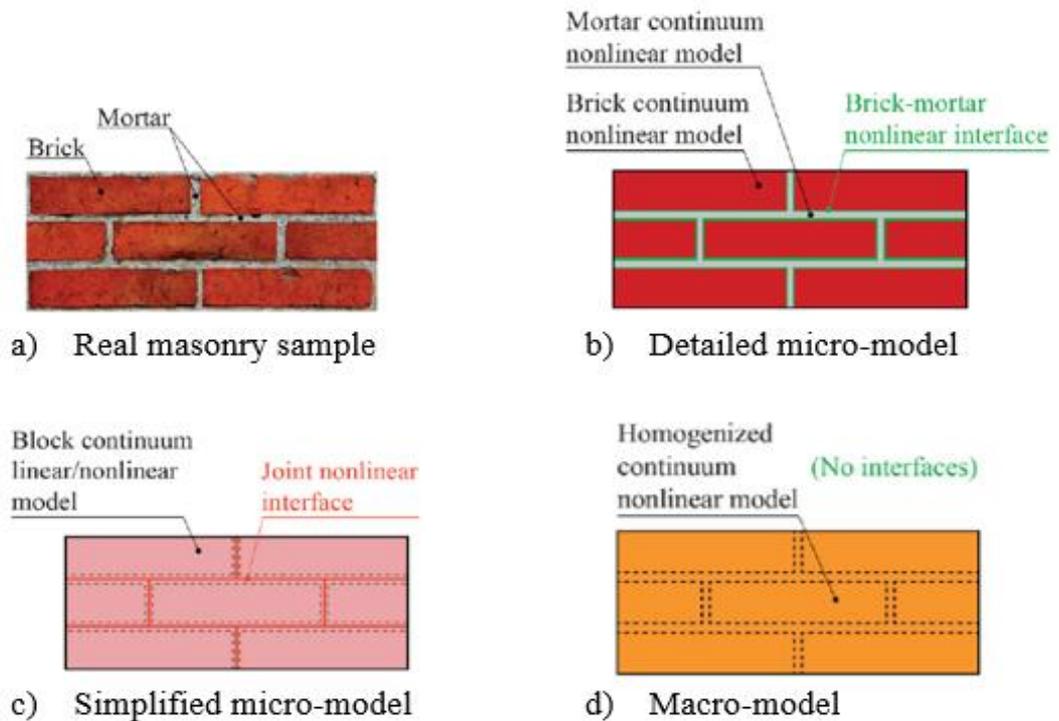
[3] Macro-modelling: This is structural level modelling techniques. Masonry is modelled as one phase material by smearing out masonry units, mortar and unit–mortar interface in a homogeneous continuum (Fig. 2.23d). This method has been previously adopted by Pande et al. (1989), Lourenco (1998), Zucchini and Lourenco (2004), Pena et al. (2010) and Dogariu (2015). This procedure is preferred for analysis of large-scale masonry structures, but not suitable for detailed stress analysis of a small masonry panel, due to the difficulty of capturing all its expected failure modes.

Figure 2.23. Masonry modelling techniques (a) real masonry sample (b) detailed micro-modelling (c) simplified micro model and (d) macro modelling

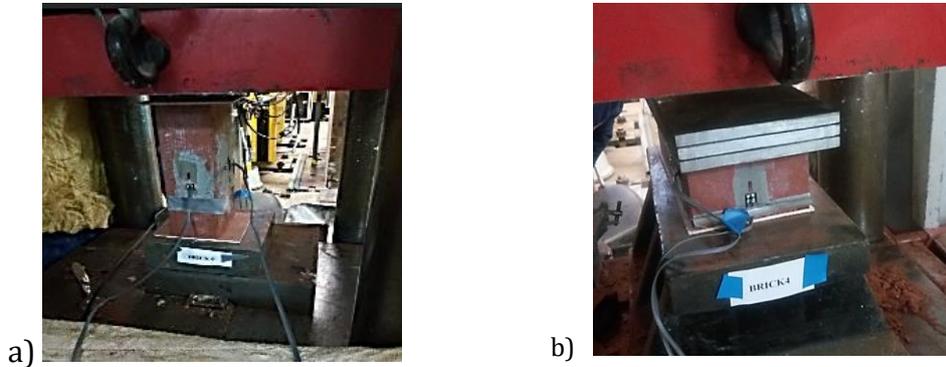
equal increments of 4kN/sec up to the failure (splitting) of the brick units. The loading and the results were monitored using a data logger connected to the compression-testing machine and f_b for each tested brick was calculated from the failure load and loaded area of the brick unit, as shown in table 4.3.

Figure 4.3. Compression test; a) load applied on header b) load applied on the bed face

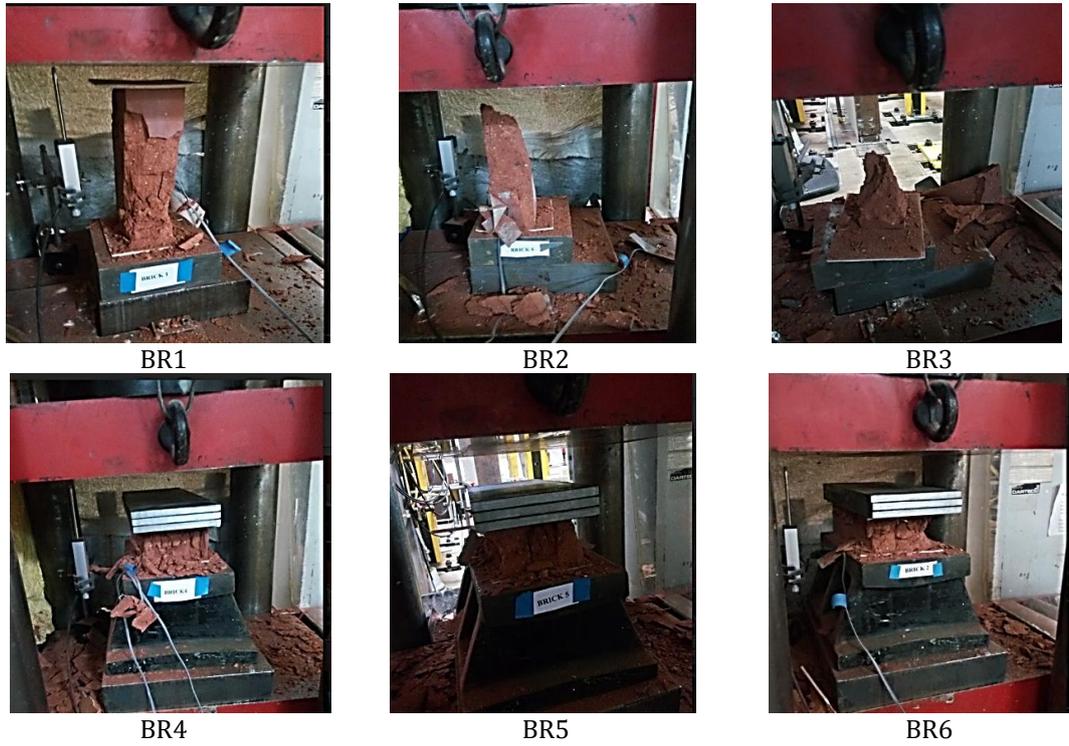
Figure 4.14a: Failure modes of brick units

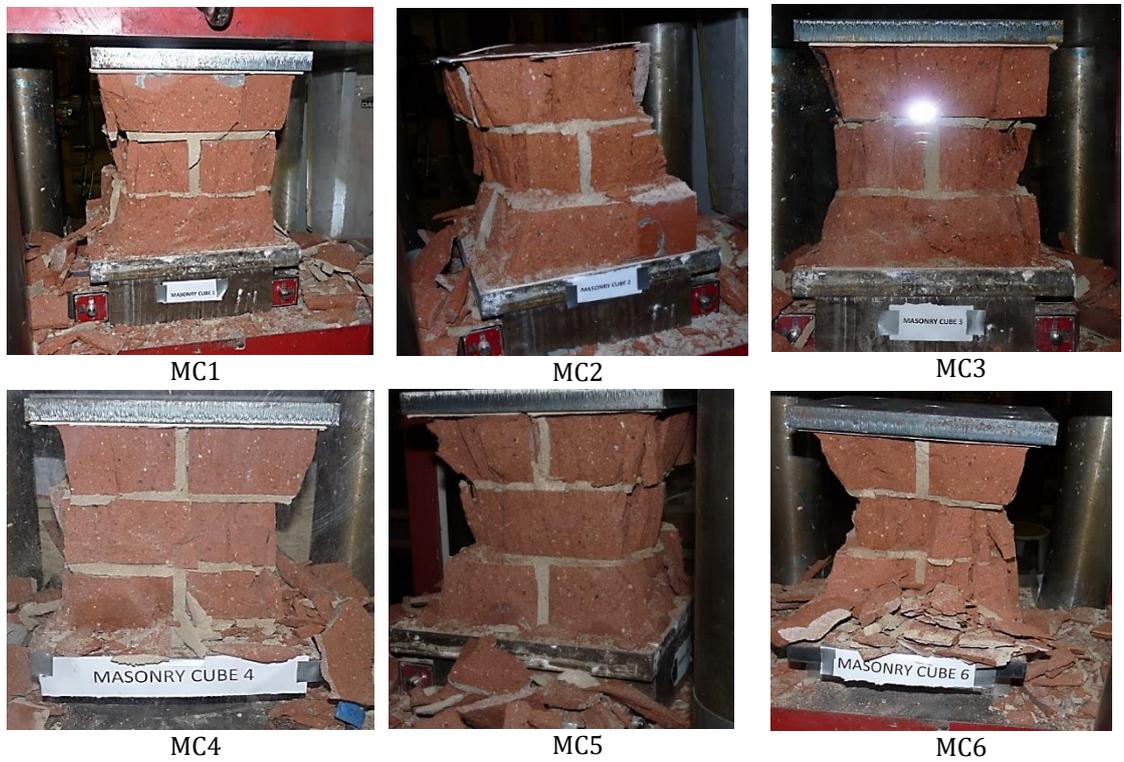
For the MC specimens, the failure was characterized by vertical splitting cracks appeared first in the central unit and extended to the other units as the stress increased. This observation is similar to what was reported by Vasconcelos & Lourenço (2009) and Mohamad and Chen (2016). This failure pattern is due to the presence of the vertical joints and the lateral expansion of the mortar inducing high tensile strength in the bricks. The splitting of MC on the side faces caused the attached LVDTs on the MC sides to fall off, which make recording the continuous deformation of MC difficult because the compression machine does not have an inbuilt LVDT.

Figure 4.14b. Failure of masonry cubic specimens

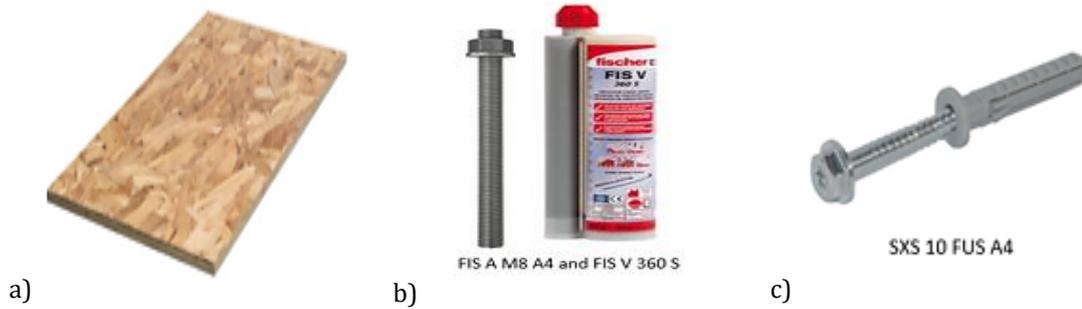
- I. Connection Type 1 (C1): This is an adhesive anchor connection system herein referred to as C1. It is a combination of FIS V 360 S injection mortar and FIS A4 anchor rod. FIS V 360 S is a high-performance injection mortar which is approved for fixings in both perforated and solid bricks. The selected FIS A4 anchor (Fig 4.15b) has 8mm diameter with 1.29kN permissible tensile load.
- II. Connection Type 2 (C2): This is a mechanical connection system classified as C2 in this study. C2 is a combination of Fischer frame fixing SXS plastic plug made of high-quality nylon and FUS A4 anchor rod. The diameter of the anchor rod is 8mm with a permissible tensile load of 1.39kN (Fig. 4.15c).

Figure 4.15. Material (a) OSB timber, (b) Adhesive anchor, (c) Mechanical anchor

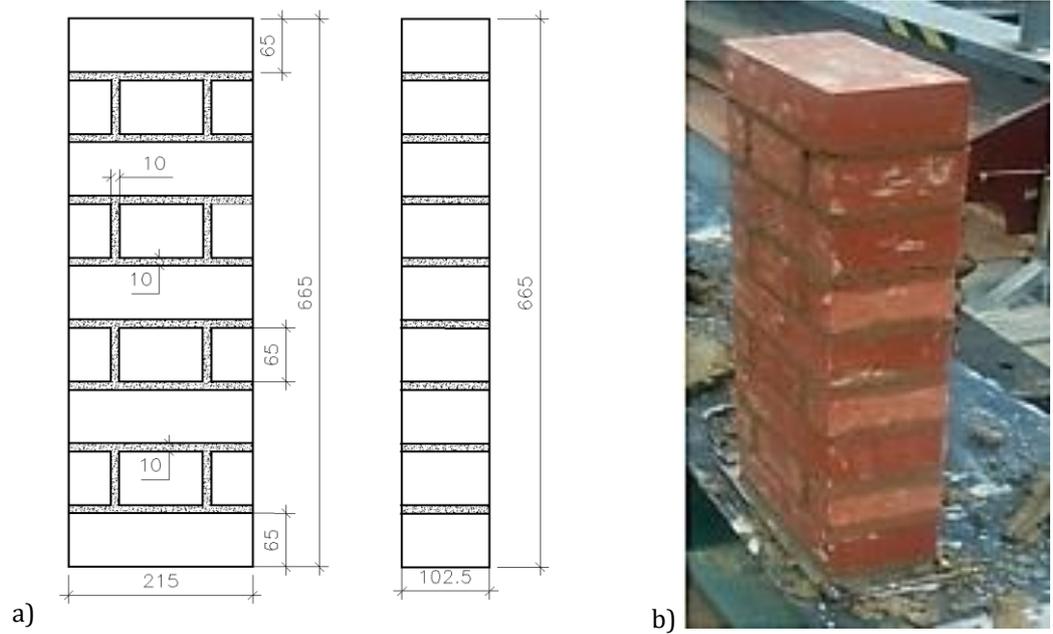
Figure 4.16. Plain masonry prism specimen a) Drawing (all dimension in mm) b) As-built specimen

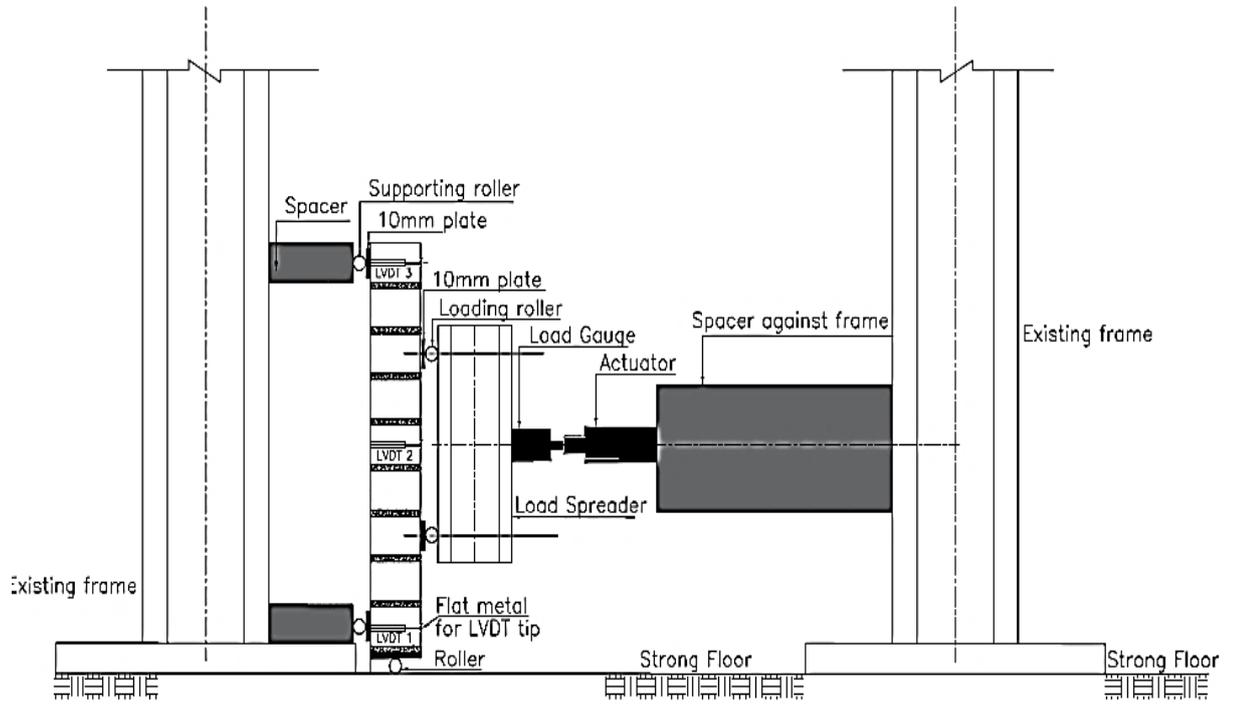
The force and the displacements were real-time monitored by connecting the load cell and LVDTs to an electronic acquisition unit interfaced with a computer. The test was load controlled, and the loading scheme is such that an initial load of 200N increments at every two minutes up to the occurrence of first cracks was applied. This loading rate represents 1/10th of the expected maximum load. The load increment was chosen so that a sufficient number of readings will be obtained to determine definitely the load-deformation curve (ASTM E72-15). After the first crack appeared, the loading was increased continually at a rate of 2N/sec up to the cracking/failure of MP specimens.

Figure 4.18. Small-scale test setup (drawing)

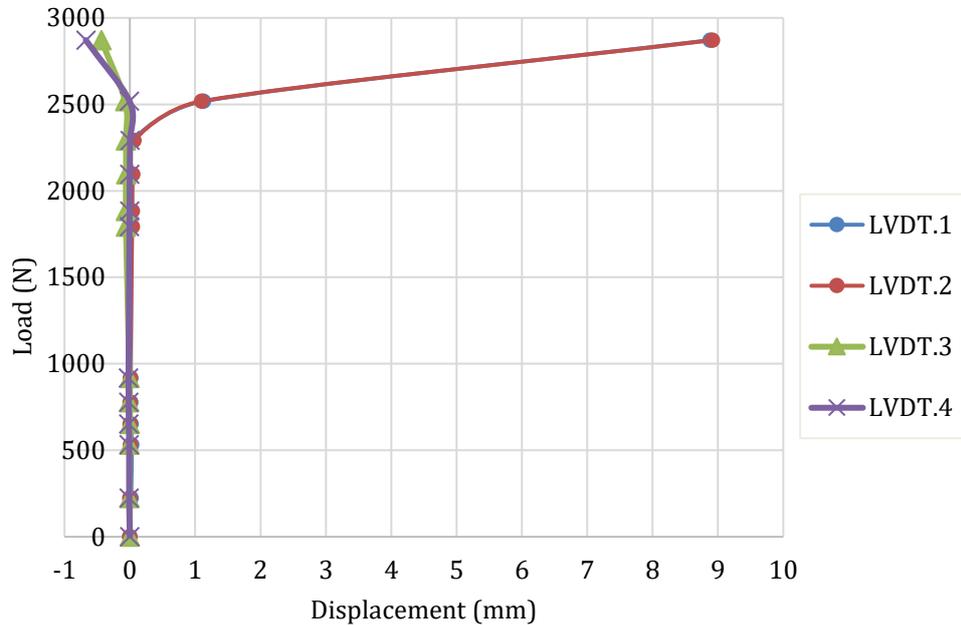
occurred, the brick separated from the joint, and the displacement jumped from 1mm to 9mm.

Figure 4.21. Typical load-displacement curve

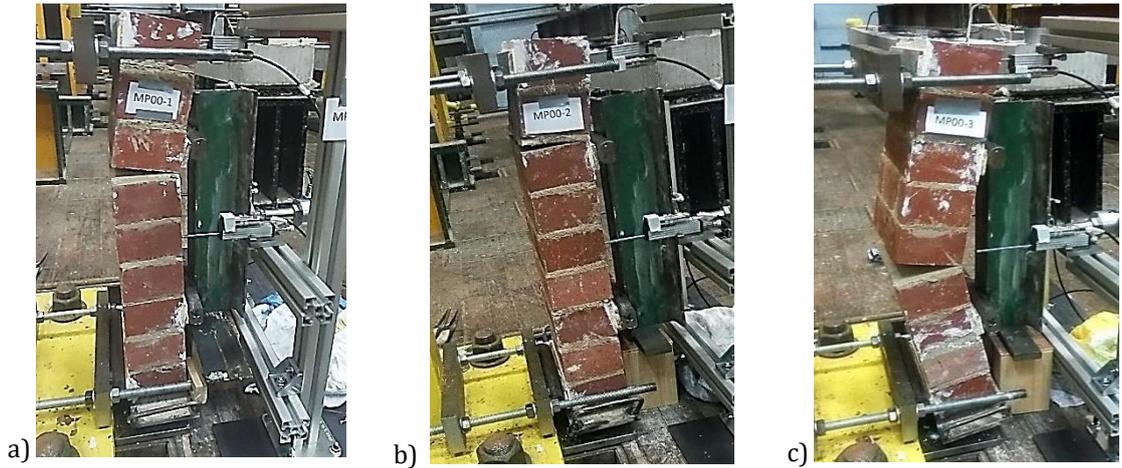
Figure 4.23. Failure pattern of (a) MP00-1; (b) MP00-2; (c) MP00-3

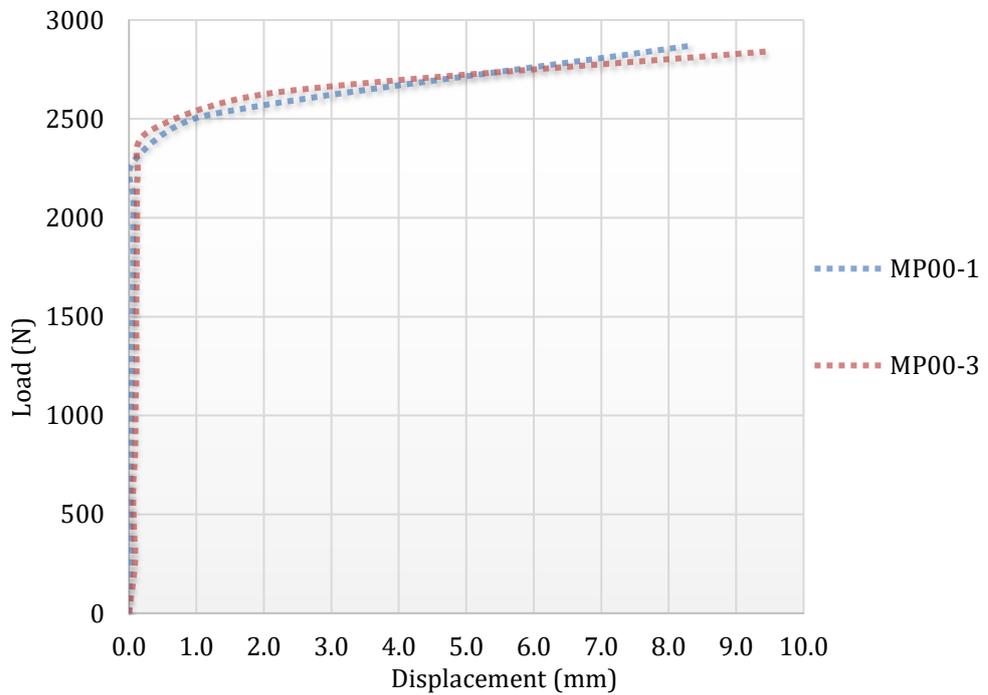
The load-displacement curve for MP00-1 and MP00-3 is shown in figure 4.24, having discarded the result for MP00-2. The inference from the figures 4.24 shows that the specimens remain undamaged for up to 80% and 85% of the average failure load (2857N) for MP00-1 and MP00-3 respectively. However, as the loading increment continues, the specimen peak load and corresponding net out of plane displacement of the damaged specimen at the mid-height were then recorded as (2871N, 8.34mm) and (2843N, 9.62mm) for MP00-1 and MP00-3 respectively. A new specimen to replace MP00-2 was not constructed because the results of MP00-1 and MP00-3 compared fairly well.

Figure 4.24. Load displacement curve for plain specimens

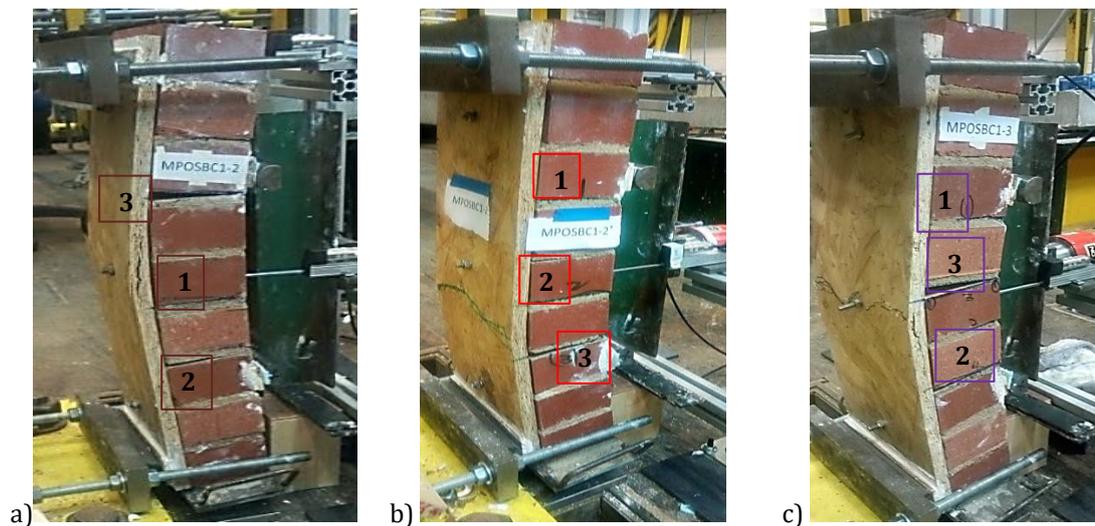
Meanwhile, since the first crack appeared in the specimens, the effect of the application of the timber panel at the back of the MPs caused the formation of other cracks in the specimens. Unlike plain MPs, the retrofitted specimens remained unseparated after the first crack. In order to ensure that the maximum load capacity of the retrofitted specimen is obtained, the loading continued until the timber panel at the back failed (broken). At this failure point, the corresponding load vs net out-of-plane displacement for all specimens including the plain MPs were plotted for comparison in figure 4.27. On the load-displacement curve shown in figure 4.27, the points at which each crack developed were identified with numerals corresponding to the ones labelled on the specimens' image in figure 4.25 and 4.26 testing. The labels are boxed with the same ink colour as shown on the graph in figure 4.27. The average maximum load and corresponding displacement at failure are (21068N, 18.74mm) and (14407N, 15.24mm) for MPOSBC1 and MPOSBC2 respectively. Notably in figure 4.27 is the strange behaviour of MPOSBC2-3 at around 4000N applied load. This behaviour is because of the manual application of load in which the increment in the applied load at this point is high which cause the sudden jump in the displacement. However, to avoid this kind of variation, an automatic loading program was written for the larger-scale test described in section 4.3.

Figure 4.25. Failure pattern of (a) MPOSBC1-2 (b) MPOSBC1-2* (c) MPOSBC1-3

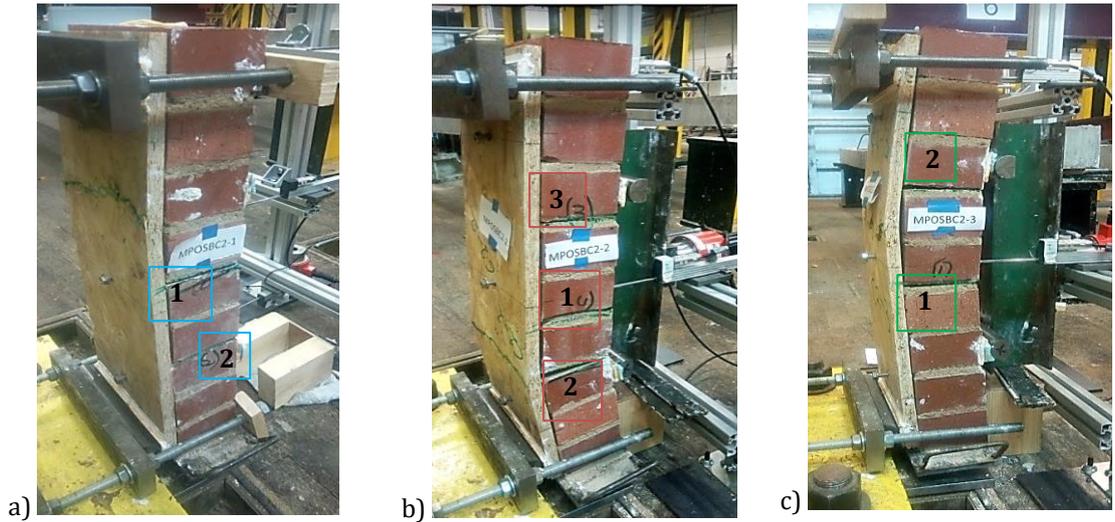
Figure 4.26. Failure pattern of (a) MPOSBC2-1 (b) MPOSBC2-2 (c) MPOSBC2-3

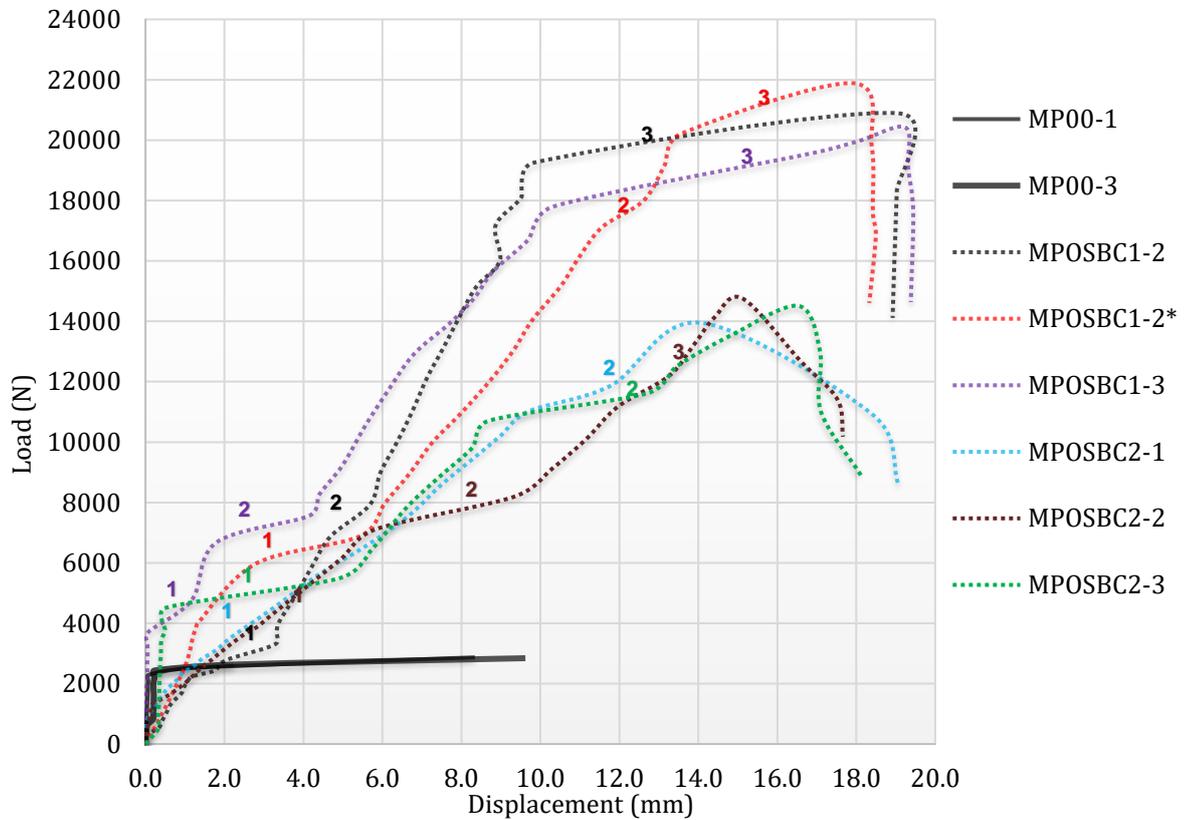
Figure 4.27. Load displacement curve for plain and retrofitted specimens

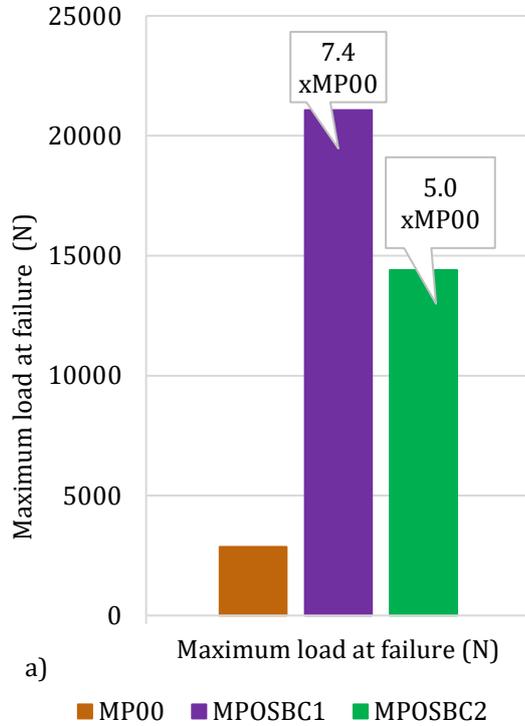
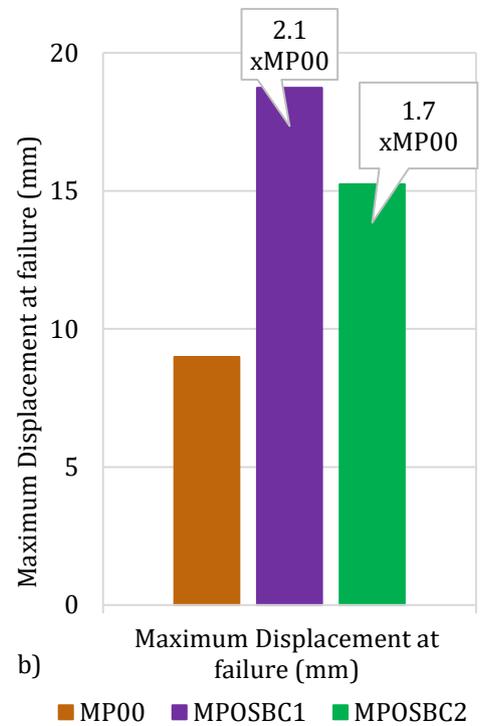
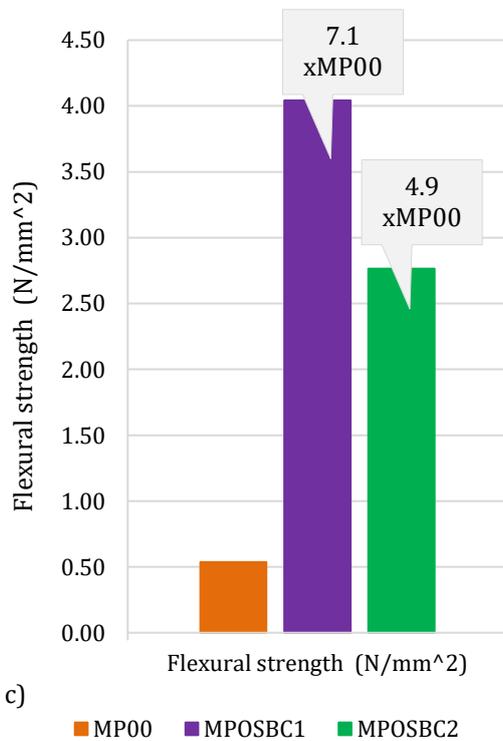
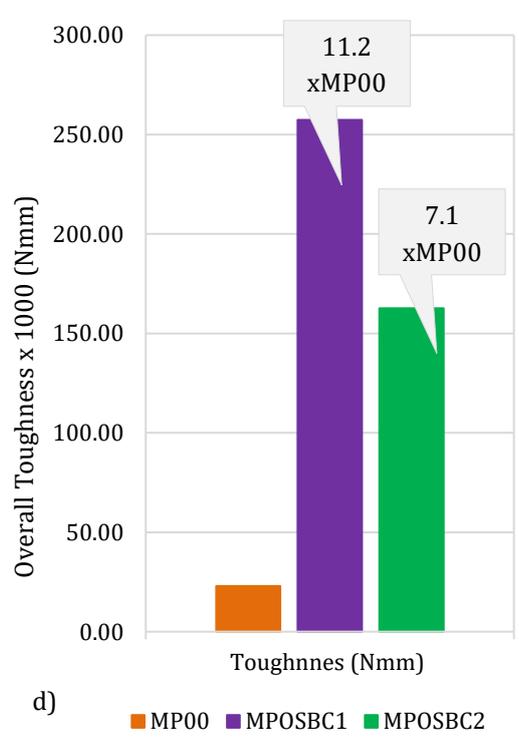
retrofitted with C1 and C2 respectively. Similarly, the increment in the flexural strength (Fig. 4.28c) is also significant when MP is retrofitted with OSB panel. C1 offered the most increment in the load capacity and flexural strength.

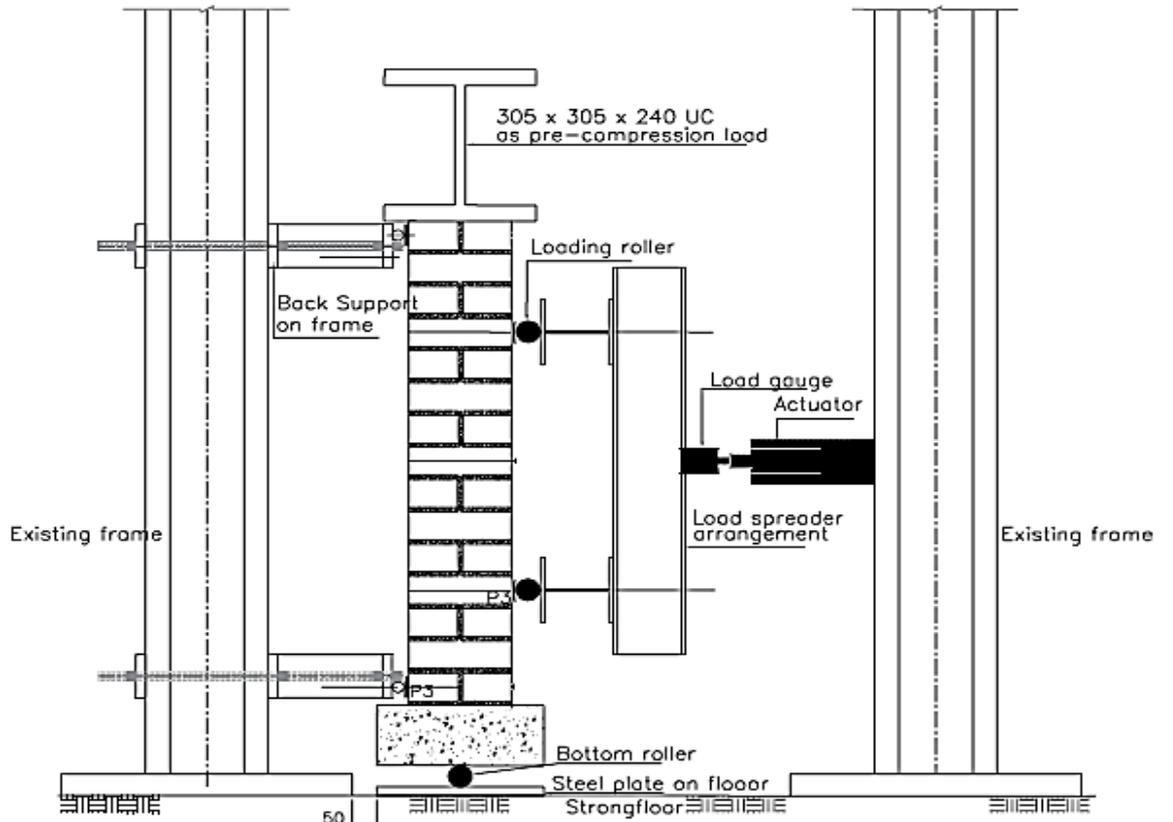
Meanwhile, all the test arrangements were carried out while the specimen constructed on the RC footing still rested on the four 60mm square pipes placed at each corner of the RC footing. These square pipes ensured that the wall was stable during preparation and also allowed the placement of 50mm diameter roller under the specimen before the start of the load application. Once the setups were completed, the 50mm diameter roller was slide under the specimen, and the four 60mm square pipes were removed. This allowed the wall specimen to rest on the 50mm diameter cylindrical roller (Fig 4.34d), with the axis of the roller parallel to the specimen's face to allow it to freely rotate around its base while deflecting out-of-plane and prevent restrained end condition.

Figure 4.33. Larger-scale test arrangement (drawing scheme)

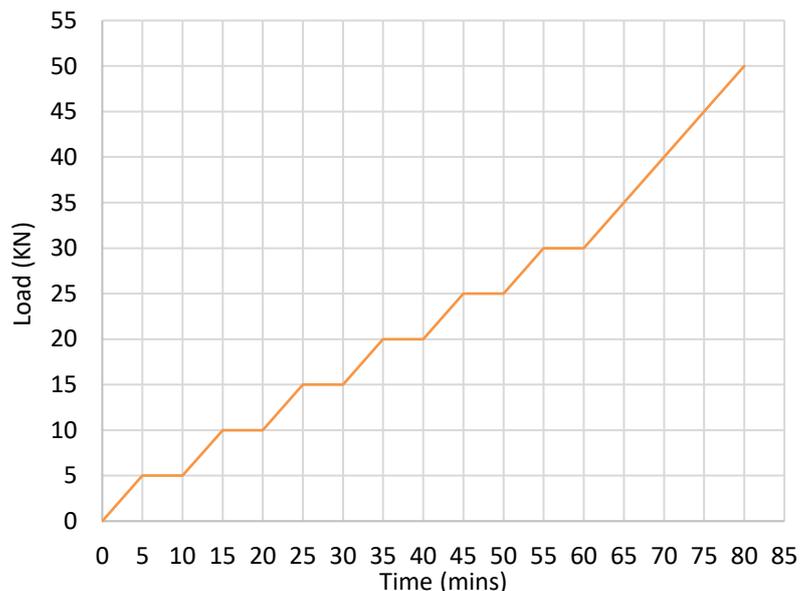
Figure 4.35. Applied out-of-plane load history.
