**Numerical and Experimental Investigation of Unreinforced
Masonry Wall Retrofitted with Timber Panels**

Submitted in accordance with the requirements for the degree of
Doctor of Philosophy

The University of Leeds
School of Civil Engineering

January 2020

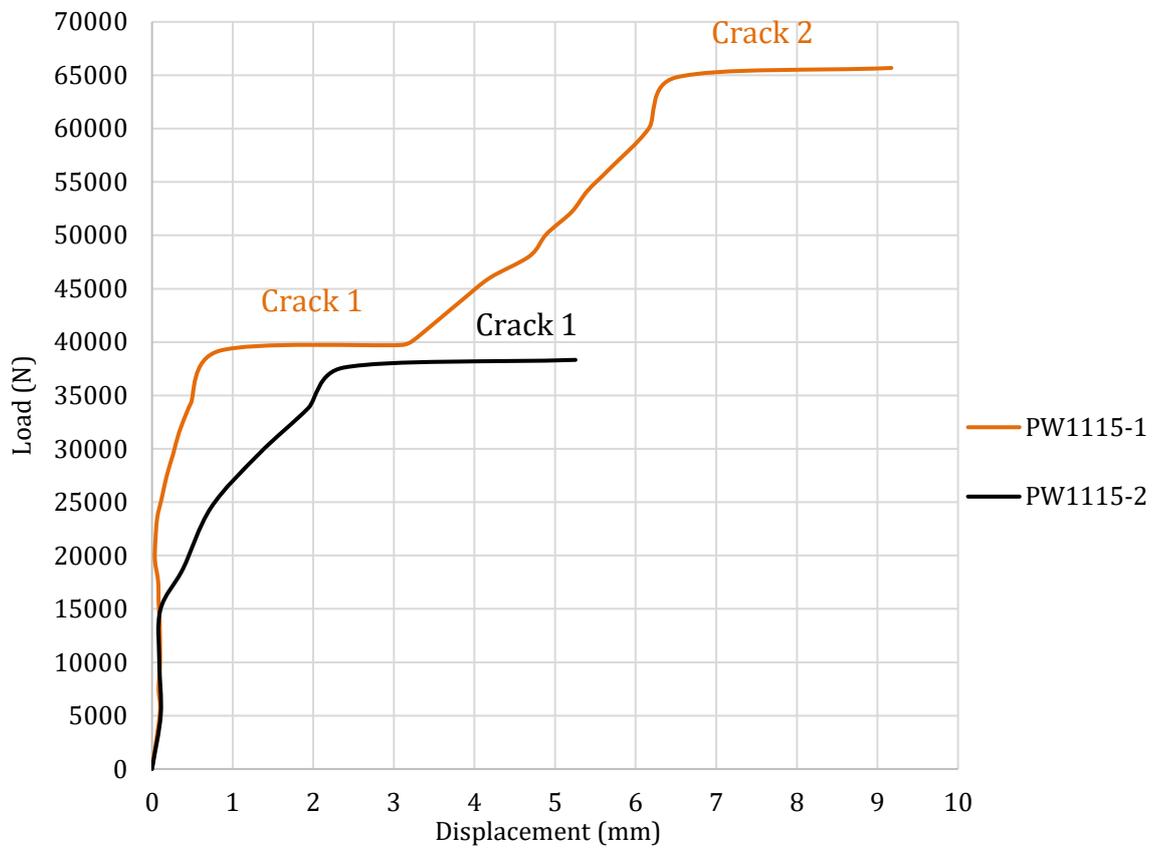
Figure 4.37. Load vs Displacement curve for plain specimens

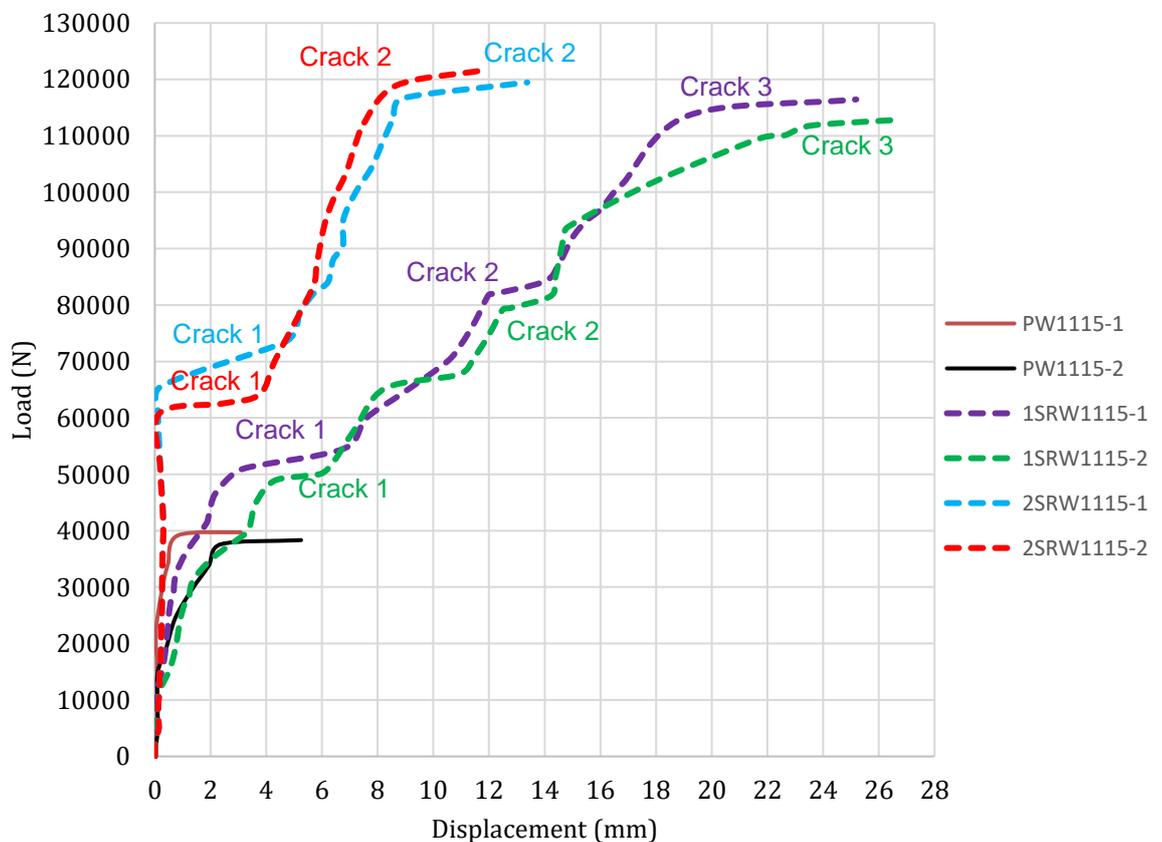
Figure 4.40. Load vs Displacement curve for specimens

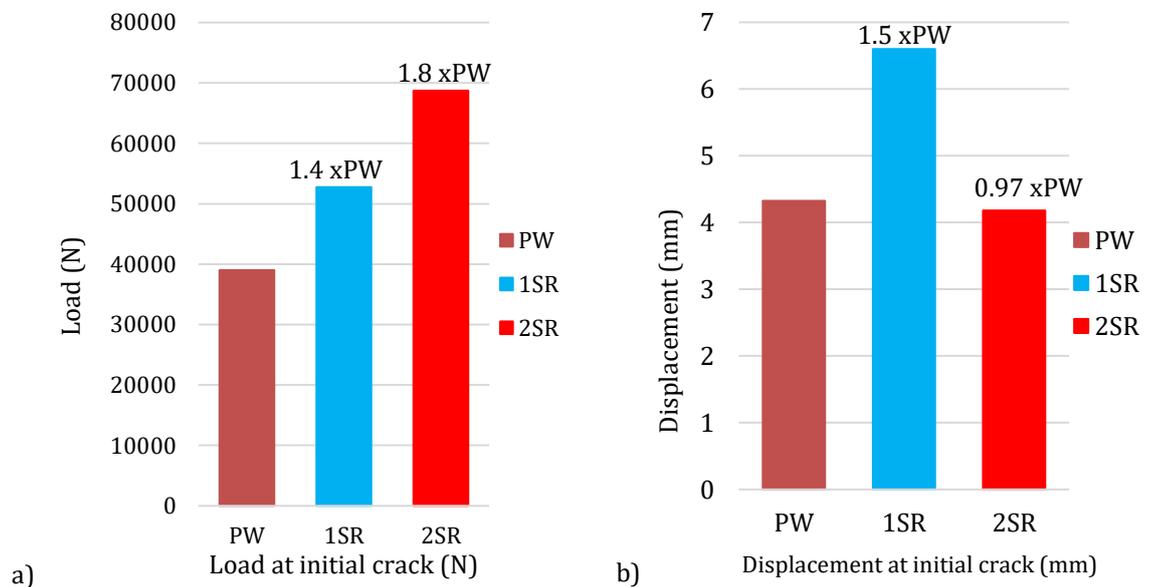
Figure 4.42. Performance at the occurrence of the first crack; (a) Load capacity (b) Displacement

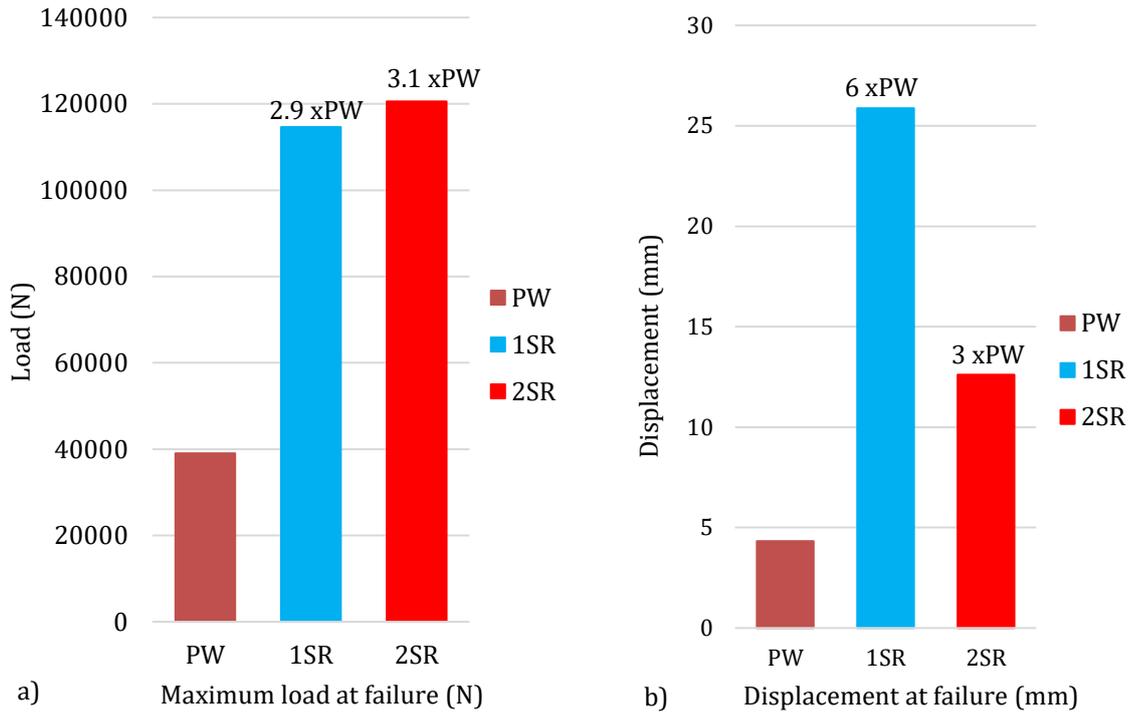
Figure 4.43. Performance at the failure; (a) Load capacity (b) Displacement

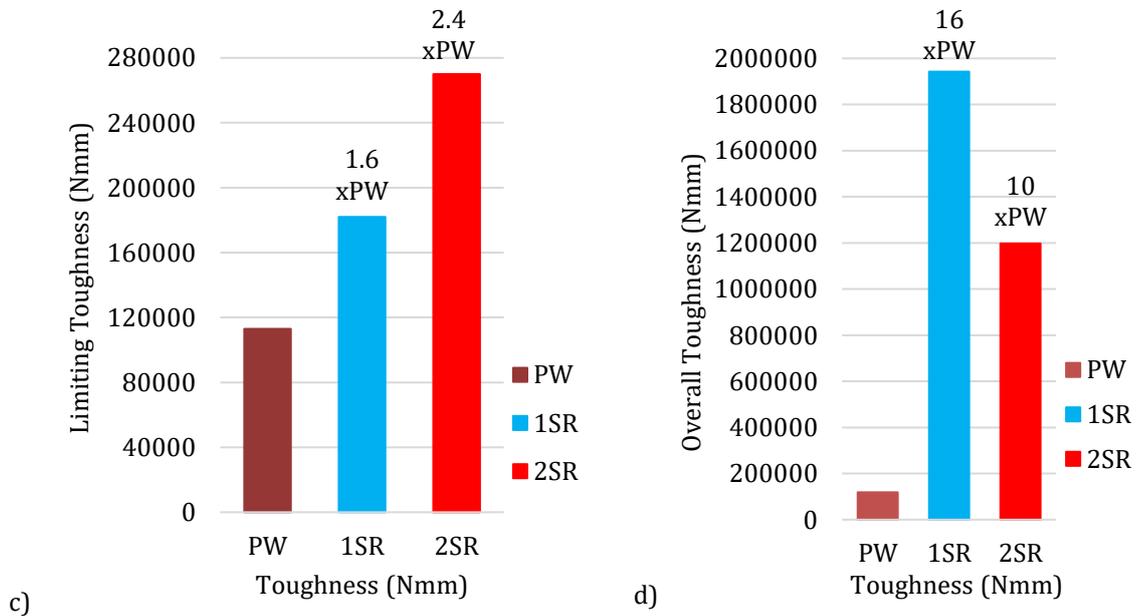
Figure 4.43. Performance at the failure; (c) Limiting Toughness (d) Overall Toughness

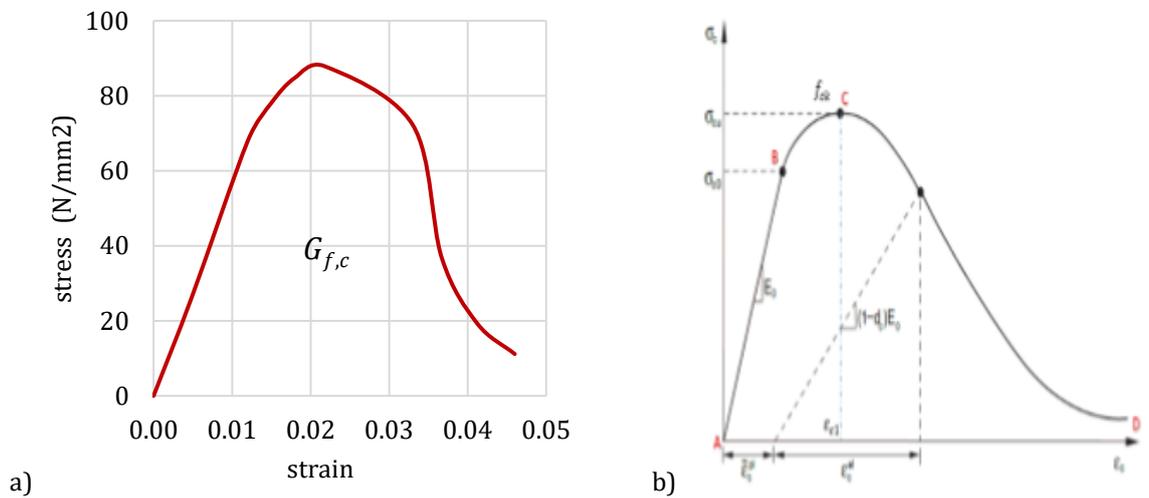
Figure 5.3: Masonry unit behaviour under uniaxial compression (a) numerical model (b) typical response in ABAQUS (Simulia, 2014).

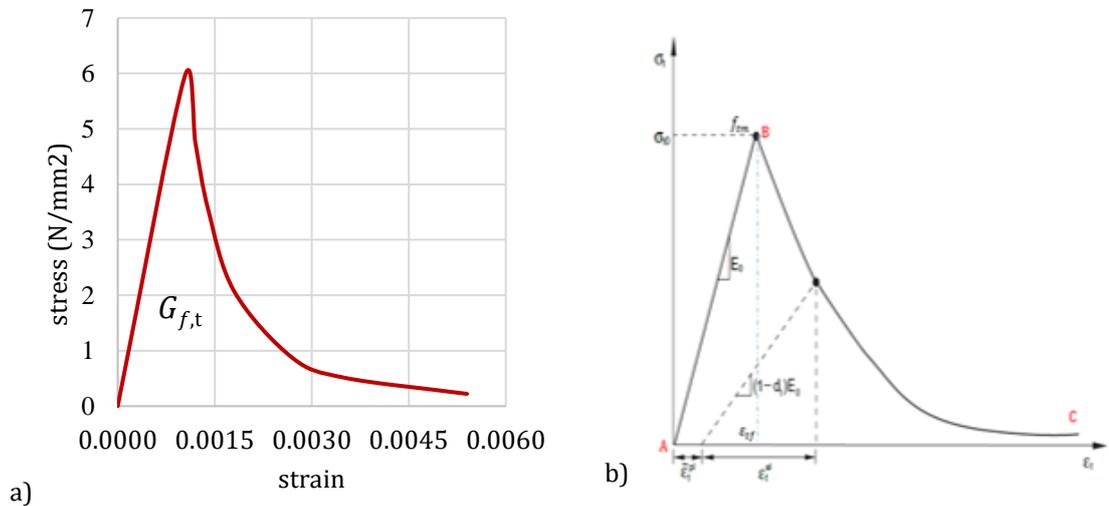
Figure 5.4: Masonry unit behaviour under uniaxial tension (a) numerical model (b) typical response in ABAQUS (Simulia, 2014).

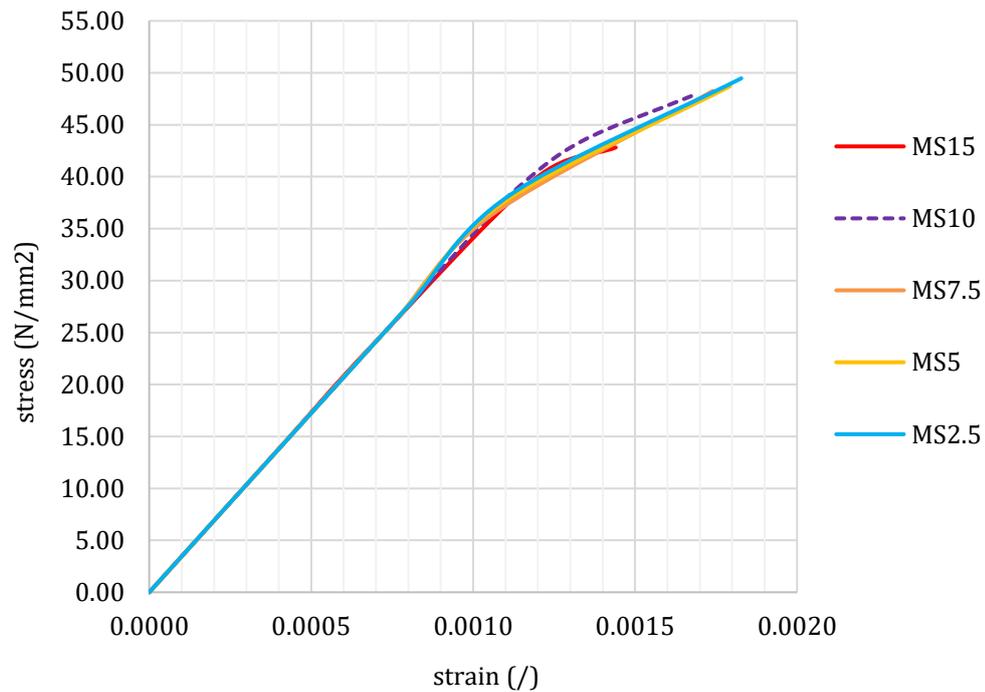
Figure 5.10: Influence of mesh density on the numerical model

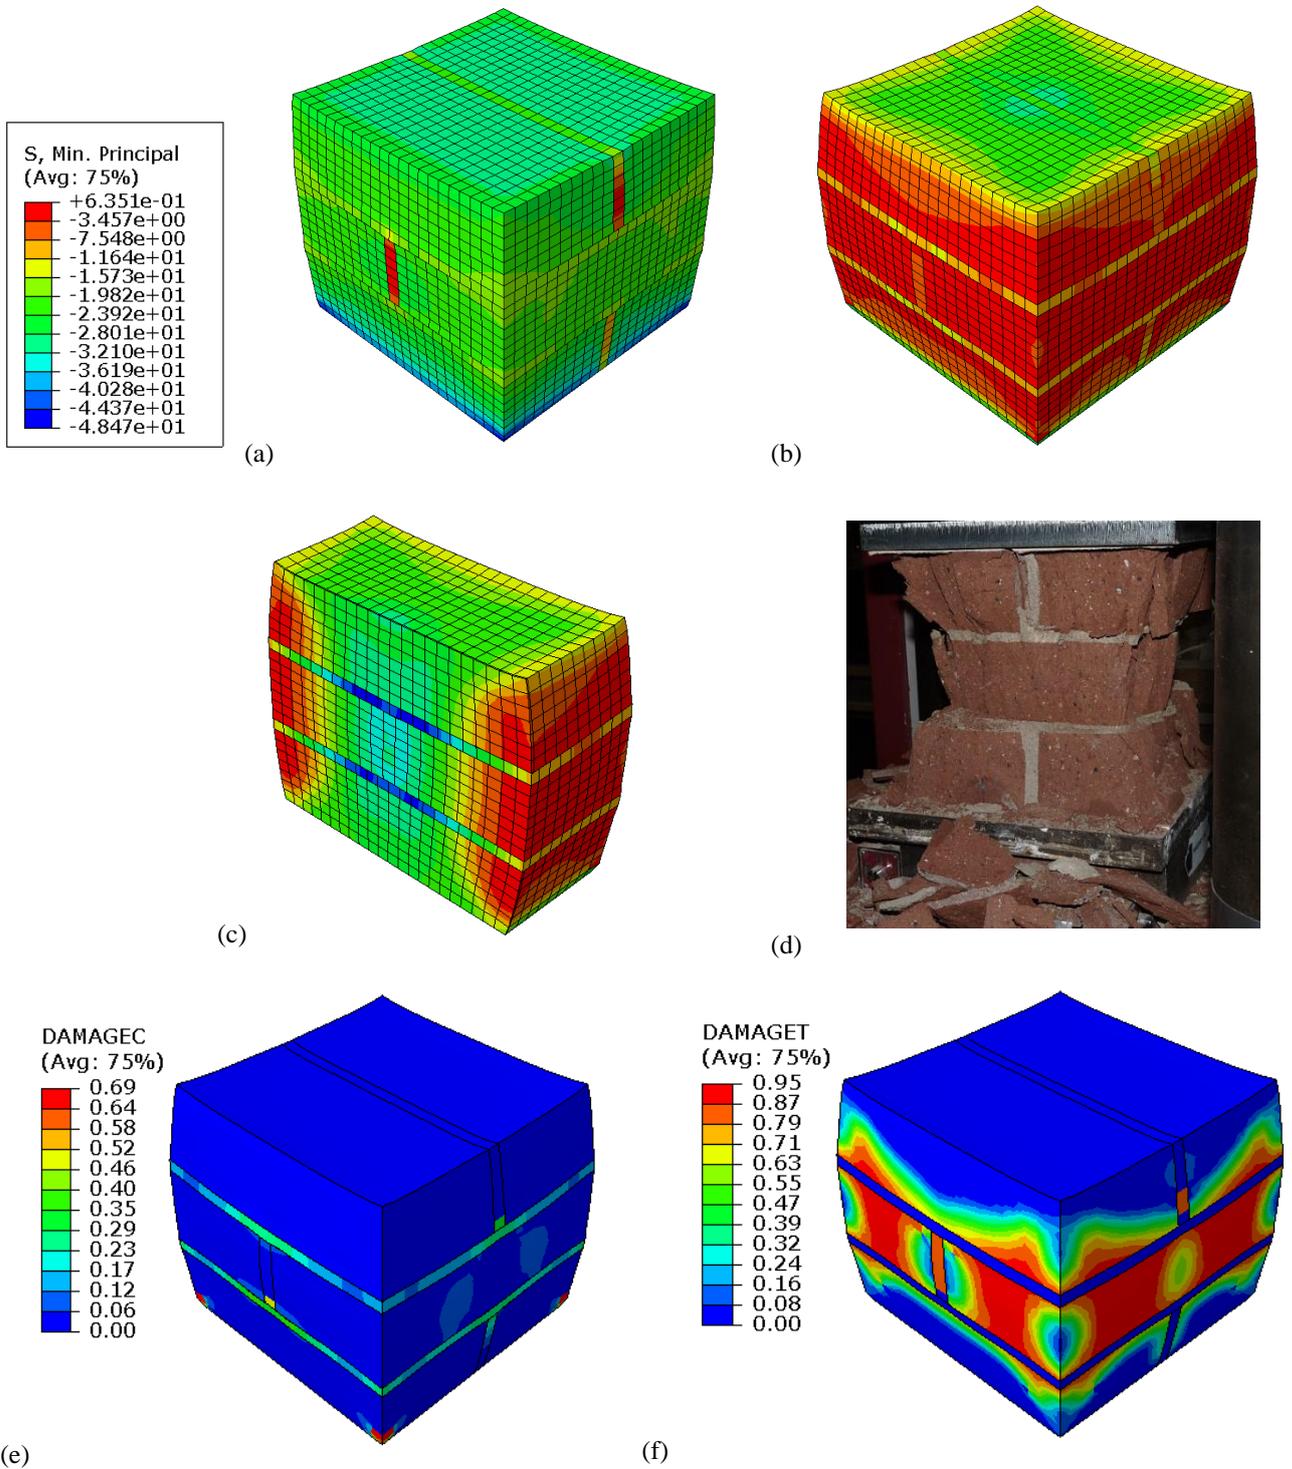
Figure 5.11: (a) minimum principal stress (b) maximum principal stress (c) view cut along y-plane to show stresses distribution in masonry cube (d) typical failure of specimen (e) compressive damage contour plot (f) tensile damage contour plot

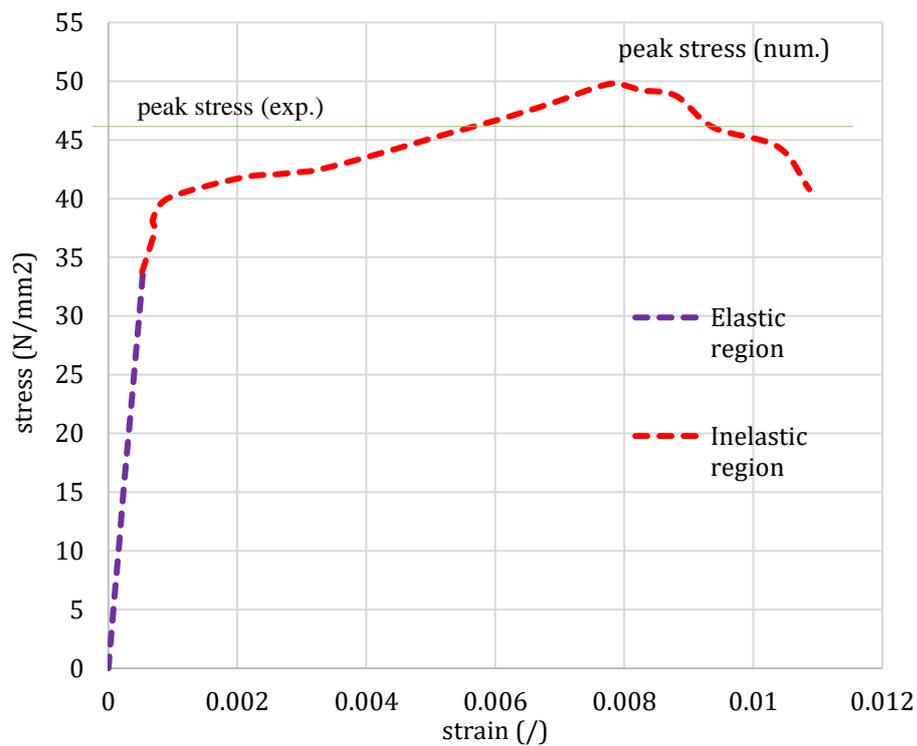
Figure 5.12: Stress-strain curve of masonry cubic model

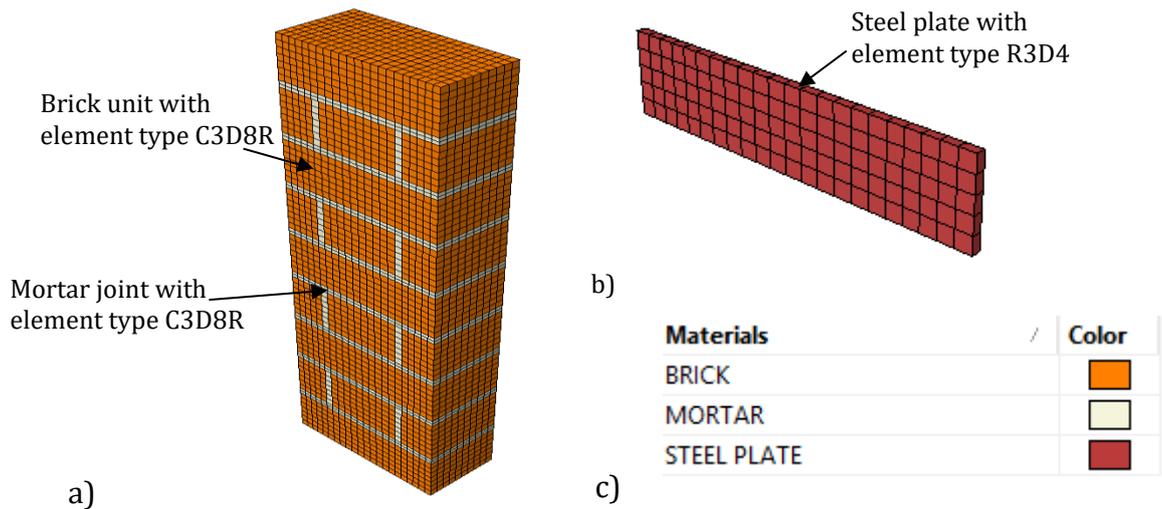
Figure 5.13: a) MP model comprising brick and mortar b) steel plate c) Material legend

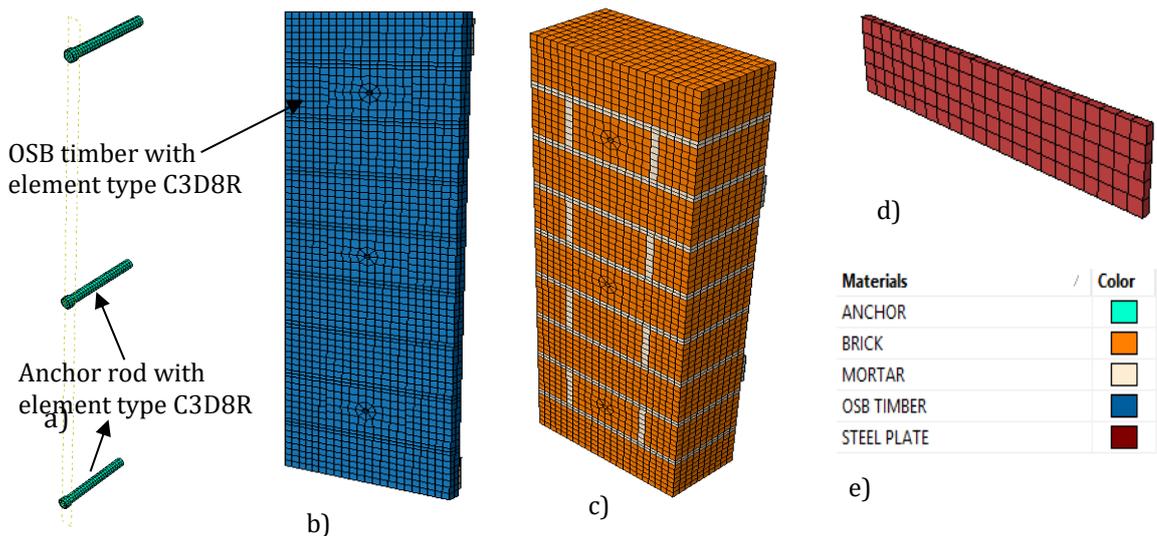
Figure 5.14: a) Anchor rod b) OSB timber c) MP model d) Steel plate e) Material legend

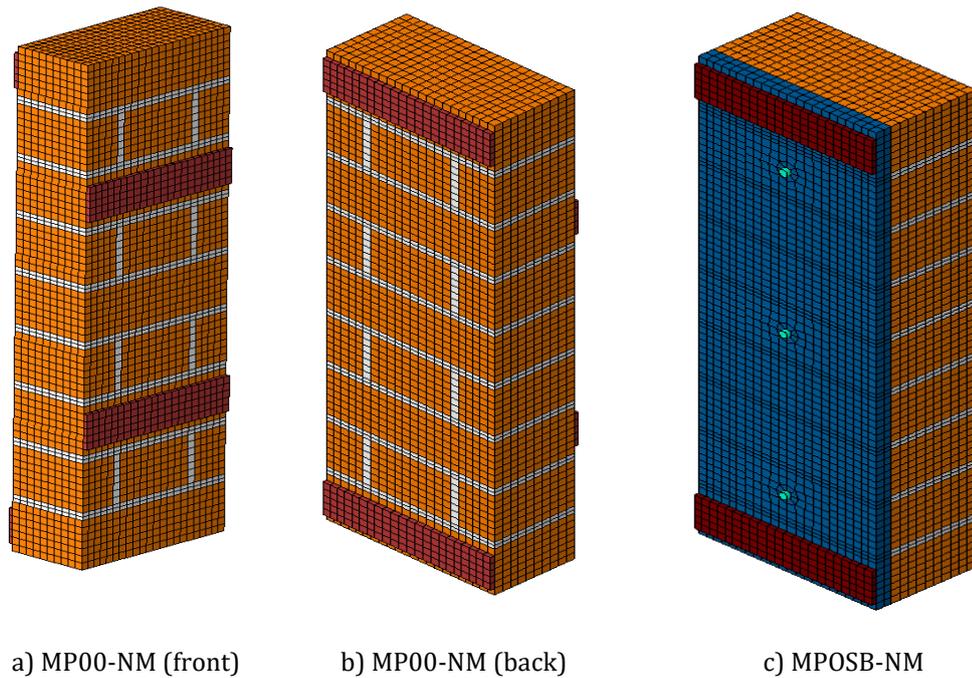
Figure. 5.16. General view of masonry prism model.

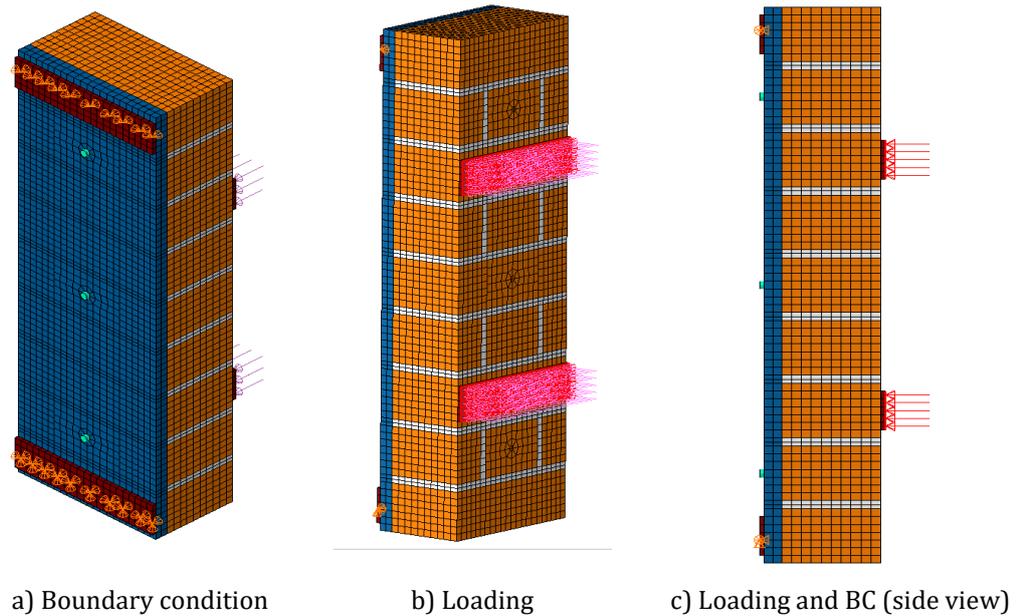
Figure. 5.17. Boundary condition and load application.

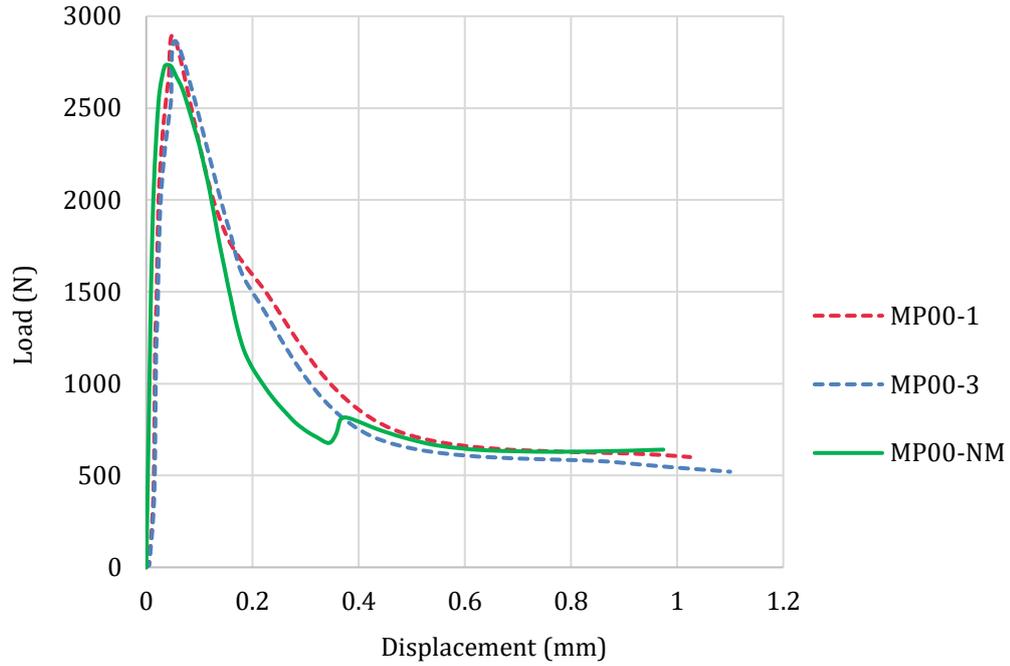
Figure. 5.19. Load displacement curve for plain MP (Experimental vs Numerical)

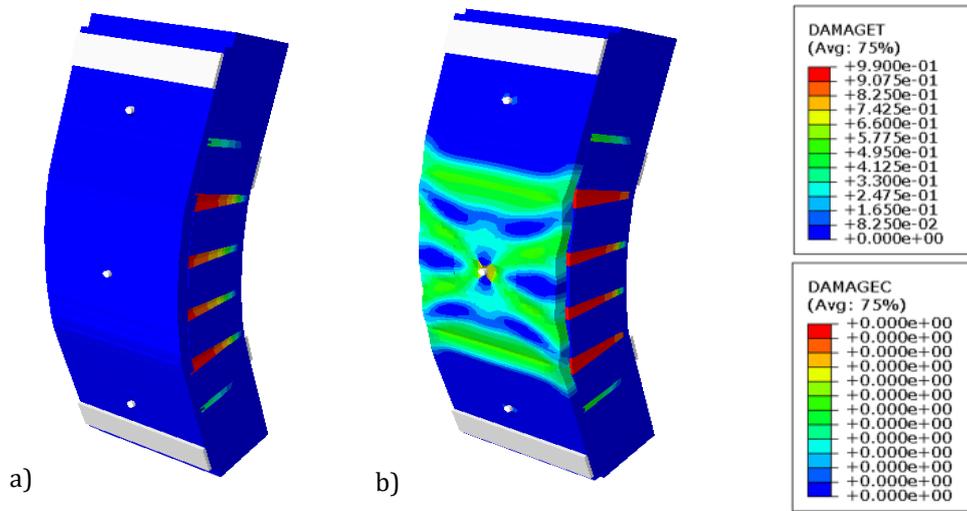
Figure. 5.20.a) Observed failure of MPOSB-NM

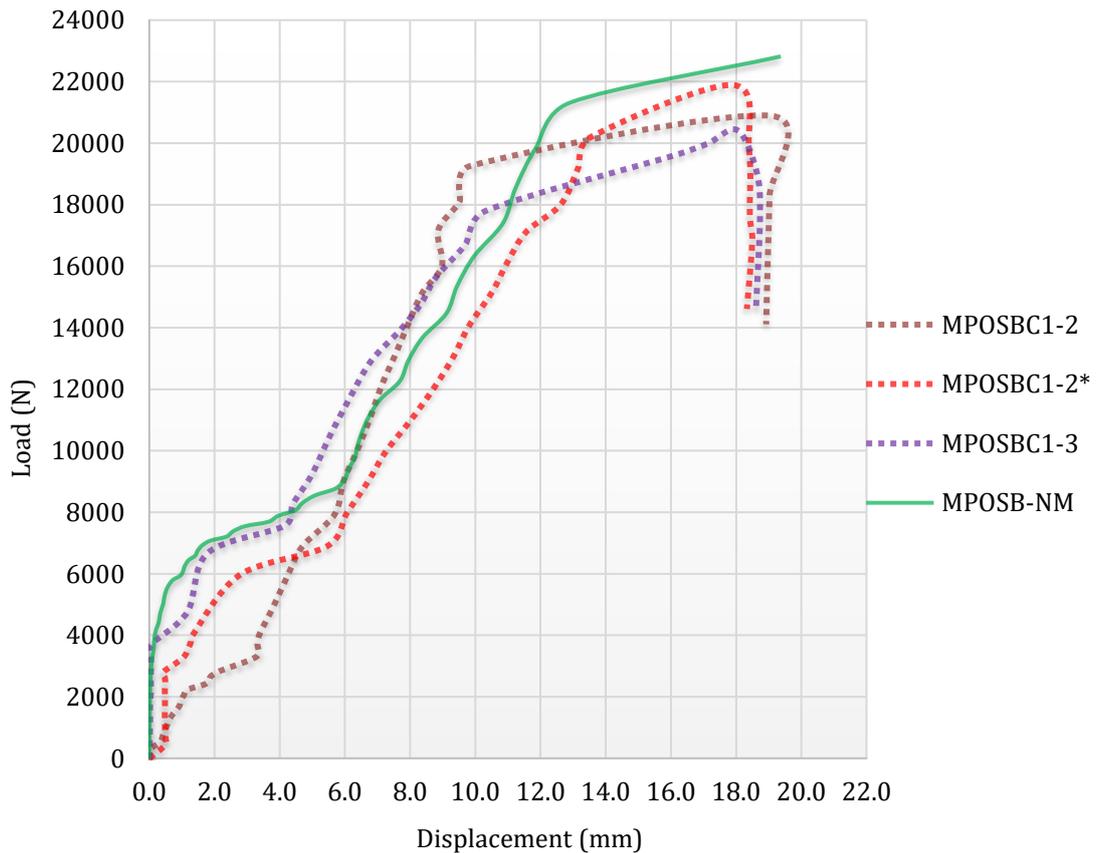
Figure. 5.21. Load displacement curve for retrofitted MP (Experimental vs Numerical)

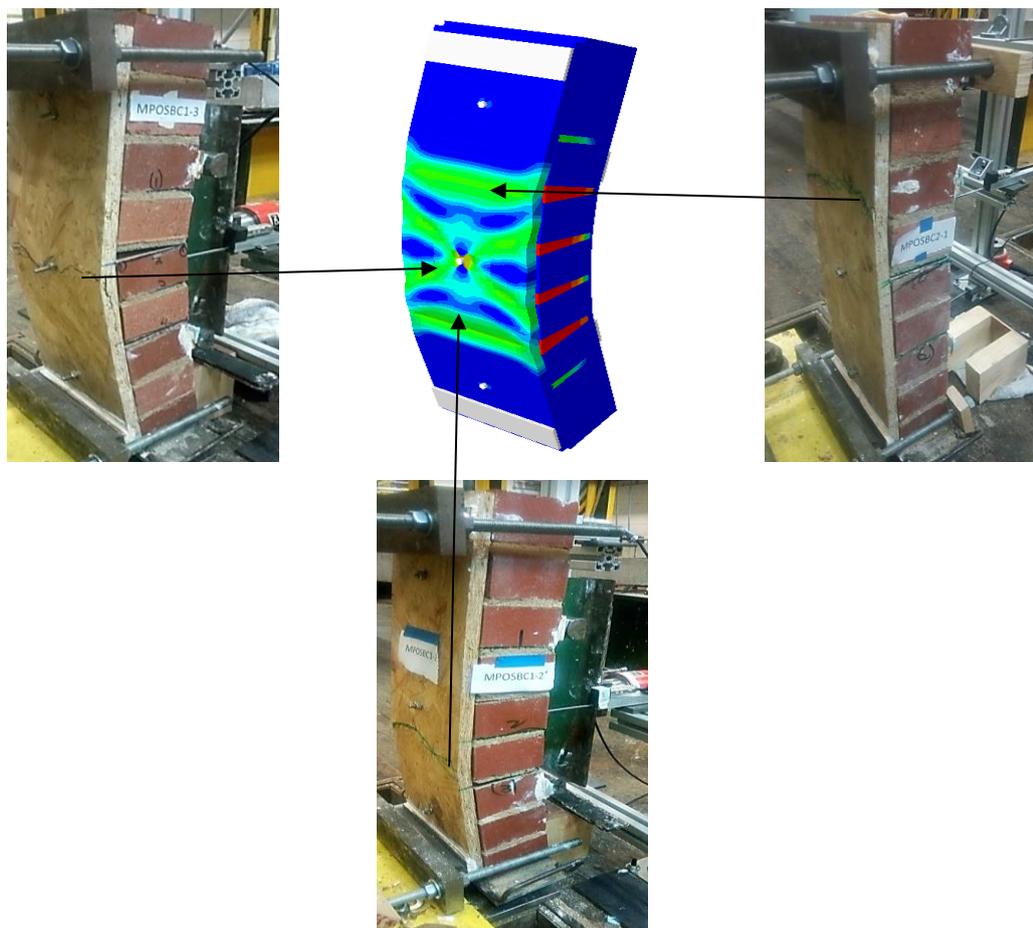
Figure. 5.22 Observed failure of MPOSB-NM vs MPOSB1

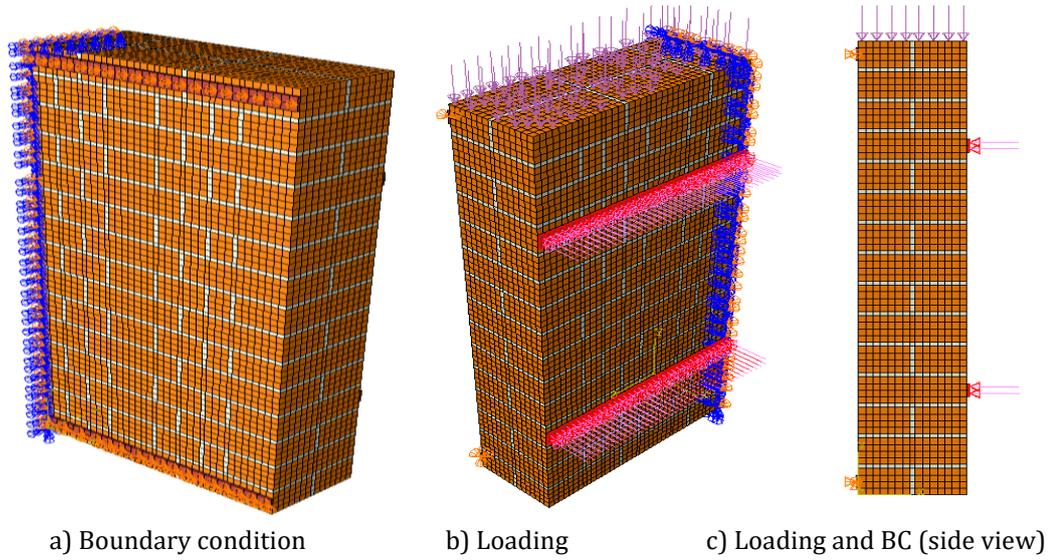
Figure. 5.23. Boundary condition and load application on PW1115-NM

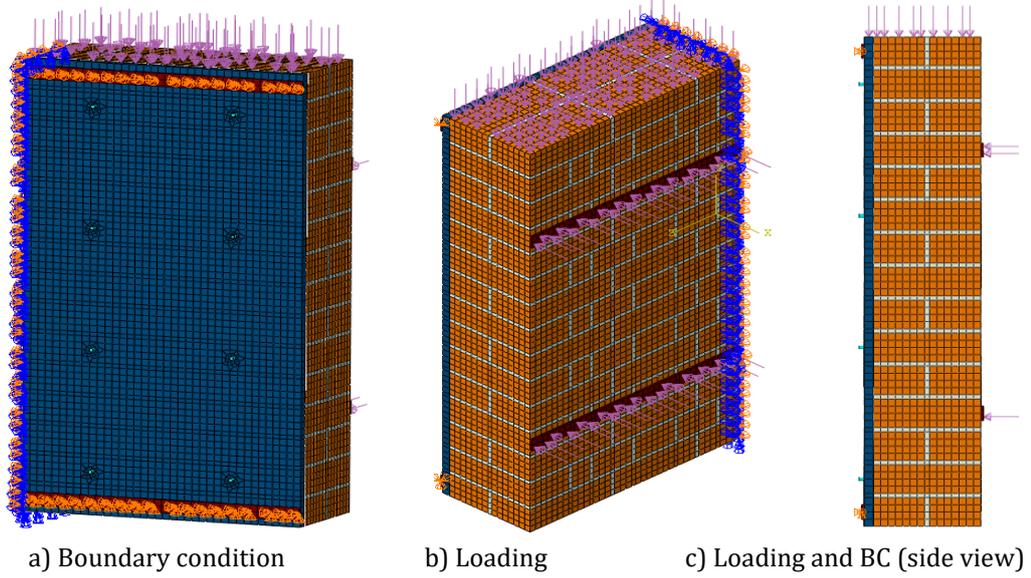
Figure. 5.24. Boundary condition and load application on 1SRW1115-NM

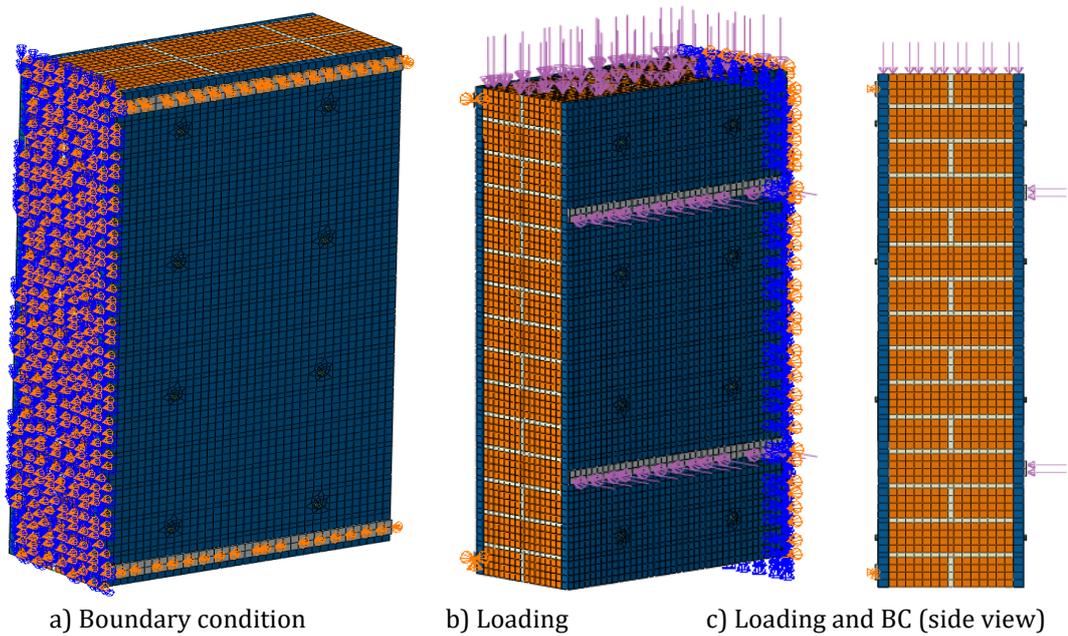
Figure. 5.25. Boundary condition and load application on 2SRW1115-NM

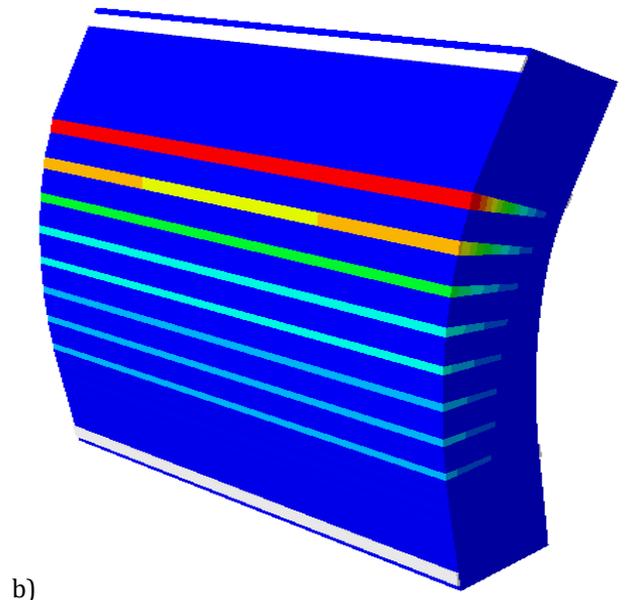
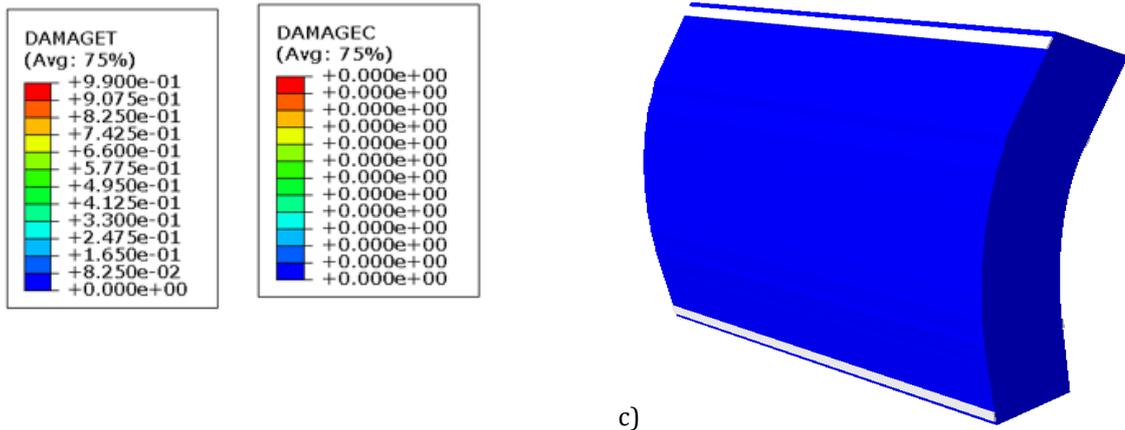
Figure. 5.26.a) Observed failure b) PW1115-NM (DAMAGET) c) PW1115-NM (DAMAGEC)

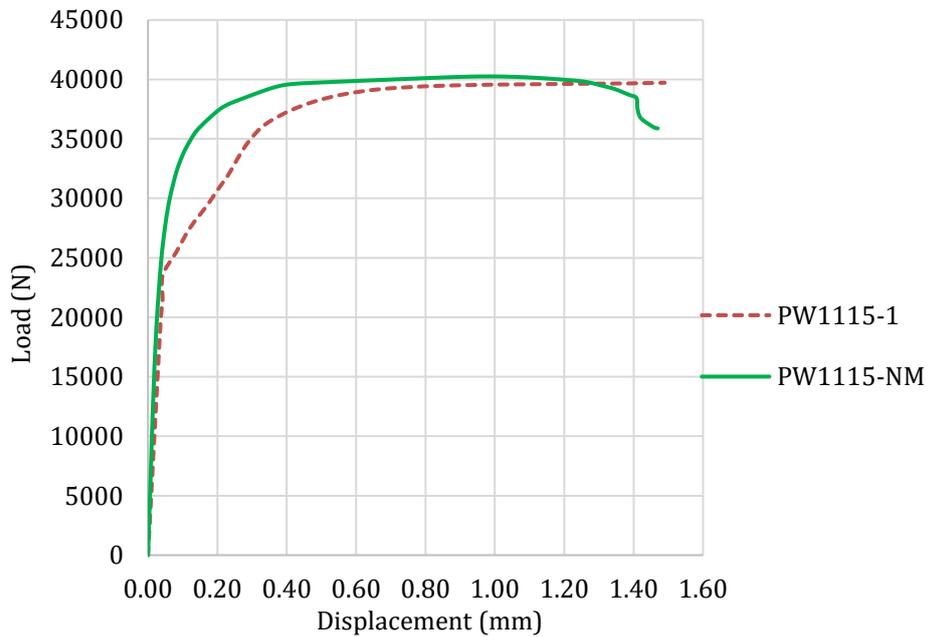
Figure. 5.27. Load displacement curve for Plain Wall (Experimental vs Numerical)

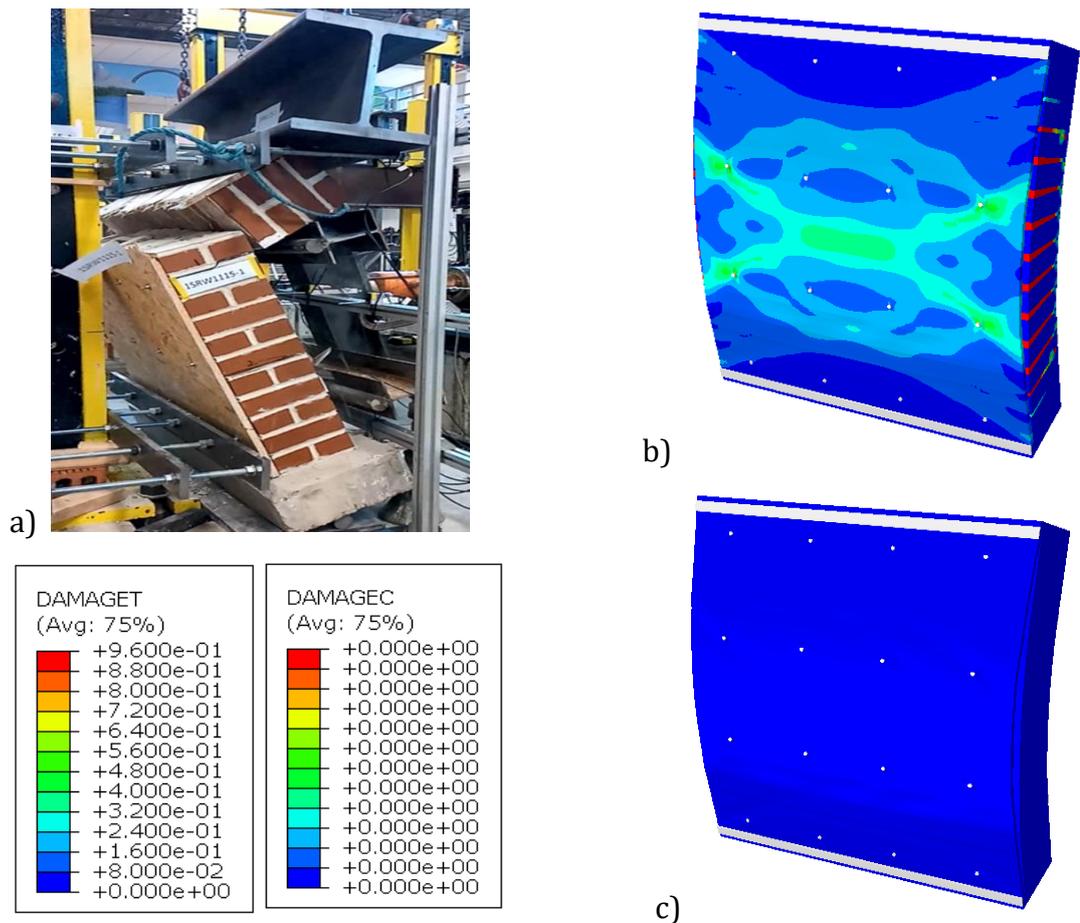
Figure. 5.28.a) Observed failure b) 1SRW1115-NM (DAMAGET) c) 1SRW1115-NM (DAMAGEC)

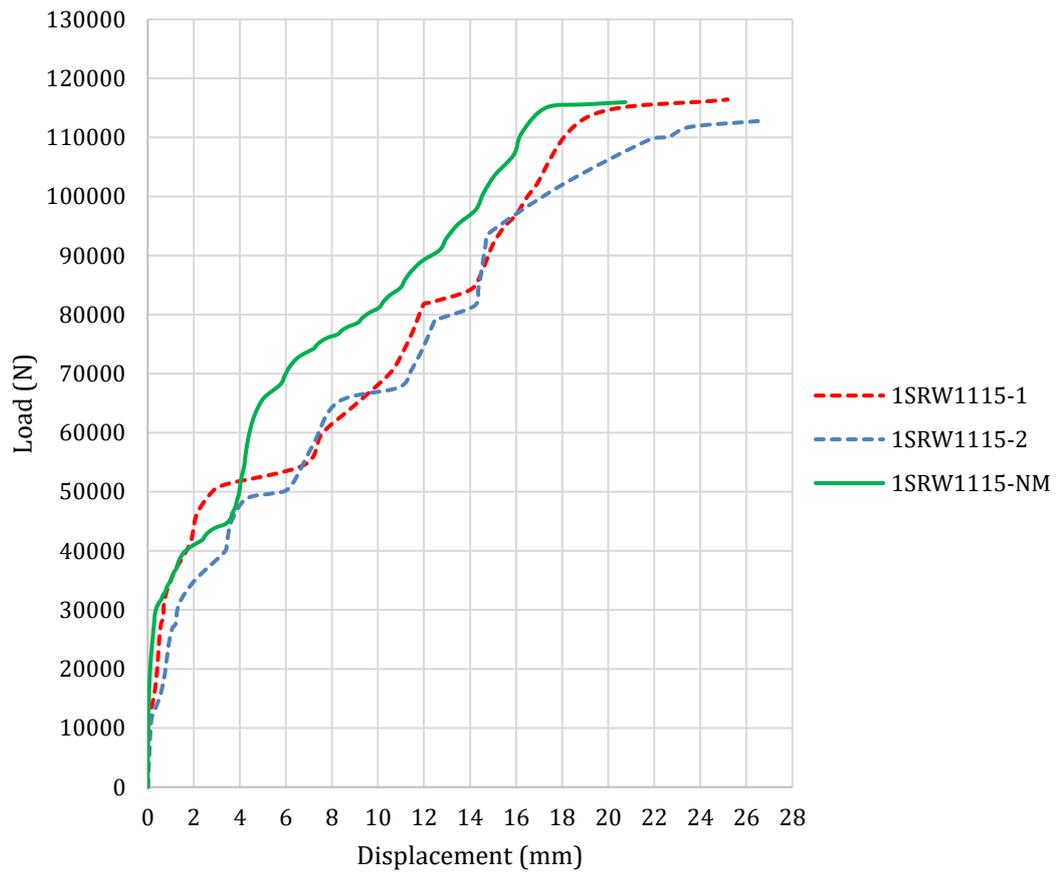
Figure. 5.29. Load displacement curve for 1SRW1115 (Experimental vs Numerical)

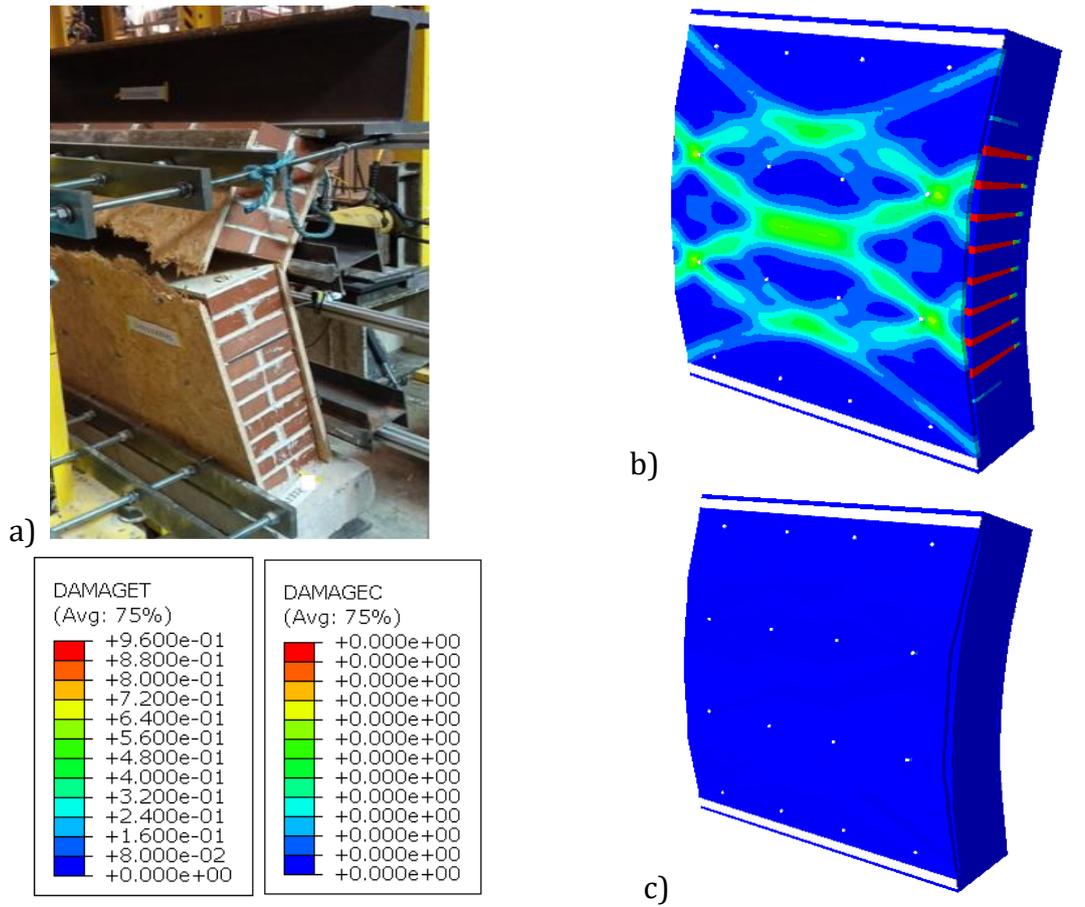
Figure. 5.30. a) Observed failure b) 2SRW1115-NM (DAMAGET) c) 2SRW1115-NM (DAMAGEC)

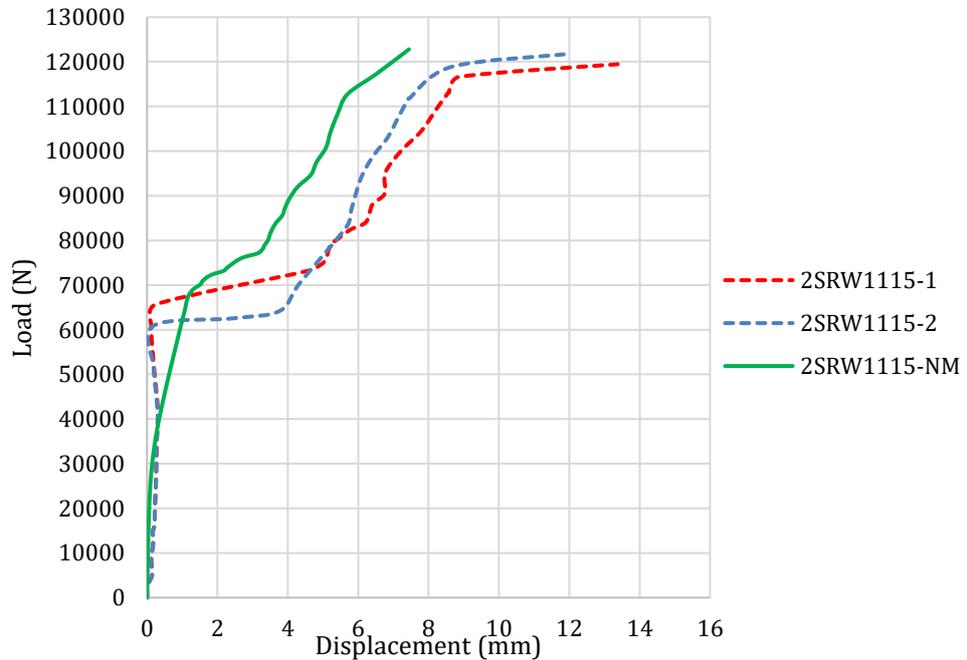
Figure. 5.31. Load displacement curve for 2SRW1115 (Experimental vs Numerical)

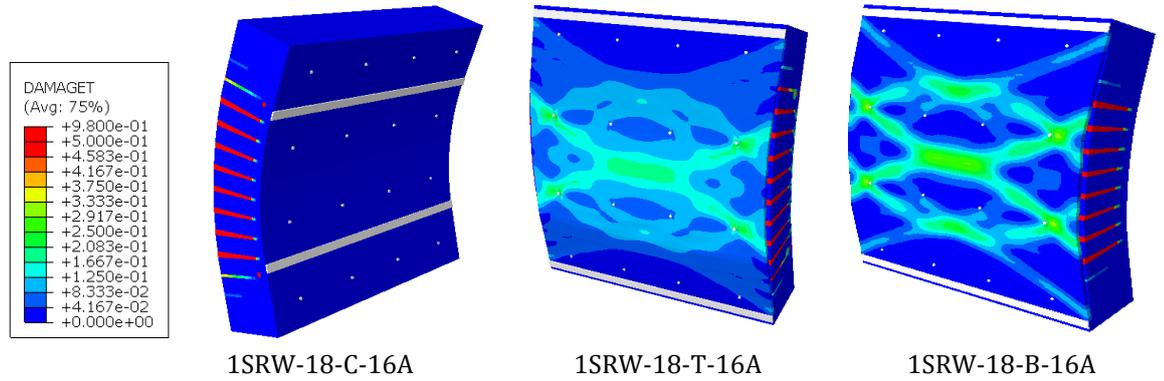
Figure. 5.32. Damage plot for different application of the proposed retrofit technique
