**Numerical and Experimental Investigation of Unreinforced
Masonry Wall Retrofitted with Timber Panels**

Submitted in accordance with the requirements for the degree of
Doctor of Philosophy

The University of Leeds
School of Civil Engineering

January 2020

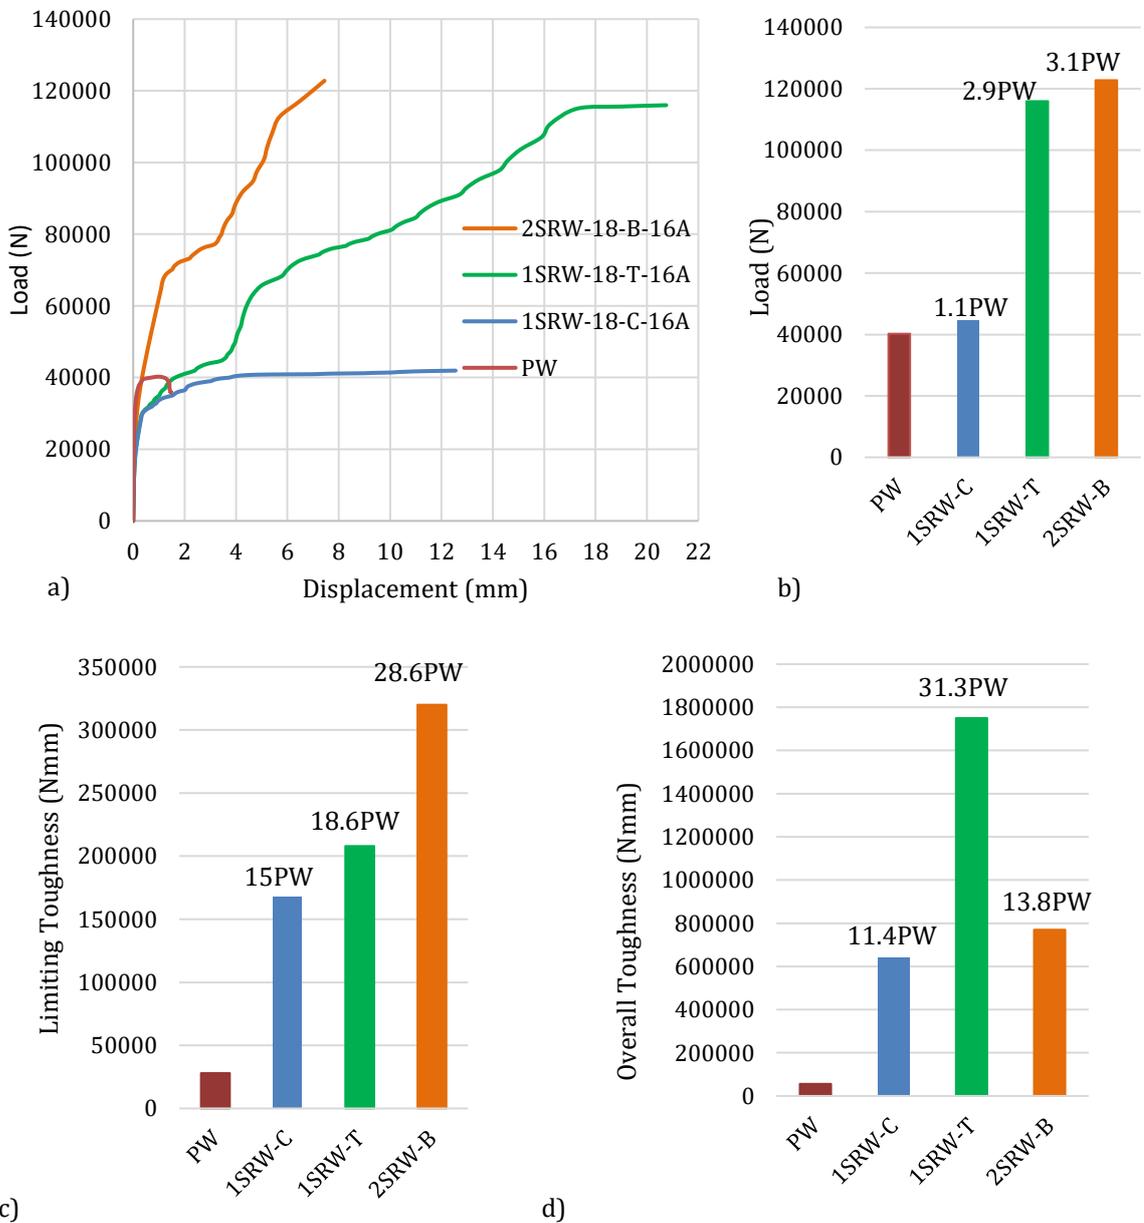
Figure. 5.33. a) Load vs Displacement curve b) Load capacity c) Limiting Toughness and d) Overall Toughness of the different application of the proposed retrofit technique

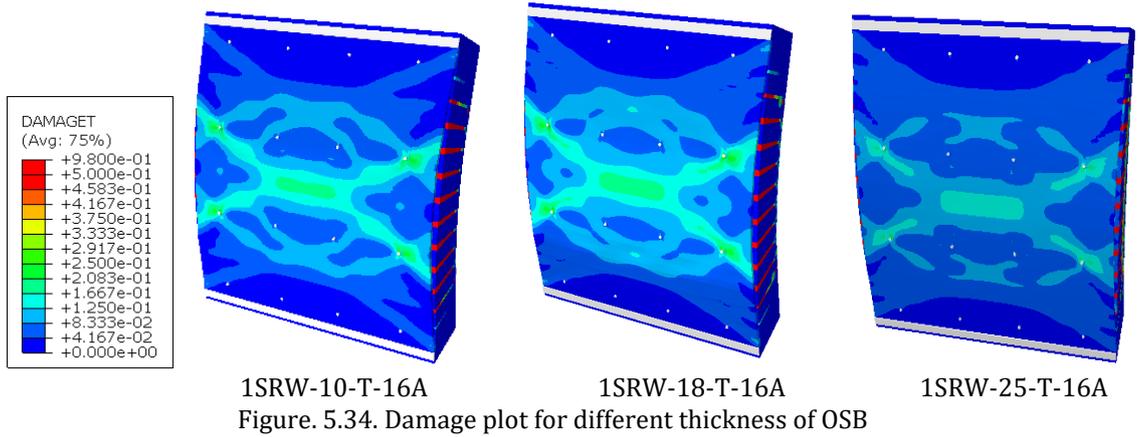
Figure. 5.34. Damage plot for different thickness of OSB

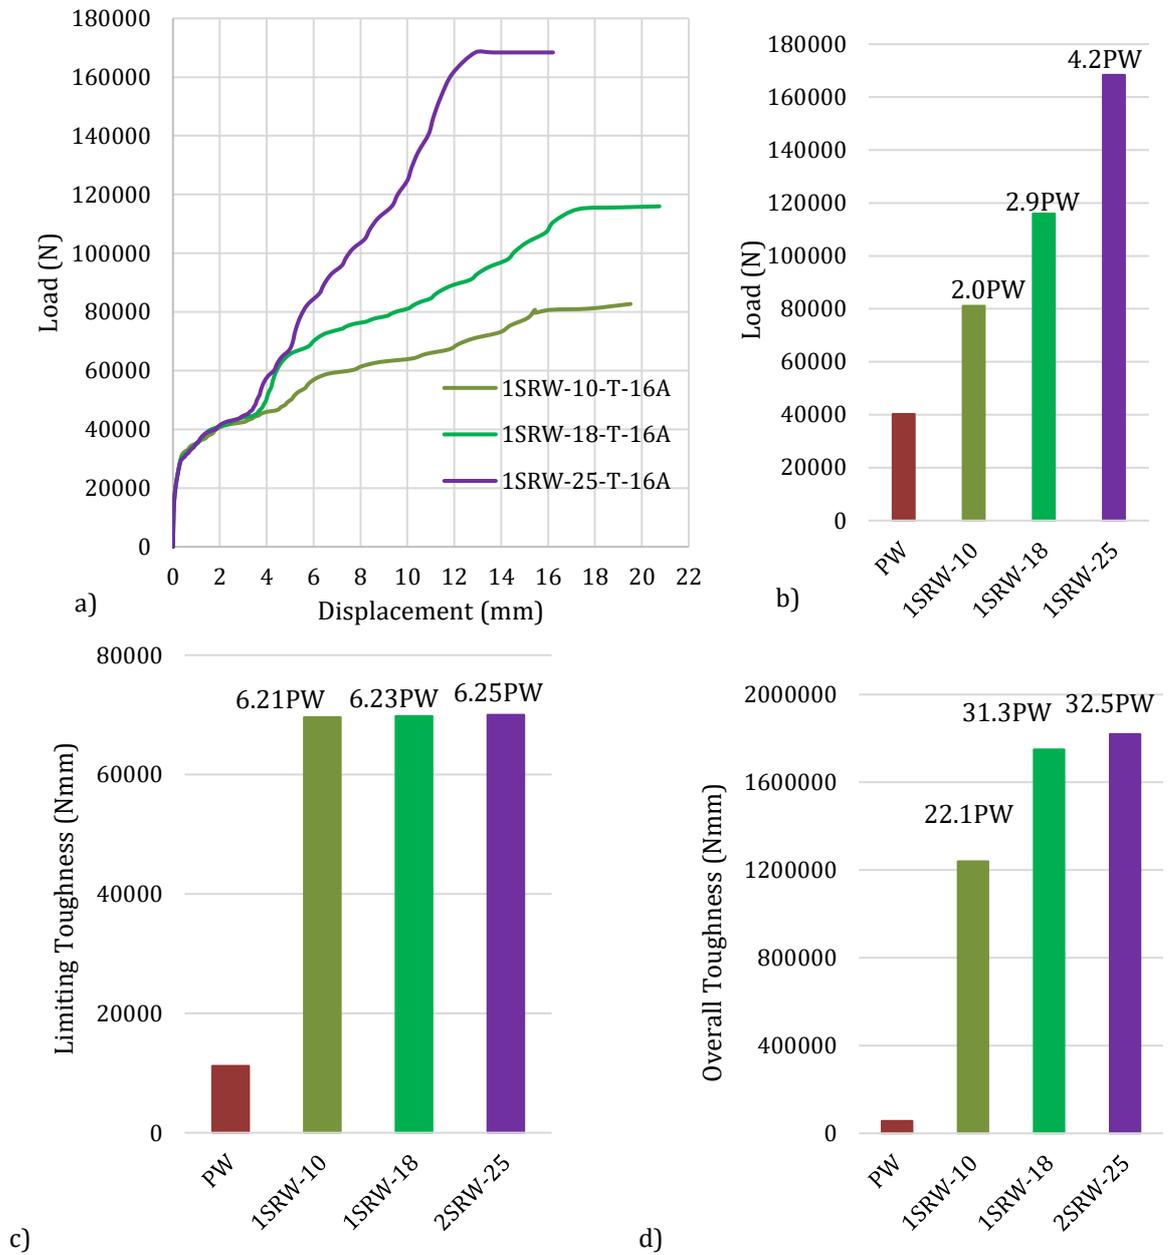
Figure. 5.35. a) Load vs Displacement b) Load capacity c) Limiting Toughness d) Overall Toughness of OSB thickness

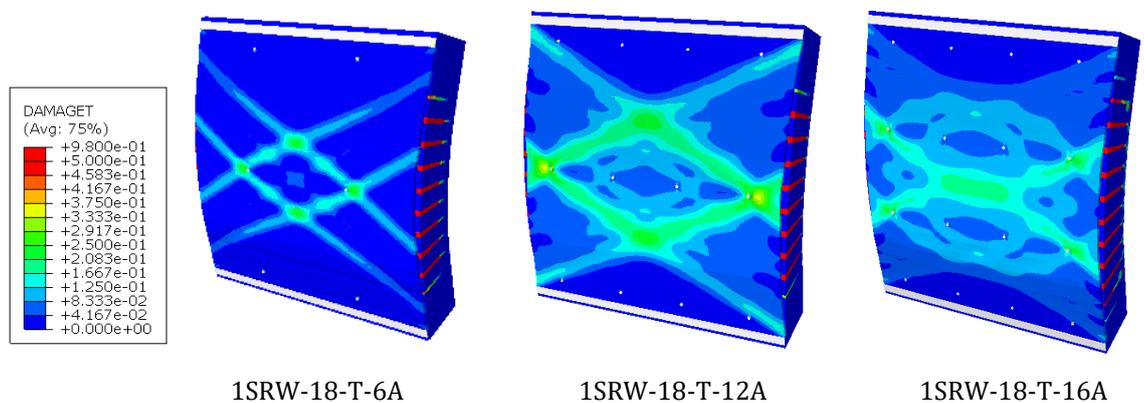
Figure. 5.36. Damage plot for different number of anchor connections

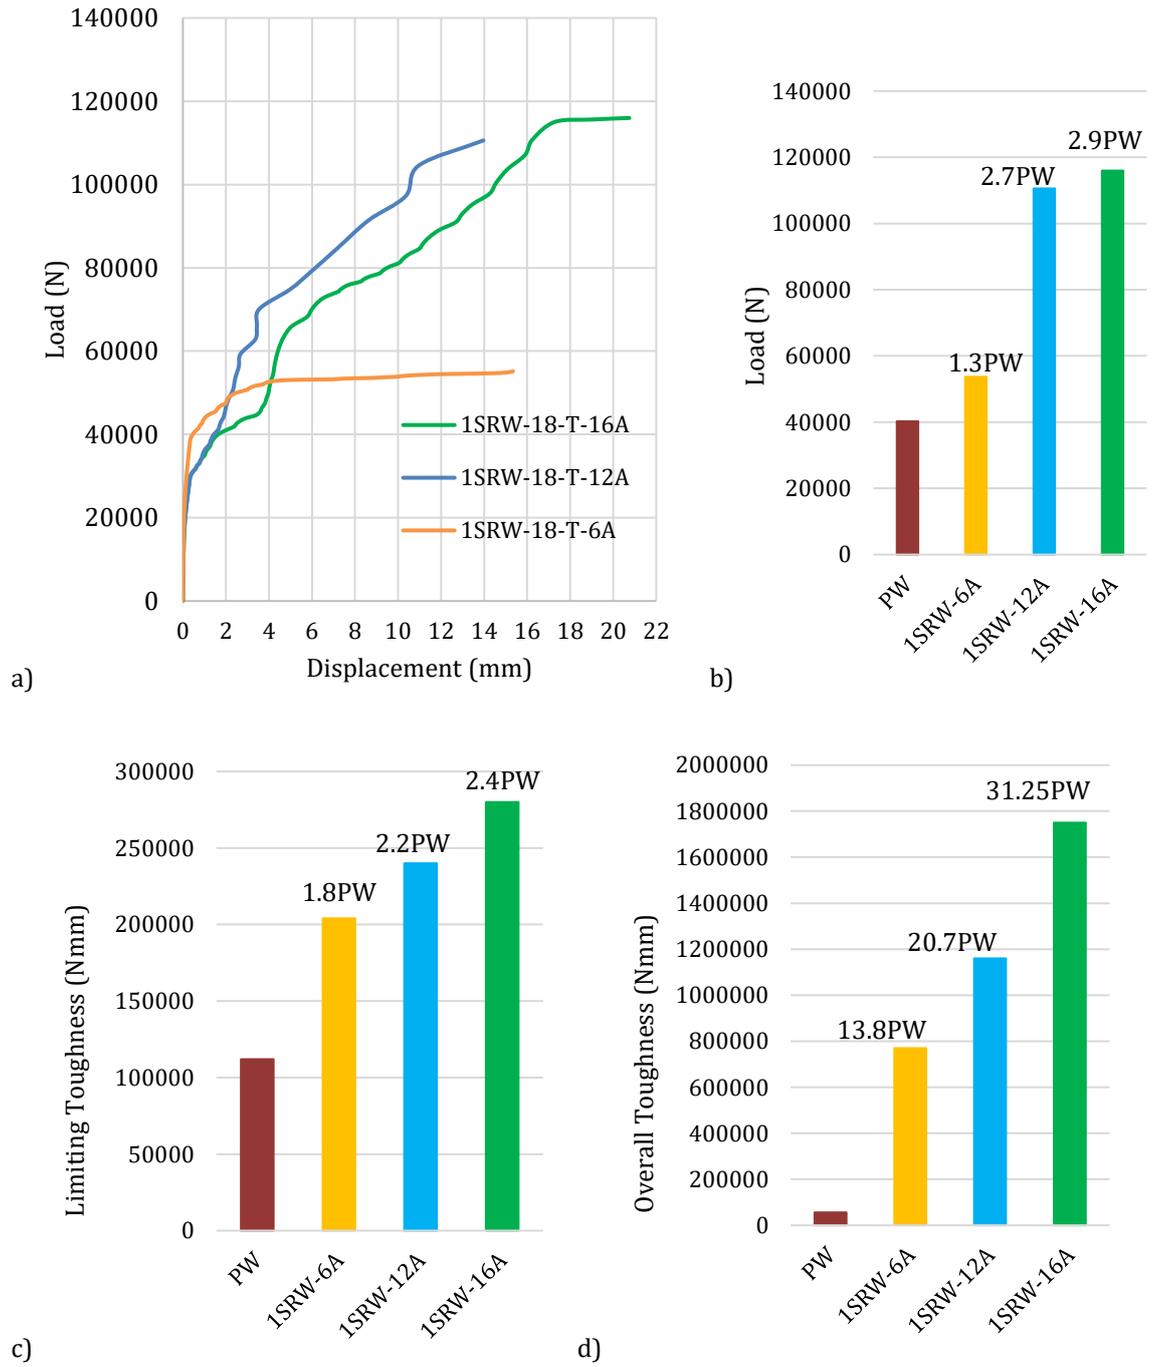
Figure. 5.37. a) Load vs Displacement curve b) Load capacity c) Limiting toughness d) Overall toughness of different number of anchors
