**An Investigation of Molybdenum Disulphide Dry Film Lubricant Coatings  
used in Aero-Engine Fan Disc Applications**

A thesis submitted in partial fulfilment of the requirements for the degree of  
Doctor of Philosophy

The University of Sheffield  
Faculty of Engineering  
Department of Mechanical Engineering

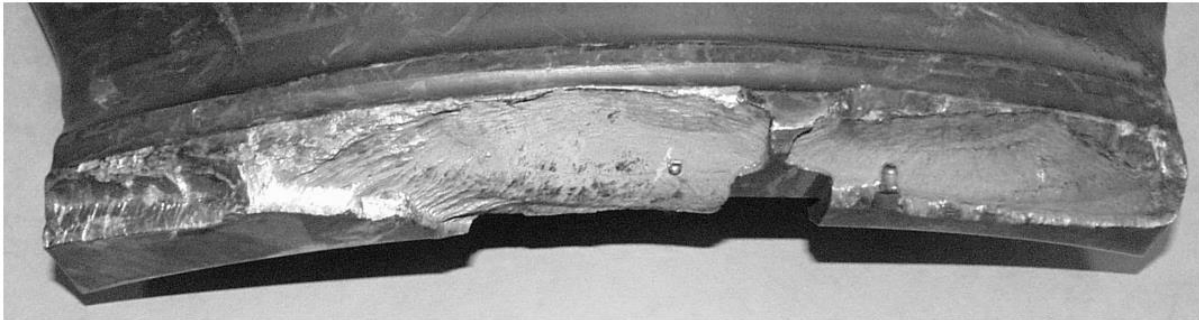
Figure 1-3: Side view of failed Trent 892 fan blade root: the picture shows the loss of two major sections of the root [10].

Despite their excellent lubrication properties, DFL coatings wear and degrade. On the 31st of January 2001 at Melbourne International Airport, a Rolls-Royce RB211 Trent 892 fan blade was released from the disc during take-off of a Boeing 777-300 as a consequence of a fatigue failure of two major sections of the root (see Figure 1-3). The failure was contained within the engine casing, no fire developed, and the take-off was safely aborted with no injuries reported. Subsequently, the failed fan blade was examined by the Australian Transport Safety Bureau and it determined that the failure originated from inappropriate DFL lubrication [10].

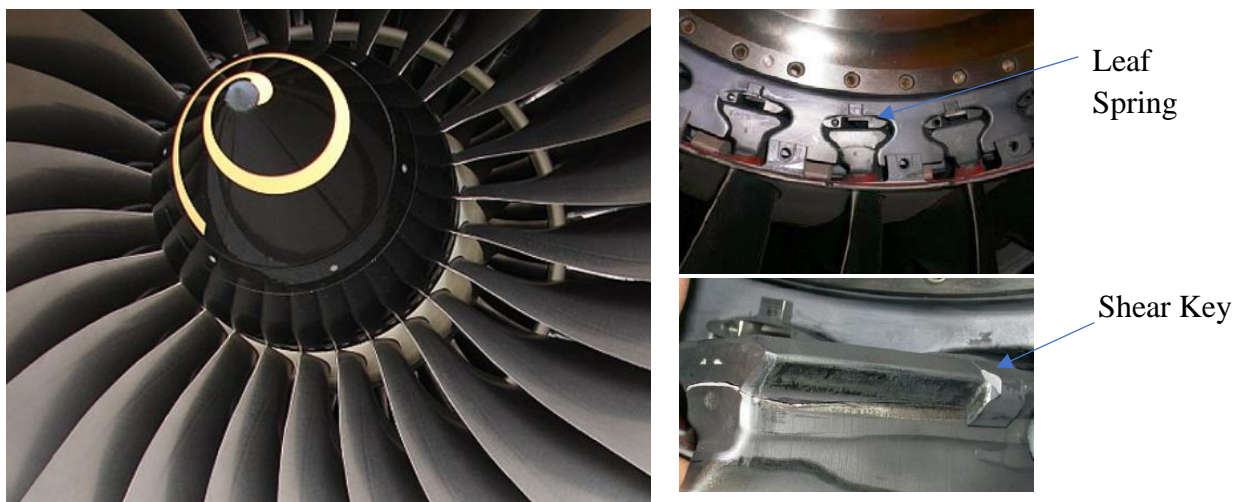
Figure 2-1: Fan assembly (left). Fan blade dovetail connection (top right) and fan blade root (bottom right) [1]

A dovetail joint connects the fan blades to the fan disc, simplifying assembly, disassembly, and inspection procedures. The blade root is slotted within the fan disc slot and secured in position with the use of a shear key and a leaf spring (Figure 2-1).

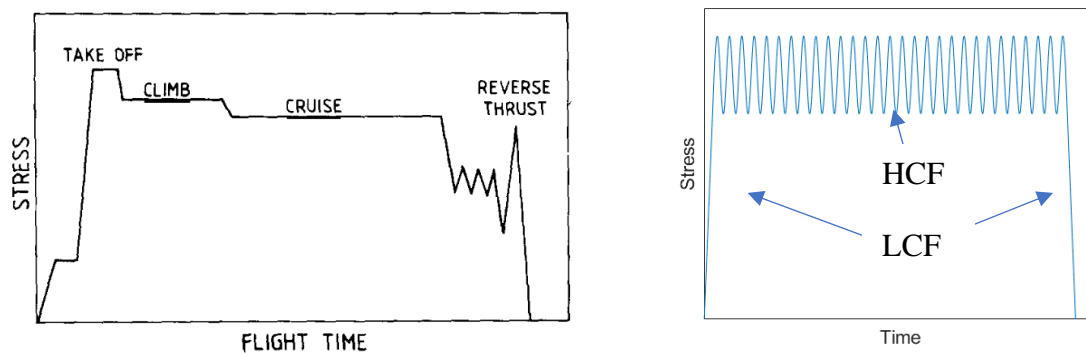
Figure 2-3: Simplified civil flight cycle (left) [9] and LCF-HCF representation

The LCF is produced by the fan rotation. At maximum thrust, the fan blade tip speed reaches 450 m/s subjecting each blade to a centrifugal load equivalent to the weight of 100 tonnes [7]. The blade is forced to move radially as a result of the disc expansion, seating into its least stressed position. The relative seating slip is estimated to range from 25  $\mu\text{m}$  [11] to 300  $\mu\text{m}$  [12]. Vibrations and air-flow instability (HCF) produce further relative movement, whose oscillatory displacement amplitude and frequency are estimated to be around a few micrometres and hundreds of Hertz respectively [11], [13]. The typical civil flight cycle consists of a main LCF period during take-off and landing and many HCF cycles. Whereas, military flights experience more severe LCF loading due to several accelerations and decelerations [9]. A simplified civil flight cycle is also represented in Figure 2-3.

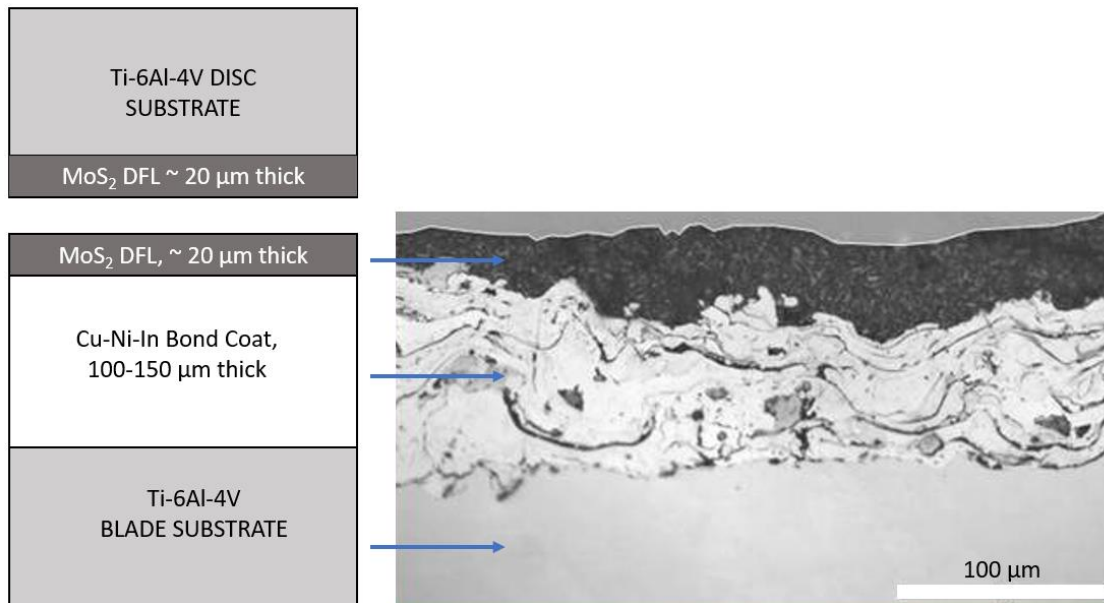
Figure 2-4: Schematics of the fan blade coating system (left). Cross-section micrograph of a coated fan blade root (right)

The final layer thickness achieved is 100-150 µm for the bond coat and around 20 µm for the DFL. The coating system (as applied) used in the root is shown in Figure 2-4, schematically illustrated using a block diagram to show the disc and blade as well as the coating layers applied to them, along with a cross-section micrograph of the blade root surface provided by Rolls Royce.

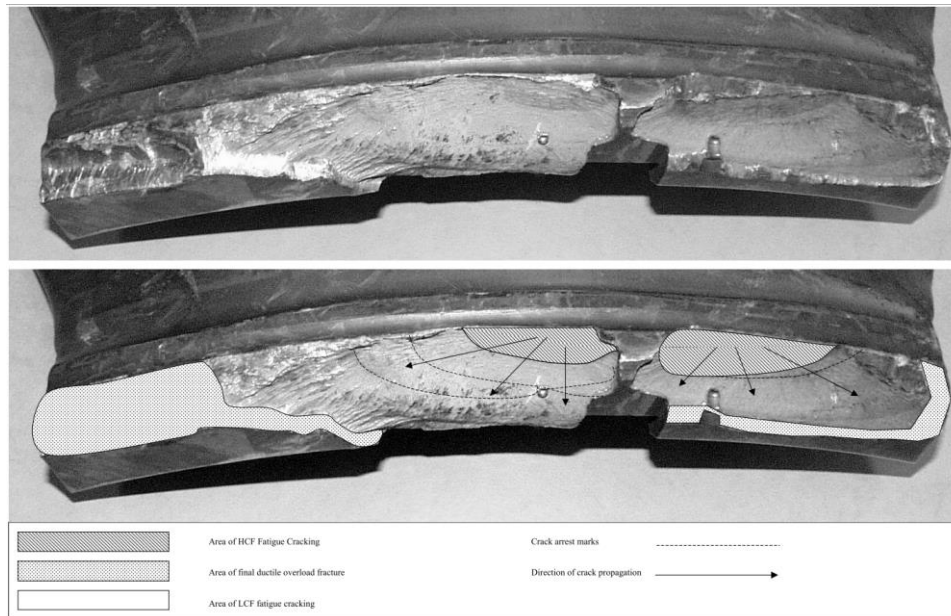
Figure 2-6: Examination of the fractured fan blade failure mode according to the ATSB [10].

This life cycle is consistent with the failure of the Trent892 blade in Melbourne [10]. The Australian Transport Safety Bureau divided the fractured root surface in three parts: HCF cracks nucleation and propagation in proximity of the shear key, an area of further propagation due to LCF, and an area of final ductile overload failure (Figure 2-6).

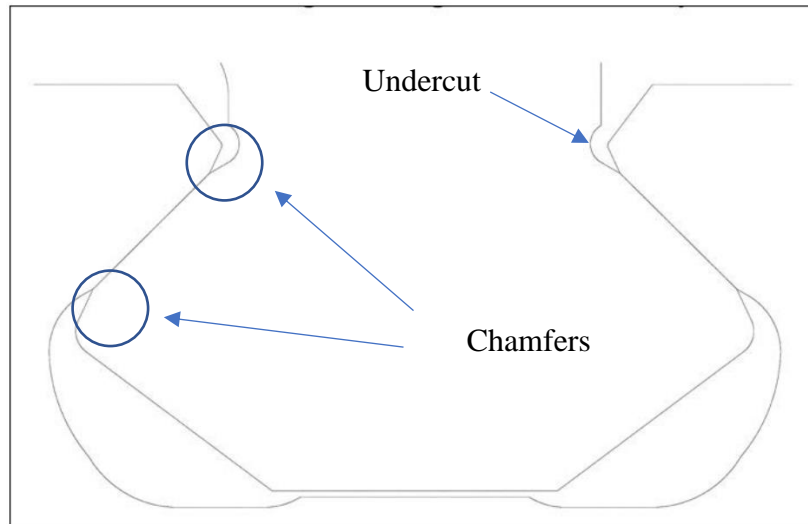
Figure 2-13: Use of chamfers, undercutting and relief radius on a dovetail joint [48].

such as the pressure distribution [47]. For dovetail attachments, the use of chamfers and undercutting is often adopted to improve fretting life [48]. Such design is currently applied by RR in the Trent 800 fan blades. Chamfers and undercuts reduce fretting and improve life by removing one of the contacting surfaces in areas where fretting is at its worst. This has the effect of allowing the blade root to deform rather than fret in these areas.

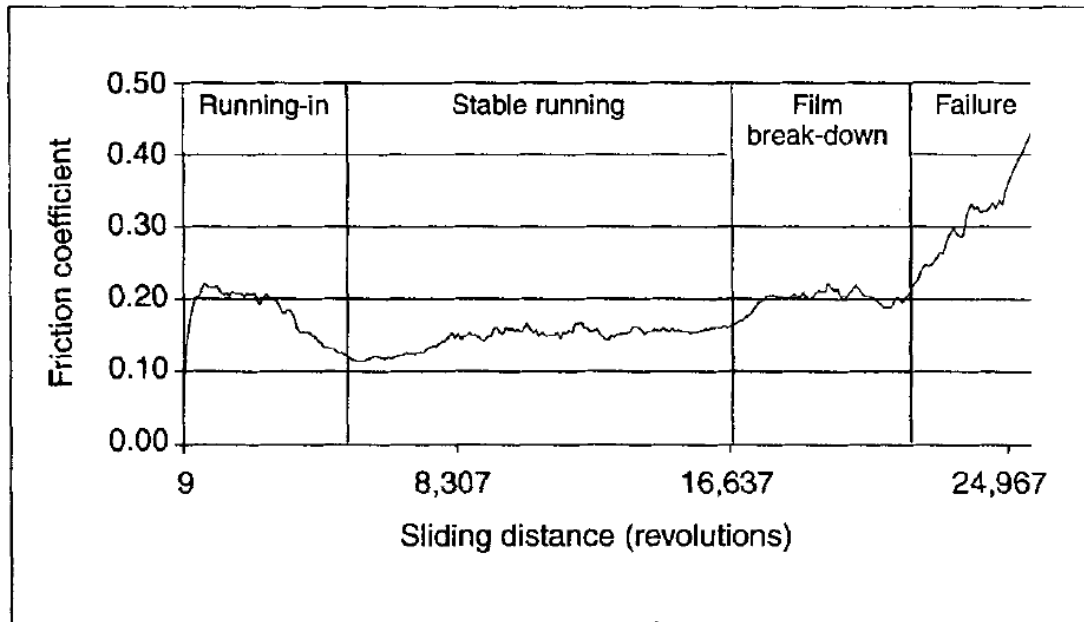
Figure 2-15: Typical stages in friction performance of MoS<sub>2</sub> [64]

Although the fretting behaviour of MoS<sub>2</sub> coating films has been largely investigated [60], [61], [63], the wear mechanism and failure modes are not fully understood. A good review of how the MoS<sub>2</sub> lubricates and fails from a macroscopic point of view was proposed by Fusaro et al. [64], which reported the results of previous studies. These suggested that MoS<sub>2</sub> compacts and sinters on the contact forming a thin and coalesced film, whose oxidation leads to embrittlement, blistering and scaling of the film. In order to extend those results the effect of the substrate surface roughness [64] and the environment [65] were investigated. The behaviour within three different atmospheres was analysed (moist air, dry air and dry argon) with moist air being the environment where the shortest life and the highest coefficient of friction was observed. In moist air the failure was due to oxidation causing blistering and break-up of the film. Whereas in dry and vacuum environments, the failure is due to gradual depletion of the film by lateral flow. The effect of the roughness was evaluated by testing on three different surfaces (polished, sanded and sandblasted) and the results suggested that rougher substrates provided increased life, but similar coefficient of frictions. Regarding the macroscopic behaviour, the work confirmed that MoS<sub>2</sub> compacts and sinters to form a thin layer that provides good lubrication and wear resistance. The extrusion of this film leads to loss of ductility, embrittlement and ultimately failure of the film with loss of material in form of a black, powdery material. Fusaro et al. [64] also showed that the CoF was split into four distinct phases as shown in Figure 2-15. First there is a run-in phase where compaction of the layer, material transfer between counter faces and generation of particles occurs. Next, a stable period of low friction occurs before the film starts to break down causing variations in friction coefficient. This friction stability is often attributed to worn particles replenishing lubrication in the contact from reservoirs and that only a thin layer of lubricant is required [66]. Finally, failure occurs when there is no longer enough MoS<sub>2</sub> to separate the surfaces with a corresponding rapid increase in friction coefficient.

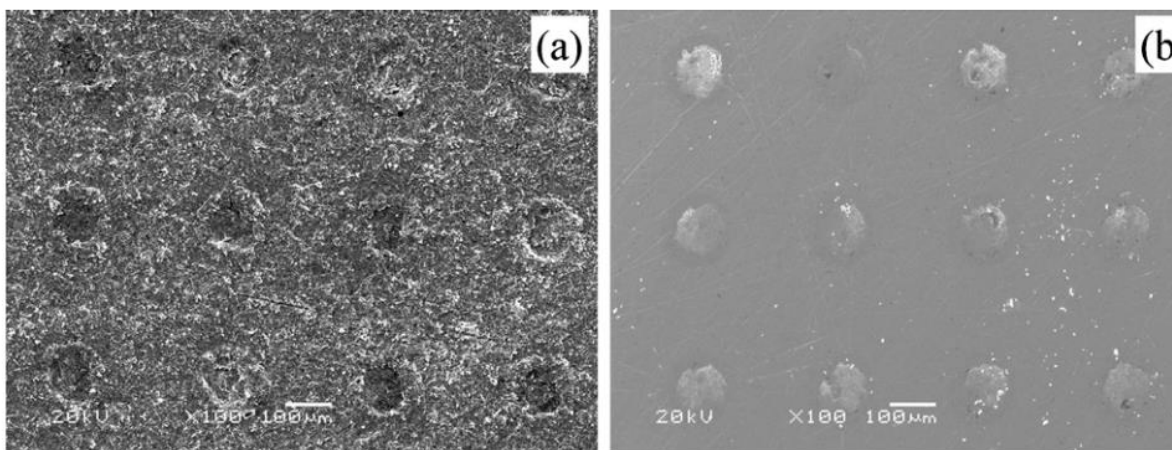
Figure 2-16: SEM micrographs of MoS<sub>2</sub> coatings by hot pressing (a) and burnishing (b) on the textured surface [60]

As noted, substrate texture is a key variable, with Hu et al. investigating its influence on the reciprocating sliding behaviour of MoS<sub>2</sub> on a steel substrate [60]. The texture consisted of an evenly spaced grid of surface depressions as shown in Figure 2-16. Two different deposition techniques were used: hot pressing and burnishing.

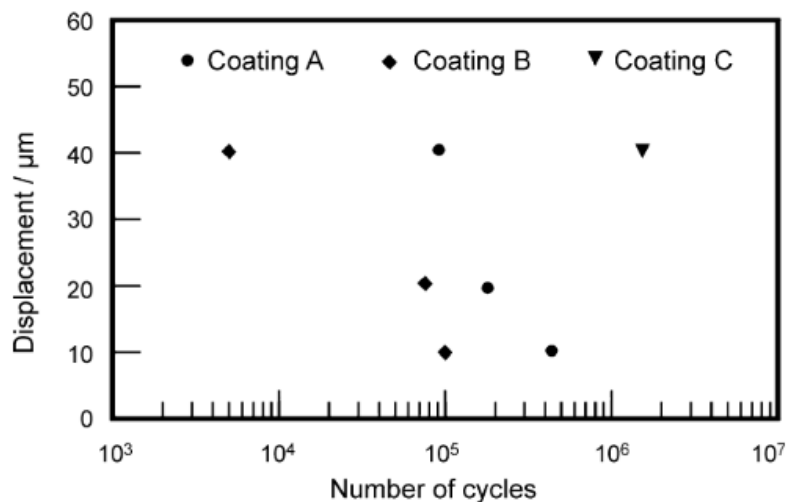
Figure 2-19: Variation of fretting life at different displacement amplitude for 3 different coatings: Coating A) MoS<sub>2</sub>, B) Graphite C) PTFE

Further, they compared the performance of bonded MoS<sub>2</sub> particles to PTFE and graphite bonded solid coatings. The results indicated the PTFE as best performing solution, as shown in Figure 2-19.

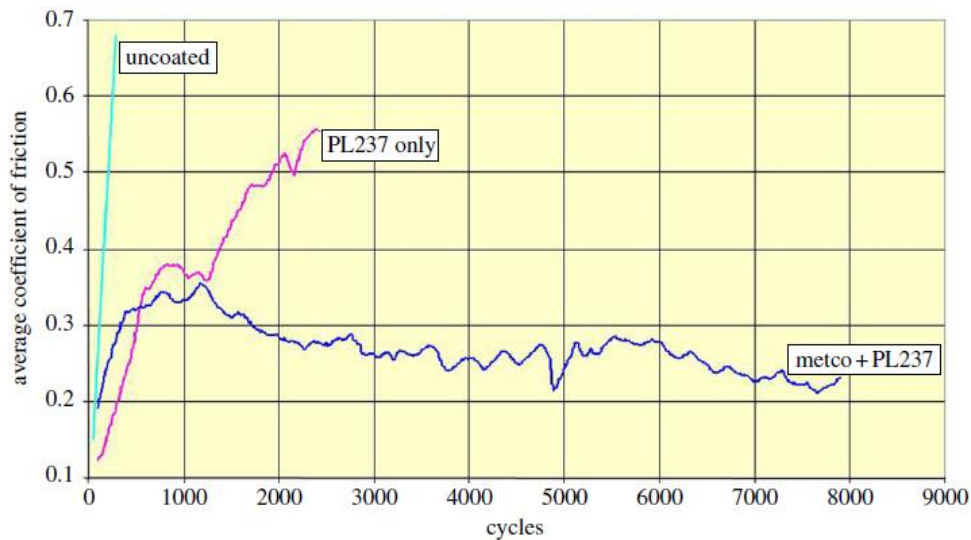
Figure 2-22: Example of results from biaxial test rig for different coatings [7]

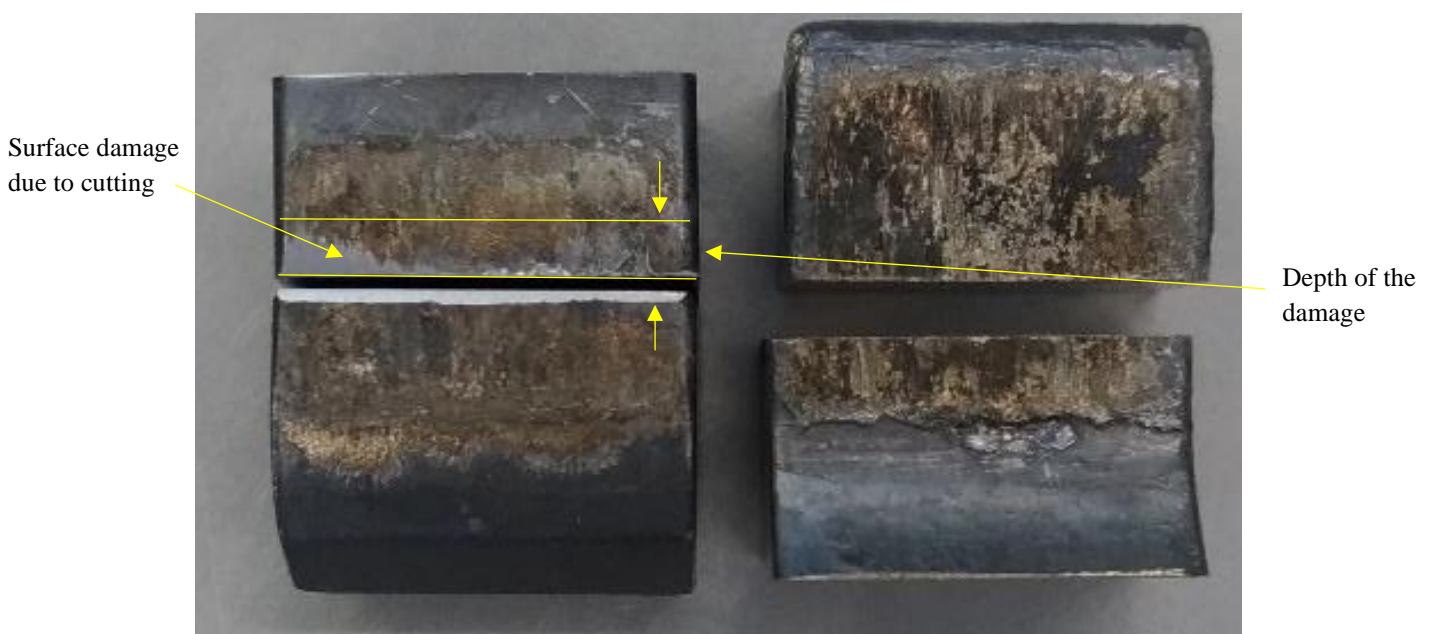
Figure 3-2: Outcome of abrasive cross-sectional cut.

Depending on shape and dimension of the component, the cut is made by either using EDM wire cut erosion or abrasive cutting machine. As this process might damage the coating, the samples are visually inspected to assess the depth to which the damage affected the surface, which is then measured and recorded. An example of a sample sectioned with abrasive cut is shown in Figure 3-2, where the damage is highlighted.

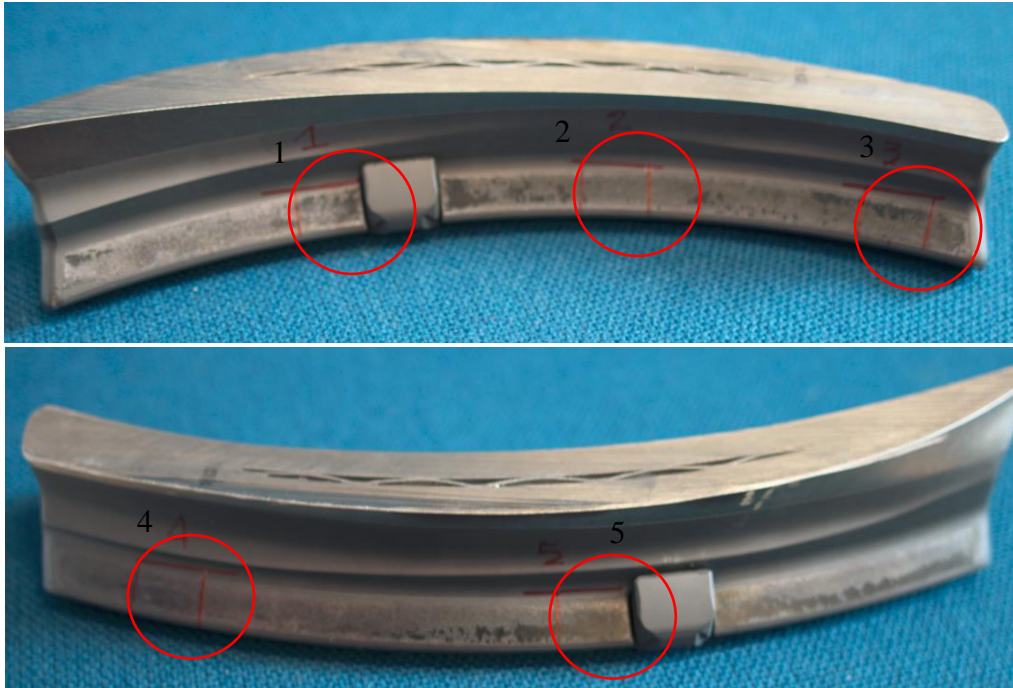
Figure 3-6: Fan blade cut positions (marked in red). Intrados (above) and extrados (below).

In order to analyse the areas identified visually, five samples were cut out of the component from different locations using electro discharge machine (EDM). The samples were sourced from both the intrados and extrados of the root at different axial locations, allowing to provide adequate coverage of each of the three areas to perform the analysis. Figure 3-6 shows the location of the samples.

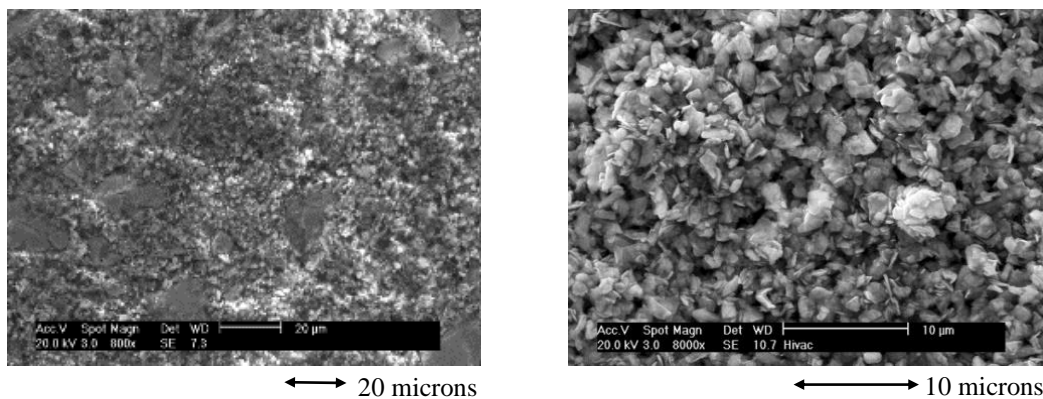
Figure 3-8: Fan blade area 1 micrograph (left),  $\text{MoS}_2$  as applied [77]. NB Micrographs have different magnification

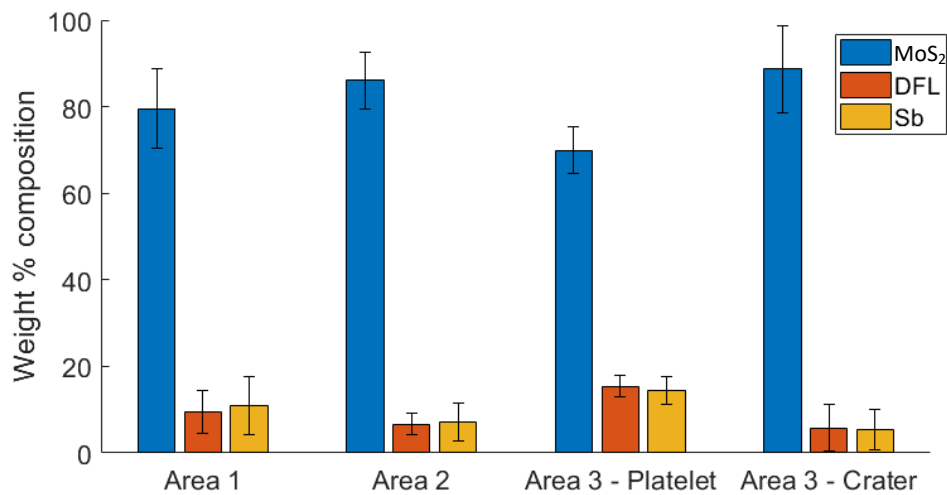
Figure 3-10: Elemental analysis of the fan blade root areas.

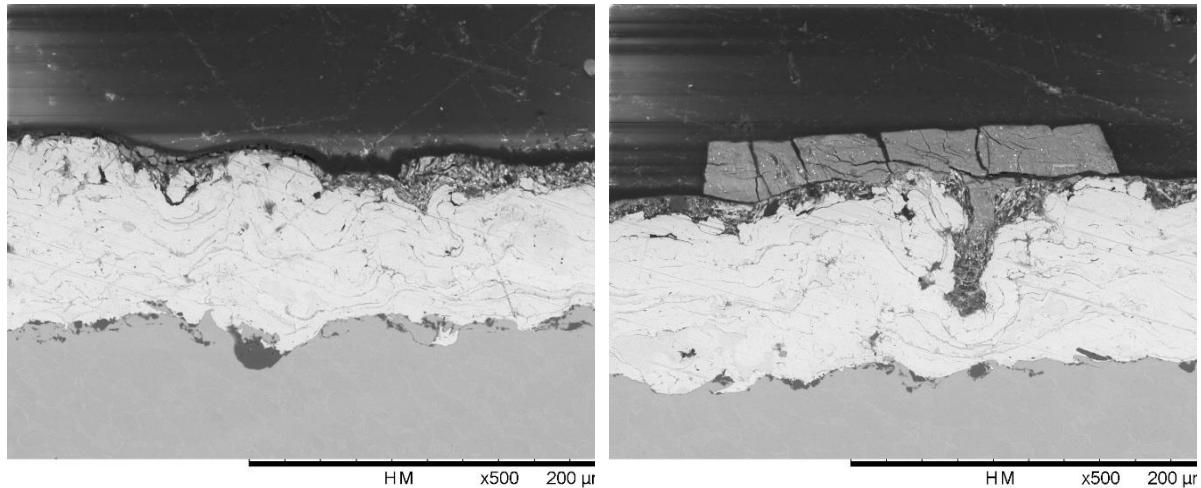
Figure 3-11: Cross-sectional micrography of blade surface: low load area 2 (left), high load area 3 (right).

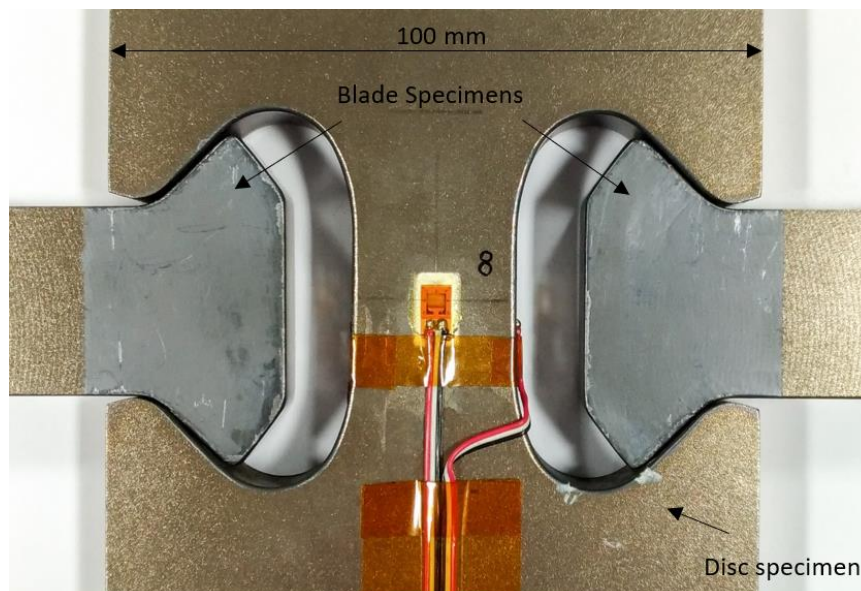
Figure 3-12: Trent800 style biaxial test rig specimens tested at Oxford University [39]

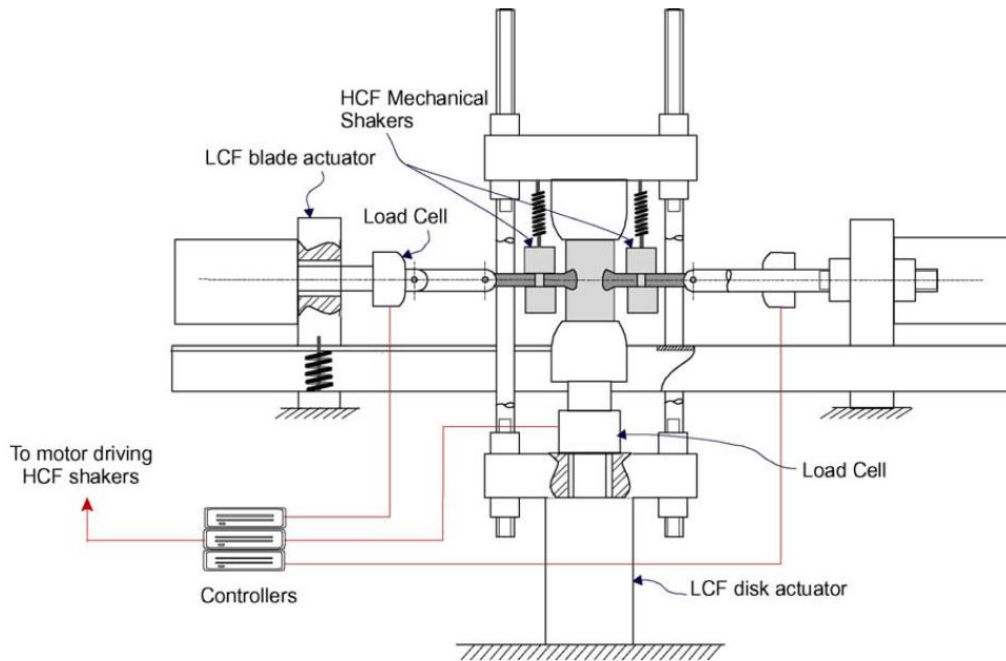
Figure 3-13: Biaxial test rig schematics [45]

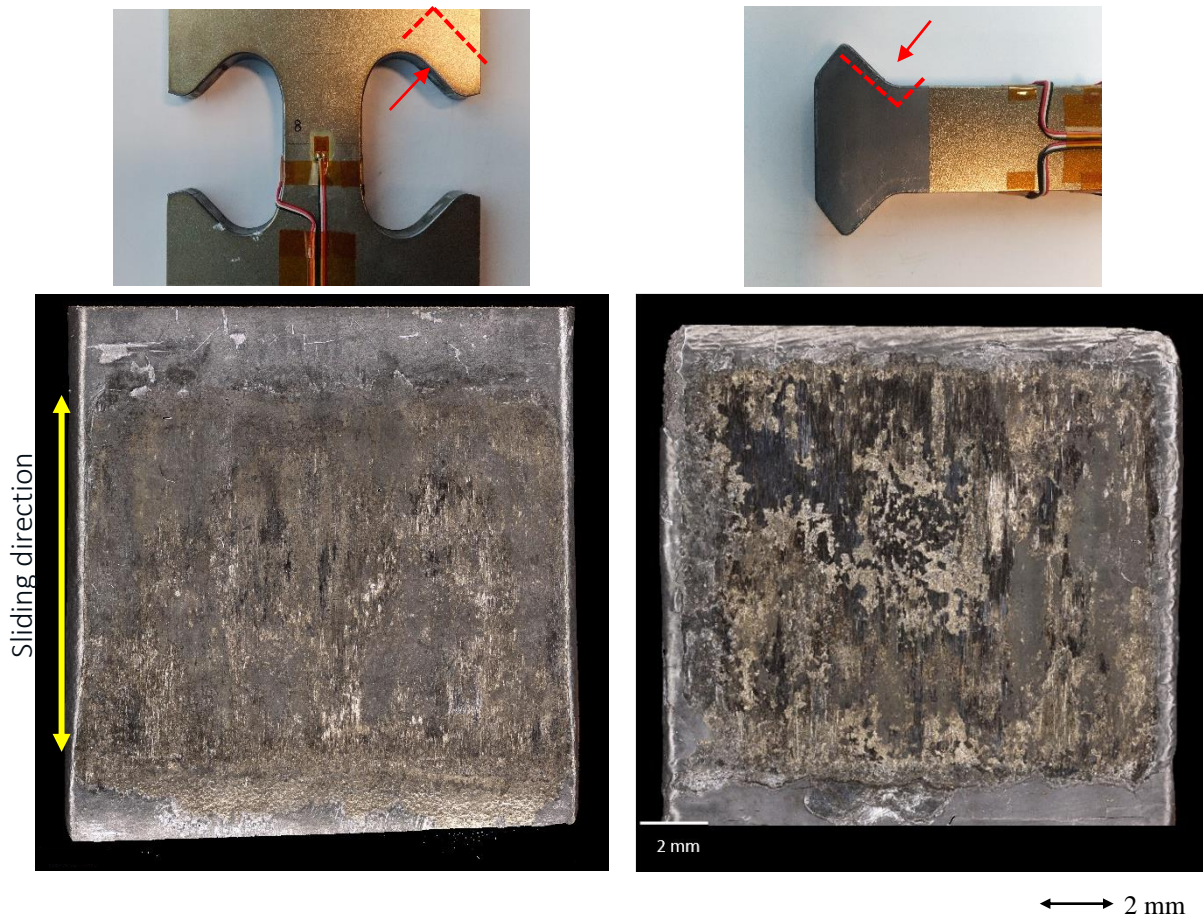
Figure 3-14: Sectioning of the samples: disc (left) and blade (right).

Figure 3-14 in order to allow for inspection of the surfaces indicated by the red arrows.

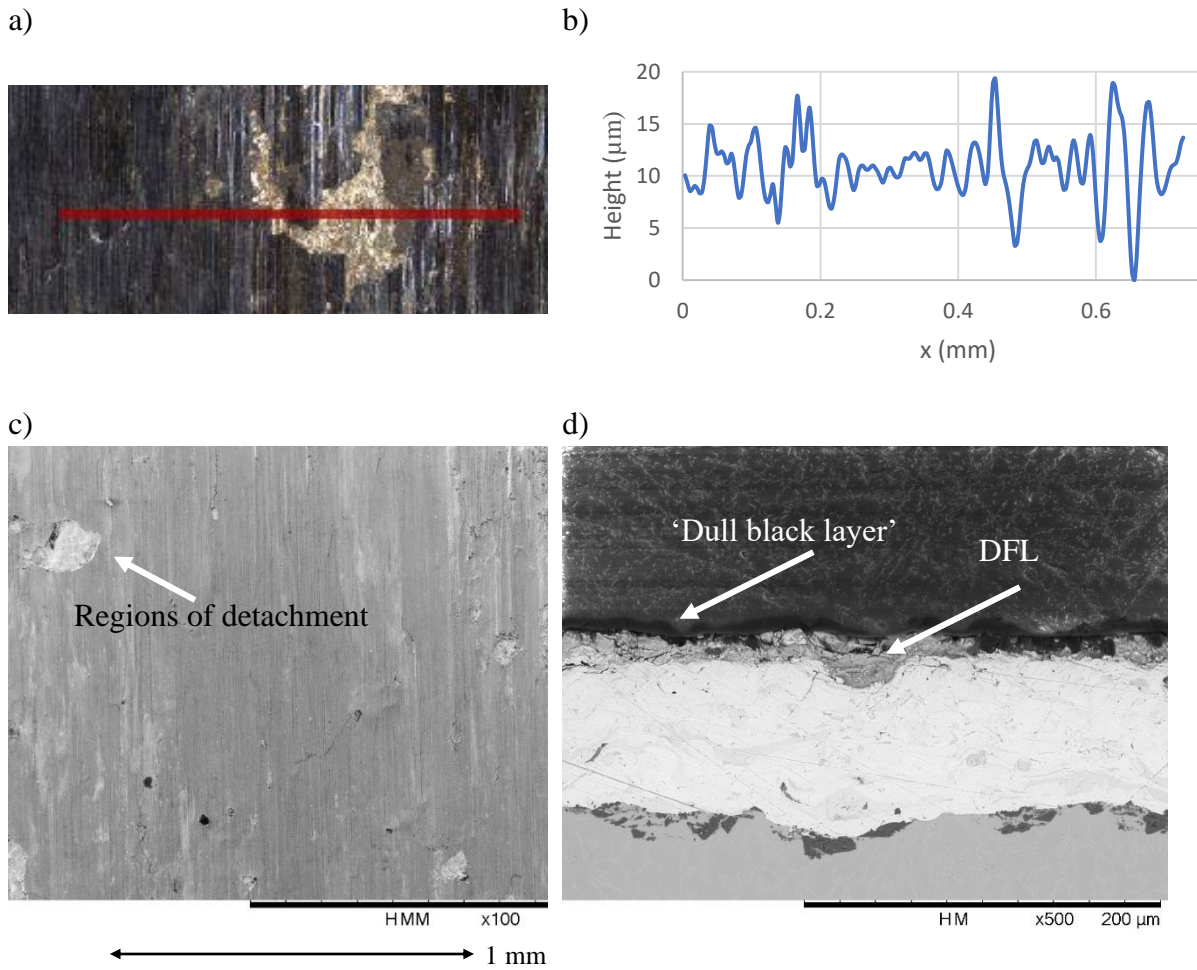
Figure 3-17: BA a) surface, b) surface profile, c) SEM d) cross section

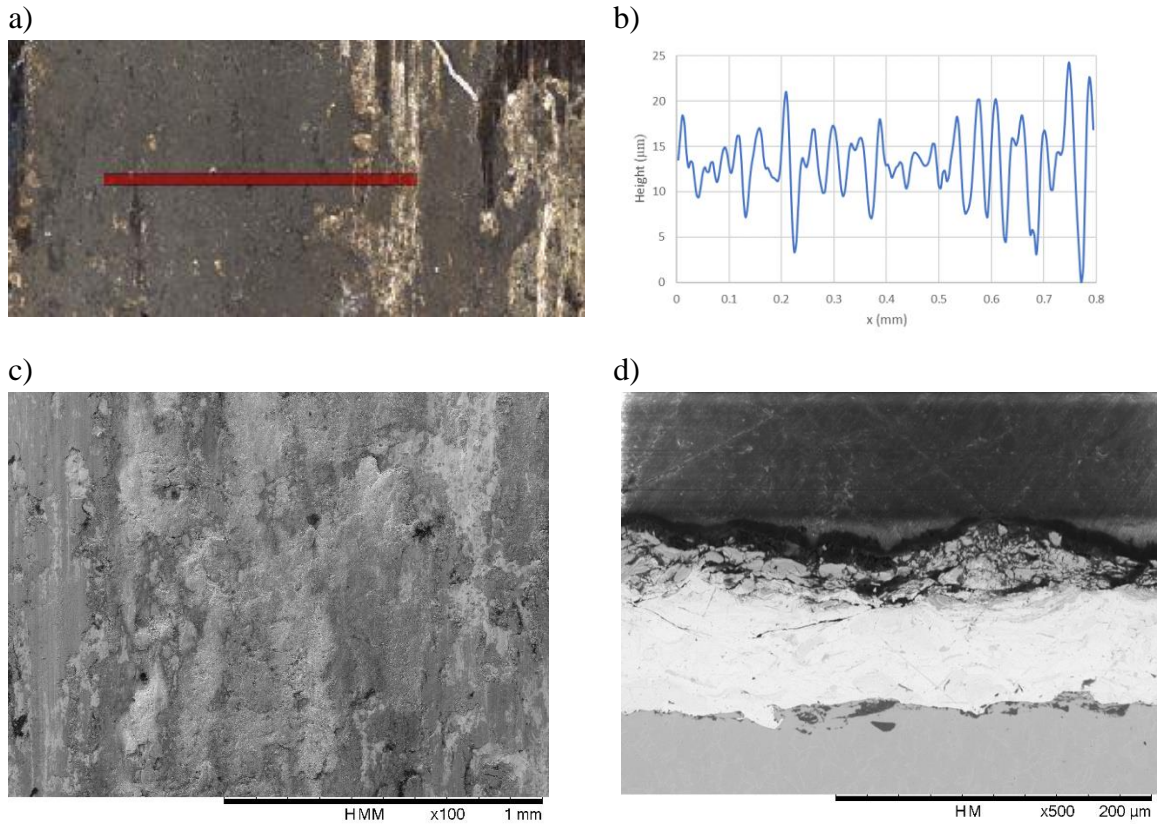
Figure 3-19: BC a) surface, b) surface profile, c) SEM d) cross section

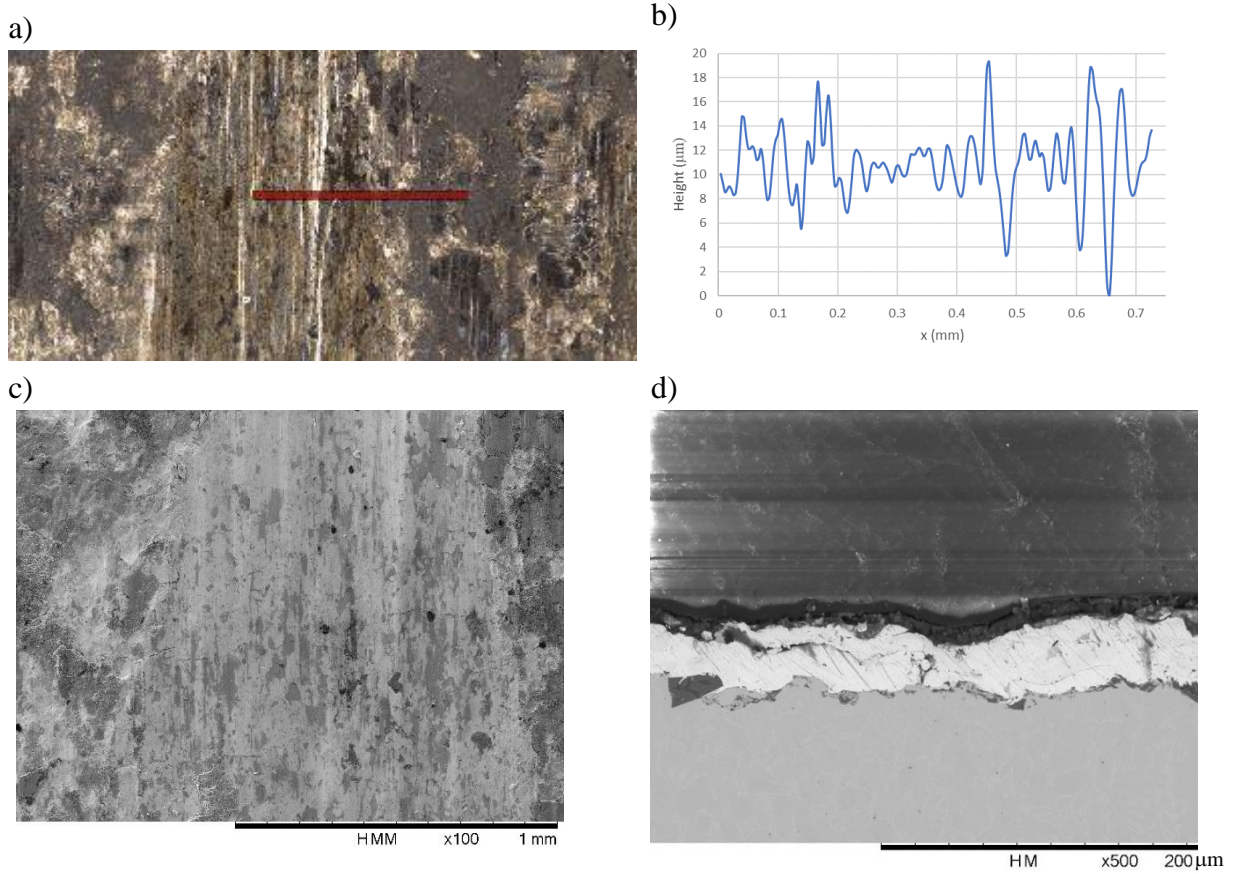
Figure 3-20: BD a) surface, b) surface profile, c) SEM d) cross section

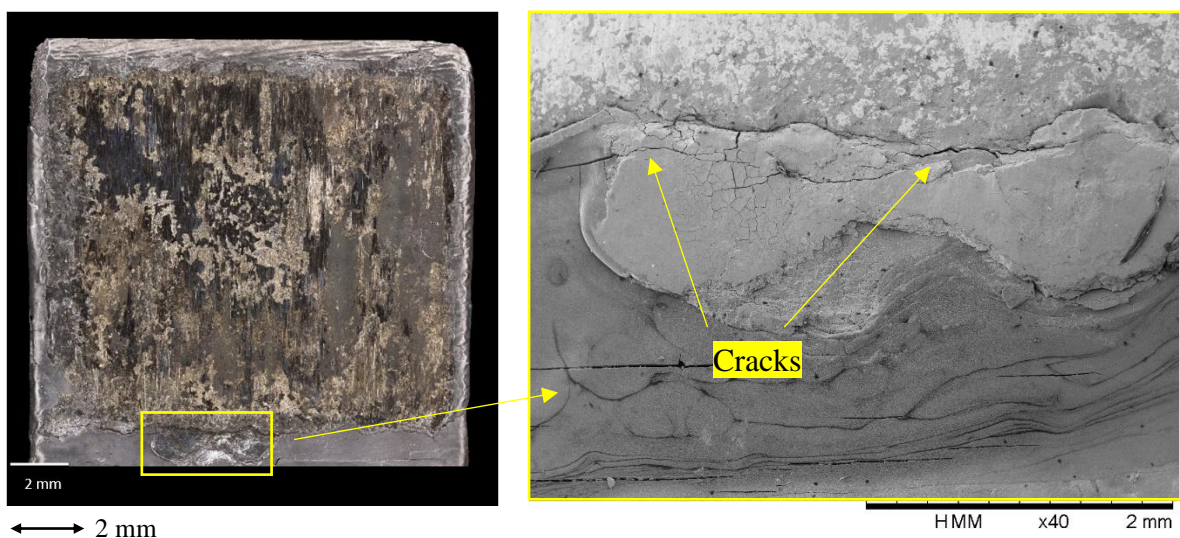
Figure 3-21: SEM micrograph of the out-of-contact area near the EOB

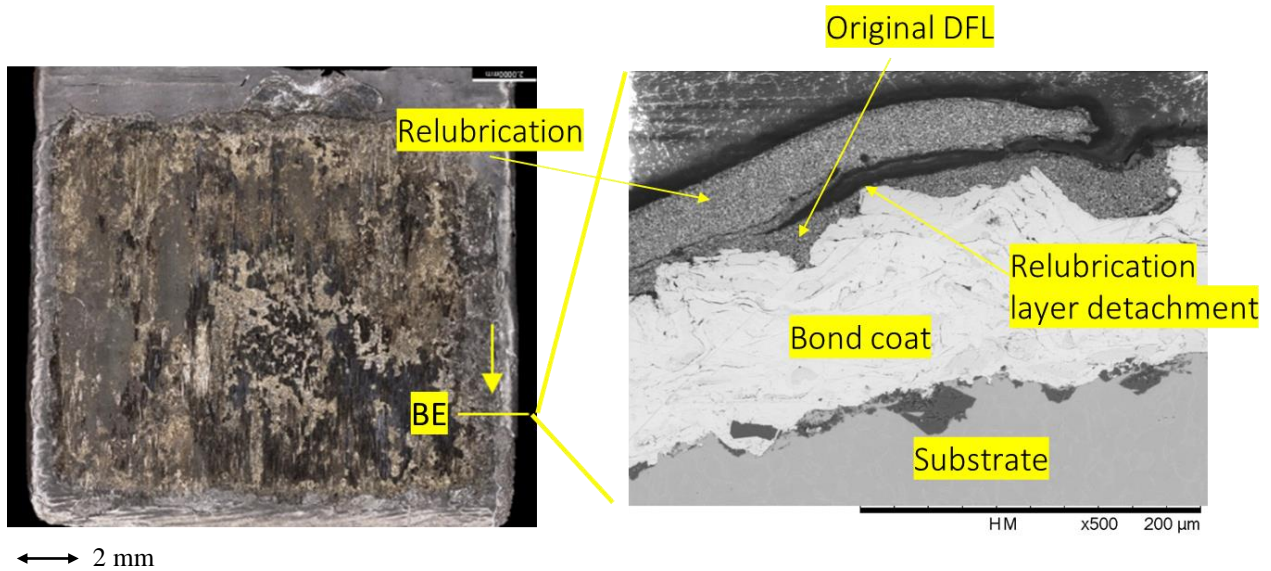
Figure 3-22: Cross-section from contact edges

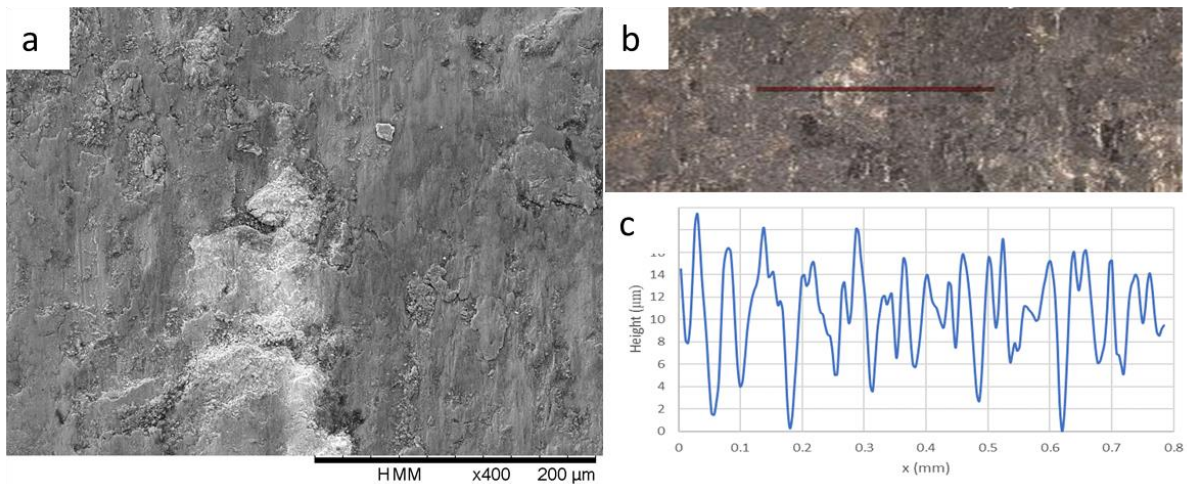
Figure 3-26: DB a) SEM, b) surface c) surface profile

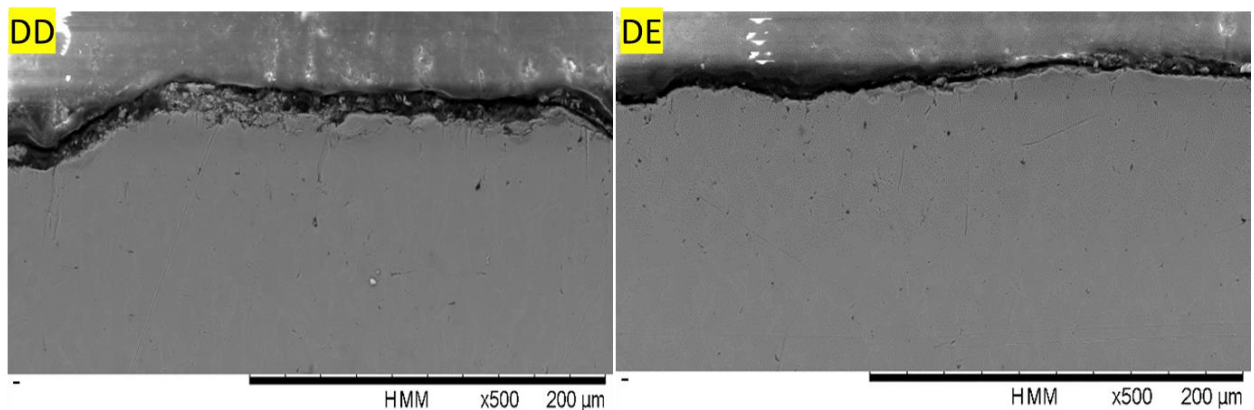
Figure 3-28: Cross sections of disc DD and DE

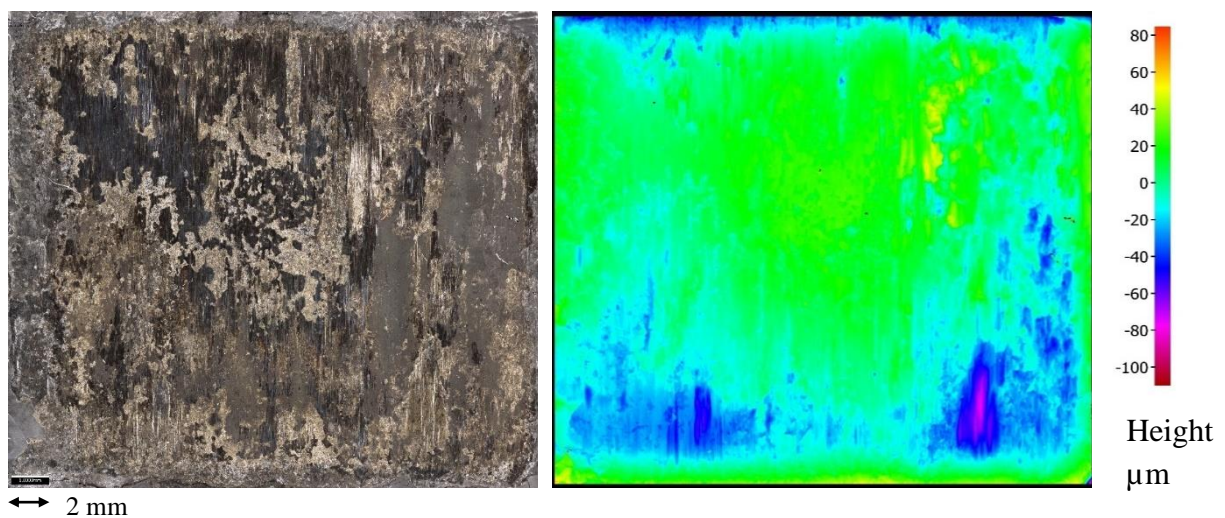
Figure 3-29: Biaxial blade sample (left) and its profile map (right)

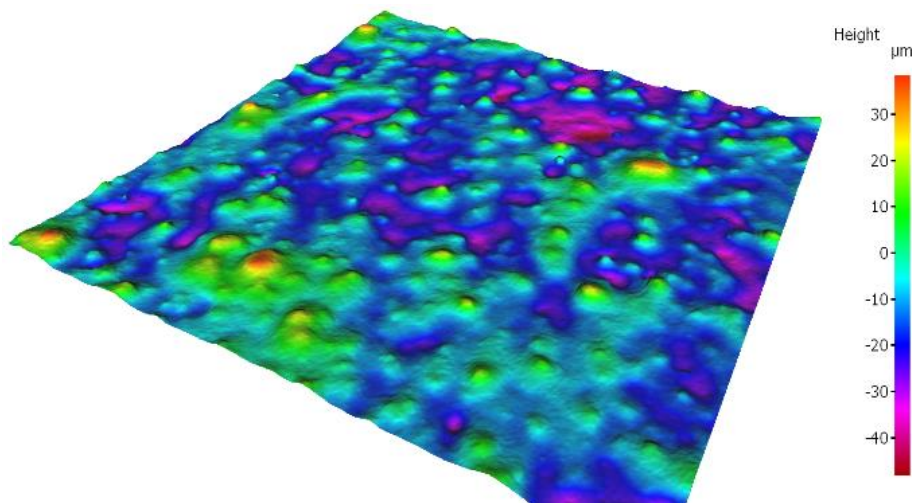
Figure 4-4: Surface of a plate sample, showing irregular topography.

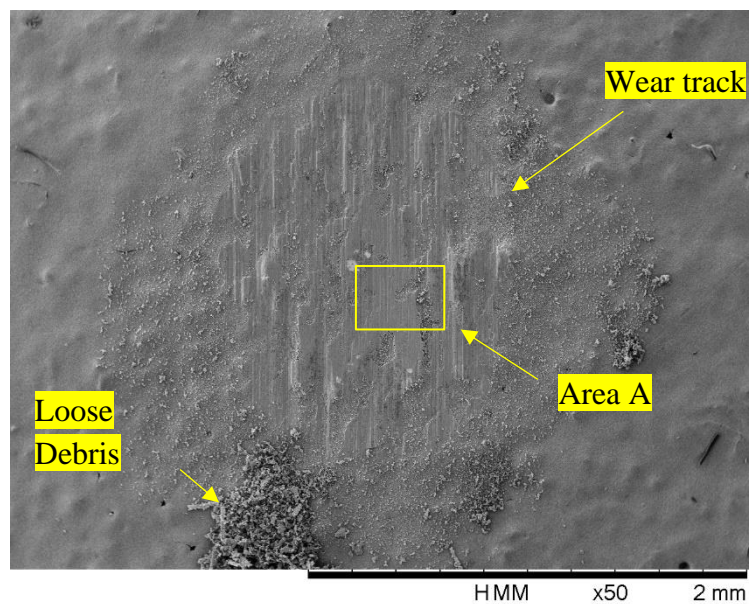
Figure 4-14: SEM micrograph (50x) of the plate specimens at 70,000 cycles. Average Hertzian contact pressure 575 MPa

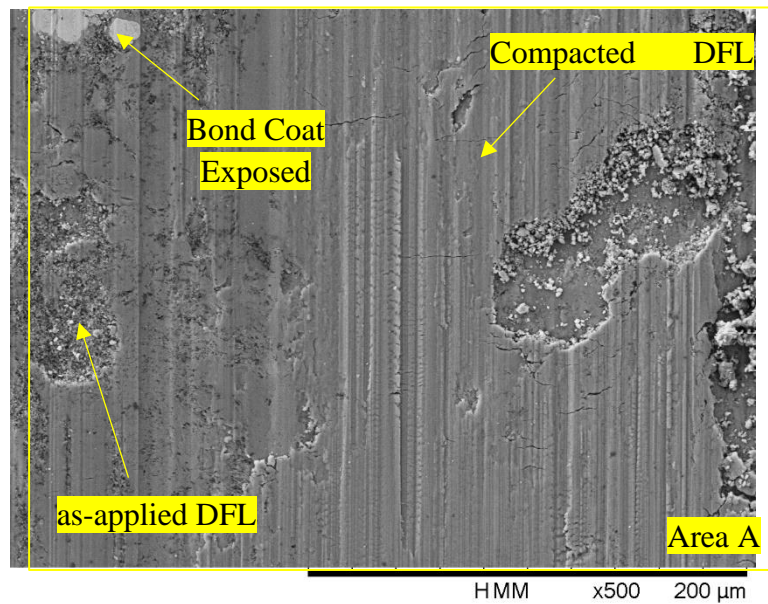
Figure 4-15: SEM micrograph (500x) of the plate specimens at 70,000 cycles (Area A from Figure 4-14). Average Hertzian contact pressure 575 MPa. The image shows the different areas: exposed bond coat, as-applied DFL, and DFL layer

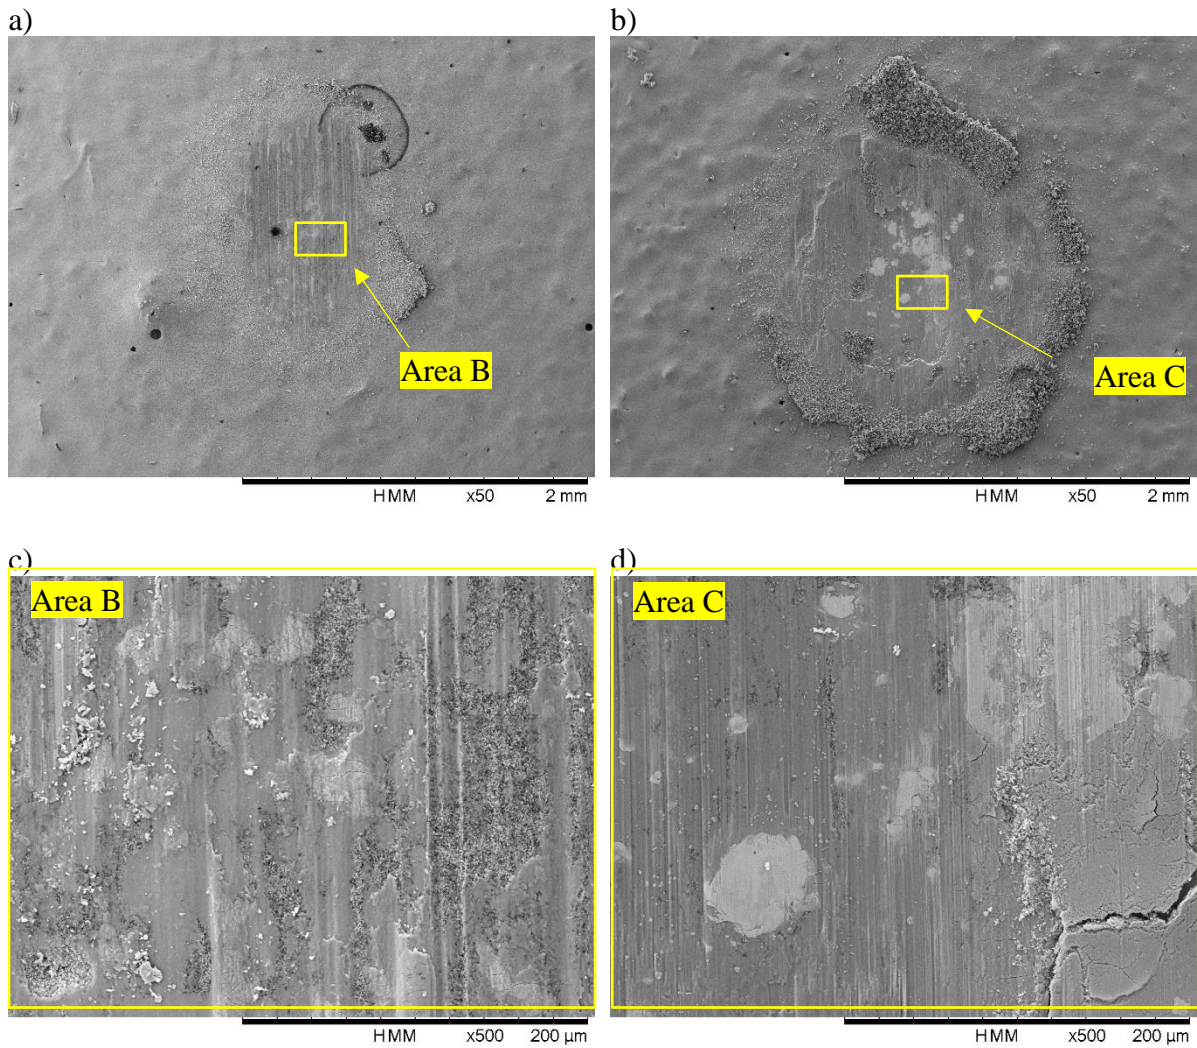
Figure 4-16: SEM micrographs of the plate specimens at the end of the test (70,000 cycles). a) 225 MPa 50x, b) 825 MPa 50x, c) zoom of area B at 500x, d) zoom of area C at 500x.

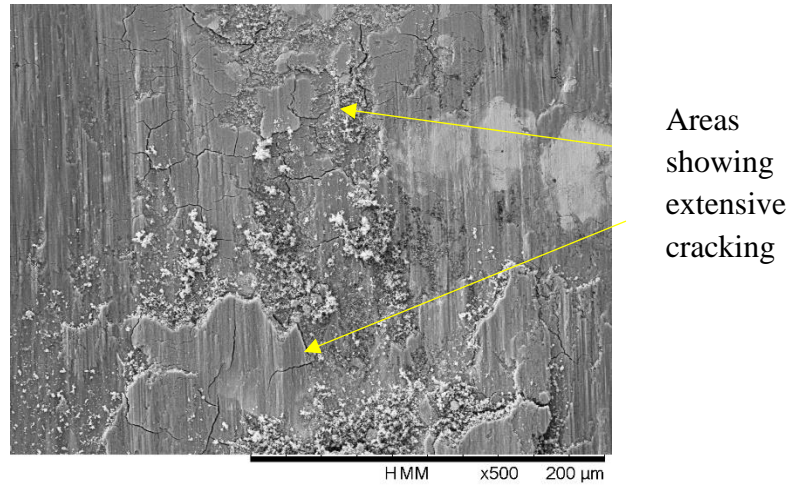
Figure 4-17: Area in the wear track of the test at 750MPa showing extensive cracking
