**An Investigation of Molybdenum Disulphide Dry Film Lubricant Coatings  
used in Aero-Engine Fan Disc Applications**

A thesis submitted in partial fulfilment of the requirements for the degree of  
Doctor of Philosophy

The University of Sheffield  
Faculty of Engineering  
Department of Mechanical Engineering

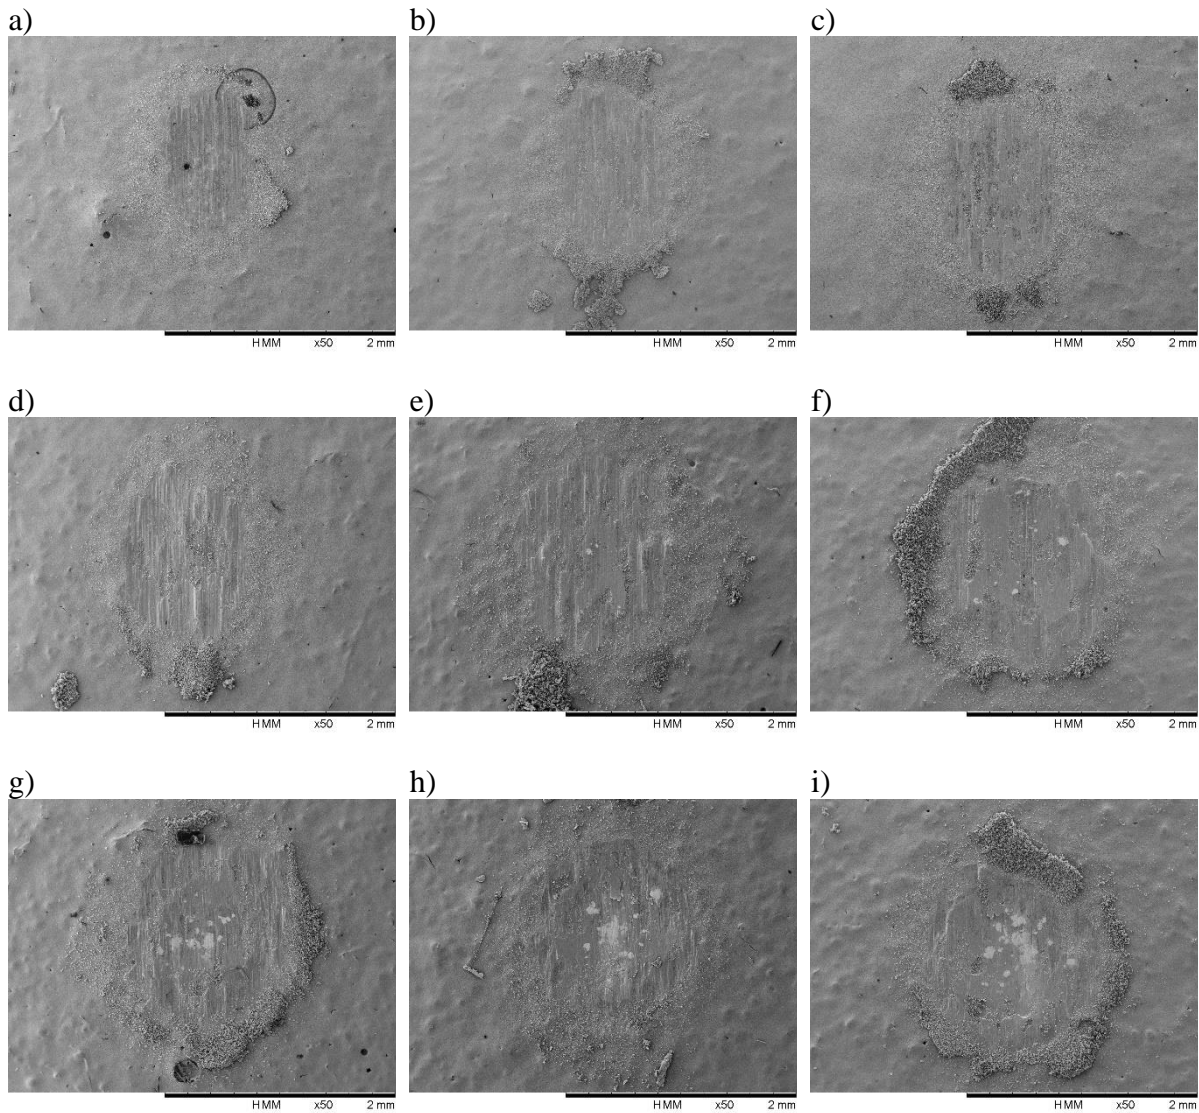
Figure 4-18: SEM images of the plate samples at 70,000 cycles. a) 225 MPa, b) 300 MPa, c) 375 MPa, d) 450 MPa, e) 525 MPa, f) 600 MPa, g) 675 MPa, h) 750 MPa, i) 850 MPa

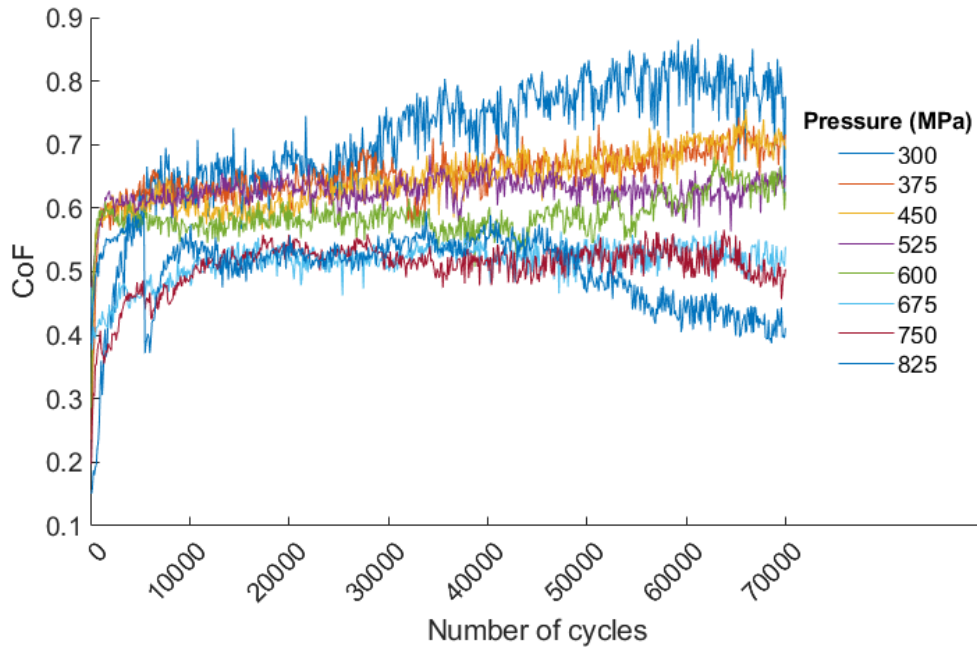
Figure 4-19: CoF evolution: influence of pressure

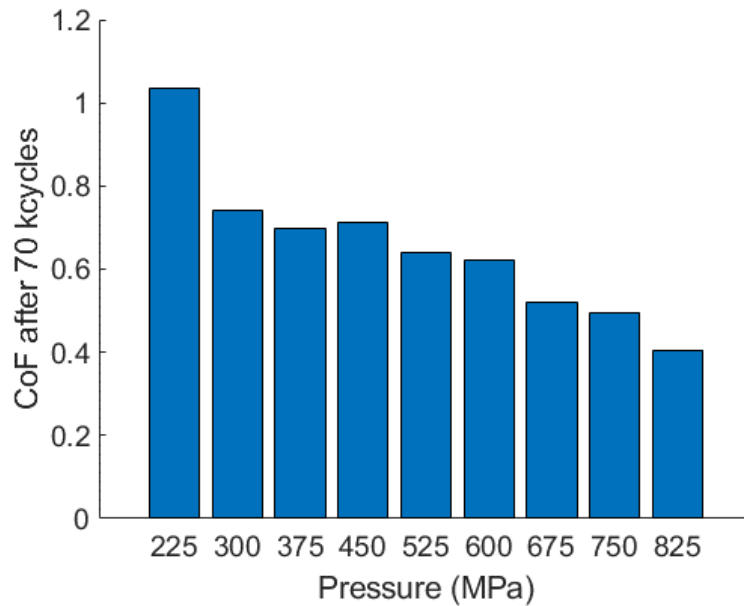
Figure 4-20: CoF at the end of test (average of last 50 cycles). A clear decreasing trend is observed

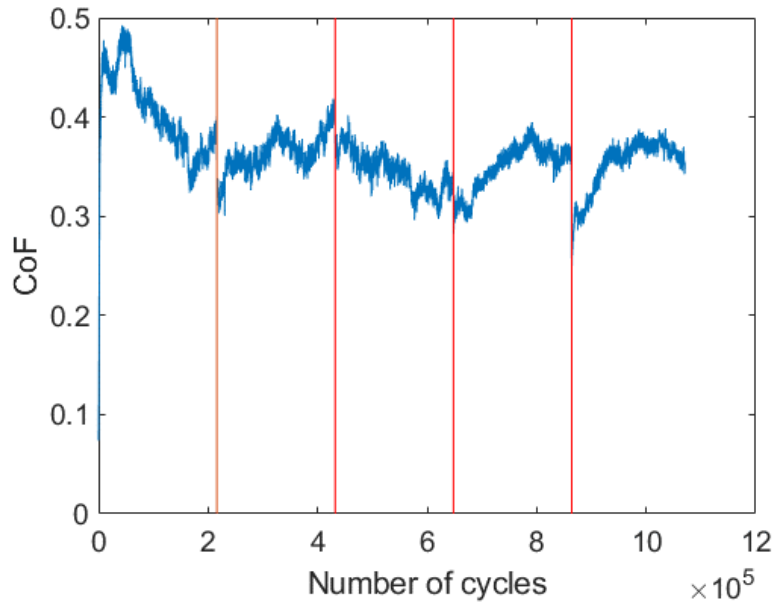
Figure 4-21: CoF evolution of a test performed at 450 MPa

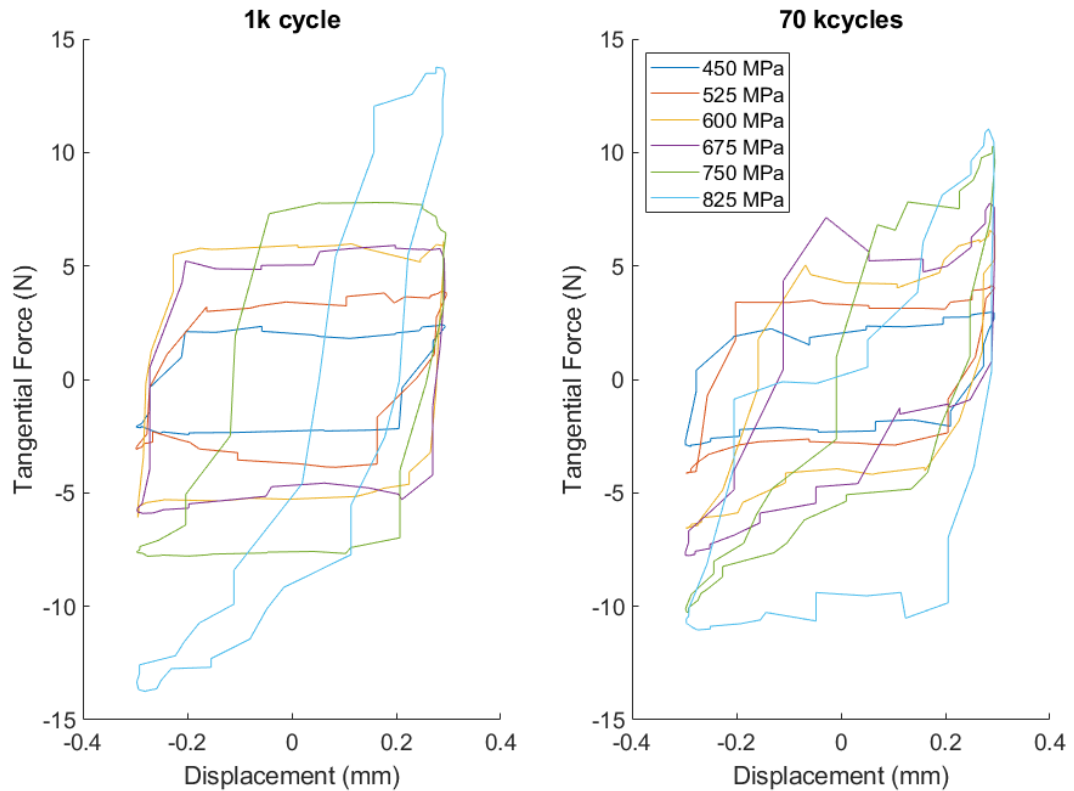
Figure 4-22: Fretting loops of the tests. The loops show that gross slip regime is achieved at the beginning of the tests in all cases except at 825 MPa at 1,000 cycles and the 750 MPa and 825 MPa 70,000 cycles

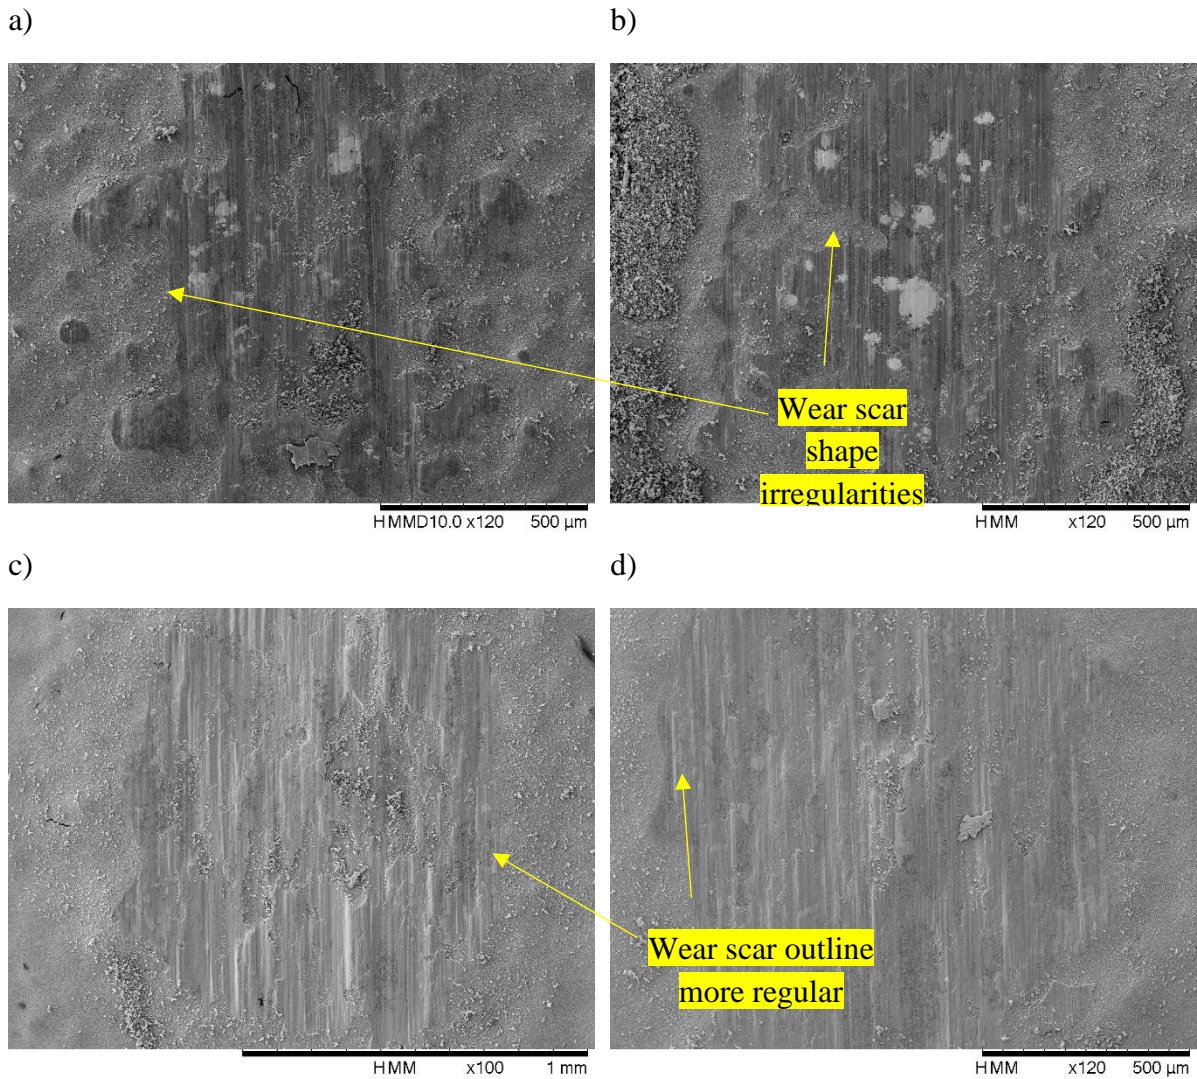
Figure 4-23: SEM micrographs of test repeated at 450MPa for 70,000. a) Test A Batch 1, b) Test B Batch 1, c) Test C Batch 2, d) Test C Batch 2

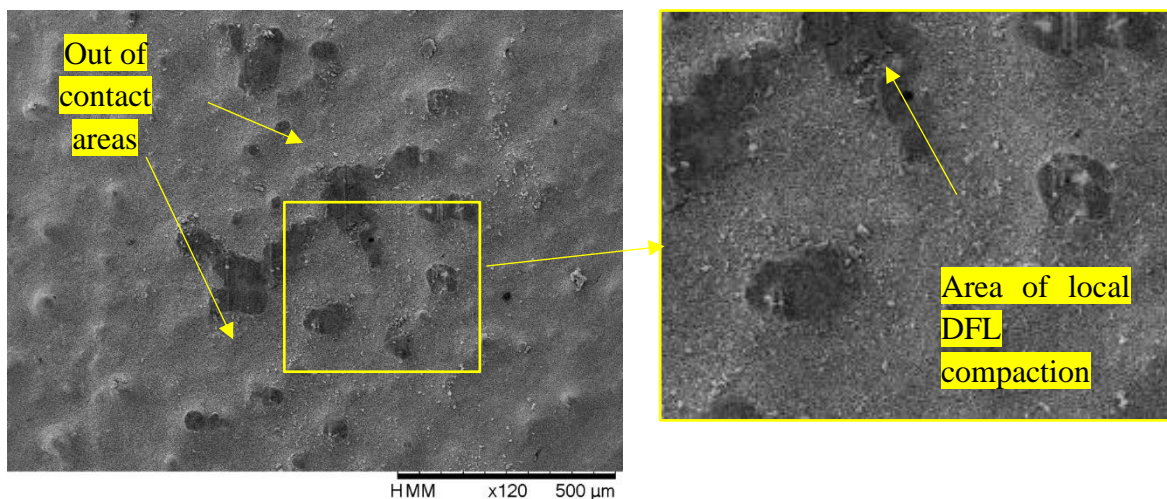
Figure 4-25: Surface of test at 300 MPa after 10,000 cycles performed on a wavy sample

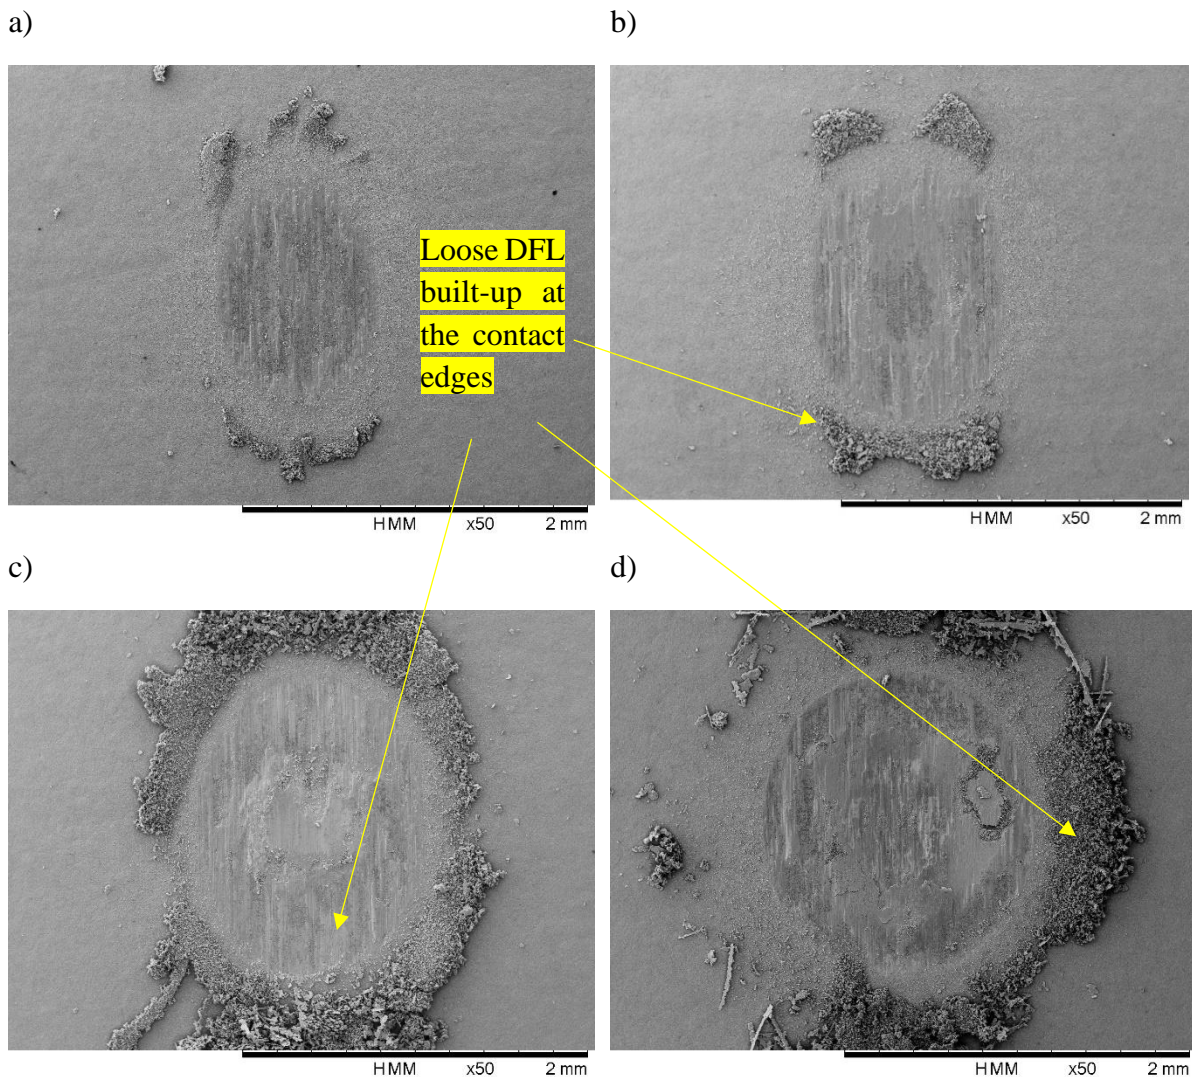
Figure 4-26: SEM micrographs of the tests performed on samples without bond coat. a) 300 MPa b) 450 MPa c) 600 MPa d) 750 MPa

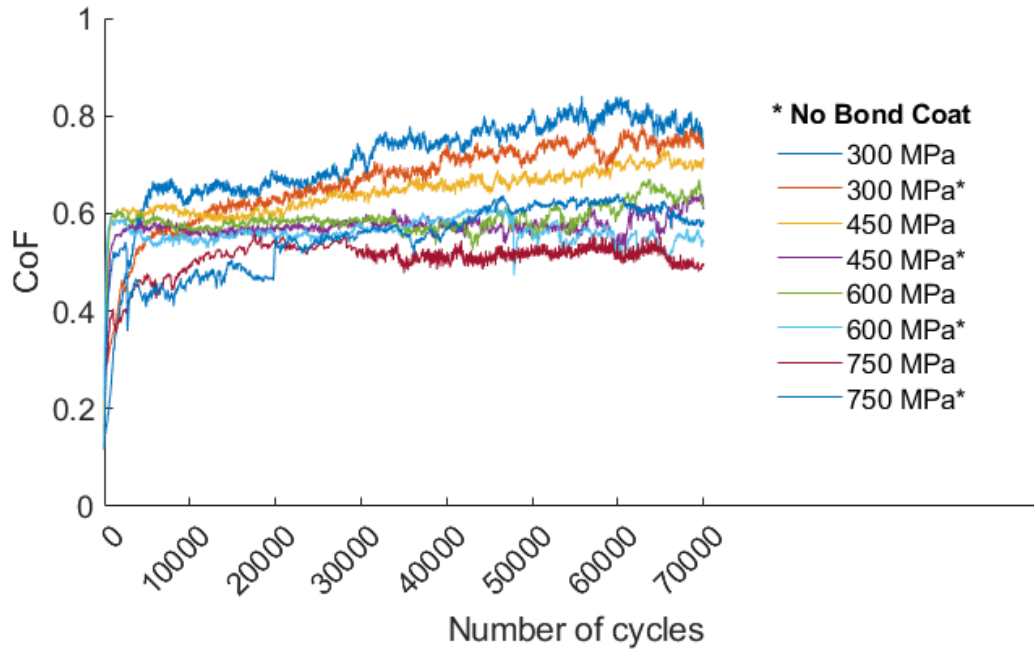
Figure 4-27: CoF evolution: influence of the bond coat. Lower CoF was recorded on the samples with no bond coat (apart from the 750 MPa test)

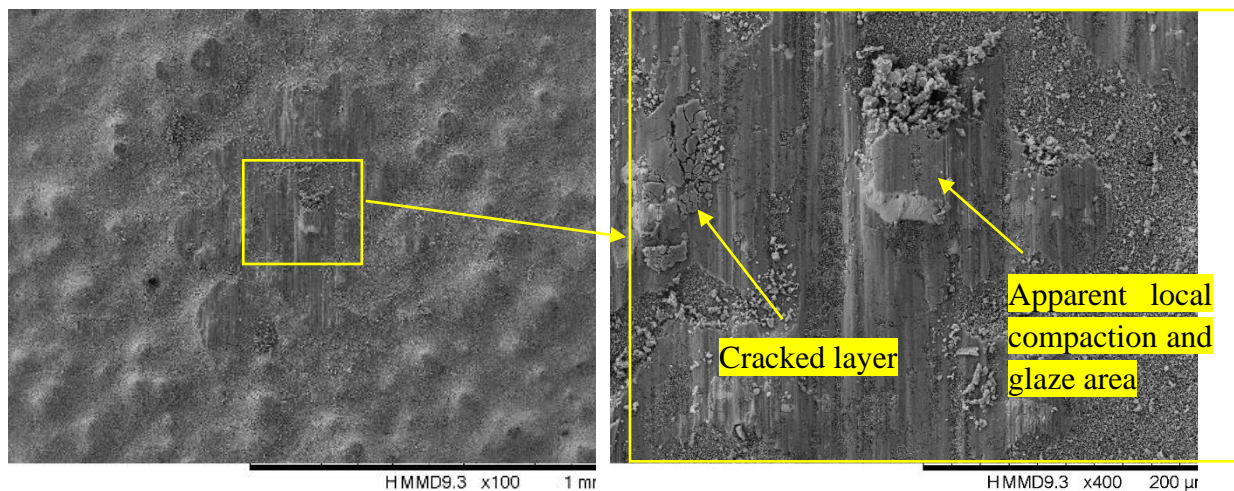
Figure 4-29: SEM image of bonded test specimen tested at 300MPa for 70'000 (left: 100x magnification, right: detail at 400x magnification). The surface shows strong heterogeneity of the surface composition

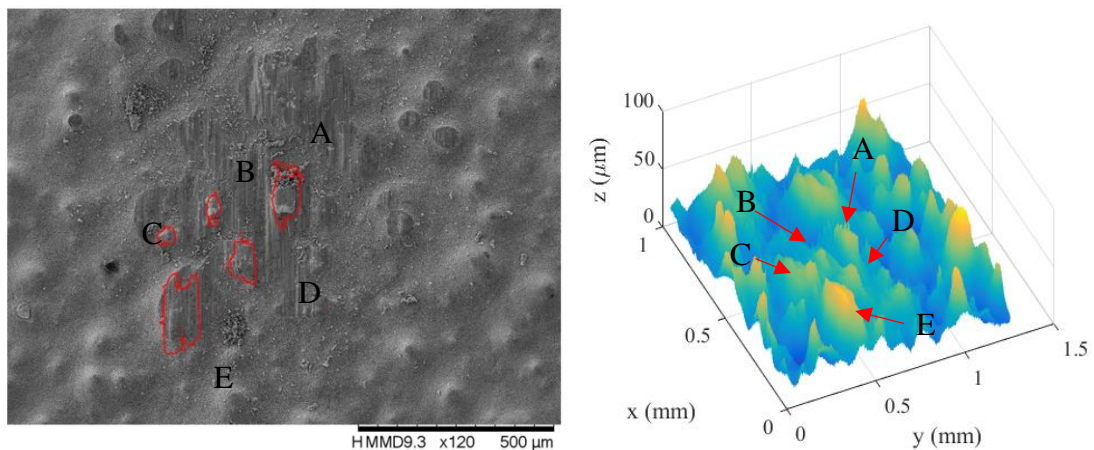
Figure 4-32: Base of the extracted asperities superimposed onto SEM image

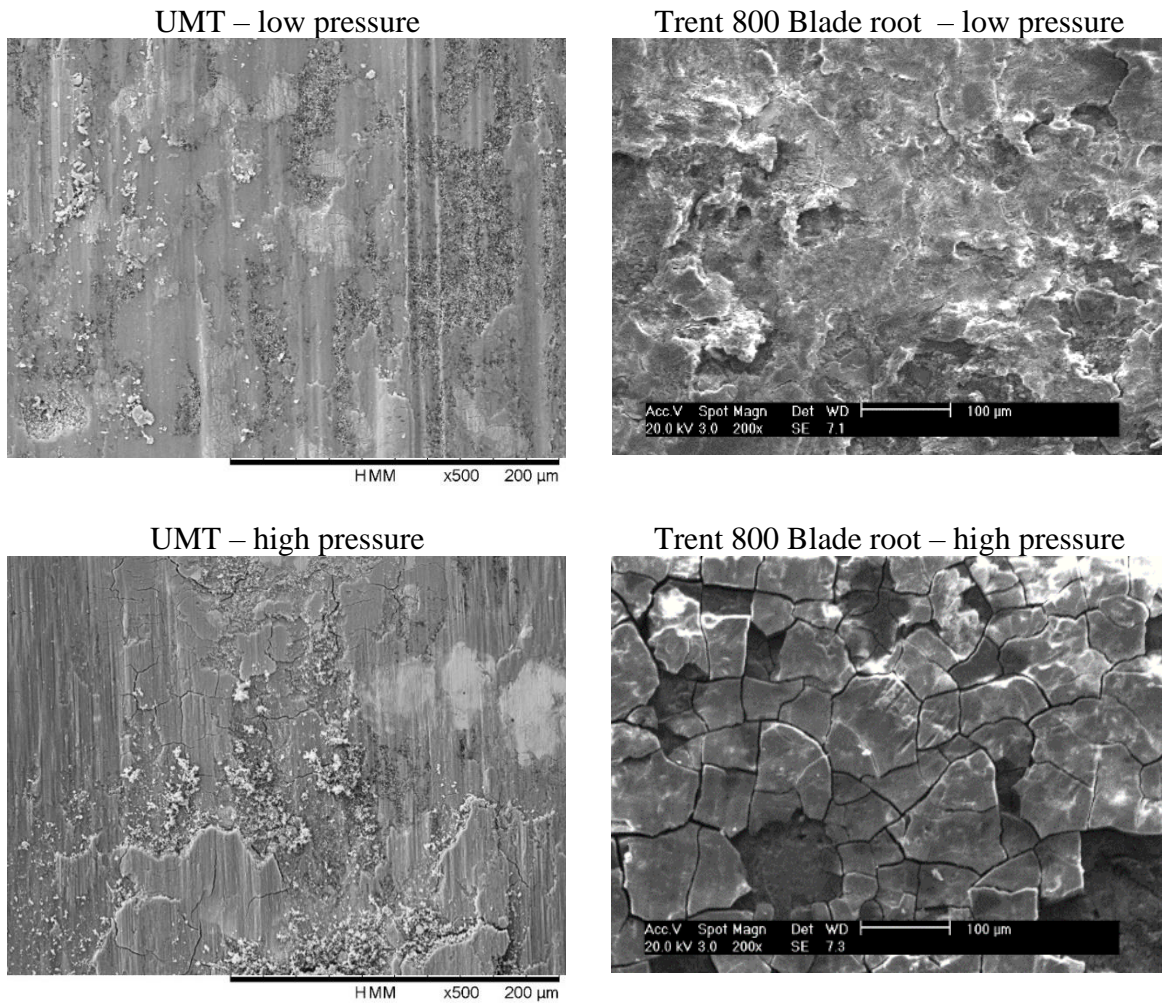
Figure 4-37: Comparison between UMT tests and Trent800 blade root surface. N.B. Images have different scales.

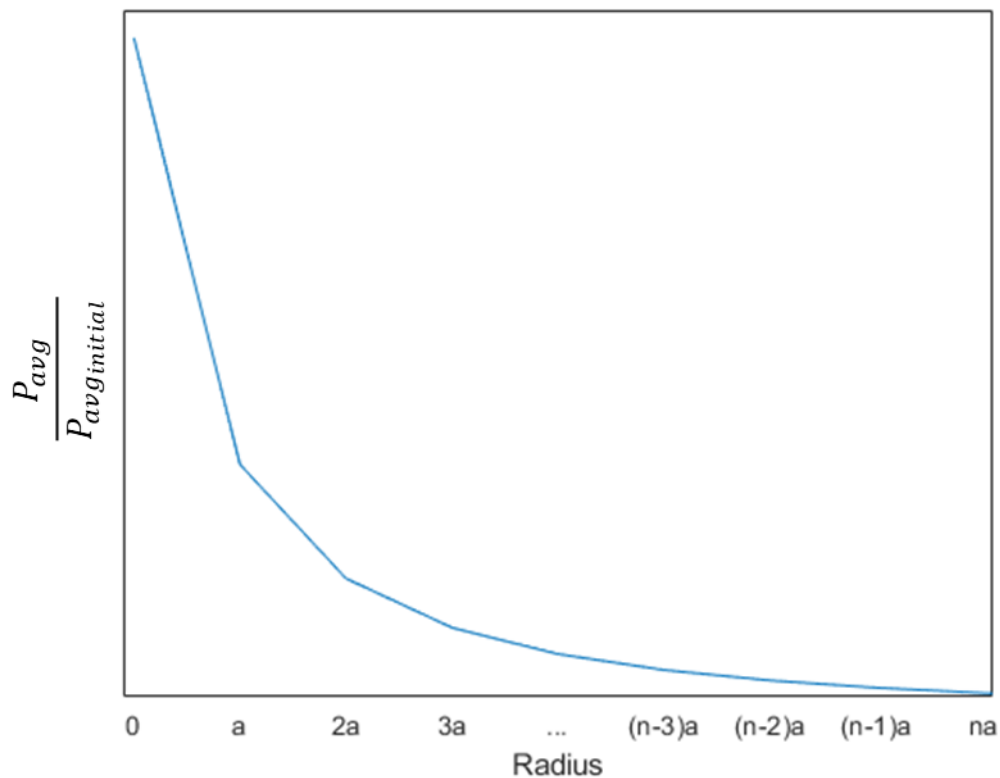
Figure 4-39: Pressure drop as contact radius increases for a ball-on-flat test

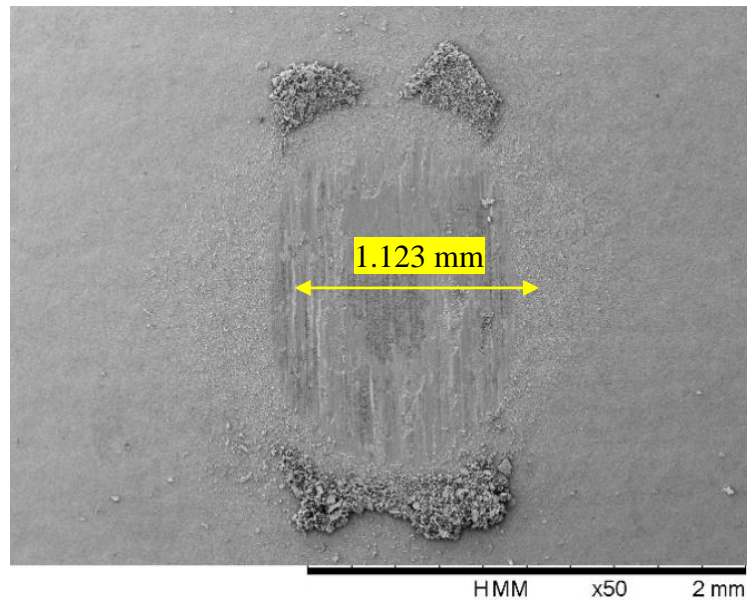
Figure 4-45: Approximate measurement of Fithe wear scar width

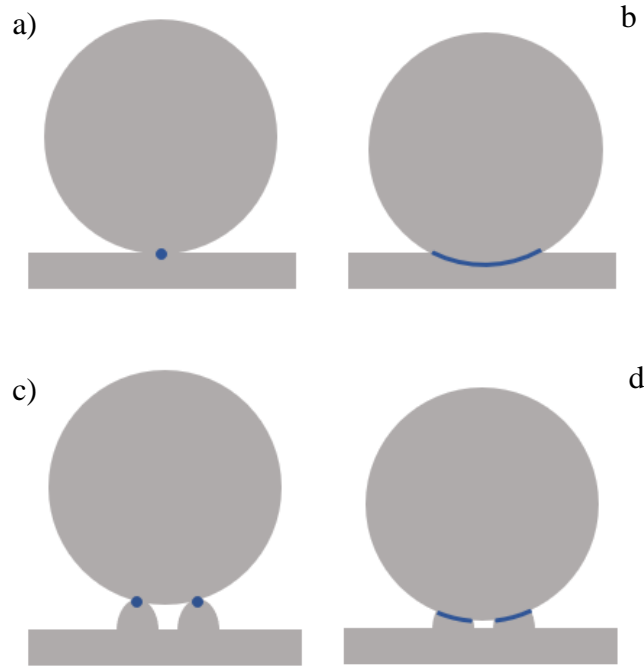
Figure 4-46: Schematics of the contact area change due to wear. a) Flat surface before wear, b) Flat surface after wear, c) Wavy surface before wear, d) Wavy surface after wear

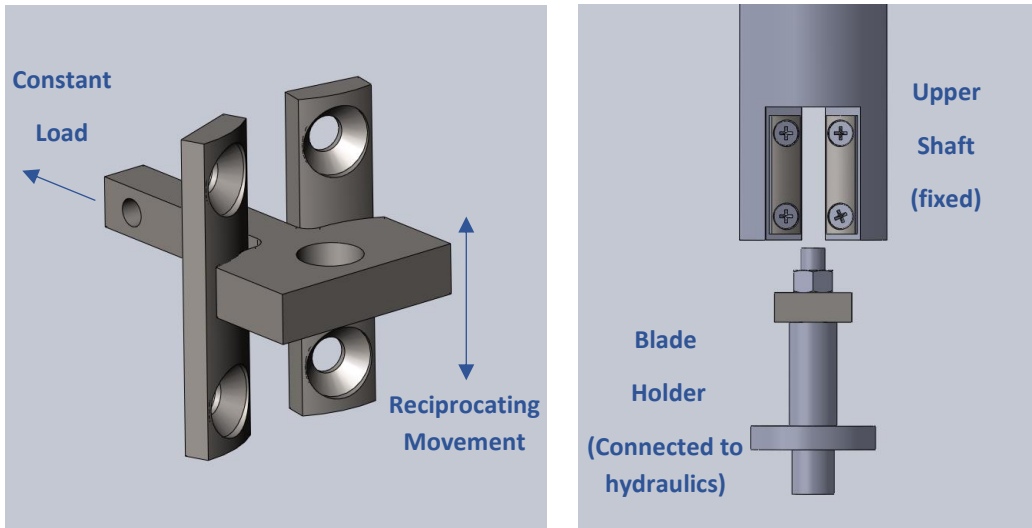
Figure 5-2 Specimens loading and relative movement (left), specimen connections (right)

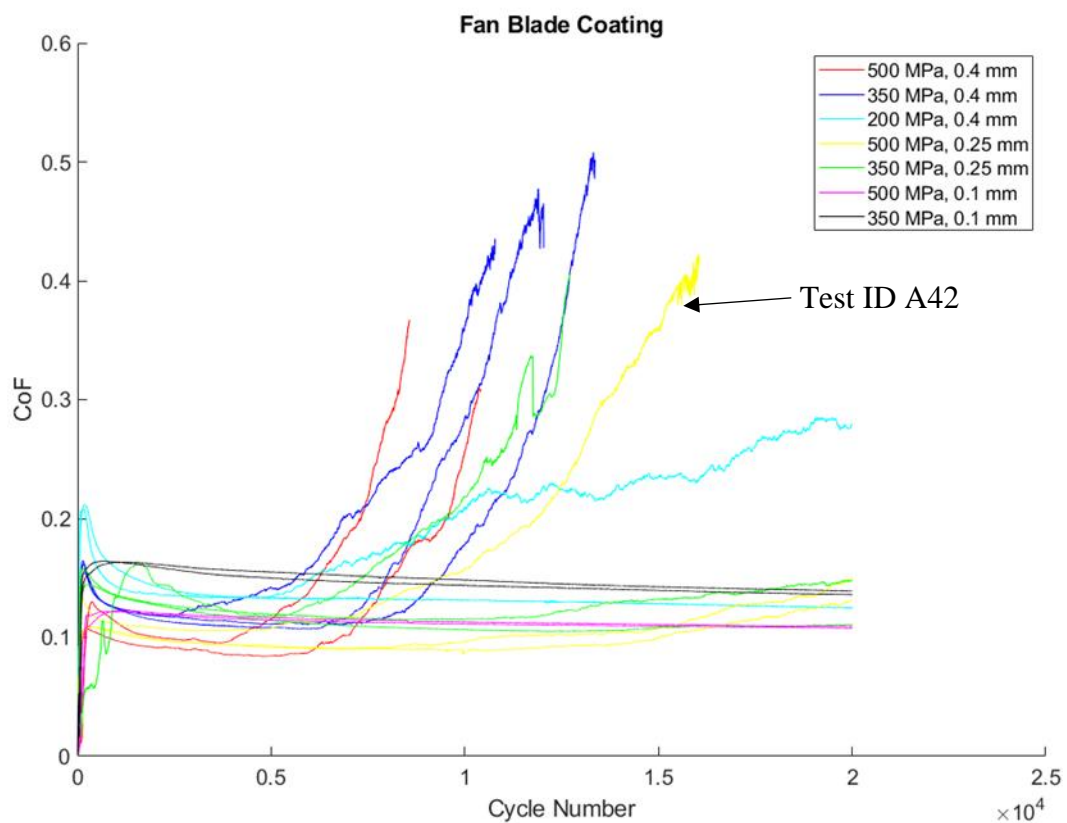
Figure 5-8: CoF of the fan blade coating system tested on the SCITEK rig tested by RR

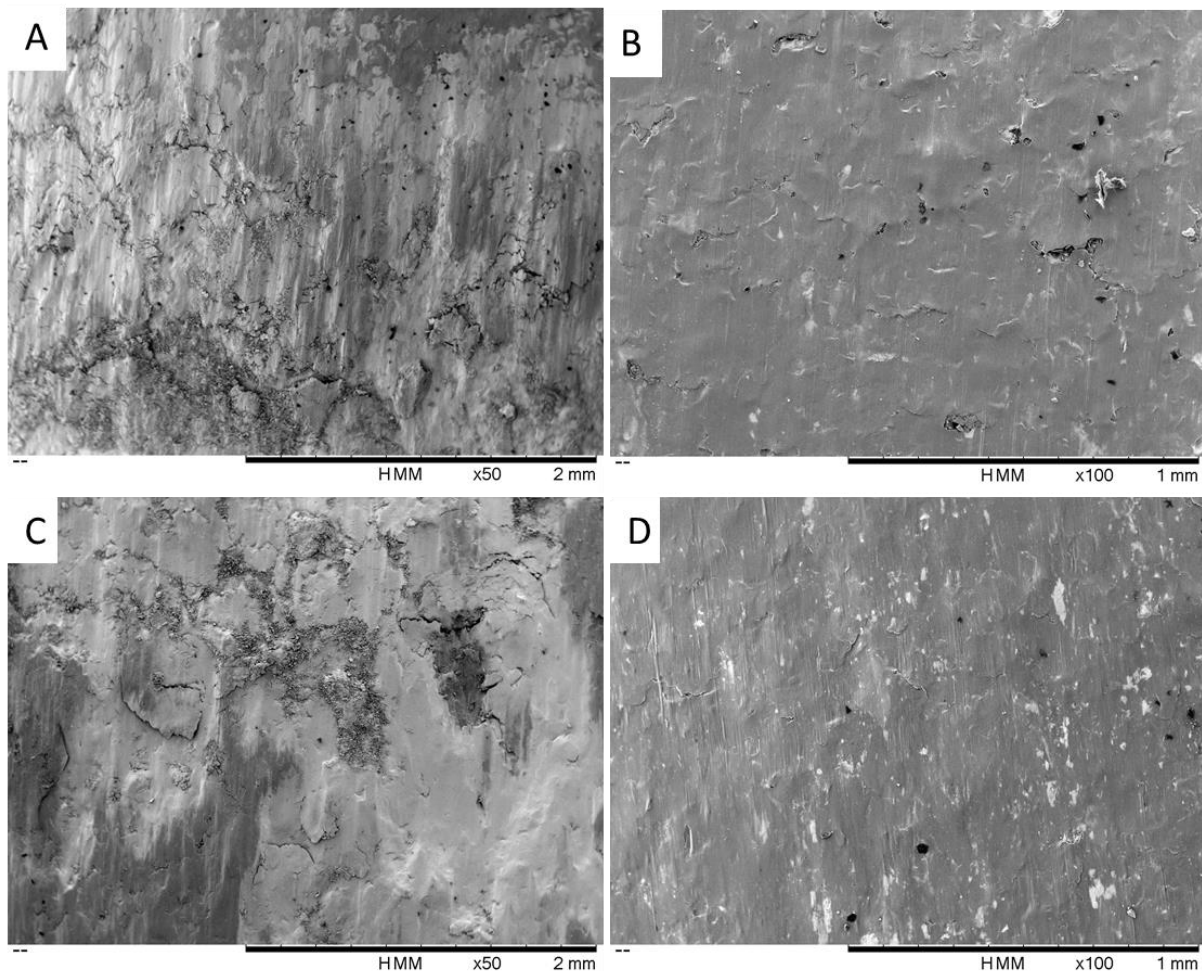
Figure 5-9: Contact pressure = 500 MPa, displacement = 0.250 mm A) Test ID 42 left specimen B) Test ID 43 left specimen, Contact pressure = 500 MPa, displacement = 0.250 mm C) Test ID 53 right specimen, D) Test ID 52 right specimen

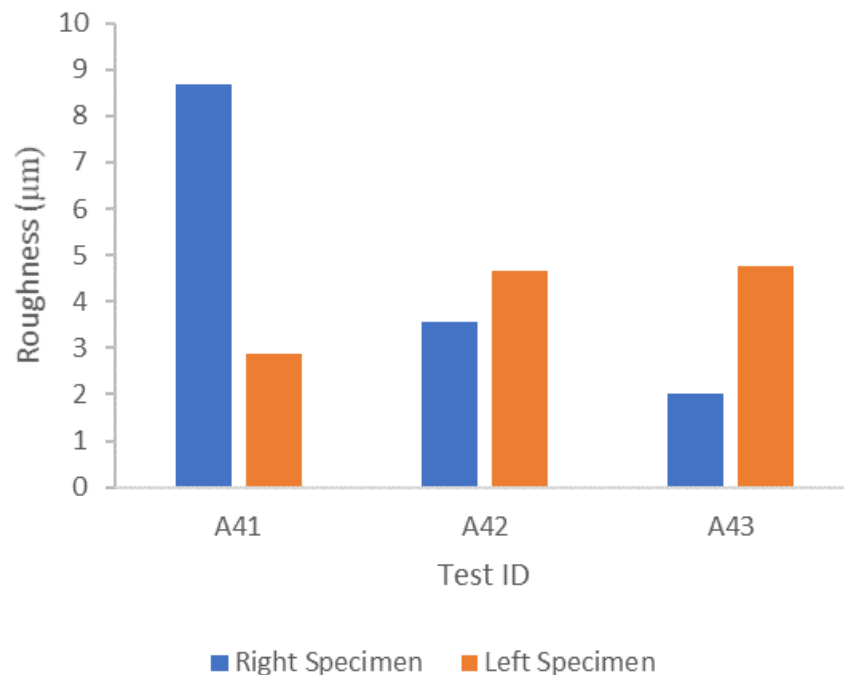
Figure 5-10: Roughness of the Left and Right specimens for Contact pressure = 500 MPa, displacement = 0.250 mm

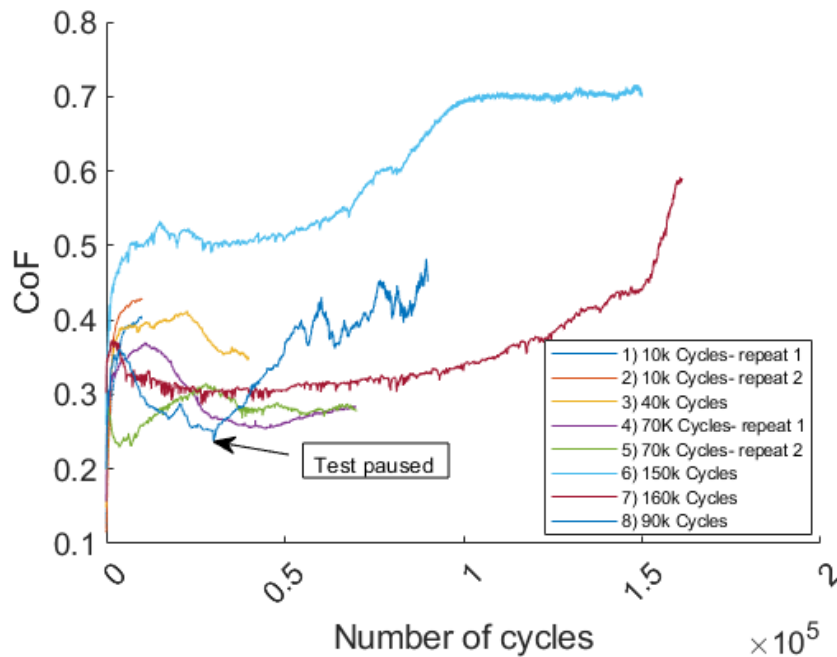
Figure 5-12: CoF evolution, nominal contact pressure 300 MPa, displacement amplitude 150  $\mu\text{m}$

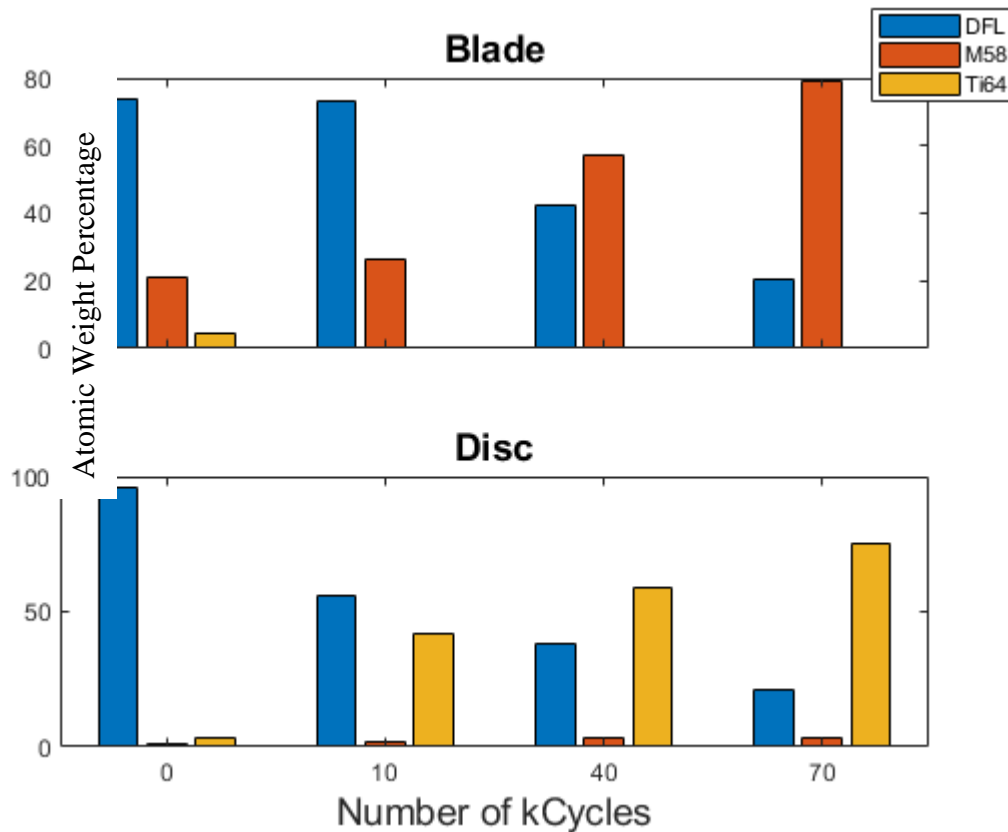
Figure 5-18: XRF averaged results for disc and compressor

Figure 6-9: Atomic weight percentages from Figure 5-18

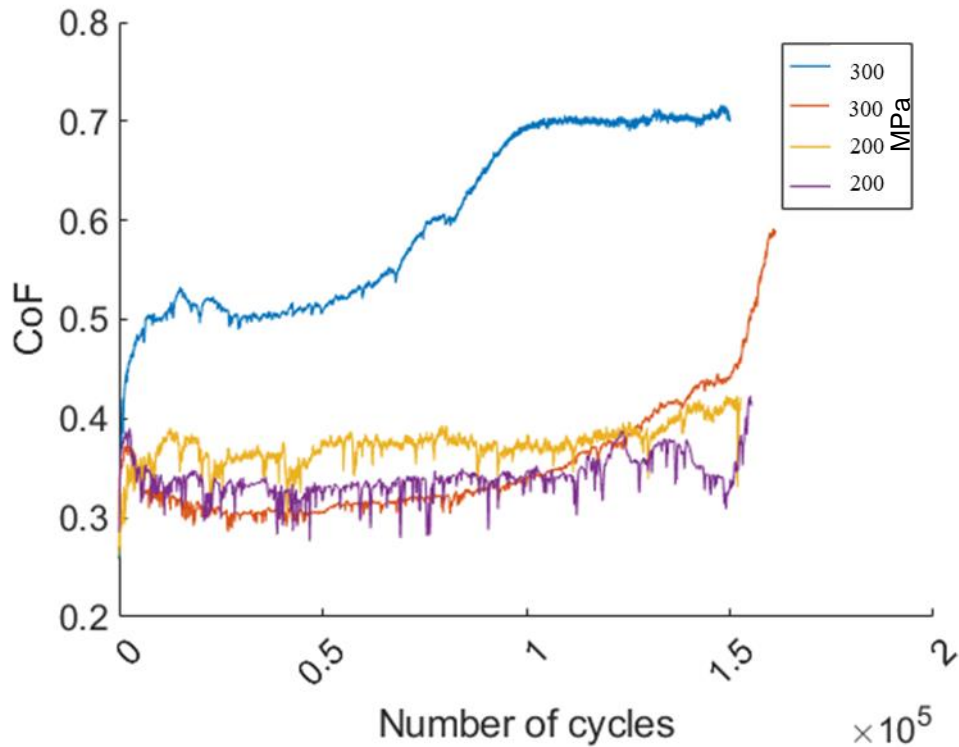
Figure 5-20: CoF evolution for 160k cycles for two different contact pressures

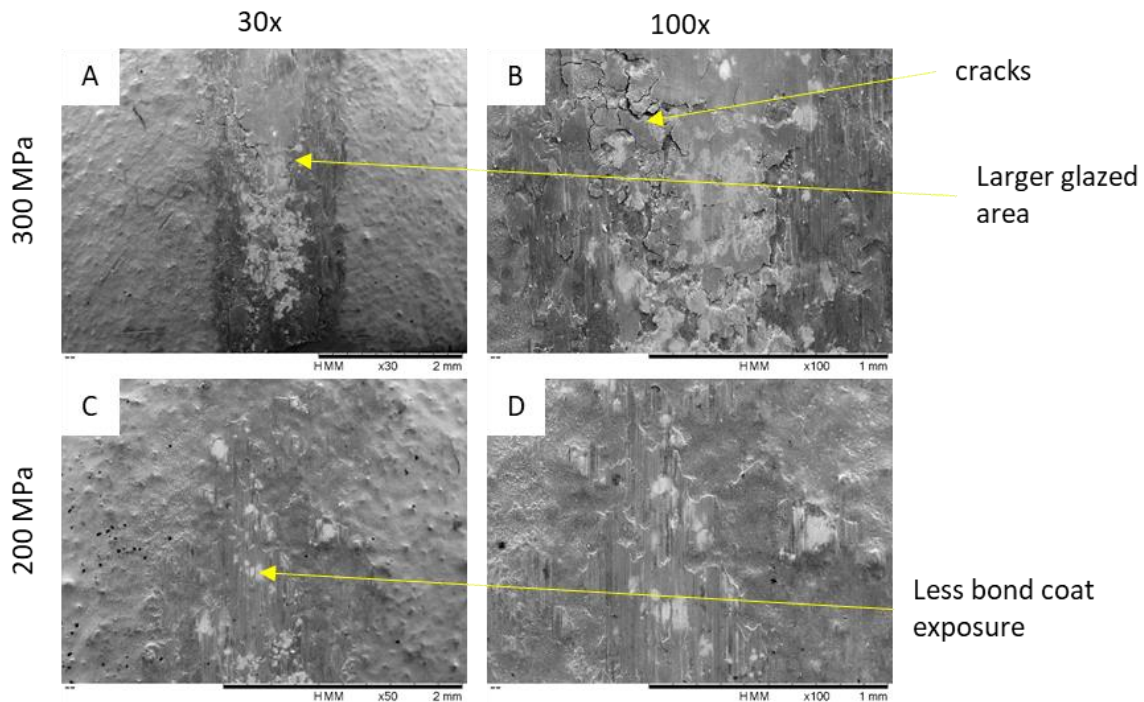
Figure 5-21: SEM images for the blade specimen for the test results shown in Figure 5-20 A) 300 MPa, 30x magnification B) 300 MPa, 100x magnification C) 200 MPa, 30x magnification D) 200 MPa, 100x magnification

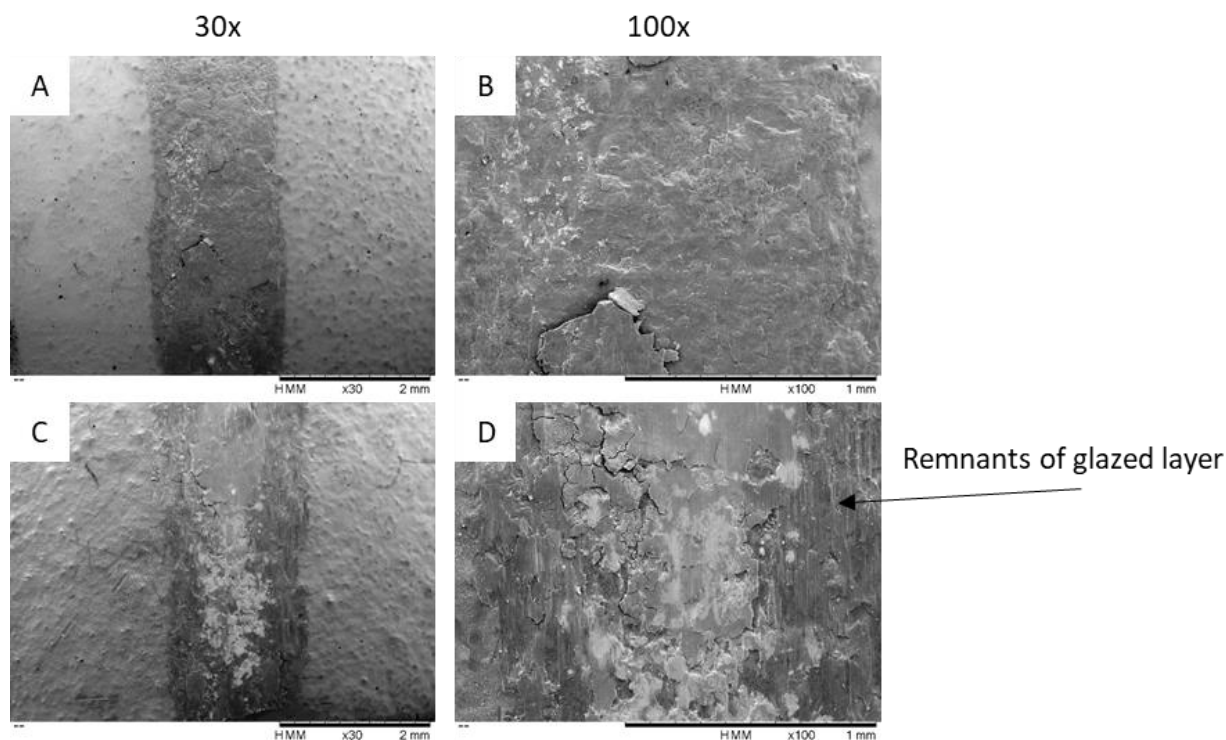
Figure 5-22: 160k tests from Figure 5-12, A) blue test 30x zoom, B) blue test 100x zoom, C) red test 30x zoom, D) red test 100x zoom

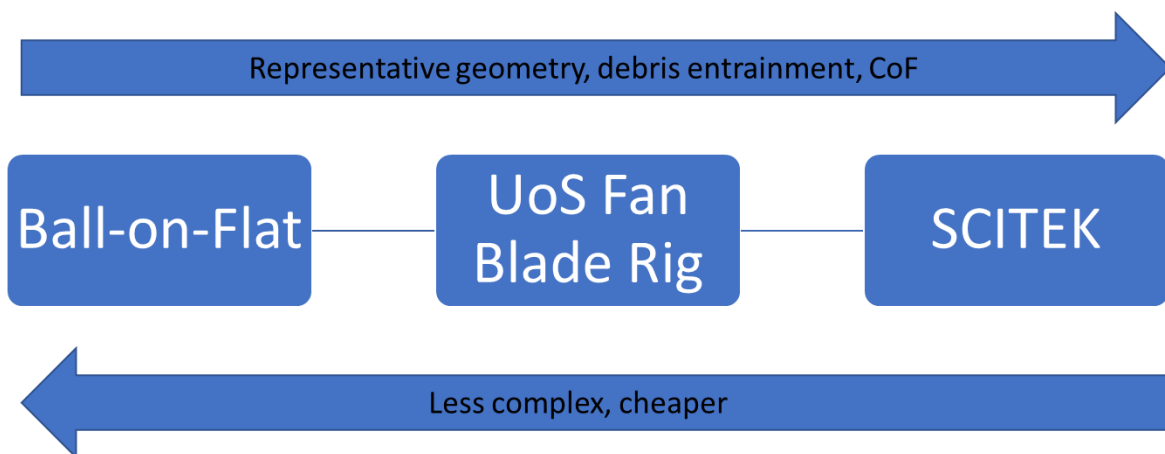
Figure 5-23: Summary of different test platforms advantages/disadvantages

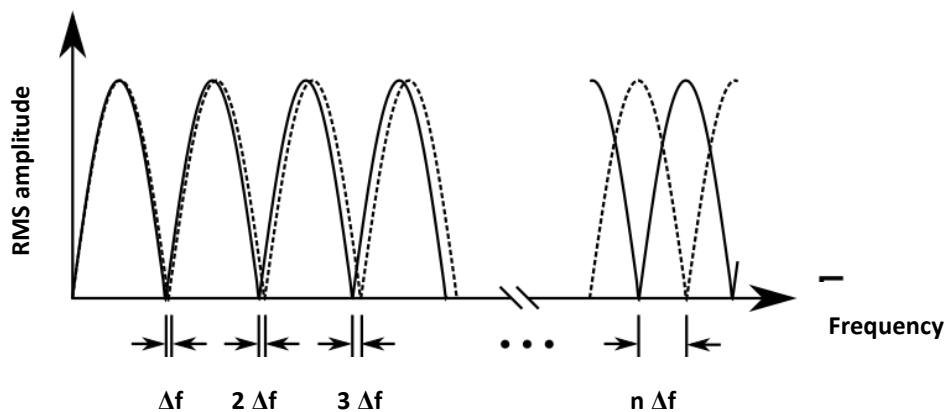
Figure 6-4: Comparison of frequency spectrums.
