**DEPARTMENT OF CIVIL AND STRUCTURAL ENGINEERING
UNIVERSITY OF SHEFFIELD**

**ASSESSMENT OF DETERIORATING POST-TENSIONED
CONCRETE BRIDGES**

**A thesis submitted to the University of Sheffield for the degree of
Doctor of Philosophy in the Faculty of Engineering**

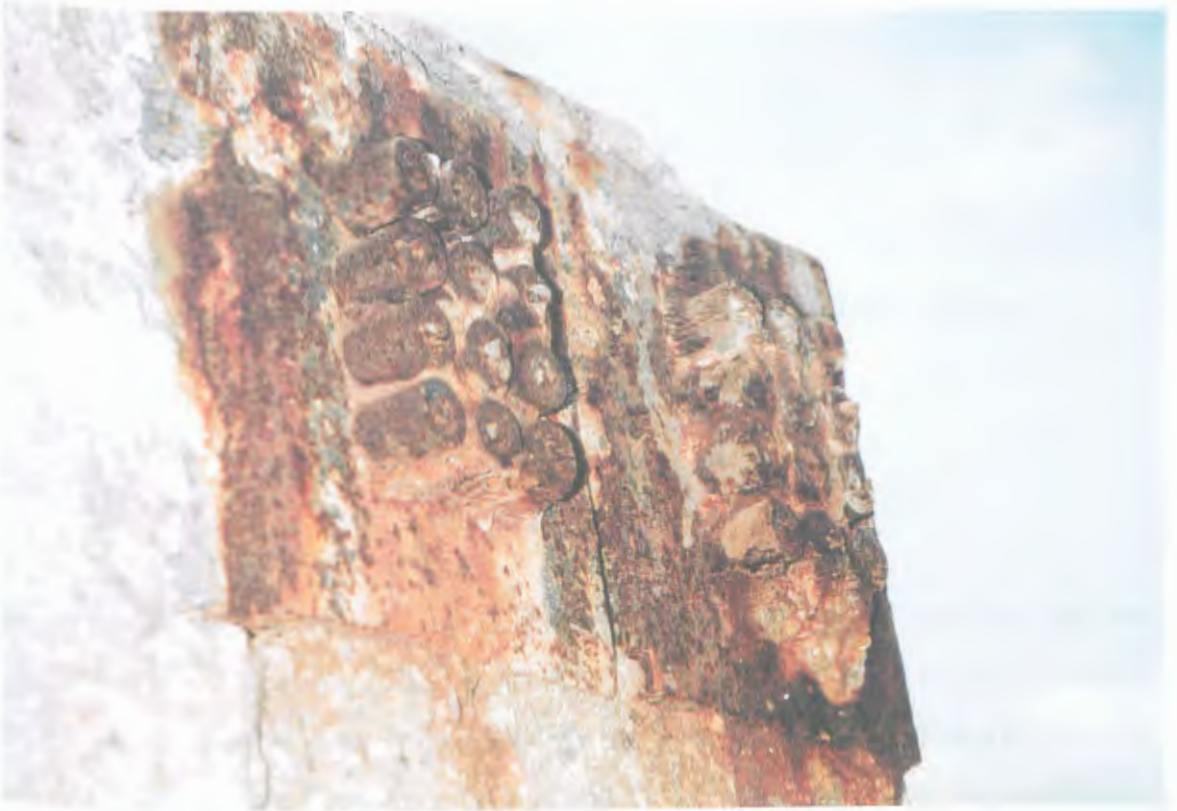
Plate 3.3 Severely corroded collets at the anchorage plate

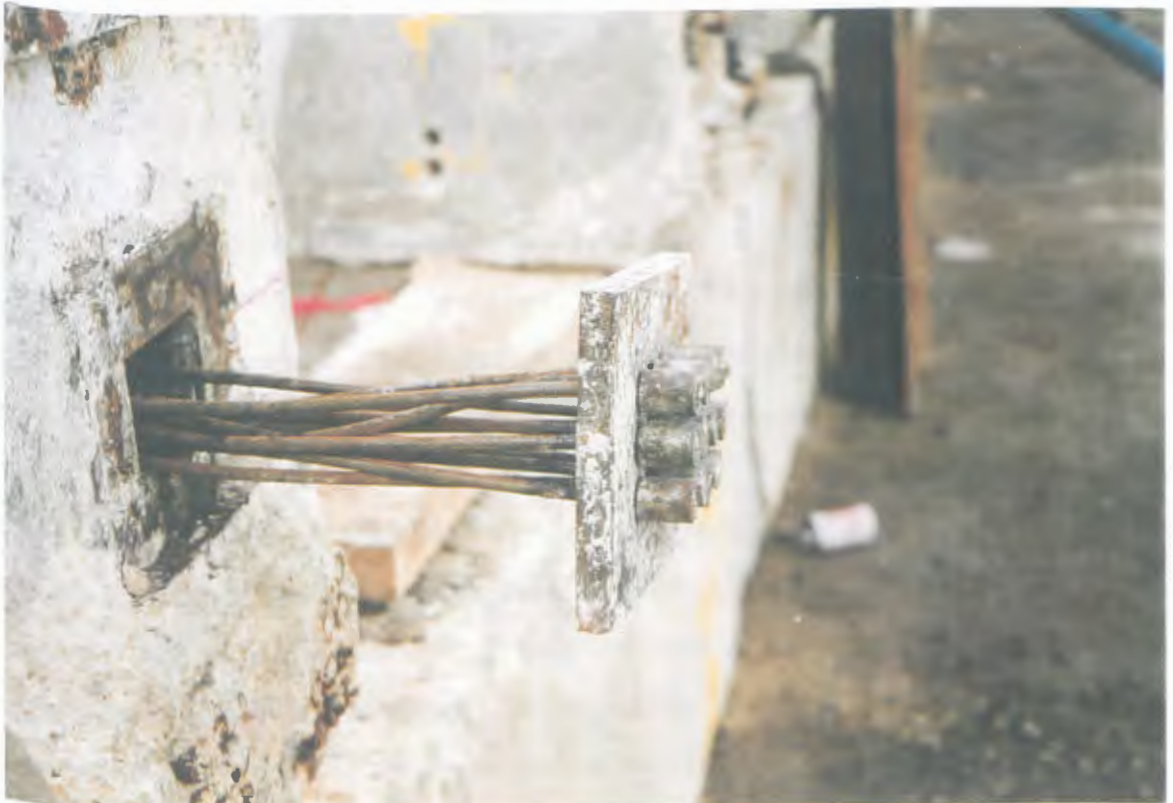
Plate 3.4 Condition at anchorage of one of the Botley beams, showing ungrouted wires

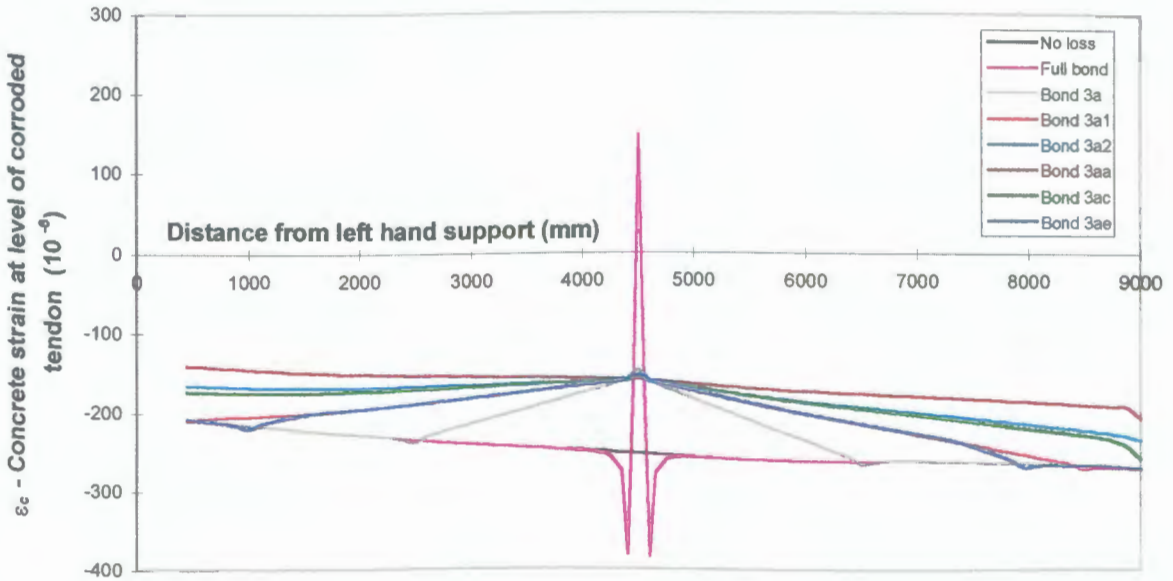
Figure 4.30 Concrete strain increase along level of corroded tendon as a result of cutting Tendon D
