DEPARTMENT OF MECHANICAL ENGINEERING  
THESIS SUBMITTED FOR THE DEGREE OF DOCTOR OF PHILOSOPHY

**An assessment of railway freight axle  
corrosion damage, considering current  
conditions and predicted future  
development**

PHILIP JAMES SHARPLES

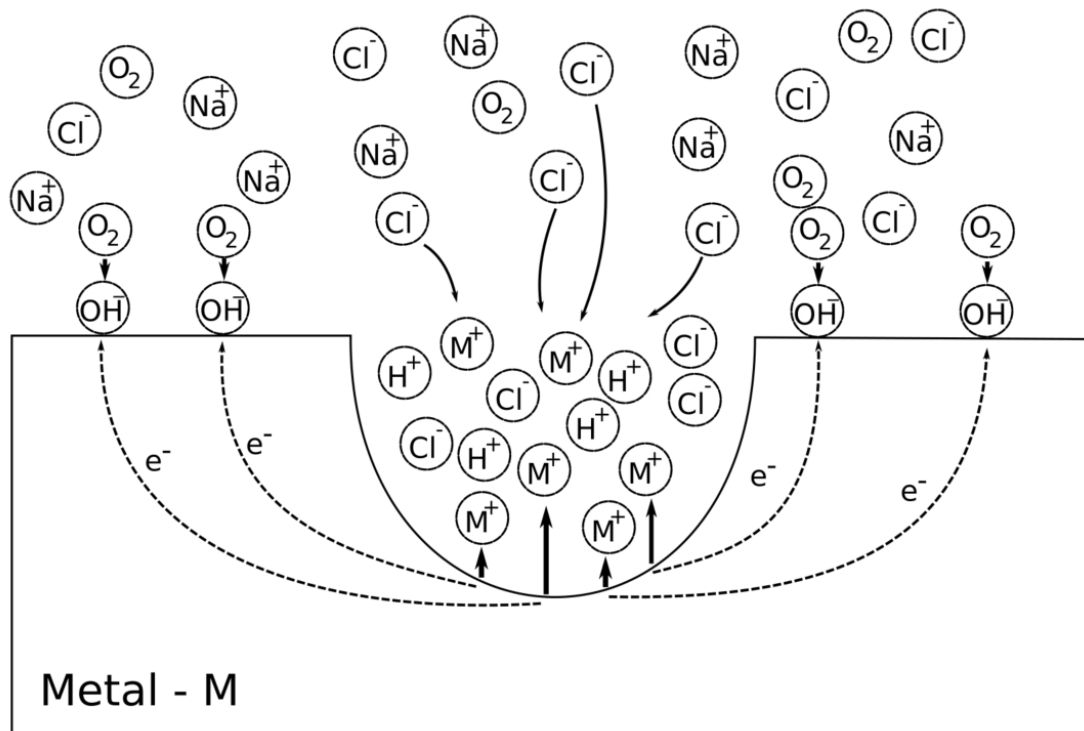
Pits tend to grow in the direction of gravity [20], the auto-catalytic nature of pitting requires a concentration of dense solutions that is most stable in this direction. Pitting also tends to occur with a stationary electrolyte, as before a pit forms any flow can sweep away concentrations of the required ions to form one [18]. These last two points are of particular interest in reference to spinning railway axles, as this will change the relative direction that gravity acts within the pit, and may ensure a moving electrolyte.

Figure 2.8: Autocatalytic processes in a corrosion pit

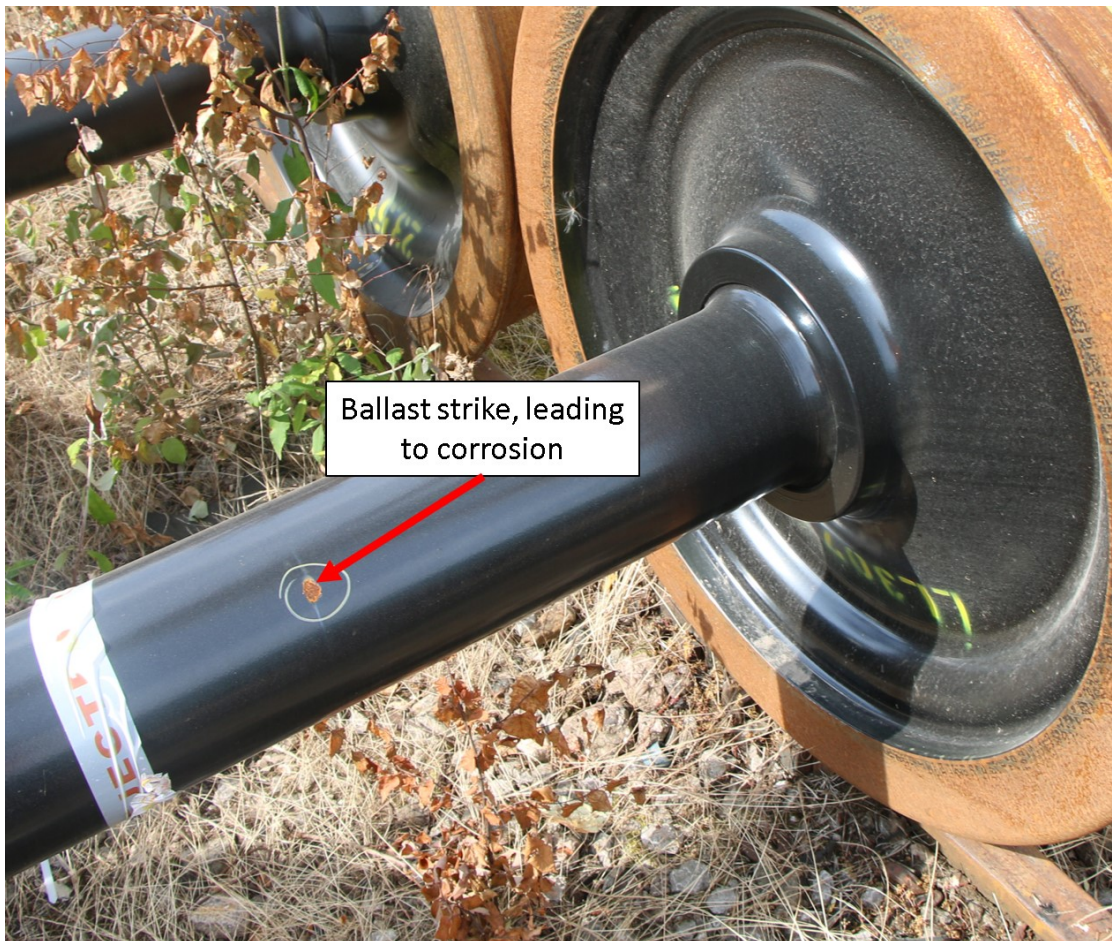
Ballast strikes are a well-known example of a process which can cause breaks in the protective paint layer, as well as significant damage to the rest of the underside of the vehicle. The ballast is able to strike the underside of the locomotive, including the axles, due to the creation of aerodynamic lift by the locomotive passing above it, and potentially aided by ground based vibrations [27]. This phenomenon has become more of a problem as the speeds on tracks have increased [27]. One survey showed that around 30% of high speed train axles exhibit this damage, while only 5% of other axles do [28]. This 5% figure is supported by the depot visits carried out as part of this project. An example of how localised this can be seen in Figure 2.9. As expected by the source of the damage, ballast strikes can remove the protective paint layer from a very localised area on an otherwise well protected axle. This occurs mostly on the axle body as it makes up the largest exposed area of the axle.

Figure 2.9: Damage to the paint layer of an axle due to a ballast strike. Corrosion has already taken place in the unprotected areas

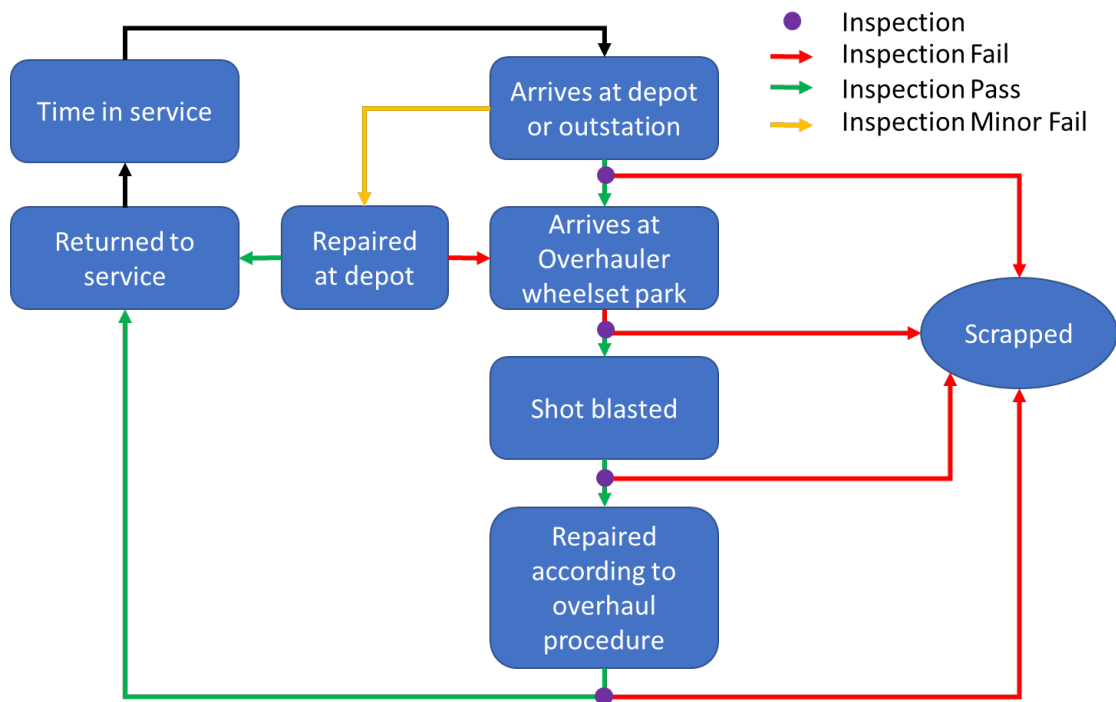
The flow of an axle through the maintenance process is described in Figure 2.18. There are different levels of inspection for the axles, with many being visual to check for obvious faults. The techniques used for inspection will be discussed later. An inspection fail involves the damage on the axle being deemed too extensive for the axle to be reclaimed under the terms of the maintenance plan relevant to the axle type. If scrapped the axle is sold for recycling.

Figure 2.18: Graphic showing the flow of axles through the maintenance process

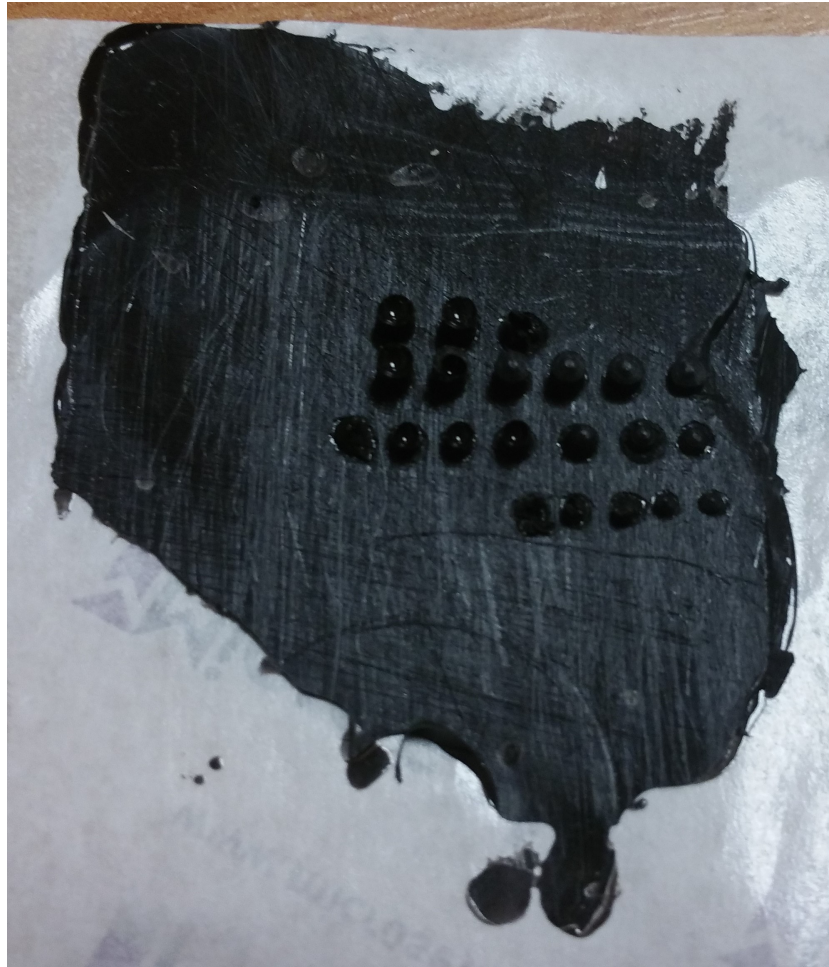
Figure 3.14: Example of a cast taken from the test sample using 101FF. Evidence of the air trapping issue can be seen at the tips of some of the columns

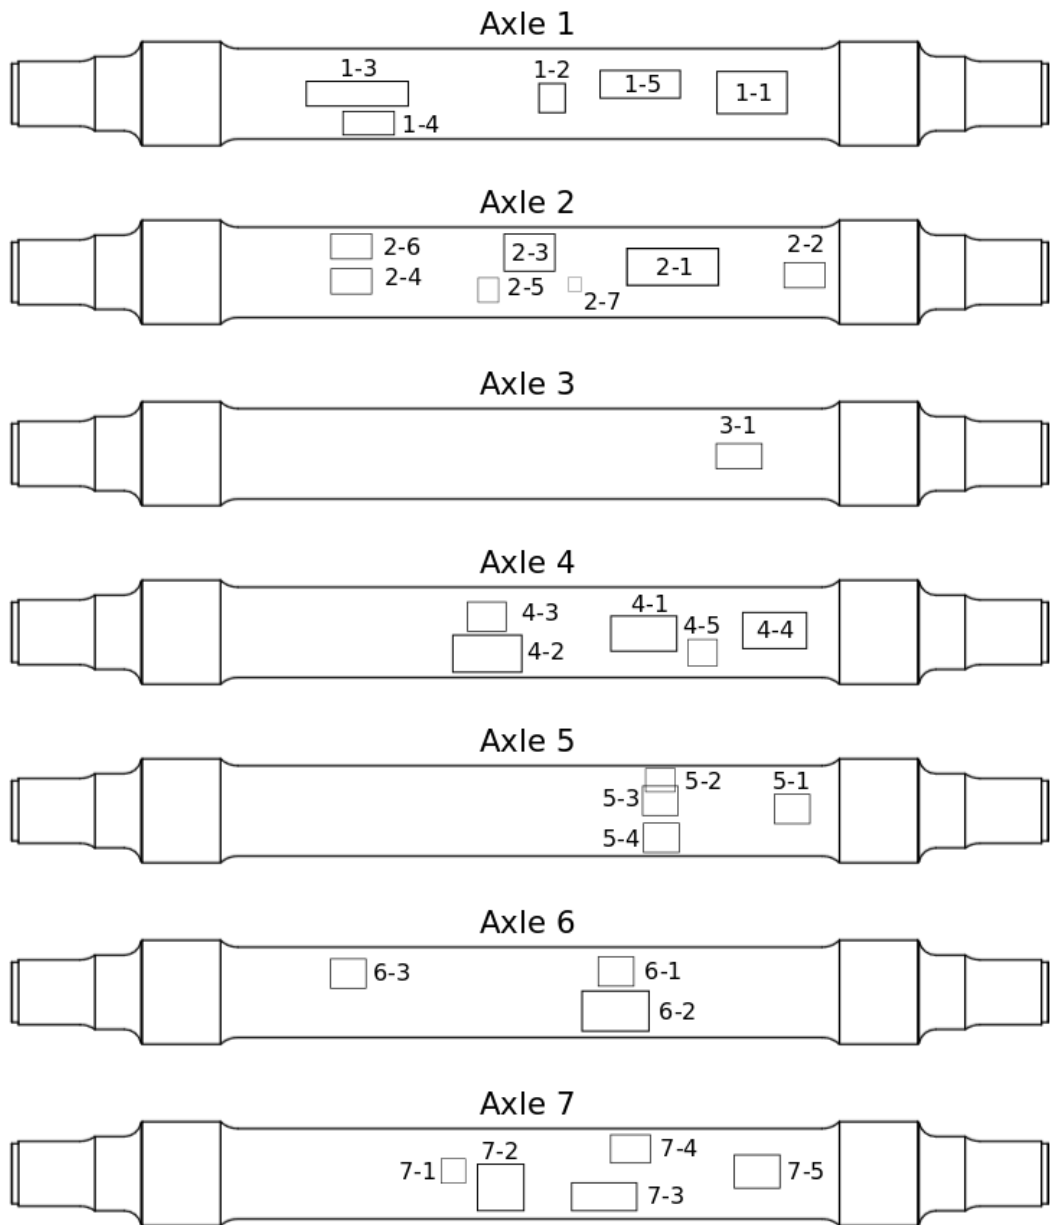
The sites selected for inspection were the areas identified by depot operators as exhibiting problematic damage. The areas identified were first cleaned by compressed air, to remove any dust or metal filings from the shot blasting process, then the replicating compound was applied and left to cure. The backing papers of the samples were numbered to ensure correct record keeping and photographs were taken. While taking photographs, small stickers of known size were placed next to the areas of corrosion to provide a reference size when analysing photographs later. The casts were then removed and packaged for return to the laboratory, an example of a cast can be seen in Figure 3.22.

Figure 3.21: Approximate locations of samples taken from axles

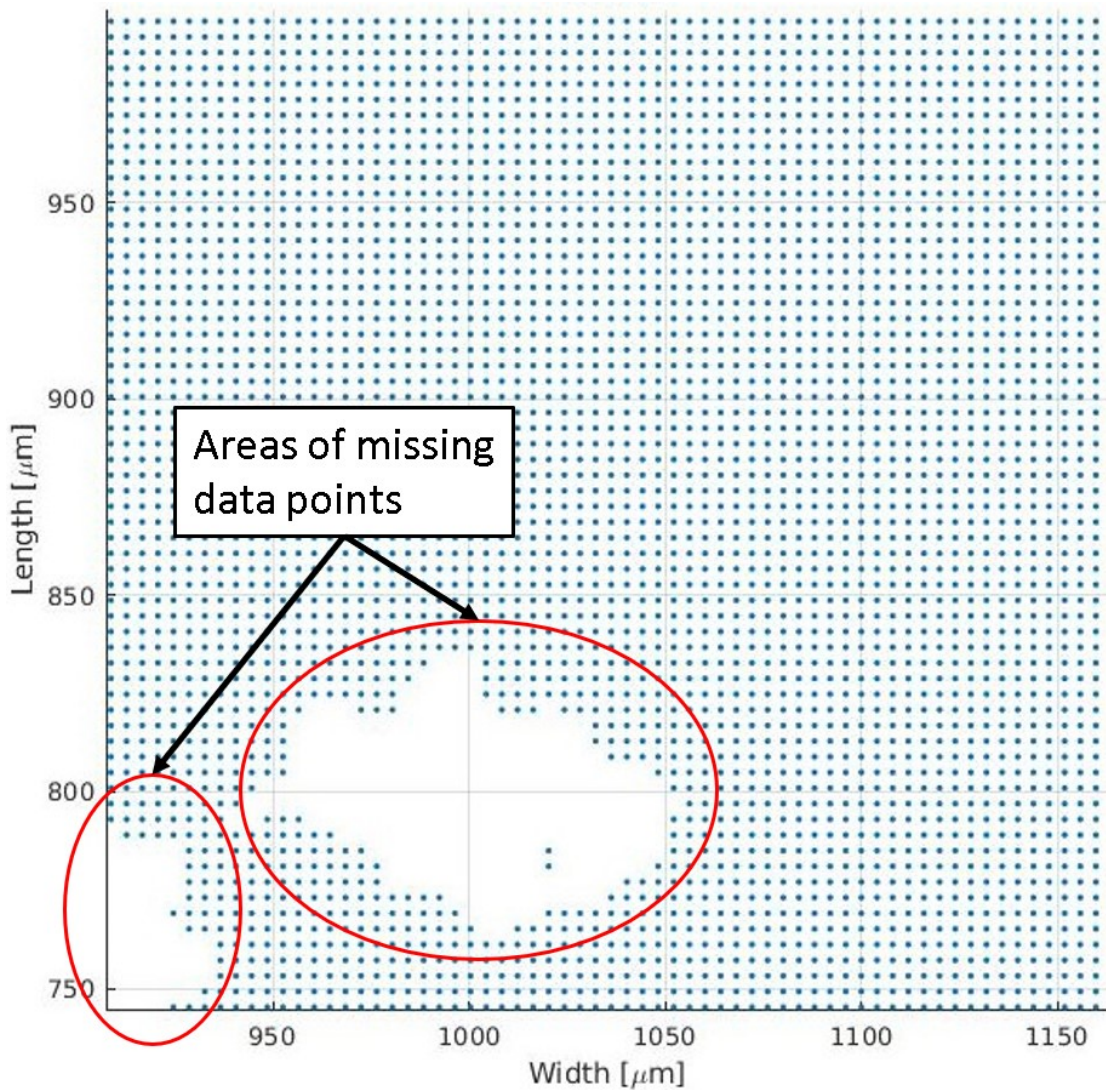
Linear interpolation of the nearest data points in the X axis and then the Y axis was used to fill in the missing data points. These two values were then averaged using the mean, to produce an approximate value. Any interpolated data point was flagged to ensure it could be tracked through any later processes.

Figure 3.24: An example of an area of missing data in a scanned region. Note the regular grid of data in the X and Y axis

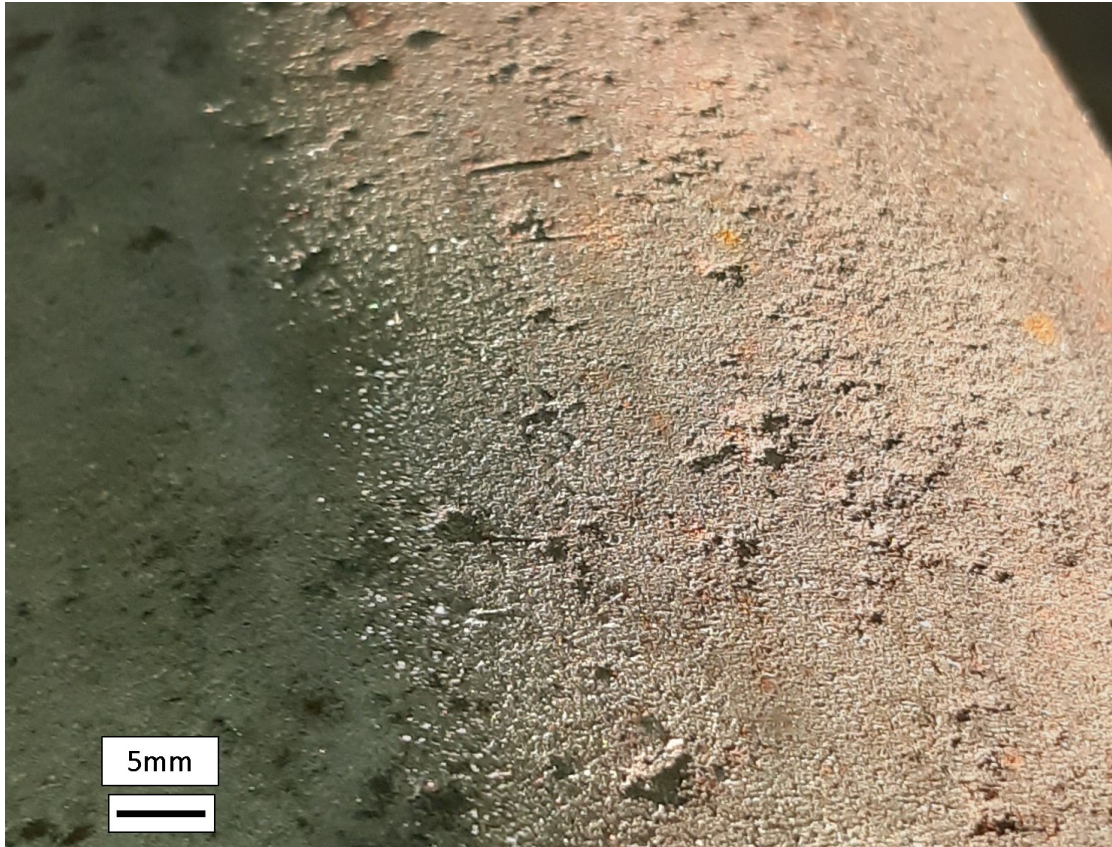
Figure 5.9: Image of the surface one of the donated axles, demonstrating visible corrosion damage

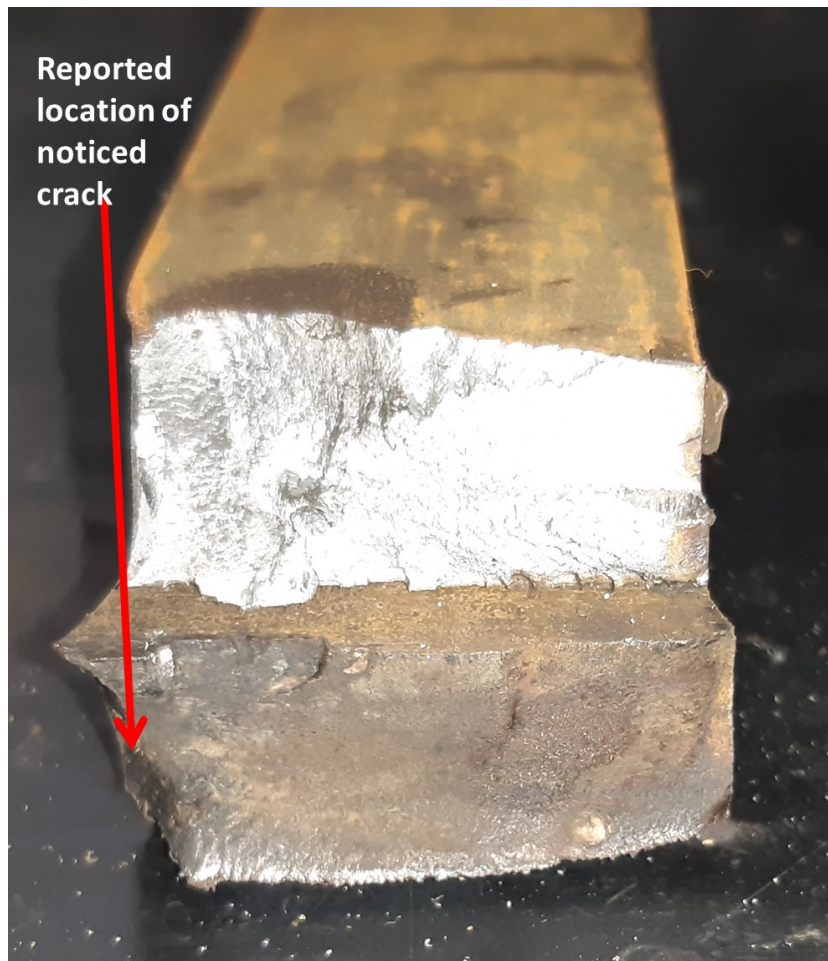
Figure 5.41: Close-up of upper fracture location

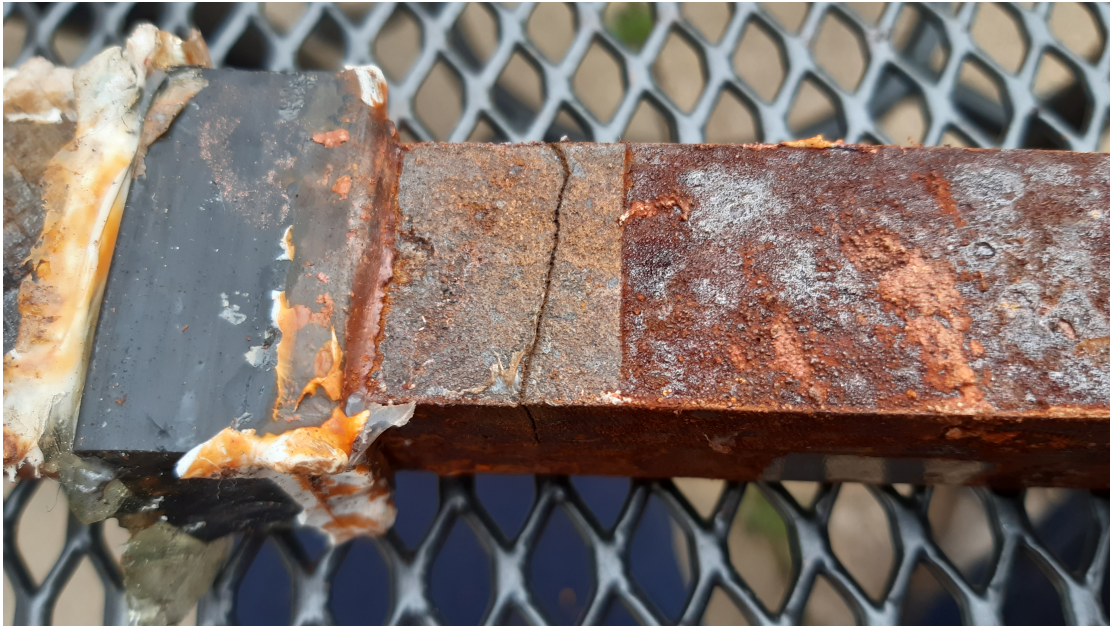
Figure 5.57: Crack that developed in one of the samples that contained the original axle surface

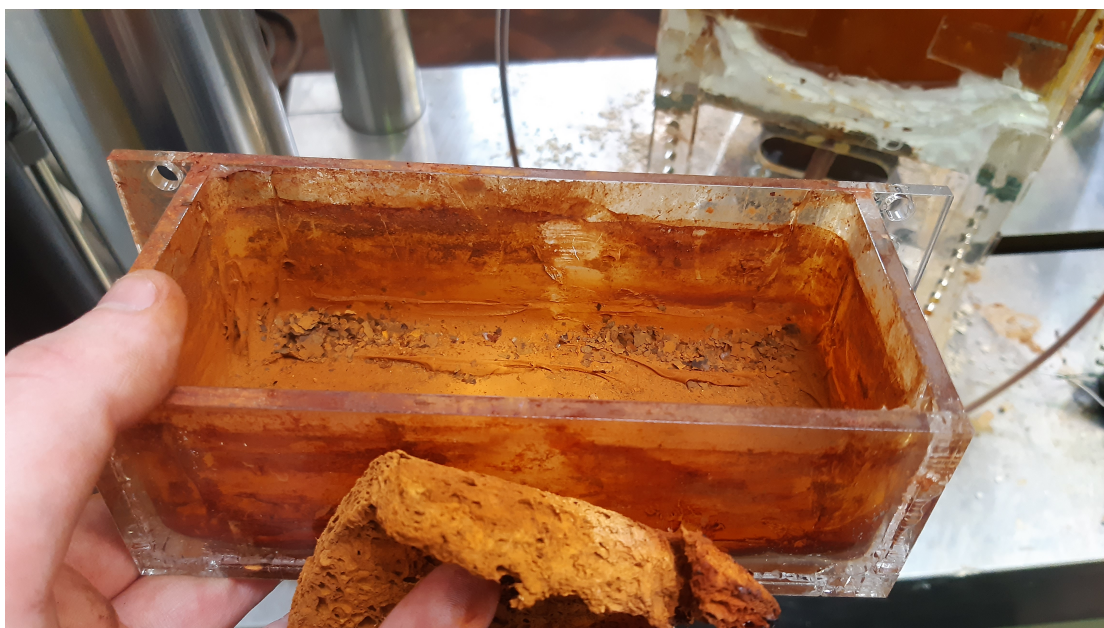
Figure 5.62: Larger sections of corrosion product that settled in the reservoirs, requiring the addition of a sponge to separate the outlets and inlets to prevent damaging the pumps
