Putting mud and stud in its place:
rediscovering the culture of Lincolnshire's
indigenous buildings, and exploring their
dwellingscapes

Jennifer Pape

MA by Research

University of York

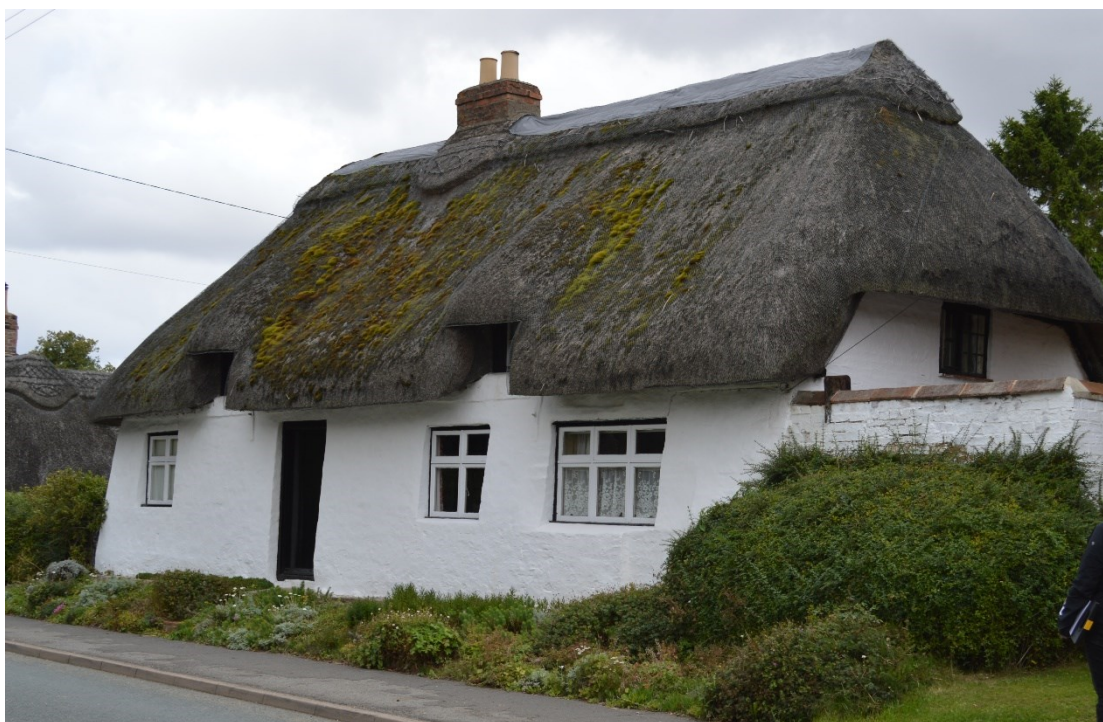
Fig. 1. A comparatively unaltered example of a mud and stud cottage (White Cottage, Thimbleby)

In the second largest county in England, a distinctive style of vernacular architecture developed and dominated the rural landscape over the course of hundreds of years, before being abandoned in the early decades of the nineteenth century (Fig. 1). Something in the order of 700 examples of ‘mud and stud’ buildings survive today, yet there has been almost no academic examination of this building culture. Consequently, the buildings are very poorly understood, and lack suitable statutory protection; hundreds of examples were lost in the twentieth century and they remain almost unprotected today.

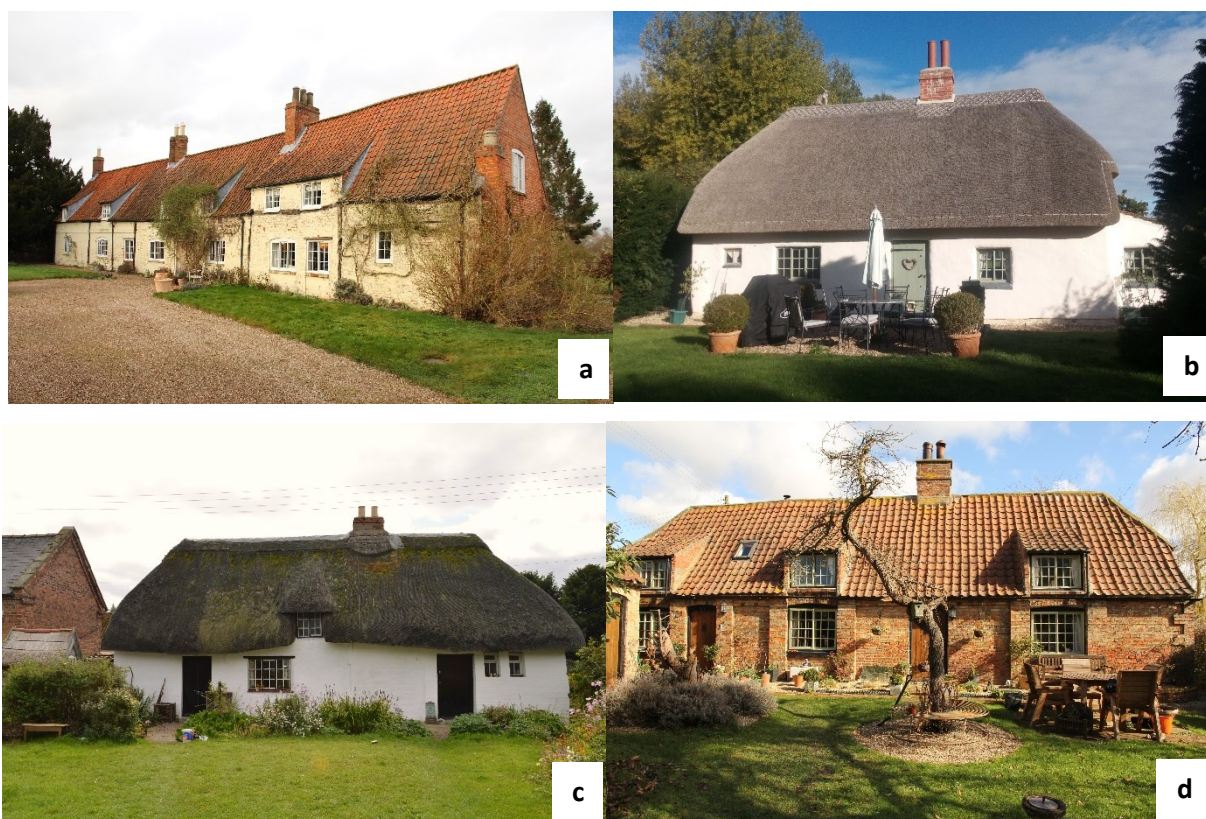
Fig. 4. Variety in mud and stud buildings in Lincolnshire
(a) Hop Hill Cottage, Aubourn, (b) The Cottage, Beesby, (c) White Cottage, Thimbleby,
(d) The Forge, South Willingham

Outshut extensions are common, as are later encasement in brick and re-roofing in pantile. Extant chimneystacks are generally axial and often associated with lobby entries, although gable stacks are also seen. In many buildings except those of late date, stacks are likely to be replacements for mud and stud smokehoods, which are attested into the eighteenth century (LAO DIOC/TER BUNDLE/LINCS/TOINTON ALL SAINTS 1707), with a few surviving today (pg. 67).

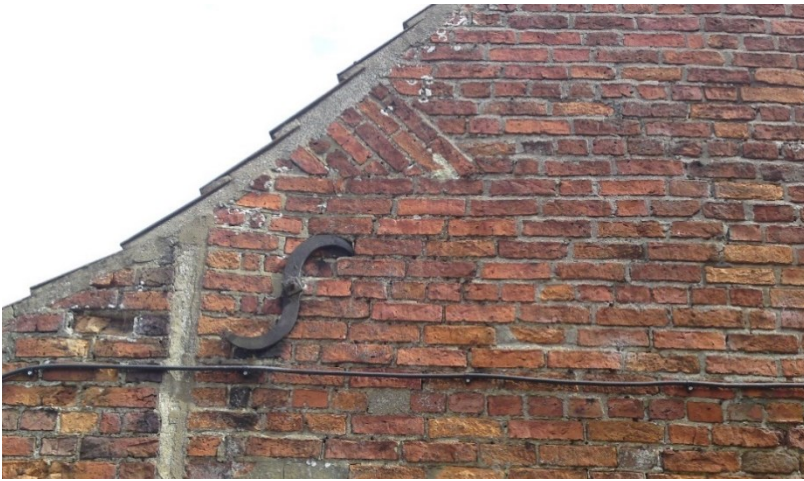
Fig. 10. The Cottage's western gable showing many repairs, but in early brick. Note the straight-line joint with the secondary outshut to the left (rear)

been identified in the villages, it seems unlikely that this clay-working population would buy them from elsewhere. Early, but undated, bricks appear in the western gable of The Cottage (Fig. 10); *if* these are truly early, they may be an ostentatious adoption of a high-status building material, perhaps when some were available from the kiln excavated a few metres further along Chapel Lane (HER MLI41033 1978).

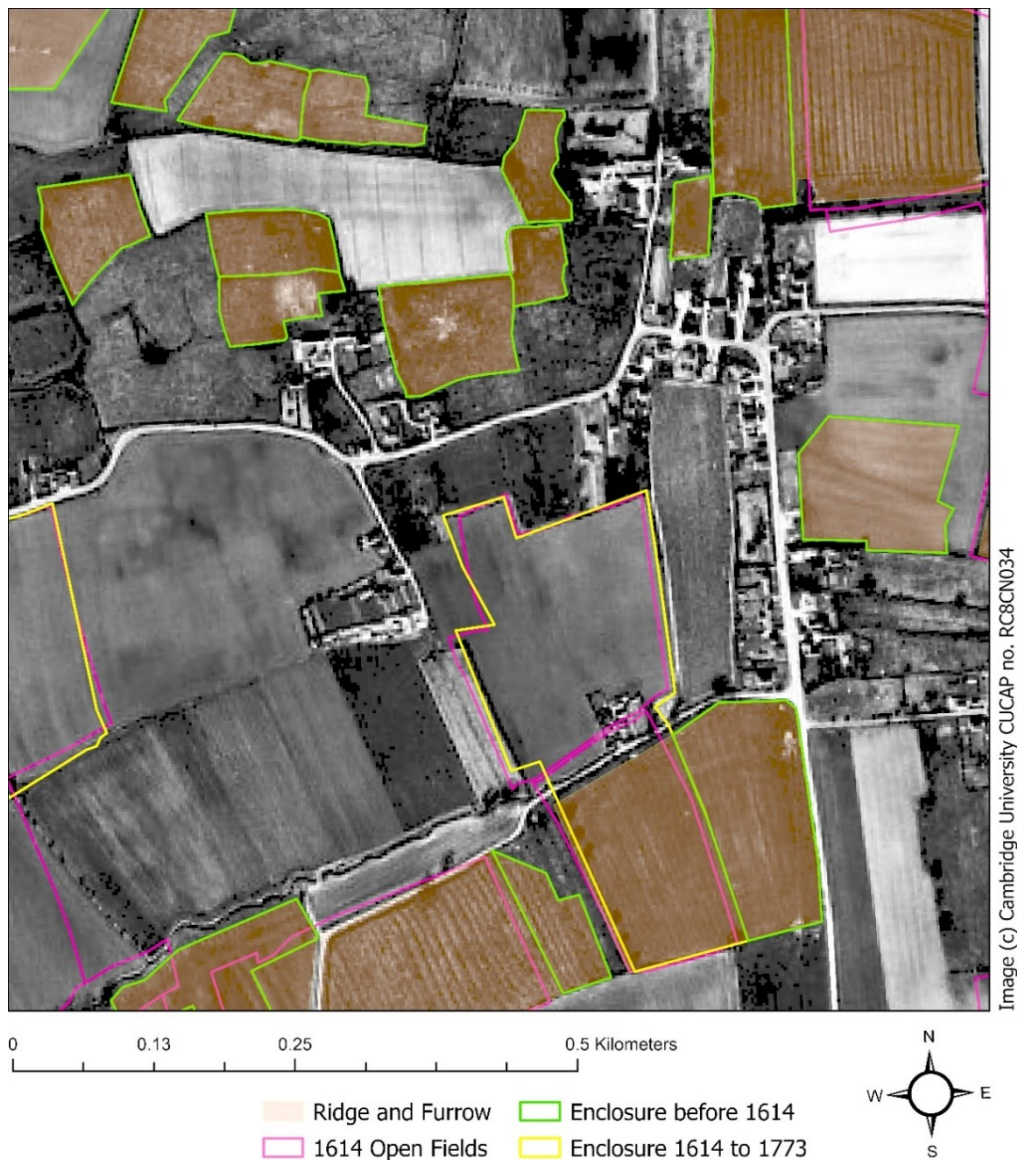
Fig. 11. 1978 aerial view of Toynton St Peter, overlaid with ridge and furrow visible on this image or the 2019 1m resolution Lidar. Also marked are the open fields as they were in 1614, and areas of former open field with their date of enclosure

Whatever caused this crash, it inevitably affected the housing in Toynton as demand reduced. In a number of closes – particularly in St Peter – surviving ridge and furrow shows that the land had originally been part of the open fields (Fig. 11). It is possible that, with the reduced population, some of the land nearest the village was quietly enclosed to reduce the burden of cultivation.⁹ Equally, the housing stock in Toynton reduced dramatically, from 127 houses recorded in 1614 down to 73 occupied at the 1663 Hearth Tax assessment; perhaps, even in 1614, many of the houses were unoccupied as a result of the 1590s’ population crash (PRO E179/333 1663).

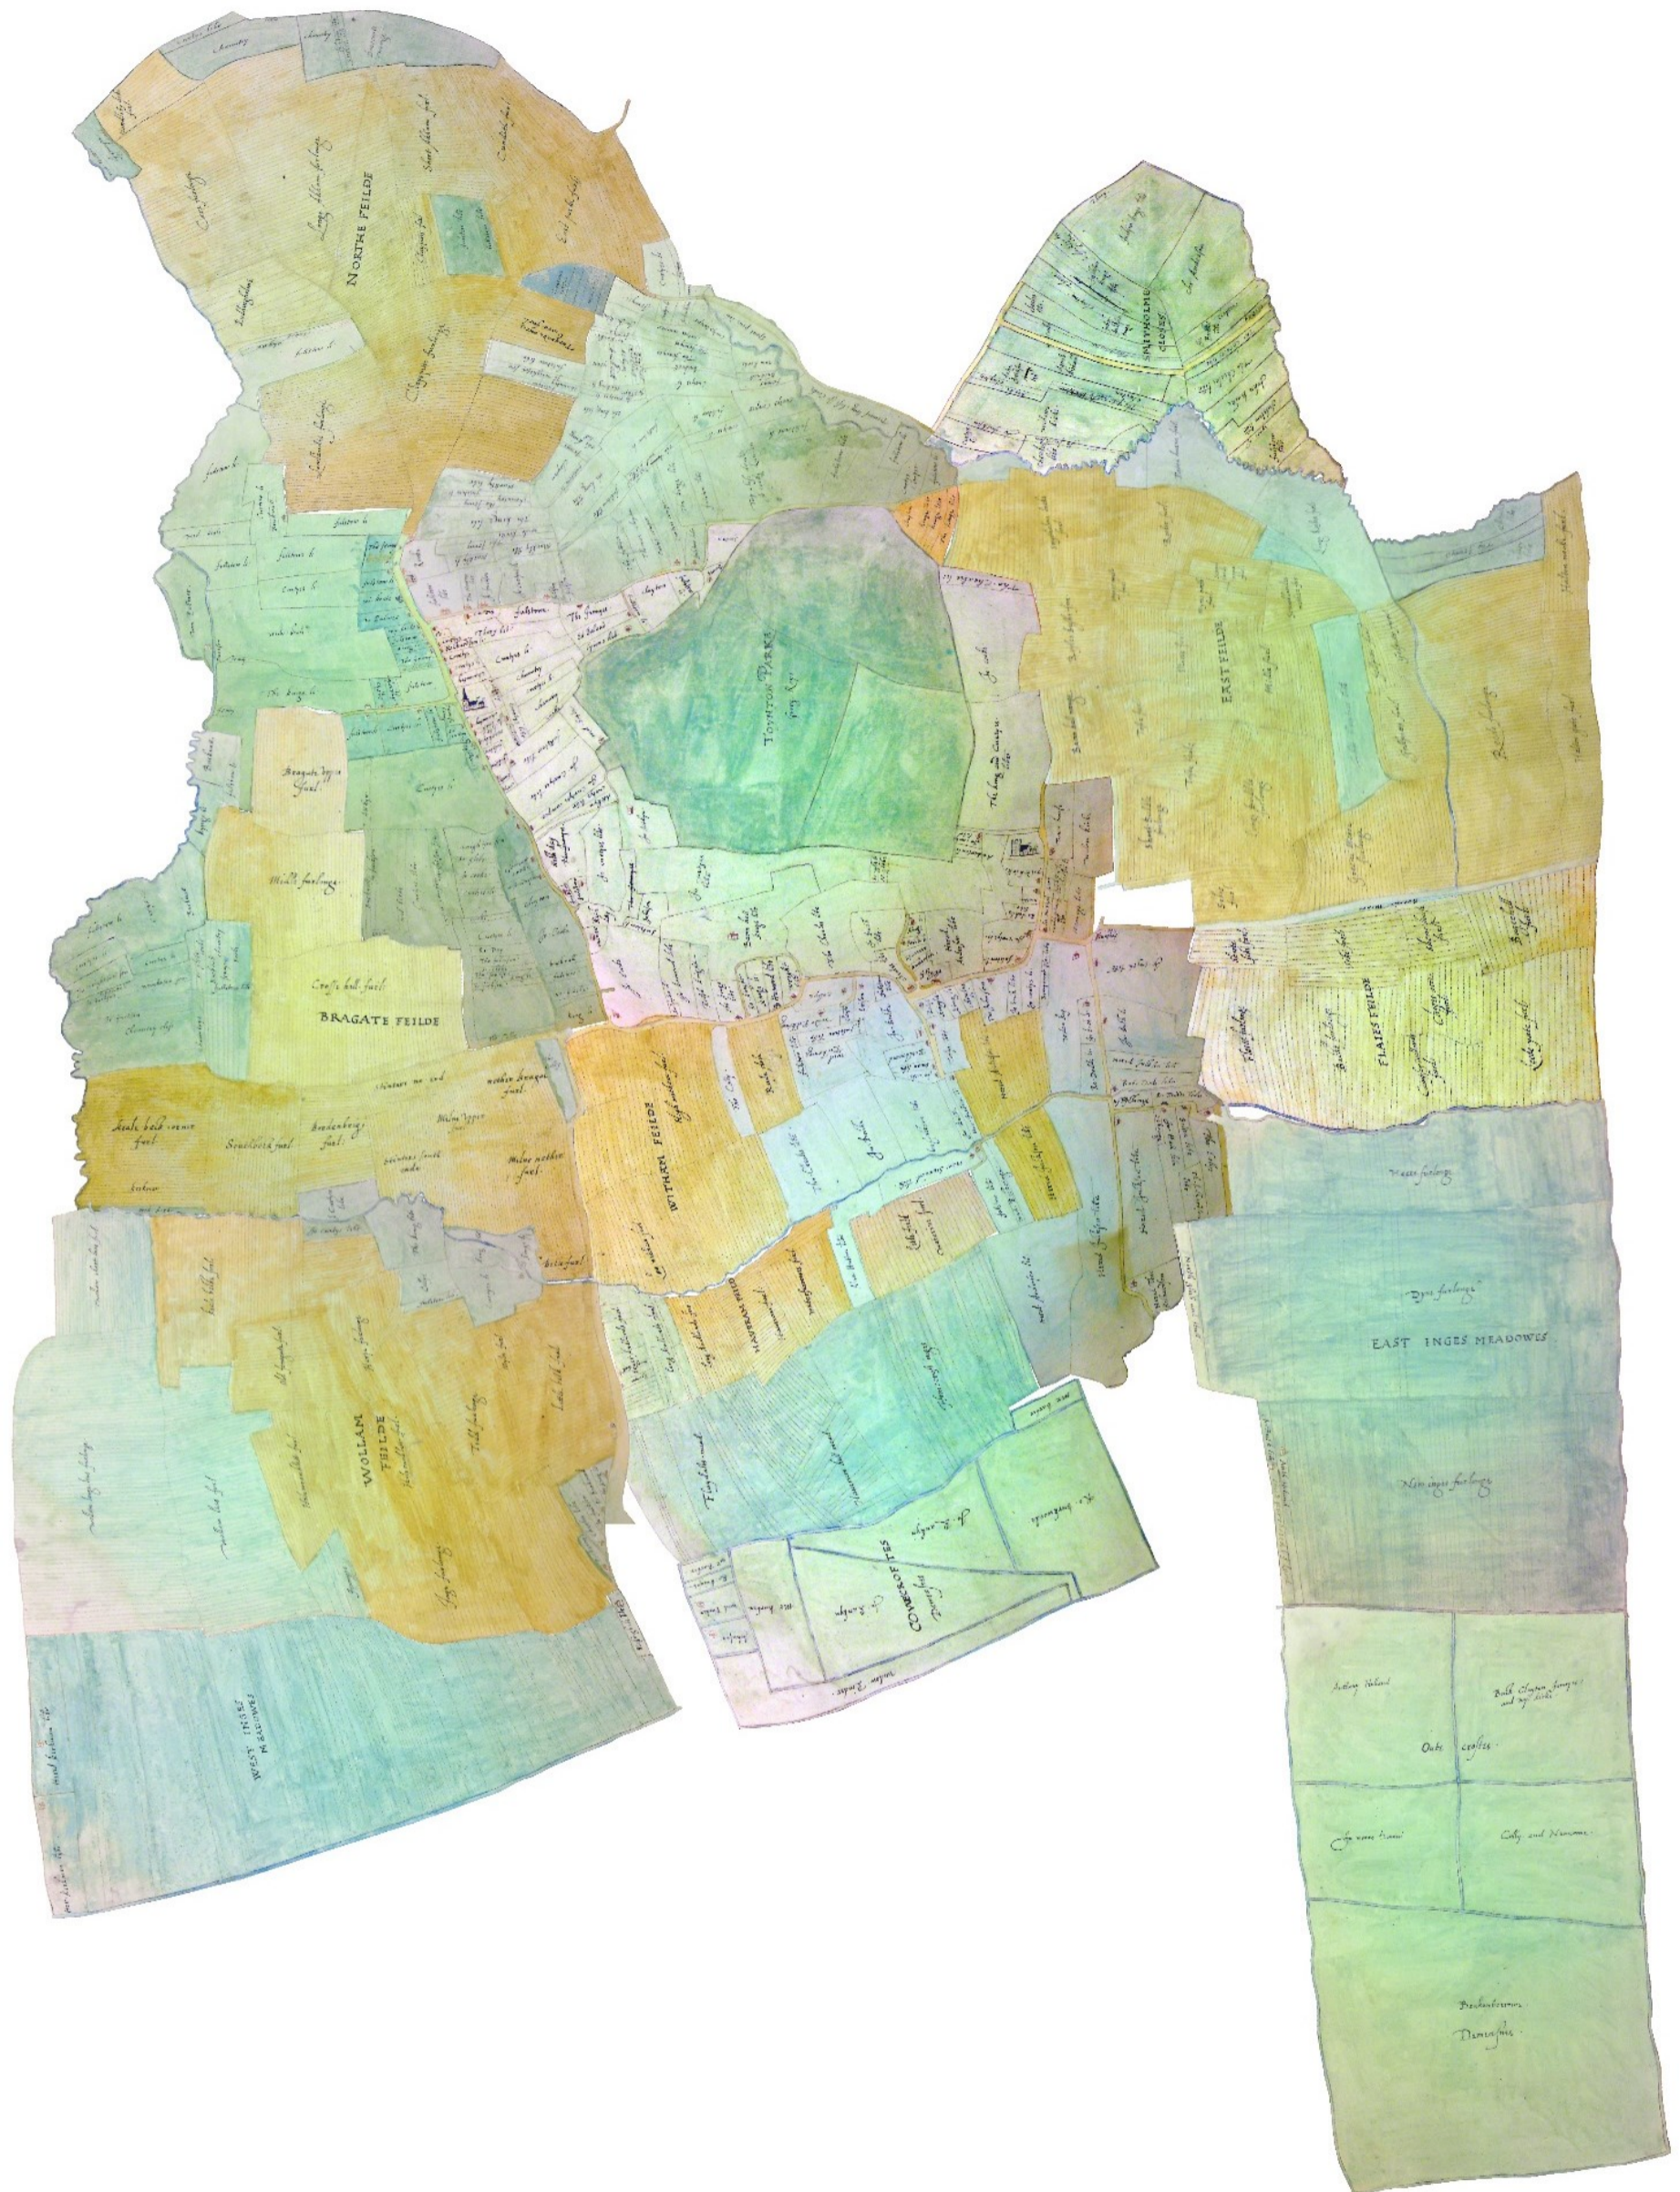
Fig. 12. Composite, georectified plan of Toynton in 1614 using Henry Valentine's fourteen individual drawings. Toynton Beck, embanked in 1339, may be seen crossing the lower middle of the map, flowing west to east. While the houses are rather small at this scale, the two churches may be discerned

Map regression was carried out for each of the buildings studied, as well as for the manor as a whole, providing spatial and chronological context for each building. Valentine's survey and maps of Toynton – the earliest surviving – provide a snapshot of the village at the beginning of the seventeenth century, accurately depicting the landscape and describing the buildings, as well as illustrating the nature of the manor at that time. The fourteen individual maps were georectified and combined into a single image of Toynton in 1614 (Fig. 12), enabling more detailed comparison with later maps. A detailed discussion of the reliability of the

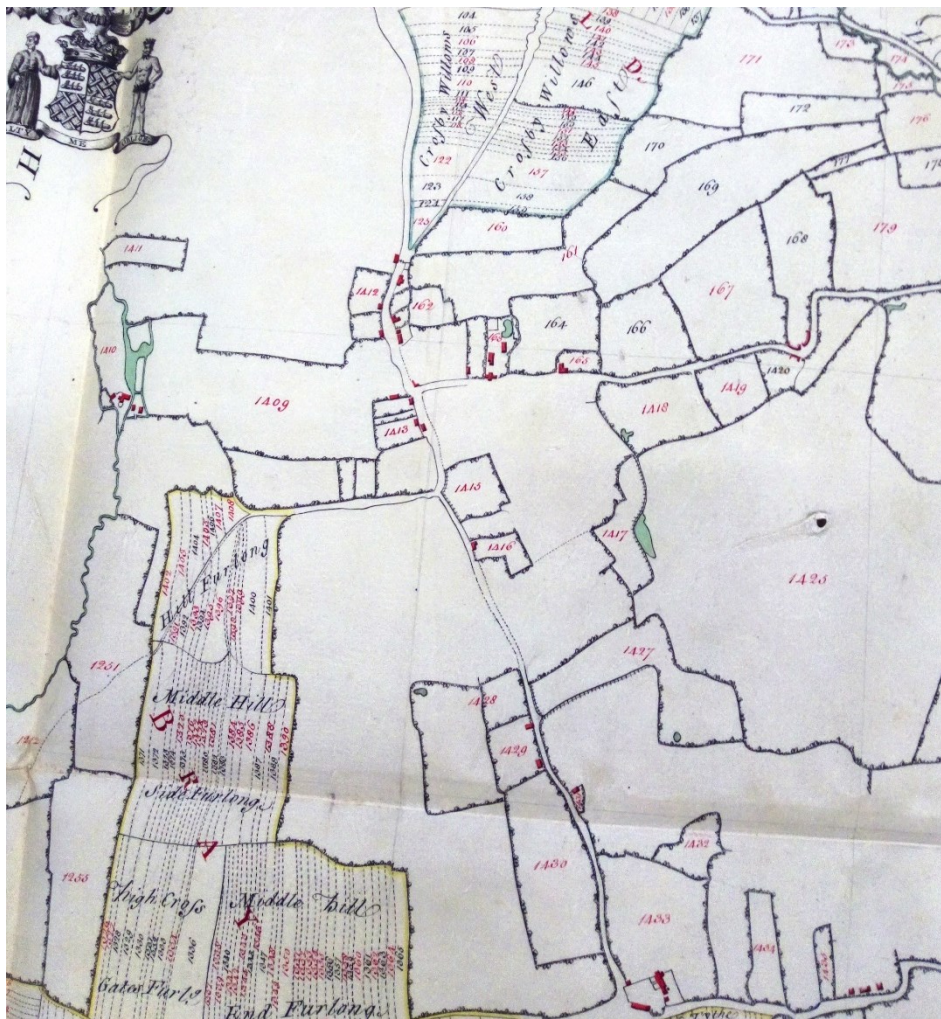
Fig. 15. Extract from the 1771 estate map (LAO 5-ANC/5/A/1 1771)

By the time of Enclosure, in 1774, the map of Toynton had changed in the patterns of ownership, although not visibly in land use. The Willoughbys had sold large parts of the manor; Figure 15 – which appears to be

a survey ahead of enclosure, and depicts and numbers every individual strip in the open fields – has large areas where even the roads are barely sketched in and buildings and field boundaries are omitted because they do not abut Willoughby holdings (LAO 5-ANC/5/A/1 1771). The family remained the largest landowners, but by Enclosure there were two other landowners who received over 100a – Varnham, Roberts & Roberts, descendants of the Curteis family and Thomas Sharpe, whose family had purchased the Fulstowes' estate in 1701 (LAO LINDSEY AWARD/87 1774; Russell and Russell 1985, 78–81). By this date, though, the major landowners were absentee; none of the Willoughbys had been resident since 1711, Ann Varnham and her nieces Ann and Frances Roberts all lived in London, and the Sharpe family were based at Elkesley in Nottinghamshire (Pacey 2010, 2).

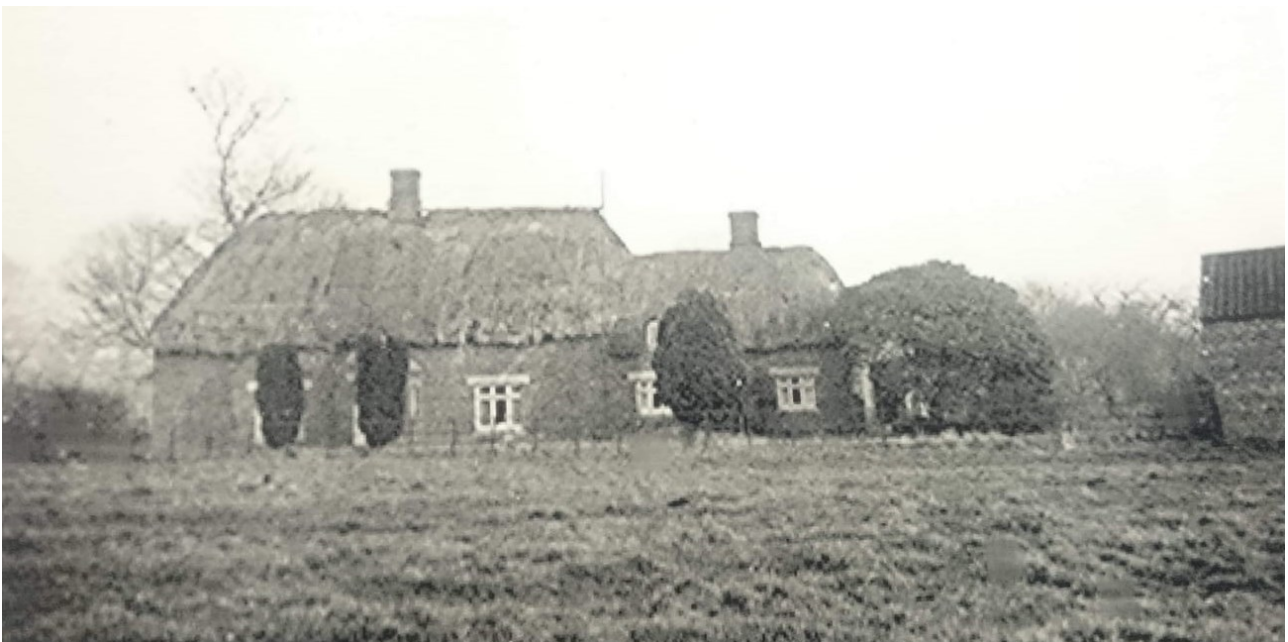
Fig. 16. The 'quaint old farmhouse' of the 1912 sale brochure, photographed before it burned down in 1959. (Photograph courtesy of Phyllis Pape)

It appears that these alterations, while improving the standard of living in the buildings, had the additional benefit of disguising the origins of the building. When, in 1912, the Willoughbys auctioned off most of their remaining land in Toynton, the descriptions of the buildings are telling; of the six known mud and stud buildings sold, two are described as 'brick built', two omit the walling material, one is 'a small thatched cottage', and only one gives any real indication of its construction – 'a quaint, old style thatched farmhouse' – unusually, this entry lists the rooms (parlour, two sitting rooms, kitchen, pantry, dairy and four bedrooms) This appealing marketing clearly worked as it sold for £450, whereas the cottages sold for between £25 and £75 (LAO 5-ANC/7/B/2/35/2 1912).²⁰ Mud and stud was clearly still deeply unfashionable – even this 'quaint farmhouse' had been encased in brick by the time it was photographed in the early years of the twentieth century (Fig. 16).

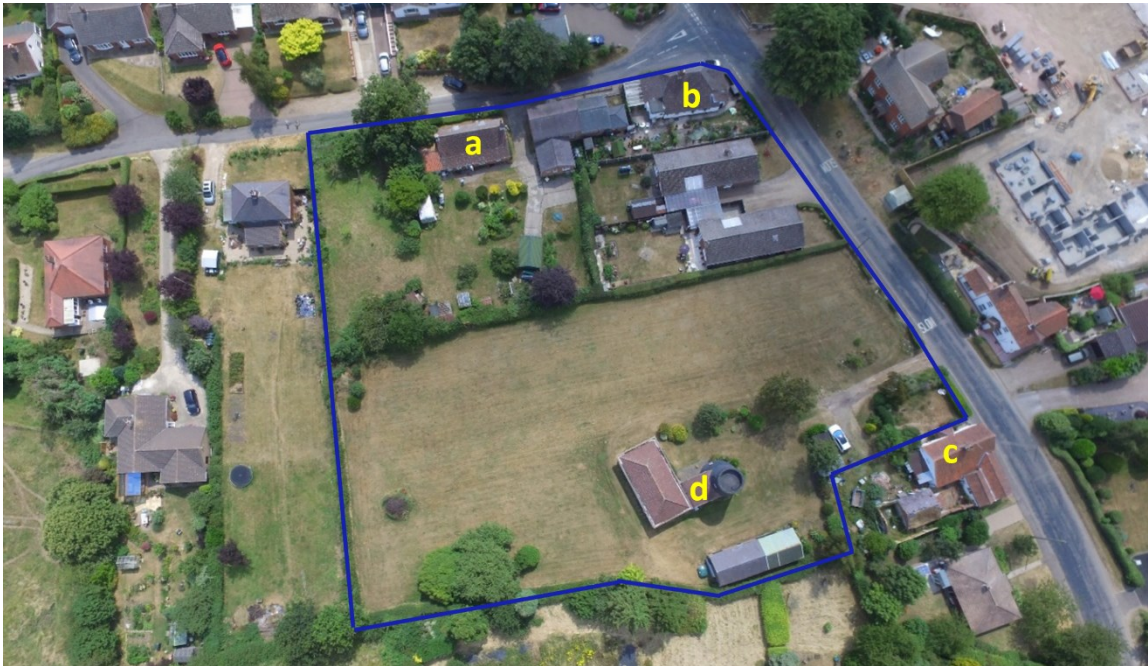
Fig. 25. Aerial view of the three cottages from the north; (a) The Cottage, (b) Chestnut Cottage, (c) Mill Cottage. The windmill is at (d). The 1614 plot is outlined in blue. (Author's image)

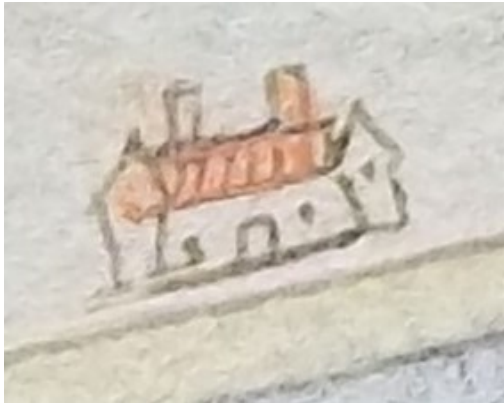
Fig. 27. Enlargement of Richard Pearsall's house (5ANC4/A/14)

The exact original extent cannot be confirmed by the surviving structure as both ends of the building have been rebuilt in brick, at different times. However, the 1614 survey illustration indicates that the building was then of a very similar form to its current one (Figs 27 & 28). On the survey it is depicted as gabled, with a chimney close to each gable. Both gables are apparently depicted – one of only 3 examples of the 127 houses illustrated where this is the case – and each appears to have a window in it, suggesting an upper floor. The door is central in the south elevation, flanked by windows. However, the detachment of the roof from the right-hand (east) gable suggests that this is a separate wing, indicating an L-shape. See Appendix 2 for further discussion of the 'double-gabled' examples.

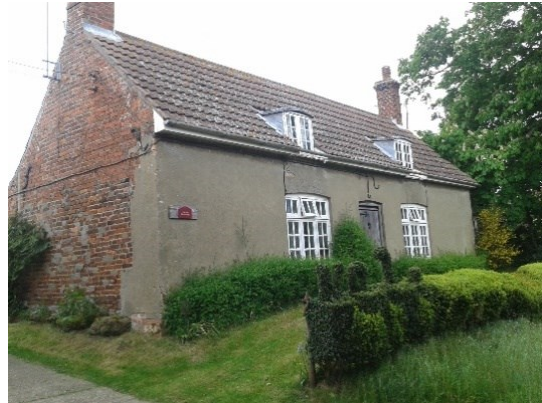
Fig. 28. The Cottage as it stands

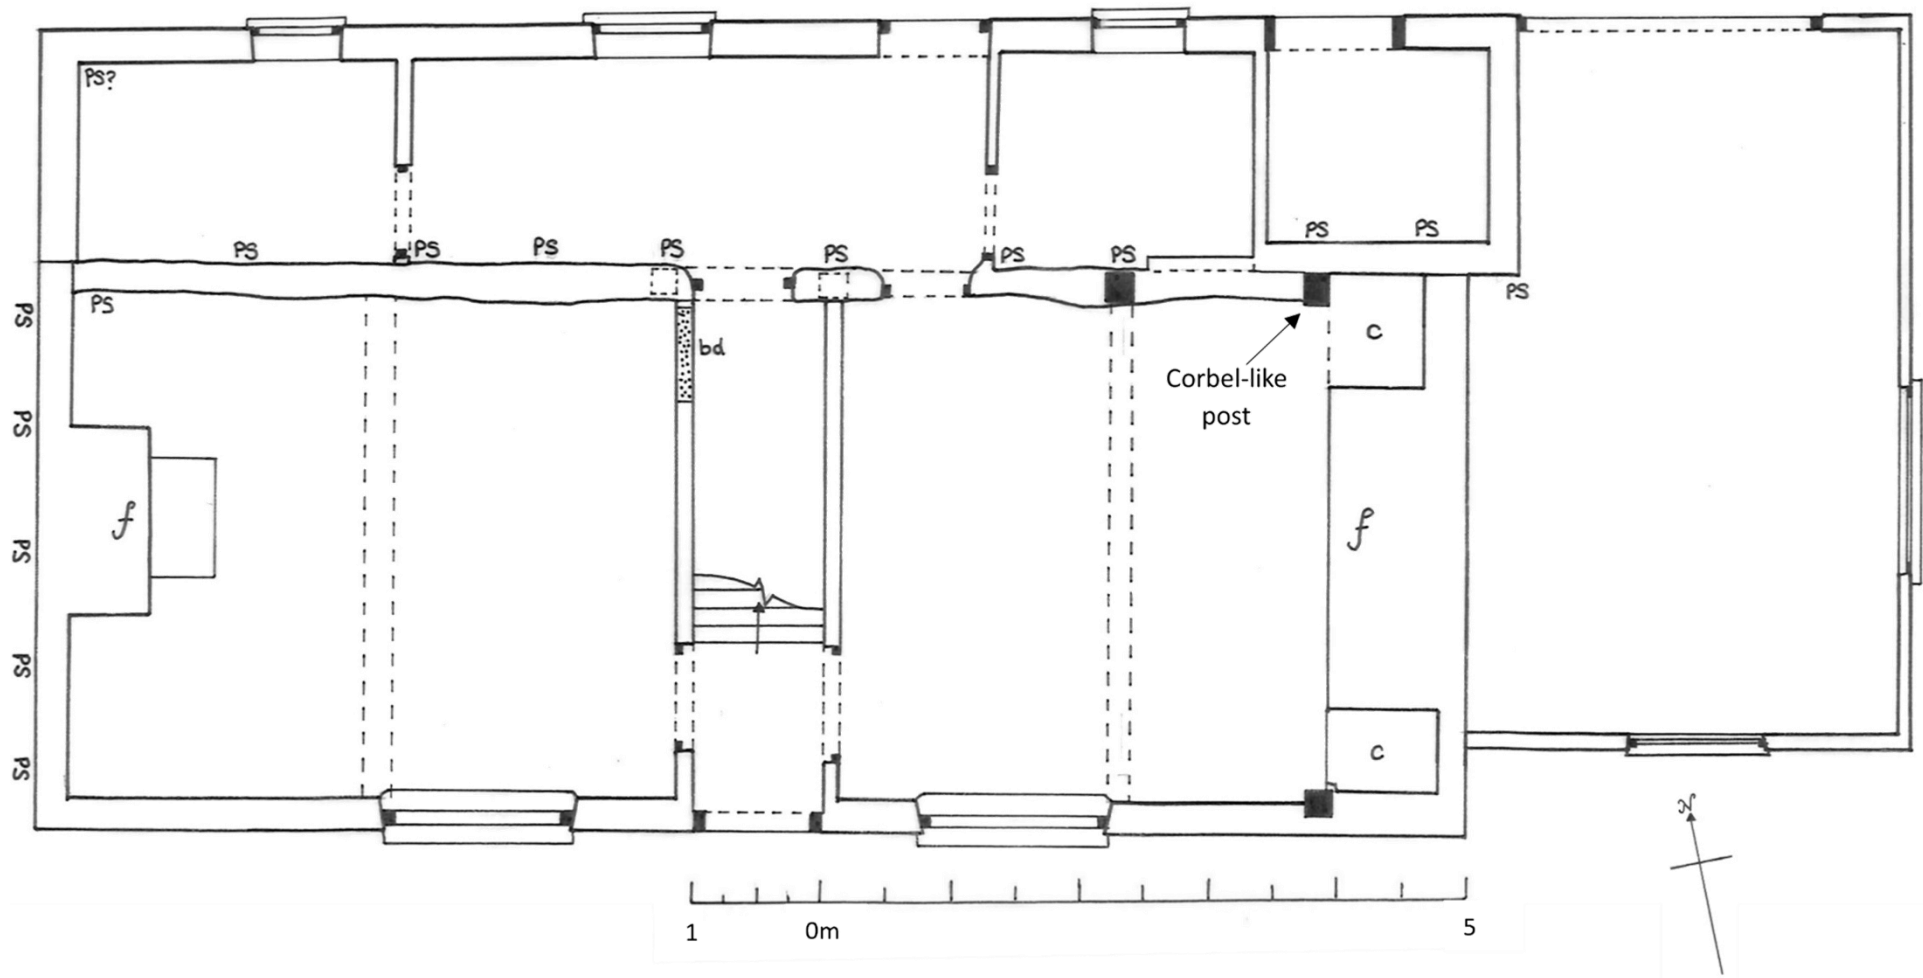
Fig. 29. Ground floor plan showing location of padstones (marked 'PS')

The earliest phase of the extant building stands on a series of large, flat boulders used as padstones, but which also form an apparently-continuous plinth as a type of 'damp proof course'. These are most visible at the western gable, but also survive along the length of the original (now internal) northern wall (Fig. 29). A further padstone is present in the south-east corner of the building, under the surviving post, although it is not visible externally. The frame of the building sits on these padstones, although this appears to have been replaced or encased in brick in the western gable (Fig. 30).

The floor plan, however, offers a clue as to the original use of the space (Figs 29 & 36). The doorway in question is directly opposite the front door which, although rebuilt when the south wall was replaced in brick, remains in the same position as on the 1614 survey. These opposed doorways may be the remnant of a cross-passage, later blocked with an inserted staircase. This doorway, then, would not be a cupboard door, but the major entry from the northern side of the building.

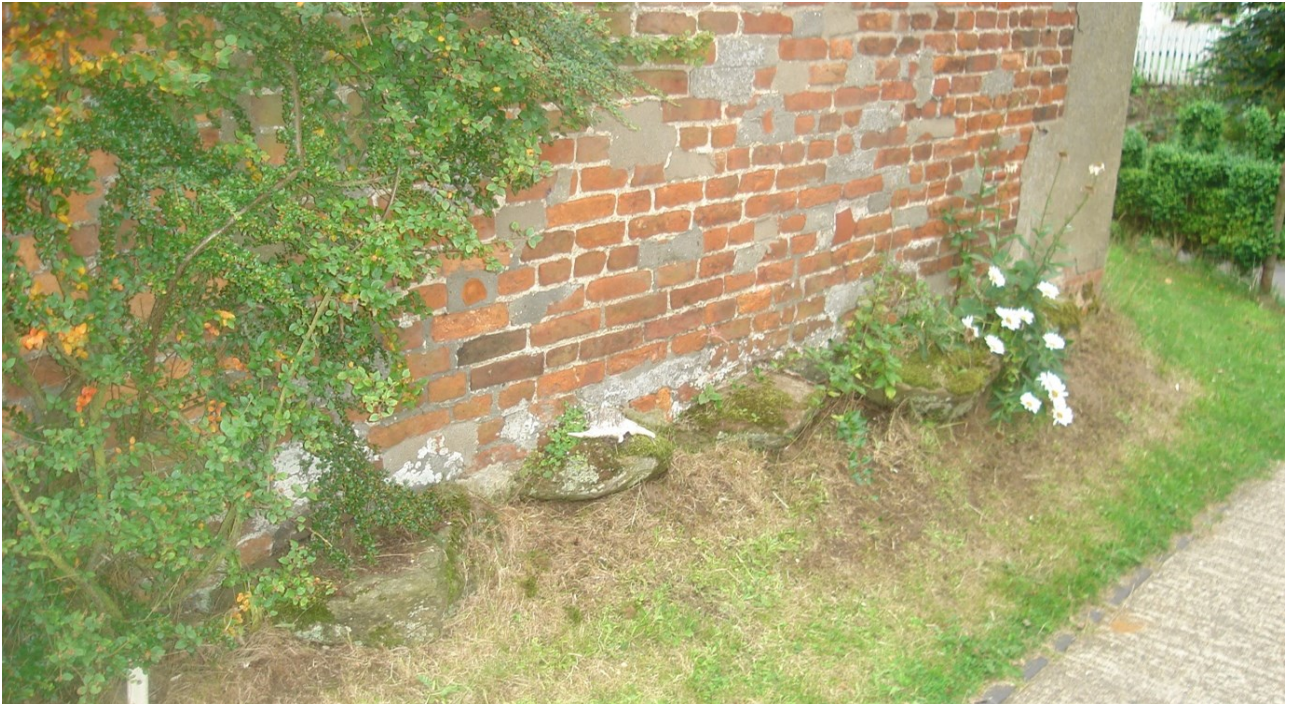
Fig. 30. Row of padstones/plinth below western gable wall

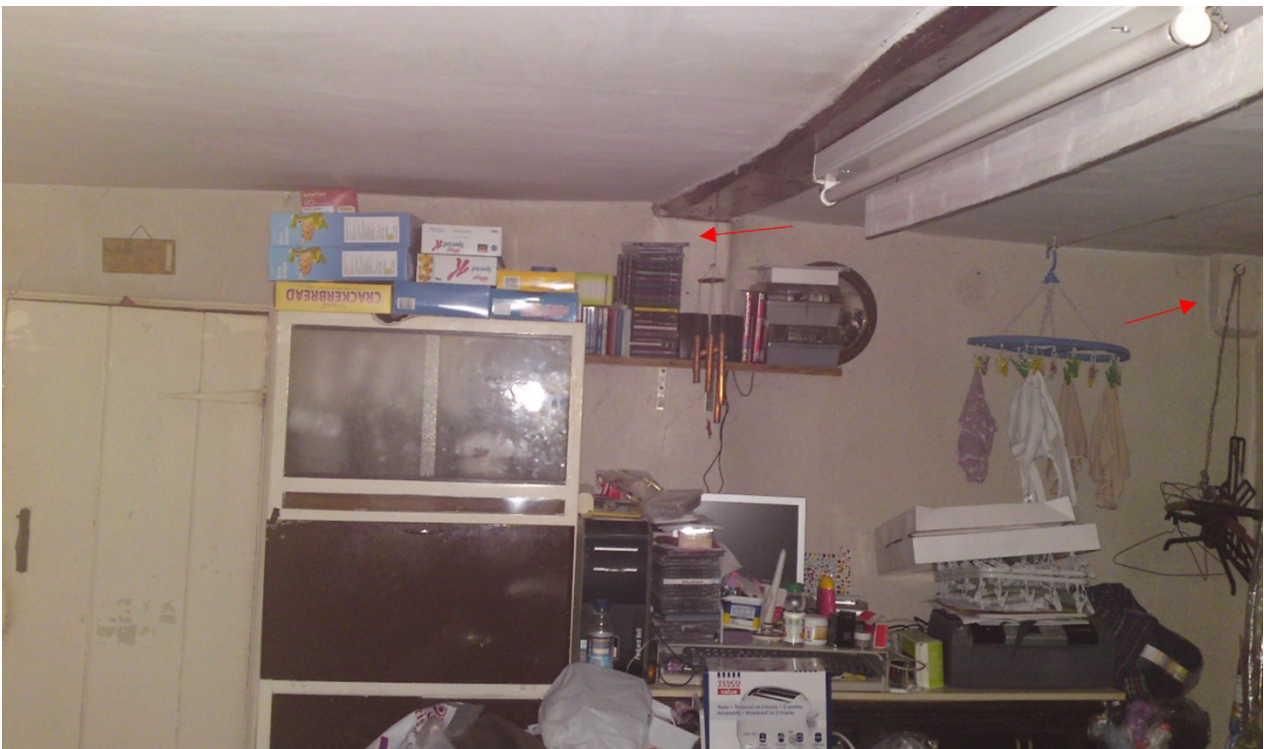
Fig. 31. Northern wall of the former hall. Note the undercut 'corbel-like' post in the top right corner, and visible mid-post, centre, supporting the binder. The door leads to the outshut, now the kitchen.

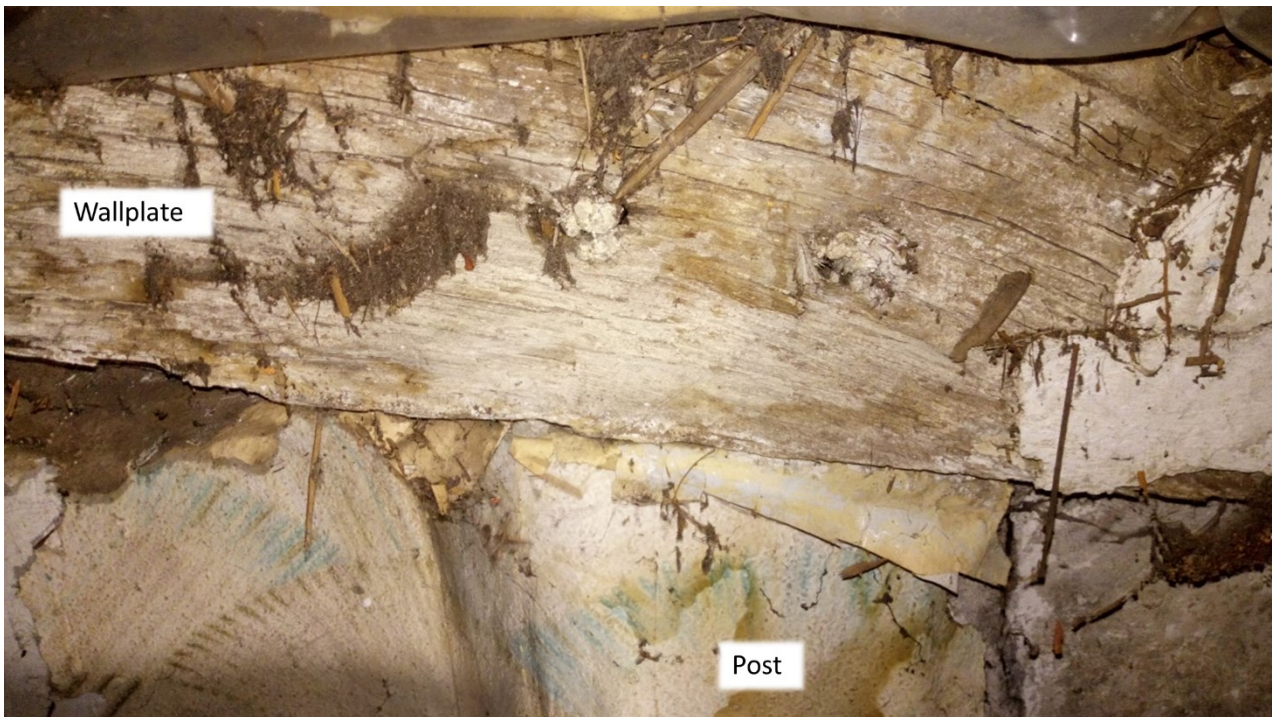
Fig. 32. North-eastern corner of the chamber above the former hall
The wallplate is visible, along with the 'now corbel-like', unjewelled post, with double-pegged tenon.

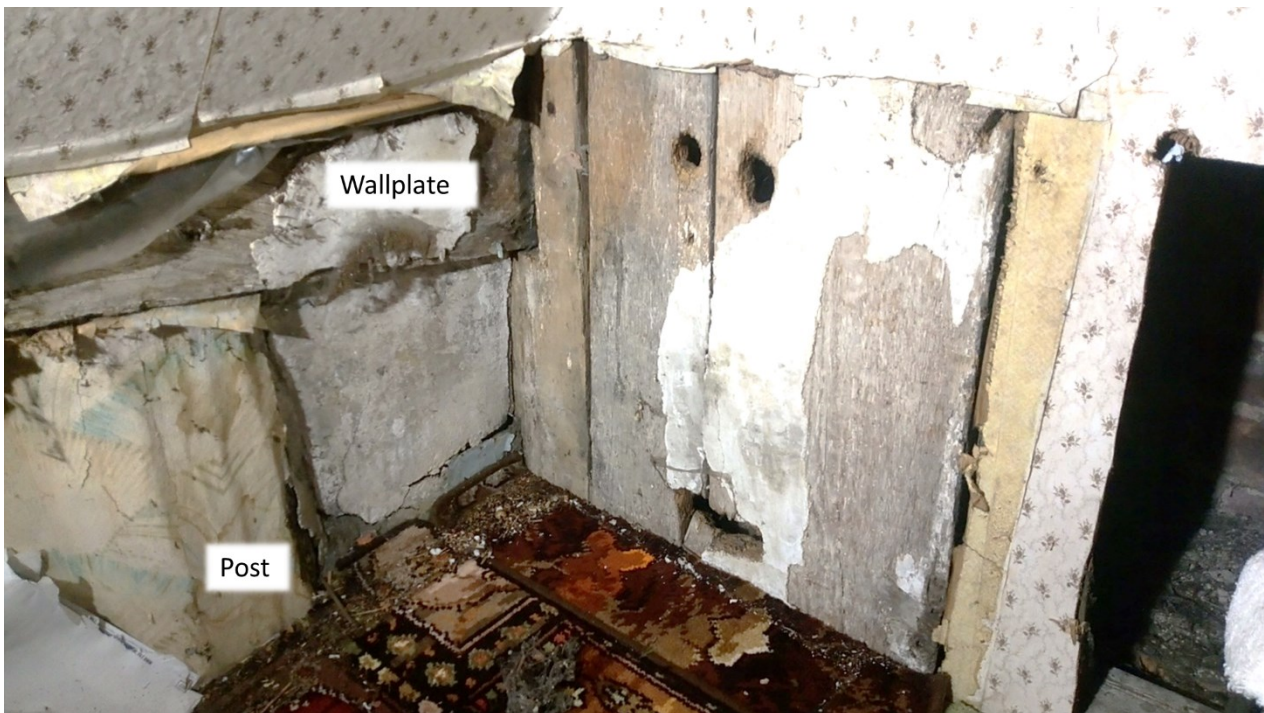
Fig. 33. North-east corner of the eastern chamber

Note the plank wall to the right, with holes for water pipes, and access hatch. The northern wallplate is just visible, and the 'corbel-like' mid-post may be discerned under the earlier wallpaper.

In the eastern chamber, however, some gaps in the plasterboard allow glimpses of the timbers in the north-eastern corner of the building, including the 'corbel-like' post, although it is again covered in wallpaper. These reveal the timber to be well-squared, and apparently oak of good quality, but with some of the characteristic 'mud and stud waniness'; Figure 32 is a close-up of the top of the corbel-like post pegged into the wallplate. This image clearly shows the grain of the wood at a different angle to the squared timber, indicating a building of some status, where a larger timber could be cut down to achieve a higher degree of straightness, rather than using the smallest timber possible, although there is still a greater degree of curve on the wallplate than might be expected in other building traditions. As may be seen from Figure 33, the wallplate continues beyond the post, which is clearly therefore an intermediate post, rather than the original corner of the building. The east wall visible on the right of the figure is a false wall; the current (brick) gable is a further 0.40m beyond the plank wall. The wallplate continues, and is embedded in the gable wall, with no further visible joints.

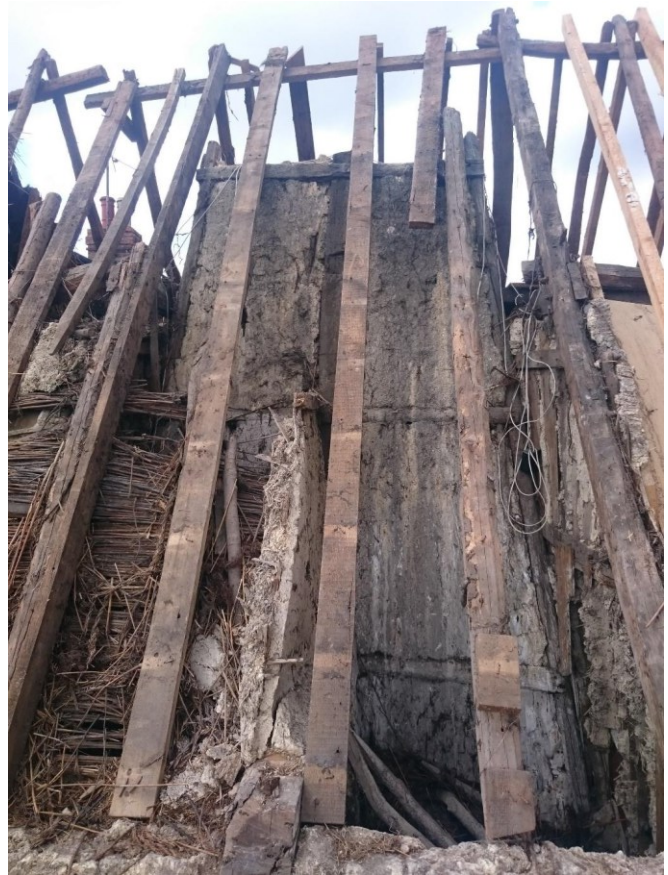
Fig. 34. Surviving smokehood at The Royal Oak, Mareham le Fen. This axial hood served two fireplaces, and is divided internally.

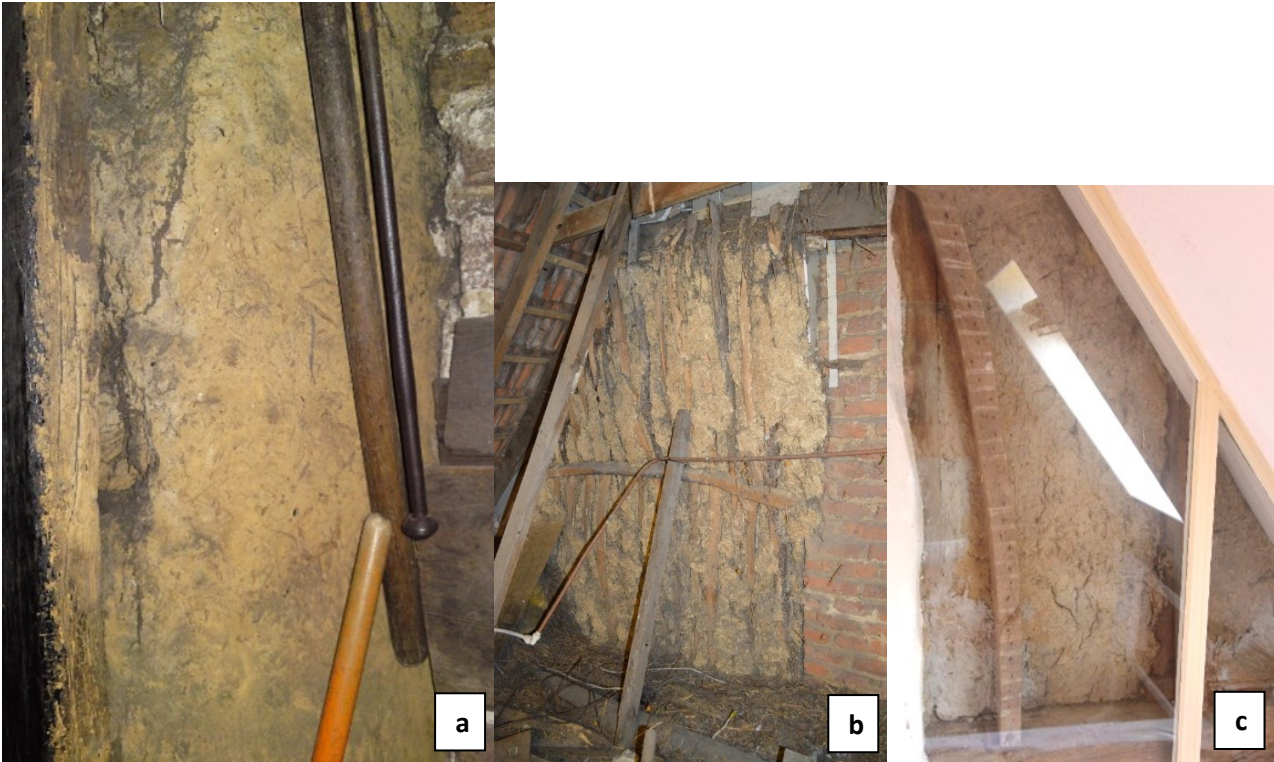
Fig. 35. Untreated daub

- (a) The Cottage, Toynton All Saints – wall to the east of the doorway into the cupboard under the stairs. Note the straw inclusions visible, and the curve of the daub towards the door frame to the left.
- (b) Hawthorn Cottage, Mareham le Fen – unused attic space above the former hall.
- (c) Hop Hill Cottage, Aubourn – internal view of gable wall.

Having explored the heating of the building, what can be said about its original layout and construction techniques? While there are few places where the frame is visible, the daub may be seen in the cupboard under the stairs (Fig. 35(a)). Its structure is clear, with straw inclusions, but the surface finish is very smooth. The colour is characteristic of local un-treated mud daub – Figs. 35(b) and (c) show two further examples – but the finish is unusually fine. Figure 35(b) is an internal partition wall in an attic, clearly intended only to be viewed from the far side. Figure 35(c), however, is the internal face of an external wall, and was clearly originally intended to be seen, although it was later covered by a battened plaster wall. The daub at The Cottage is smoother, and has been carefully finished, perhaps with linseed oil, indicating that it was in a space intended to be seen. This is somewhat surprising for an under-stairs cupboard, latterly used as a coal cellar.

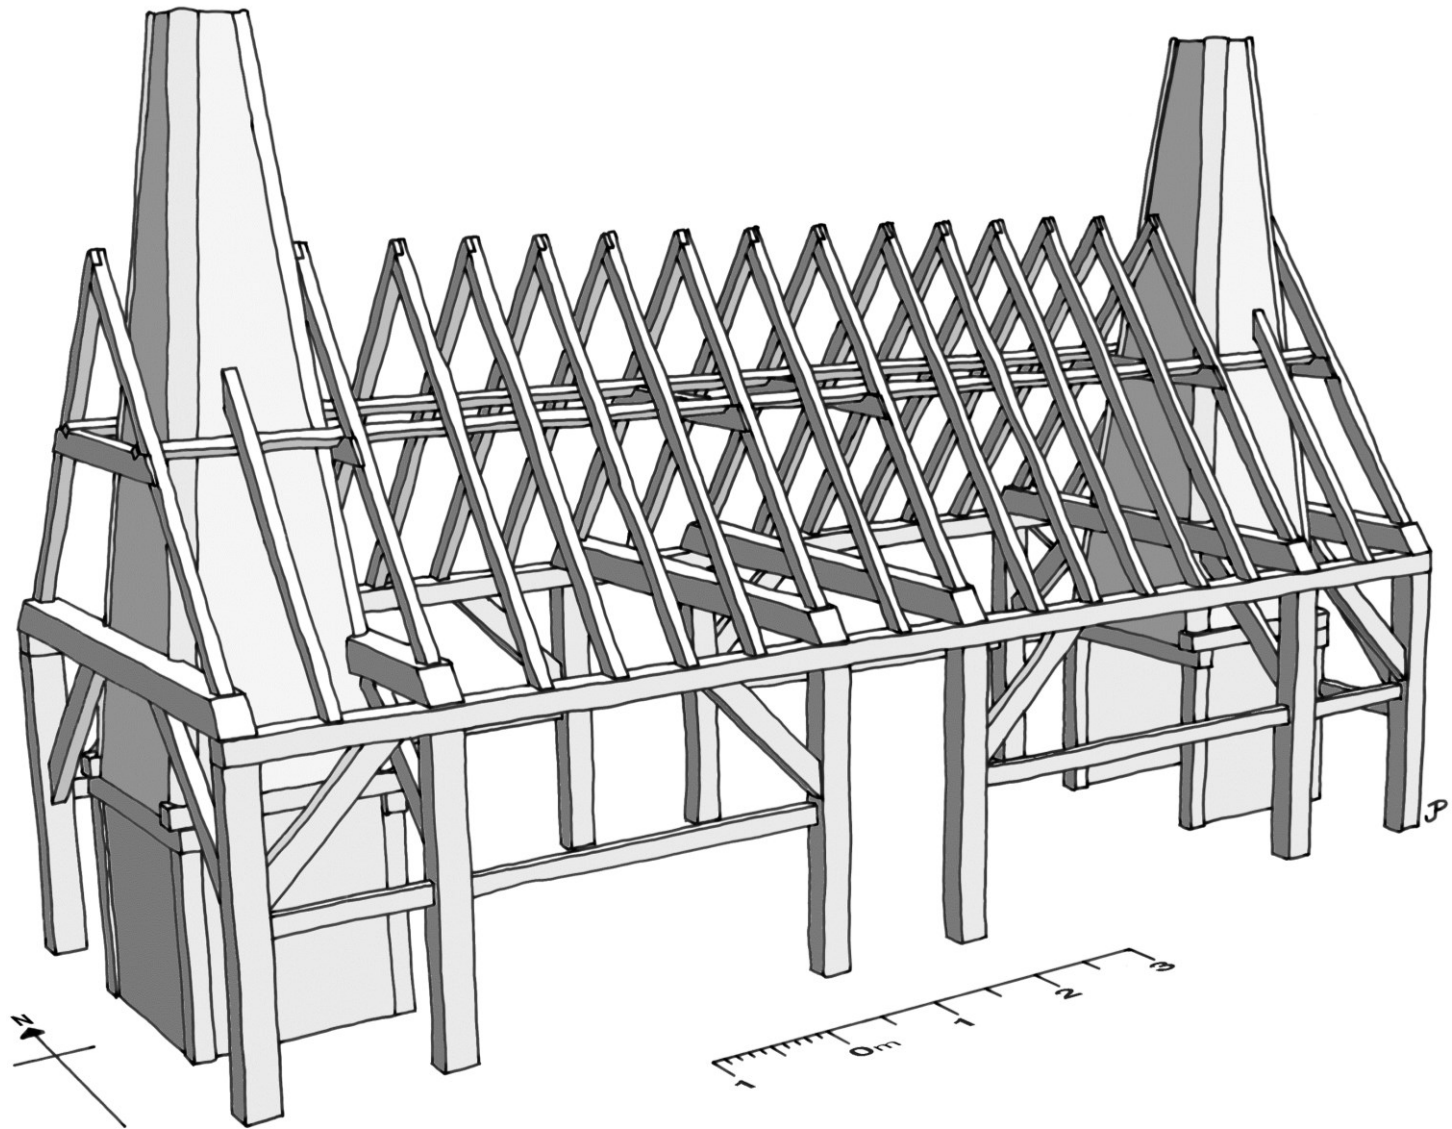
Fig. 36. Reconstruction of The Cottage's original frame, incorporating smokehoods in both rooms but omitting padstones and any upper floor for clarity

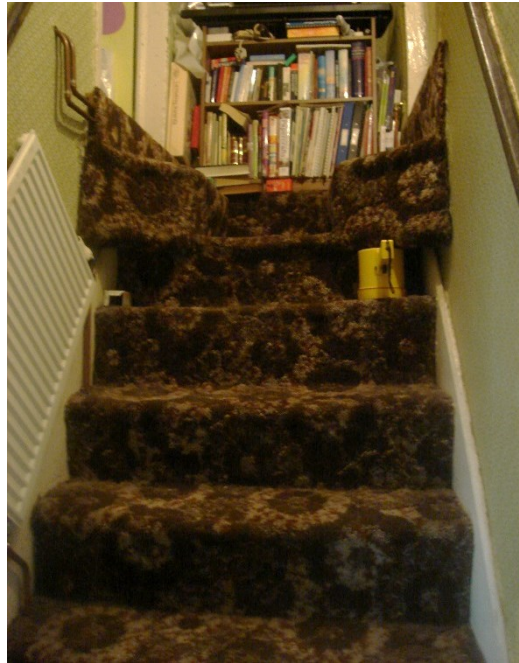
Fig. 37. The extremely steep staircase

Cottage matching the one at Lincoln Lane Farmhouse closely too.²⁸ The steepness and idiosyncrasy of The Cottage's staircase also supports the suggestion that it is inserted (Fig. 37); similarly, the applied beam on the mud and stud north wall, on which the boards of the landing rest, appears to somehow be secured with bolts into the daub.
