Putting mud and stud in its place:
rediscovering the culture of Lincolnshire's
indigenous buildings, and exploring their
dwellingscapes

Jennifer Pape

MA by Research

University of York

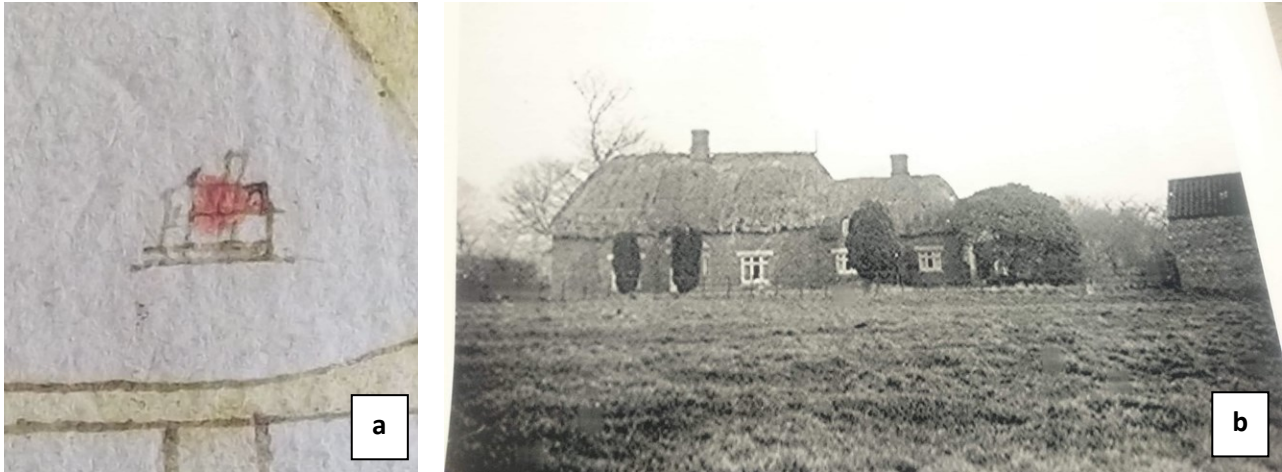
Fig. 38. John Cooke's house
(a) on the 1614 survey and (b) in the early twentieth century (photo courtesy of Phyllis Pape)

There is evidence for another house of similar, medieval plan in Toynton. In 1614 John Cooke's house was described in detail, listing hall, parlour with boarded chamber over, another parlour with a milkhouse and an earth-floored chamber over, a kitchen 'below the entrie' and a cook house at the back of the kitchen. The house description appears to conform to a medieval plan of open hall with cross-passage (entry) with kitchen at the low end and parlour(s) at the high end, with chambers. Cooke appears to have died in 1613, leaving an inventory which matches the described rooms almost exactly, although it also mentions a little buttery with the hall, and describes the parlours as new and old (LAO INV/114/22 1613). Presumably the chimney has been inserted into the former cross-passage (Fig. 38(a)), creating a lobby-entry, perhaps suggesting that the house may not even have had a smokehood. Alternatively, perhaps this house represents a transitional design, retaining the open hall and the concept of a low end with service rooms, but adopting a fully-formed lobby-entry, again indicating that the medieval way of living had not died out completely. When Cooke died in 1613 his inventory was valued at £317-5-0, although he was described by

his peers as a yeoman; this was clearly a substantial dwelling, which appears to have survived largely unaltered until it burned down in 1959. When the Willoughbys sold it in 1912, the description is almost identical, albeit using modern room names; parlour, two sitting rooms, kitchen, pantry, dairy and now four bedrooms – presumably the hall had been ceiled over to create more sleeping accommodation (LAO 5-ANC/7/B/2/35/2 1912).

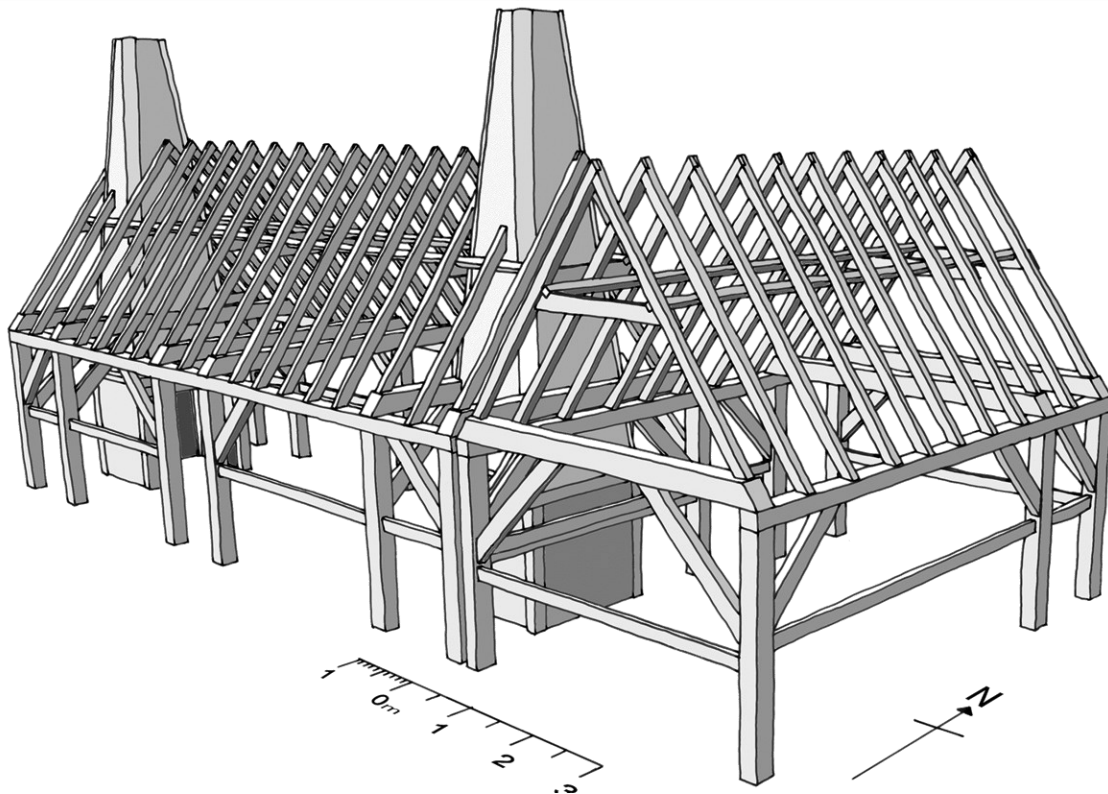
Fig. 40. Reconstruction of the extension as a separate frame, as seen at Lavender Cottage, Thimbleby; it may have instead been jointed into the original frame

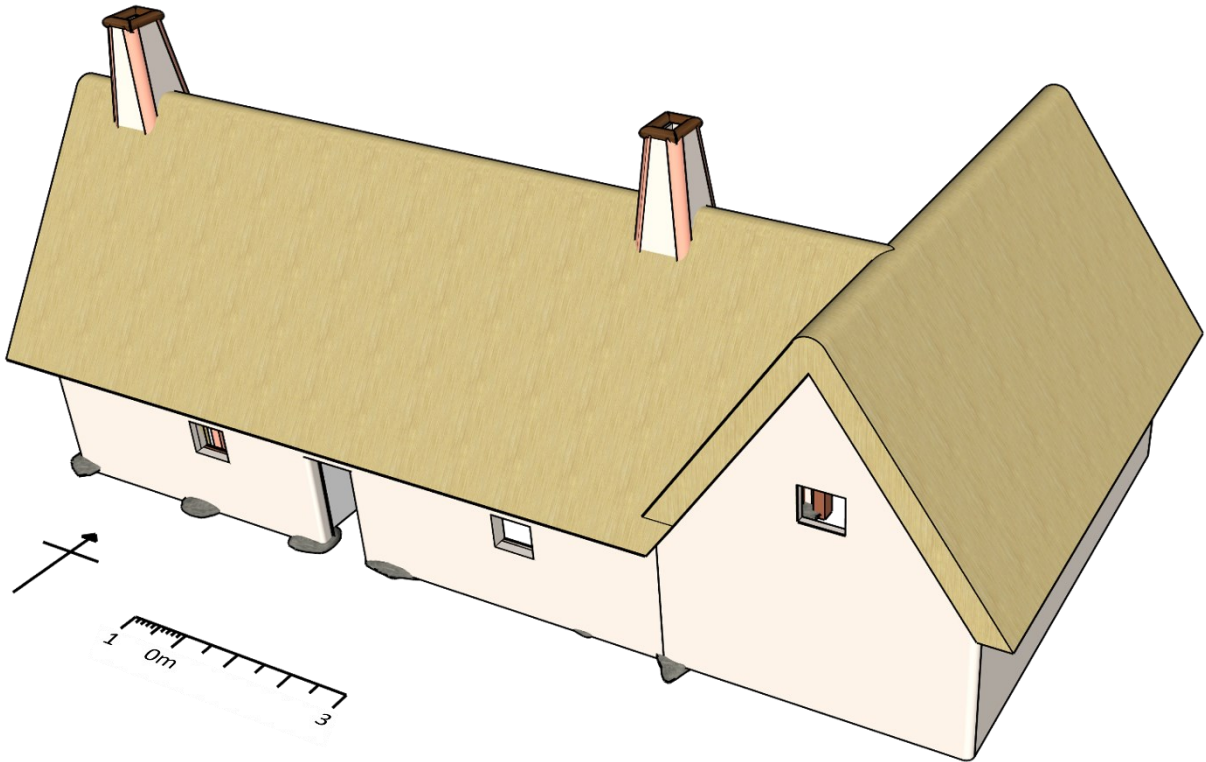
Fig. 41. Visualisation of the extended house, with windows as illustrated in the 1614 survey

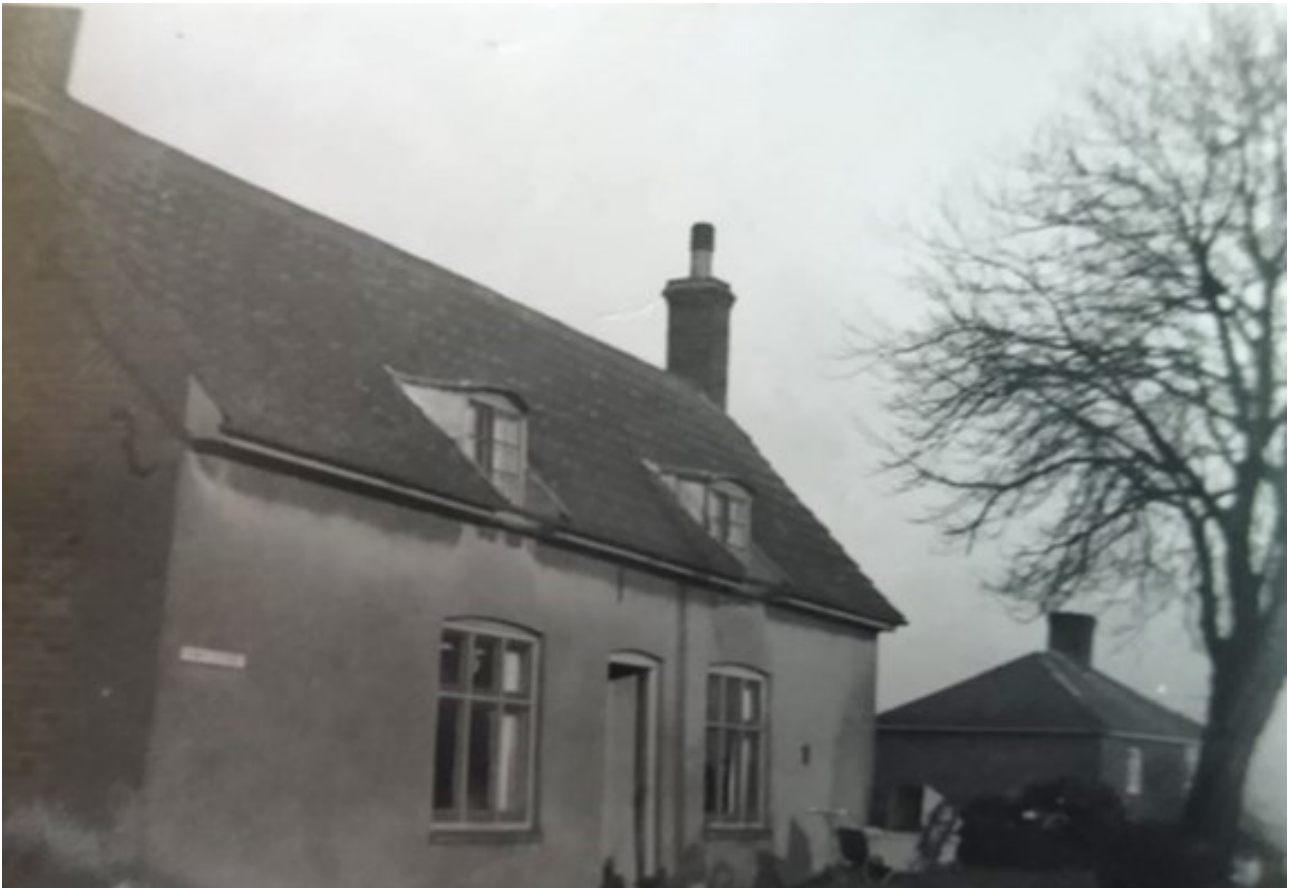
Fig. 42. The Cottage c.1952. Note the rendered front wall and pantiled roof (courtesy of Phyllis Pape)

over the tenancy. In the 1911 census the Ransons reported having four rooms (excluding sculleries, landings, lobbies, closets and bathrooms), suggesting that the eastern room, with its range, was their kitchen and that the outshut rooms at the back of the house fell into the excluded categories ('William Ranson' 1911). Before World War Two, the entire southern wall of the building appears to have been rebuilt in modern bricks and rendered. This may have coincided with the replacement of the thatched roof with pantiles; PD Pape recalled having seen a photograph of the building with its thatch, suggesting that its replacement happened in or after the later nineteenth century (Fig. 42).

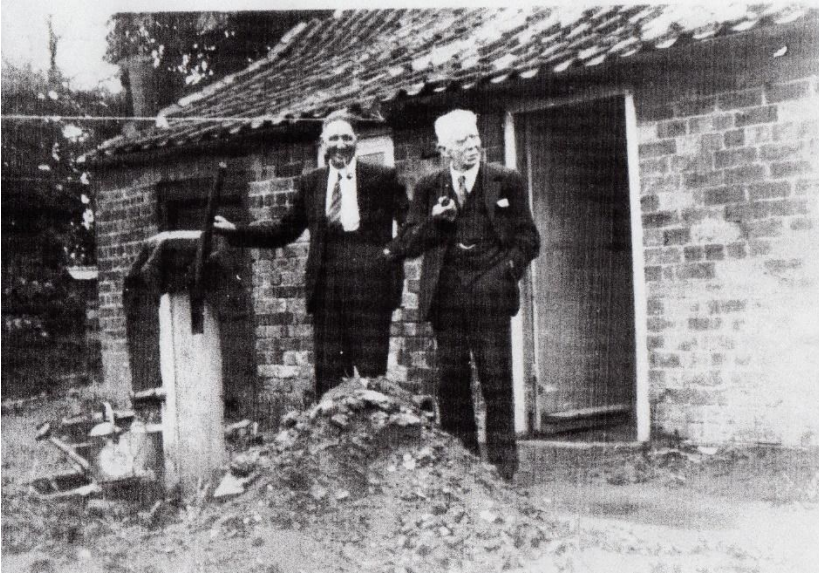
Fig. 43. Rear of The Cottage soon after purchase in 1951, with water pump and chimney for the copper visible (courtesy of Phyllis Pape)

When CP Pape bought the cottage from the Benniworth estate in 1951 he was informed that the Rural Housing Survey of 1946 had classified it as category 4 – 'needing reconstruction' (Cottell 1951). There was no running water, although the pump was just outside the back door (Fig. 43). He quickly applied to have a water supply in the house, and also arranged for a cesspit and indoor toilet. The copper in the outhouse survived into the 1970s, and the range in the eastern room was removed in the early 1990s. In 1951 the outshut room at the western end of the north elevation was derelict, and was renovated using a Yorkshire slider from another mud and stud building in the village, Jack Street's house, which was being demolished at the time (Pape 2009a).

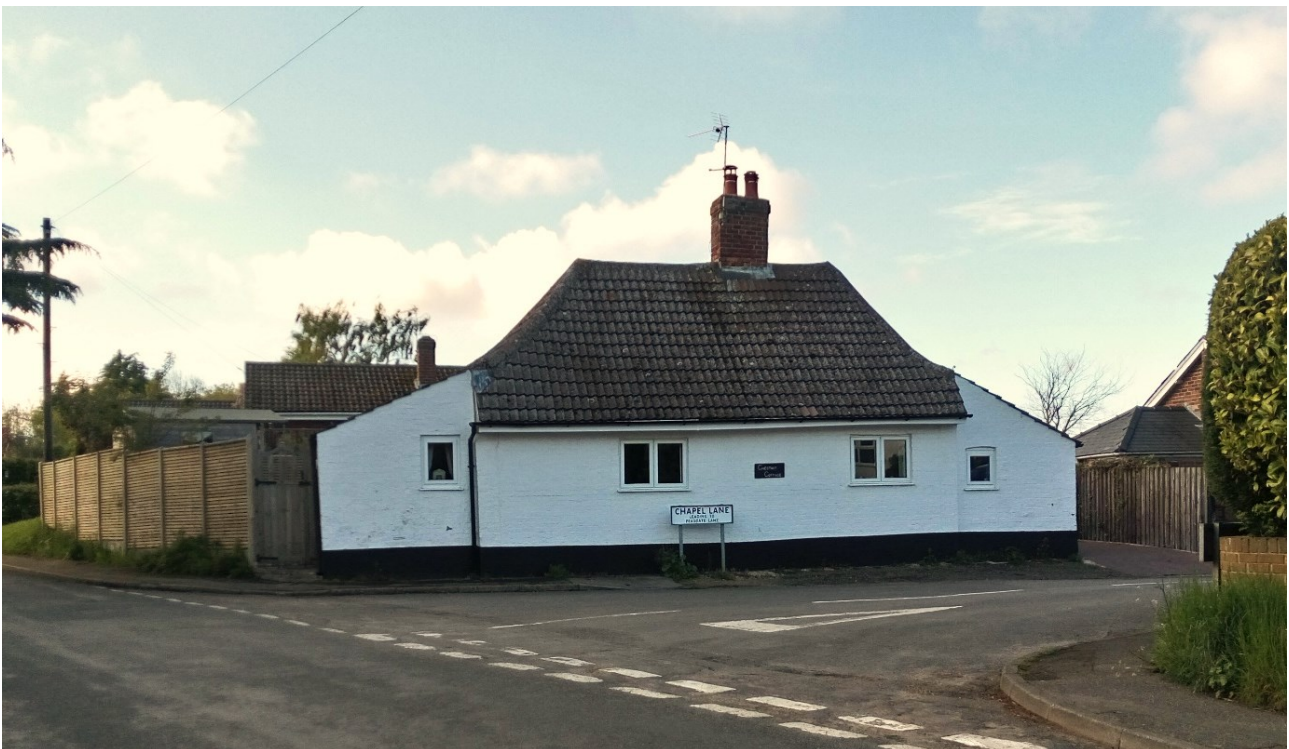
Fig. 45. Chestnut Cottage from the south-west

The building, albeit with later extensions, conforms to Cousins' mud and stud stereotype; single storey, with axial stack and half-hipped roof (Fig. 45). However, the stack is off-centre, with the room to the west larger than the one to the east. To the rear is a brick-built outshut with catslide roof, while the building is bookended by brick-built pent extensions. These three extensions have preserved the former external walls in mud and stud, with slightly battered profile and padstones evident in the eastern gable, but the south, front wall has been encased in brick.

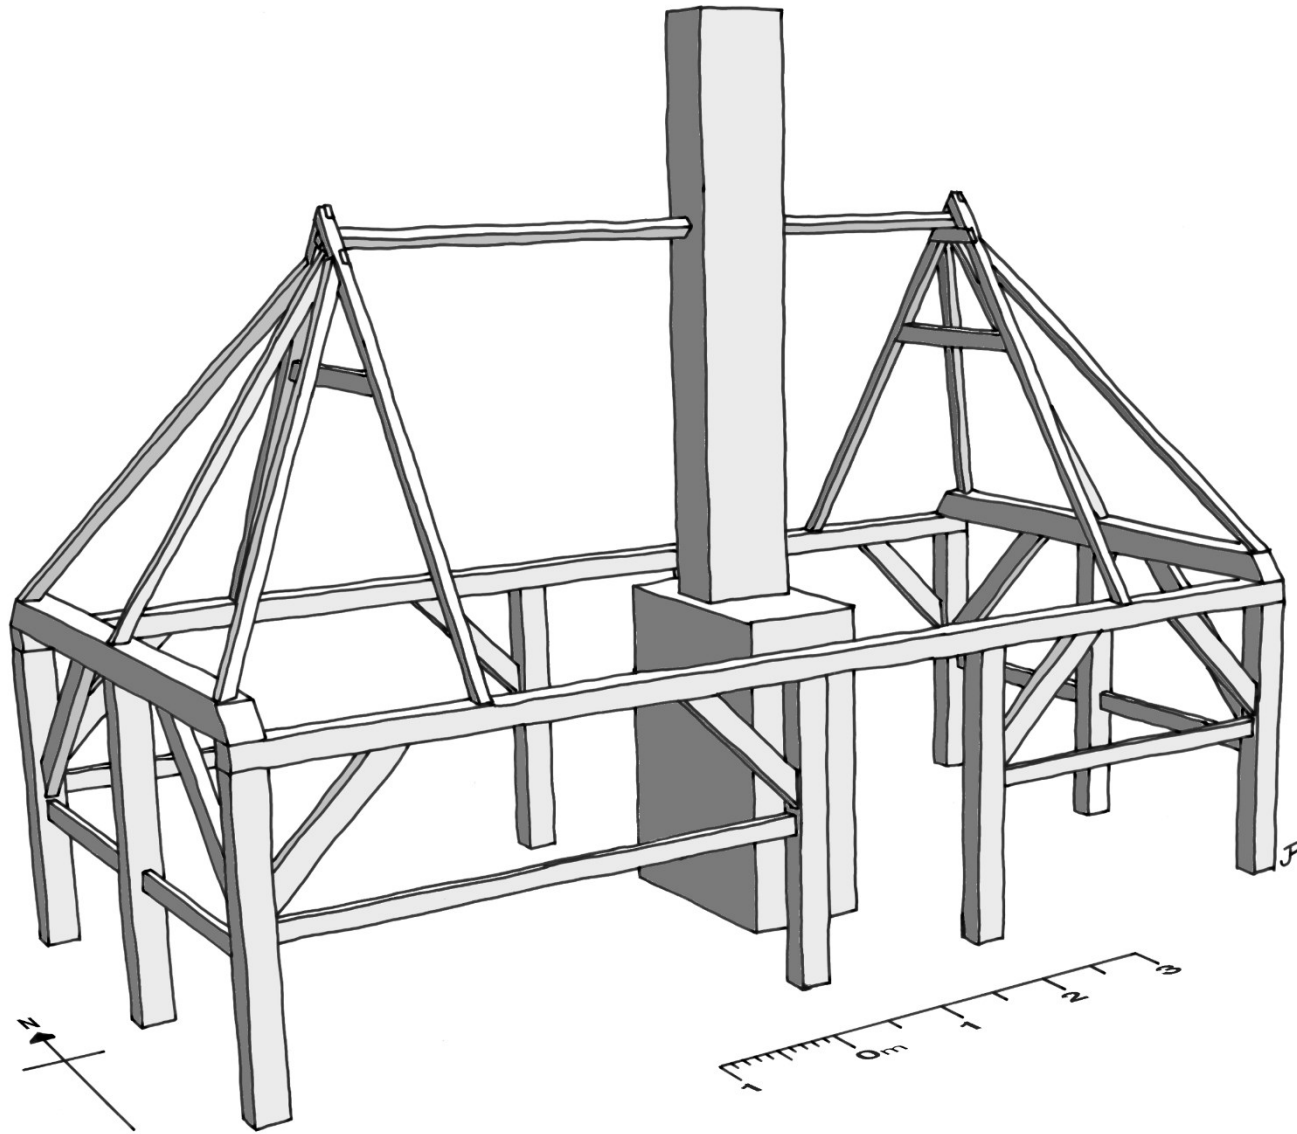
Fig. 46. Sketch reconstruction of Chestnut Cottage from the south-west. 'Basket-like' roof structure omitted for clarity.

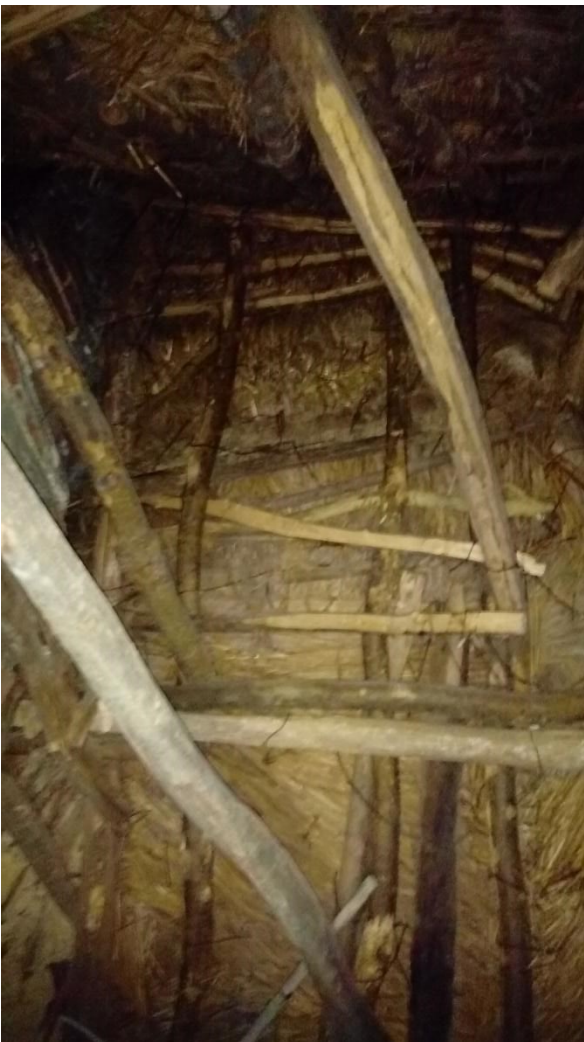
Fig. 48. Roof structure above eastern room, looking north. Note the morticed collar and principal rafter assembly (in red box). The underthatch appears to have been applied at random angles, with an area of darker coloured reeds laid horizontally in the top right hand corner.

In the roof void, the structure, including surviving thatch, is remarkable (Fig. 47). It is constructed of coppiced poles, around 8cm in diameter, forming an extremely rough-and-ready structure. There is some evidence of joinery, with a collar morticed into a slightly more substantial 'principal rafter' (Fig.s 48 and 49),

The visible thatch is unusual in its application; rather than being laid as a horizontal base layer, or vertically over battens, the lowest layer of thatch runs in differing directions (Fig. 48). Much of it is fundamentally parallel to the wallplates or tie-beams, but in other places it is perpendicular, or diagonal. An area of the hip has horizontally-laid reeds, similar to those seen at The Cottage but in a thinner layer, with thatch on top.

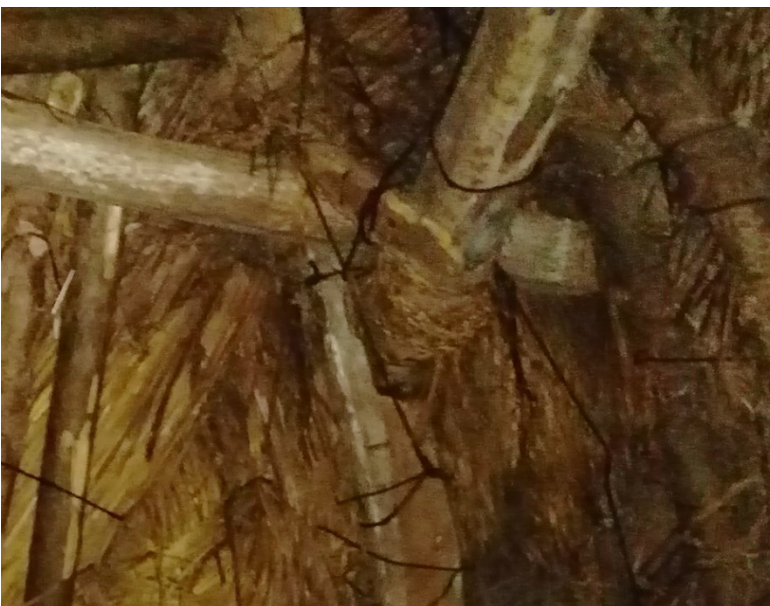
Fig. 49. Enlarged view of principle rafter and collar. Note the nailed-on clasp piece trapping the purlin pole in the angle of the collar, and black string holding on the underthatch and possibly some of the poles

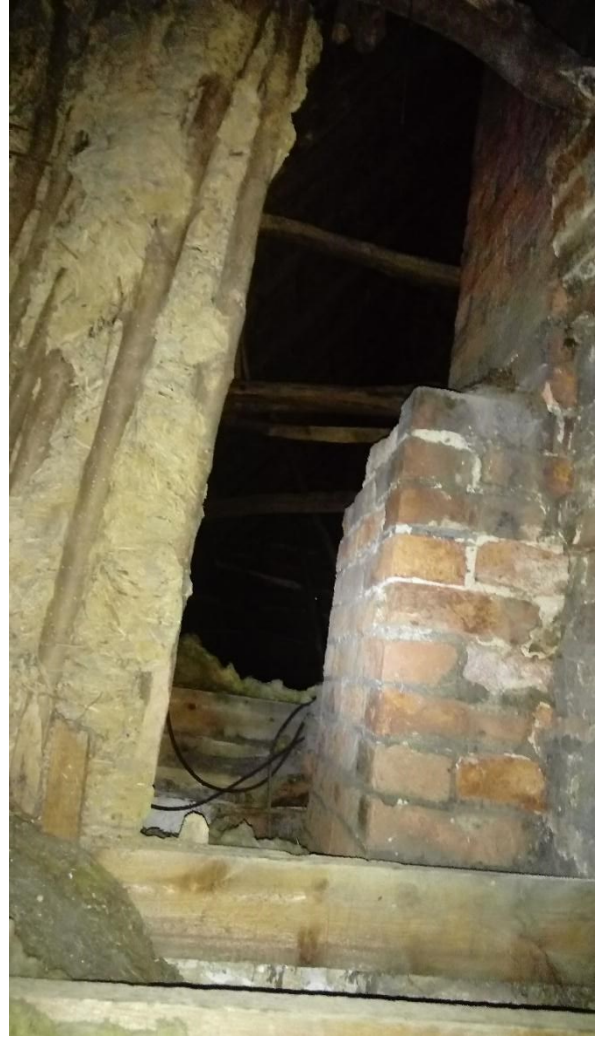
Fig. 50. Looking west from the loft hatch, note the mud and stud partition and later ceiling joists

to the south by the remains of a mud and stud partition, again using coppiced wands (Fig. 50), indicating that the building was originally open to the rafters. There is some evidence that the smoke control may have been altered in the building, as a collar passes through the middle of the stack and the partition does not reach the stack.³⁰ Differences in the brickwork suggest that the eastern room's stack may have been added to the western at a later date.

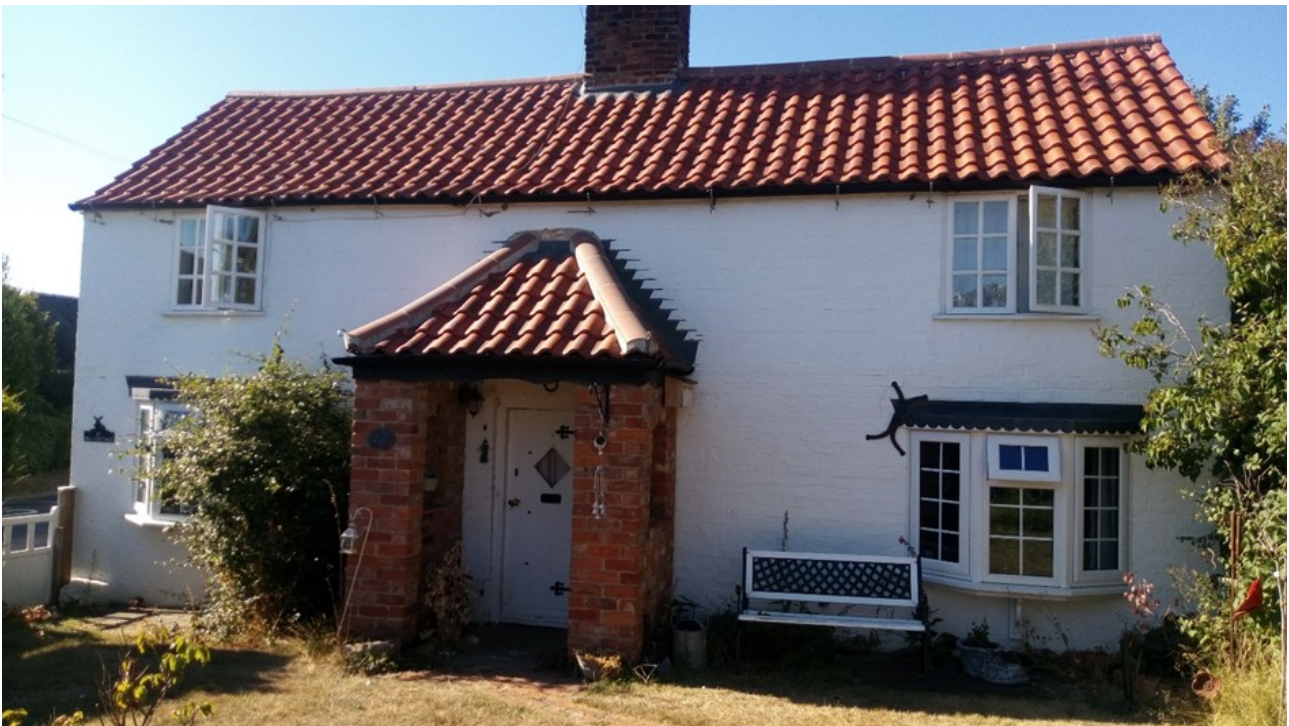
Fig. 52. Mill Cottage from the south

Mill Cottage sits on Main Road in Toynton All Saints, a little north of Chapel Lane. The core of the building is at right-angles to the road, facing roughly south, although extensions to the north present a long, low, brick elevation to the passer-by, while later encasement and alteration mean that the original mud and stud cottage now appears to be a two storey Victorian brick house (Fig. 52).

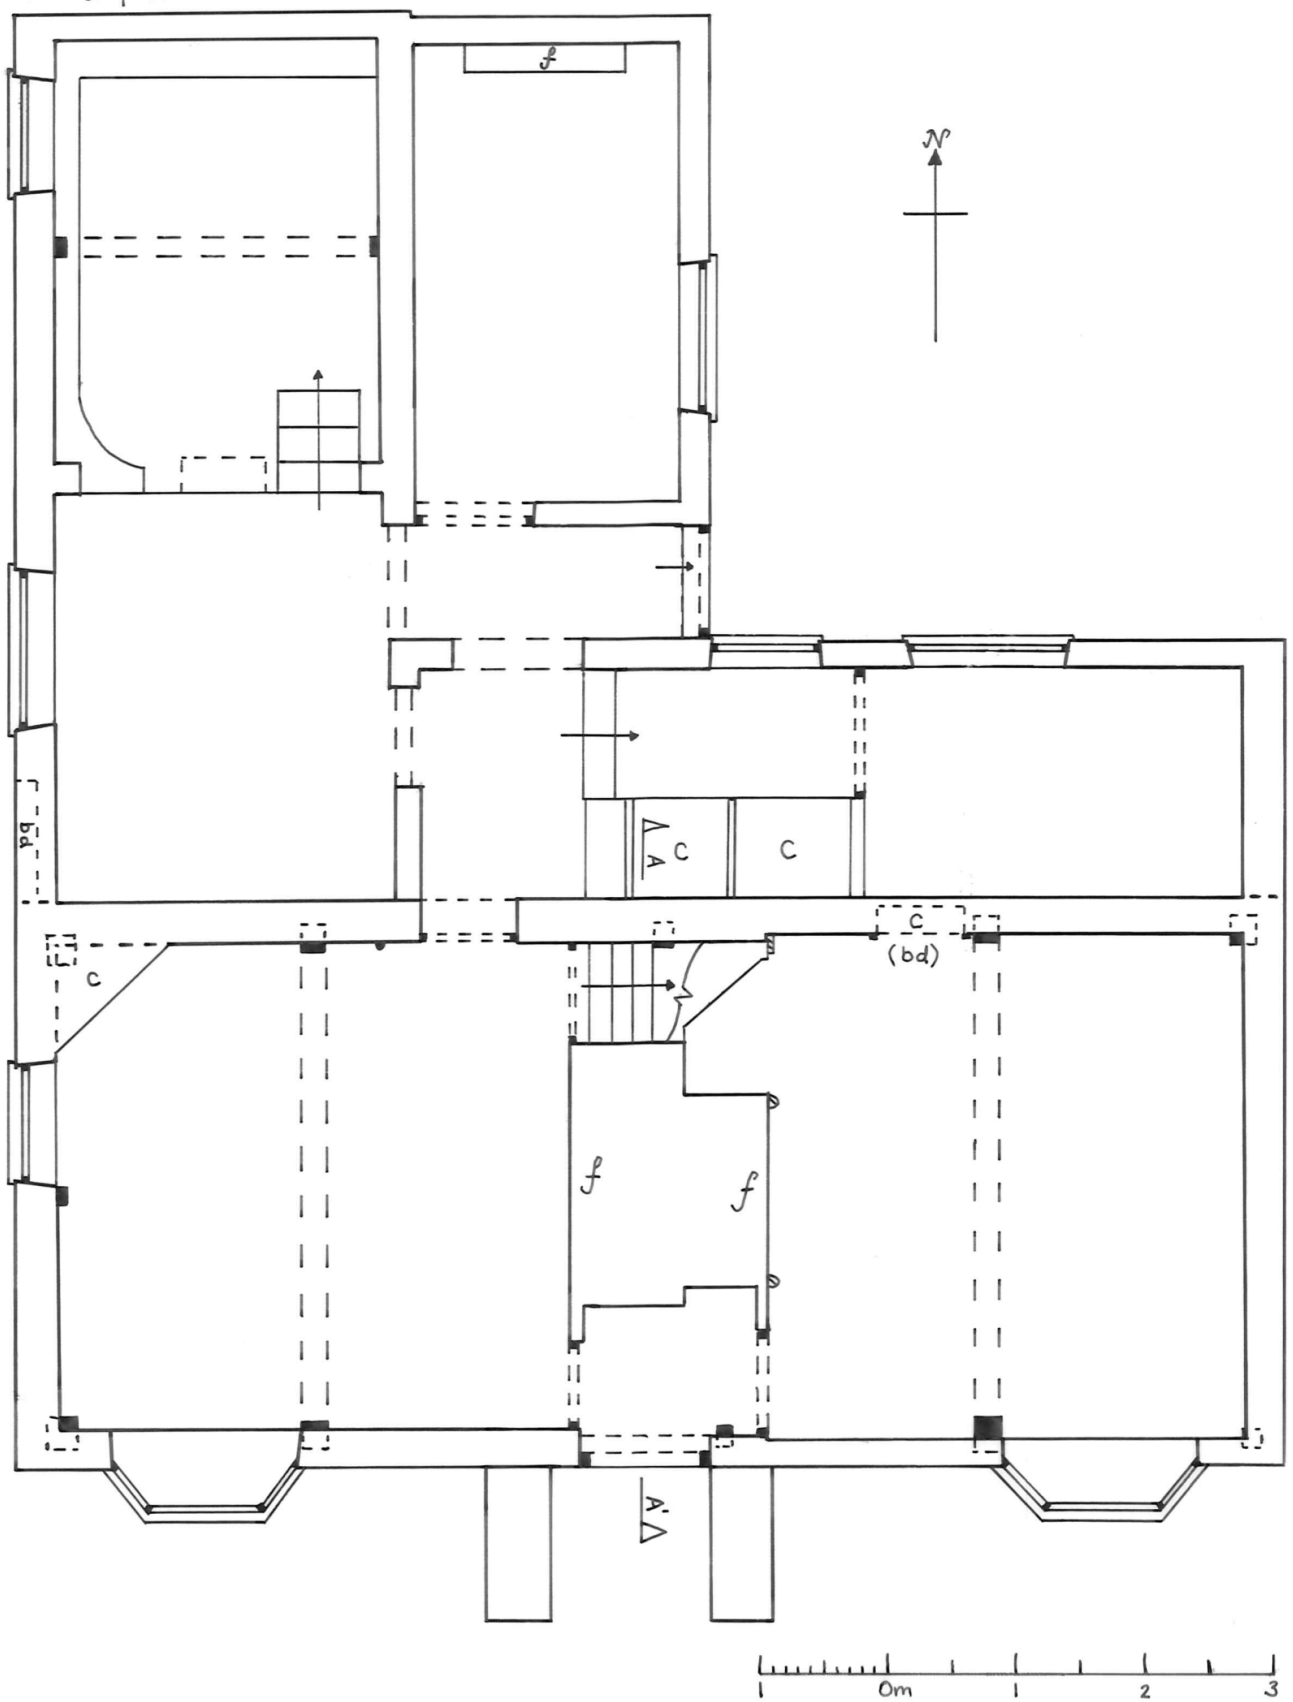
Fig. 53. Ground floor plan of Mill Cottage

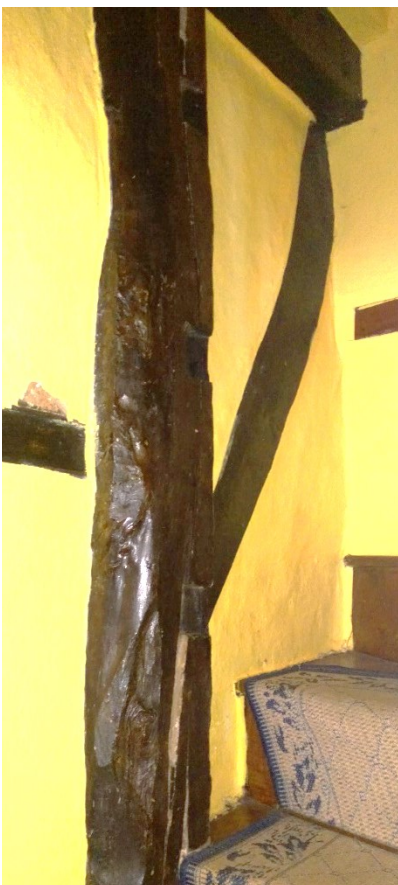
Fig. 56. Post showing rafter seats, evidence of reuse.

Much of the original fabric of the building survives within the encasement, although everything above the level of the wallplate was lost when the roof was raised. The frame consists of well-squared, adze-hewn posts, wallplates and tie beams. Most timbers appear to be in the position they were originally shaped for, although several posts are reused and significantly wanier (Fig. 56). Braces and mid-rails are straight-sawn, showing no signs of reuse. They are relatively well-shaped for mud and stud; the braces are gently convex, and more regular than is sometimes seen.

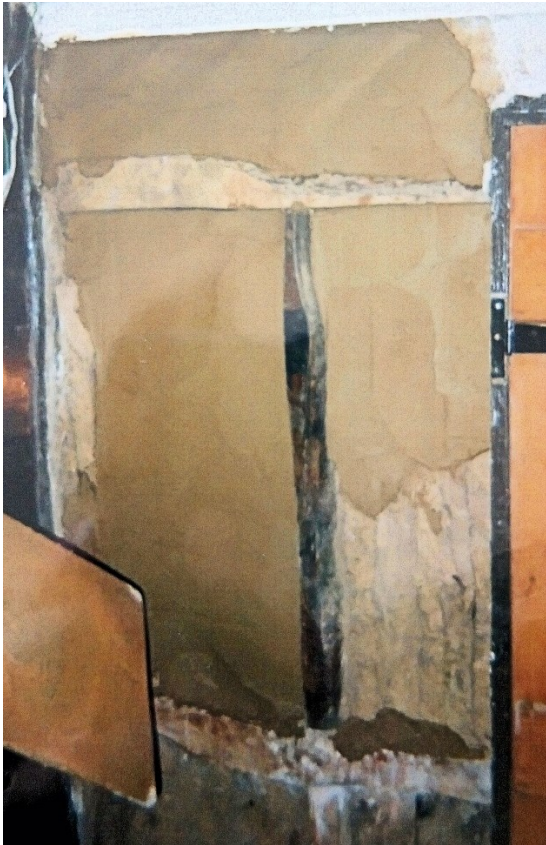
Fig. 57. Mid-rails and intermediate timbers. Note exposed laths in unplastered section. North wall of western room (photo courtesy of Richard & Janice Locke-Wheaton, taken 1997)

As is common in mud and stud buildings, there is no evidence for a sole plate, nor therefore any downward bracing. The cladding of the frame – the lighter timbers visible in Figure 57 and the laths revealed in Figure 58 – are very different in character to the major timbers; they are waney, and a mixture of roughly shaped

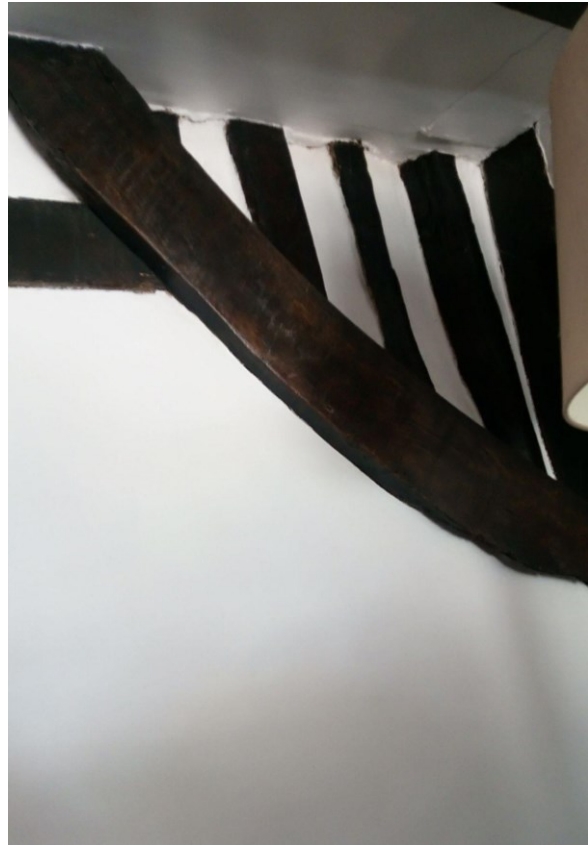
Fig. 58. North-eastern brace in eastern room, with laths exposed from the inside by the current owners. Note also the mid-rail

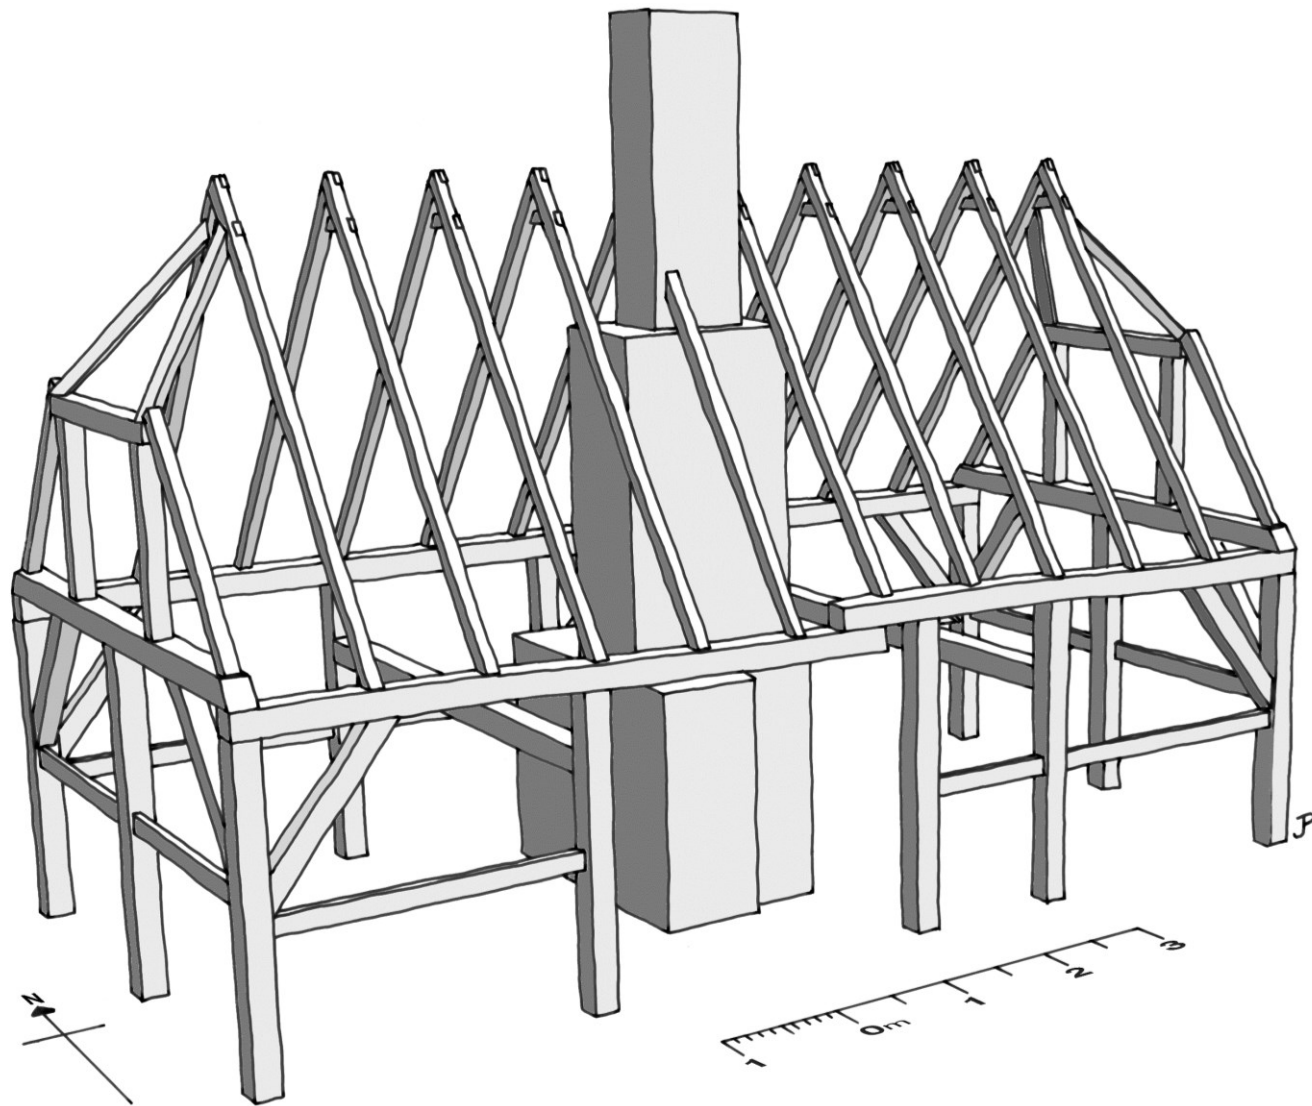
Fig. 60. Reconstruction of Mill Cottage from the south-west, with conjectural half-hipped roof

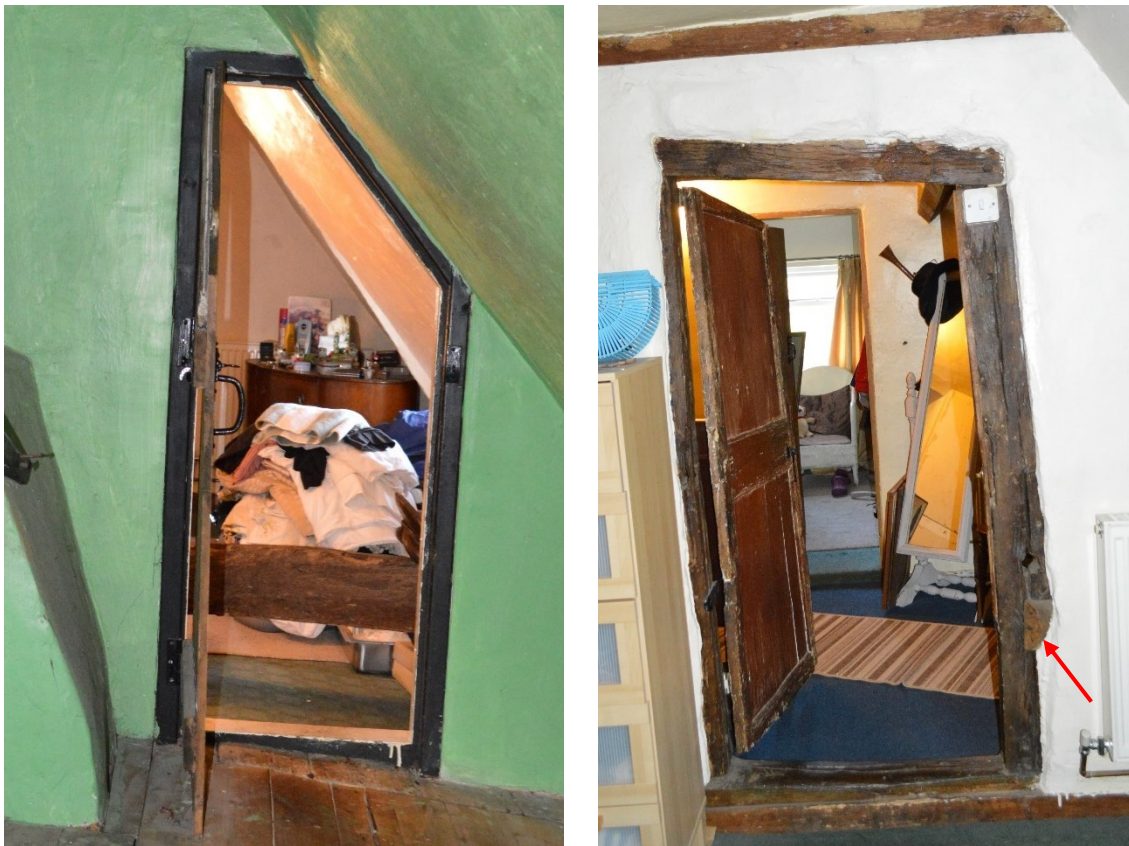
Fig. 61. Two solutions to awkward tie beams, both in the same room at the Blue Bell Inn, Tattershall Thorpe. (L) Tie beam left in place close to doorway. (R) Tie beam cut, and corseted doorway inserted – cut beam indicated by arrow

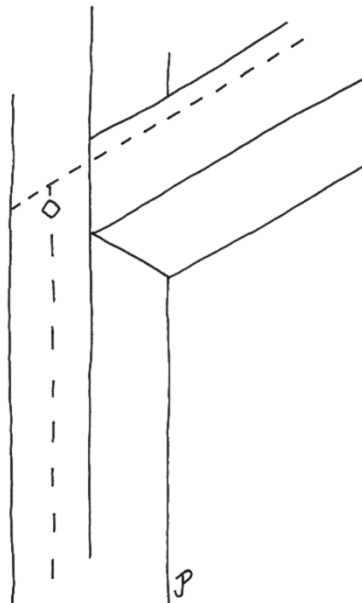
Fig. 62. Sketch looking up at the interface between north-east binder post and binder. Dotted lines indicate position of plastered surfaces

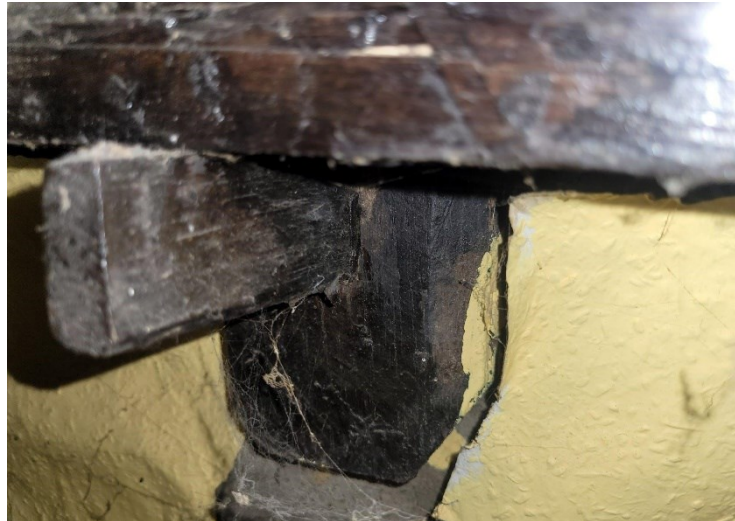
Fig. 63. Joint in the southern wallplate (courtesy of Richard Locke-Wheaton)

A further unusual, and somewhat enigmatic, feature of the building is the scarfing of the southern wallplate, as supported by the post next to the front door. This unfortunately sits within the cupboard above the entrance, and was not accessible during the survey. The owner later took some photographs of the timber (Fig. 63), which appear to show the underside of the wallplate, with a keyed, apparently-free-tenoned joint. Figure 64 contains two possible reconstructions of this assembly as a scarf joint; 64(a) is

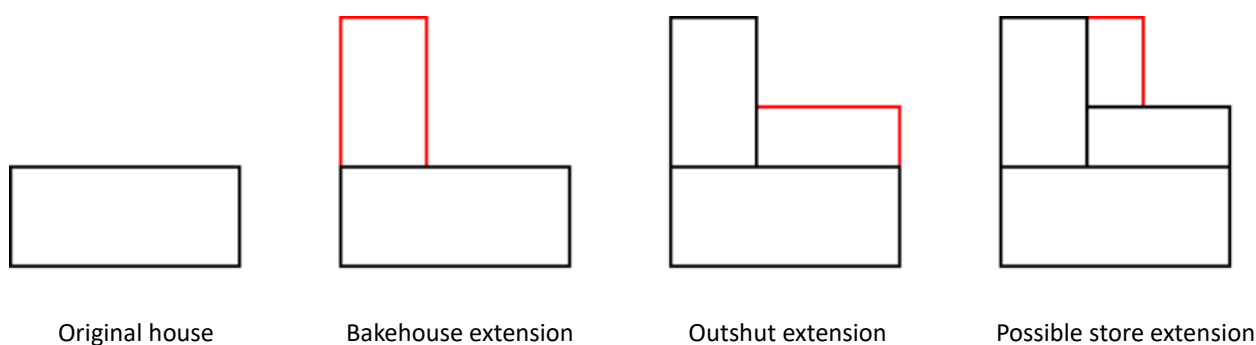
Fig. 65. Development of Mill Cottage

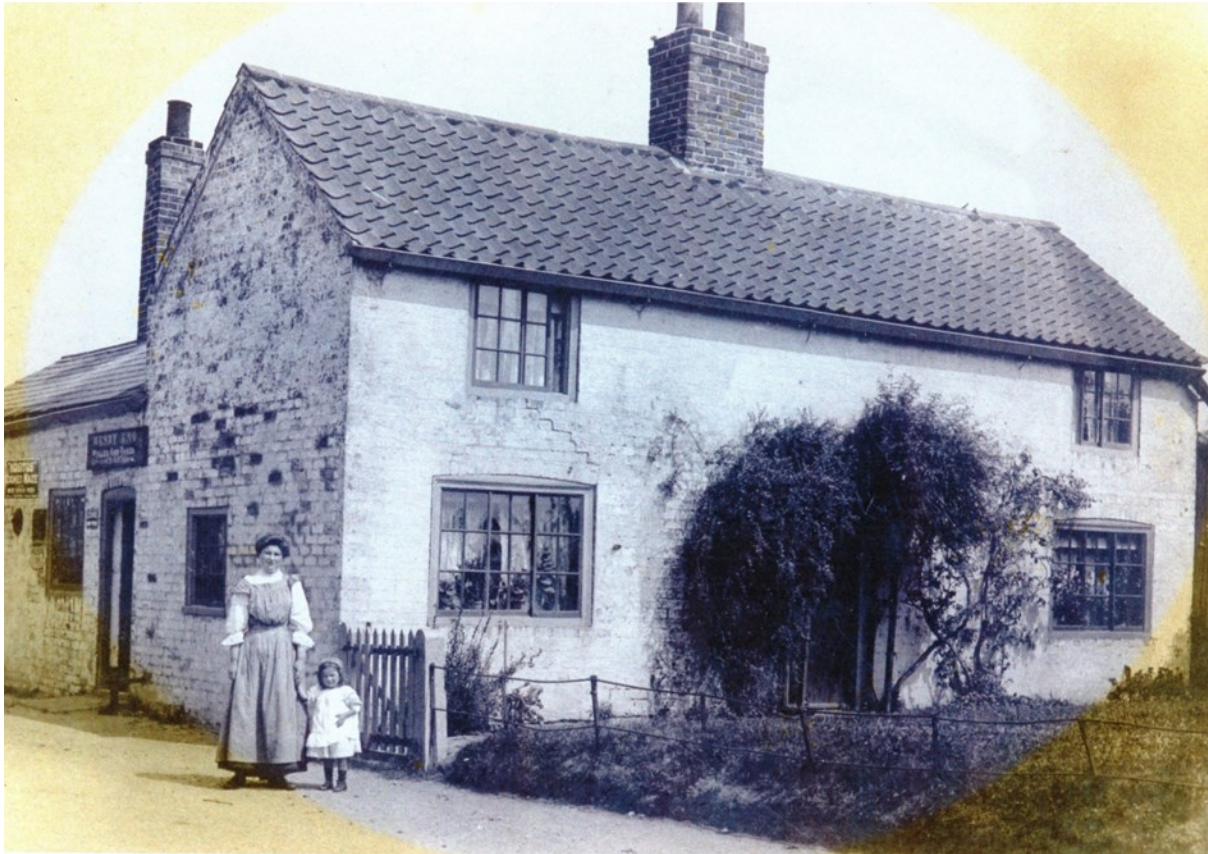
Fig. 66. Mill Cottage c.1912 (courtesy of Richard & Janice Locke-Wheaton)

twentieth. In 1911 Henry Eno, his wife and three children, were living with two of his employees (bakers) in six rooms in the cottage ('Henry Eno' 1911); Figure 66 depicts the cottage at this time. Exactly which rooms were domestic, and which were commercial at that date is uncertain, but it represents a house at the larger end of the scale for Toynton; at this date 1 Chapel Lane was counted as 4 rooms, while Chestnut Cottage was two dwellings, each of two rooms. The building continued to be adapted to its circumstances.

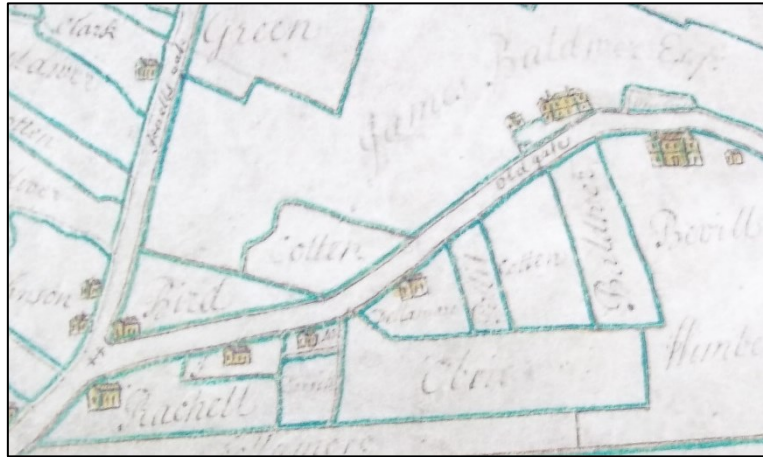
Fig. 73. Detail of Hall's map, showing a variety of house designs and sizes (LAO Jackson/I)

gives more of the space over to coats of arms and the decorative cartouche than it does to the map itself, although this is also very detailed, with watercourses and roads marked, along with 3D sketches of the houses and other prominent buildings (such as the windmill and churches) and each field's owner annotated (Fig. 73).

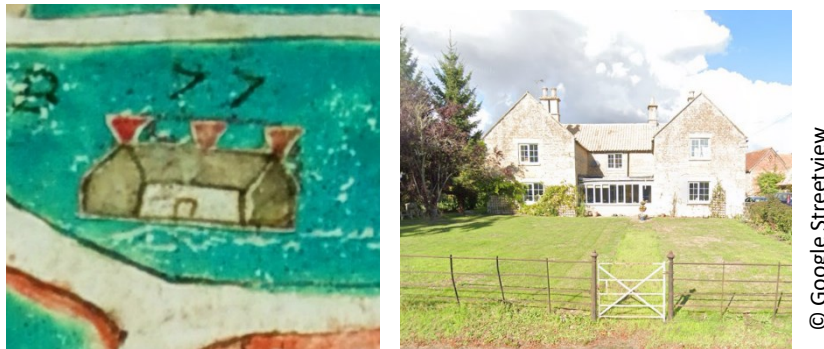
Fig. 76. Comparison between the map and a standing building (L) Building on plot 77 (west of the church) (LAO Little Bytham PAR/23/1) (R) The building standing on the plot today, both with two projecting wings, three stacks and central entry

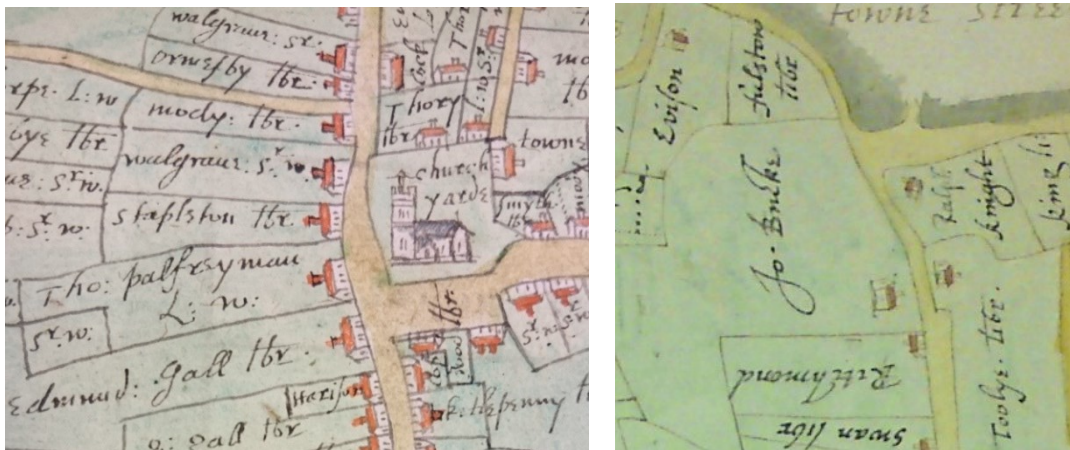
Fig. 78. Henry Valentine's mapping style. (L) is unattributed (LAO 2-BRACK/2/1 1630), but extremely similar in style to (R), the 1614 Survey of Toynton (LAO 5-ANC/4/A/14 1614)

It seems, therefore, that many Lincolnshire maps of the seventeenth century were drawn with attention to the accurate depiction of buildings, although the precise details varied from surveyor to surveyor. Unfortunately, there are no instances of two surveys known to be by the same surveyor, although stylistically it is very likely that Henry Valentine, who produced the 1614 Toynton survey, also produced a survey of Partney called the Acre Book, which is undated but ascribed to c.1630 (LAO 2-BRACK/2/1)⁴⁴. The treatment of the houses is similar in both surveys (Fig. 78), as are many other map details and the layout of the written survey.

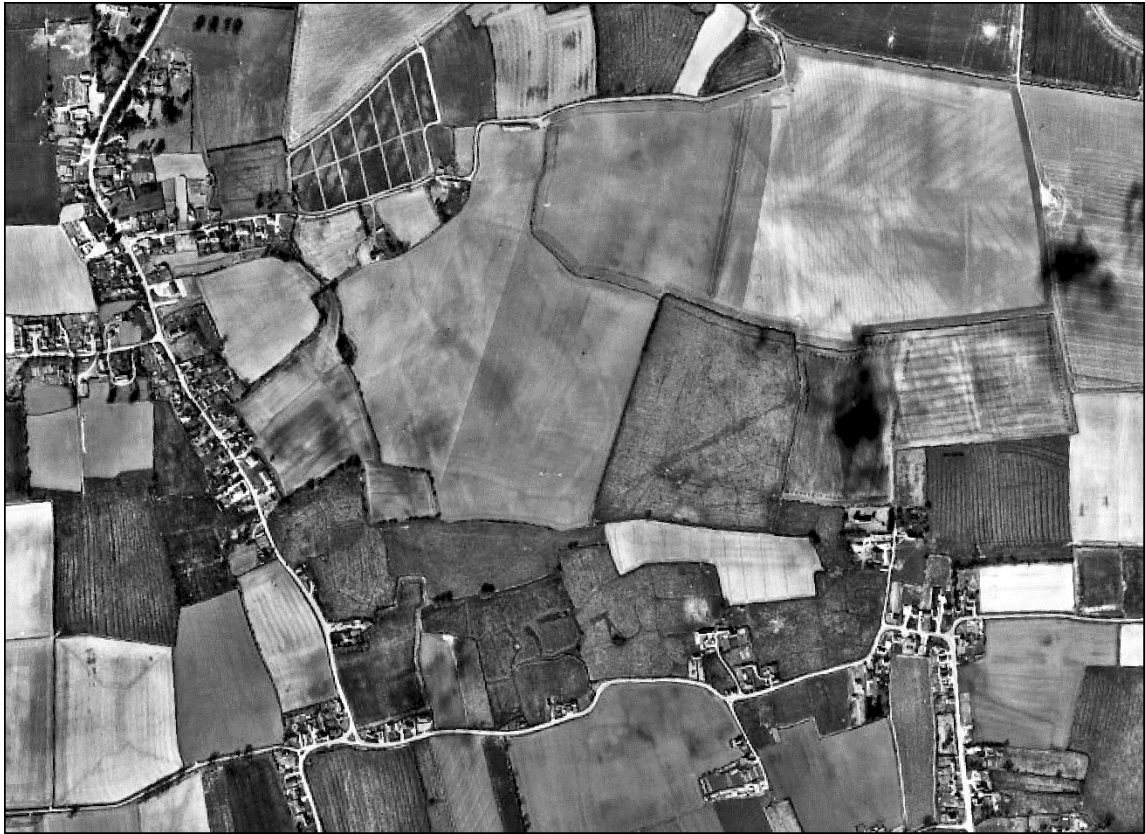
Fig. 83. 1978 aerial photograph of Toynton (CUCAP RC8CN034 1978)

In order to test the accuracy of the maps, the raw photograph of each page of Valentine’s map was georeferenced onto a modern vertical aerial photograph (CUCAP RC8CN034 1978, Fig. 83), using a spline transformation. (Fig. 84 shows the same image as Fig. 81, but georeferenced). This exactly places each reference point on its location, prioritising precision over the risk of skewing the map, to maximise the ‘match’ between Valentine’s map and the photograph (Fig. 85). Nevertheless, a remarkably low skew was produced; as may be seen, the overall shape of the page was not distorted enormously,⁴⁵ nor were the field boundaries.
