Putting mud and stud in its place:
rediscovering the culture of Lincolnshire's
indigenous buildings, and exploring their
dwellingscapes

Jennifer Pape

MA by Research

University of York

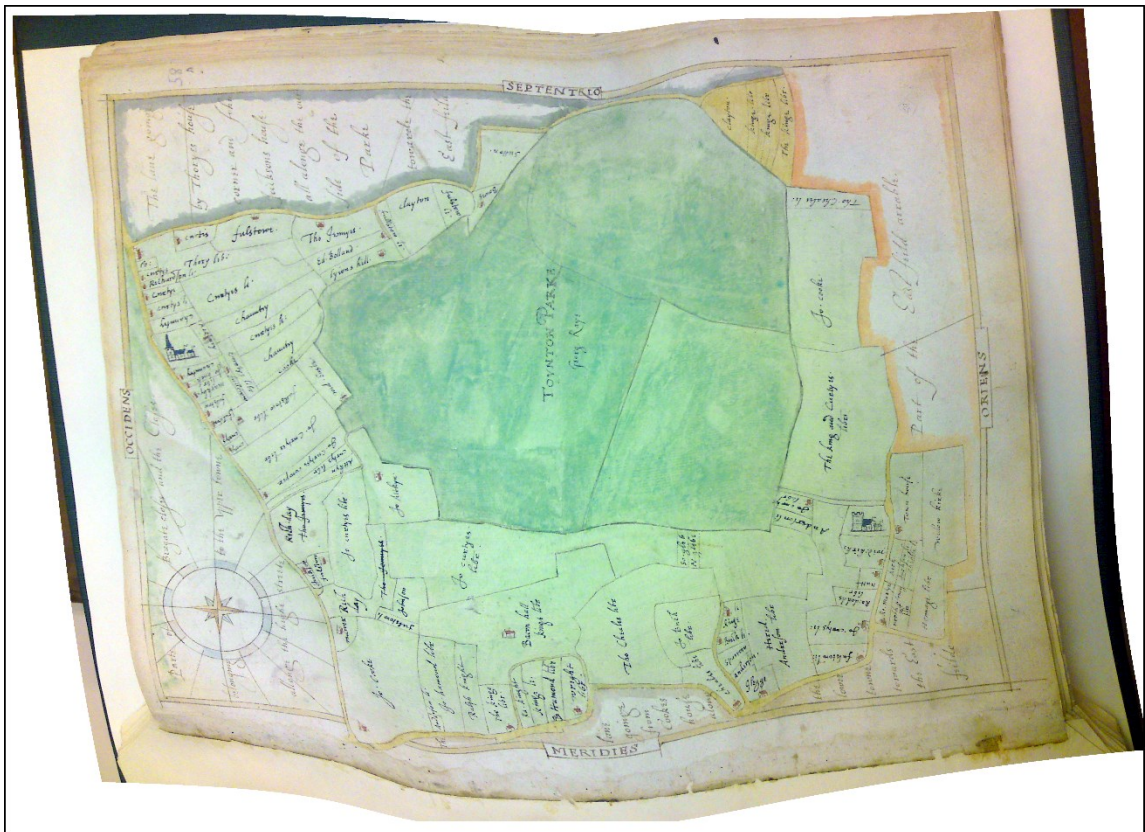
Fig. 84. Valentine's map georeferenced using a spline transformation (LAO 5-ANC/4/A/14 1614)

In order to test the accuracy of the maps, the raw photograph of each page of Valentine’s map was georeferenced onto a modern vertical aerial photograph (CUCAP RC8CN034 1978, Fig. 83), using a spline transformation. (Fig. 84 shows the same image as Fig. 81, but georeferenced). This exactly places each reference point on its location, prioritising precision over the risk of skewing the map, to maximise the ‘match’ between Valentine’s map and the photograph (Fig. 85). Nevertheless, a remarkably low skew was produced; as may be seen, the overall shape of the page was not distorted enormously,⁴⁵ nor were the field boundaries.

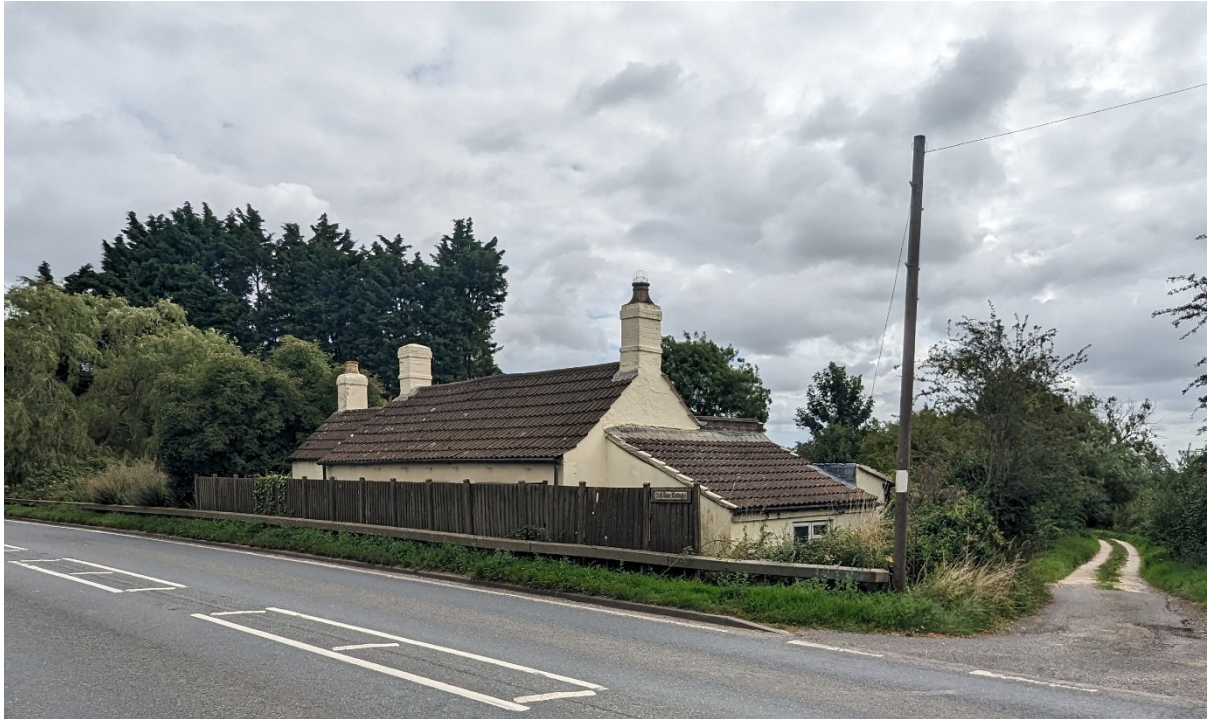
Fig. 87. Difficult to photograph due to its proximity to the road, Toll Bar Cottage probably dates to the turnpiking of the Boston-Alford road in 1765

2½ bay single storey cottage parallel to the road, with central doorway, gable stacks and extension to east. Pent extension to west, with further extensions to the south, all rendered but apparently all brick externally. This property first appears on the 1771 Willoughby estate map and is still standing. Rodney Cousins noted it (2000, 37), and it was recorded on the Mud and Stud Survey as retaining all its walls in mud and stud (Fig. 89).

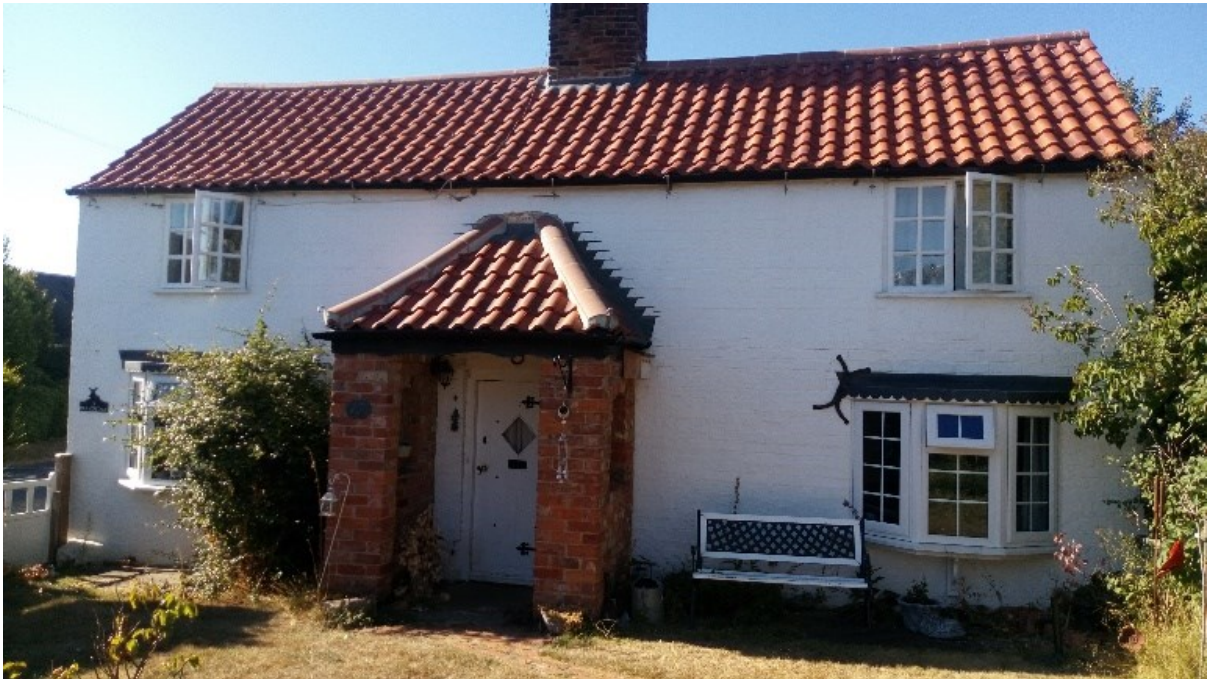
Fig. 92. Mill Cottage from the south

2½ bay two storey cottage with gable stacks, at right angles to the road and facing south. Originated as single storey mud and stud of late character, then encased and extended. The frame and a significant proportion of the mud and laths survive. Later the roof was removed and raised to two storeys. A building parallel with the road appears on the 1614 survey (Fig. 93) and again on the 1771. By 1825 (and possibly by 1774) it has been rebuilt at right angles to the road.

The solution seen at Mill Cottage overcomes all of these shortcomings. It is therefore surprising that it is not found more widely. The only other tentative example is known from a single, grainy photograph showing a similar arrangement of binder and post in a partly-demolished building; this happens to also be in Toynton All Saints, in an unknown location on Peasegate Lane (Fig. 97) (Rudkin, 2001, 17).

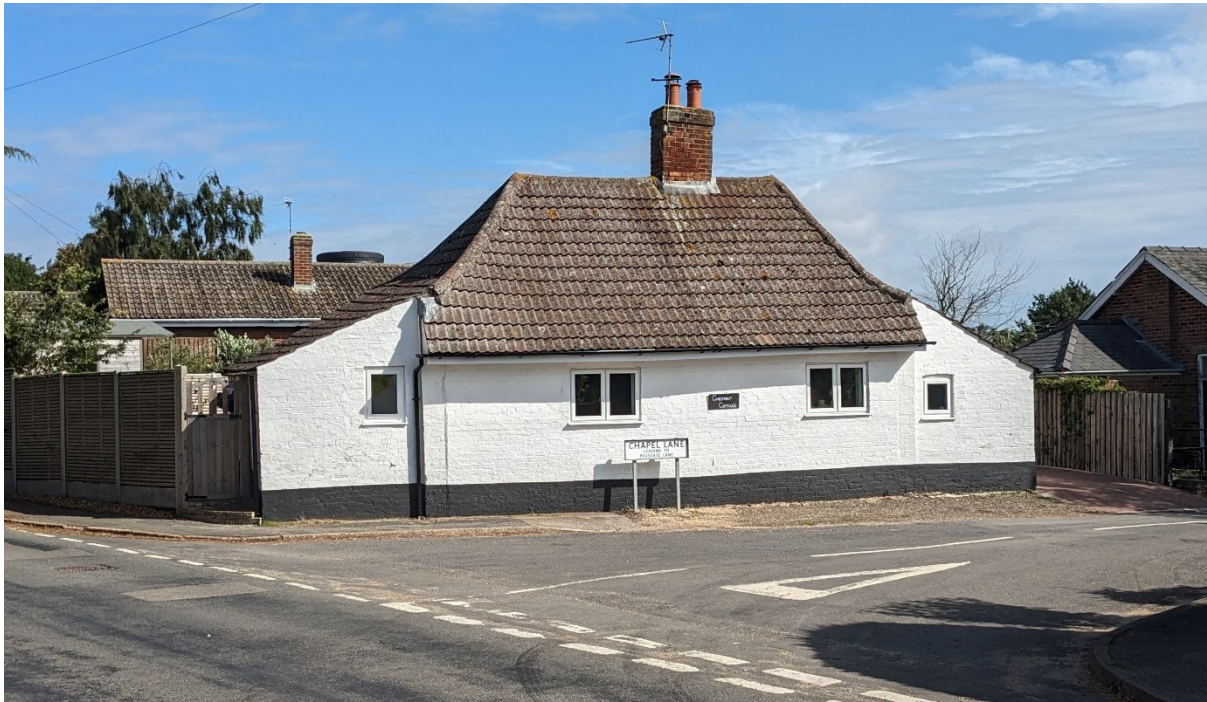
Fig. 94. Chestnut Cottage from the south-west

Single storey 'lobby entry' cottage parallel to Chapel Lane, although without surviving evidence for a door onto the lane as south wall rebuilt/encased in brick. Axial stack, with later outshut extensions to north, east and west. These enclose surviving mud and stud walls, along with a mostly-extant frame and surviving haphazard roof structure with thatch under the roof tiles. Appears from the 1771 map onwards. Grade II listed and standing. Cousins assessed it as 'Poss C17th' (Cousins 2000, 37), and it was recorded on the Mud and Stud Survey (LAO 26 MLL 1984, 167)

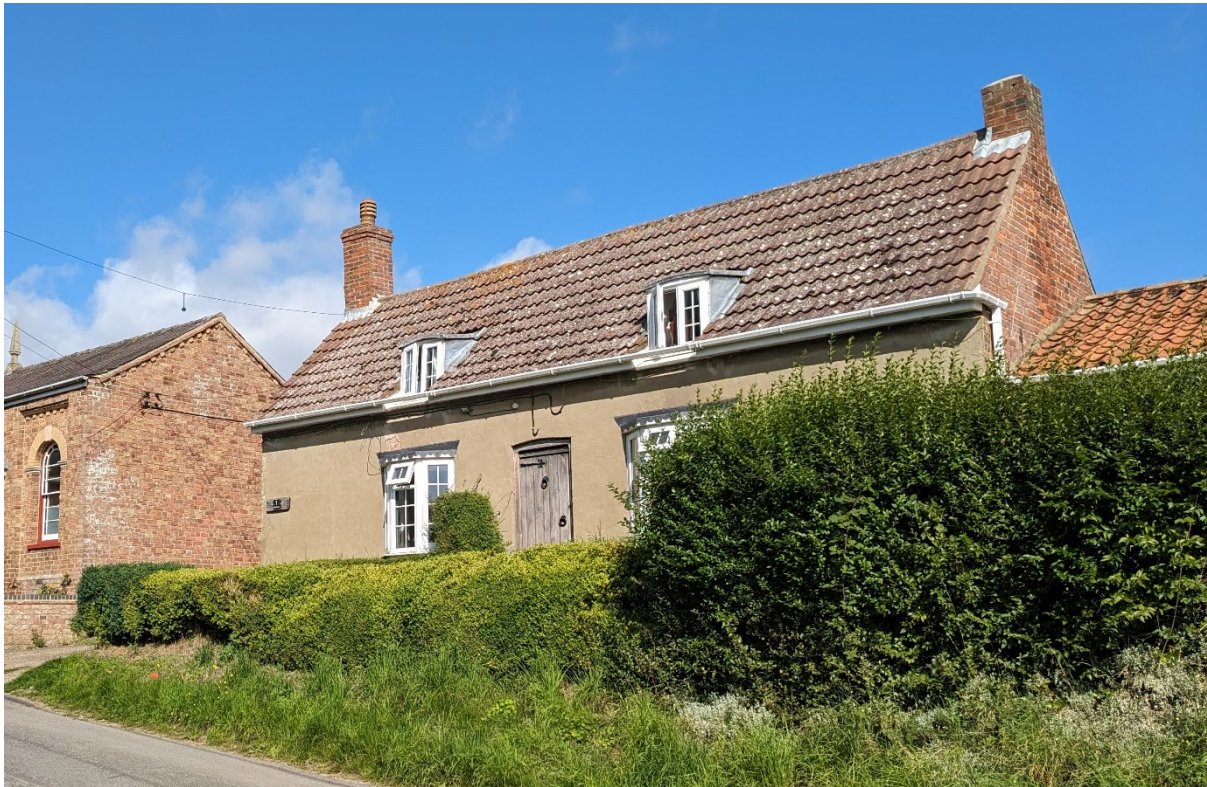
Fig. 95. The Cottage from the south-east

2½ bay cottage with chambers in the roof space, parallel with the road. Originated as cross-passage house with gable smokehoods, later extended and encased. North wall retains mud and stud on padstones; padstones survive in west wall too, along with other elements of the frame, the roof structure and reed thatch base. Believed to have retained its thatch into the age of photography, although the image has been lost (Pape 2022). Appears on 1614 map in the occupation of Richard Pearsall. Apparently extended to the east before 1632, but later reduced in size before modern extension built in the same place. Standing, Cousins (2000, 37) assessed it as 'Poss C18th. Encased.' Also recorded on the Mud and Stud Survey (LAO 26 MLL 1984, 166).

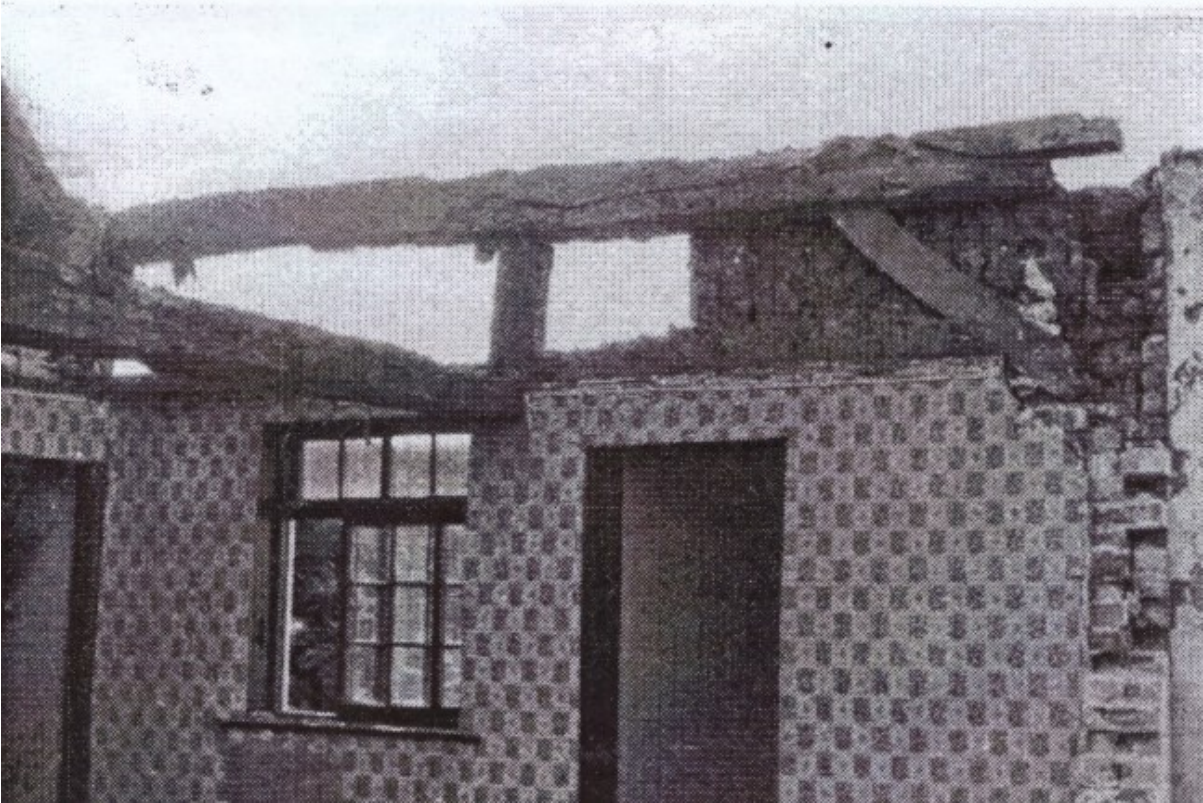
Fig. 97. Unnamed cottage in Peasgate Lane (Rudkin 2001, 17)

Small mud and stud cottage of late framing character (similar to Mill Cottage), suggesting it had attic bedrooms from first construction. Figure 97 shows the house during demolition, but neither specifies the exact location nor illustrates the layout of the building, merely captioning it 'An old cottage in Peasgate Lane'.

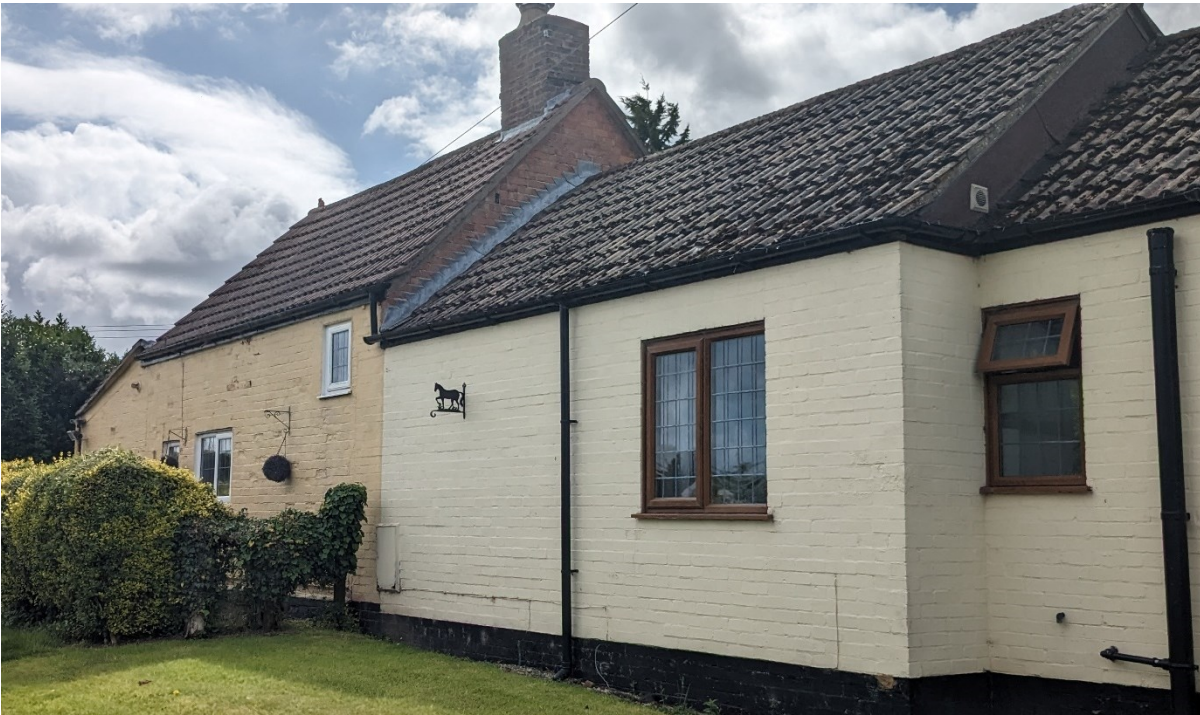
Fig. 98. End View (L) and Far Cottage (R) from the north-west

Two semi-detached cottages parallel to the road which may have originated as a single cottage, but were more probably built as two. Single axial, shared stack, with half-hipped roof and attic windows to east and west. A small window under the high eaves of the south elevation suggests that they were of late framing character, with attic rooms from the start, similar to the unnamed cottage also in Peasgate Lane. PD Pape recalls visiting the cottage as a child, and confirmed that it was of mud and stud construction (Pape 2022).

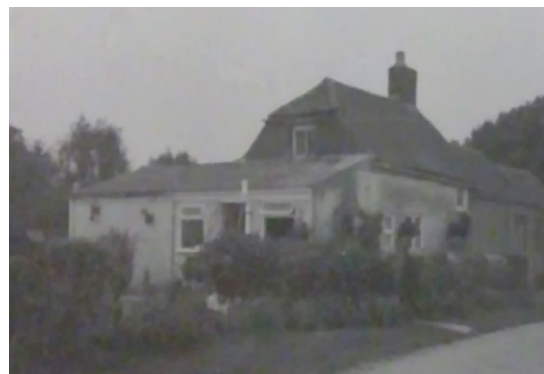
Fig. 100. Viewed from the north-east in 1983 (LAO 26 MLL 1984, 168)

Figure 99 shows the exterior of the cottages before they were rebuilt in the late twentieth century. Figure 100, from the Mud and Stud Survey, shows End View with an unchanged roof, while Far Cottage had already been altered. End View was re-roofed soon after the survey, which recorded that the north wall retained framing. Cousins (2000, 37) assessed it as 'Poss C18th. Encased.'

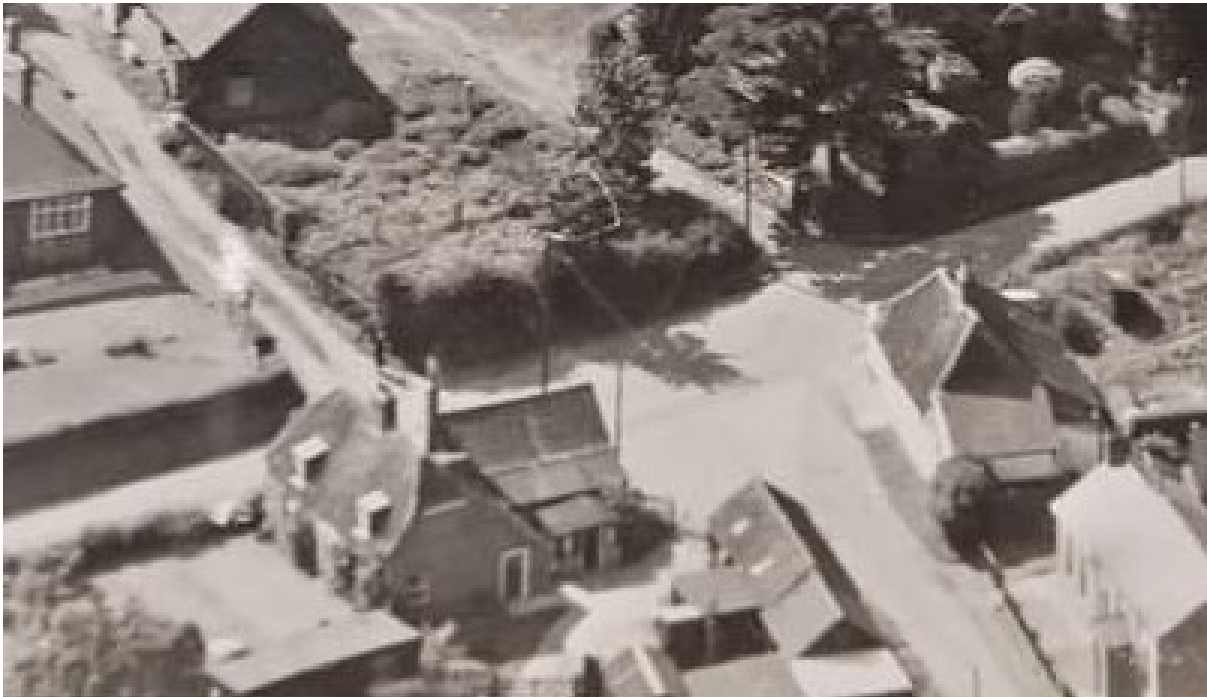
Fig. 101. The Post Office from the south-east, c.1975 (courtesy of Phyllis Pape)

Large two and a half-bay lobby entry cottage with half-hipped roof. At right angles to Main Road, but in its latter form facing south, away from Chapel Lane. Encased in brick, with outshut extension to the north and large extension beyond to the north. No evidence for windows below half hips, but two dormers to south. The northern extension was the village shop and post office in the post-WWII period.

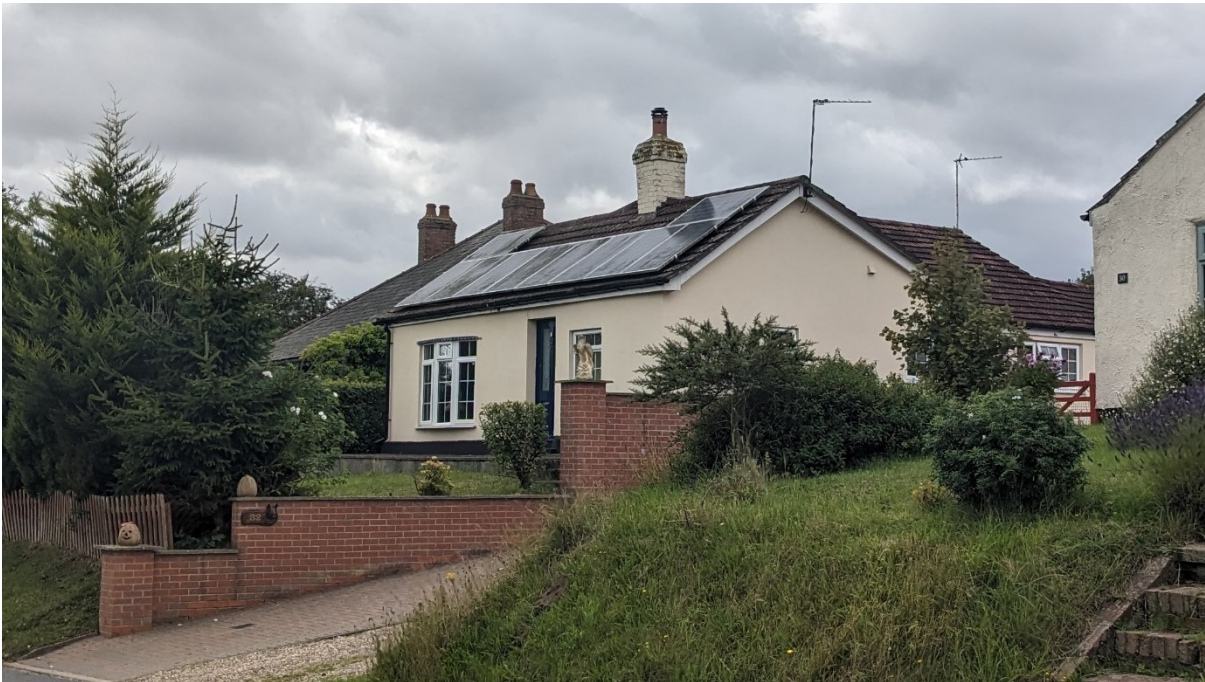
Fig. 105. Rosery Nook from the north-east

Identified during the Mud and Stud Survey as retaining 'a few' walls of mud and stud (LAO 26 MLL 1984, 169). Cousins (2000, 37) assessed it as 'Poss C18th encased'. Now a lobby entry bungalow with shallow-pitched, gabled roof, parallel with the road. Extended to the rear in several phases. Fundamental proportions of the front part appear plausible for a mud and stud building. An excellent illustration of how easy it is to completely obscure a mud and stud building.

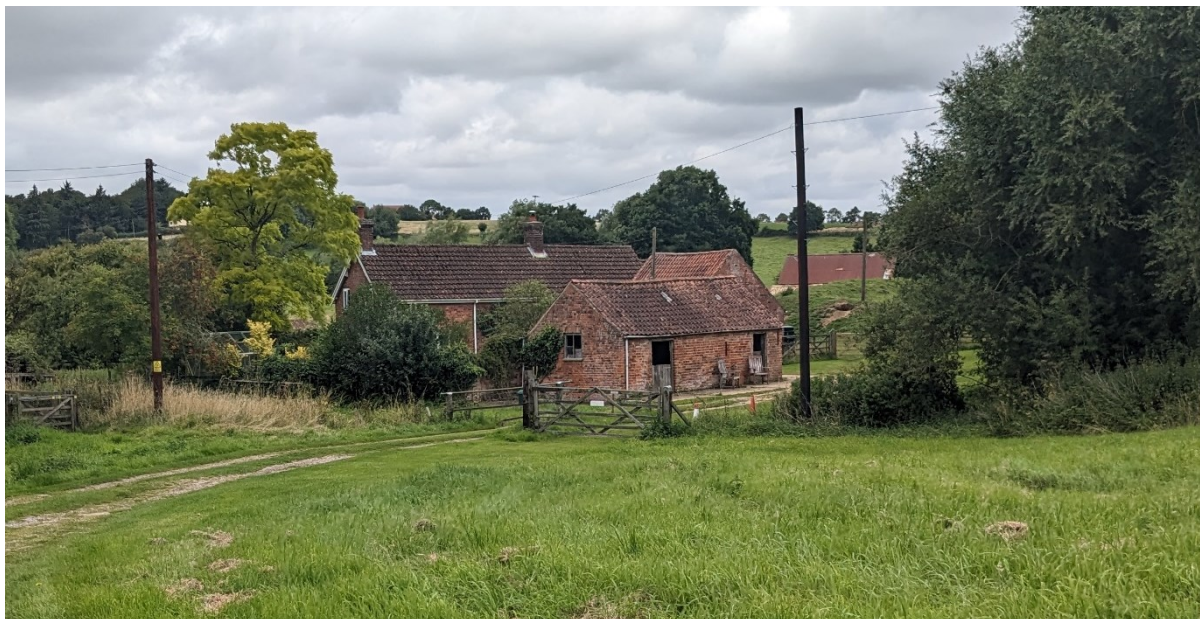
Fig. 107. The Watermill from the south-east. The mill building is the short pan-tiled building behind the stable, with the mud and stud mill cottage to the left (with modern roof)

Early photographs⁴⁸ show a long 3 bay lobby entry cottage with gabled roof running north-south, at right angles to, and detached from, the mill building (Fig. 108, Lawie 1962, 37). Dormer on the west elevation, with a small window in the northern gable. Extension to the south (the left in Fig. 107) had a higher roof. The building appears, in the early photographs, to be underbuilt in brick to the window sills, and then mud and stud above. The mill building appears to be a single storey in brick, but to have had its roof raised by a few courses (Fig. 108). The waterwheel, now removed, is overshot, on the eastern gable.

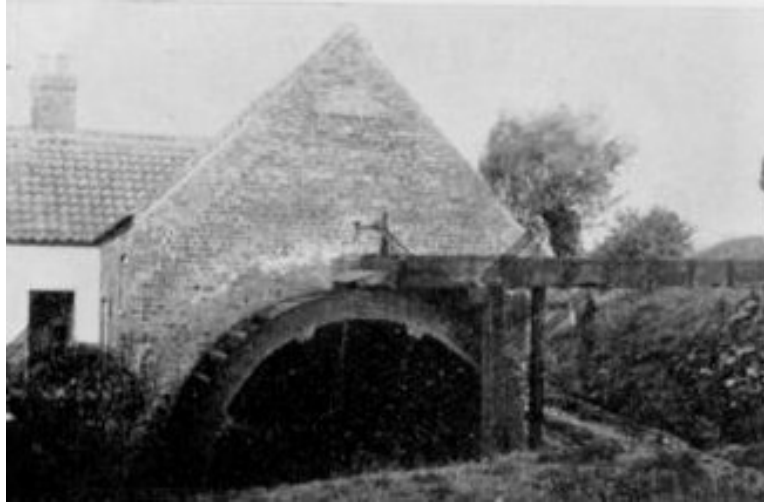
Fig. 108. The mill in 1907 (Lawie 1962, 37)

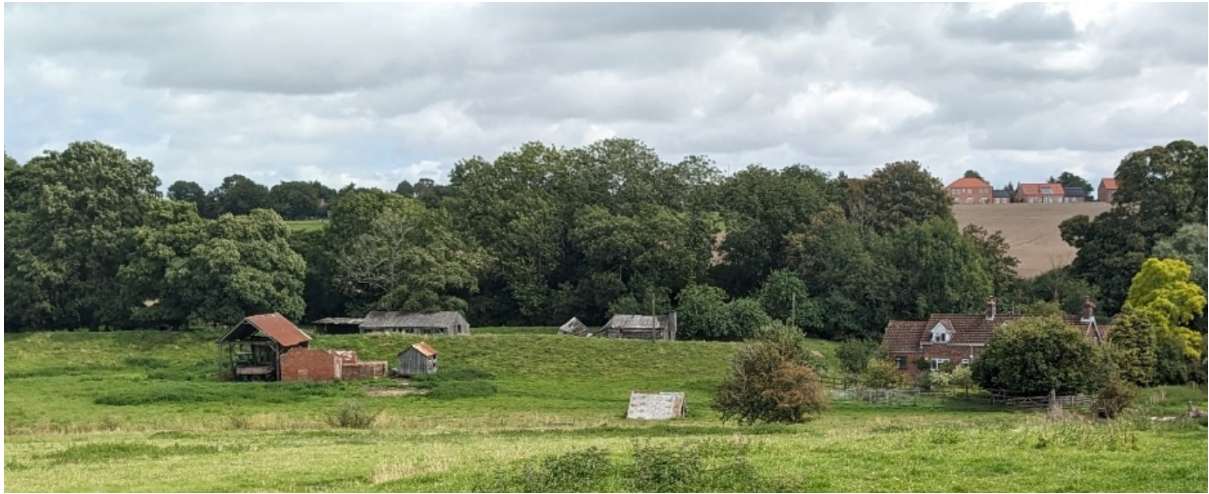
Fig. 111. Viewed from the west, the long bank of the millpond survives, although the pond has been drained. The mill building is beyond the white dormer on the cottage, with the tail race beyond that.

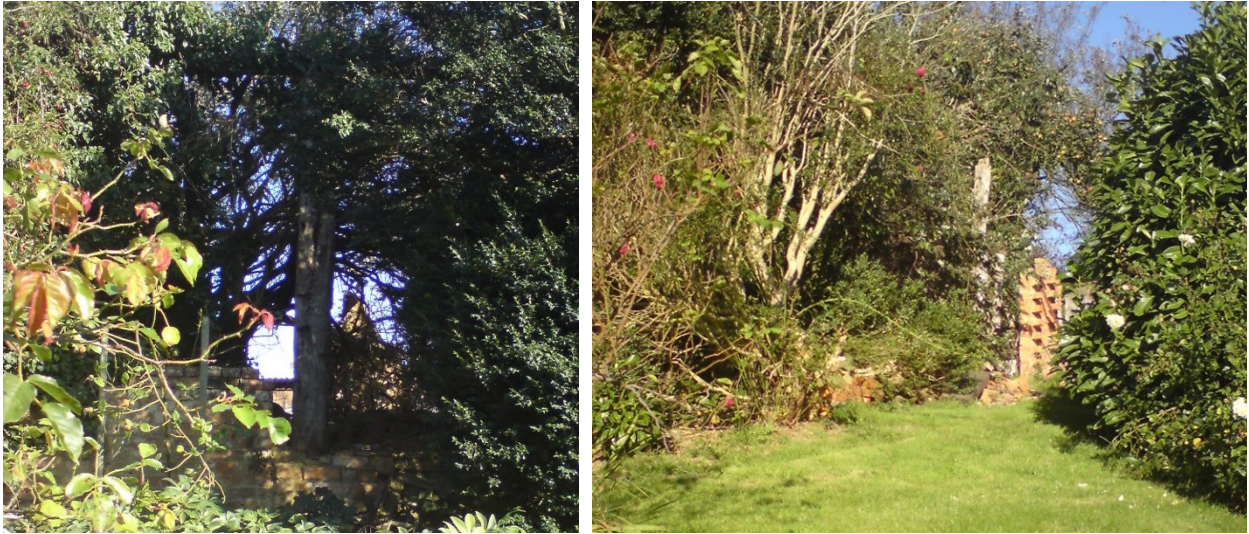
Fig. 115. Two views of the remains of Saville's Cottage in 2011

The remains of a 2½-bay lobby entry cottage with low, gabled roof (latterly), parallel to Main Road. The building was partially encased, with no evidence of an upper floor, but the roof appears to have been remodelled. Some framing is now visible; post with conventional tenon, mid-post and wallplate. Timber is well-shaped, of sturdy scantling and not waney. It was reported to Cousins (2000, 37), but not visited.

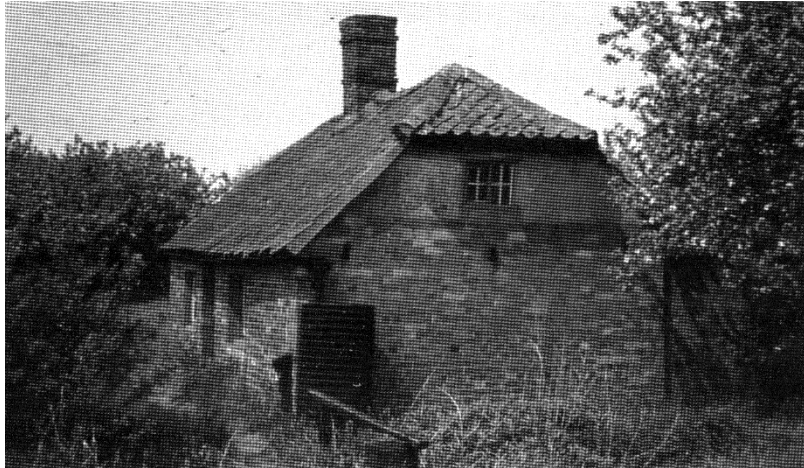
Fig. 118. Sewell's Cottage (Roberts 2018, 301)

Lobby entry cottage with half-hipped roof, apparently early nineteenth century (according to DL Roberts) and partially in brick from first construction. Parlour and kitchen flank back-to-back hearths, with ladder access to garrets. Photograph shows it encased in brick to the tie-beam level, with mud and stud above; range of service rooms (latterly coal house, pantry, dairy and scullery-cum-entry) in an outshut behind. The dairy and kitchen were half-sunk, although the plan does not indicate how this worked with the rest of the cottage.

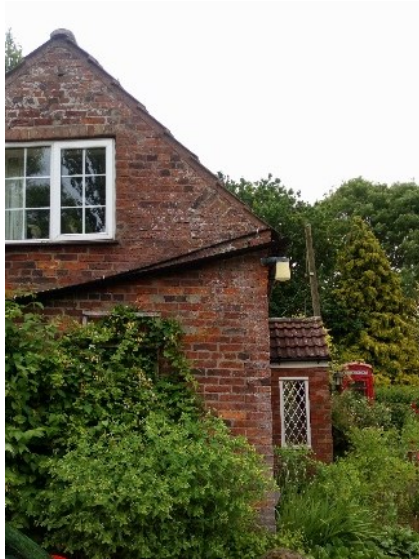
Fig. 119. Fall Farm Cottage from the west

2½-bay lobby entry cottage with gabled roof, facing south. Brick with tumbling at the gables, later porch and outshut extensions to rear and east. Chamber windows in gables and fairly shallow pitch to roof. No visible framing internally, but proportions suggest any frame may have been of late character, with chambers from the outset.

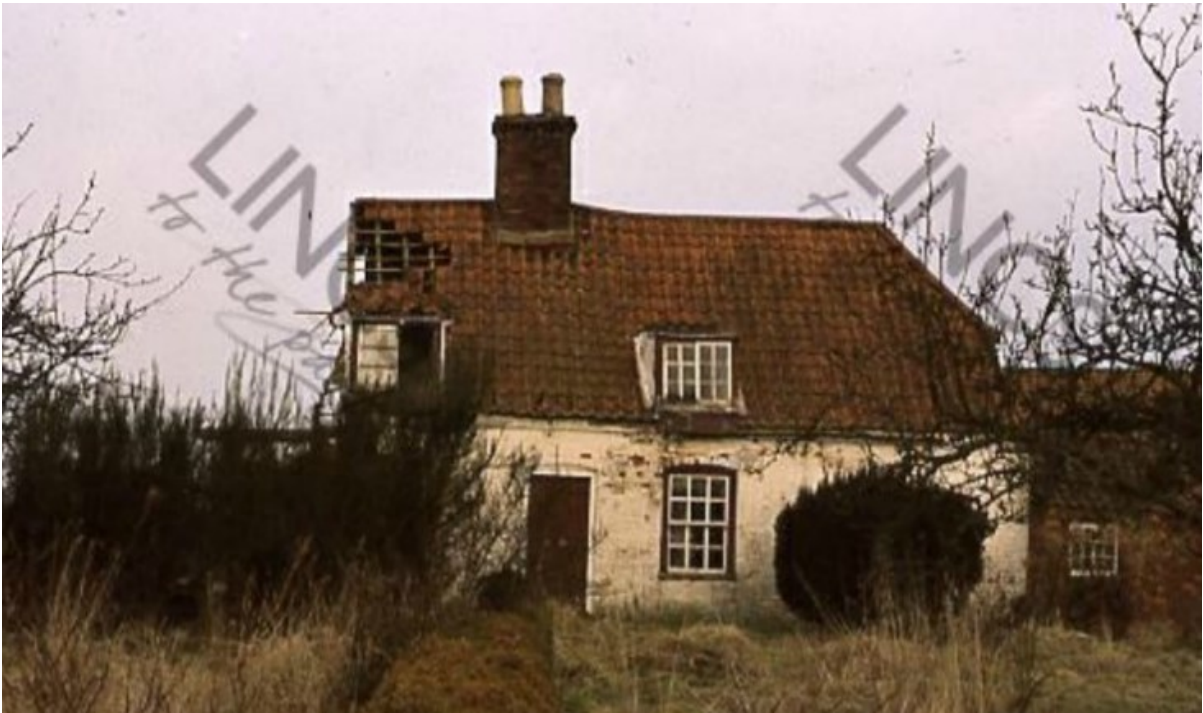
Fig. 123. White House Cottage (LAO MLL 4261)

Large, 3+ bay half hipped lobby entry. Two surviving photographs (LAO MLL 4261, including Fig. 123) depict it with one end demolished, so full length unknown, but map evidence suggests 3 bays. Several rooms in attic; window in gable end and two dormers in south elevation. Some daub apparently surviving in the photographs; PD Pape recalls it being 'a cottage with slopey walls' (Pape 2022). Length of straight wallplate visible at demolished end. Building appears to be quite a deep example front-back.

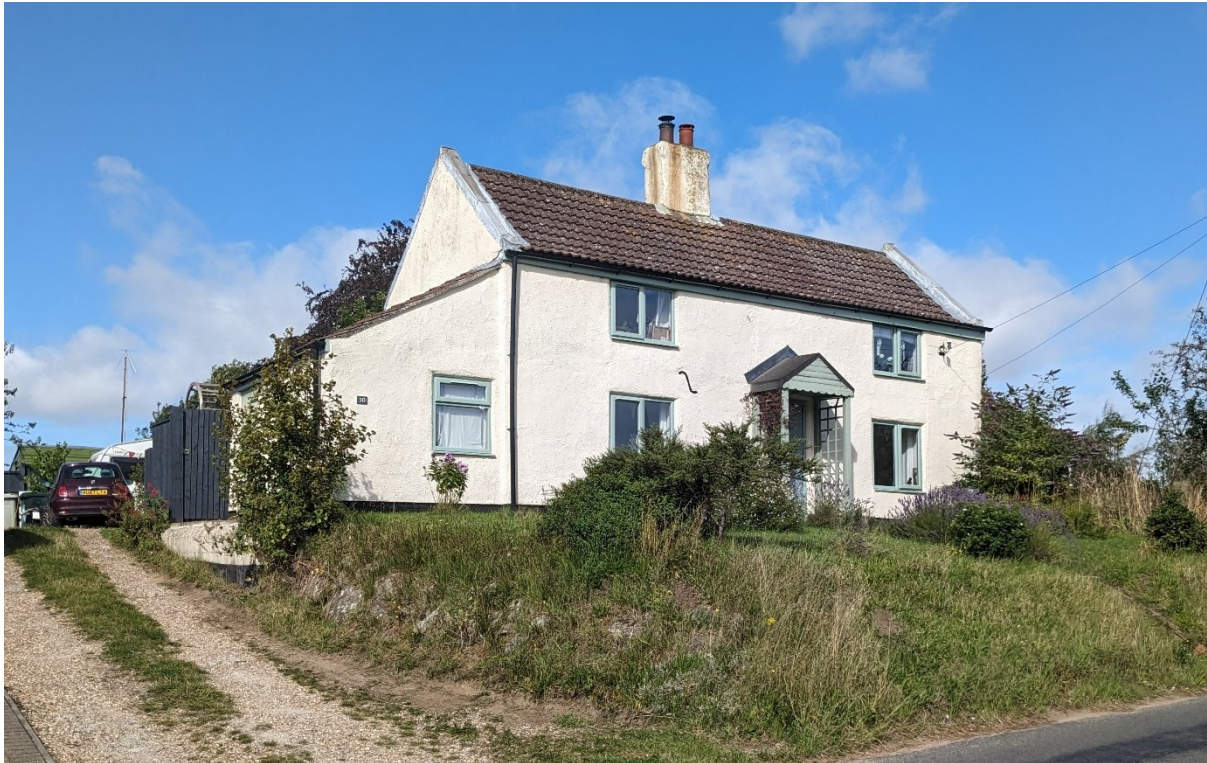
Fig. 124. Valentine Cottage from the south-east

Two-storey brick lobby entry cottage, parallel to the road. Very similar proportions and layout to Mill Cottage. No known evidence of mud and stud or frame surviving, but extremely similar to Mill Cottage, and displaying several phases of brickwork in the northern gable, suggesting a refacing of the front elevation. A cottage of similar proportions occupied the same position on the 1614 map (Fig. 125). Not visited.

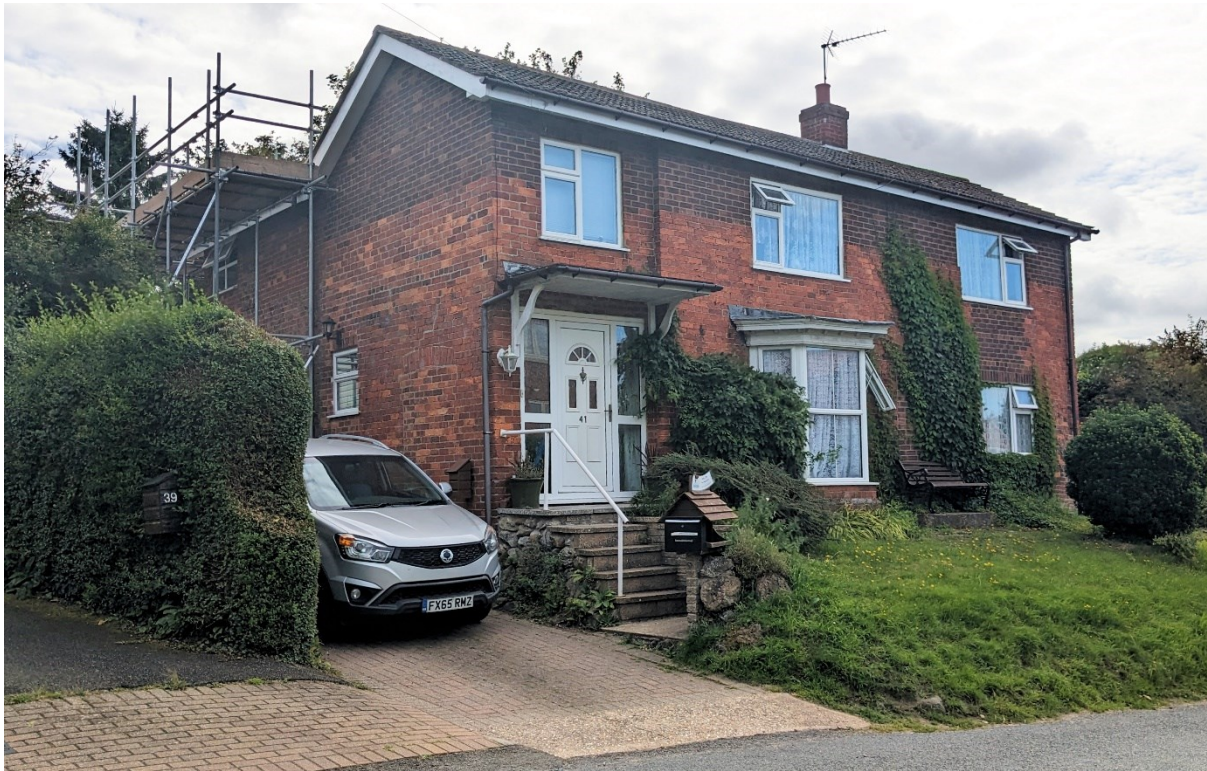
Fig. 126. Harboro House from the north-west

Brick cottage with blocked lobby entry plan (door behind ivy to the right of the bay window). Extended to the north, with multiple phases of brickwork suggestive of encasement and including at least one raising of the roofline to two full storeys. Core of the building similar to Mill Cottage. A similar cottage occupies the plot in 1614 (Fig. 127).

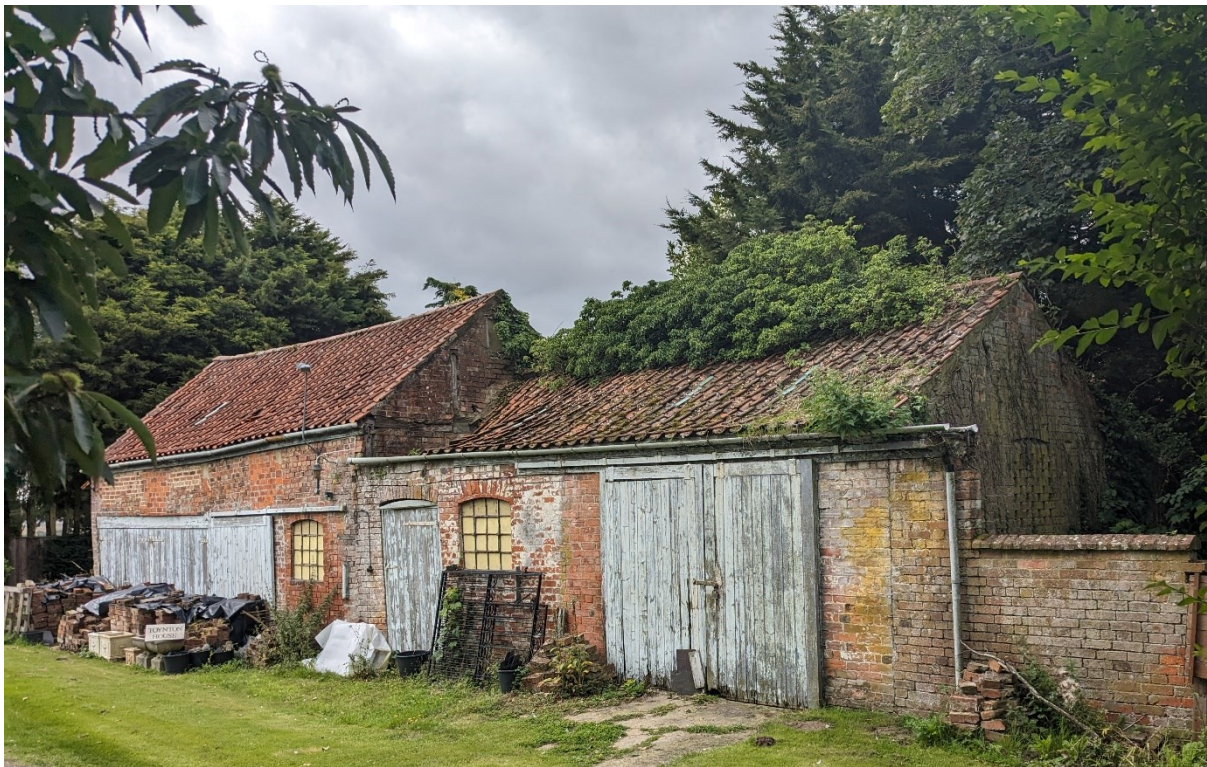
Fig. 128. Toynton House barn. The left-hand, taller part has visible remnants of timber framing in the gable wall

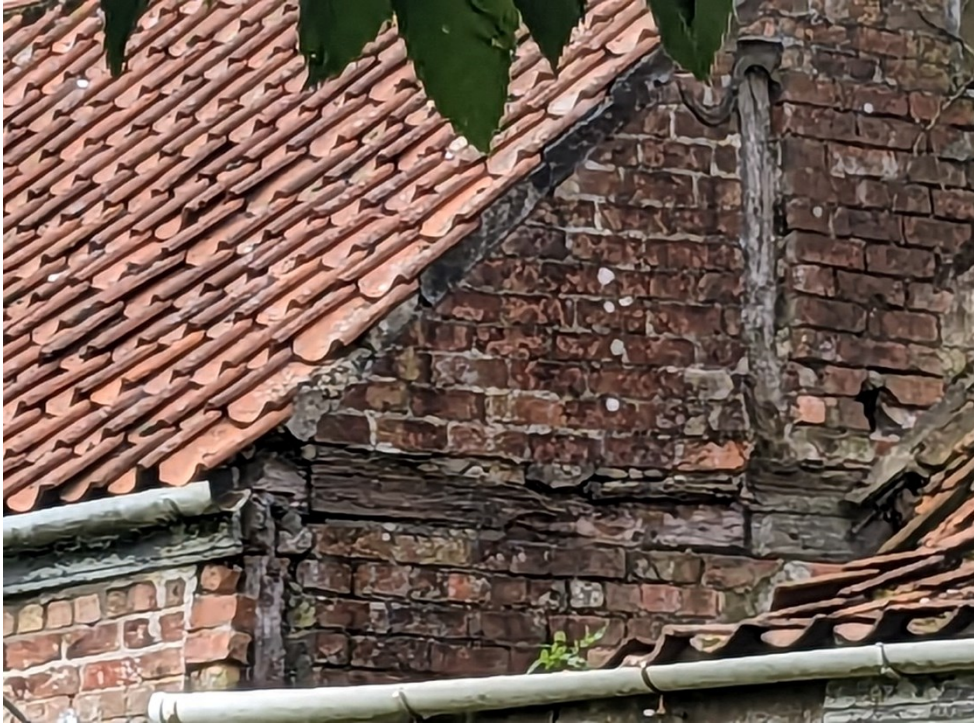
Fig. 129. Close-up of remnant frame. Note the mortise and tenon for the post, and the possibly patched tie beam.
