**The Effect OF Wetting and Drying Cycles  
and Carbonation on Thaumaside Formation**

A thesis submitted for the degree of Doctor of Philosophy in  
the Faculty of Engineering of the University of Sheffield

By  
Jumma Musbah Abualgasem

DEPARTMENT OF CIVIL AND STRUCTURAL ENGINEERING  
THE UNIVERSITY OF SHEFFIELD

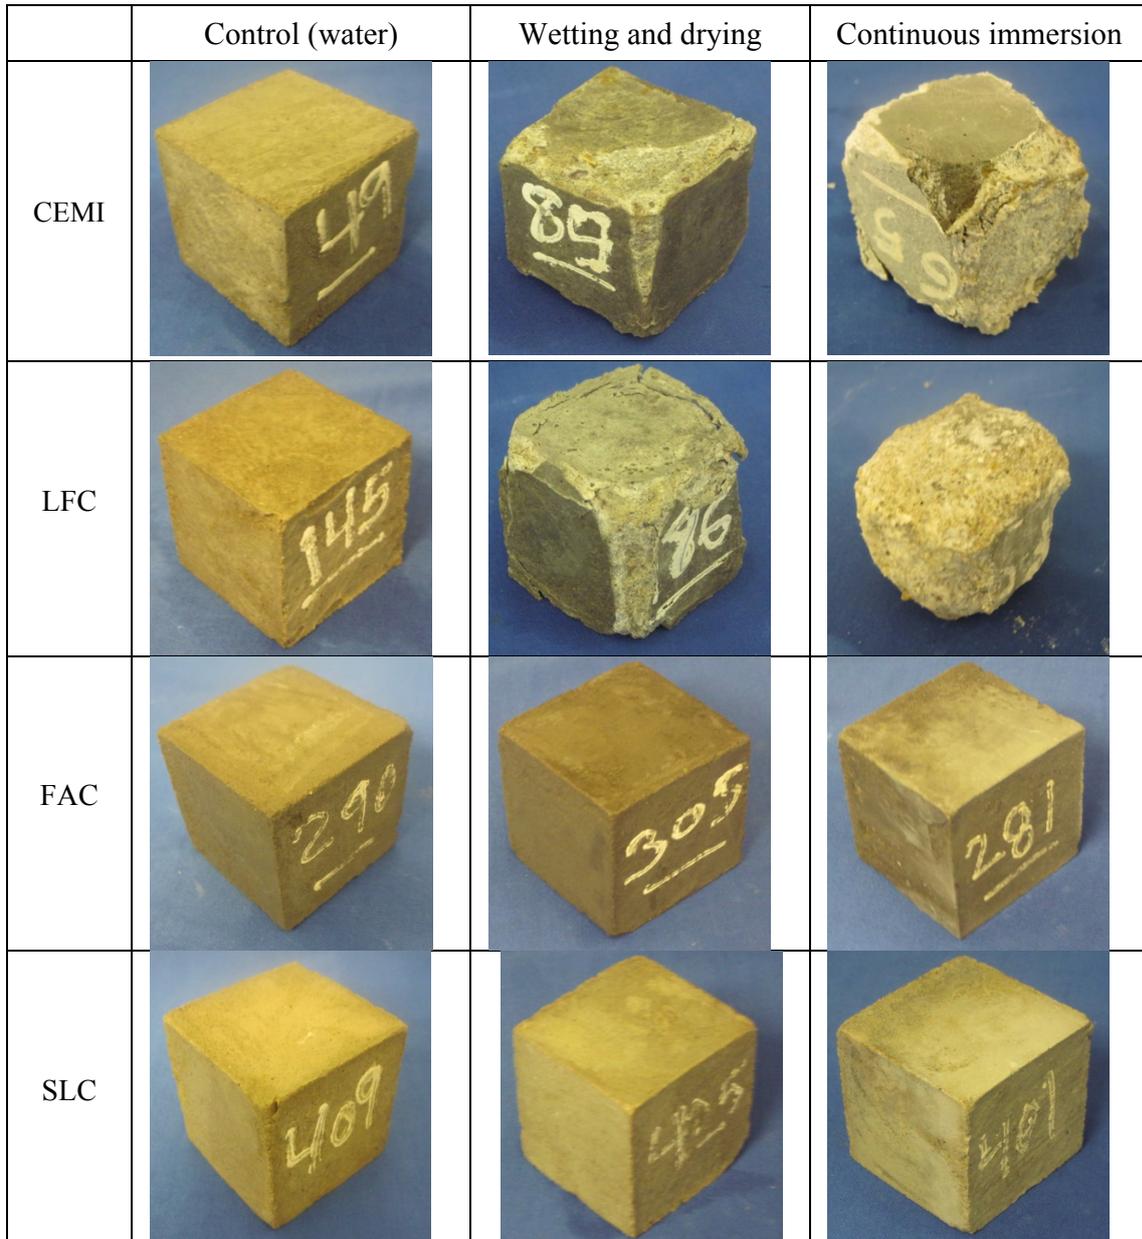
**Figure 4.1 Mortar cubes in DS4 sulfate solution at 5 °C after 24 months.**

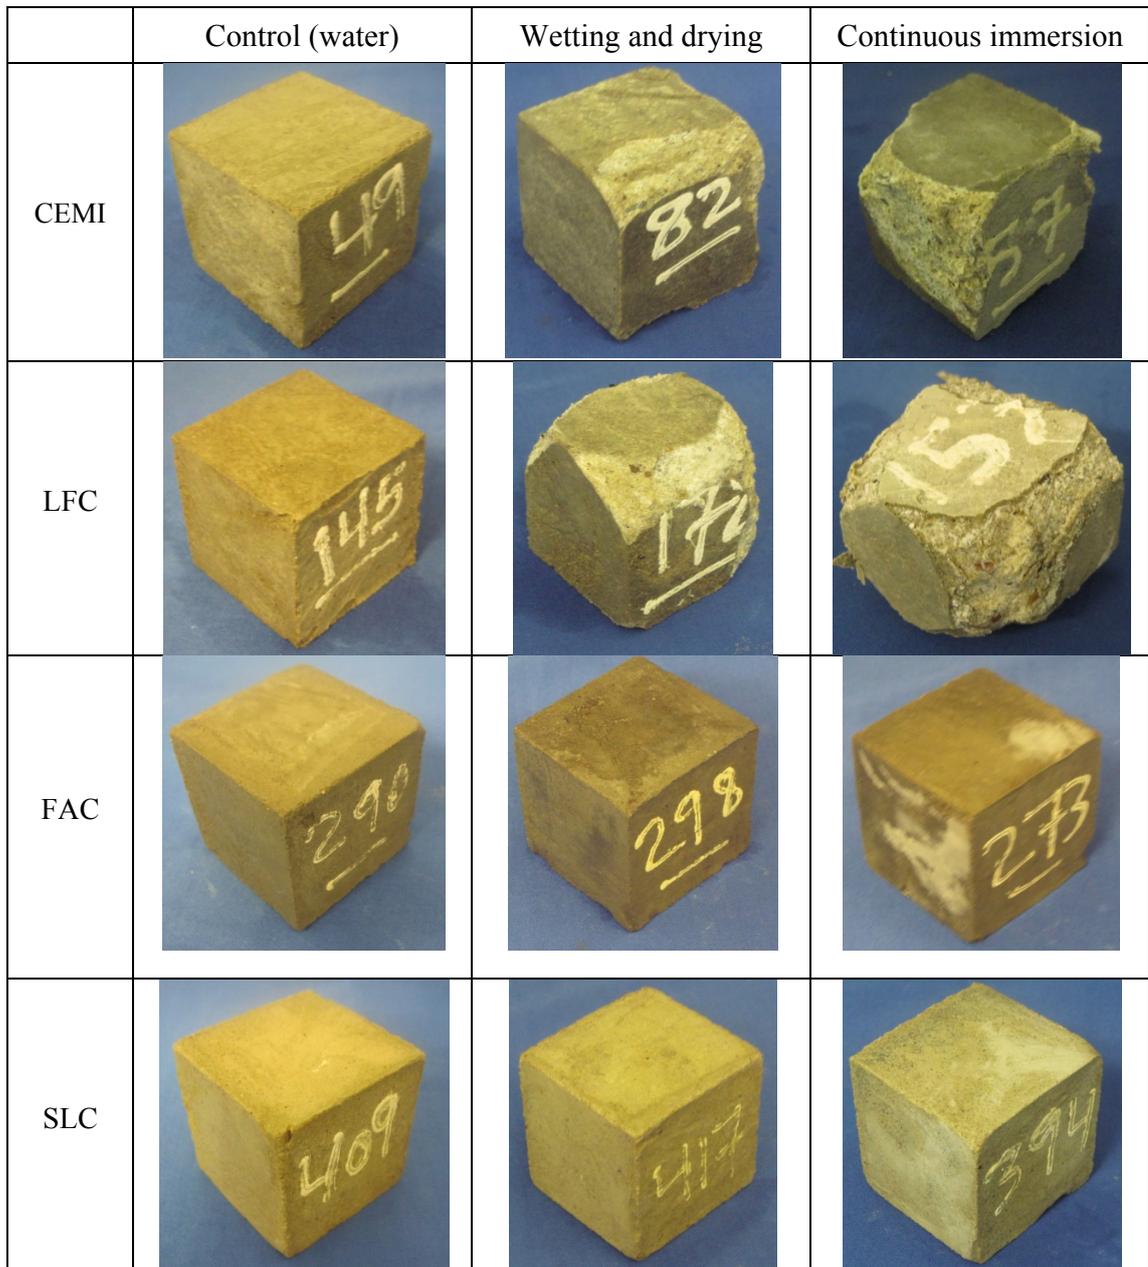
Figure 4.2 Mortar cubes in DS3 sulfate solution at 5 °C after 24 months.

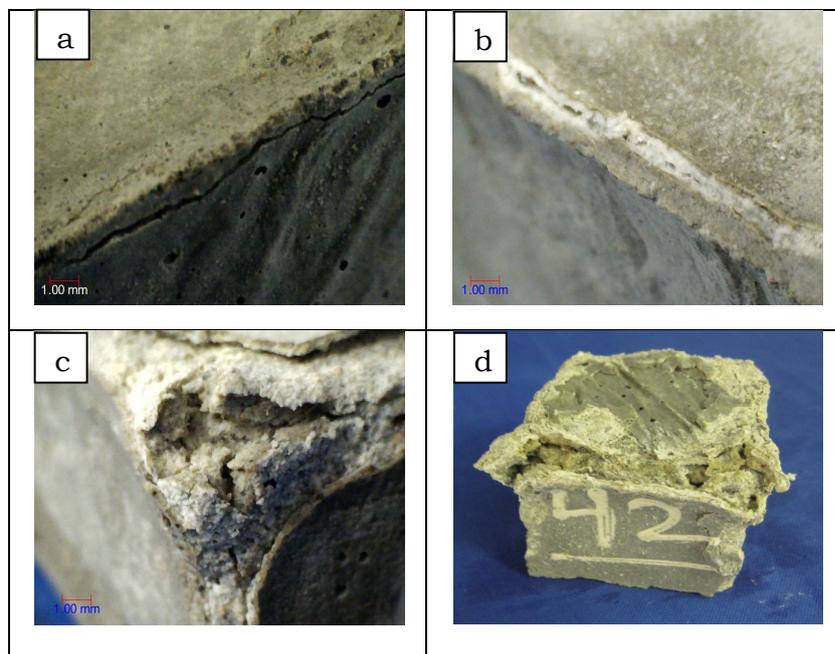
Almost all deteriorated samples showed the same patterns of attack. As Figure 4.6 shows this started as a fine crack along the edges and around the corners of the cube, which then became filled with white materials. The attack then progressed under the outer surface layer which resulted in it becoming detached from the sample. At this stage the specimen would start to lose its integrity and become mushy and friable.

**Figure 4.6 Deterioration Patterns a) cracks started to appear around the edges, b) cracks then filled with white substance (thaumasite), c) Spall off the corners and edges, d) deterioration of the sample**

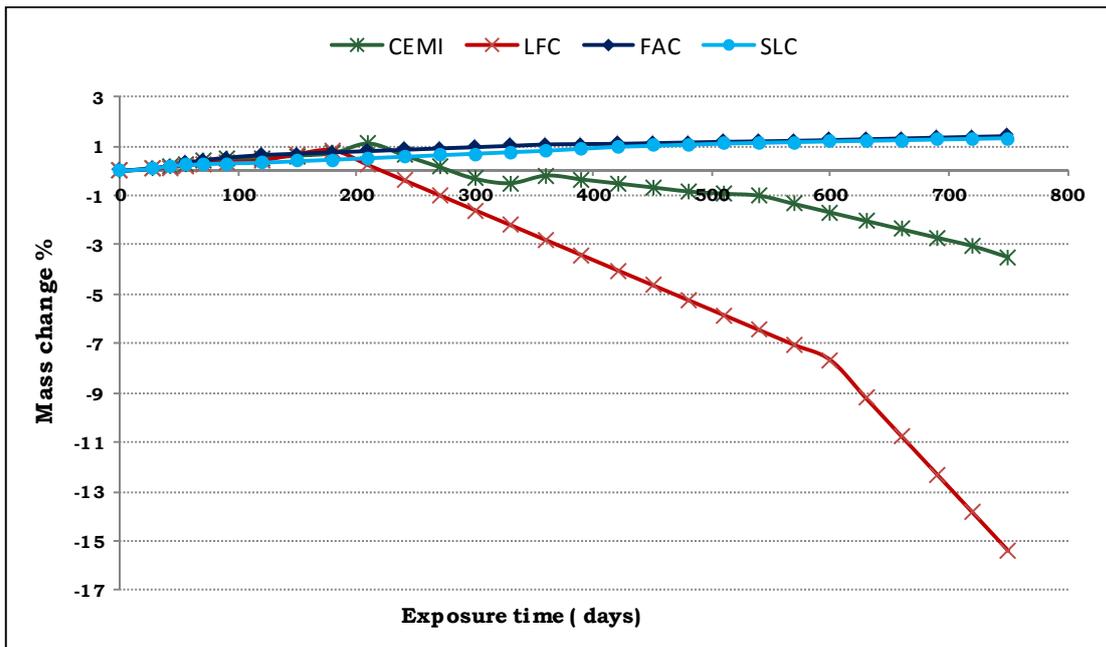
**Figure 4.7 Mass change for samples in DS3 solution at 5C. (continuous immersion)**

It can be observed in Figures 4.7 and 4.8 that during the first 200 days at 5 °C, all samples showed slight increases in their mass that is apparently due to uptake of solutions and formation of hydration products which fills the voids and pores. It seems that weight gain increased after the samples started to show evidence of deterioration and the opening of the cracks allowed more solution to enter the unaltered mortar and cause expansion. At a later stage of deterioration loss of mass was observed as material was lost as a consequence of spalling. Samples made with FLC and SLC continued gradually to gain mass and ended up with an increase of their mass of about 1.5% in both sulfate solutions. Samples made with both CEMI and LFC showed significant mass loss at the end of the exposure.

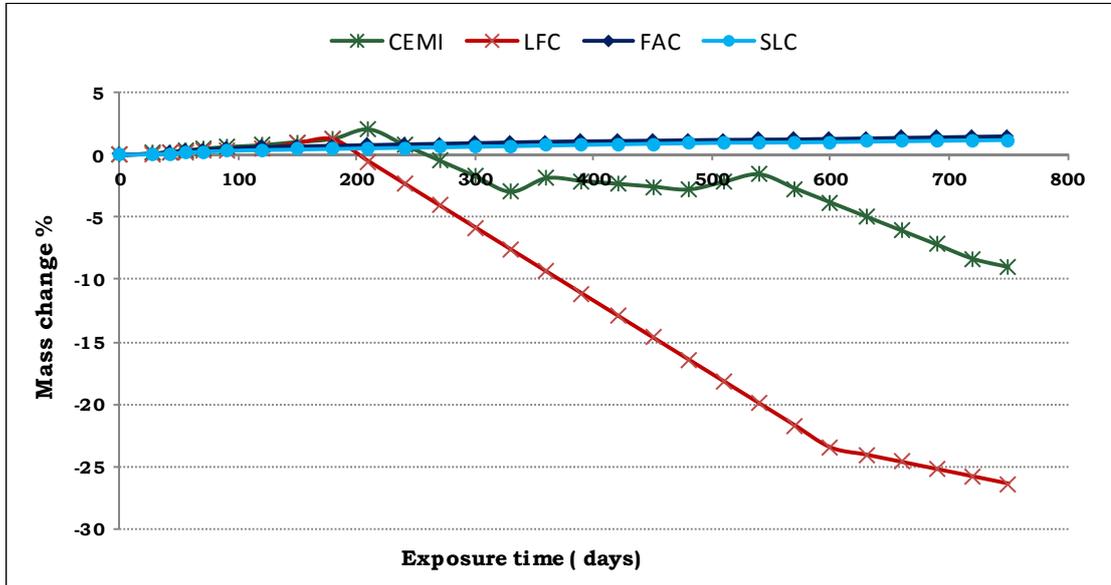
**Figure 4.8 Mass change for samples in DS4 solution at 5 °C (continuous immersion)**

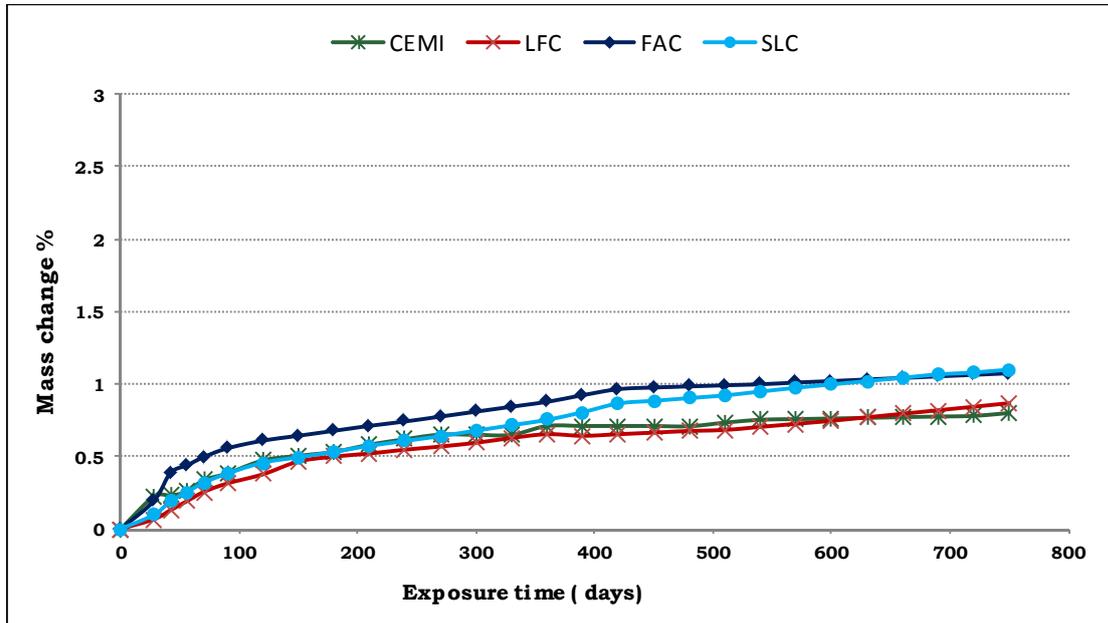
Figure 4.9 Mass change for samples in DS3 solution at 20 °C. (continuous immersion)

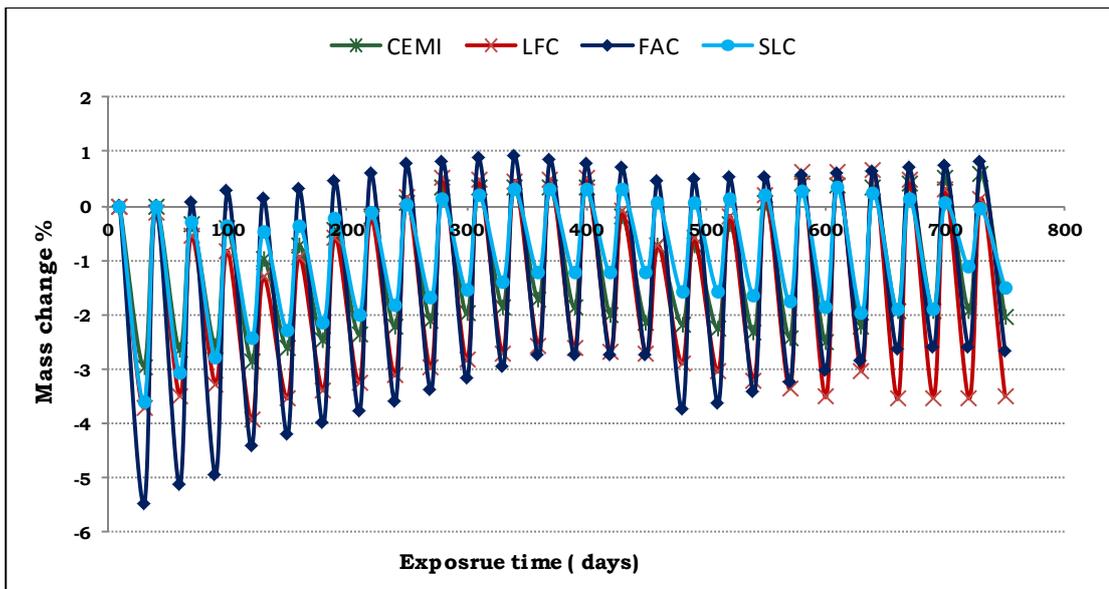
Figure 4.11 Mass change for samples in DS3 solution at 5 °C. (Wetting & drying)

Cyclic wetting and drying caused a slightly different pattern of mass change as presented in Figure 4.11 to Figure 4.14. As it can be seen, the trend for all samples is a similar gradual mass gain during the exposure time. FAC samples showed the highest variation in mass change due to the different in the moisture content as a result of wetting and drying cycles, while the SLC samples showed the lowest change.

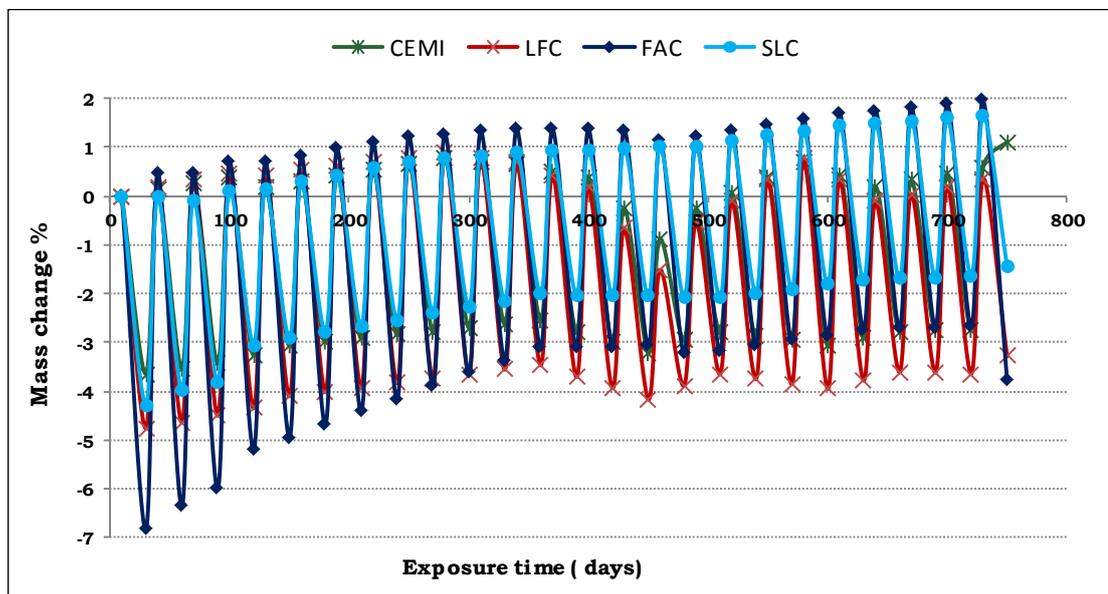
Figure 4.14 Mass change for samples in DS4 solution at 20 °C. (Wetting & drying)

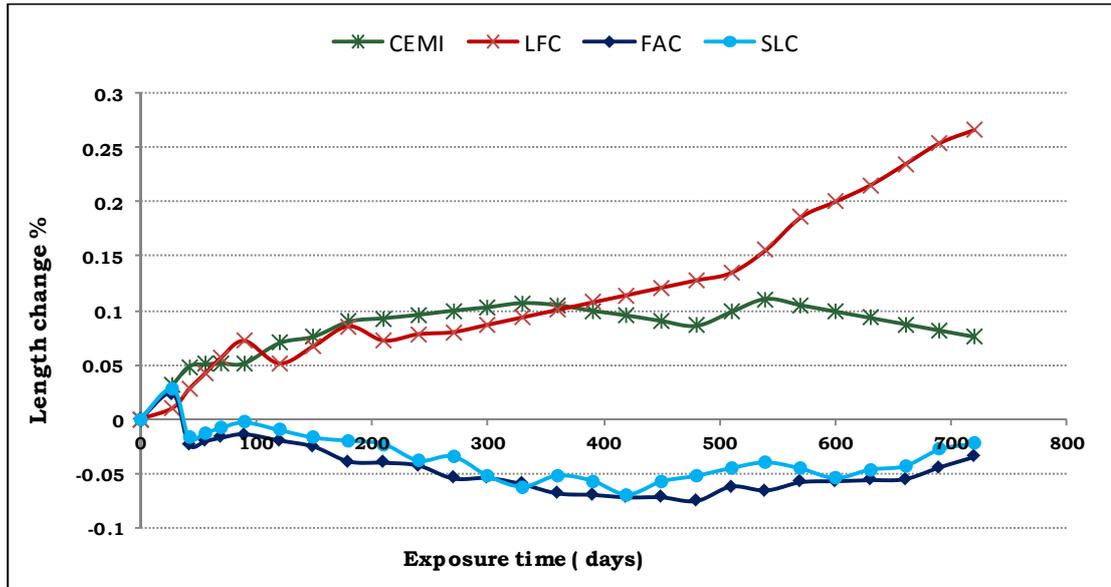
**Figure 4.15 Length change for samples in DS3 solution at 5 °C. (Continuous immersion)**

where, LFC samples showed the greatest expansion followed by CEMI, while FLC and SLC blended cements showed no expansion at all, but instead underwent a little shrinkage. Length change values were higher for samples kept in DS4 than those in DS3 solution.

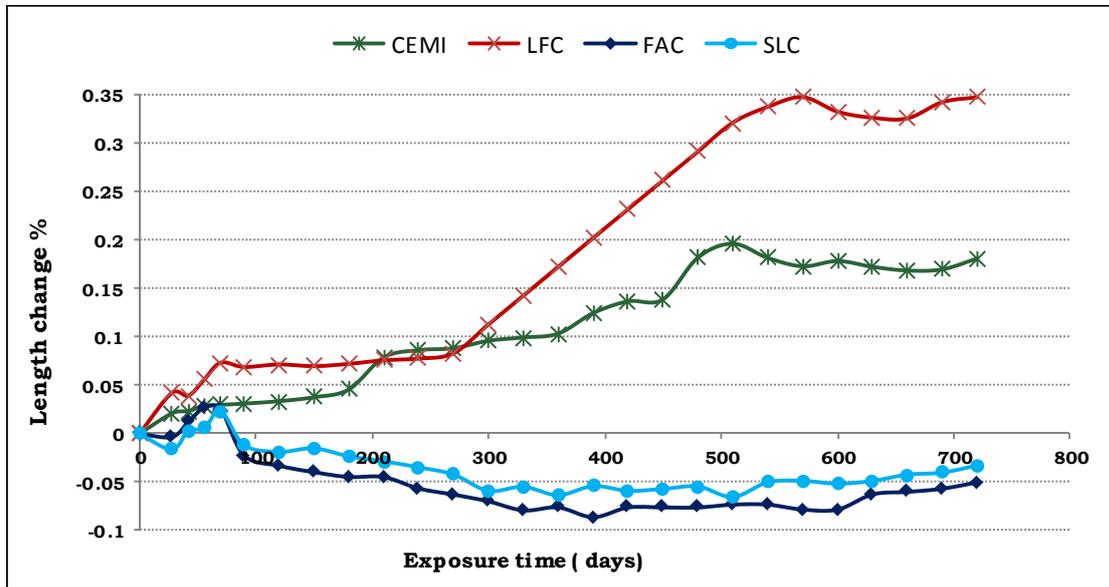
**Figure 4.16 Length change for samples in DS4 solution at 5 °C. (Continuous immersion)**

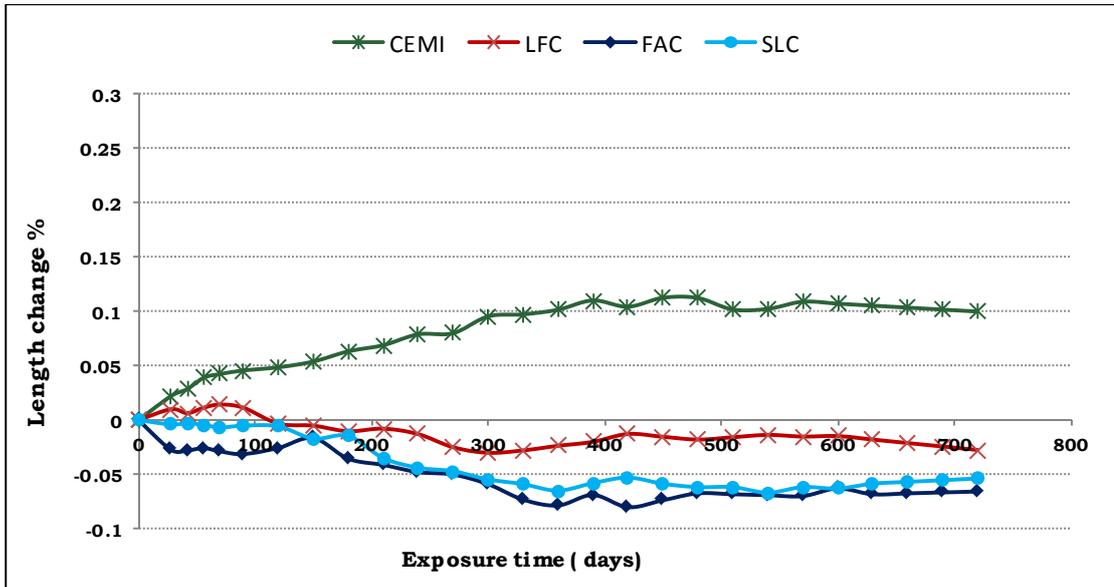
Figure 4.17 Length change for samples in DS3 solution at 20 °C. (Continuous immersion)

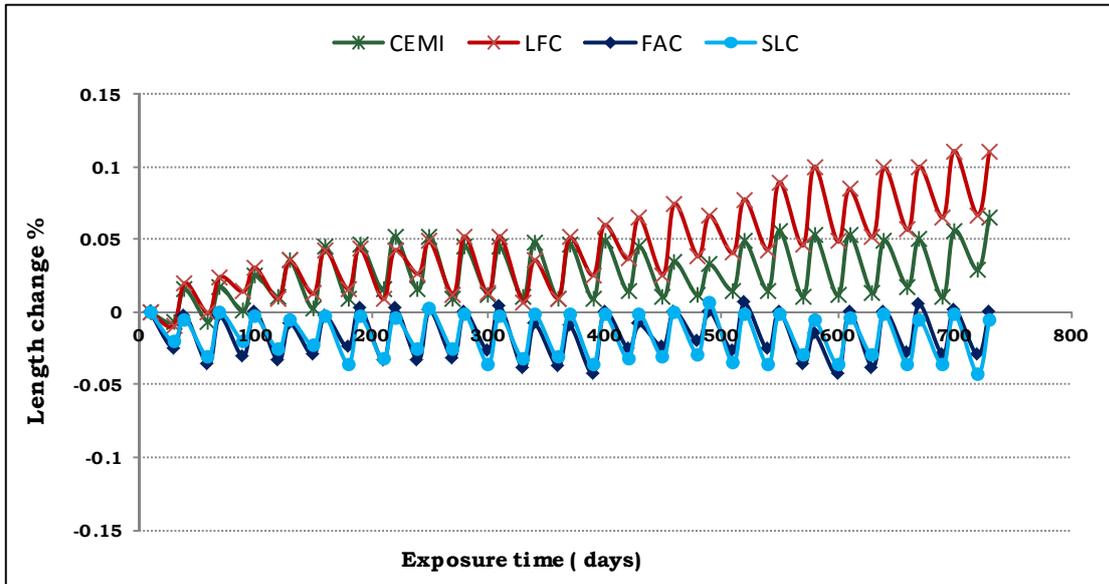
Figure 4.19 Length change for samples in DS3 solution at 5 °C. (Wetting & drying)

Cyclic wetting and drying caused a smaller change in length than continuous immersion. Figure 4.19 to Figure 4.22 show the results of mass change measurements for wetting and drying samples in different solutions and temperatures. LFC samples showed the highest expansion values of about 0.1% and 0.13% in DS3 and DS4 correspondingly, while 0.06% and 0.09% were recorded for CEM I samples in the same solutions. It was noted that despite the formation of the thaumasite and mass loss in these samples, the corresponding over-all length change was not significant with expansion values well below the standard limit of 0.1%. Only LFC samples, after 600 days of exposure expanded more than this. As these graphs show that the cyclic wetting and drying caused a very obvious change in length in the LFC samples compared to CEMI samples.

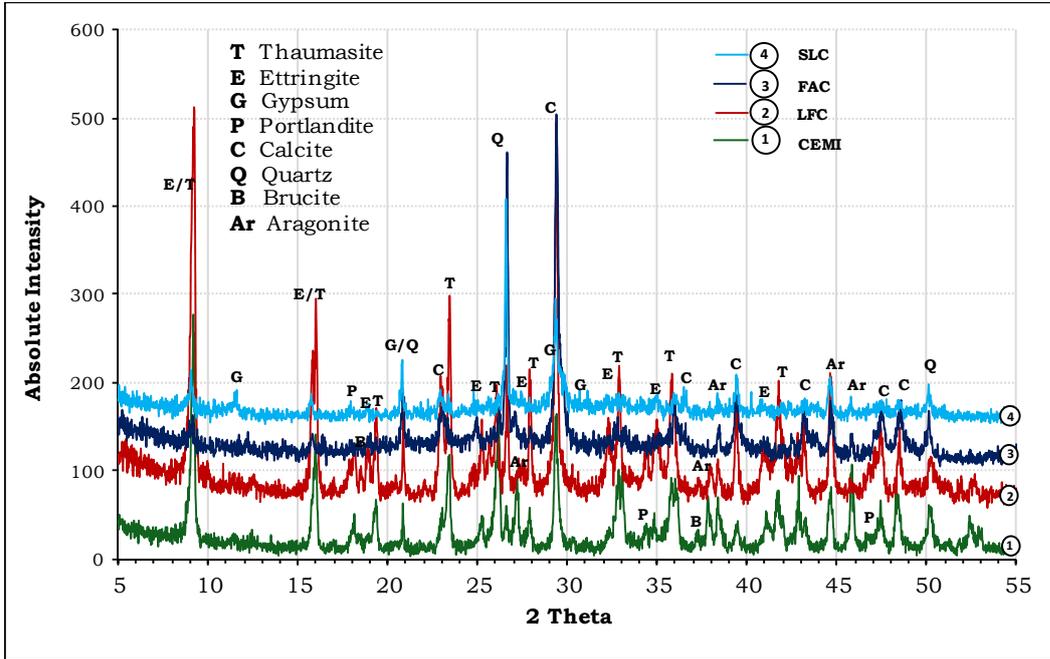
Figure 4.23 XRD patterns for samples in DS3 solutions at 5 °C (continuous immersion)

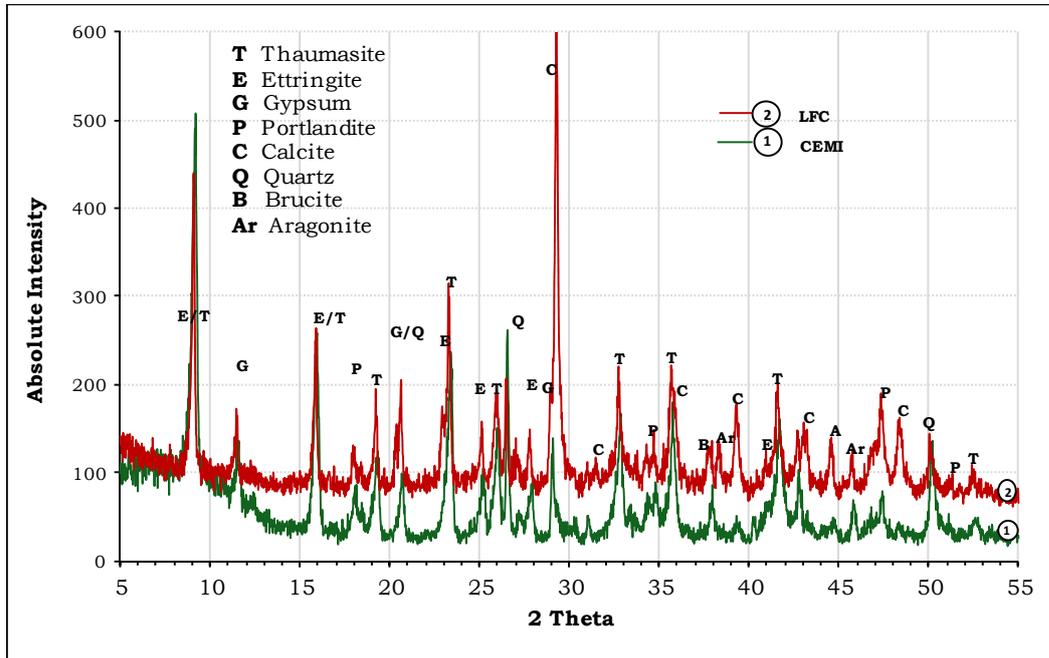
**Figure 4.25 XRD patterns for samples in DS4 solutions at 5 °C (12 months)**

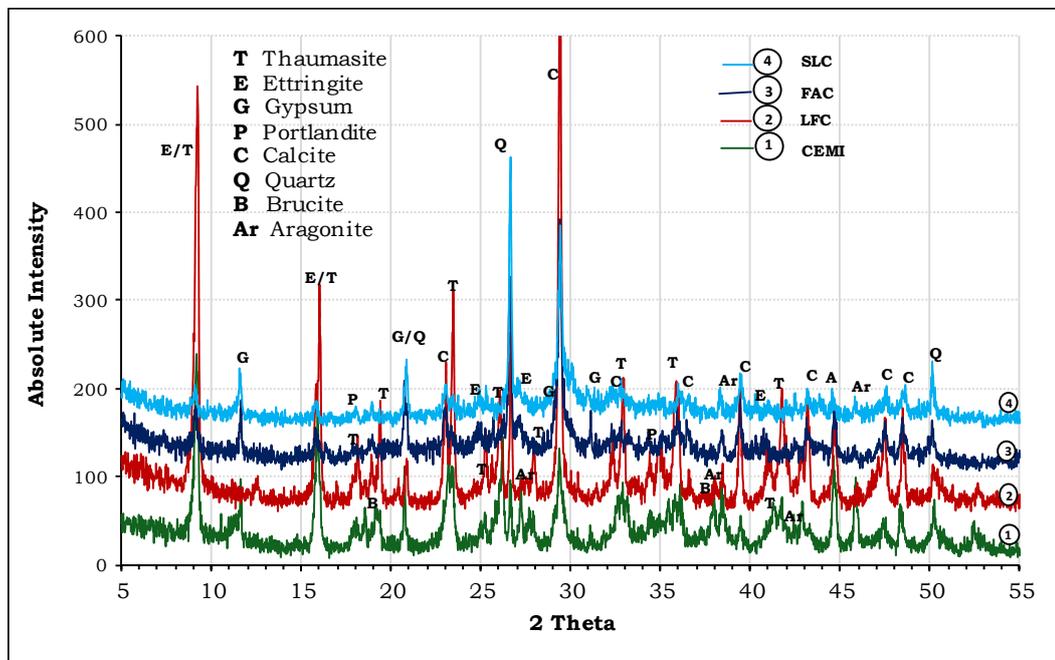
Figure 4.26 XRD patterns for samples in DS4 solutions at 5 °C (continuous immersion)

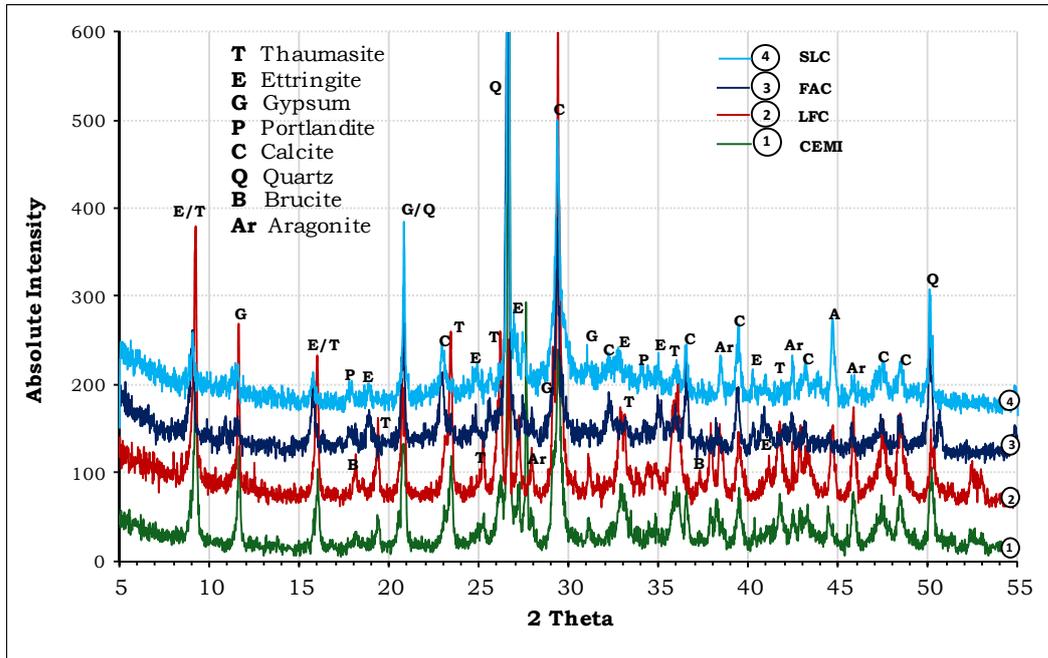
**Figure 4.27 XRD patterns for samples in DS4 solutions at 5 °C(wetting and drying)**

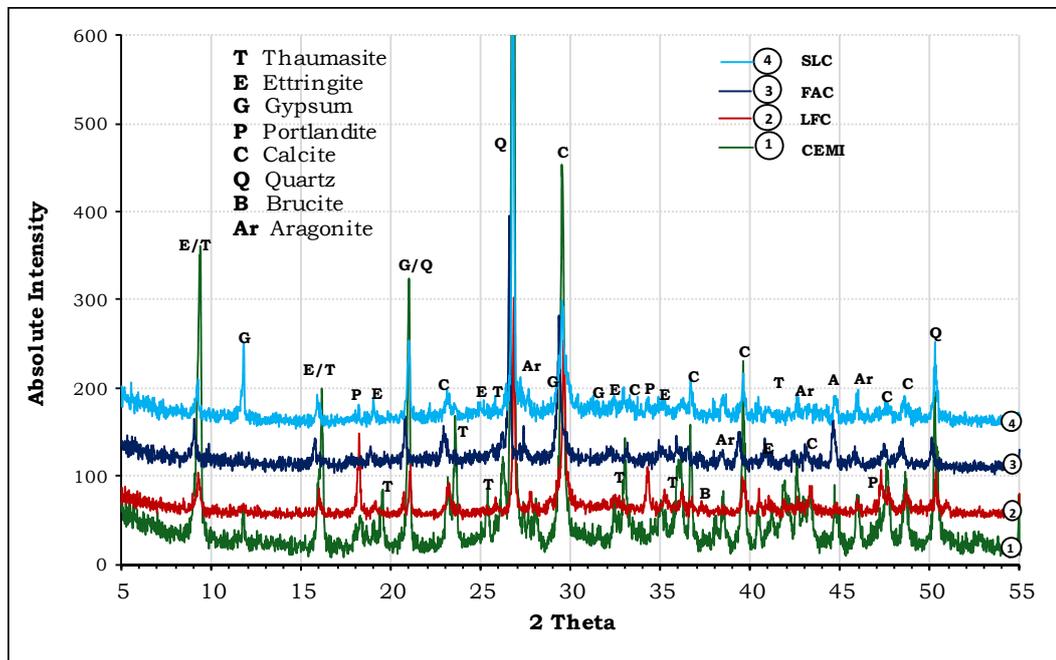
Figure 4.28 XRD patterns for samples in DS3 solutions at 20 °C (continuous immersion)

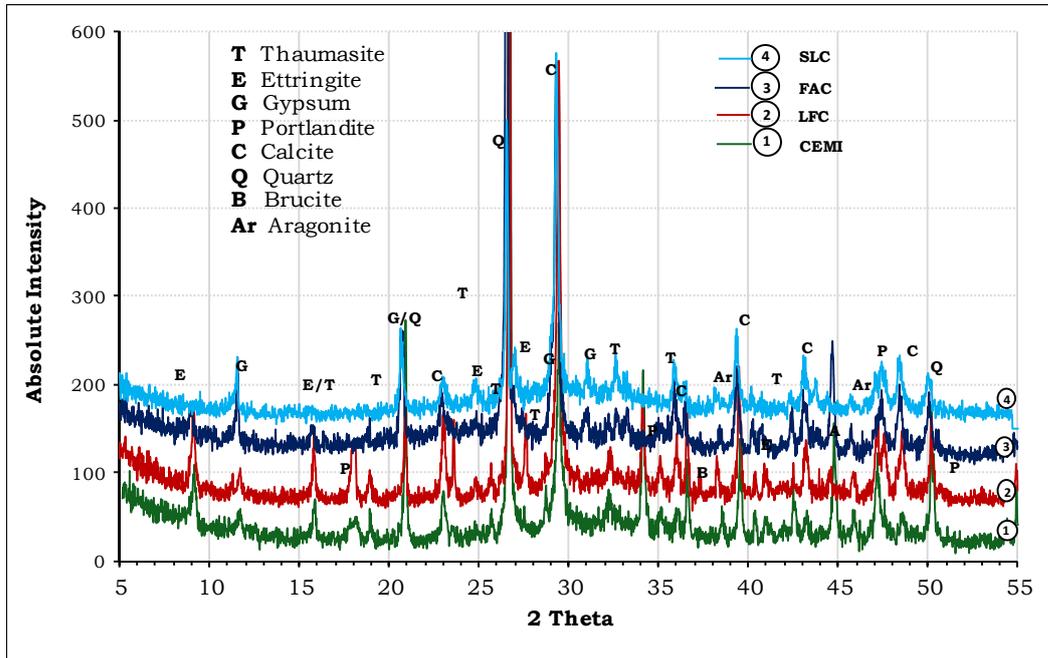
**Figure 4.29 XRD patterns for samples in DS3 solutions at 20 °C (wetting and drying)**

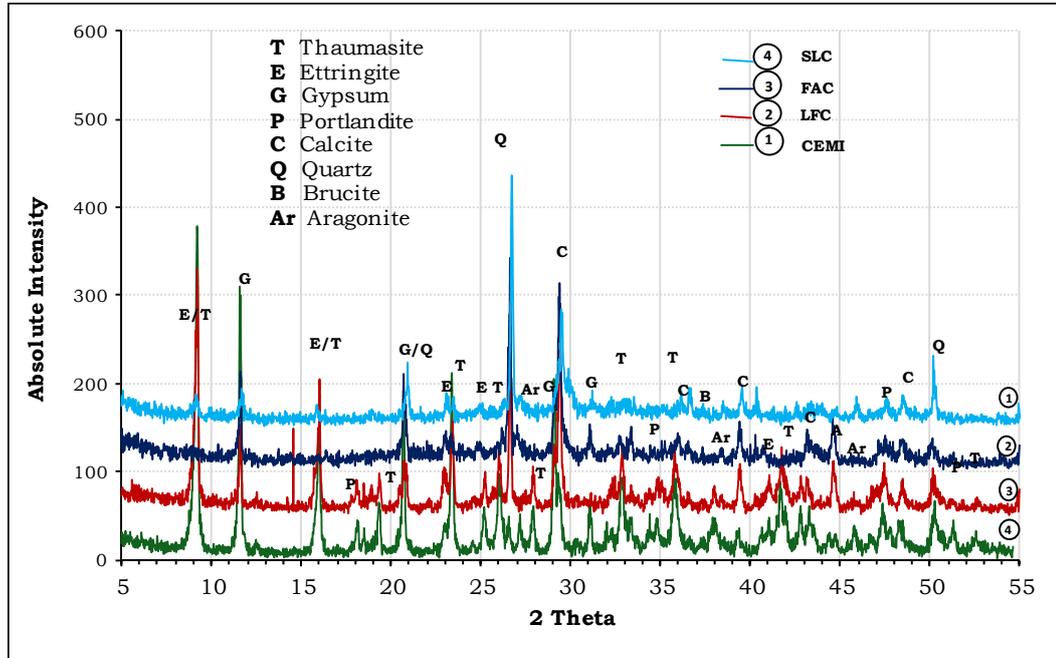
**Figure 4.30 XRD patterns for samples in DS4 solutions at 20 °C (continuous immersion)**

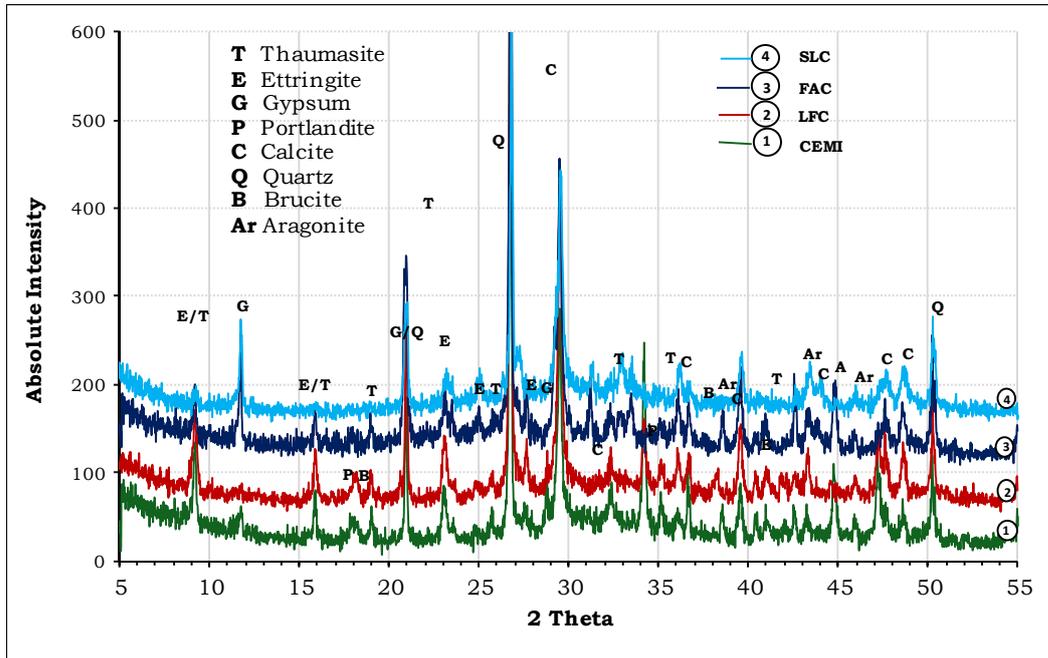
**Figure 4.31 XRD patterns for samples in DS4 solutions at 20 °C (wetting and drying)**

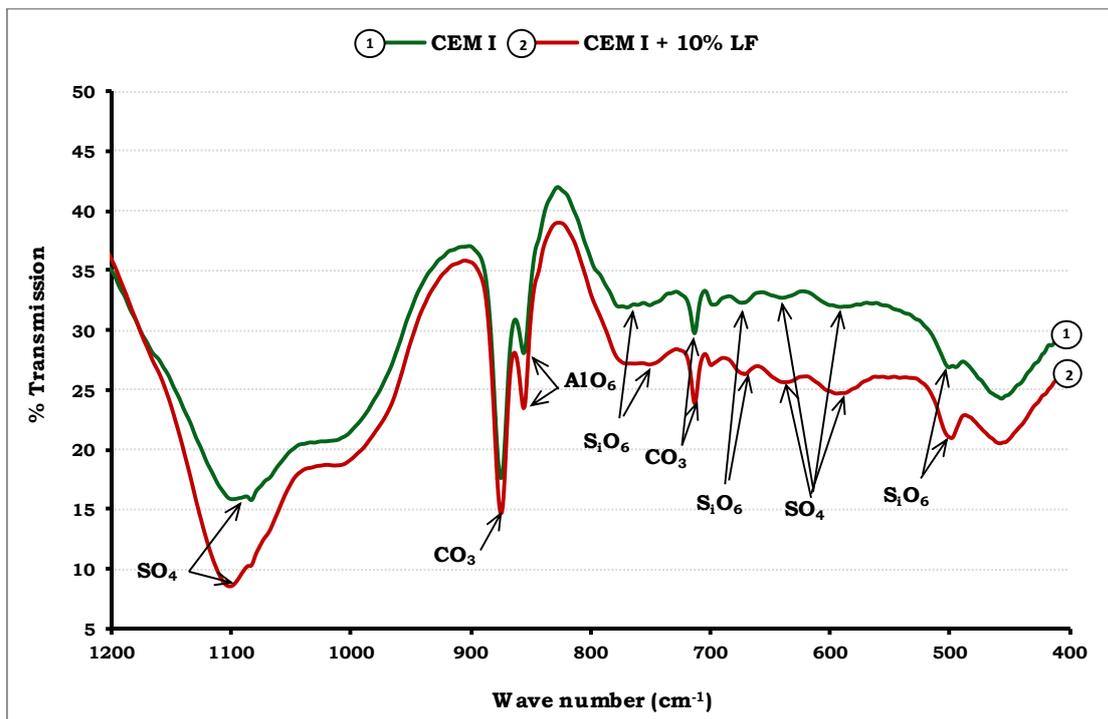
**Figure 4.33 IR spectra for samples in DS3 solutions at  $5\text{ }^{\circ}\text{C}$  (Wetting and drying cycles)**

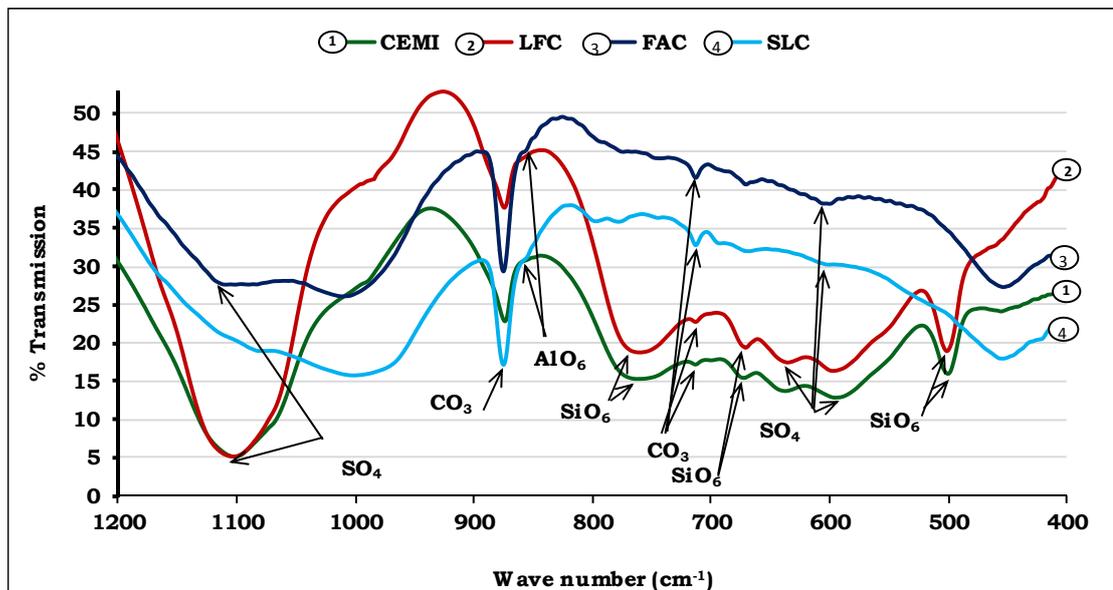
Figure 4.34 IR spectra for samples in DS4 solutions at  $5\text{ }^{\circ}\text{C}$  (continuous immersion)

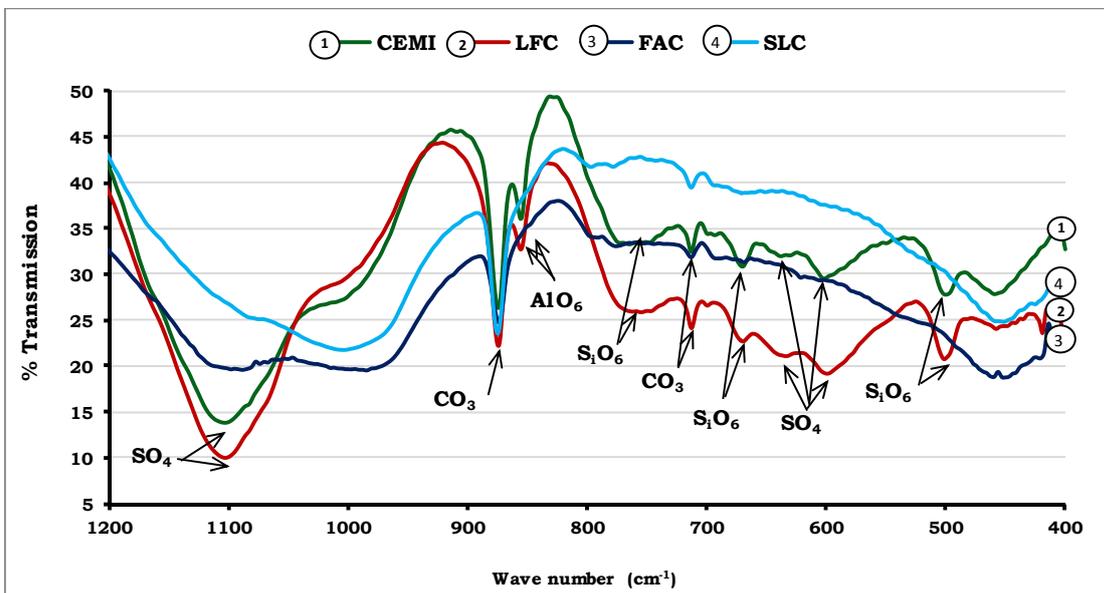
Figure 4.35 IR spectra for samples in DS4 solutions at  $5\text{ }^\circ\text{C}$  (Wetting and drying cycles)

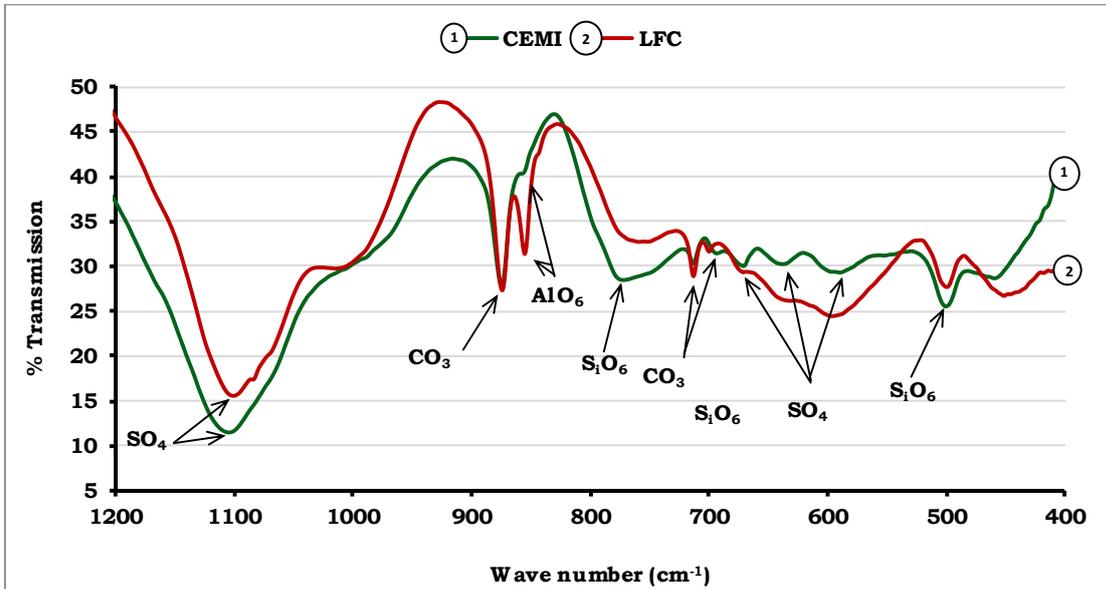
Figure 4.36 IR spectra for samples in DS3 solutions at 20 °C (continuous immersion)

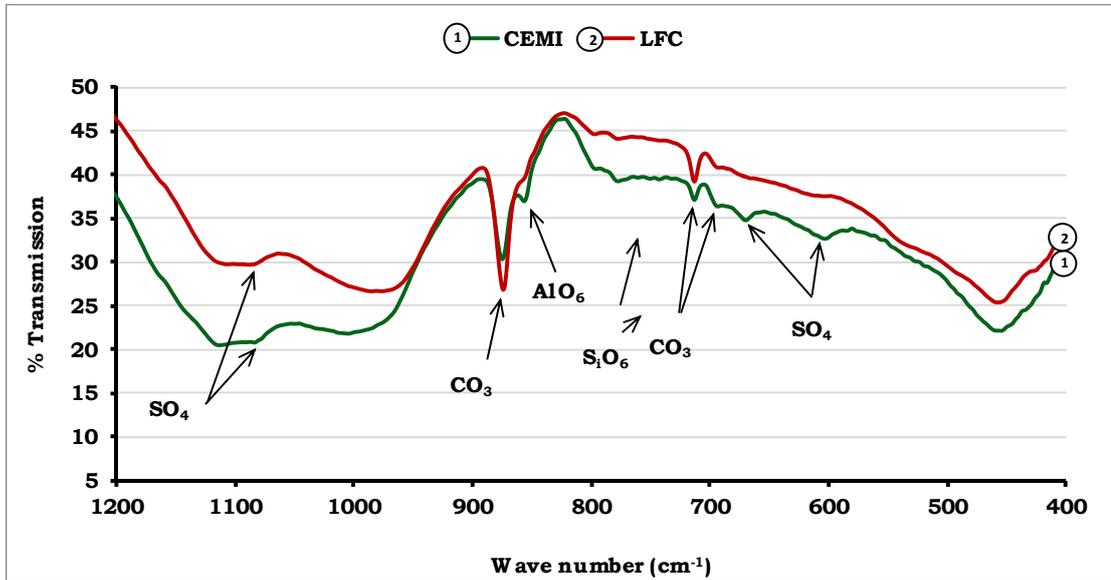
Figure 4.37 IR spectra for samples in DS3 solutions at 20 °C (Wetting and drying cycles)

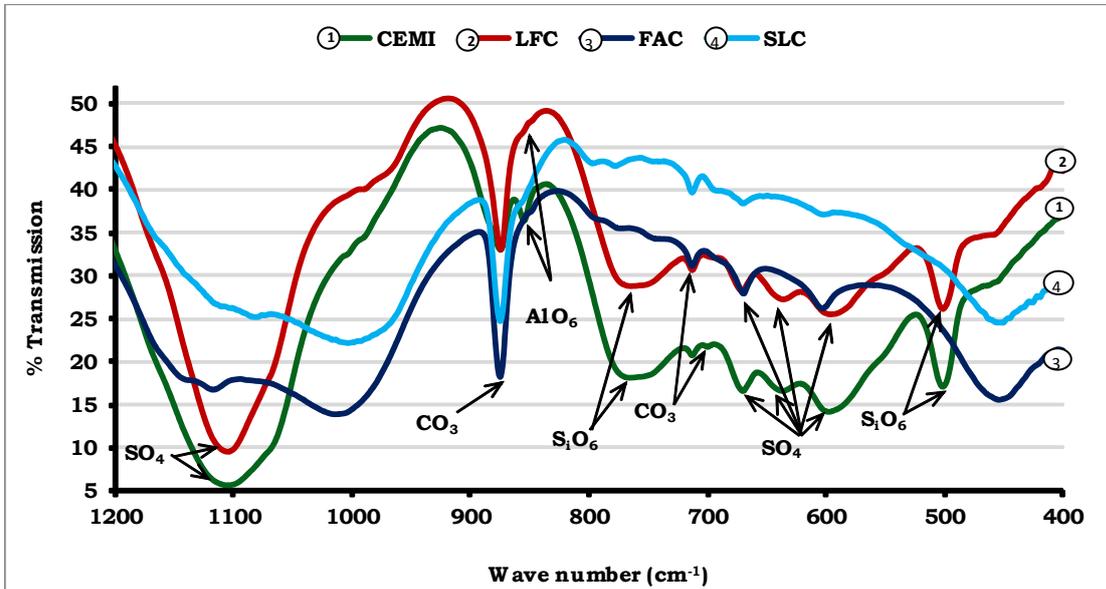
Figure 4.38 IR spectra for samples in DS4 solutions at 20 °C (continuous immersion)

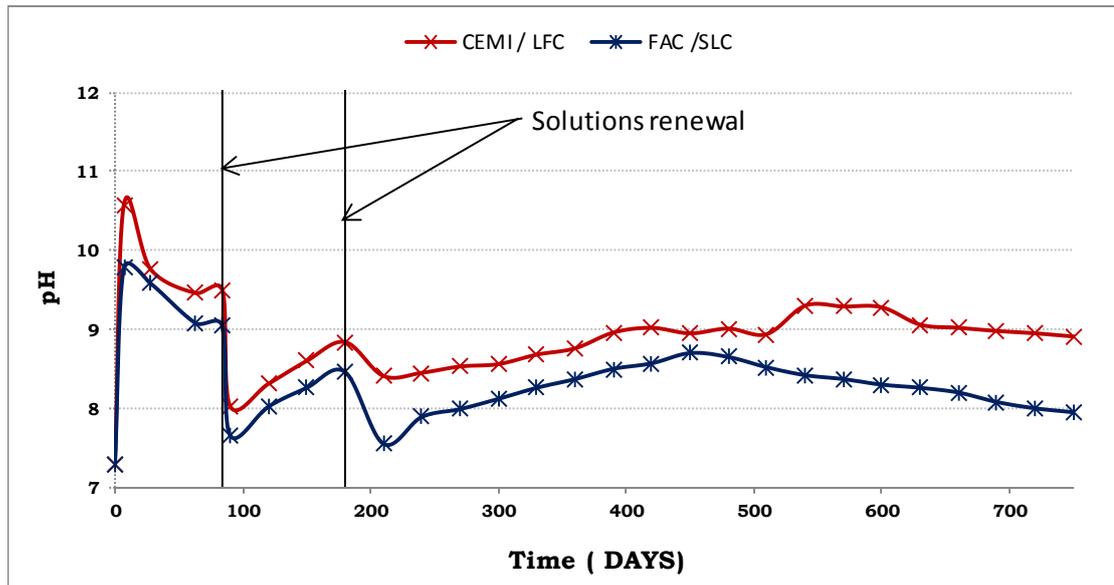
**Figure 4.41 pH values for samples in DS3 solutions at 5 °C (wetting and drying cycles)**

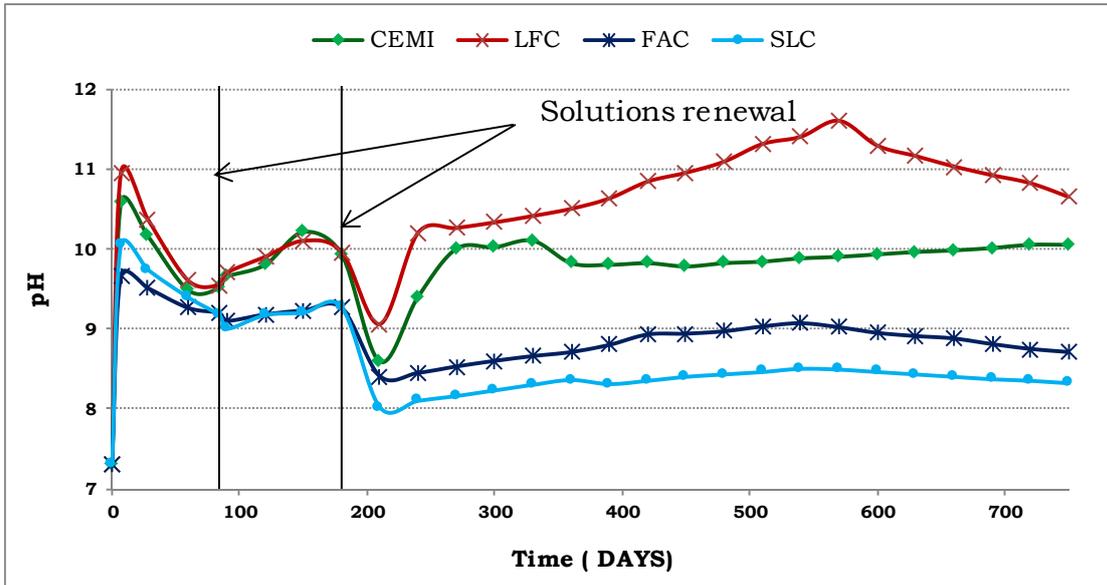
**Figure 4.42 pH values for samples in DS4 solutions at 5 °C (continuous immersion)**

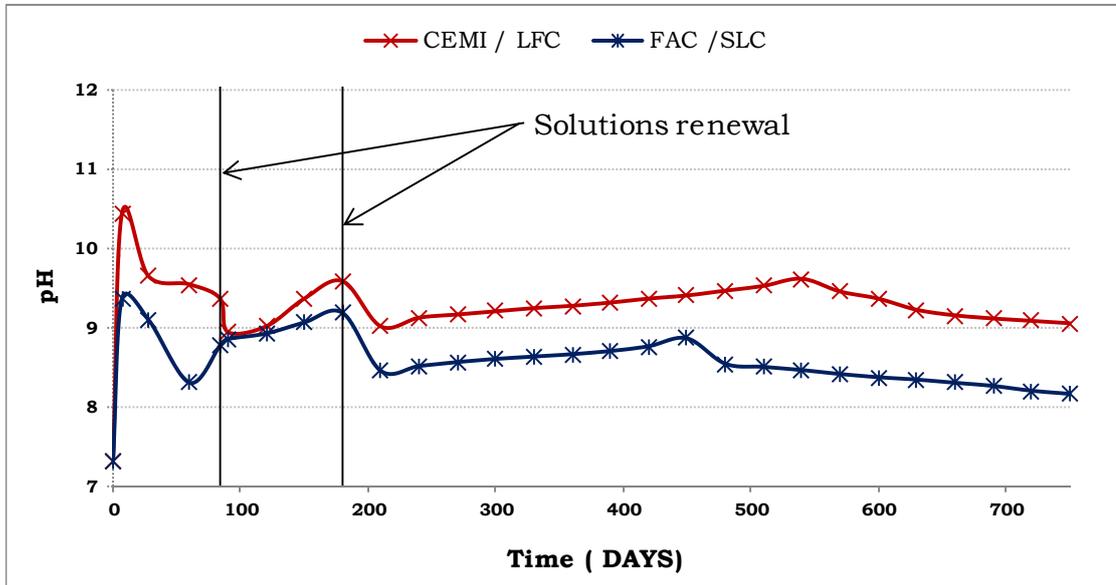
**Figure 4.43 pH values for samples in DS4 solutions at 5 °C (wetting and drying cycles)**

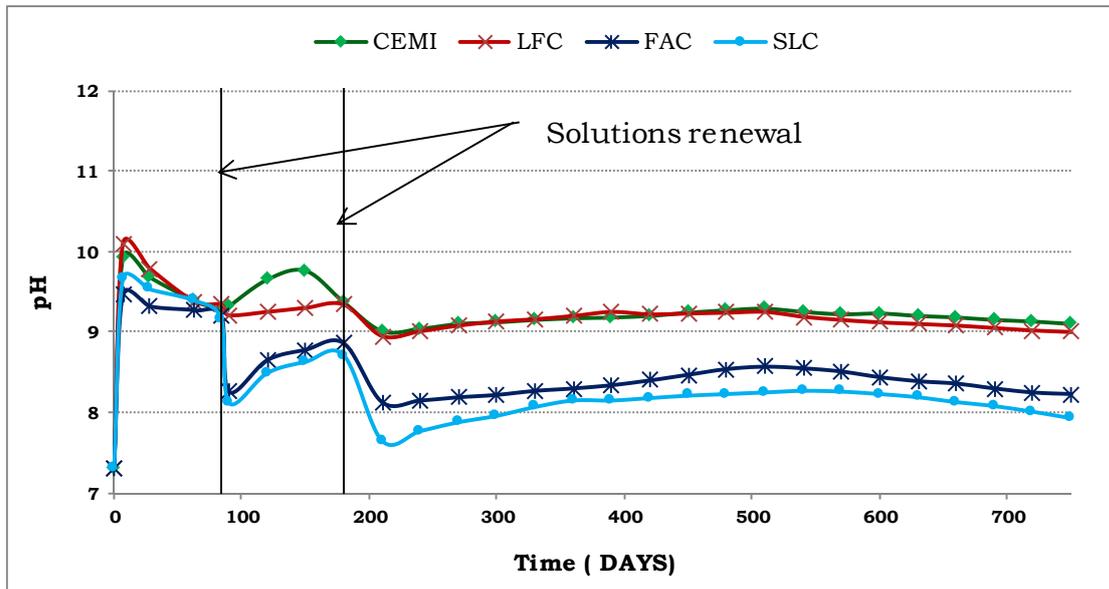
Figure 4.44 pH values for samples in DS3 solutions at 20 °C (continuous immersion)
