**The Effect OF Wetting and Drying Cycles  
and Carbonation on Thaumaside Formation**

A thesis submitted for the degree of Doctor of Philosophy in  
the Faculty of Engineering of the University of Sheffield

By  
Jumma Musbah Abualgasem

DEPARTMENT OF CIVIL AND STRUCTURAL ENGINEERING  
THE UNIVERSITY OF SHEFFIELD

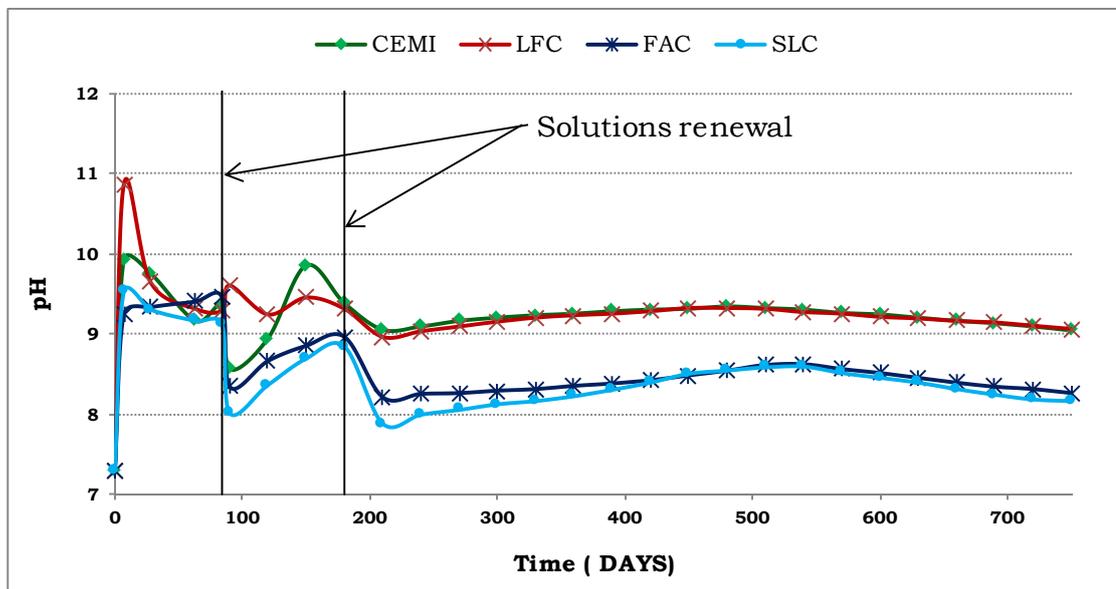
Figure 4.46 pH values for samples in DS4 solutions at 20 °C (continuous immersion)

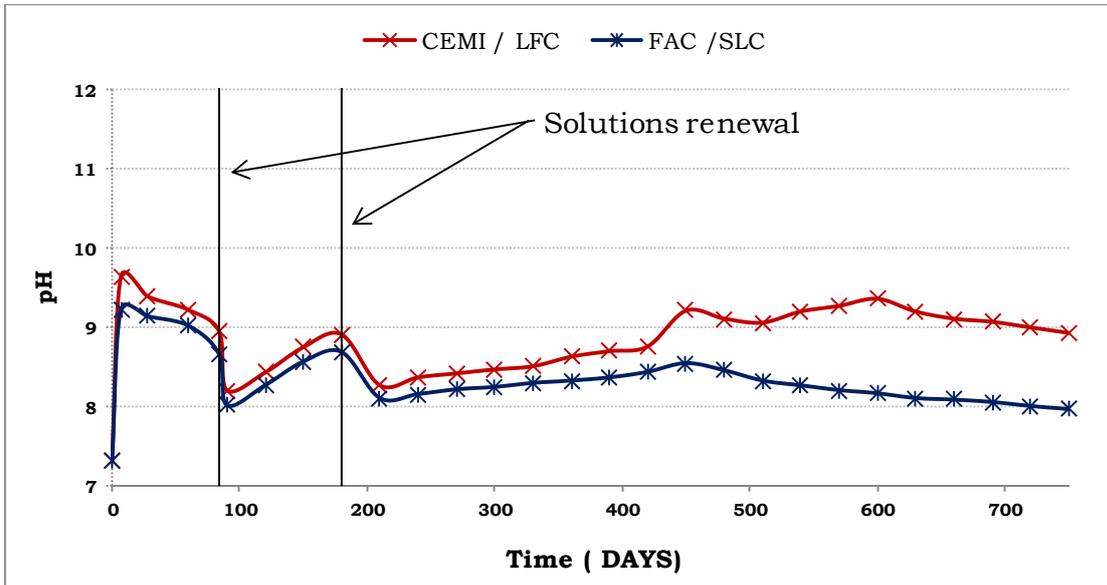
Figure 4.47 pH values for samples in DS4 solutions at 20 °C (wetting and drying cycles)

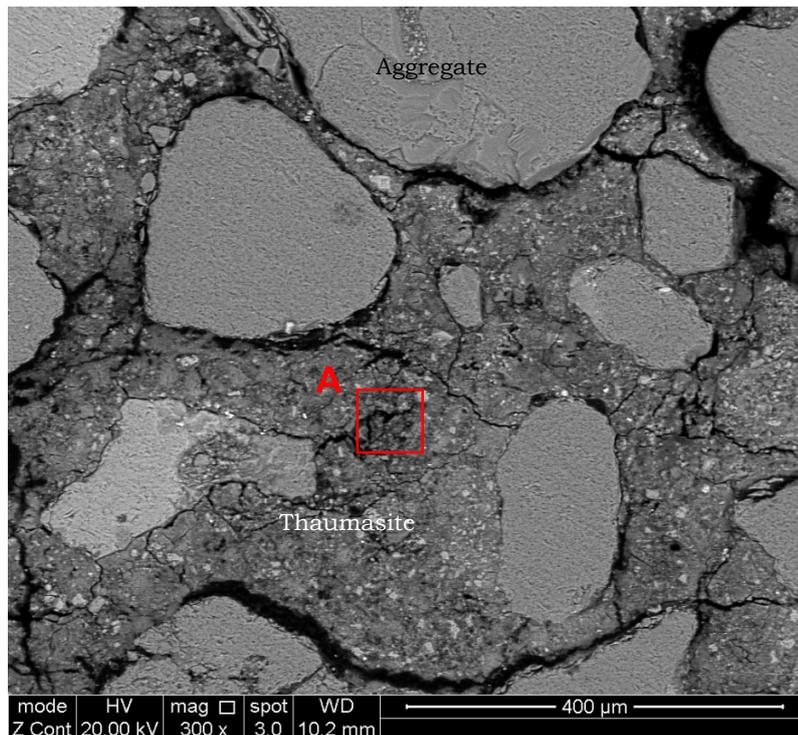
The SEM results for LFC are shown in Figure 4.53, in which cracks are seen to be developed in the sample and around the aggregate particles, and much of the sample is converted to thaumasite and badly deteriorated.

**Figure 4.53 BSE of LFC sample in DS4 at 5 °C in continuous immersion**

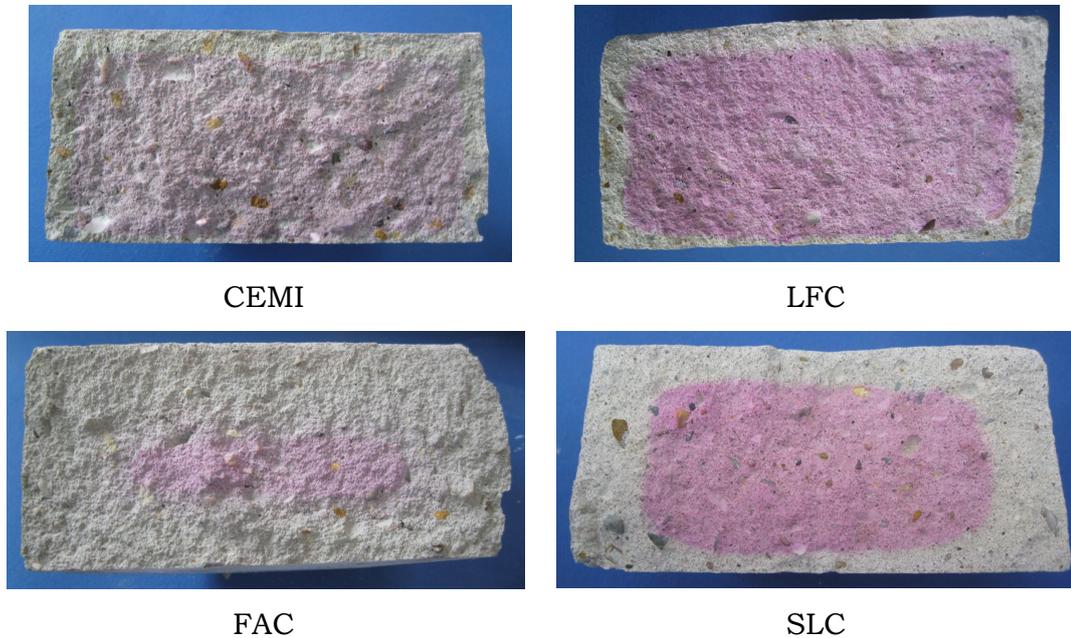
Figure 5.1 Carbonation results for different samples

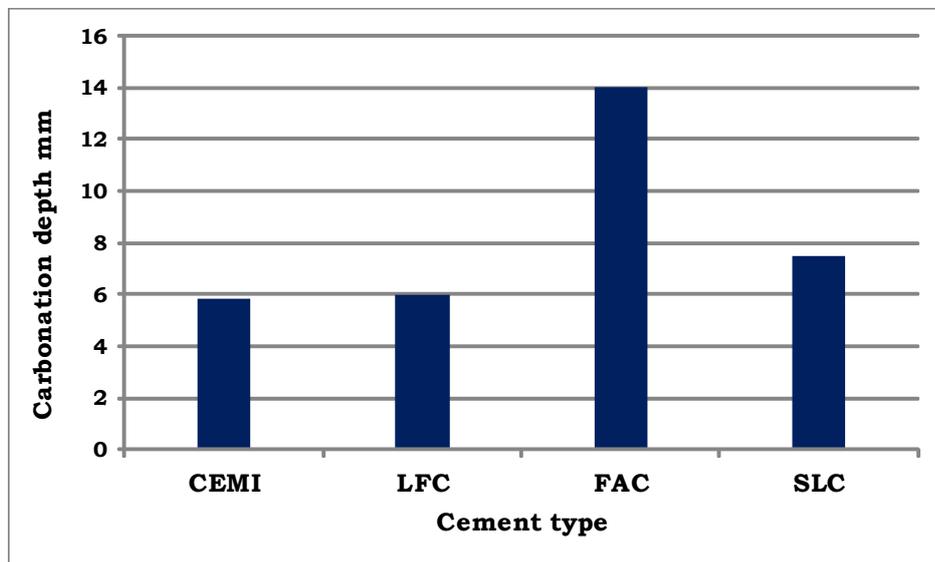
Chapter 4. FAC sample has the highest carbonation depth of 14 mm while SLC has a carbonation depth of 7.5 mm.

Figure 5.2 carbonation depth for different samples

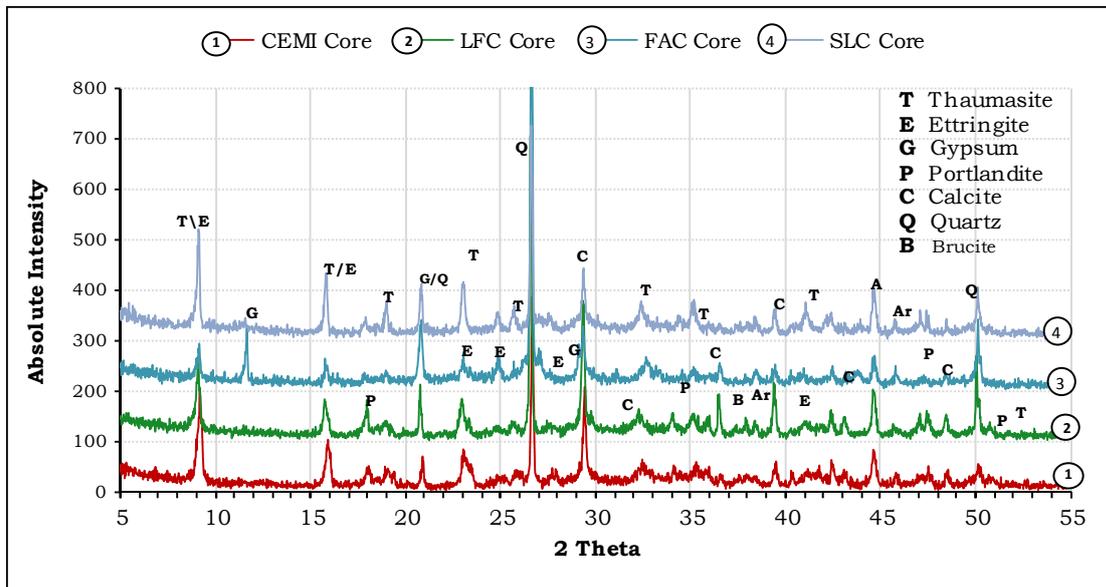
Figure 5.4 XRD patterns for core samples in DS4 at 5 °C

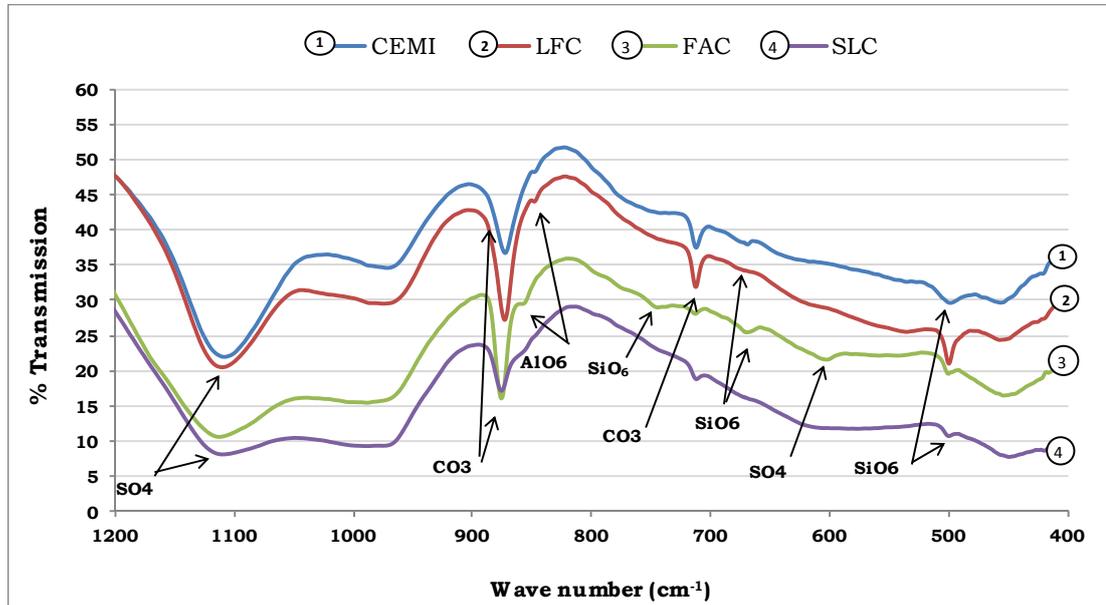
The results of FTIR analysis for none-carbonated samples (core) are presented in Figure 5.6 . A presence of peak at  $500\text{ cm}^{-1}$  which is an indicative for thaumasite (Bensted and Varma 1973, Torres et al. 2004), these peaks can be seen in all samples with higher intensity in limestone containing sample LFC. Peak at around  $611\text{cm}^{-1}$  assigned to gypsum is only present in FAC in agreement to what was observed in XRD analysis for the same sample. Calcite peaks around  $712\text{ cm}^{-1}$  and  $875\text{ cm}^{-1}$  can be seen in all samples, they are more notable in CEMI and LFC probably due to more cement content and portlandite in these cements, while aragonite peaks at around  $700\text{ cm}^{-1}$  are absent from all samples. Ettringite peaks at around  $855\text{ cm}^{-1}$  are detectable in all samples with small intensities. However, the presence of these peaks indicates the co-existence of thaumasite and ettringite in these samples either as a two separate minerals or as a solid solution between the two. Peaks at around  $980\text{ cm}^{-1}$  are indicative for the presence of CSH gel in these samples, this suggests that this phase is still present in these samples and it is not converted to thaumasite yet. Sulfate peaks at around  $1100\text{ cm}^{-1}$  are attributed to sulfate in thaumasite structure and they are present in all samples.

**Figure 5.6 FTIR spectra for core samples in DS4 at 5 °C SiO<sub>6</sub> indicating Thaumasite, AlO<sub>6</sub> indicating Ettringite**

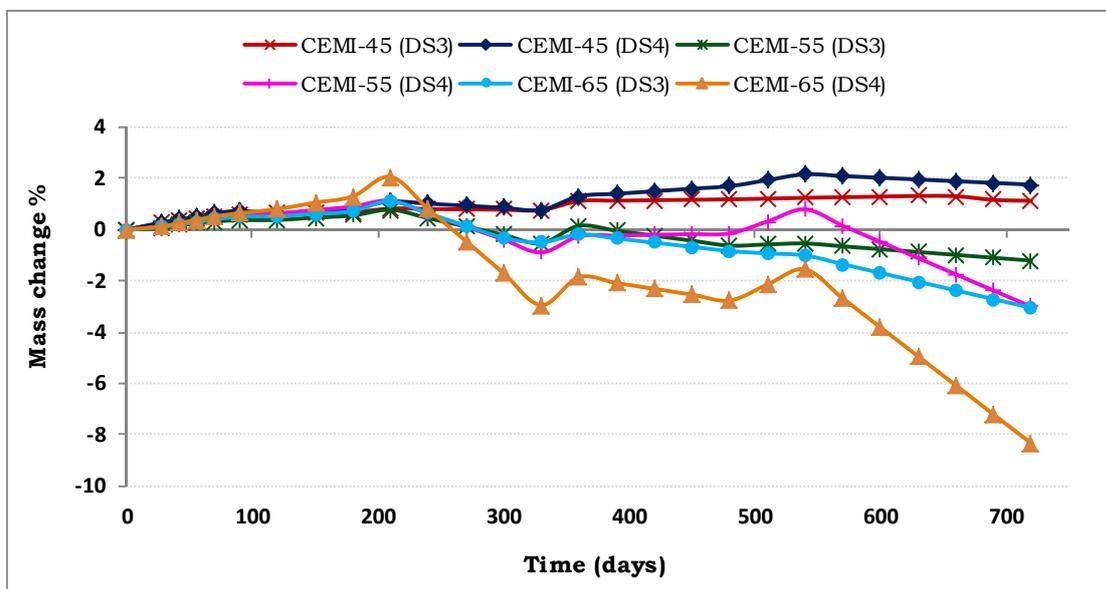
Figure 6.5 Mass change for CEMI samples in sulfate solutions at 5 °C .

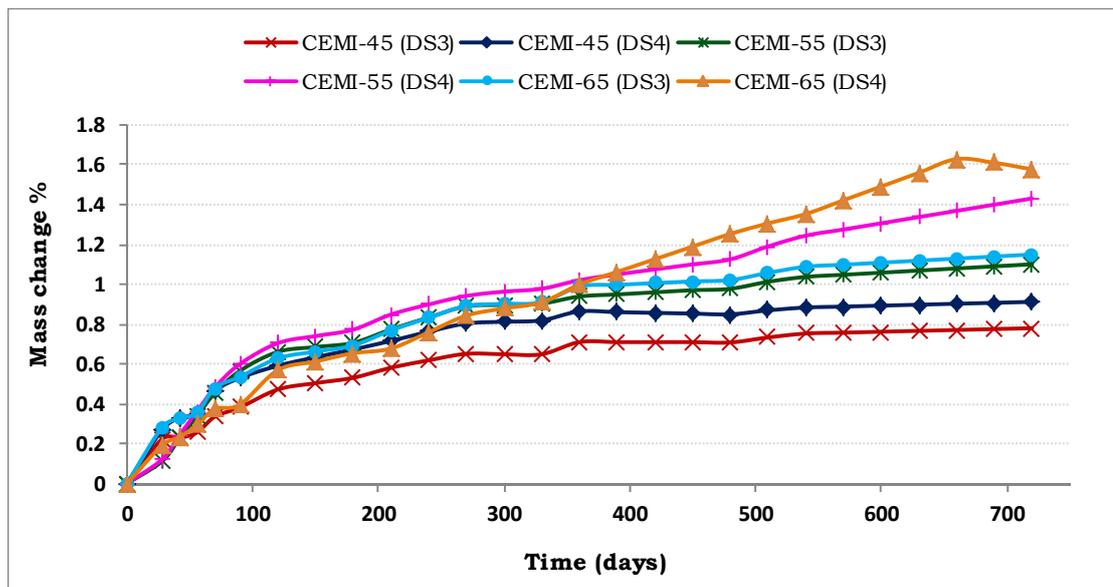
Figure 6.6 Mass change for CEMI samples in sulfate solutions at 20 °C .

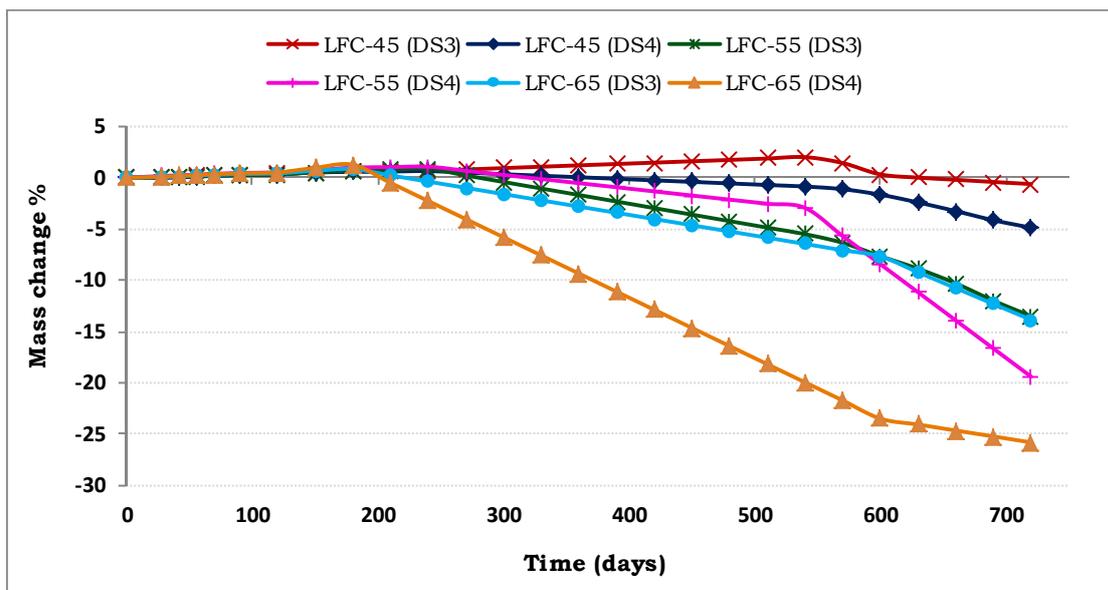
Figure 6.7 Mass change for LFC samples in sulfate solutions at 5 °C .

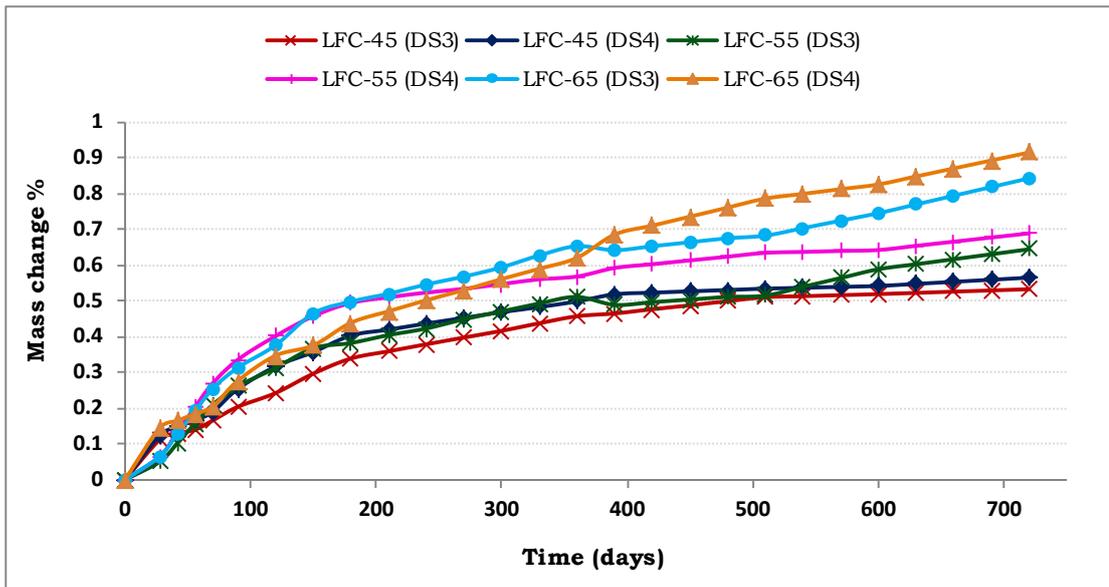
Figure 6.8 Mass change for LFC samples in sulfate solutions at 20 °C .

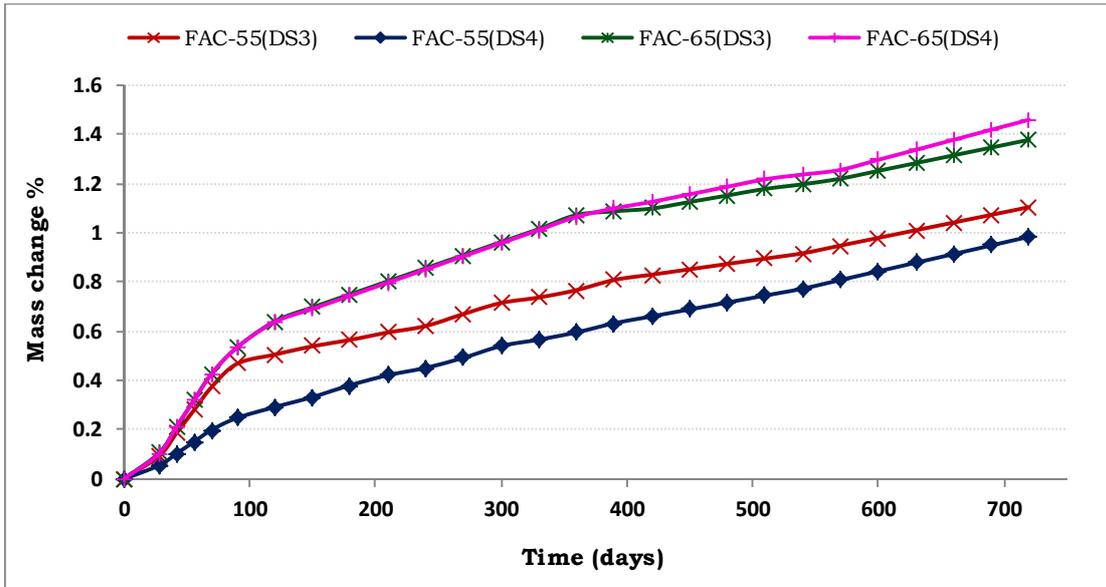
**Figure 6.9 Mass change for FAC samples in sulfate solutions at 5 °C.**

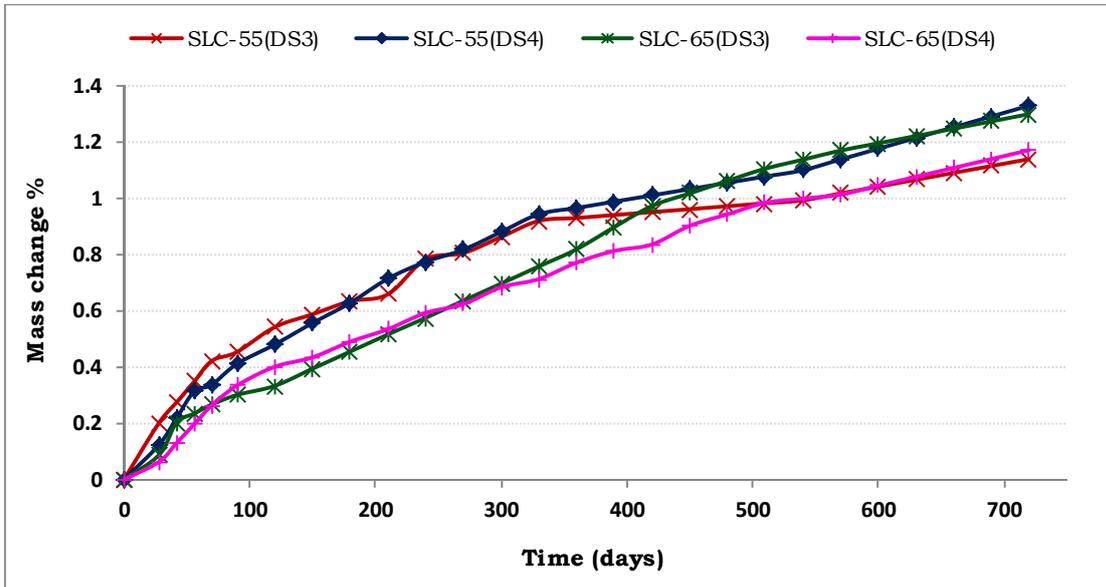
Figure 6.11 Mass change for SLC samples in sulfate solutions at 5 °C.

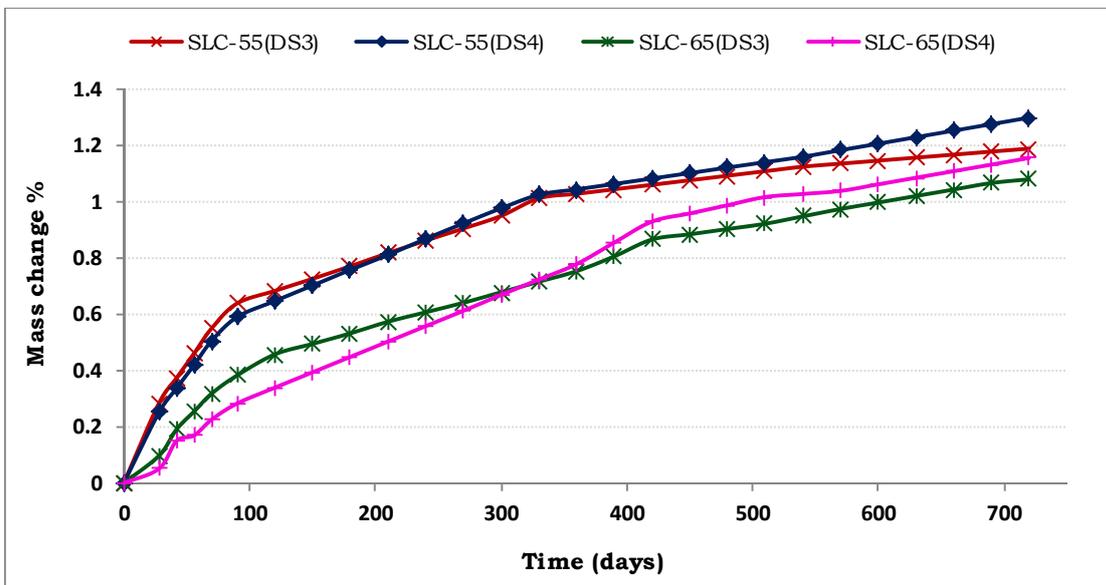
Figure 6.12 Mass change for SLC samples in sulfate solutions at 20 °C.

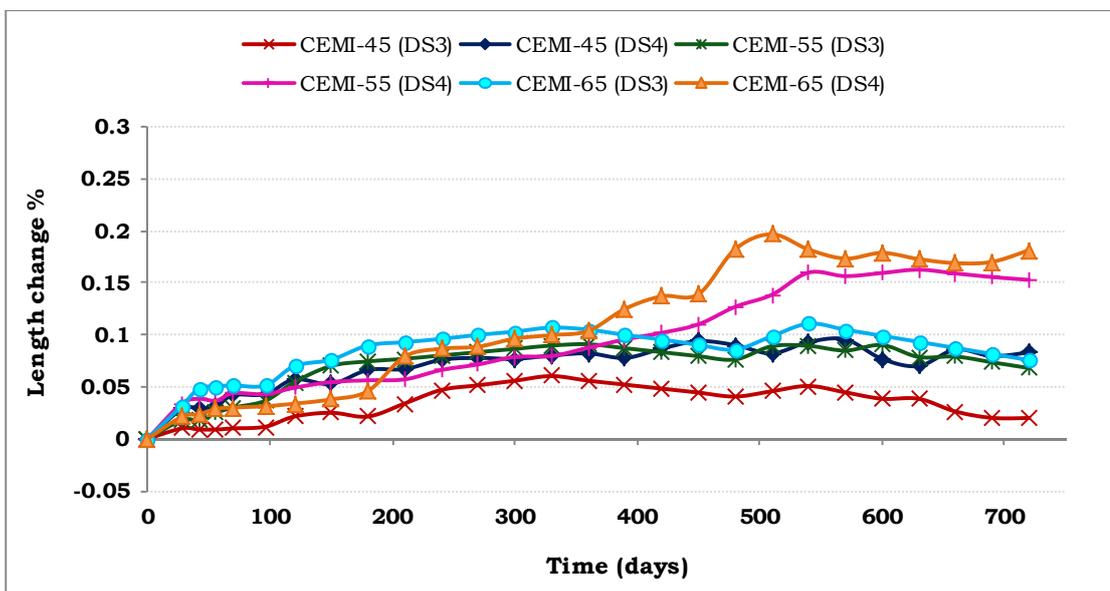
**Figure 6.13 Length change for CEMI samples in sulfate solutions at 5 °C**

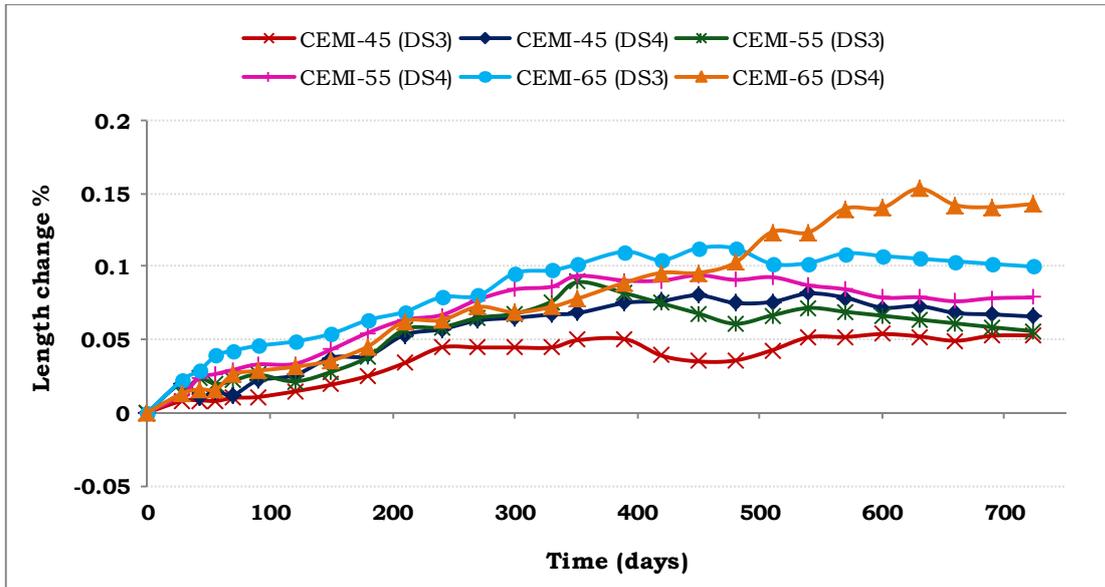
Figure 6.14 Length change for CEMI samples in sulfate solutions at 20 °C

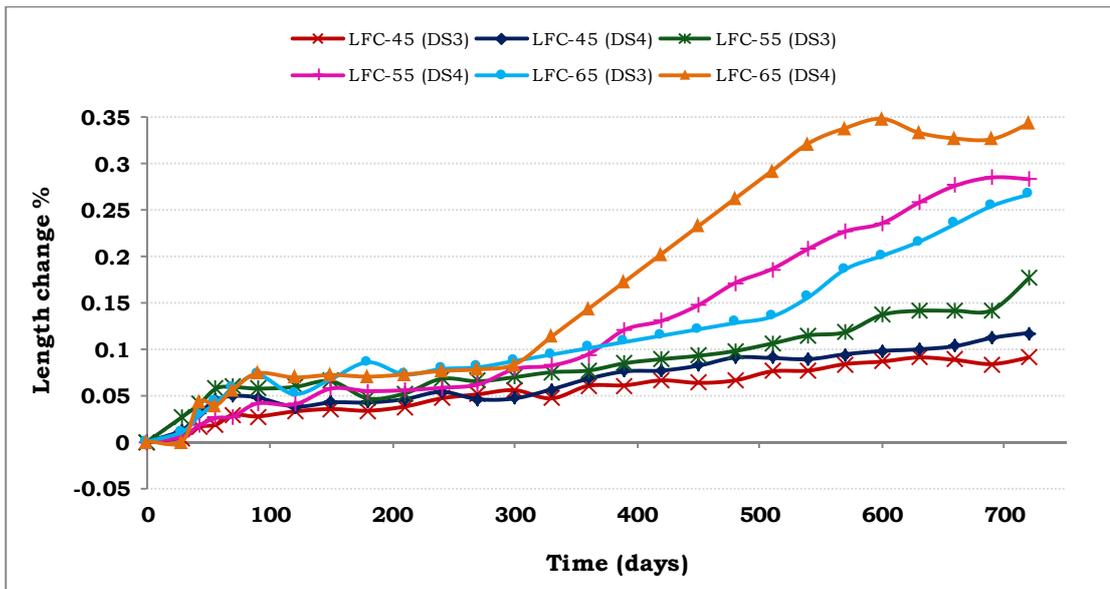
Figure 6.15 Length change for LFC samples in sulfate solutions at 5 °C

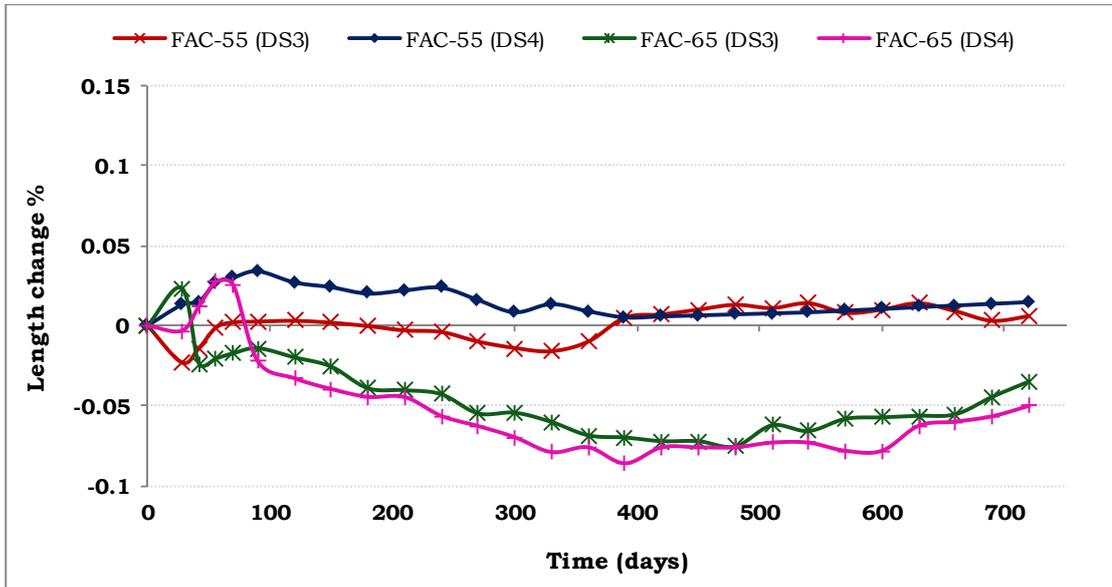
Figure 6.17 Length change for FAC samples in sulfate solutions at 5 °C

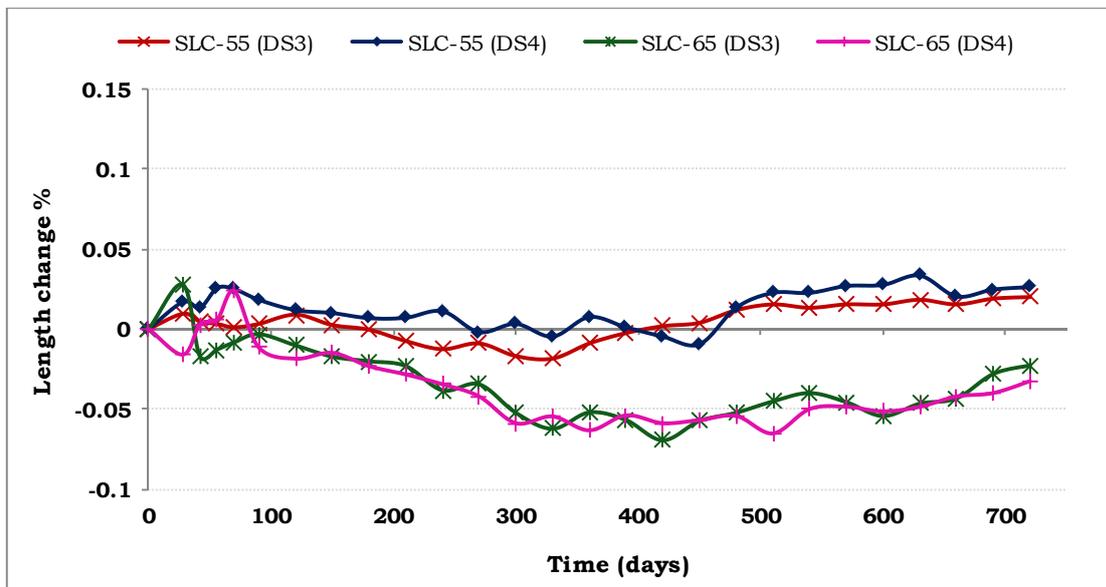
Figure 6.19 Length change for SLC samples in sulfate solutions at 5 °C

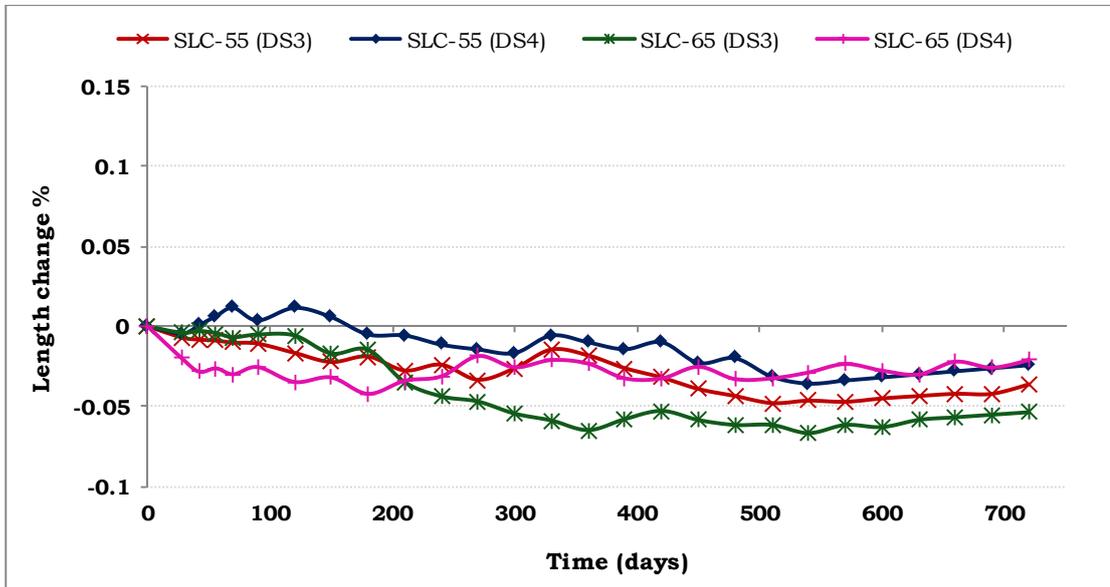
Figure 6.20 Length change for SLC samples in sulfate solutions at 20 °C

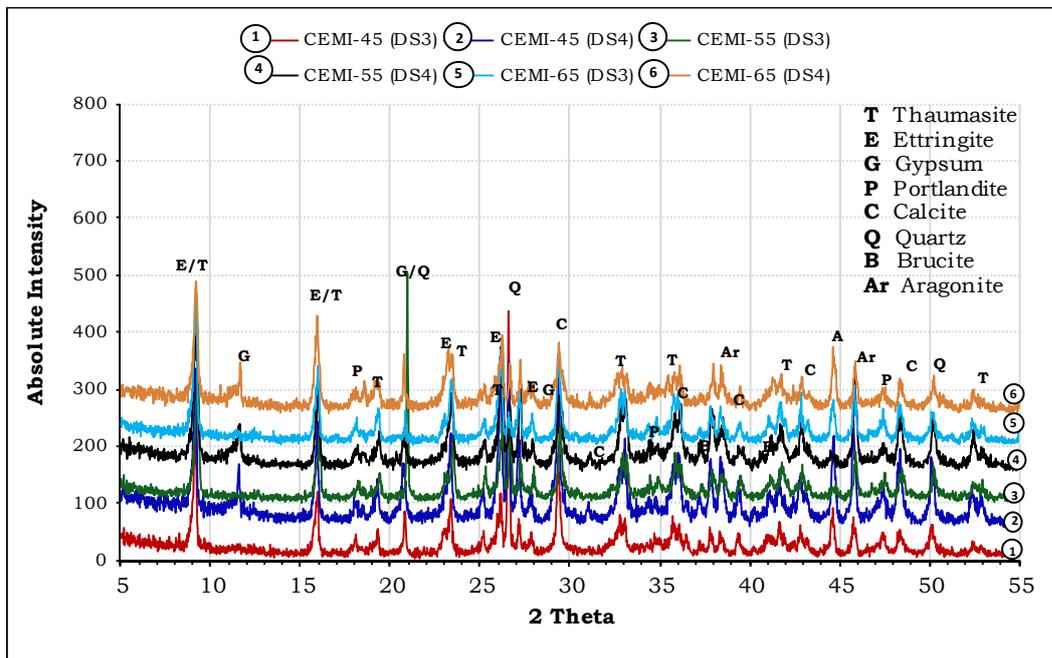
Figure 6.21 XRD patterns for CEMI solid samples at 5 °C

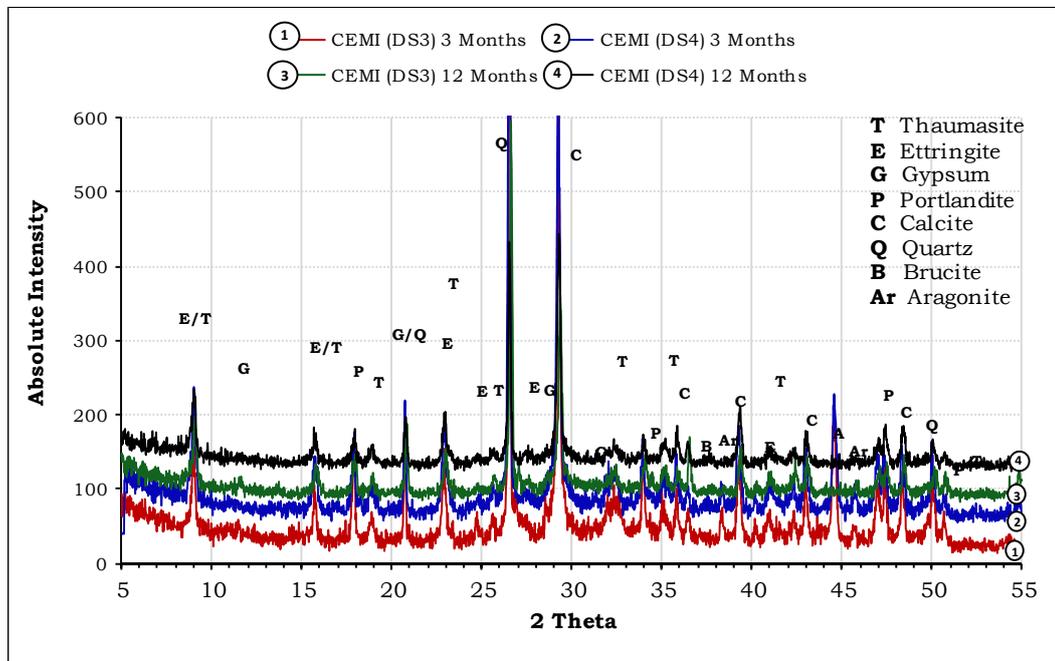
Figure 6.22 XRD patterns for CEMI Powder samples at 5 °C

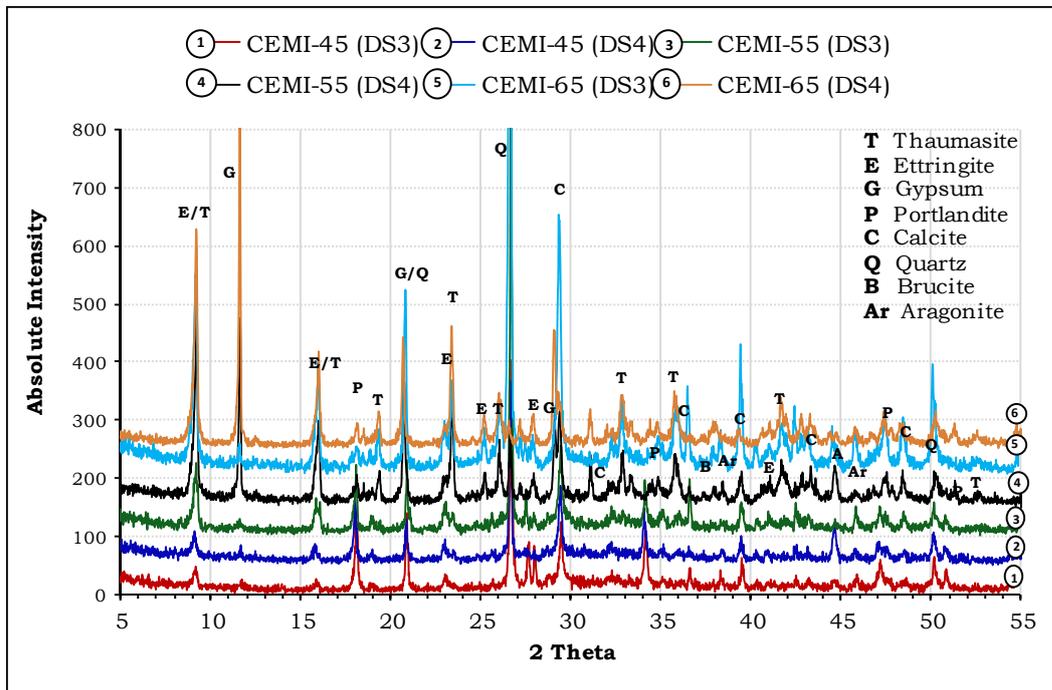
Figure 6.23 XRD patterns for CEMI solid samples at 20 °C

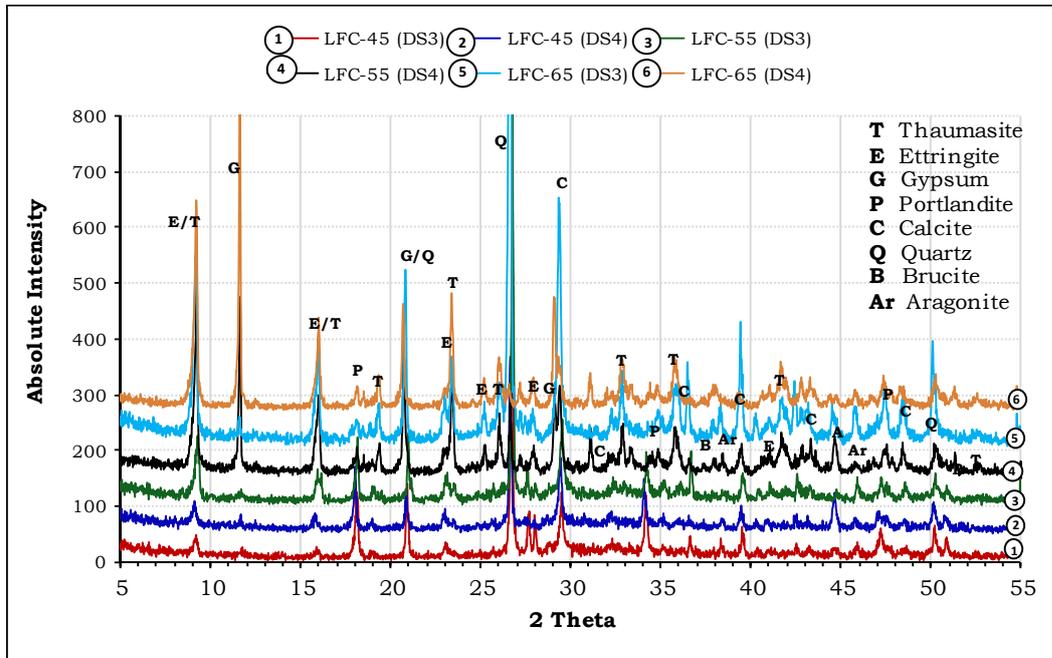
Figure 6.25 XRD patterns for LFC solid samples at 5 °C

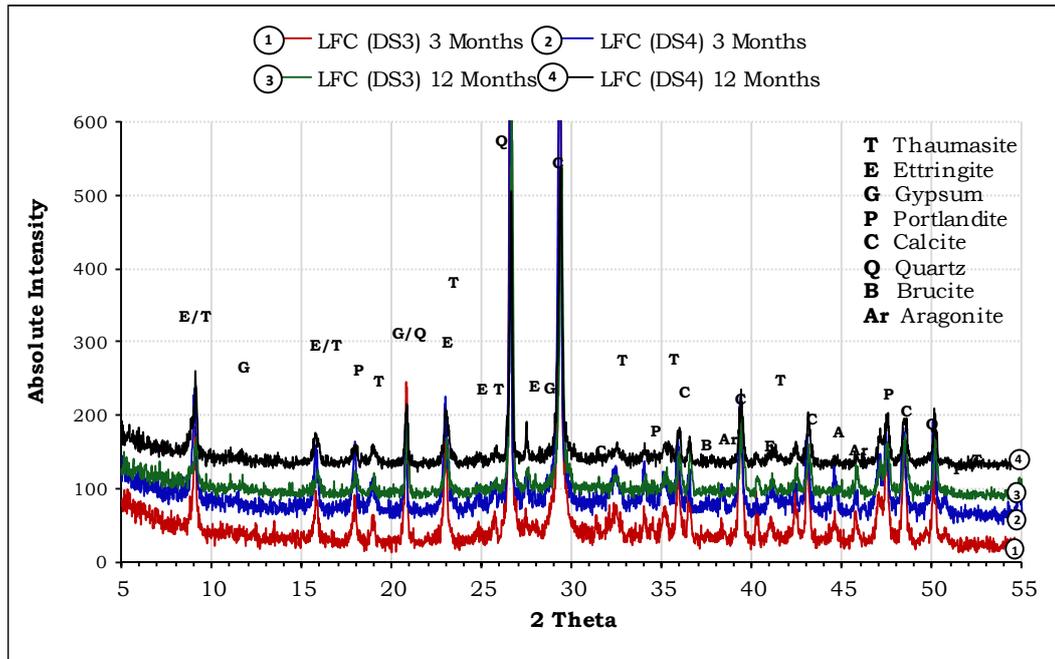
Figure 6.26 XRD patterns for LFC powder samples at 5 °C

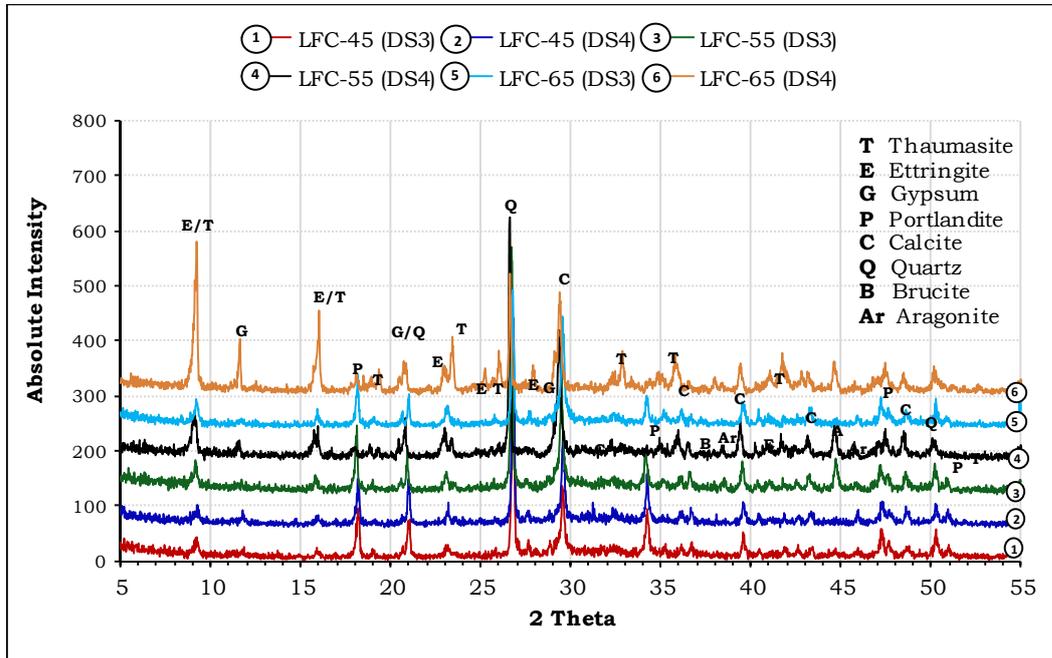
**Figure 6.27 XRD patterns for LFC solid samples at 20 °C**

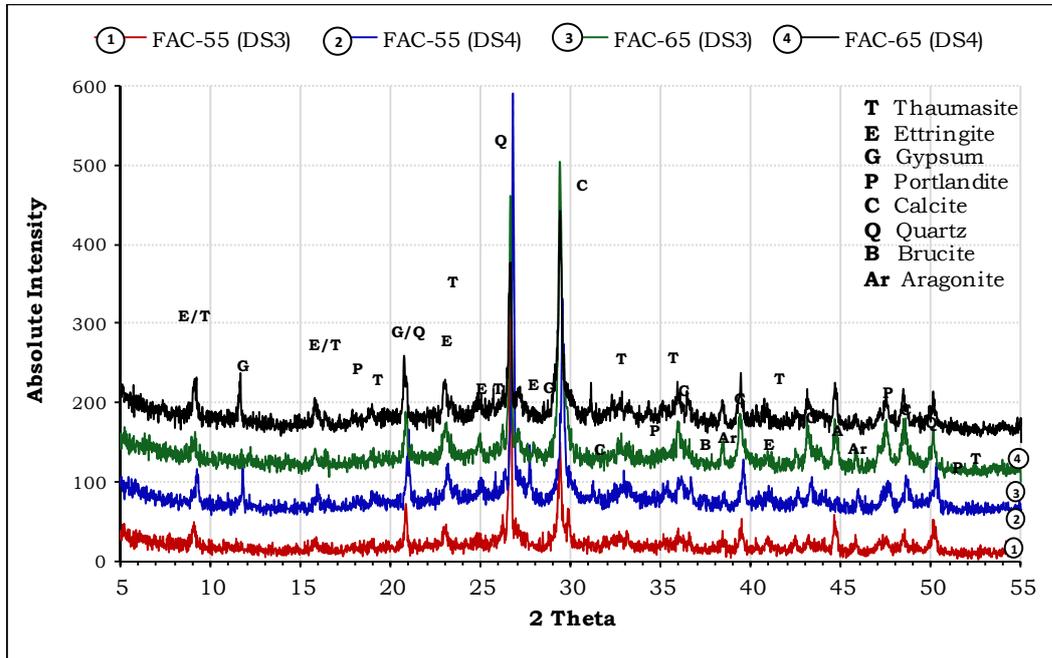
Figure 6.29 XRD patterns for FAC solid samples at 5 °C

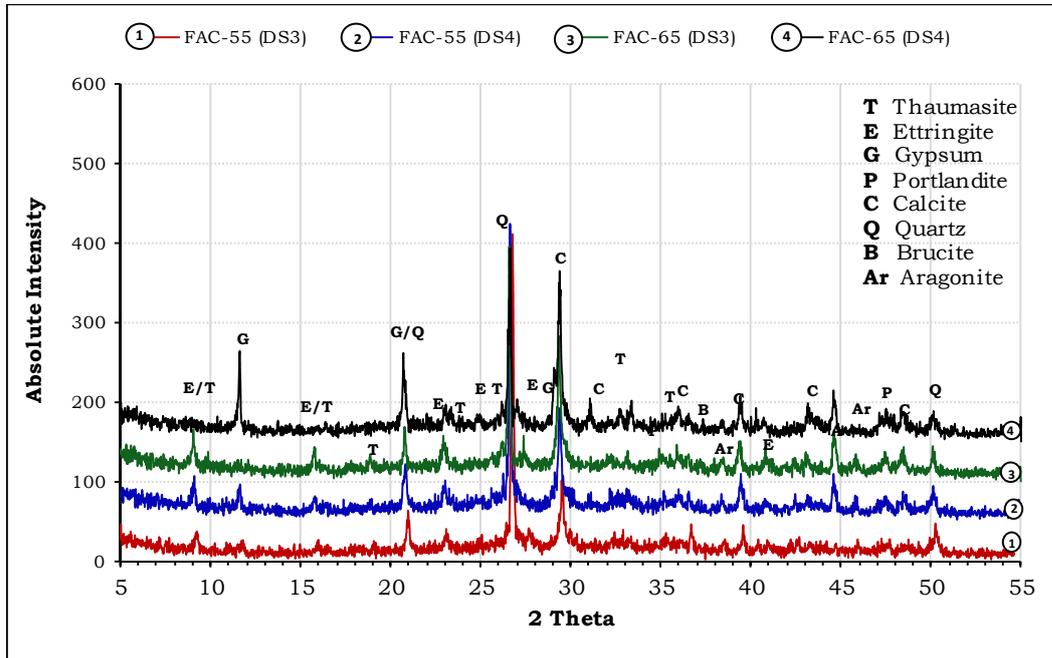
Figure 6.31 XRD patterns for FAC solid samples at 20 °C

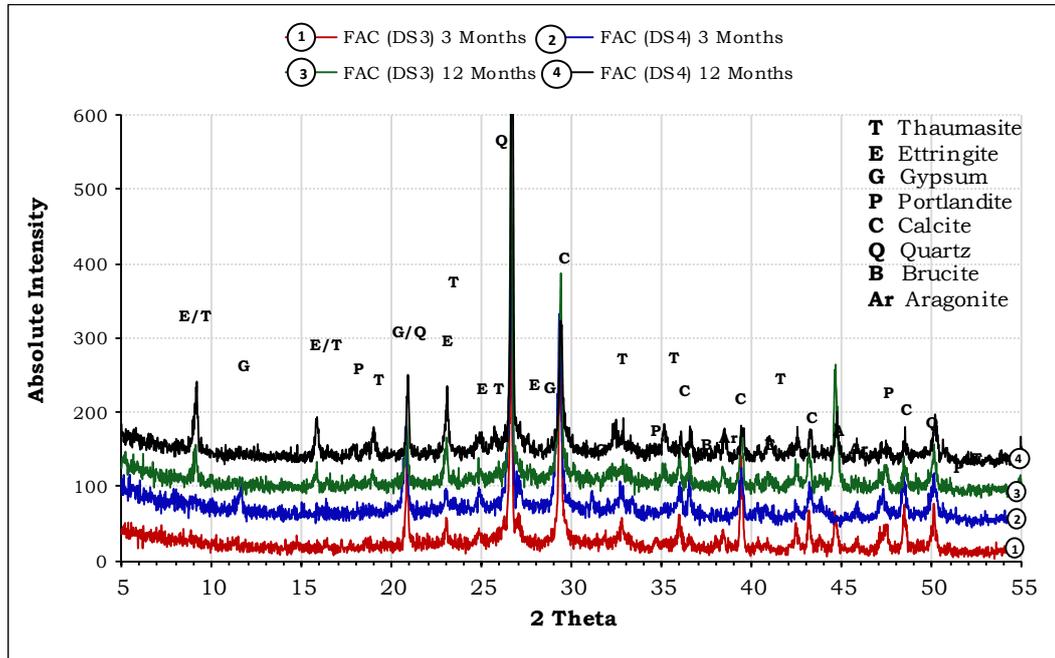
Figure 6.32 XRD patterns for FAC powder samples at 20 °C

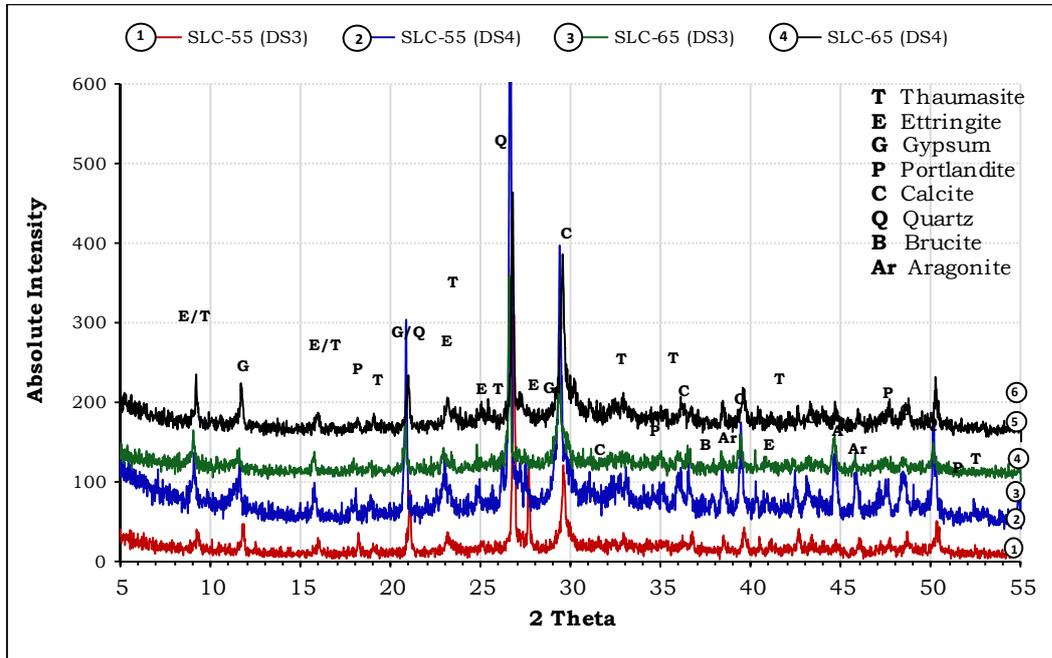
Figure 6.33 XRD patterns for SLC solid samples at 5 °C

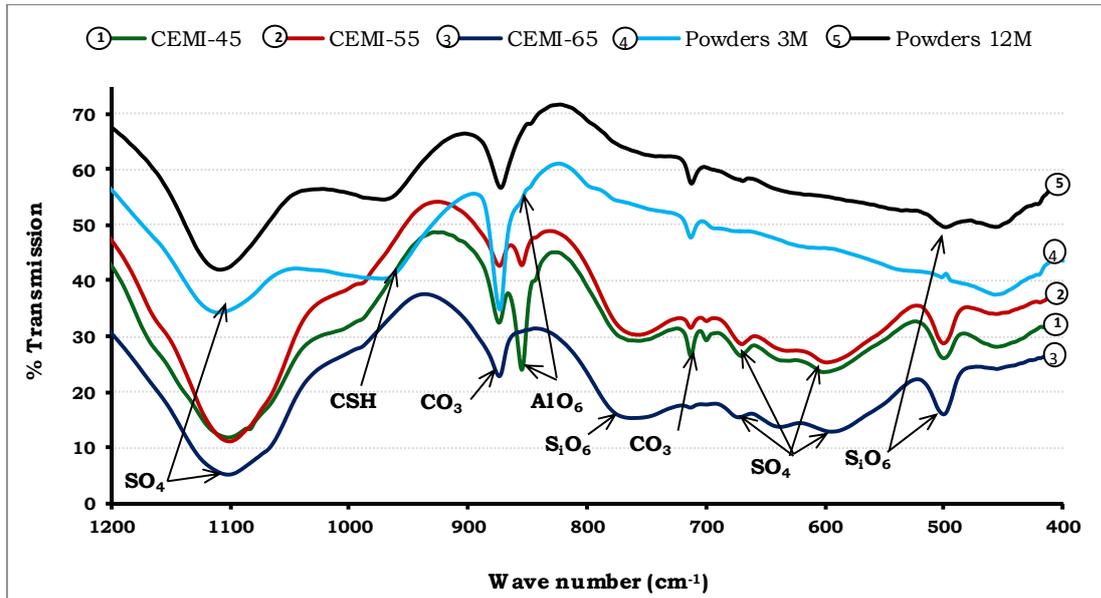
Figure 6.37 IR spectra for CEMI samples in DS4 solutions at 5 °C

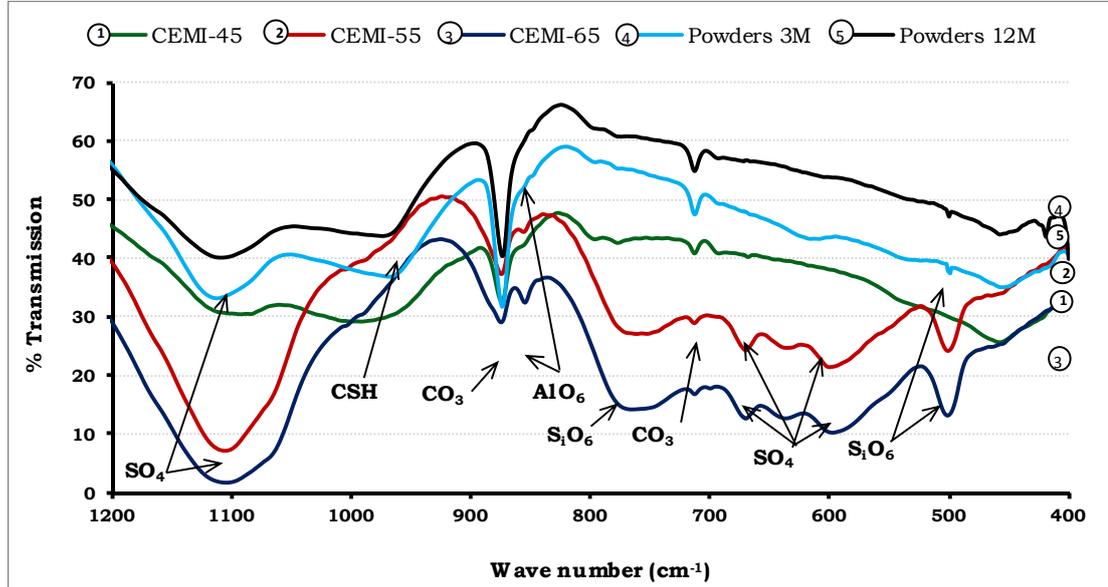
**Figure 6.38** IR spectra for CEMI samples in DS4 solutions at 20 °C

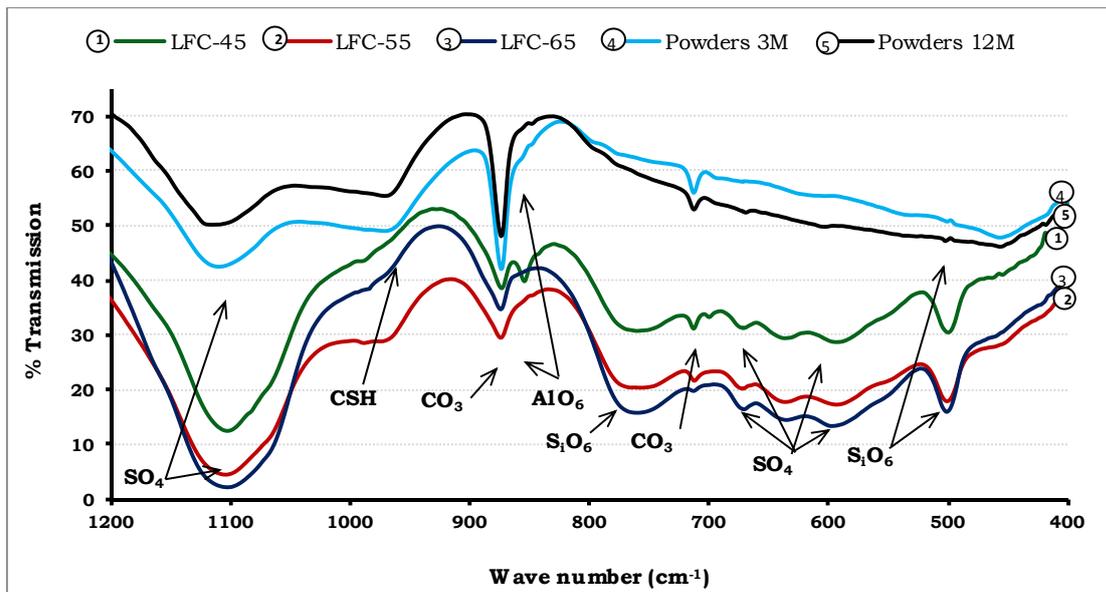
Figure 6.39 IR spectra for LFC samples in DS4 solutions at 5 °C
