**The Effect OF Wetting and Drying Cycles  
and Carbonation on Thaumaside Formation**

A thesis submitted for the degree of Doctor of Philosophy in  
the Faculty of Engineering of the University of Sheffield

By  
Jumma Musbah Abualgasem

DEPARTMENT OF CIVIL AND STRUCTURAL ENGINEERING  
THE UNIVERSITY OF SHEFFIELD

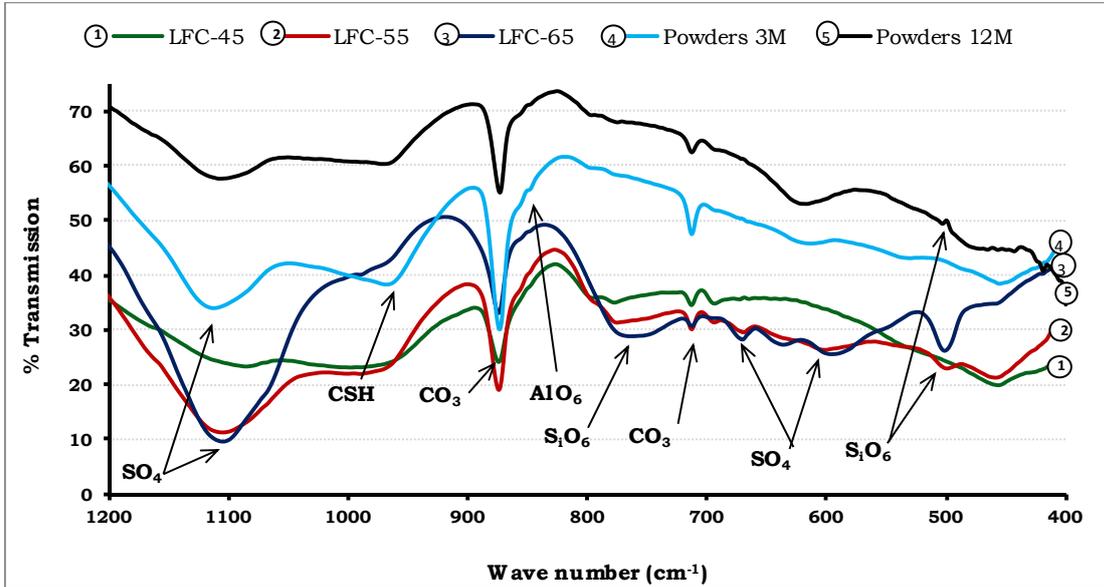
Figure 6.40 IR spectra for LFC samples in DS4 solutions at 20 °C

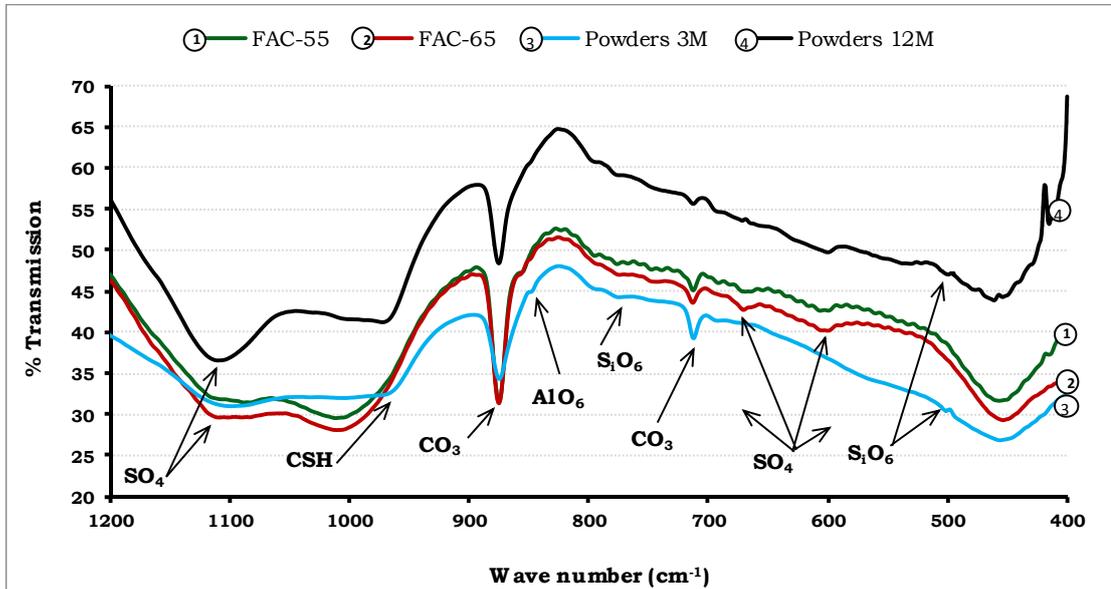
Figure 6.41 IR spectra for FAC samples in DS4 solutions at 5 °C

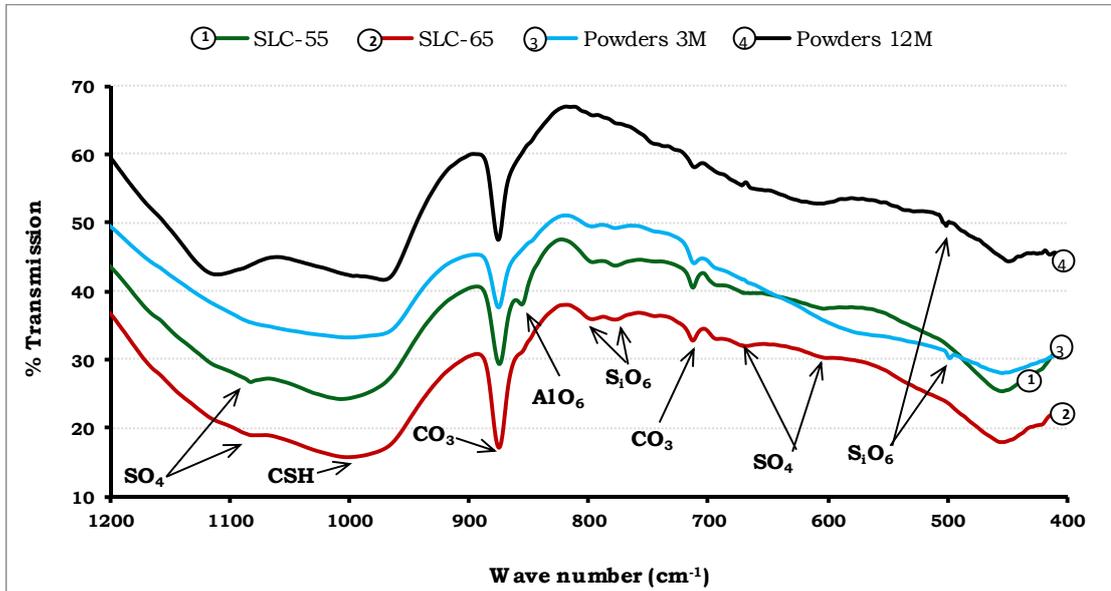
Figure 6.43 IR spectra for SLC samples in DS4 solutions at 5 °C

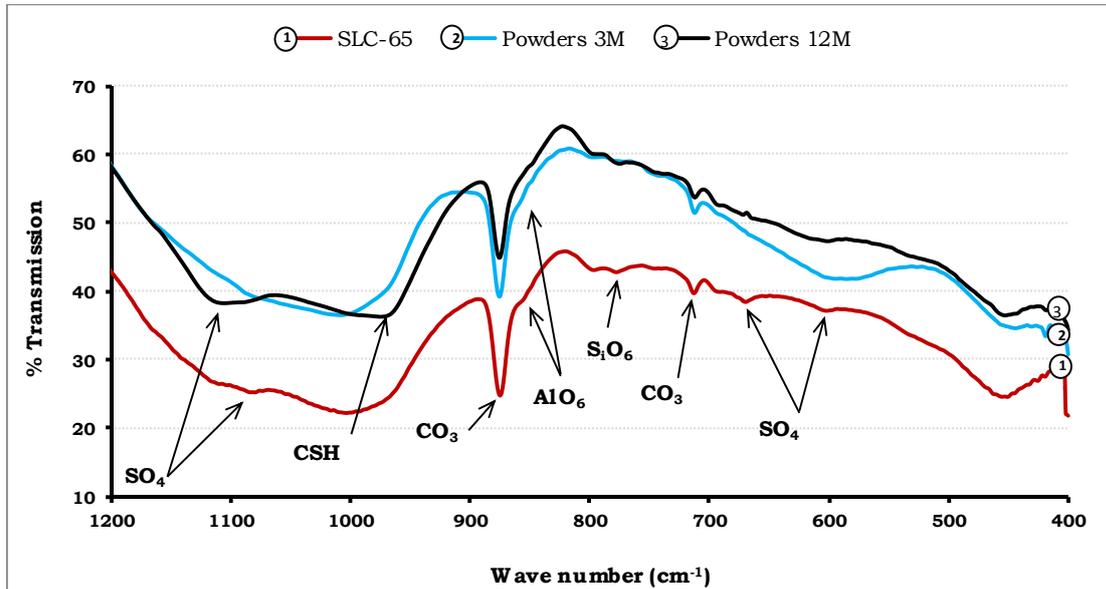
Figure 6.44 IR spectra for SLC samples in DS4 solutions at 20 °C

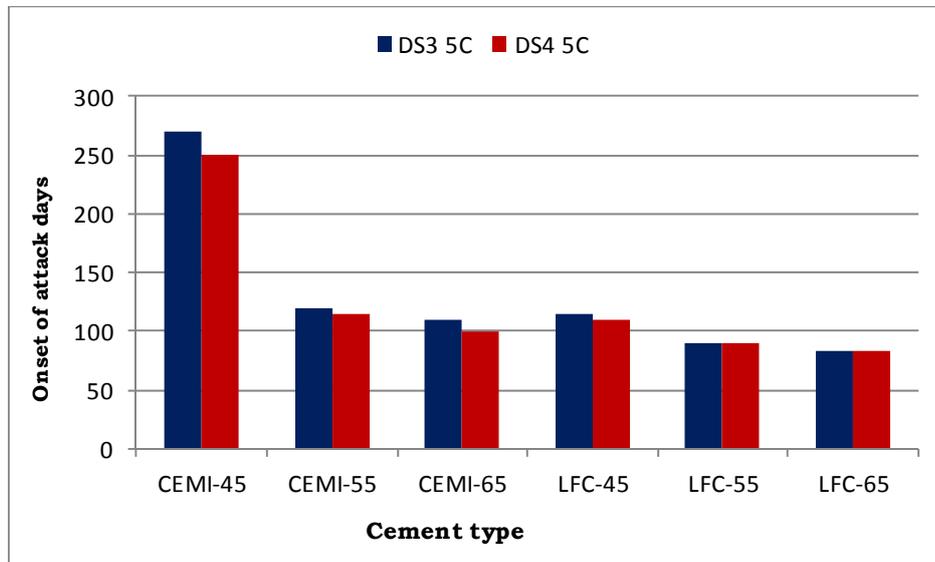
**Figure 7.2 Relationship between onset of attack and w/c ratio**

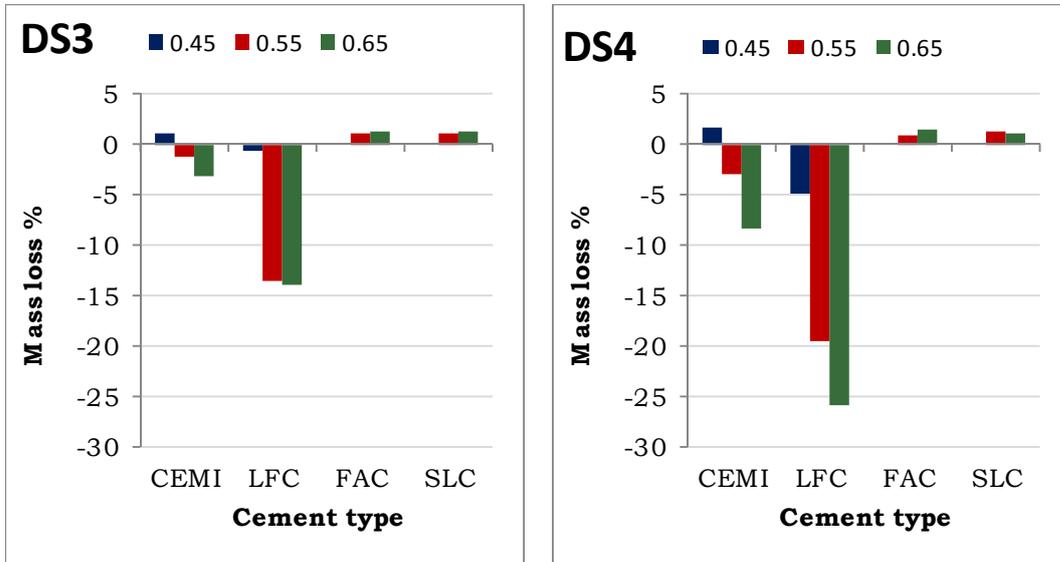
Figure 7.3 Relationship between mass change and different w/c ratios

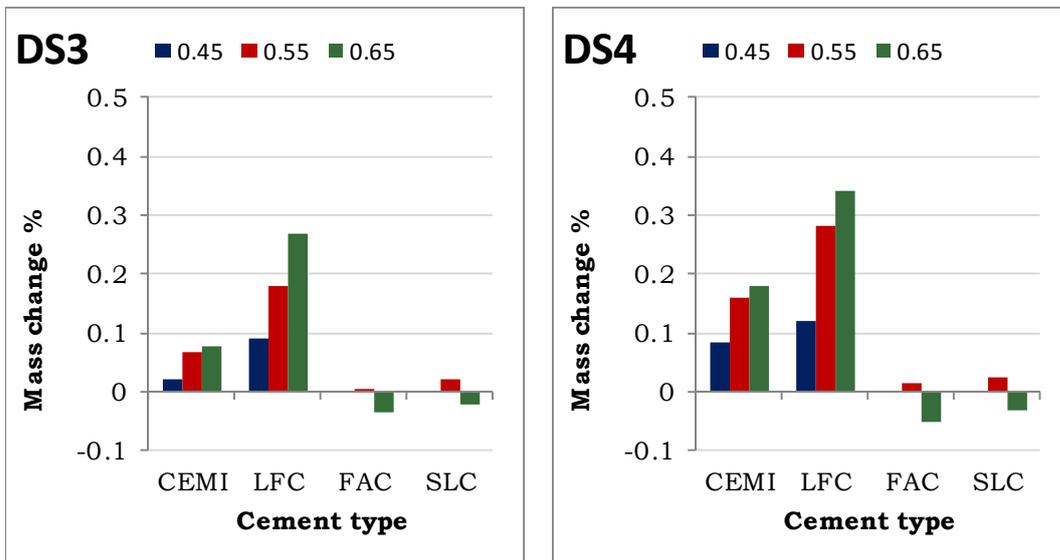
Figure 7.4 Relationship between length change and different w/c ratios
