Vandalism and Social Duty: The Victorian Rebuilding of the 'Street Parish' Churches, Ryedale, North Yorkshire

Volume II of II

David C Smith

PhD University of York

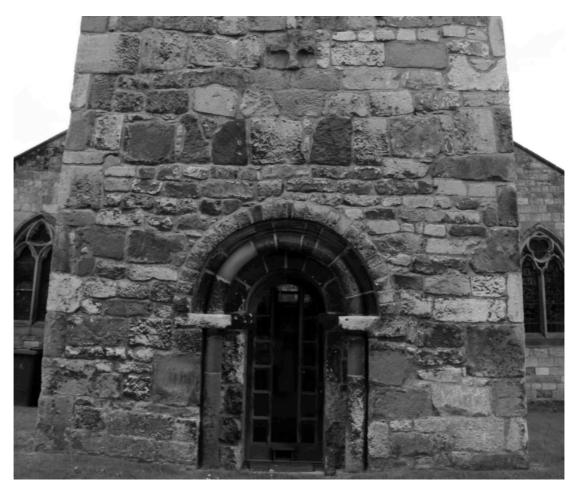
Figure 4.32 Detail of a window head (inverted) reused as a quoin in the tower

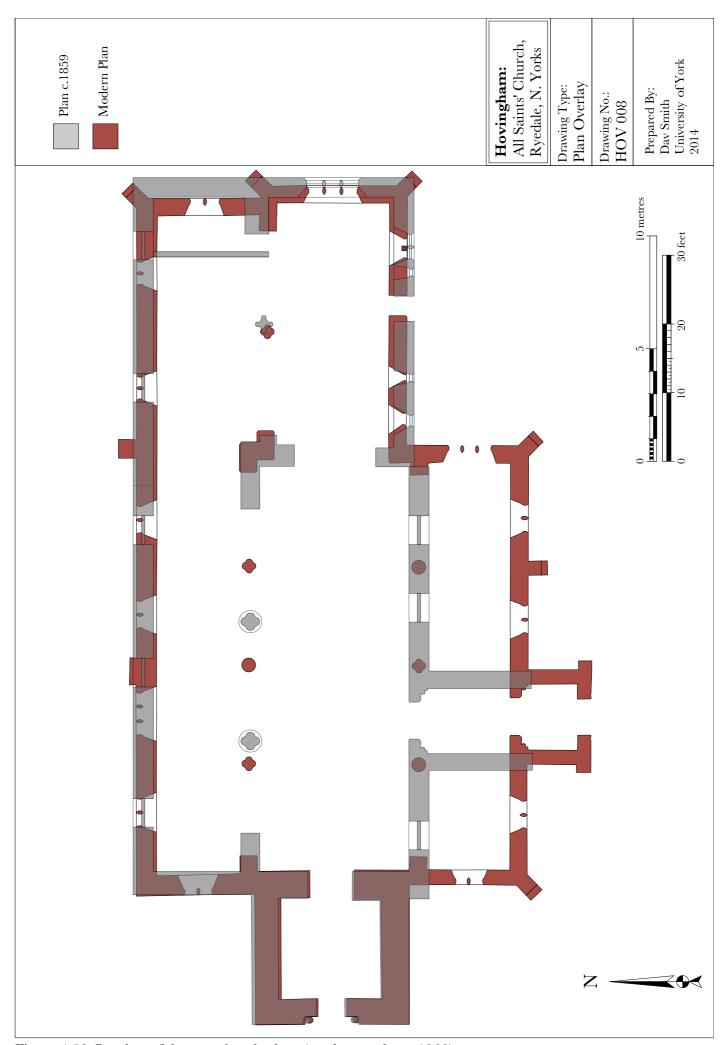
Figure 4.58 Comparison of the pre-1860 and current plans

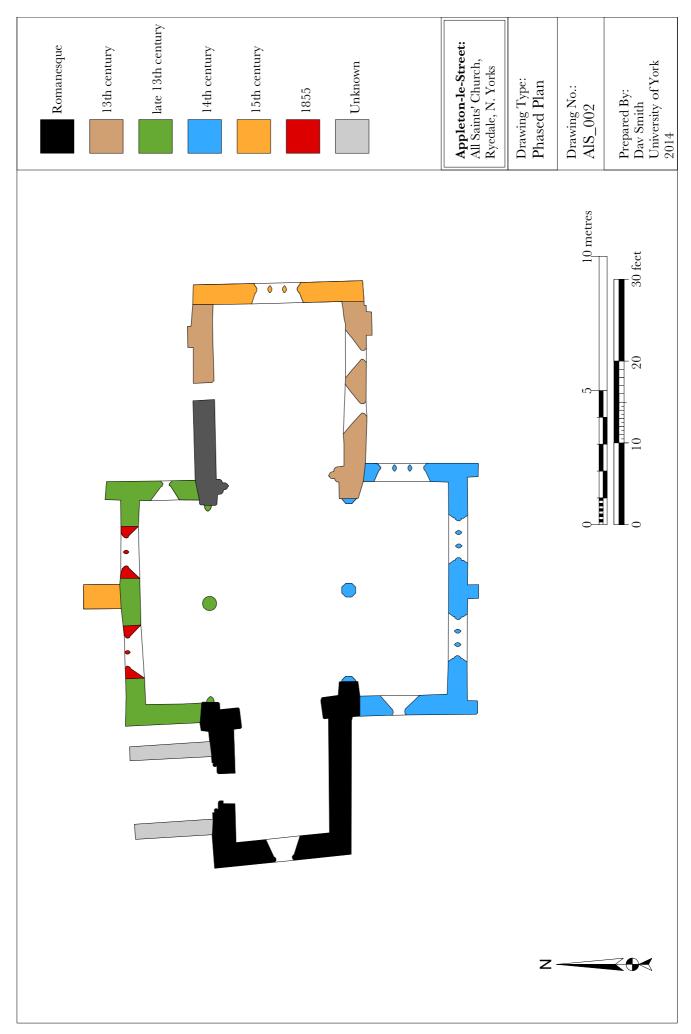
Figure 7.3 Plan of the present All Saints, Appleton-le-Street

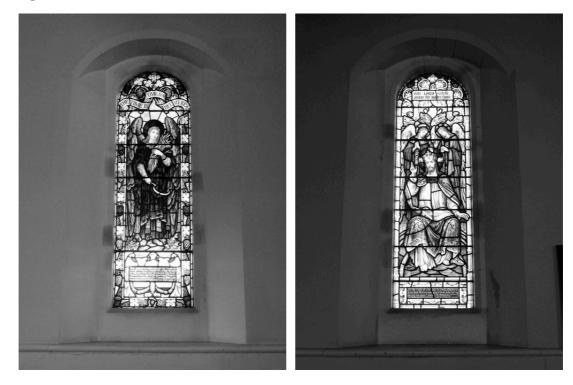
Figure 8.27 Stained glass commemorating G.N & E.E. Strickland (left) and J.A. Warren (right)

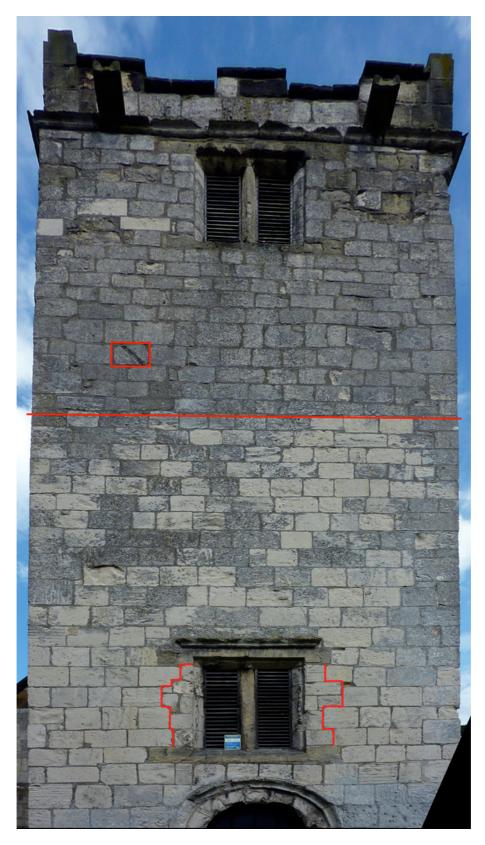
Figure 8.37 General view of the west tower, showing the west elevation

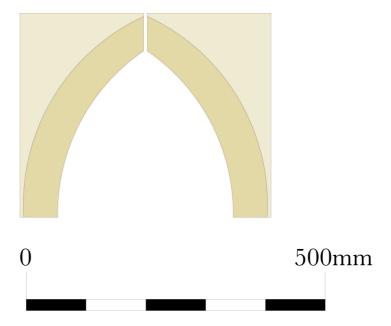
Figure 8.50 Fragments of lancet window found in the churchyard
