**‘Cotting On’ to Workers’ Housing:  
A Historical Archaeology of Industrial  
Accommodation in the Derwent Valley  
1776-1821**

**Volume 2 of 2**

**Suzanne Lilley**

**University of York**

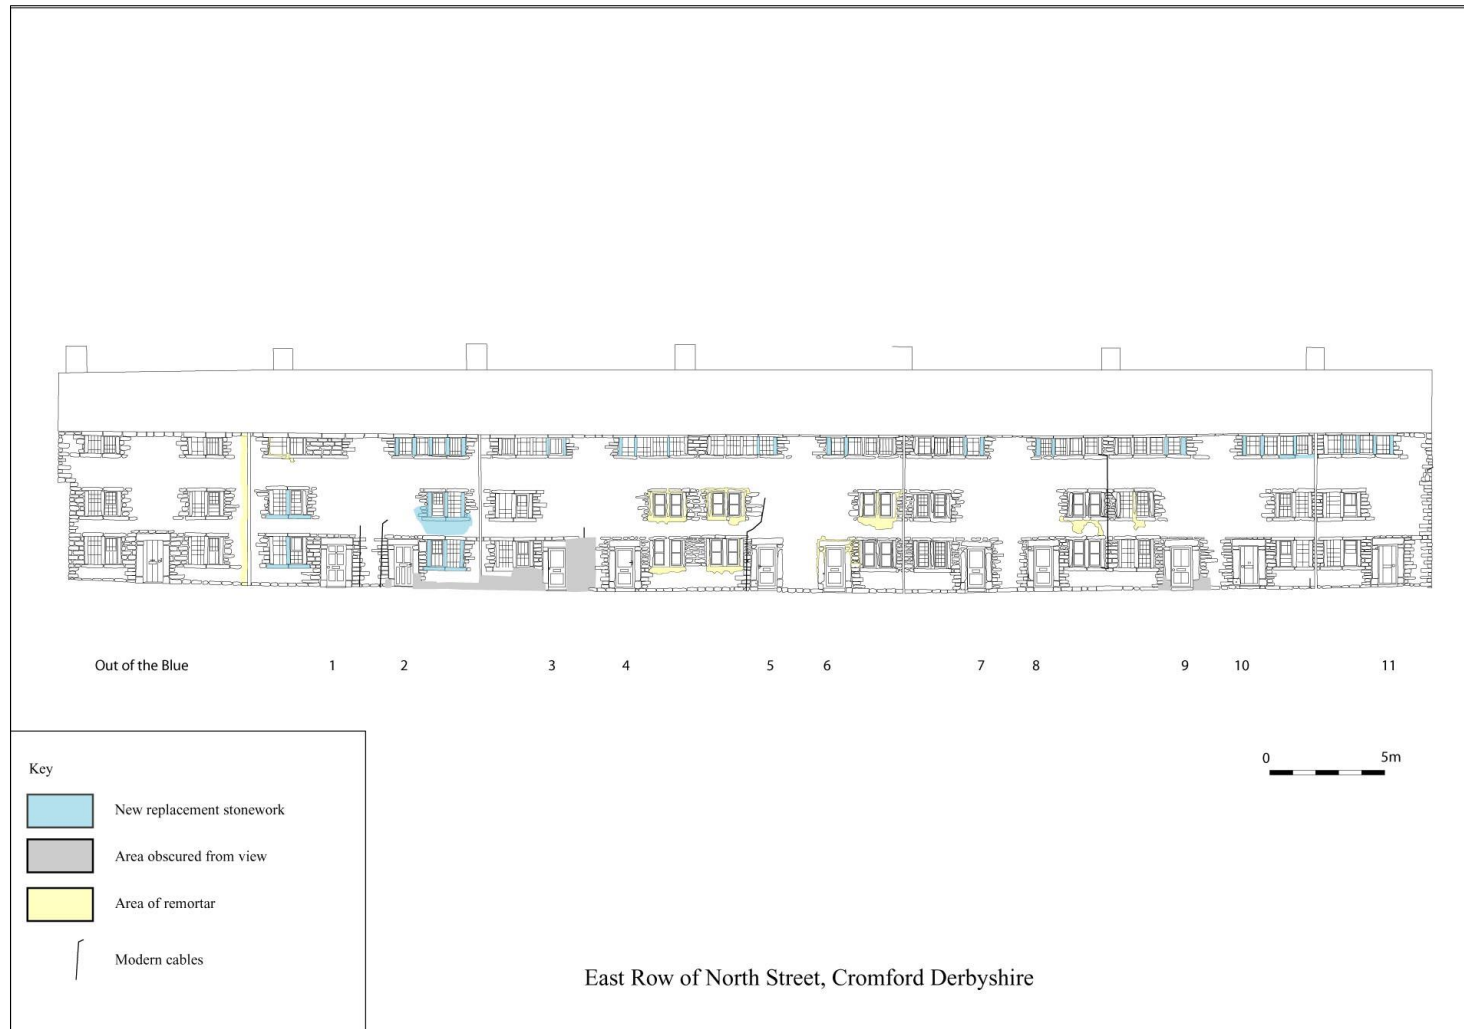
Figure 3.10: Elevation of the eastern row of North Street, depicting *Groups A* and *B* (source: author's own survey data)

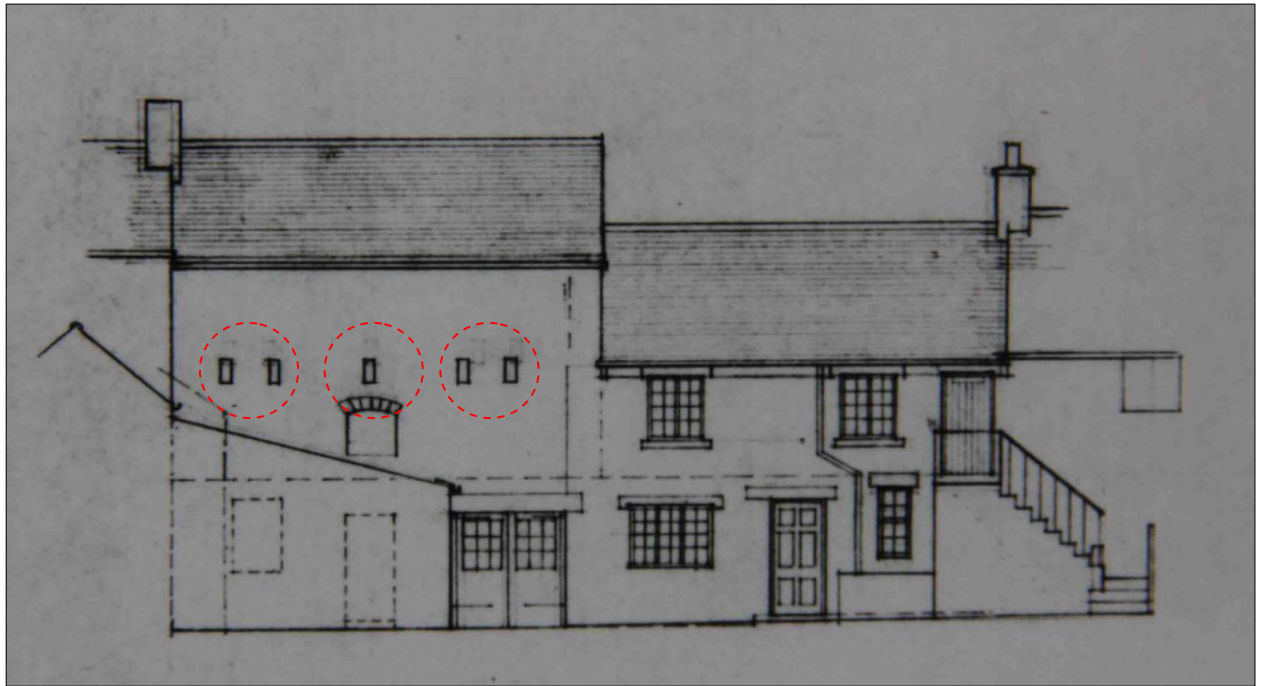
Figure 3.20: Schematic elevation drawing of *Group B* property, note the ventilation slots (circled)  
(source: Crown Copyright NMR)

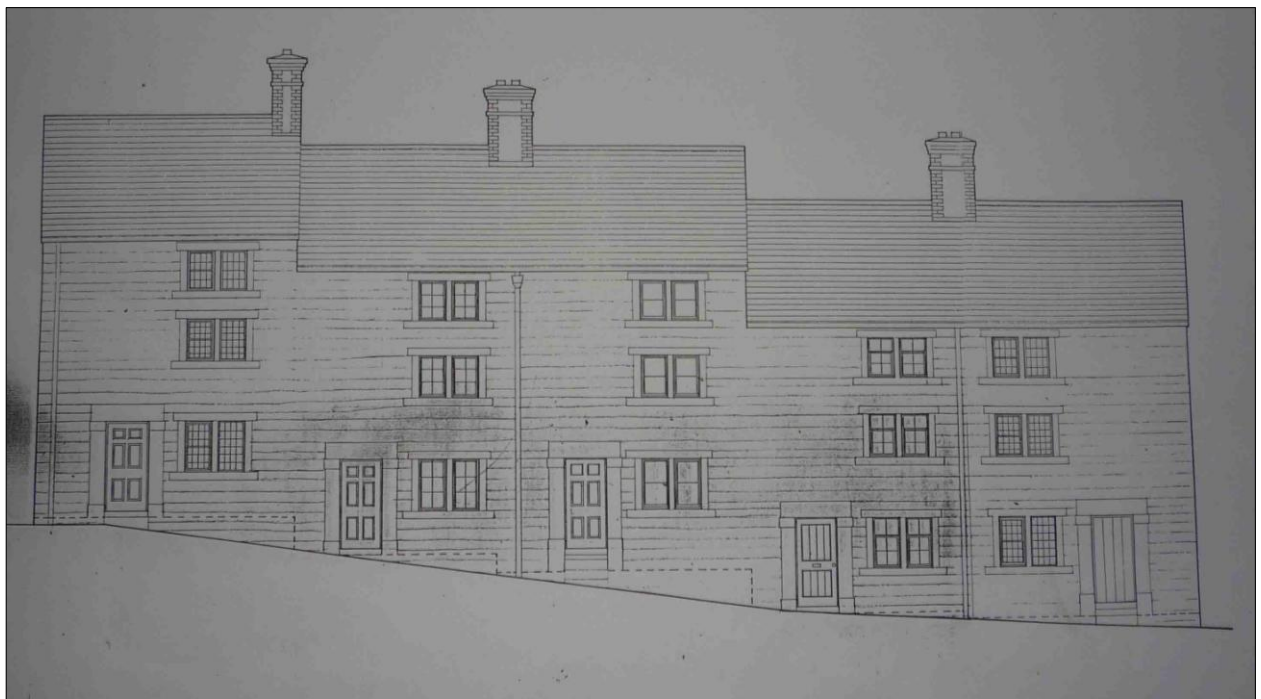
Figure 3.21: Schematic elevation drawing of *Group C* properties at Nos.100-108 The Hill, Cromford  
(drawn by Tony Short)

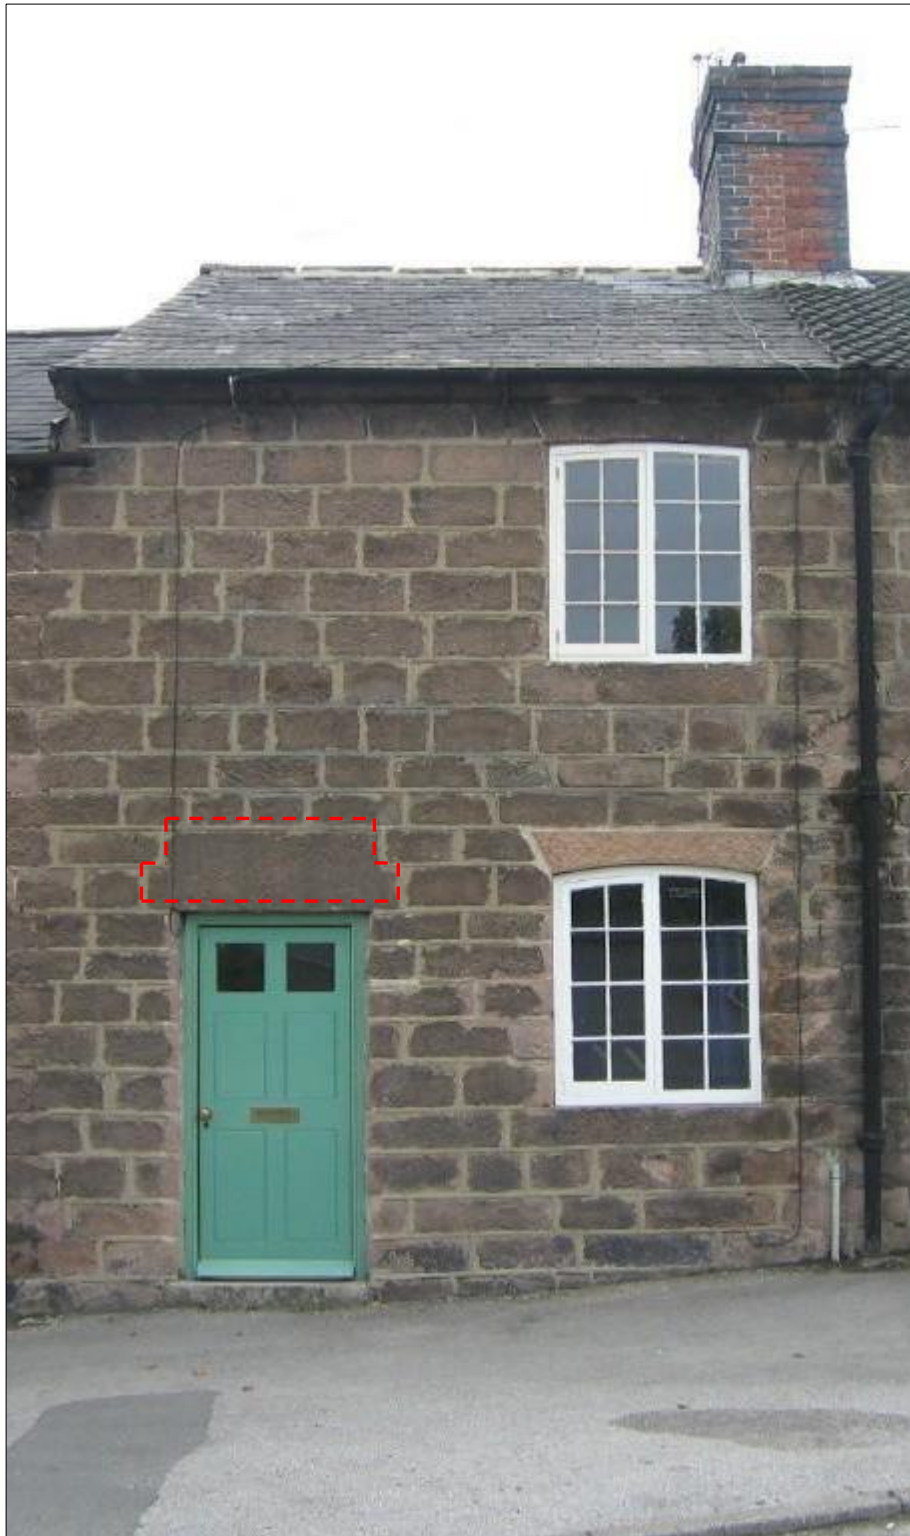
Figure 3.27: A *Group E* property with distinctive reverse-T stone lintels (outlined) (source: author's own photo)

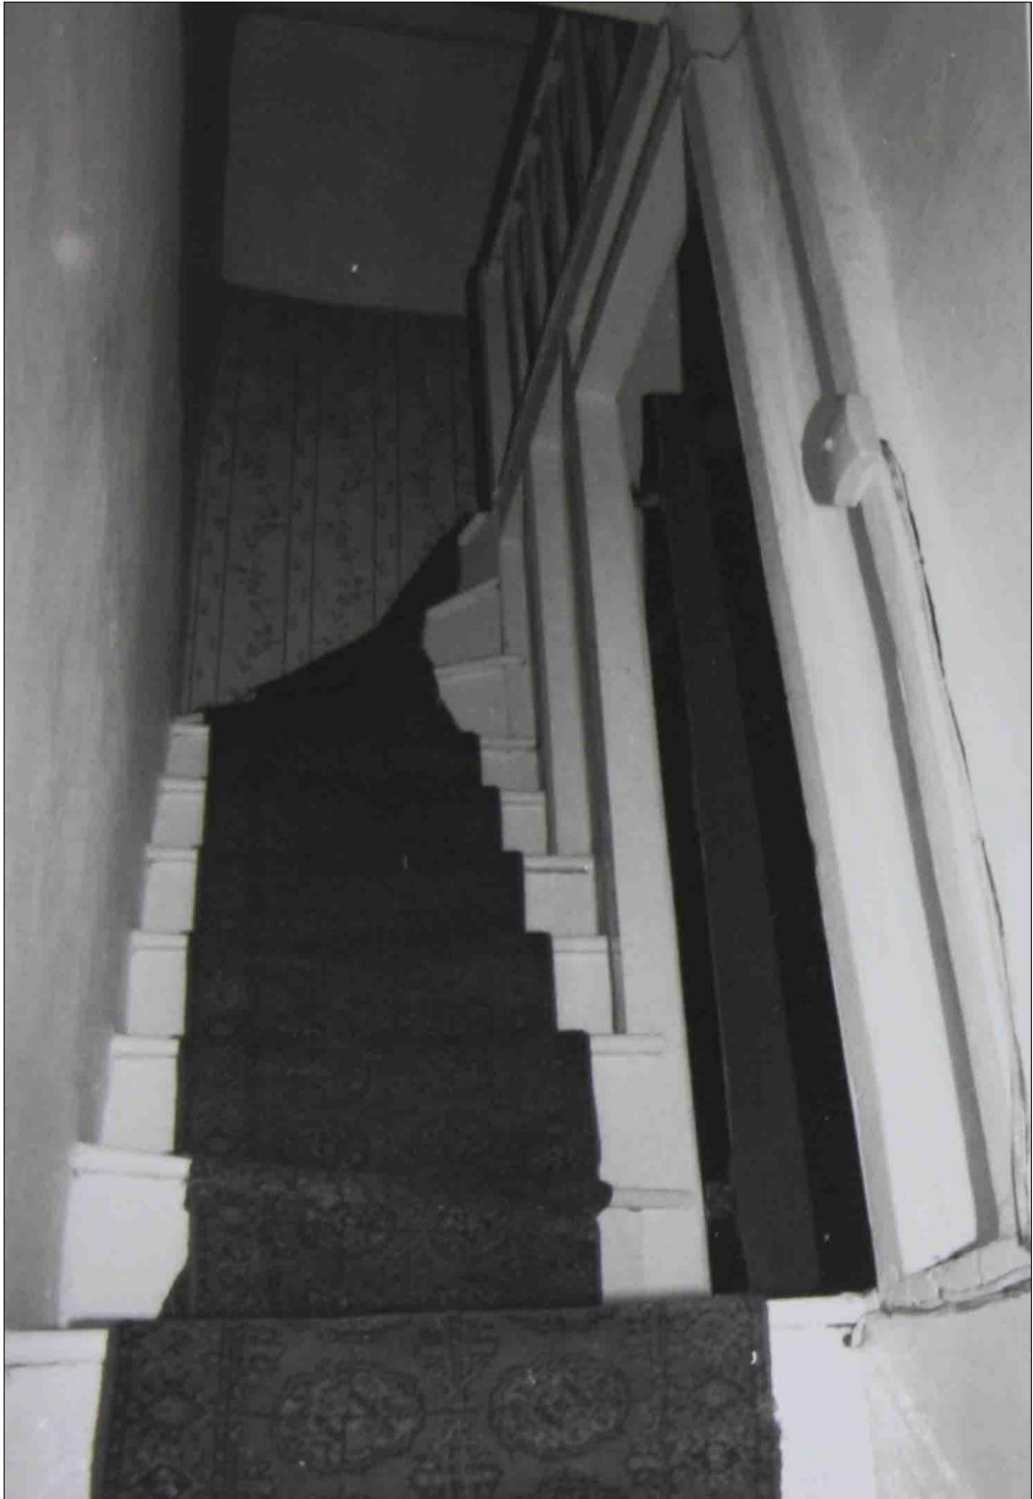
Figure 3.45: Detail of staircase at No.148 The Hill (source: Crown Copyright NMR)

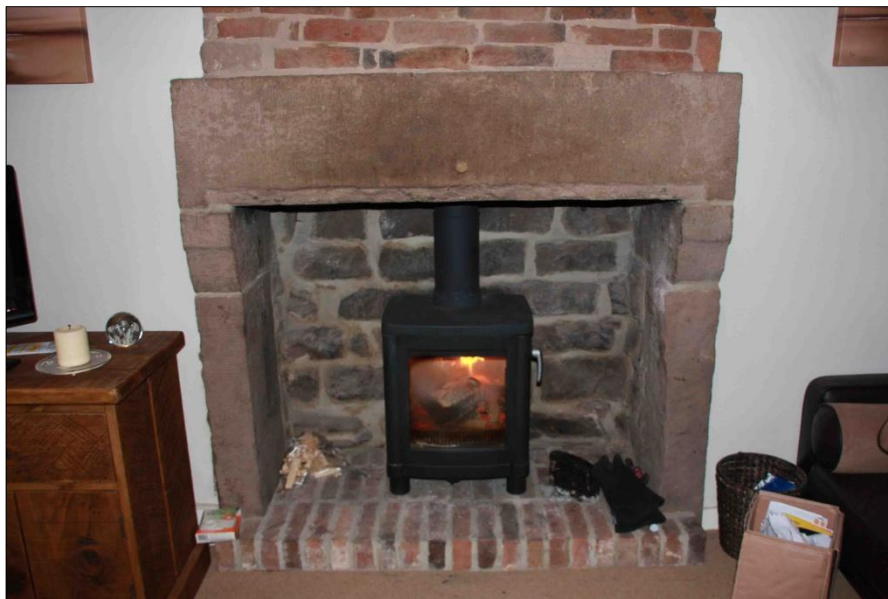
Figure 3.50: Ground floor fireplace found in *Plans 1 and 3* houses (properties on The Hill) (source: author's own photo)

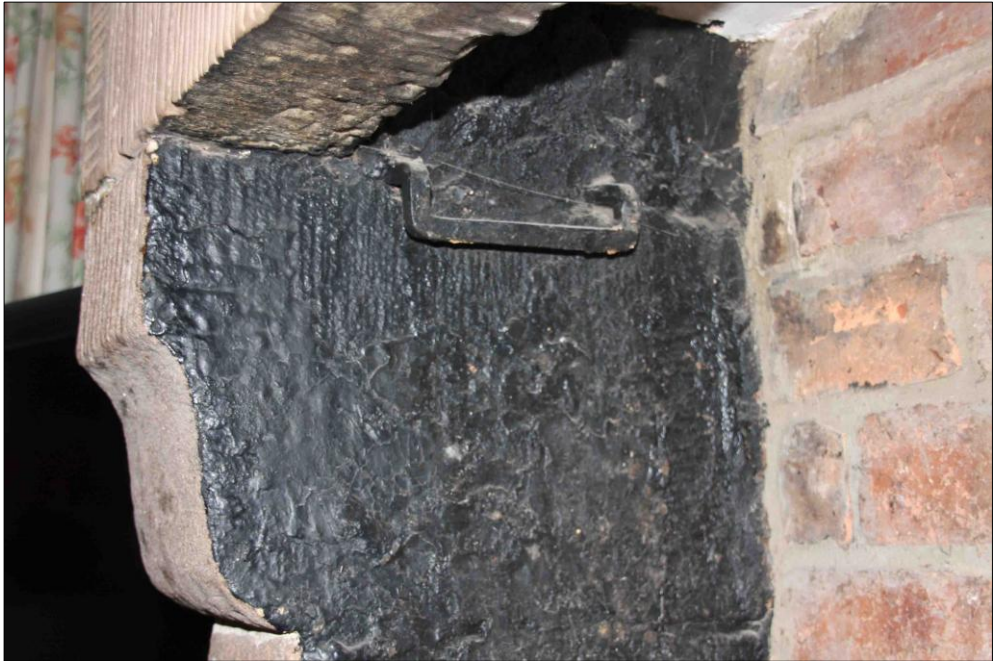
Figure 3.51: Detail of ground floor fireplace showing handle-shaped piece of metalwork situated on the inner face of the jamb (source: author's own photo)

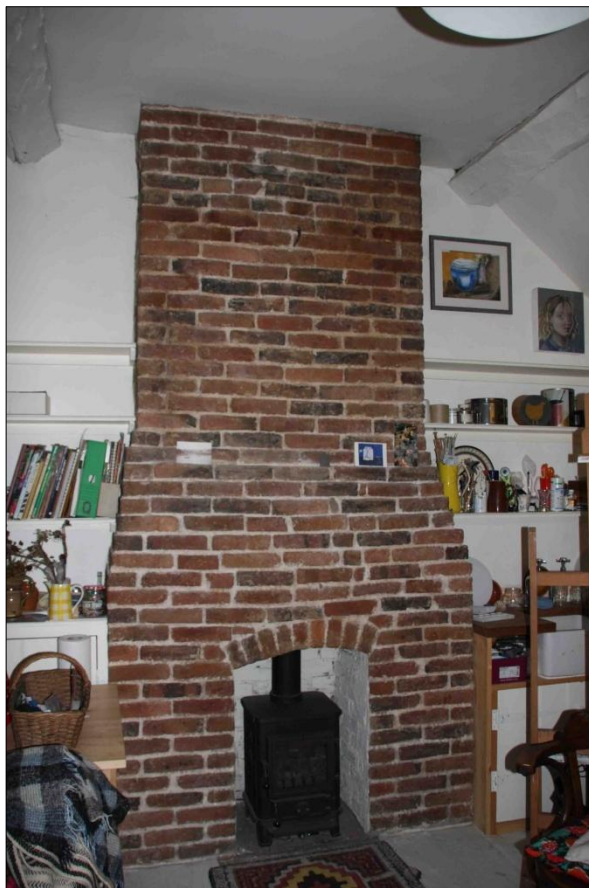
Figure 3.57: Second floor chimney breast arrangement at No.25 North Street (source: author's own photo)

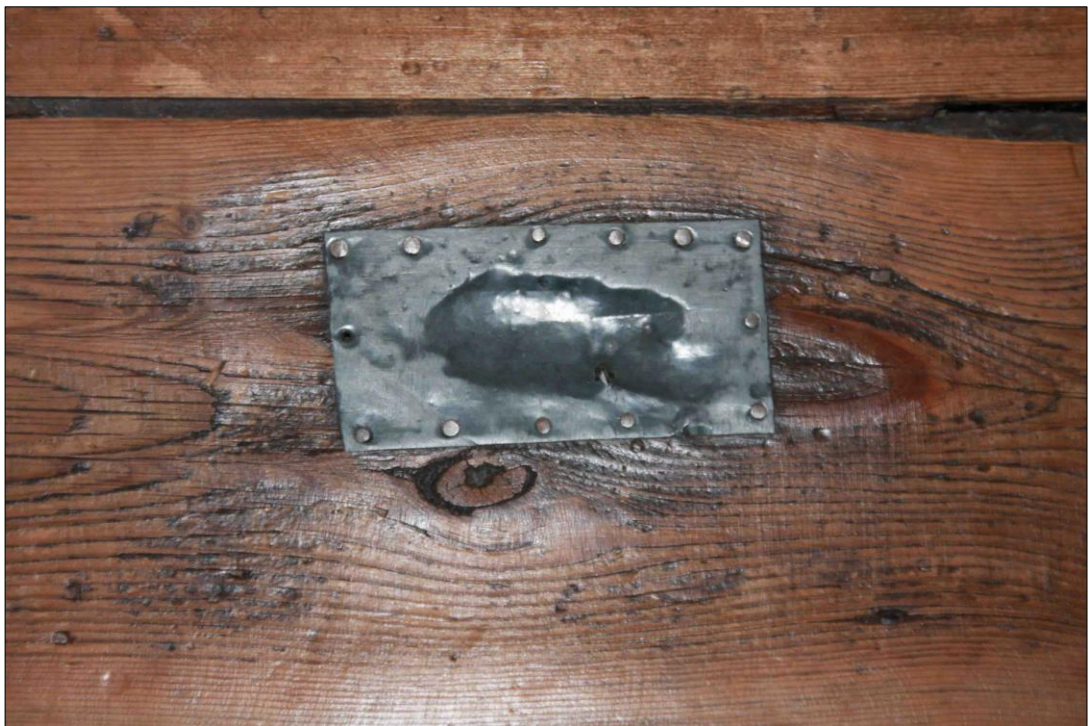
Figure 4.49: Detail of metal repair to first floor of No. 10 Mill Street (source: author's own photo)

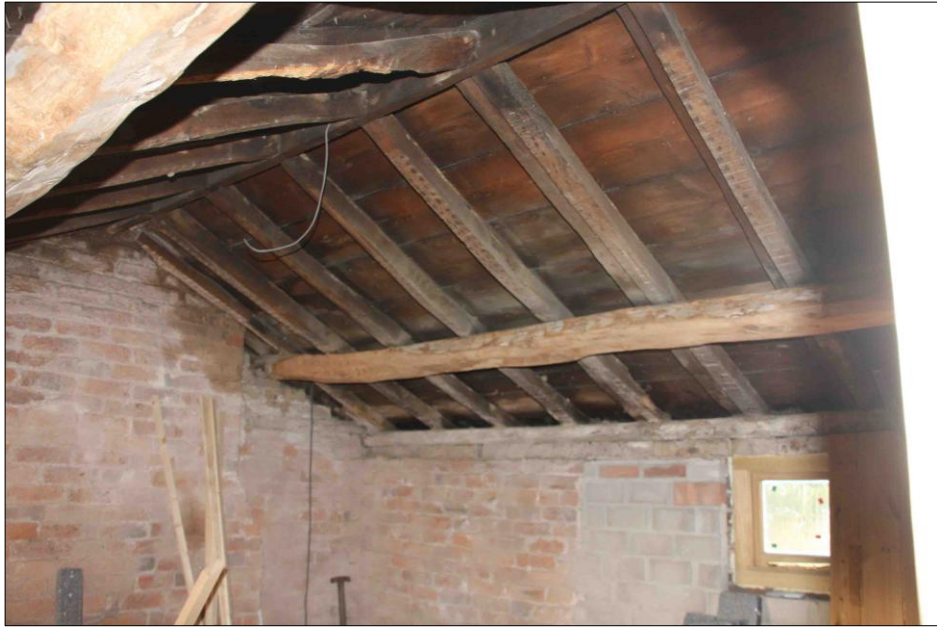
Figure 4.50: Detail of roof structure at No.15 Mill Street (source: author's own photo)

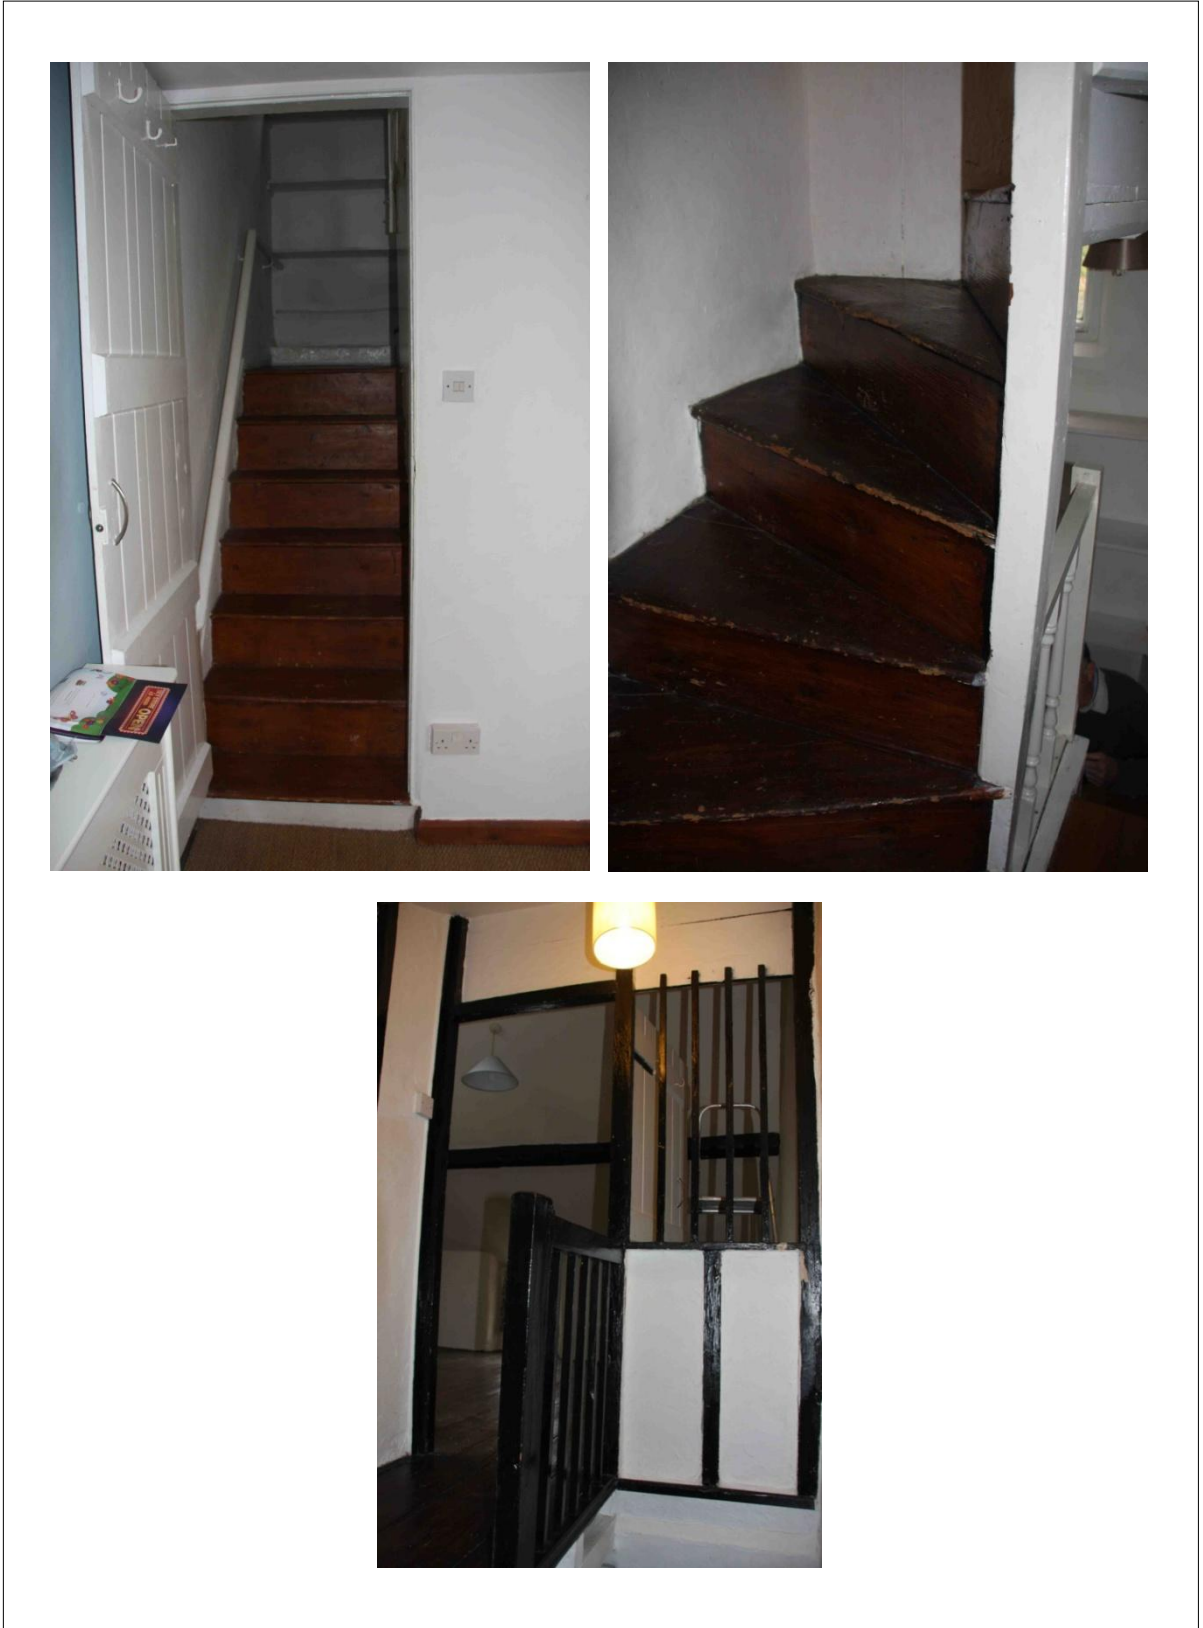
Figure 5.37: Staircase furniture of No. 12 Hopping Hill  
Top Left: Ground floor. Top Right: First Floor landing. Bottom: Second floor balustrade (source:  
author's own photos)

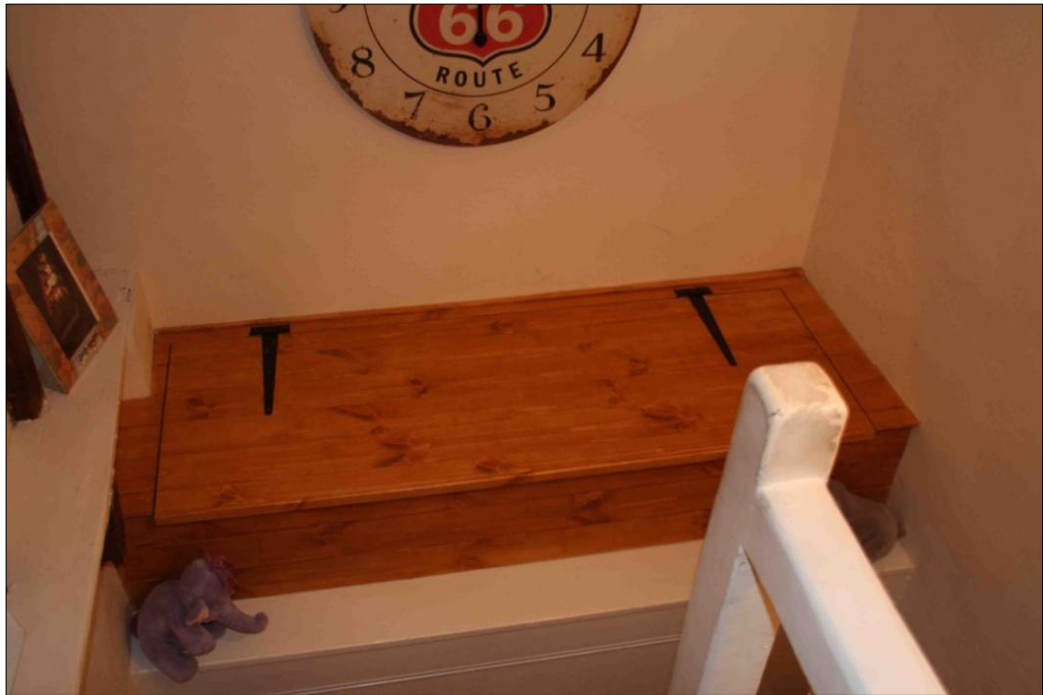
Figure 5.38: Timber box with modern replacement lid at the top of the staircase of *Plan 10* properties (source: author's own photos)

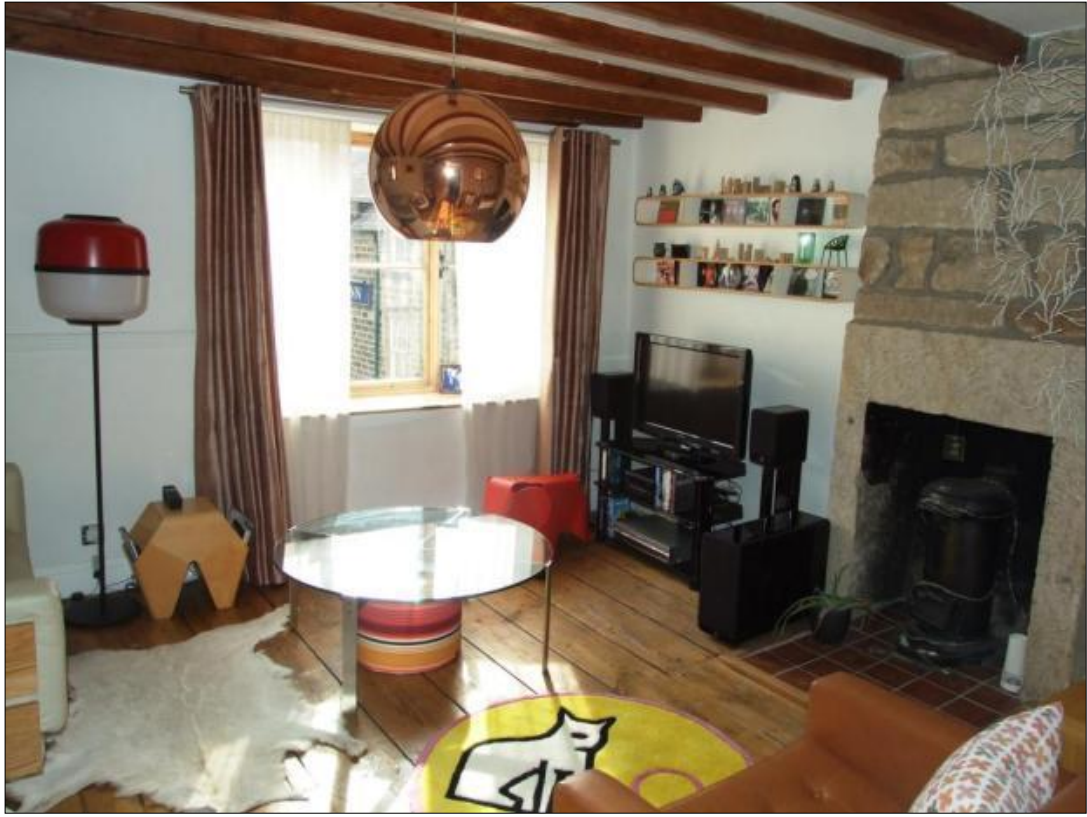
Figure 5.58: First floor fireplace at No. 37 Hopping Hill, note the soot patterns consistent with use of a hob-grate (source: author's own photo)
