Experimental Testing Procedures to Investigate and Improve Insulated Rail Joint Design and Life Cycle

Thesis Submitted for the degree of Doctor of Philosophy

Department of Mechanical Engineering

The University of Sheffield

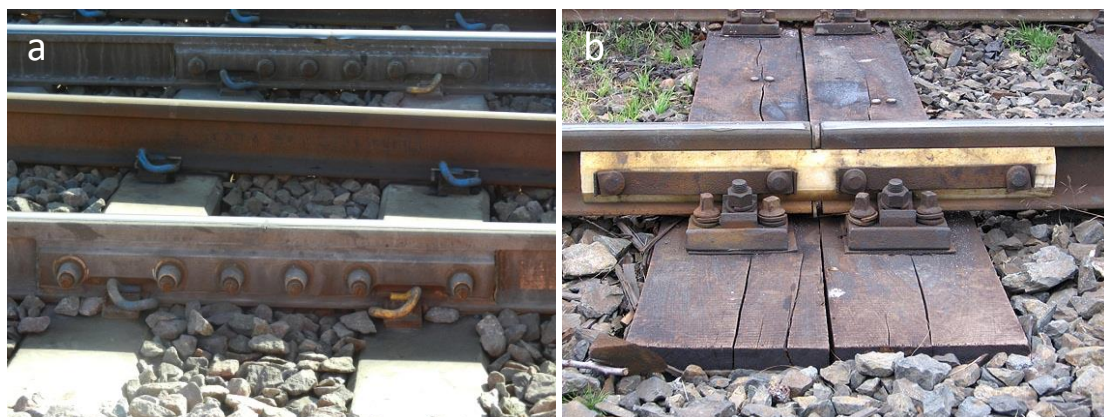
The design of the support system of a joint also varies in different railway systems around the world. The simplest way to alter the support system of the joint is by altering where the sleepers lie underneath the joint. Standard practice in the UK is to suspend the insulated joint between two sleepers that are spaced at standard intervals, this allows automated maintenance practices to still be used around the joint. A supported joint can be created by placing the middle of the joint over a sleeper, or sometimes over two sleepers that are fastened together. This aims to give the joint more support, however, it disrupts the use of automated maintenance as sleepers are not distributed normally. This also alters the track stiffness which will affect other components and possibly lead to failures or degradation elsewhere in the system. The difference between these types of support situation can be seen in Figure 5.

Figure 5: Images showing a suspended joint (a) and a joint supported with two sleepers under the centre of the joint (b) (4)

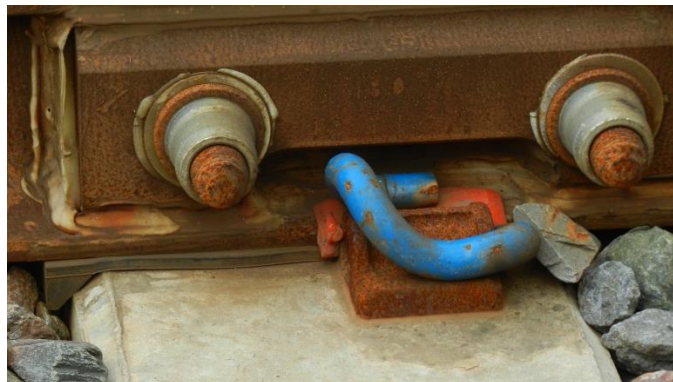
IBJs were originally manufactured with four bolts to secure the fishplates into the rail, to keep the designs in line with non-insulating fishplates which have been around much longer and generally are of a four bolt design. To increase the stiffness and durability of joints longer fishplates were introduced that have six fasteners. The increase in length means that fishplates no longer fit in the gap between sleepers and therefore six hole plates have to provide space for the rail fastening system. An example of how this is achieved can be seen in Figure 9. Some joints are now designed with even longer fishplates requiring eight fasteners. A problem with this increase in length is the increase in cost of the IBJ where these spaces need to be provided, this also limits where the IBJ can be placed.

Figure 9: A six hole fishplate with material removed to allow fitment of the fastening system, in this case a Pandrol 'e-clip'

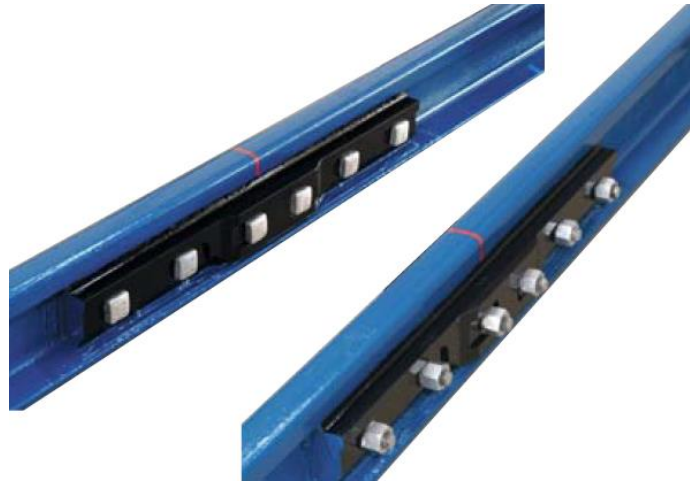
Fishplates have been designed that have an increased cross section in their centre, therefore increasing the stiffness of the joint where it is most vulnerable. An example of this type of fishplate can be seen in Figure 10. This also increases the cost of the IBJ as a fishplate that is not uniform in cross section cannot be manufactured by standard rolling processes and has to be forged or machined which can be more expensive processes.

Figure 10: Fishplate strengthened in the centre to give higher modulus and reduced deflection (9)

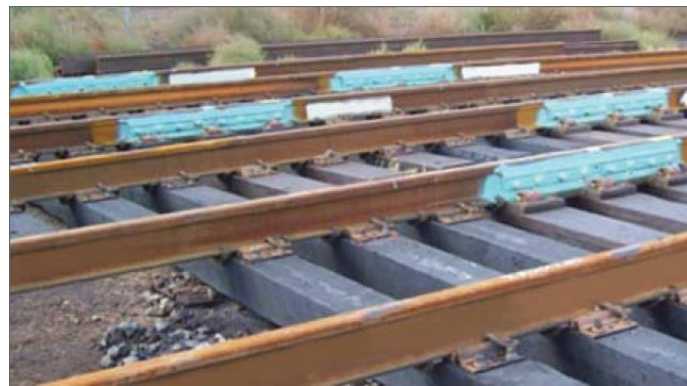
In an attempt to eradicate failure by contamination at the foot of the rail and electrical failure due to material build up between the joined rails, a few different methods are now employed. An endpost with specially designed lips and covers which increases the distance of the tracking path is sometimes used in the UK (14). UK railways including London Underground have tried to tackle the issue by increasing the endpost thickness, again in order to increase the distance between the two rail ends. Standard UK endposts are 6mm in thickness and endposts up to 12mm have been installed (15). The technique employed by LB Foster in the USA is to fully coat the joint in paint after installation which can be seen in Figure 12. This works for a new IBJ but paint can easily be worn away on the bottom of the joint by contact and abrasion by the ballast underneath.

Figure 12: Installed IBJs painted to stop failure by contamination (16)

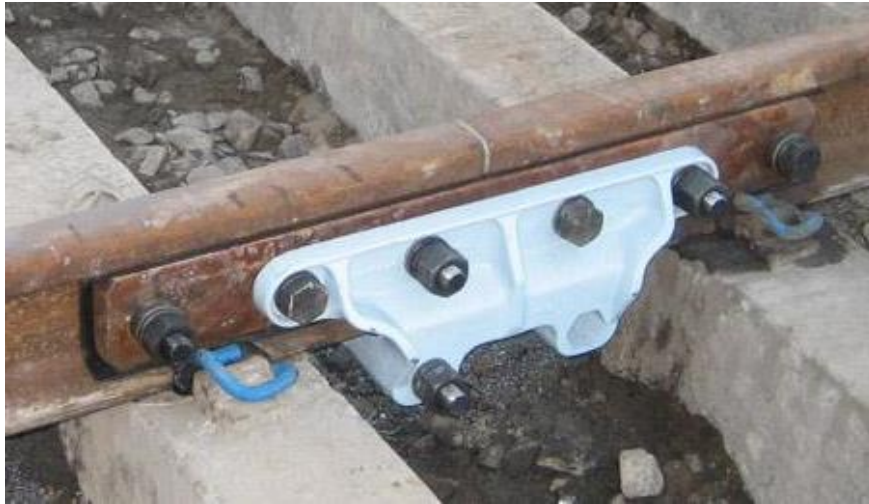
To improve the joint stiffness additional products have been used to supplement the IBJ, the 'Hercules' joint (17) is an example of this and can be seen in Figure 13. This type of product increases the section modulus of the joint and increases the stiffness to try to stop the joint being a weak point in the track. This type of design, however, cannot be used in every location due to its size and the fact that it may obstruct sleeper placement. It can also lead to an increased risk of electrical failure due to contamination build up or insulation failure as there is a higher area of insulated surface.

Figure 13: 'Hercules' insulated rail joint support plates (17)

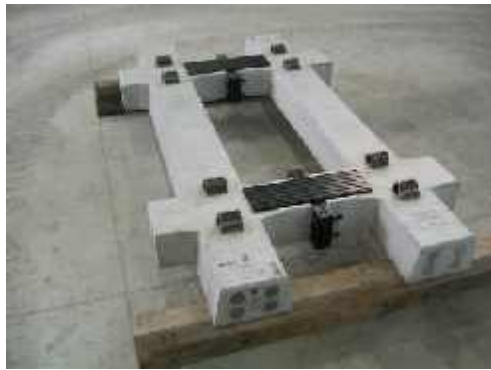
method was making sure that the concrete used to join the sleepers does not crack as it is exposed to the high dynamic forces imparted on the rail.

Figure 14: A joint supporting sleeper arrangement where two adjacent sleepers are fastened together (20)

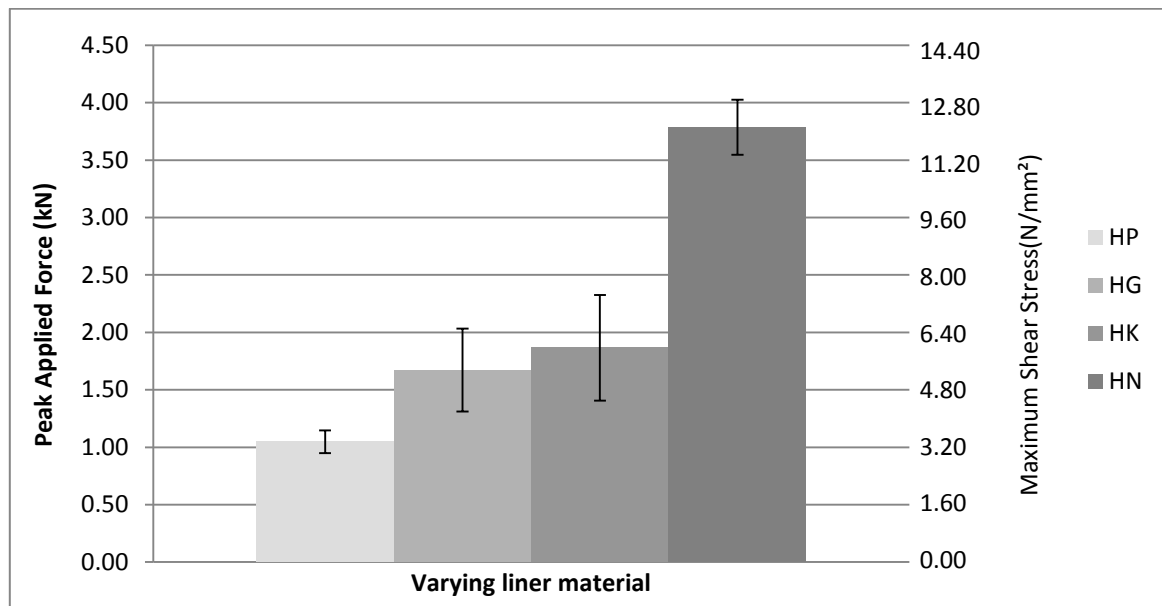
All four liner materials being tested were assembled into test specimens using one type of glue so that the liner could be assessed independently of the adhesive. The results of this can be seen in Figure 23, where the maximum applied force that could be held by the specimen is shown. The peak applied force directly relates to the shear strength of the samples due to the consistent bond area of each different sample. The spread of results is displayed in Figure 23 by the range bars.

Figure 23: Results of varying the insulating liner material with range of results displayed (all samples using Huntsman Araldite adhesive)

Figure 23 shows that the pultruded glass fibre liner (HP) performs worse than the flexible glass fibre and Kevlar liners (HG and HK) which show fairly similar results. It is thought that this is because the flexible liners allow the glue to impregnate the weave of the fabric resulting in a better bond than can be obtained using the smooth pultruded material. This is backed up by the images in Figure 24 which show that there is more de-bonding of the glue from the liner when using the pultruded liner than using the flexible glass fibre liner. In the case of the flexible glass fibre liner it can be seen that the de-bonding occurs solely at the interface between the glue and the steel. The use of no liner (HN) has dramatically improved the shear performance of the specimens, indicating that the insulating liner creates a weakness in the joint.

It is worth noting that the errors in the test set-up could be up to 0.25 kN, this represents the 0.005% accuracy of the 50 kN load cell used. This error value is not displayed on the graphs in Figure 23 or Figure 25.

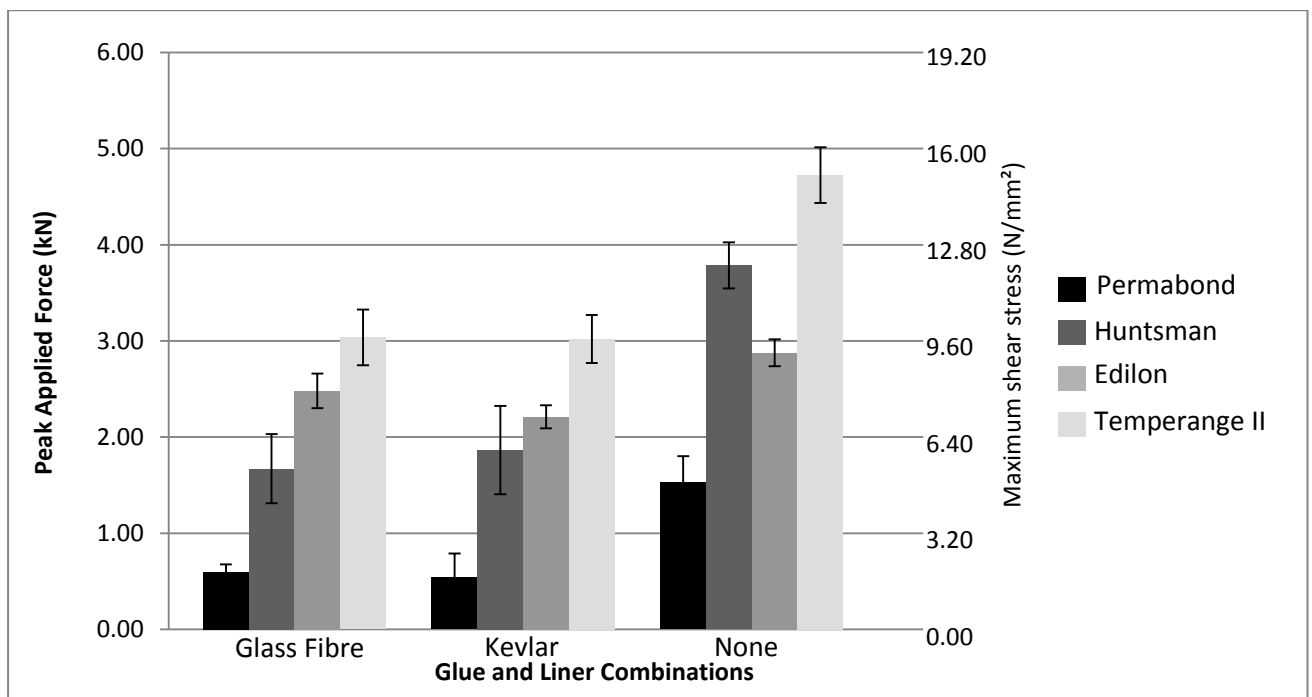
Changing the glue type also had a large effect on the performance of the test specimens. Figure 25 shows the performance of the four tested glues using flexible glass fibre, Kevlar and no liner. It can be seen that the Temperance II epoxy is the best in each situation. The Permabond adhesive displays the lowest strength in each situation and the Edilon and Huntsman glues are between these two. As confirmed in chapter 5.2.1 the lack of an insulating liner provides a specimen that has the best strength and the flexible glass fibre and Kevlar liners show a similar performance.

Figure 25: Results of varying the glue type used in the test specimens with the range of results displayed

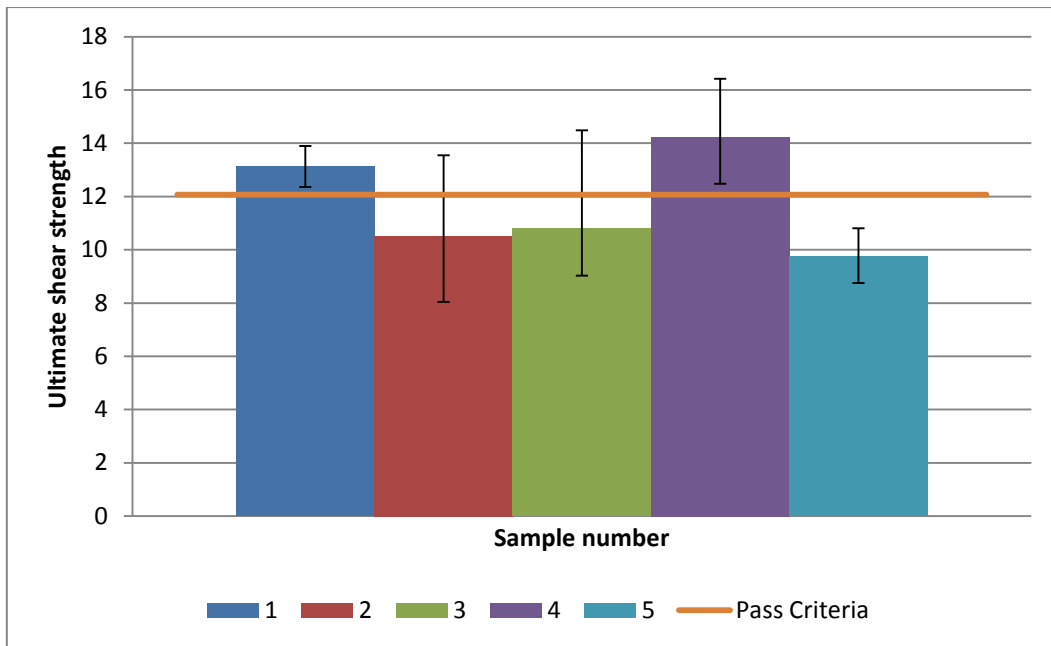
Figure 32: Bar chart showing average performance for each joint design with error bars to display the distribution of results of each set of test pieces

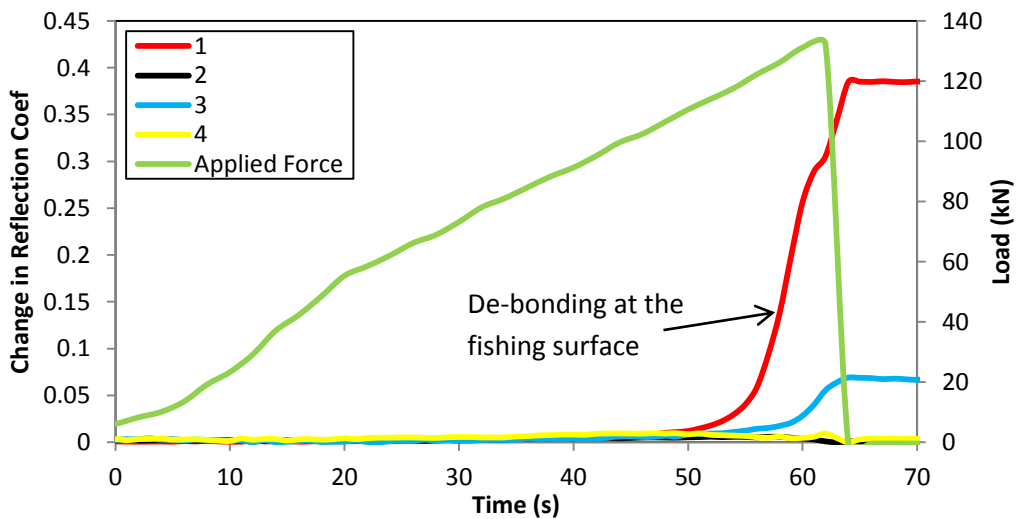
Figure 35: Plot showing ultrasonic and force data for standard UK IBJ design sample.

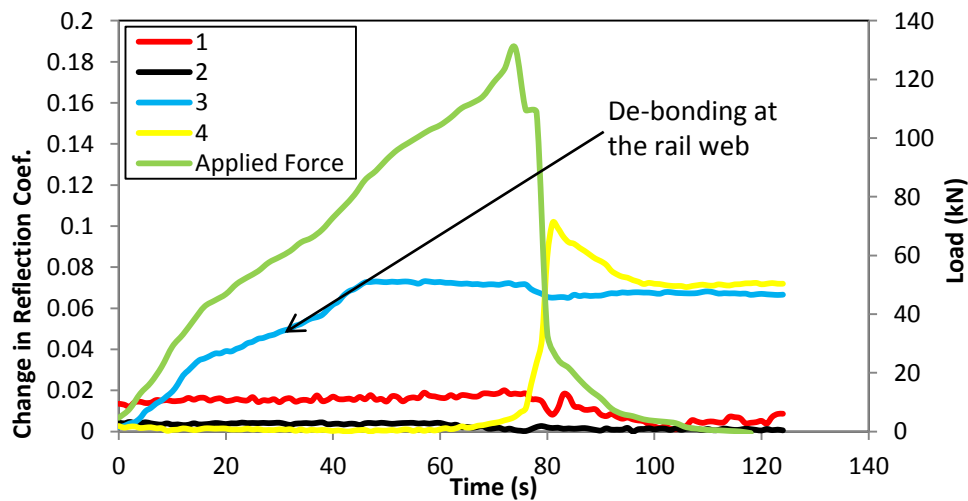
Figure 42: Plot showing ultrasonic and force data for a Kevlar full fit IBJ design

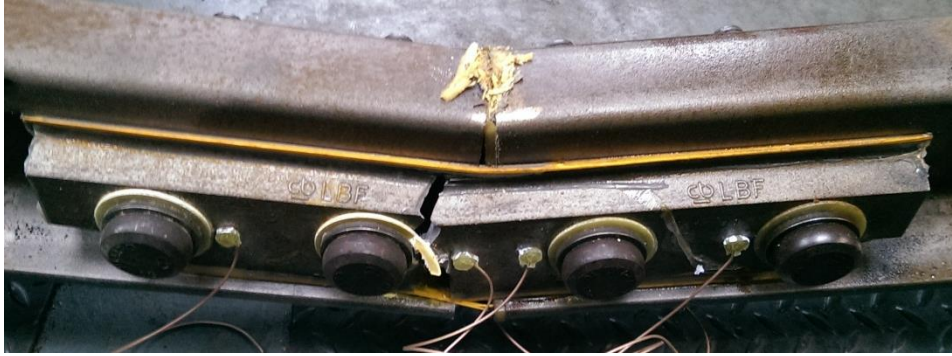
Figure 79: Failure of the standard IBJ due to fishplate failure

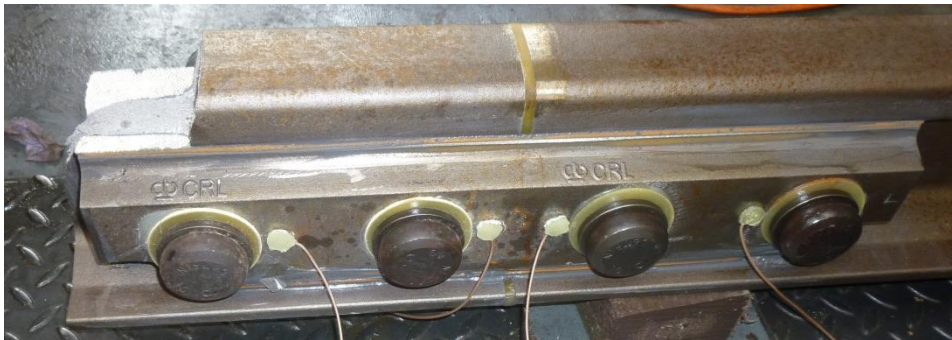
Figure 80: Failure of the full fit IBJ due to a failure of the rail

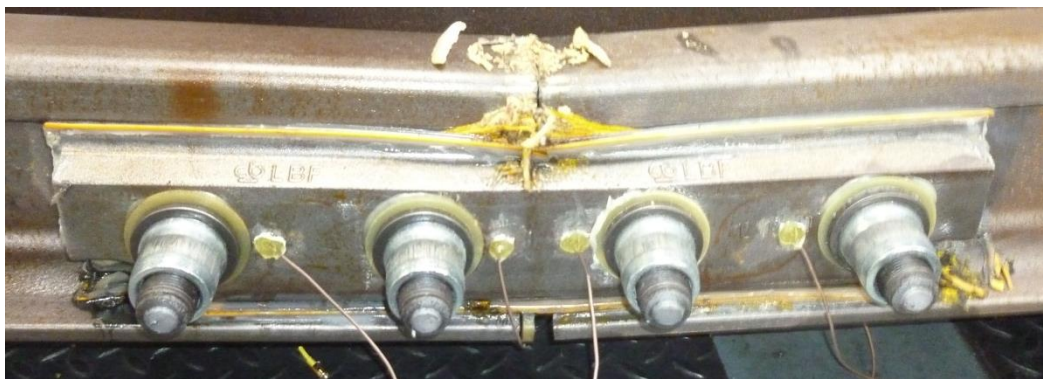
Figure 82: Fishplate of standard rail joint that did not fail due to cracking
