Field Investigation of Discolouration Material Accumulation Rates in Live Drinking Water Distribution Systems

This thesis is submitted in part fulfilment of the degree of
Doctor of Philosophy in the Faculty of Engineering

The University of Sheffield
Department of Civil and Structural Engineering
November 2007

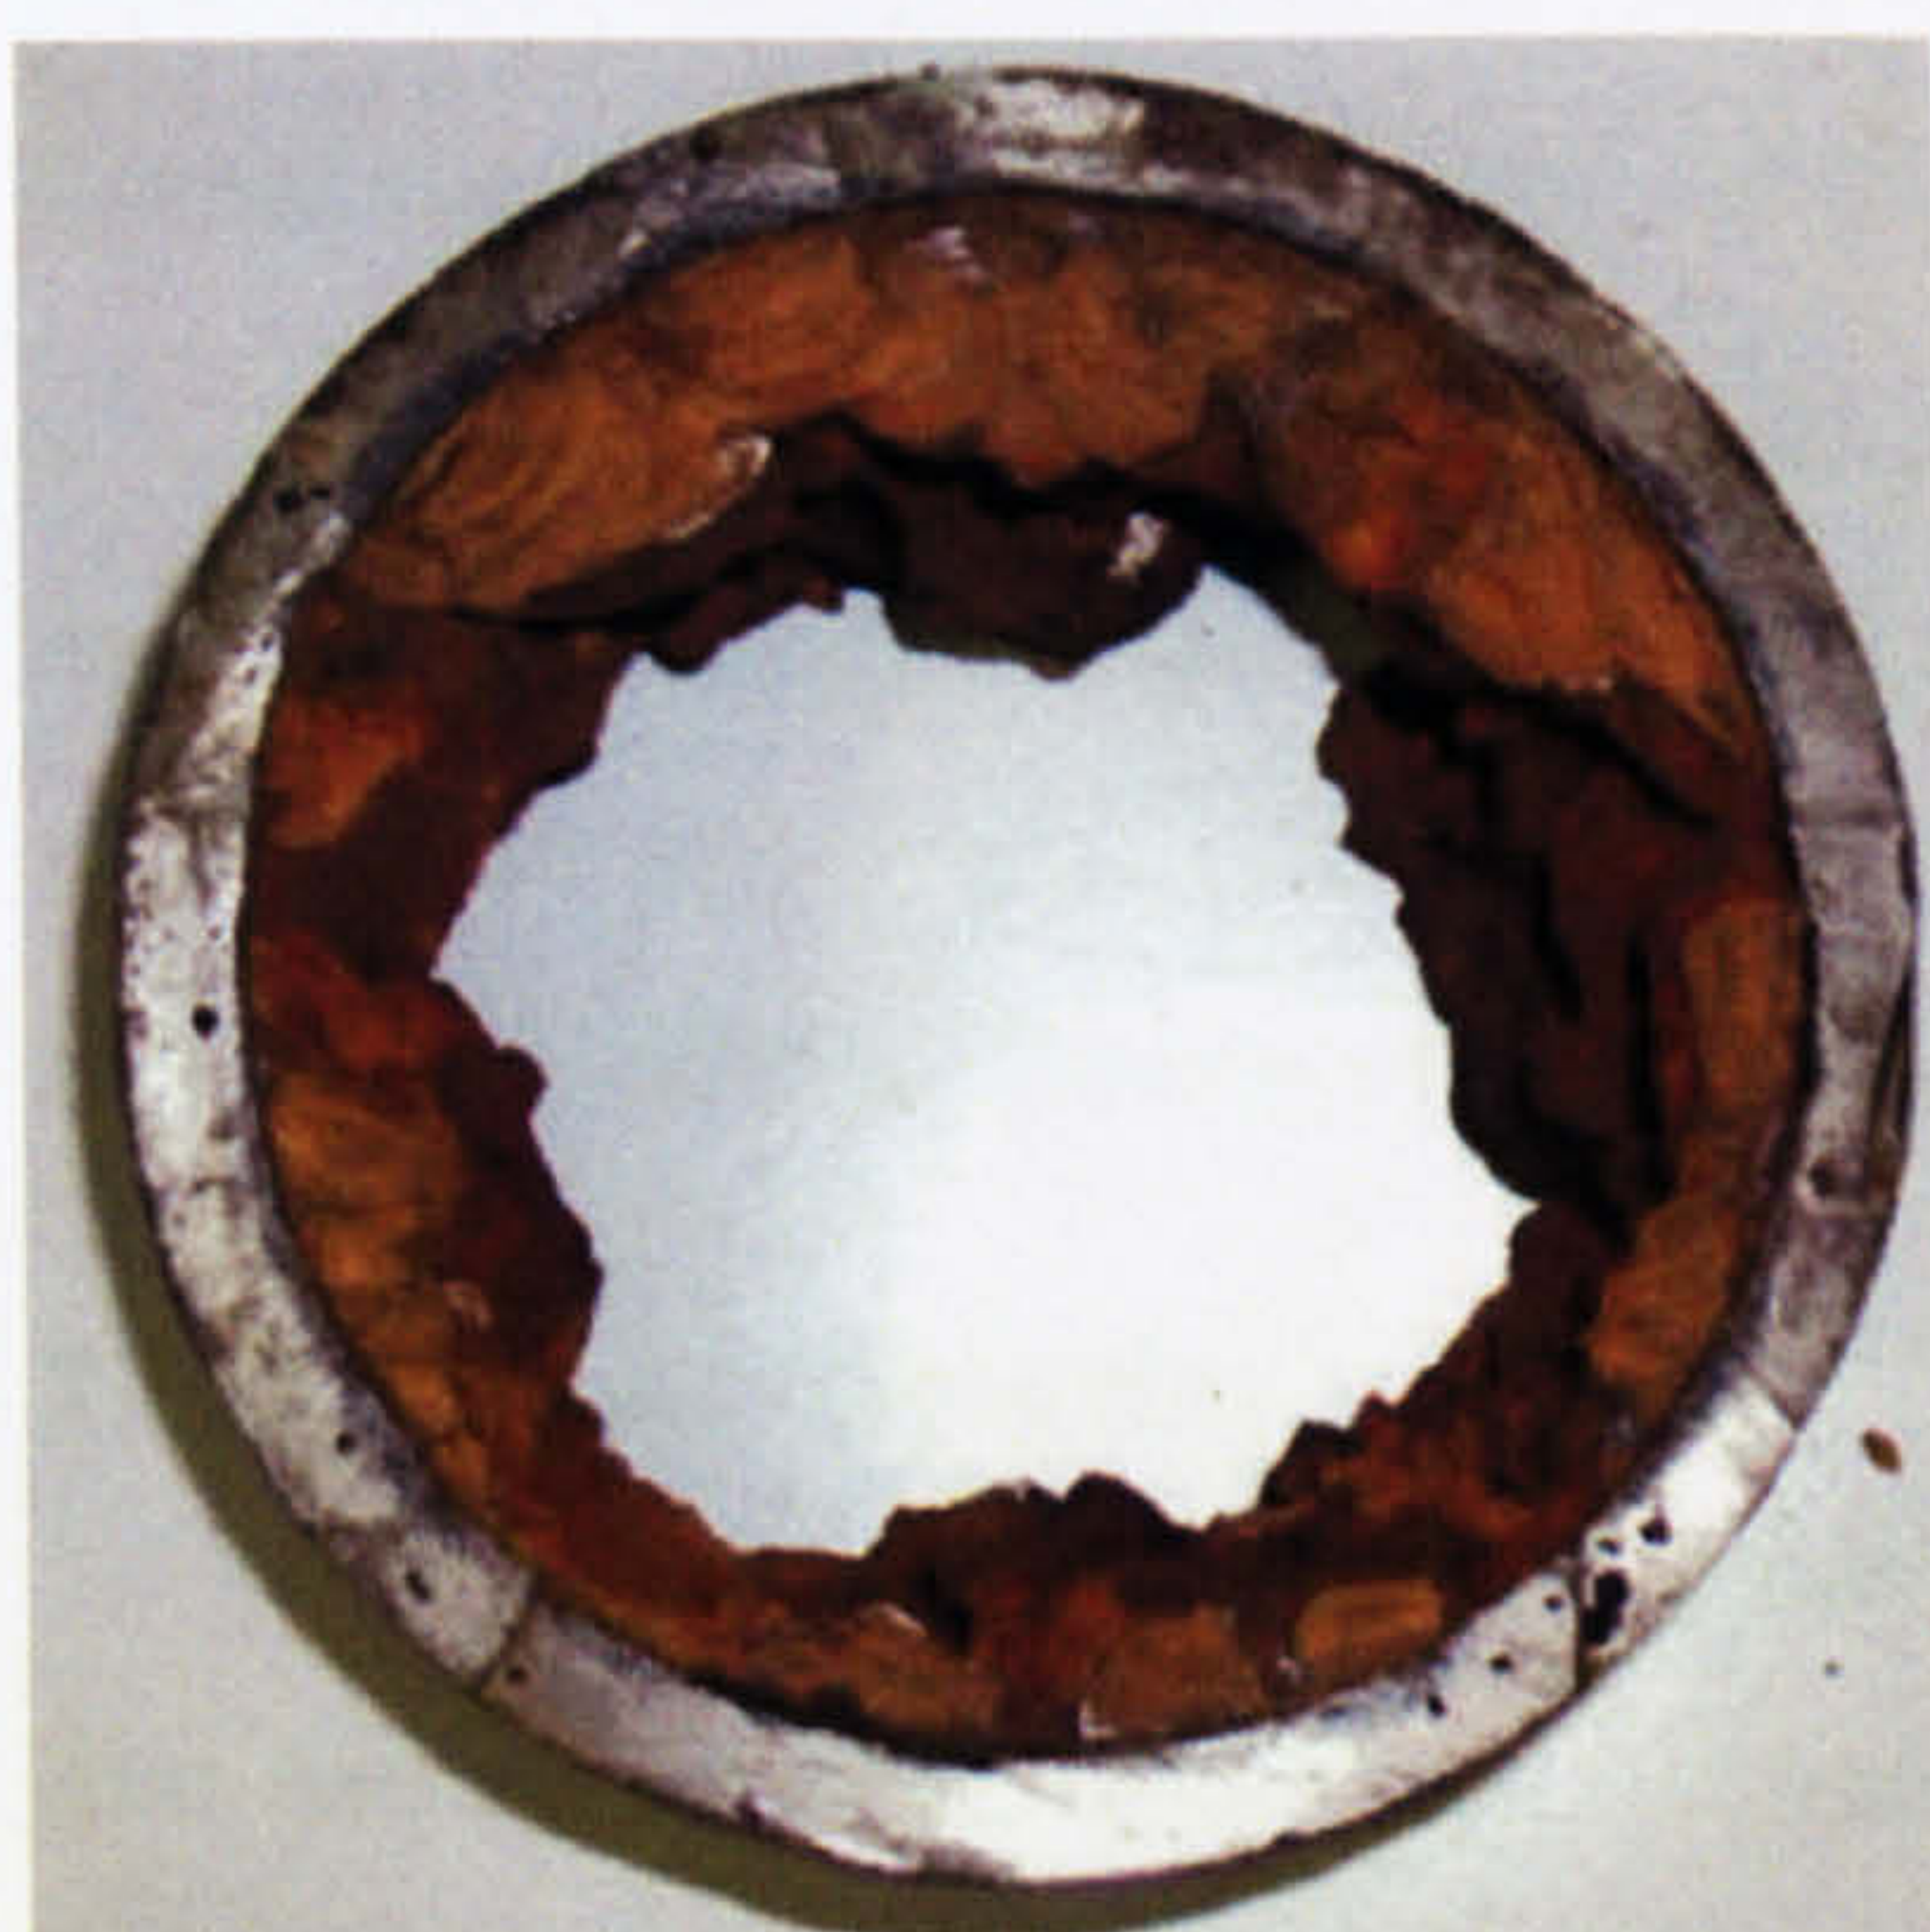
Figure 3 Iron corrosion in a 6' cast iron water main. (www.corrosion-doctors.org)

As water travels through the distribution network, water quality changes occur. This may be a result of water interactions with the pipe wall or due to chemical processes such as flocculation and precipitation (Seth et al. 2003). Manganese precipitates have often been found in pipe samples (Sly et al. 1990). Of importance are particles that result from the corrosion of iron pipes. Figure 3 shows typical corrosion tubercles found in unlined cast iron water mains in the UK which can lead to reduced hydraulic capacity. Sarin et al. (2004) characterises typical corrosion and tubercle formation seen in Figure 3 with the schematic depicted in Figure 4.

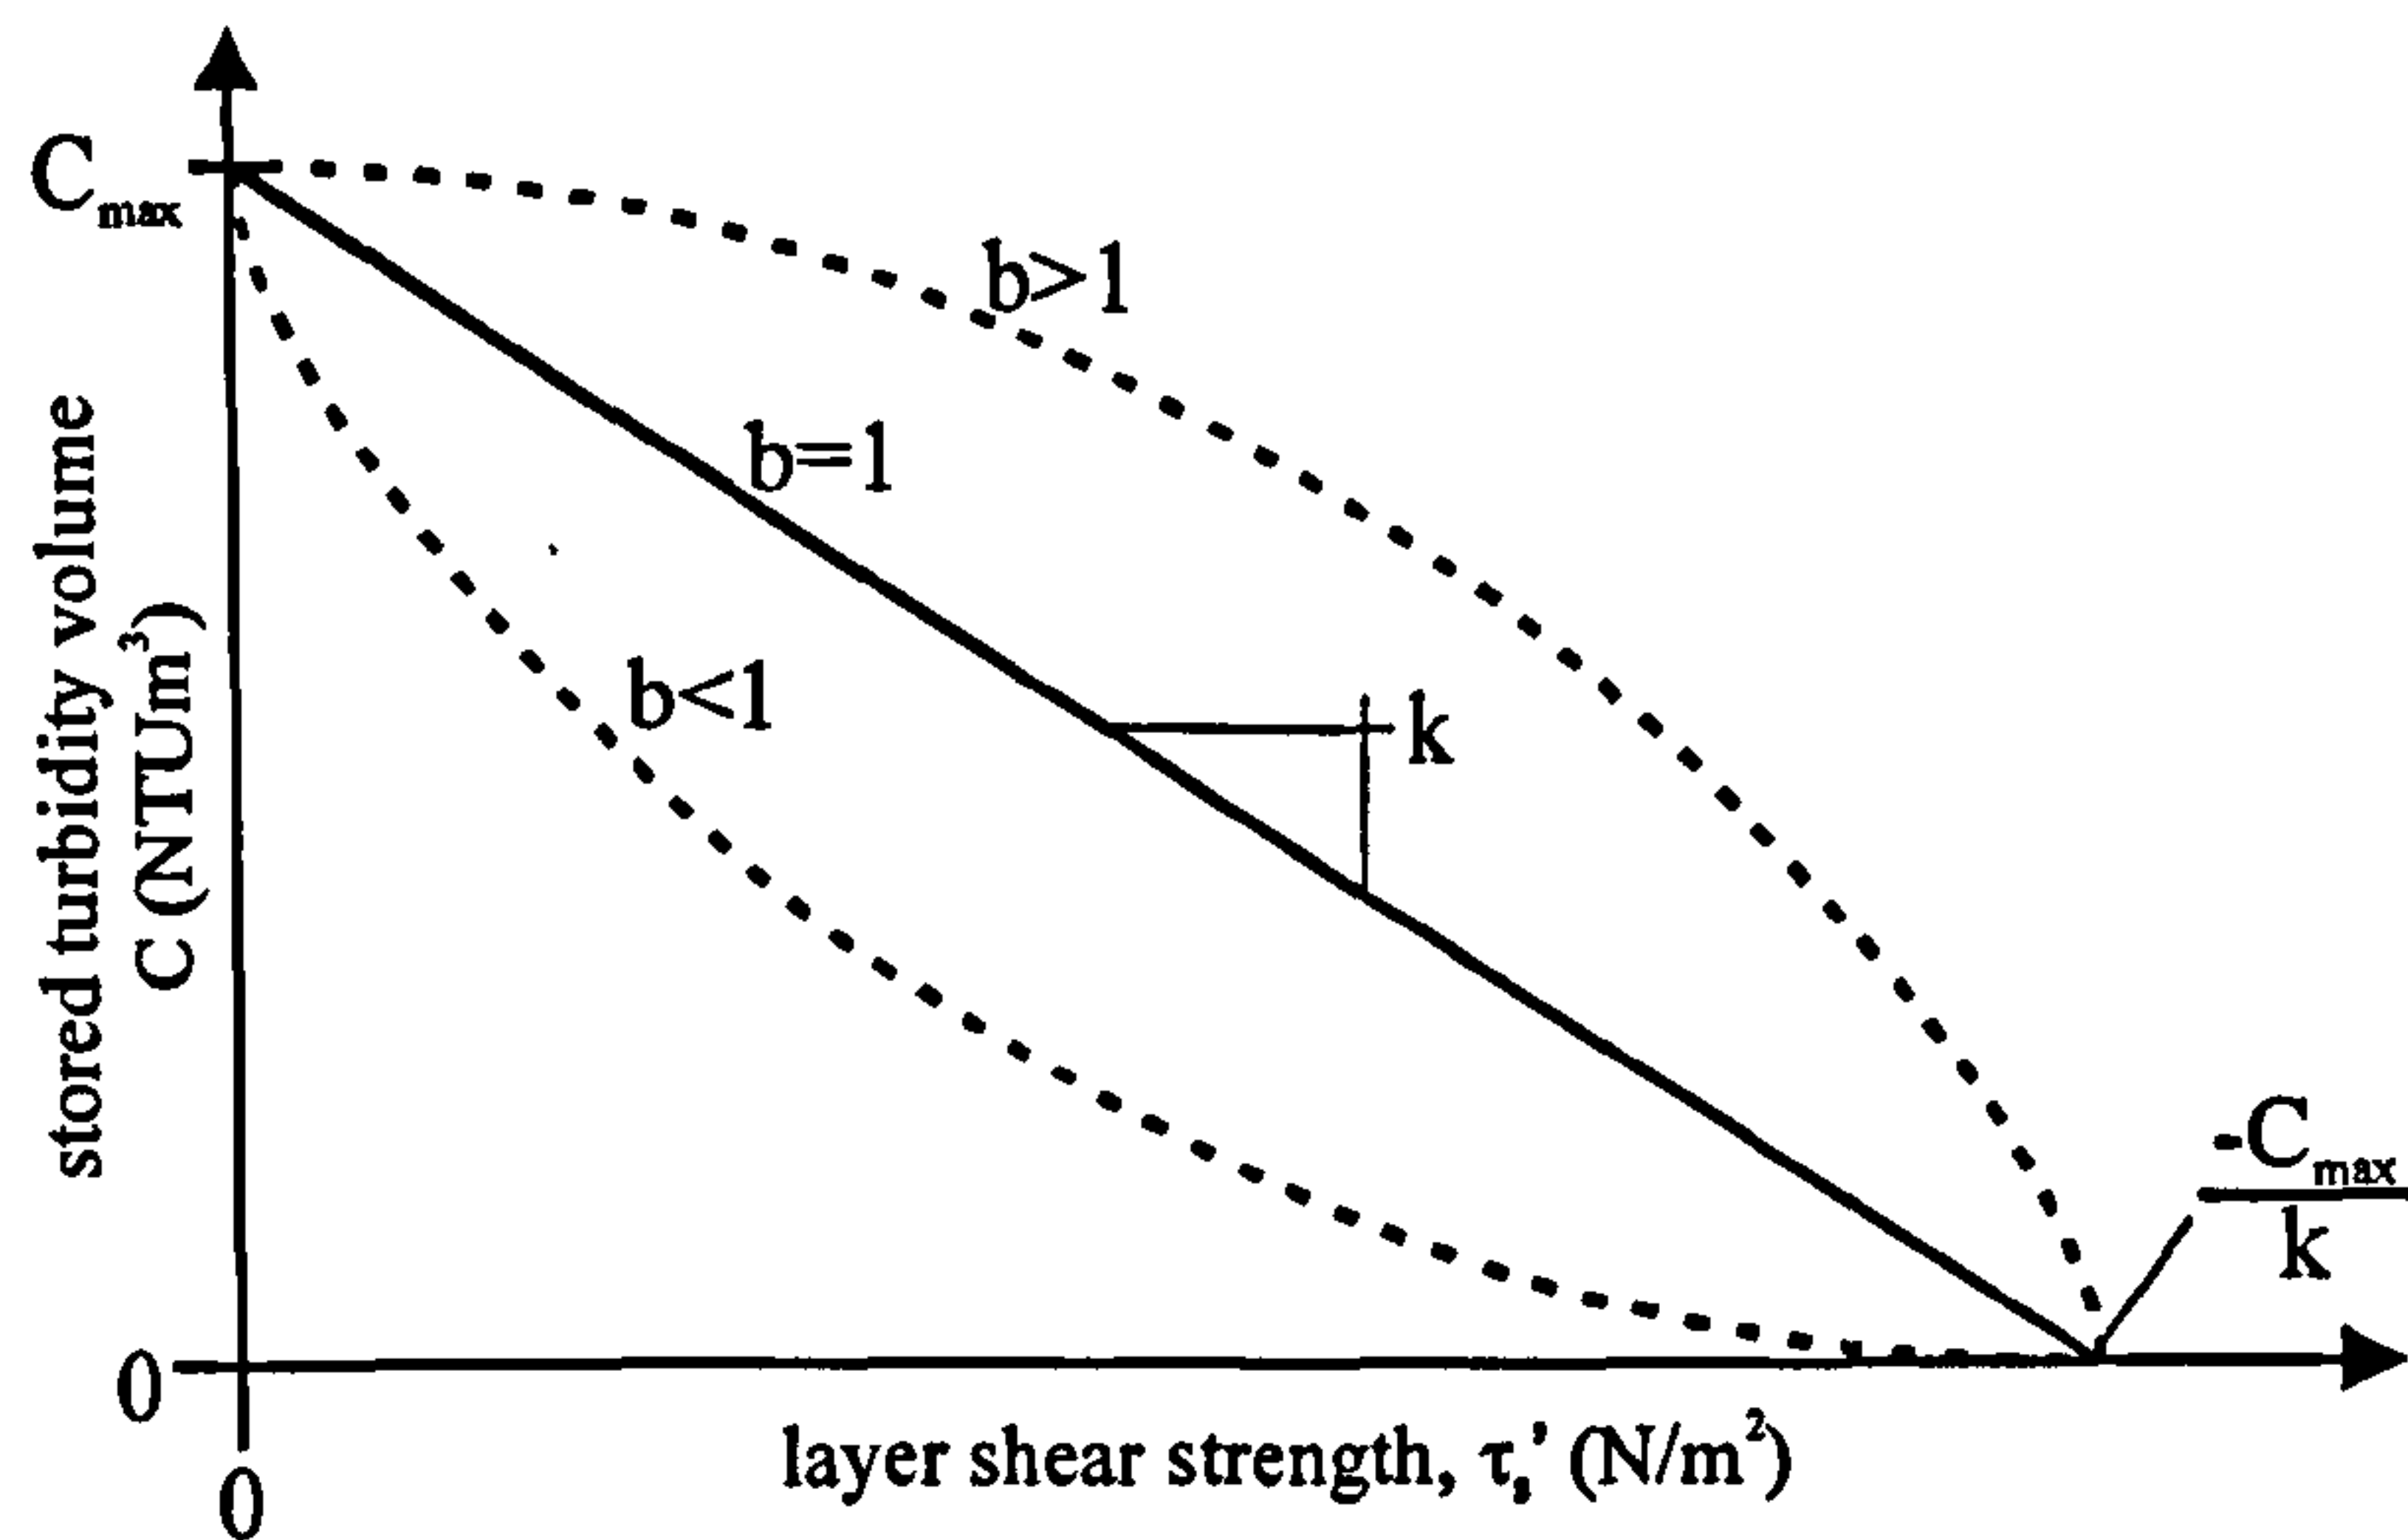
Figure 9 Representation of layer strength versus stored turbidity volume (Boxall et al. 2001).

This relationship between stored turbidity and layer strength is represented in figure 3, which demonstrates the influence of the gradient k and the power term b .

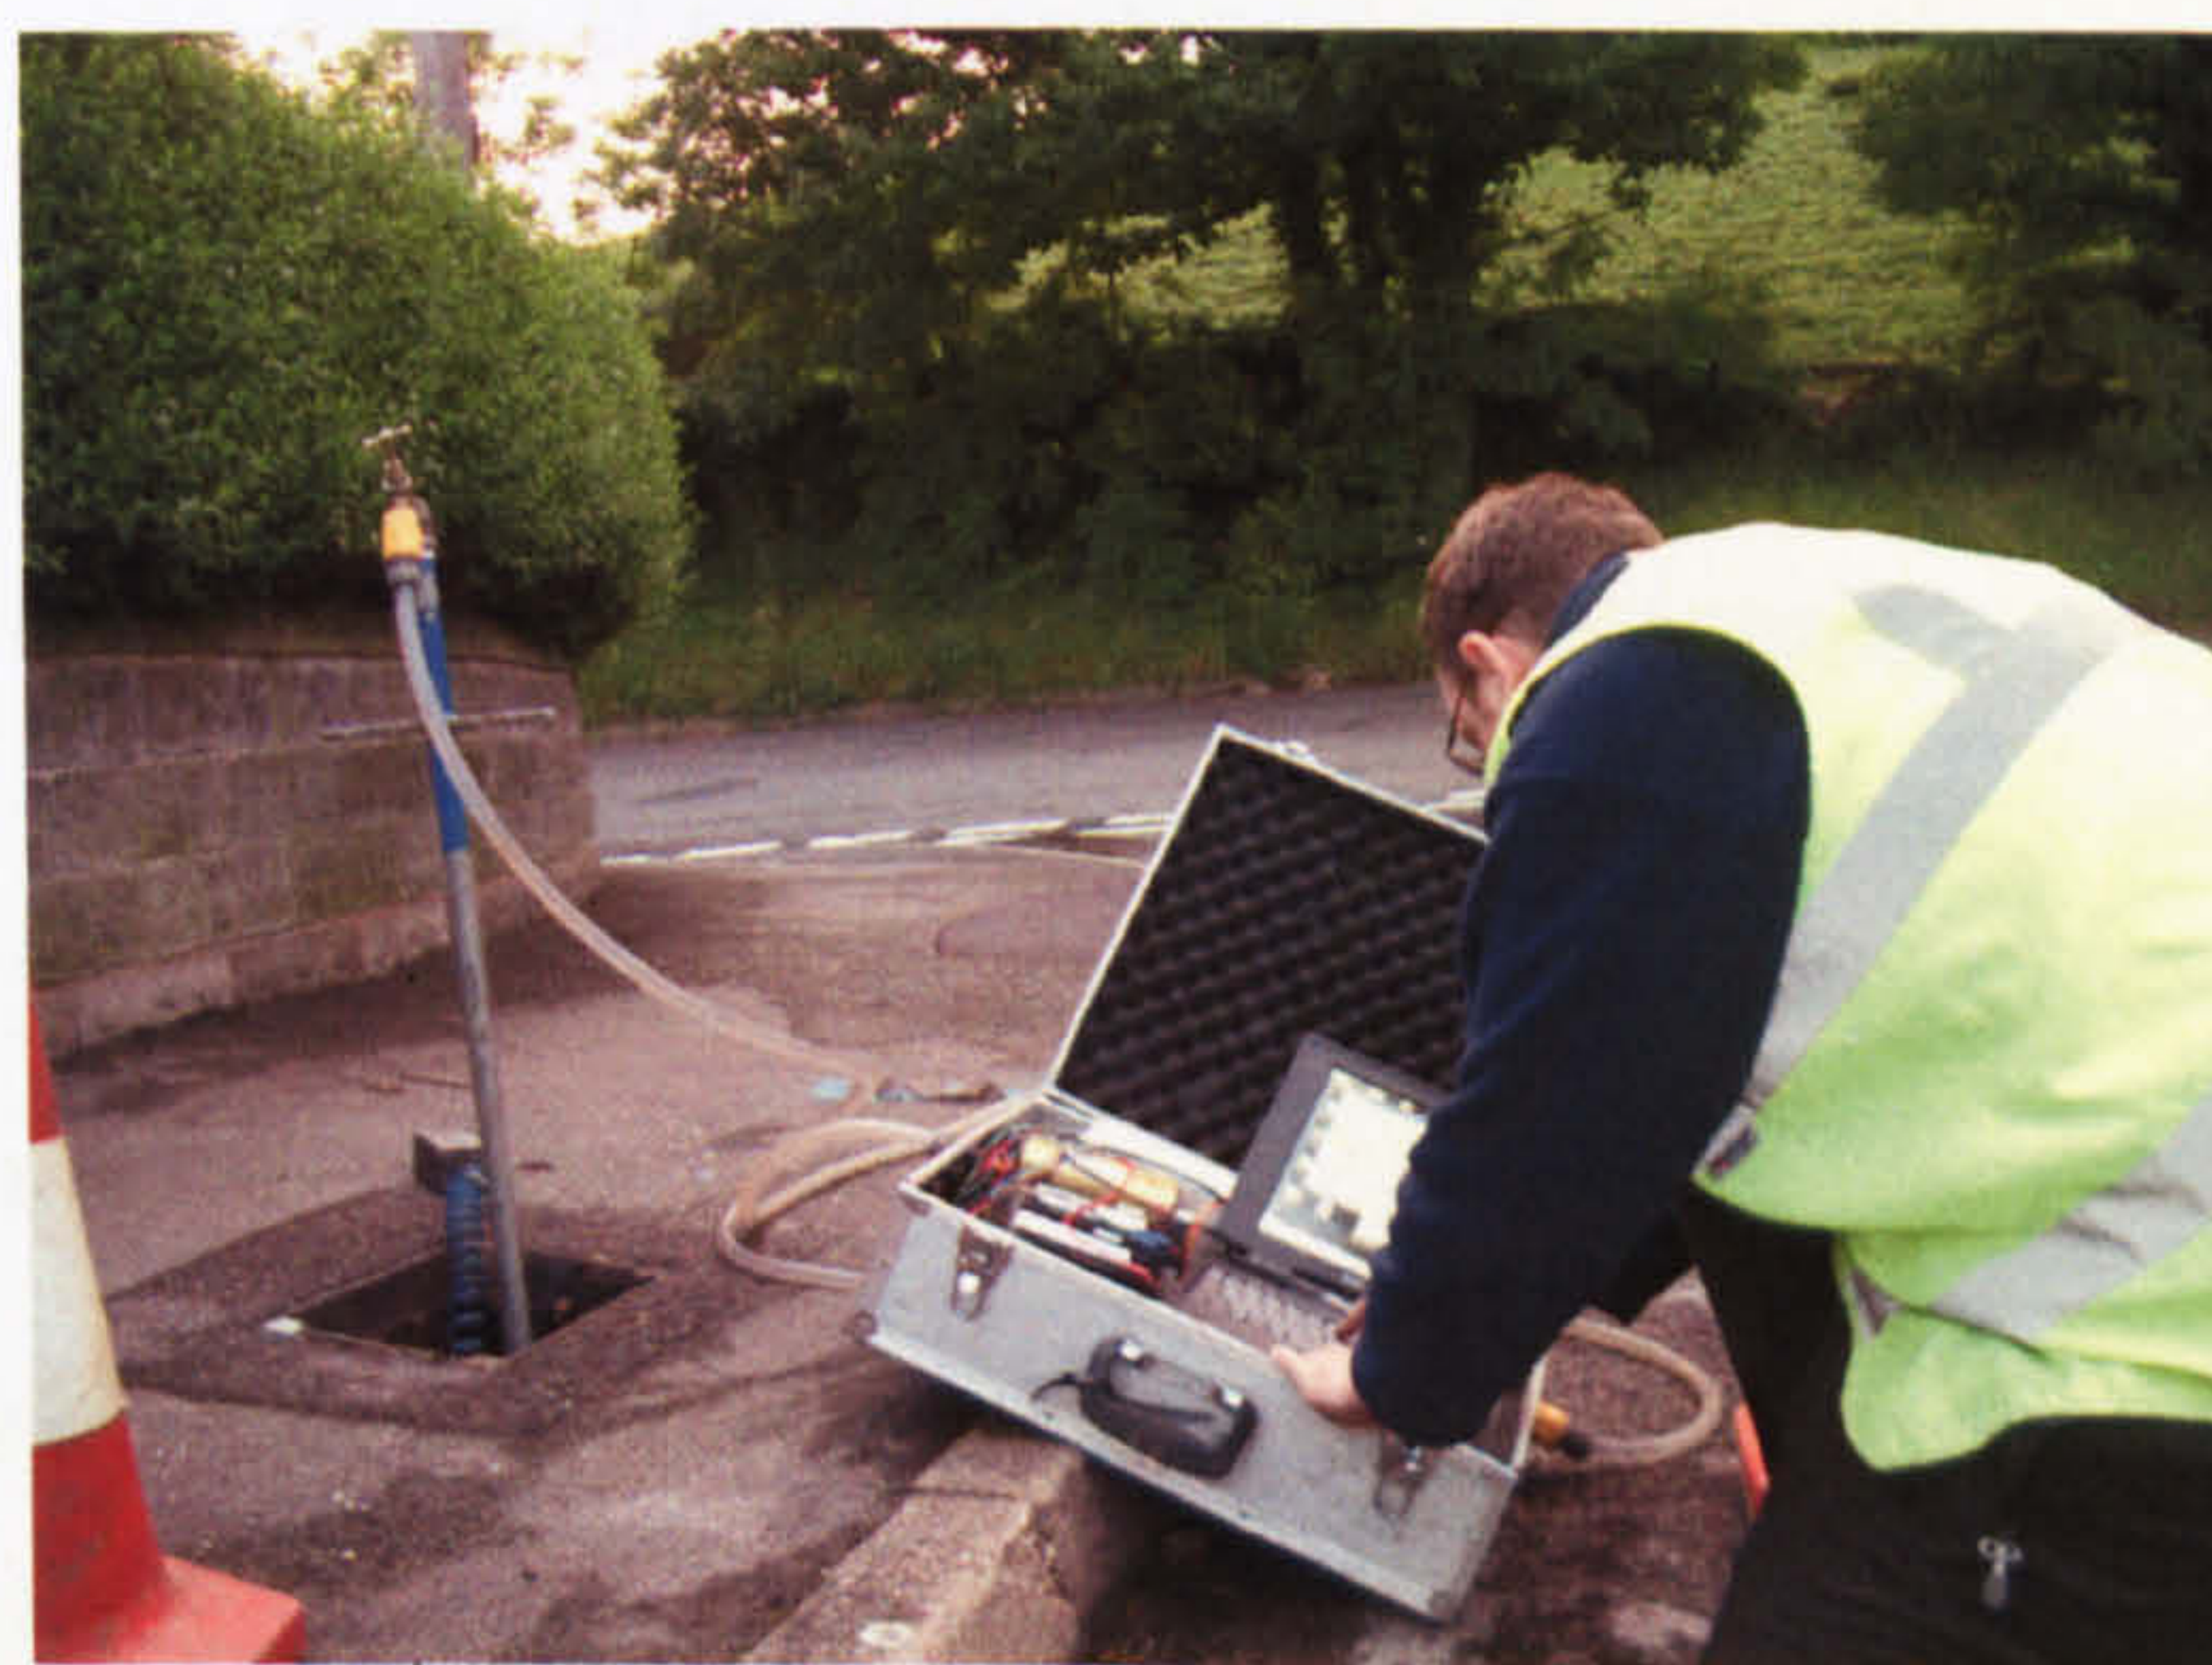
Figure 41 Intermediate monitoring location setup.

and the main was not flushed. Any water that collected in the hydrant was then allowed to drain away and the standpipe was then screwed onto the hydrant. A pressure logger recording at 1 minute intervals was connected to the nipple at the base of the standpipe. Hoses were then connected from the standpipe to the inlet of the aluminium case and the outlet to drain. Ensuring that the valves around the flow cell and the brass tap were closed the hydrant was then opened by a few turns. The brass tap was then opened slightly. In order to reduce air bubbles in the flow cell the upstream valve was fully opened before the downstream valve. The downstream side of the box could also be elevated on the kerb or hydrant lid to allow the bubbles to escape. Increasing the flow through the cell and opening and closing the downstream cell valve was effective in removing any persistent bubbles. Flow was adjusted with the brass tap to ensure that there would be water constantly flowing through the cell, even when the pressure dropped during flushing. The laptop was then turned on and the logger set to record calibration mode using 'Talk Sense' which enabled 11 second sampling. The screen on the laptop was then turned off to preserve battery life and the aluminium case was closed. Cones were then placed around the equipment to warn pedestrians and vehicles, Figure 41.

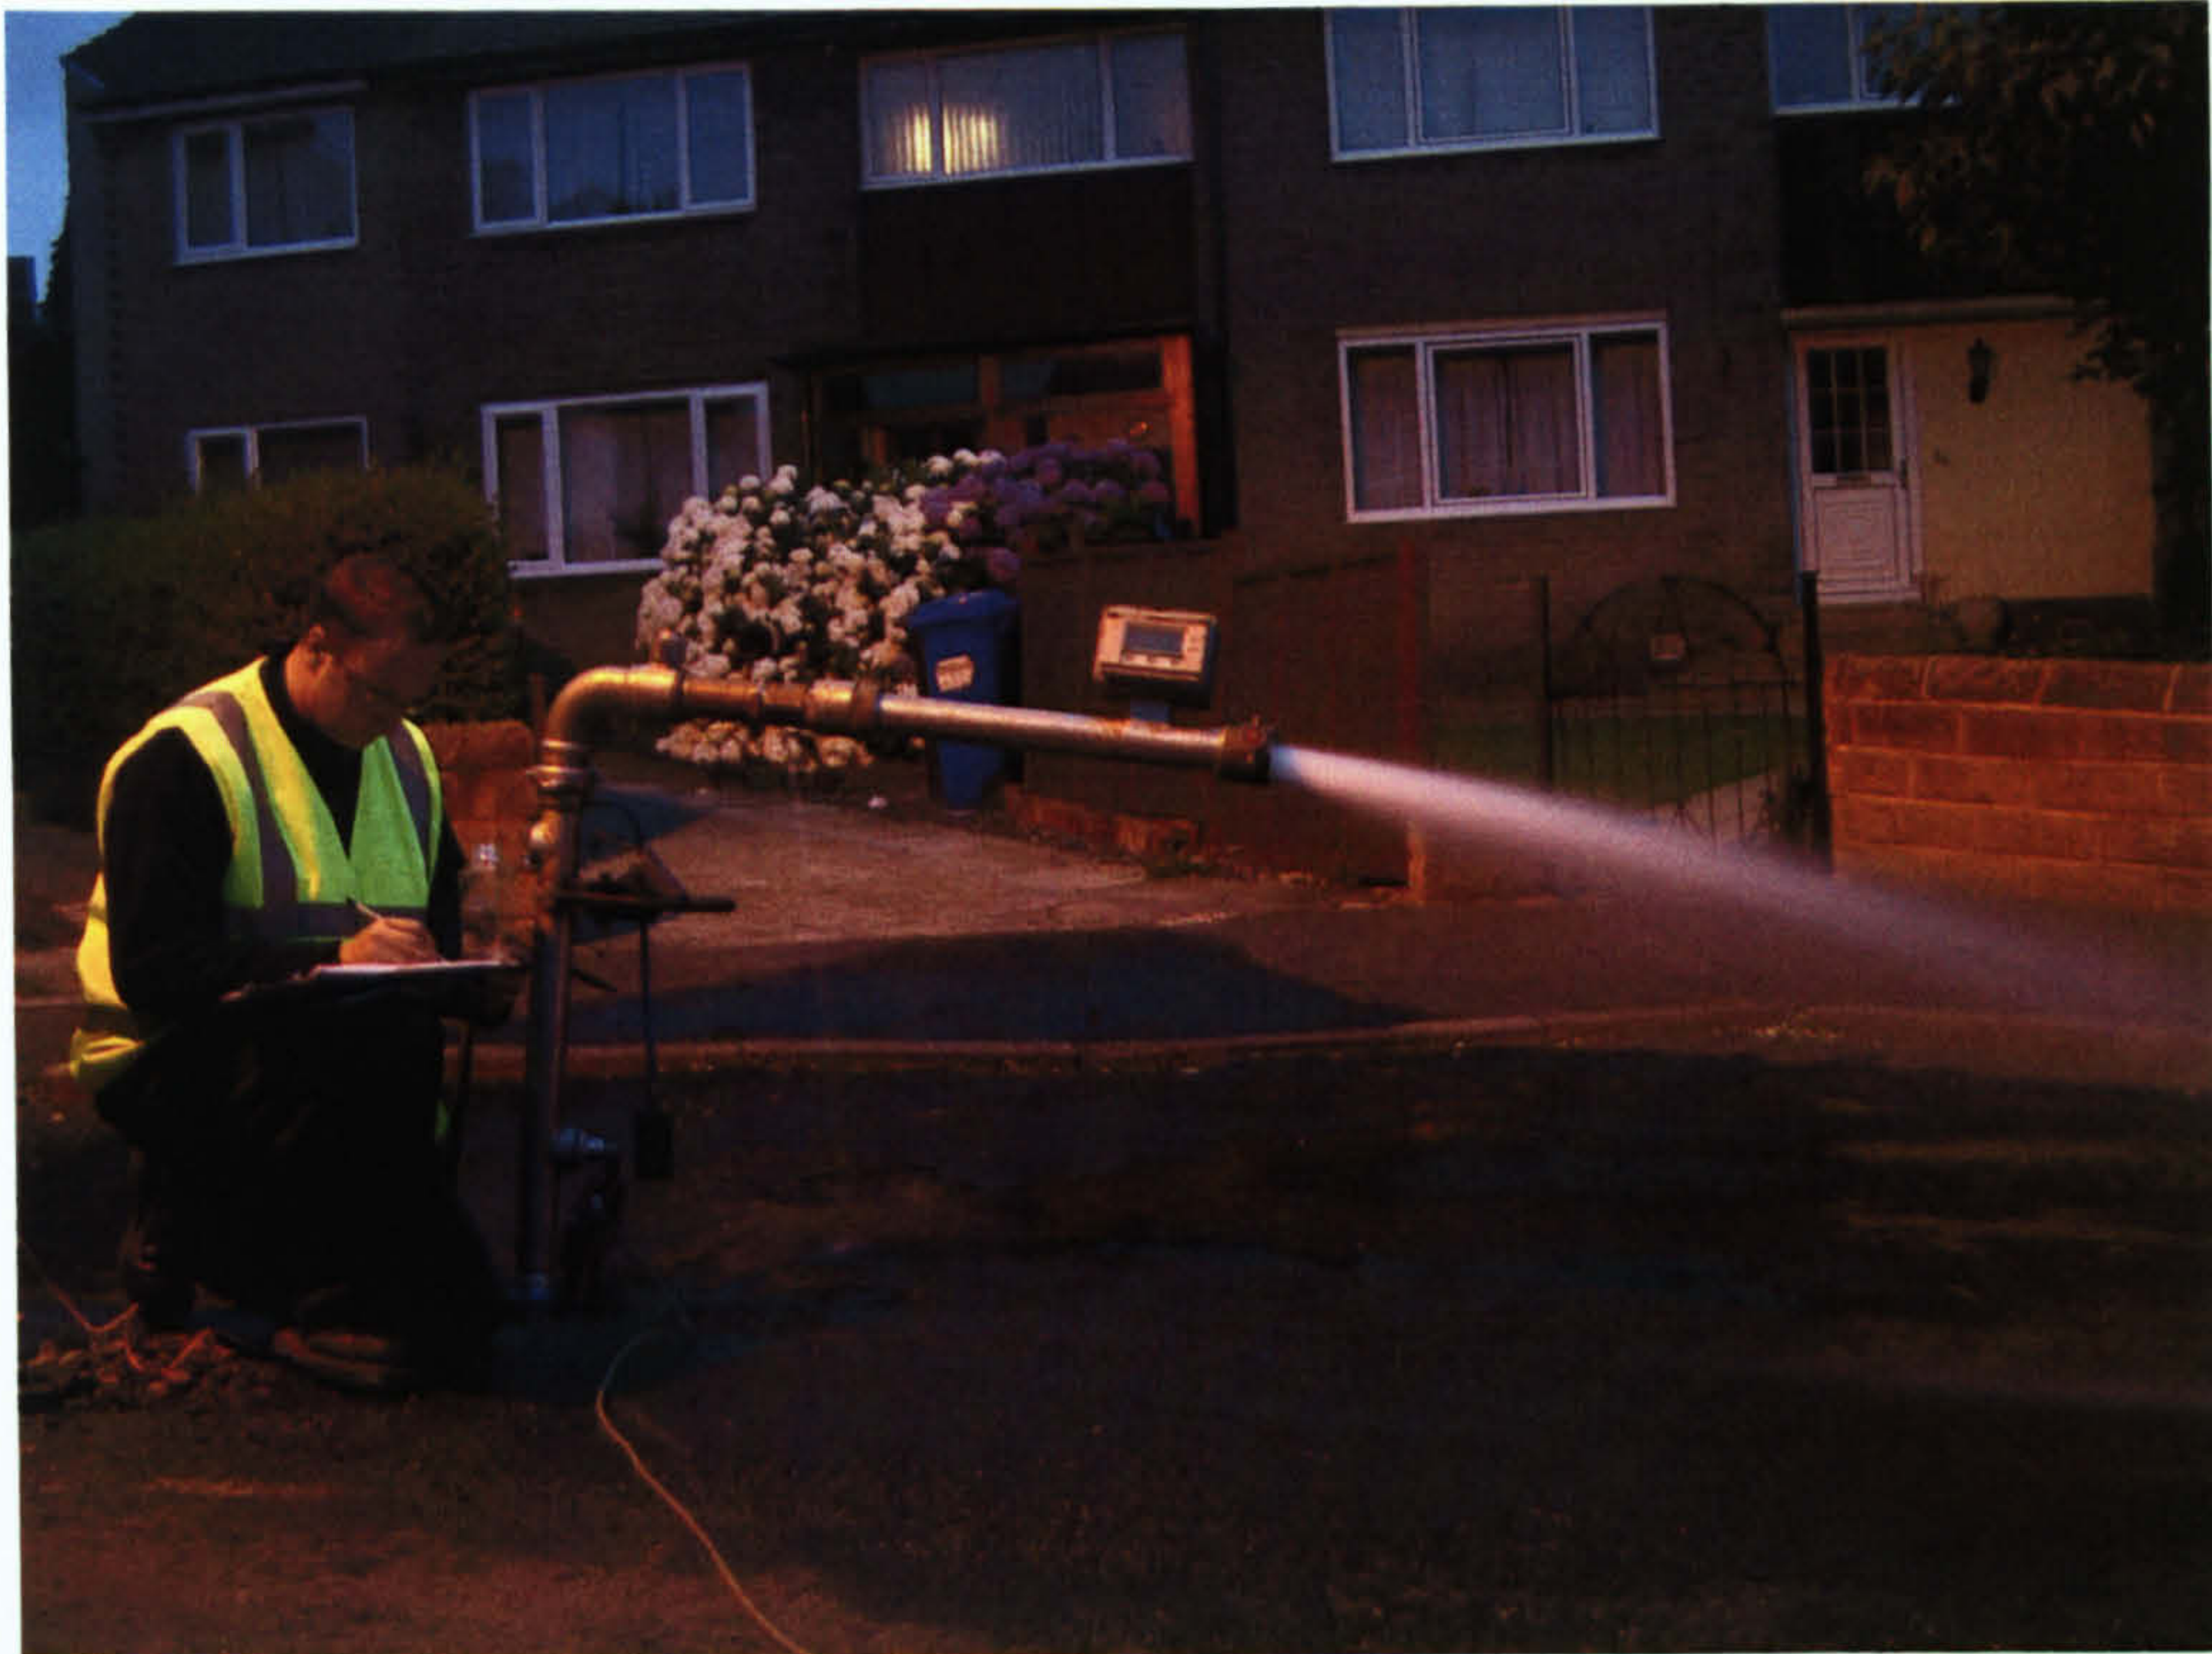
Figure 42 Flushing setup normal operation.

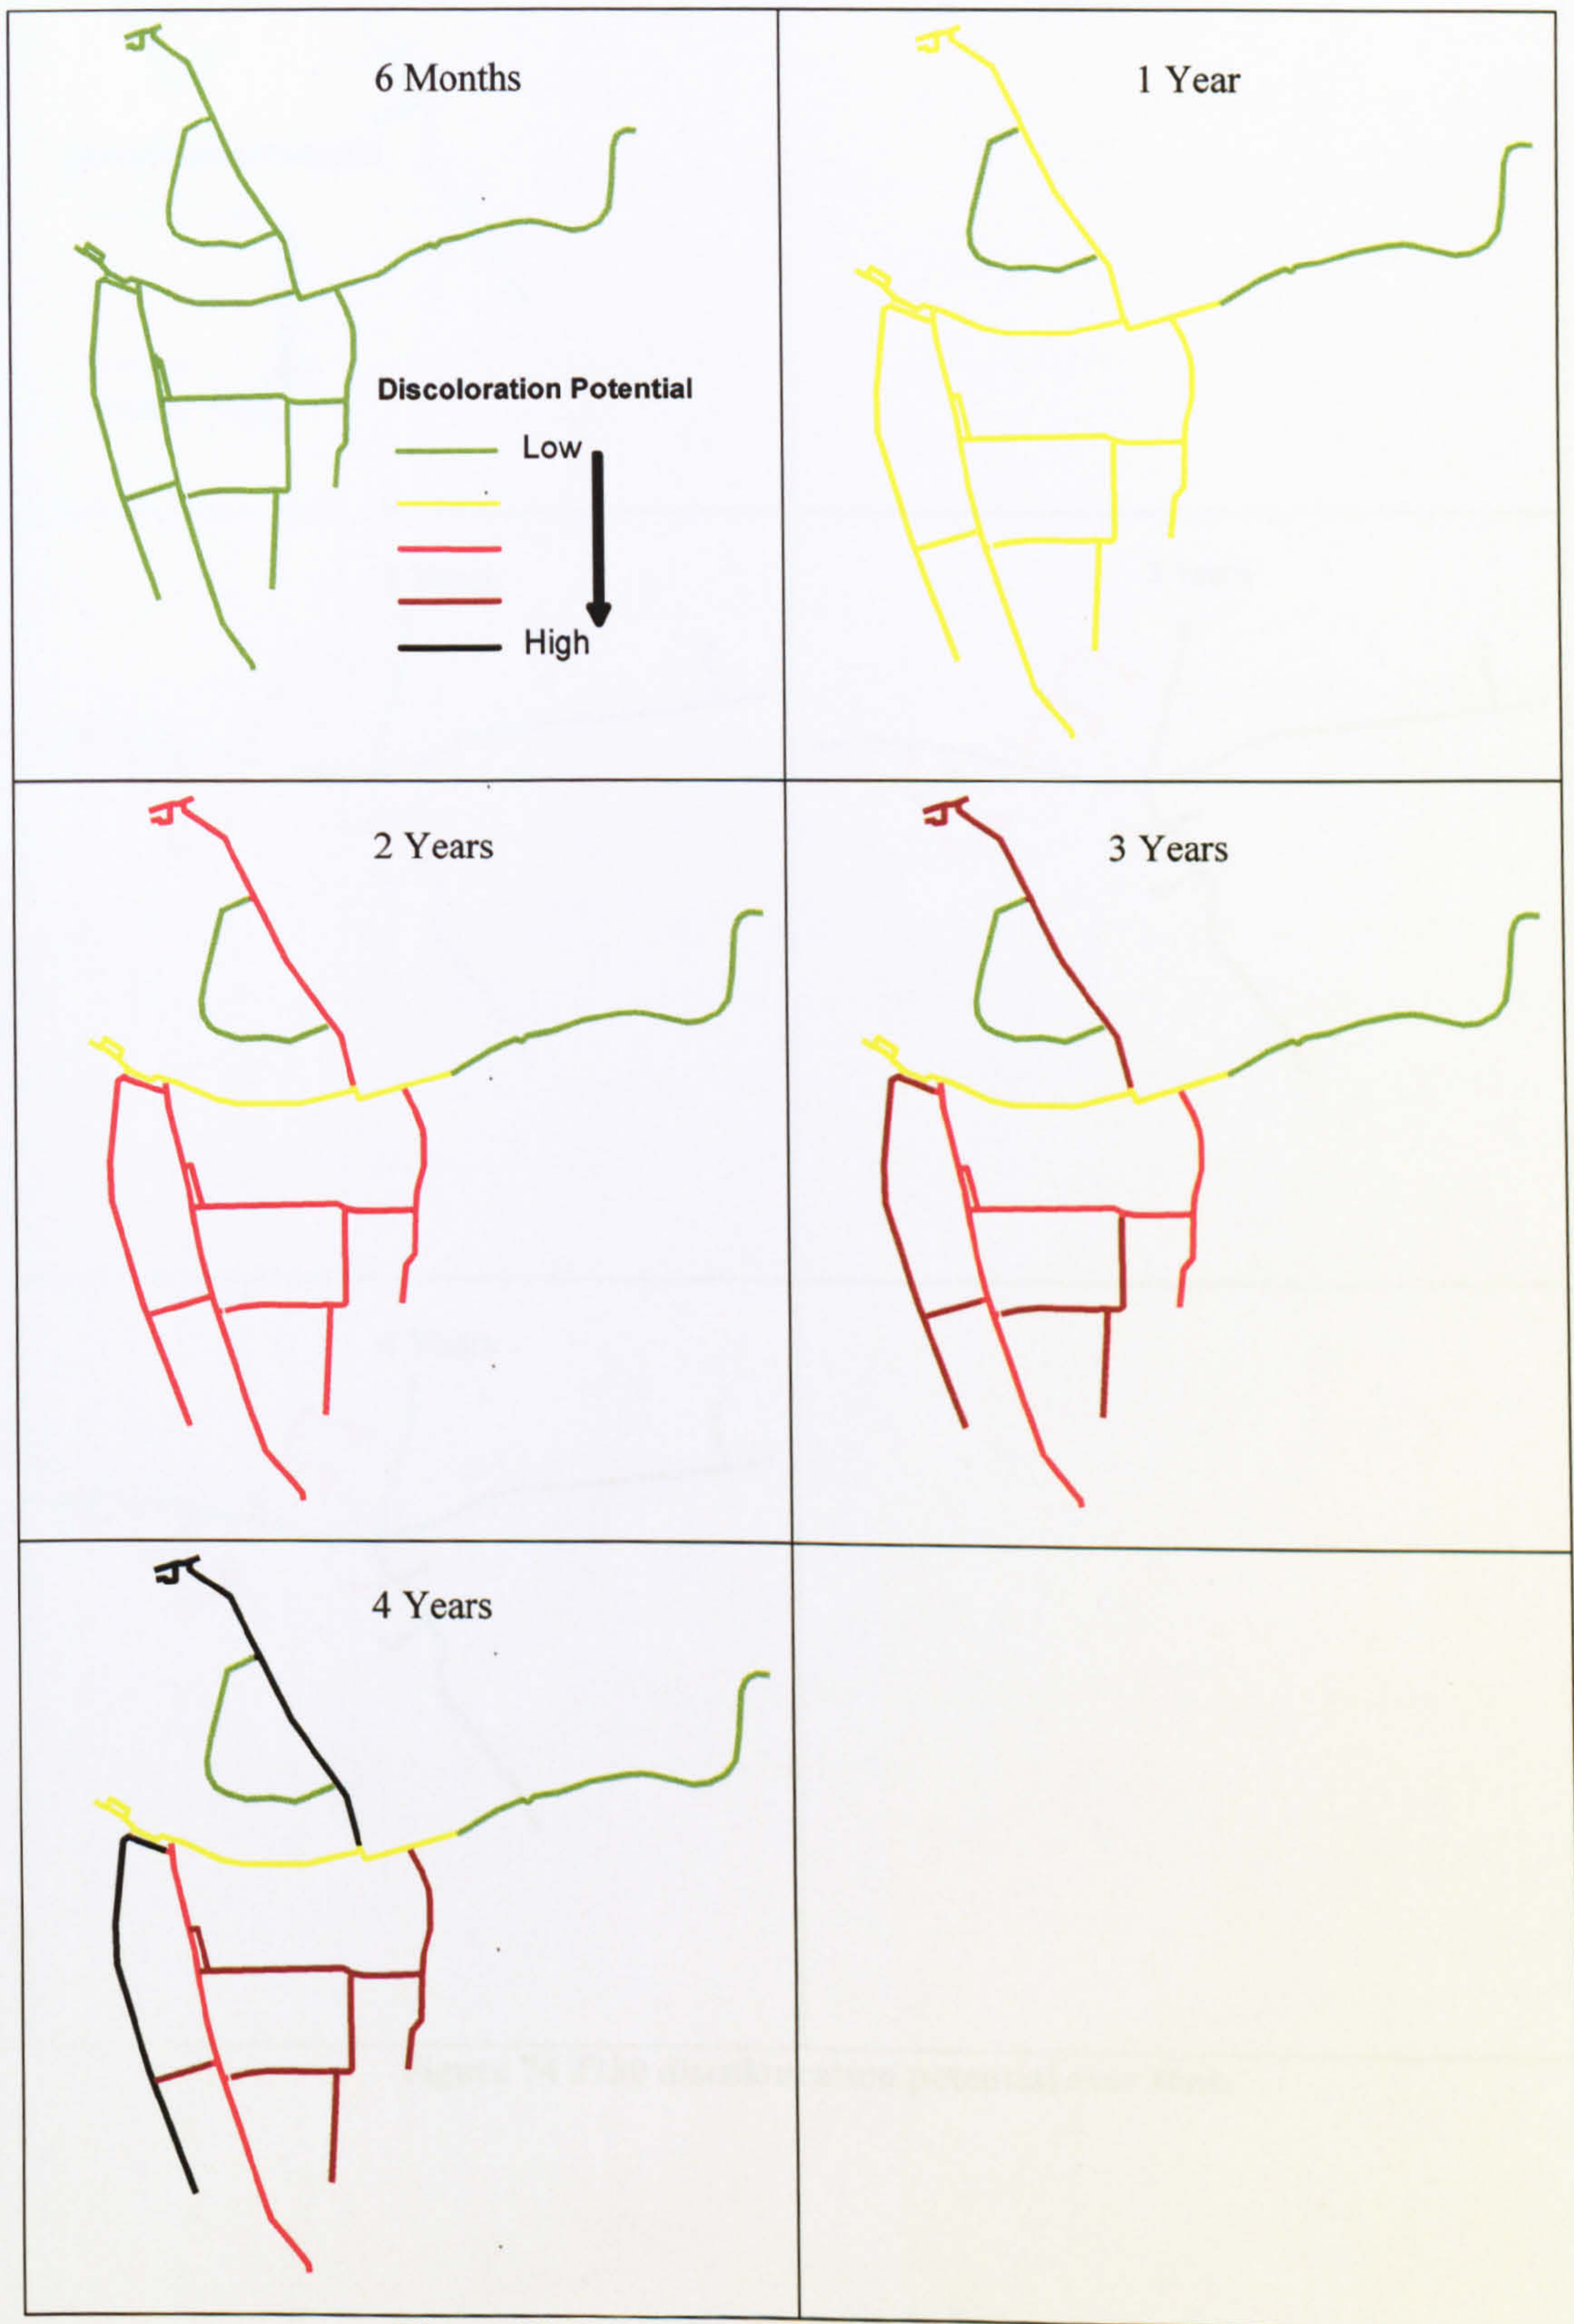
Figure 73 J722 discolouration potential over time.

constraints the accumulation rate for J730 only comprises of one data point, therefore no verification of complete regeneration within 6 months can be made between Figure 65 and Figure 74.
