**Guildhalls and Social Identity in Late Medieval and
Early Modern York, c.1350 - 1630.**

2 volumes: volume 2.

**Submitted for the degree of D. Phil to the University of York.
Department of Archaeology.
August 1999.**

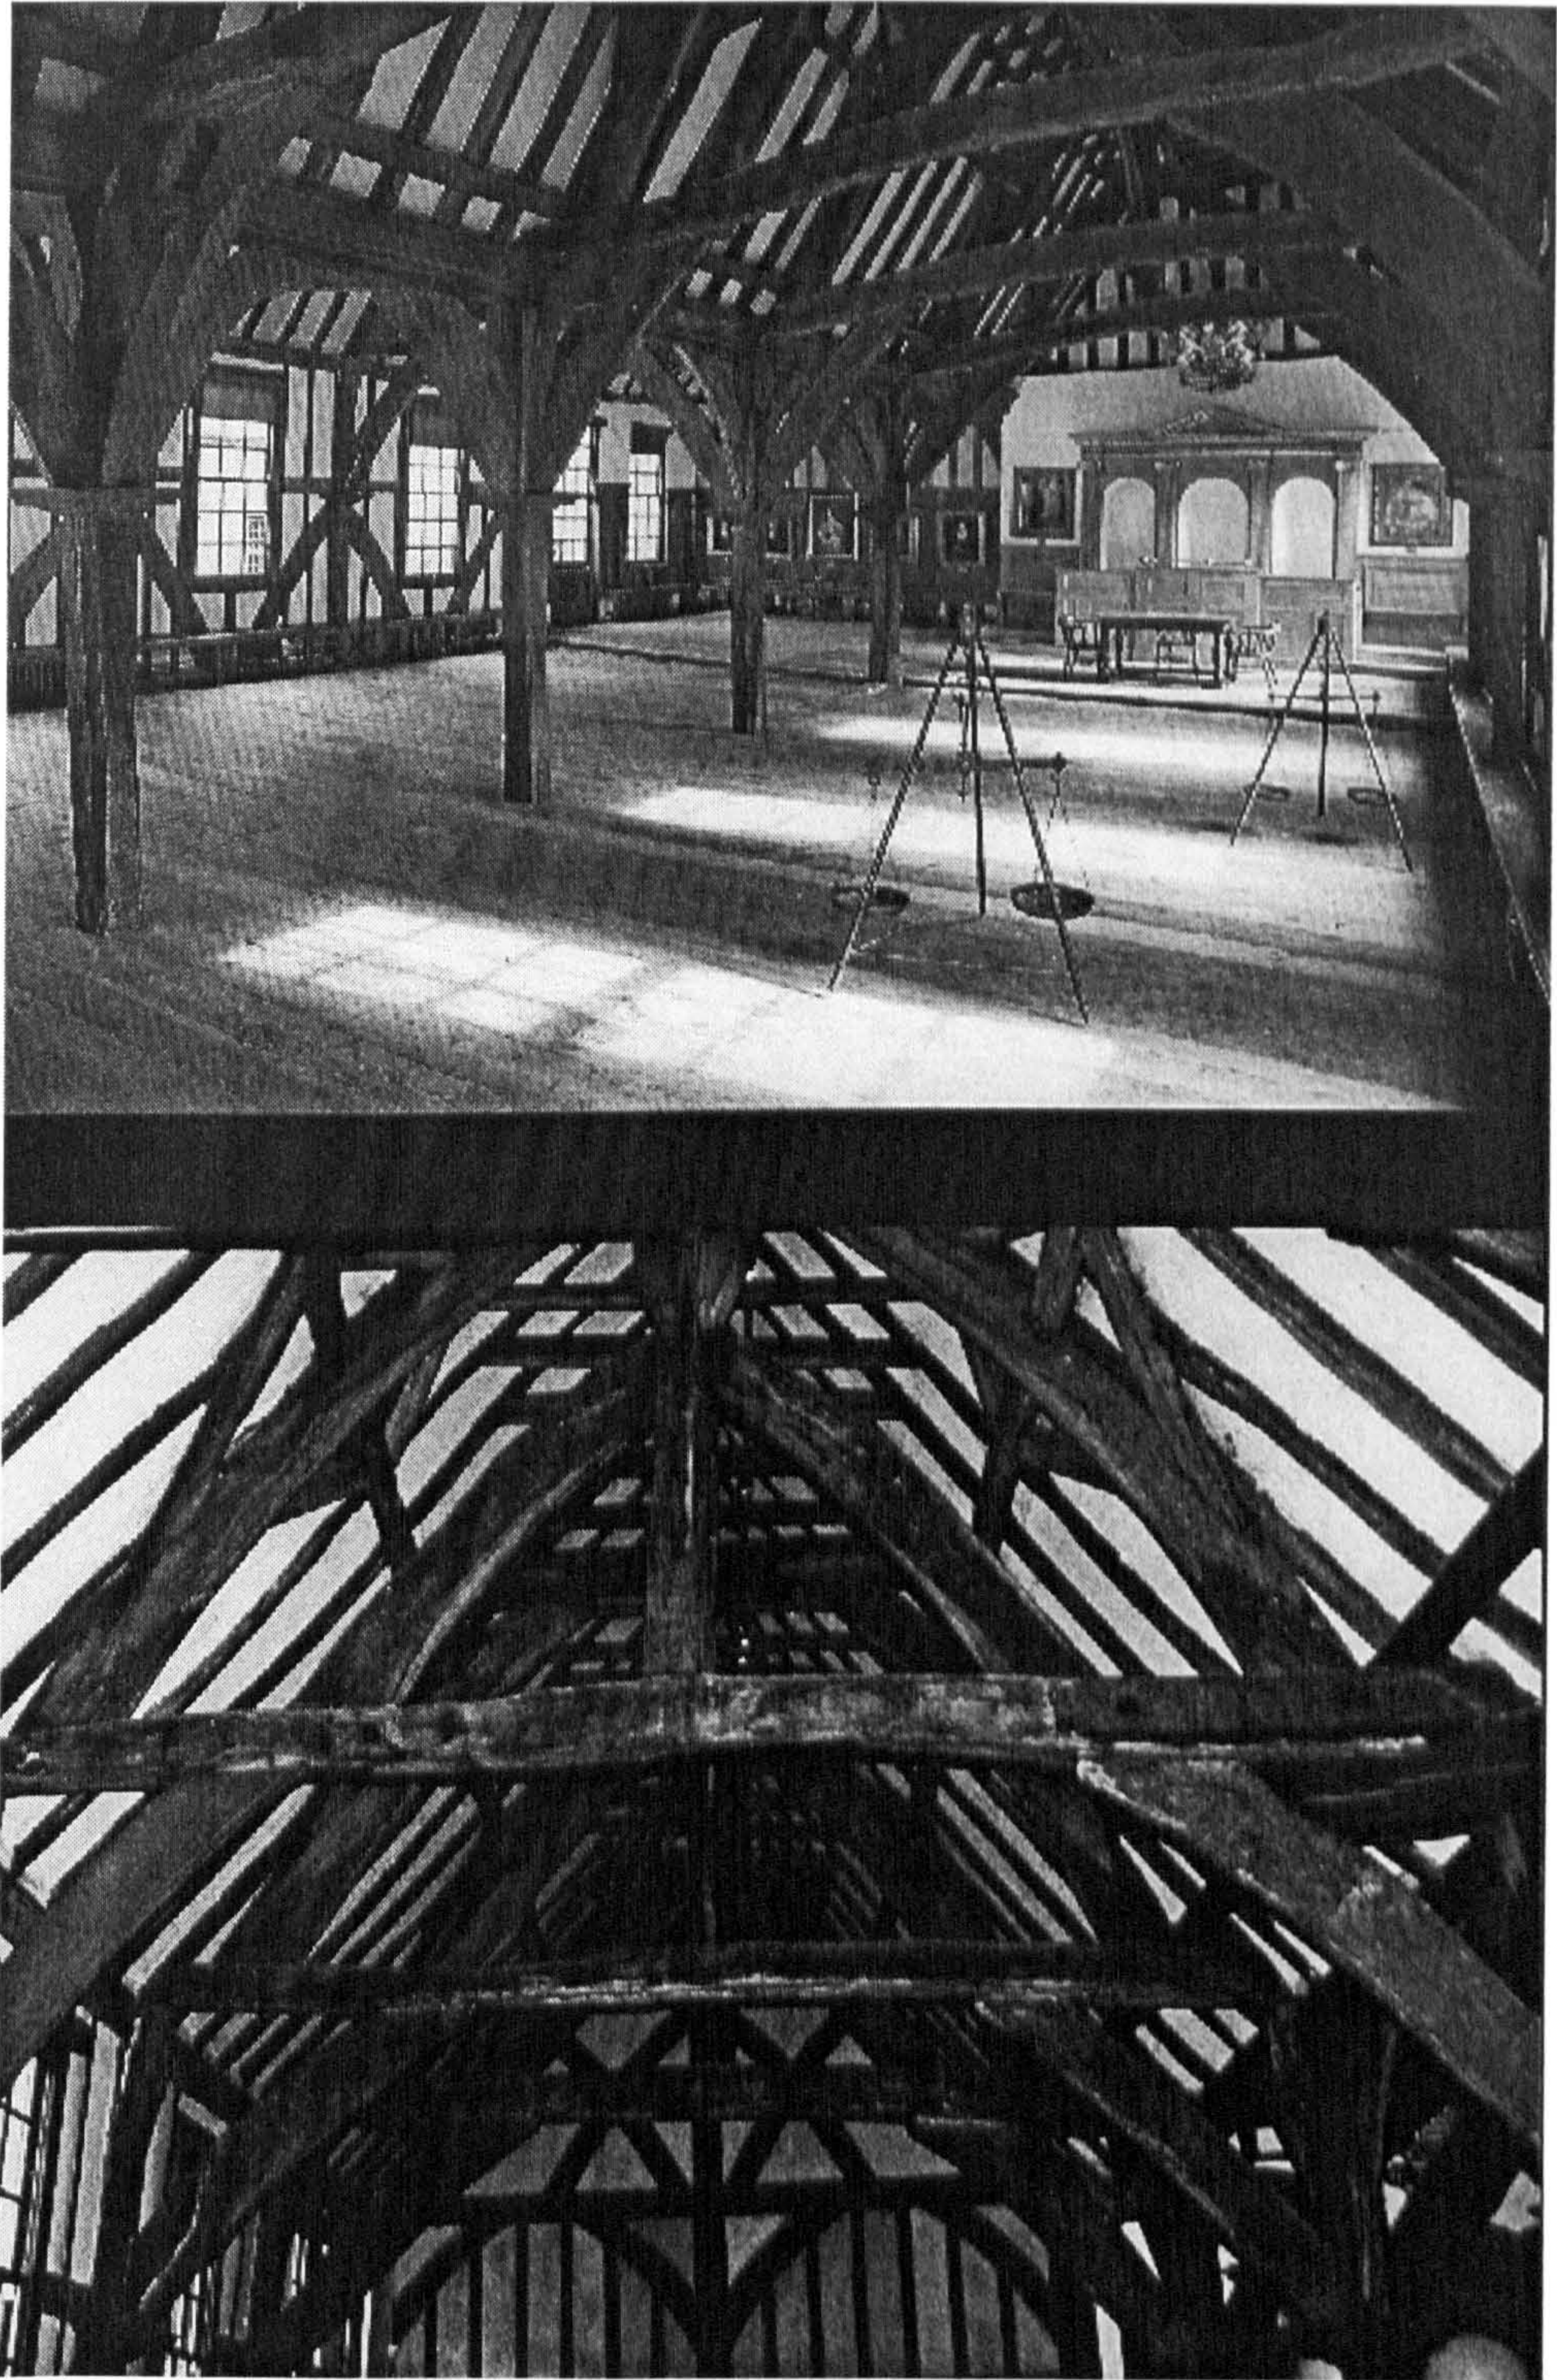
Fig. 6. The interior of Trinity hall, looking south-east, and showing detail of crown post roof trusses.

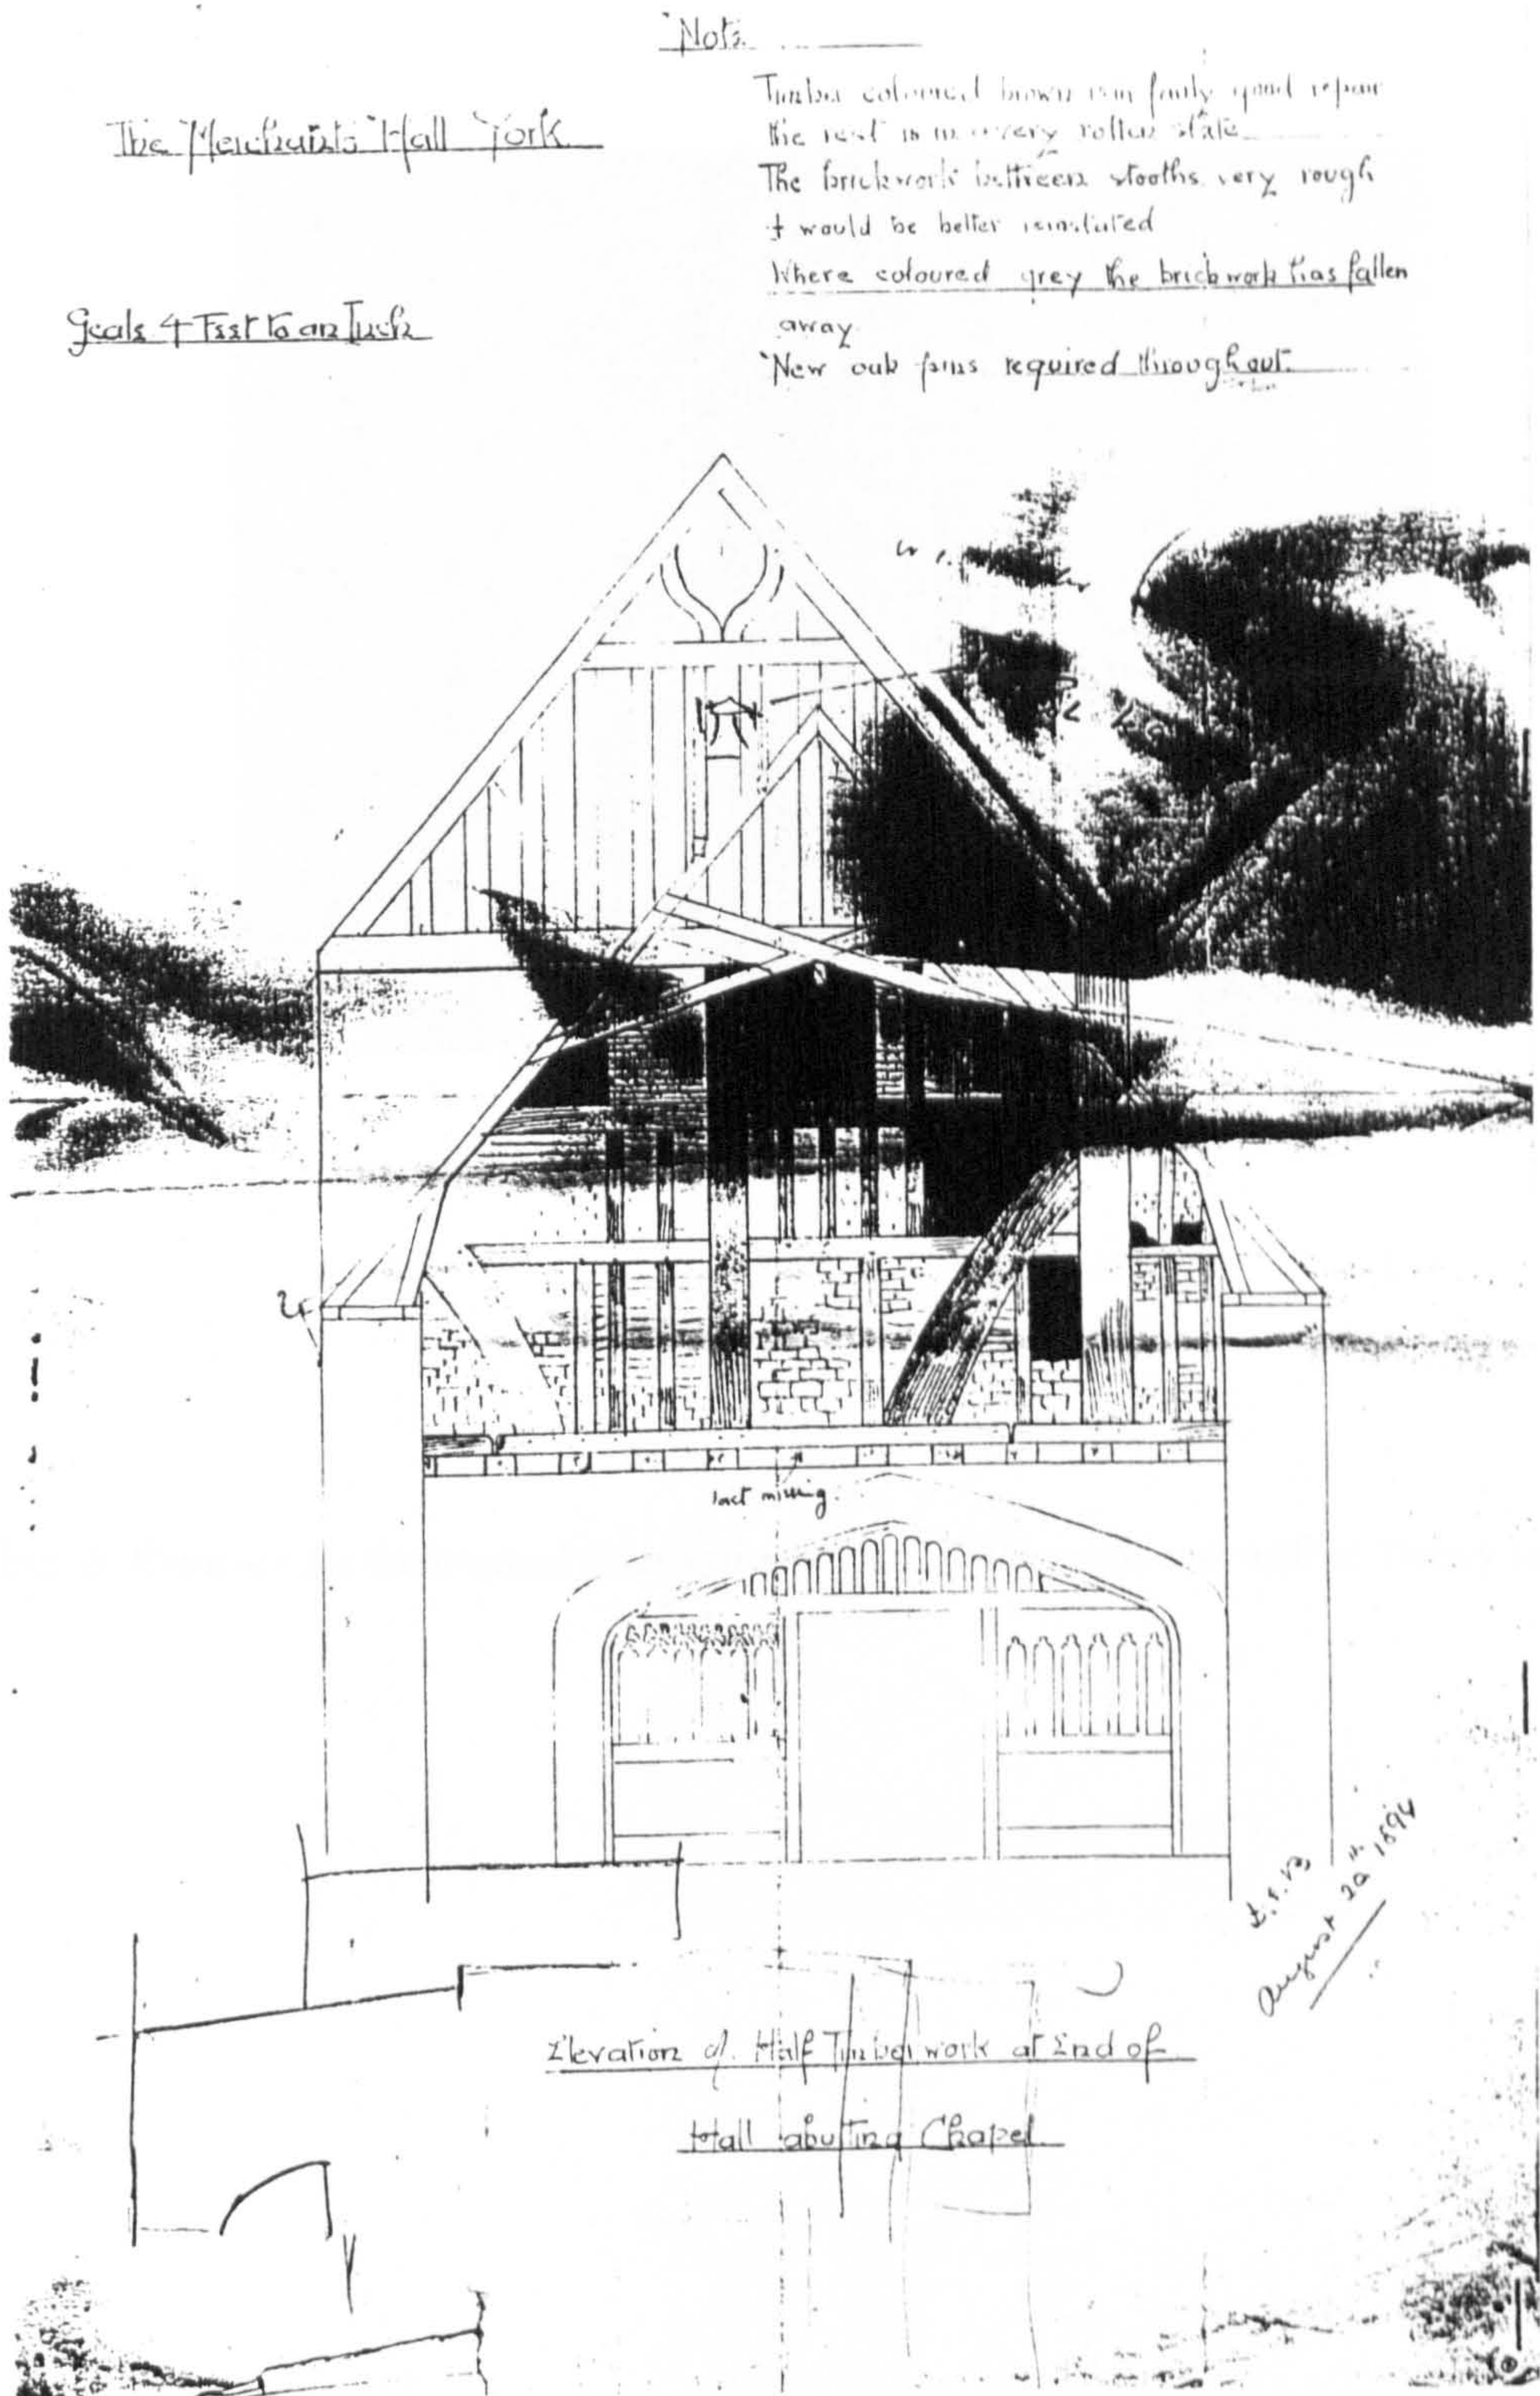
Fig. 7. The reconstruction of the south-west gable end of The Merchant Adventurers' Hall.
(BIHR AB collection)

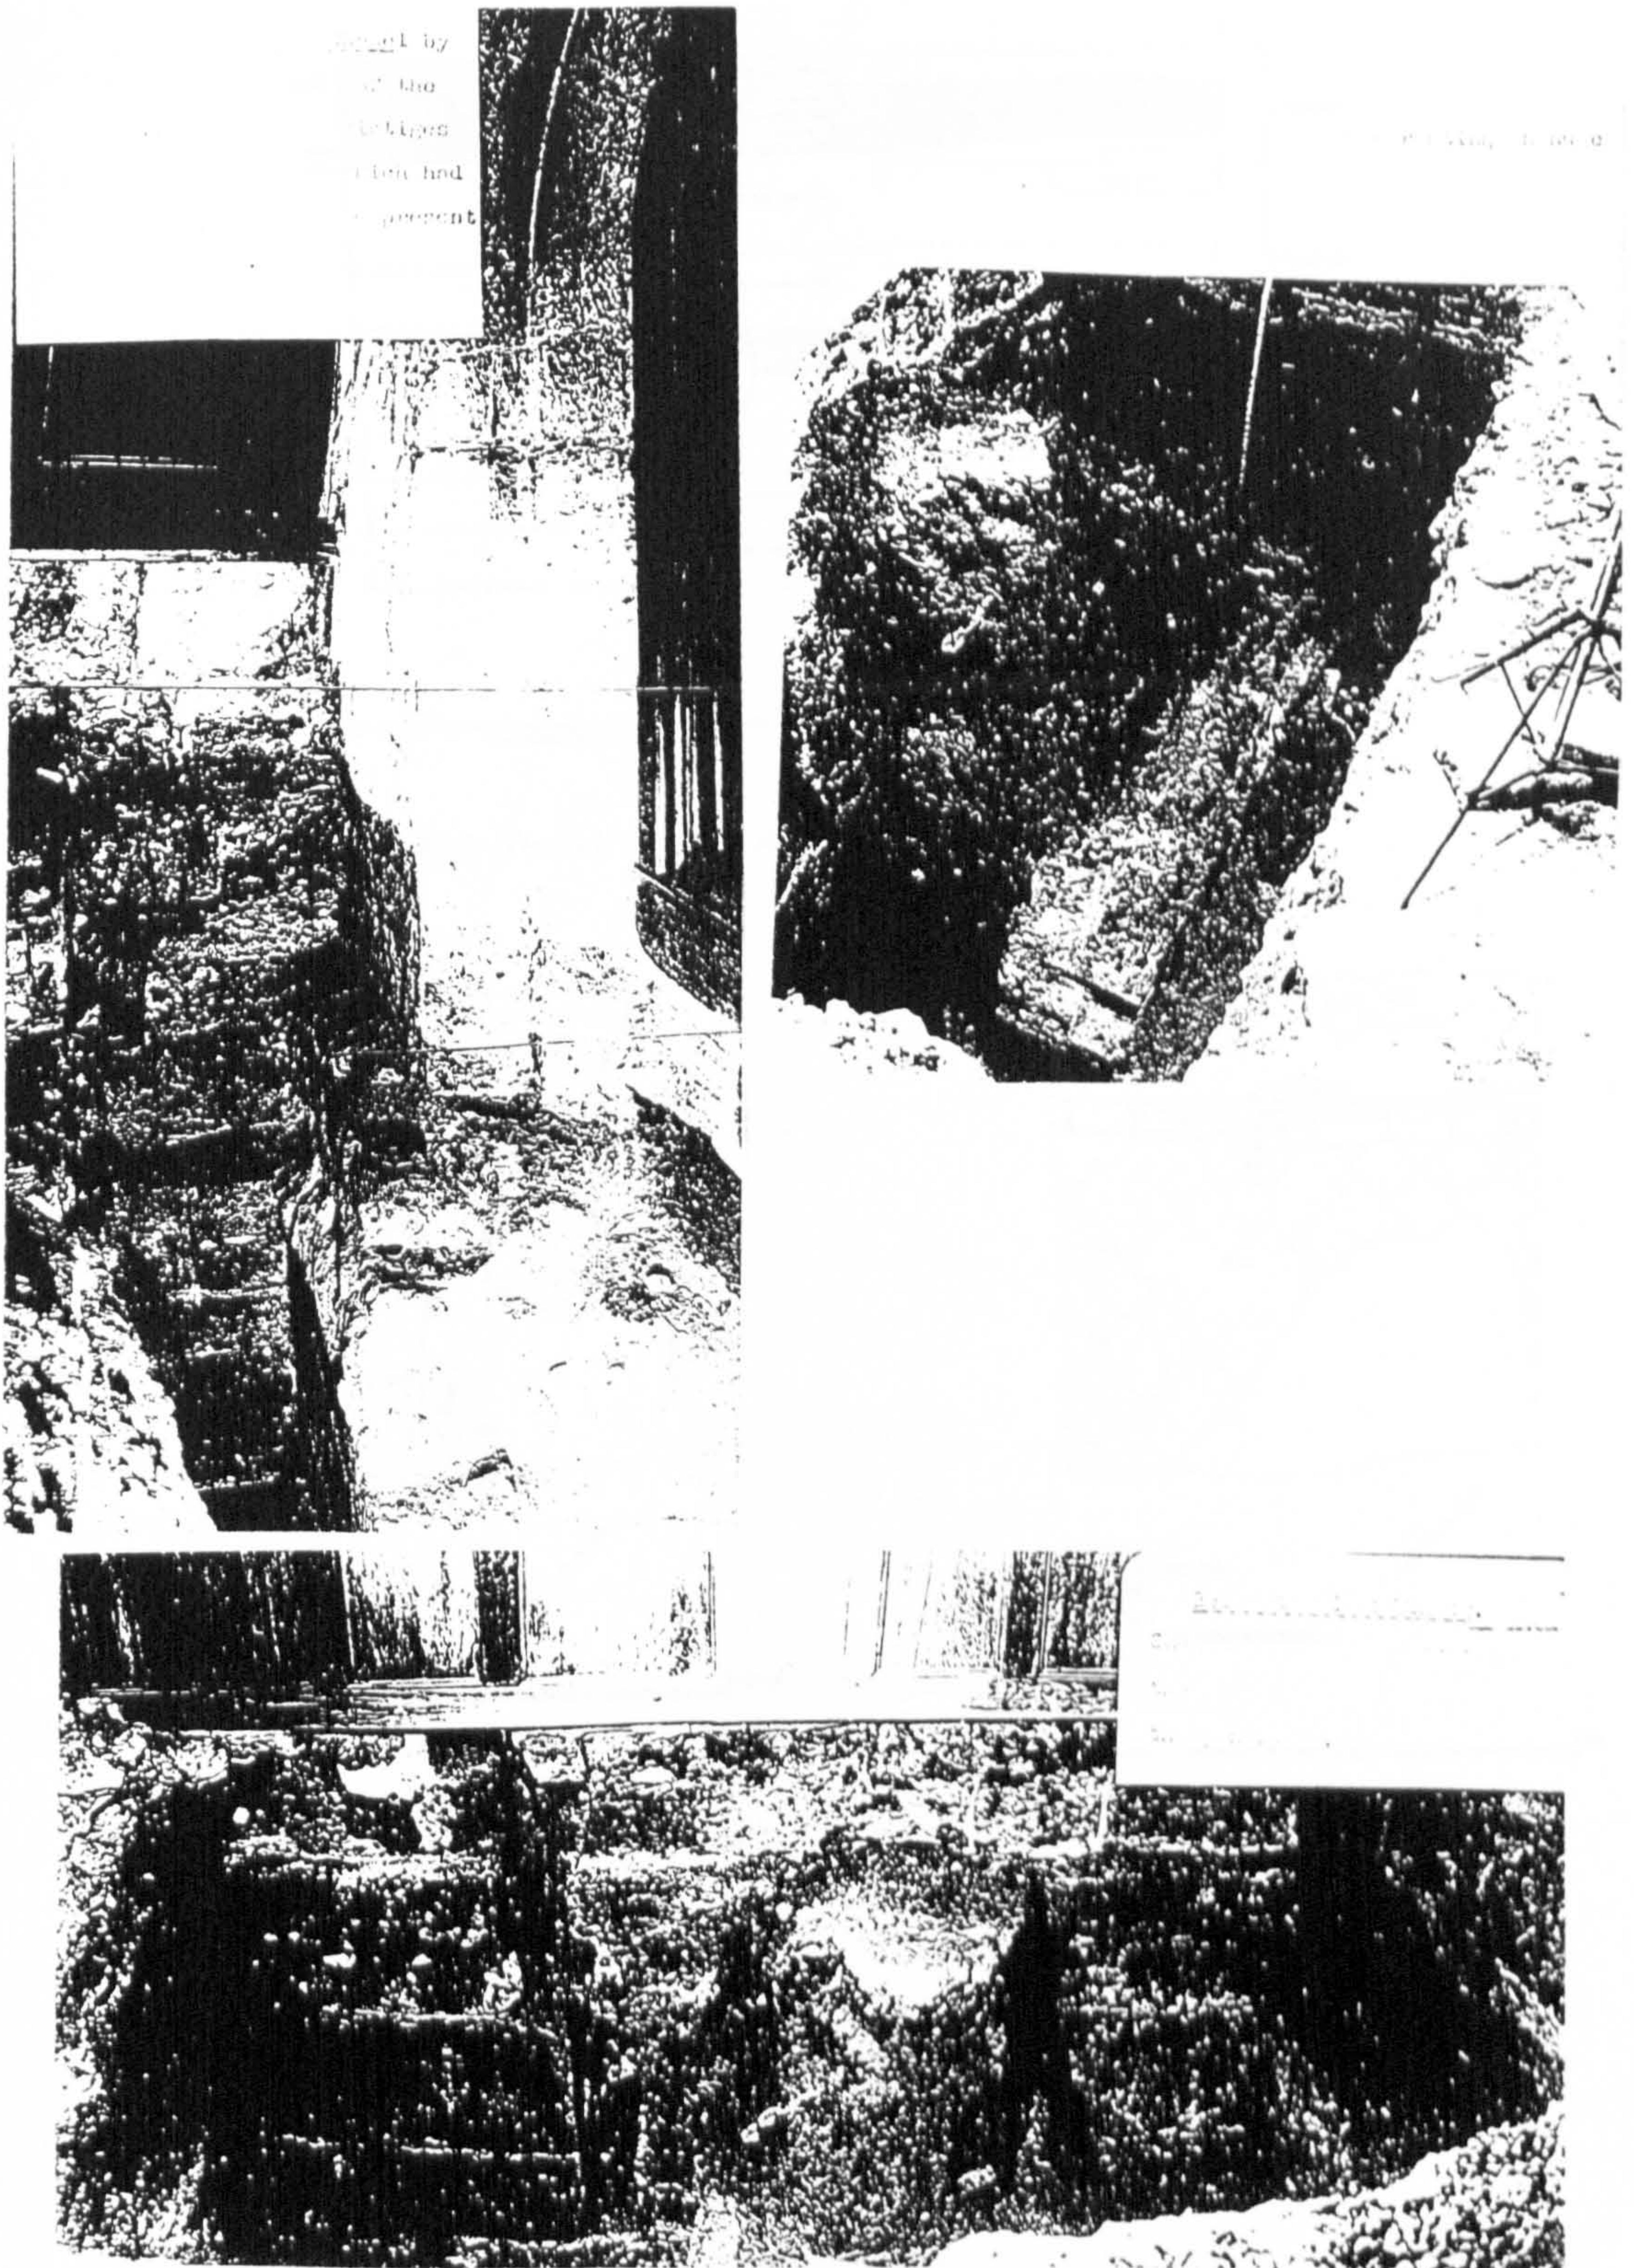
Fig. 11. Earlier foundations beneath the chapel at Trinity Hall.
Excavated by Y.AYA's 1949-50.

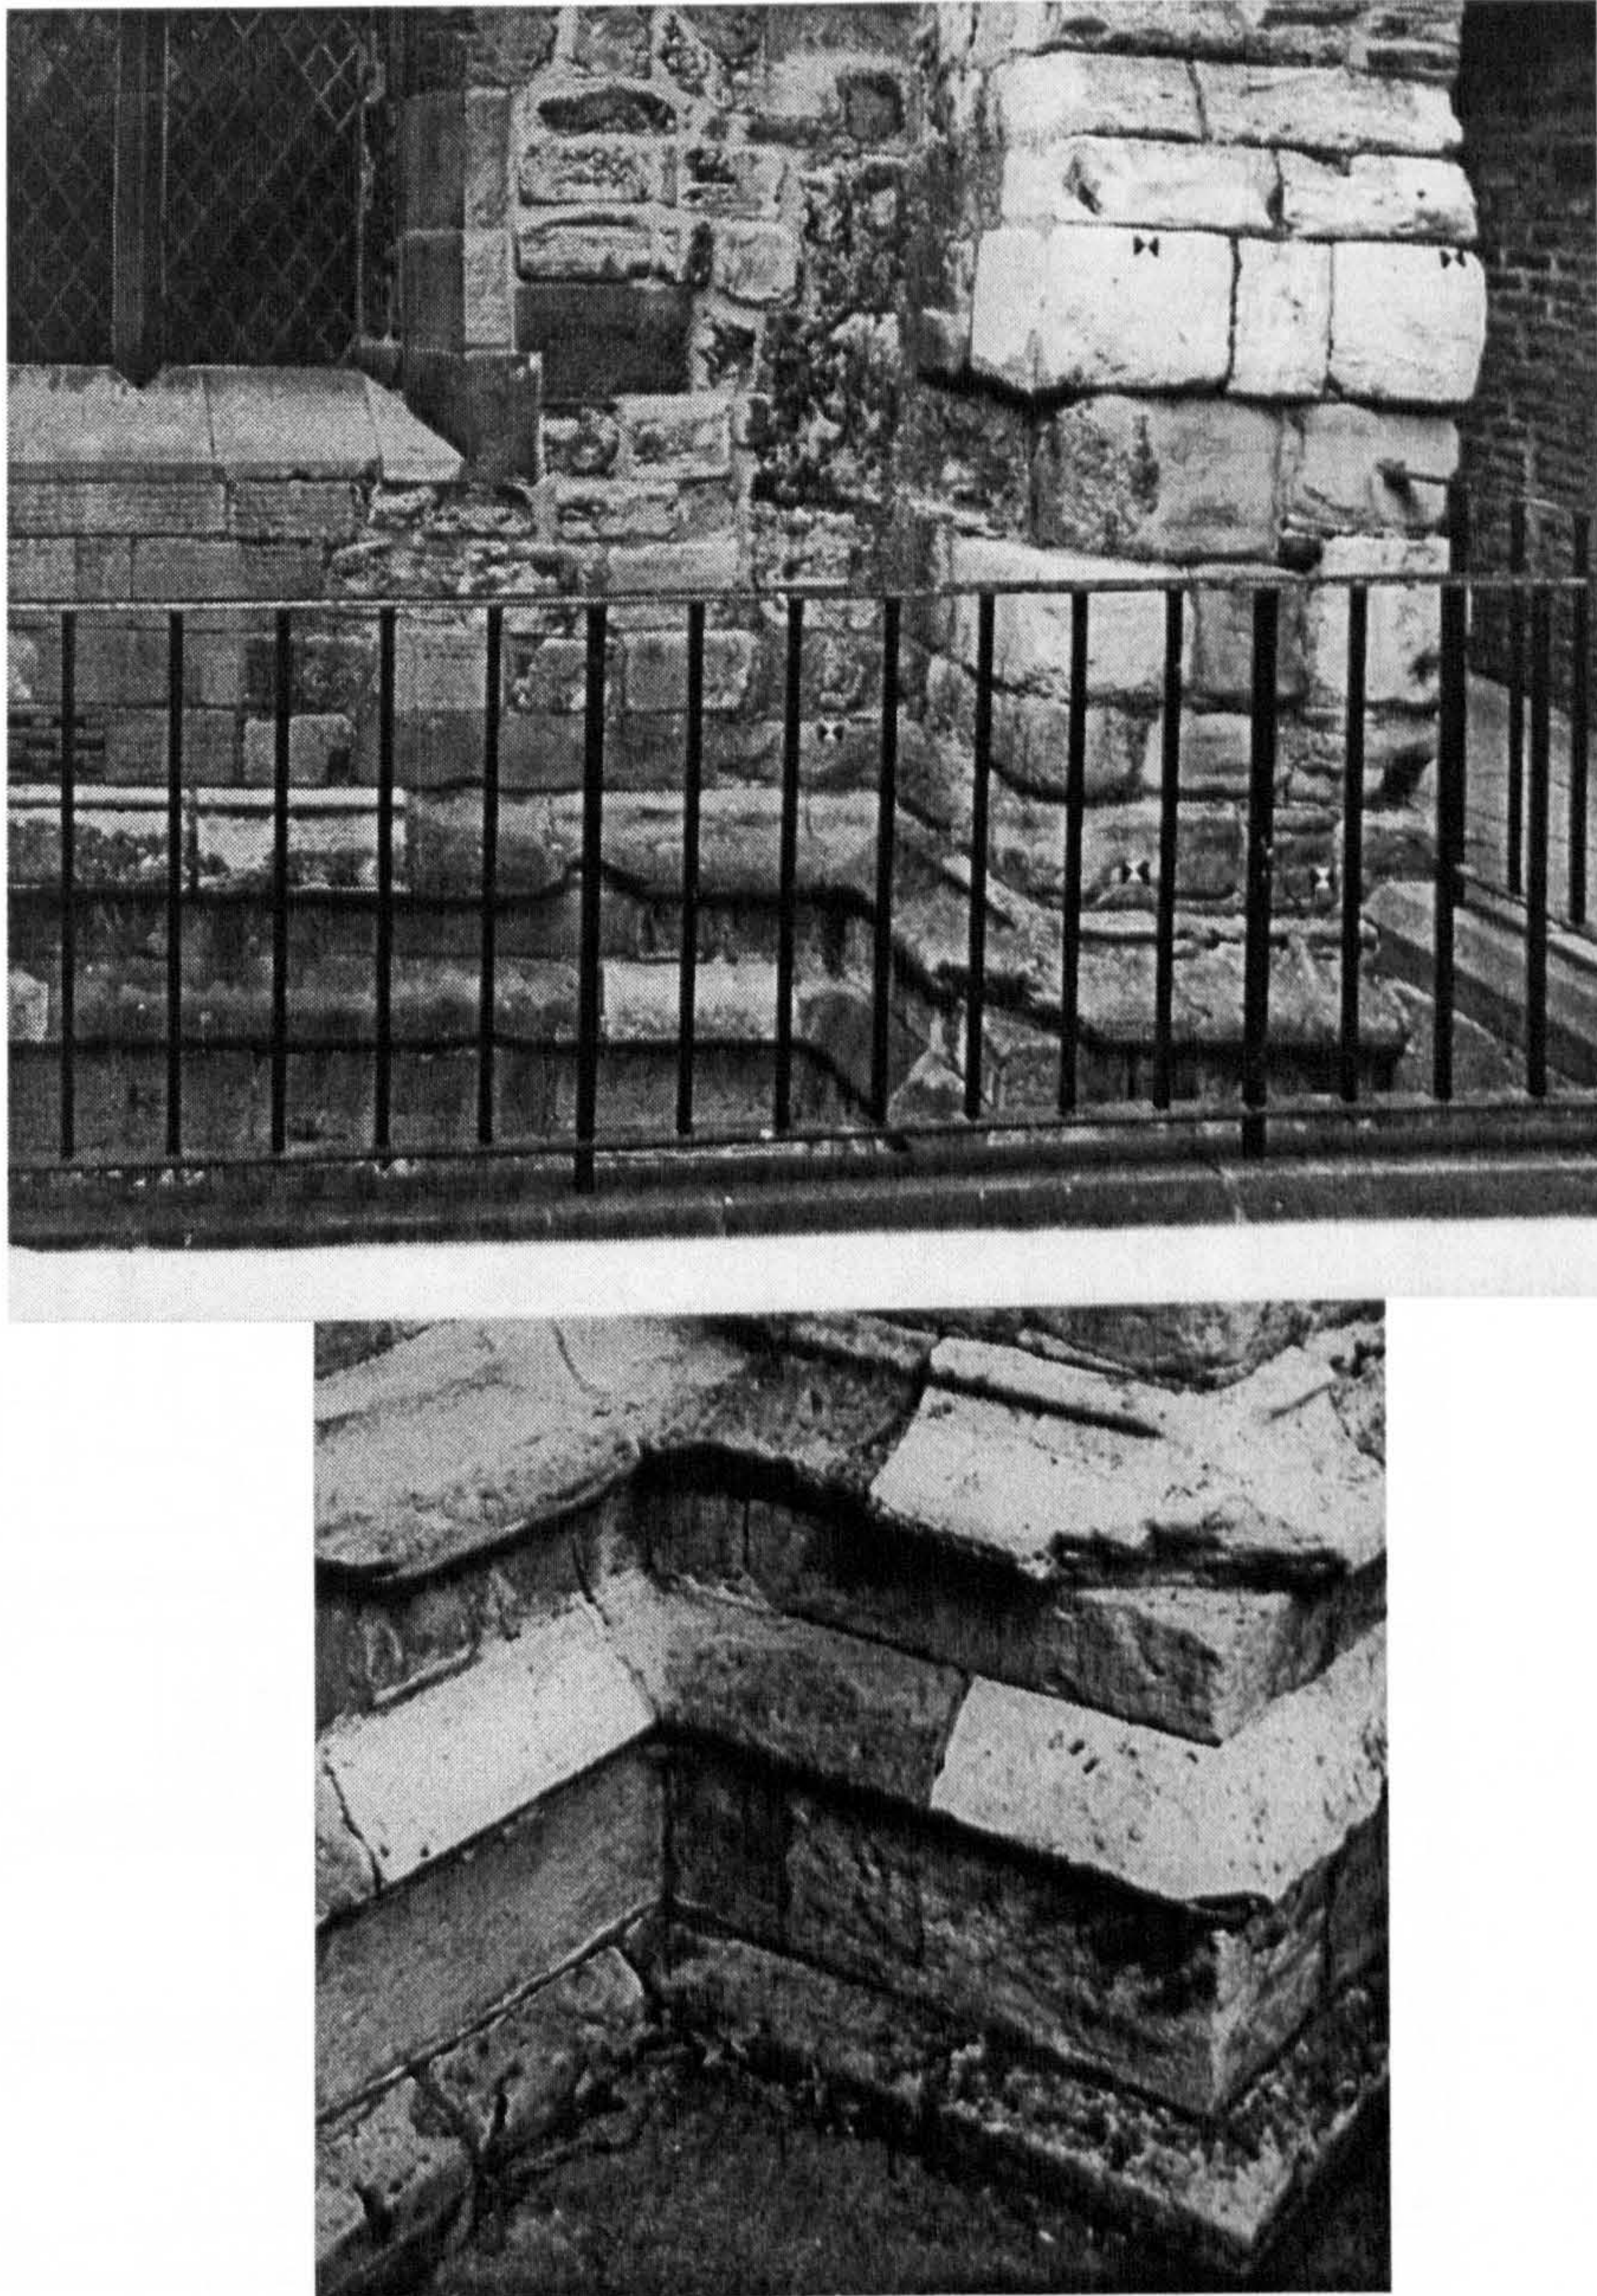
Fig. 44. Exposed rubble core in the north-east wall of the undercroft, Trinity hall, flush with fourteenth century timber-framing above.

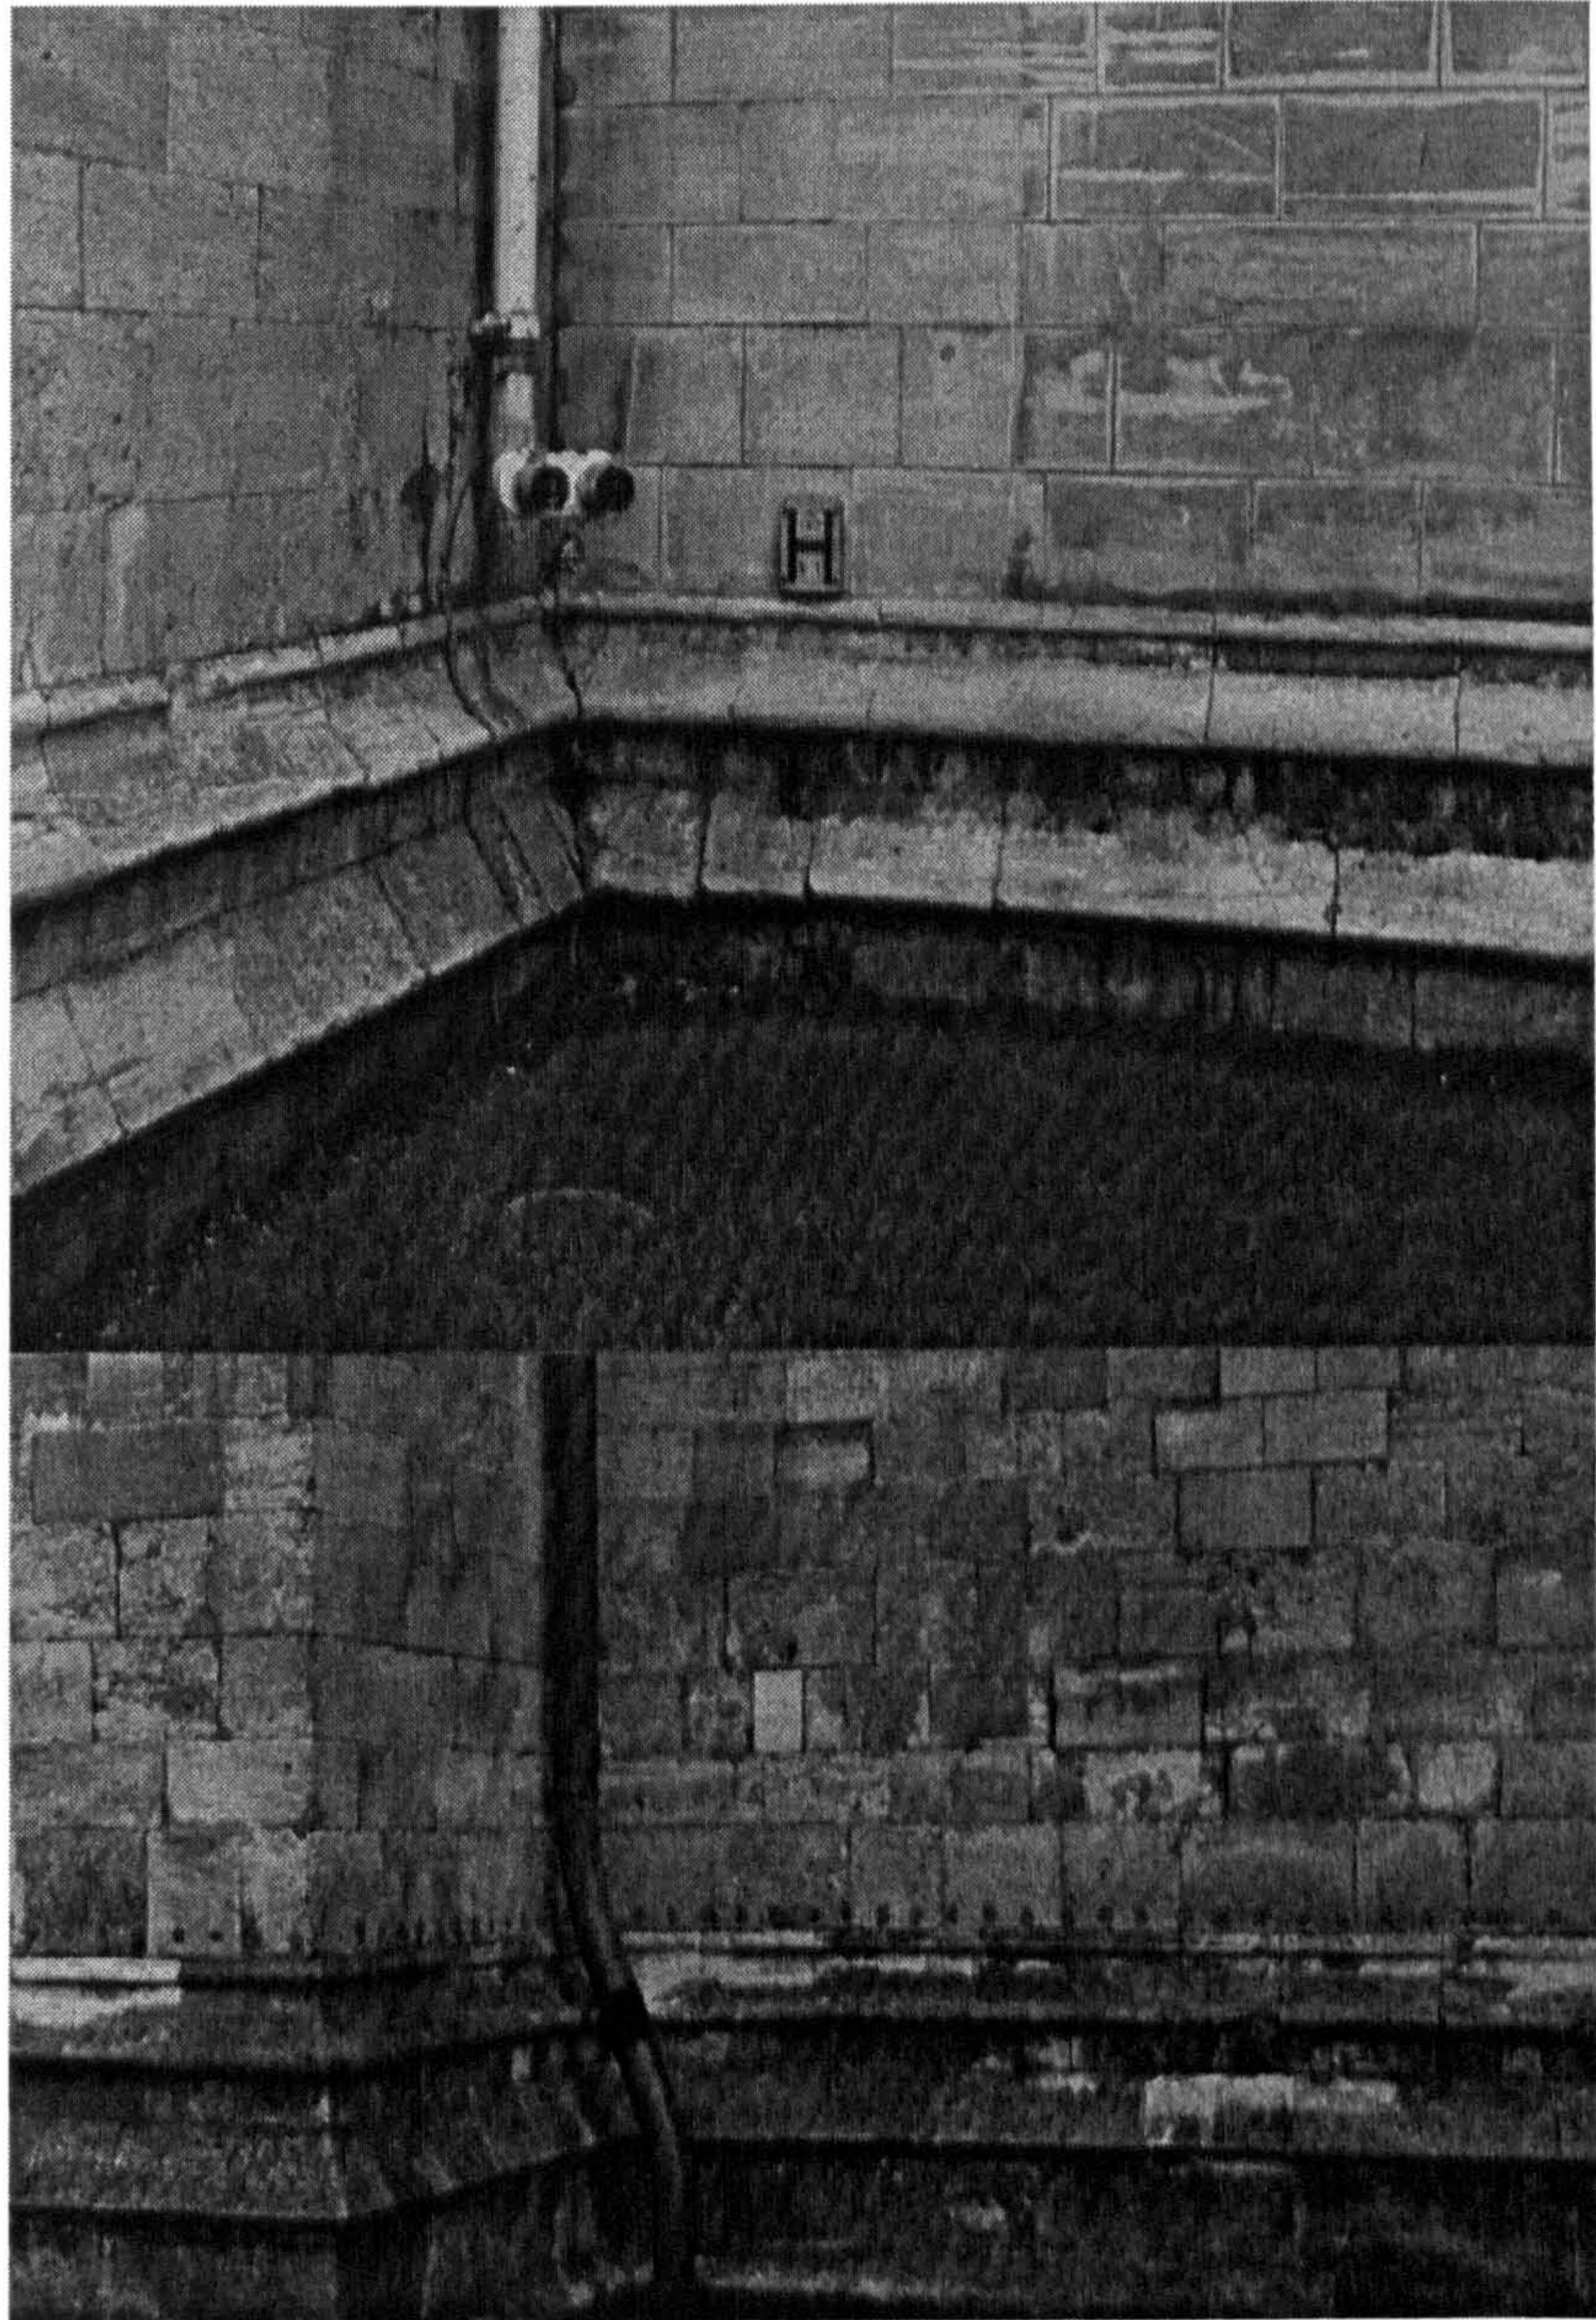
Fig. 46. The south-east wall of the undercroft, Trinity hall, York.

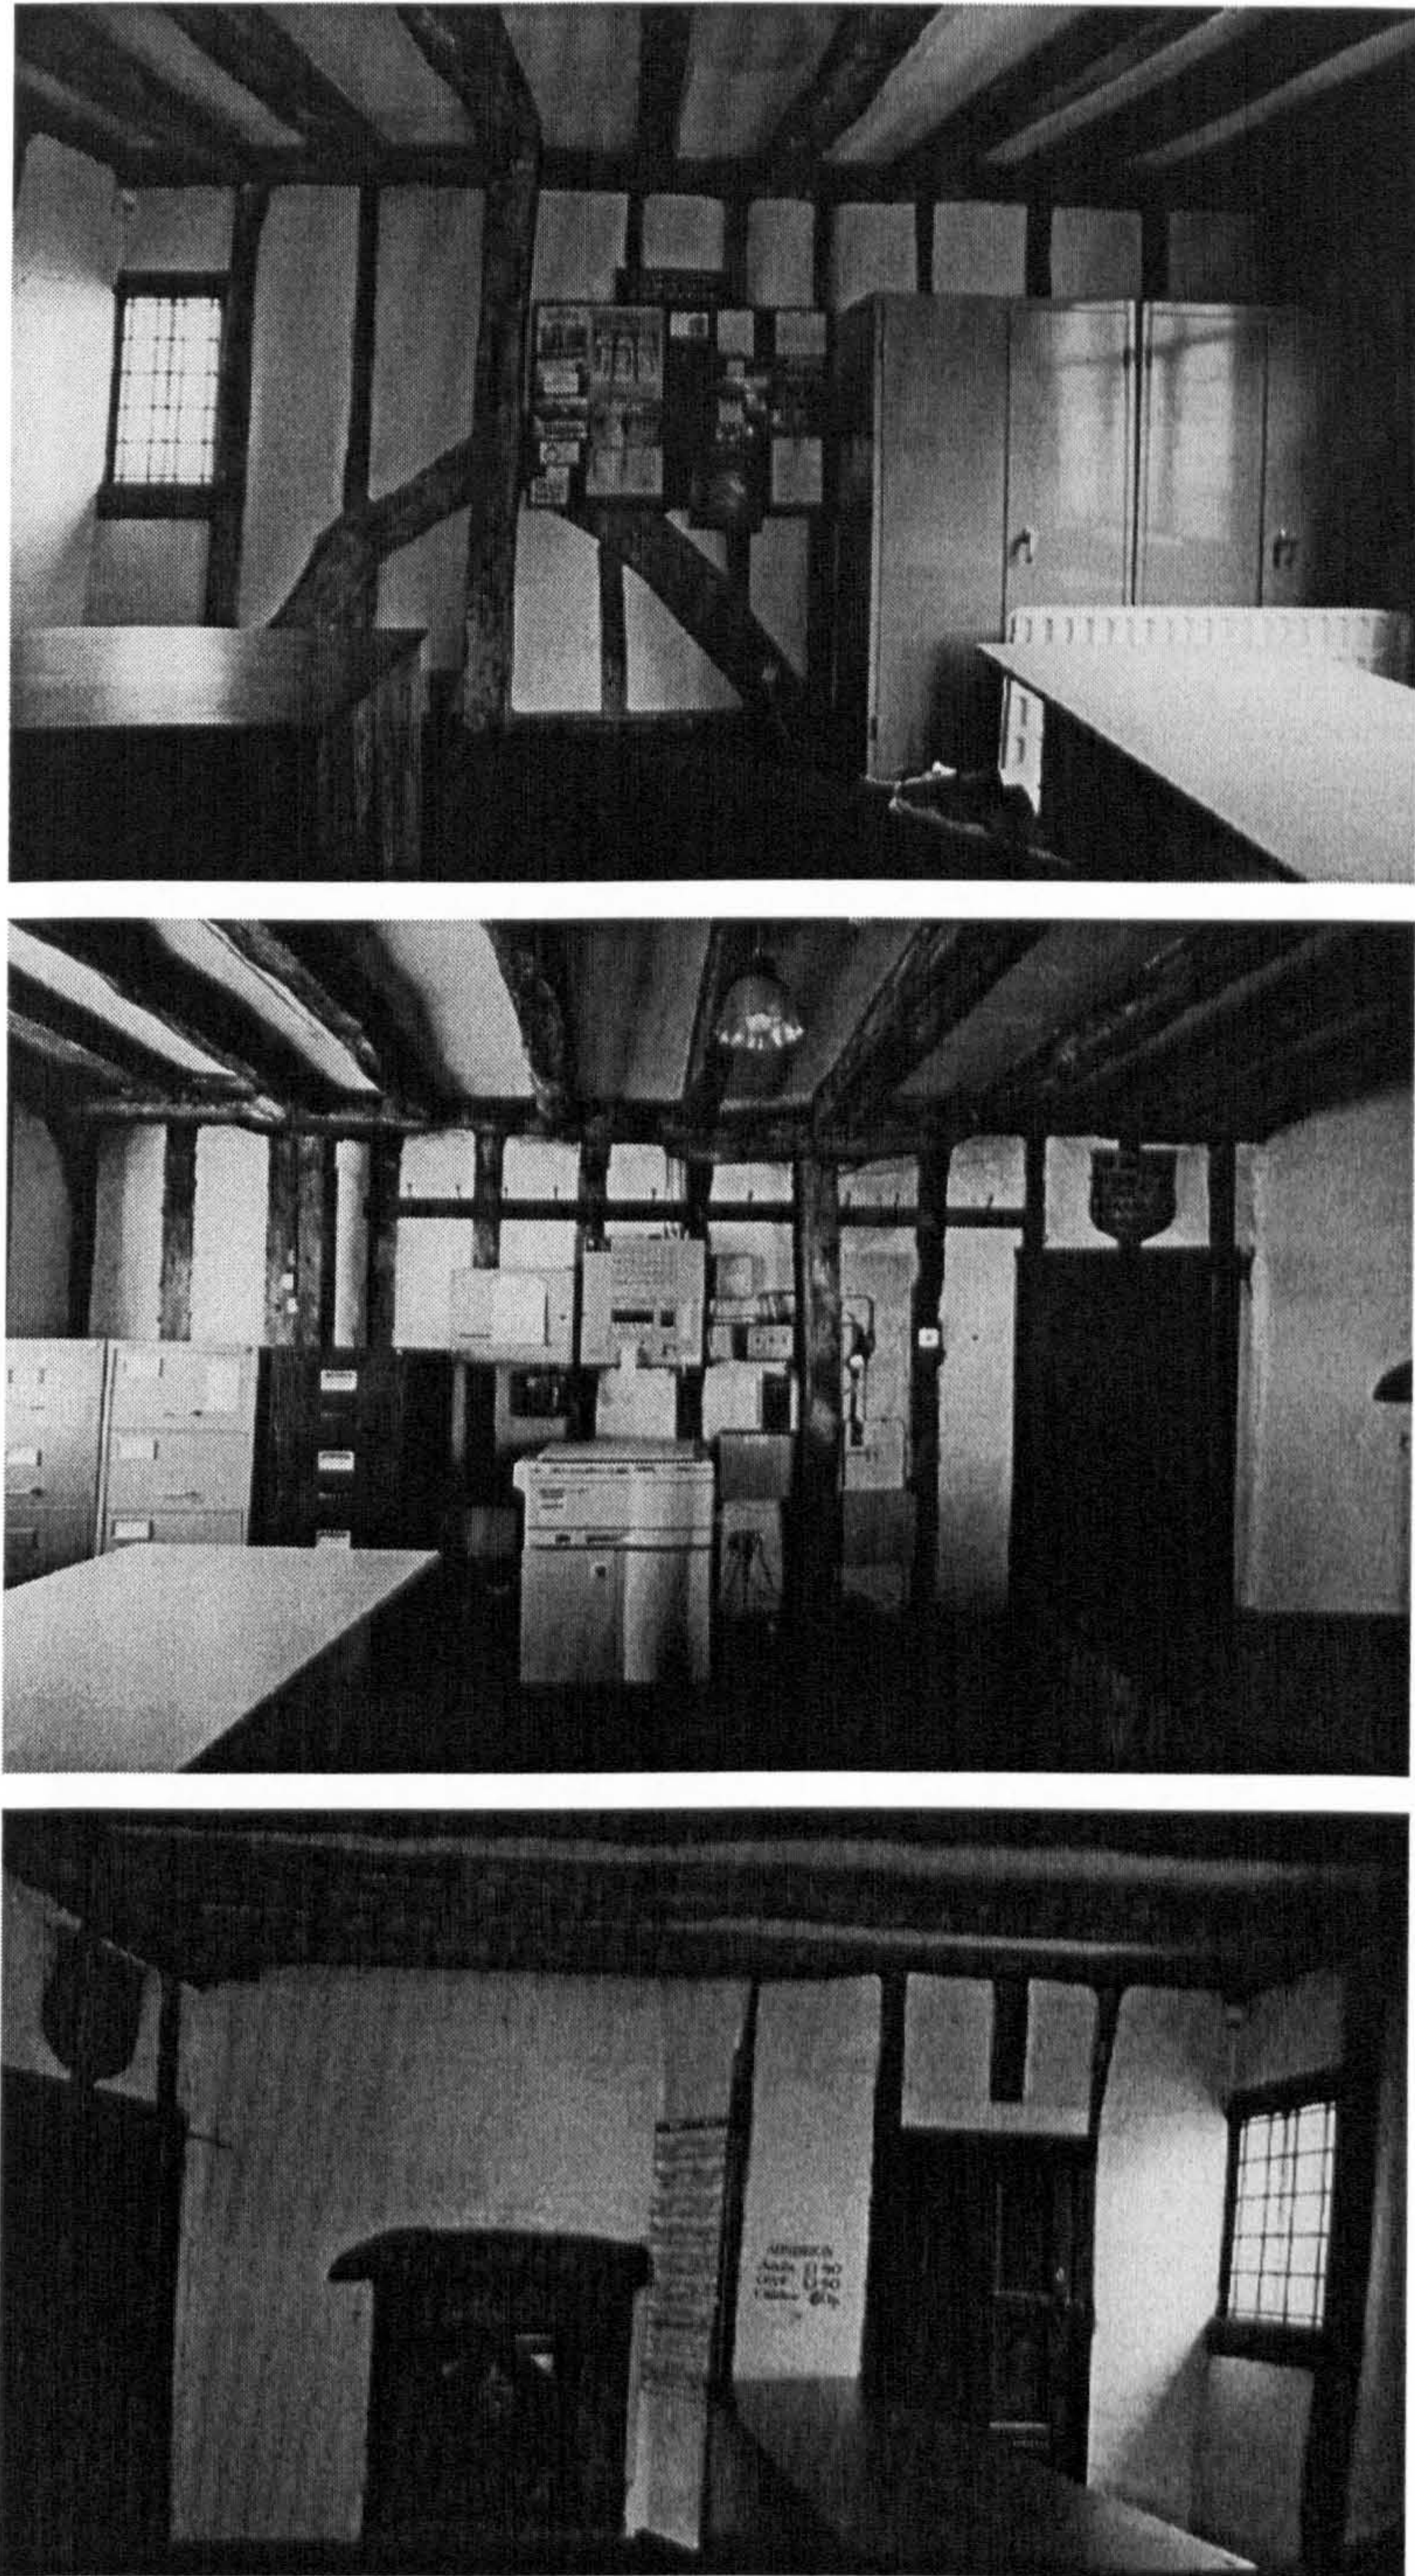
Fig. 94. Chisel cut assembly marks (and plumb and levelling mark) in the exterior face of re-used timber in the north-east range of Trinity hall.
