**Guildhalls and Social Identity in Late Medieval and
Early Modern York, c.1350 - 1630.**

2 volumes: volume 2.

**Submitted for the degree of D. Phil to the University of York.
Department of Archaeology.
August 1999.**

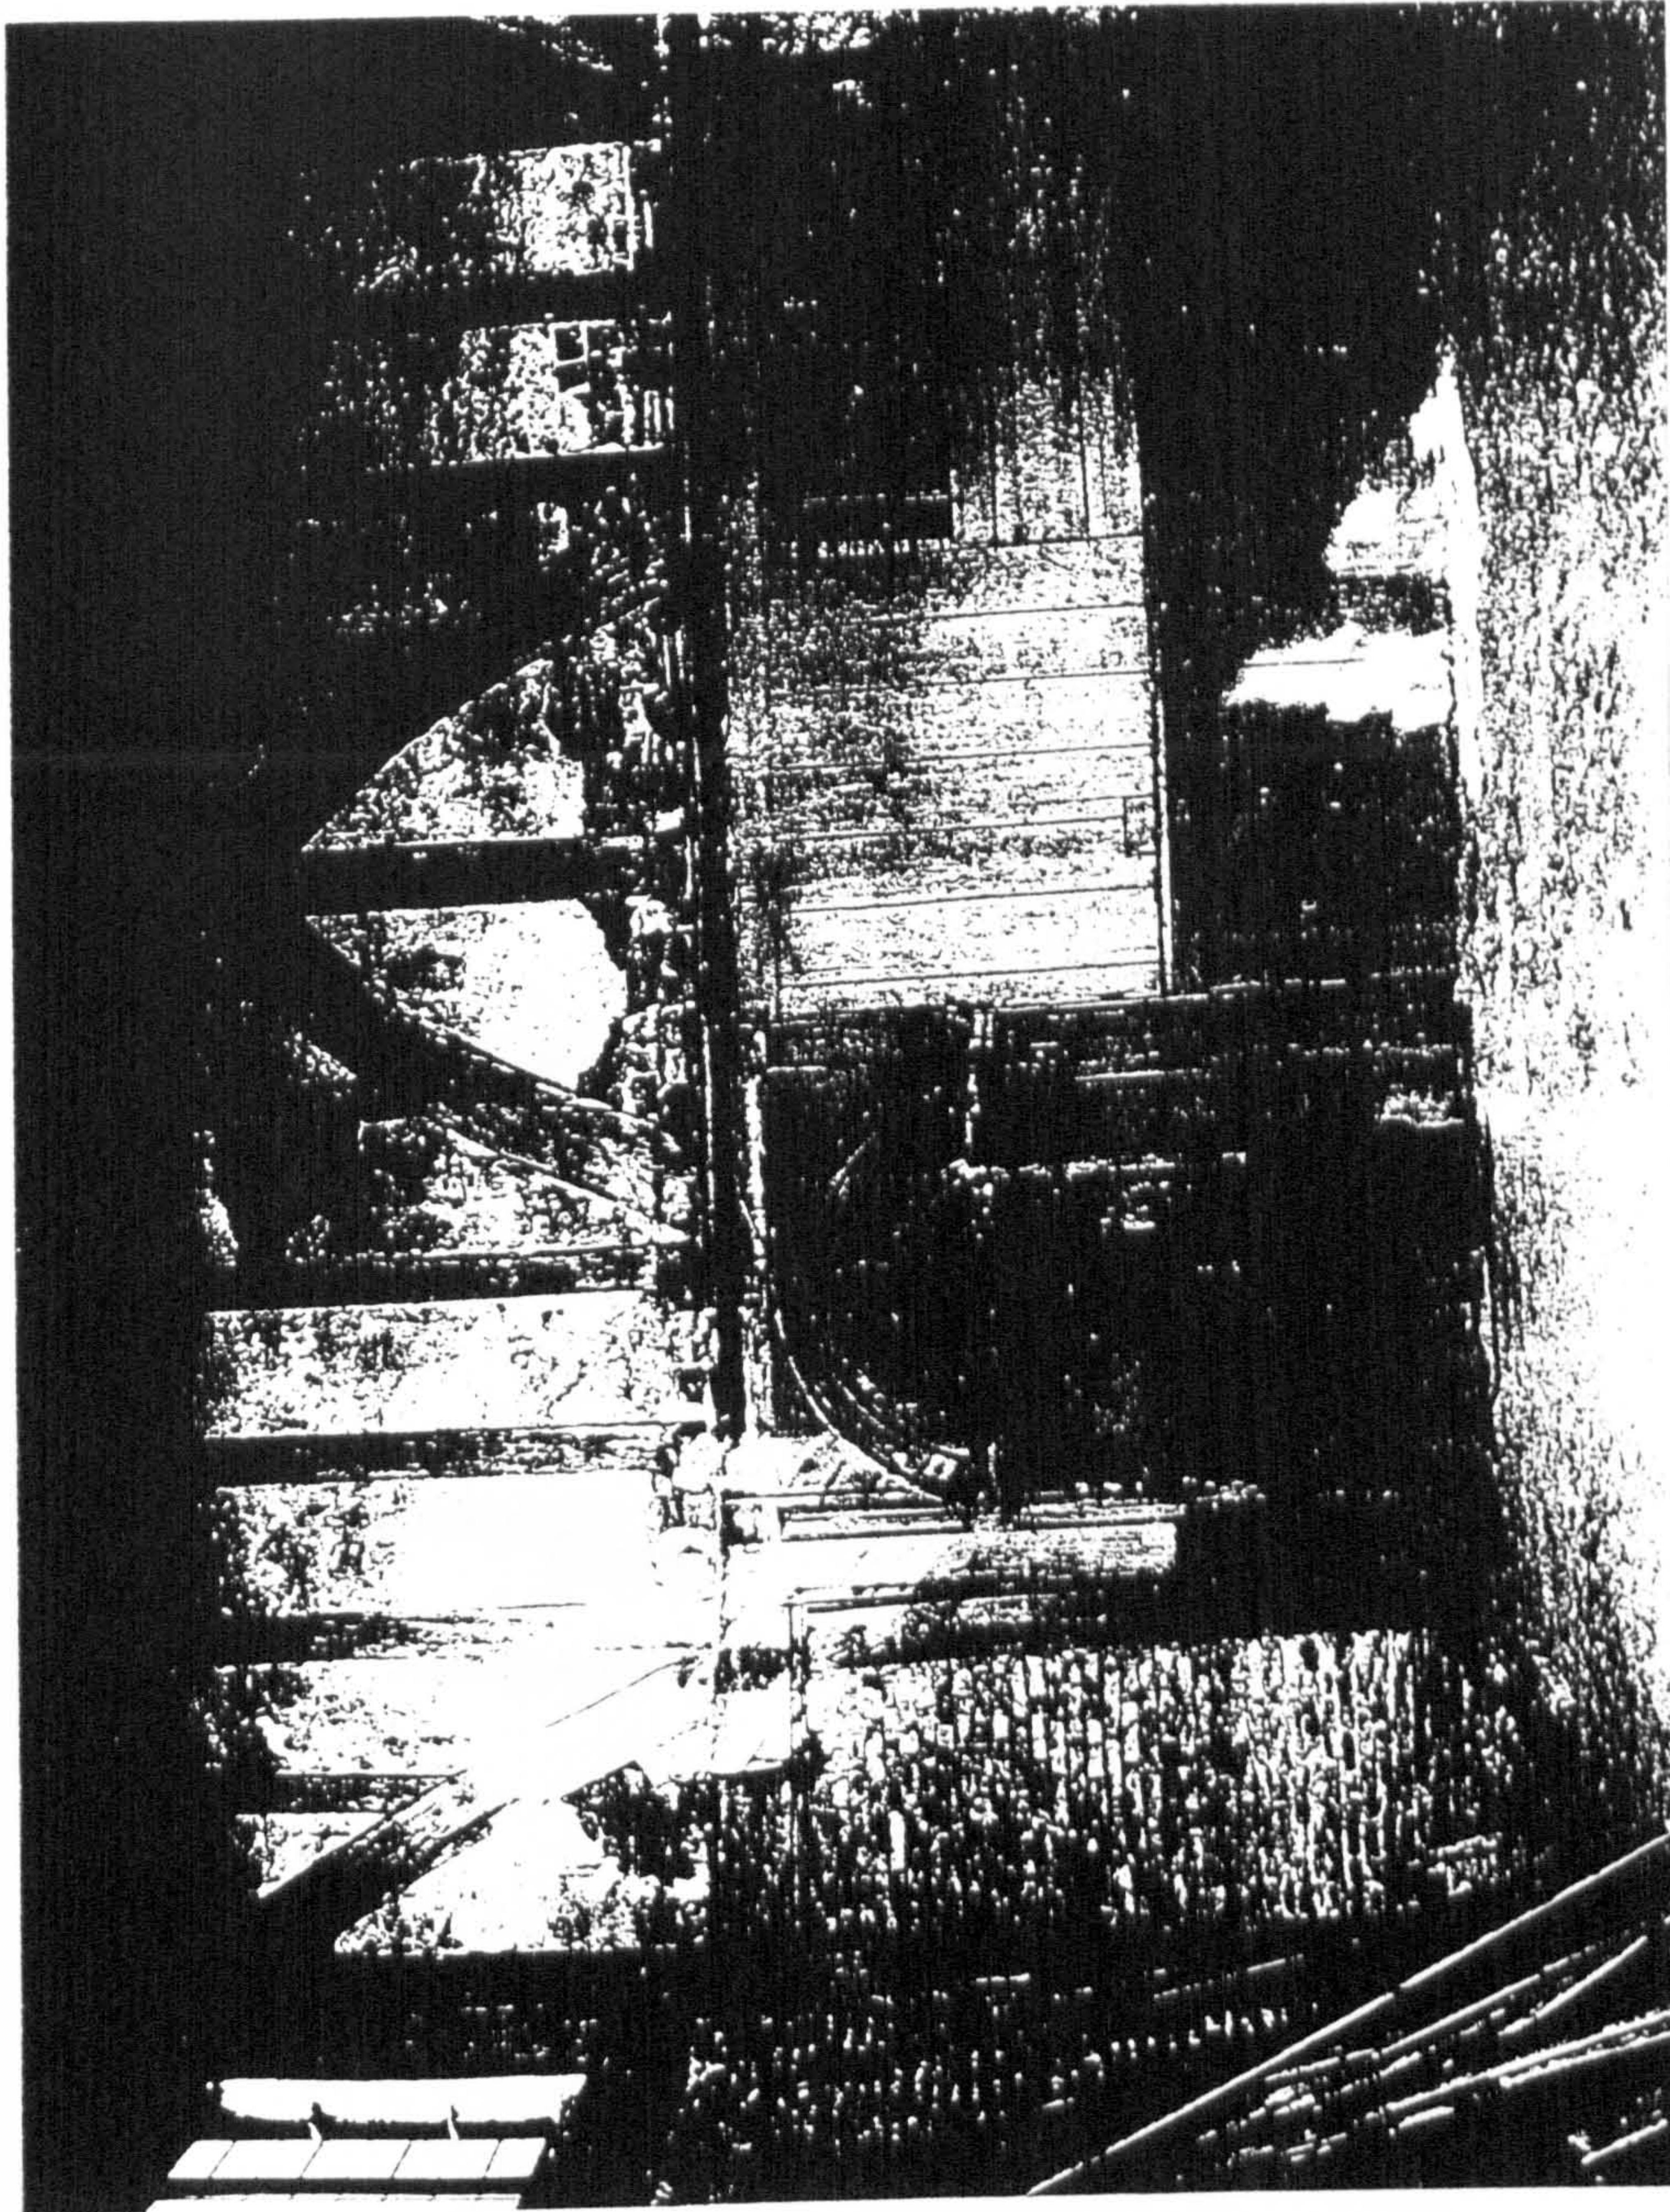
Fig. 105. Excavations at the north-west end of St. John the Baptist's hall (YAT 1991).

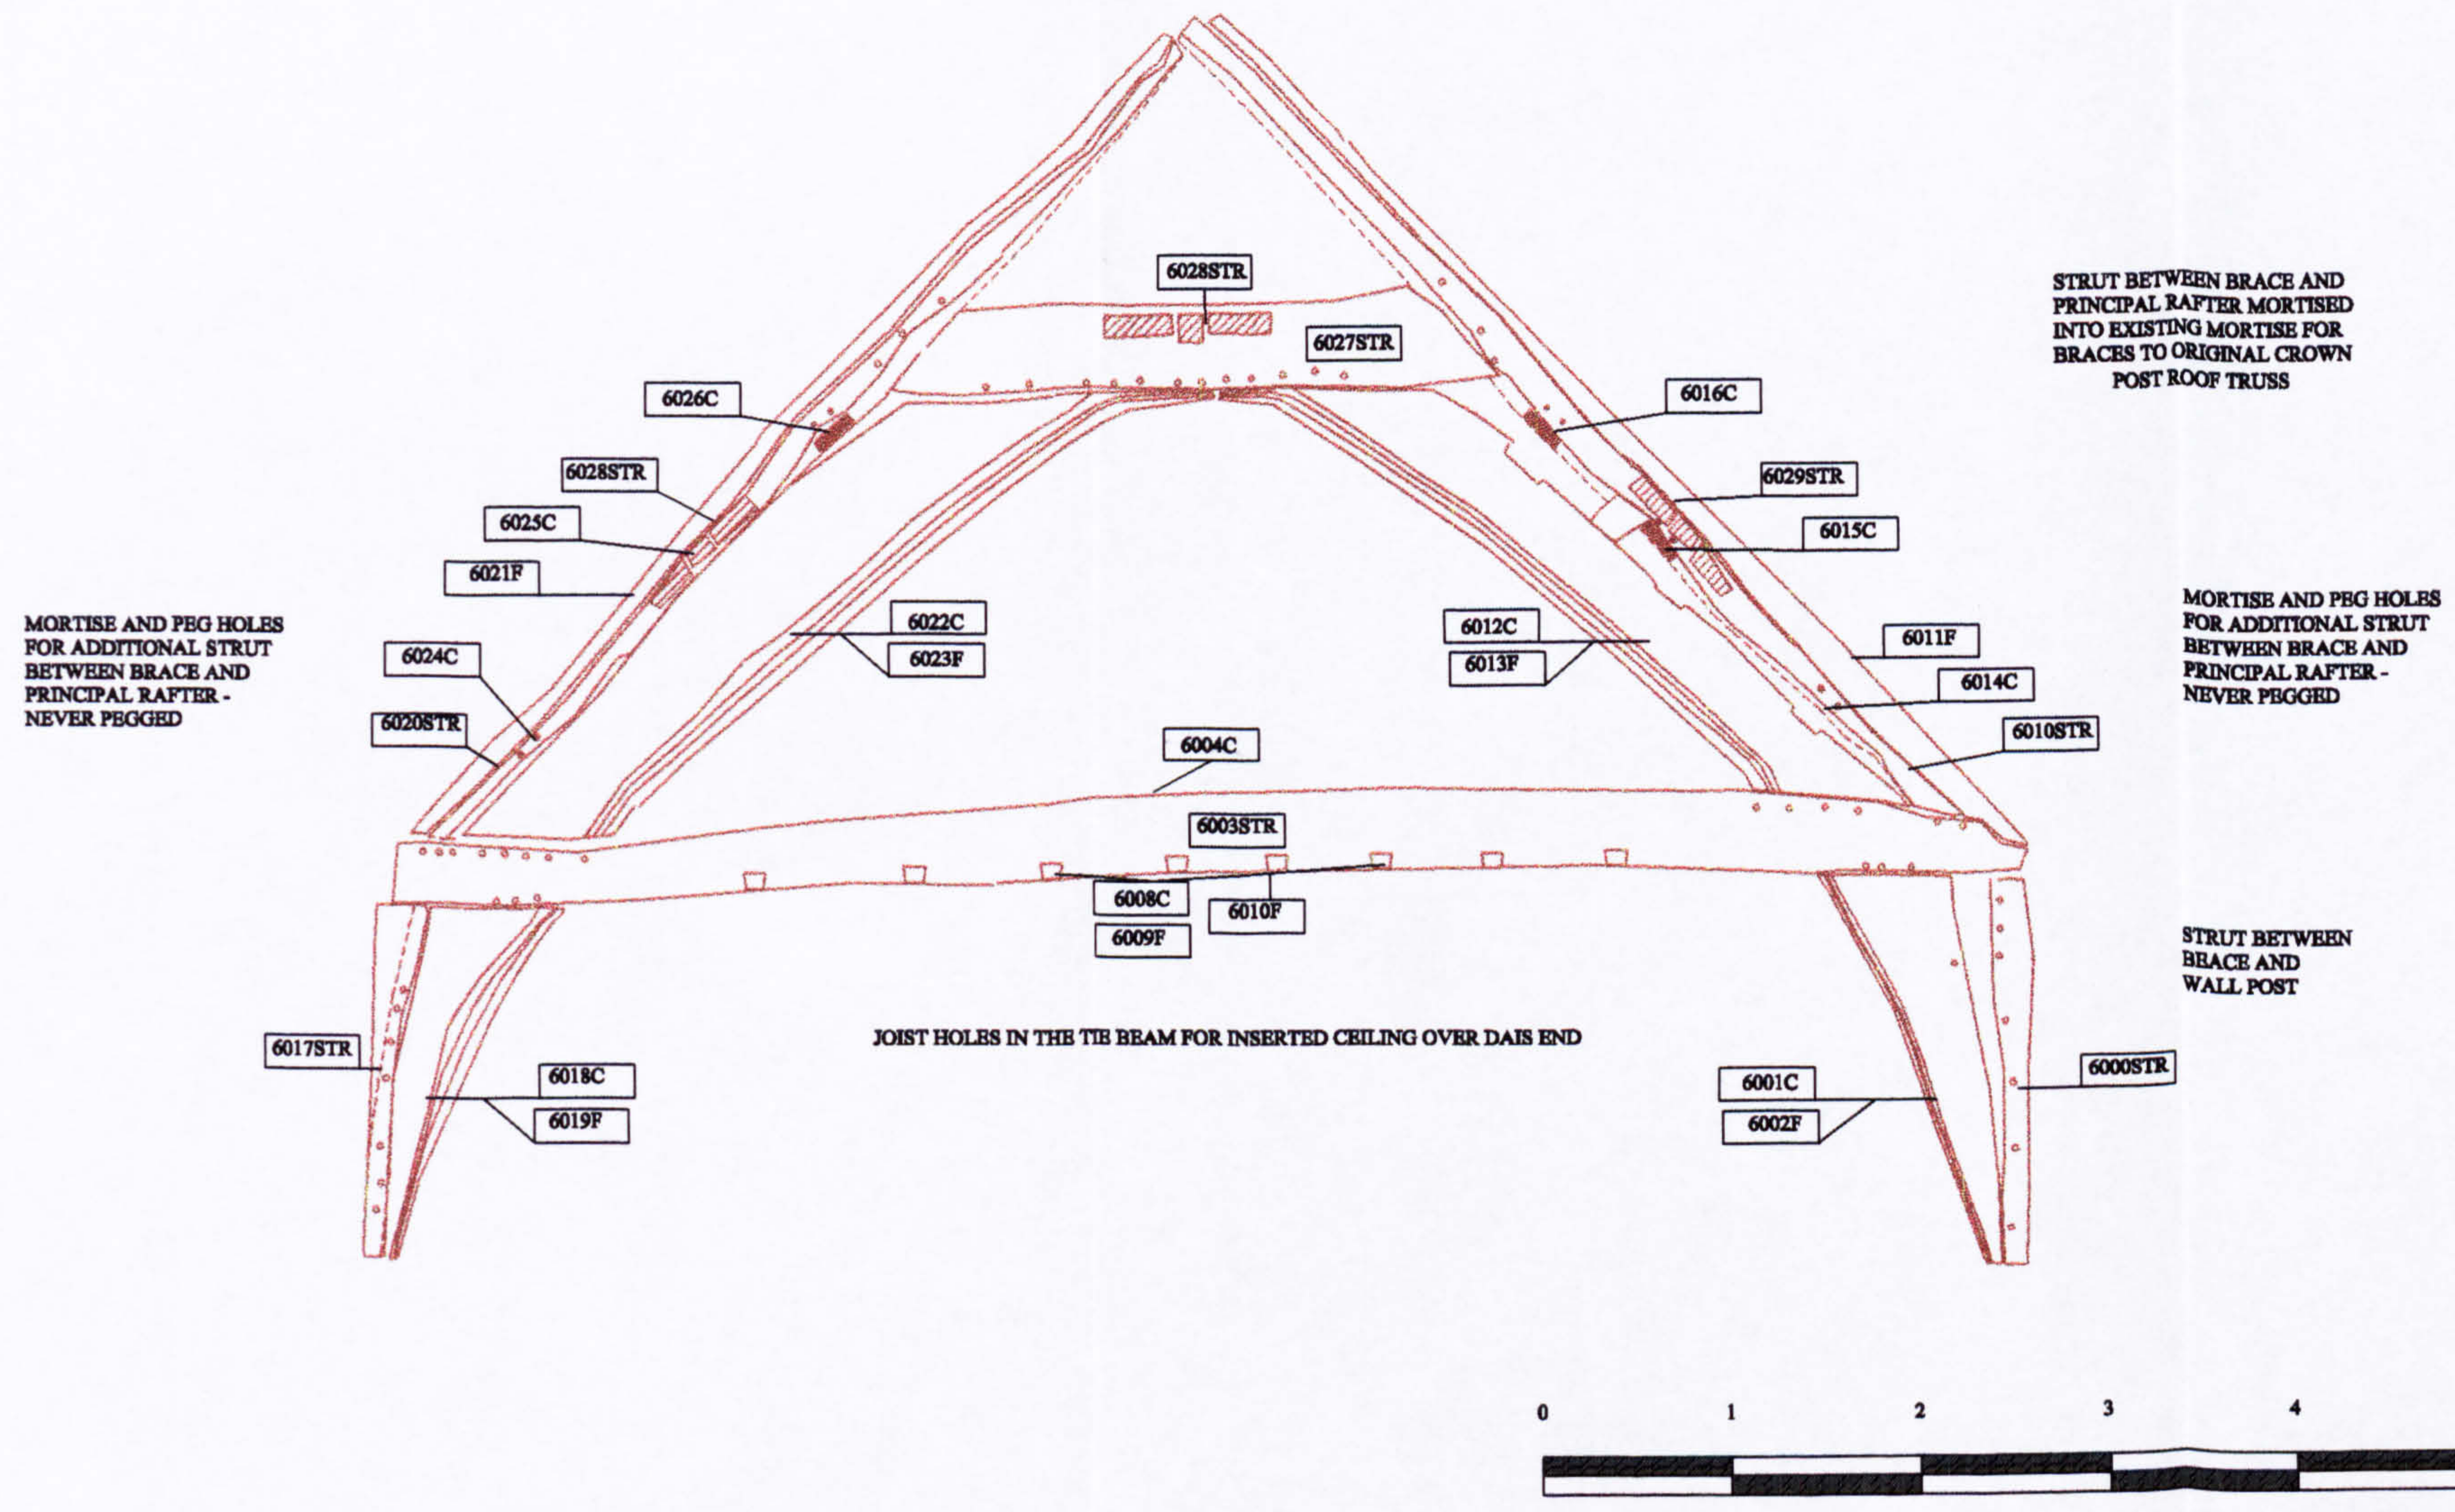
ST. JOHN THE BAPTIST'S HALL (THE MERCHANT TAYLORS'), YORK. ROOF TRUSS 6.

Fig. 111. Cross section of roof truss 6, St. John the Baptist's hall, York.

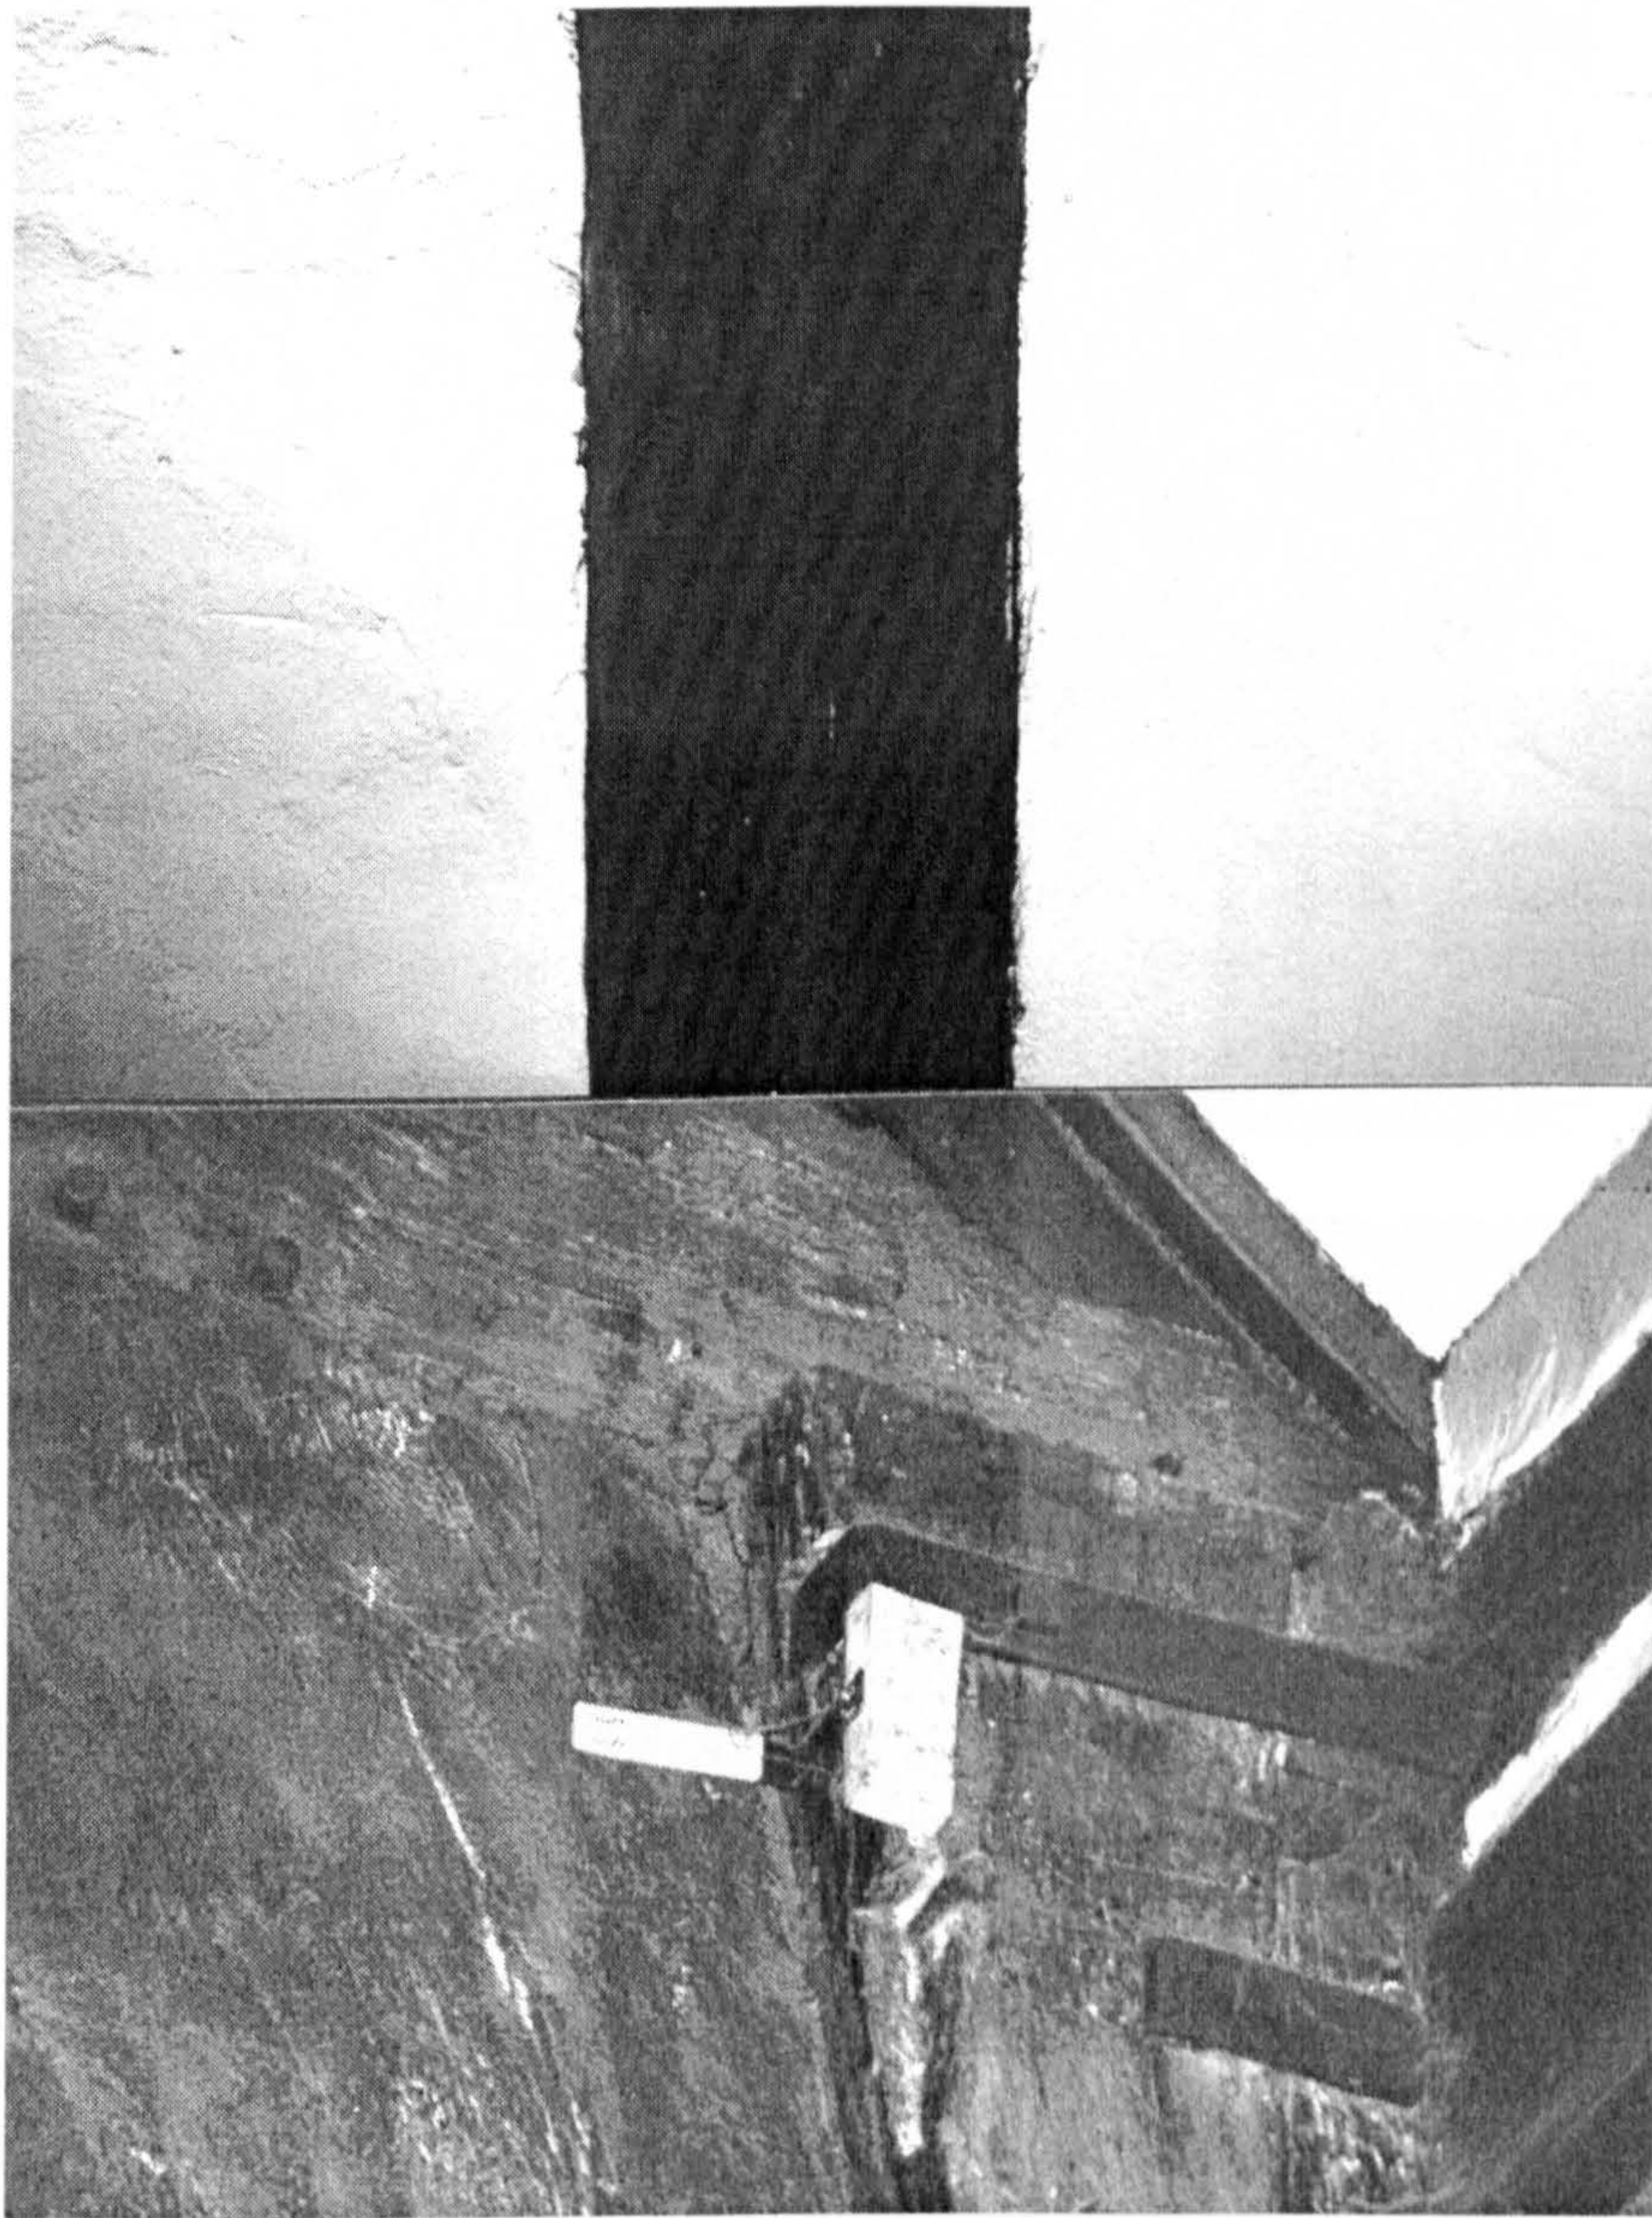
Fig. 117. Ground floor plan of St. John the Baptist's hall, showing location of carpenters' marks.

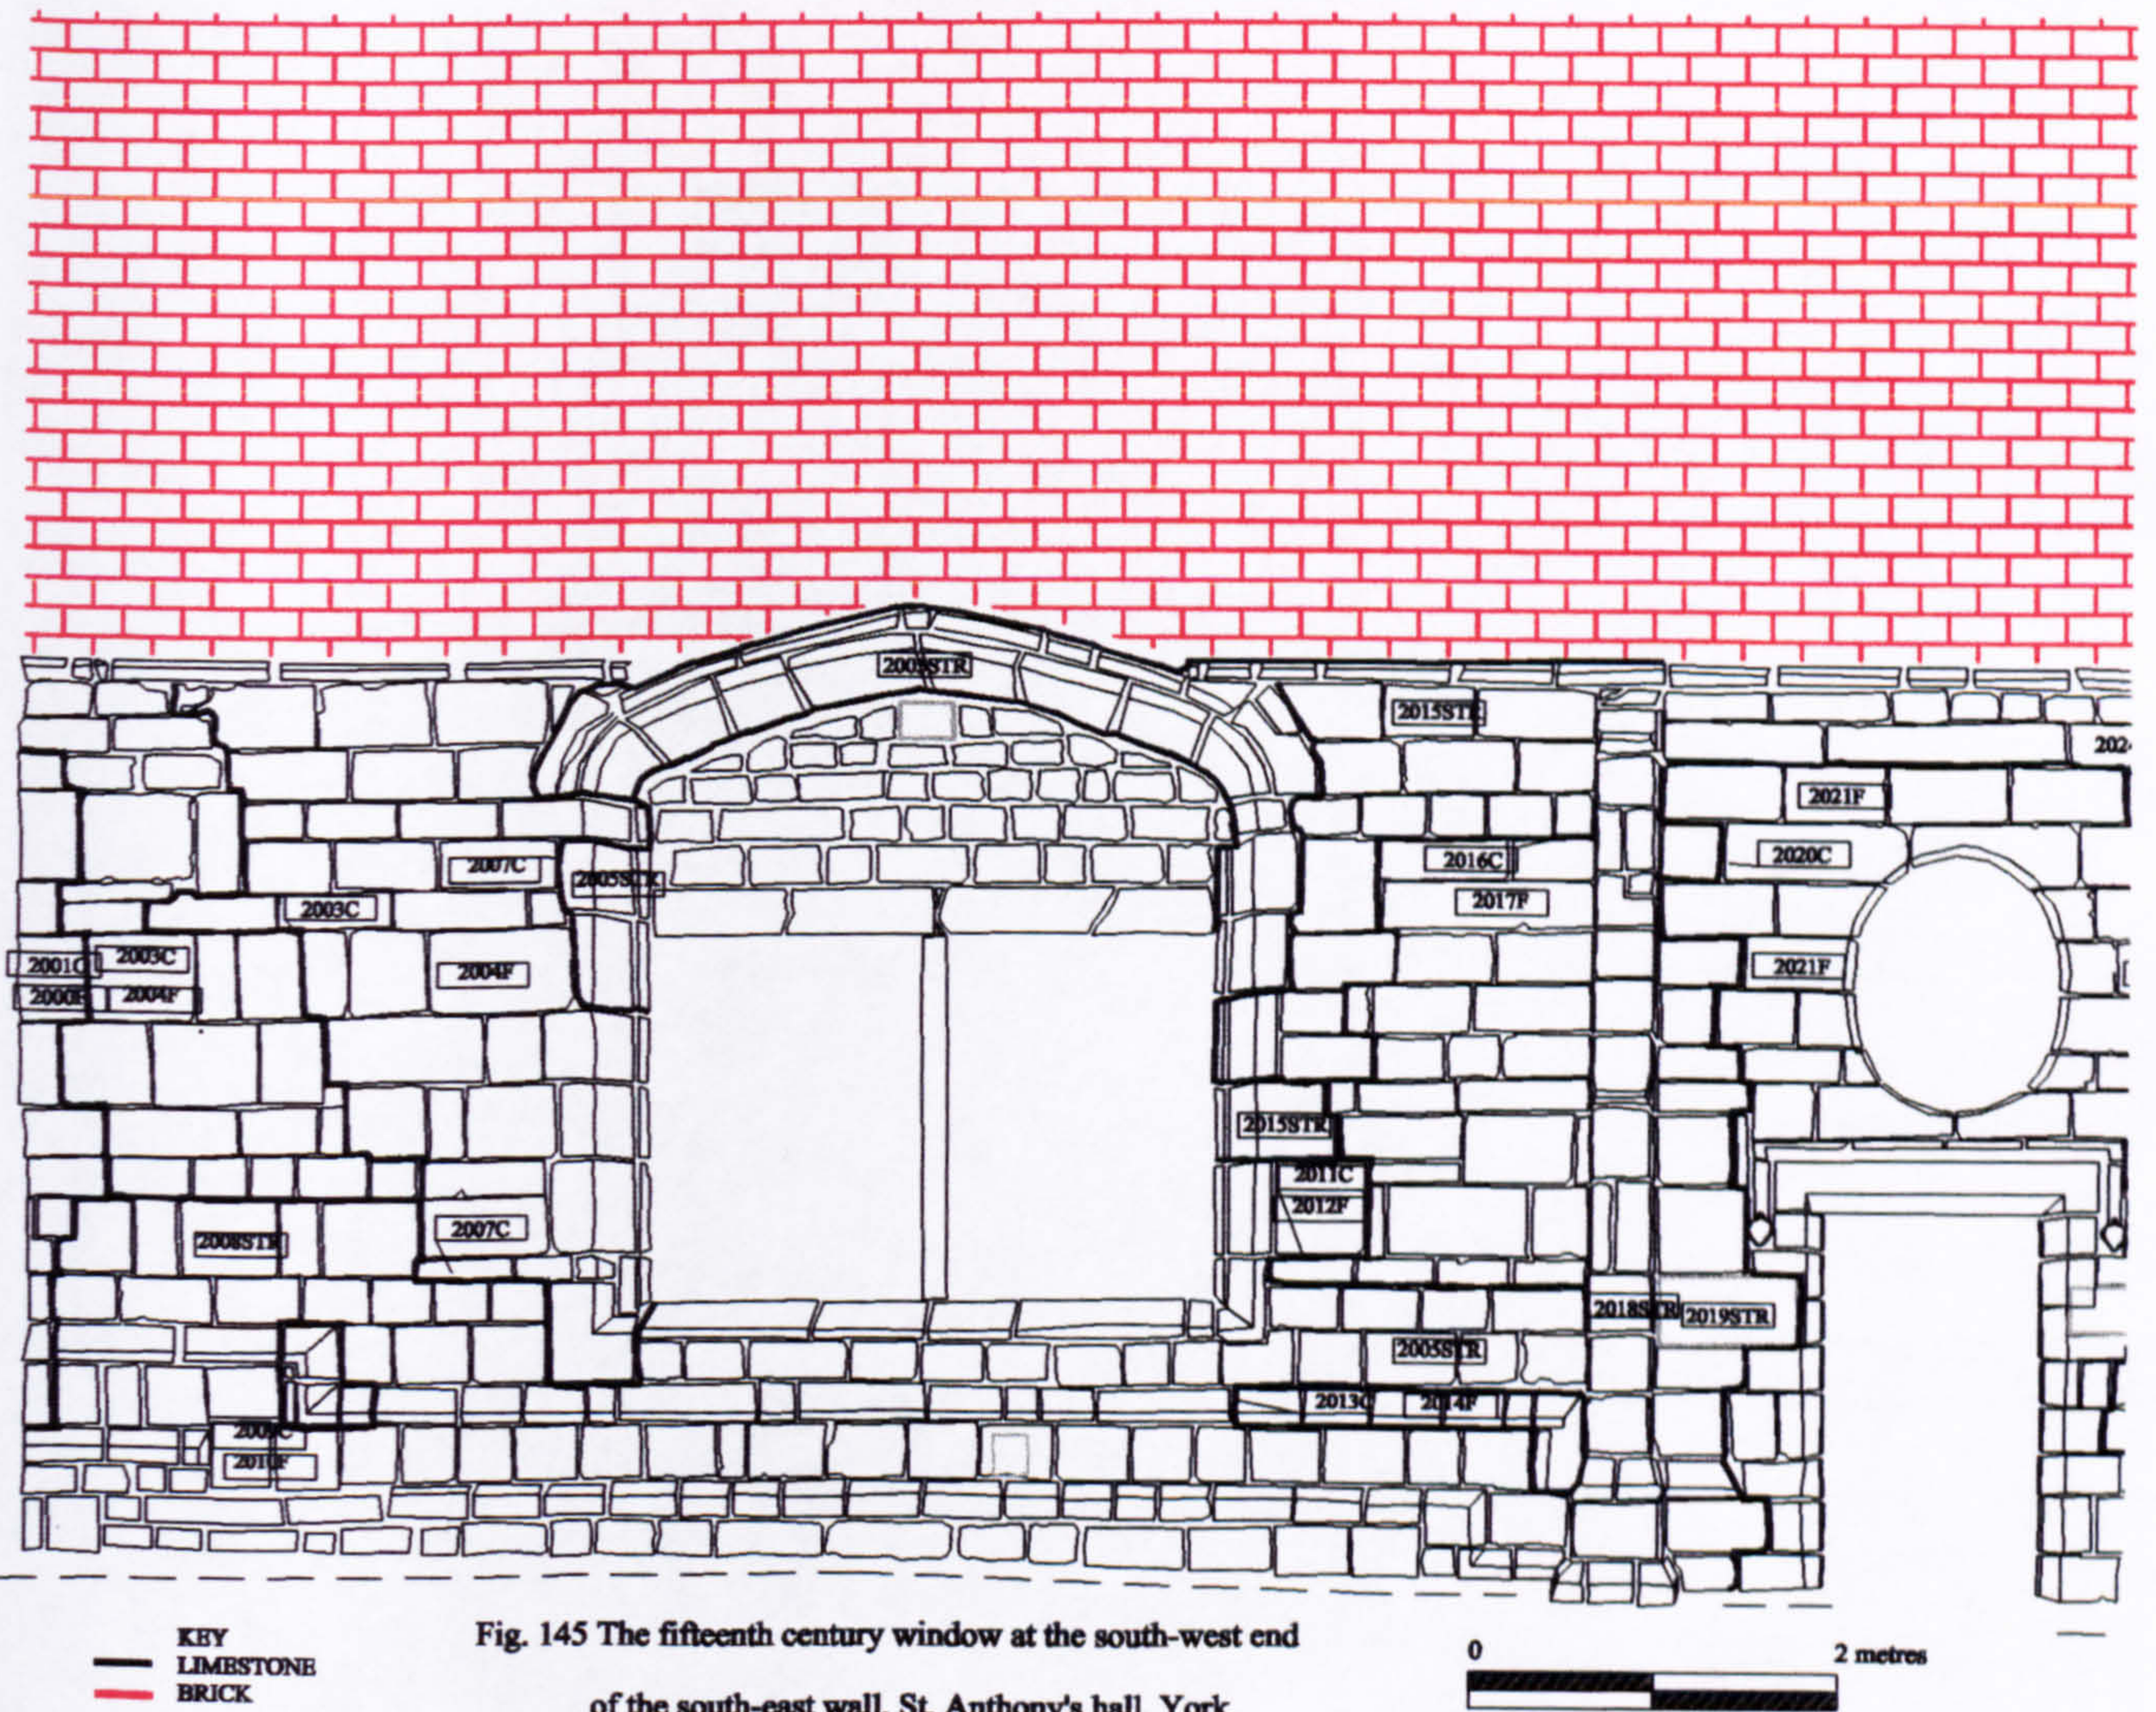
Fig. 144. The fifteenth century window at the south-east end of the chapel,
St. Anthony's hall.

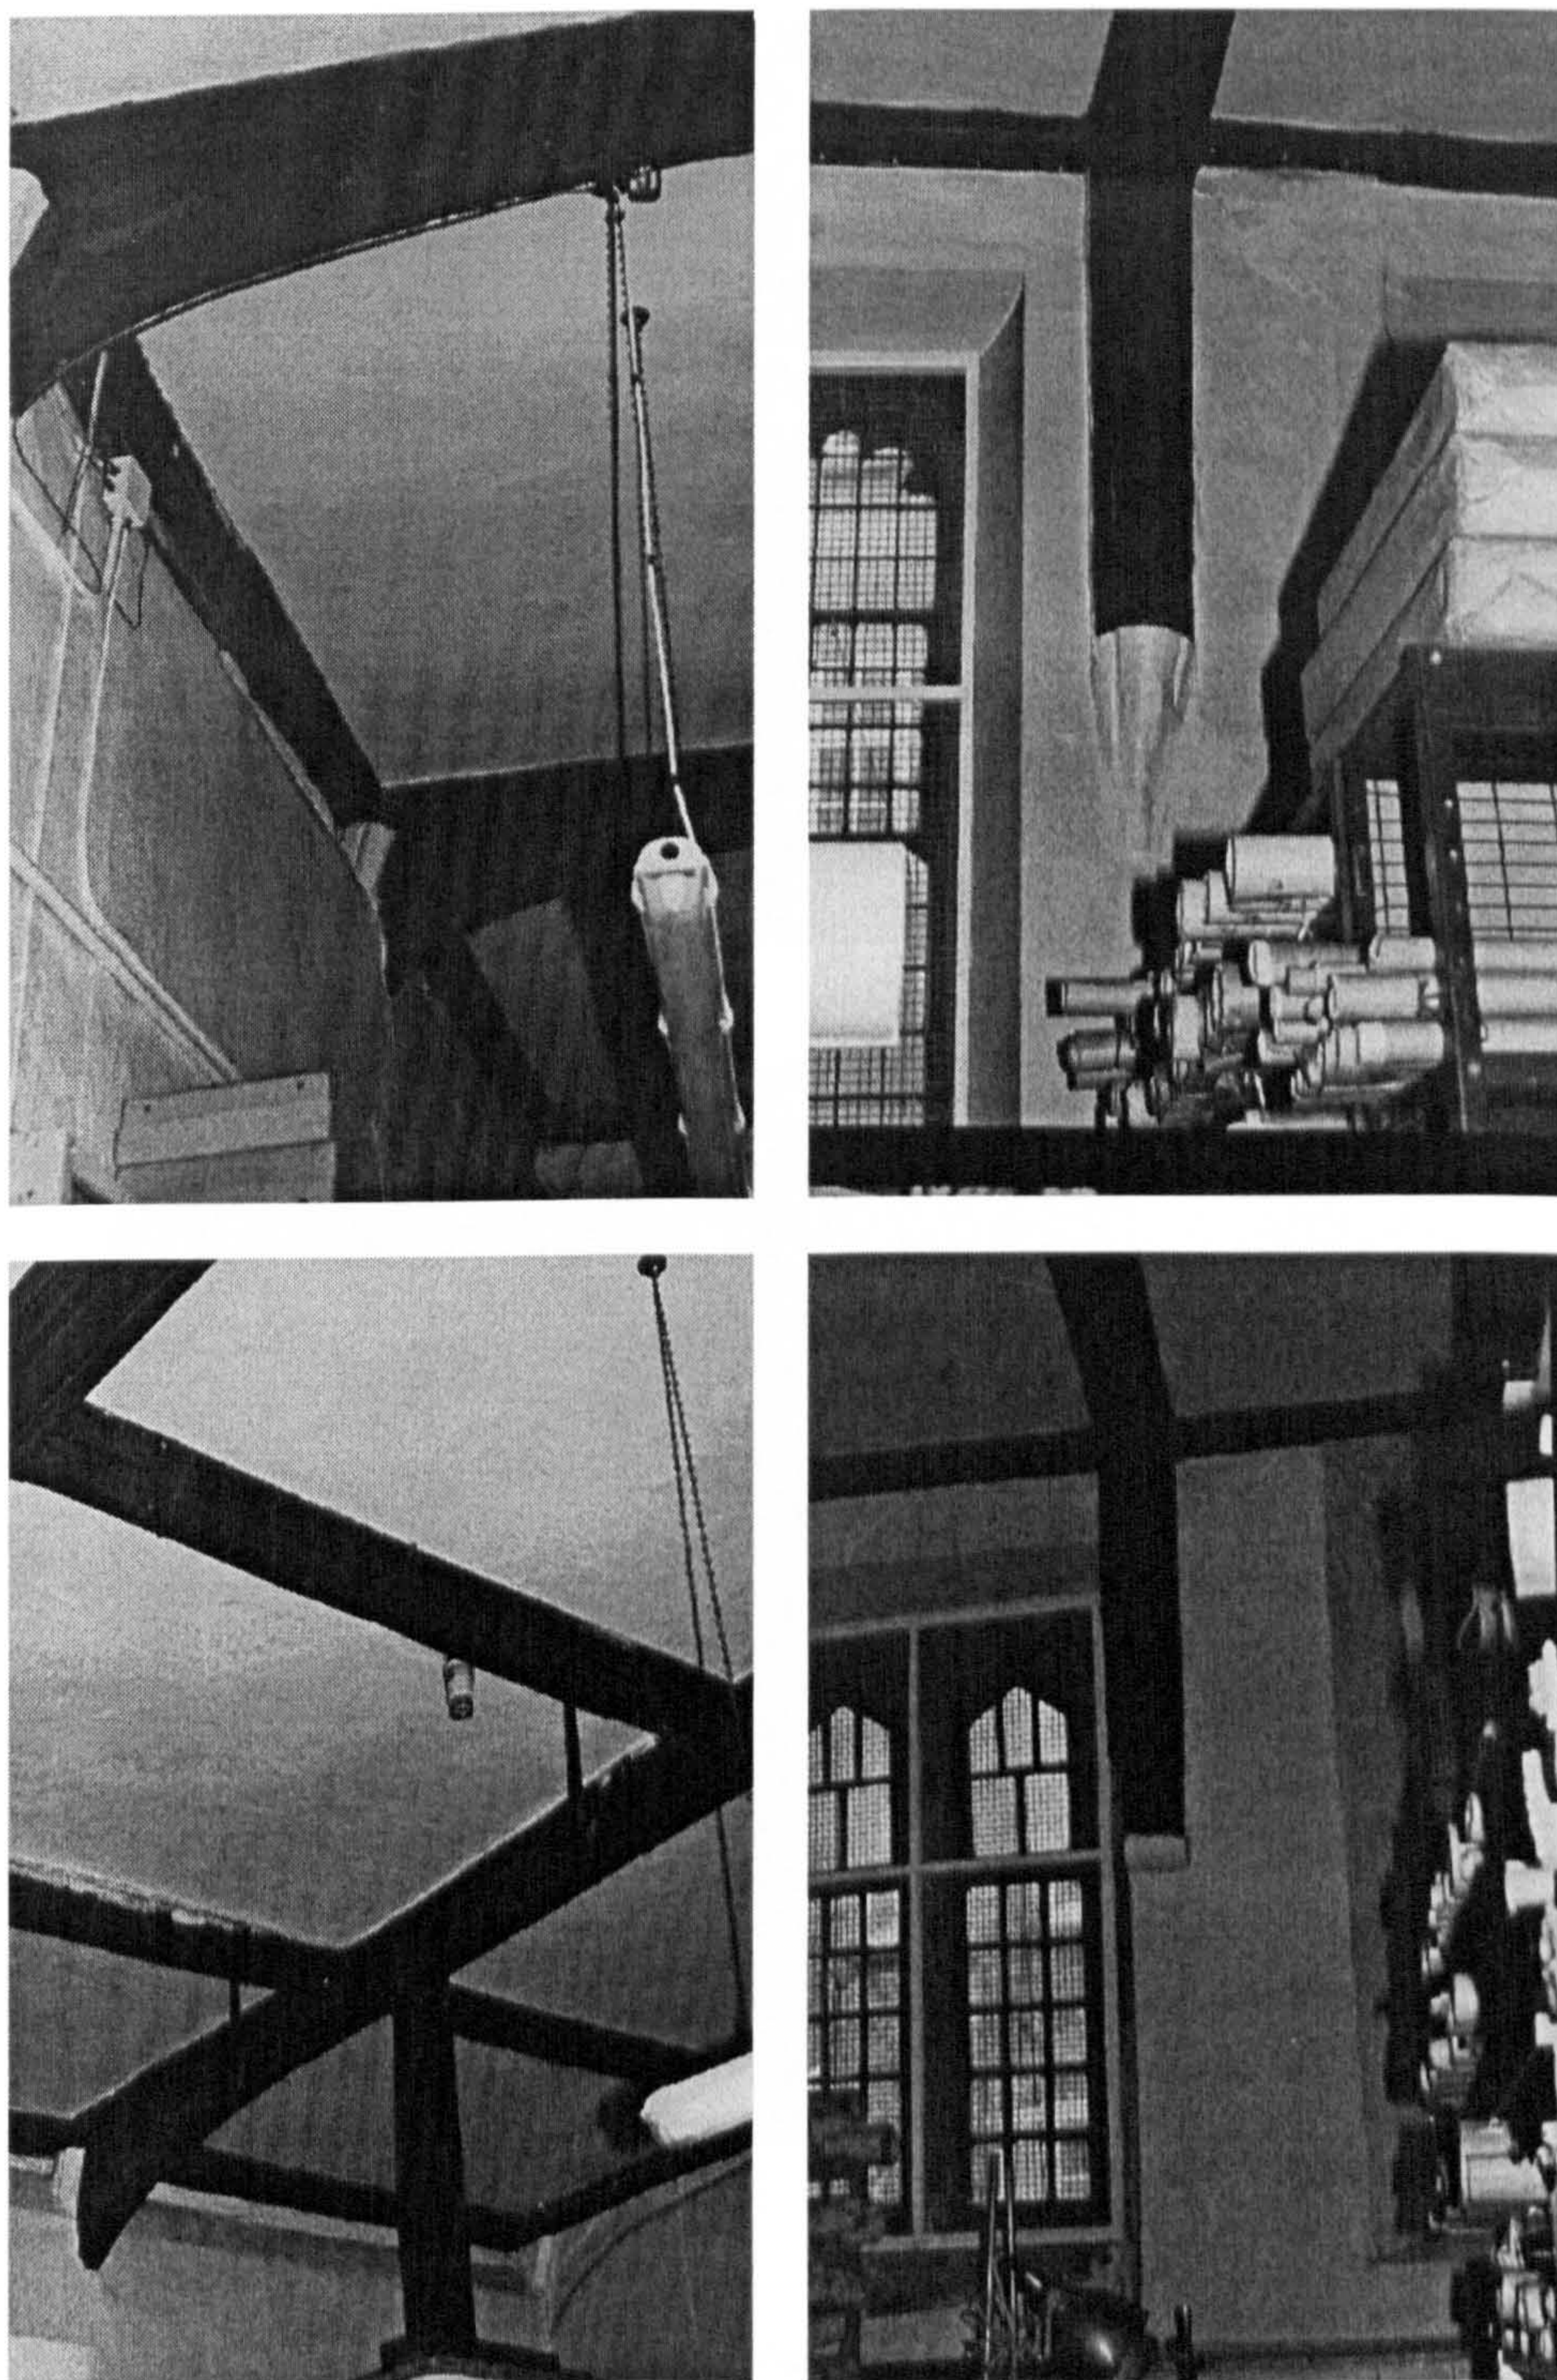
Fig. 151. Timber-framing in the area south-west of the ground floor passageway, St. Anthony's hall.

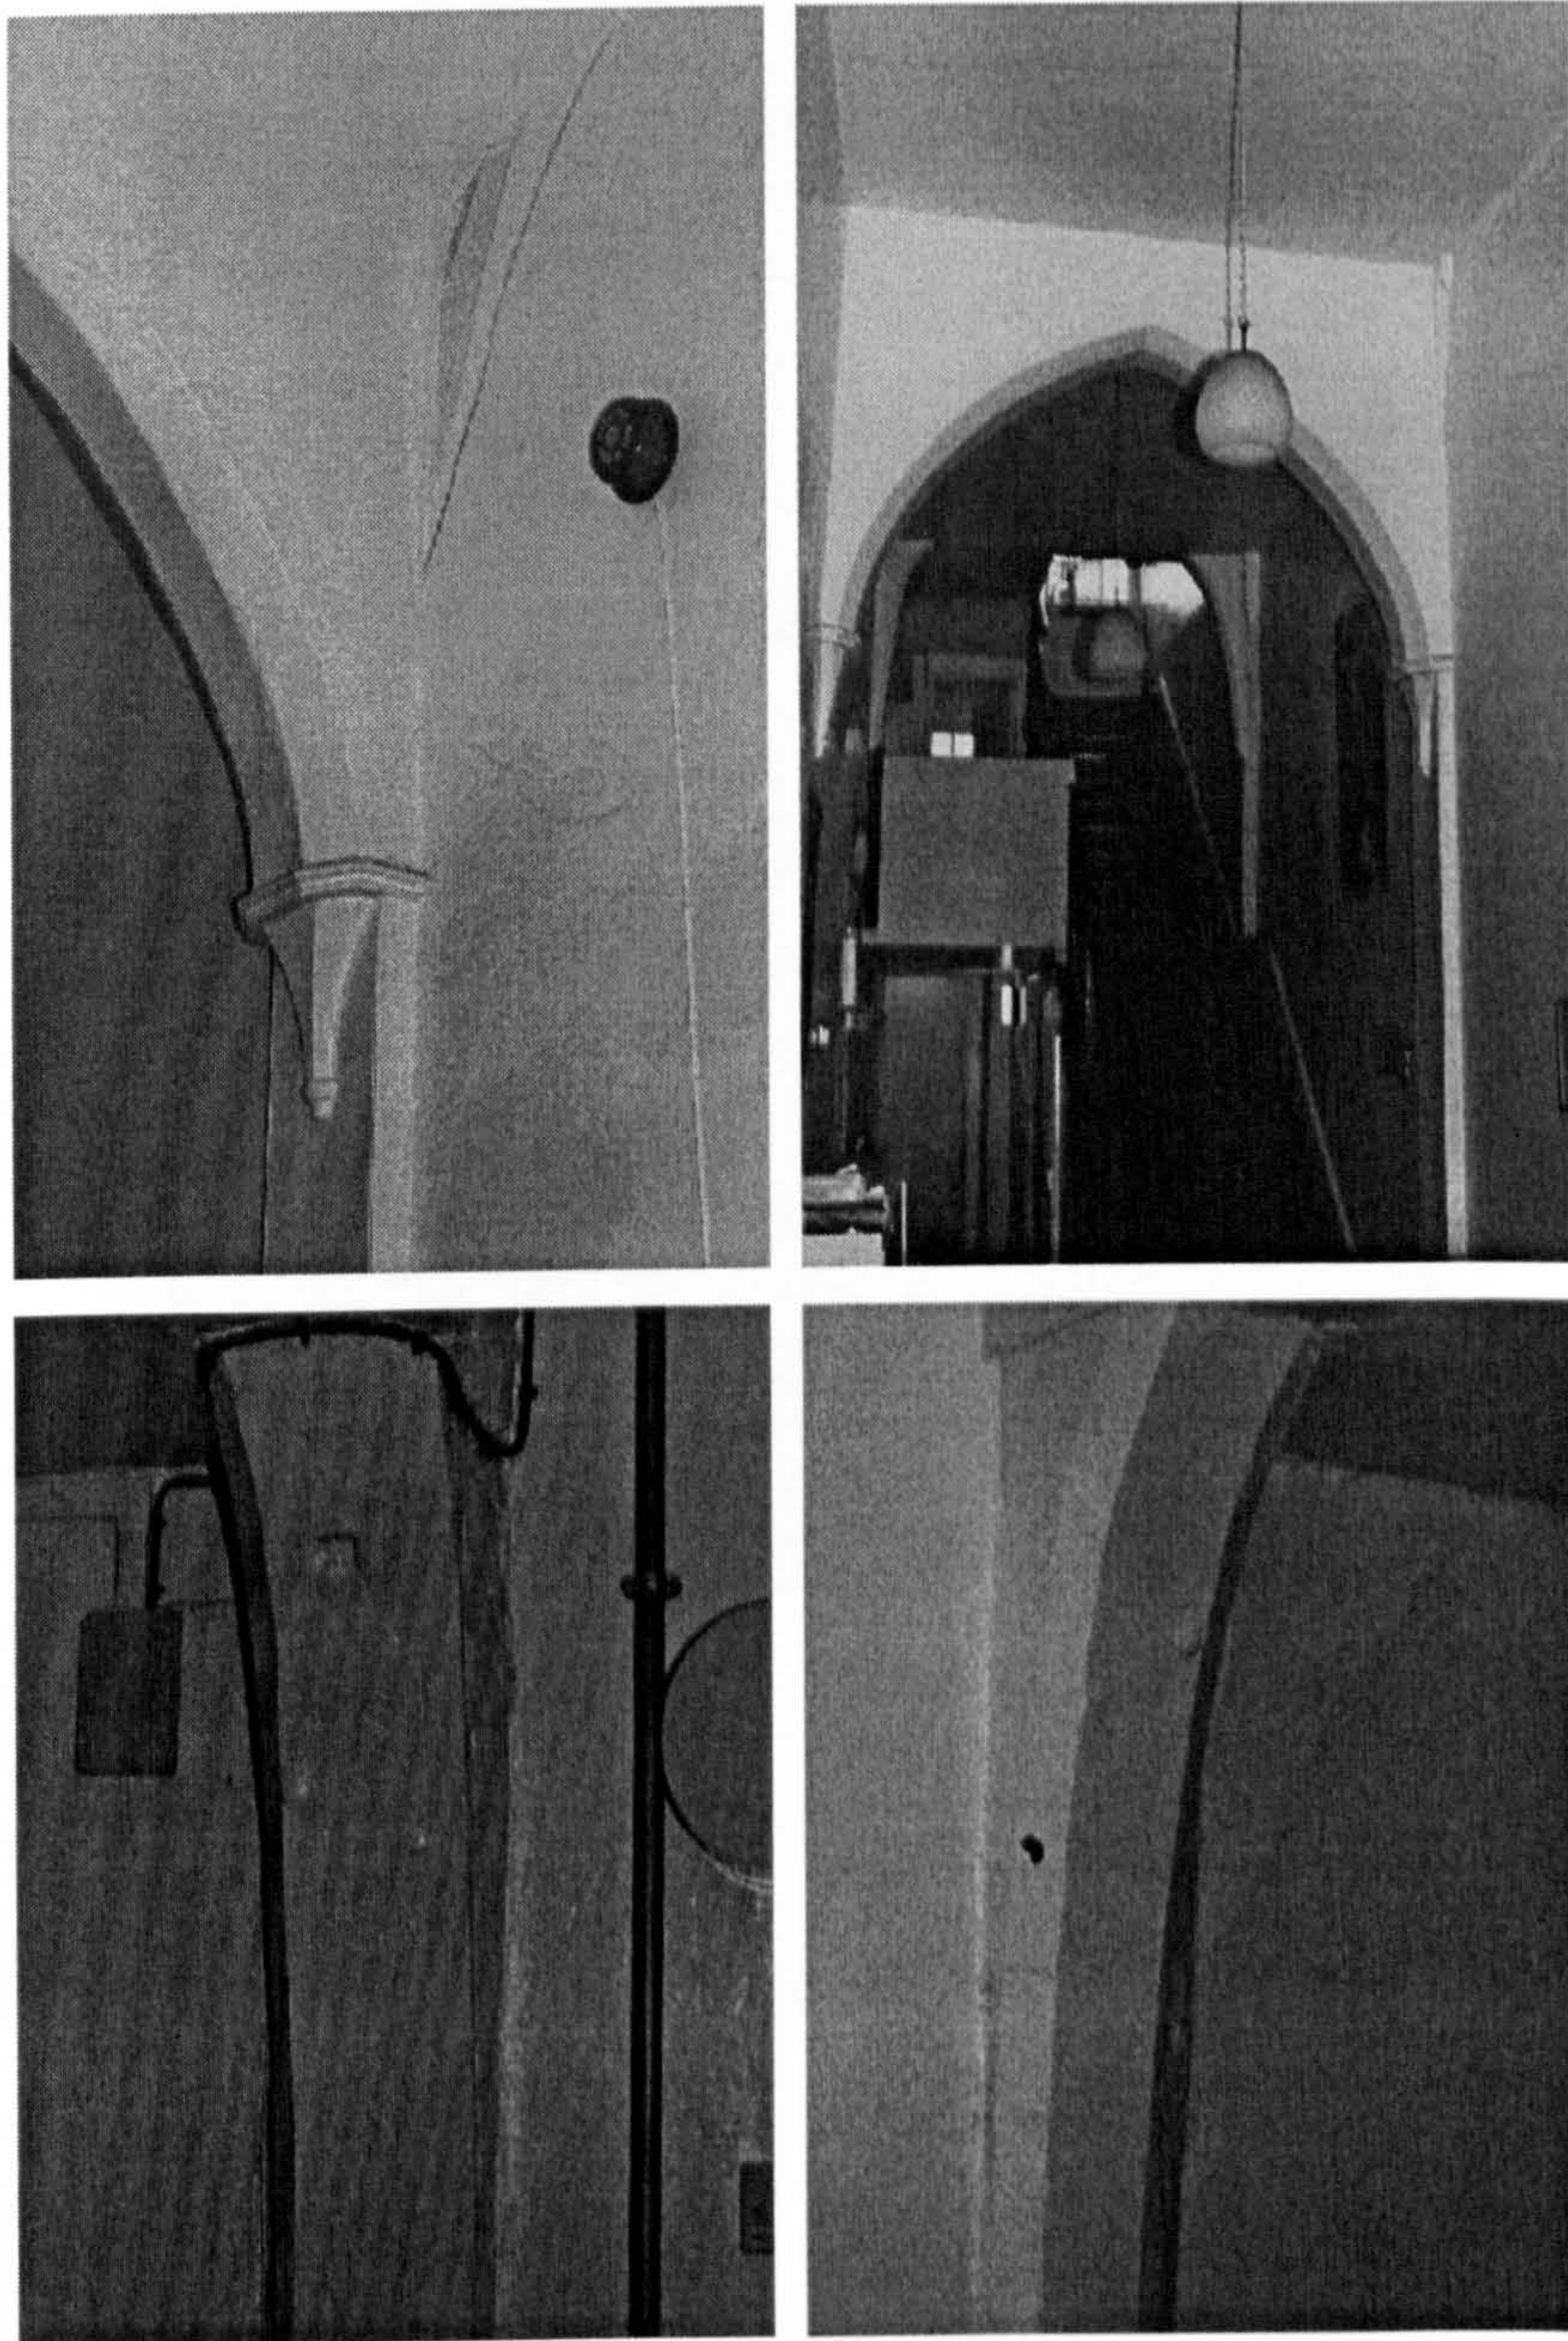
Fig. 153. Substantial mortises running along the transverse timbers of the last two bays at the north-east end of the ground floor of St. Anthony's hall.
