**Guildhalls and Social Identity in Late Medieval and
Early Modern York, c.1350 - 1630.**

2 volumes: volume 2.

**Submitted for the degree of D. Phil to the University of York.
Department of Archaeology.
August 1999.**

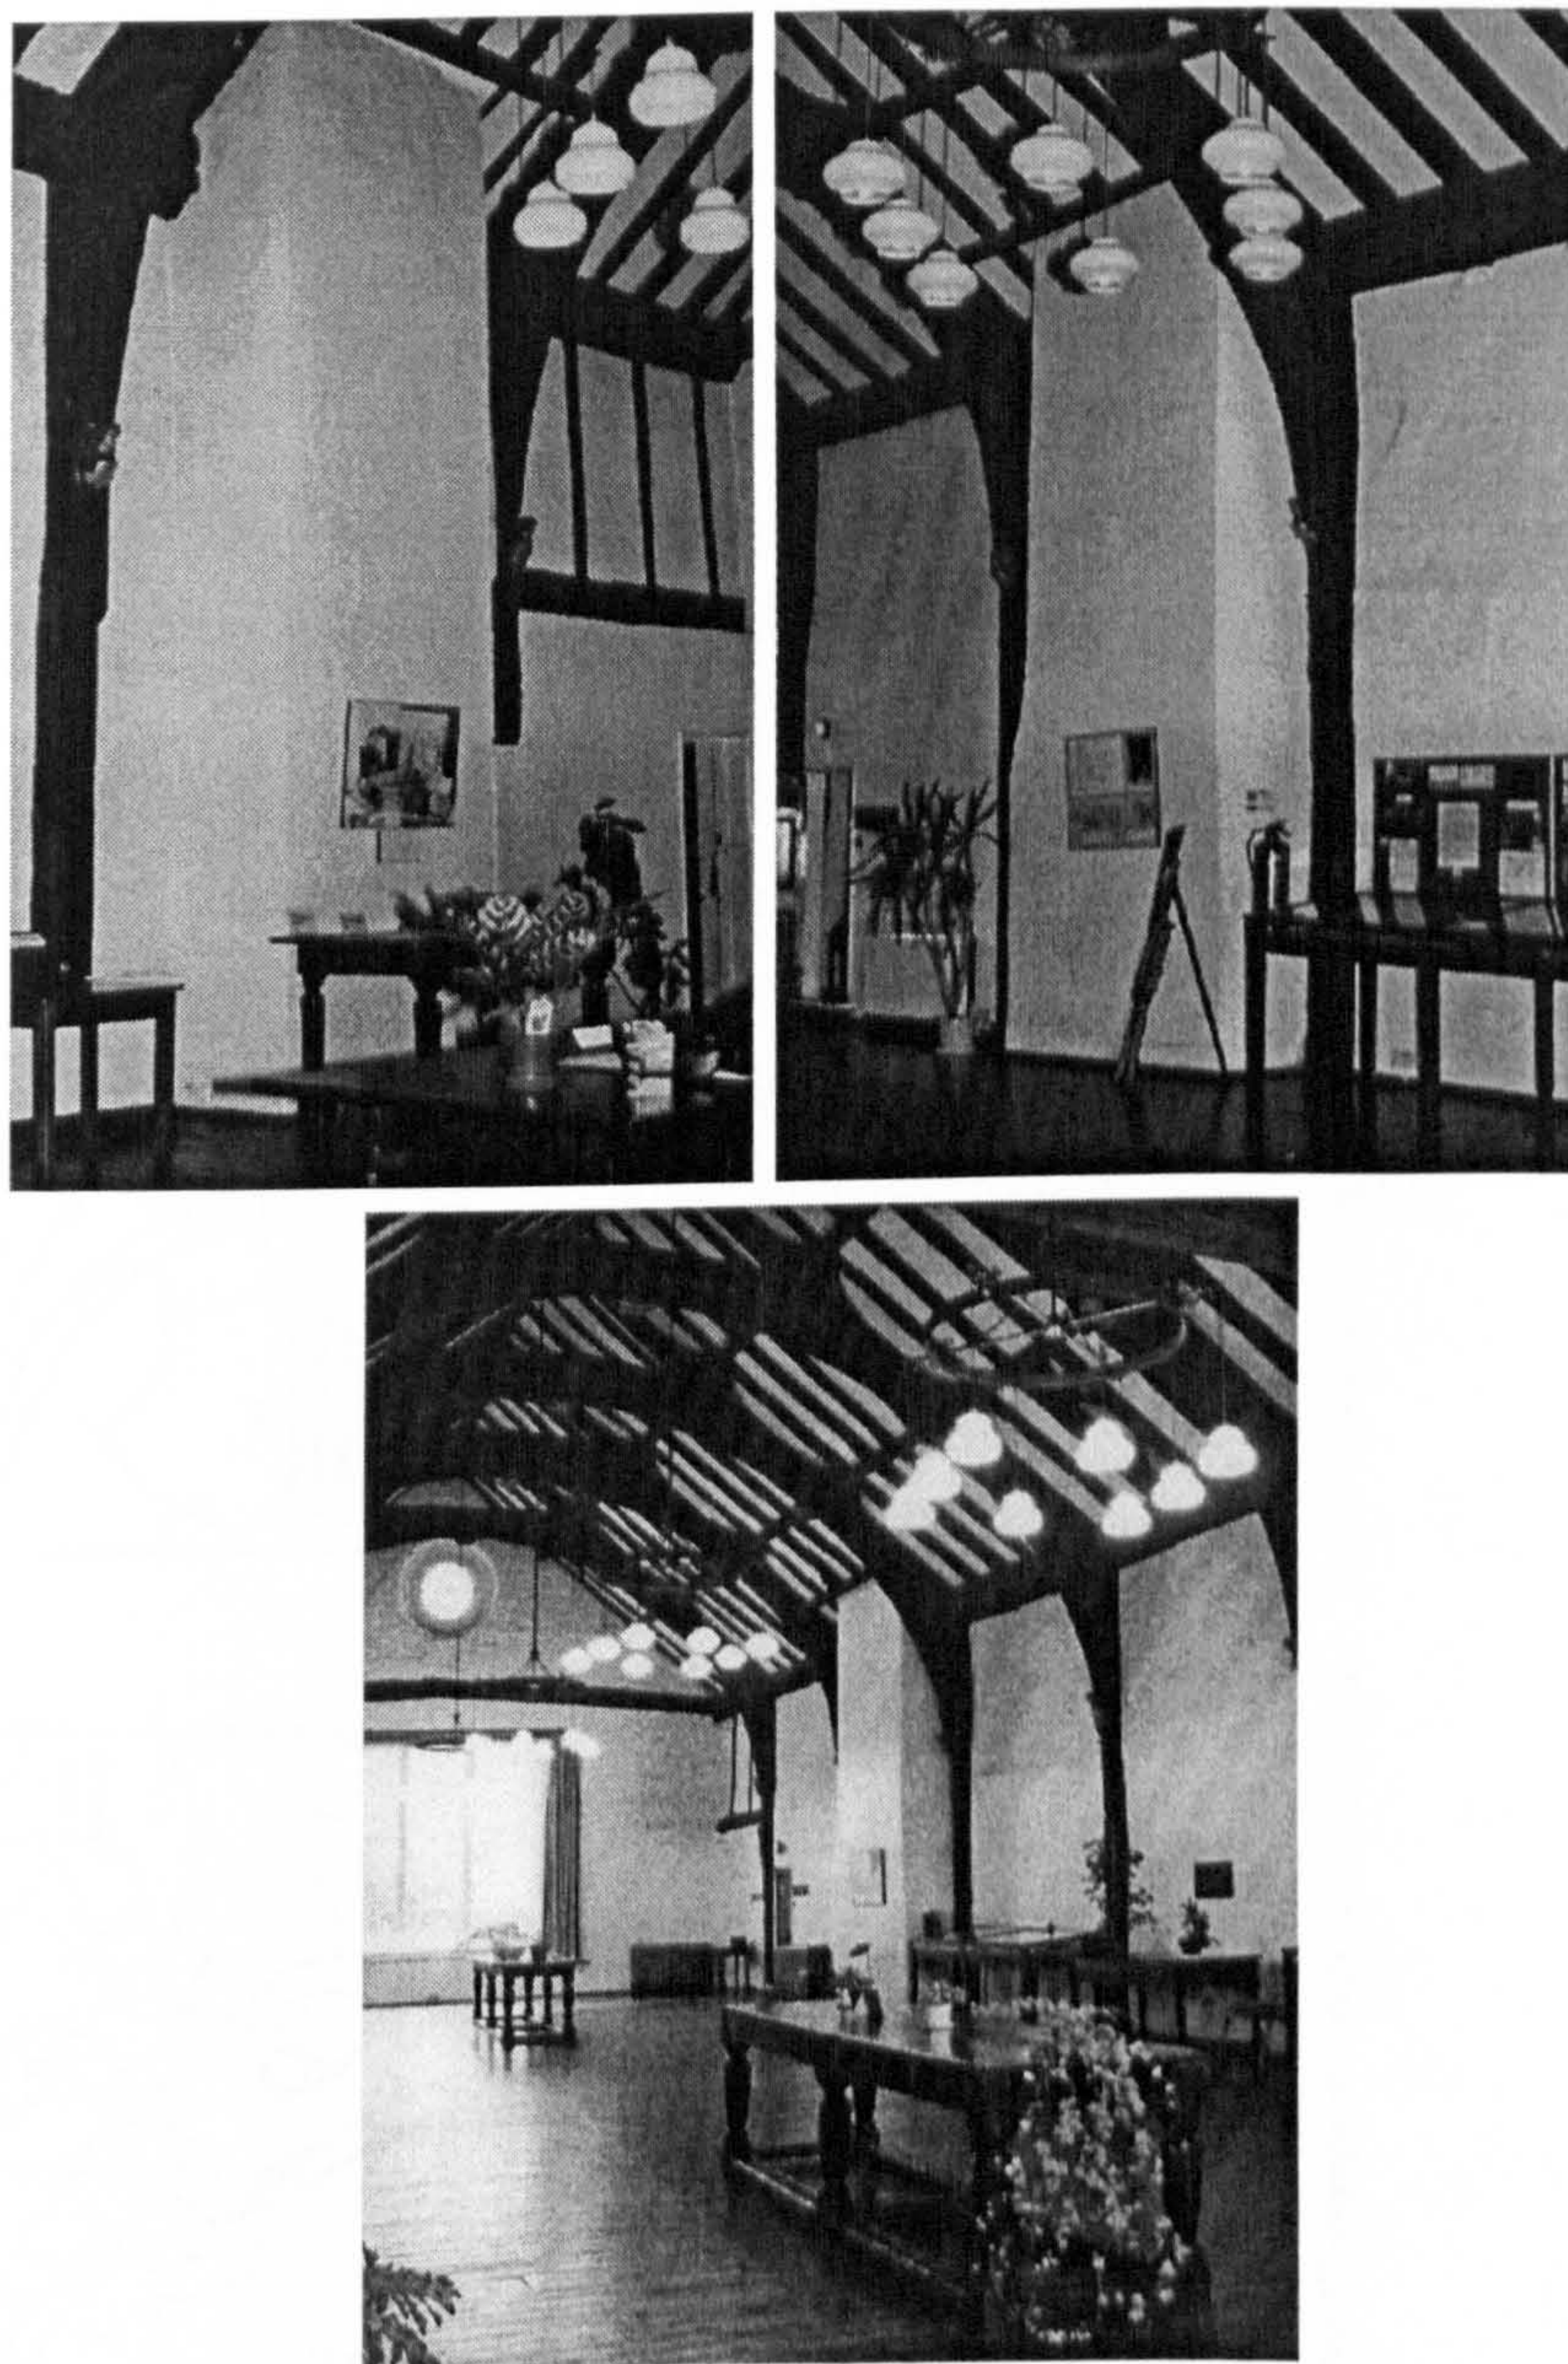
Fig, 165. Timber-framing associated with the buttery and pantry in the south-east and north-west walls of St. Anthony's hall, York.

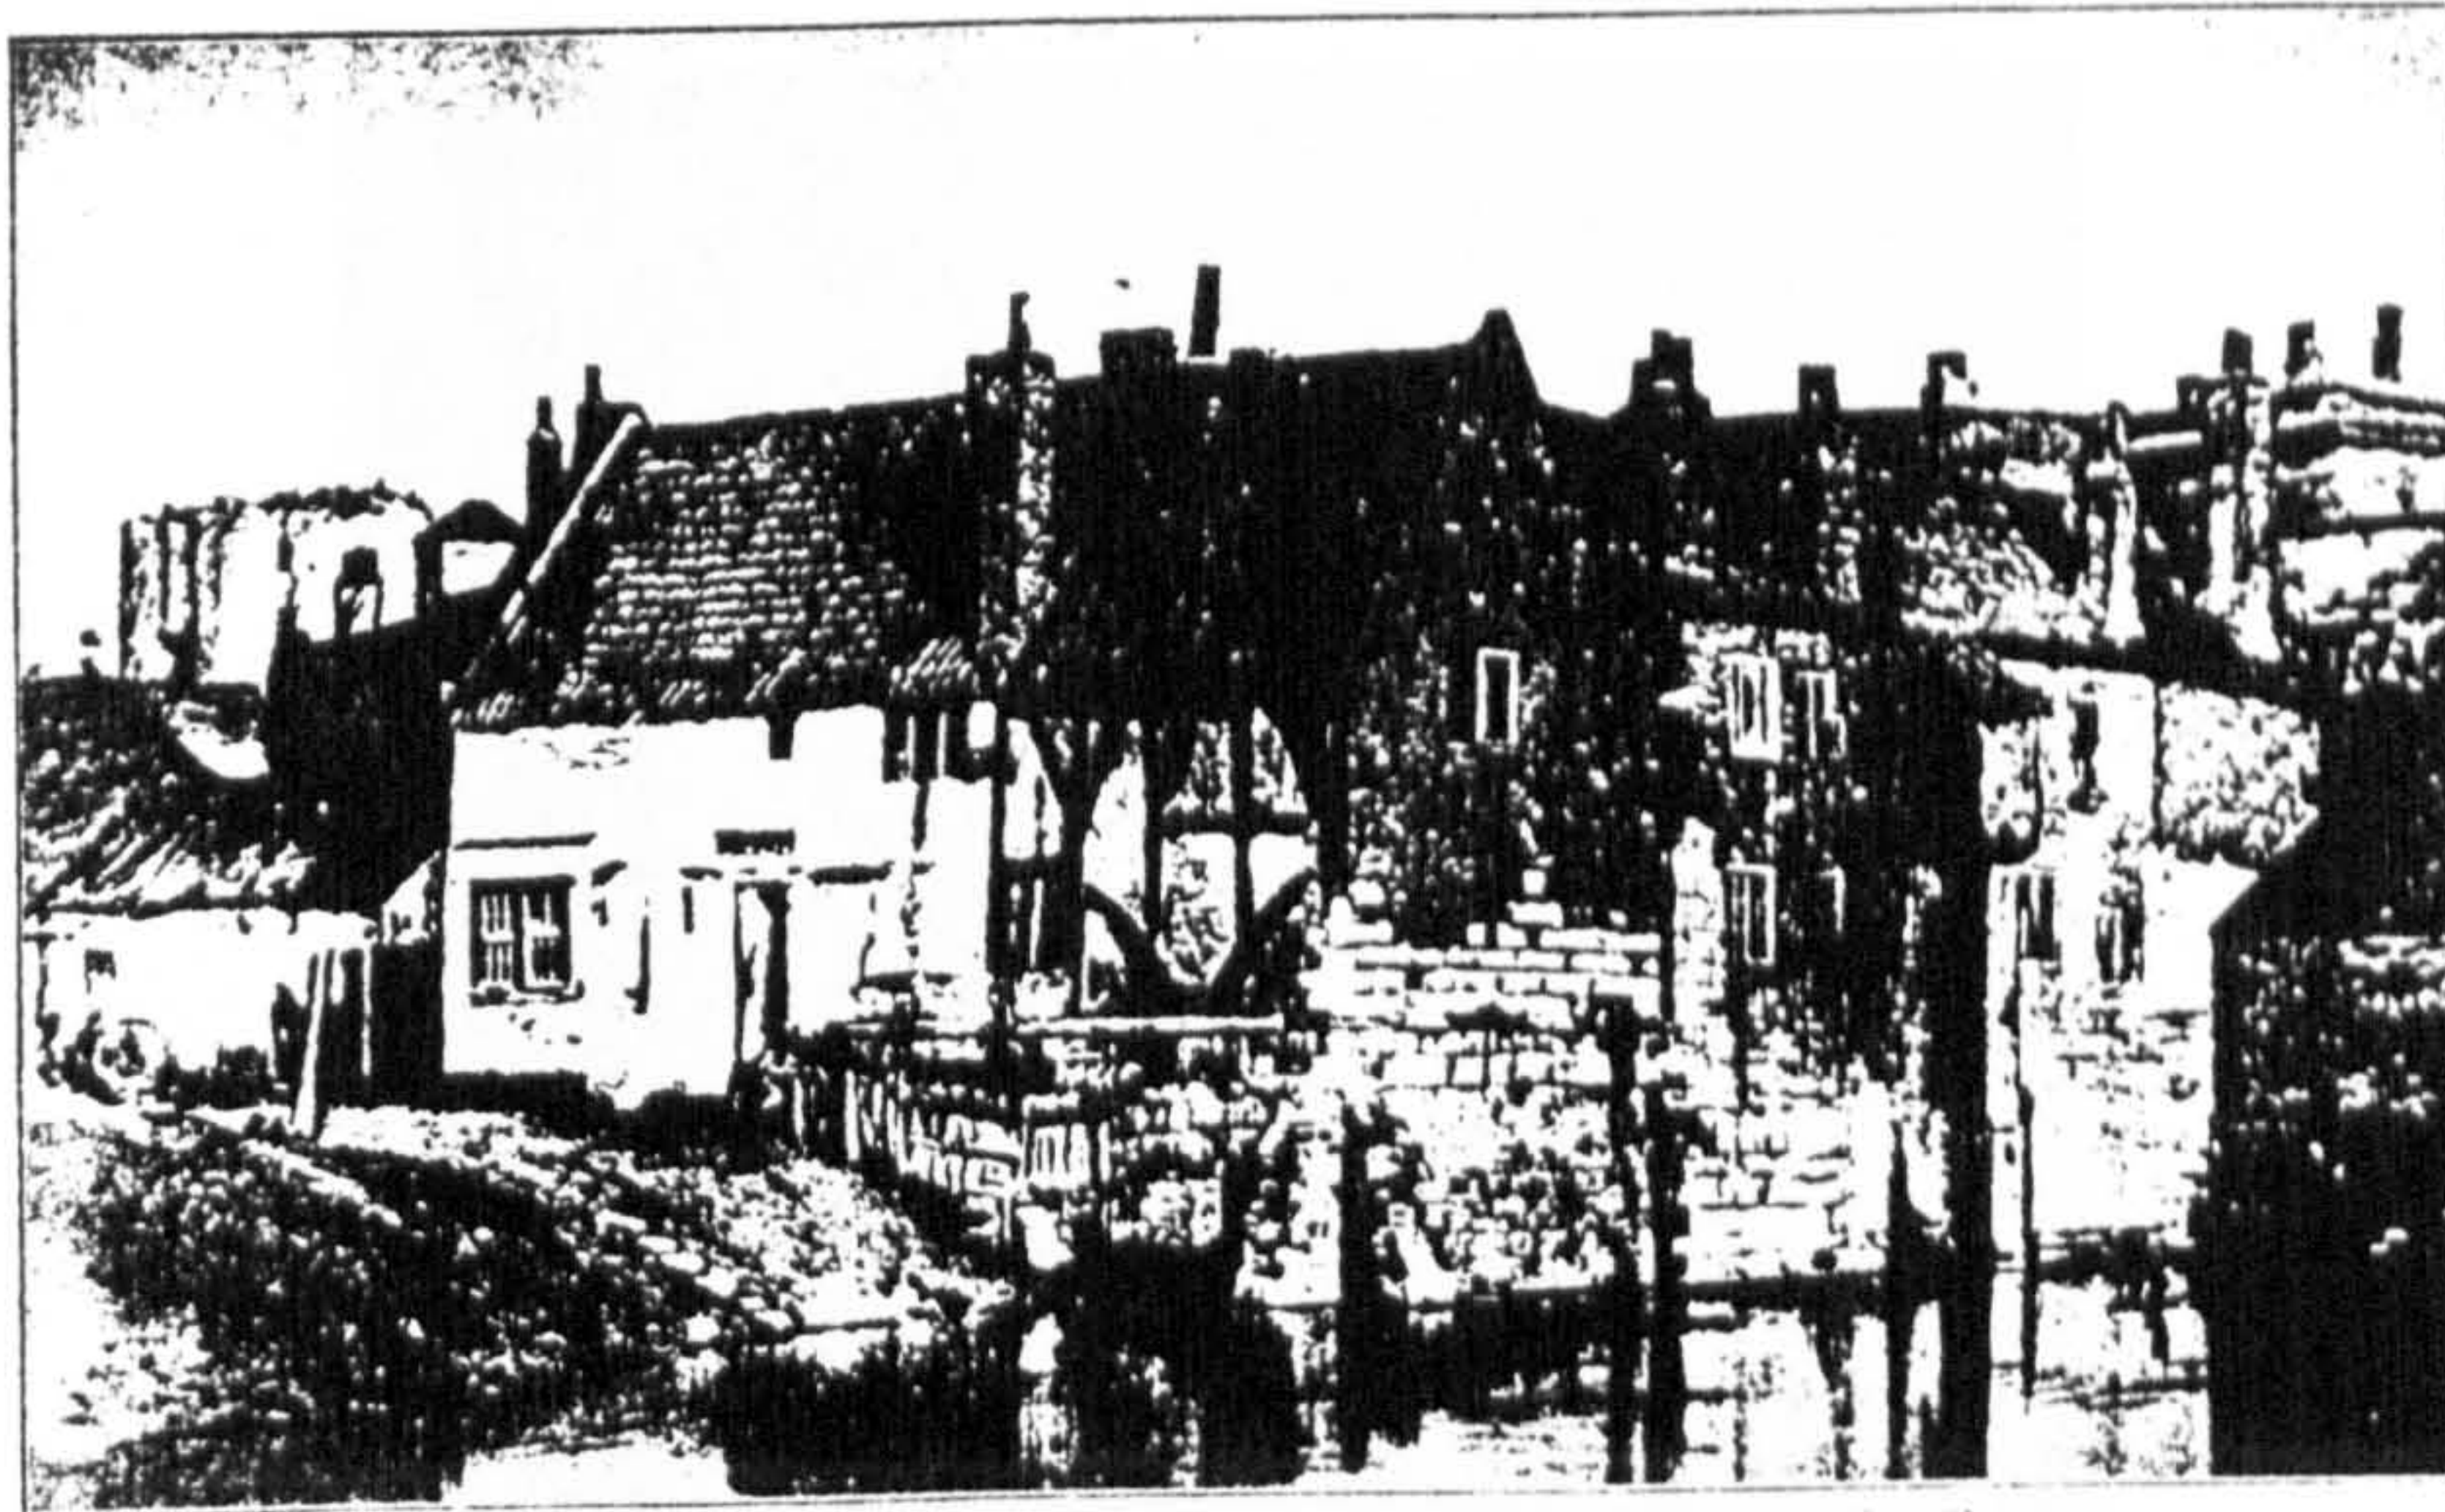
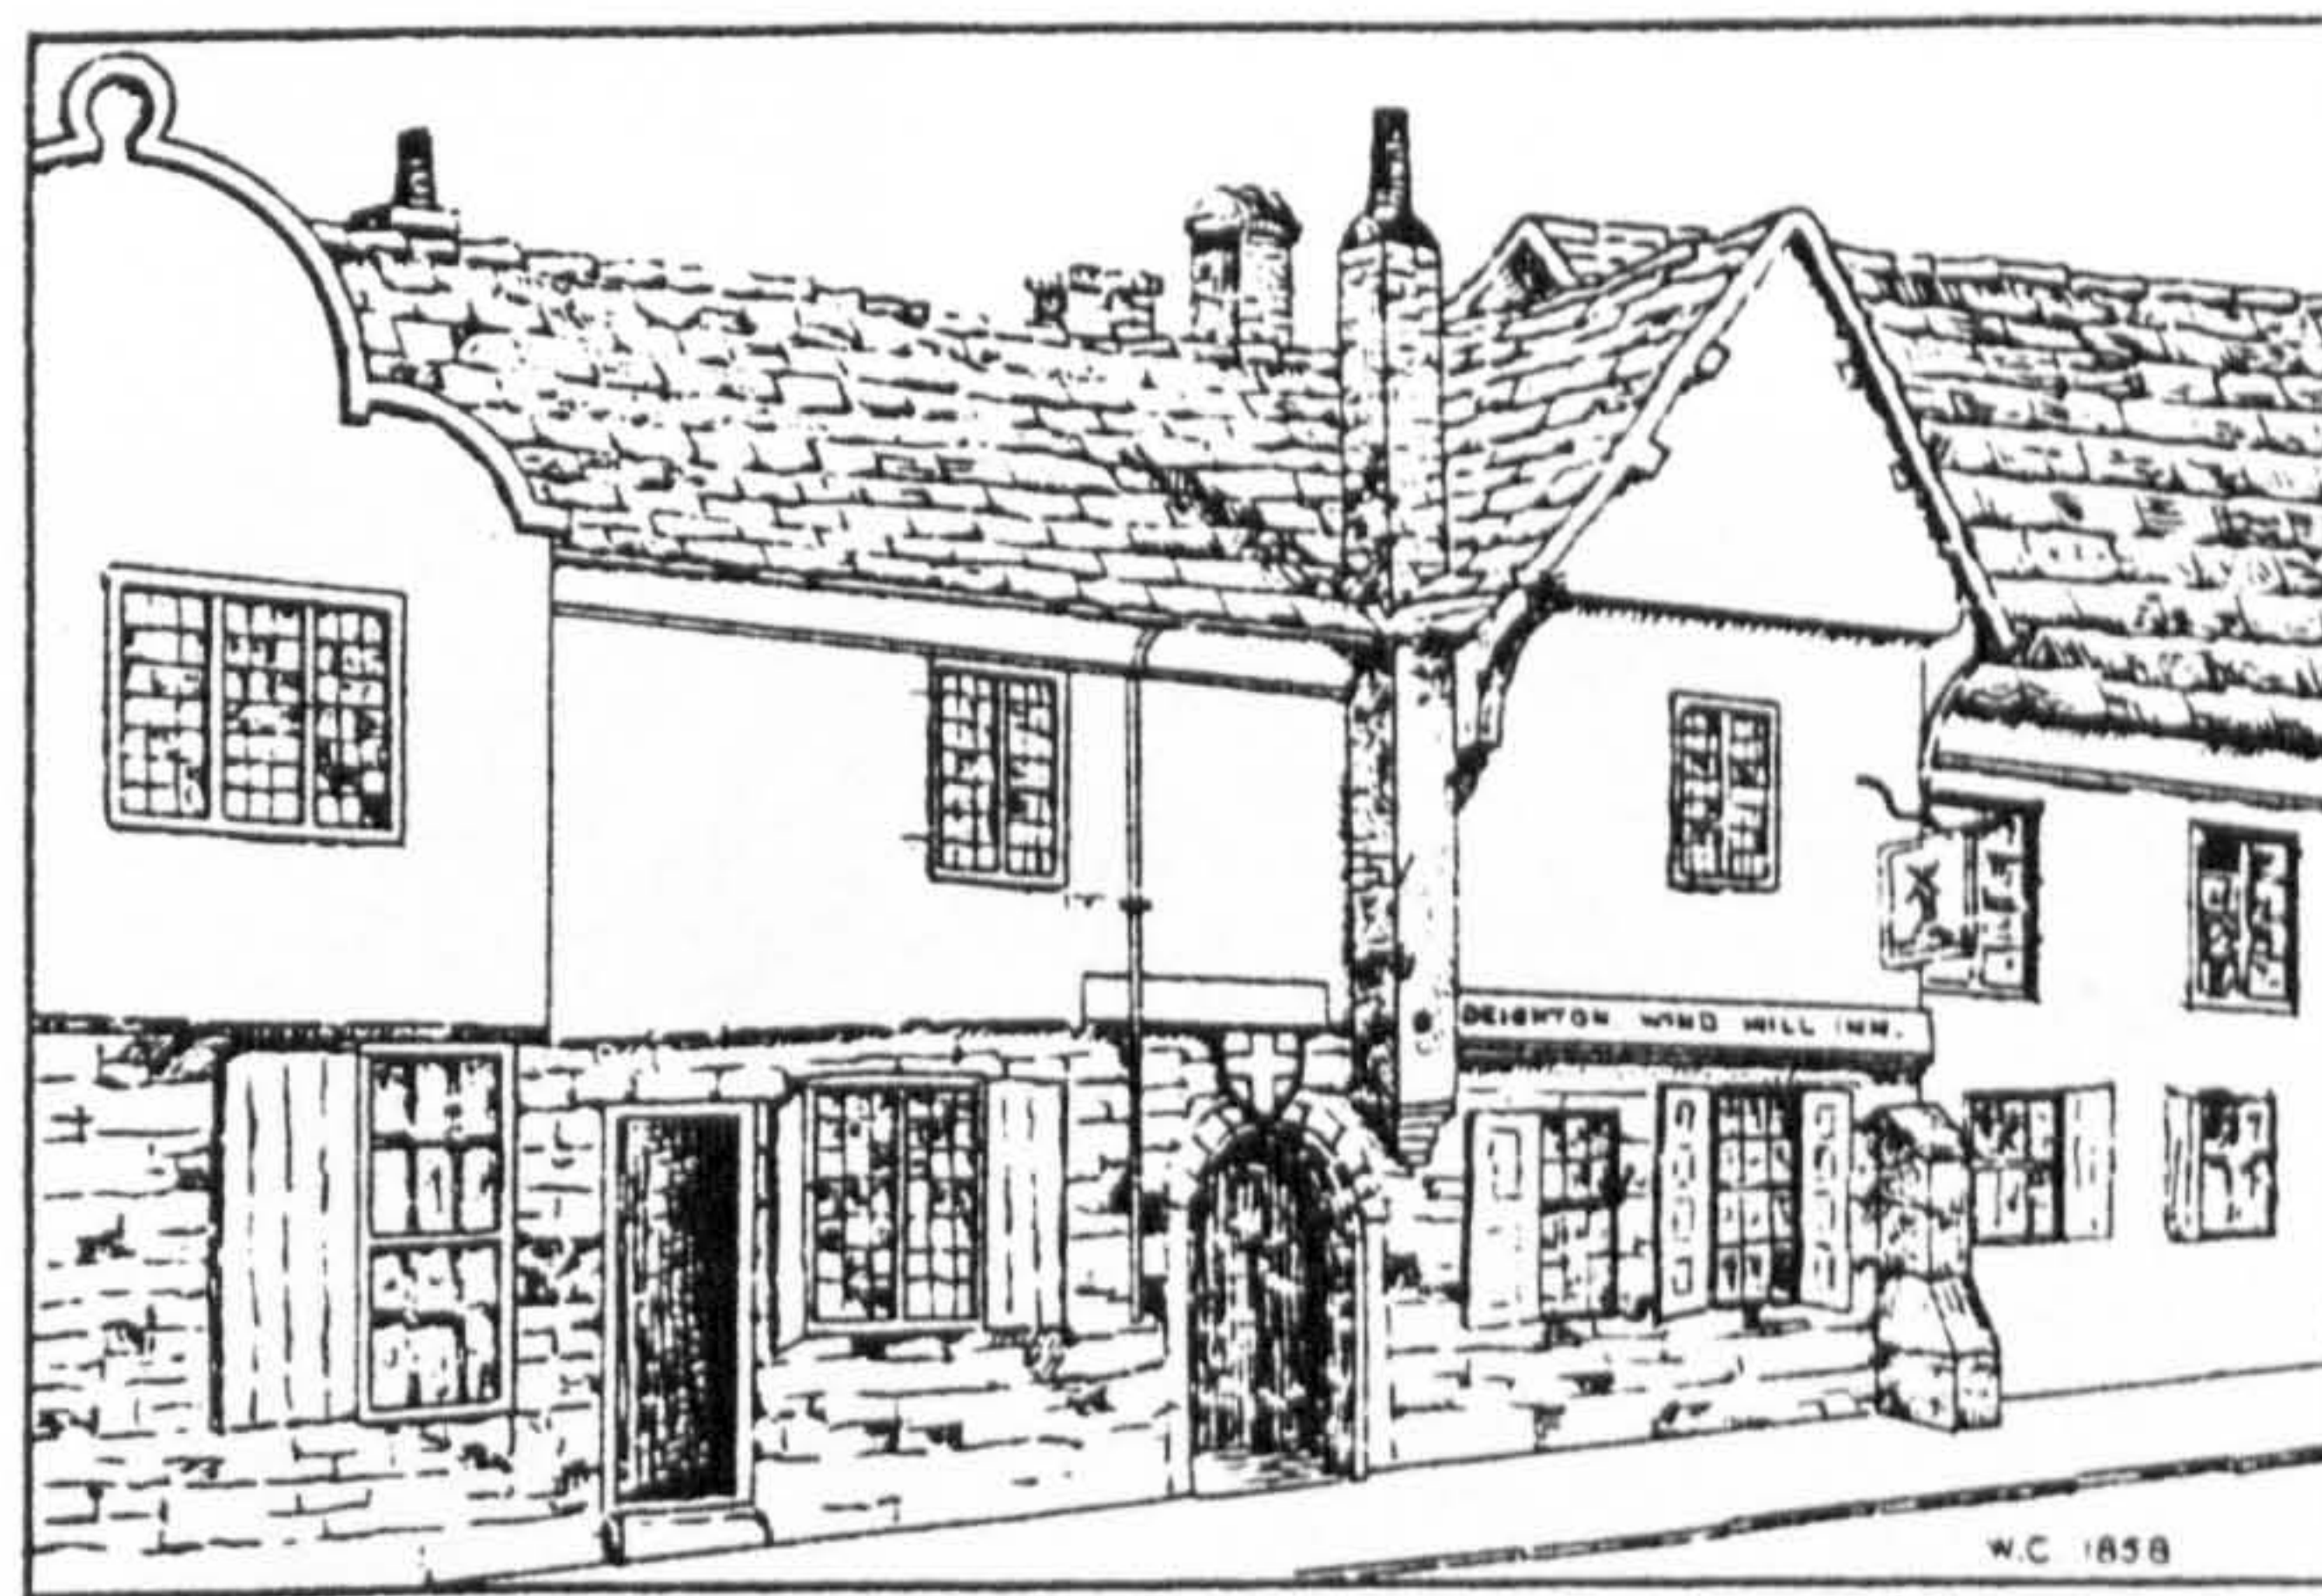
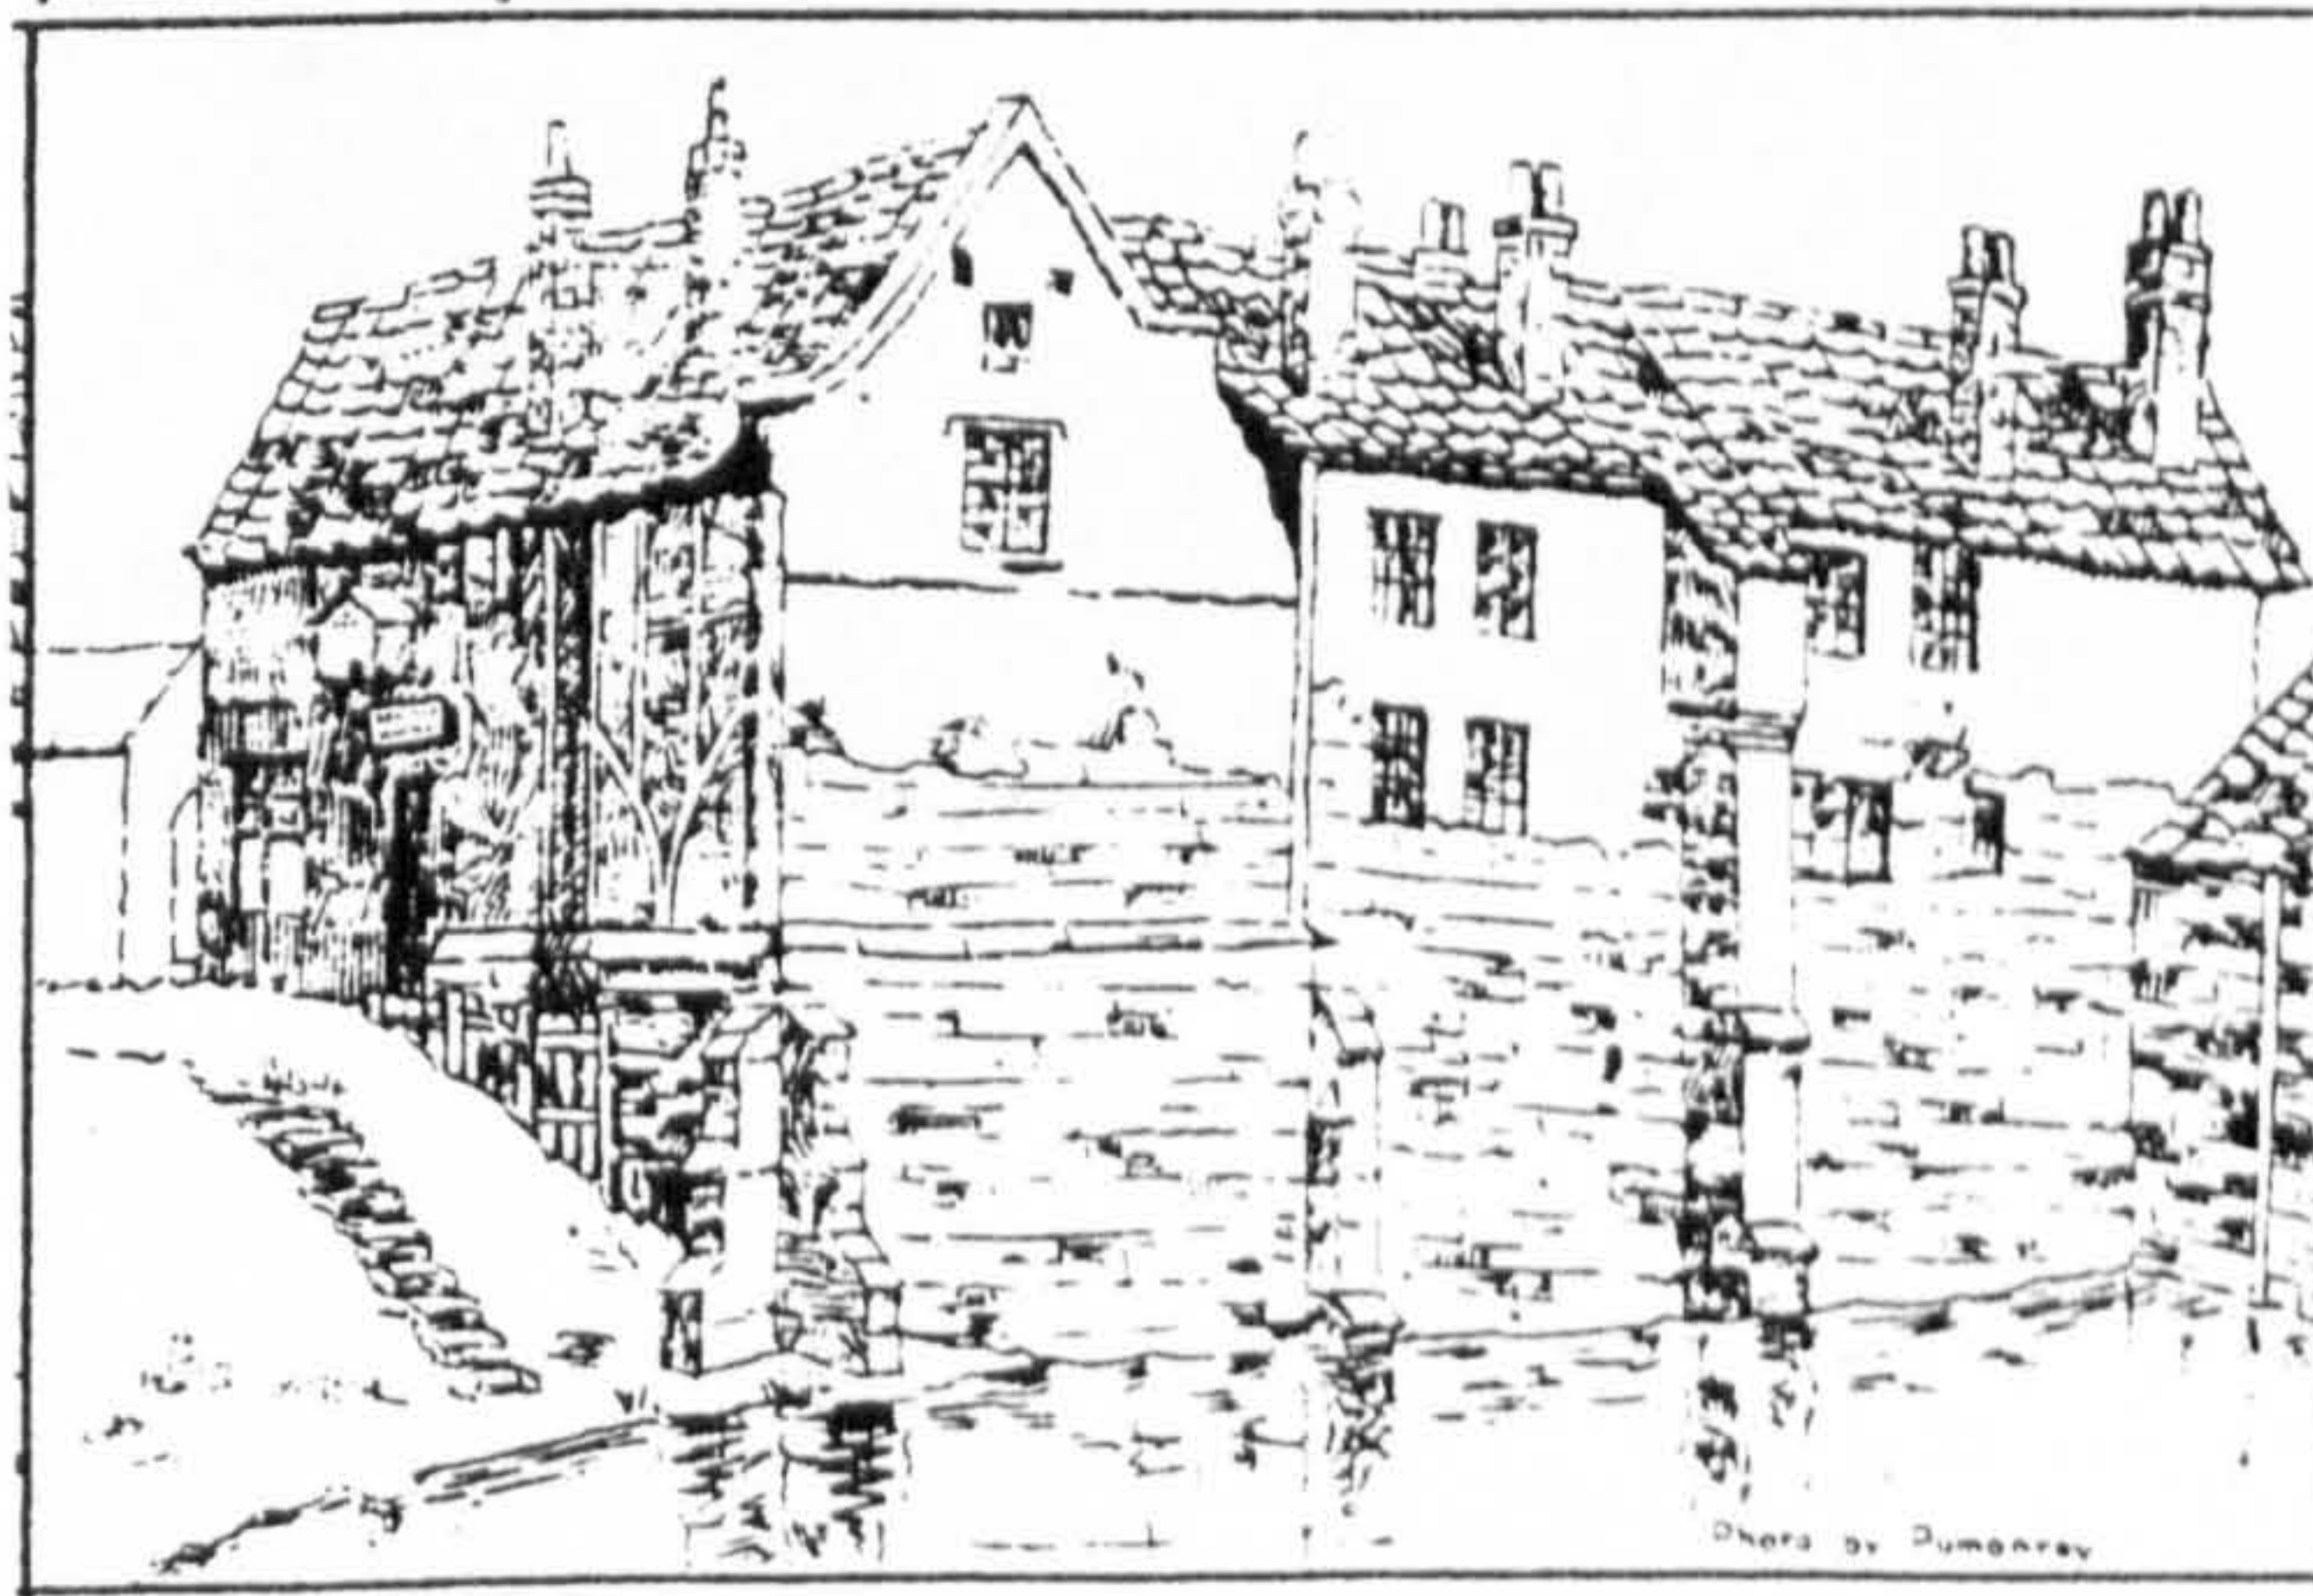
TENEMENTS ERECTED ON THE FOUNDATIONS OF THE CHAPEL OF ST. GEORGE.

Fig. 168. St. George's chapel, York (Cooper 1911; Benson 1925).

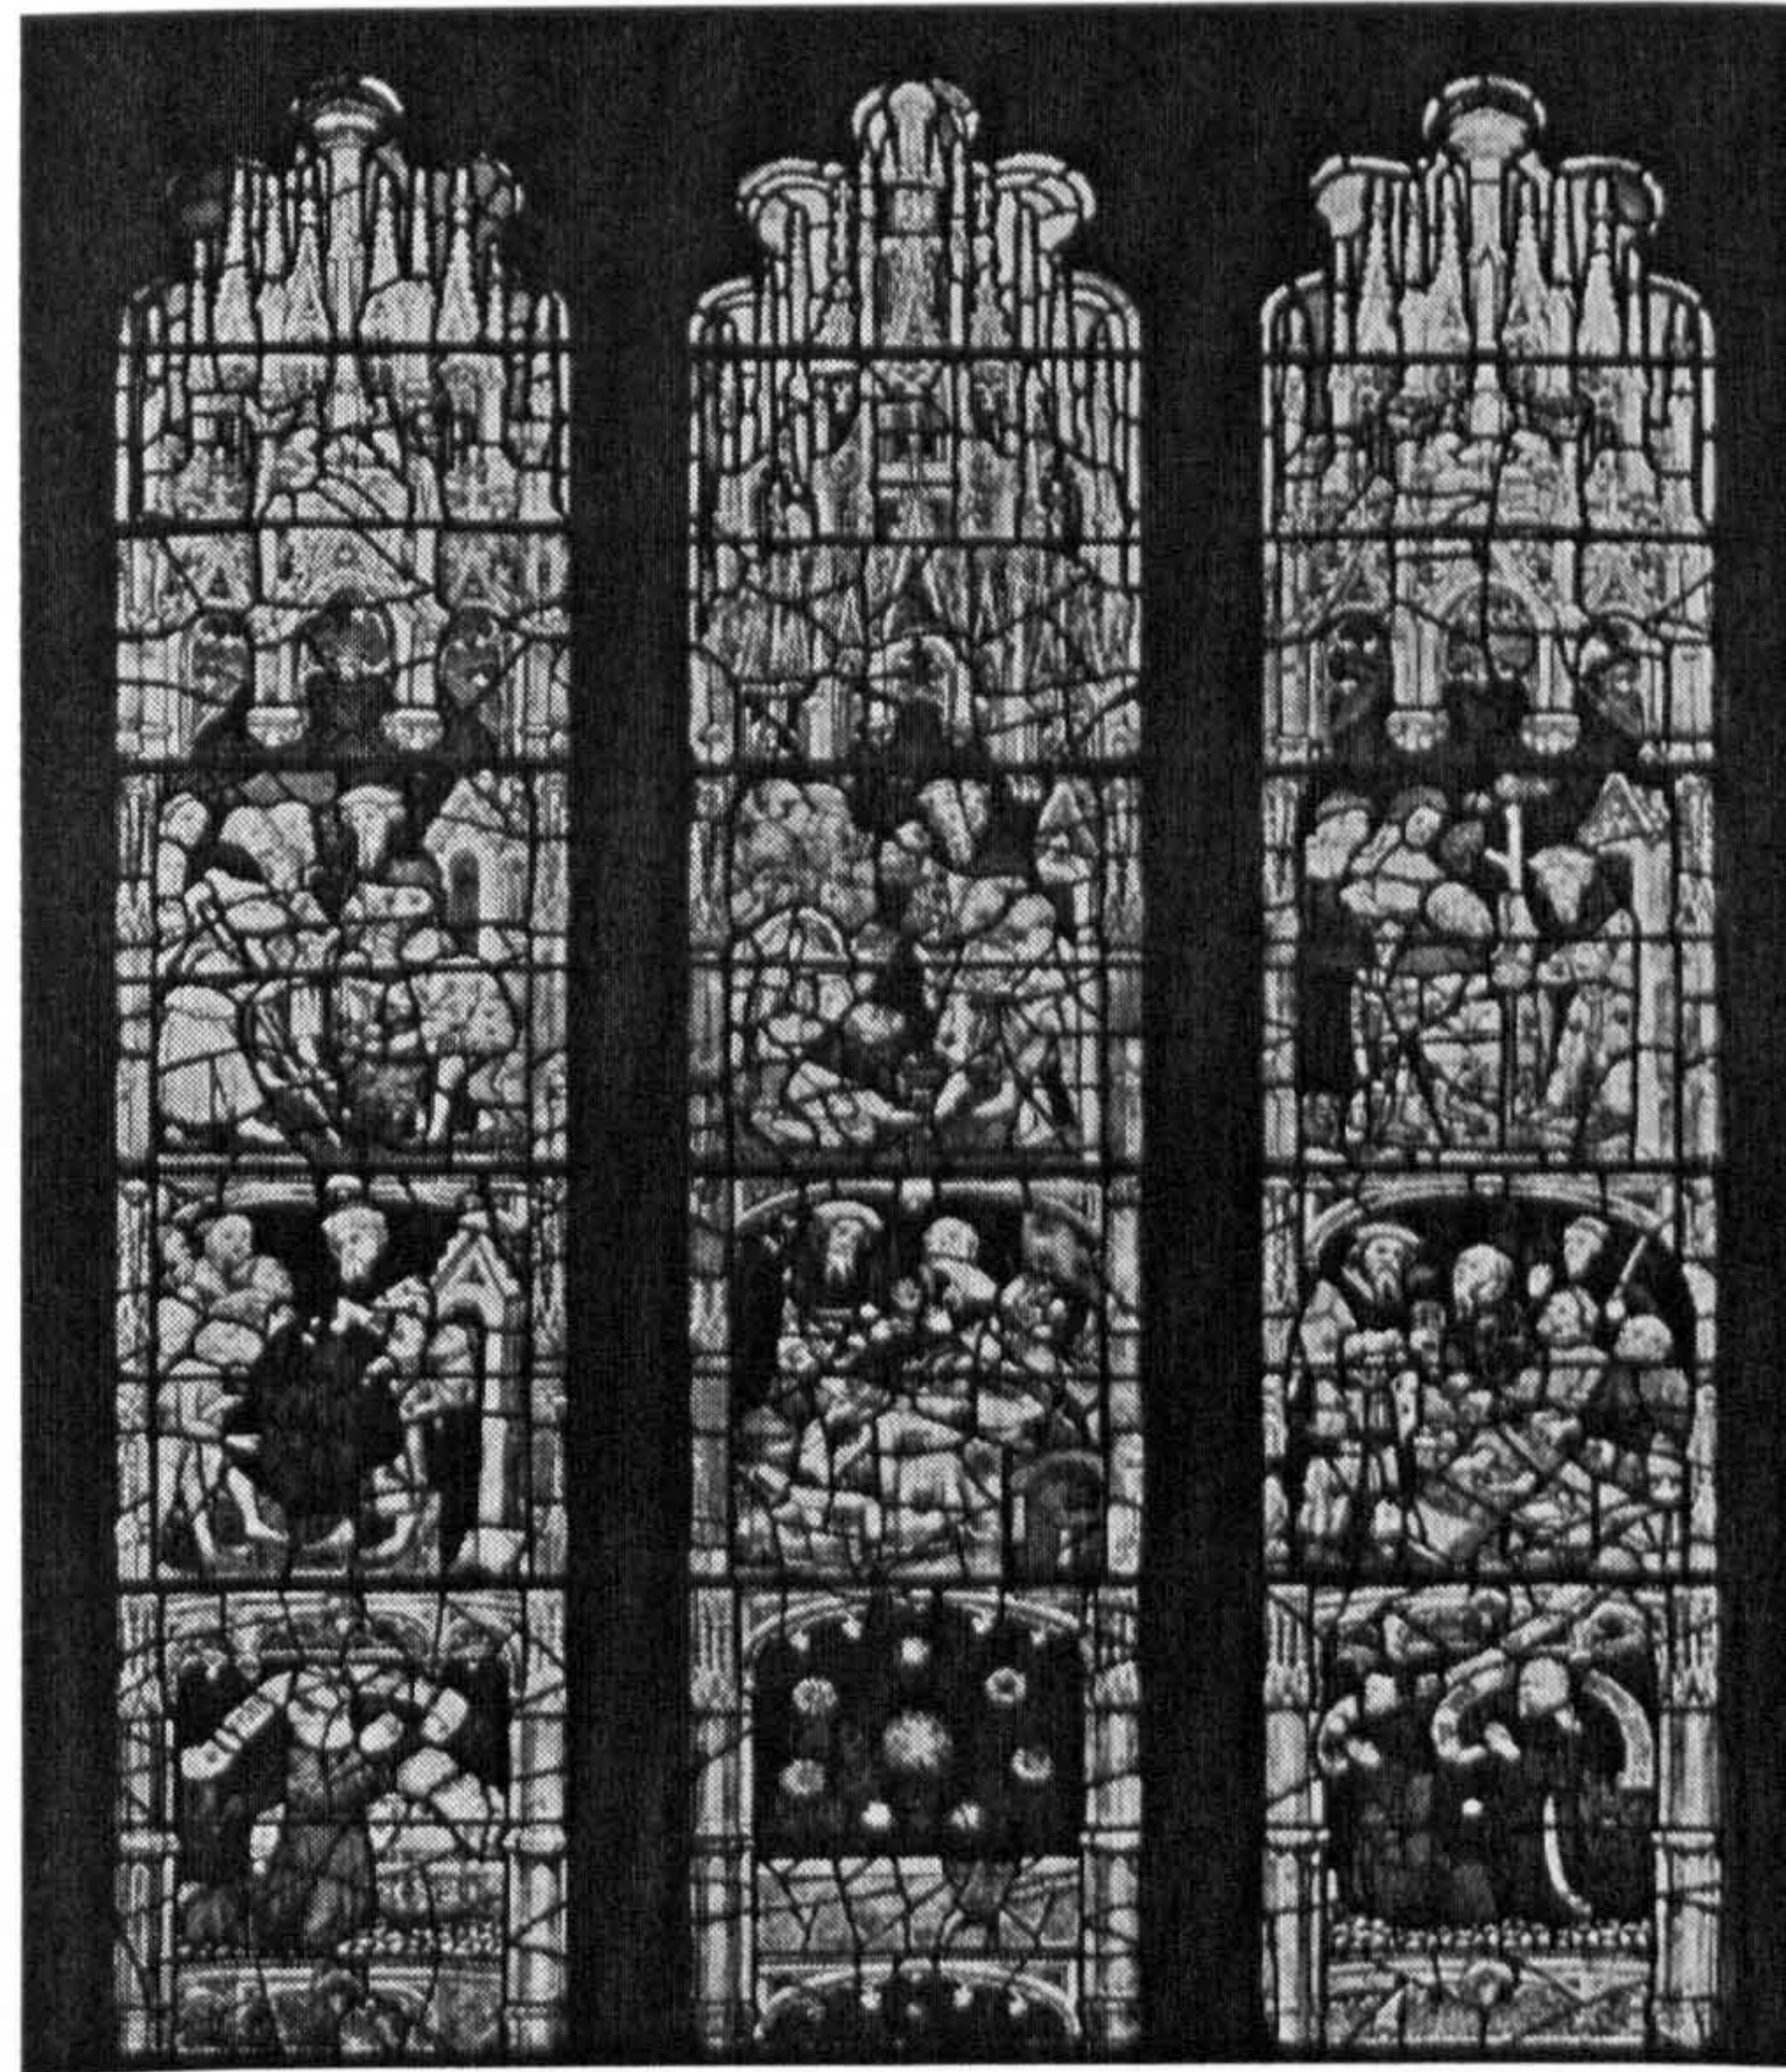
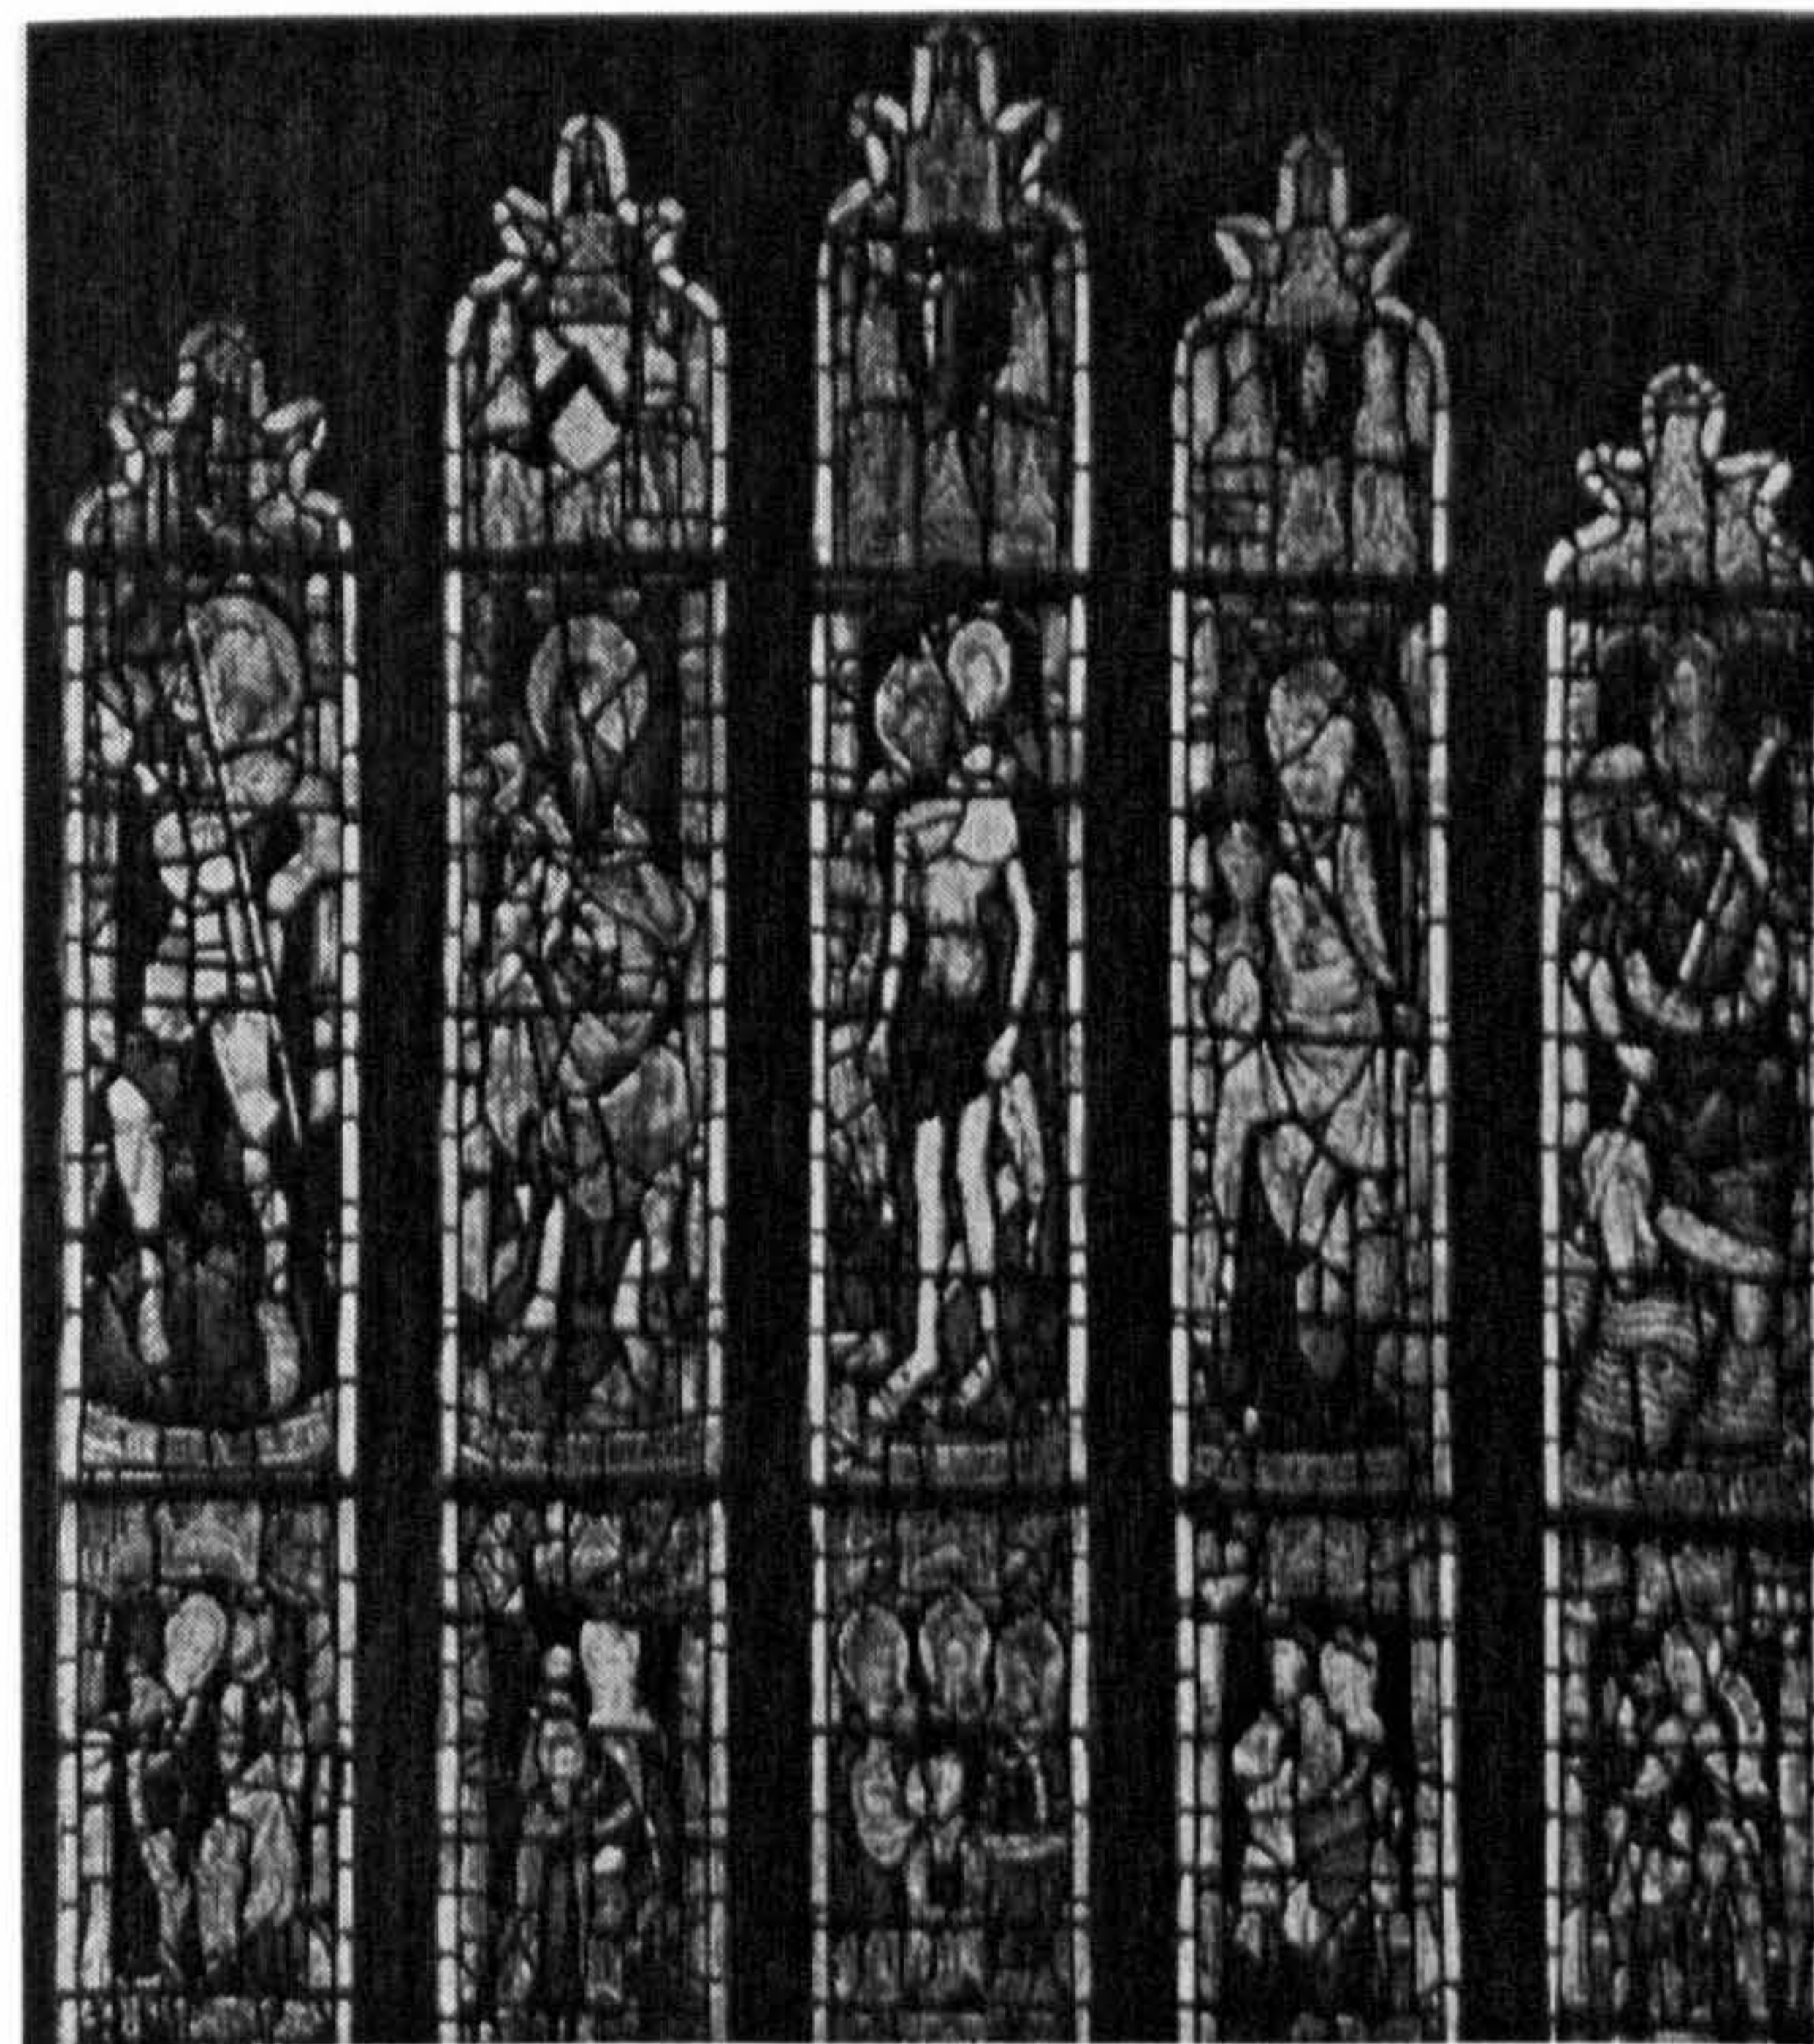
Fig. 179. Plan of Trinity chapel showing hypothetical position of altars in relation to the fifteenth century fenestration scheme.

179. Plan of Trinity chapel with hypothetical reconstruction of the position of altars in relation to the late fifteenth century fenestration scheme.
180. Fifteenth century stained glass in York: the Corporal Acts of Mercy window, All Saints', North Street and the Holy Trinity, Holy Trinity Goodramgate, York.
