**CONSERVATION AND SEISMIC STRENGTHENING OF
ARCHITECTURAL HERITAGE**
BYZANTINE CHURCHES
OF THE NINTH TILL THE FOURTEENTH CENTURIES IN MACEDONIA

Dissertation submitted for DPhil Degree

Lazar Sumanov

York 1999

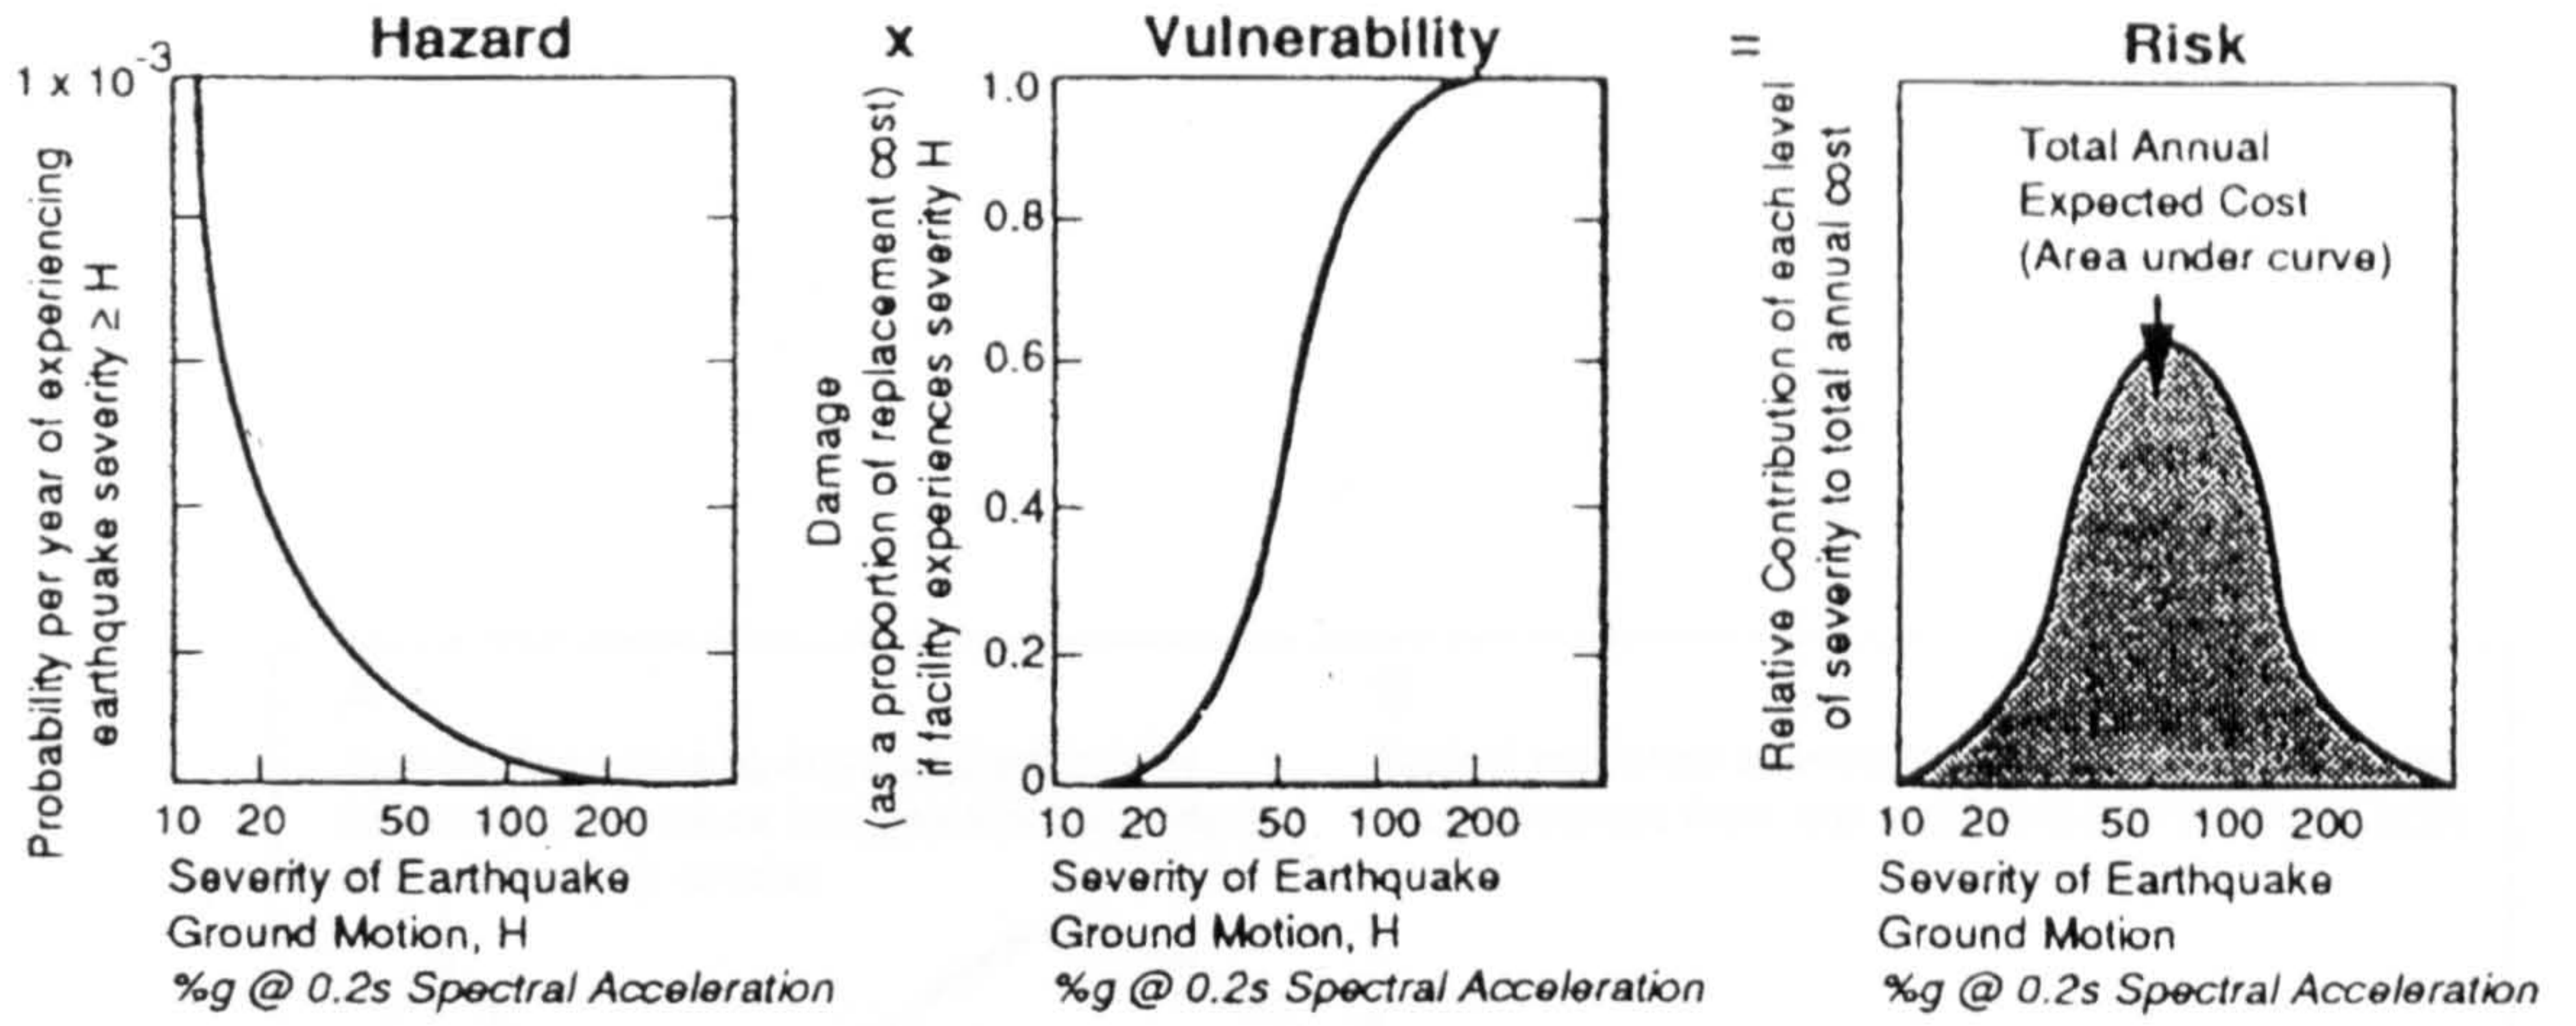
Figure 2.3 Risk is a product of hazard and vulnerability: typical curve shape
 Source: Coburne et al. (1992:258)

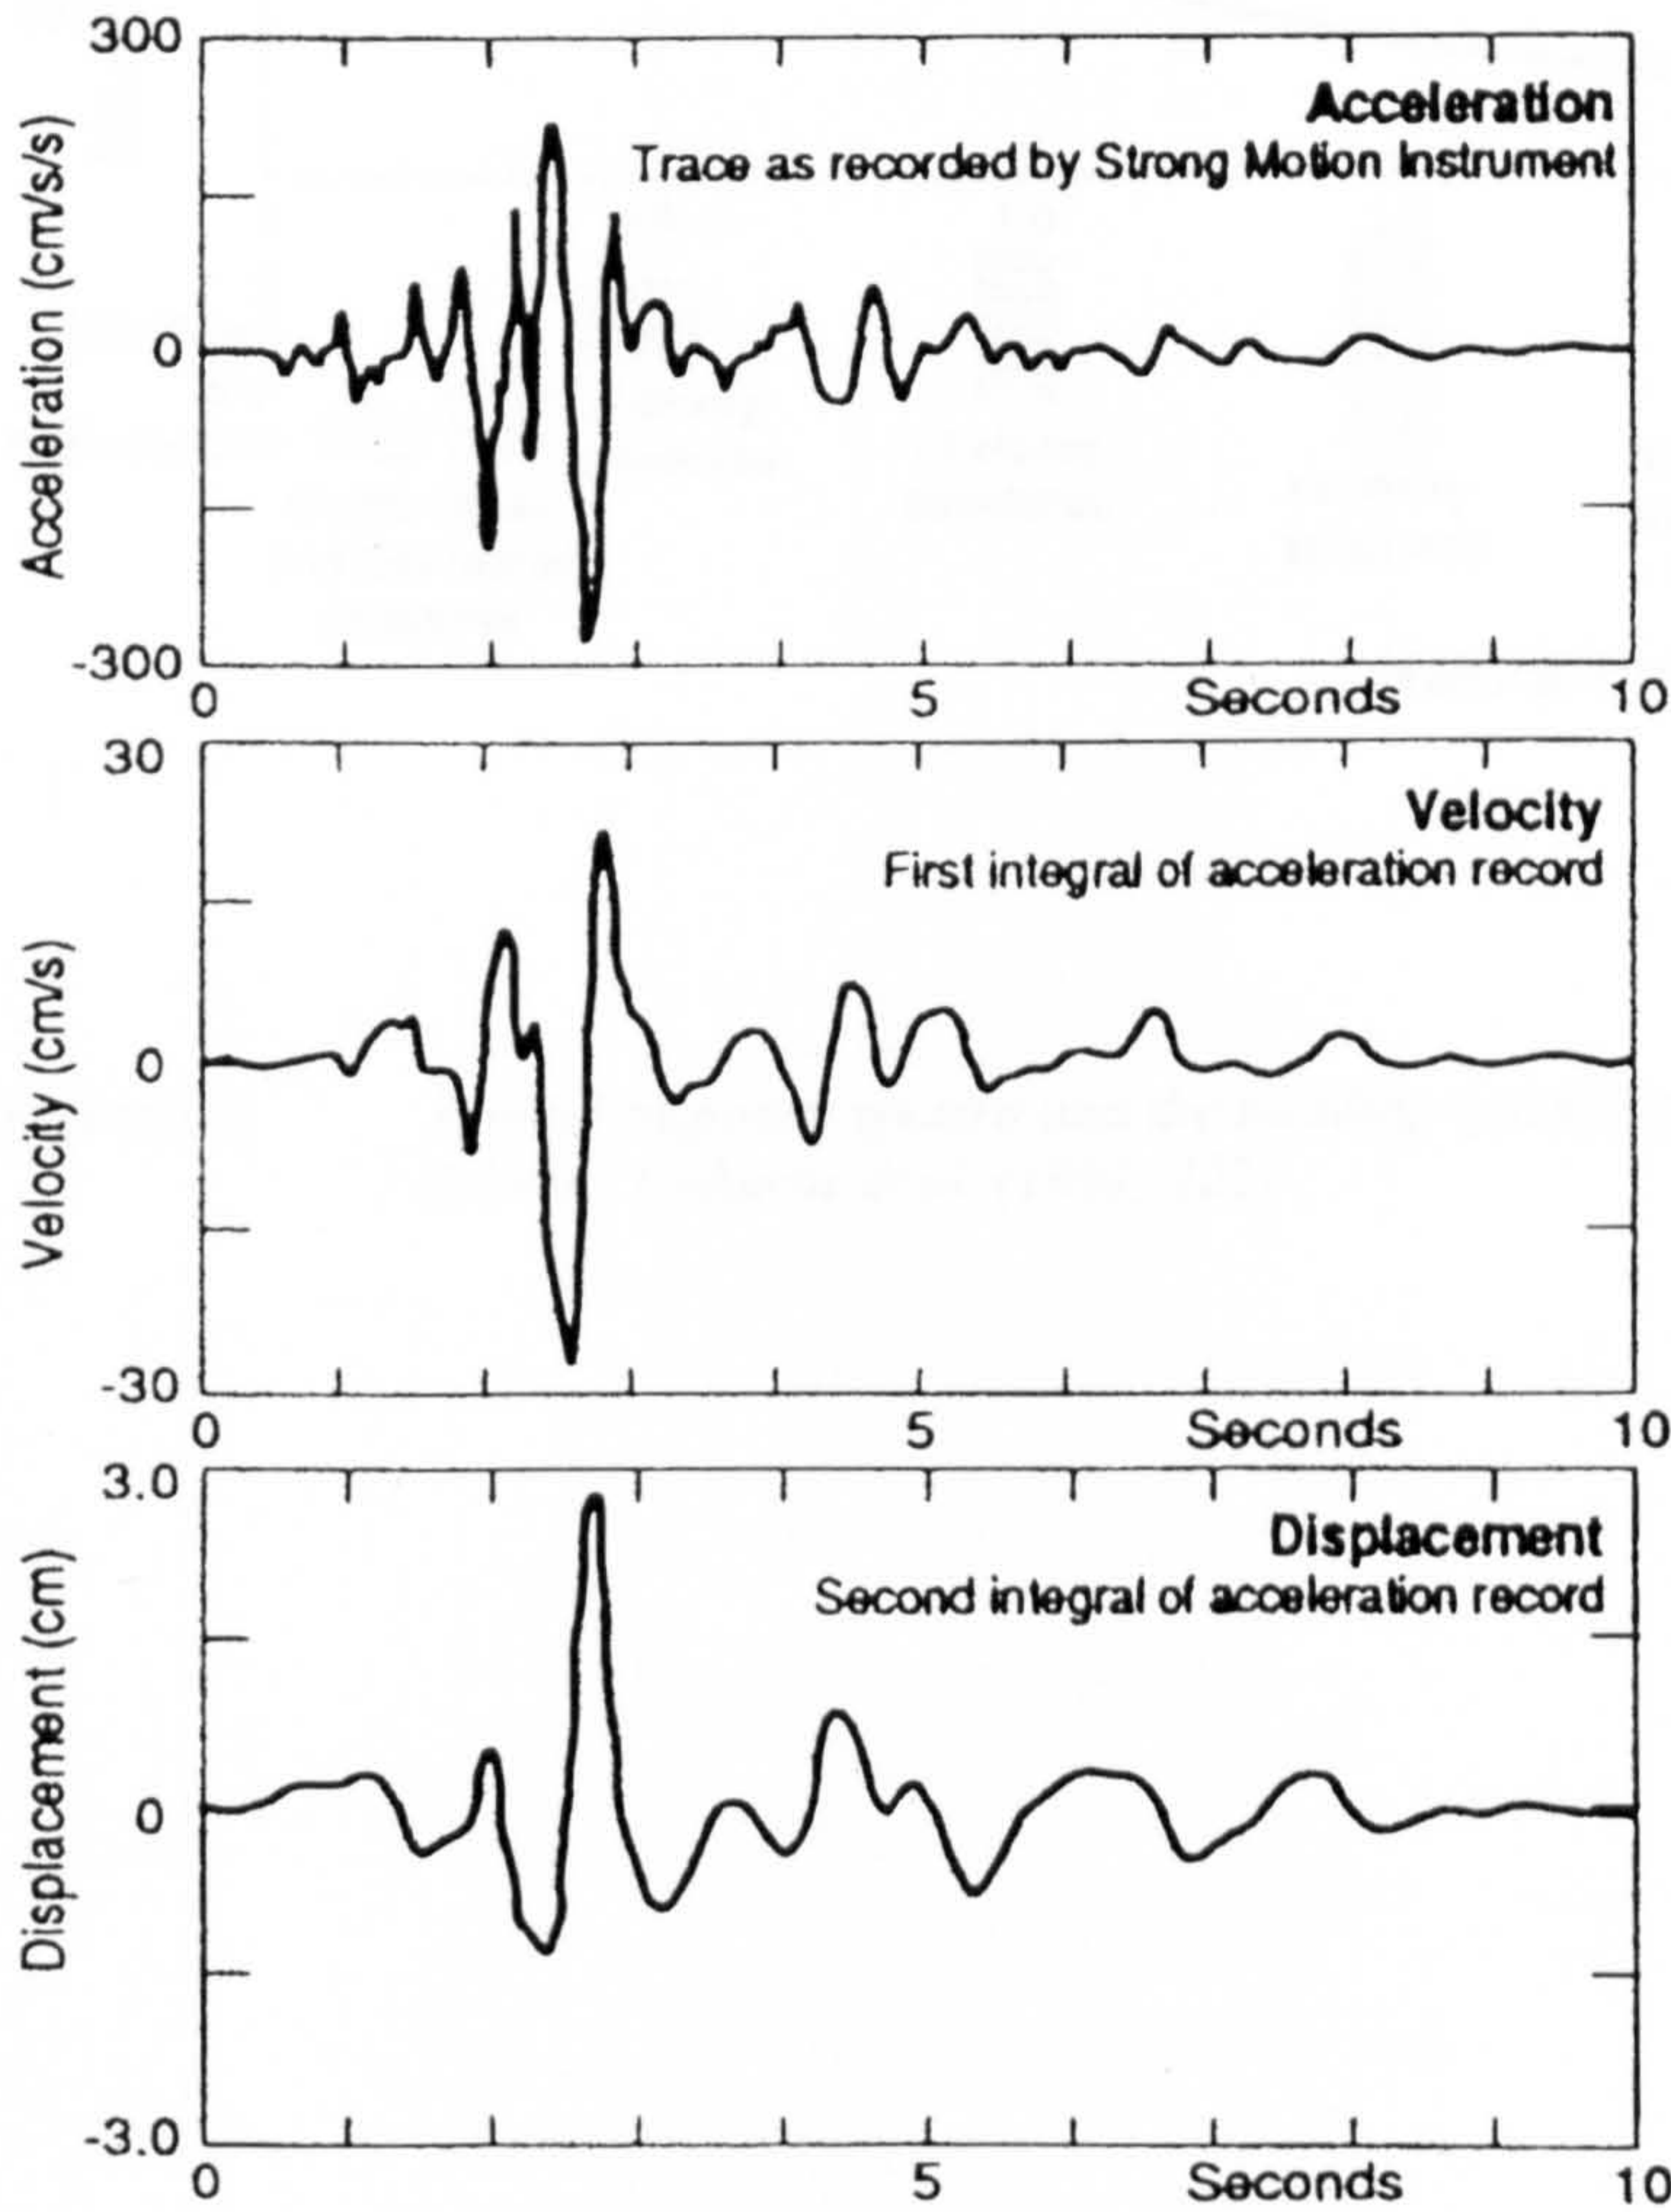
Figure 2.4 A typical earthquake strong motion record
 Source: Coburne et al. (1992: 219)

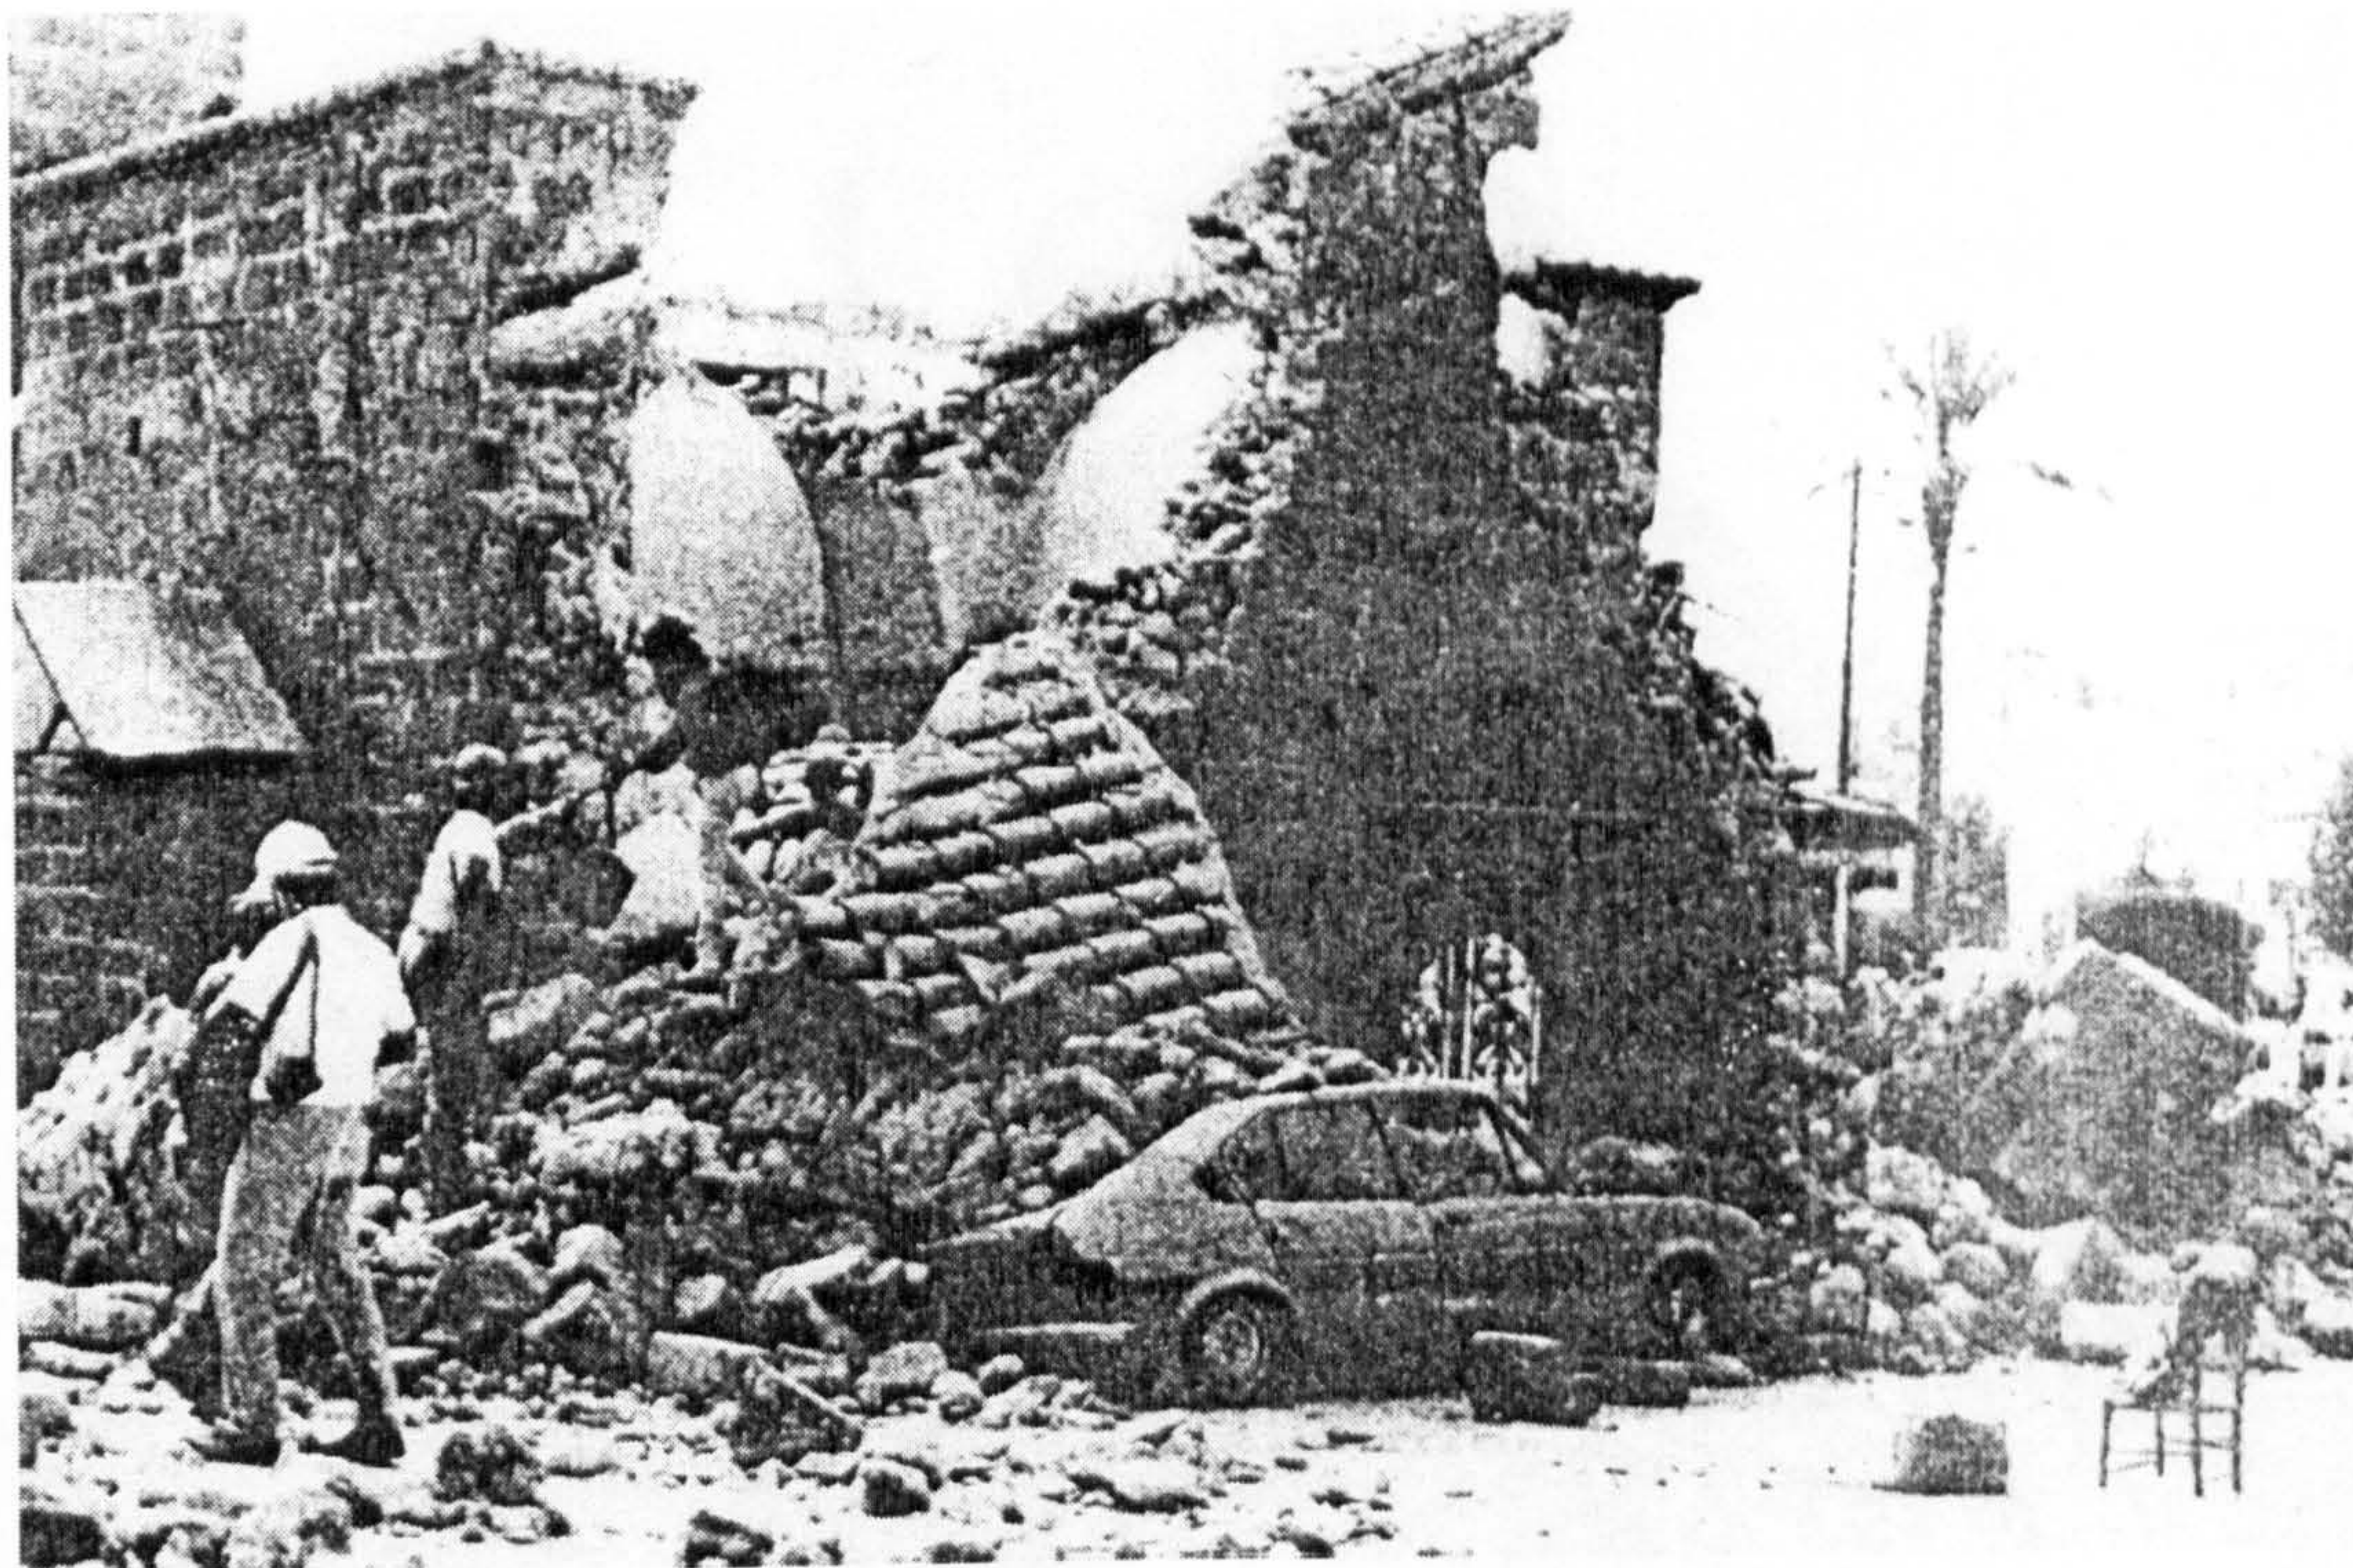
Figure 4.90 Church of the Holy Apostles, Kalamata. Damage pattern.
Source: Voziatzis et.al 1990

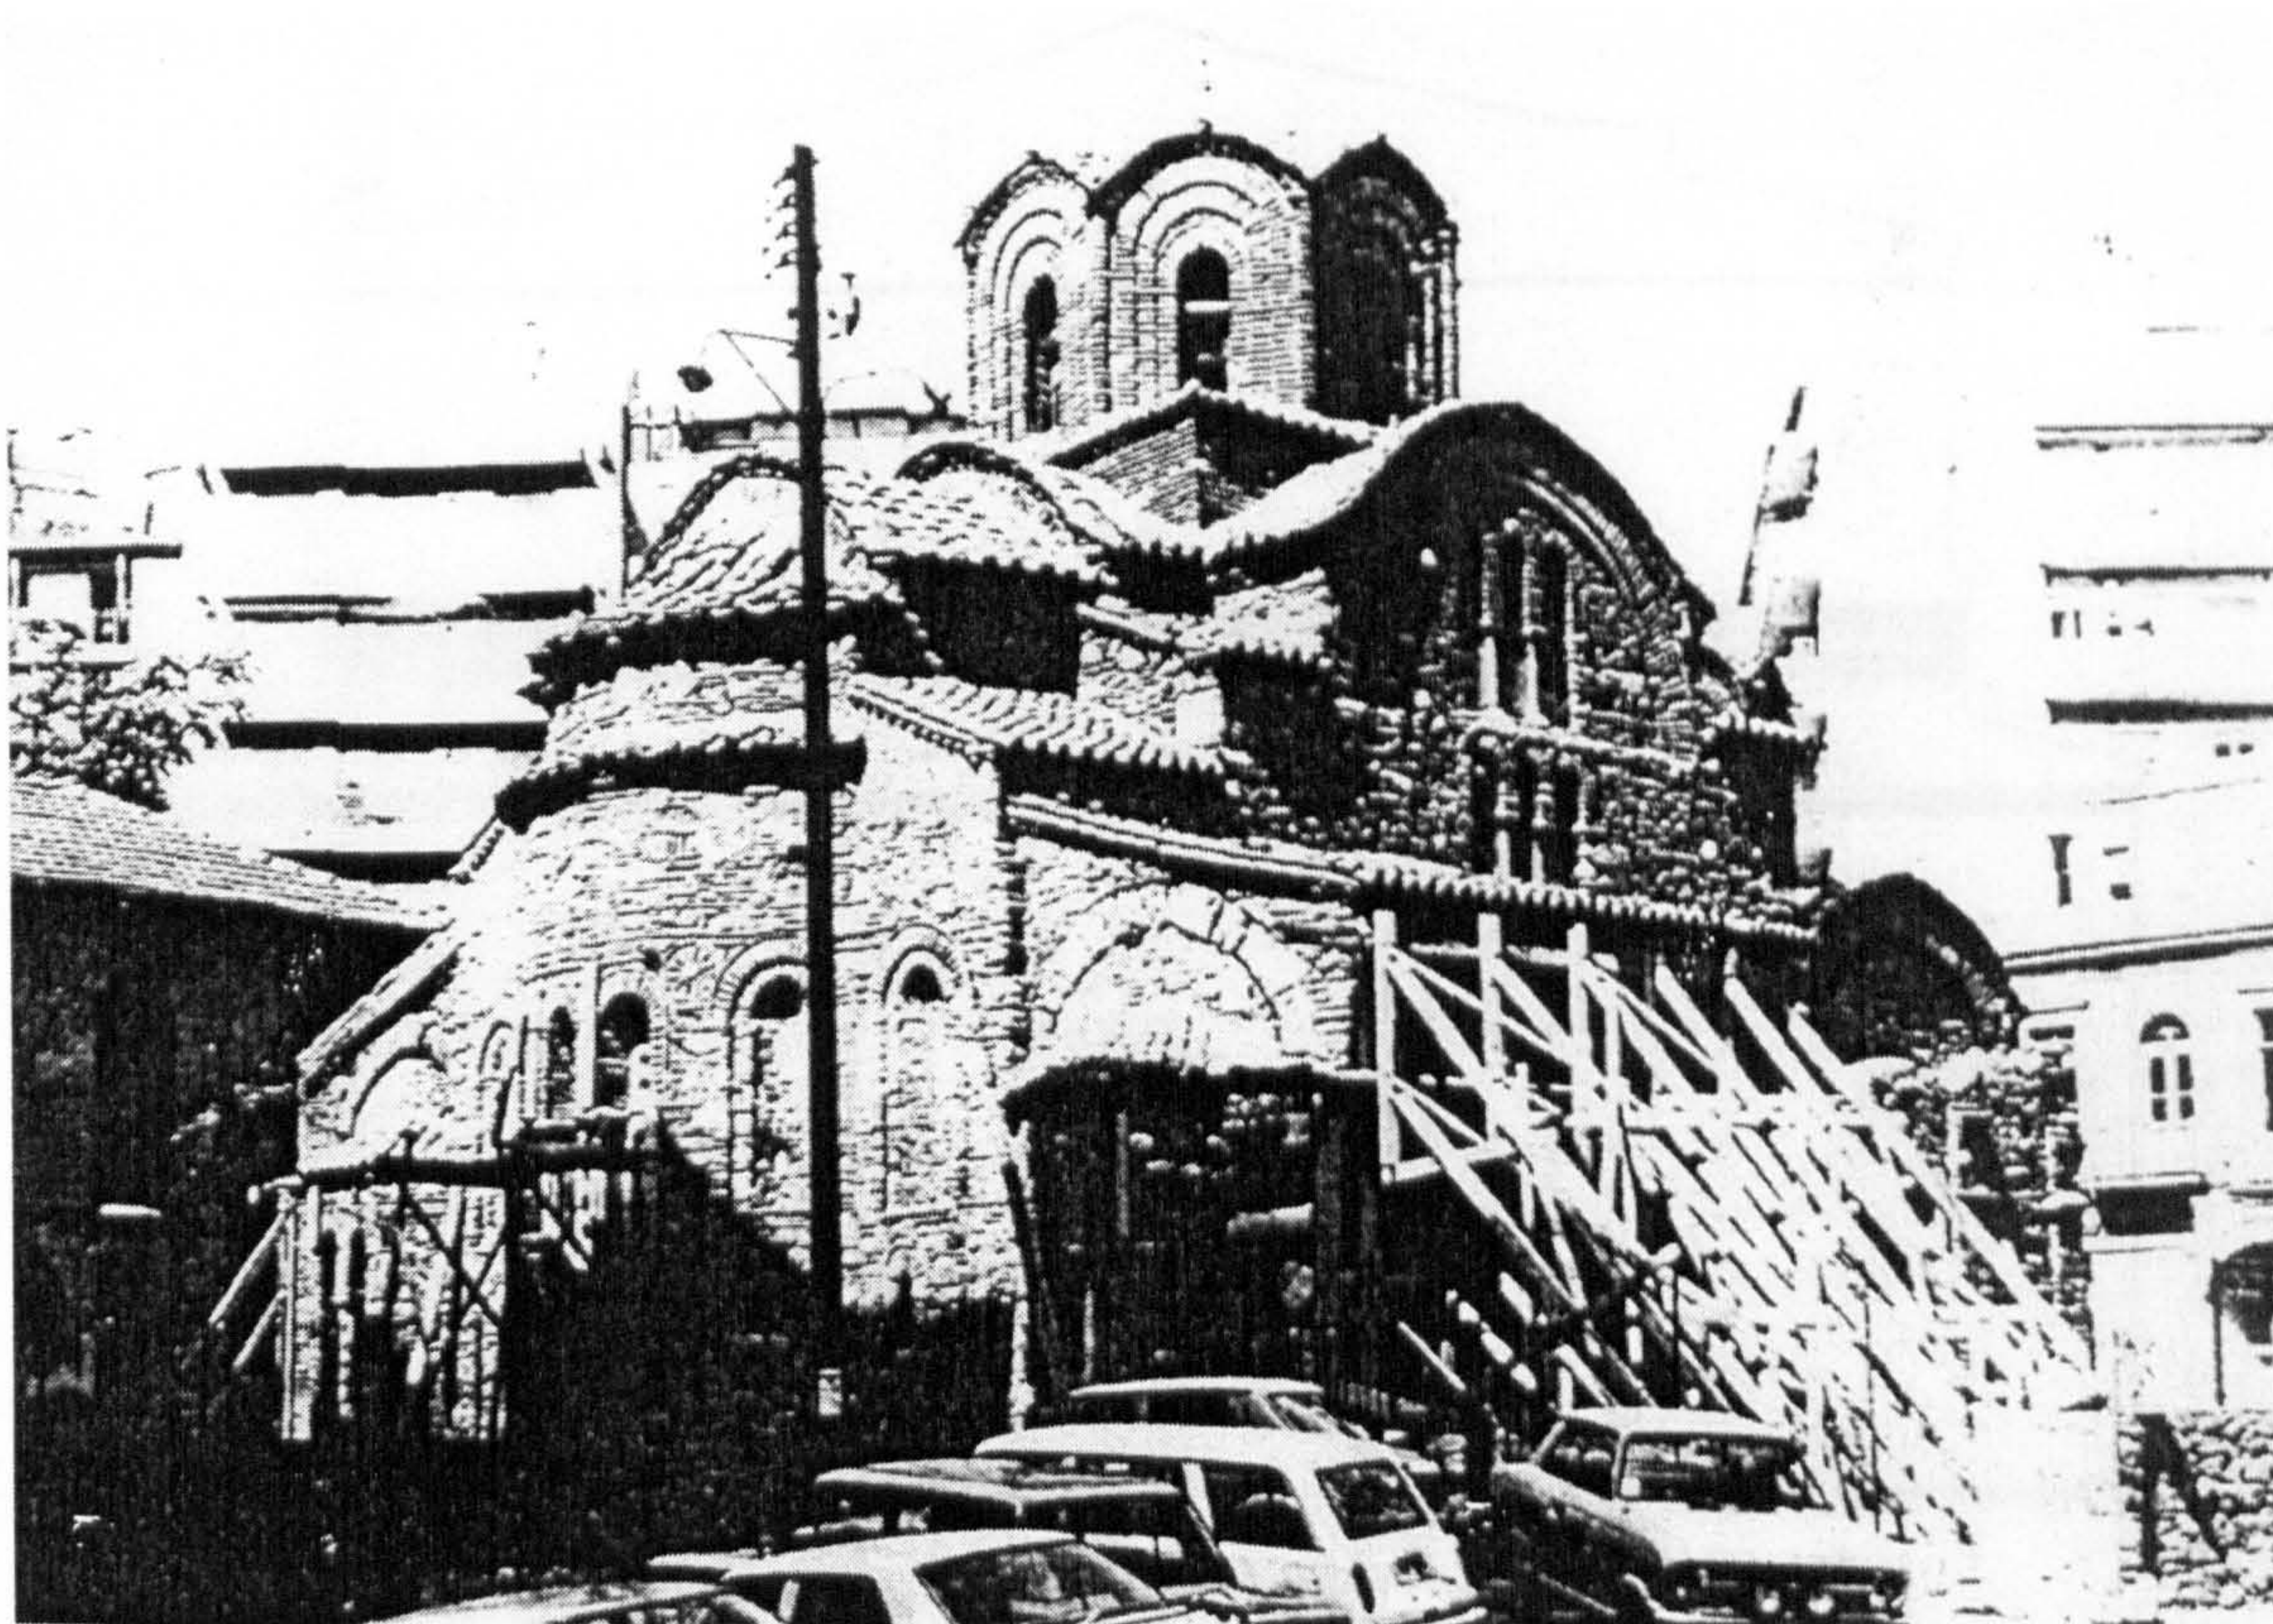
Figure 4.92 St. Panteleimon, Thessaloniki. Temporary supporting of Northern wall.

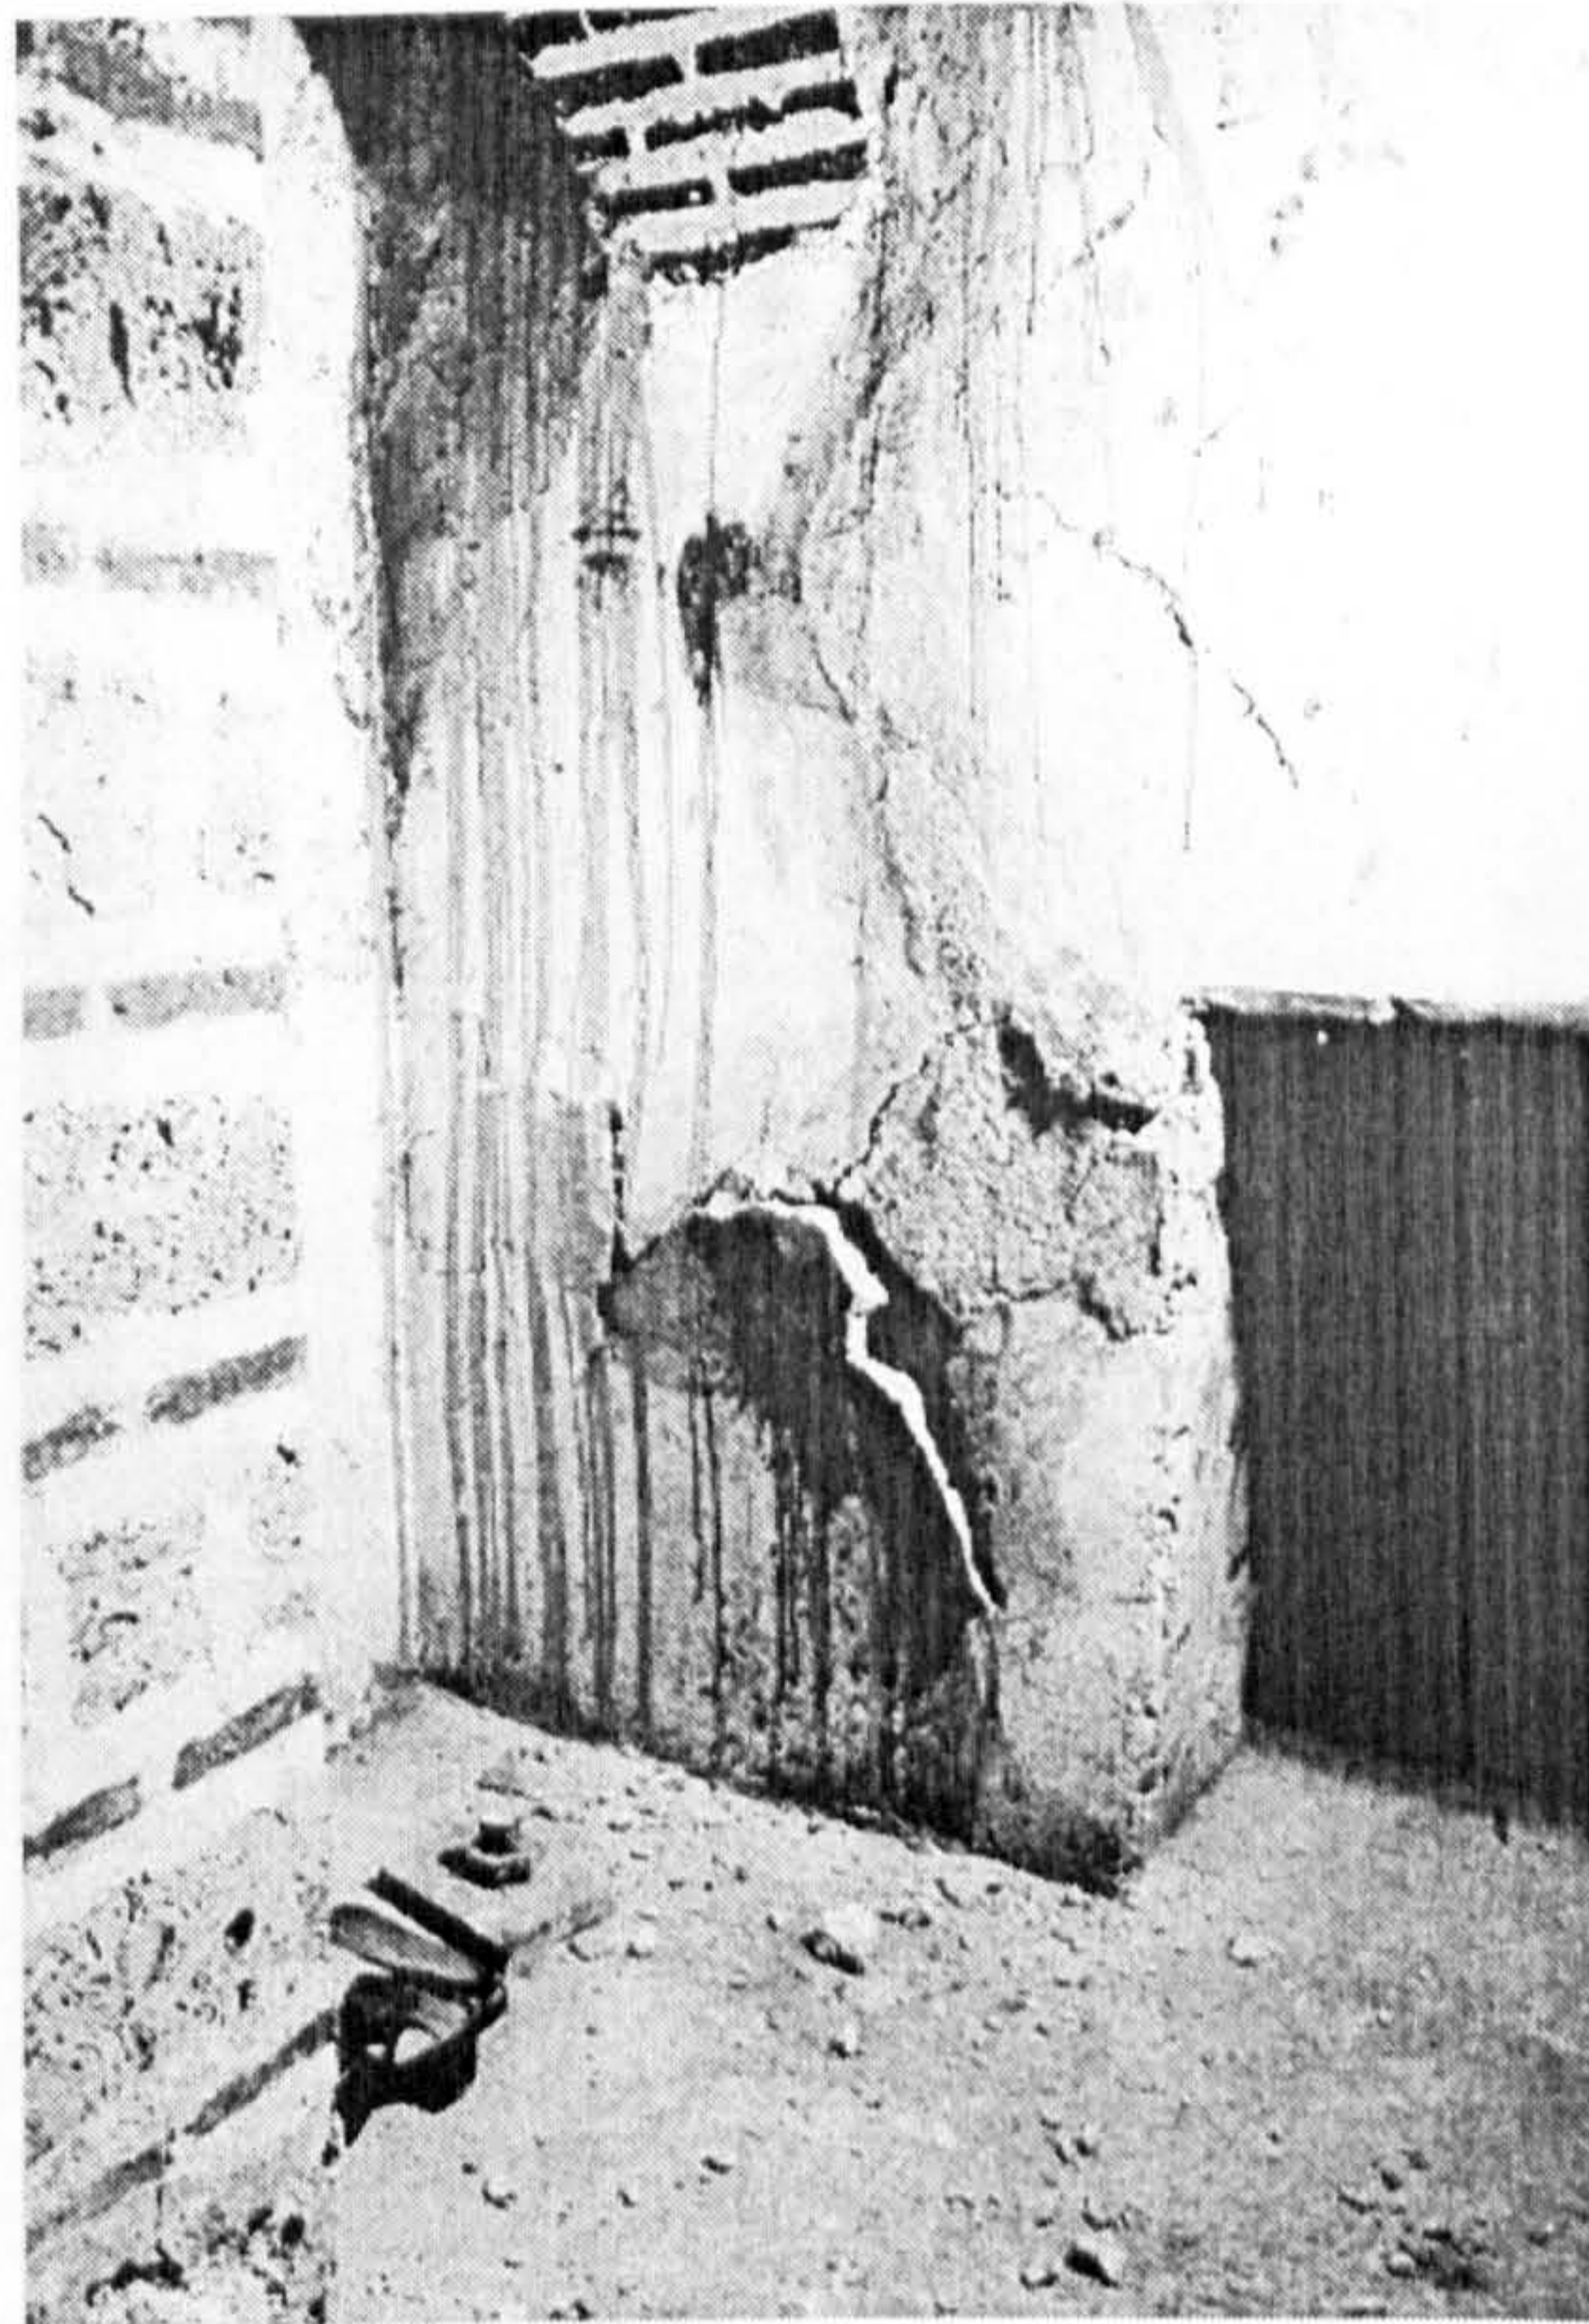
Figure 5.36 *Damage pattern of non - strengthened model after the final shaking table test.*
a) - Interior. Dome; b) - Interior. Western wall of the naos.

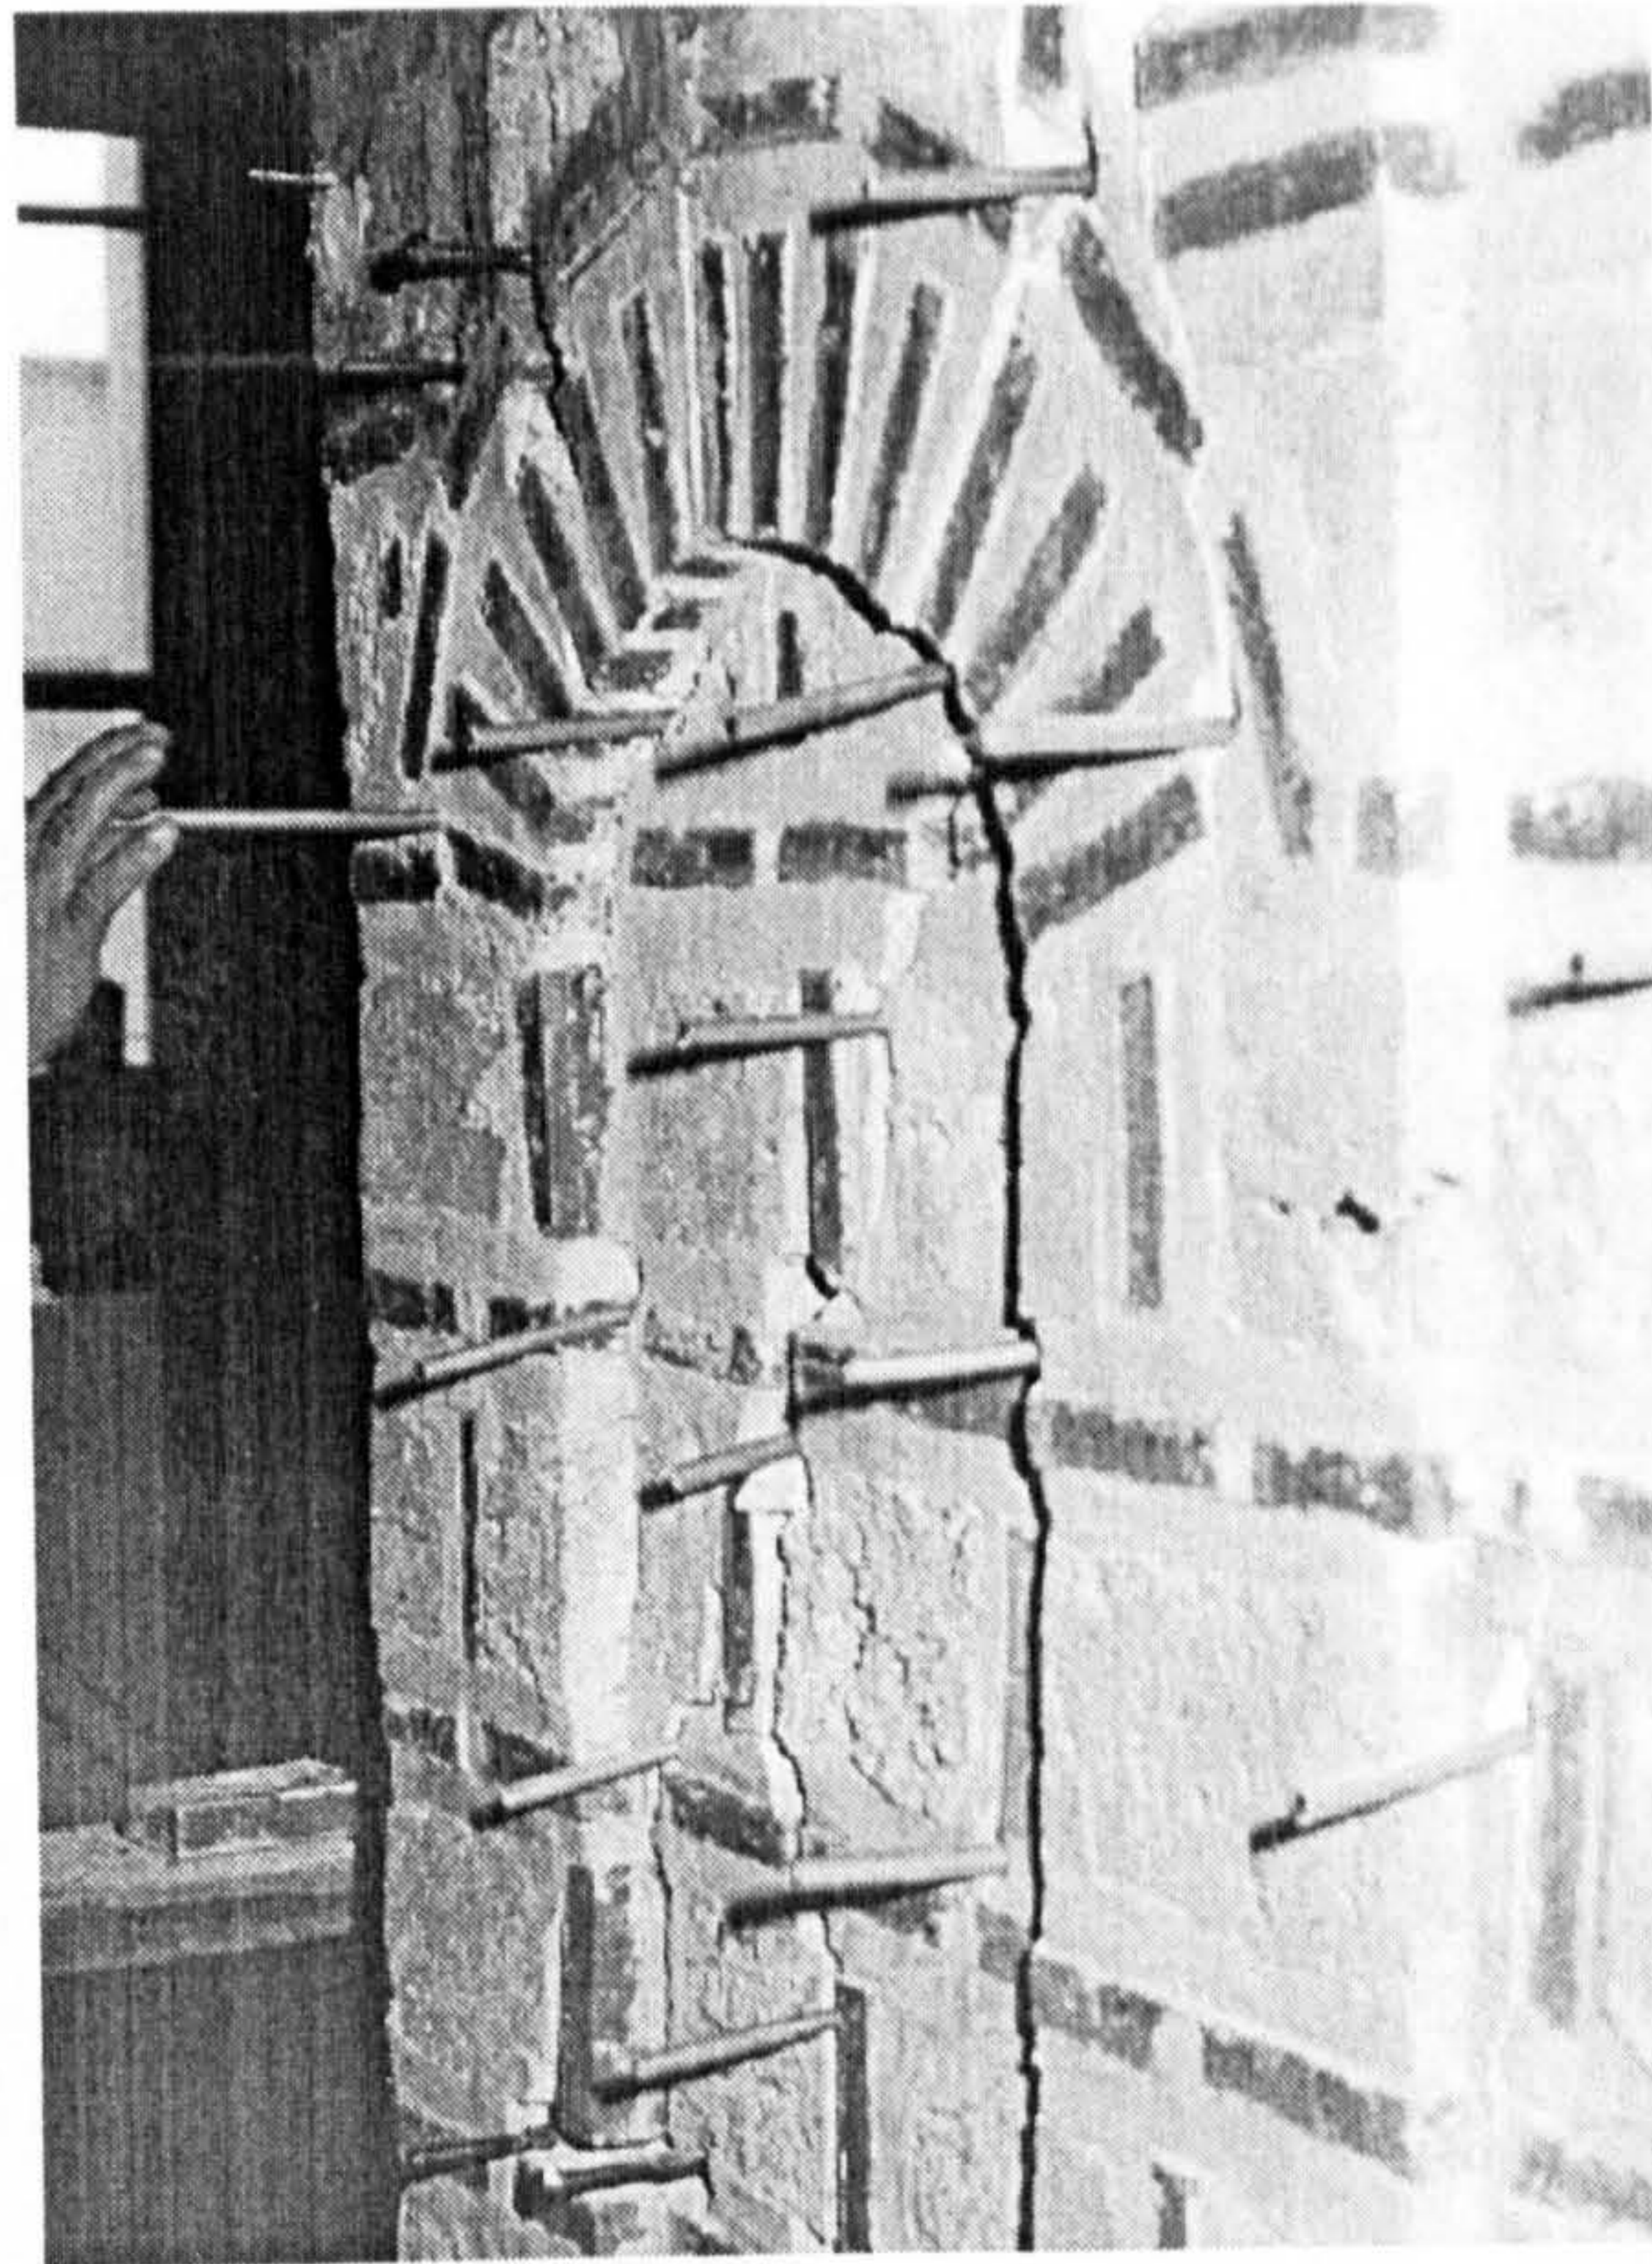
Figure 5.42 *Repair of damaged a) - wall sample (WAC 1) and b) - damaged model. Prepared for injection.*
